### INSPECTION REPORT

| <b>Type of inspection:</b> | CEI - Compliance Evaluation Inspection | |
| <b>Permittee Name:</b> | Republic Services | |
| <b>Permit and Application Number:</b> | ILR006145 | |

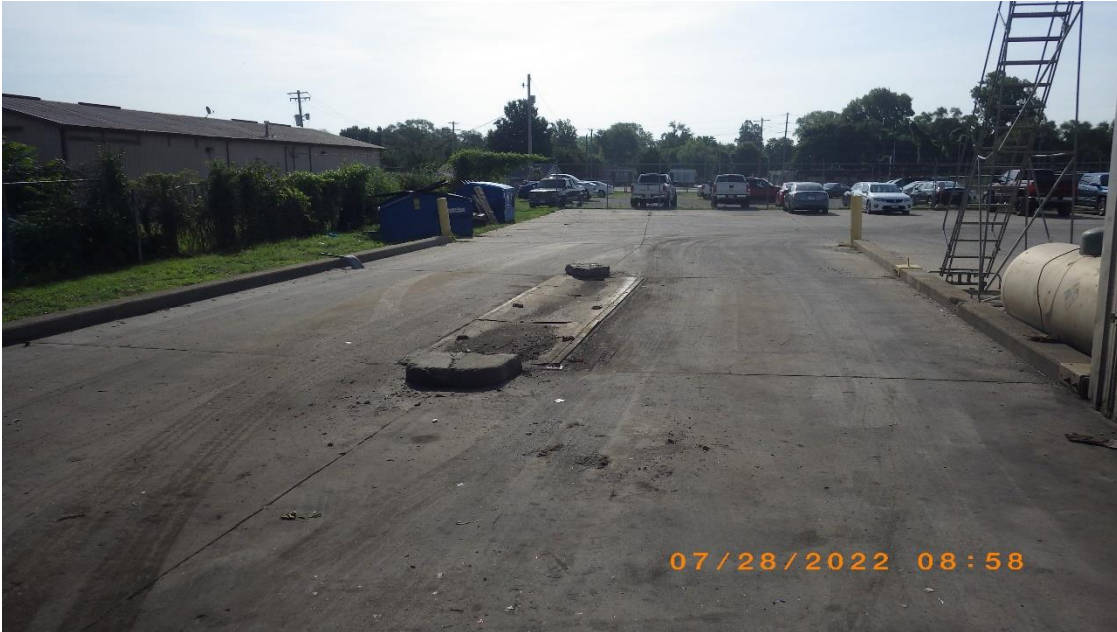
1: RIMG0070

The inspectors began in the truck washing area north of the fueling station. This area is not covered by a structure. The area has an oil-water separator where wash water drains to. Mr. Prentice stated that the oil-water separator is not connected to the sewer and is drained by a contractor when it is full. The April 2022 SWPPP states that the oil-water separator is comprised of two tanks with capacities of 500 and 2,500 gallons. According to Richard Moreno, maintenance supervisor, trucks are washed weekly on Saturdays using a pressure washer stored in the building between the truck washing area and the fueling area. Truck washing is performed by a contractor.

Description: Truck washing area. Oil-water separator located underground, covered by gray covers in center of photo.

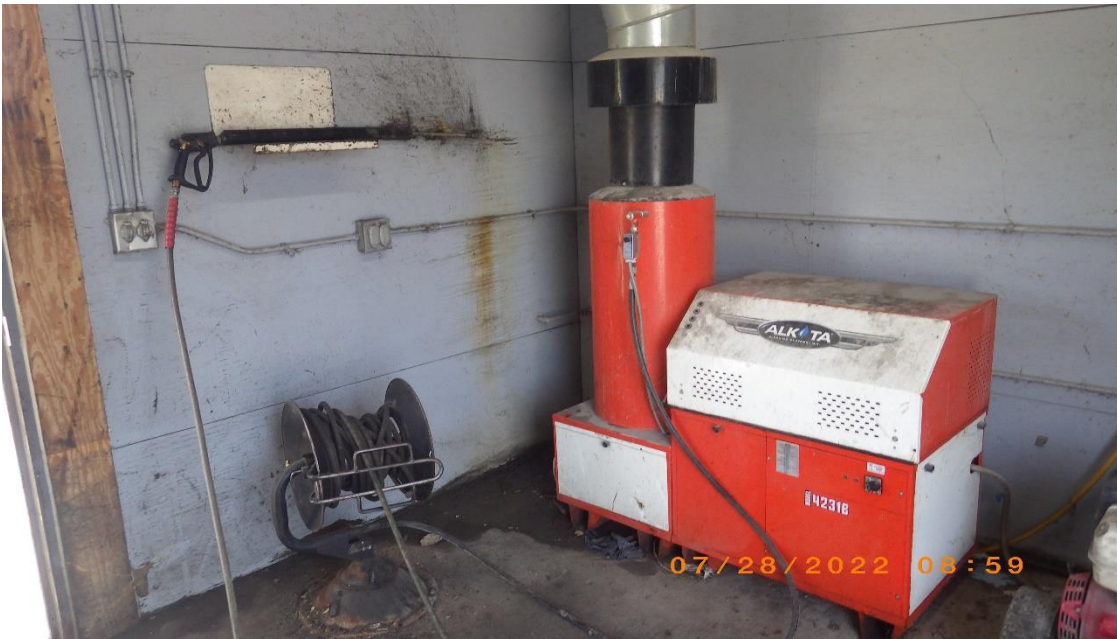
2: RIMG0071

Description: Pressure washer used for truck washing.

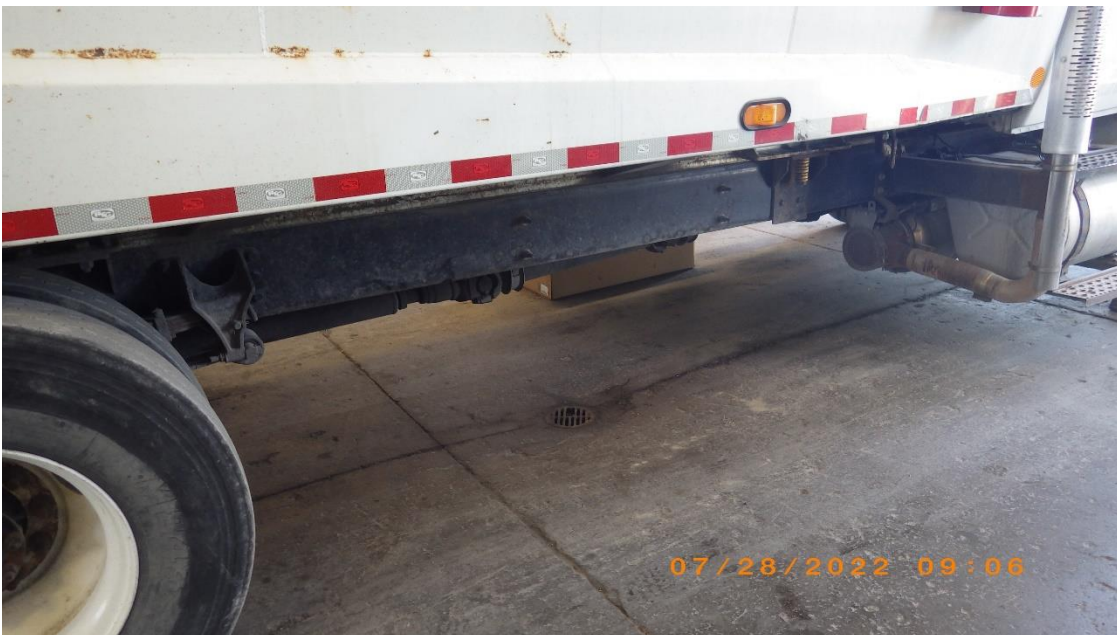
3: RIMG0072

Description: Floor drain in maintenance building. Drains to oil-water separator.

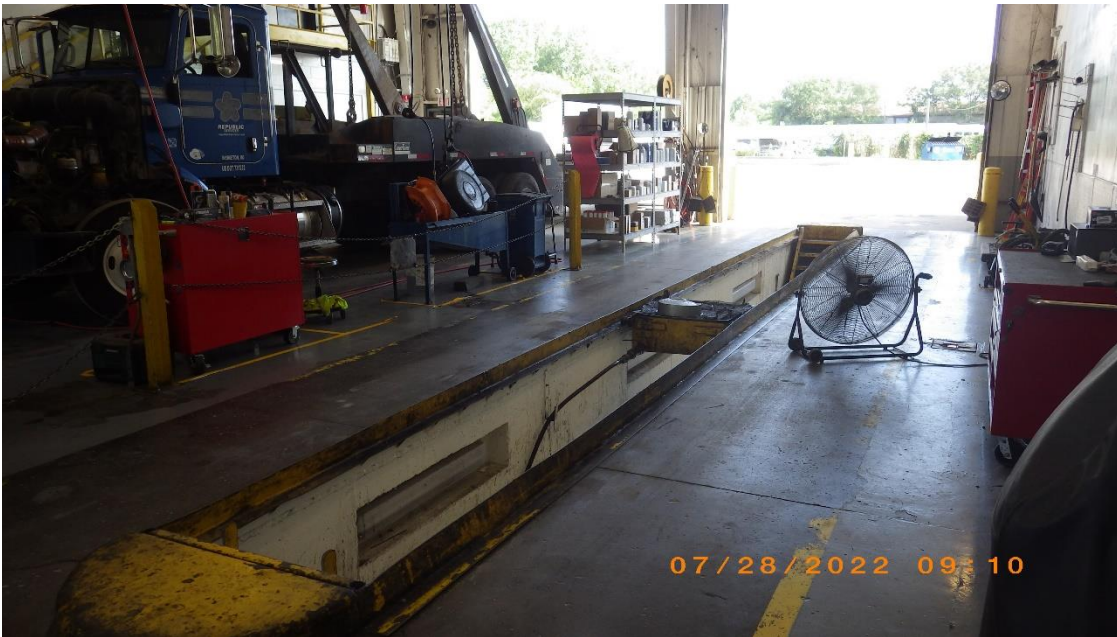
4: RIMG0073

Description: Engine fluid collection system and maintenance pit.

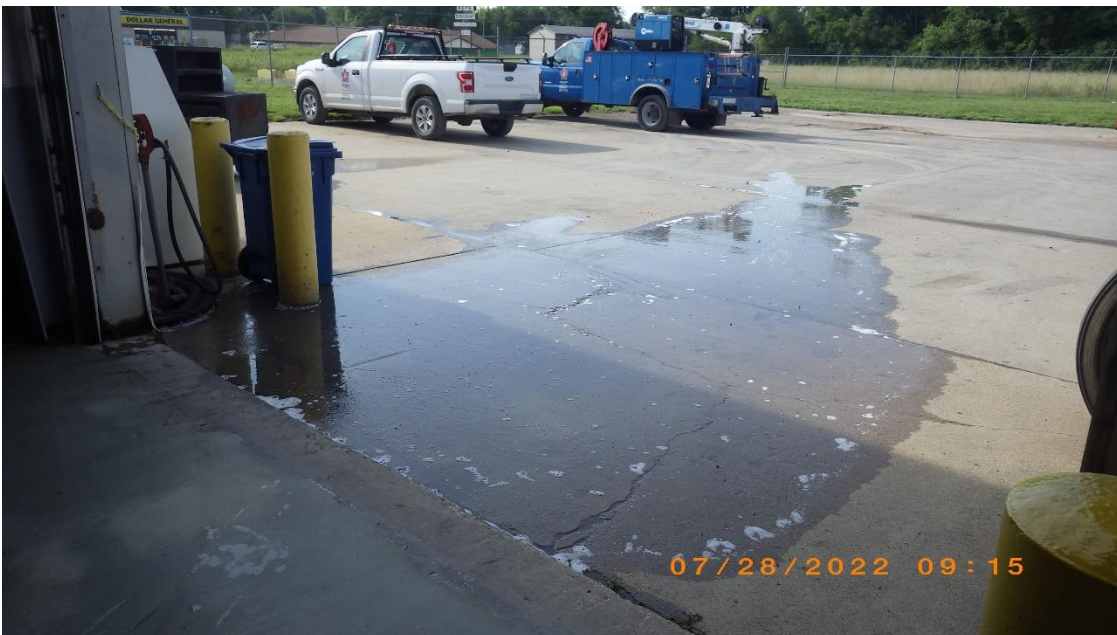
5: RIMG0074

| Unique Identifying No. | Observation | Area of Concern? |
|---|---|---|
| TF-OB-004 | A Facility employee disposed of oily mop water on the ground outside. | Yes |

| <b>Unique Identifying No.</b> | <b>Record</b> |
|---|---|
| <b>TF-OB-004</b> | A Facility employee disposed of oily mop water on the ground outside.<br><br><b>Permit ILR006145, Section H.1.a</b> |

Description: Facility employee dissipated of mop water outside.

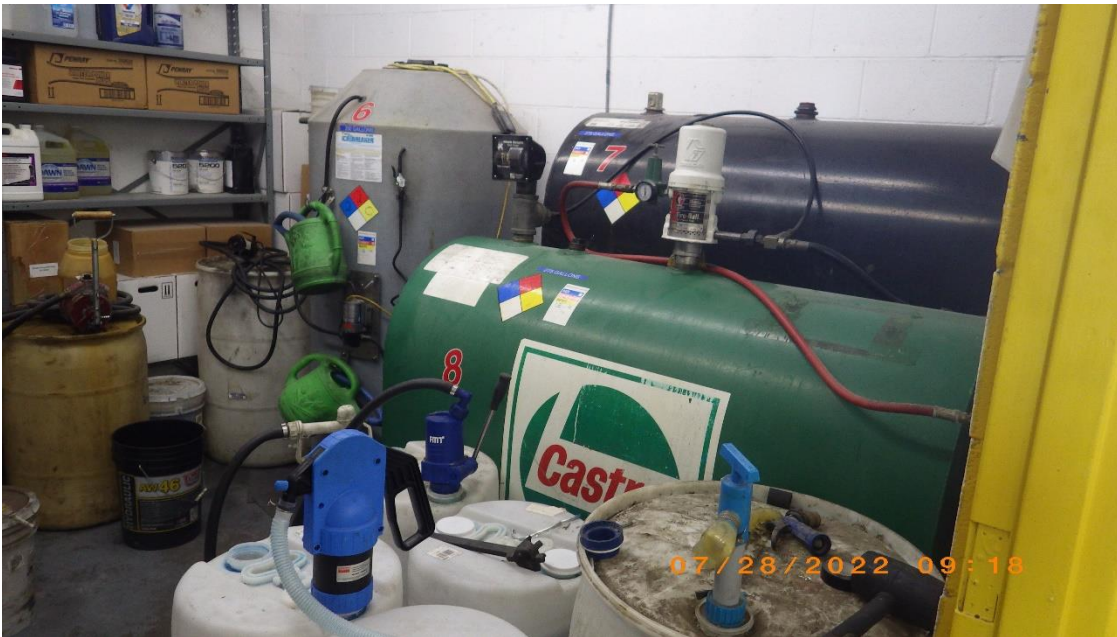
6: RIMG0075

Description: Overview of fluids storage area.

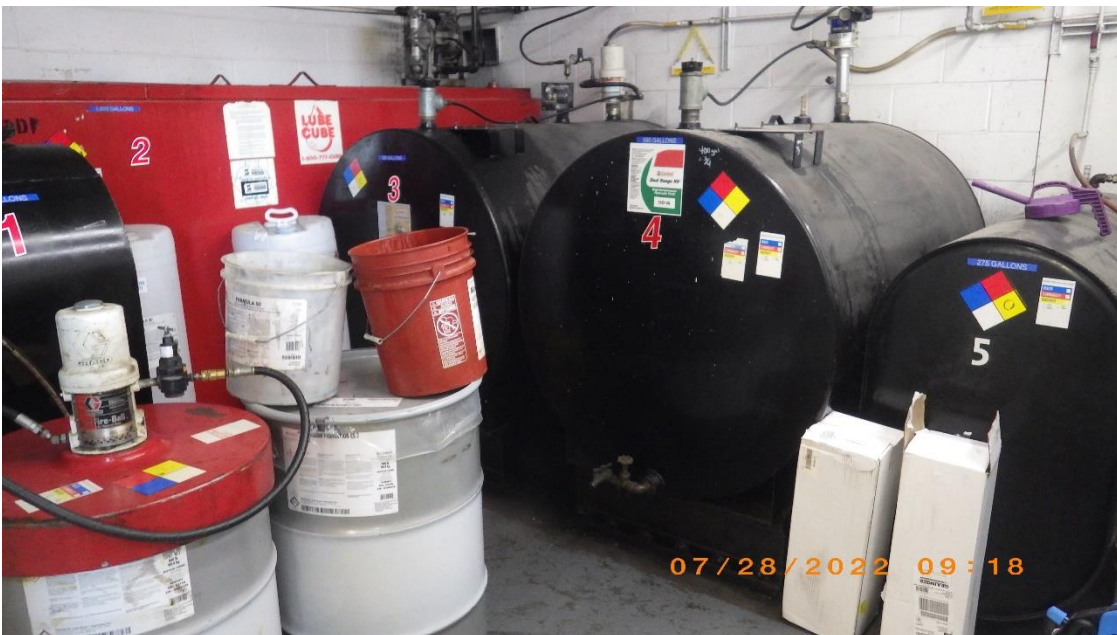
7: RIMG0076

Description: Overview of fluids storage area.

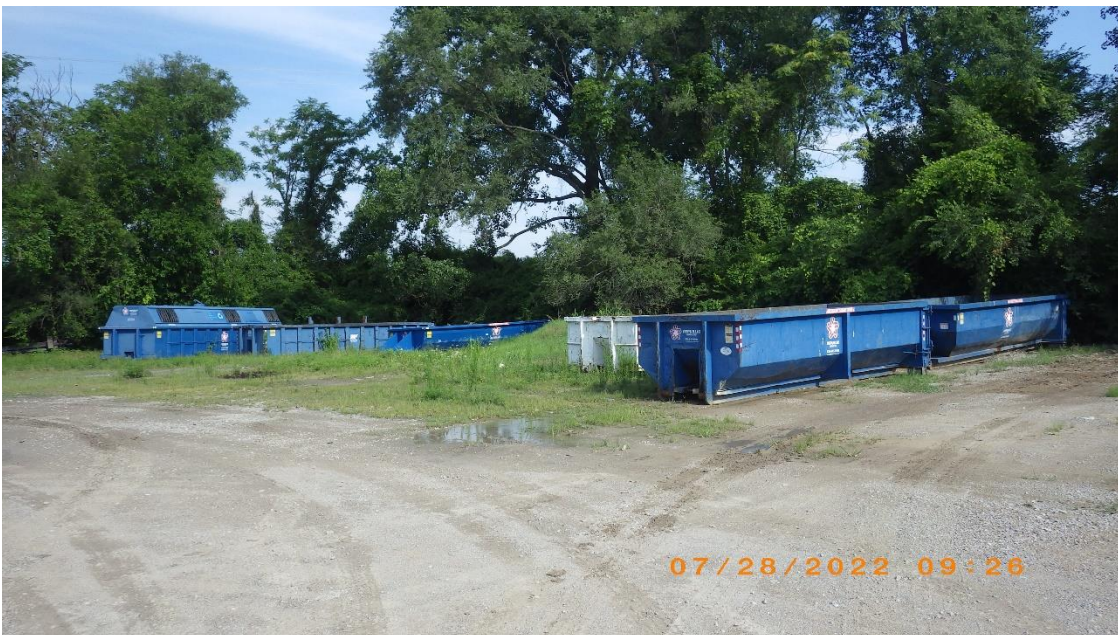
9: RIMG0078

| <b>TF-RR-012</b> | <p>The April 2022 SWPPP states that all trash containers stored outdoors shall be covered. Inspectors observed containers that were not covered.</p> <p><b>Permit ILR006145, Section E.9.a</b></p> |

Description: Roll off storage area. Note some containers are not covered.

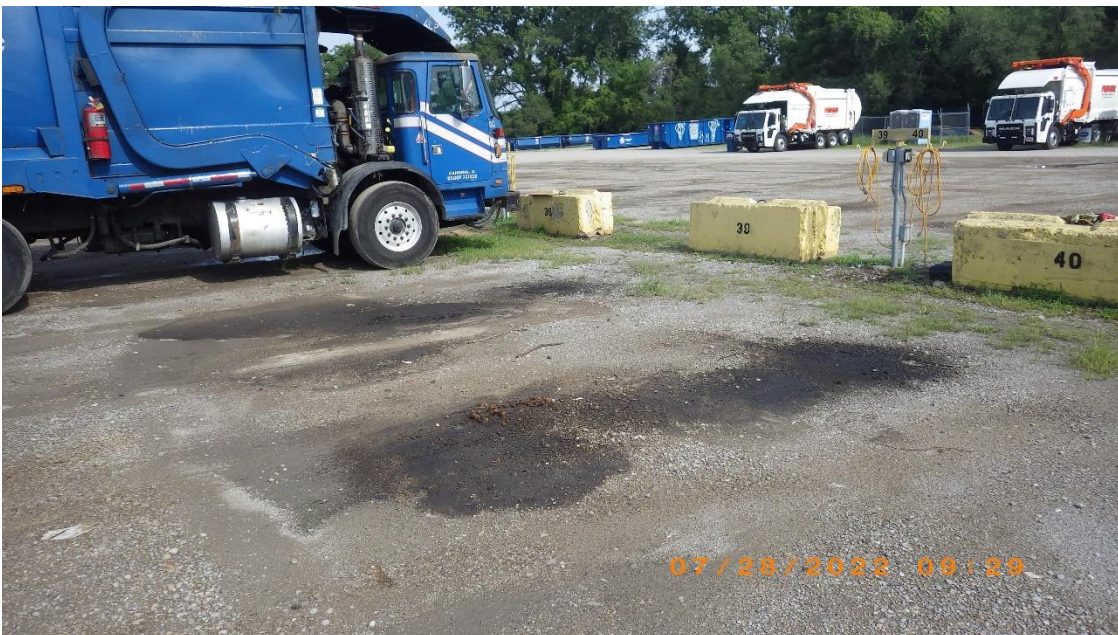
11: RIMG0080

| Unique Identifying No. | Observation | Area of Concern? |
|---|---|---|
| TF-OB-003 | There was stained soil in the truck parking area. | Yes |

| <b>Unique Identifying No.</b> | <b>Record</b> |
|---|---|
| <b>TF-OB-003</b> | There was soil contamination in the truck parking area.<br><br><b>Permit ILR006145, Section H.1.a</b> |

| <b>TF-RR-011</b> | <p>Inspectors observed soil staining in the truck parking area. There was no documentation in the SWPPP regarding a corrective action to clean up stained soil and to prevent future contamination.</p> <p><b>Permit ILR006145, Section H.1.a</b></p> |

Description: Soil staining.
