## MULTI-SECTOR GENERAL PERMIT NON-FILER INSPECTION CHECKLIST

| <b>Inspection Date(s):</b> | 2/7/2023 | |
| <b>Operator Name:</b> | Dutchland, Inc. | |

Stormwater Inspection Date: February 7, 2023

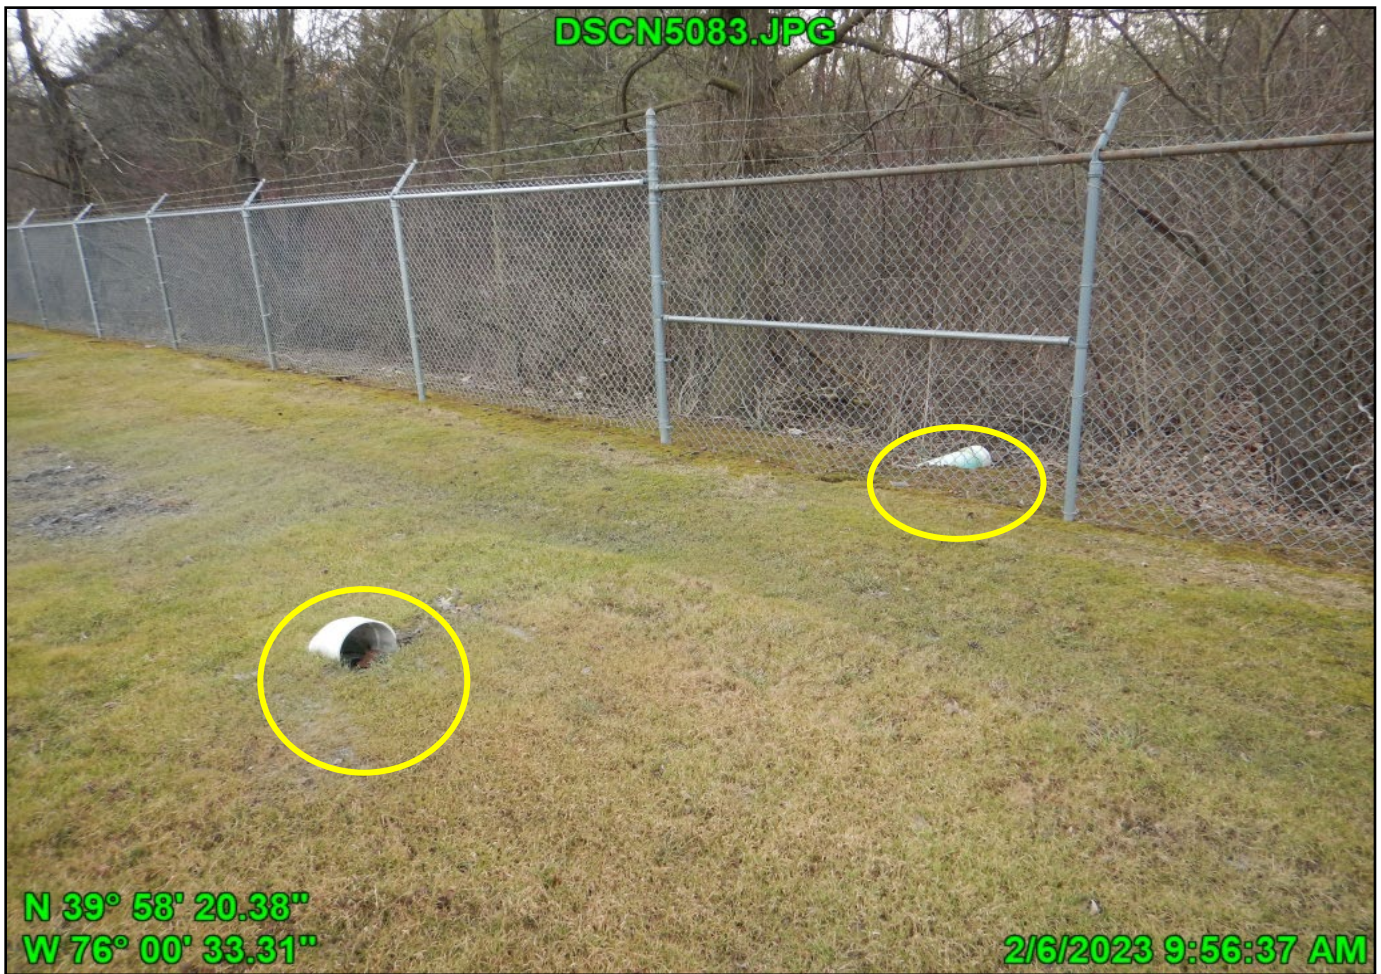
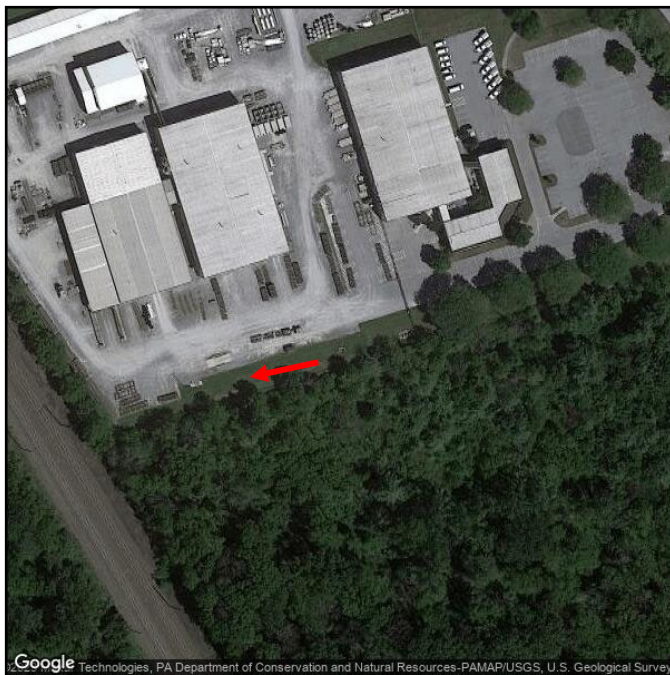
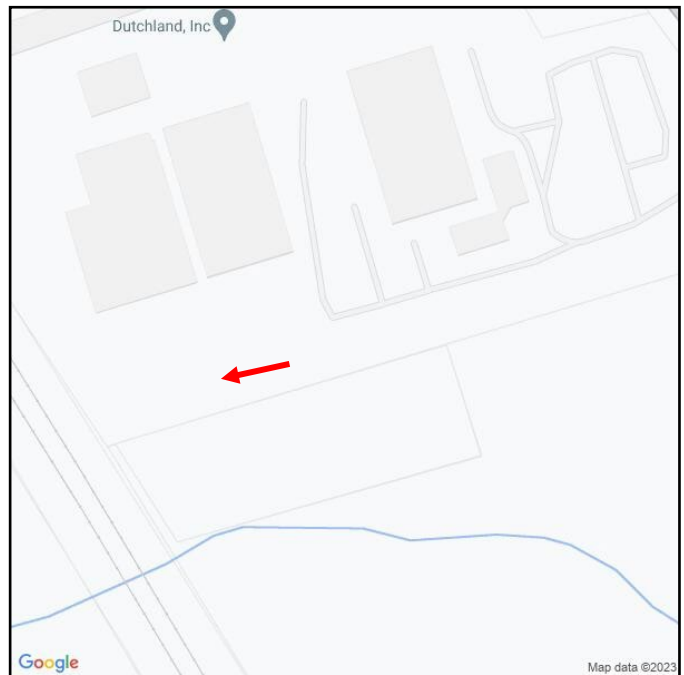
| Description | Two (2) additional PCV pipes that convey stormwater from the adjacent catch basins that convey stormwater from areas with loading/unloading activities and materials storage. One pipe conveys stormwater directly into the observed drainage swale. The other conveys stormwater into the adjacent woods. |

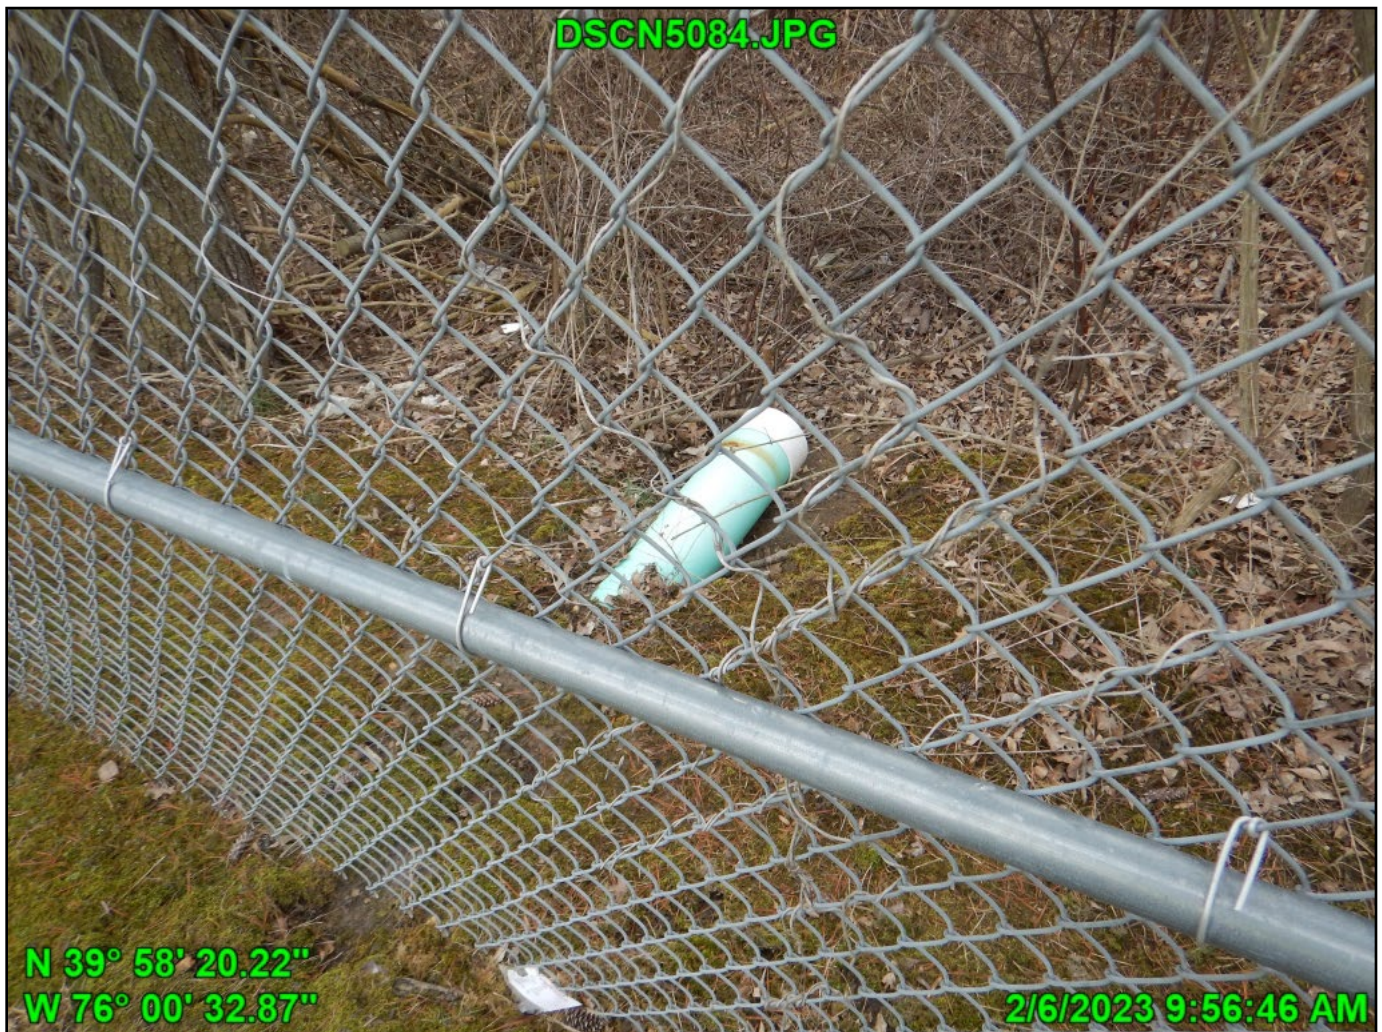
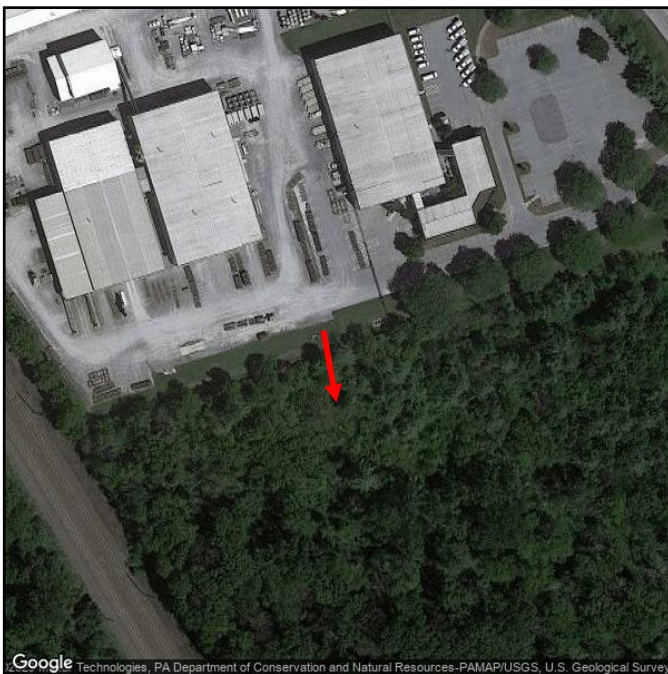
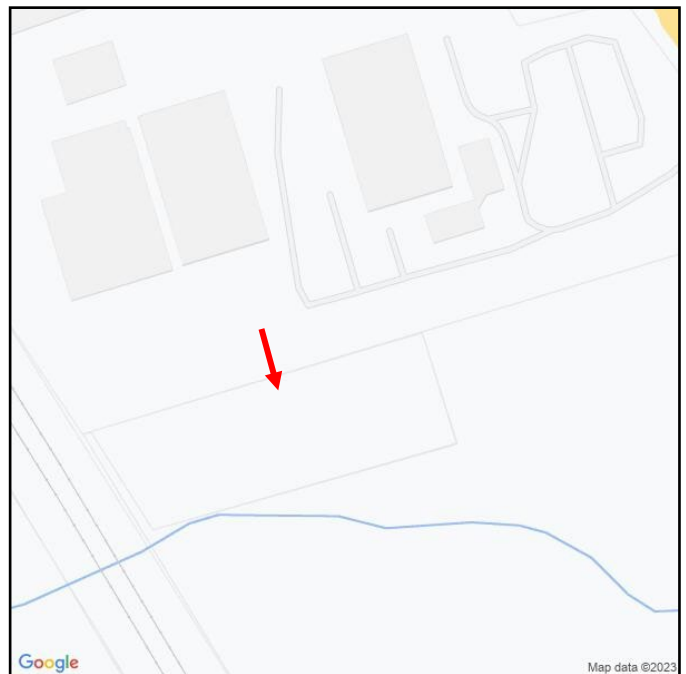
| Description | Closer view of the outlet pipe as shown in Photograph DSCN5083. |

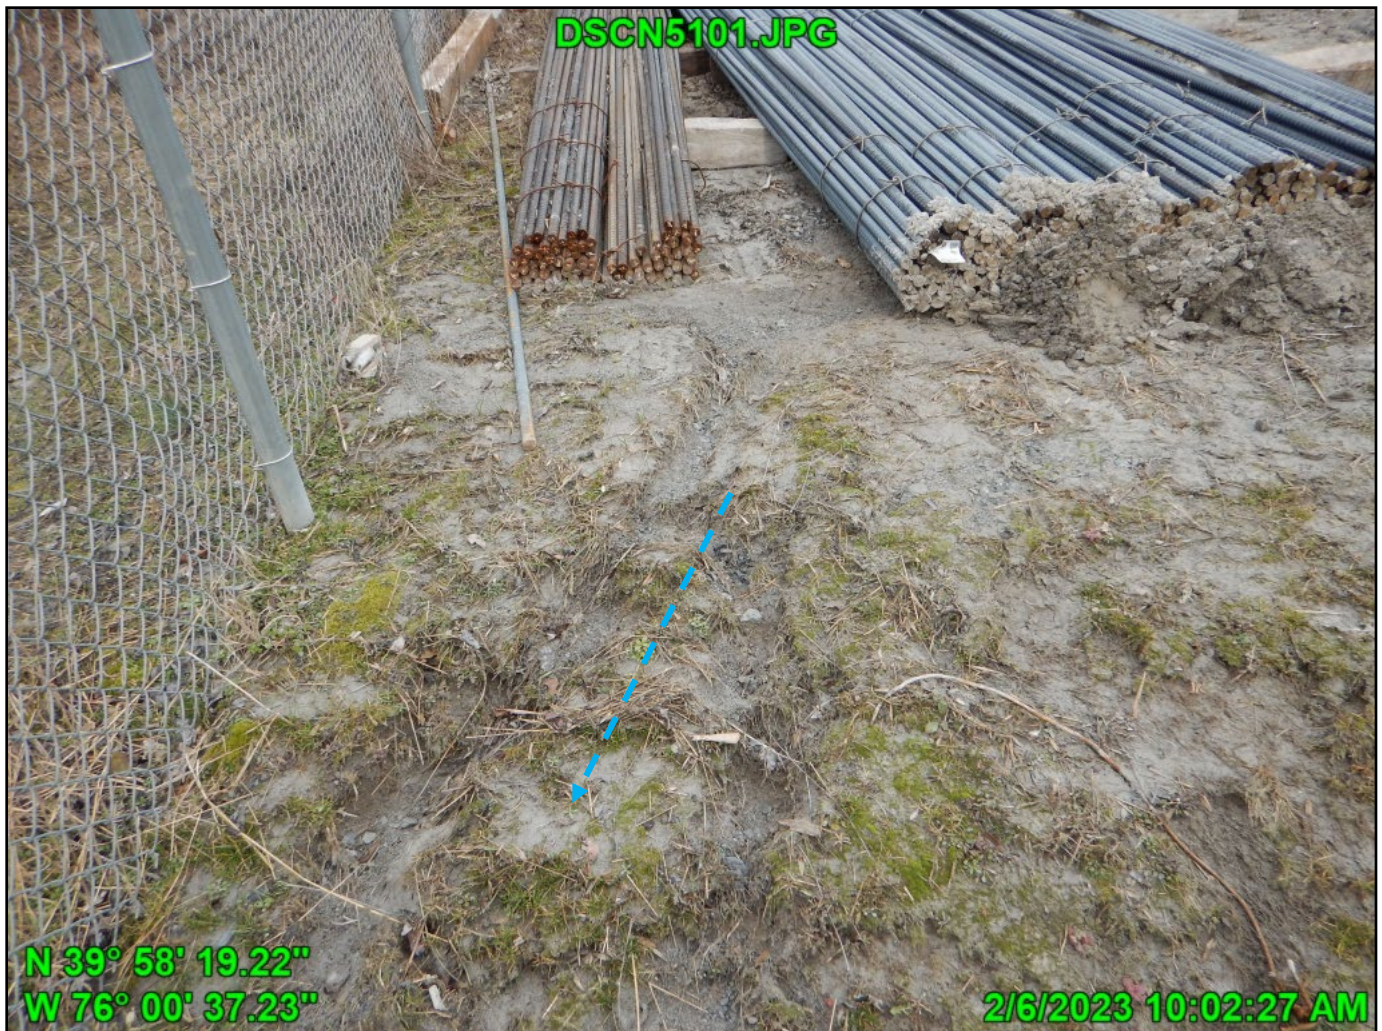
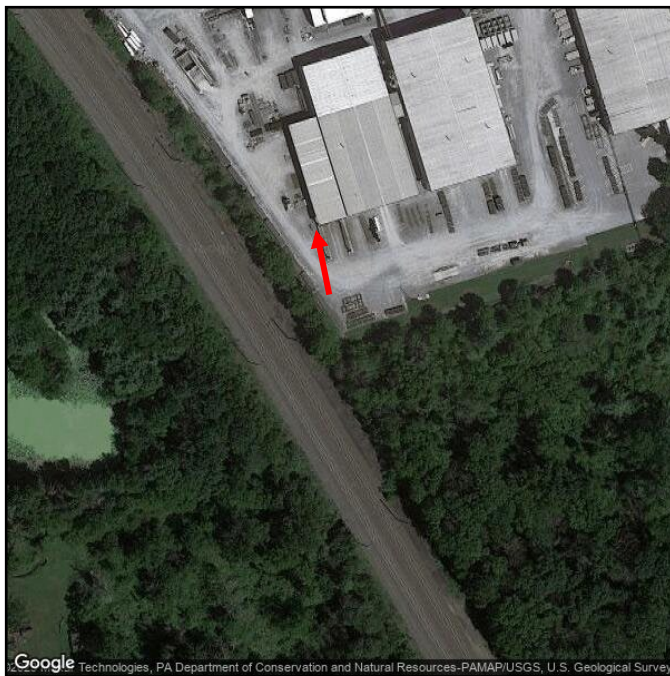
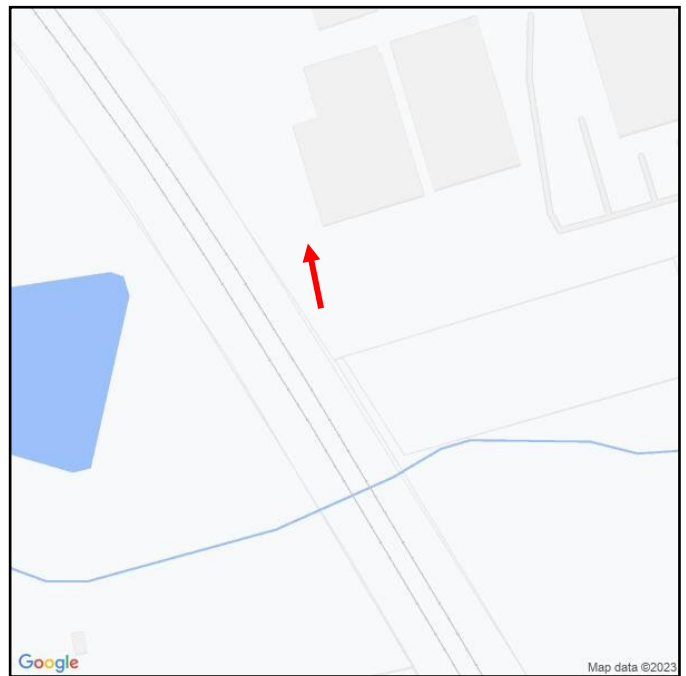
| Description | View of the estimated flow path towards the Facility's southwest corner. Rill erosion was observed in this area. |

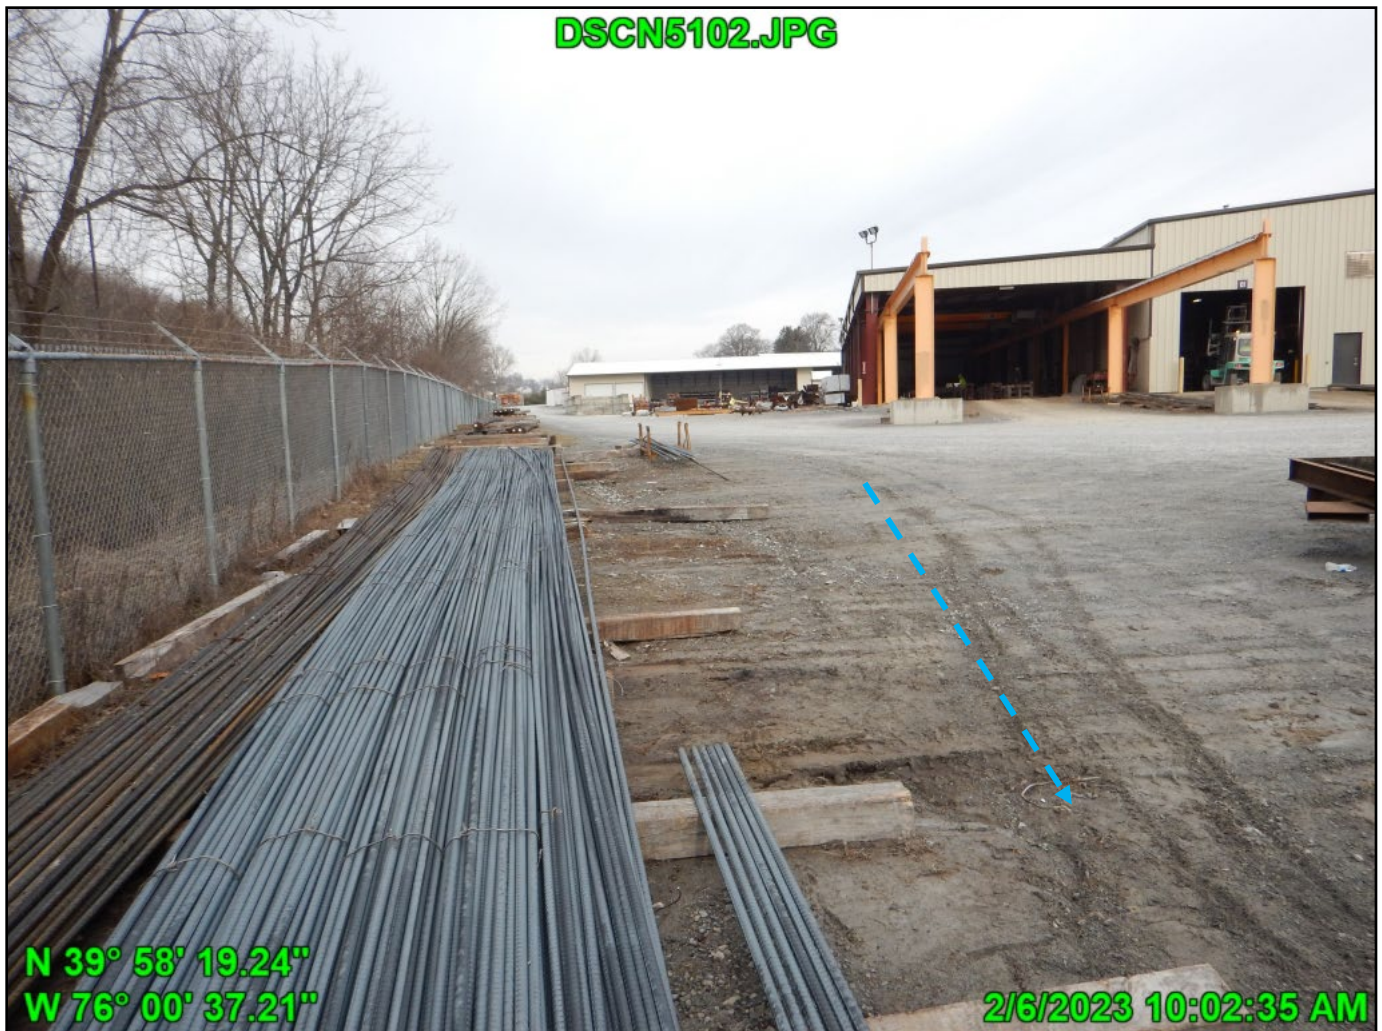
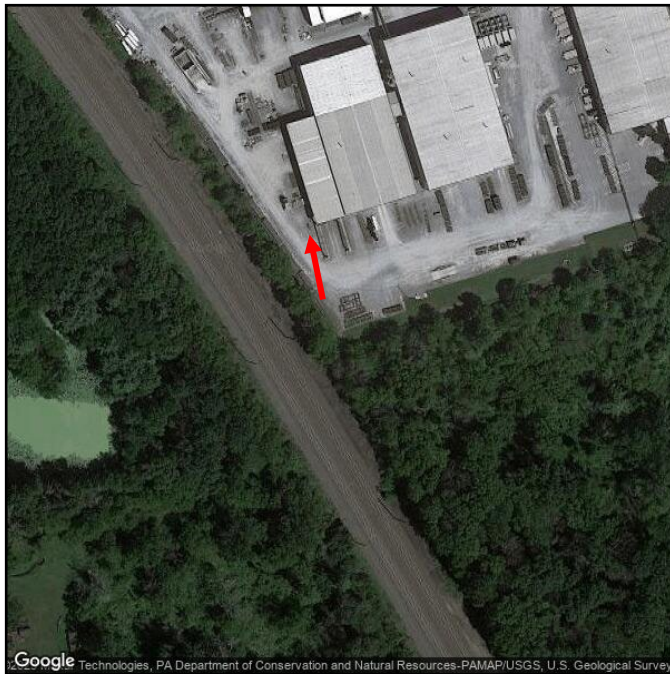
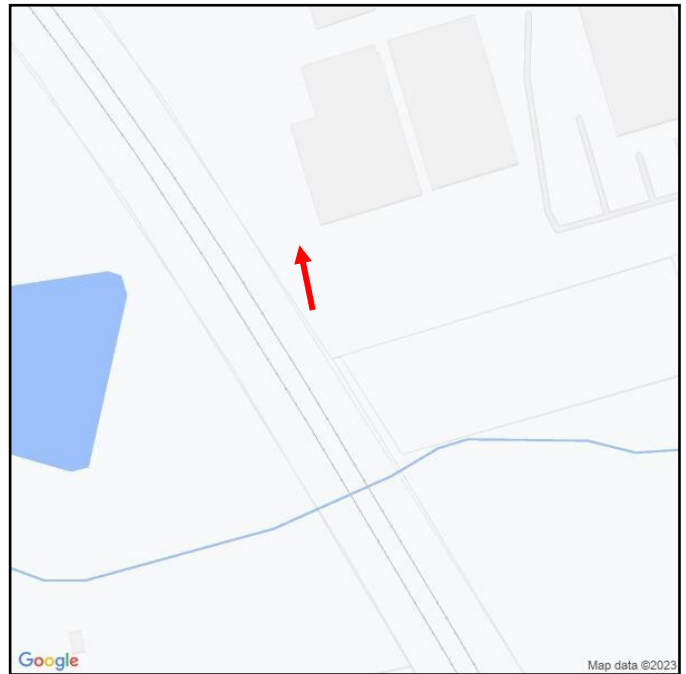
| Description | Upgradient view of materials stored outdoors in the southwest corner of the Facility. Note the estimated stormwater flow path. |

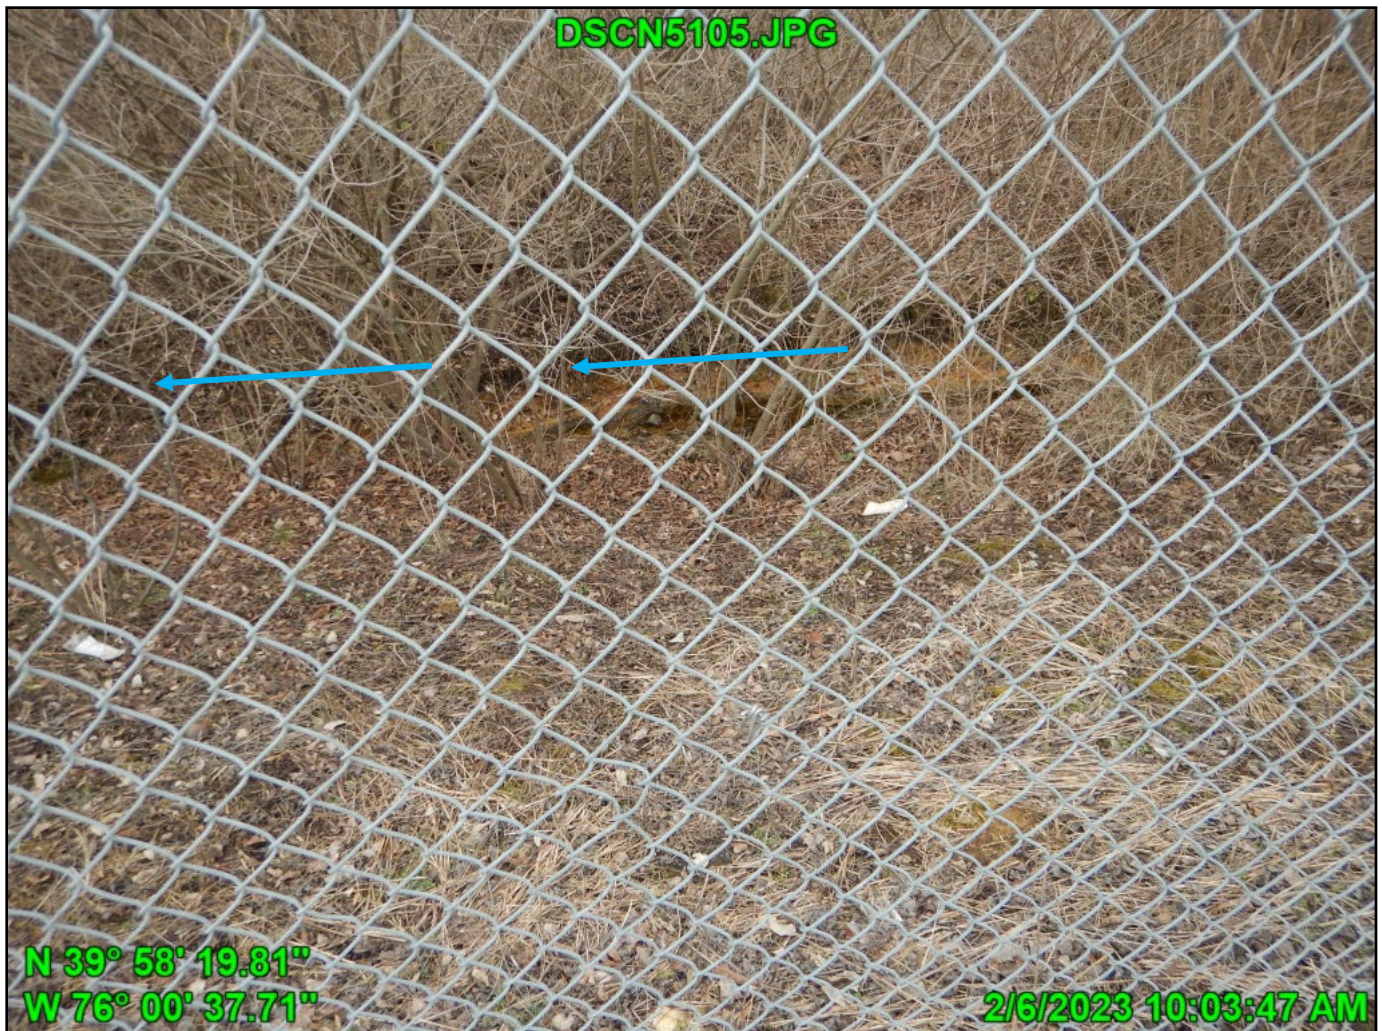
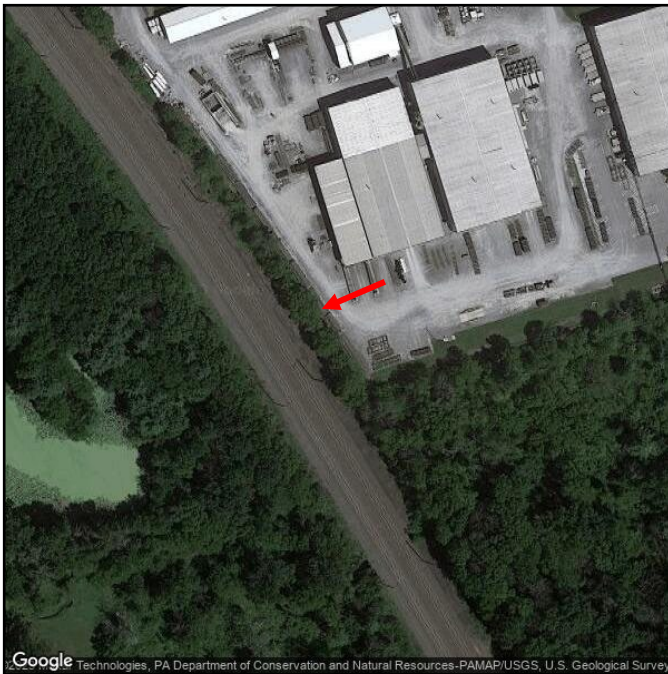
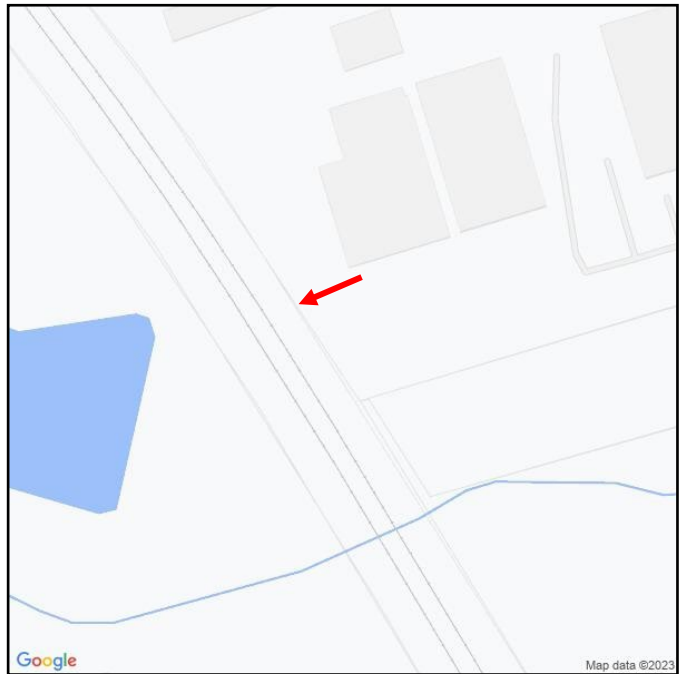
| Description | View of the observed drainage ditch, adjacent to the Facility along the west boundary. |

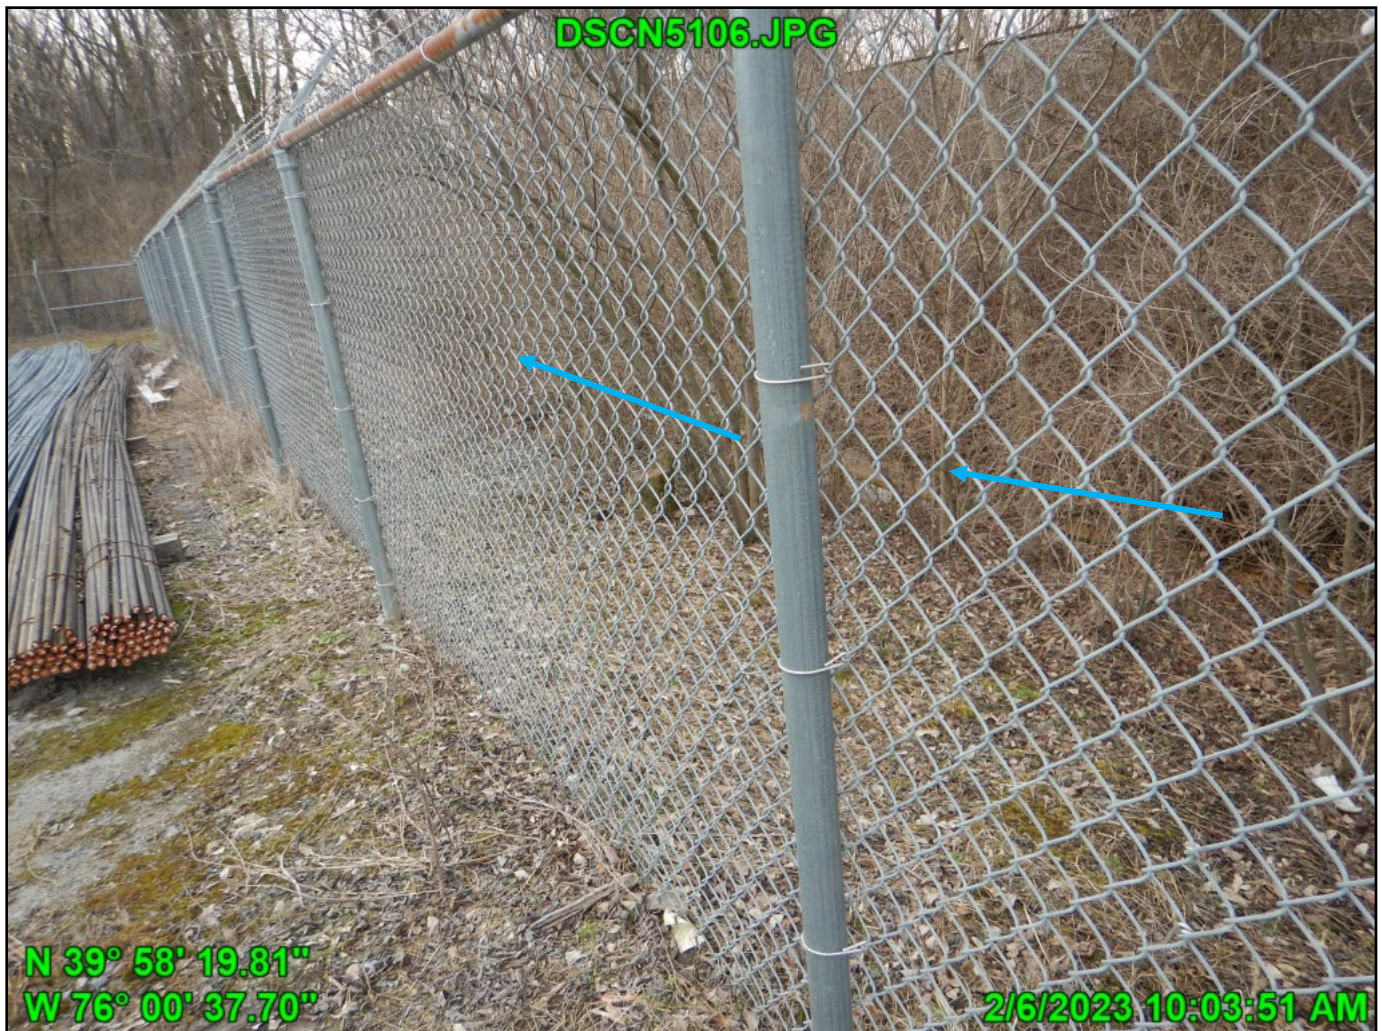
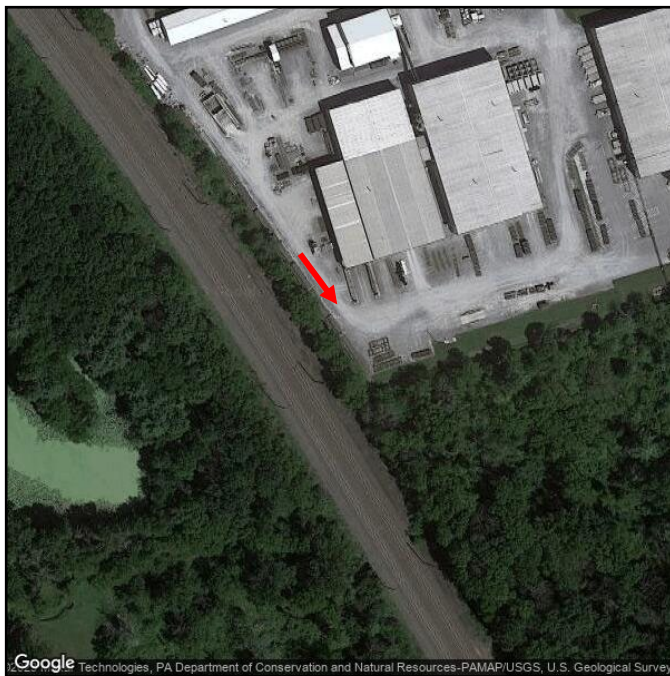
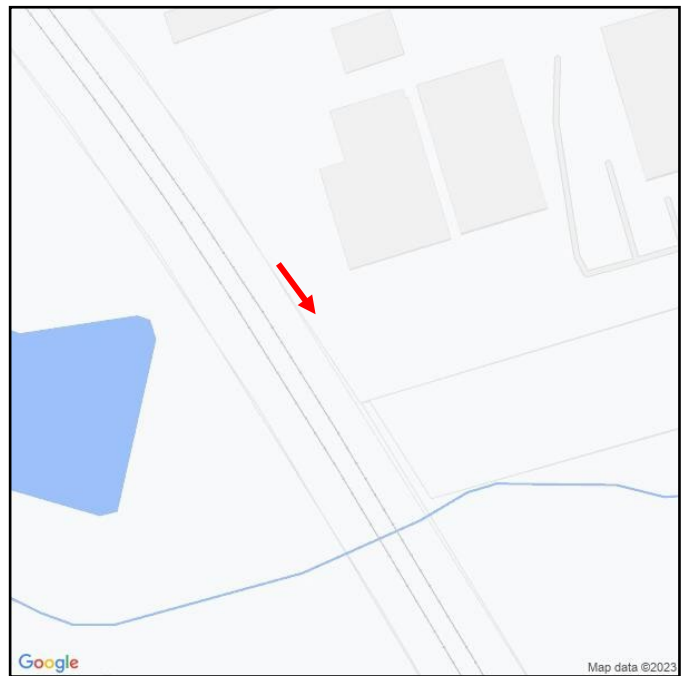
| Description | View of the Facility's west boundary fence line. Note the drainage ditch offsite to the west. |

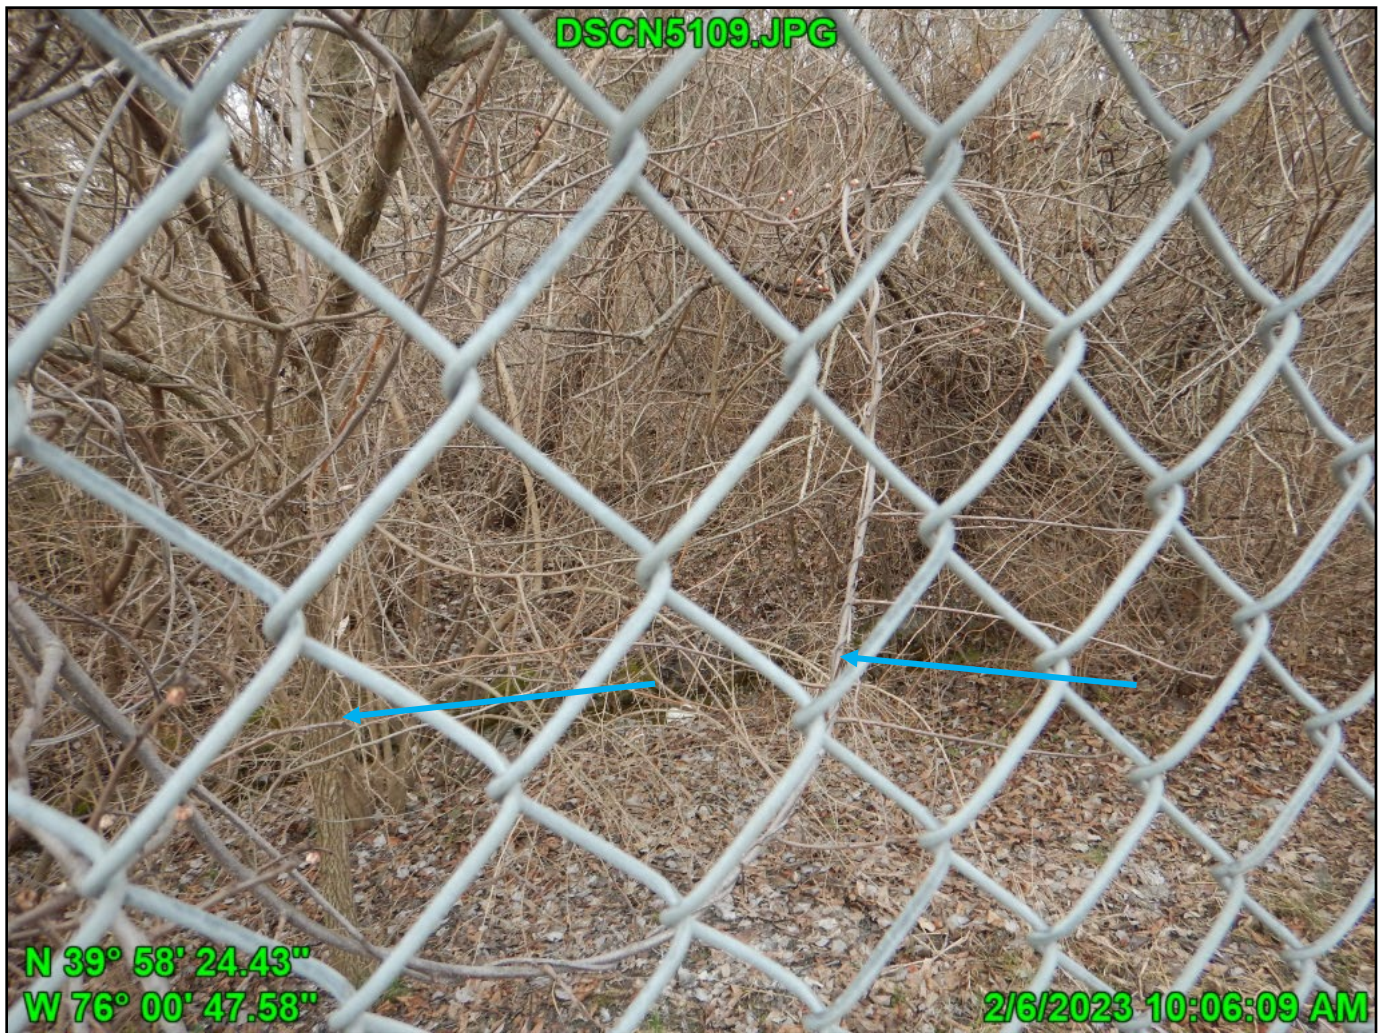
| Description | Drainage ditch adjacent to the Facility's west boundary fence line. |

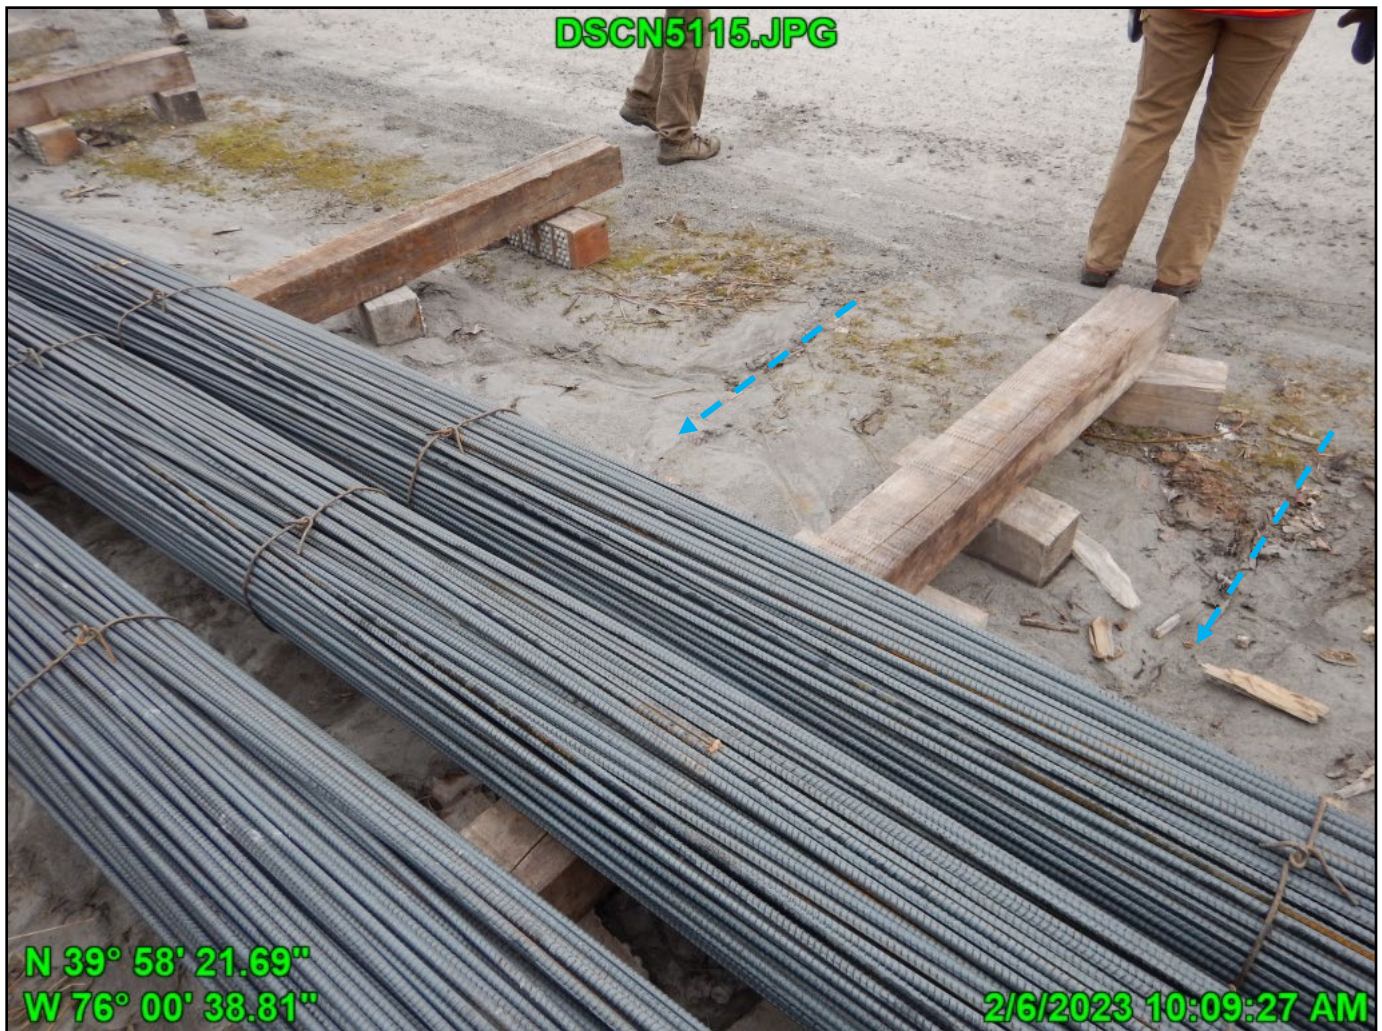
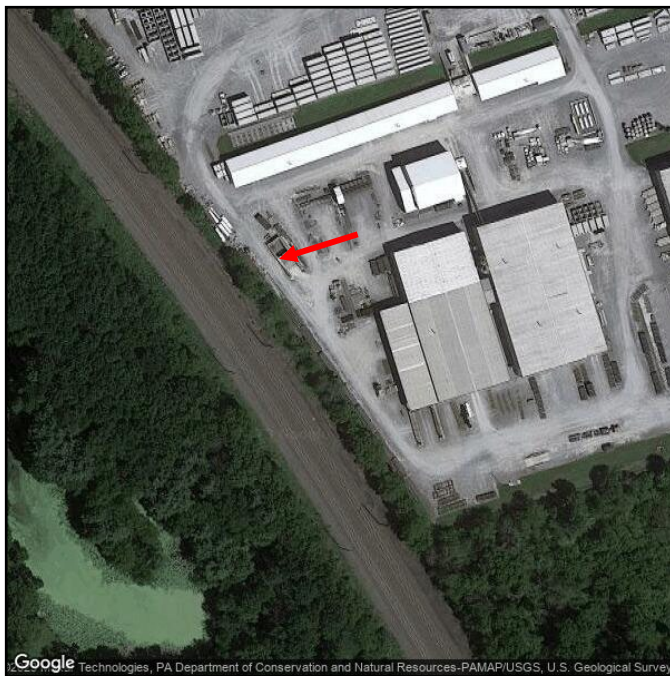
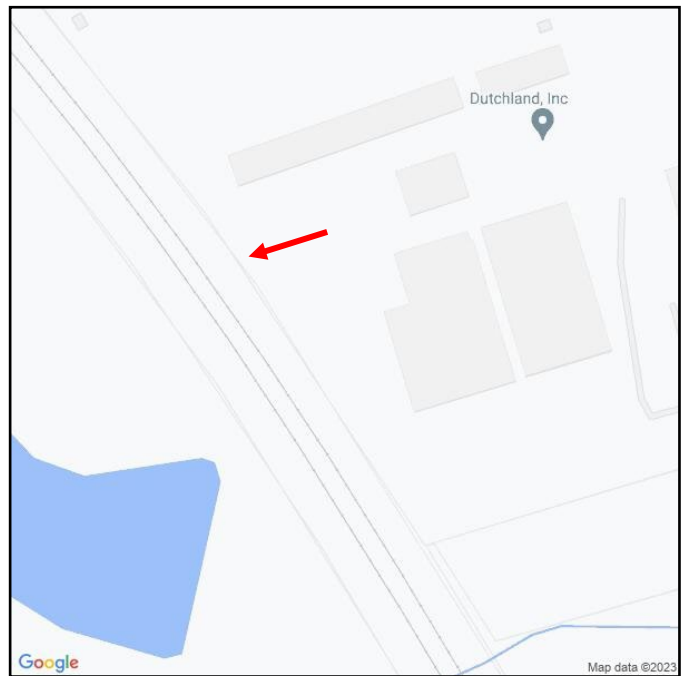
| Description | Observed estimated stormwater flow path from the outdoor materials storage towards the west boundary fence line and drainage ditch. |

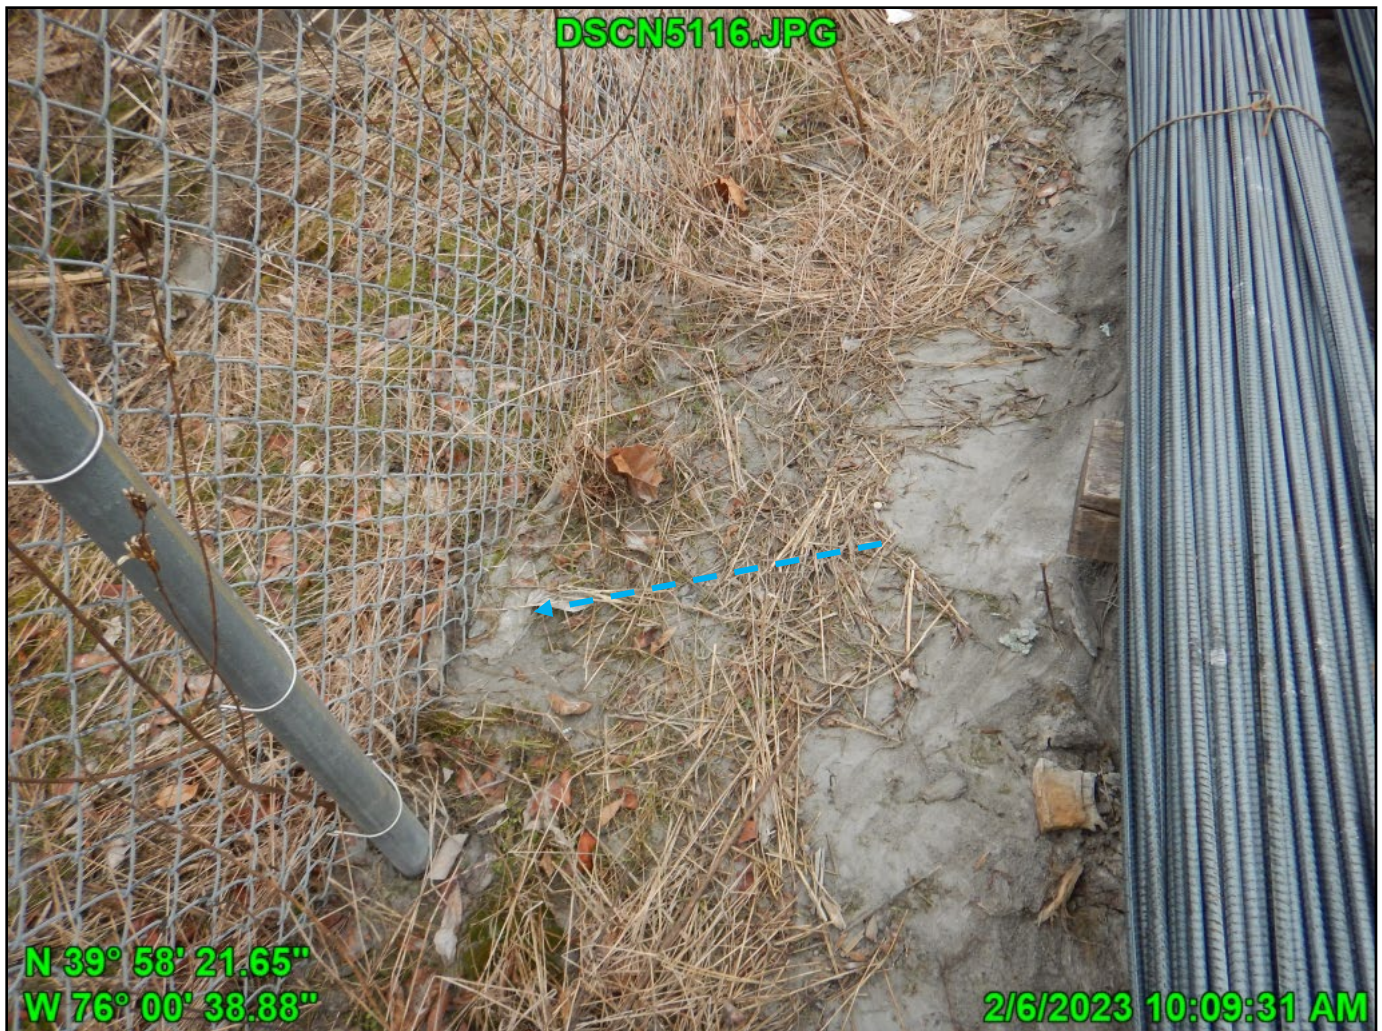
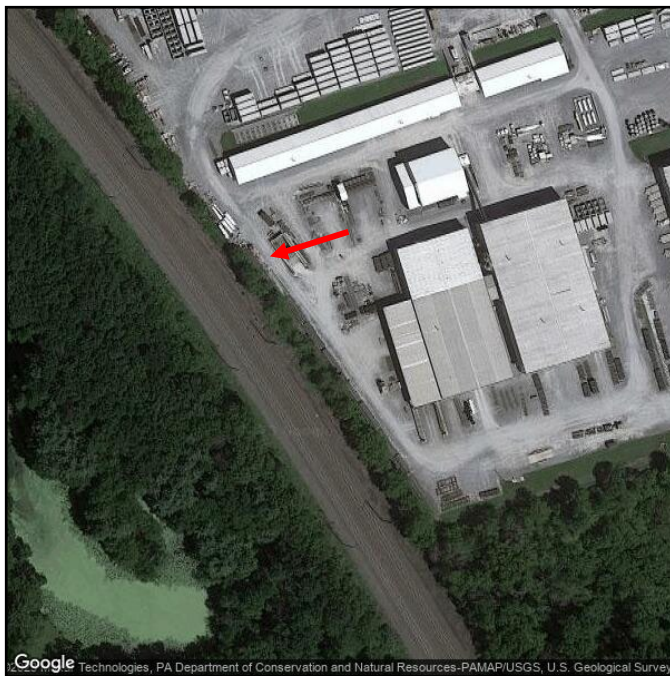
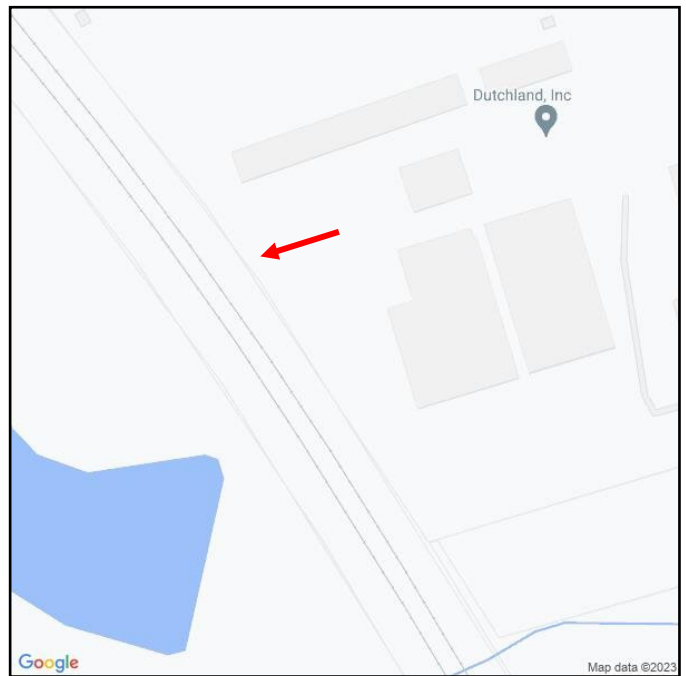
Estimated stormwater flow path from the outdoor materials storage are shown in Photograph DSCN5115 towards the west boundary fence line and drainage ditch. Materials stored outdoors in this area were on blocks to minimize contact with surface runoff.

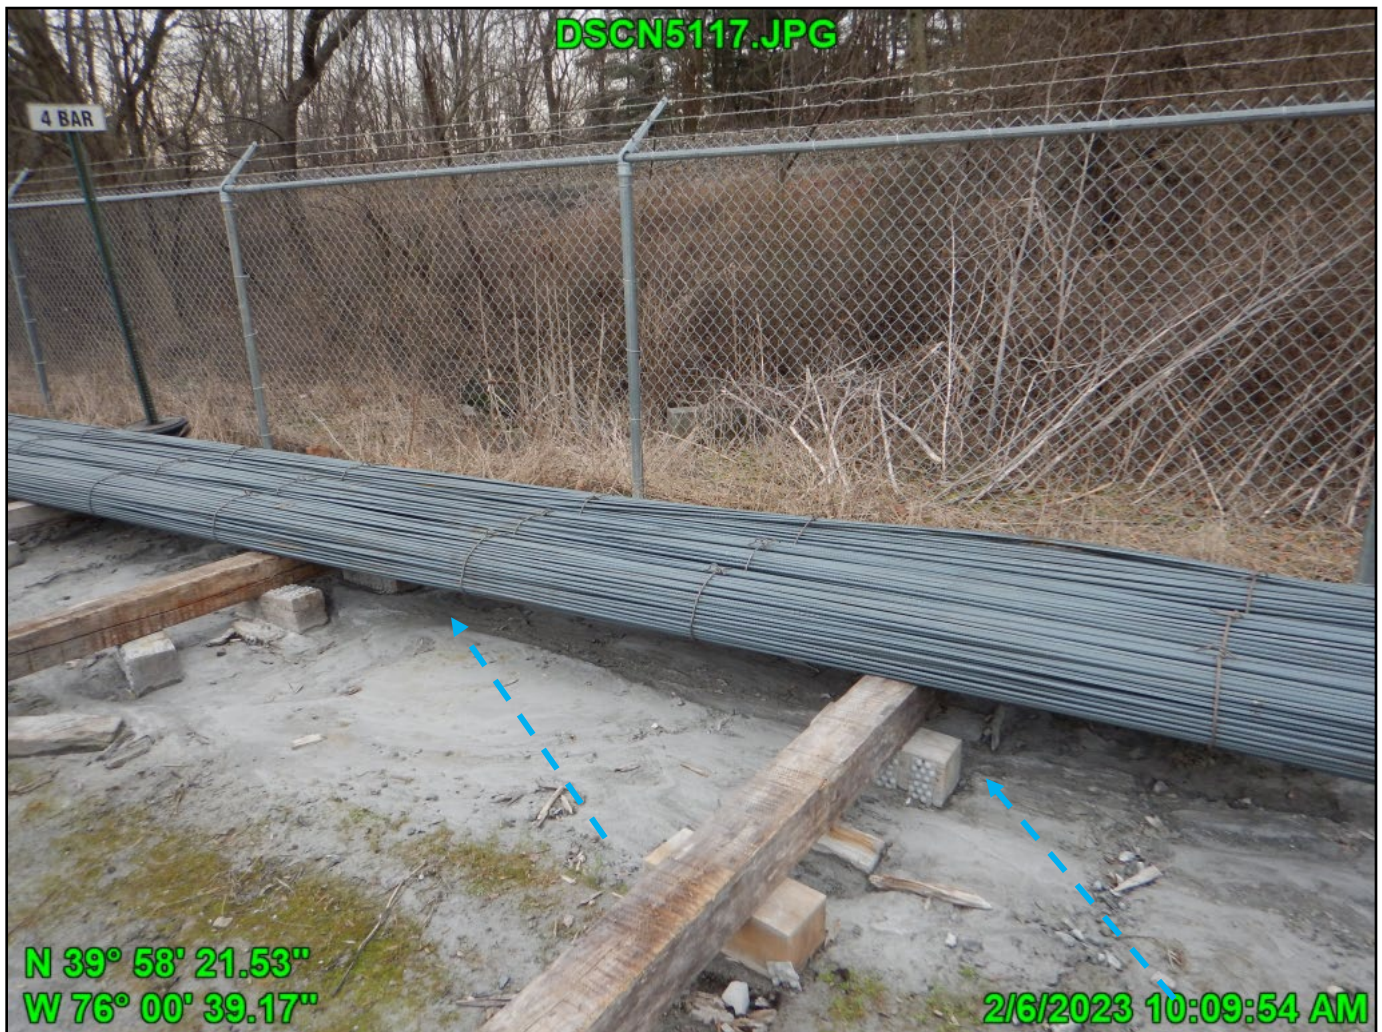
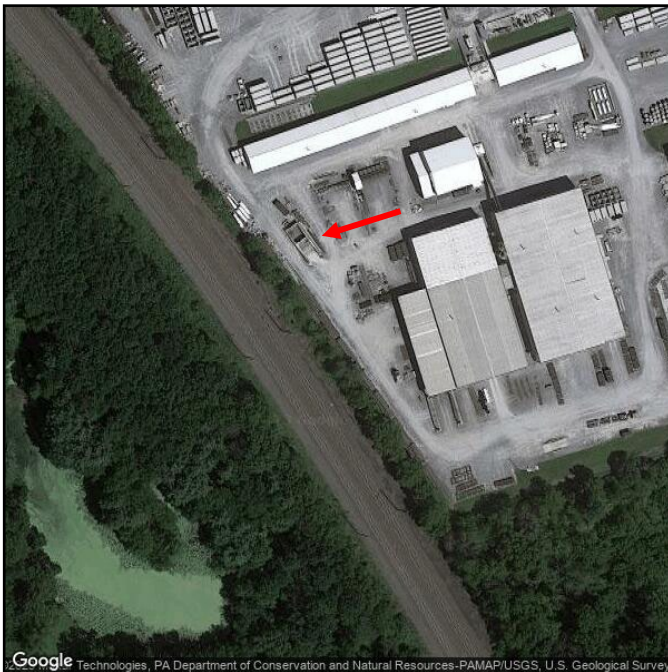
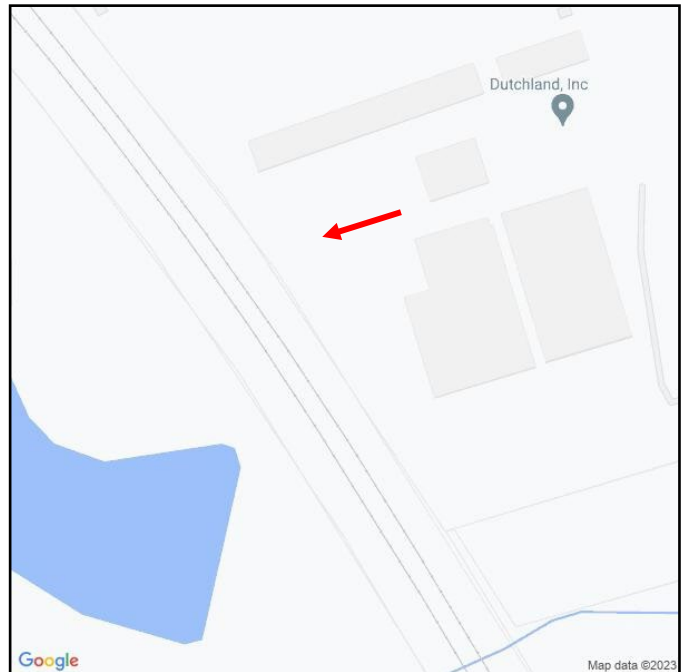
| Description | Observed estimated stormwater flow path from the outdoor materials storage towards the Facility's west boundary fence line and drainage ditch. |
