## MULTI-SECTOR GENERAL PERMIT NON-FILER INSPECTION CHECKLIST

| <b>Inspection Date(s):</b> | 2/7/2023 | |
| <b>Operator Name:</b> | Dutchland, Inc. | |

Stormwater Inspection Date: February 7, 2023

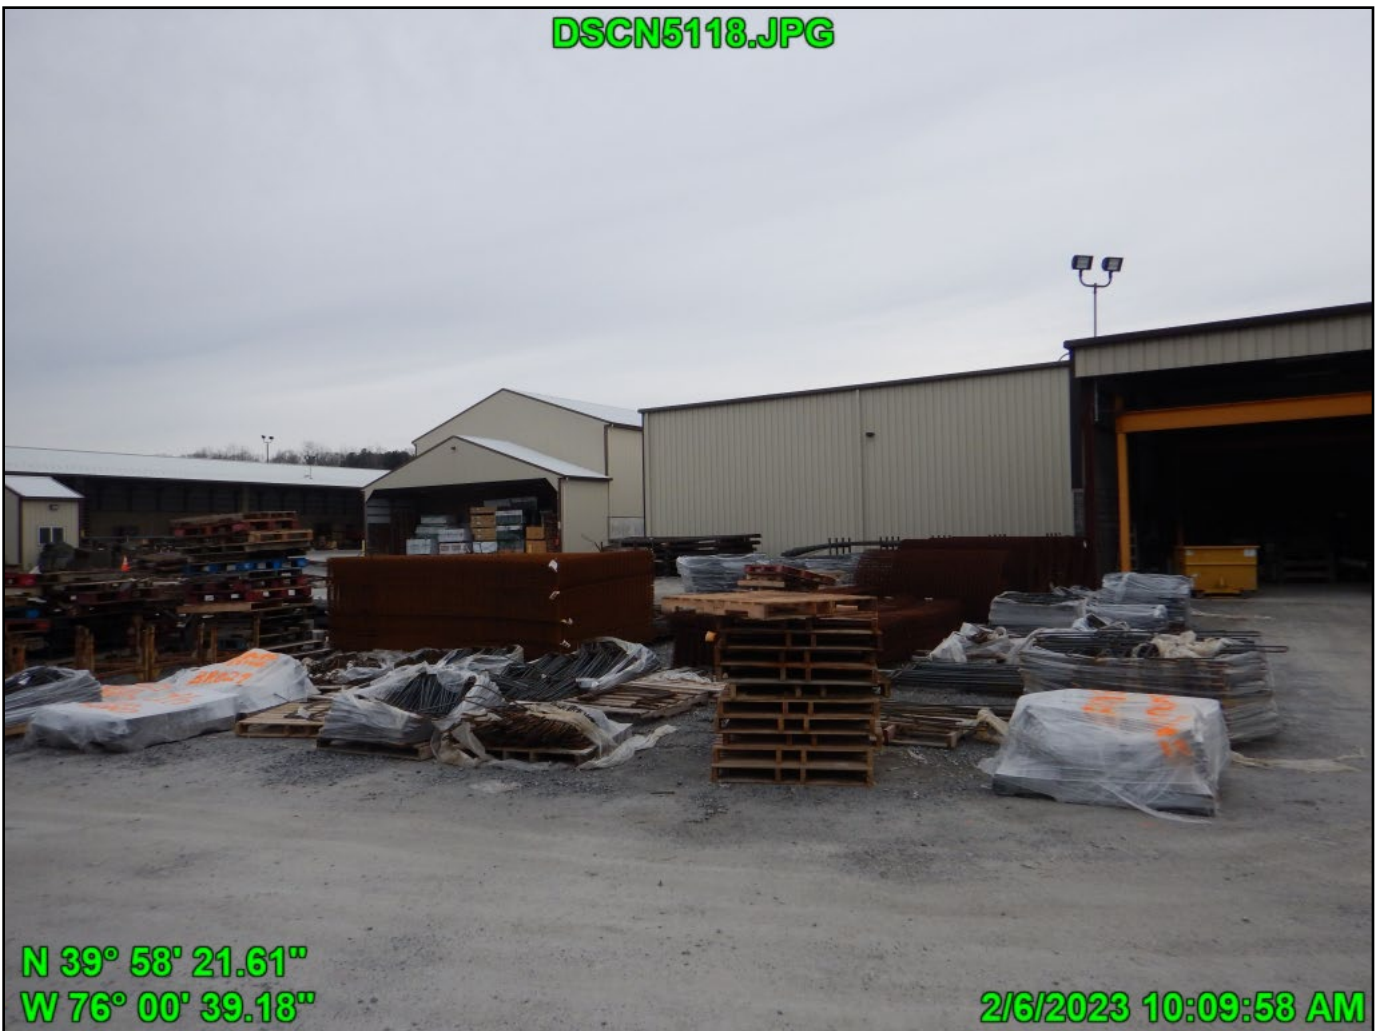
DSCN5118.JPG

| Description | Outdoor uncovered steel and steel rebar materials storage area in the west portion of the Facility. |

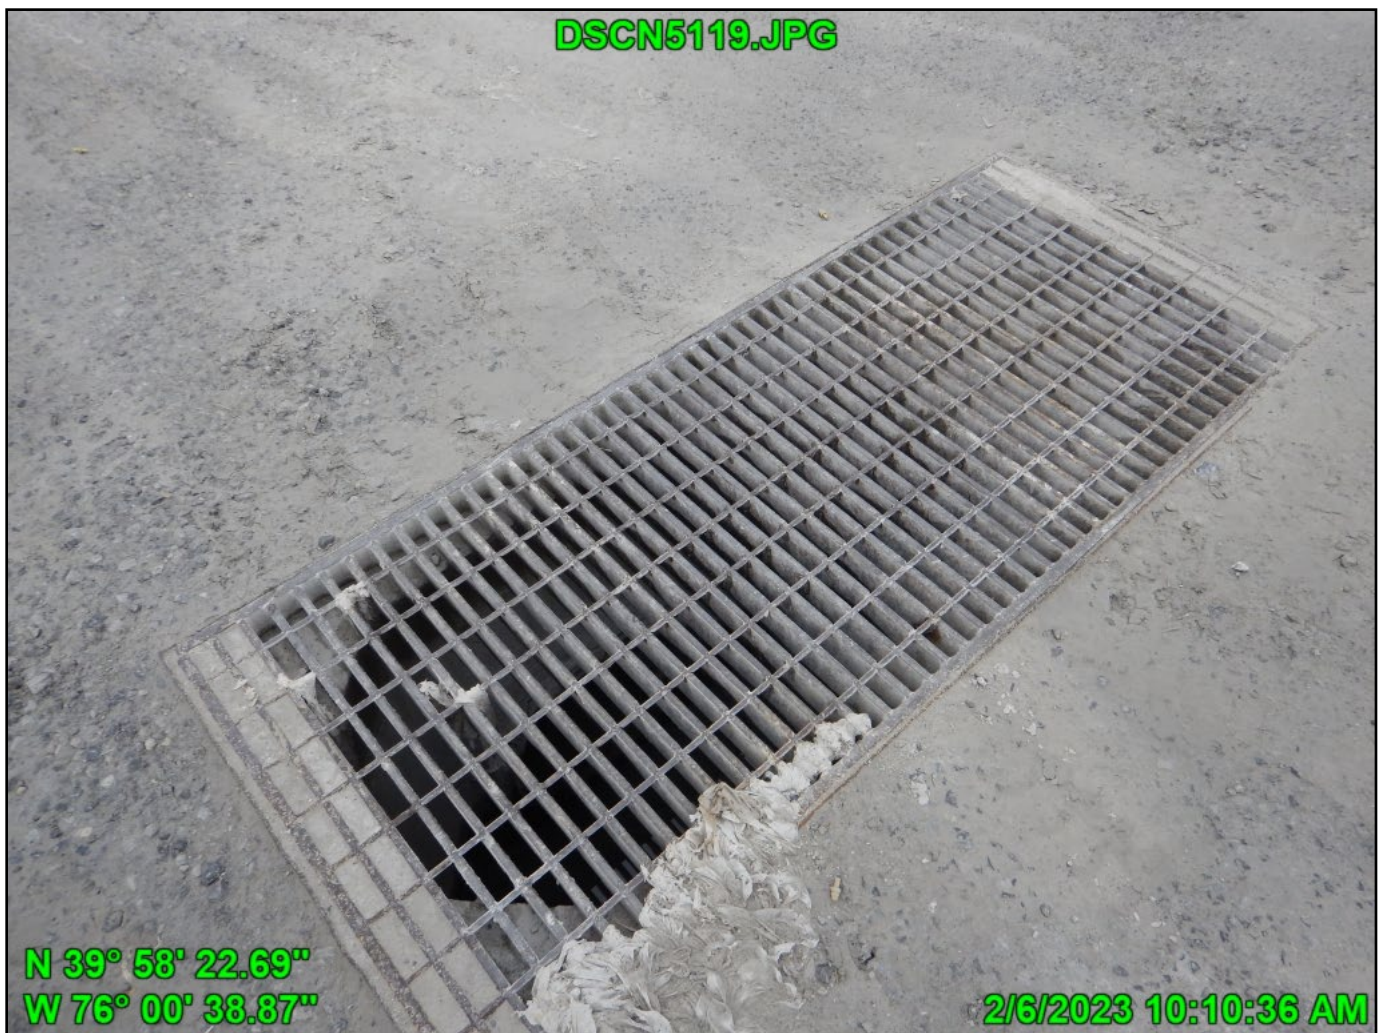
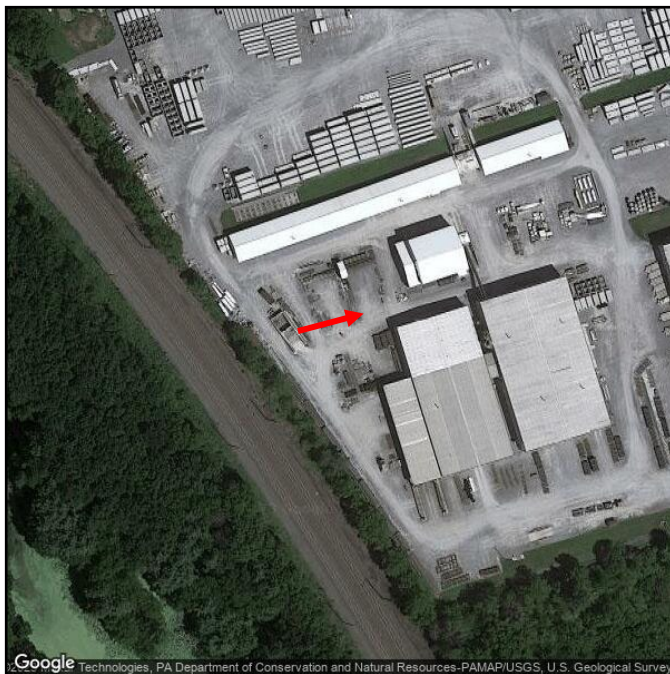
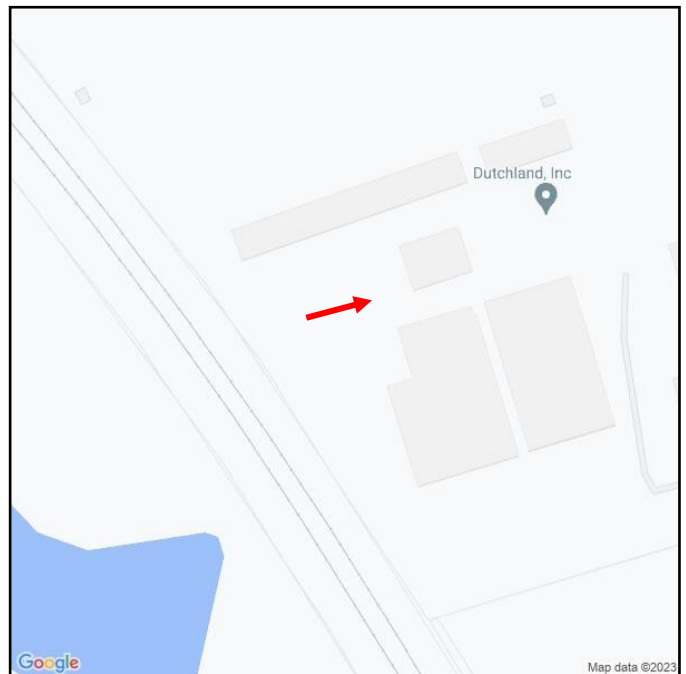
| Description | Catch basin, that according to the Facility representative, convey stormwater towards the headwall shown in Photograph DSCN5114. There was no observed inlet protection. Industrial activities in this area included materials storage and loading/unloading activities. |

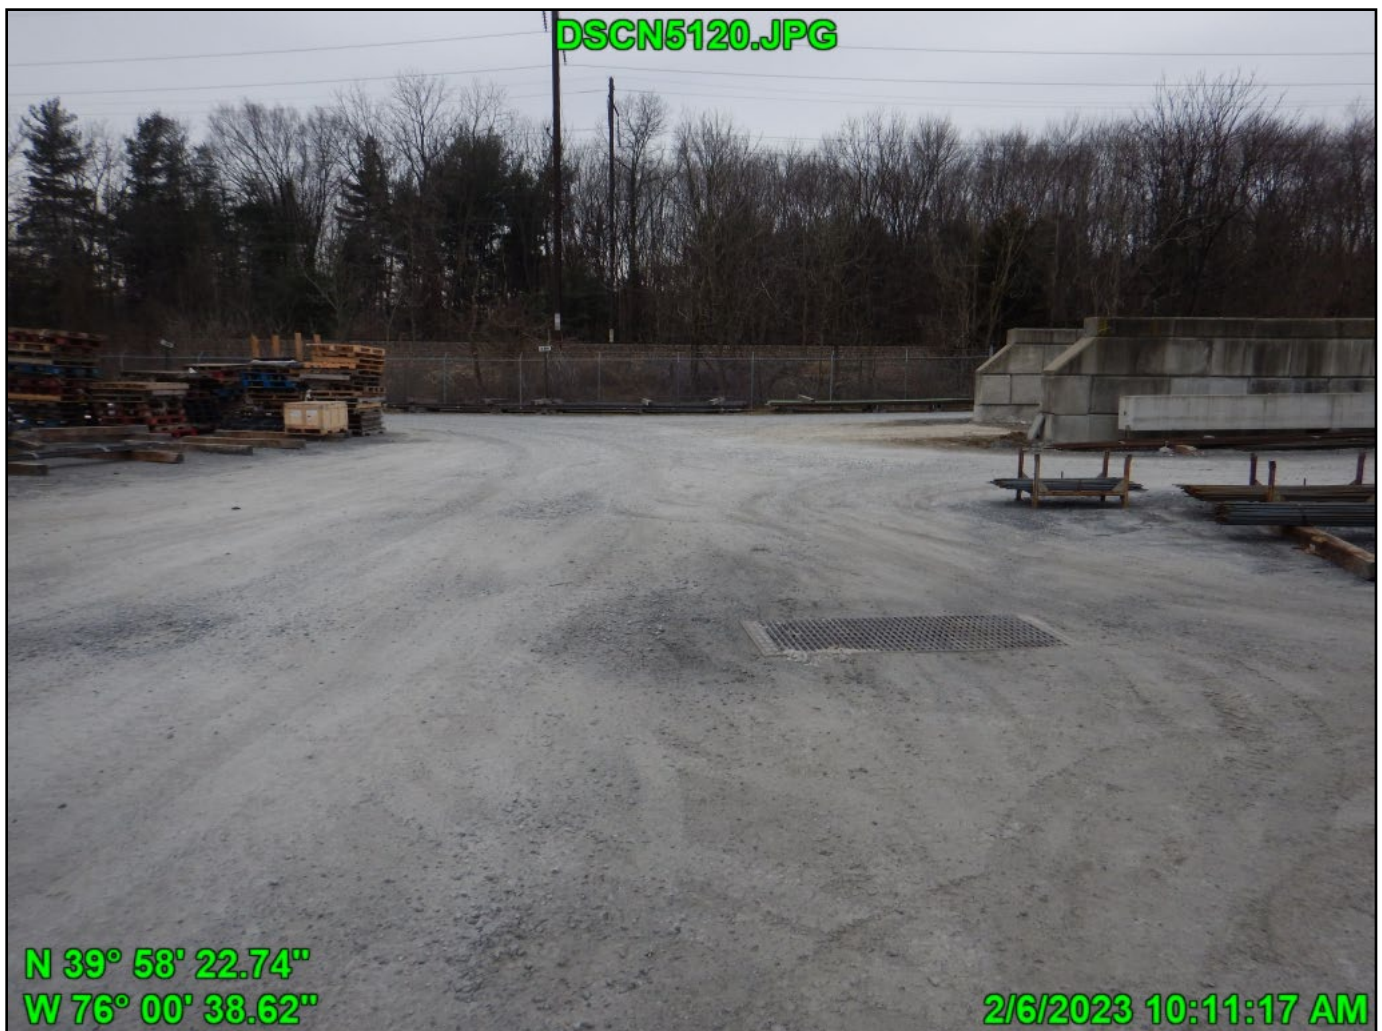
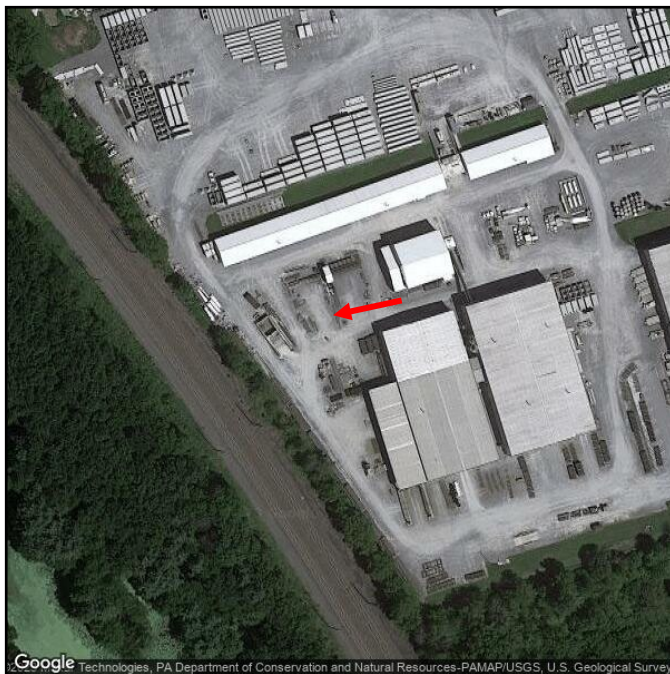
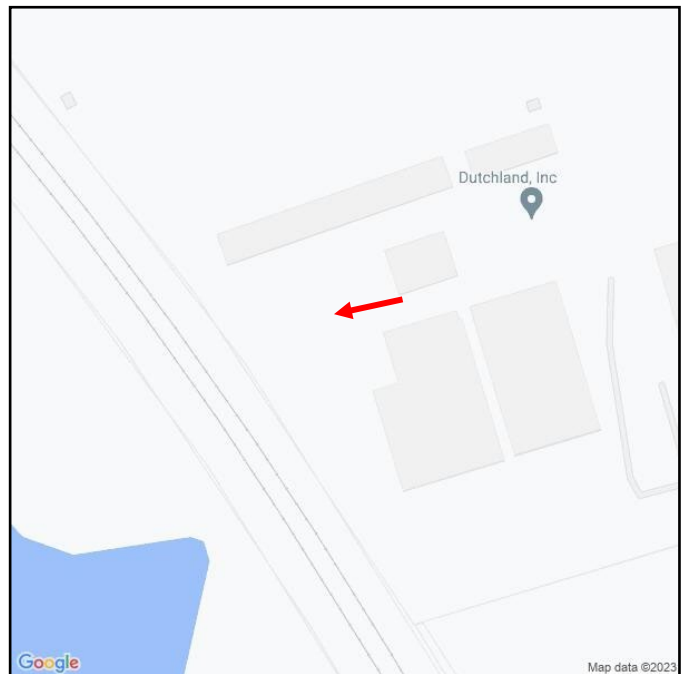
| Description | Additional view of the catch basin shown in Photograph DSCN5120. |

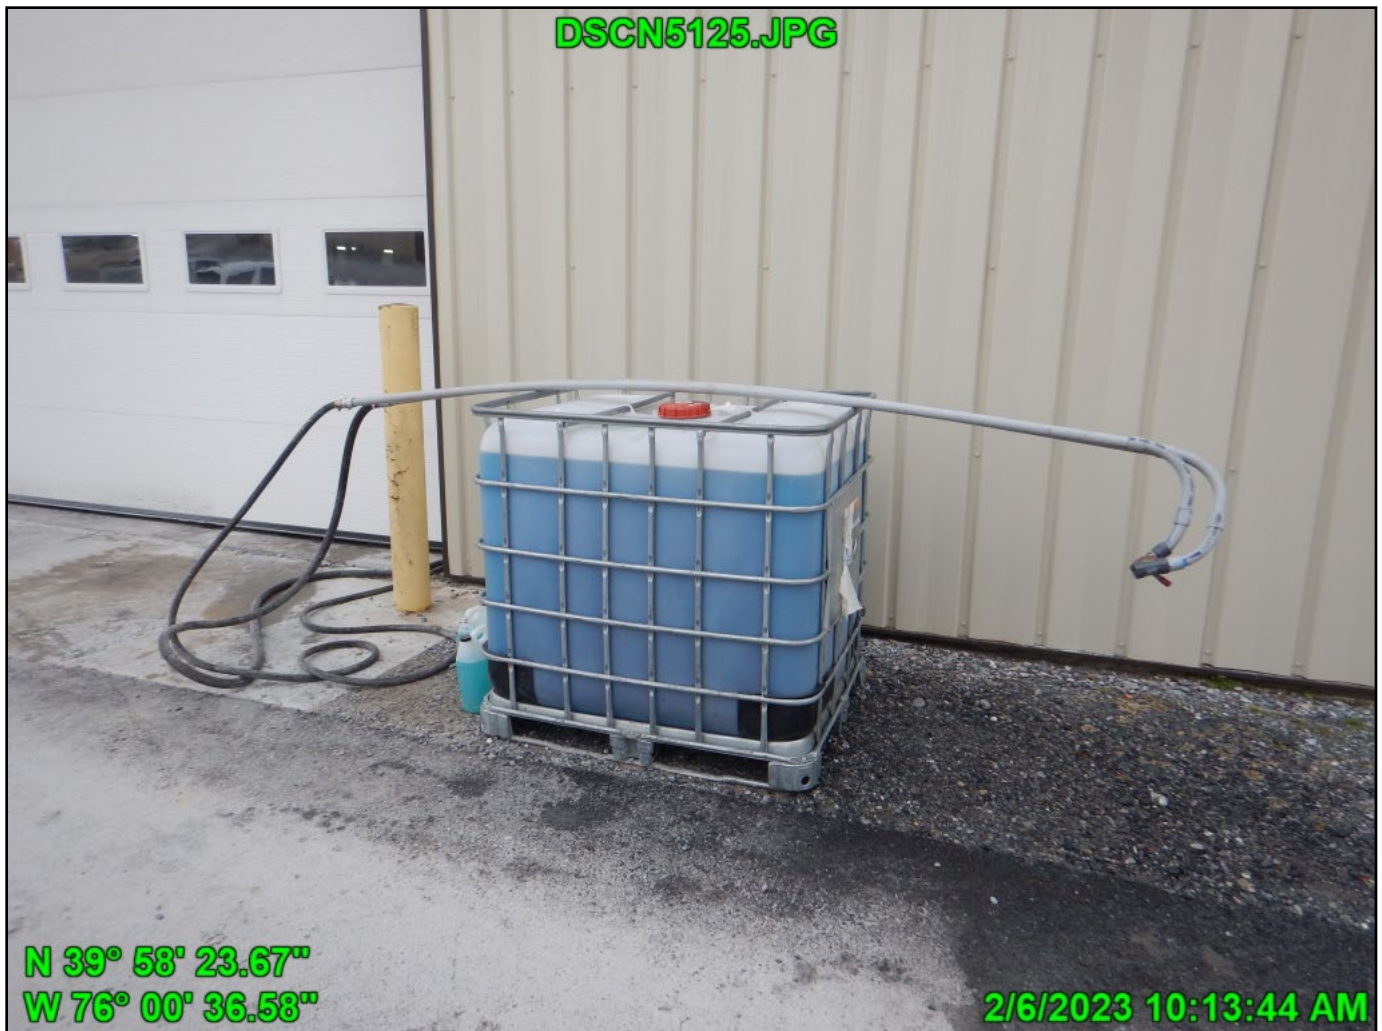
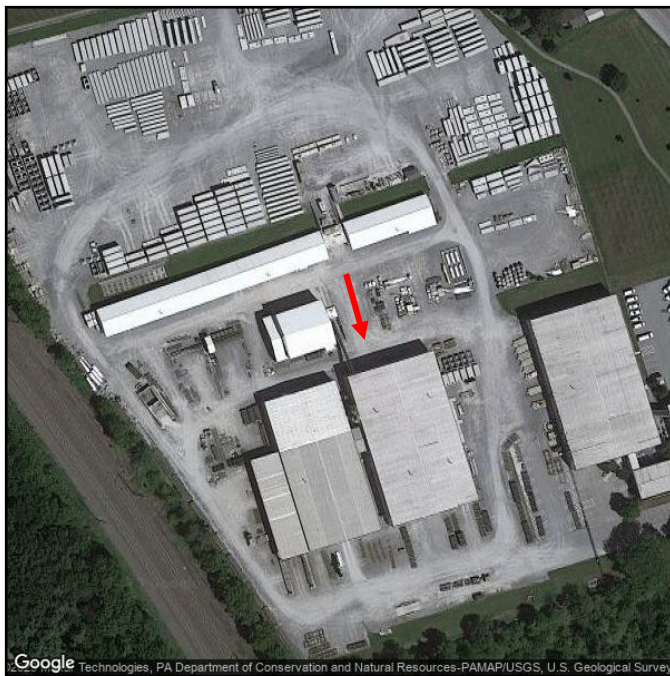
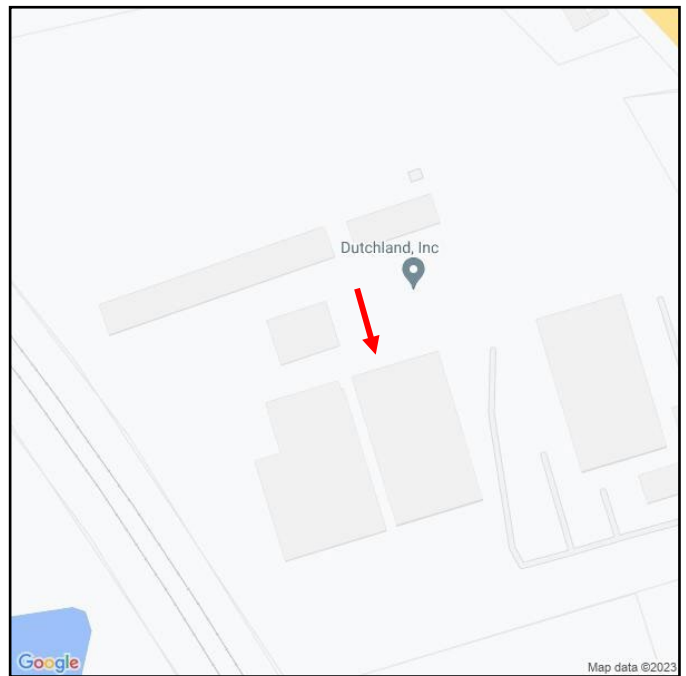
| Description | Approximate 275-gallon tote of accelerating admixture being stored outside without cover or containment. Note the staining on the adjacent ground. |

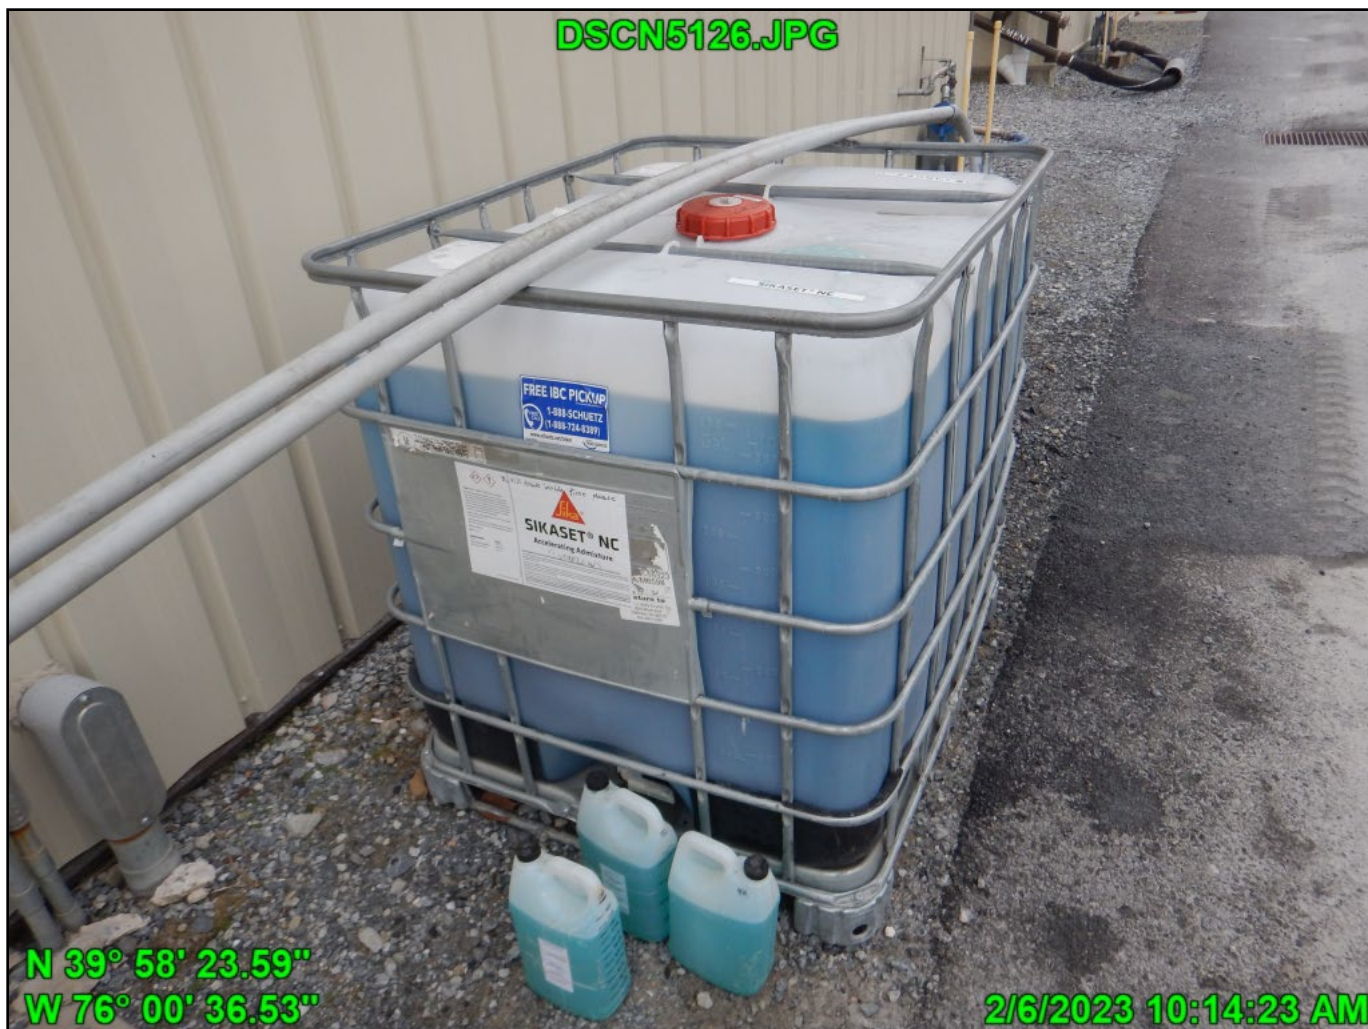
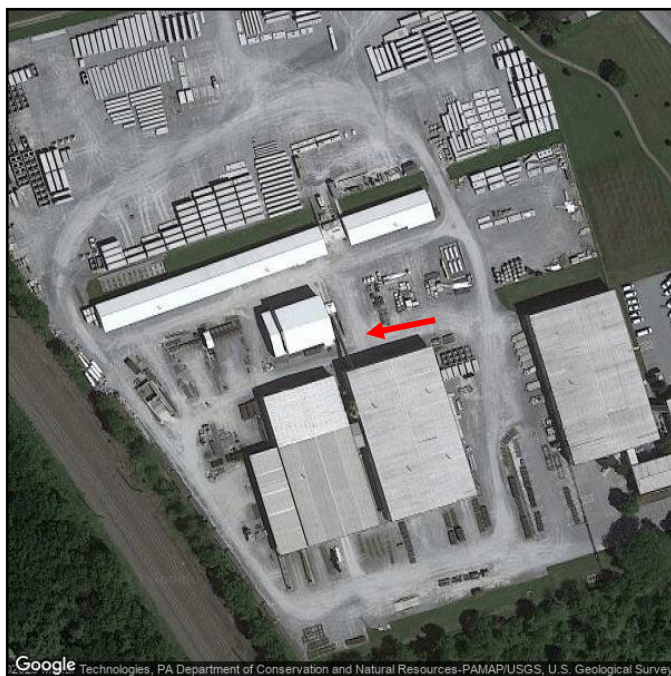
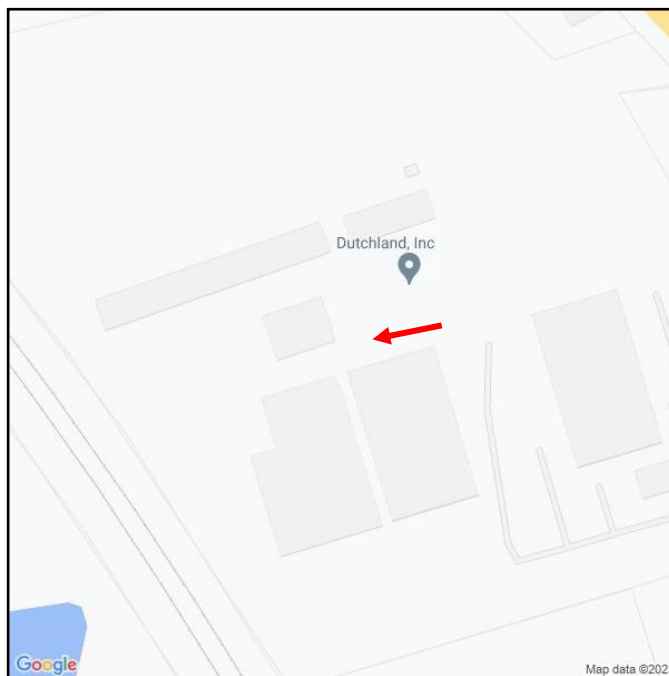
| Description | Closer view of the approximate 275-gallon tote of accelerating admixture (as shown in Photograph DSCN5125) being stored outside without cover or containment. |

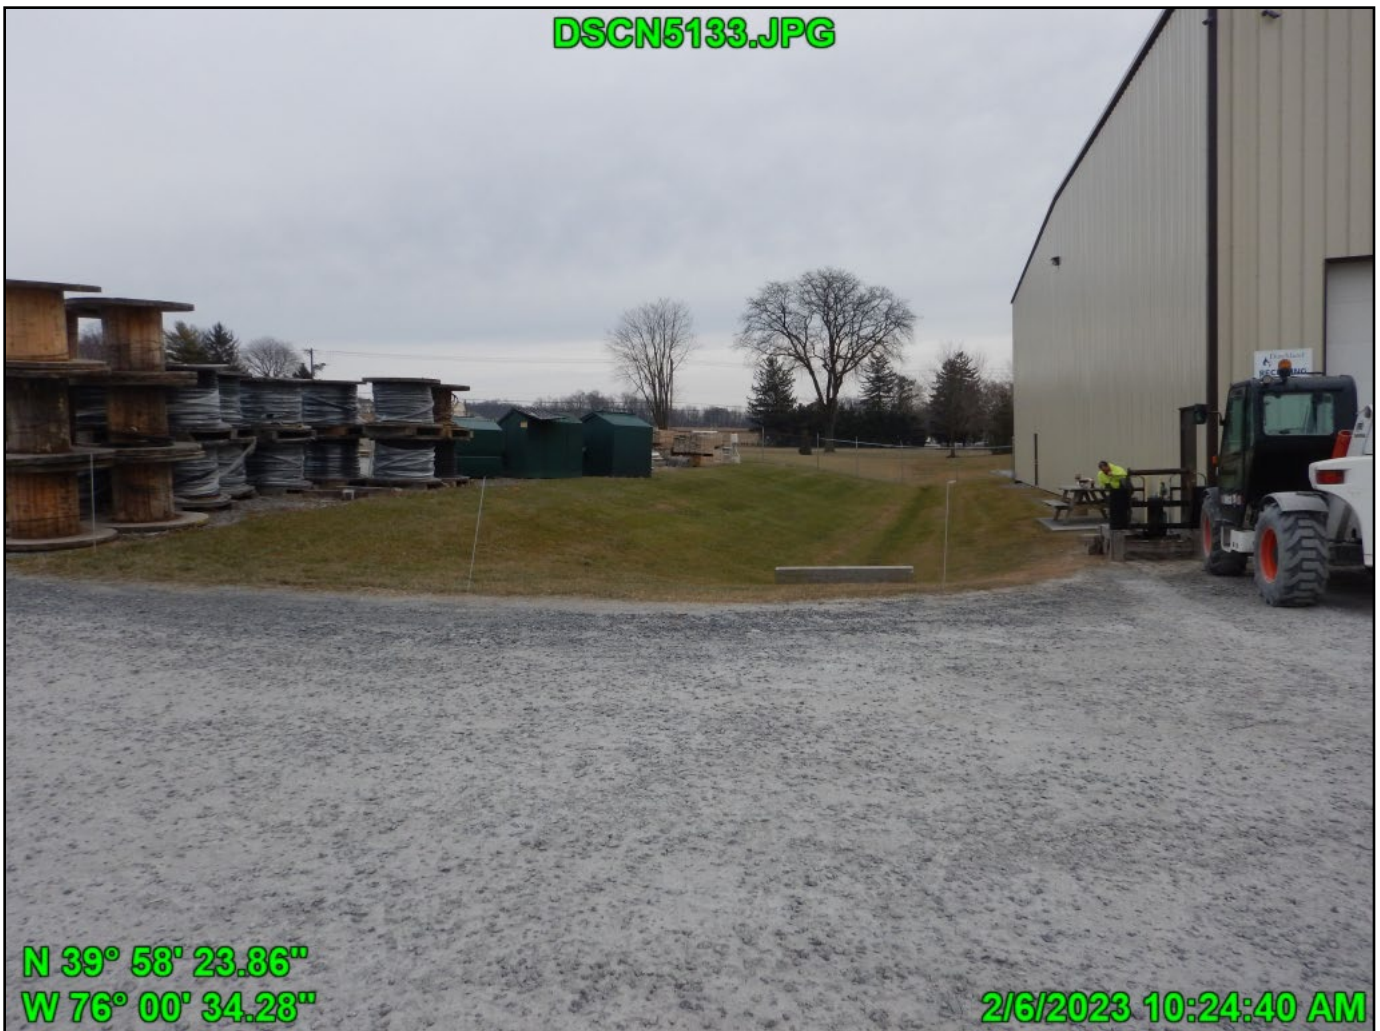
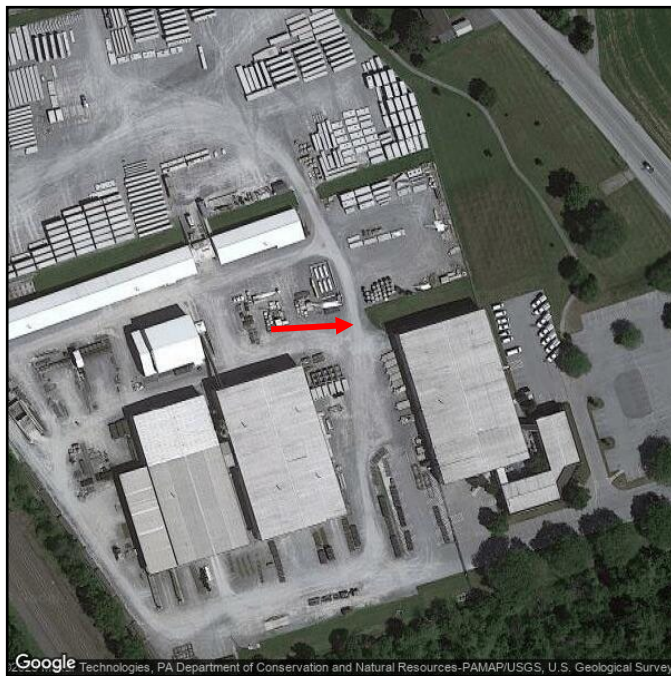
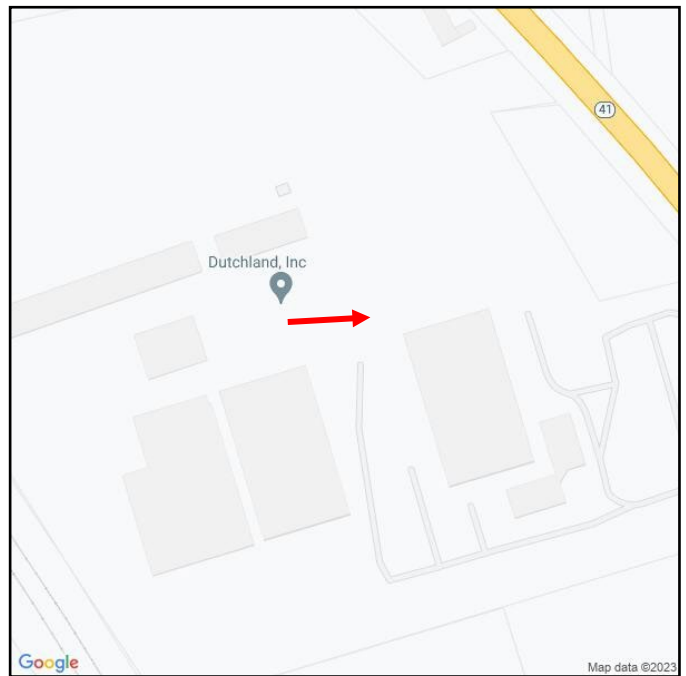
| Description | Headwall outlet structure that conveys stormwater from the catch basin shown in Photograph DSCN5132 to the observed drainage swale. |

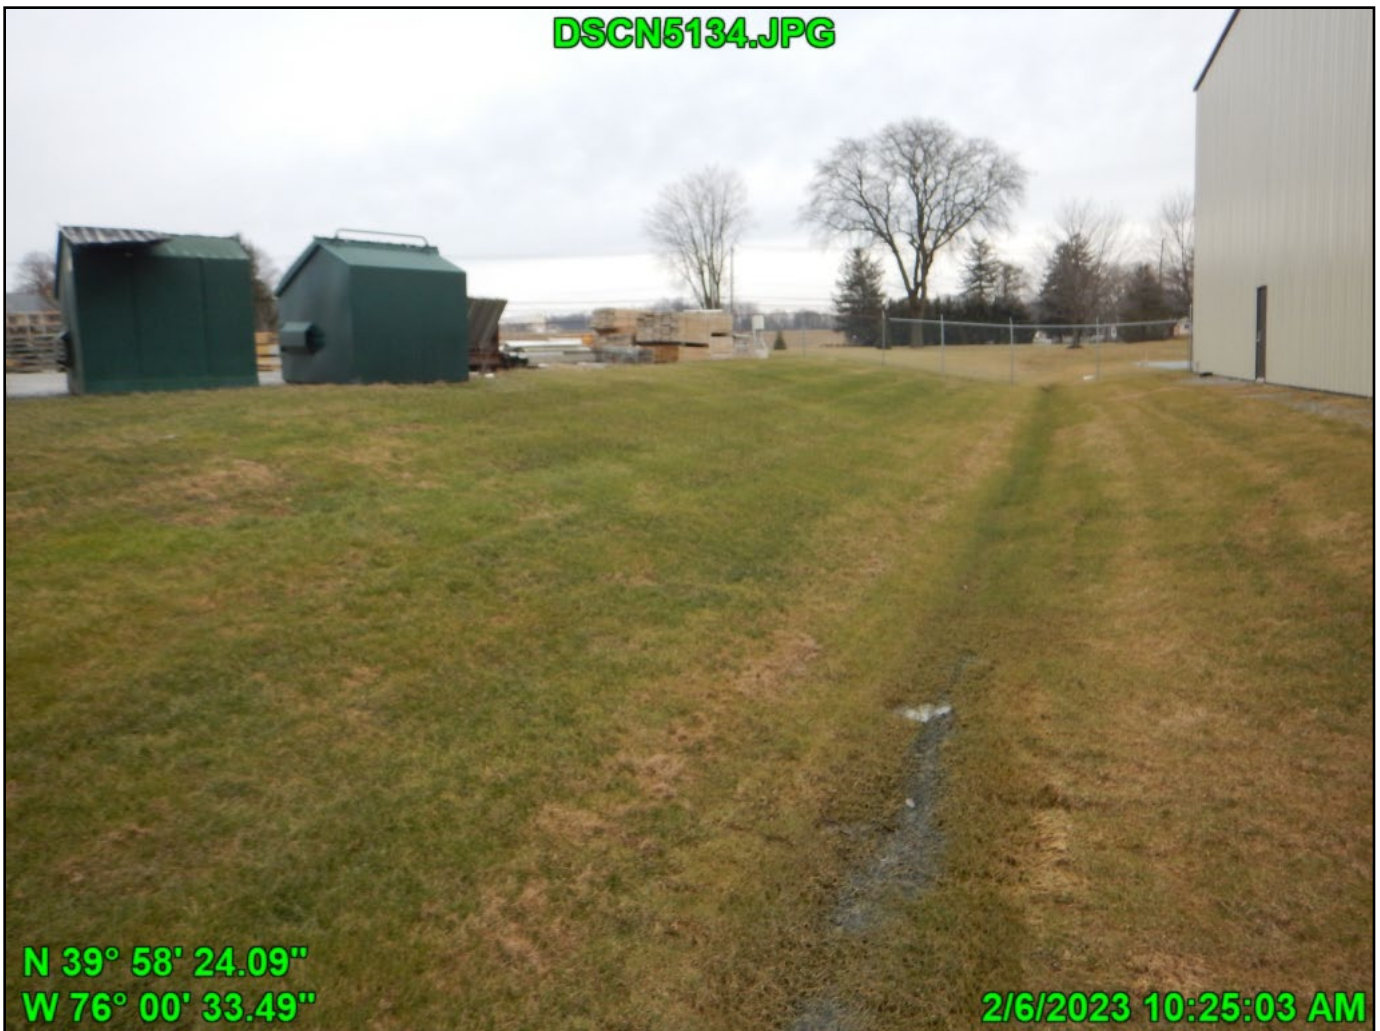
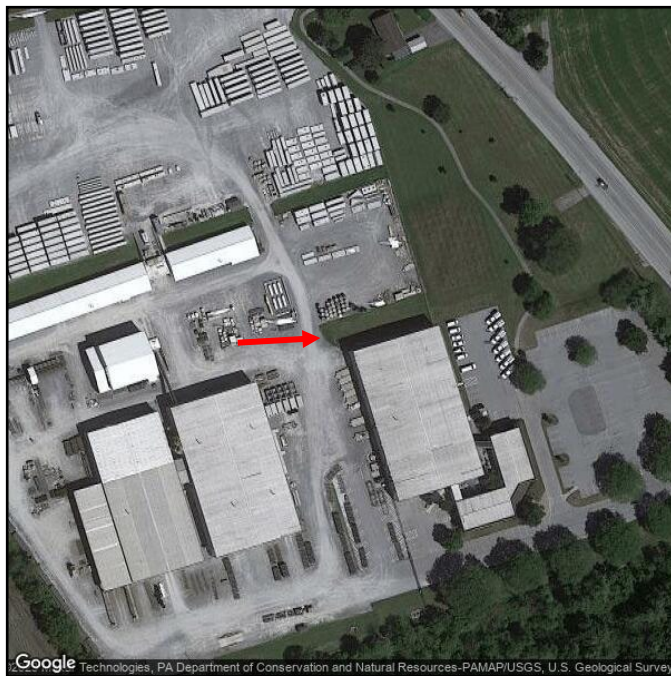
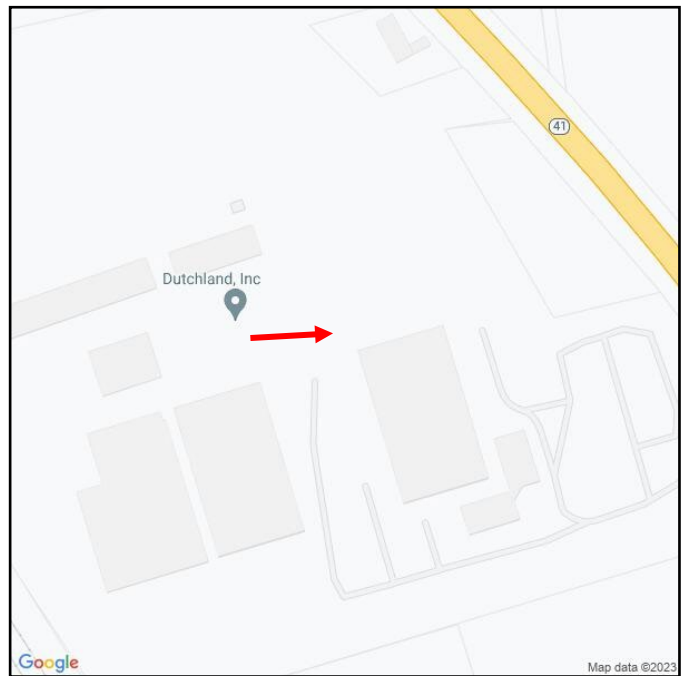
| Description | Drainage swale in the middle area of the Facility. |

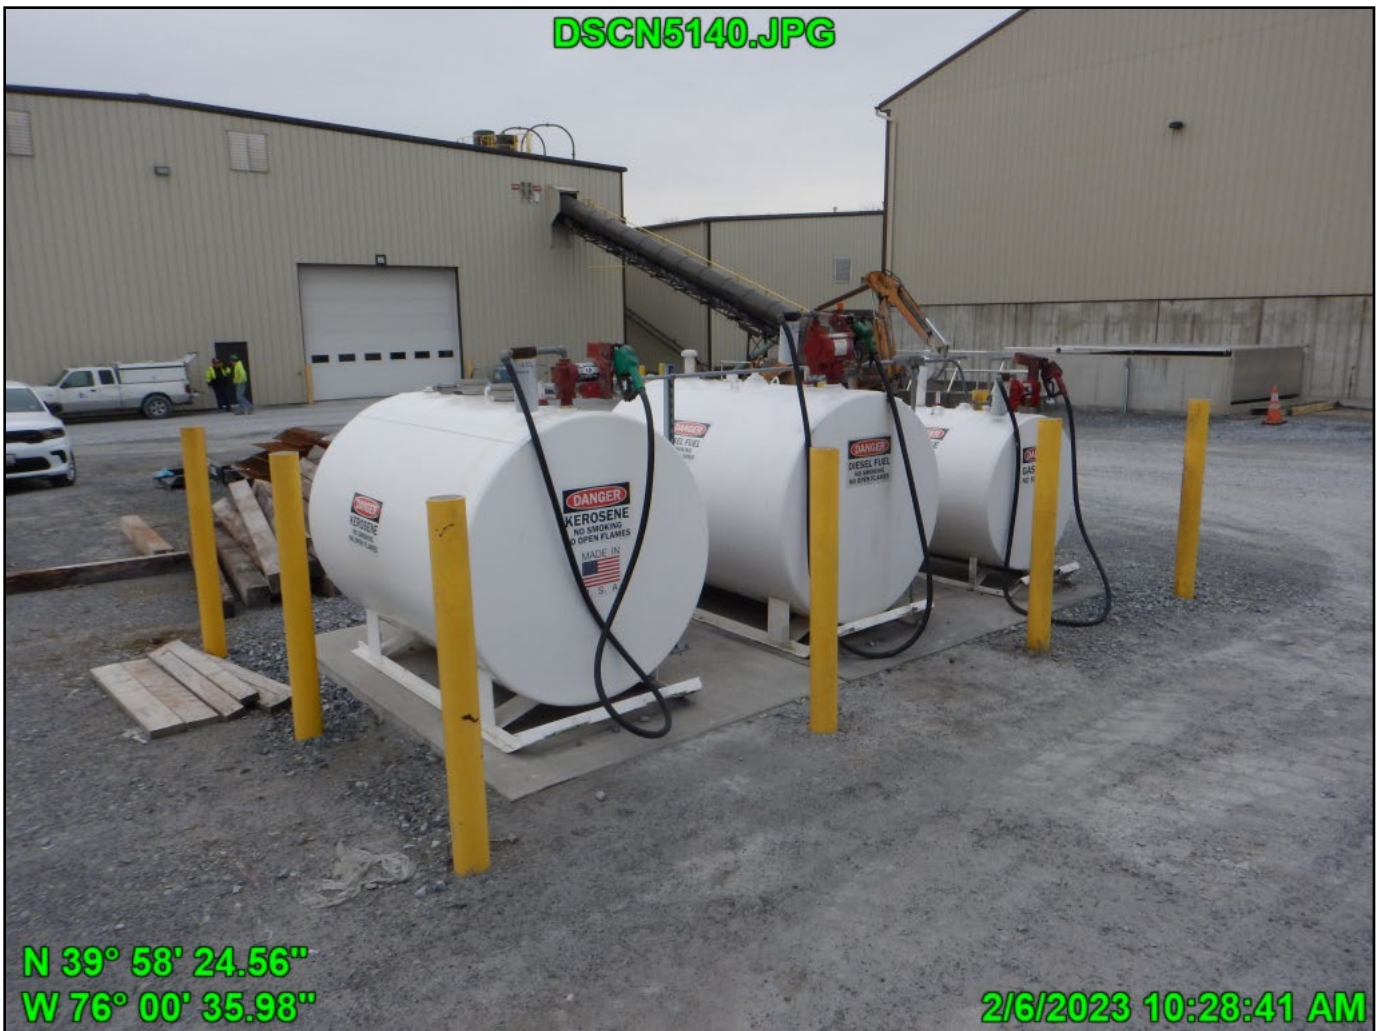
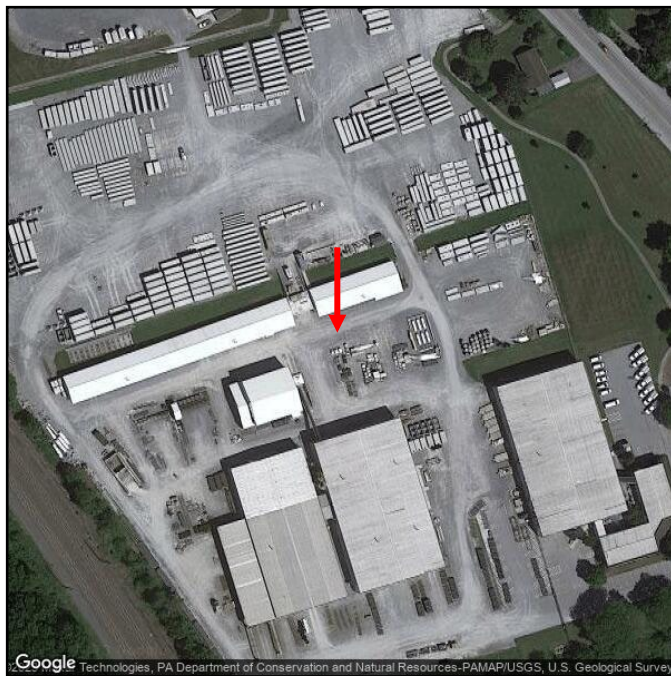
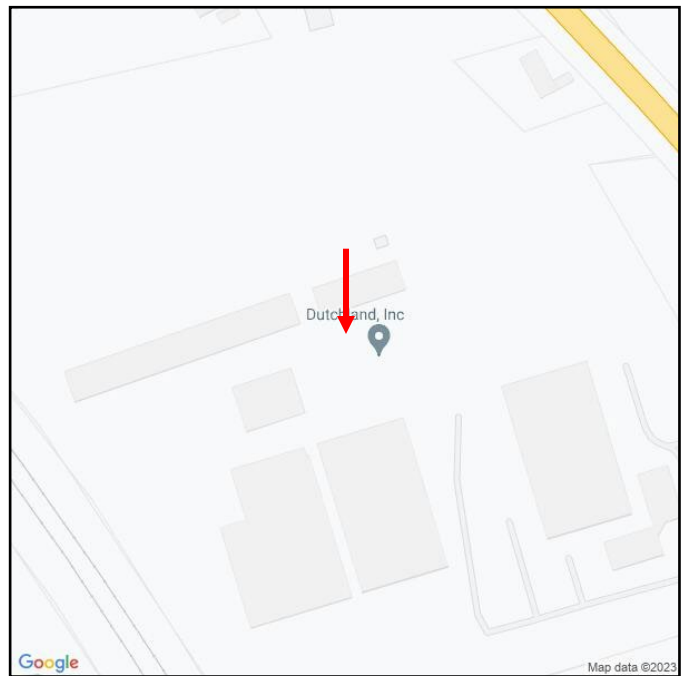
| Description | Three (3) double-walled aboveground storage tanks (ASTs) with volumes of approximately 500 gallons of kerosene, 500 gallons of diesel, and 300 gallons of gasoline. There was no spill kit observed in the area. |

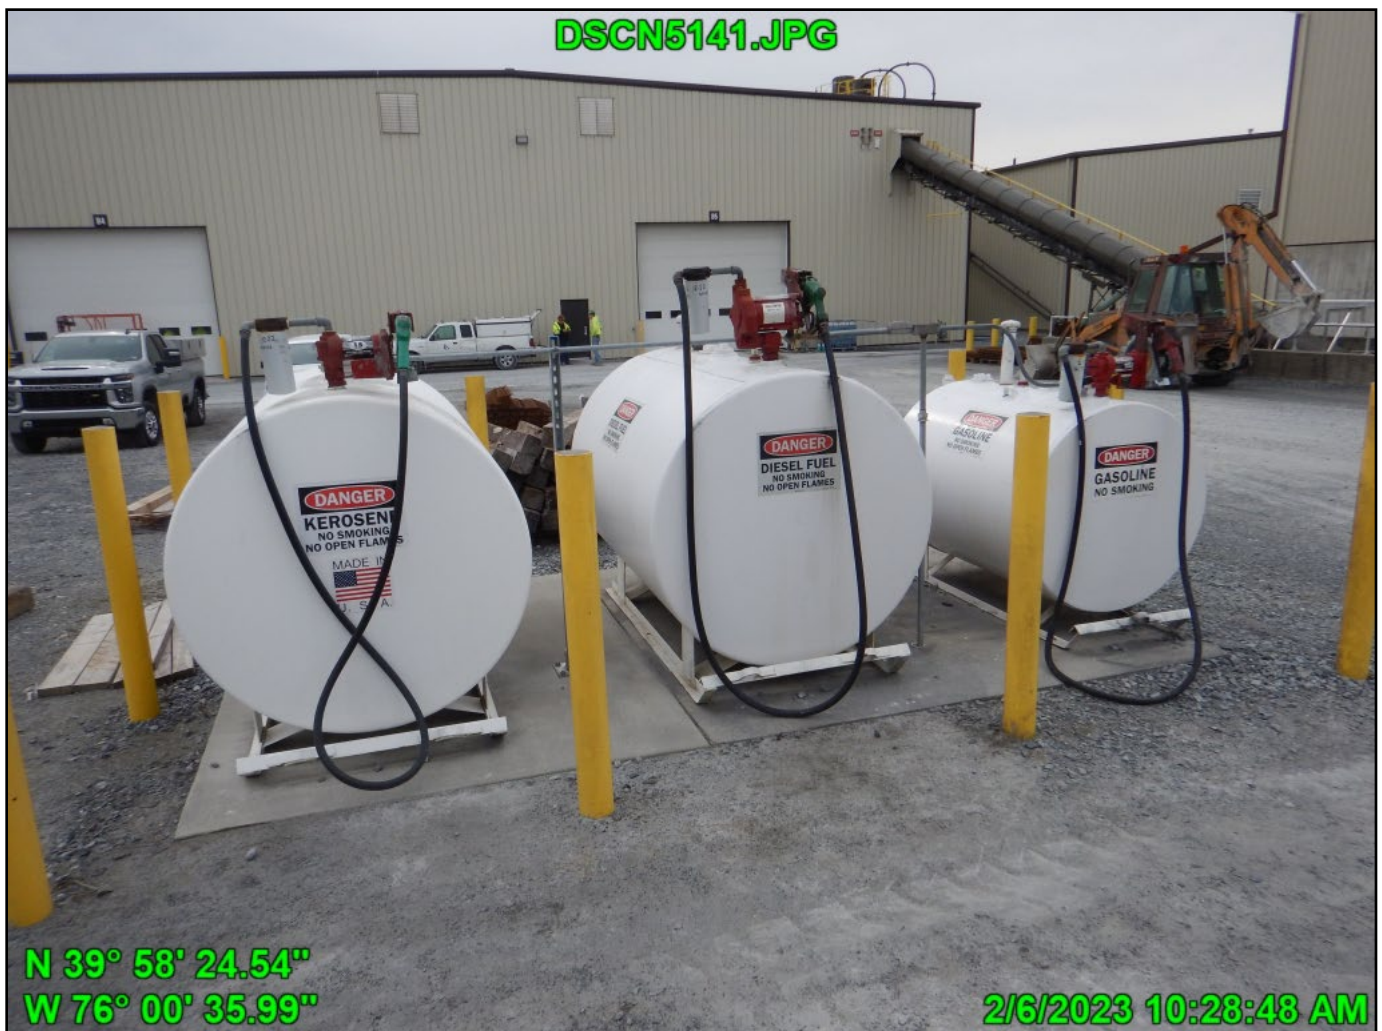
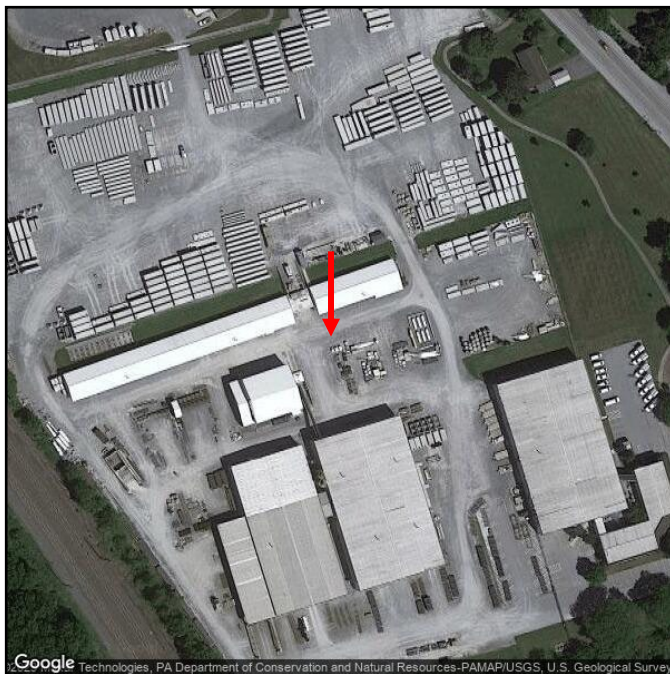
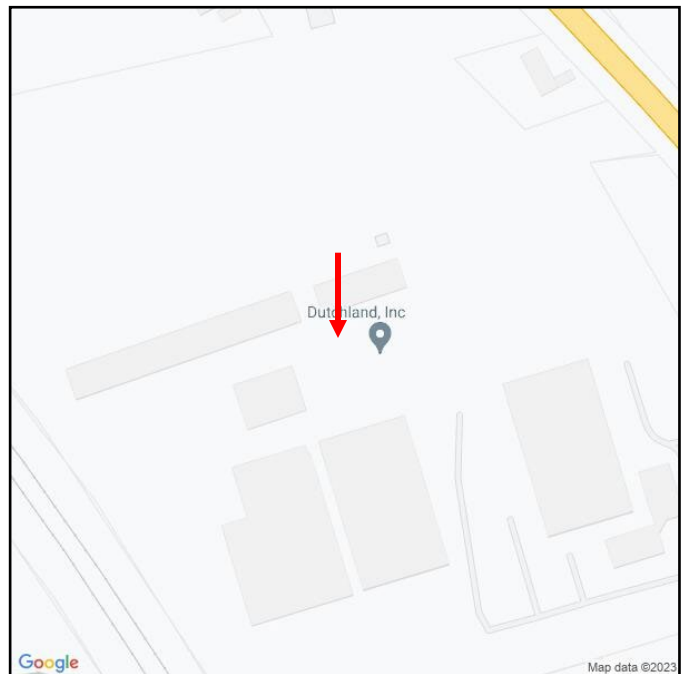
| Description | Closer view of the ASTs shown in Photograph DSCN5140. |

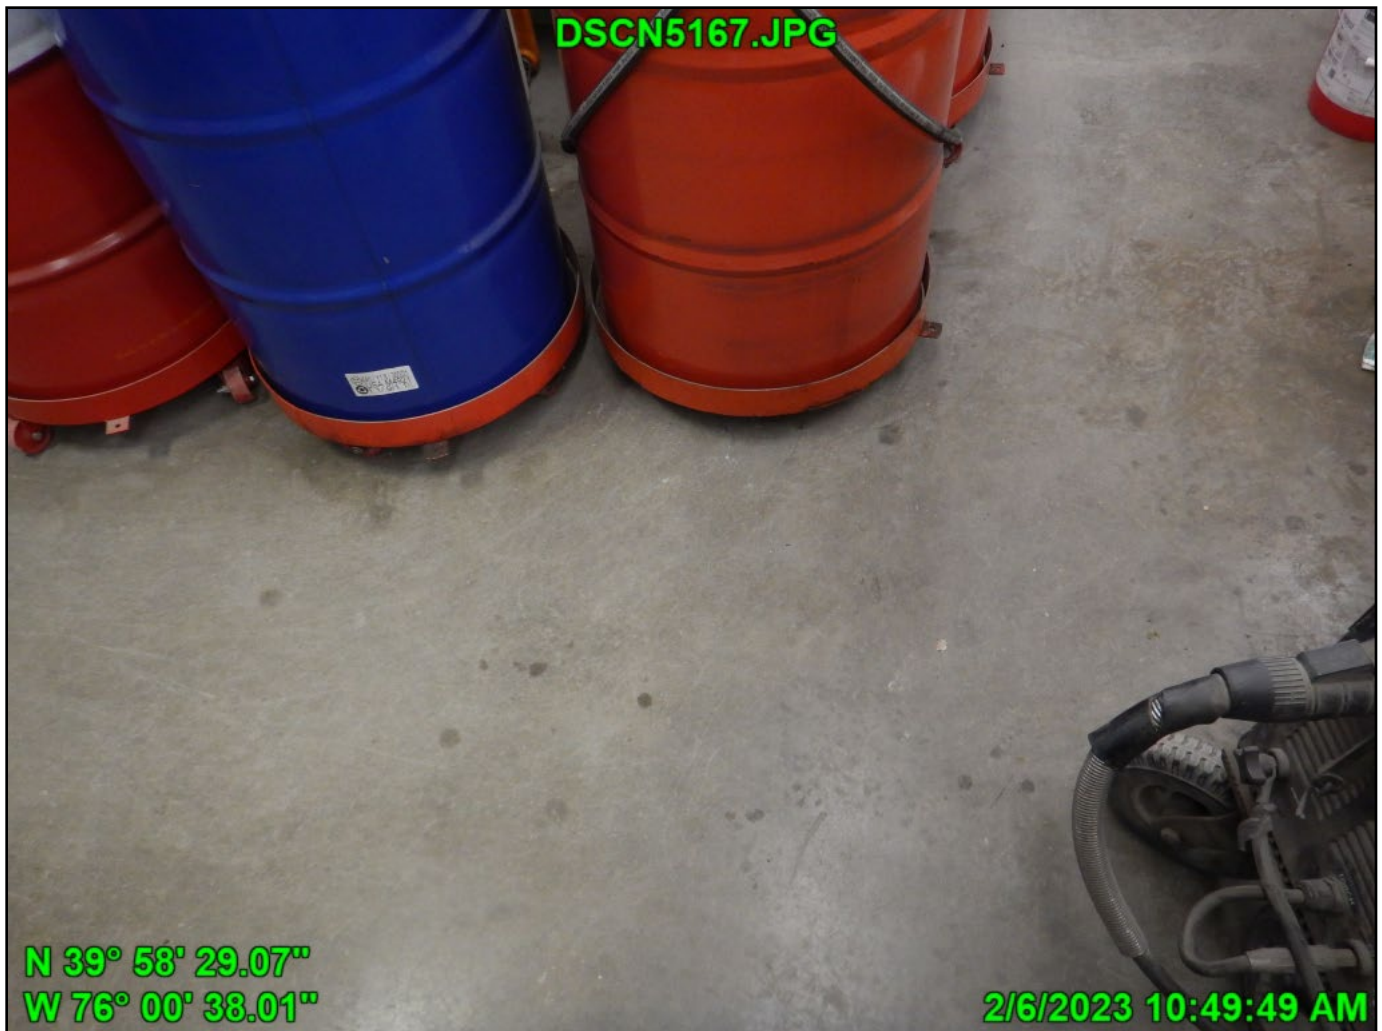
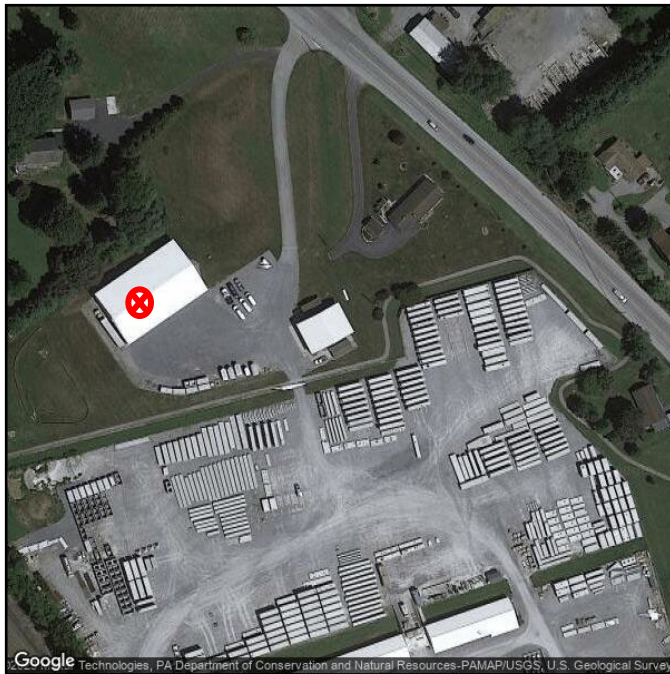
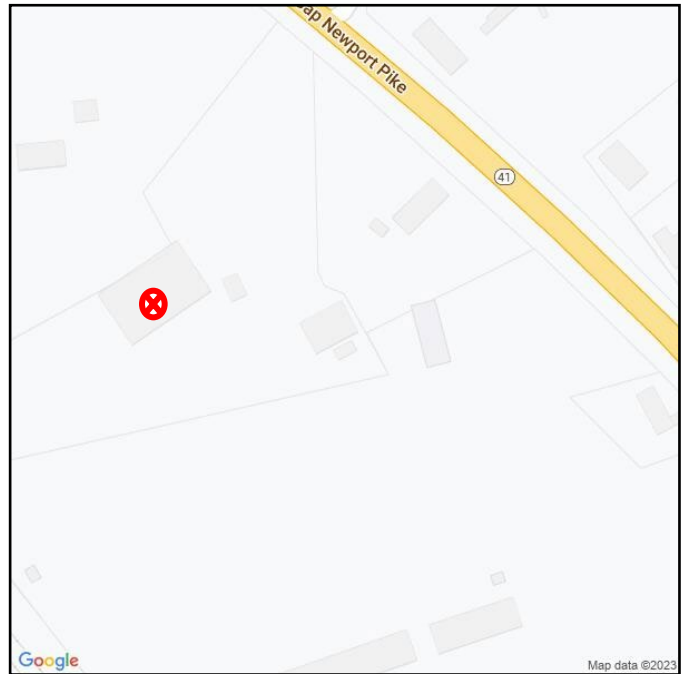
| Description |
|---|
| Small petroleum stains on the floor in fleet maintenance shop. |
