## MULTI-SECTOR GENERAL PERMIT NON-FILER INSPECTION CHECKLIST

| <b>Inspection Date(s):</b> | 2/7/2023 | |
| <b>Operator Name:</b> | Dutchland, Inc. | |

Stormwater Inspection Date: February 7, 2023

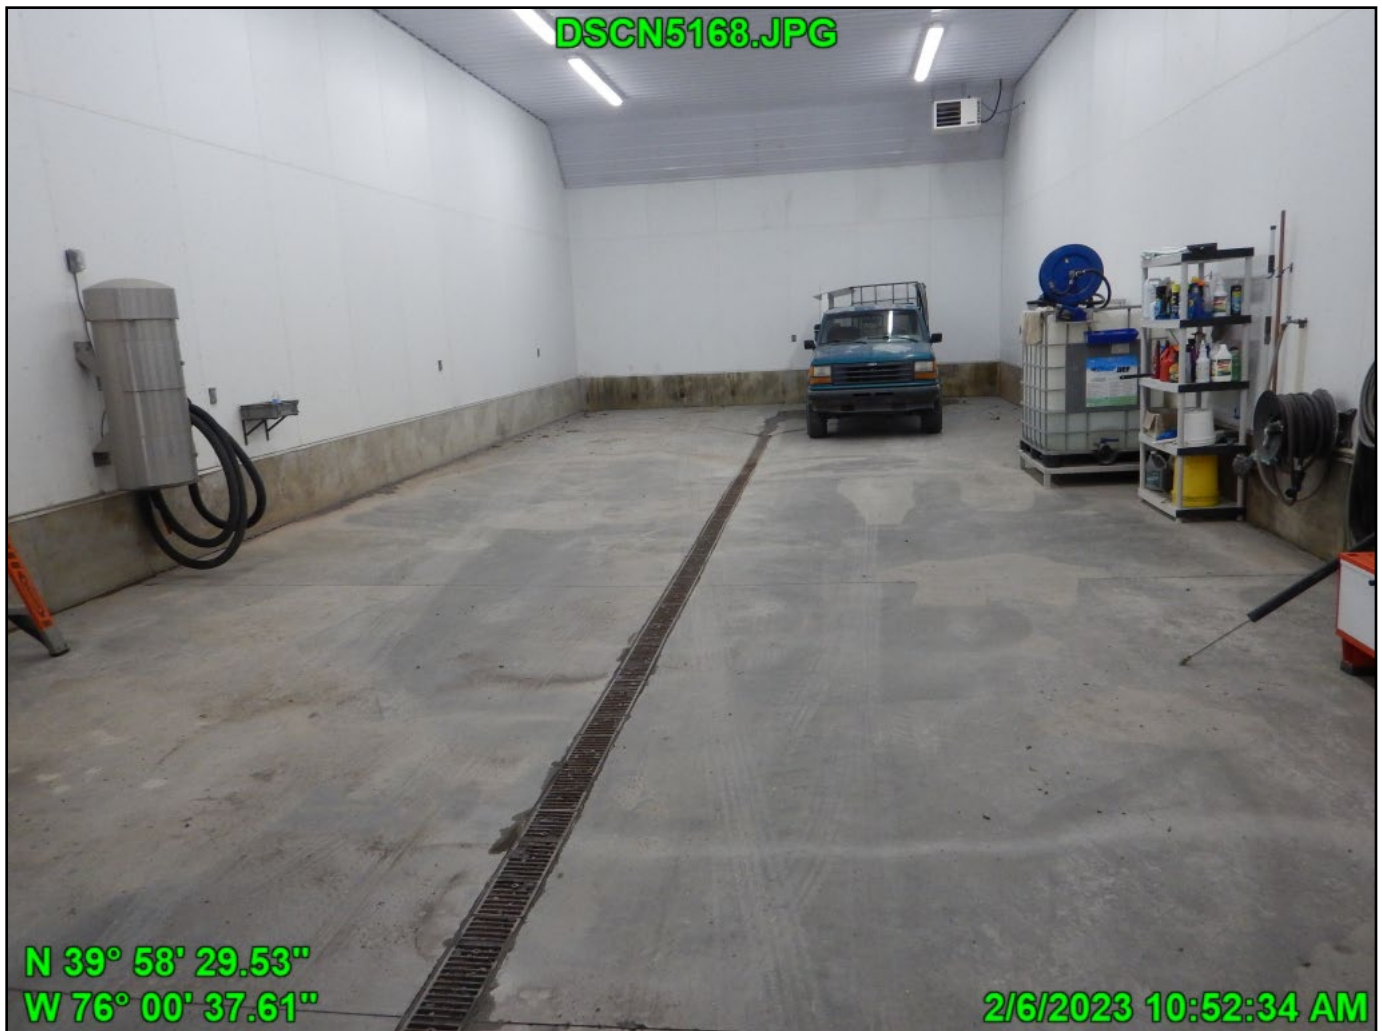
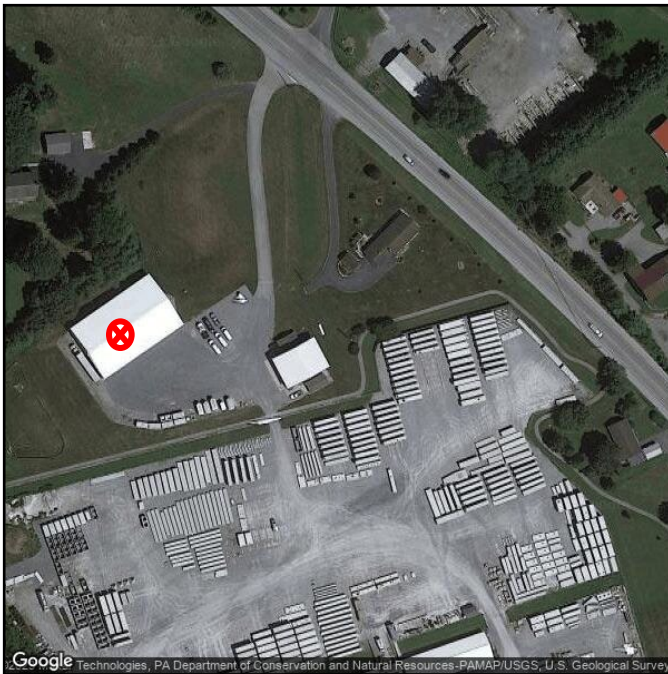
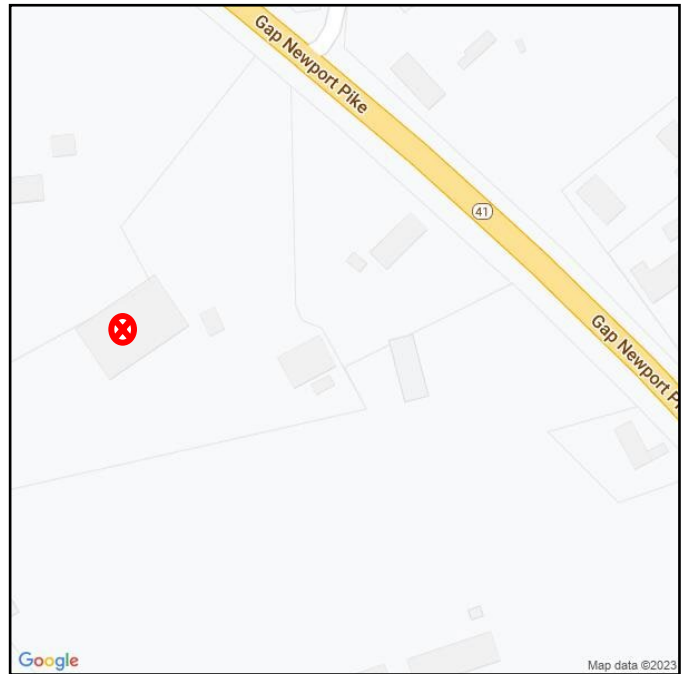
| Description | Additional floor drain in fleet maintenance shop. Note the chemical tote with no secondary containment. |

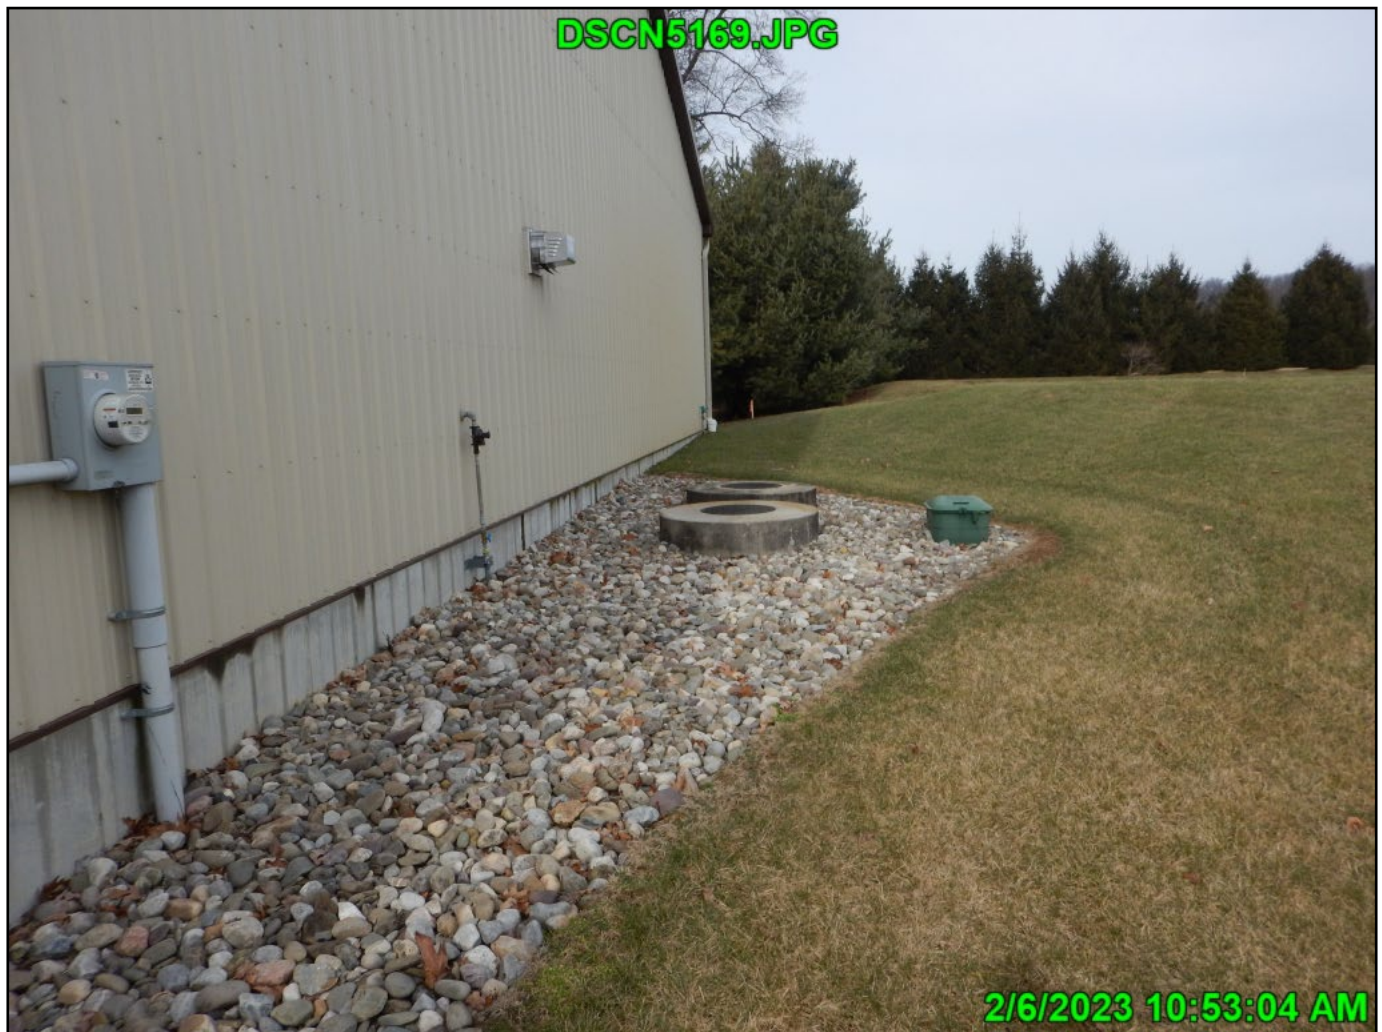
| Description | Infiltration area adjacent to the fleet maintenance shop. |

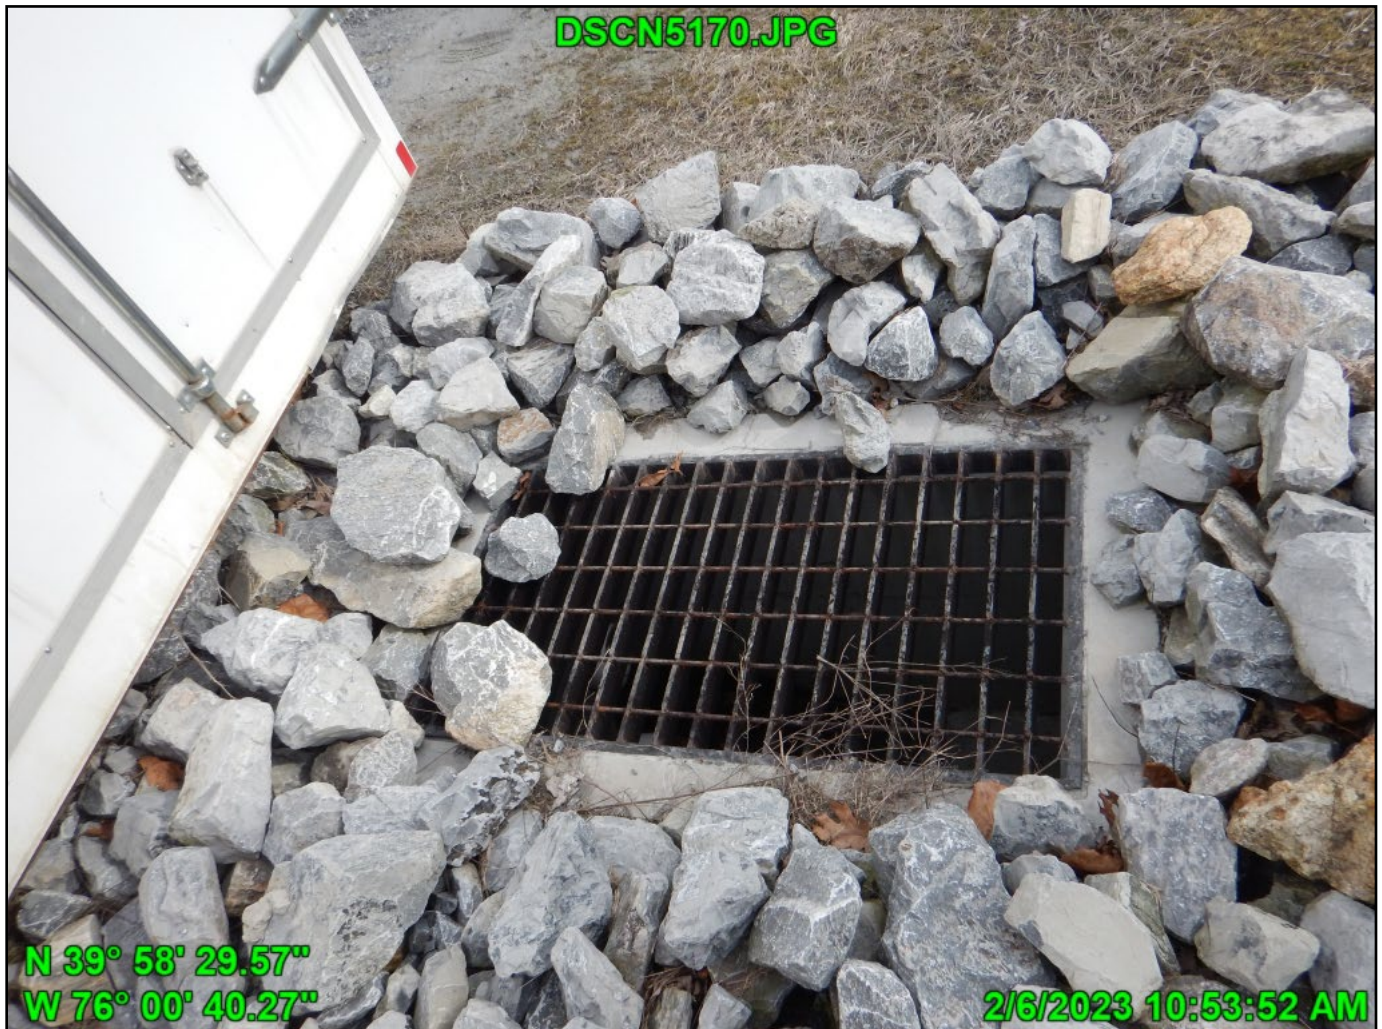
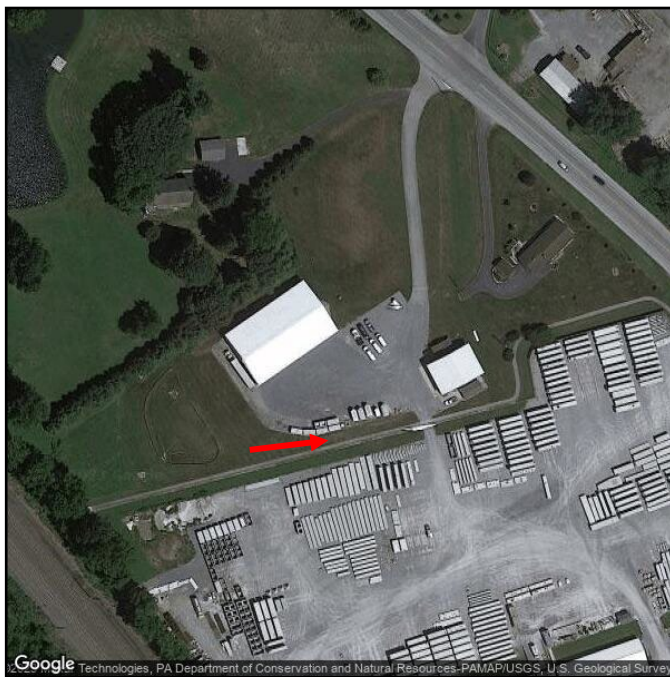
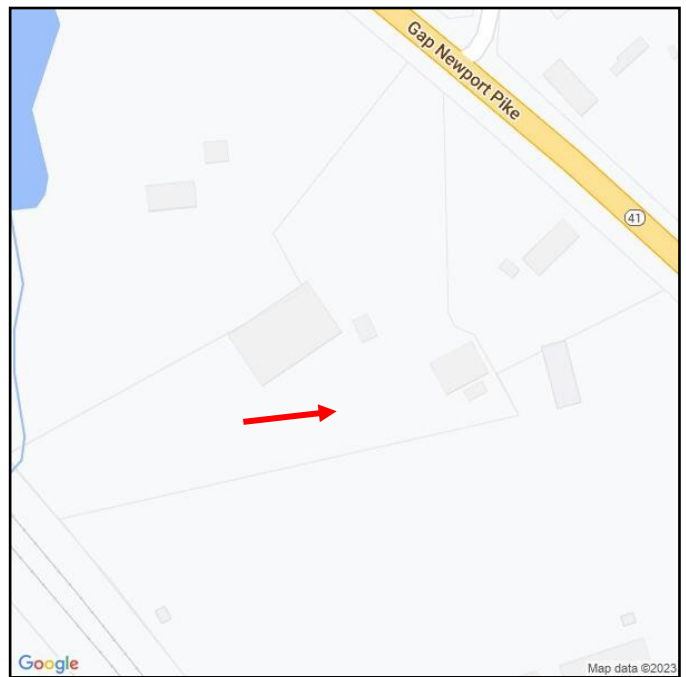
| Description | Catch basin in the north area of the Facility. It was unclear where the catch basin connects or discharges to. |

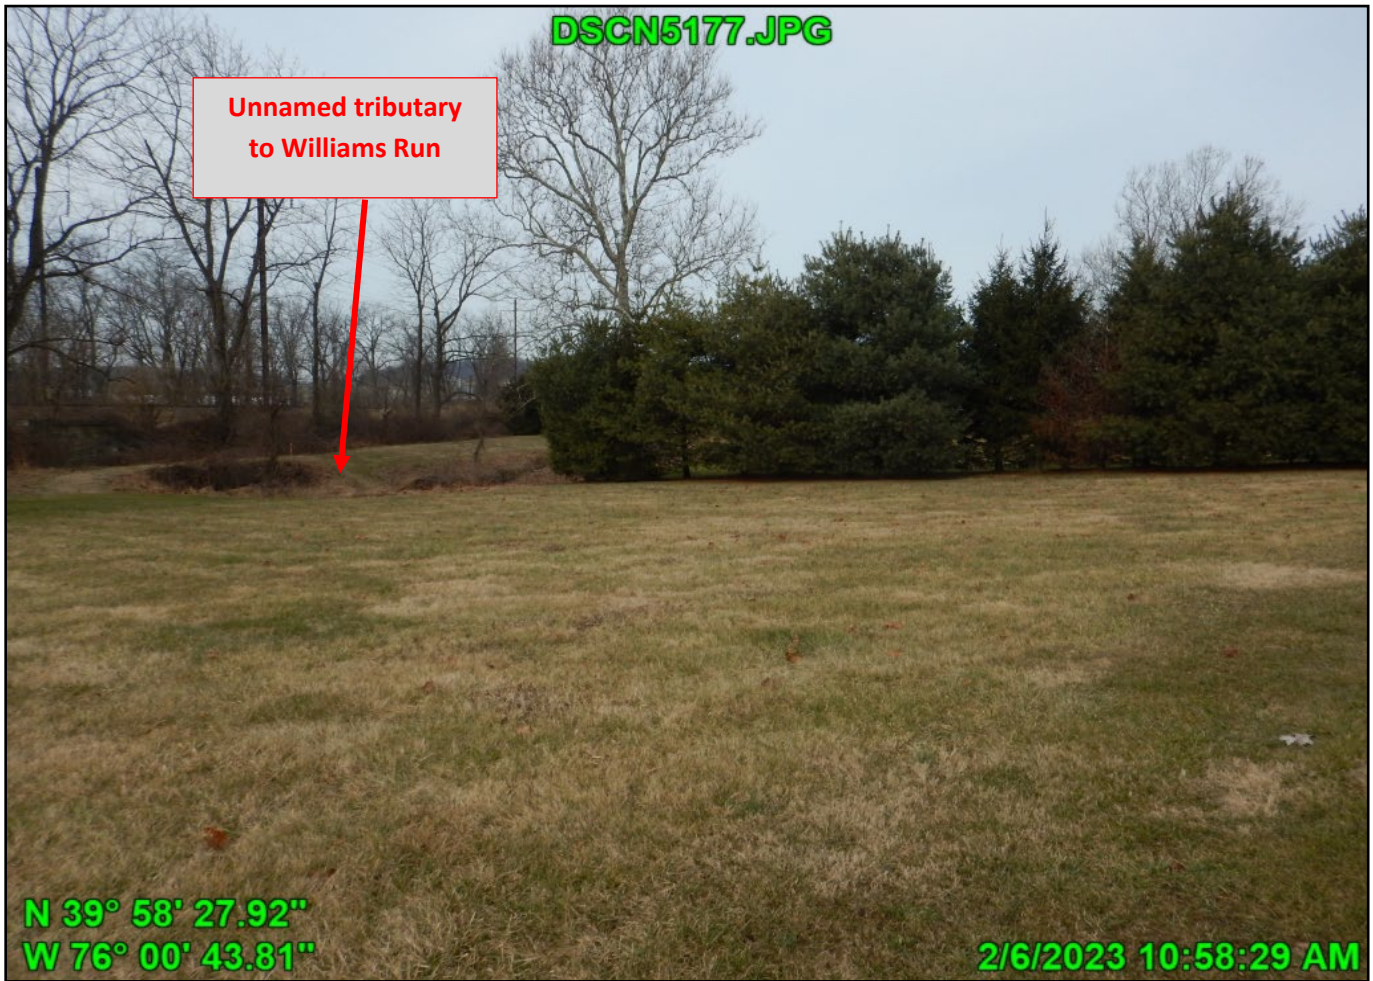
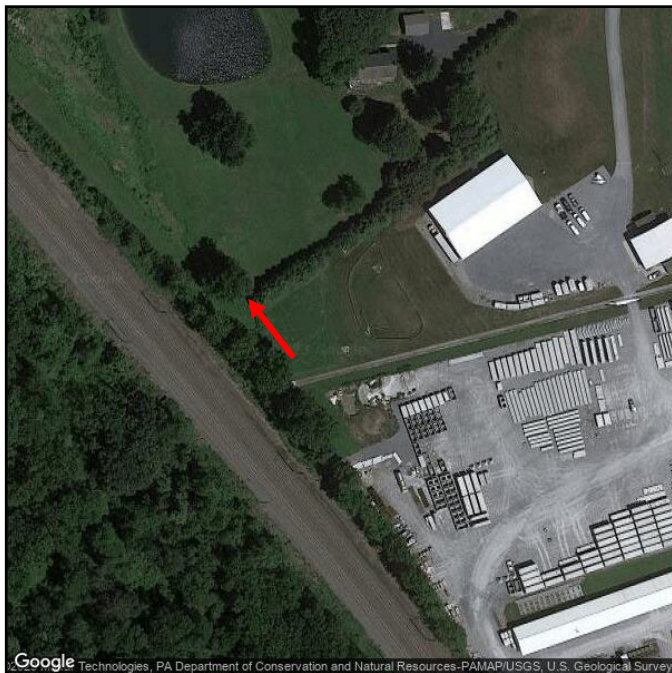
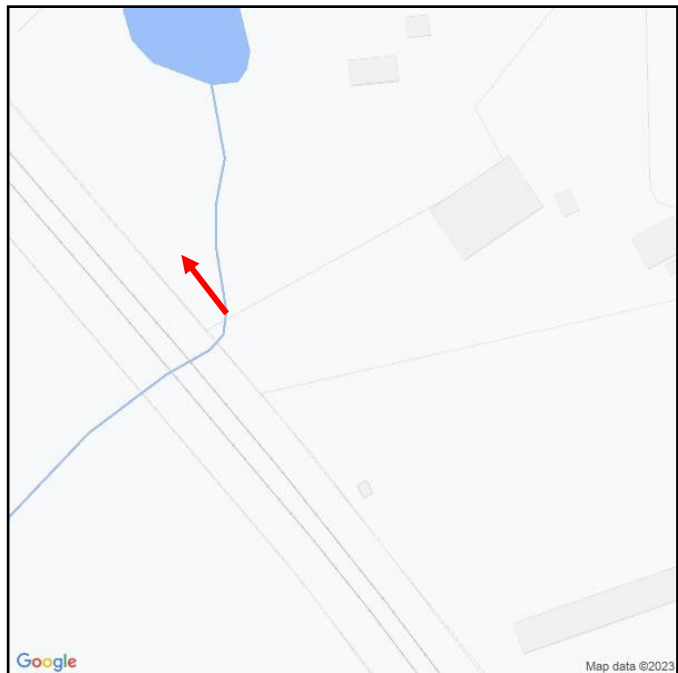
| Description | Unnamed tributary to Williams Run adjacent to the northwest part of the Facility. Excess stormwater runoff from the adjacent basin could be conveyed towards the unnamed tributary to Williams Run. It was unconfirmed if this is connected to the drainage ditch observed along the west Facility perimeter (refer to Photographs DSCN5092, DSCN5097, and DSCN5105). |

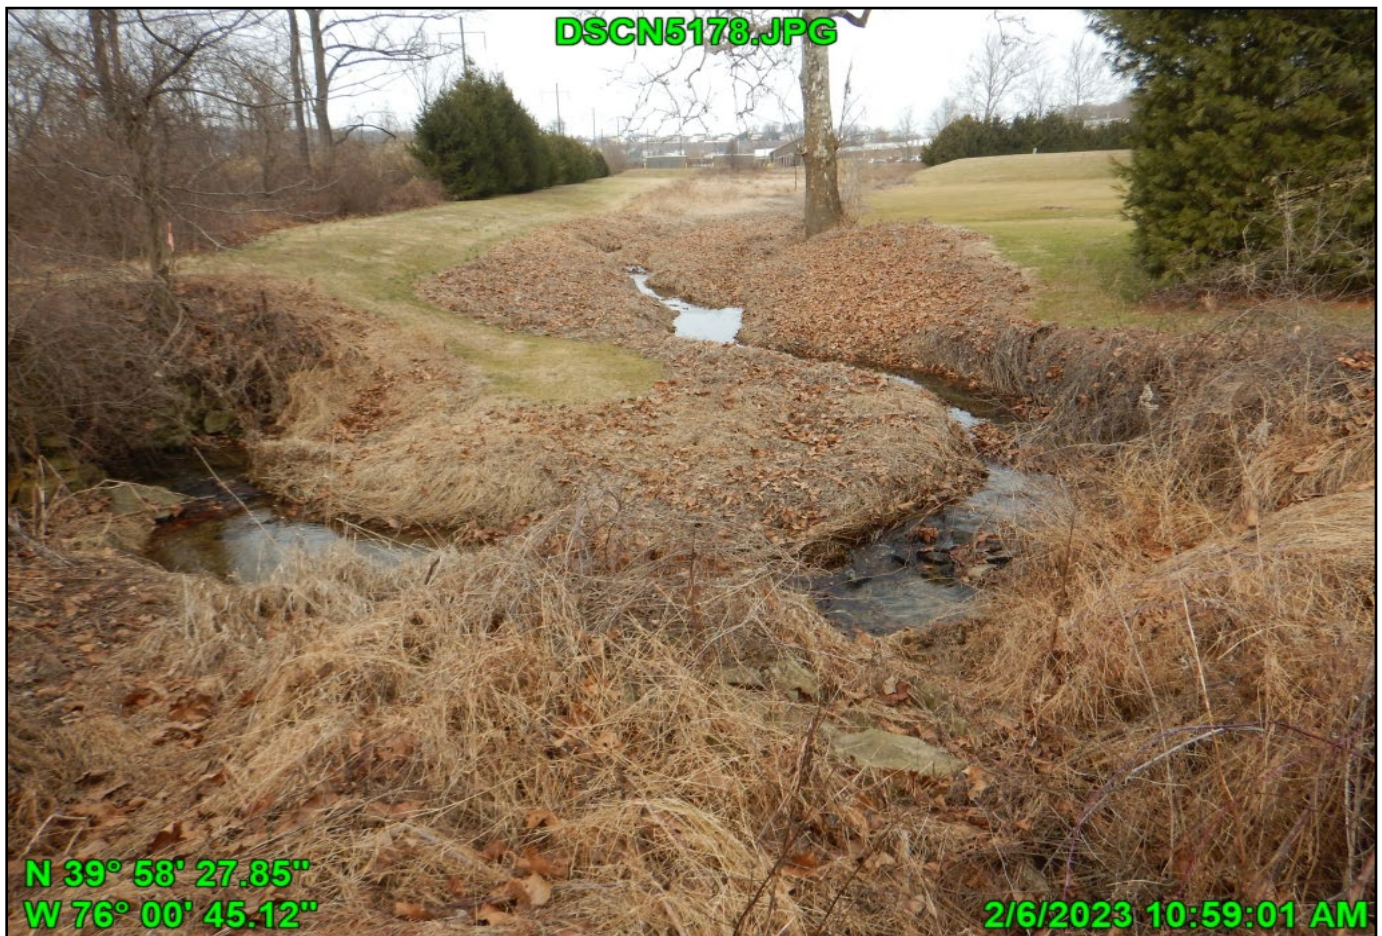
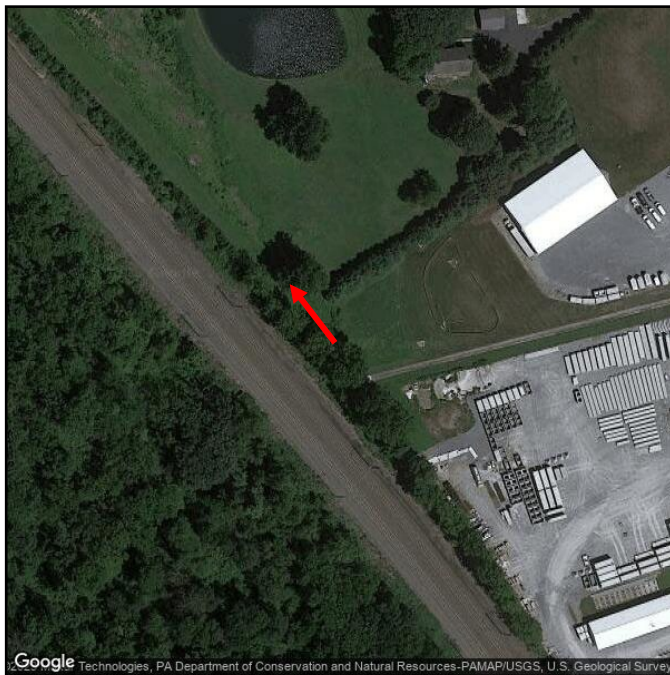
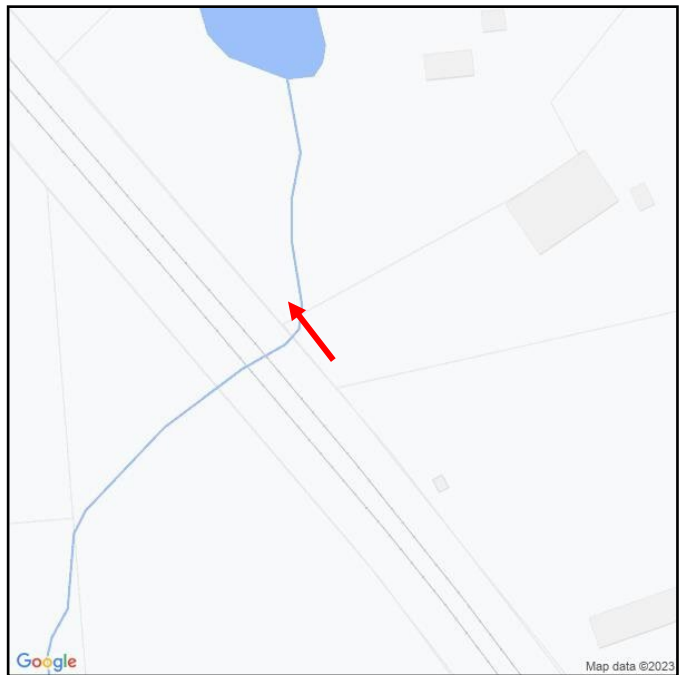
| Description | Unnamed tributary to Williams Run adjacent to the Facility shown in Photograph DSCN5177. |
