**Region 6 Compliance Assurance and Enforcement Division  
INSPECTION REPORT**

| Regulatory Program(s) | NPDES - Oil and Gas, Produced/Brine Water | | |
| Company Name: | <b>Belva Oil L.L.C.</b> | | |
| Facility Name: | <b>Taylor 2 Lease</b> | | |

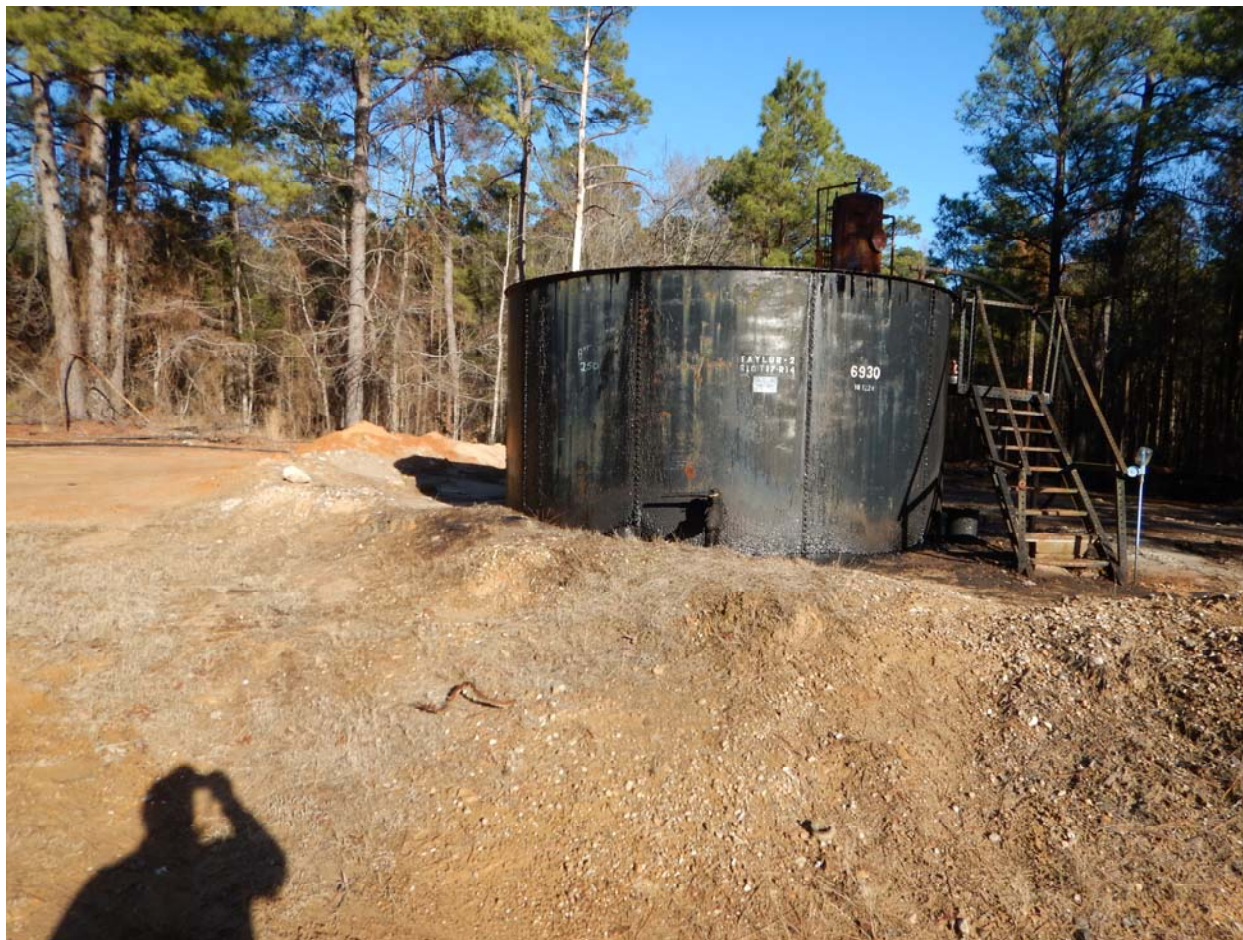
Photo No. 1

Photograph File Name: DSCN3281.JPG  
Date of Photograph: 02/20/2018  
Latitude: 33.254899 N  
Longitude: -92.534644 W  
Orientation: W  
Map Datum: WGS-84  
Time of Photo: 04:55 AM  
Photographer: Jack Arias  
Description: This image shows the sign and tank at Belva Oil, LLC – Taylor 2 lease.

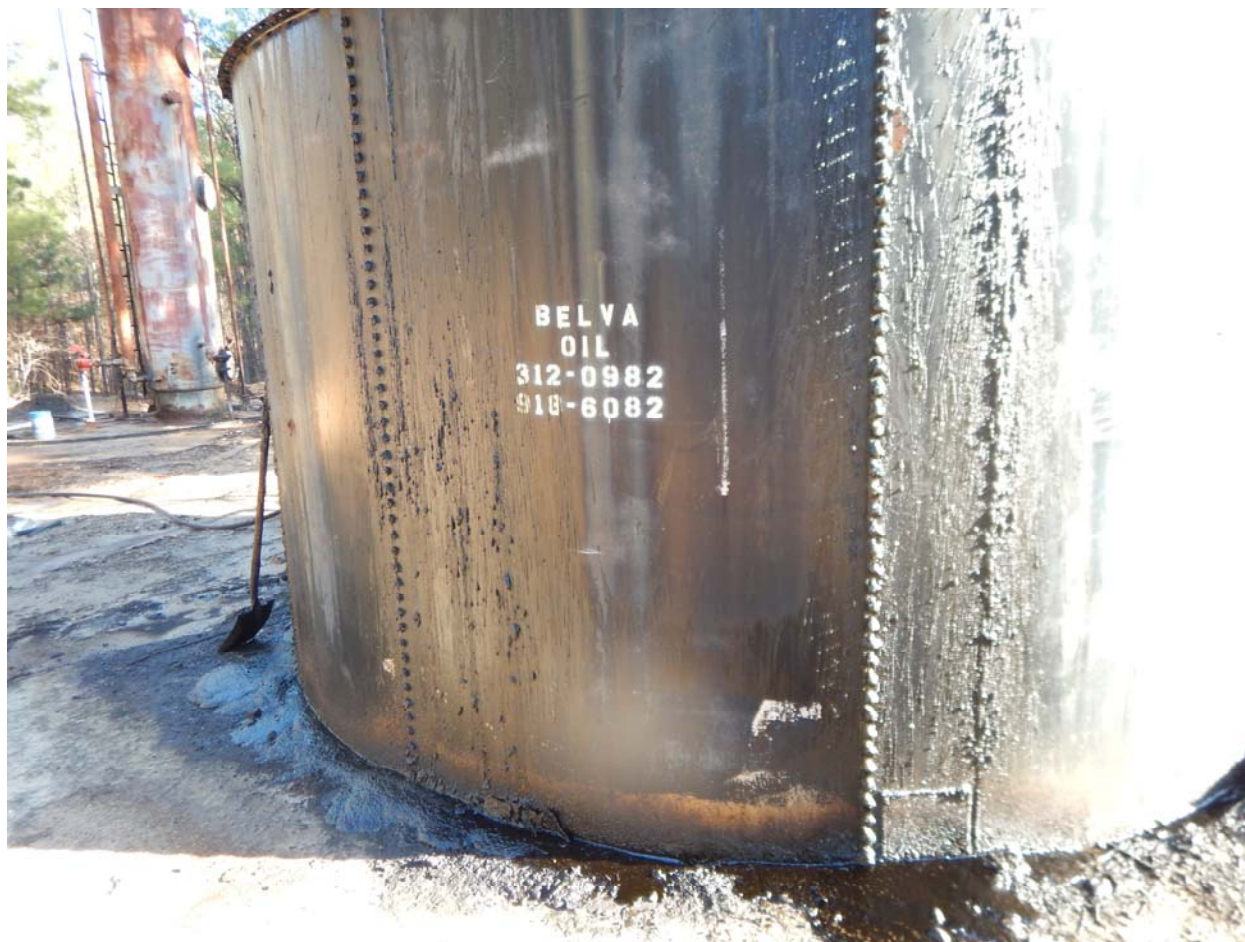
Photo No. 2

Photograph File Name: DSCN3279.JPG  
Date of Photograph: 02/08/2018  
Latitude: 33. 254899 N  
Longitude: -92. 534644 W  
Orientation: W  
Map Datum: WGS-84  
Time of Photo: 04:55 PM  
Photographer: Jack Arias  
Description: This image shows the sign at Belva Oil, LLC – Taylor 2 Lease and a pool of fluids around the tank inside the containment area.

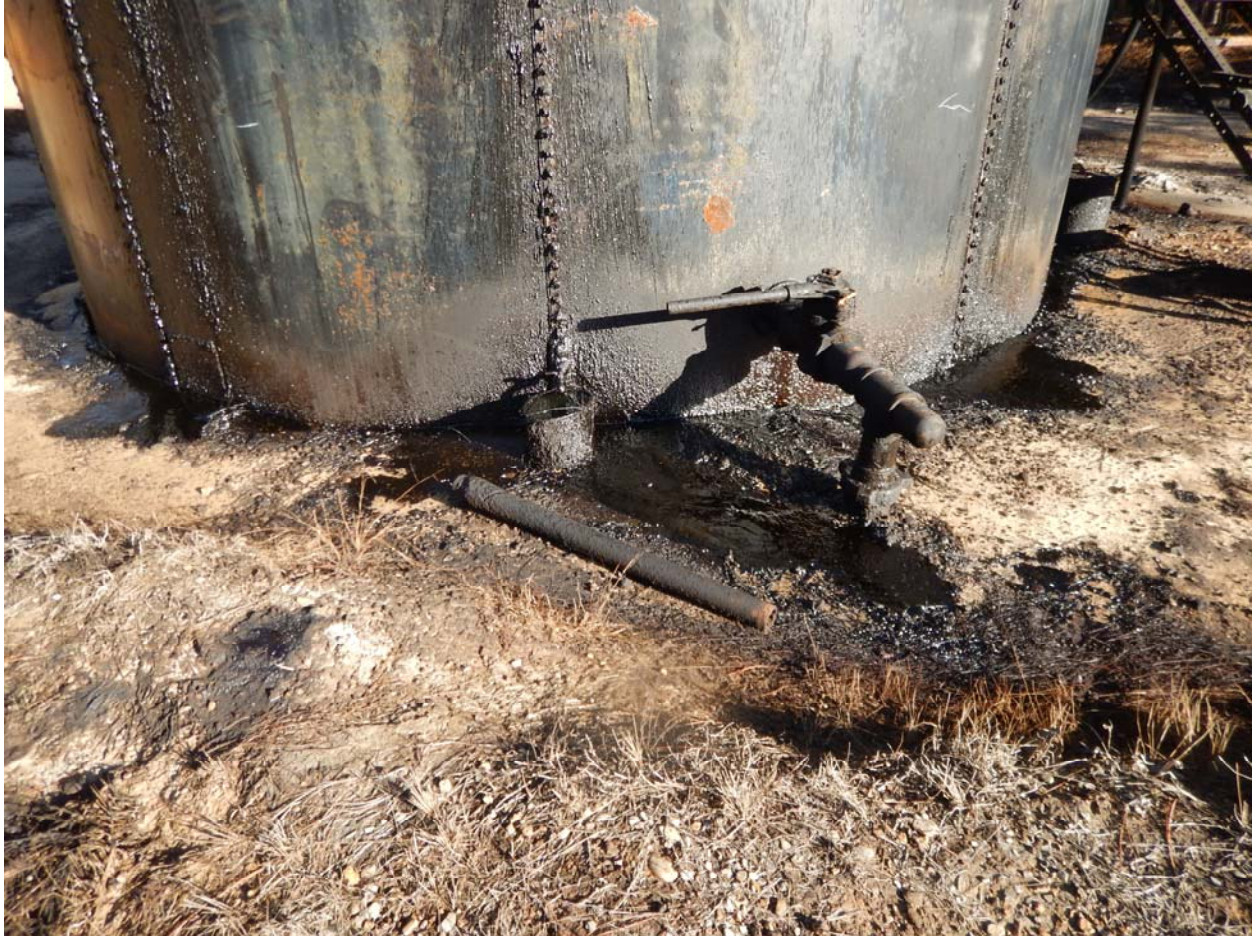
Photo No. 3

Description: This image shows an oil storage tank, a pool of fluids inside the containment area, oil staining in the containment area and tank, visible erosion on the containment wall, and corrosion on tanks and flowlines.

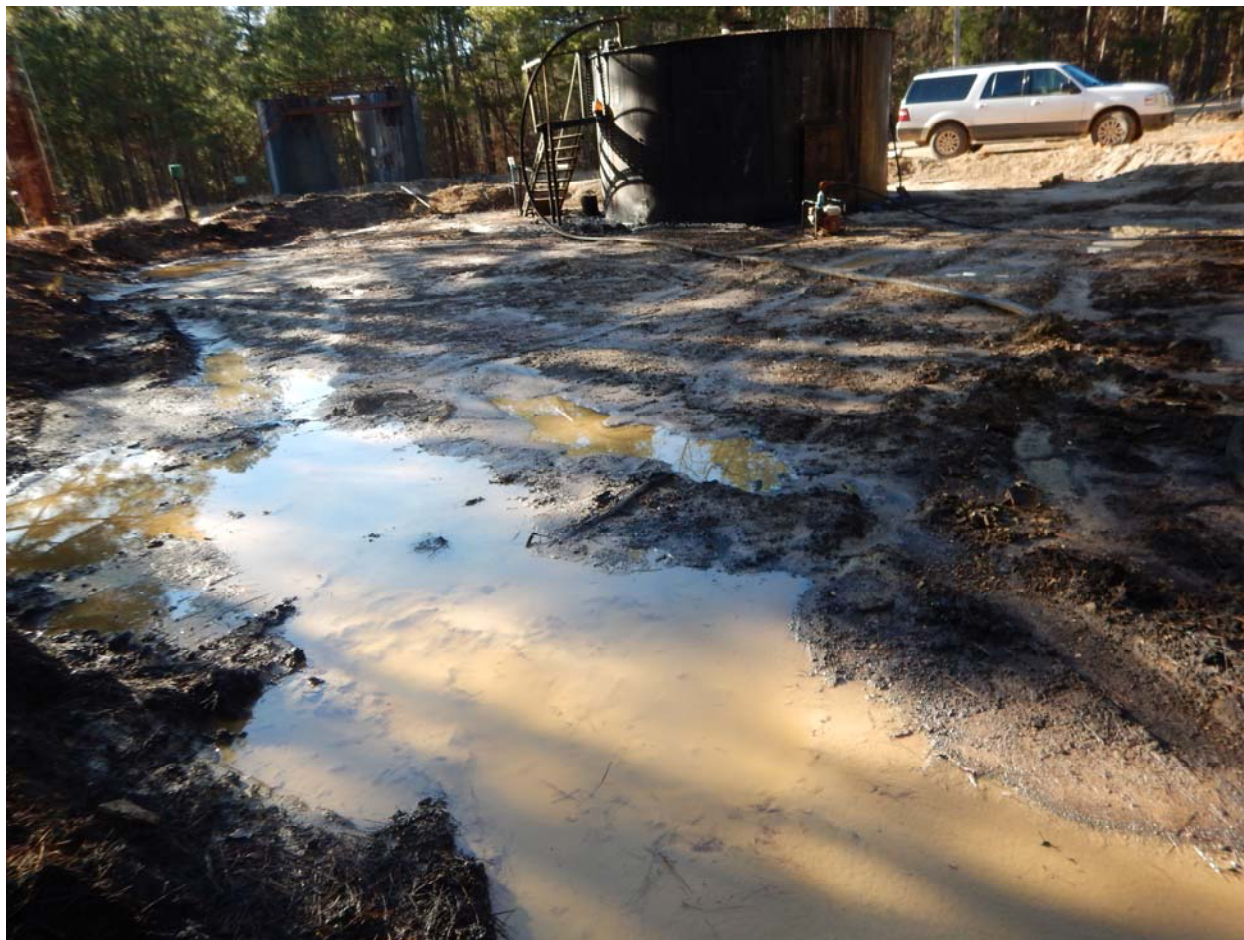
Photo No. 4

When I arrived at this facility on February 08, 2018, at around 4:47 pm, I conducted a preliminary evaluation of the tanks and the secondary containment wall conditions. I observed that the facility had an inadequate raised secondary containment wall around the oil and heater treater separator. I observed visible erosion on the containment wall; oil staining and produced water pools in and out the containment area; oil and produced water leaks from tanks and lines; and visible corrosion on tanks and flowlines. At the time of the inspection, I observed that the heater treater separator was open at the bottom of the tank (lowest point of the tank) and all fluids were discharged out of the tank. I observed oil, produced water, sediments fully saturated with oil, and a flow path of fluids out of the containment area. Also at the north west corner of the wall, I observed the existence of a trench and a drain flowline installed over the trench and containment area. The trench allowed fluids to flow out of the containment area. I observed a flowpath of fluids going downhill and downstream from the facility to the tributary of Mill Creek. Also, I observed visible oil staining and dead vegetation downstream along the flow path (See Photo Nos. 2 – 8 in Appendix 1).

Description: This image shows the existence of fluids inside the containment area near the oil tank. Also, I observed that the facility had an inadequate size and elevation of raised secondary containment wall around the oil tank.

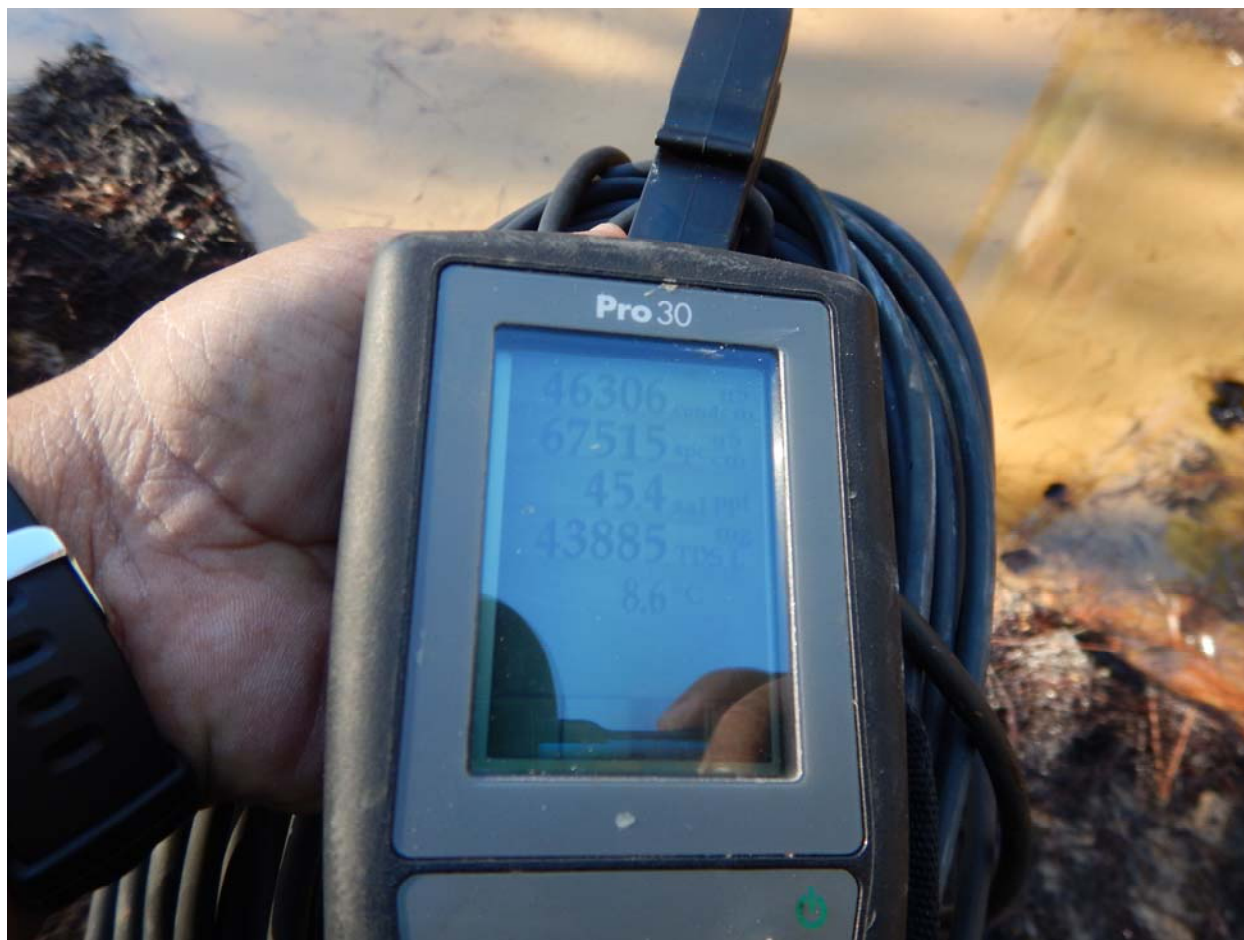
Photo No. 5

Using a calibrated YSI 30 Pro Conductivity Meter (EPA #00000), at the point source of contamination (next to the facility's separator), at latitude 33.254667 N and longitude -92.534389 W, I took a Total Dissolved Solids (TDS) measurement of 43,885 parts-per-million (ppm) inside the containment area near the separator and trench I observed oil staining and pool of fluids inside and outside the containment area (See Photo Nos. 5 – 6 in Appendix 1).

Photograph File Name: DSCN3262.JPG  
Date of Photograph: 02/08/2018  
Latitude: 33.254899 N  
Longitude: -92.534644 W  
Orientation: SW  
Map Datum: WGS-84  
Time of Photo: 04:47 PM  
Photographer: Jack Arias  
Description: This image shows a Total Dissolved Solids (TDS) measurement of 43,885 ppm in the containment area near the heater treater separator.

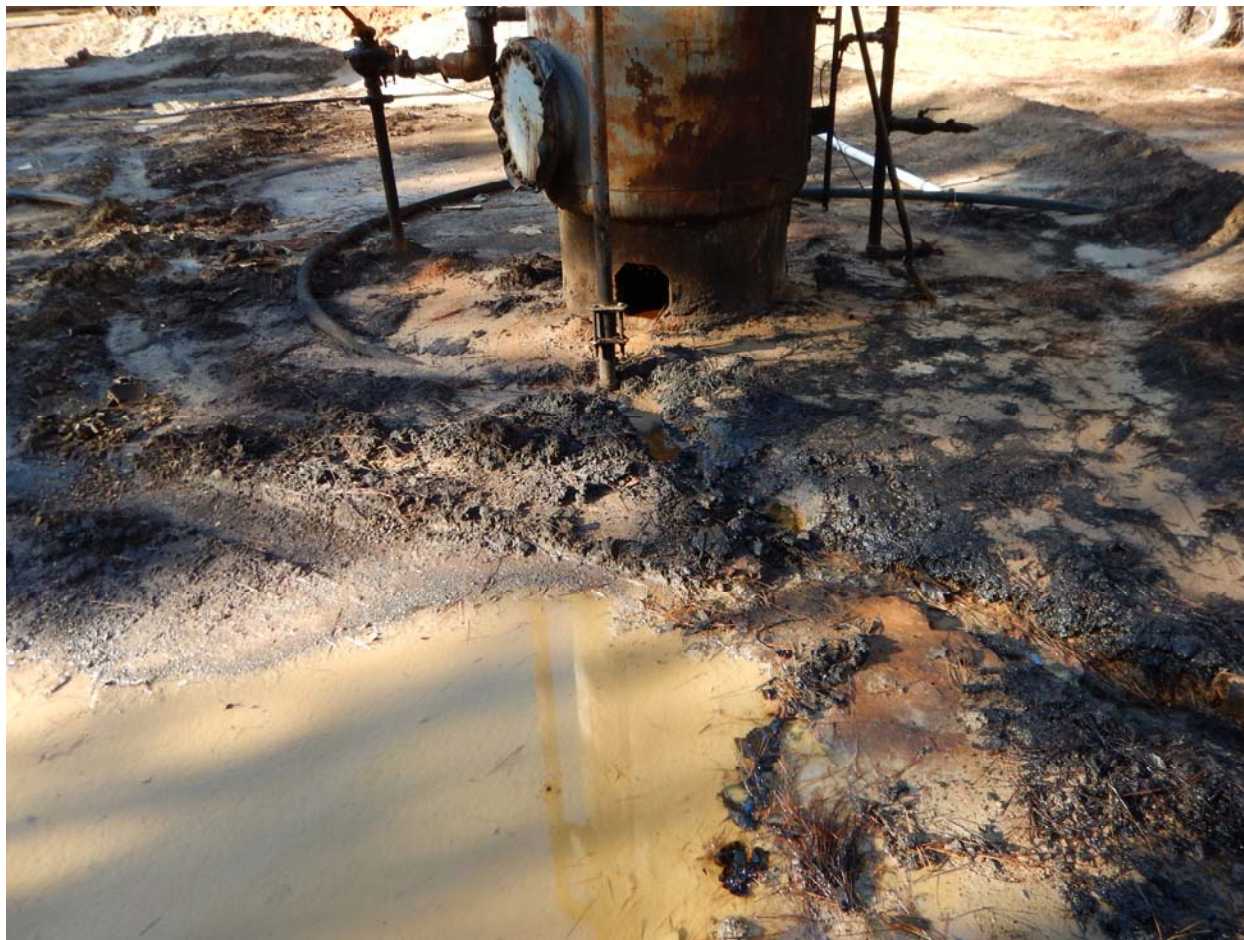
Photo No. 6

Description: This image shows that the heater treater separator was open at the bottom of the tank (lowest point of the tank) and all fluids were discharged out of the tank. I observed oil, produced water, sediments fully saturated with oil, and a flow path of fluids out of the containment area.

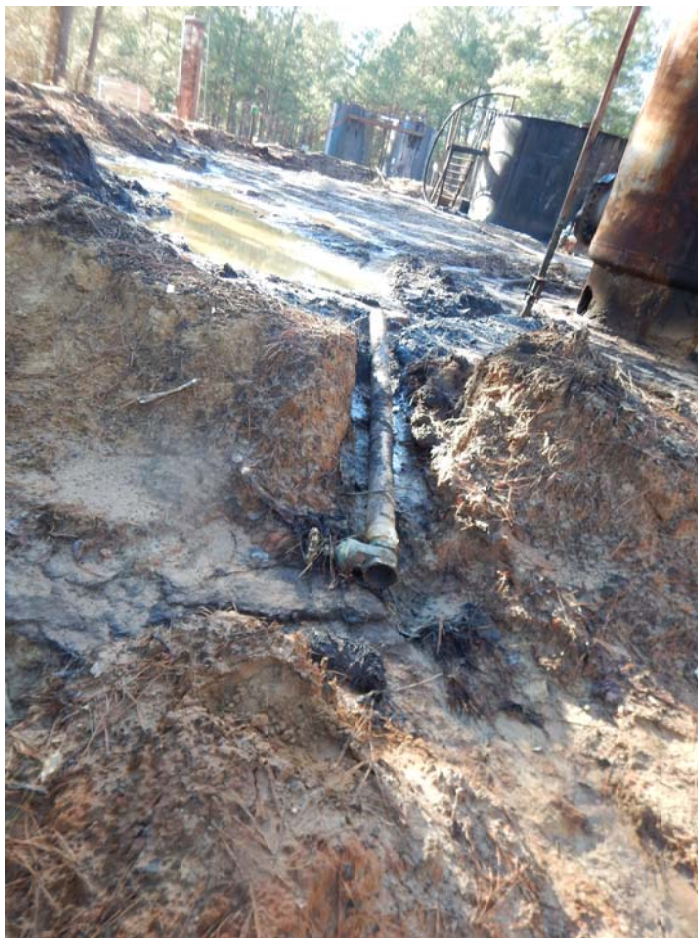
Photo No. 7

Description: This image shows the existence of a trench and a drain flowline installed over the trench and containment wall. The trench allowed fluids to flow out of the containment area.

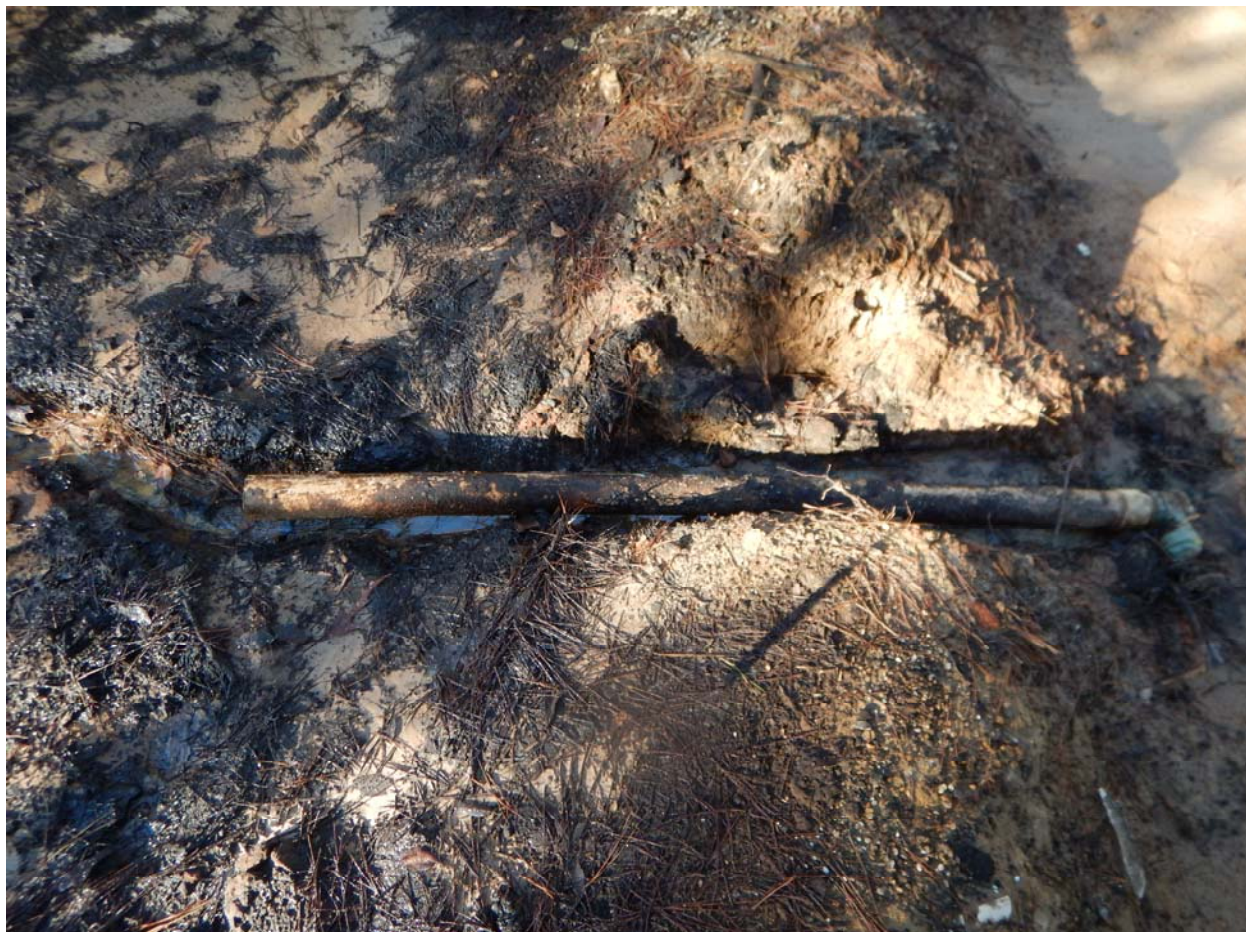
Photo No. 8

Description: This image shows the existence of a trench and a drain flowline installed over the trench and containment wall. The trench allowed fluids to flow out of the containment area.

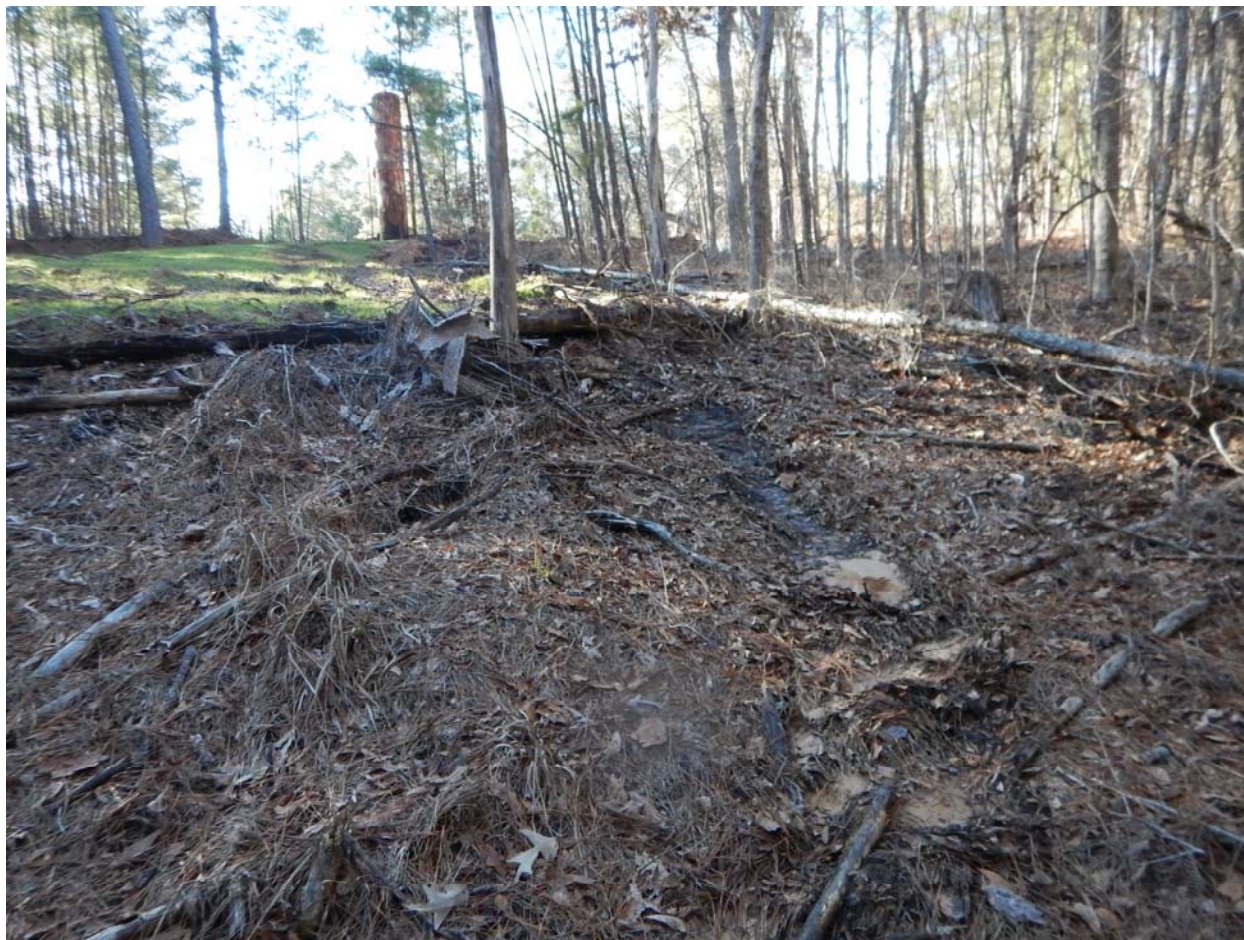
I followed the flow path of fluids downstream from the facility to Mill Creek and at approximately 165 feet from the facility to the tributary of Mill Creek, I identified the Point of Entry (POE) of fluids at latitude 33.254702 N and longitude -92.533788 W. At this point, using the calibrated YSI 30 Pro Conductivity Meter, I took a TDS measurement of 39,711 ppm. At the POE, I observed a clear flowpath of fluids, dead vegetation along the flowpath, defined bed and bank, high water marks, and debris along the tributary of Mill Creek and Mill Creek (See Photo No. 9 - 11 in Appendix 1).

Description: This image shows visible downstream flowpath of fluids, dead vegetation, and debris and oil along the along the flowpath.

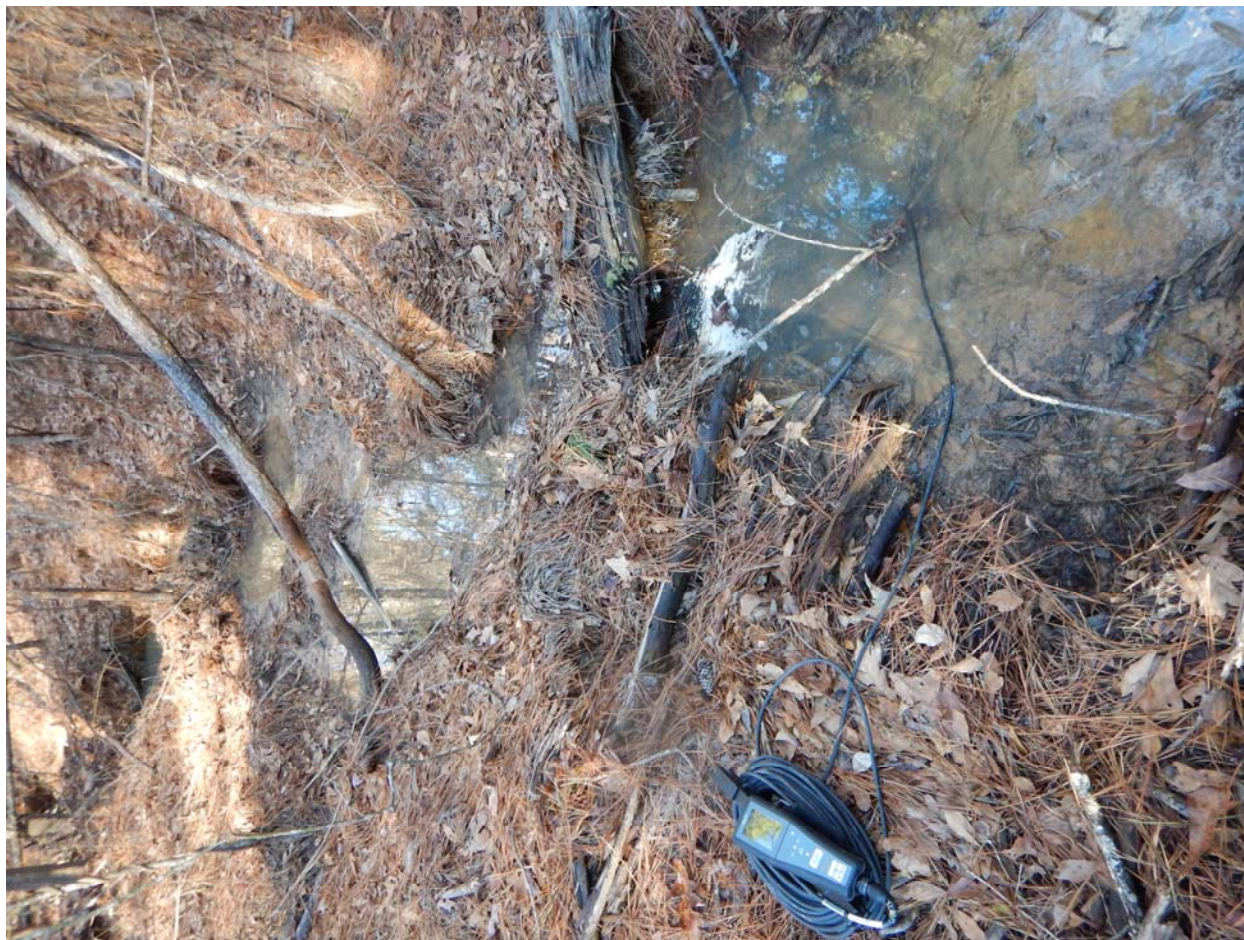
Photo No. 10

Description: This image shows visible downstream flowpath of fluids, dead vegetation, defined bed and bank, high water marks, and debris along the tributary of Mill Creek. It also identified the Point of Entry (POE) of fluids. At this point, using a calibrated YSI 30 Pro Conductivity Meter, I took a TDS measurement of 39,711 ppm.

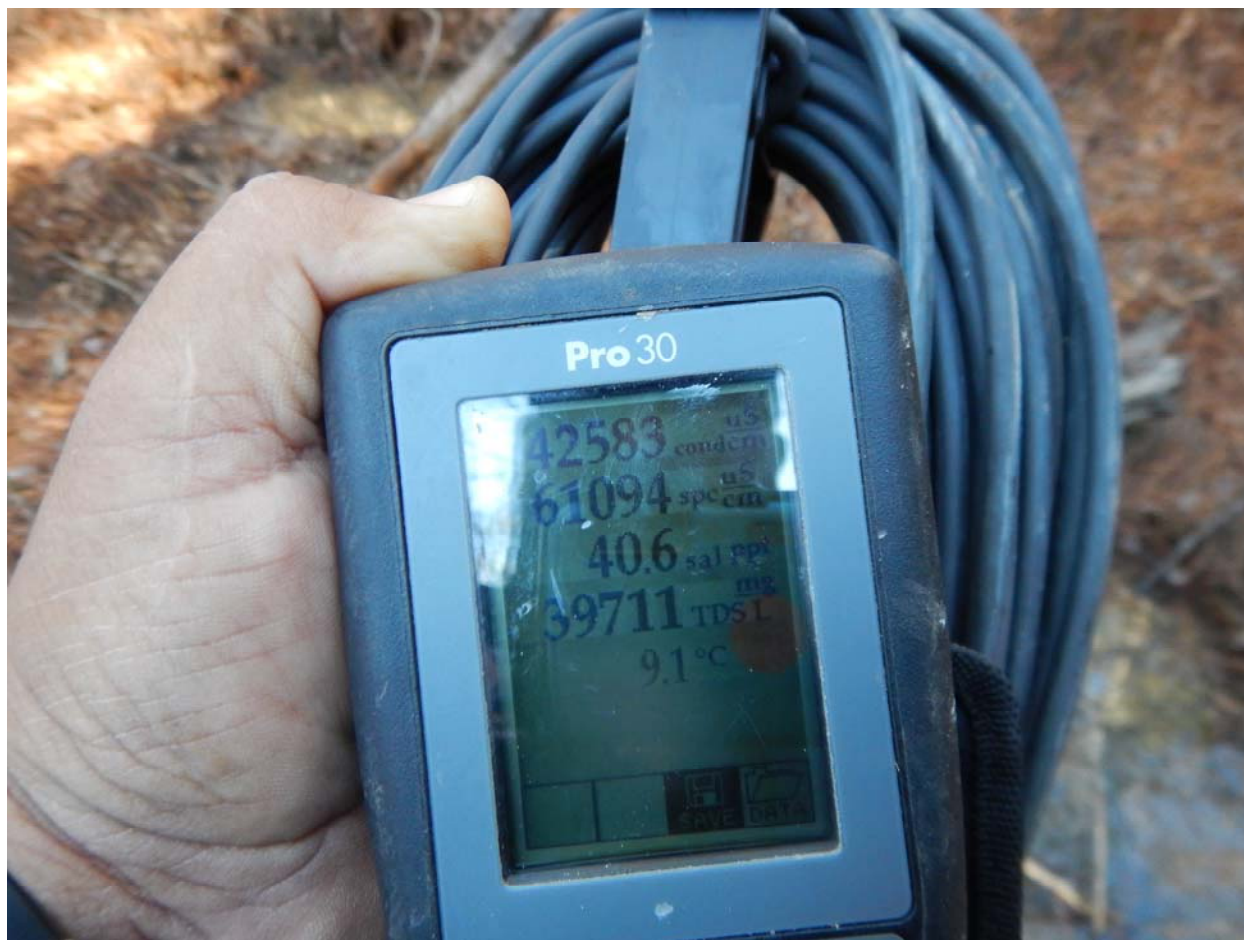
Photo No. 11

Description: This image shows visible downstream flowpath of fluids, dead vegetation, defined bed and bank, high water marks, and debris along the tributary of Mill Creek. It also identified the Point of Entry (POE) of fluids. At this point, using a calibrated YSI 30 Pro Conductivity Meter, I took a TDS measurement of 39,711 ppm.

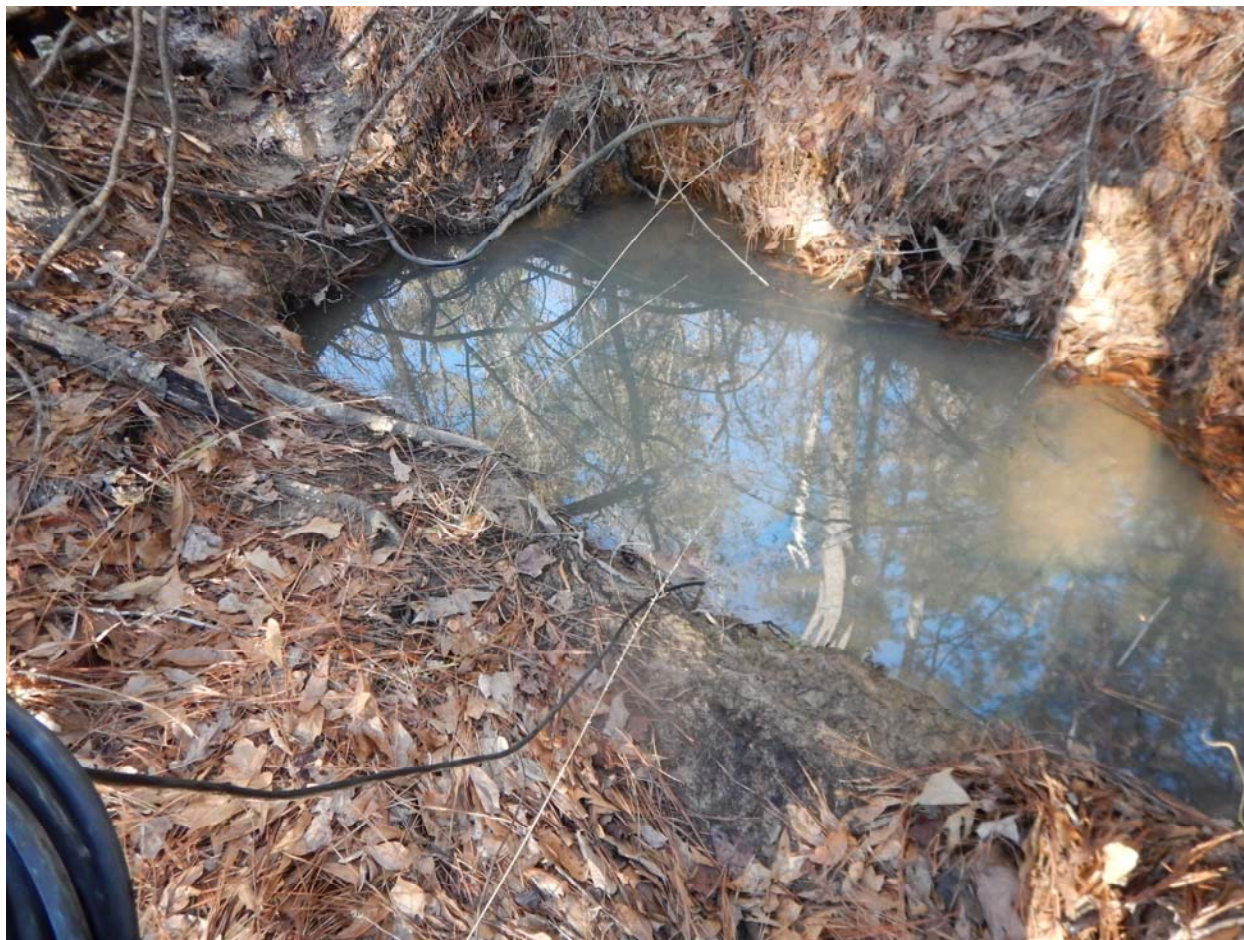
Photo No. 12

I followed the tributary downstream to determine if low lying areas and potential vegetation along the tributary were impacted by oil and produced water discharges. At approximately 66 feet downstream from the POE at latitude 33.254527 N and longitude -92.533815 W, I found a flow path of fluids with oil staining on vegetation, defined bed and bank, high water marks, and debris. At this point, using the calibrated YSI 30 Pro Conductivity Meter, I took a TDS measurement of 12,679 ppm (See Photo Nos. 12 - 13 in Appendix 1).

Photograph File Name: DSCN3271.JPG  
Date of Photograph: 02/08/2018  
Latitude: 33.254527 N  
Longitude: -92.533815 W  
Orientation: SW  
Map Datum: WGS-84  
Time of Photo: 04:50 PM  
Photographer: Jack Arias  
Description: This image shows a flow path of fluids with oil staining on vegetation and debris.

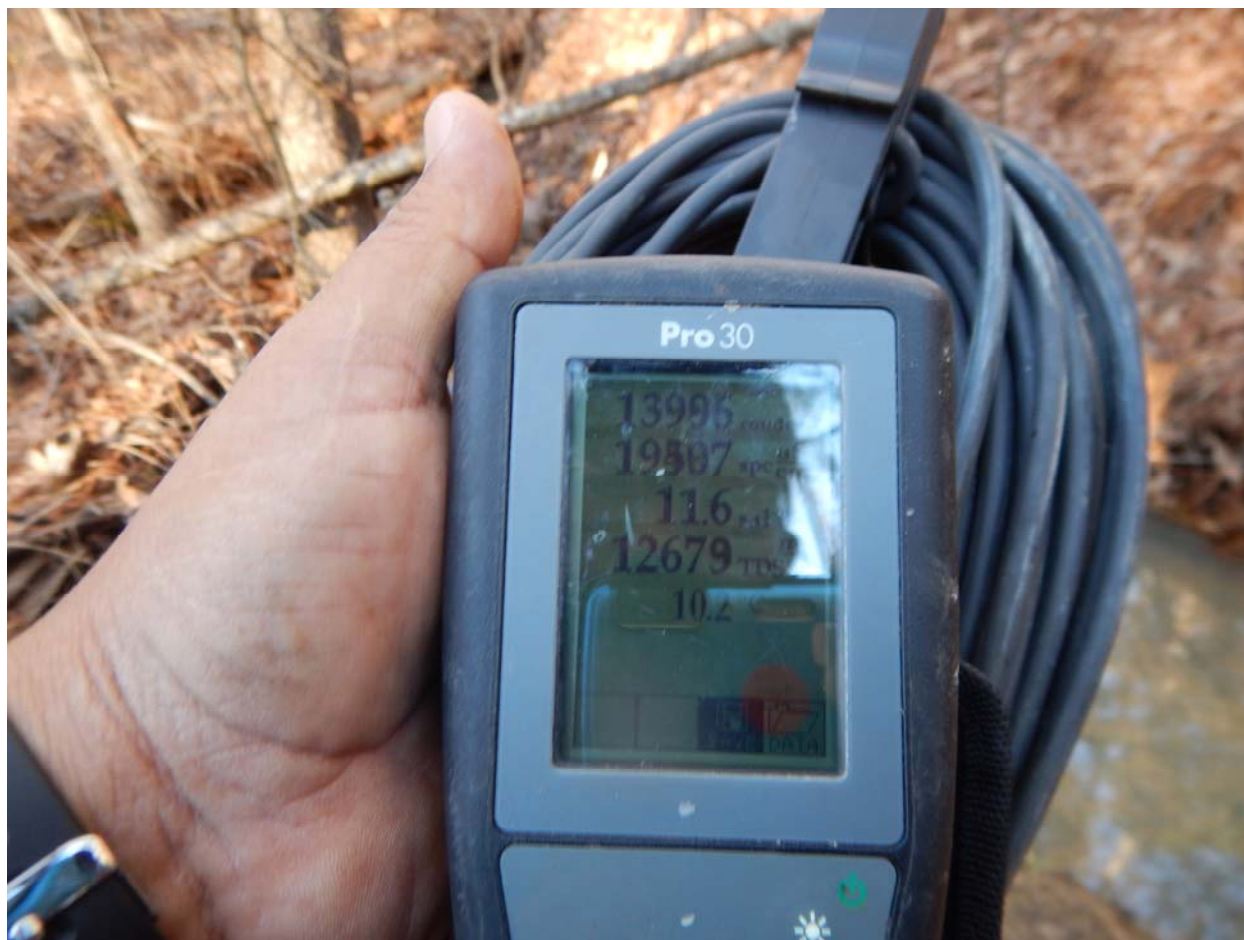
Photo No. 13

Description: This image shows a Total Dissolved Solids (TDS) measurement of 12,679 ppm at approximately 66 feet downstream from the POE.

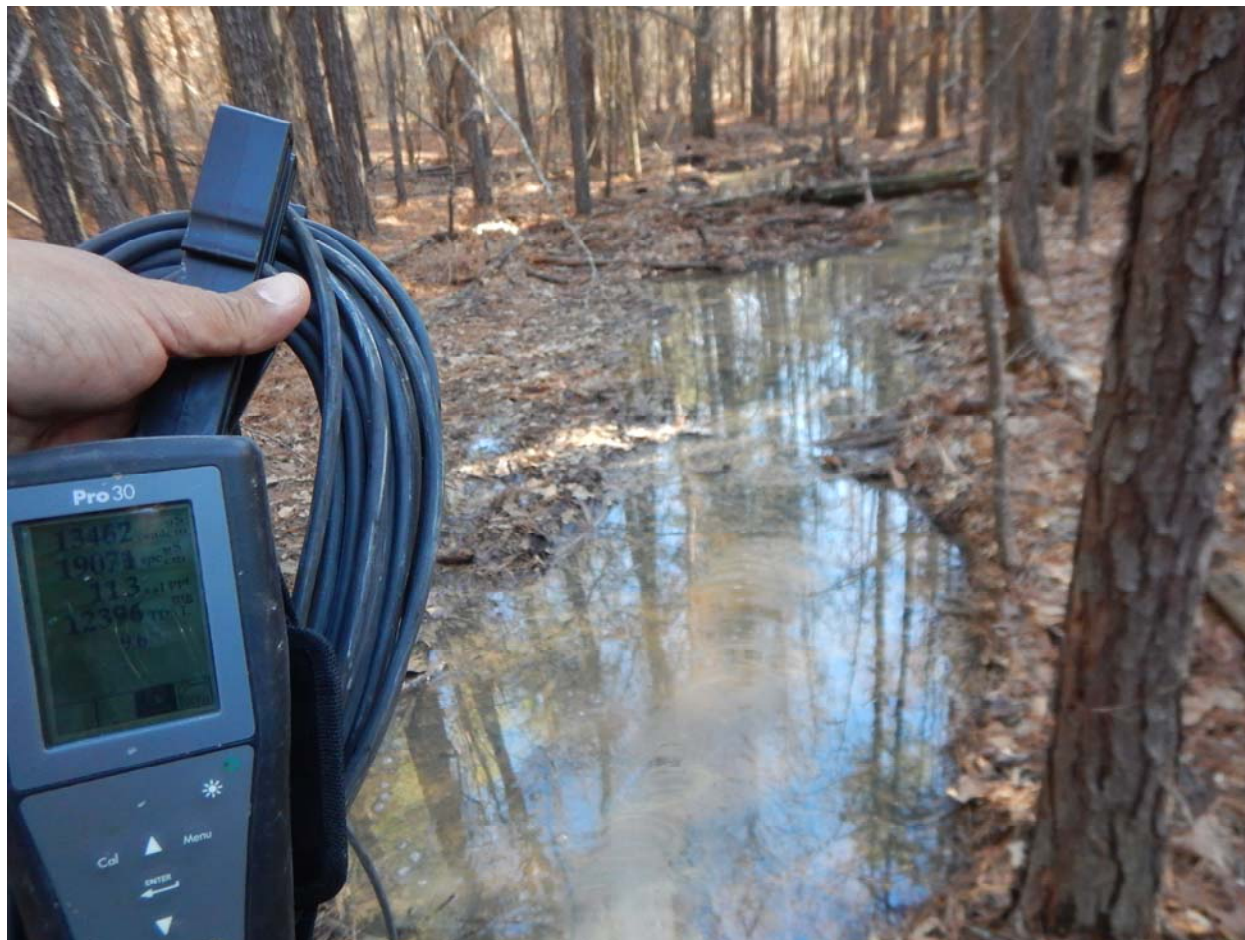
Photo No. 14

Description: This image shows a Total Dissolved Solids (TDS) measurement of 12,396 ppm at approximately 70 feet downstream from the POE, a flow path of fluids, dead vegetation, defined bed and bank, high water marks, and debris along the tributary of Mill Creek.

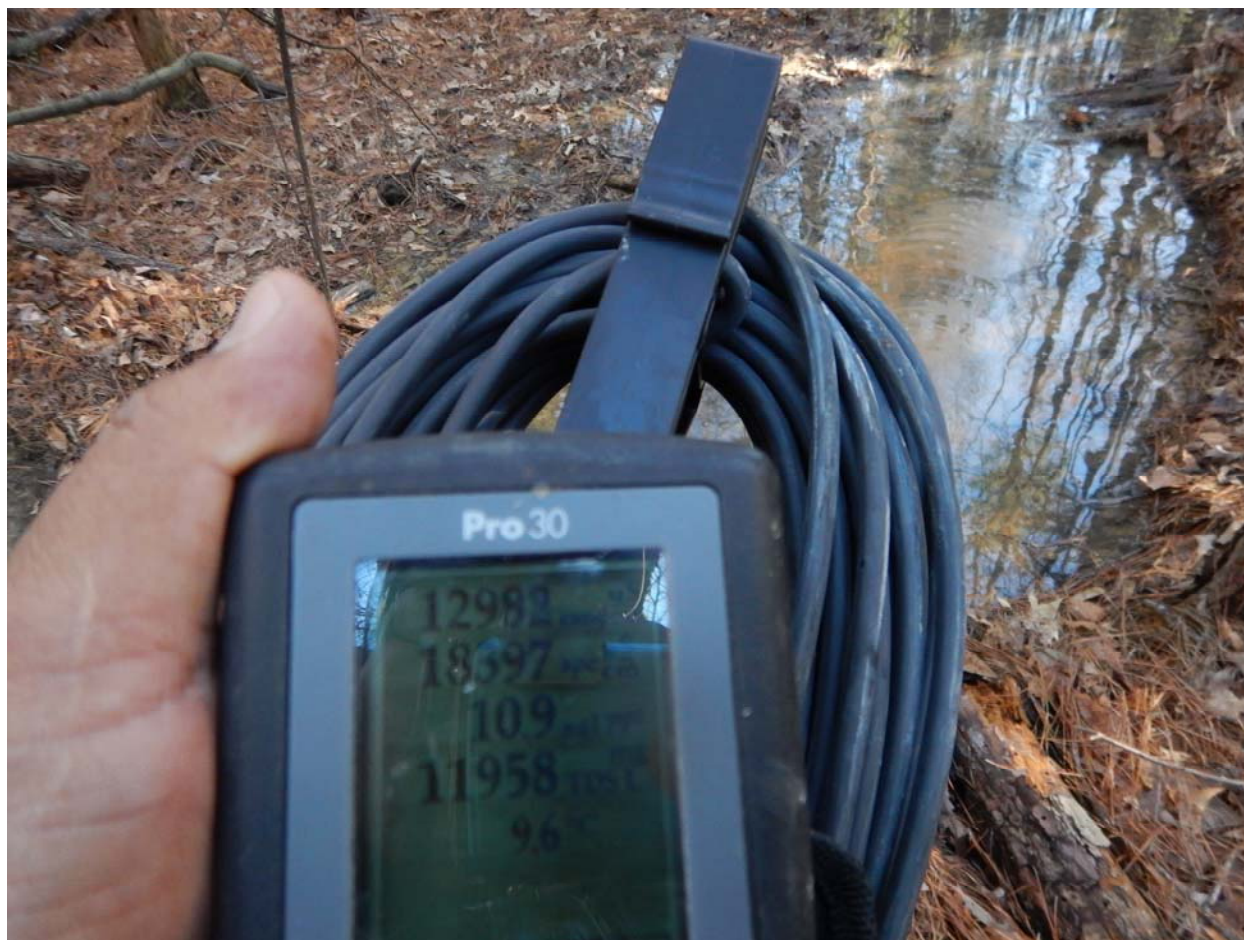
Photo No. 15

At approximately 166 feet downstream from the POE at latitude 33.254194 N and longitude -92.533583 W, I found a flow path of fluids with oil staining on vegetation, defined bed and bank, high water marks, and debris. At this point, using a calibrated YSI 30 Pro Conductivity Meter, I took a TDS measurement of 11,958 ppm (See Photo Nos. 15 in Appendix 1).

Photograph File Name: DSCN3272.JPG  
Date of Photograph: 02/08/2018  
Latitude: 33.254194 N  
Longitude: -92.533583 W  
Orientation: NE  
Map Datum: WGS-84  
Time of Photo: 04:51 PM  
Photographer: Jack Arias  
Description: This image shows a Total Dissolved Solids (TDS) measurement of 11,958 ppm at approximately 166 feet downstream from the POE.

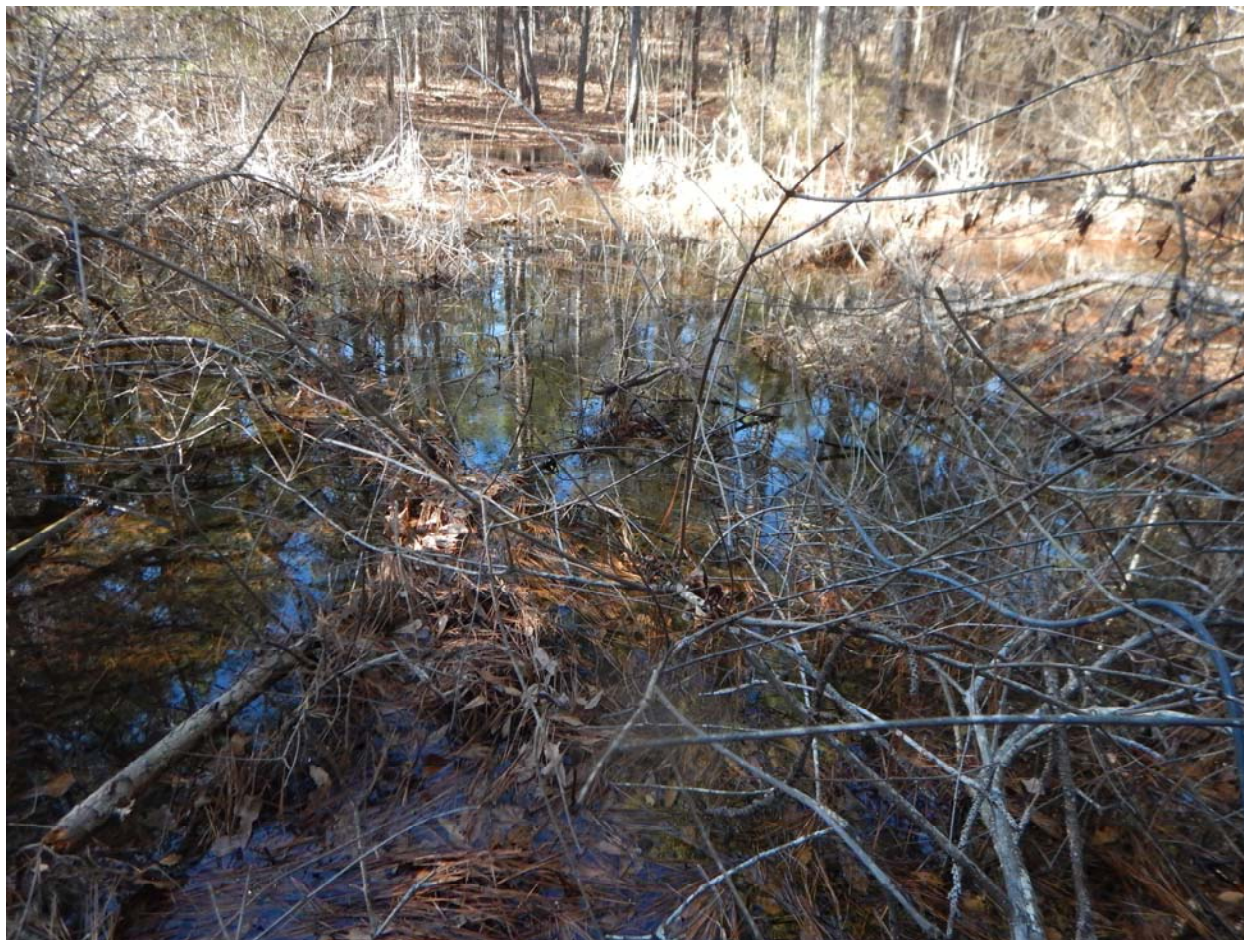
At approximately 487 feet downstream from the POE at latitude 33.253483 N and longitude -92.533984 W, I found a flow path of fluids with oil staining on vegetation and debris. At this point, using the calibrated YSI 30 Pro Conductivity Meter, I took a TDS measurement of 9,819 ppm (See Photo No. 16 – 17 in Appendix 1).

Description: This image shows at approximately 487 feet downstream from the POE at a flow path of fluids with oil staining on vegetation and debris.

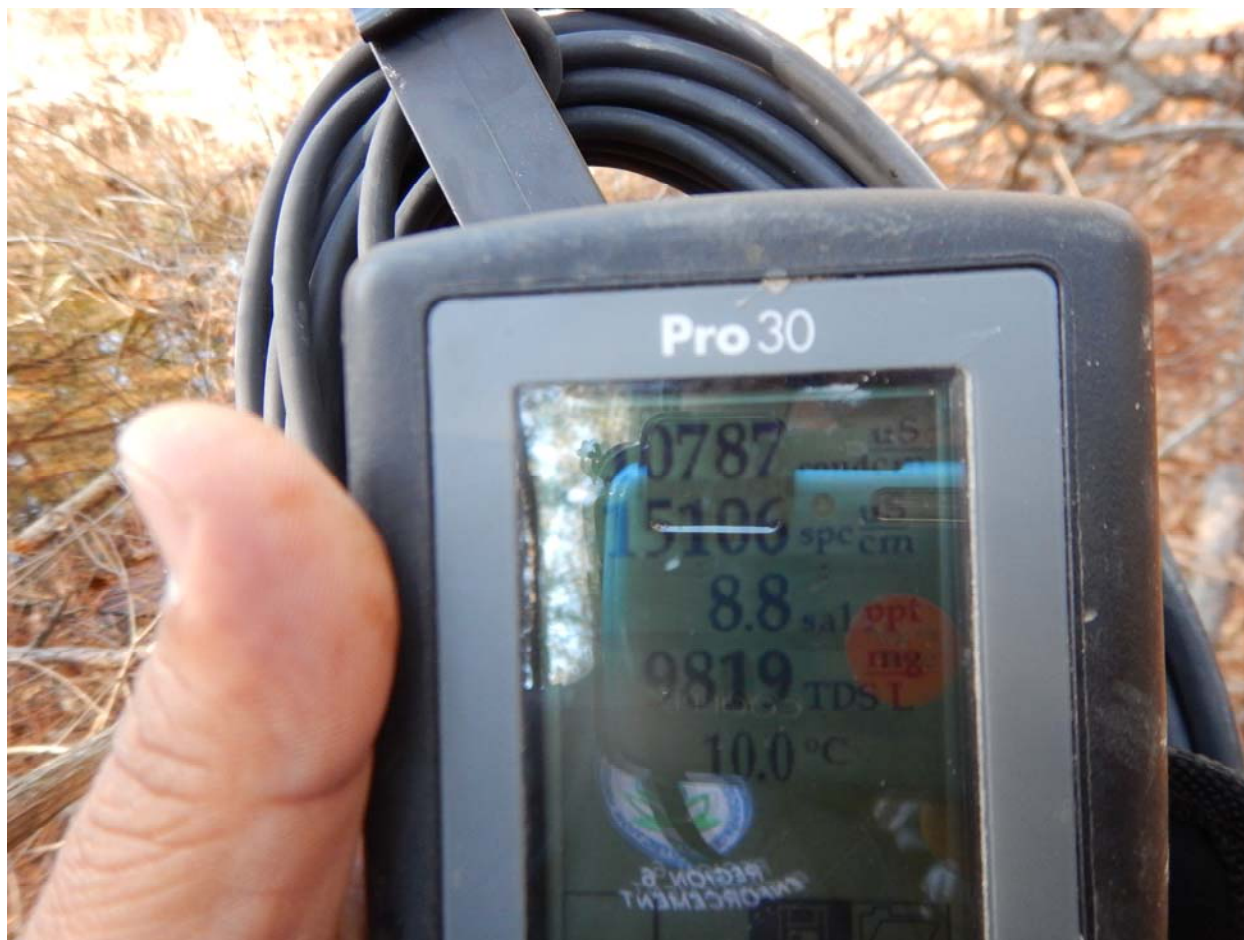
Photo No. 17

Description: This image shows a Total Dissolved Solids (TDS) measurement of 9,819 ppm at approximately 487 feet downstream from the Point of Entry (POE) to the tributary of Mill Creek.

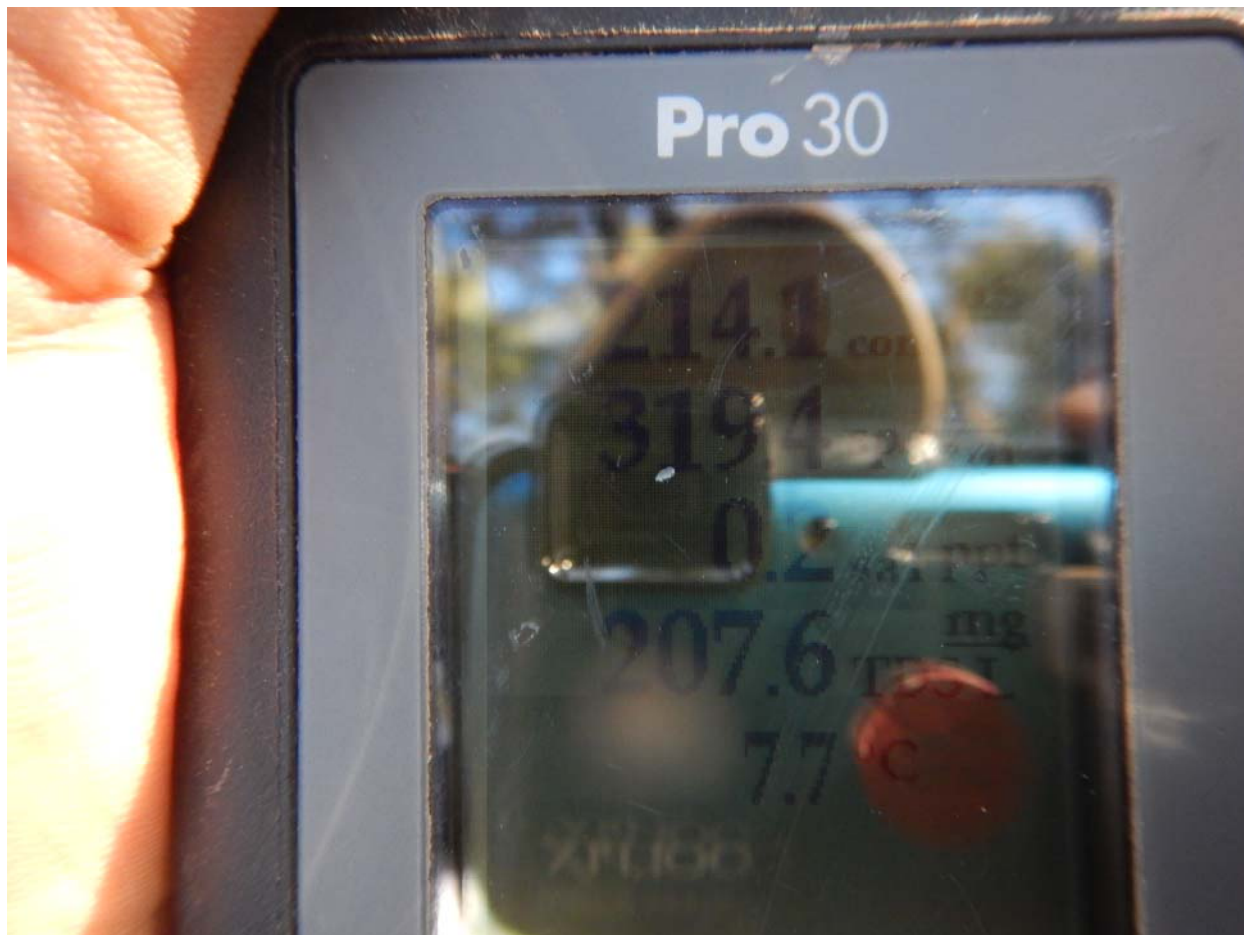
I followed the tributary upstream to determine if higher lying areas of the tributary were impacted by oil and produced water discharges and to obtain TDS background information. Therefore, at approximately 0.18 miles upstream from the point between tributary of Mill creek and mill Creek at latitude 33.25450 N and longitude -92.53654 W, I took a TDS reading of 207.6 ppm. We observed defined bed and bank, high water marks, debris, and riparian vegetation and plants growing along the tributary (See Photo No. 18 in Appendix 1).

Description: This image shows a Total Dissolved Solids (TDS) measurement of 207.6 ppm at approximately 792 feet upstream from the Point of Entry (POE) to the tributary of Mill Creek.
