**CLEAN WATER ACT COMPLIANCE EVALUATION INSPECTION REPORT  
U.S. ENVIRONMENTAL PROTECTION AGENCY  
REGION 5**

**Purpose:** Compliance Evaluation and Stormwater Inspection

**Facility:** U.S. Department of the Navy (Navy)  
Naval Surface Warfare Center, Crane Division (NSWC Crane)

**Date of Inspection:** February 7-9, 2023

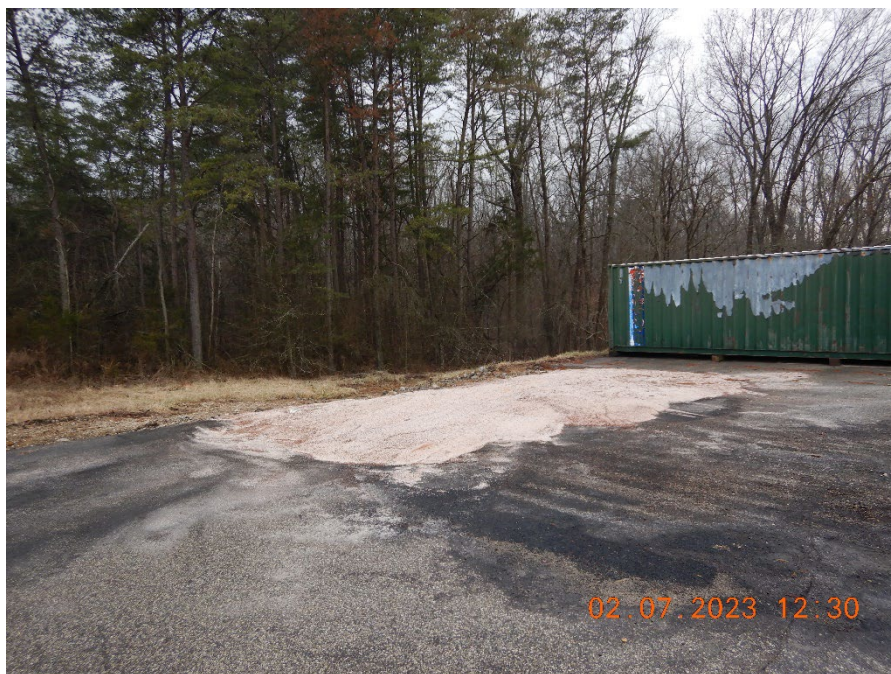
2: DSCN1128

2. Sand covering the location of the fire was present in stormwater runoff.
3. CAAA or NSWC Crane did not perform a complete hazard assessment for the storage of red phosphorus, as reflected in the standard operating procedures present at the time of the fire, until after the fire occurred.

Description: Sand cover at red phosphorus fire location with potential stormwater runoff

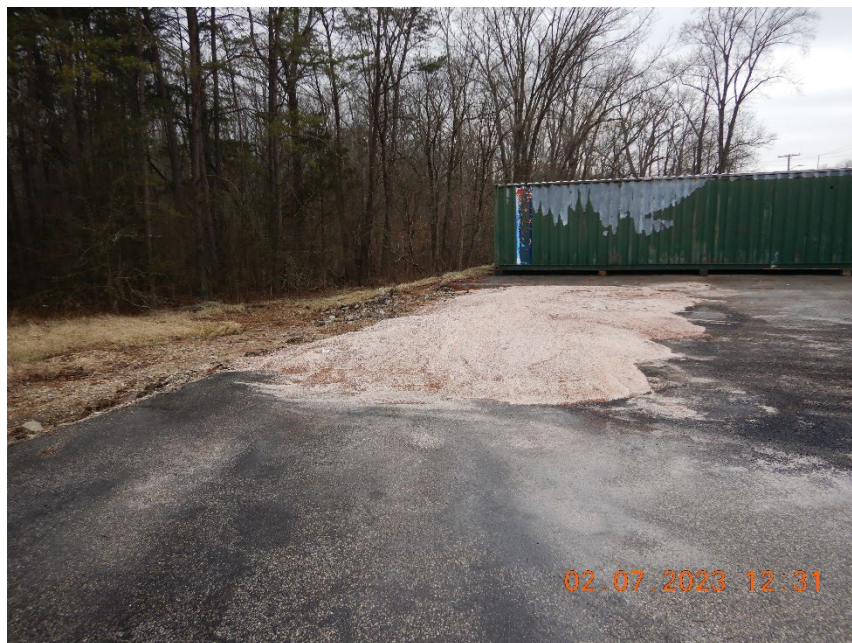
3: DSCN1129

Description: Sand cover at red phosphorus fire location with potential stormwater runoff

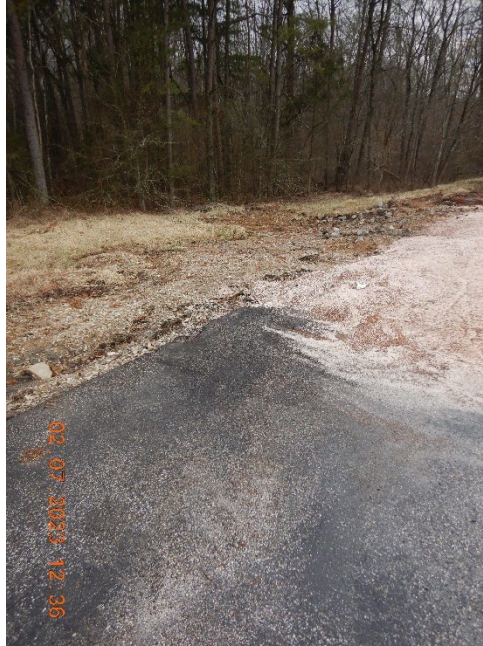
4: DSCN1130

Description: Sand cover at red phosphorus fire location overflowing into trench connected to a tributary of Boggs Creek

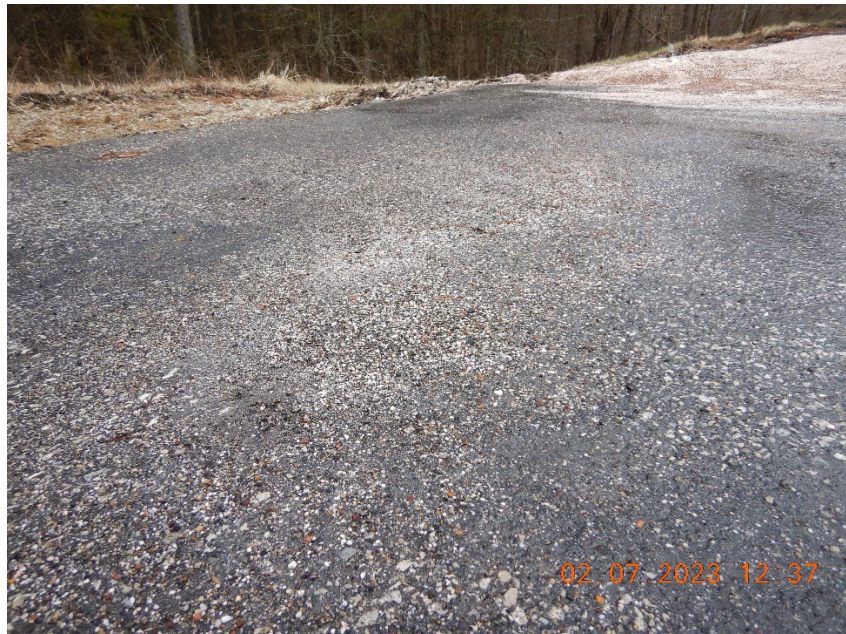
5: DSCN1131

Description: Closeup of sand particles spread on ground near sand cover

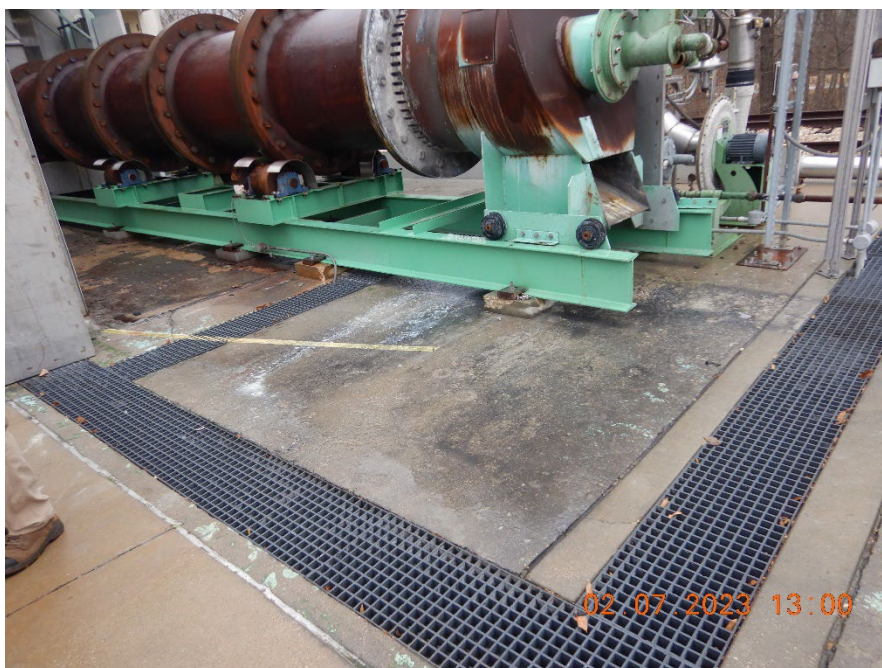
6: DSCN1132

We observed ash around the incinerator, which would be washed away with stormwater into a surrounding grate that goes to a sump to which all drains in the area are gravity fed (Photos 6-9). A facility representative confirmed that no overflow from process operations goes into this sump. Process water overflow goes to a phosphoric acid holding tank, and when that tank is two-thirds full, the water is pumped to a neutralization tank (Photo 10). An operator uses litmus strips to test the pH in the sump and does pH neutralization if necessary to bring the pH to 6.0 before pumping the water within to the sewer going to the WWTP. The majority of the time, CAAA will recycle the water back through the system to save the acid for reuse. At the time of the inspection, the neutralization tank was disconnected because the intermittent phosphoric acid production process was not running. CAAA will turn on the pump, which operates automatically when the water level in the sump reaches a set height, only after three tests of the pH show values in the proper range. Facility representatives stated that they have never seen the sump overflow, and during the inspection, the water level was several feet below the surface grate. According to Ms. Ranard, pumping records are not kept, and she did not know the last time it occurred.

Description: Rotary kiln incinerator for phosphorus with ash on ground

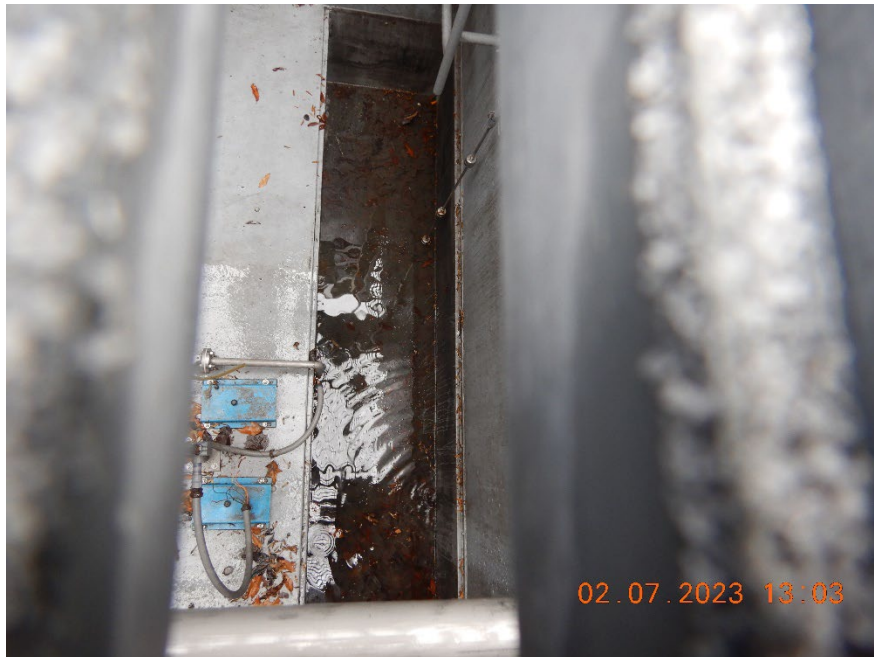
8: DSCN1134

Description: Sump with barrel on top for ash

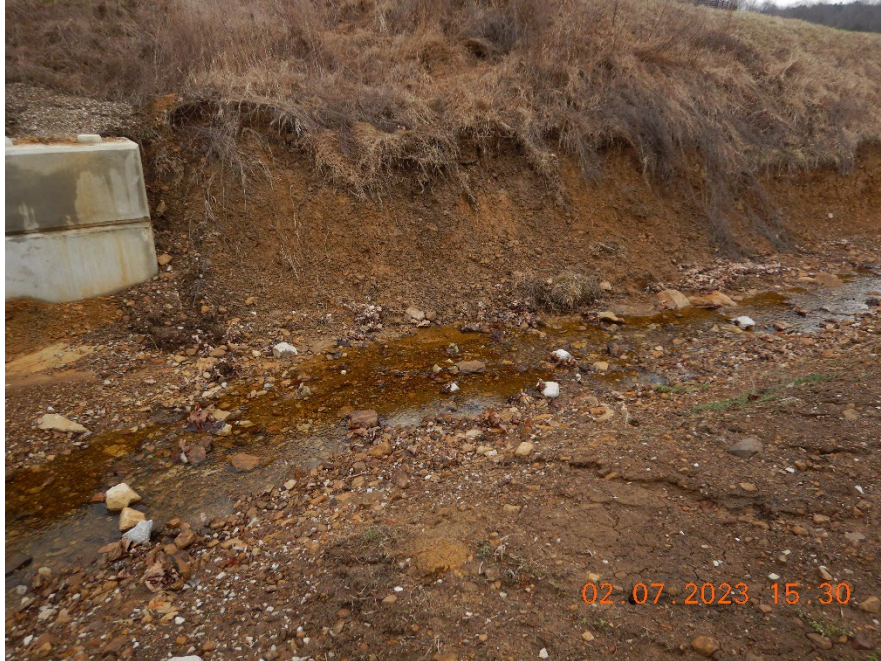
17: DSCN1143  
Description: Concrete blocks to combat erosion at stormwater trench from burn pits  
Location: ABG  
Camera Direction: Northeast  
Date/Time: 2/7/23, 3:30 p.m.

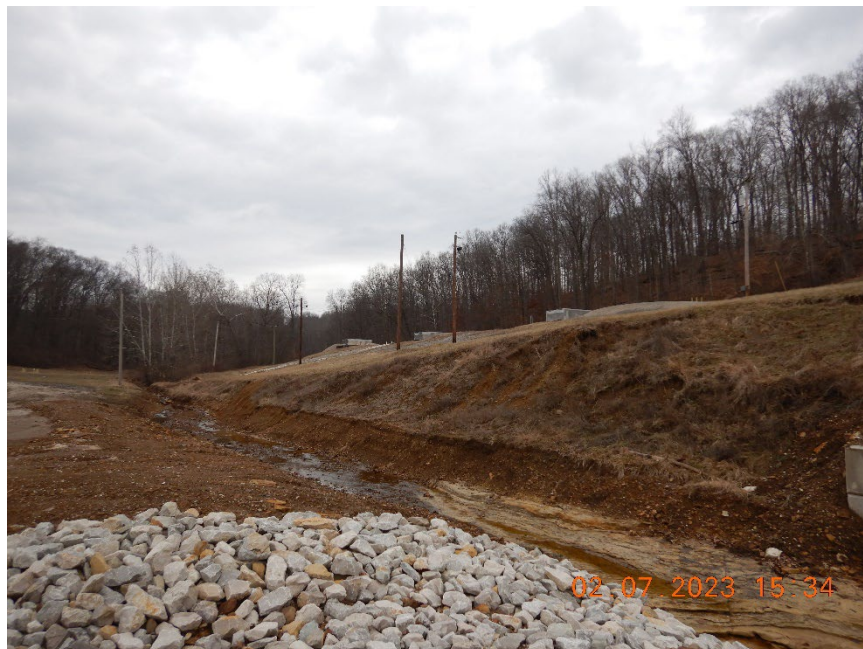
18: DSCN1144

Description: Erosion at stormwater trench from burn pits, east of Photo 17

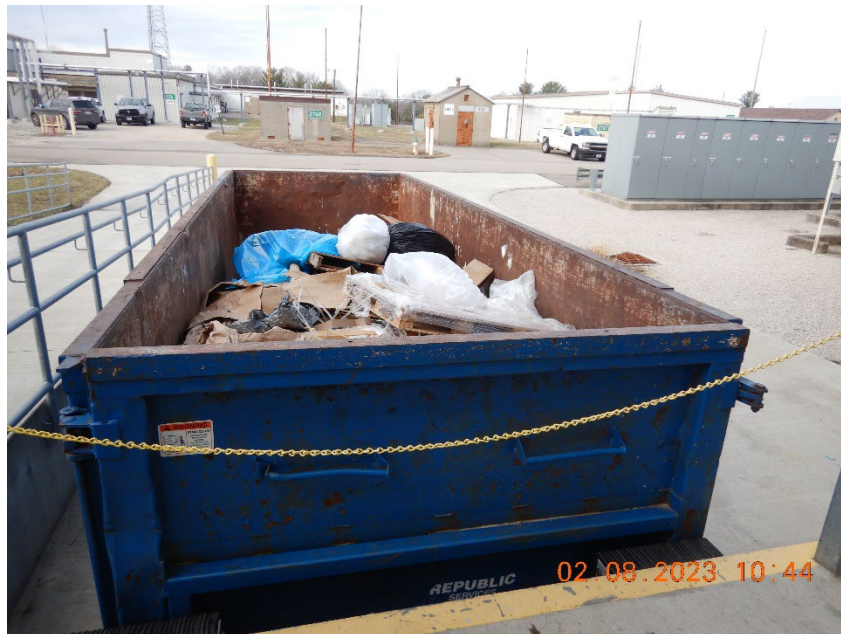
23: DSCN1149

At the loading dock outside the west side of Building 3637, we saw water on the ground around an uncovered dumpster going to a storm drain (Photos 23-26). The water had debris and the ground it covered appeared to be stained.

12. The NPDES permit erroneously states that the Outfall 101 discharge is limited to process wastewater from Building 3064 instead of Building 3637.
13. At the loading dock outside Building 3637, there was water on the ground, which appeared to be stained, around an uncovered dumpster going to a storm drain.

Description: Uncovered roll-off dumpster

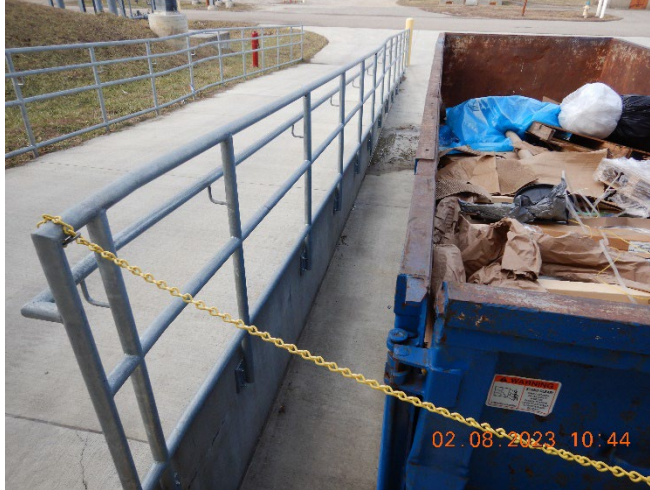
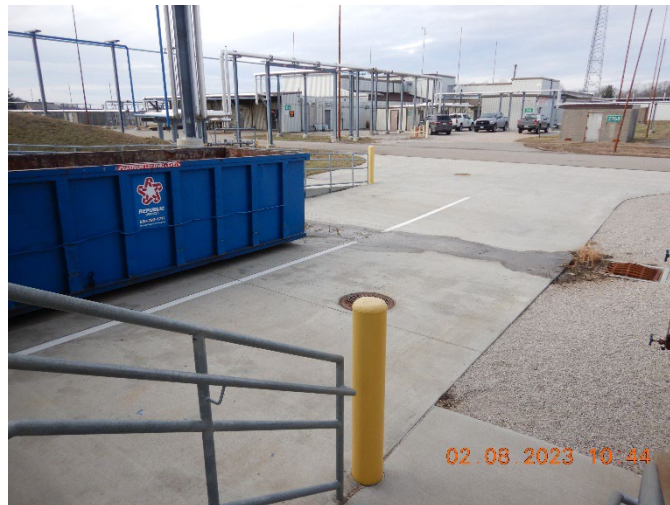
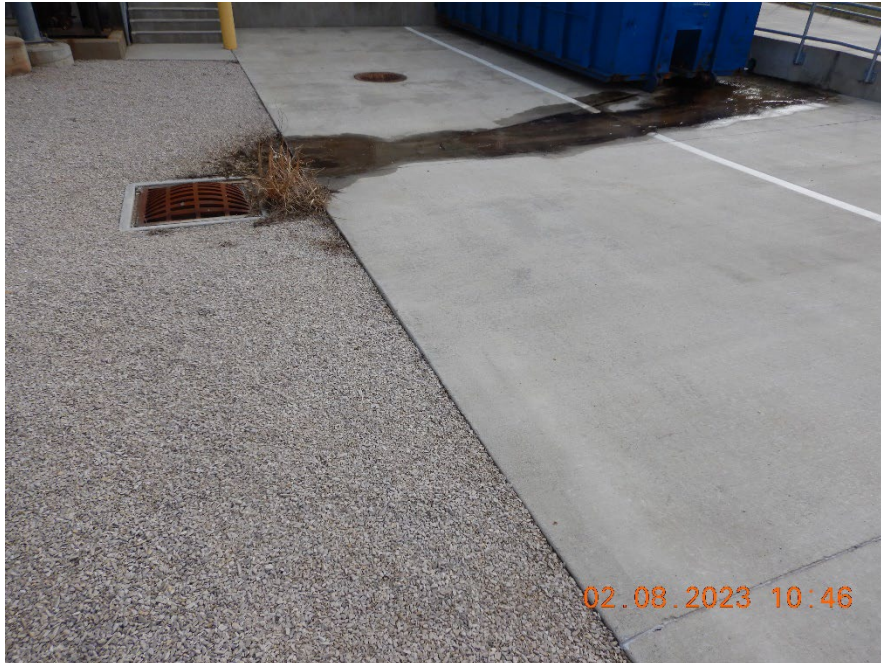
Description: Stormwater flowing to drain next to dumpster in Photo 23

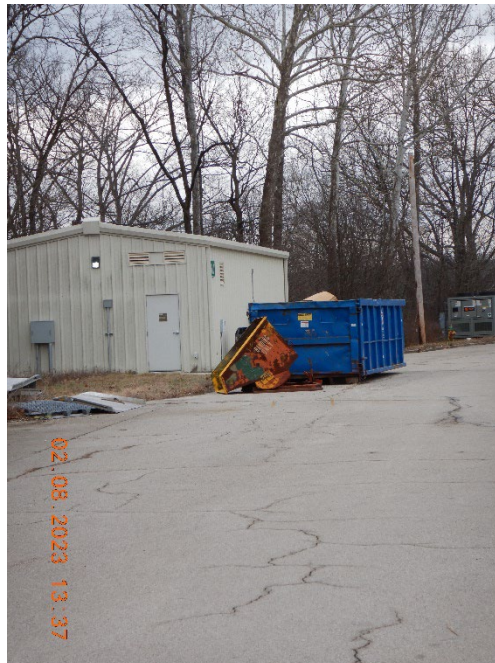
35: DSCN1161

Description: Uncovered dumpster

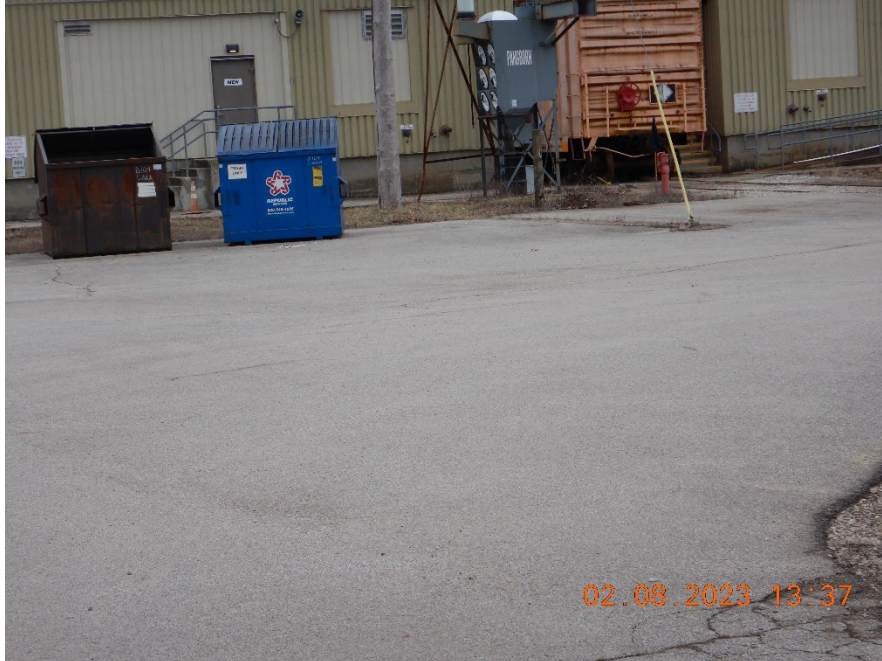
36: DSCN1162  
Description: Uncovered dumpster  
Location: Building 104 Area  
Camera Direction: Southeast  
Date/Time: 2/8/23, 1:37 p.m.

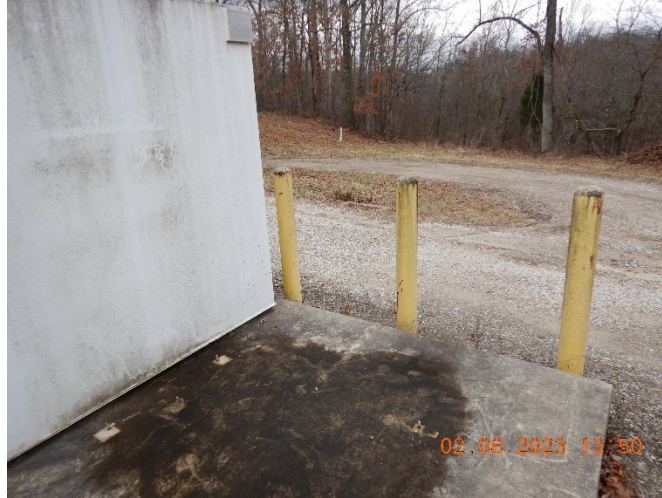
38: DSCN1164

Further to the west is Building 2654, outside of which sat an approximately 10,000-gallon fuel oil tank on a concrete pad that had oil stains (Photo 38). A storm drain is located adjacent to this tank. The SWPPP erroneously refers to this tank as being 30,000 gallons.

15. In the Building 104 Area, outside of Building 2654, sat a 10,000-gallon fuel oil tank on a concrete pad with oil stains next to a storm drain.
16. The SWPPP erroneously describes the 10,000-gallon fuel tank outside of Building 2654 as being 30,000 gallons.

Description: Oil staining next to 10,000-gallon fuel oil tank with stormwater drain in background

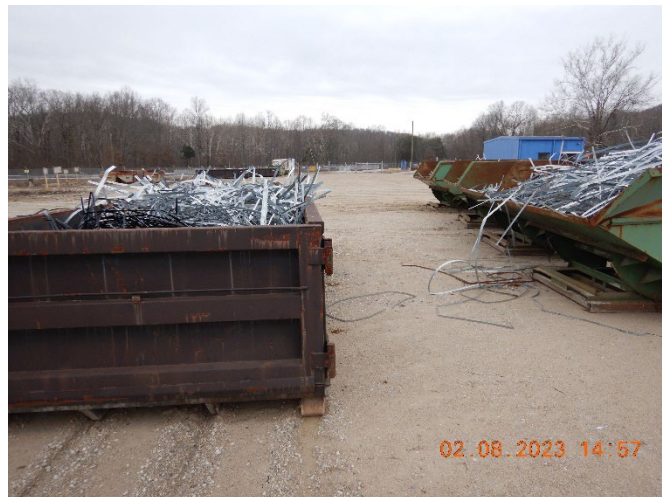
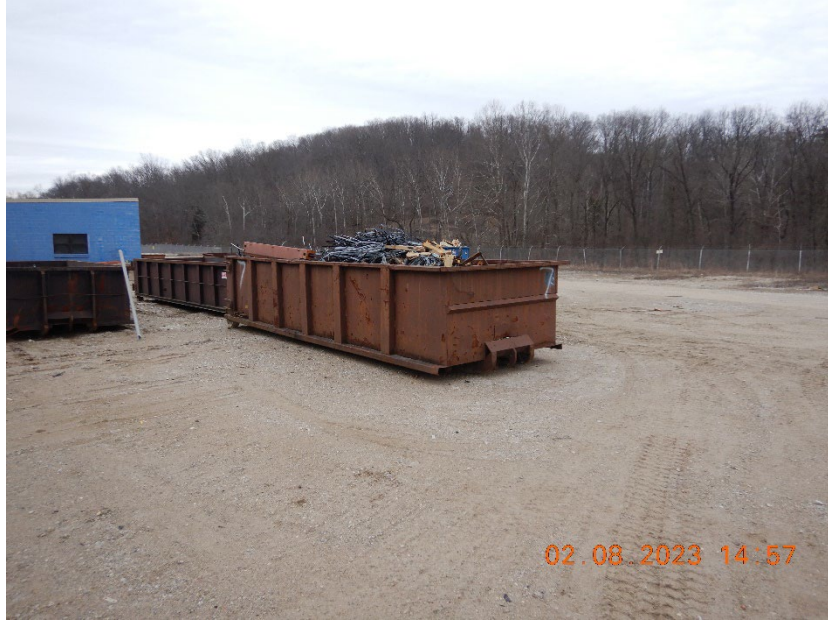
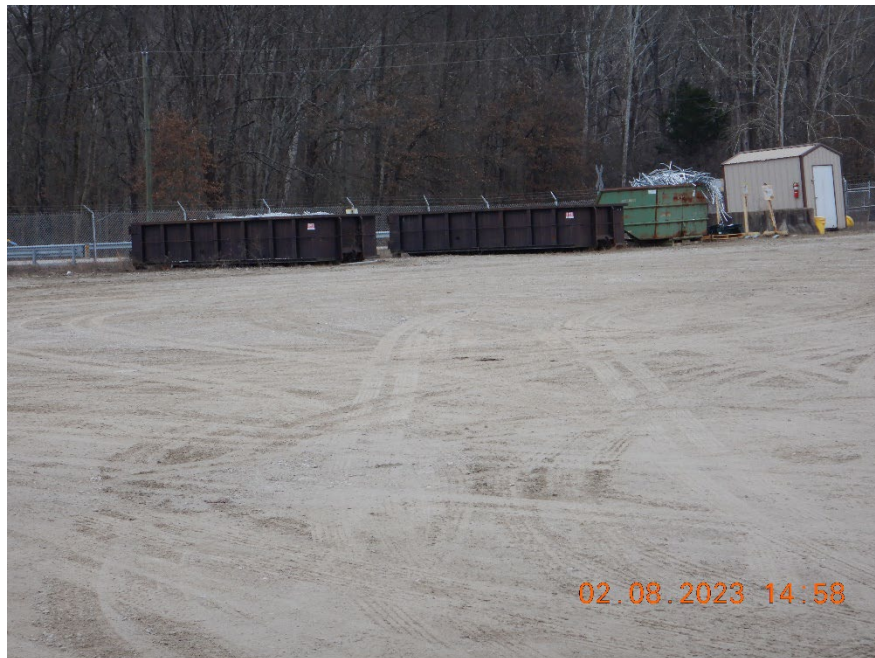
Next, we walked around the DLA Scrap Yard, where we observed dumpsters overflowing with scrap metal (Photos 39-41). Ms. Ranard said that NSW Crane is in the process of transferring the scrap yard operations to another location at the facility, and she confirmed that she will submit a notice of intent (NOI) to IDEM for this change. She expects that she will need to conduct one more annual stormwater sampling event at the current DLA Scrap Yard before the transfer is complete. The area that will become the new scrap yard is currently being dug out and graded and is not yet receiving any material.

17. In the Building 200 Area loading dock, there was oil staining on the ground.
18. In the DLA Scrap Yard, dumpsters were overflowing with scrap metal.

Description: Dumpsters overflowing with scrap metal

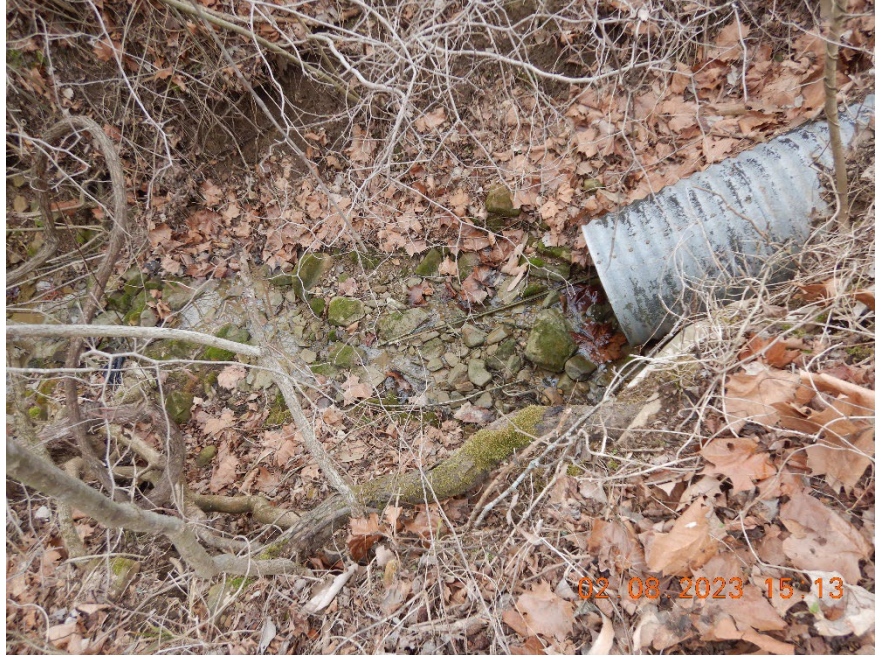
42: DSCN1168

Description: Discharge of water from pipe coming from under scrapyard to stormwater trench

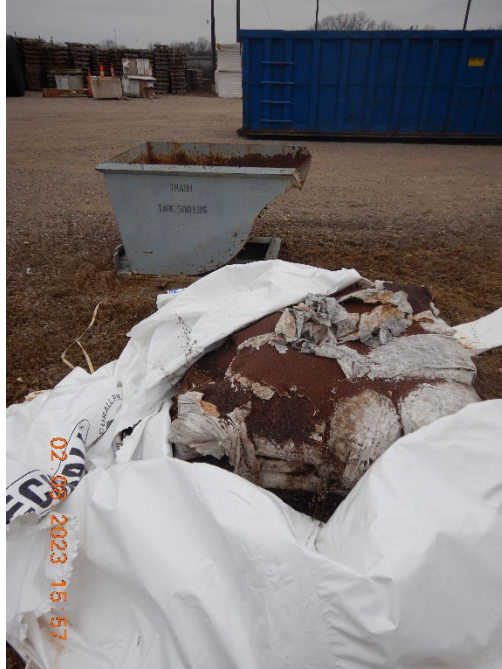
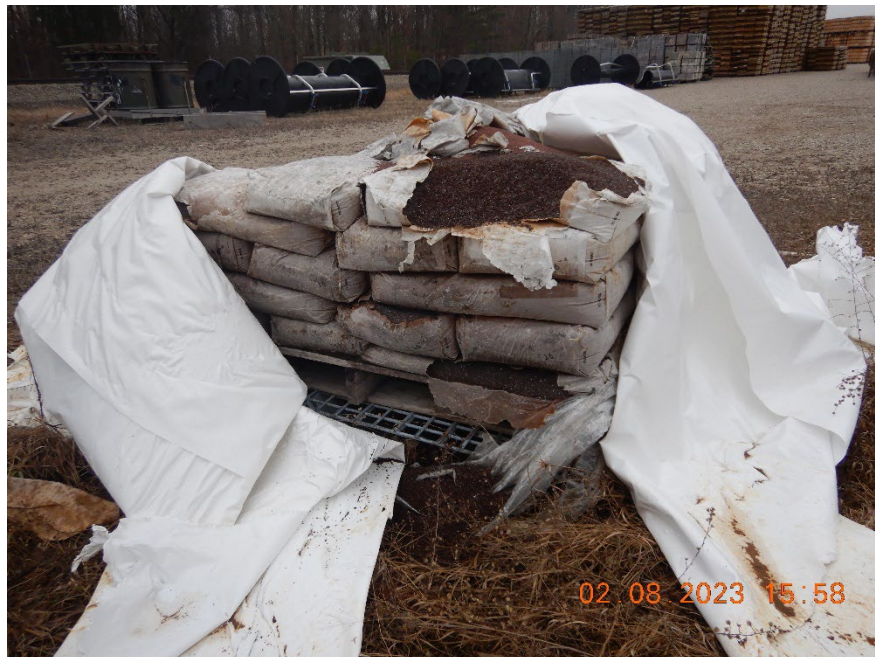
East of Building 2950, we observed open bags containing a red, sandy substance near a culvert that drains to Stormwater Outfall 030 (Photos 46-49). Facility representatives at the time were unaware of what it was.

Description: Tote with red, sandy substance spilling out

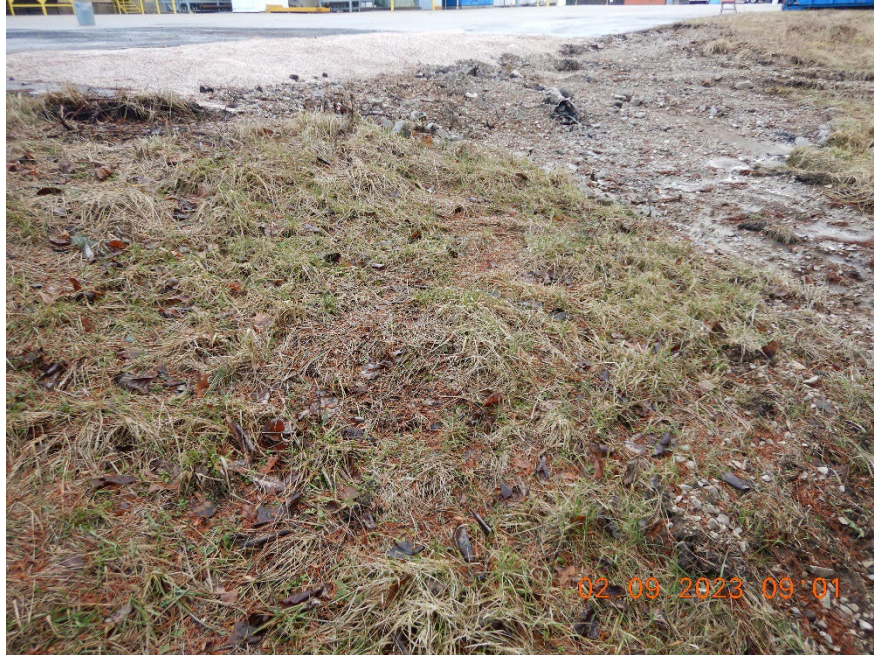
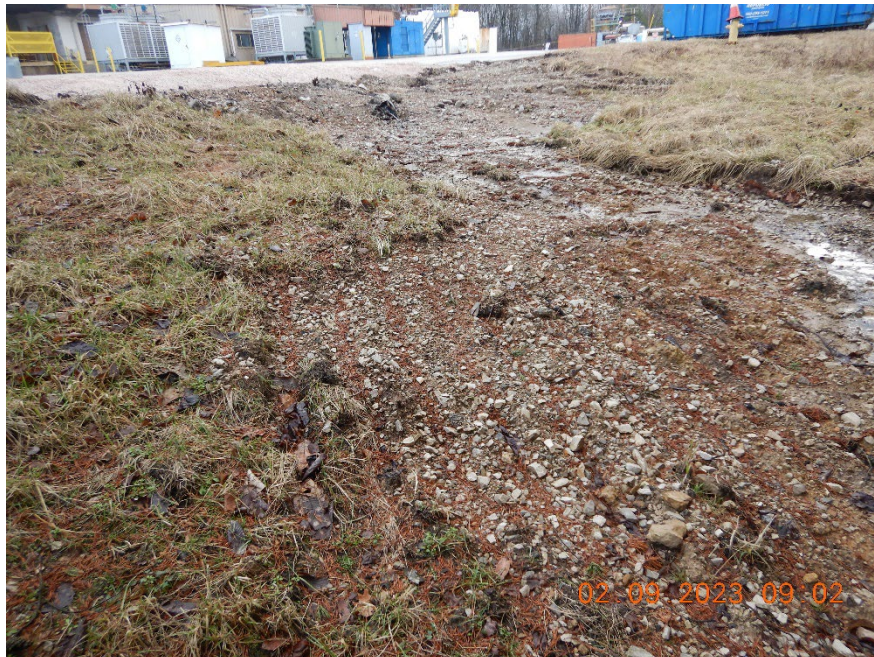
We visited the location of the fire again the morning of February 9<sup>th</sup>. At that time, a storm event had recently occurred, and we noticed that stormwater had pushed the sand used to cover the location into the stormwater trench, where stormwater was actively flowing (Photos 50-54). Using an Aqua TROLL 600 sonde manufactured by In-Situ with a pH probe and a temperature/specific conductivity probe<sup>1</sup>, Mr. Moody monitored the water at the base of the slope running away from where the fire occurred (near Stormwater Outfall 020) and obtained a pH of 7.1 and conductivity of 155 microsiemens per centimeter ( $\mu\text{S}/\text{cm}$ ). A little further downstream, he found the pH to be 6.3 and the conductivity to be 63  $\mu\text{S}/\text{cm}$ .

Description: Stormwater runoff path from red phosphorus fire location containing red sand

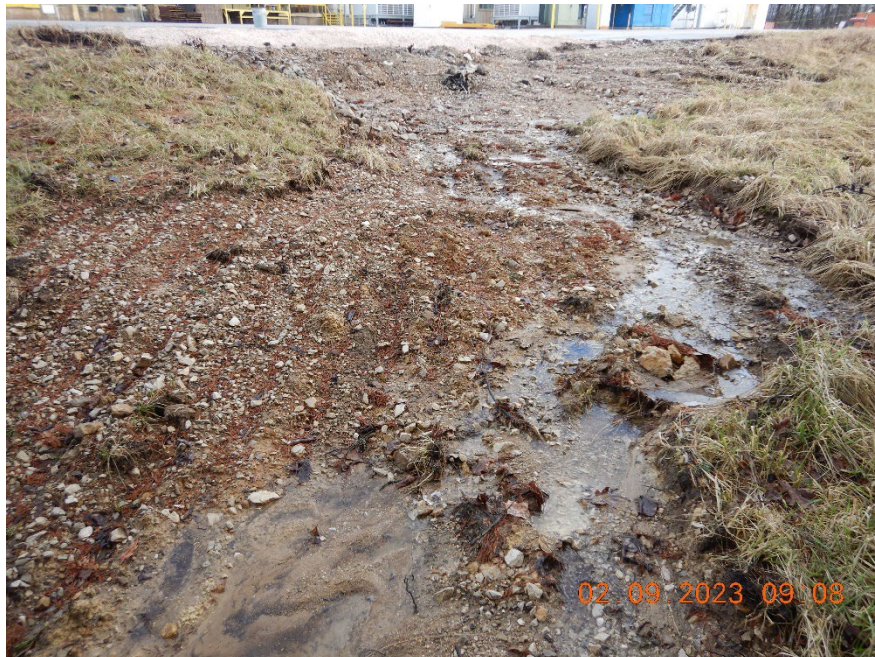
53: DSCN1180

Description: Stormwater runoff from red phosphorus fire location

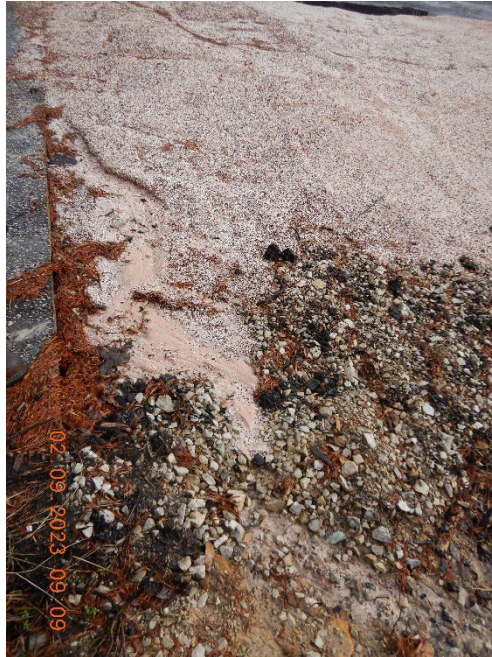
54: DSCN1181

Description: Closeup of sand in stormwater runoff near red phosphorus fire location

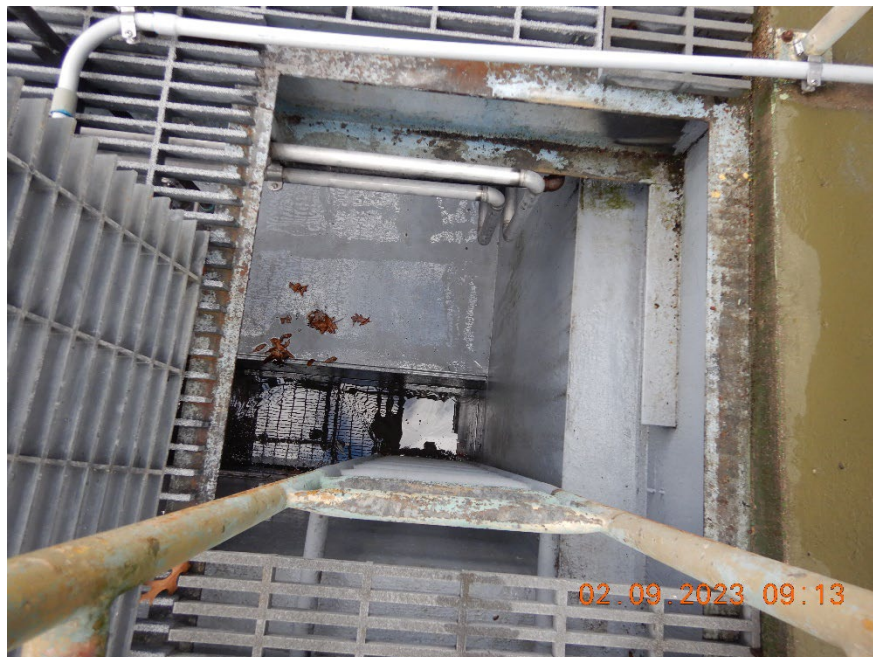
55: DSCN1182

In addition, in the sump lies a tank that Ms. Ranard stated receives dilute acid overflow. On February 9<sup>th</sup>, Mr. Moody monitored the water in the sump and obtained a pH reading of 3.5 and a conductivity reading of 439  $\mu\text{S}/\text{cm}$ . At that time, the water surface seemed to show a sheen

(Photo 55). Despite this low pH reading, a facility representative stated that the pH meter at Lift Station 20, which the water in the sump flows through, has not showed any readings out of range lately. James Huff, the WWTP operator, met us at the lift station. He measured the pH there and obtained a reading of 5.98 (Photo 64). While the display showed this number, Mr. Moody put his sampling probe into the lift station water and obtained a pH reading of 6.7. Adjacent to this lift station is a creek that receives stormwater from the Building 69 Area and the Building 200 Area (discussed in more detail below) (Photos 60-63). Mr. Moody tested this water and obtained pH readings of 6.9 in the stream coming from the Building 69 Area, 6.0 in the stream coming from the Building 200 Area, and 5.8 at the confluence of these streams.

4. CAAA had applied water to the fire without knowing the cause or realizing the environmental impact with regard to the phosphorus.
5. Testing of the water in the sump in the Building 69 area showed a very low pH (2.5), but pH monitoring that had been done at Lift Station 20 through which the sump water flows has not shown anything out of range.

Description: Sheen on water in sump
