## Clean Water Act Section 404: Site Visit/Case Development

| Site Name | Dick's Concrete | | | | |
| Site Address* | 1053 County Road 37 (Pellets Island Road) and 1326 Co Route 12 | | | | |

CWA 404 Inspection Photolog  
Dick's Concrete  
1053 Co Rd 37 and 1326 Co Rt 12  
Orange County, NY

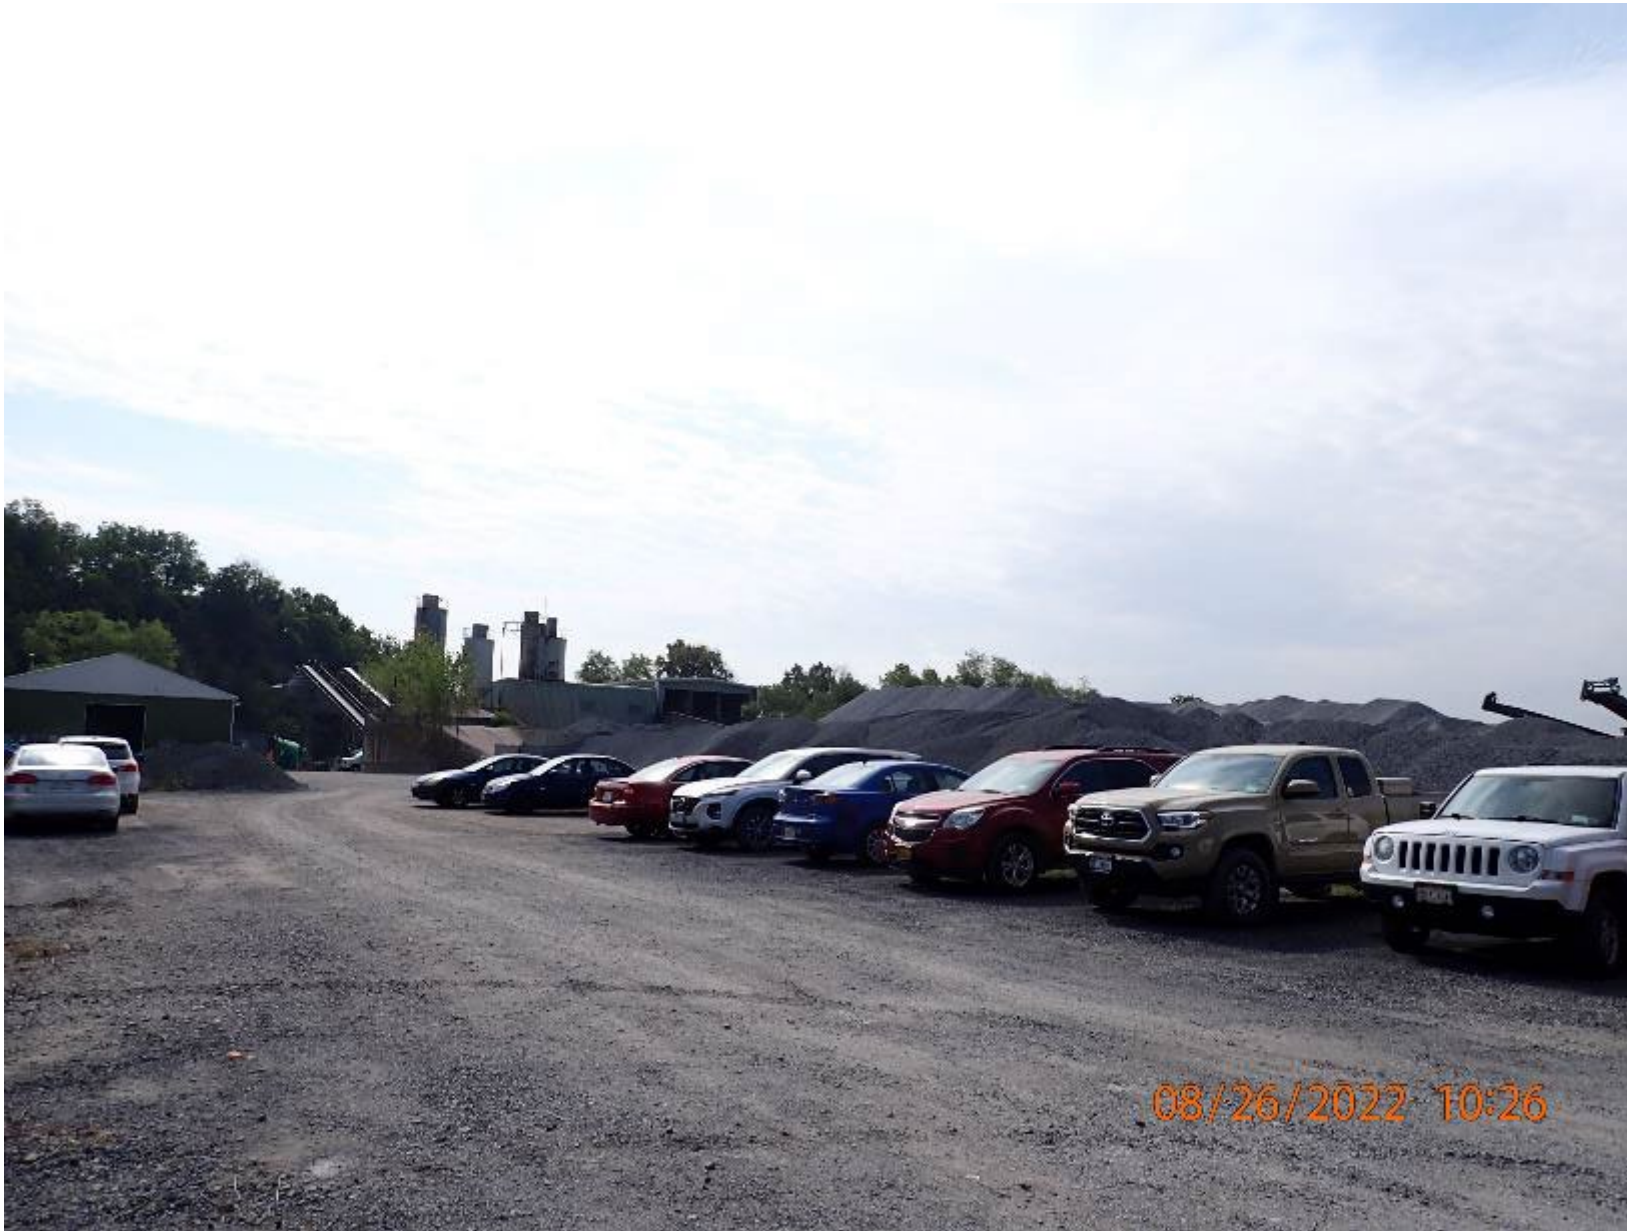
**Date:** 8/26/2022  
**Time:** 10:26 AM  
**Photographer:** SSA  
**Photo ID:** 1 – P8260369

Parking and entrance to Dick's  
Concrete facility

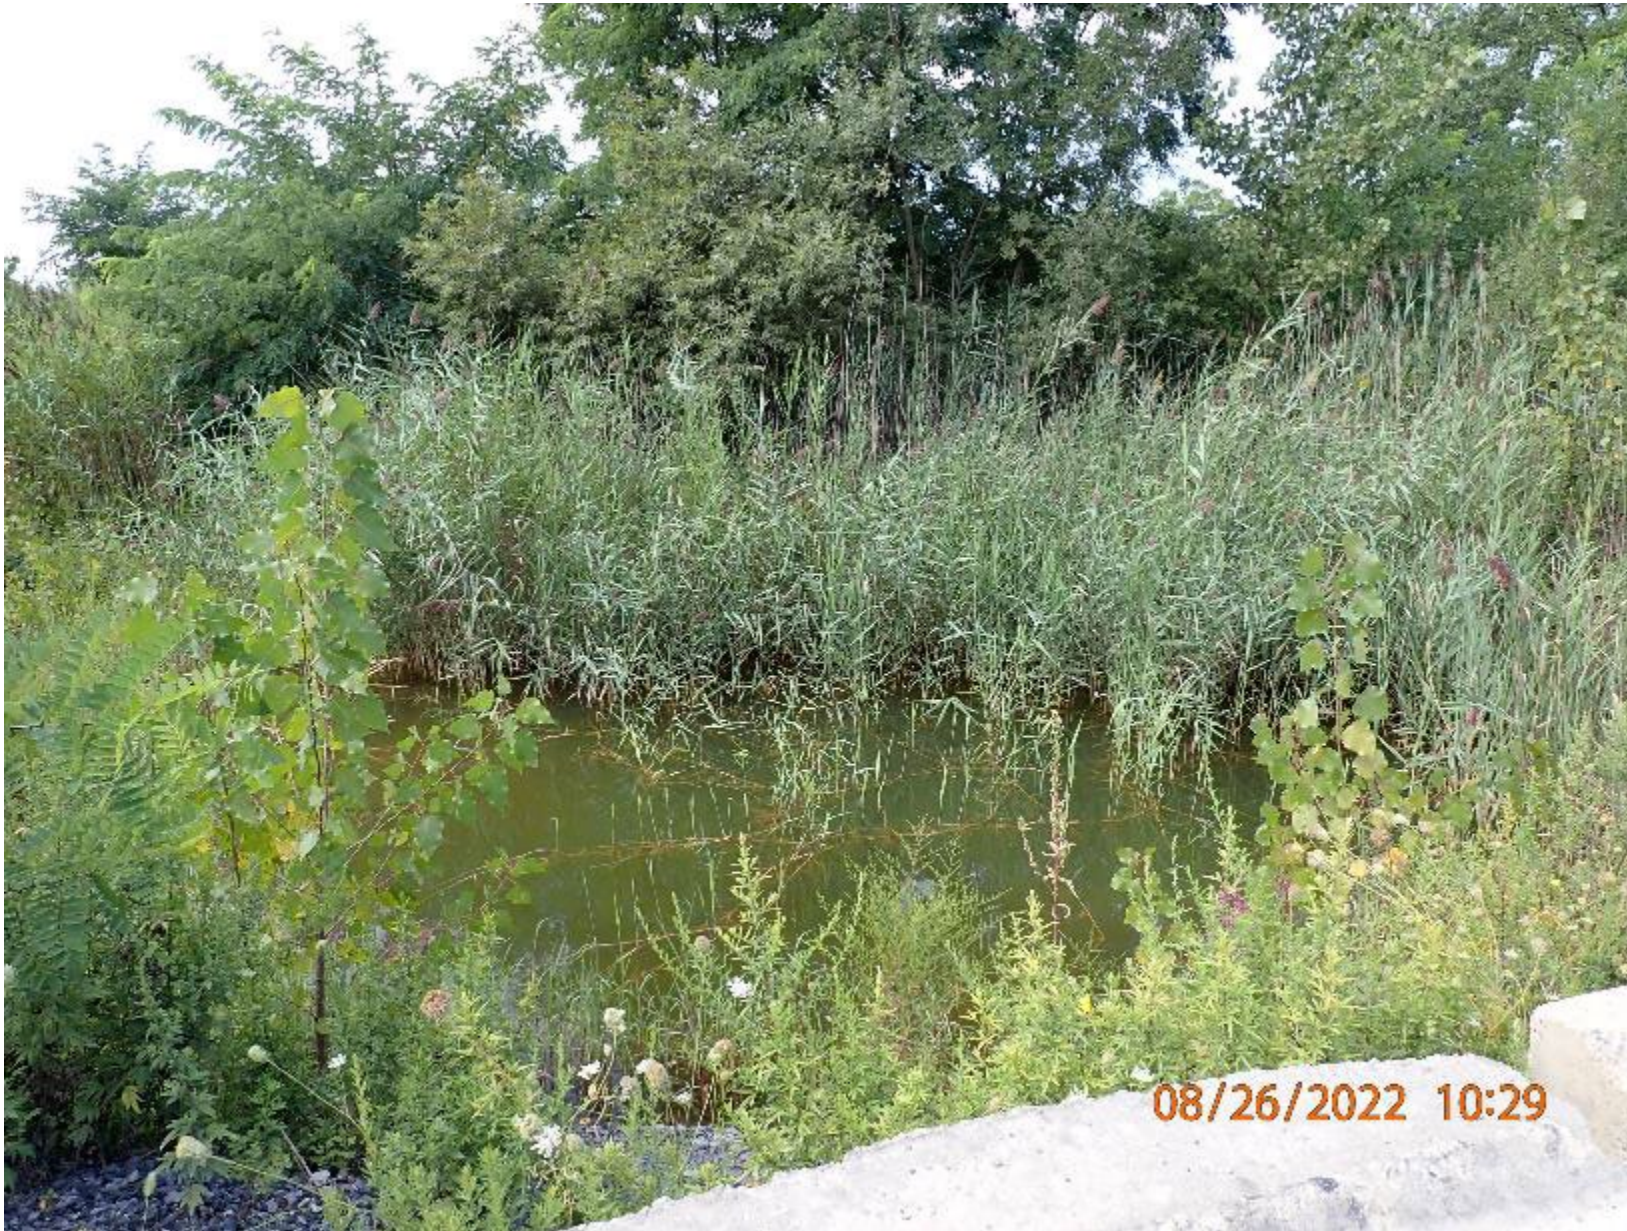
**Date:** 8/26/2022  
**Time:** 10:29 AM  
**Photographer:** SSA  
**Photo ID:** 2 – P8260370

Man-made pond/basin on  
western edge of Dick's Concrete  
property

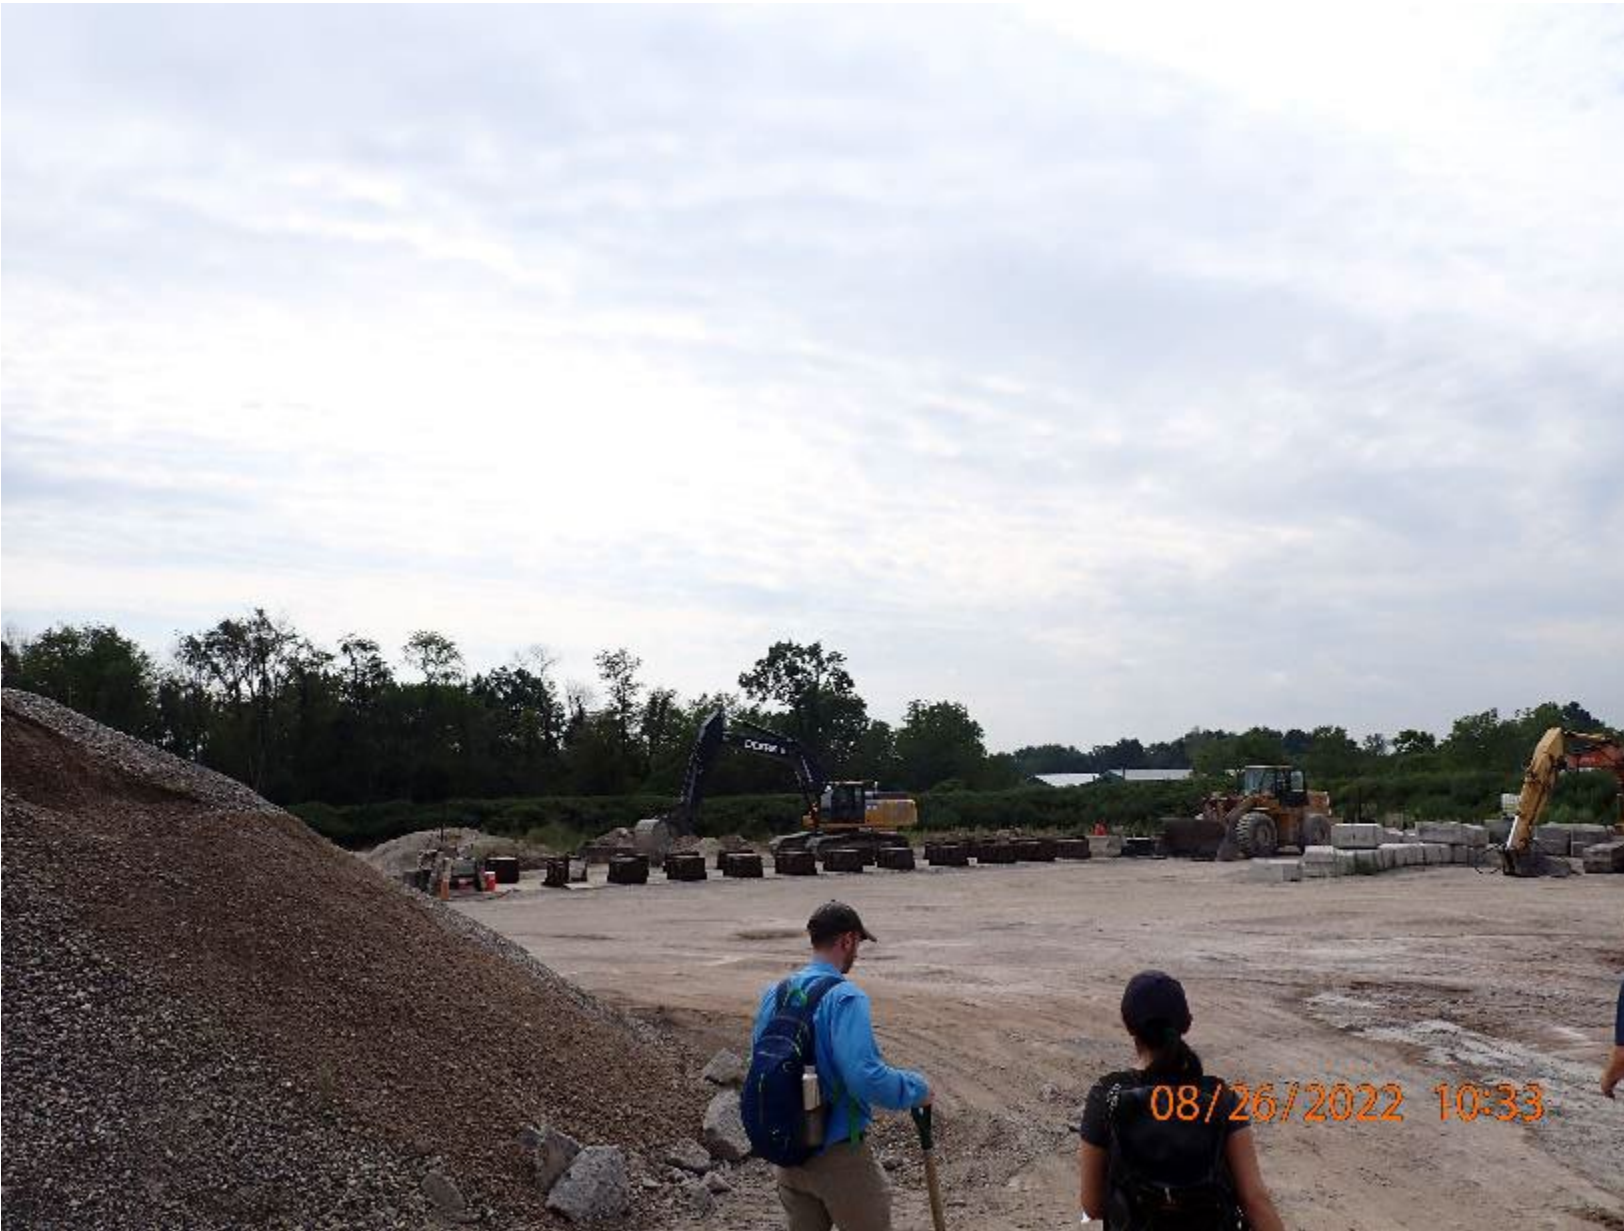
**Date:** 8/26/2022  
**Time:** 10:33 AM  
**Photographer:** SSA  
**Photo ID:** 3 – P8260371

Facility expansion area, disposal  
area for returned concrete

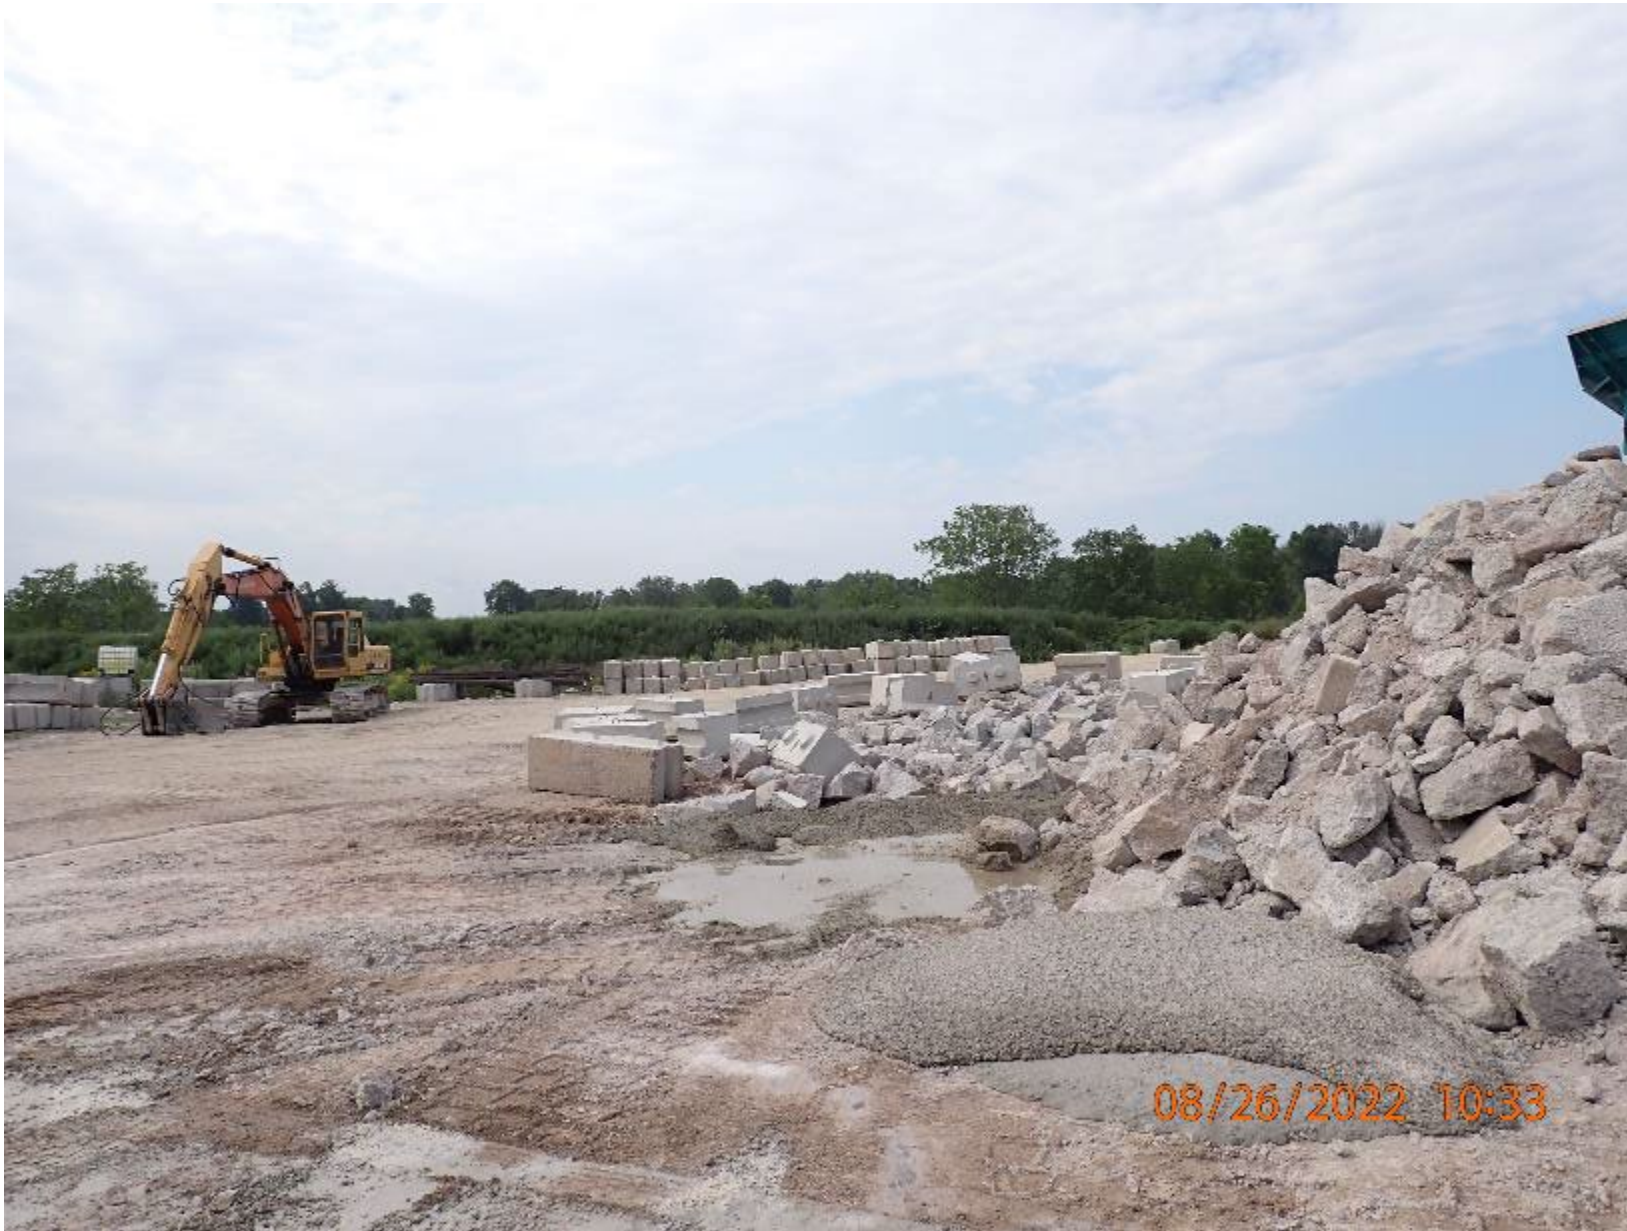
**Date:** 8/26/2022  
**Time:** 10:33 AM  
**Photographer:** SSA  
**Photo ID:** 4 – P8260372

Facility expansion area, disposal  
area for returned concrete

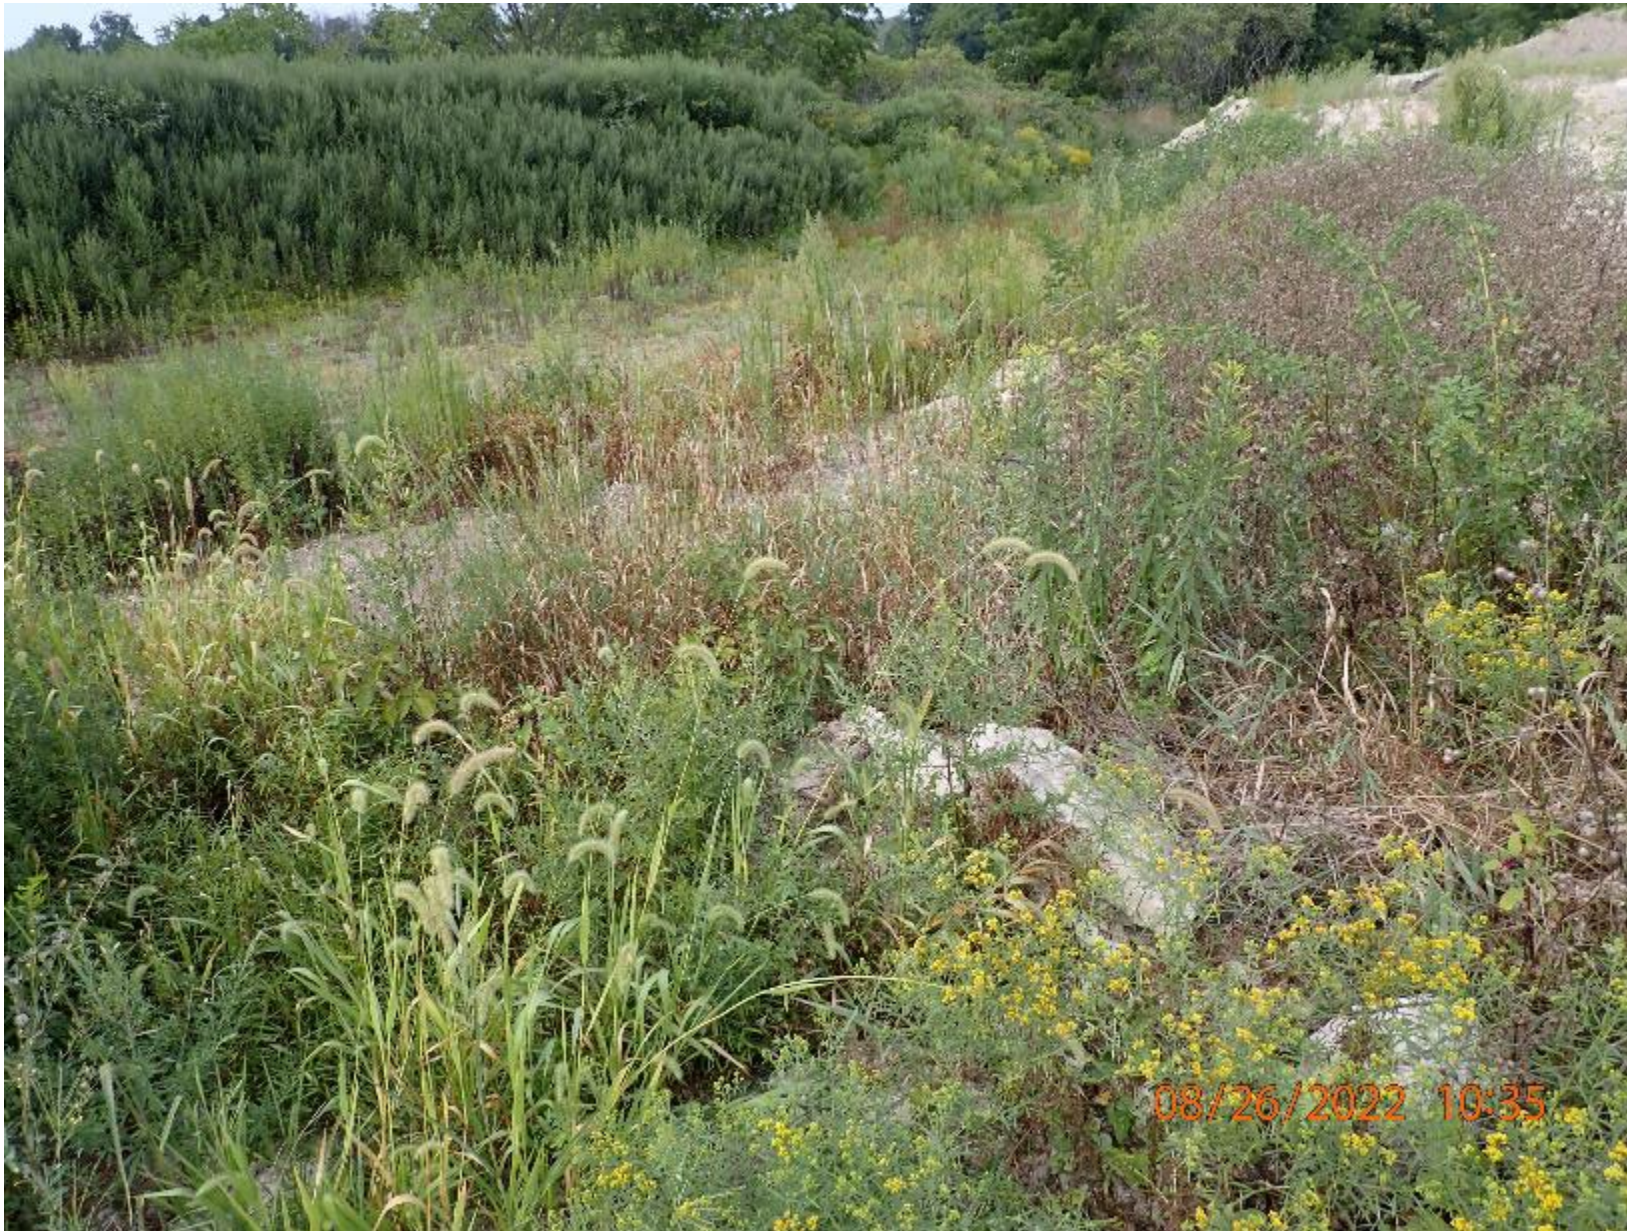
**Date:** 8/26/2022  
**Time:** 10:35 AM  
**Photographer:** SSA  
**Photo ID:** 5 – P8260373

Southern border of expansion area; berm in background

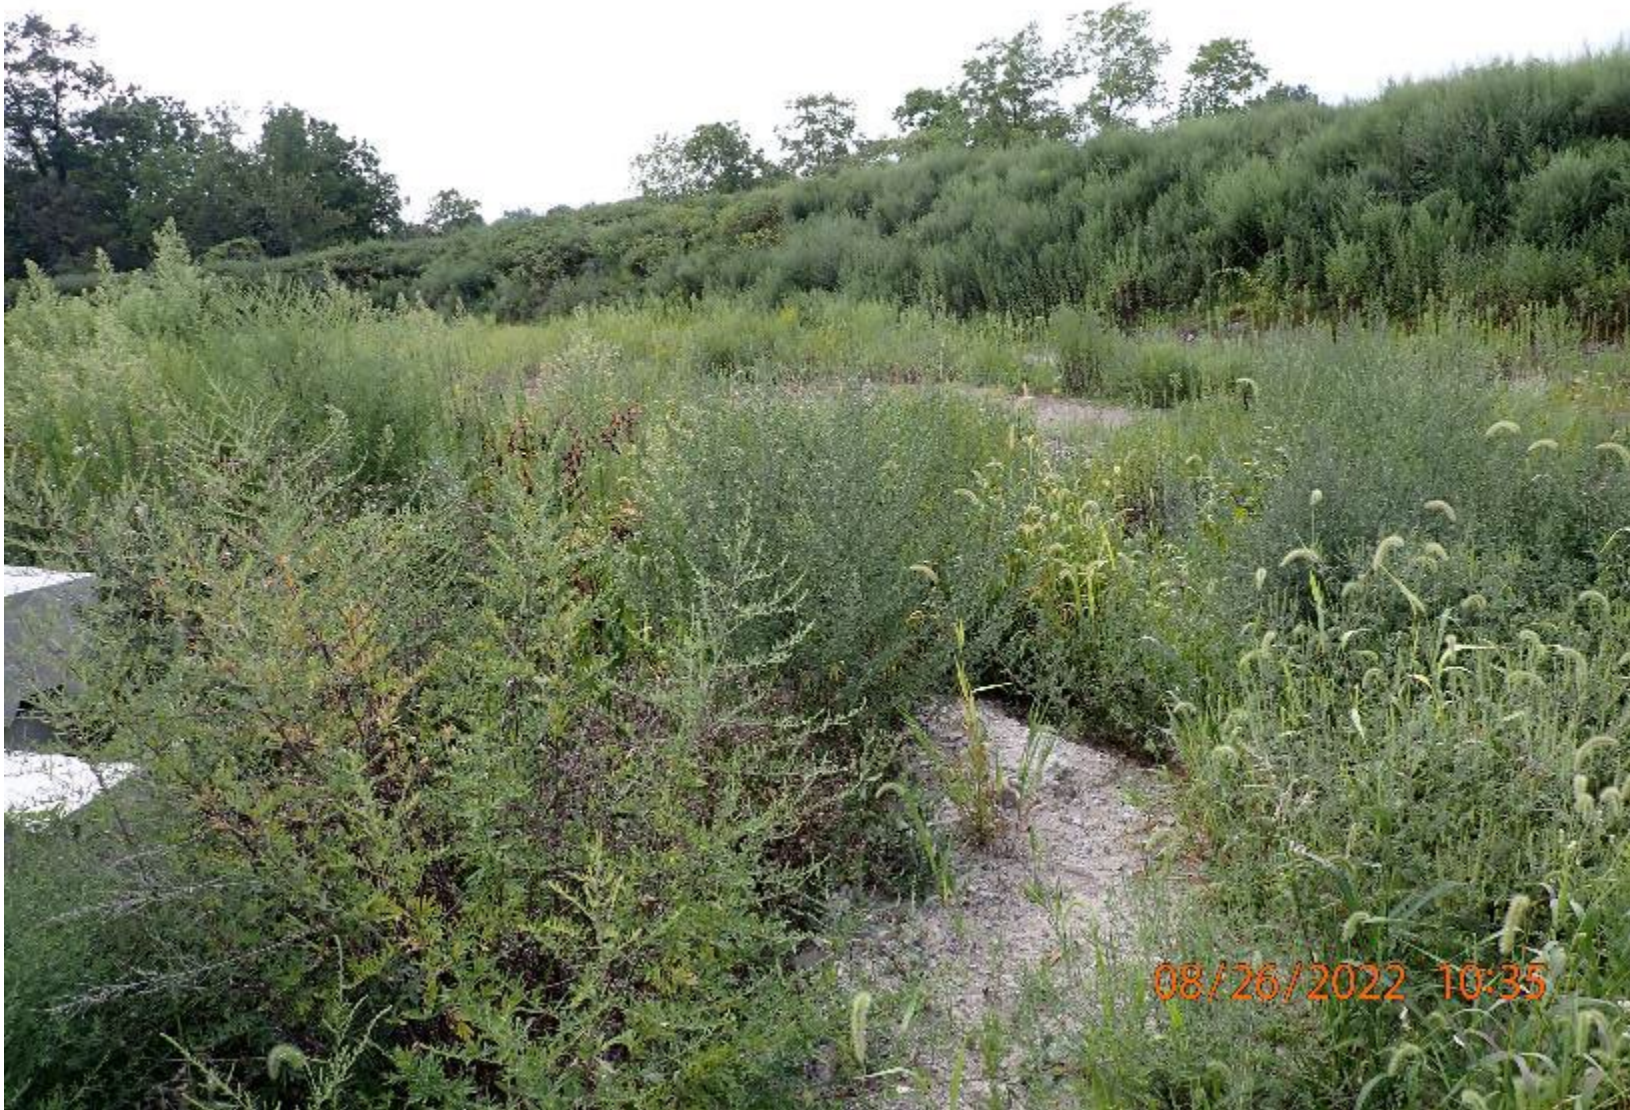
**Date:** 8/26/2022  
**Time:** 10:35 AM  
**Photographer:** SSA  
**Photo ID:** 6 – P8260374

Southern border of expansion area; berm in background

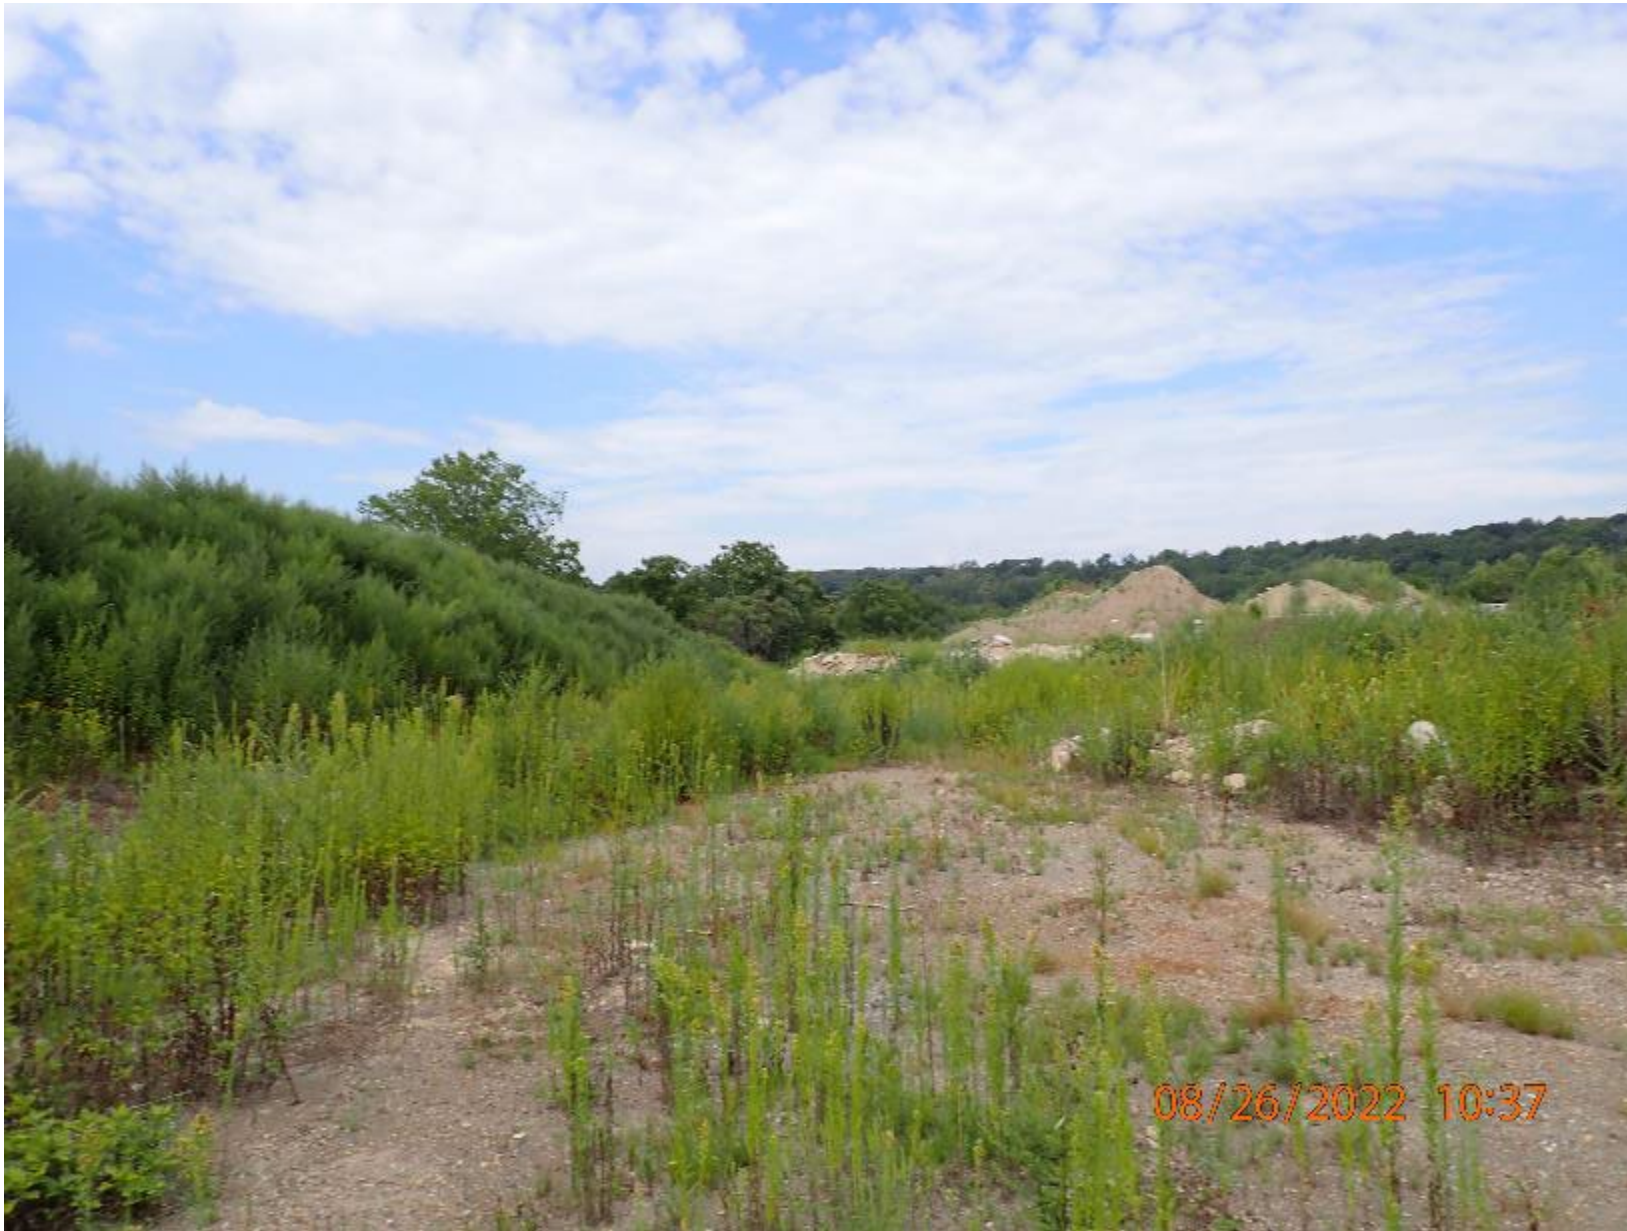
**Date:** 8/26/2022  
**Time:** 10:37 AM  
**Photographer:** SSA  
**Photo ID:** 7 – P8260375

**Description:**  
Border of facility expansion area

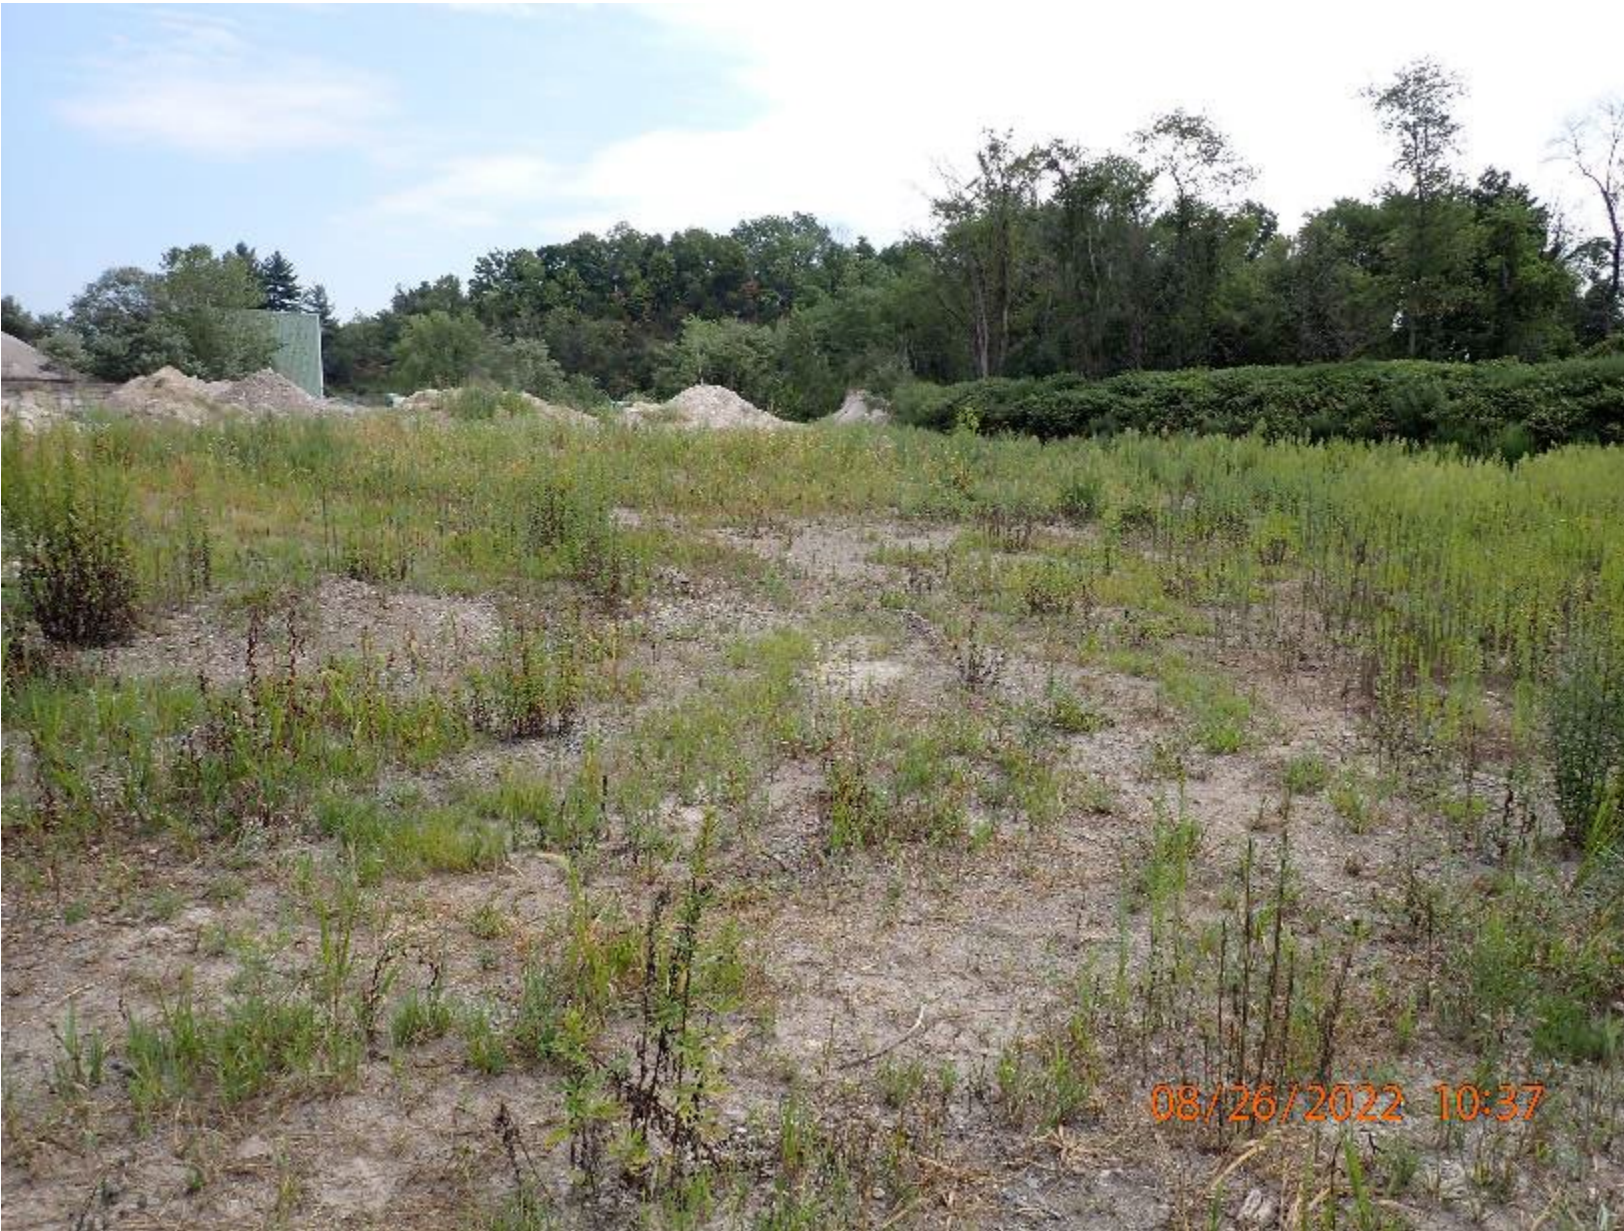
**Date:** 8/26/2022  
**Time:** 10:37 AM  
**Photographer:** SSA  
**Photo ID:** 8 – P8260376

Border of facility expansion  
area; berm in background

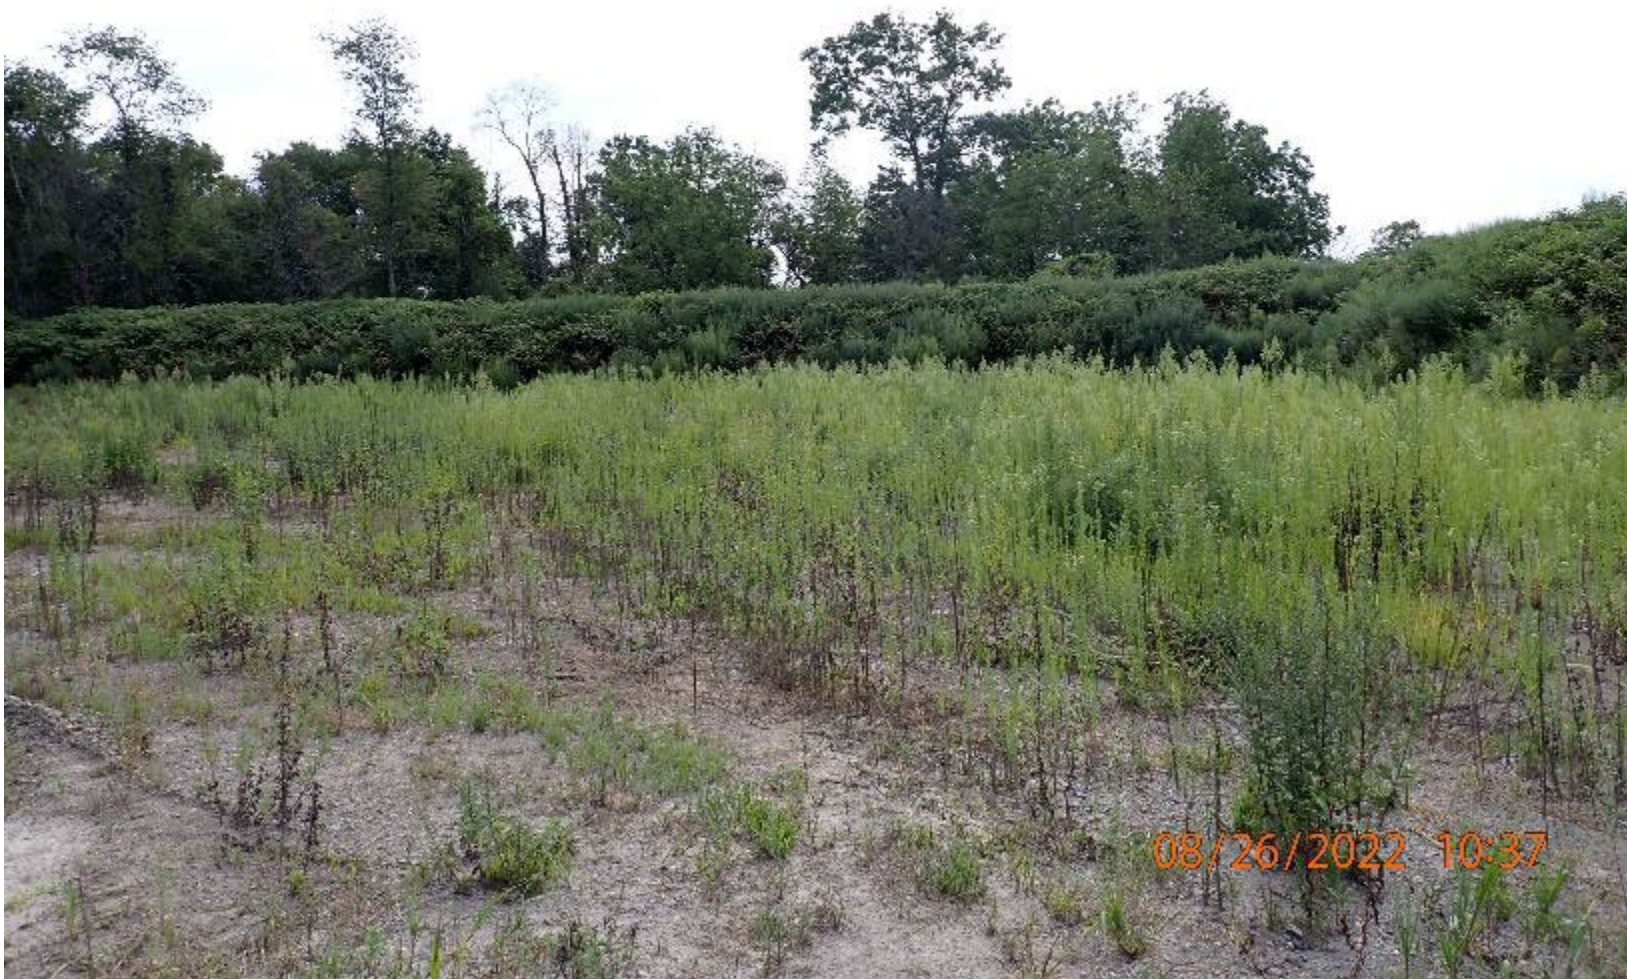
**Date:** 8/26/2022  
**Time:** 10:37 AM  
**Photographer:** SSA  
**Photo ID:** 9 – P8260377

Border of facility expansion  
area; berm in background

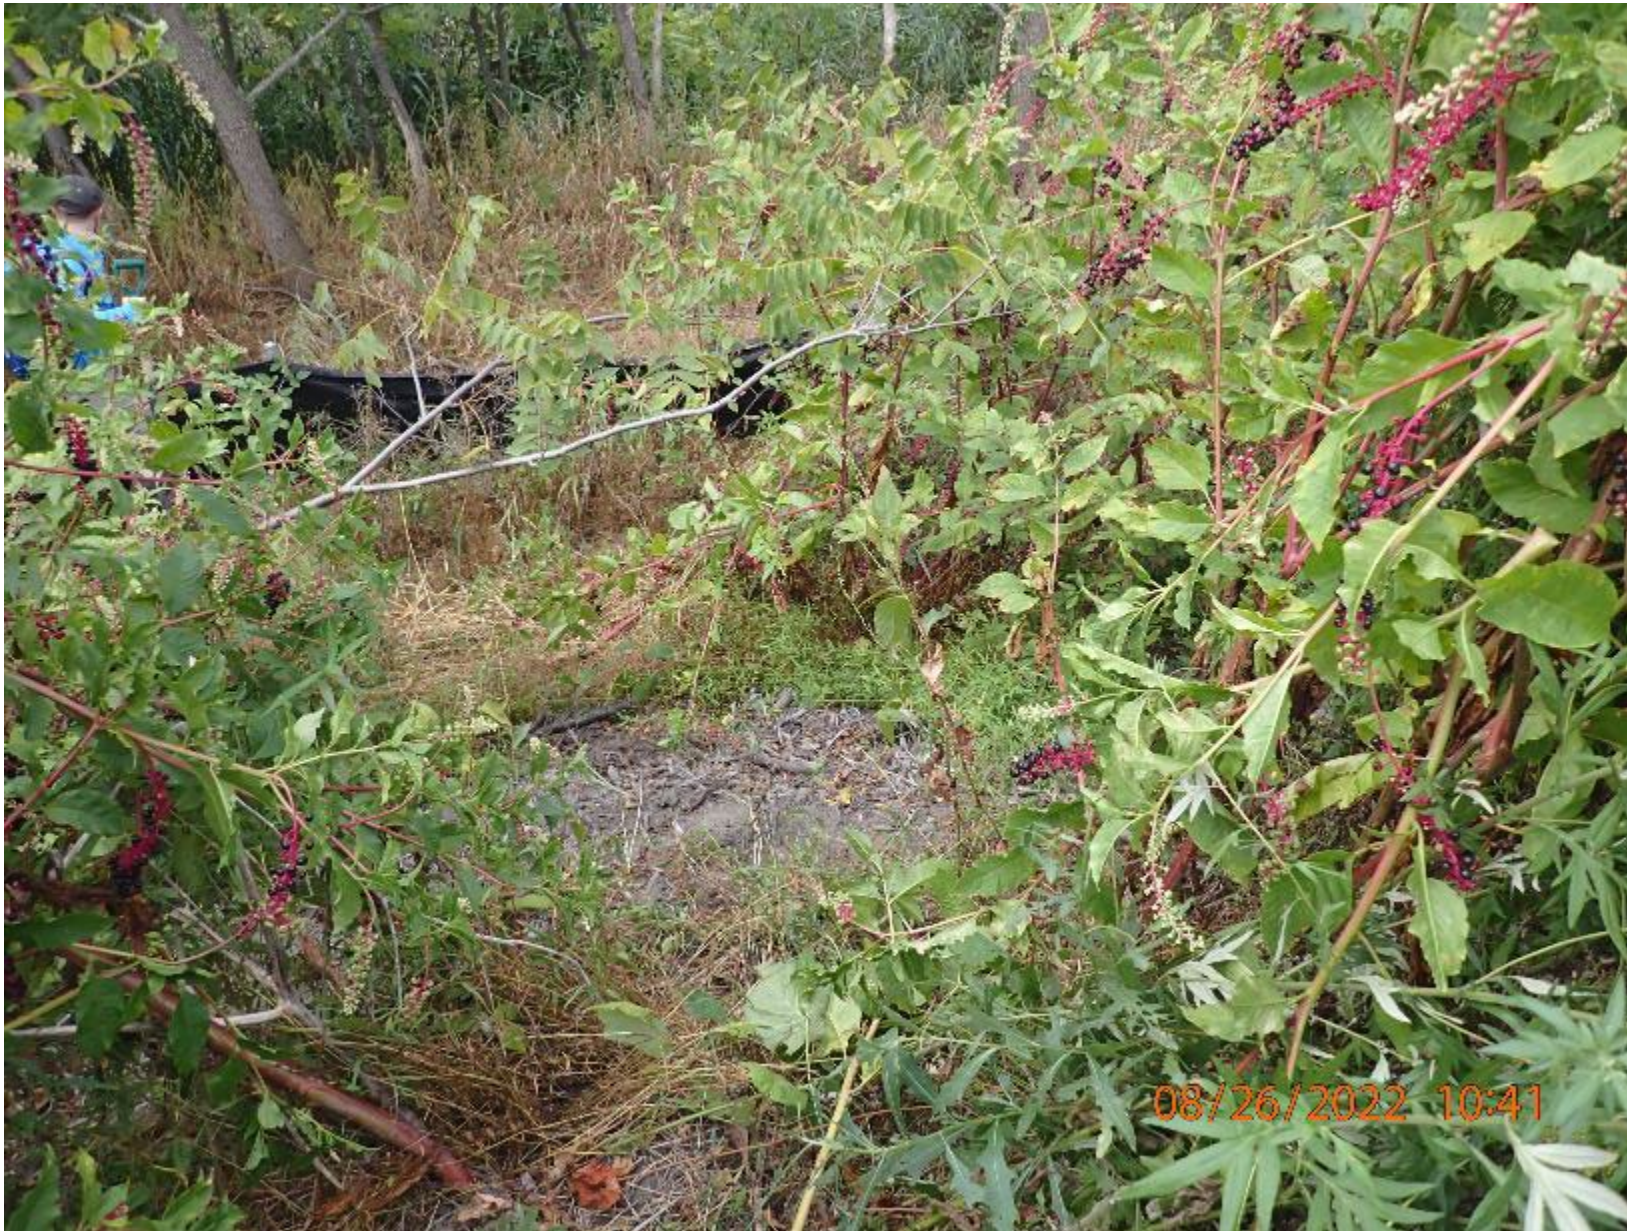
**Date:** 8/26/2022  
**Time:** 10:41 AM  
**Photographer:** SSA  
**Photo ID:** 10 – P8260378

Area adjacent to facility  
expansion area; area not  
impacted by expansion

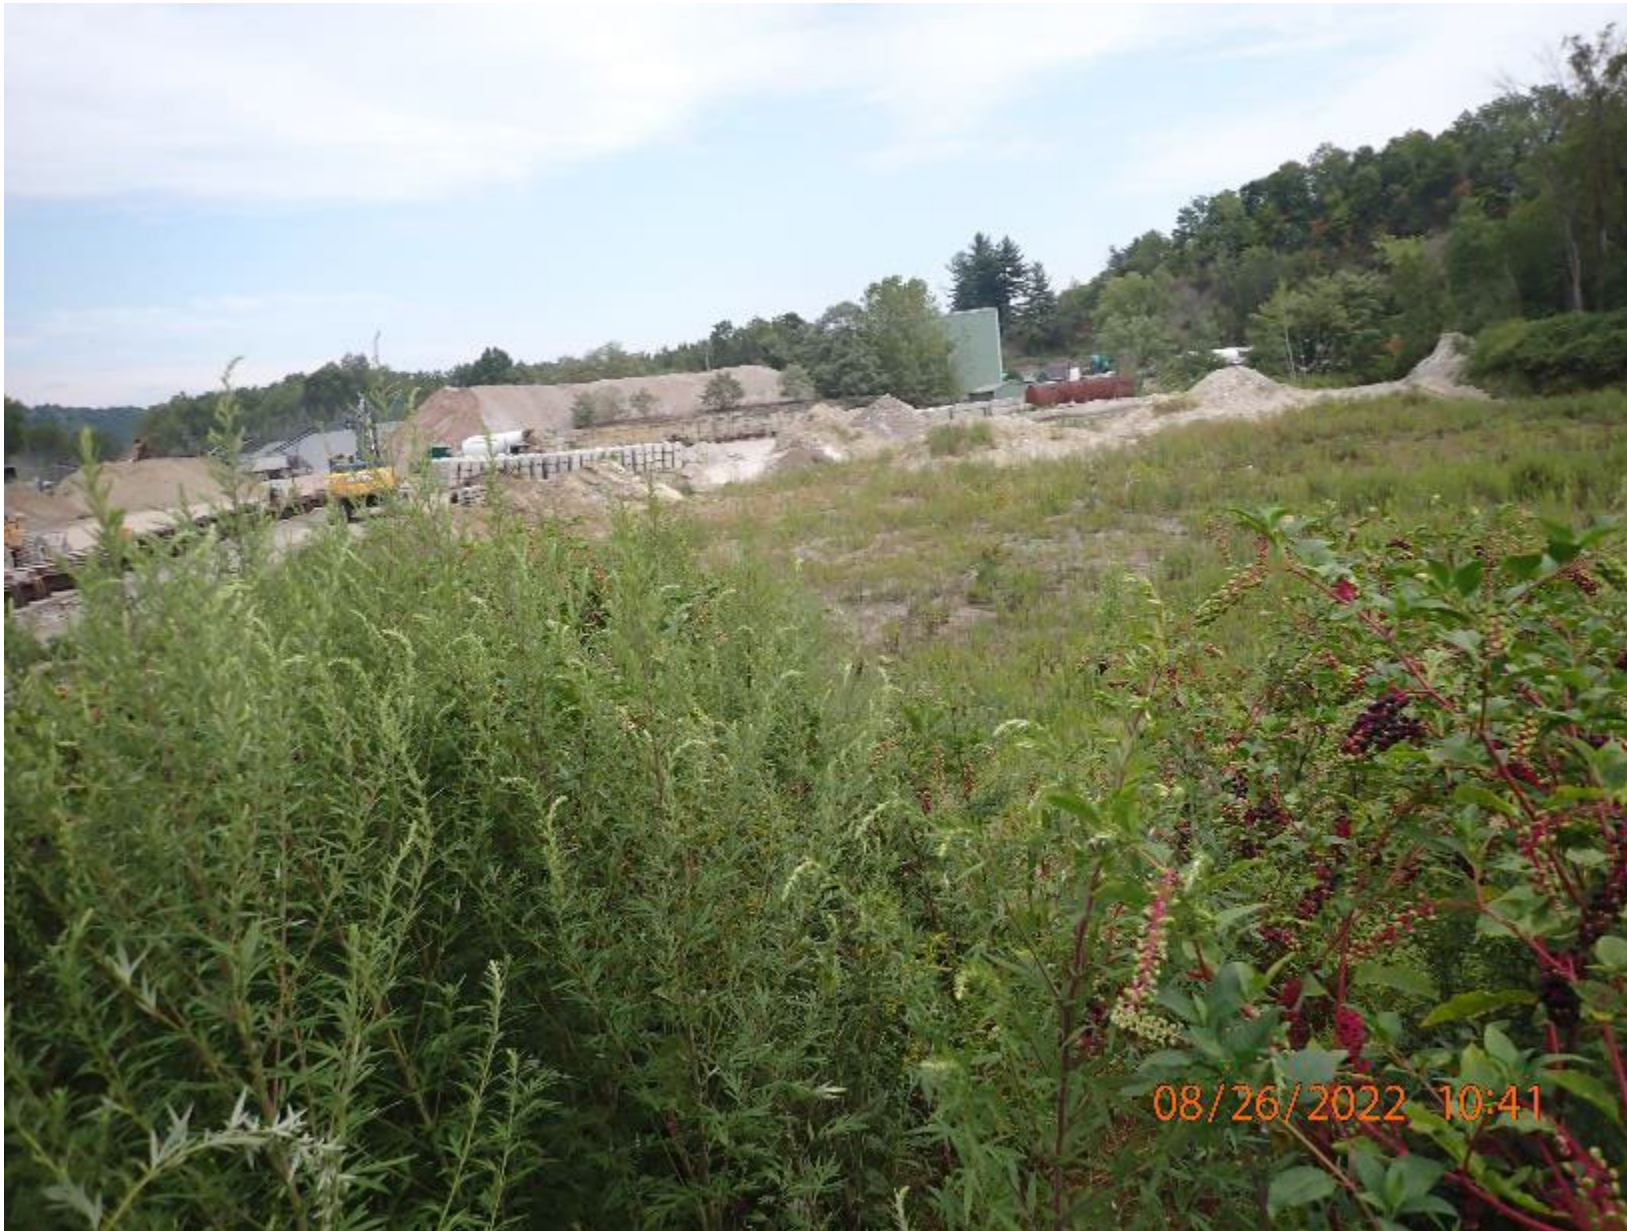
**Date:** 8/26/2022  
**Time:** 10:41 AM  
**Photographer:** SSA  
**Photo ID:** 11 – P8260379

Photo taken from top of berm  
facing facility
