## Clean Water Act Section 404: Site Visit/Case Development

| Site Name | Dick's Concrete | | | | |
| Site Address* | 1053 County Road 37 (Pellets Island Road) and 1326 Co Route 12 | | | | |

CWA 404 Inspection Photolog  
Dick's Concrete  
1053 Co Rd 37 and 1326 Co Rt 12  
Orange County, NY

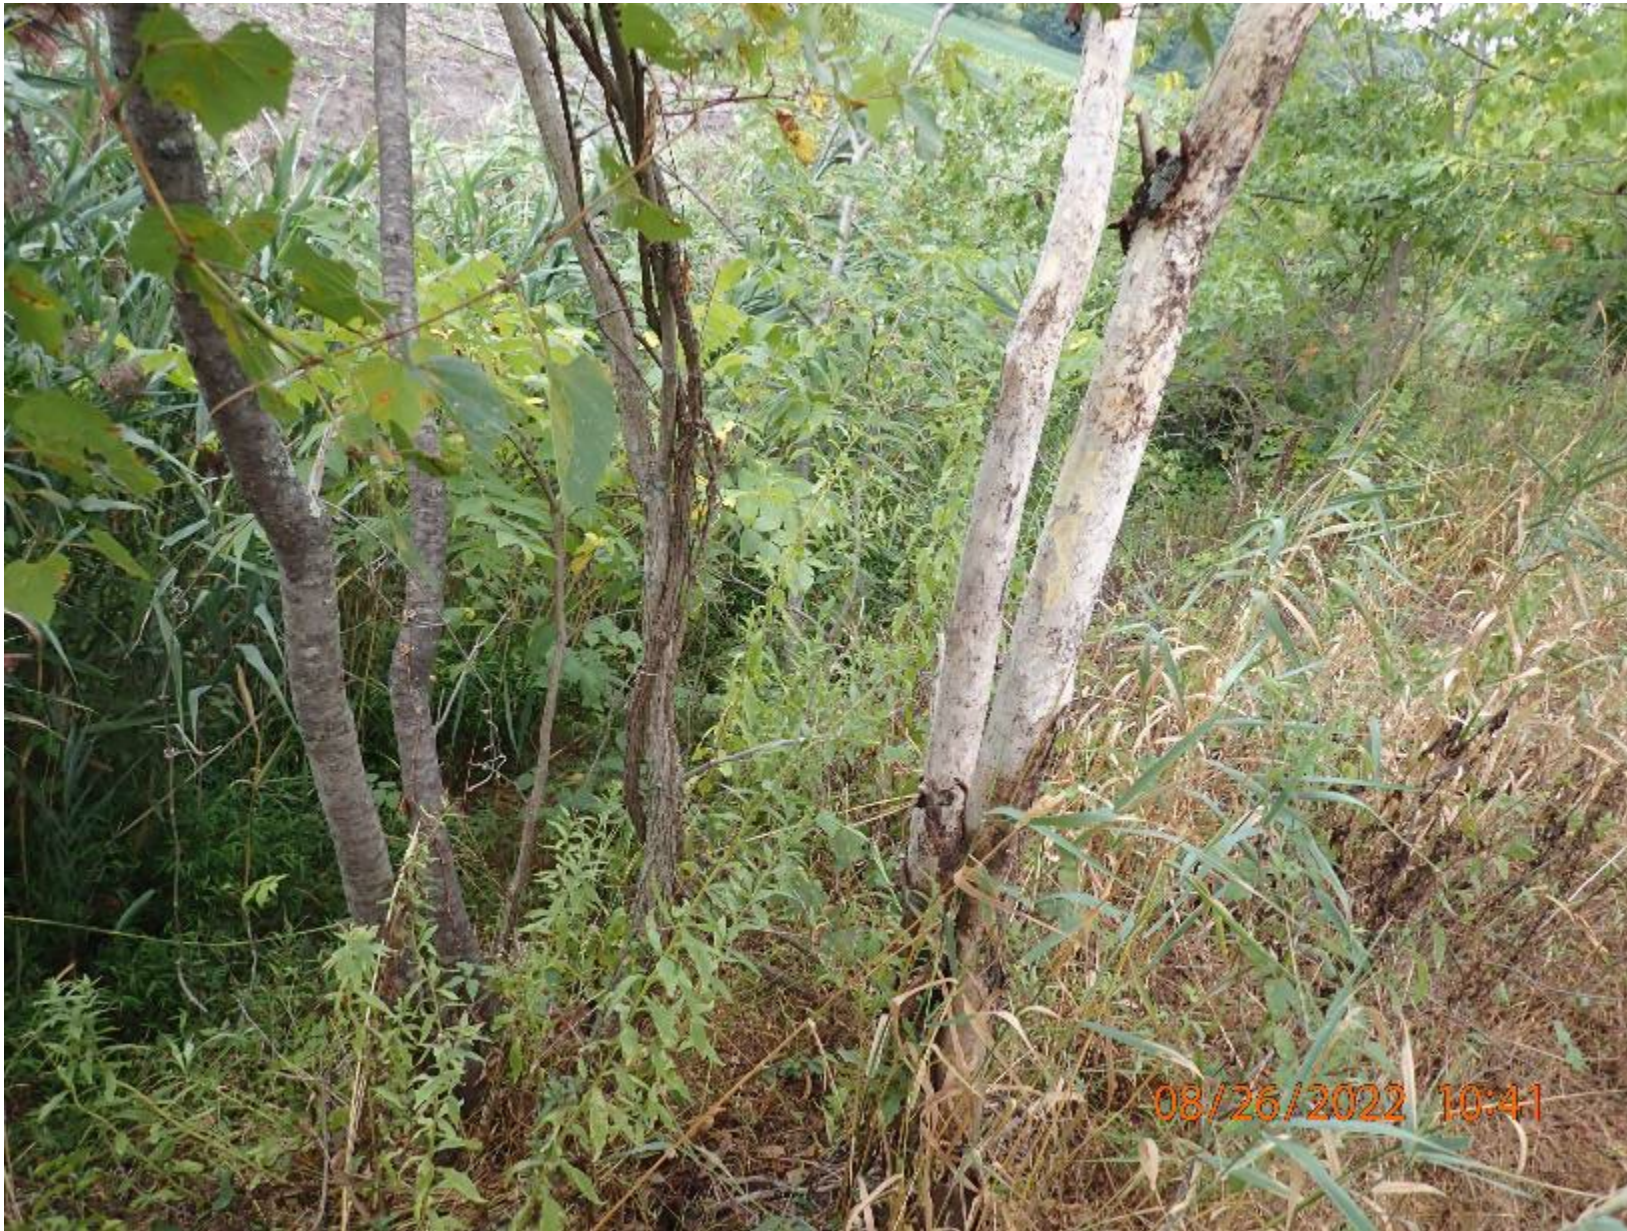
**Date:** 8/26/2022  
**Time:** 10:41 AM  
**Photographer:** SSA  
**Photo ID:** 12 – P8260380

**Description:**  
Photo taken from top of berm

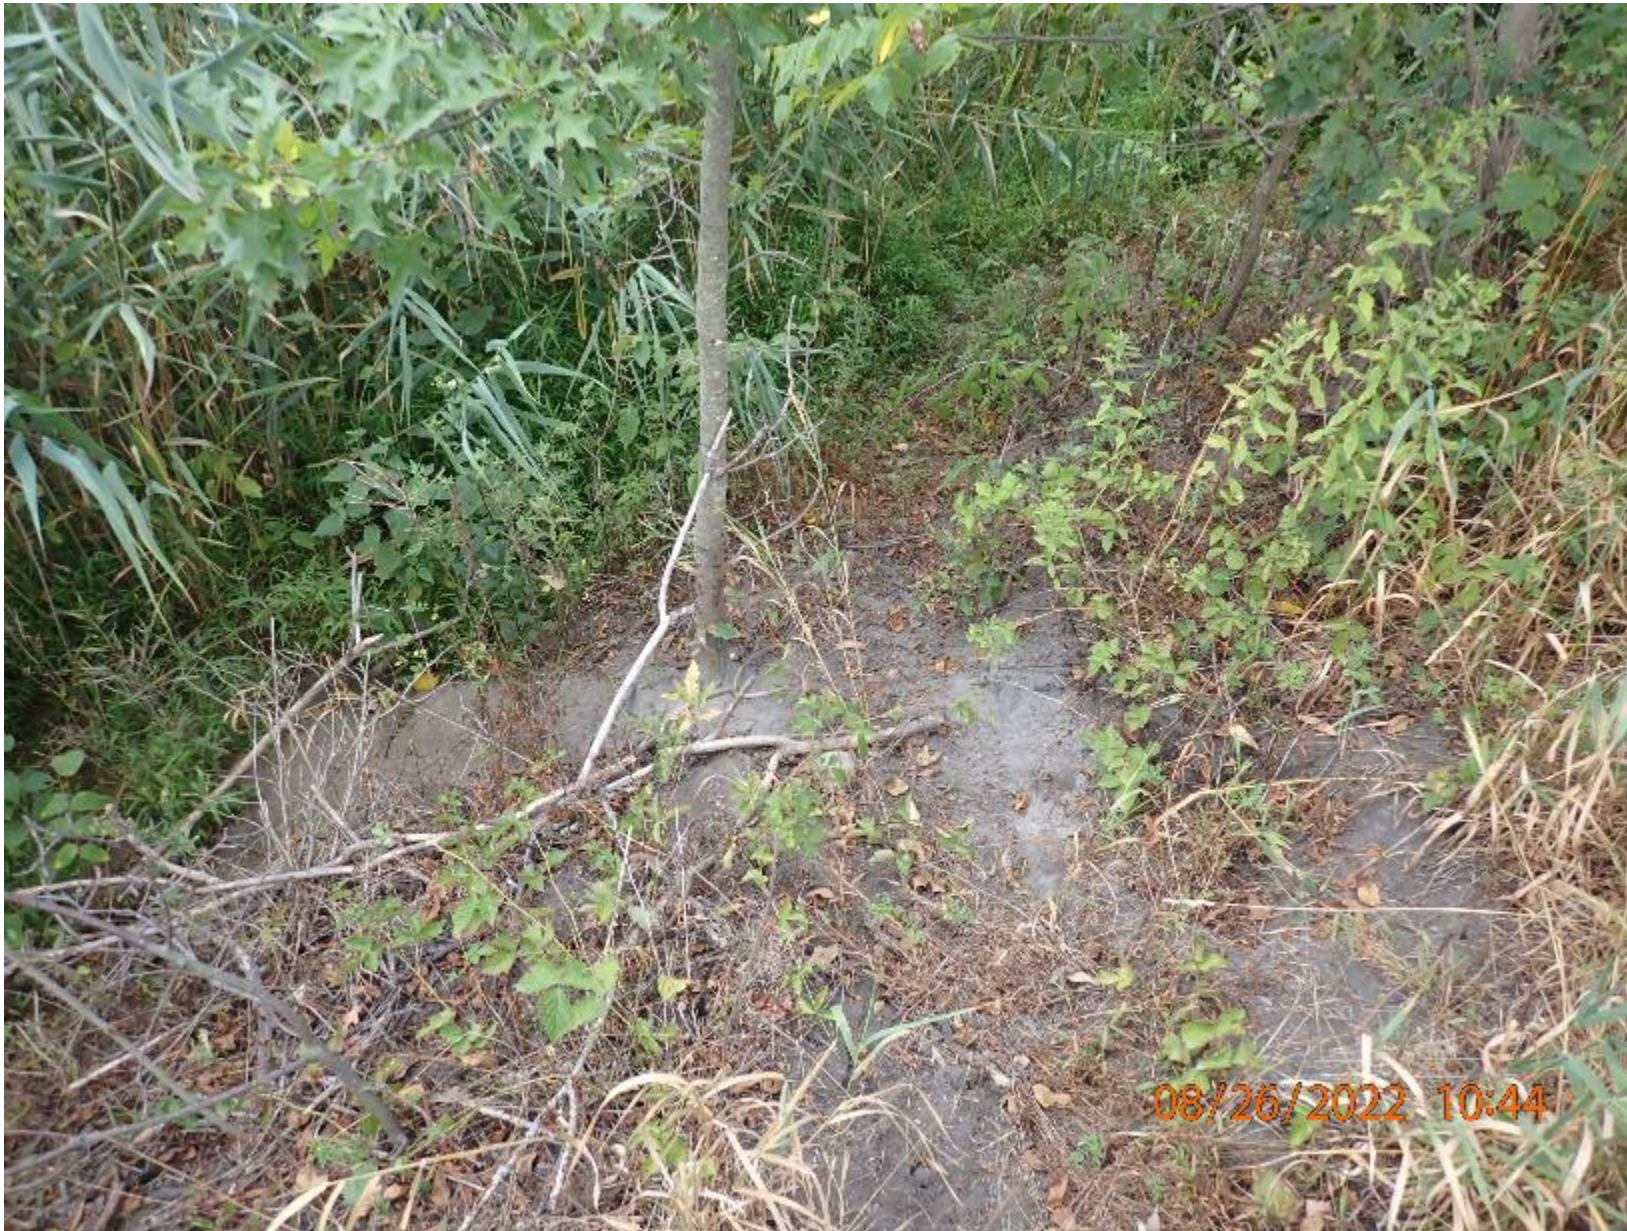
**Date:** 8/26/2022  
**Time:** 10:44 AM  
**Photographer:** SSA  
**Photo ID:** 13 – P8260381

Channel that runs along  
southern border of expansion  
area on other side of berm

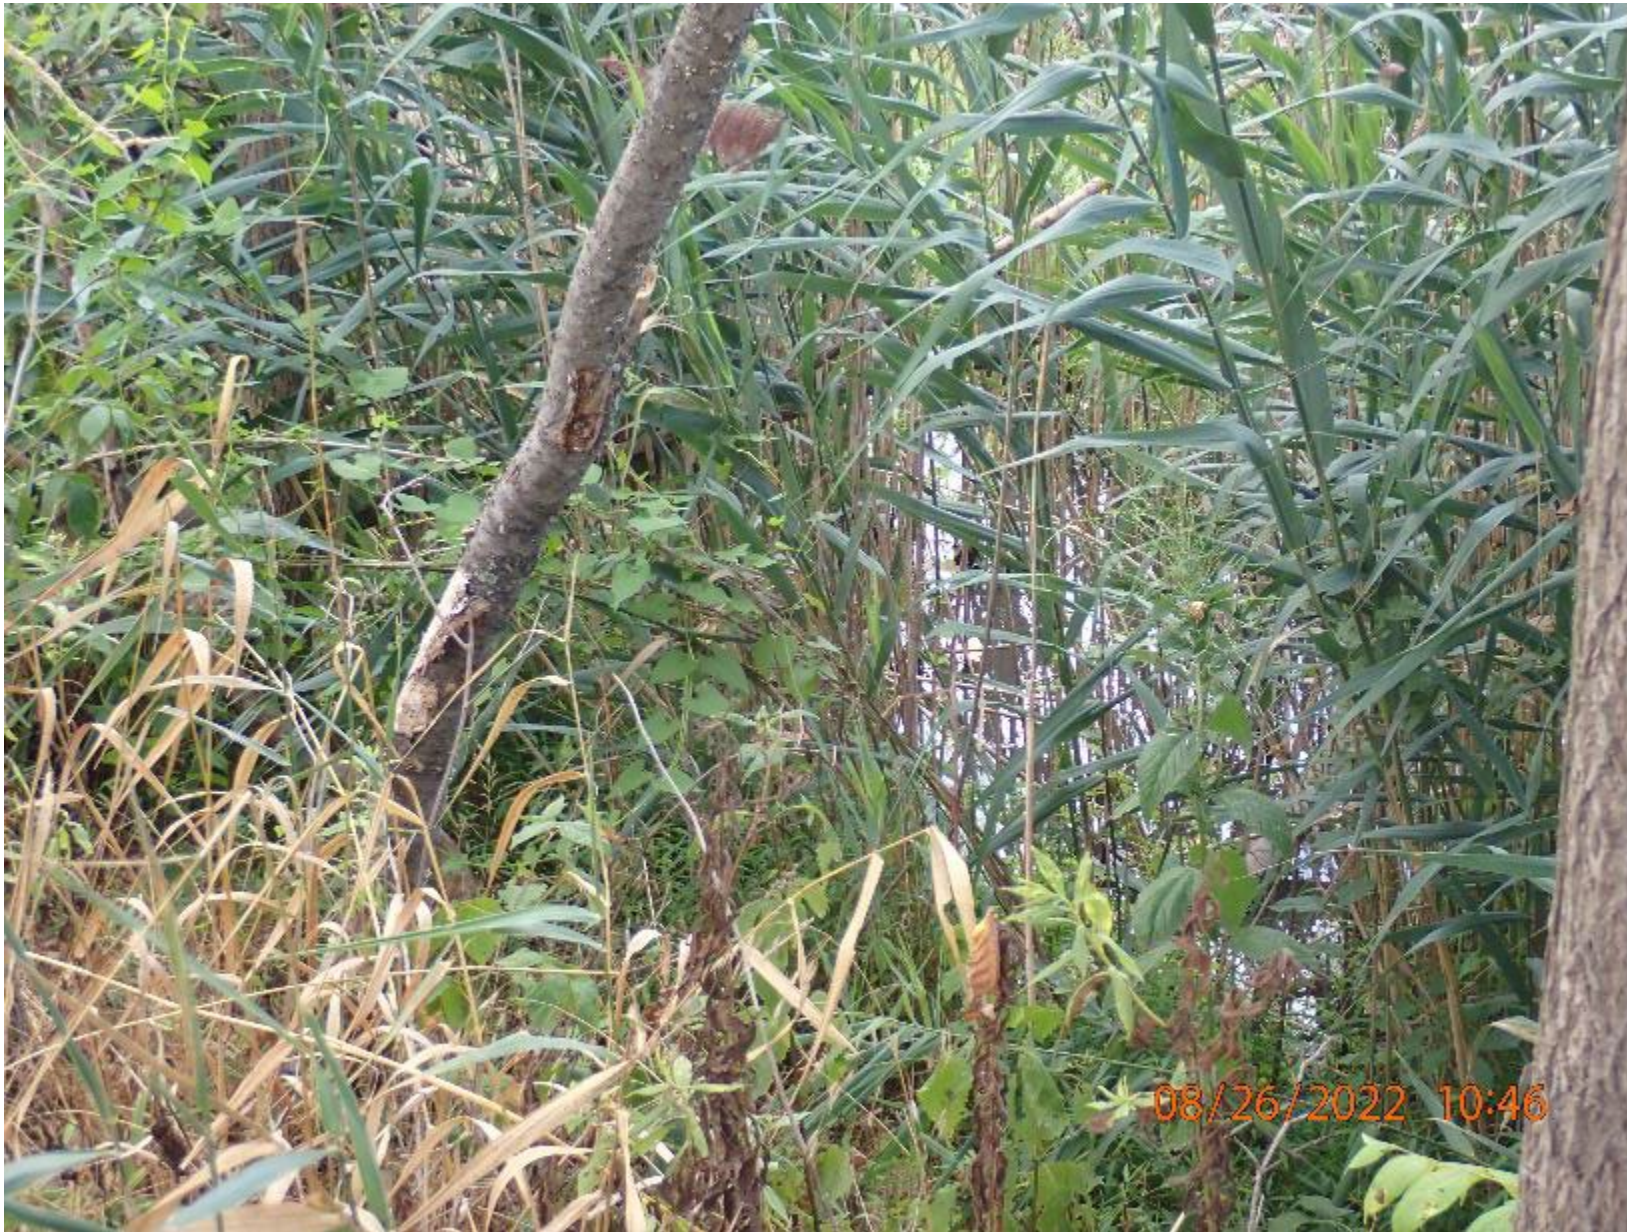
**Date:** 8/26/2022  
**Time:** 10:46 AM  
**Photographer:** SSA  
**Photo ID:** 14 – P8260382

EPA observed water in the agricultural channel south of the expansion area. The channel flows east to the Wallkill River.

Channel that runs along  
southern border of expansion  
area; surface water in channel

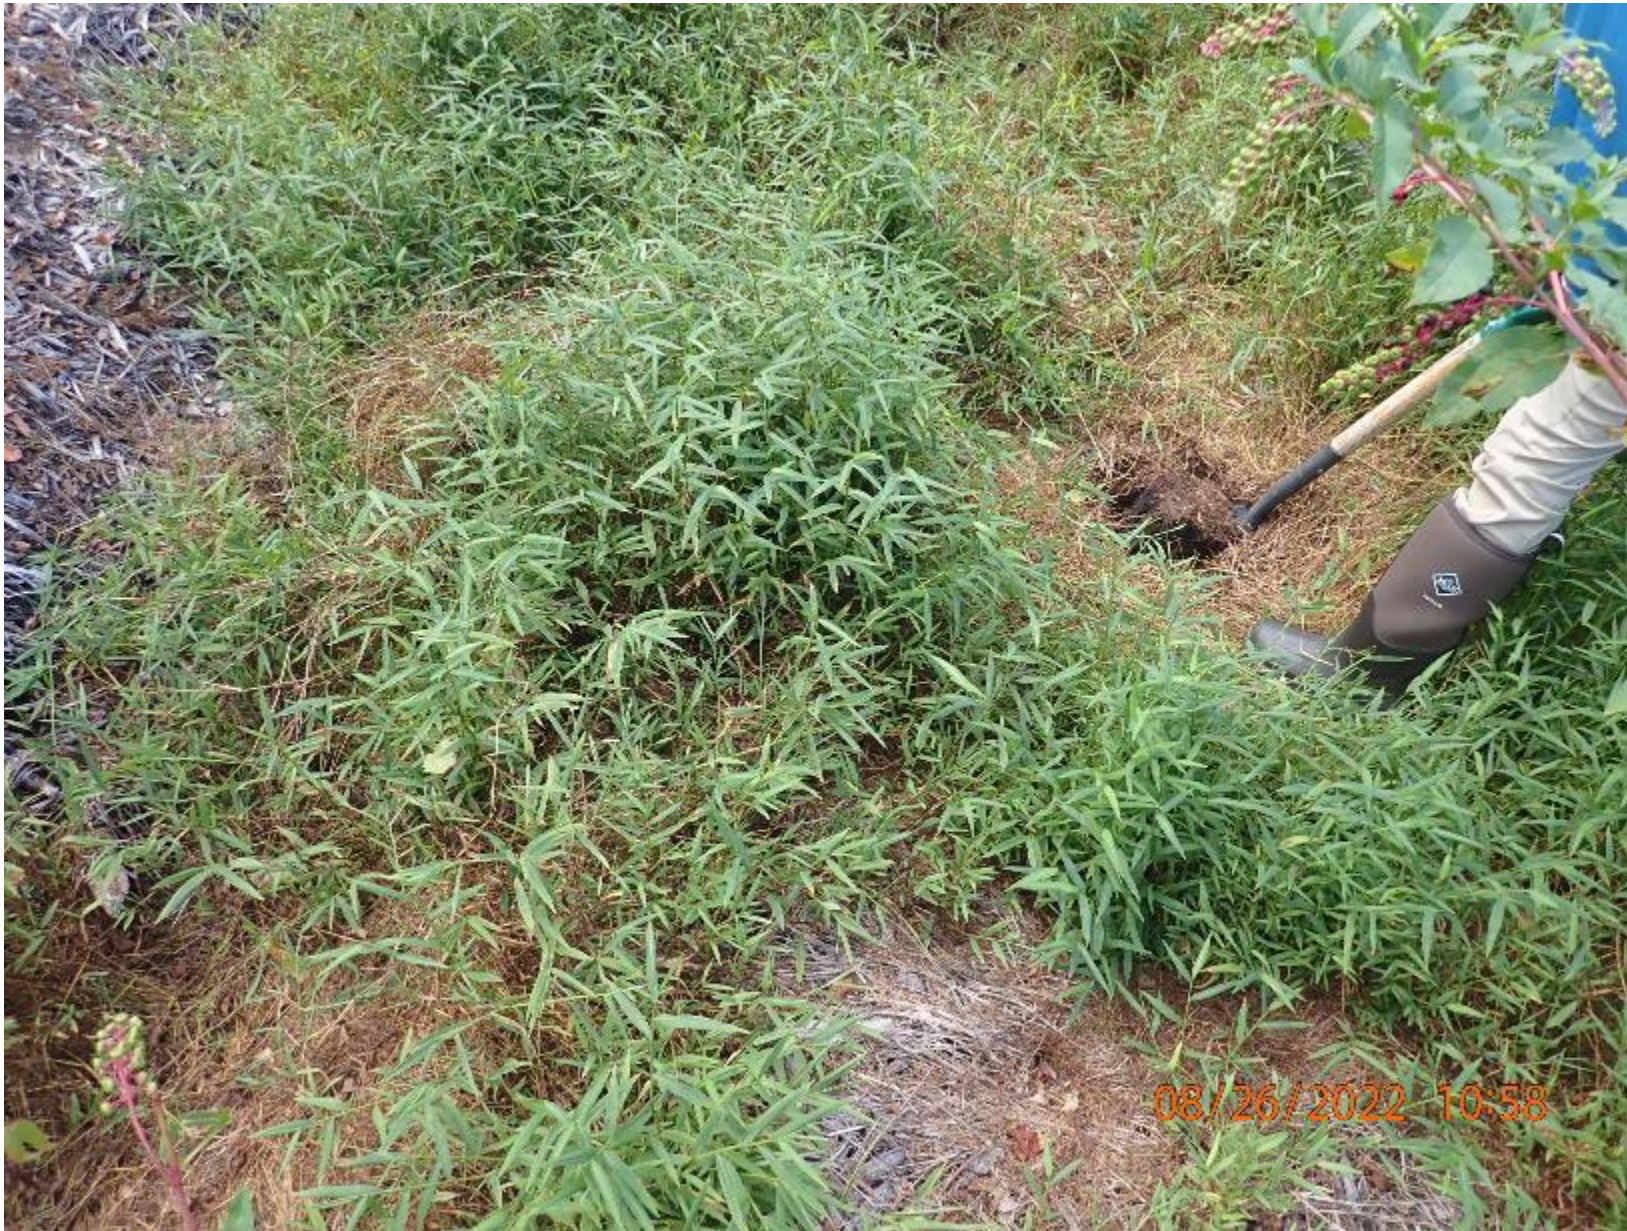
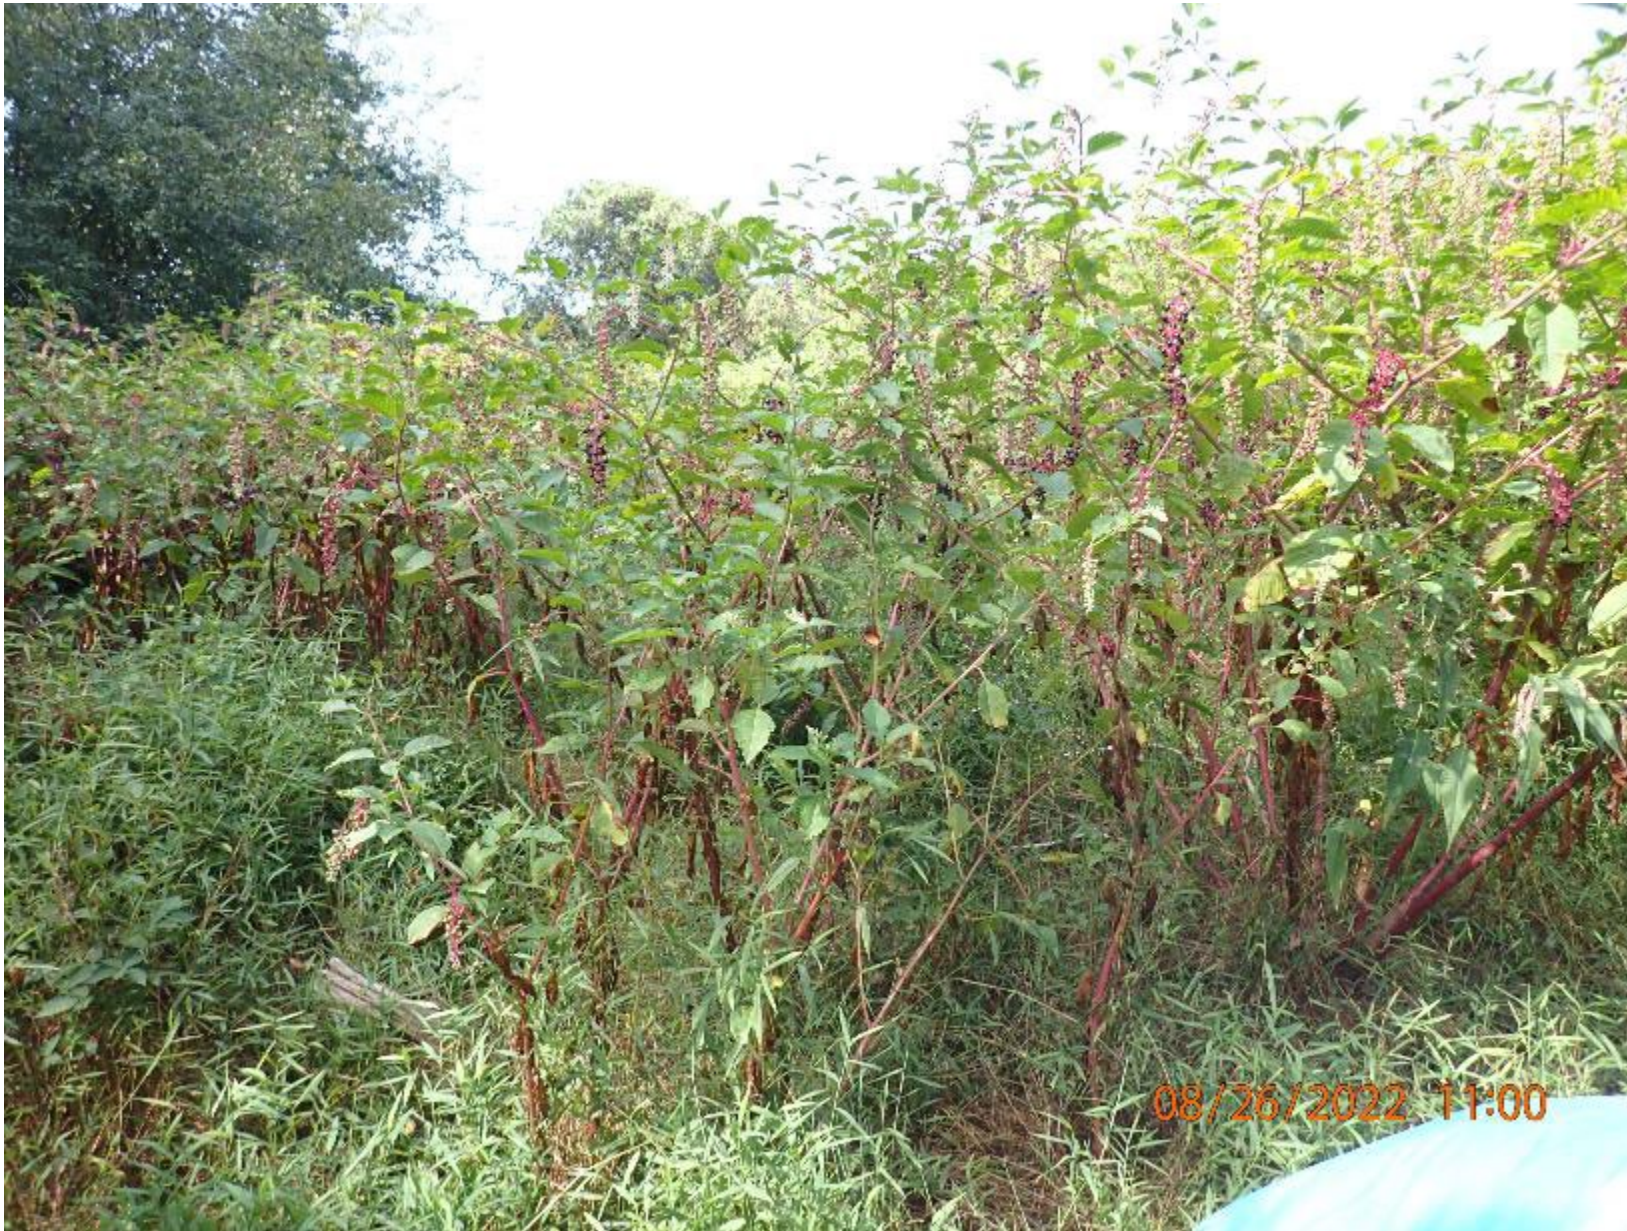
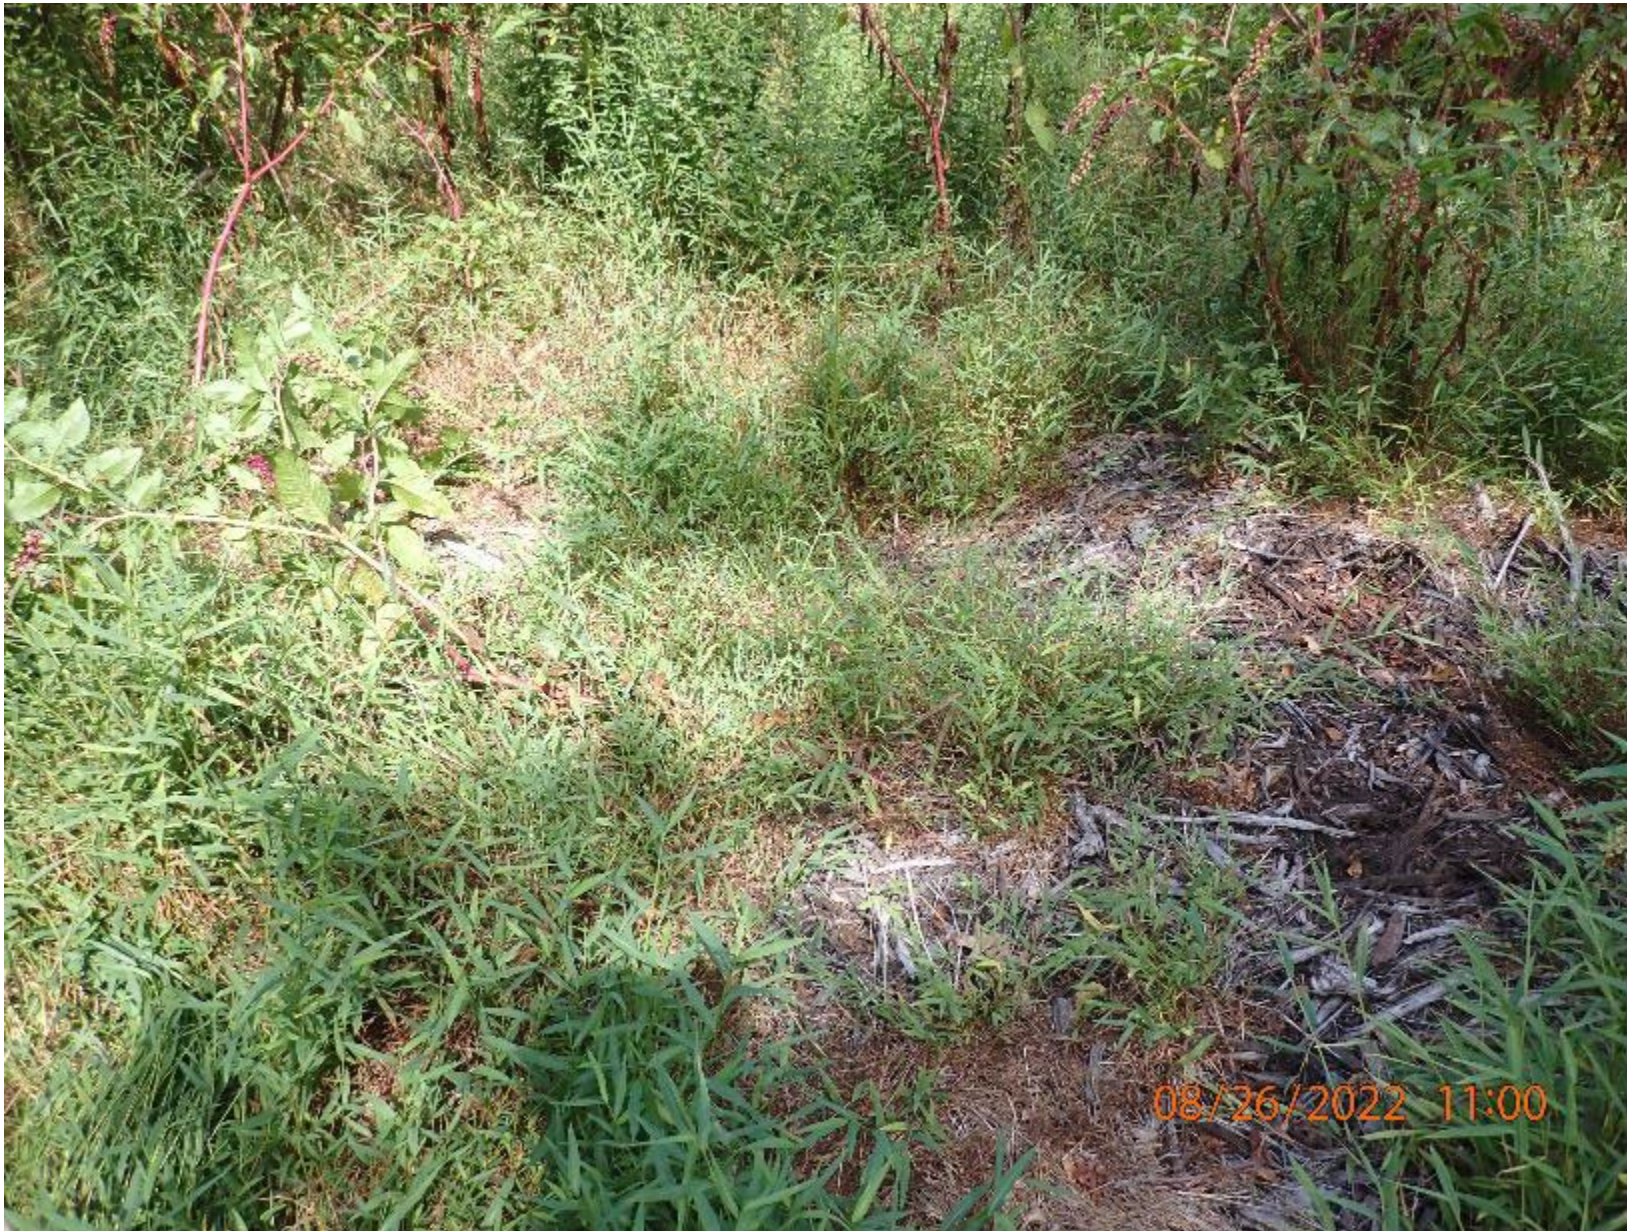
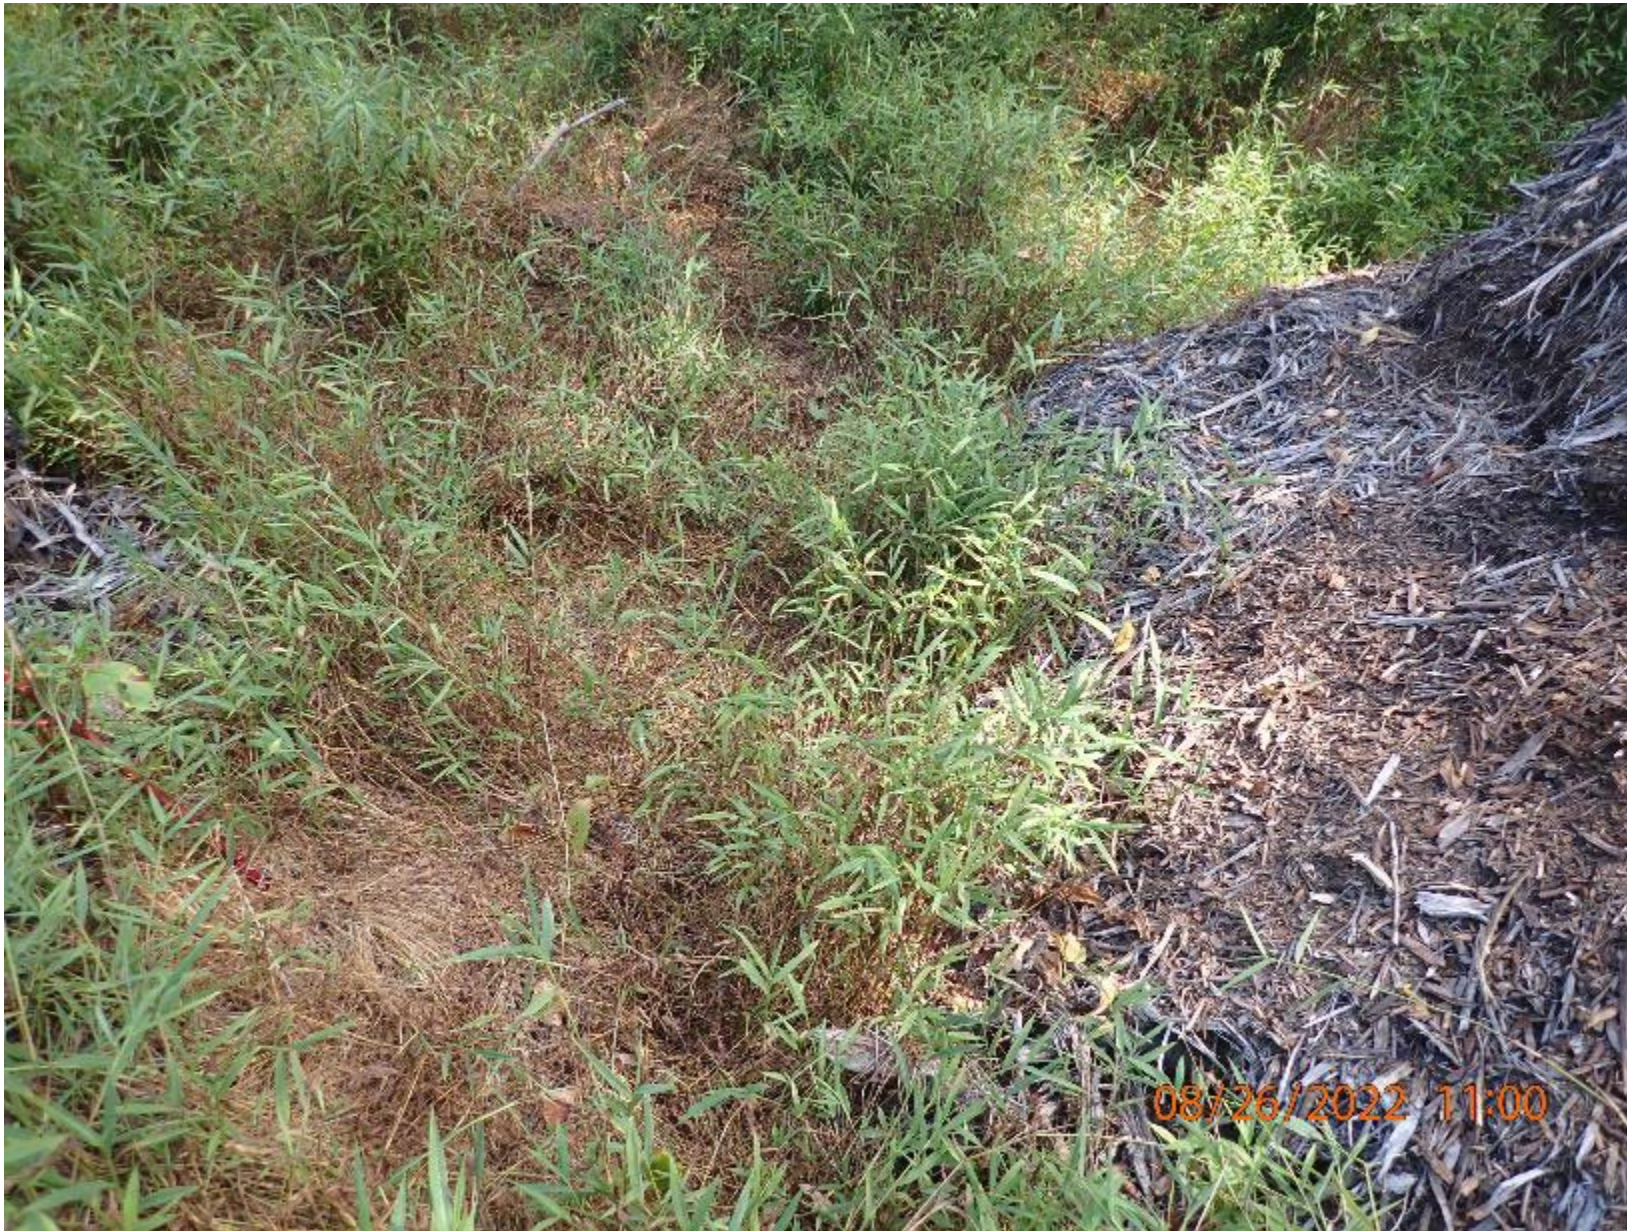
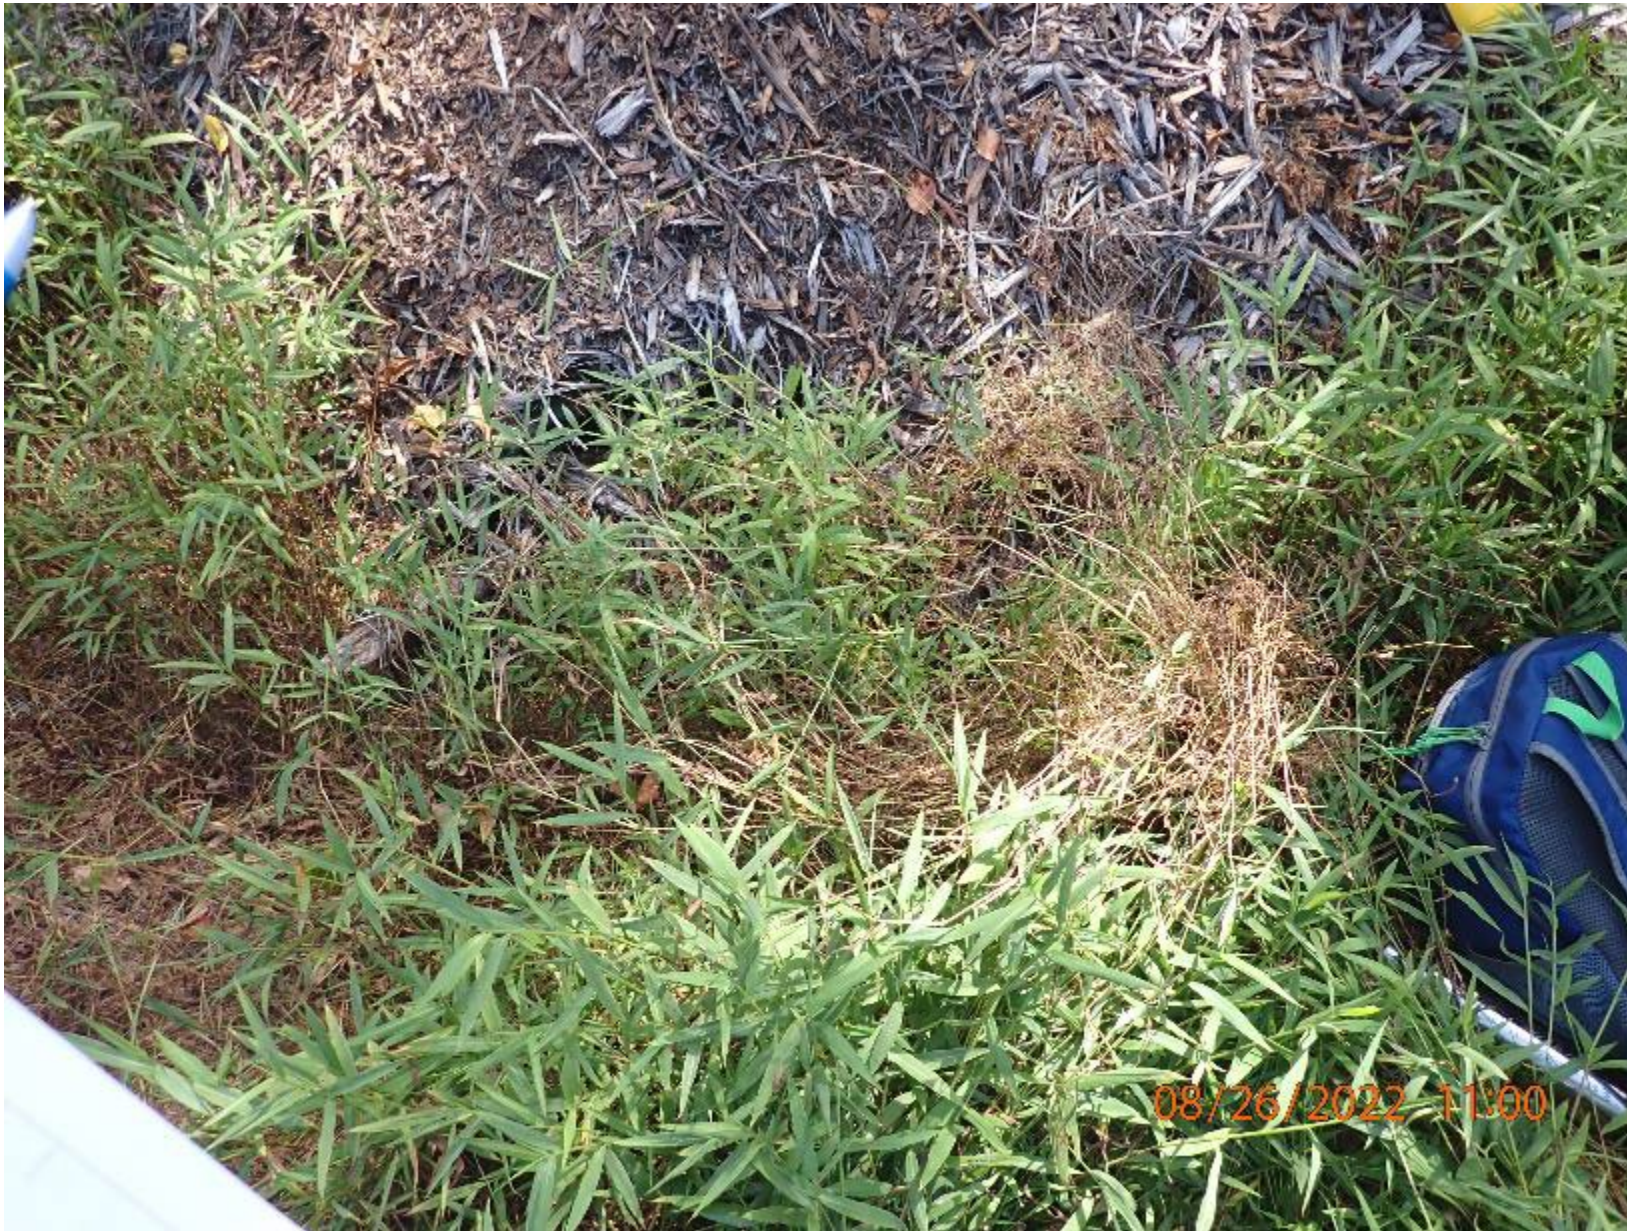
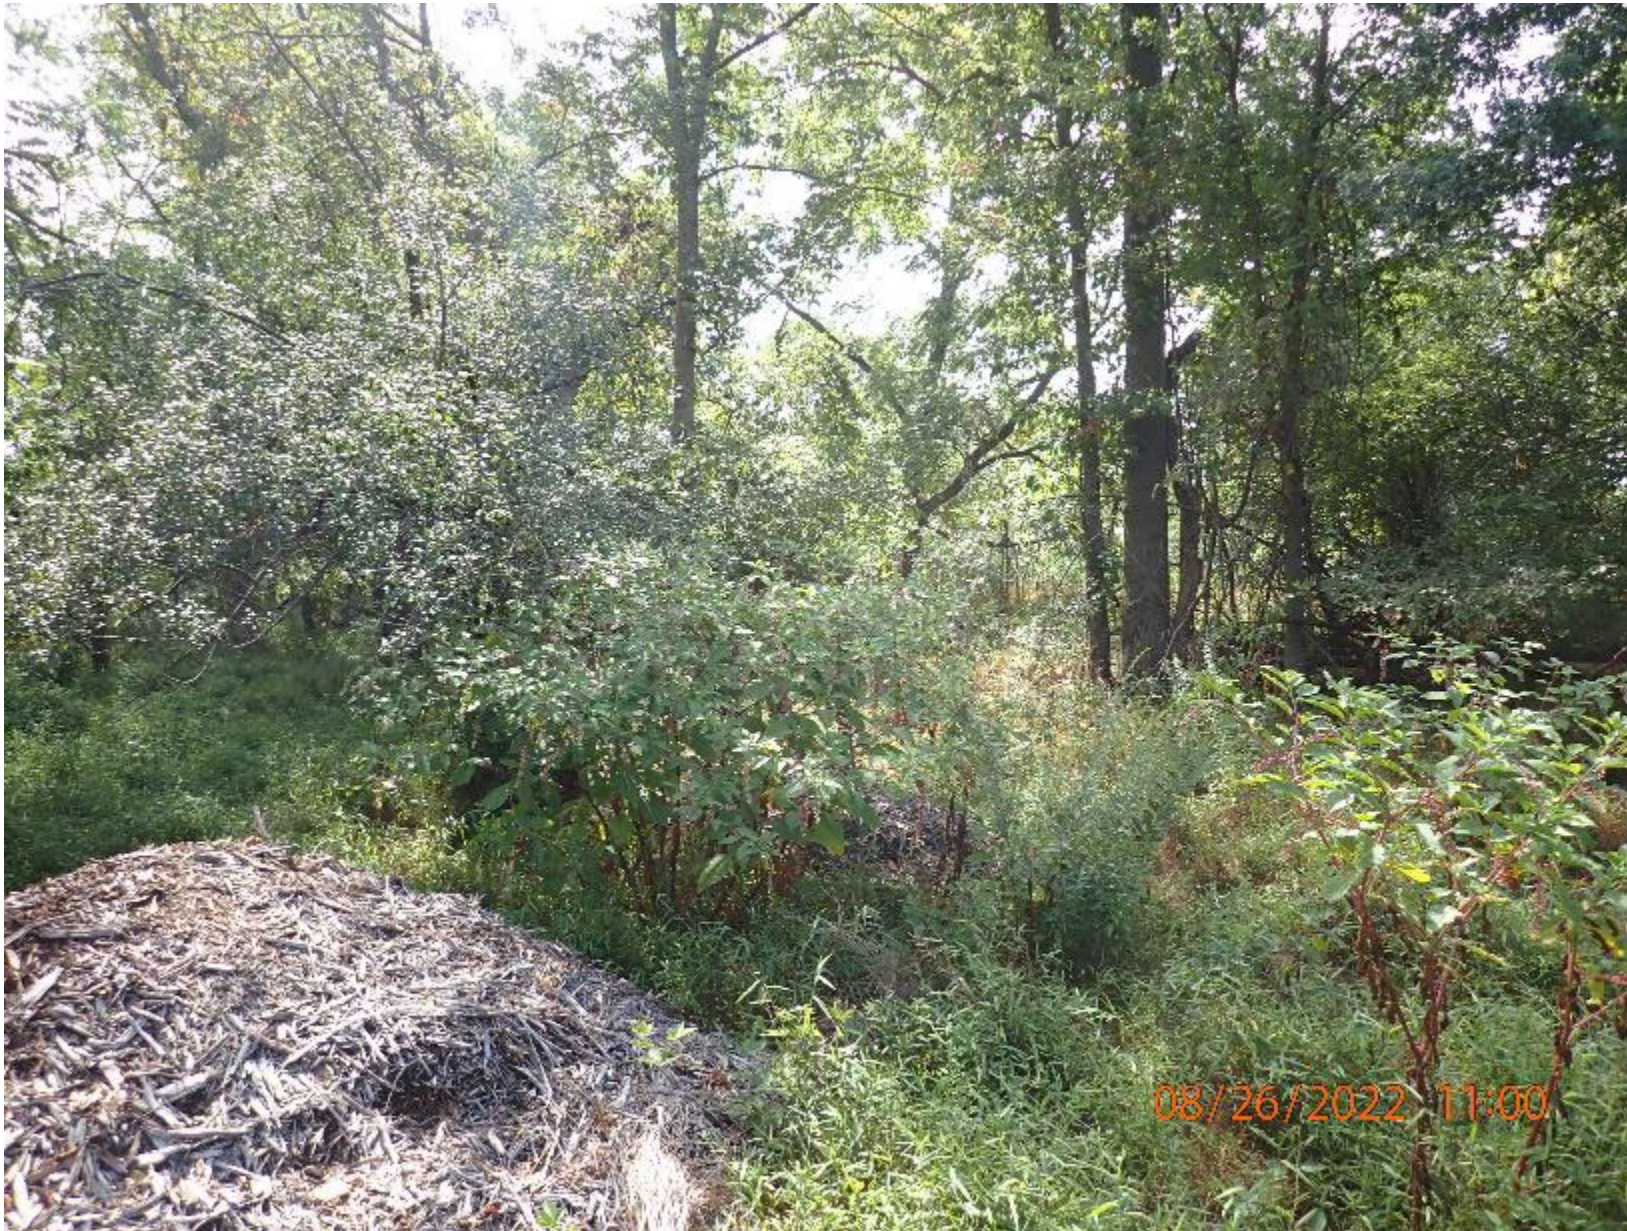
EPA took two soil samples. The first soil sample, located in a scrub-shrub/herbaceous area east of the expansion, was found to not be in a wetland due to a lack of hydrological indicators. The second soil sample, located between the berm and an agricultural channel south of the expansion area was also found to not be in a wetland.

**Description:**  
Area around Soil Pit #1 (SS1)
