## Clean Water Act Section 404: Site Visit/Case Development

| Site Name | Dick's Concrete | | | | |
| Site Address* | 1053 County Road 37 (Pellets Island Road) and 1326 Co Route 12 | | | | |

CWA 404 Inspection Photolog  
Dick's Concrete  
1053 Co Rd 37 and 1326 Co Rt 12  
Orange County, NY

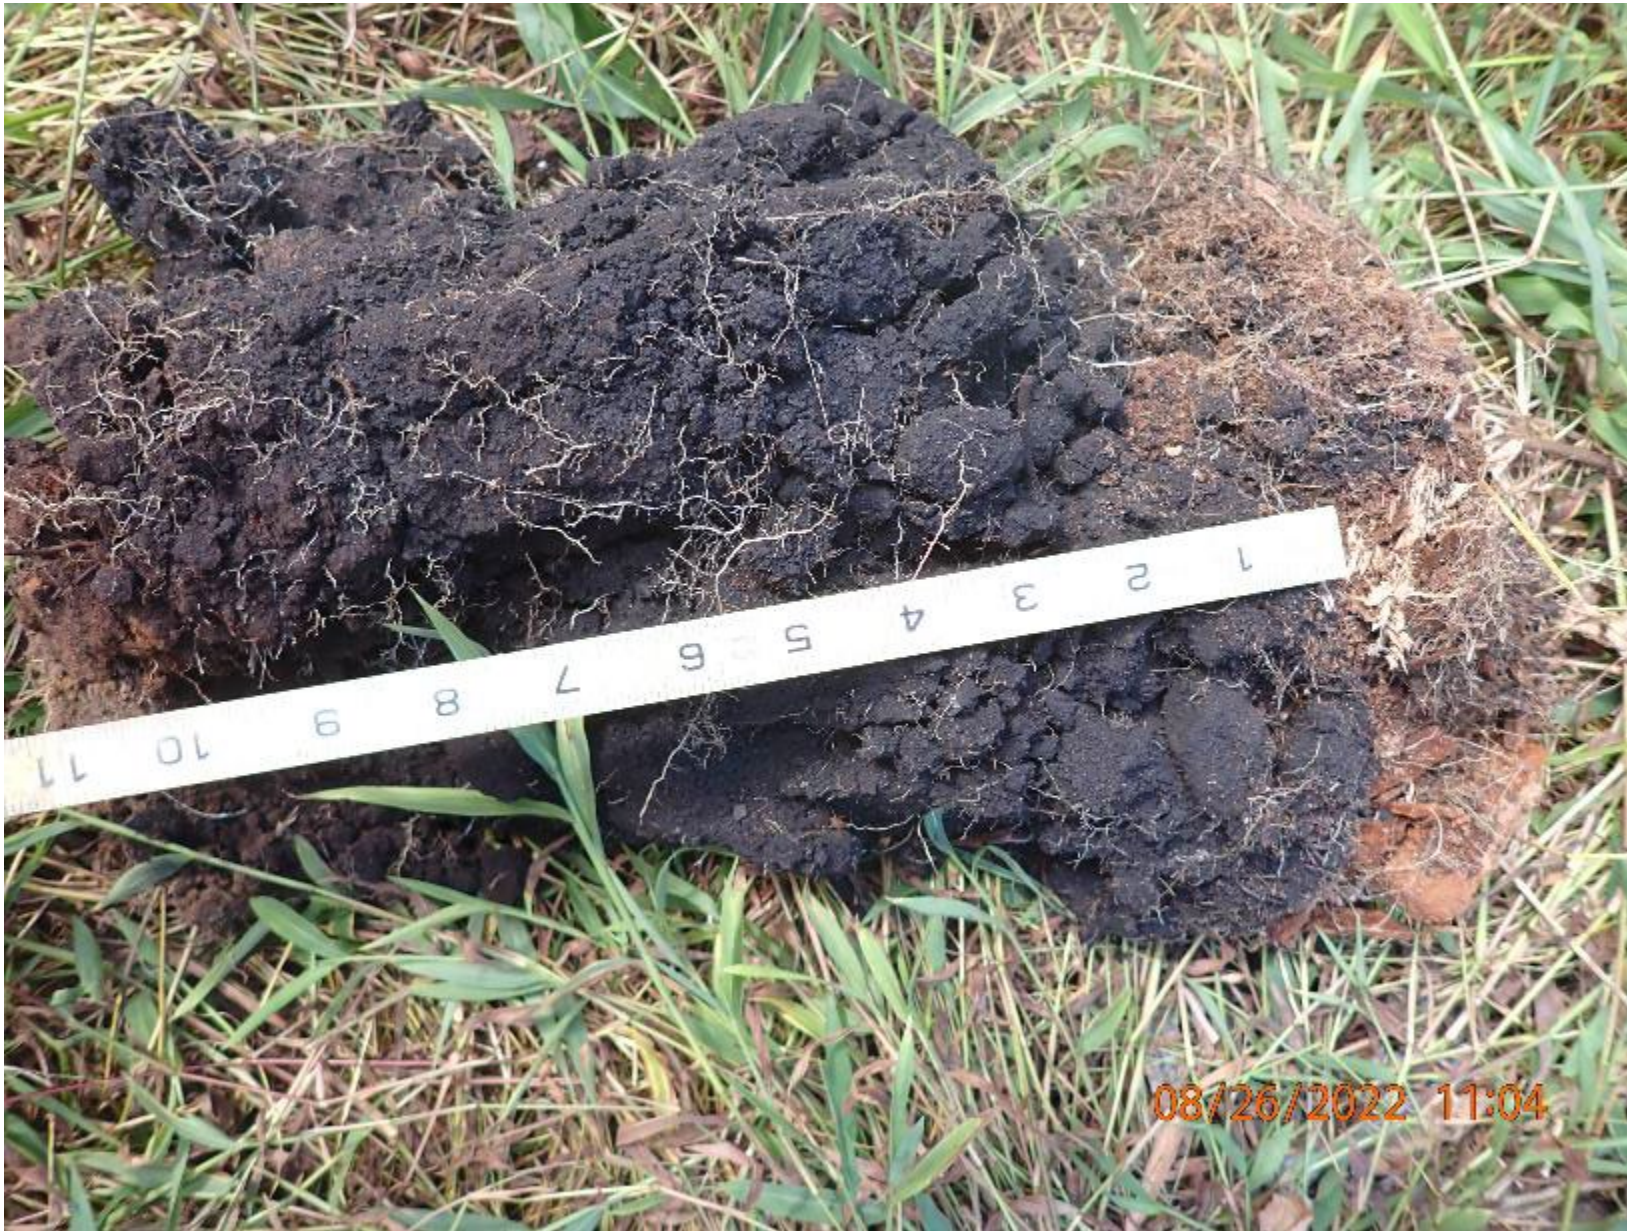
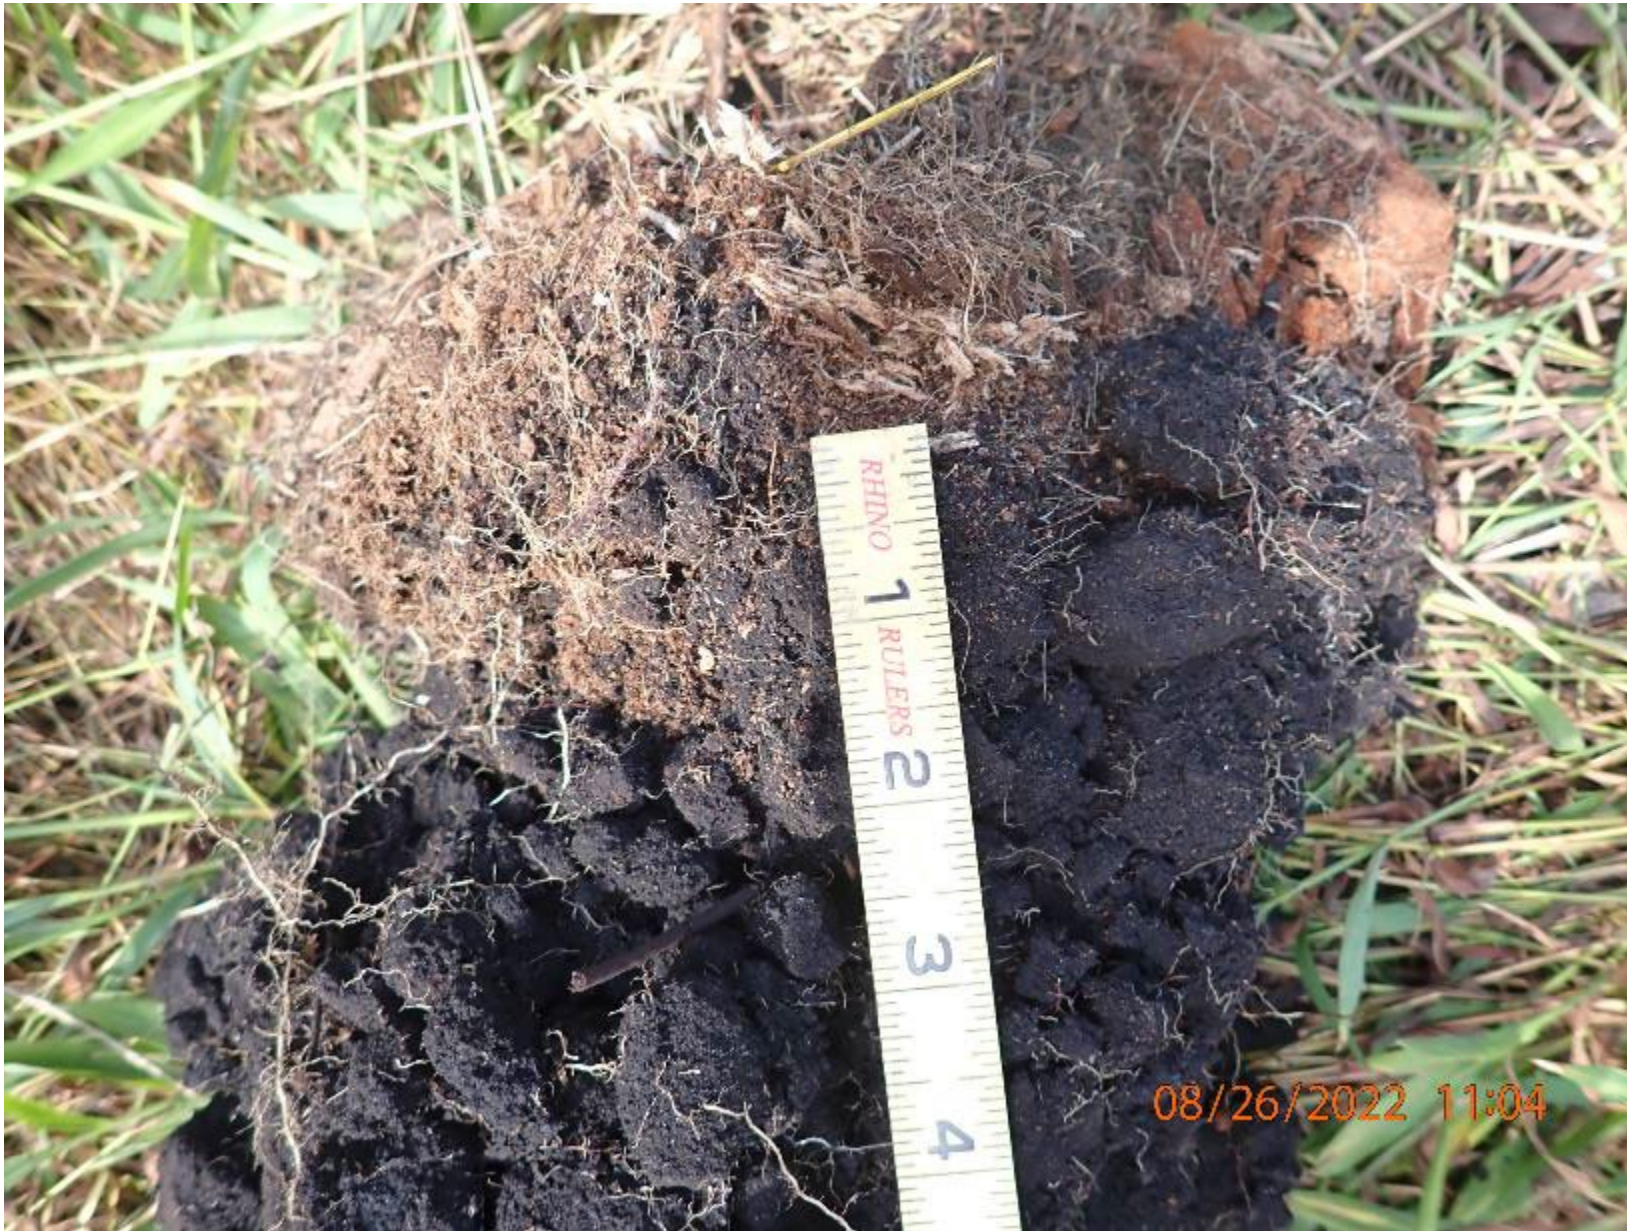
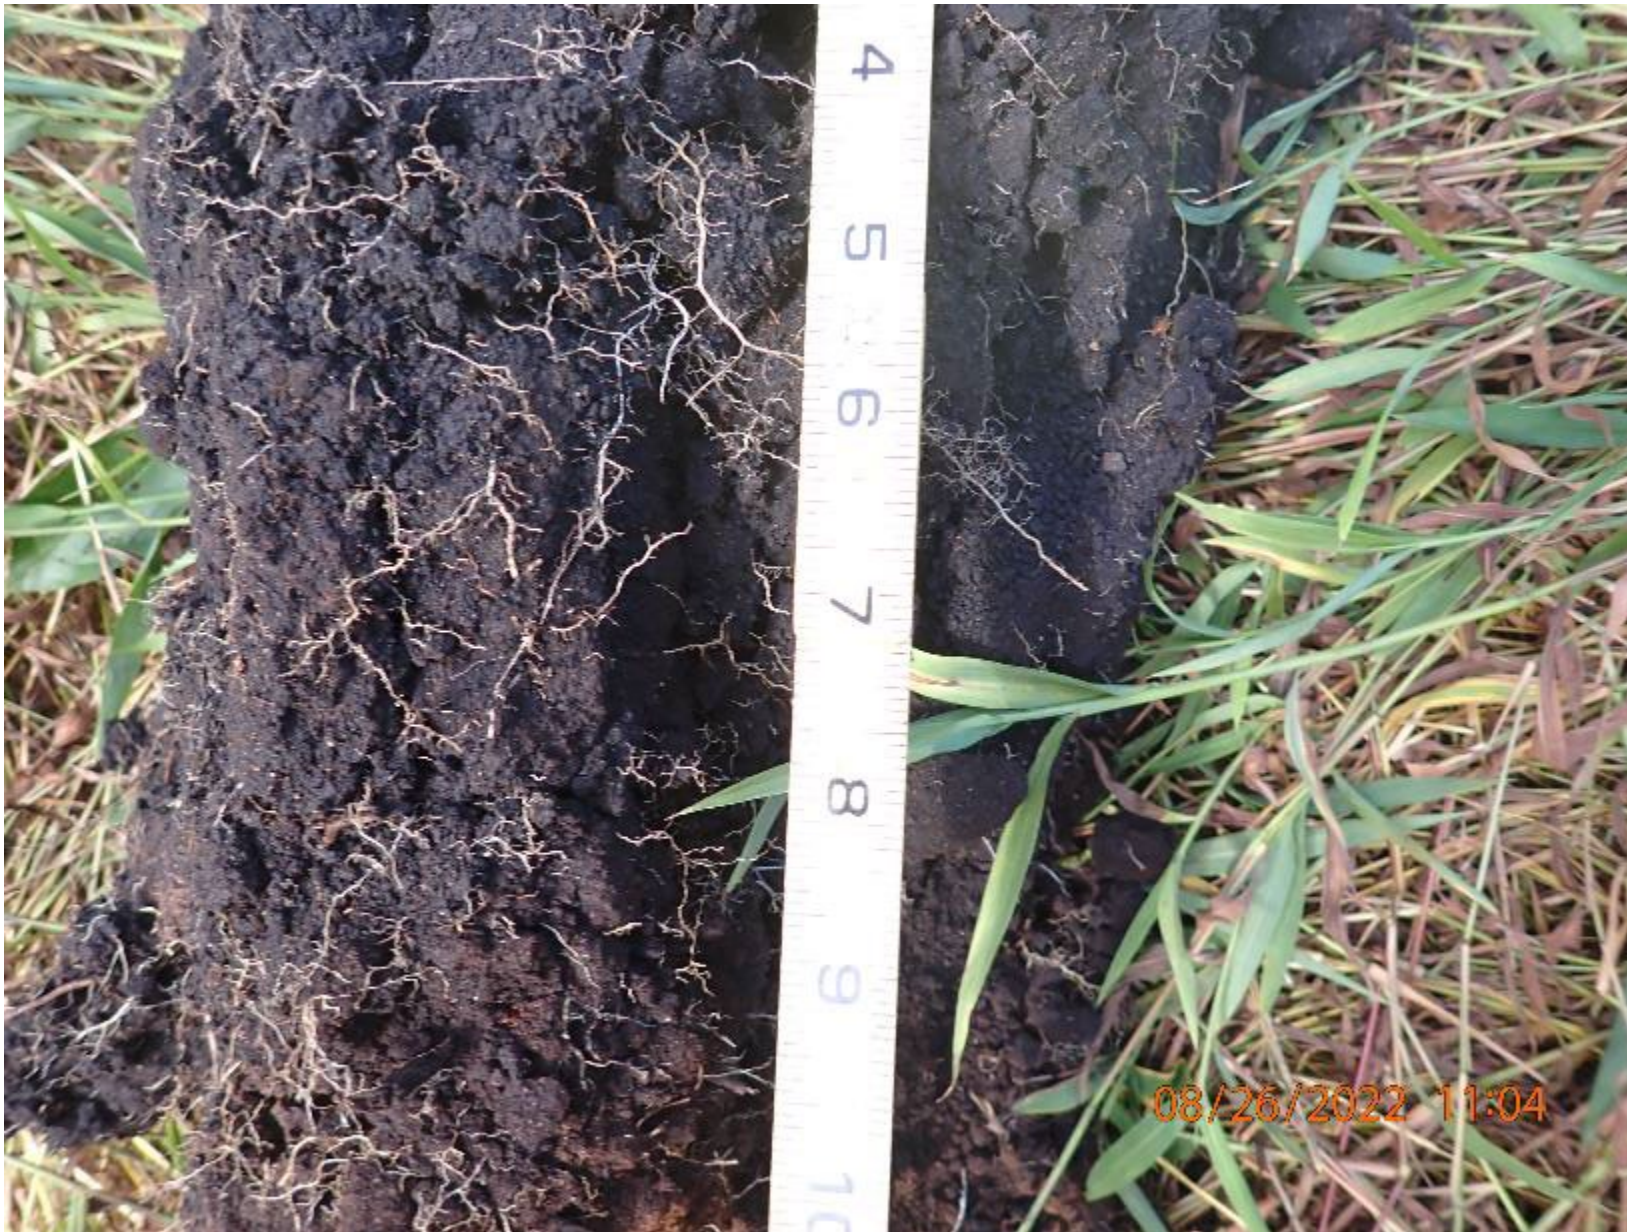
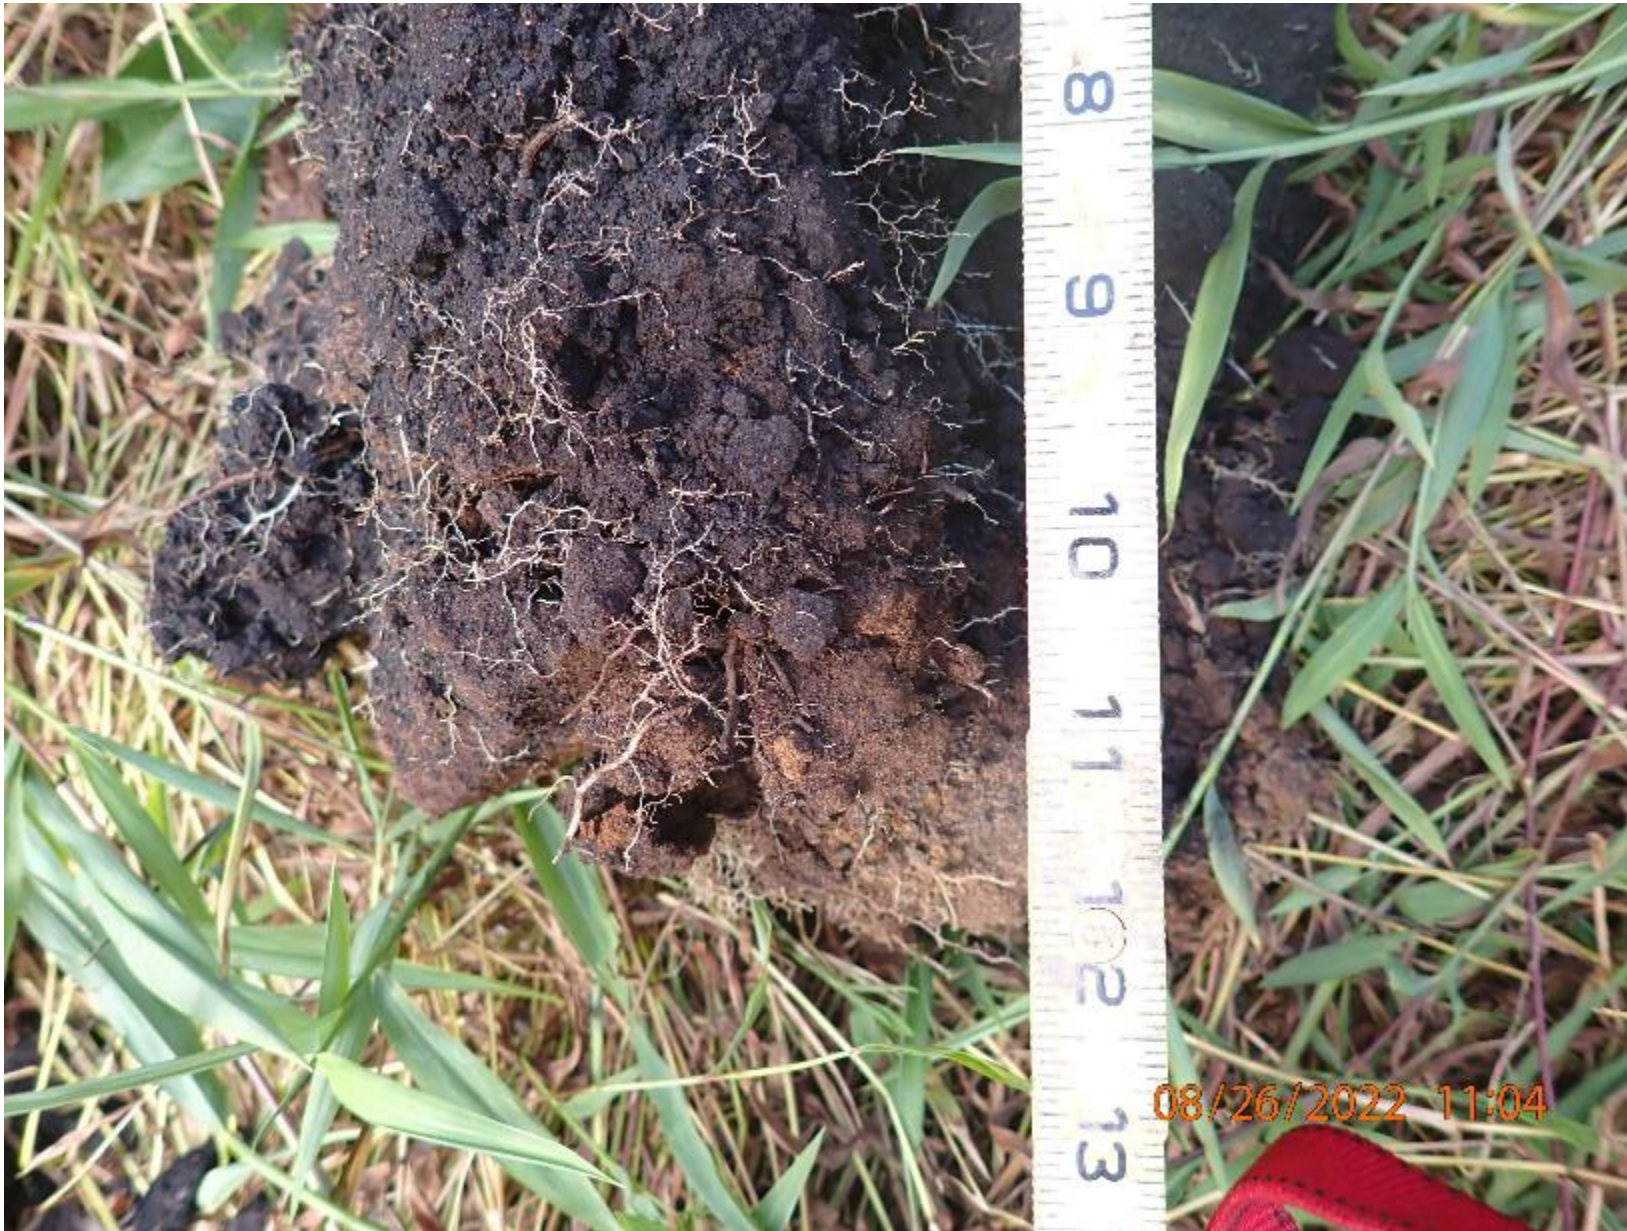
EPA took two soil samples. The first soil sample, located in a scrub-shrub/herbaceous area east of the expansion, was found to not be in a wetland due to a lack of hydrological indicators. The second soil sample, located between the berm and an agricultural channel south of the expansion area was also found to not be in a wetland.

**Description:**  
Soil Pit #1 (SS1) soil profile

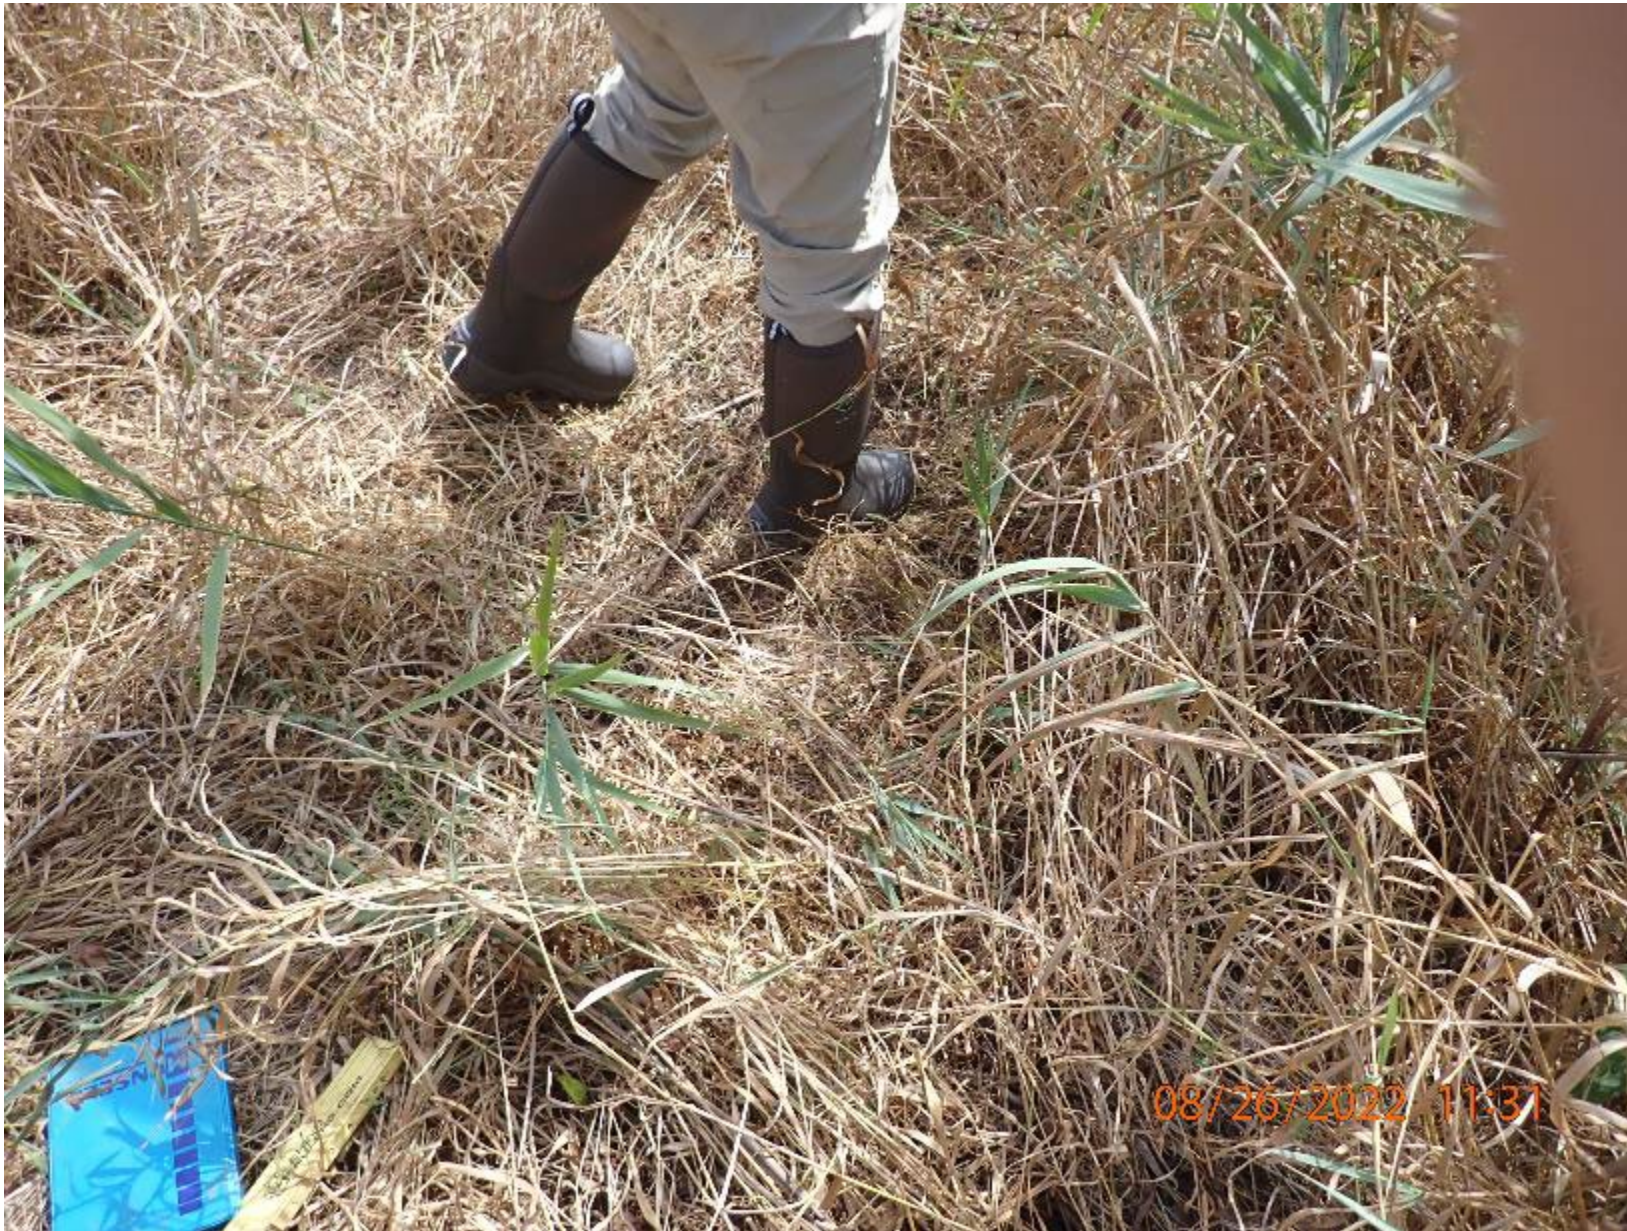
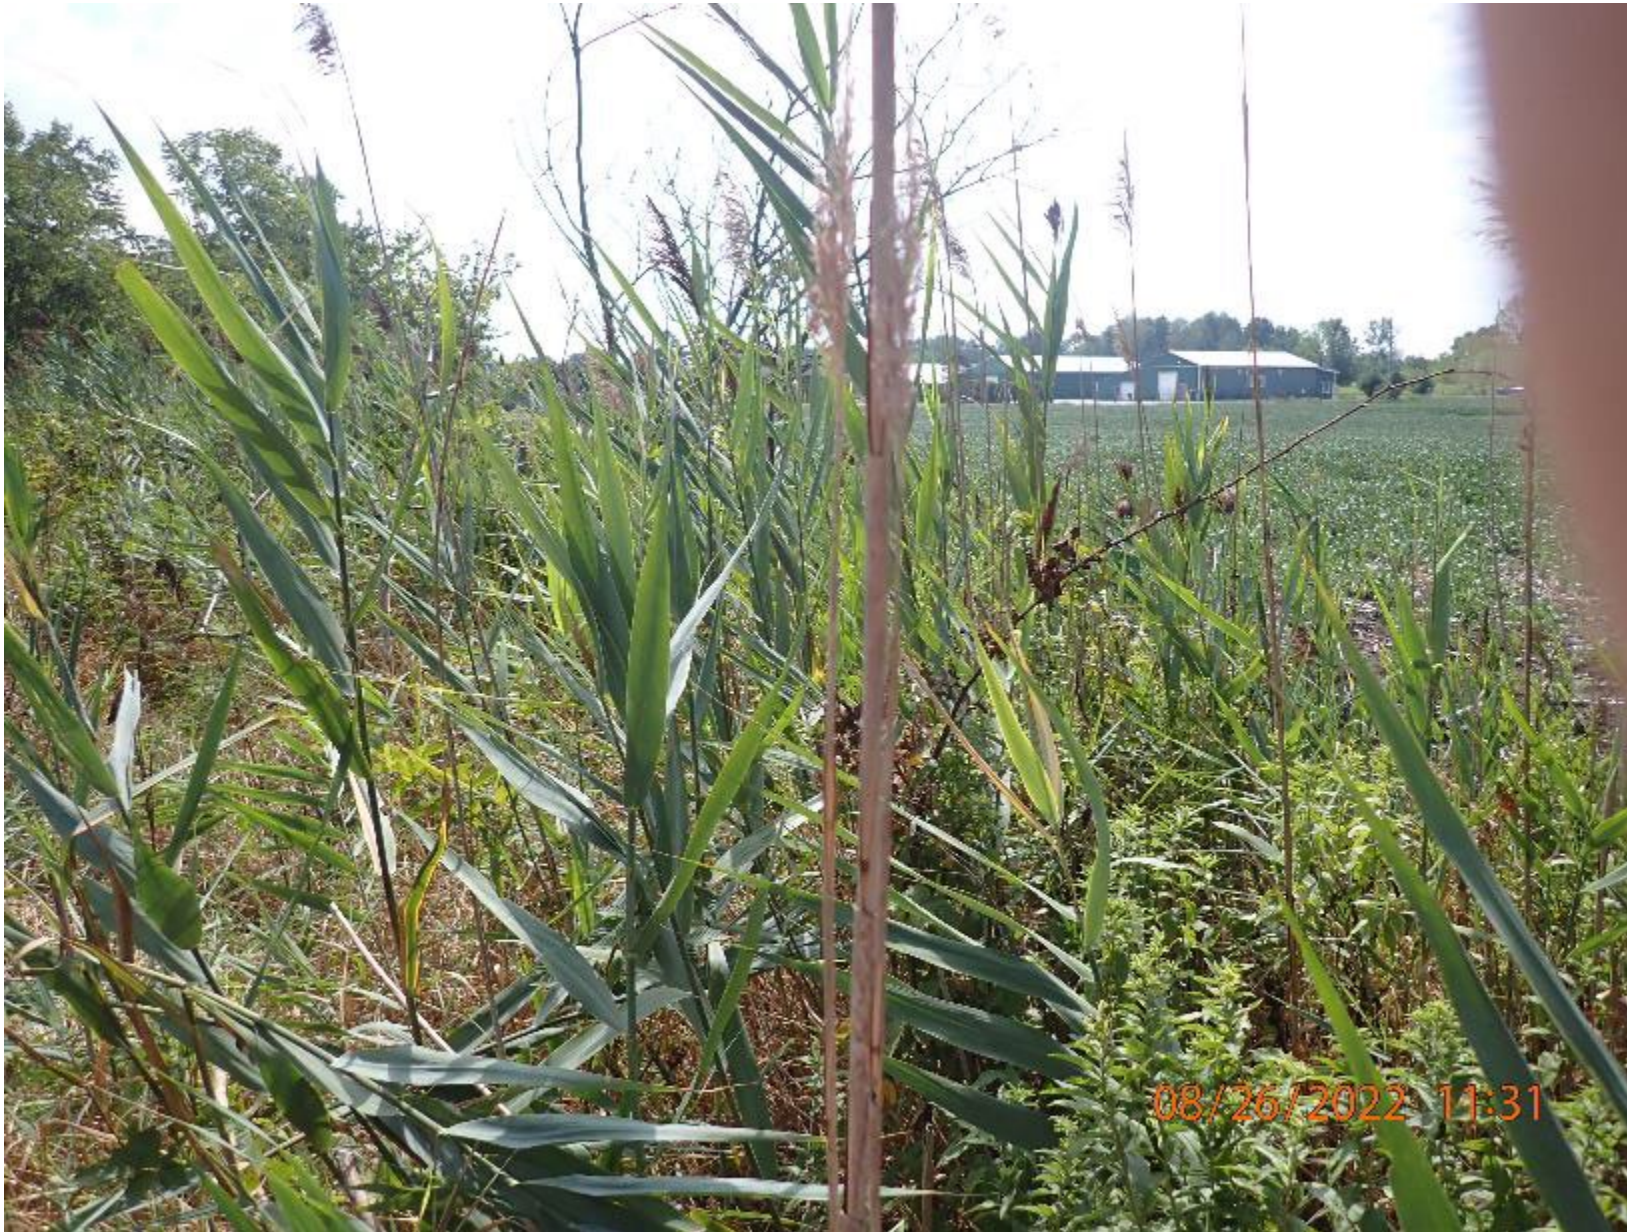
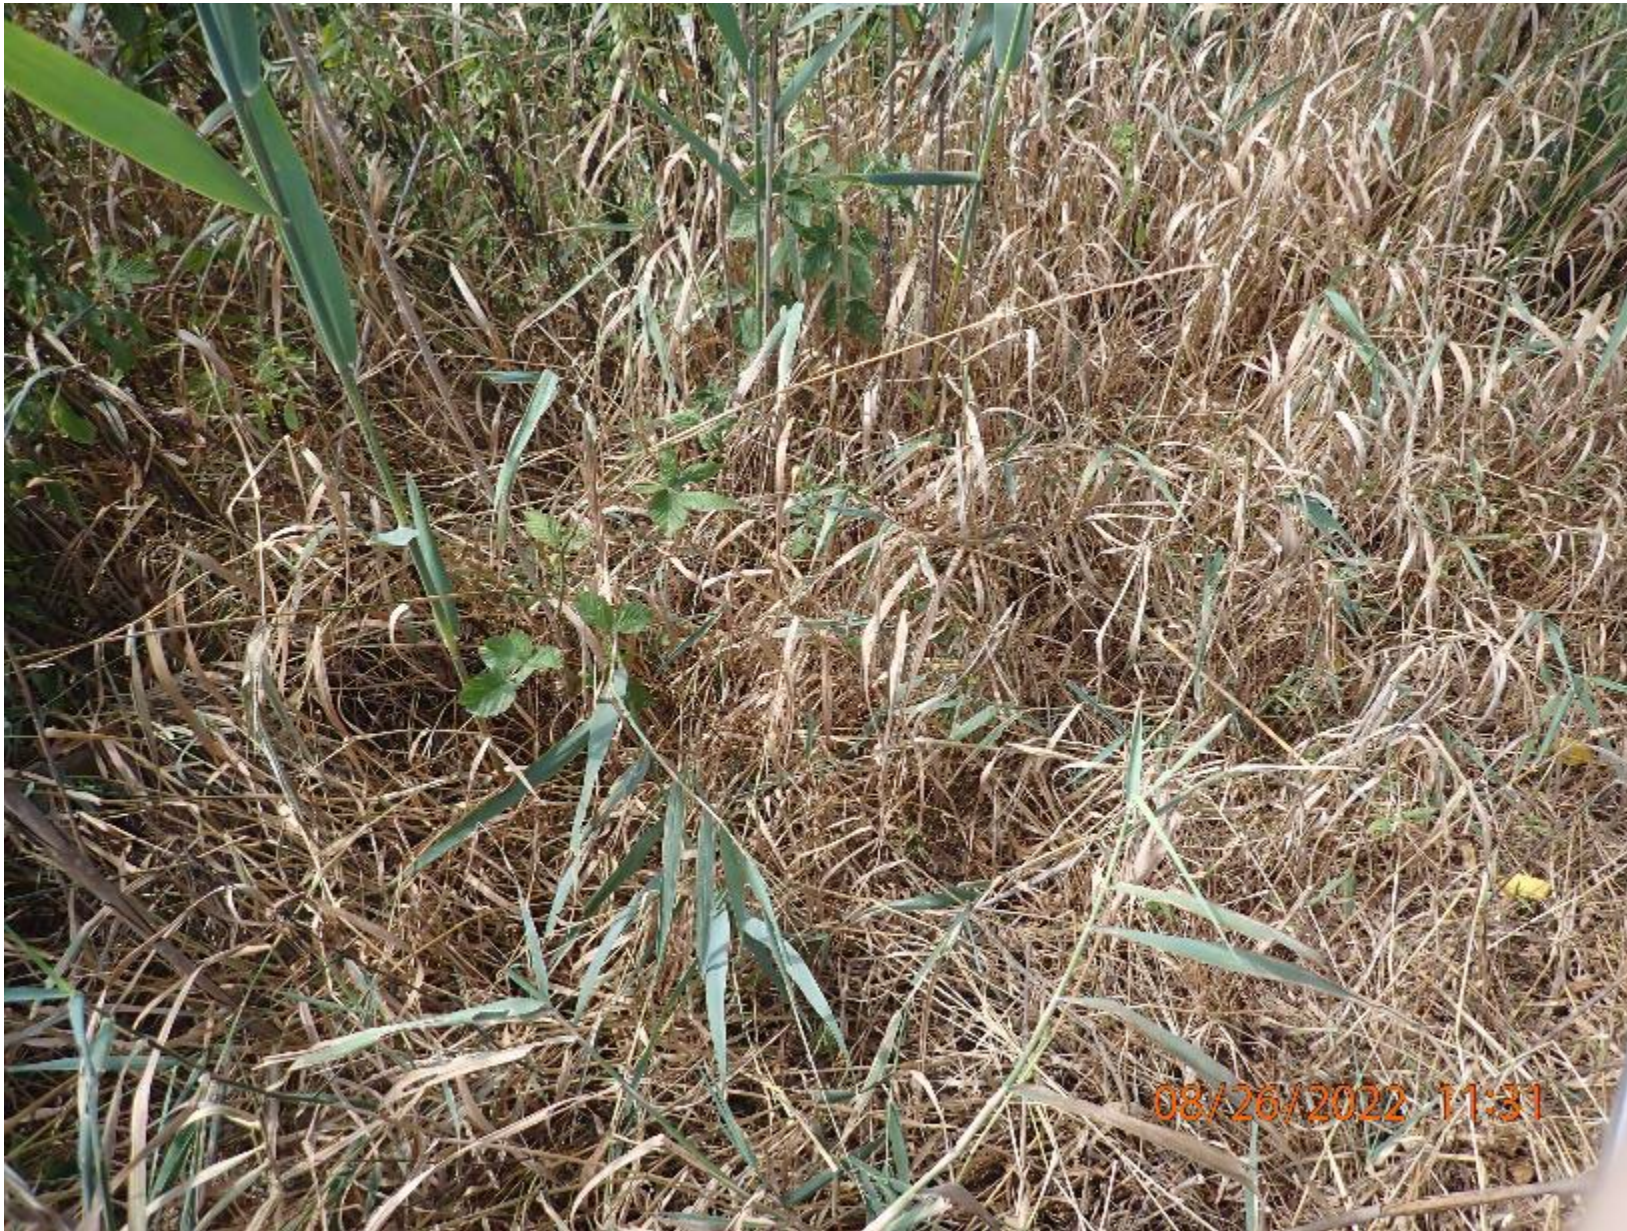
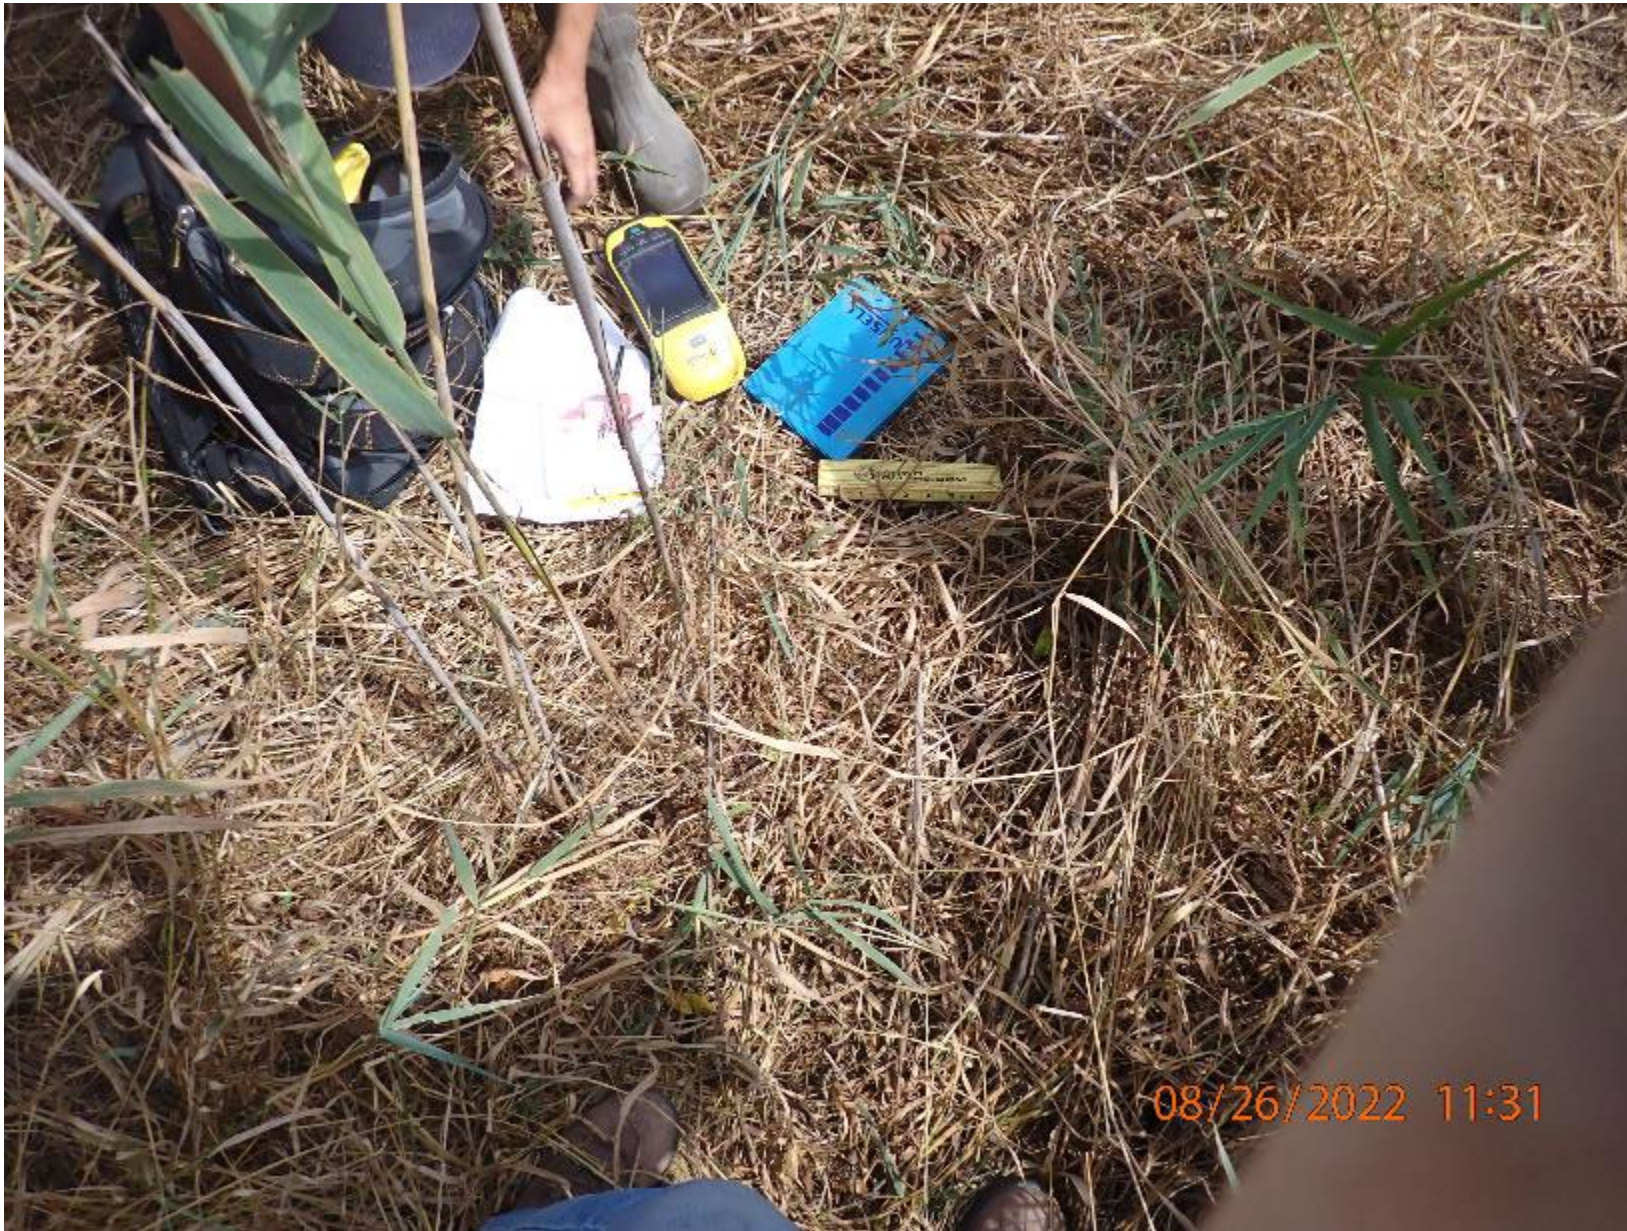
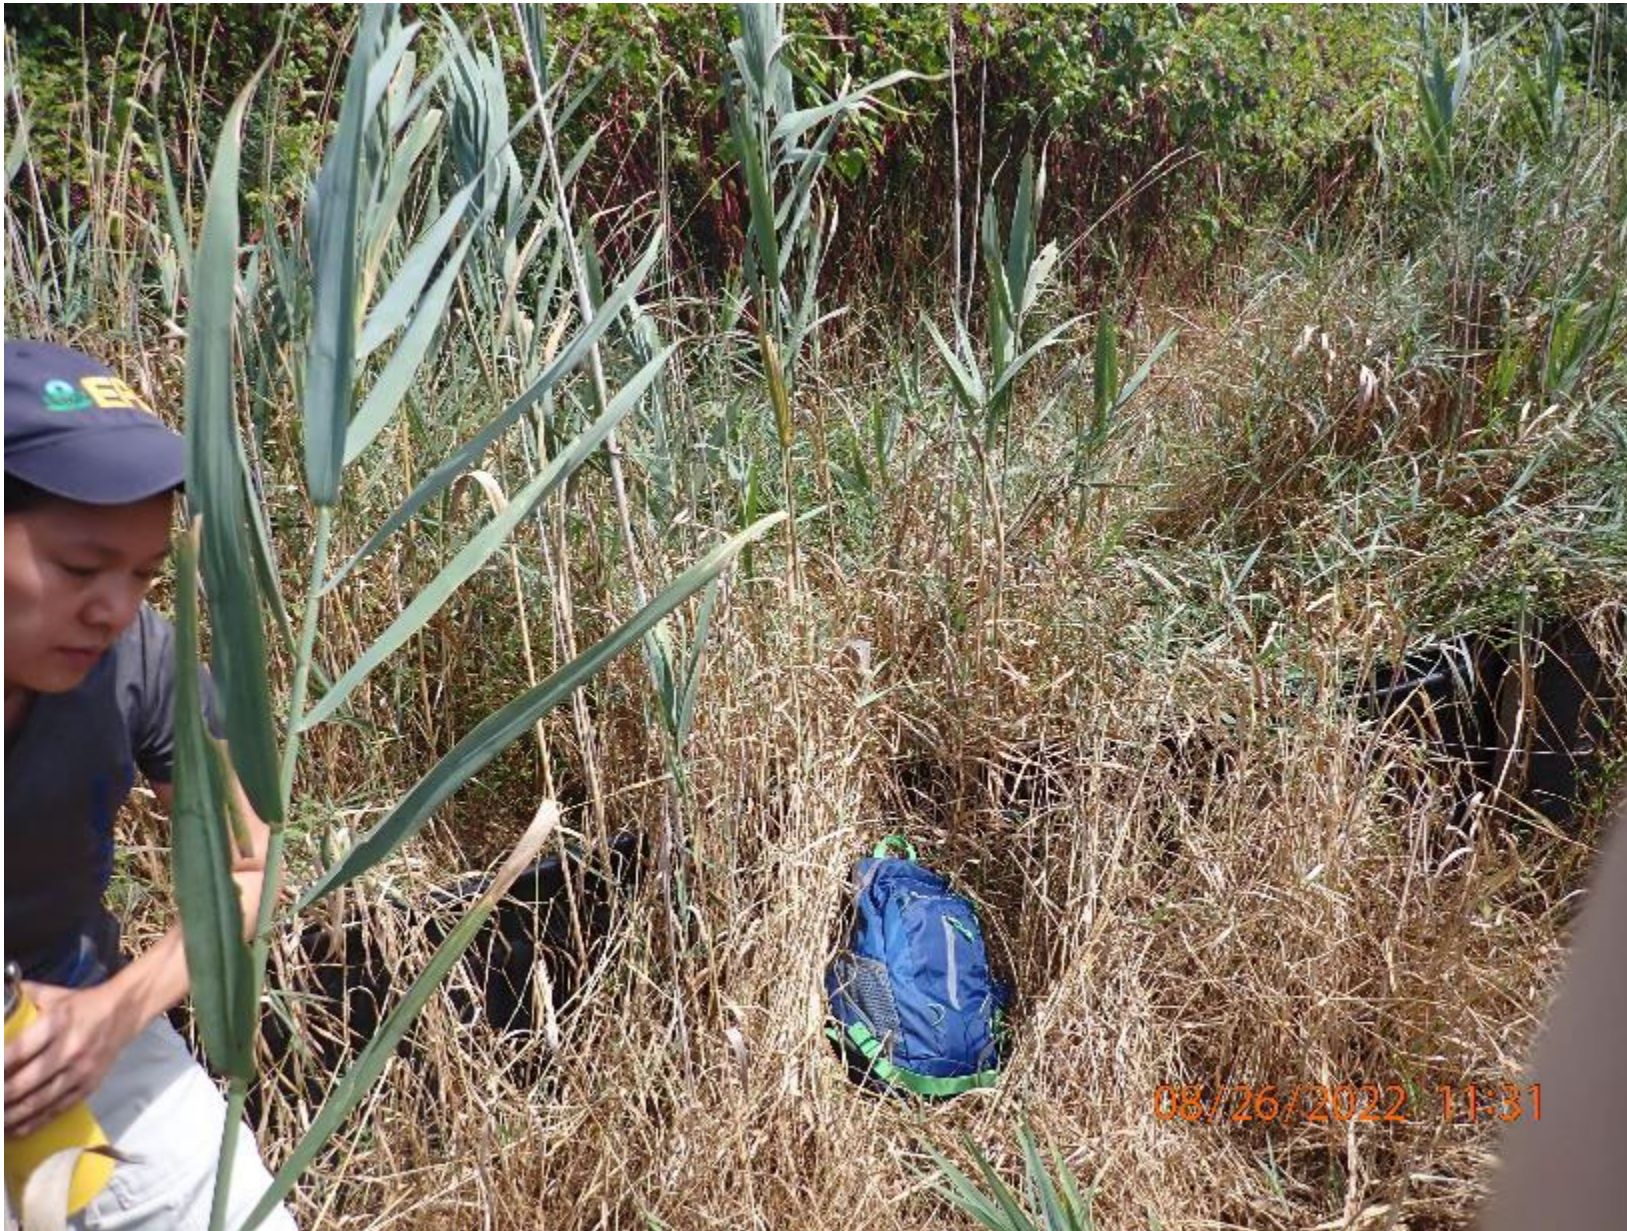
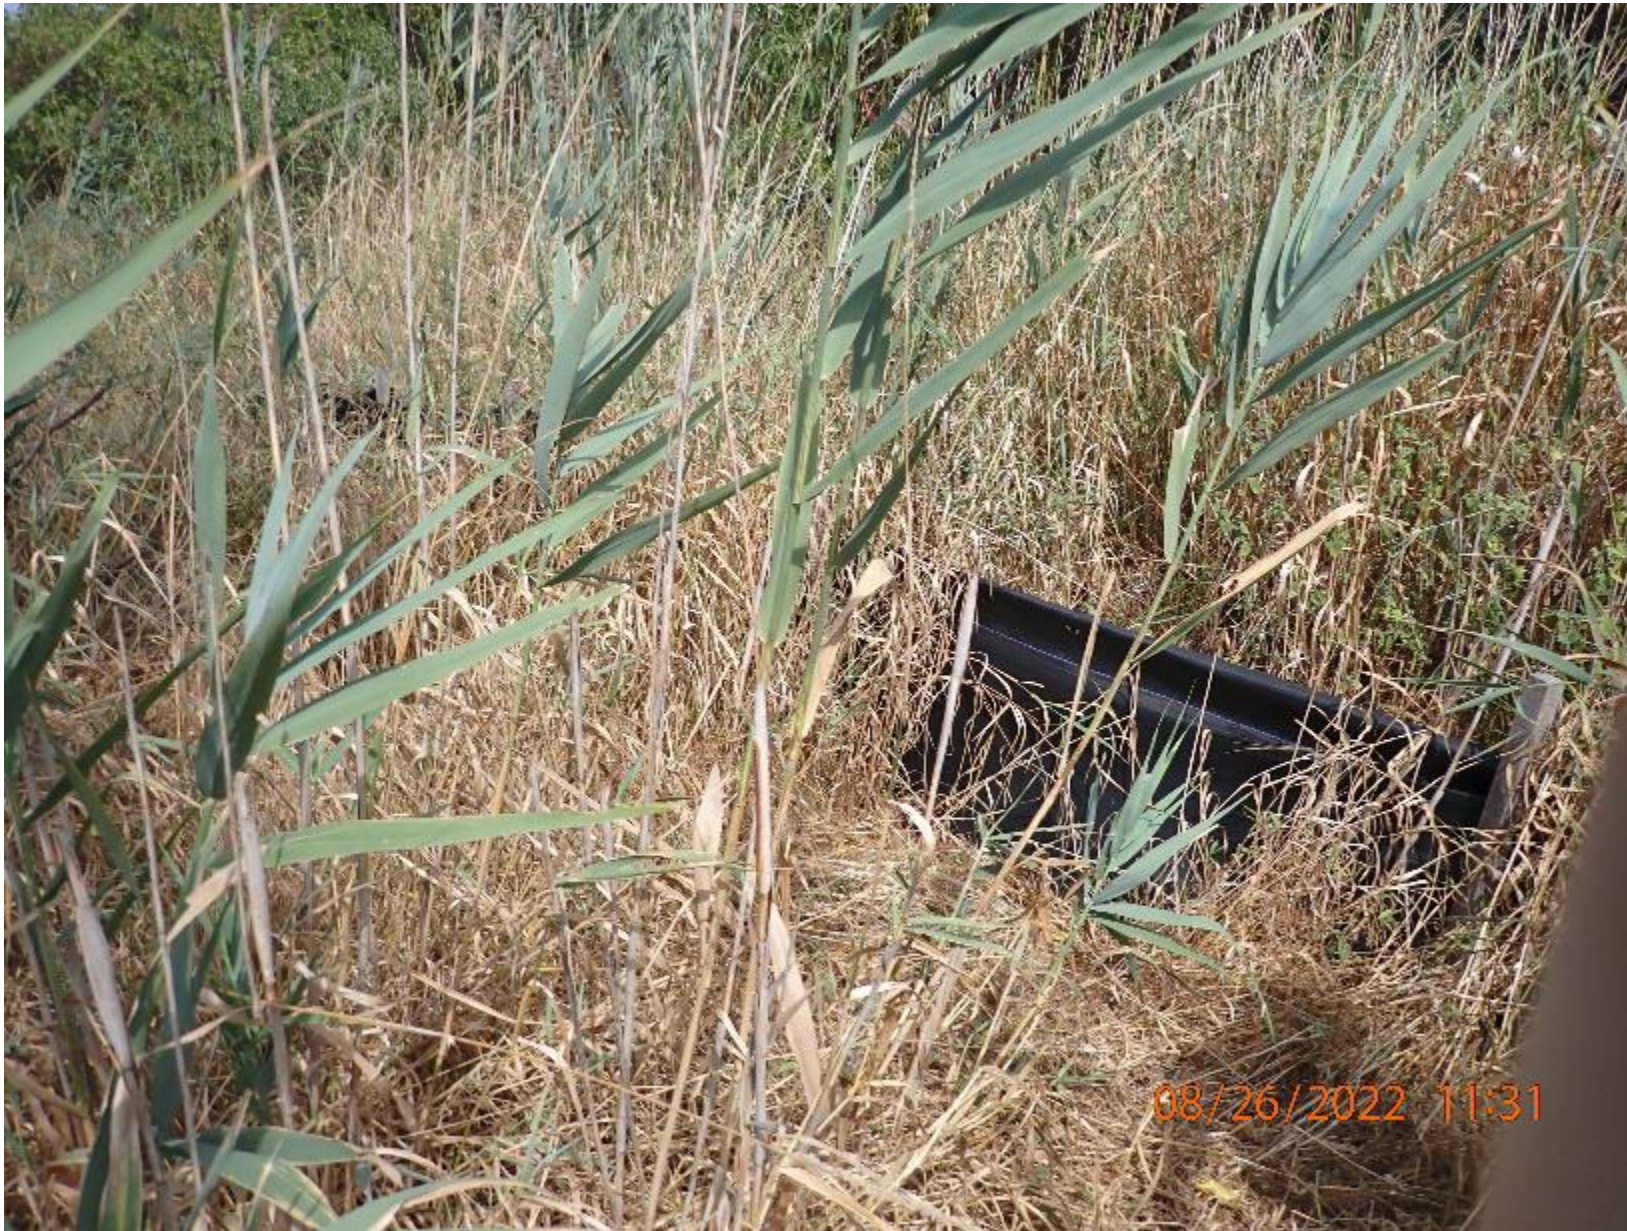
**Description:**  
Area around Soil Pit #2 (SS2)
