## Clean Water Act Section 404: Site Visit/Case Development

| Site Name | Dick's Concrete | | | | |
| Site Address* | 1053 County Road 37 (Pellets Island Road) and 1326 Co Route 12 | | | | |

CWA 404 Inspection Photolog  
Dick's Concrete  
1053 Co Rd 37 and 1326 Co Rt 12  
Orange County, NY

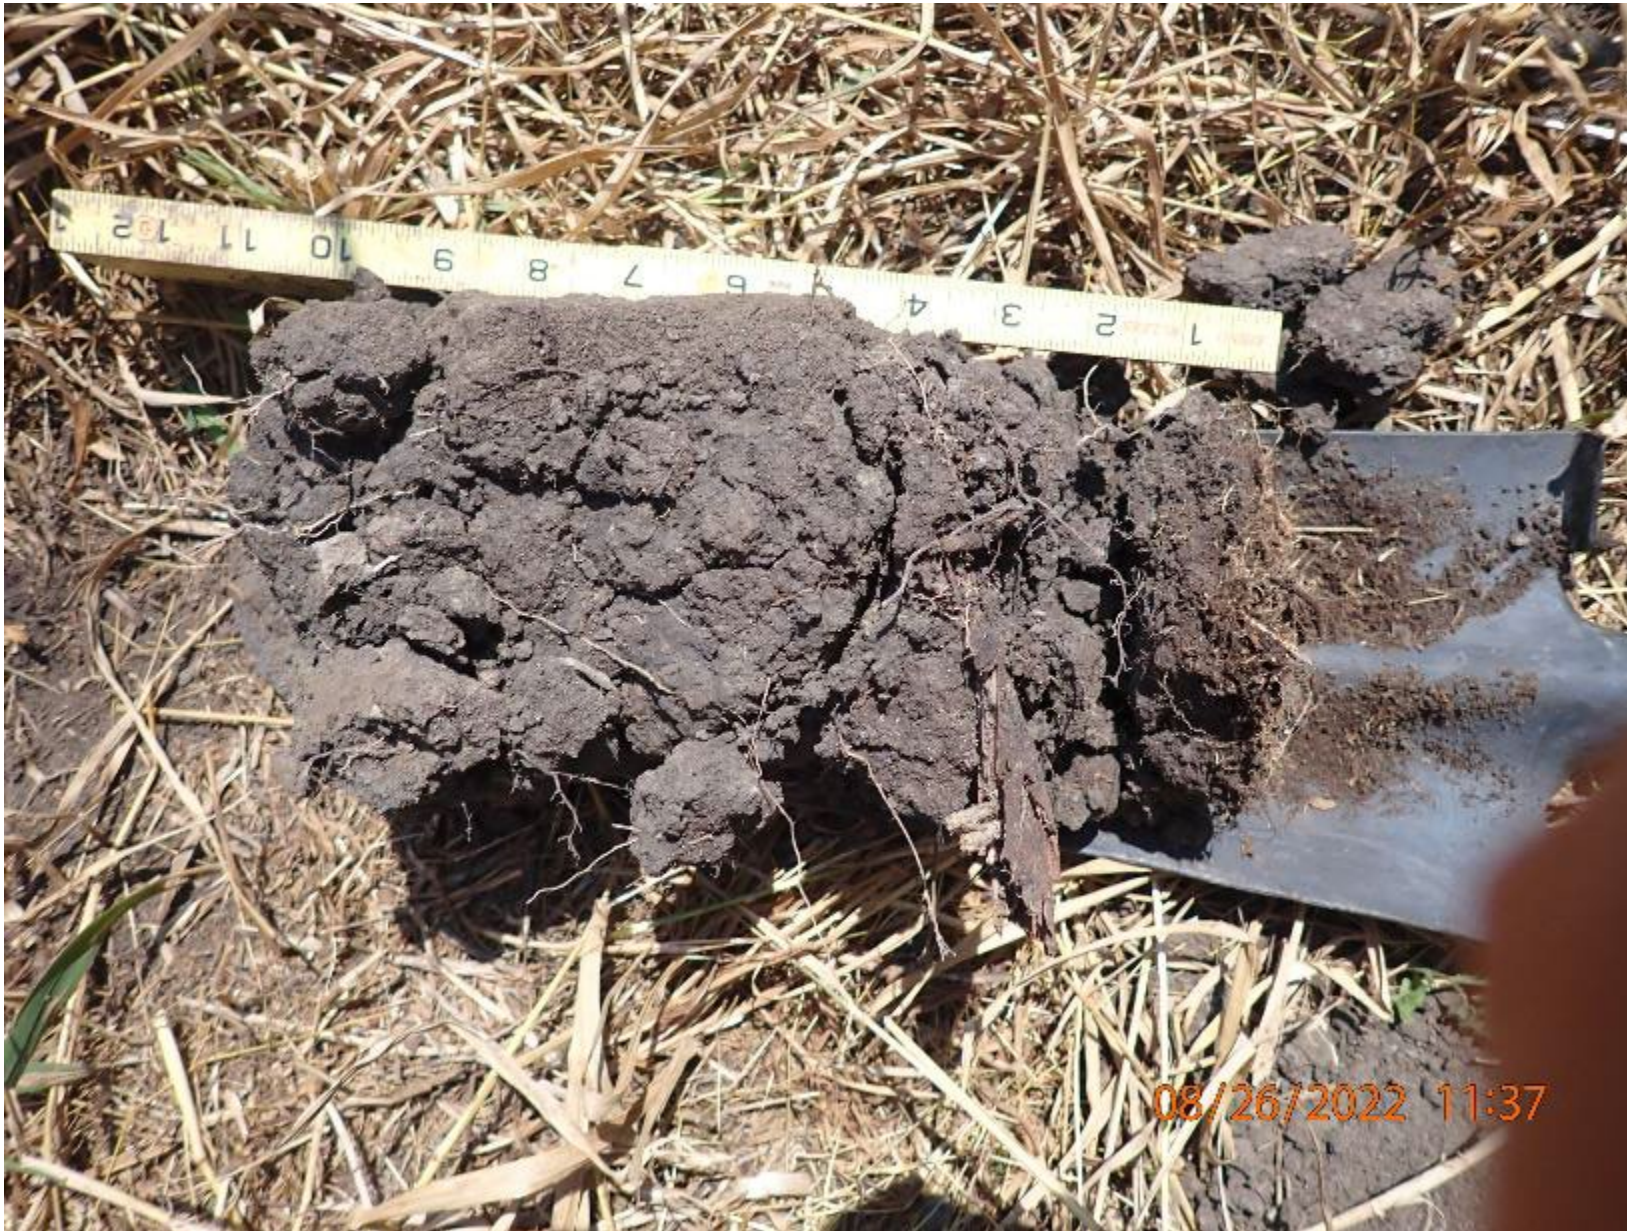
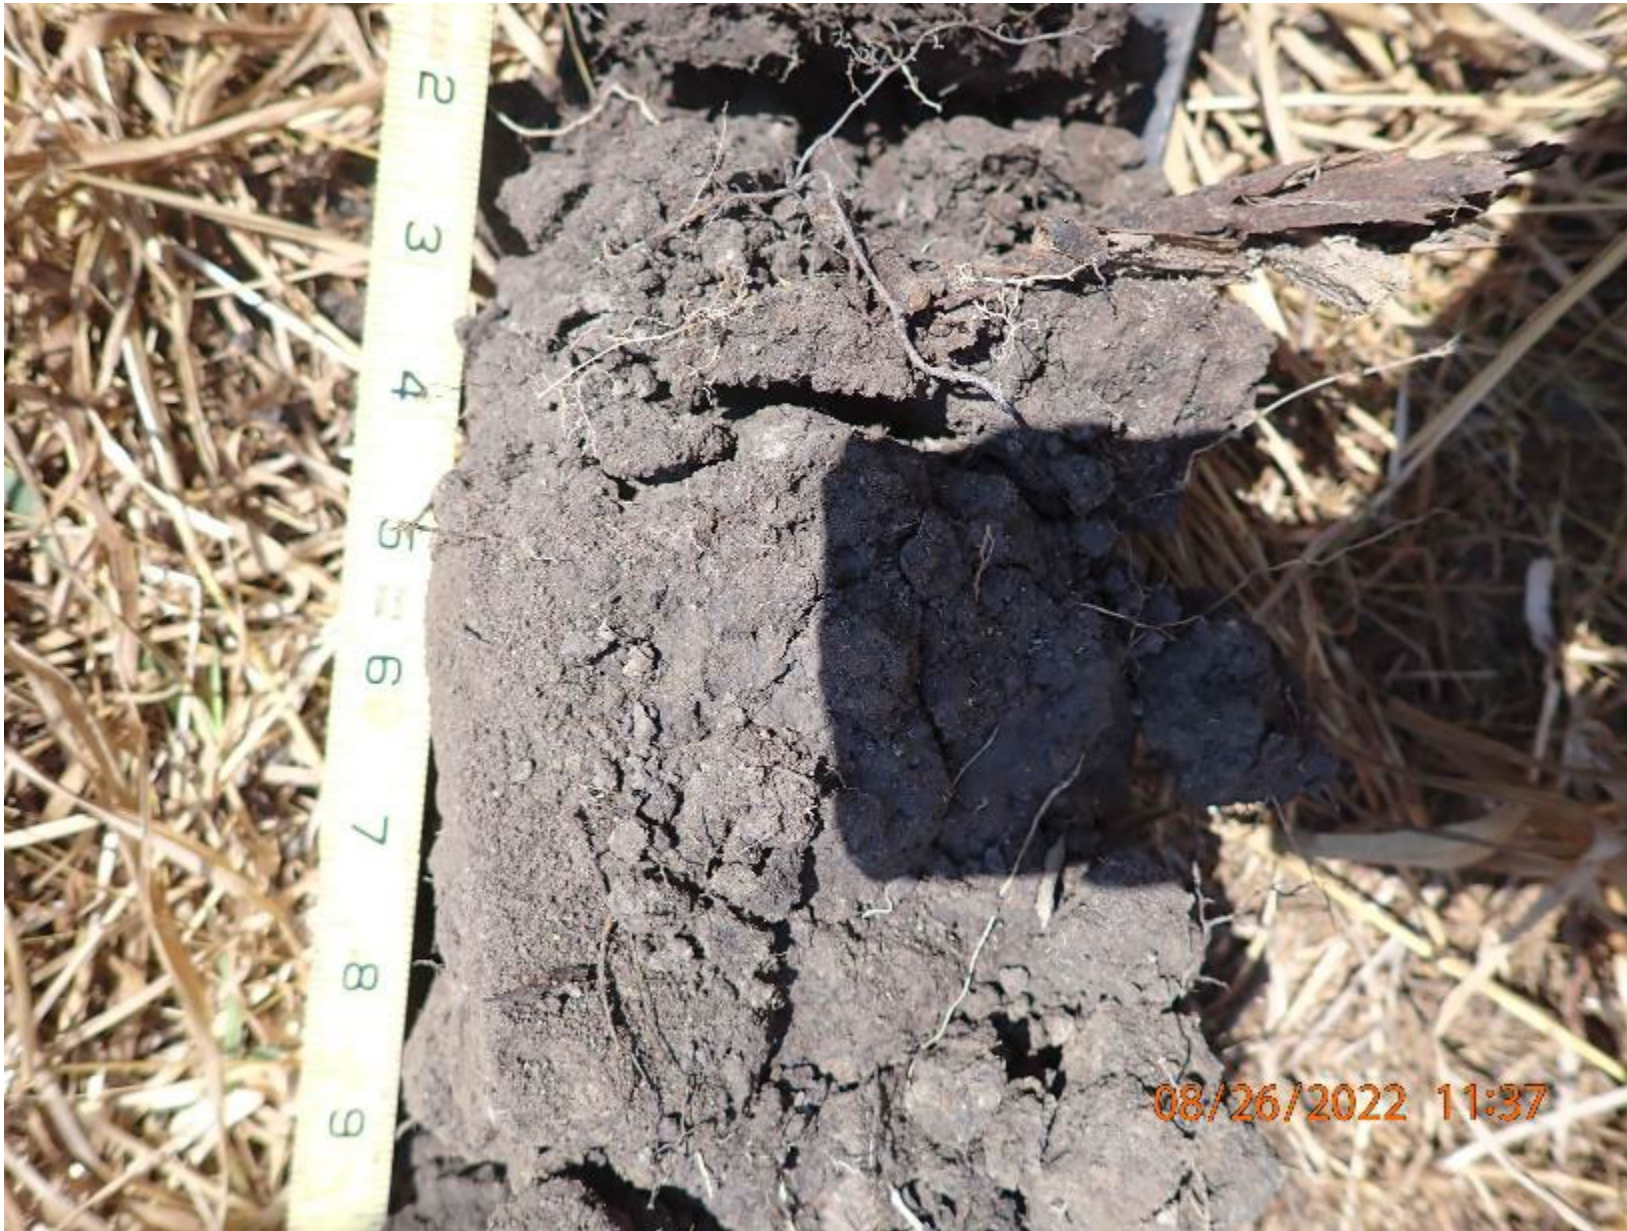
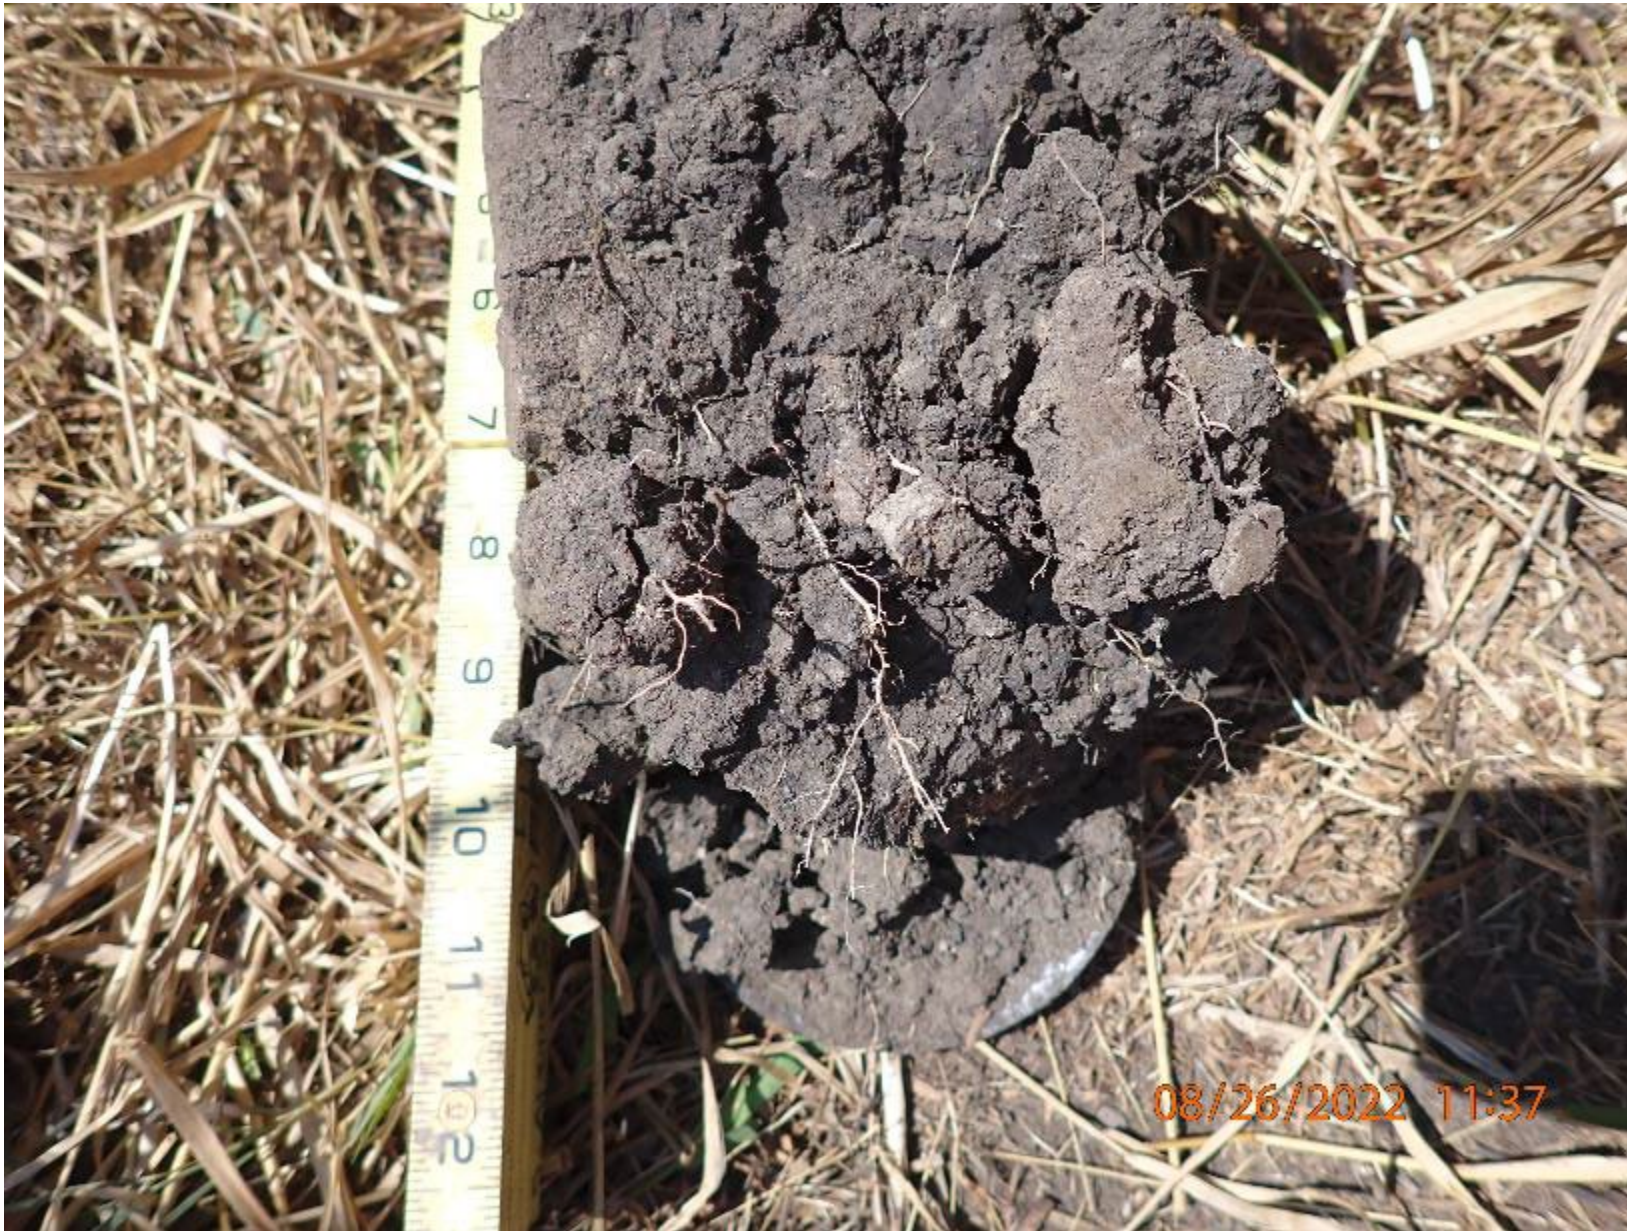
EPA took two soil samples. The first soil sample, located in a scrub-shrub/herbaceous area east of the expansion, was found to not be in a wetland due to a lack of hydrological indicators. The second soil sample, located between the berm and an agricultural channel south of the expansion area was also found to not be in a wetland.

**Description:**  
Soil Pit #2 (SS2) soil profile

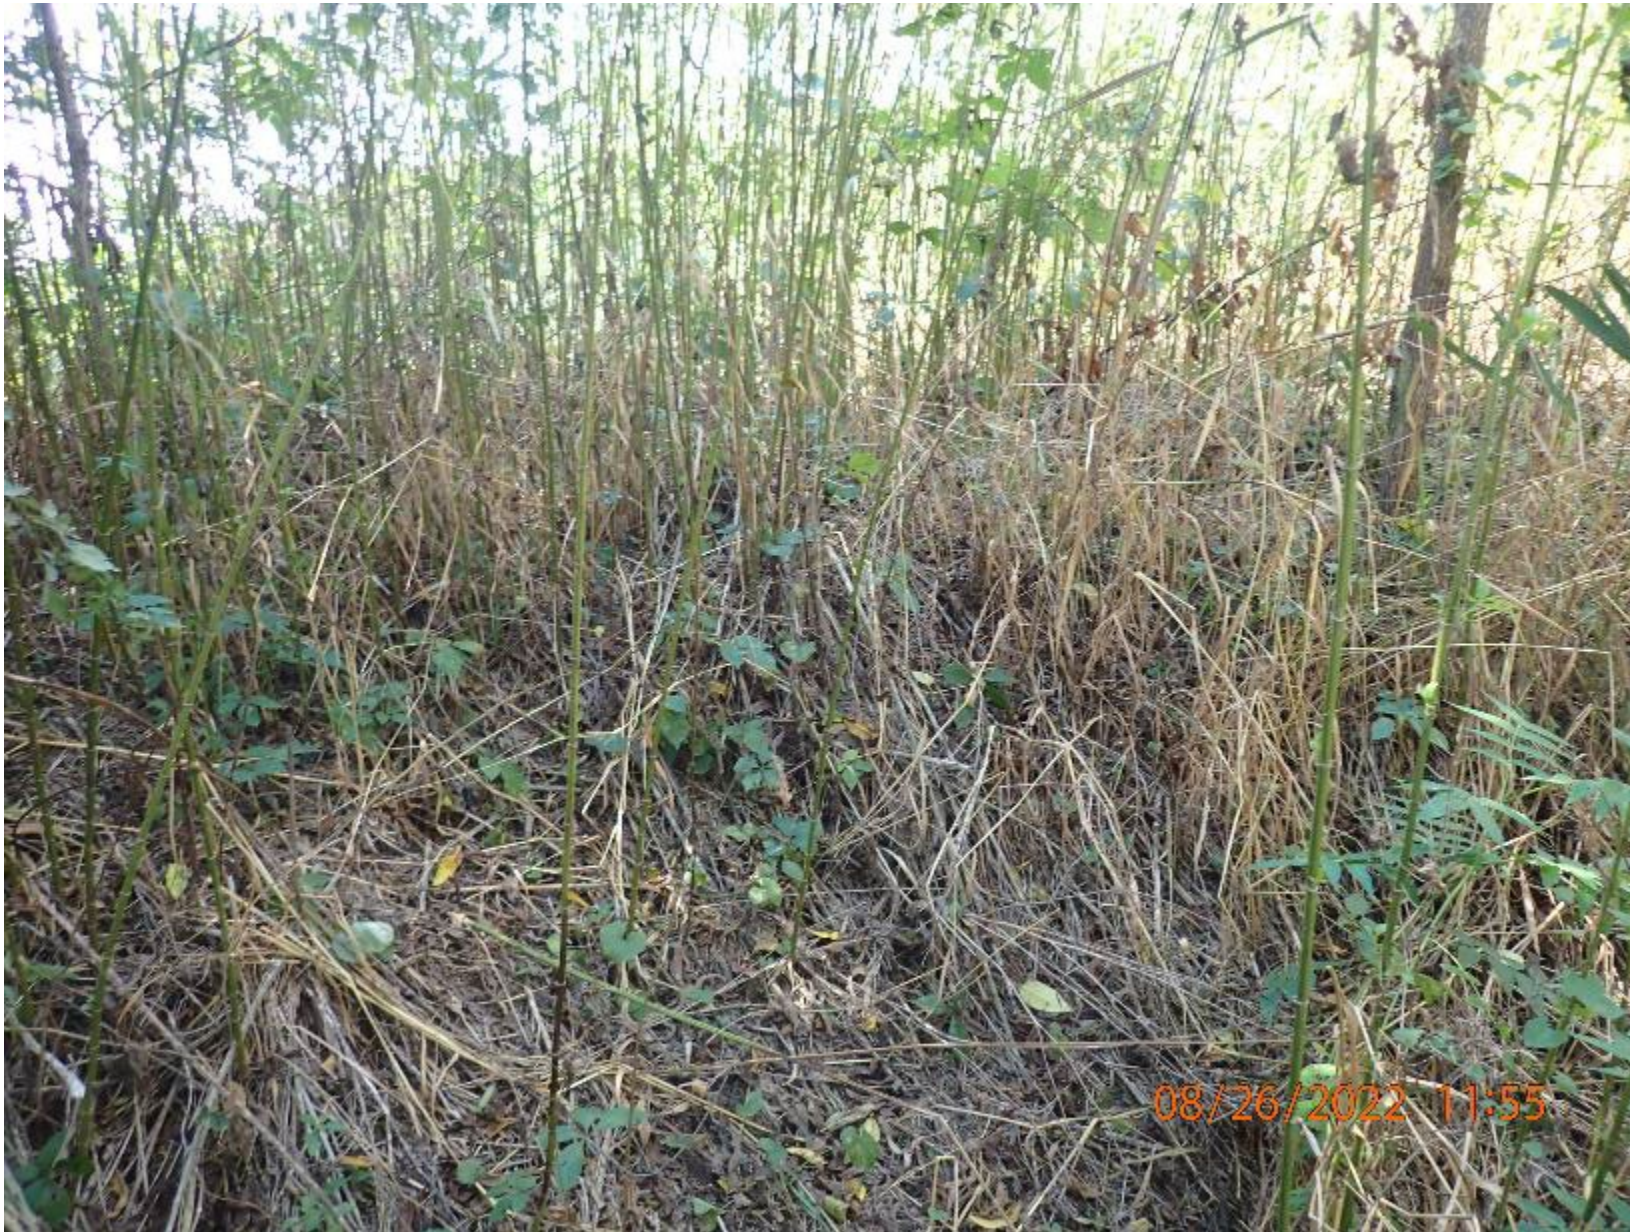
**Date:** 8/26/2022  
**Time:** 11:55 AM  
**Photographer:** SSA  
**Photo ID:** 34 – P8260402

**Description:**  
Area near berm

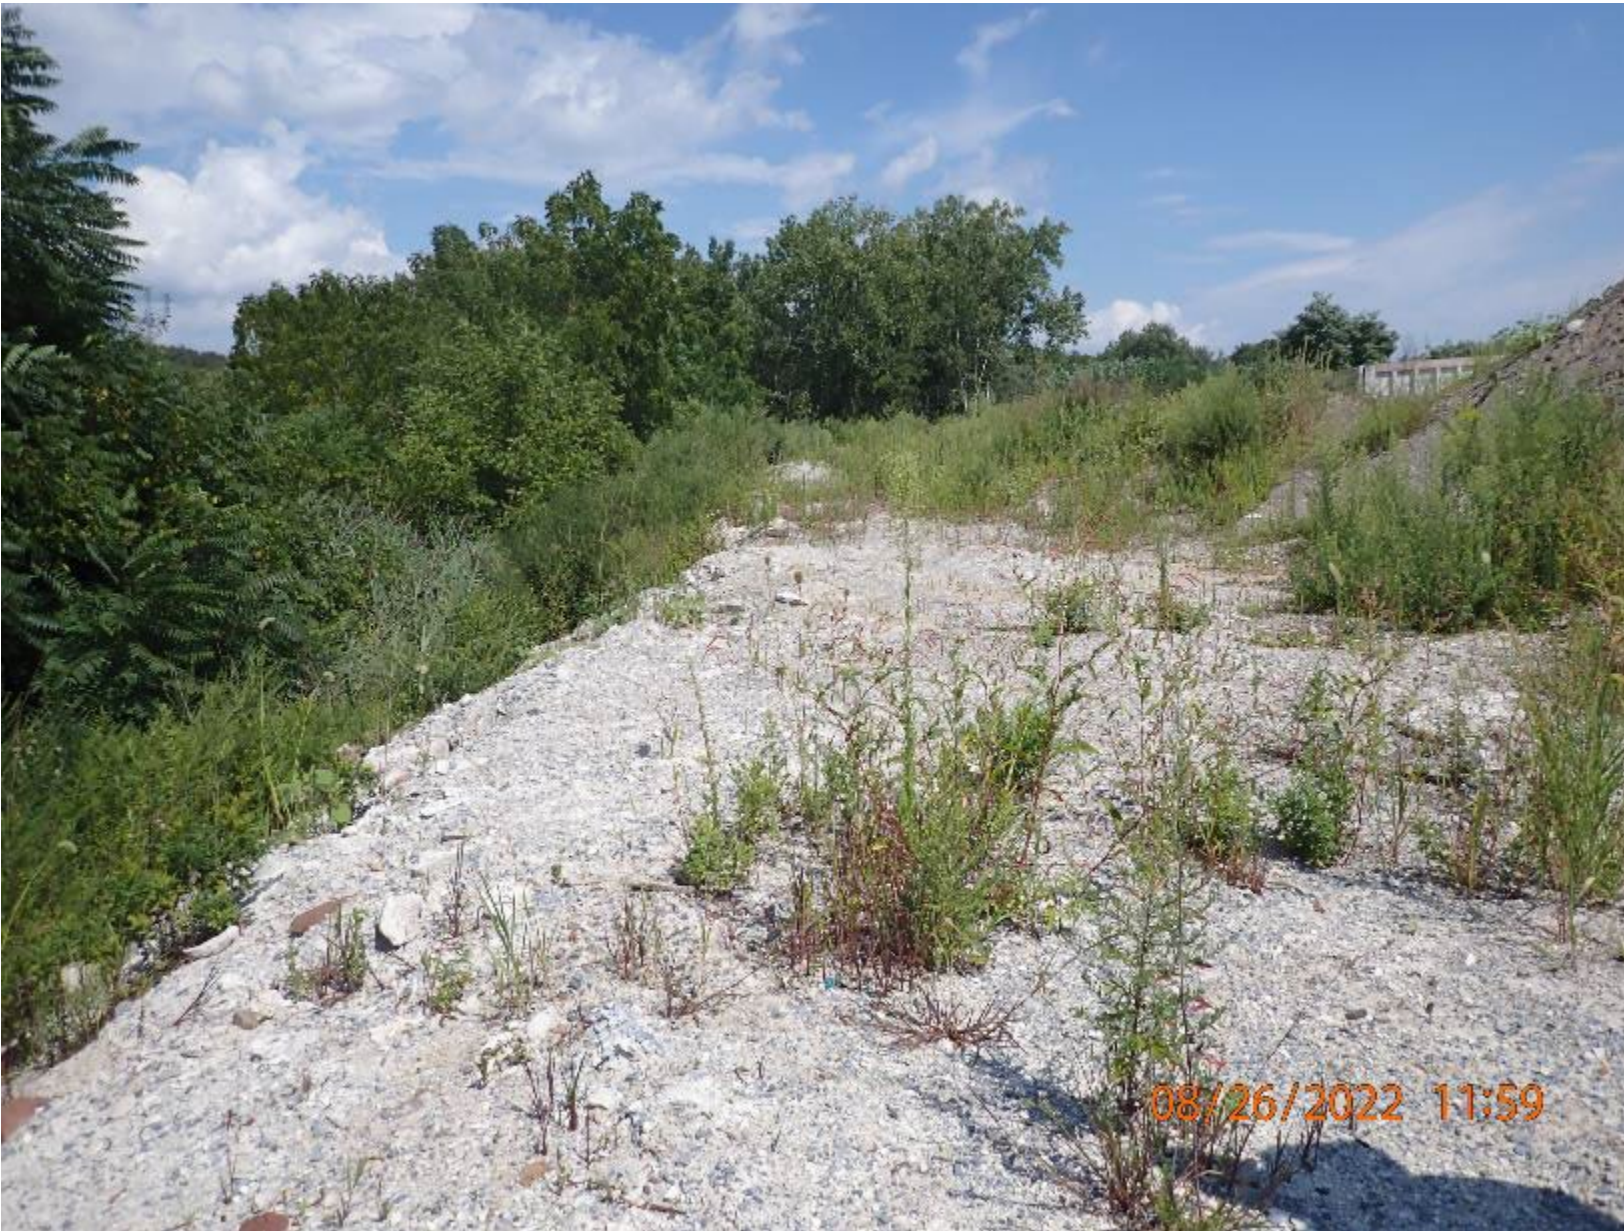
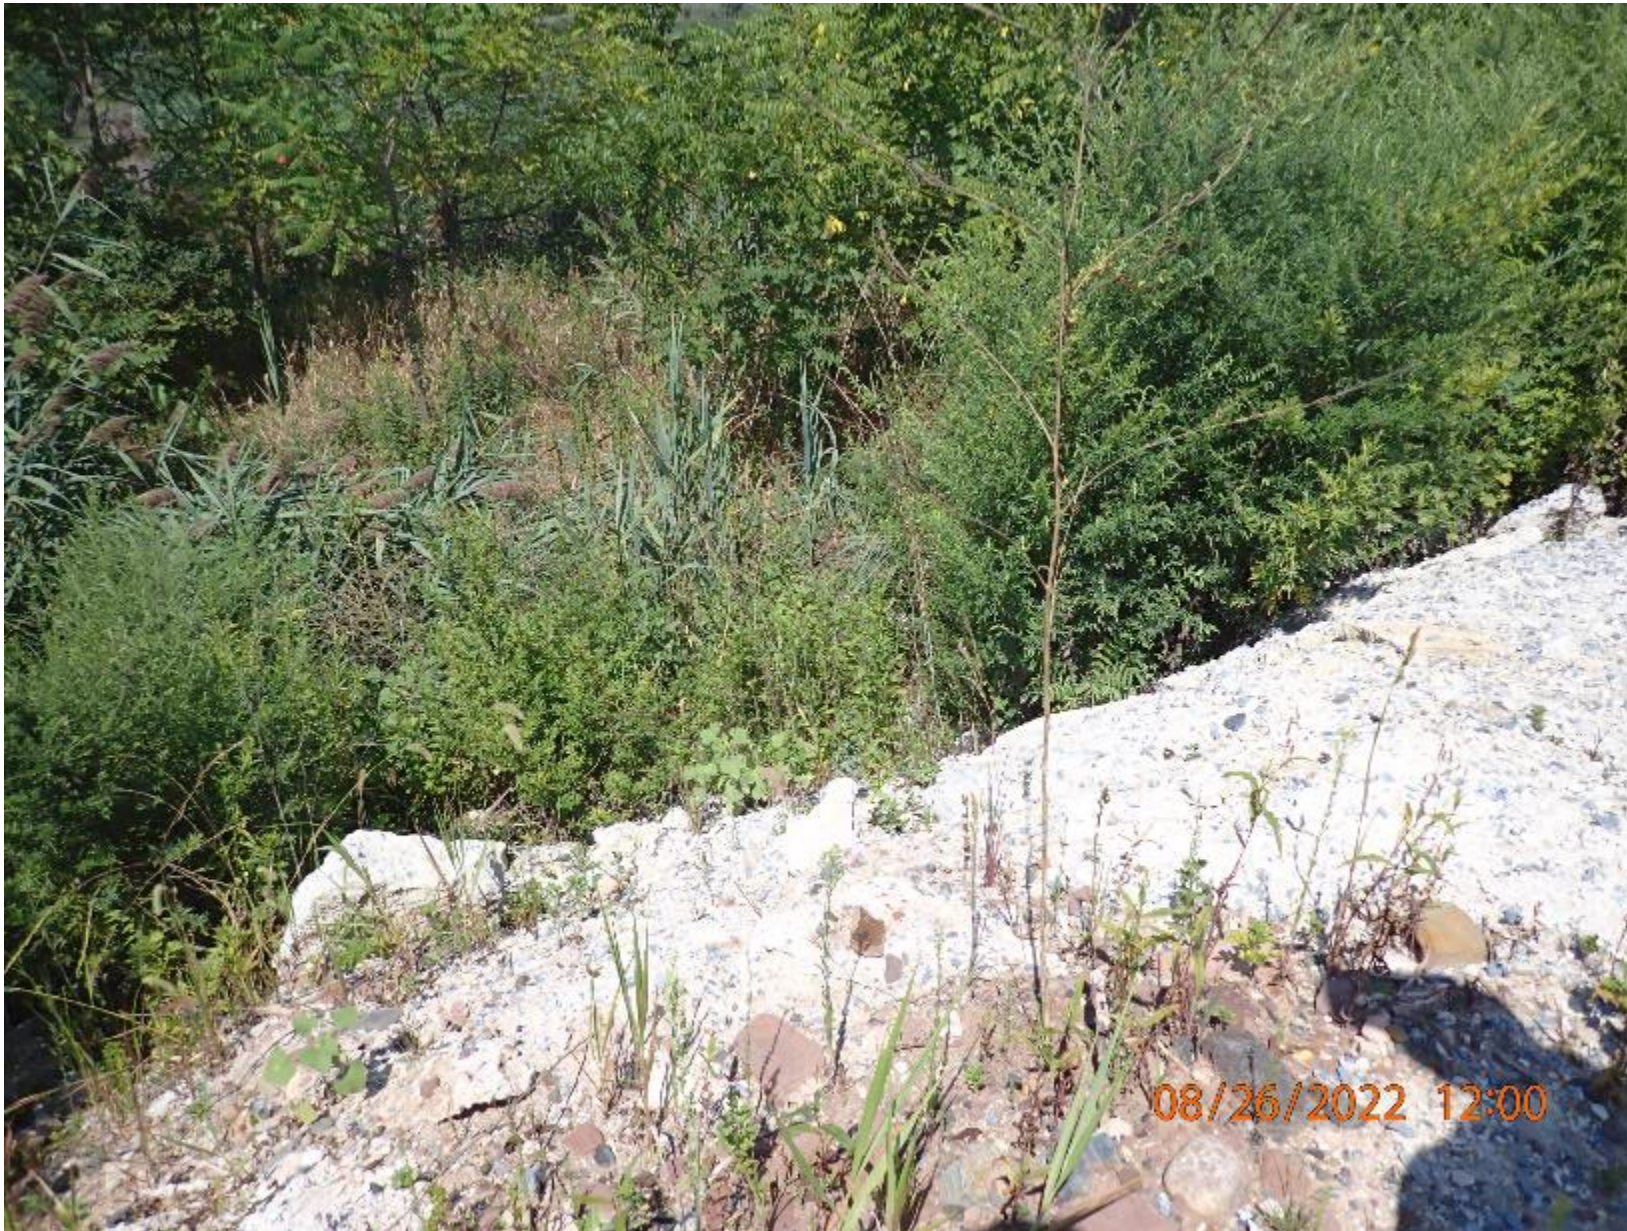
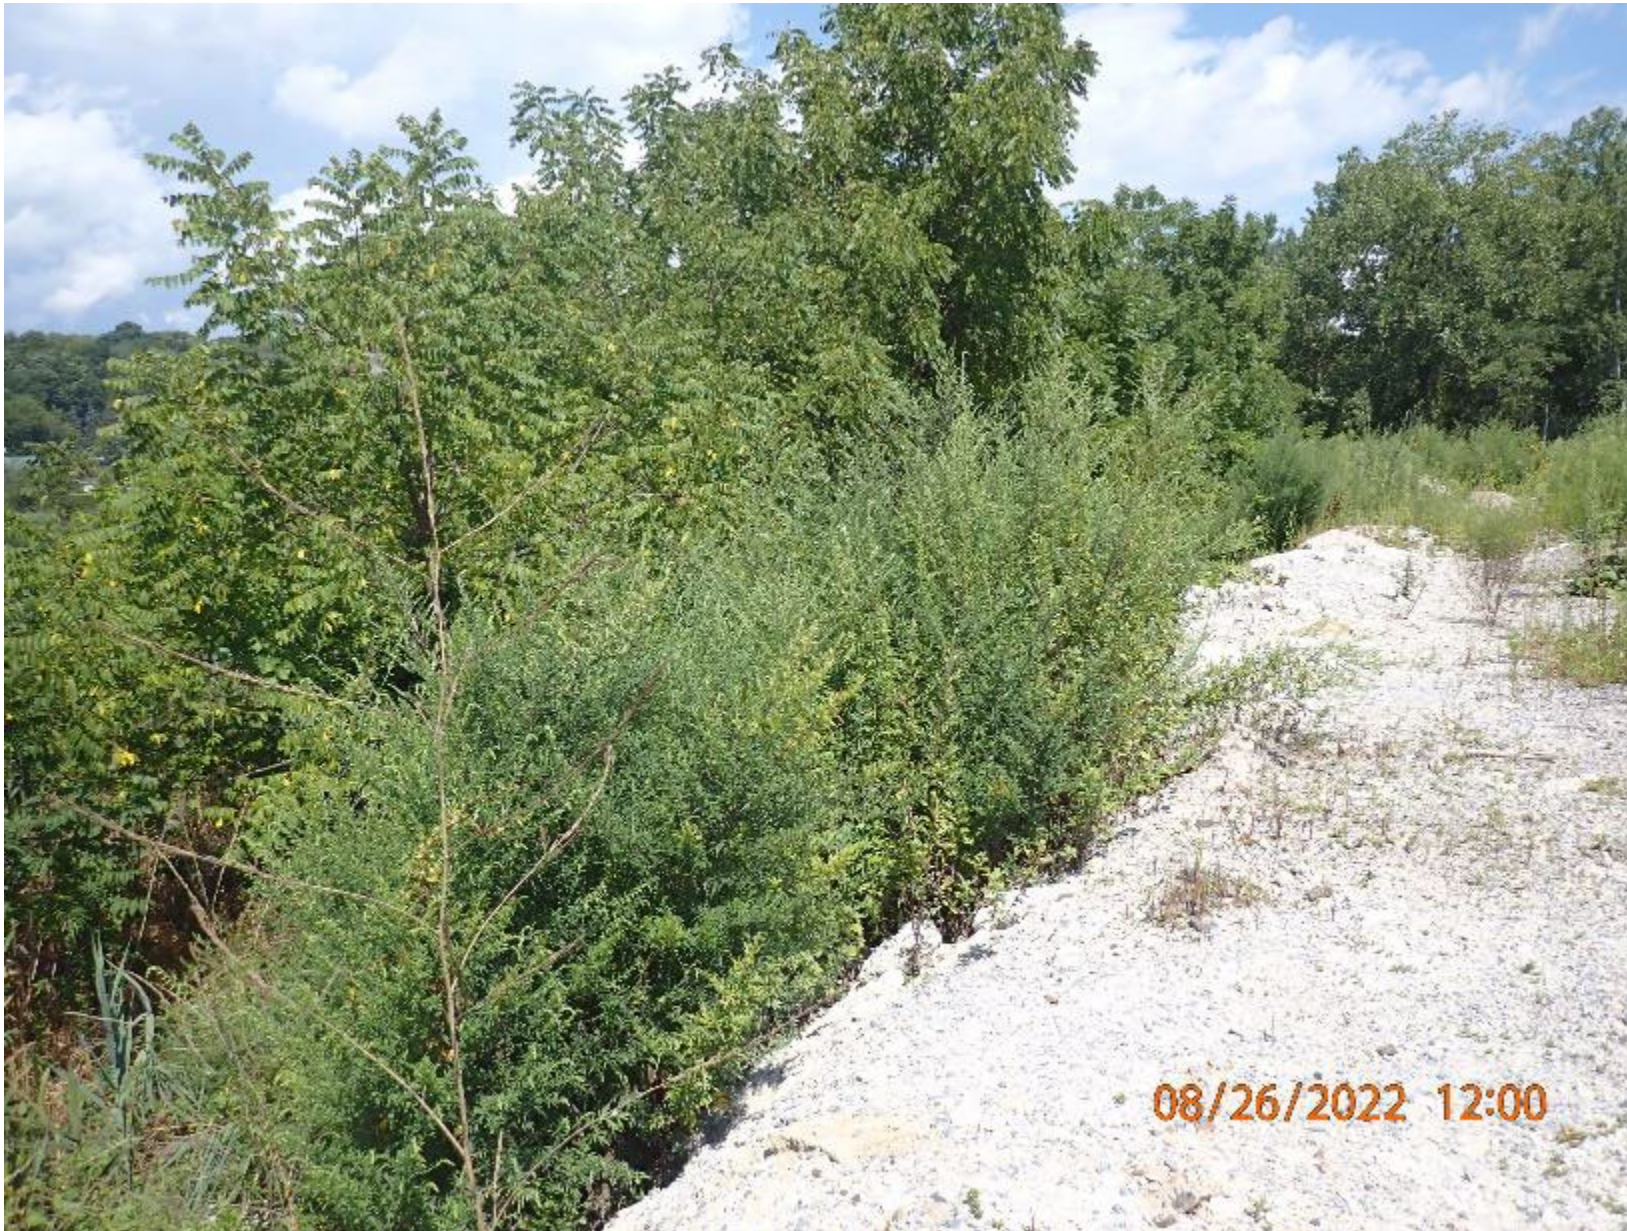
SW corner of expansion area;  
area on top of berm
