**Region 6 - Enforcement & Compliance Assurance Division**  
**INSPECTION REPORT**

| Inspection Date(s): | 03/25/2024 | |
| Company Name: | <b>RS Livestock DBA Beaver County Stockyards</b> | |
| Facility Name: | <b>Beaver County Stockyards</b> | |

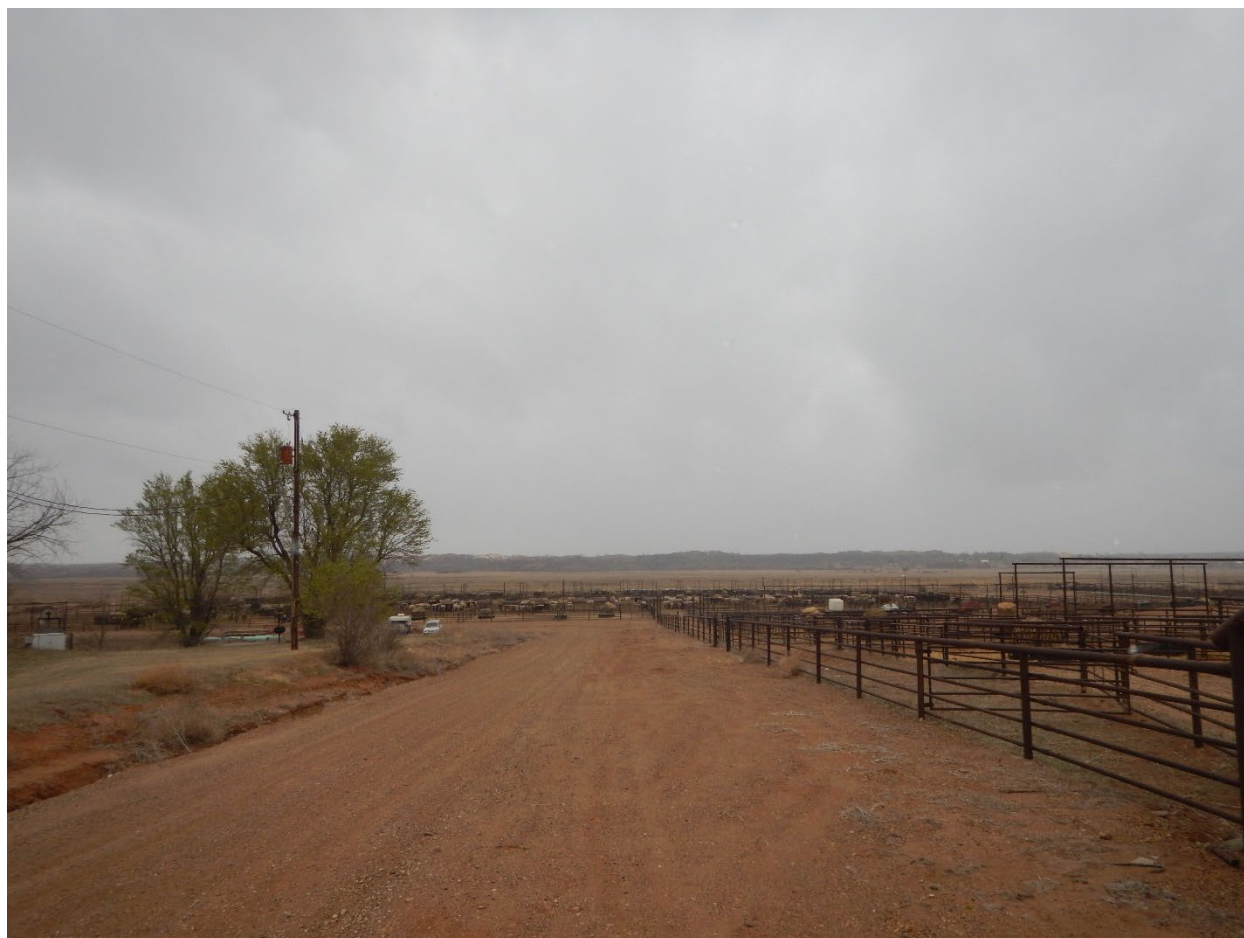
*Photo No. 1*

Description: View to the north. Shot of the open lots showing slope.

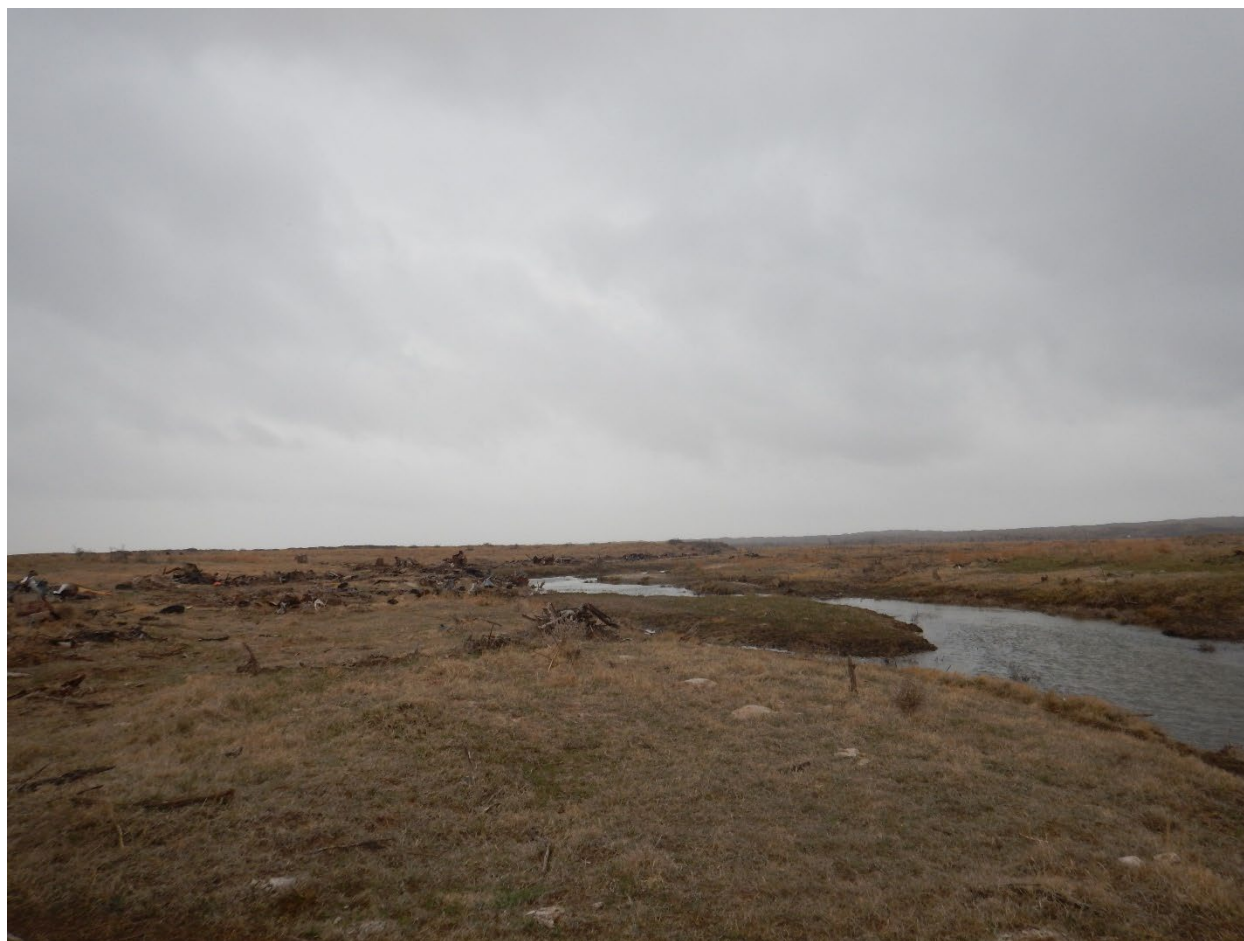
*Photo No. 2*

Description: View to the northwest. Beaver River on the north end of the site.

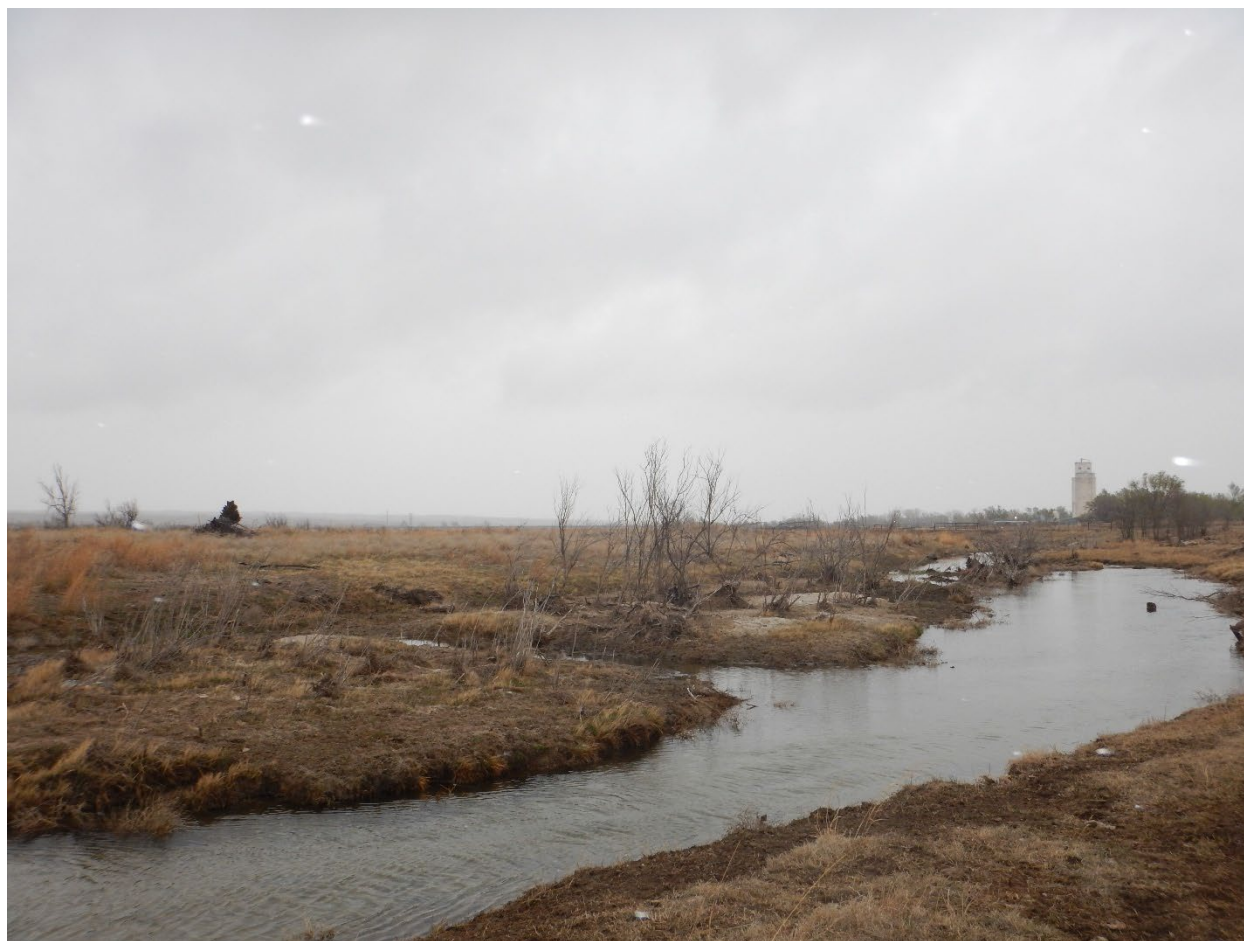
*Photo No. 3*

Description: View to the east. Beaver River with pens in the background.

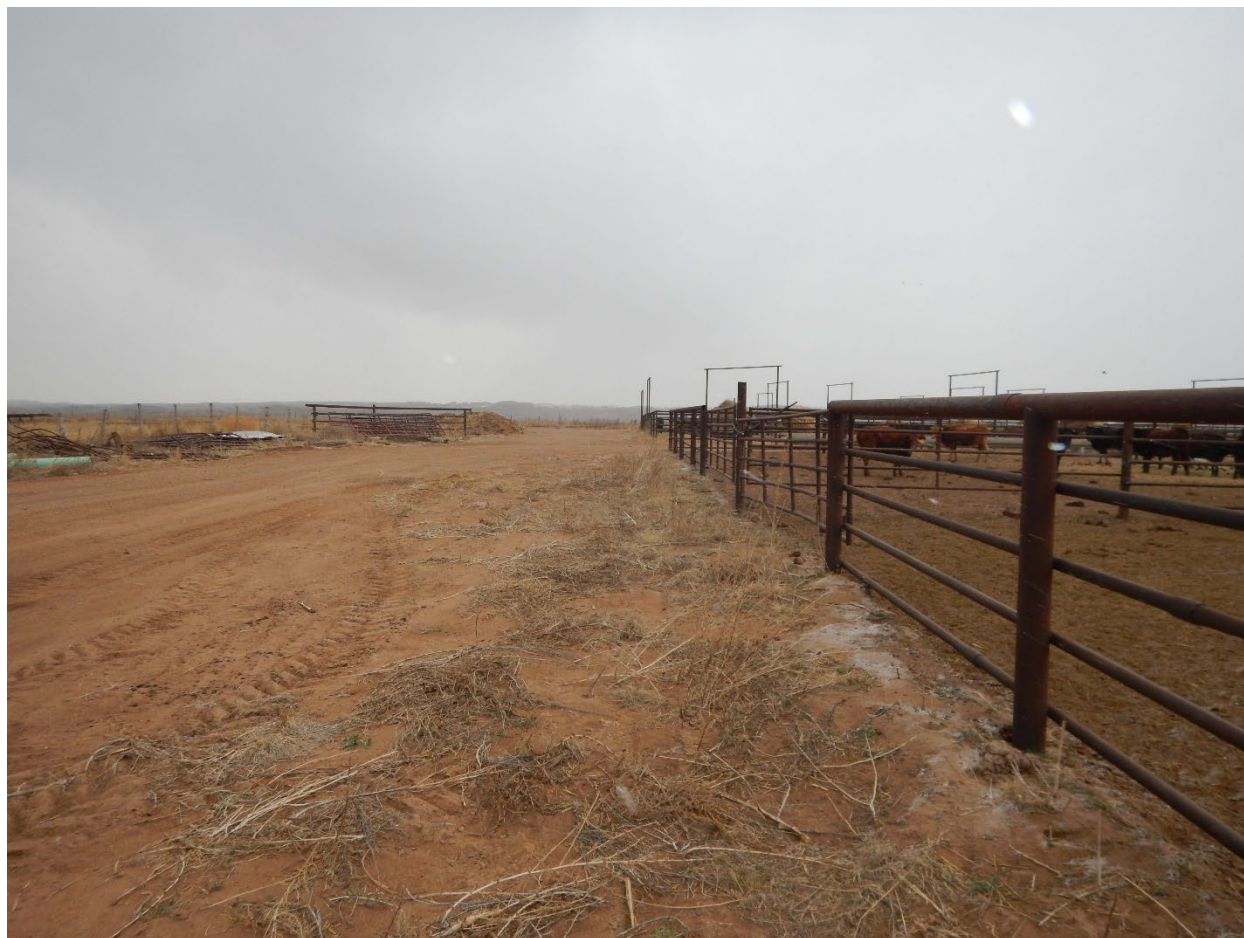
*Photo No. 4*

Description: View to the north. Western edge of the pens.

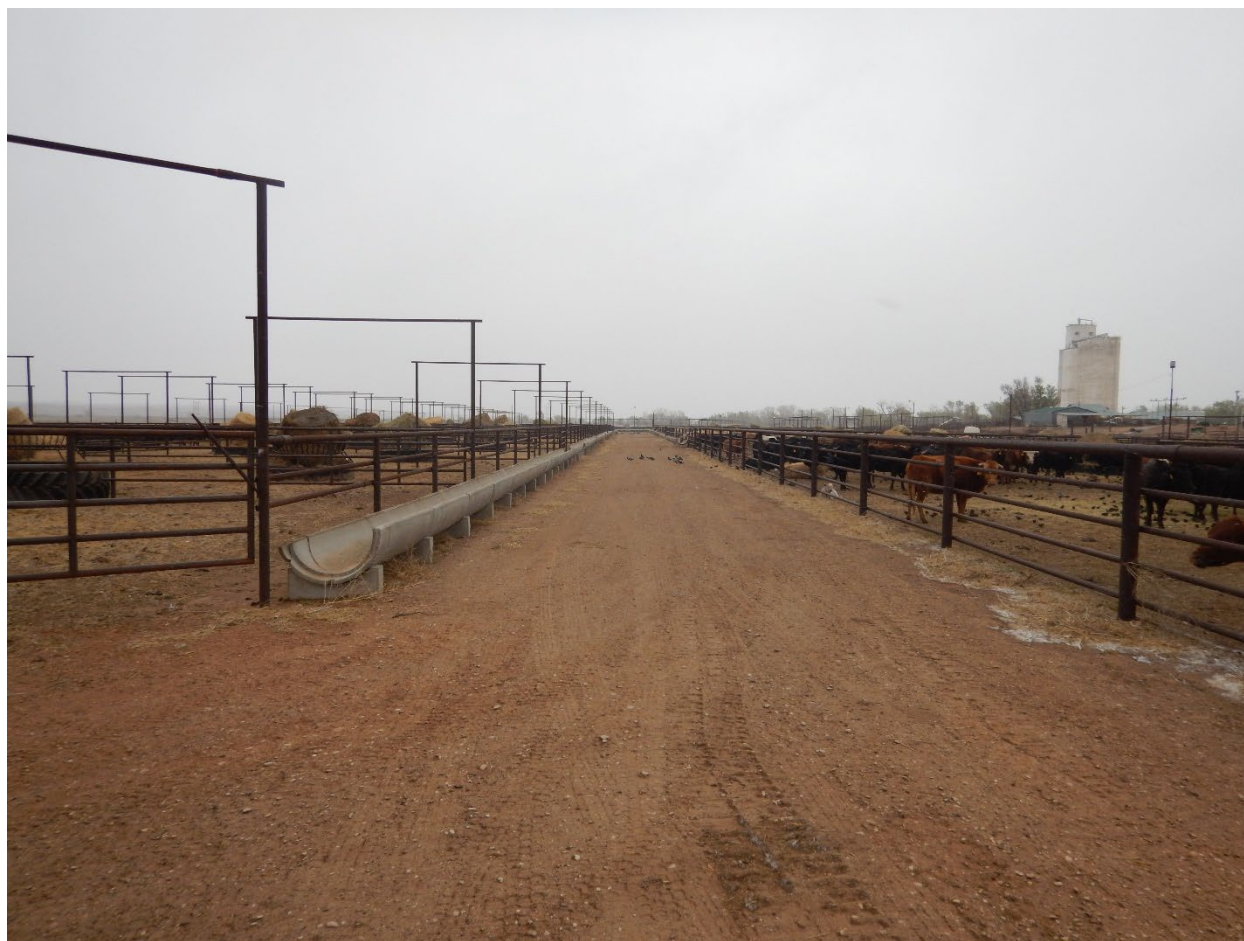
*Photo No. 5*

Description: View to the east. Open lot pens.

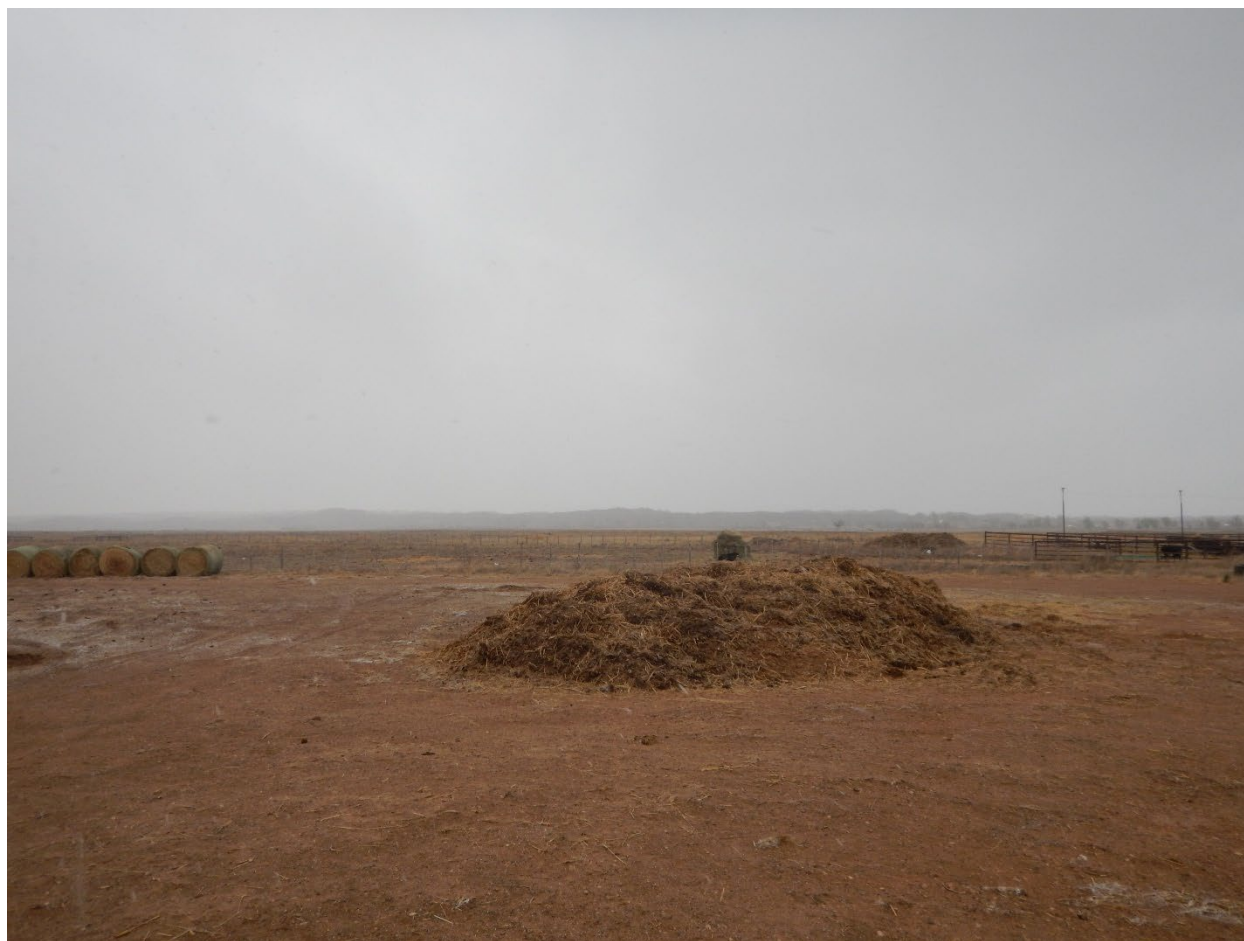
*Photo No. 6*

It was snowing during the entirety of the inspection. The open lot pens were clean and without any visible manure piles inside the pens. There were a few visible manure stockpiles outside the pens without any runoff prevention control (Appendix 1, Photos 6 & 13) (See Areas of Concern). There is a vegetative strip running along most of the northern and eastern edge of the facility (Appendix 1, Photo 10).

1) There were manure stockpiles without any runoff prevention control. (Agriculture Pollutant Discharge Elimination System General Permit for Discharges from Concentrated Animal Feeding Operations in Oklahoma Part II.A.2.b.vii.: “There shall be no discharge of rainfall runoff from manure or litter storage piles.”)

Description: View to the north. Manure pile and hay storage.

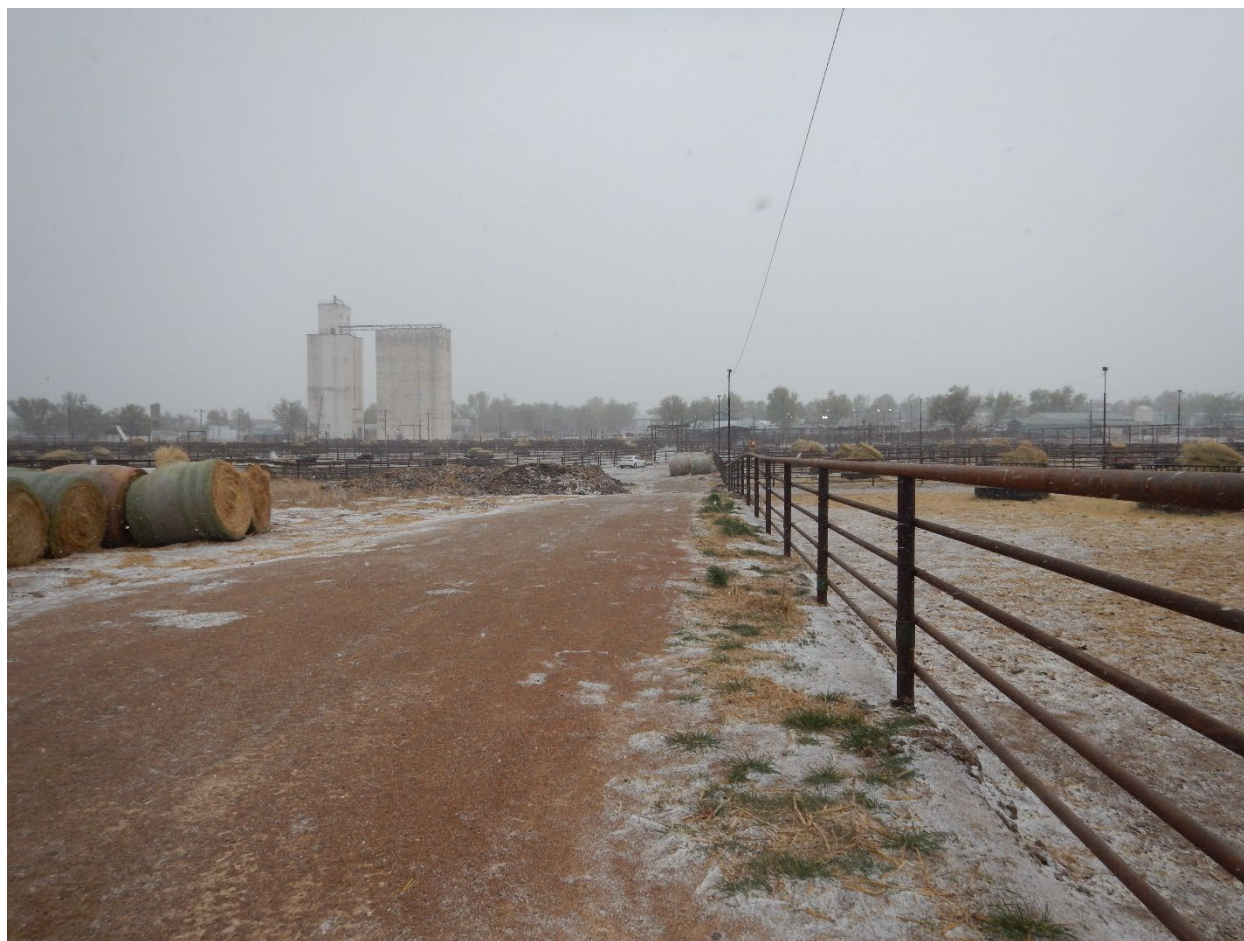
*Photo No. 7*

Description: View to the south. Shot of the pens showing grading of site.

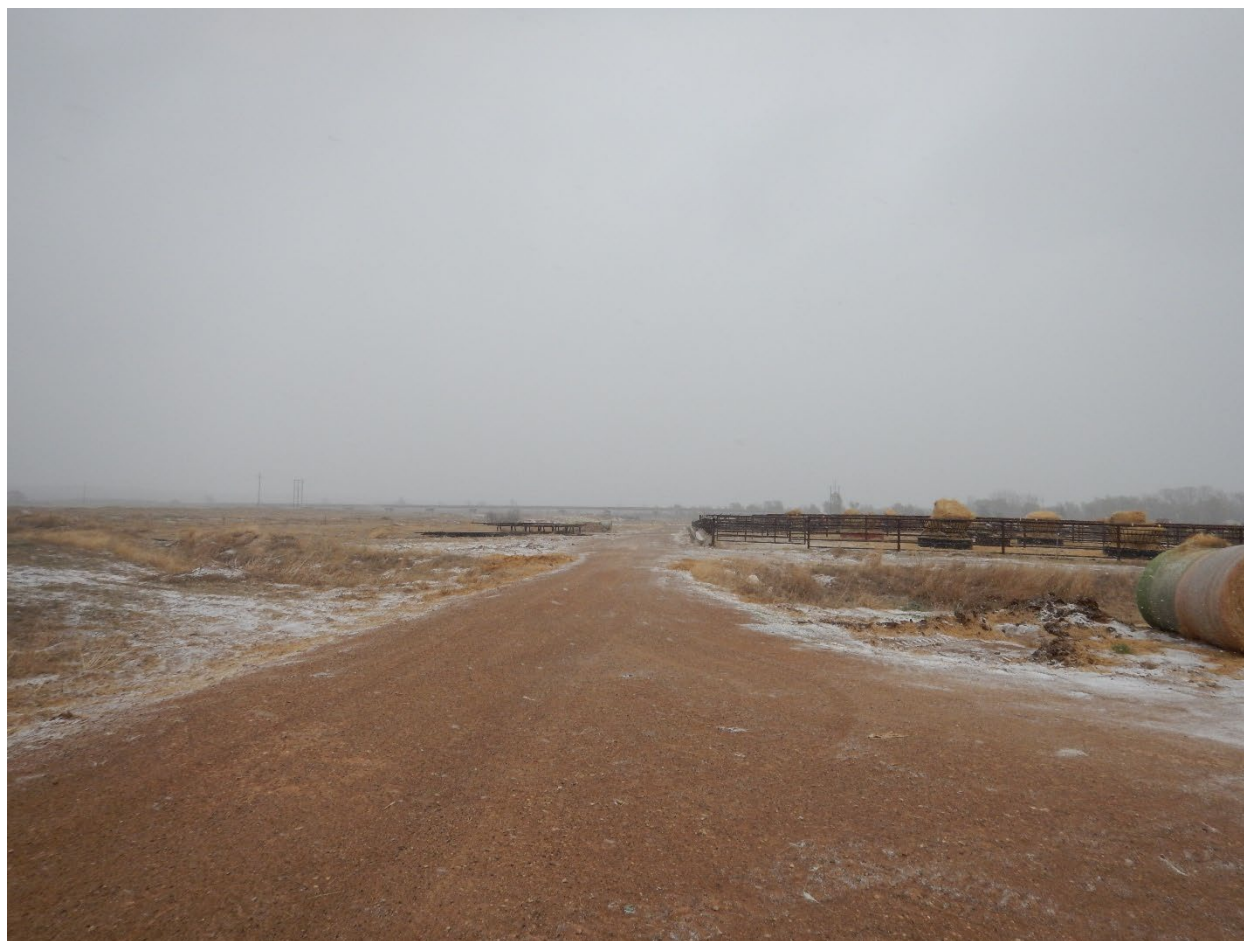
*Photo No. 8*

Description: View to the east. North end of the pens.

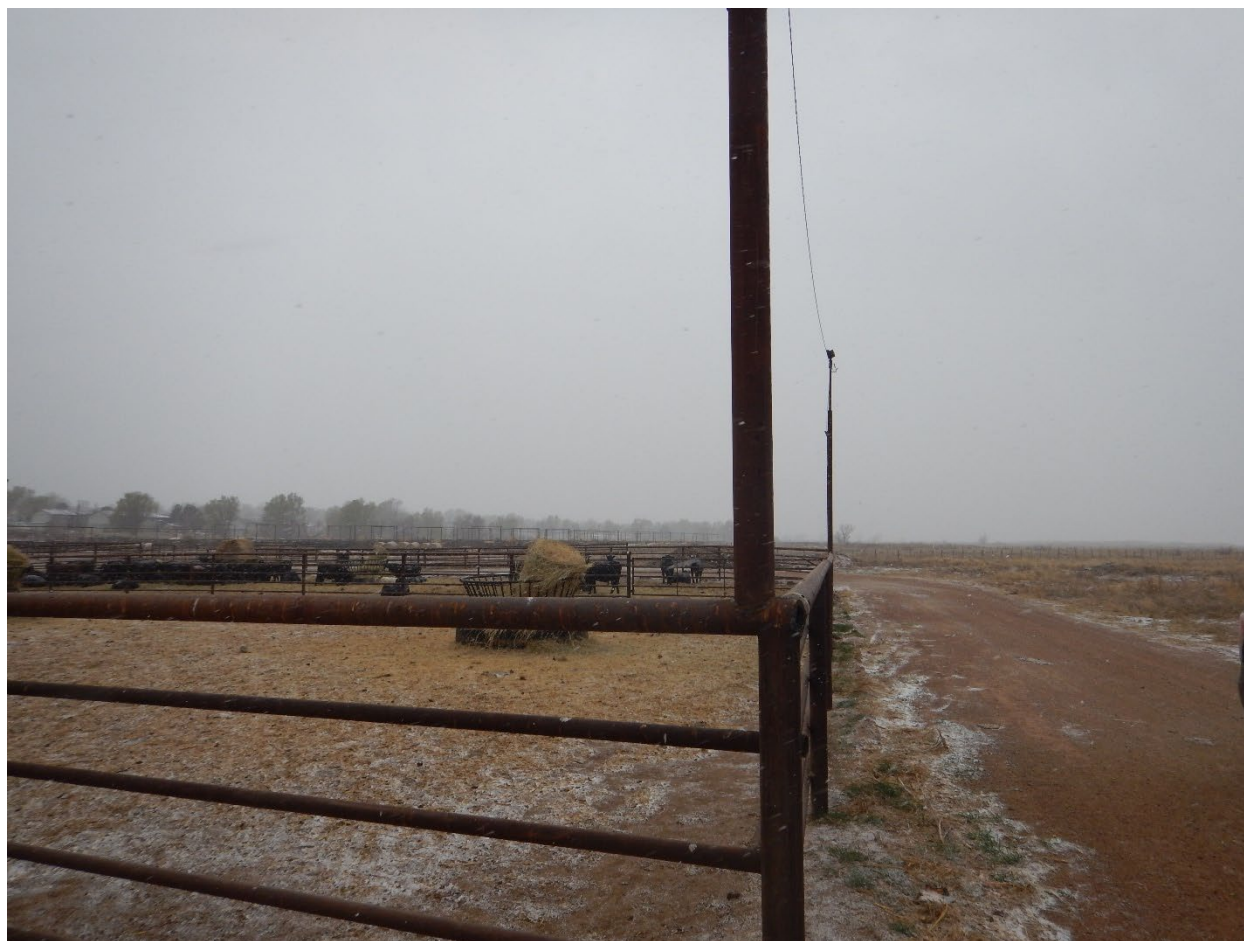
*Photo No. 9*

Description: View to the west. North end of the pens.

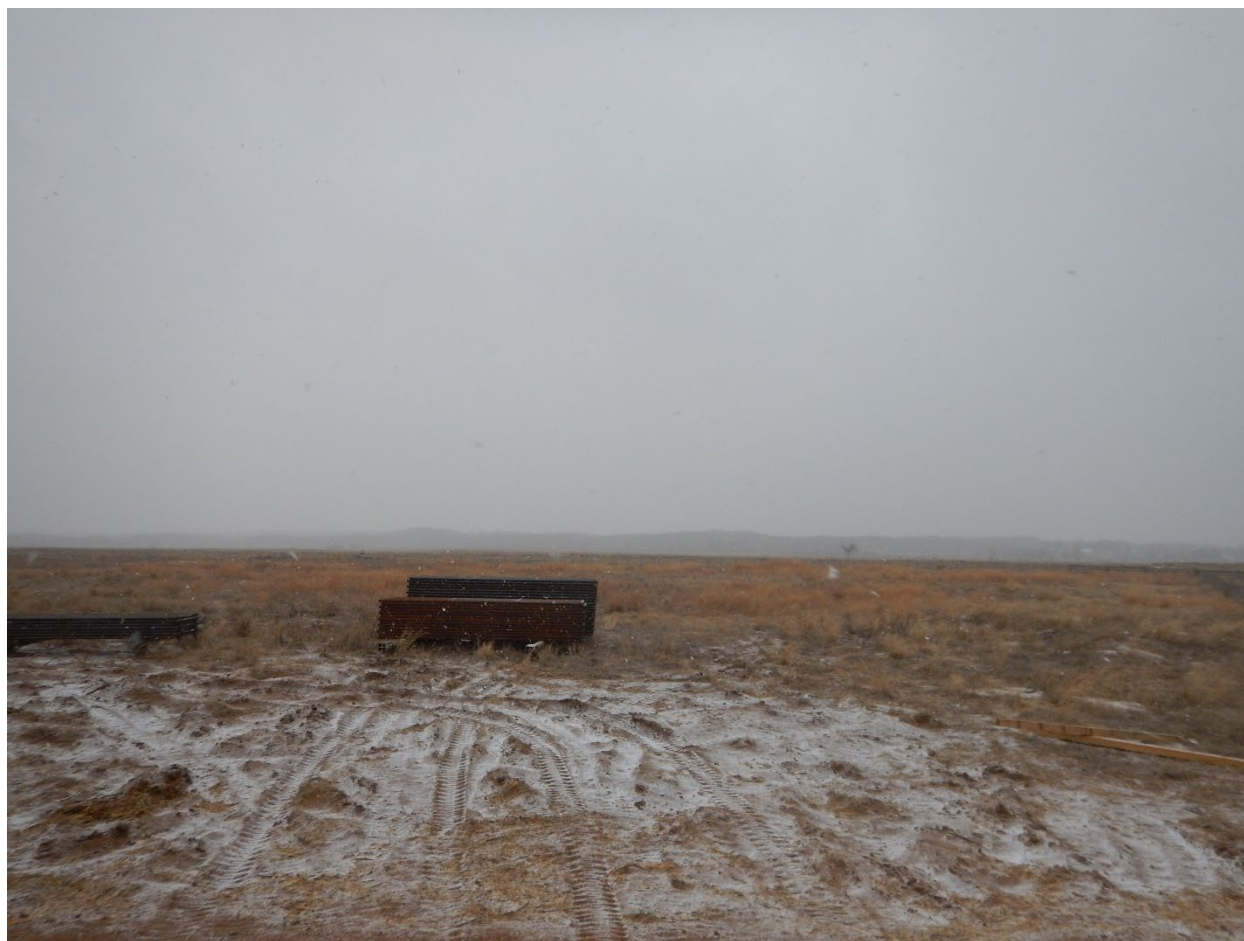
*Photo No. 10*

Description: View to the north. Vegetative strip between pens and the Beaver River.

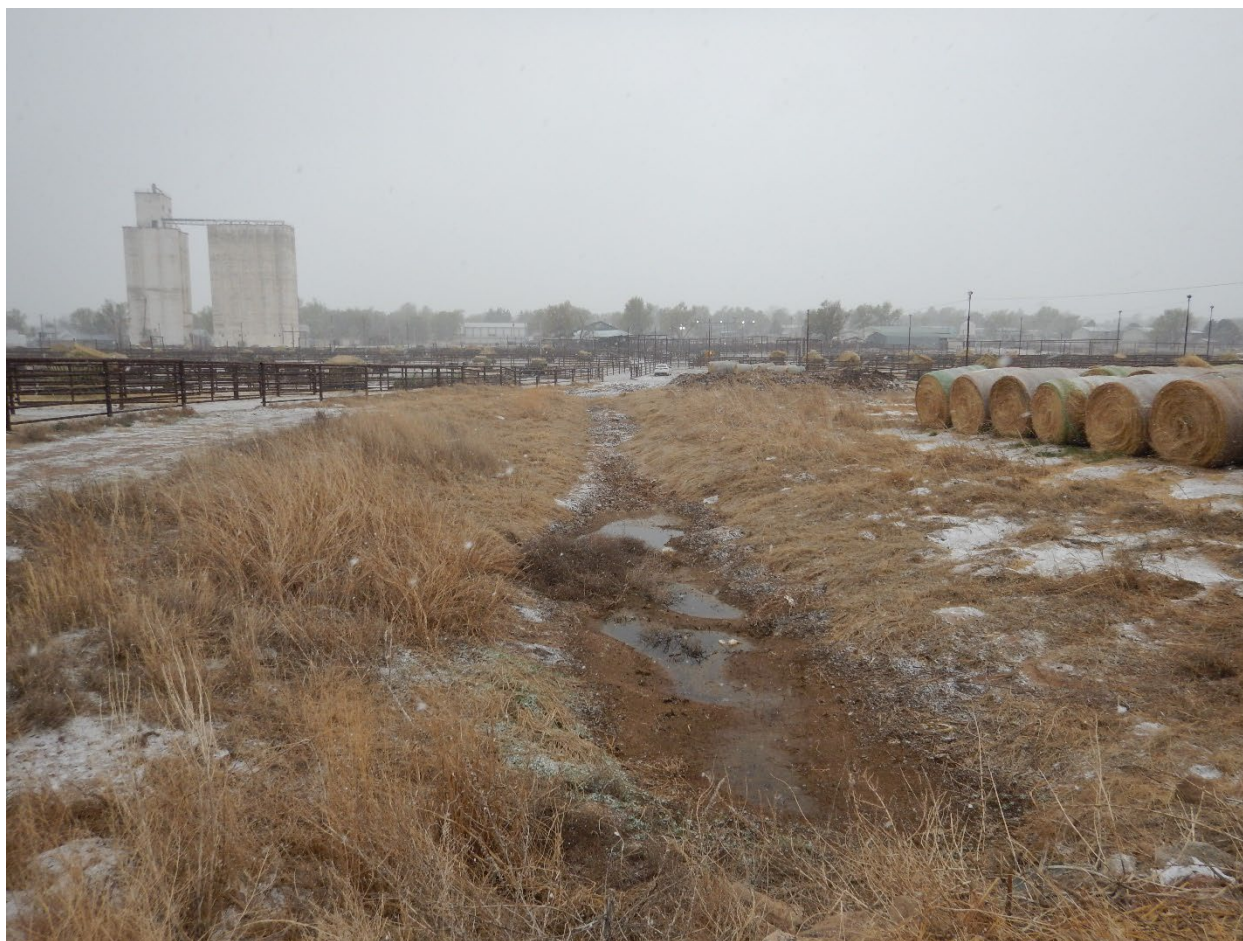
*Photo No. 11*

There is a culvert on the north end of the facility that collects runoff from the pens to the south and has a drainage channel to the Beaver River (Appendix 1, Photos 11-12) (See Areas of Concern). There is also a culvert on the east end of the facility that collects runoff from the pens, manure stockpiles, and hay bales and has a drainage channel to the Beaver River (Appendix 1, 13-15) (See Areas of Concern).

2) There is a culvert on the north end of the facility that collects runoff from pens with a drainage channel to the Beaver River. (Agriculture Pollutant Discharge Elimination System General Permit for Discharges from Concentrated Animal Feeding Operations in Oklahoma Part II.A.1: There shall be no discharge of manure, litter, or process wastewater pollutants into waters of the United States from the production area...”)

Description: View to the south. Culvert on the north end of the facility collecting runoff from the pens to the south.

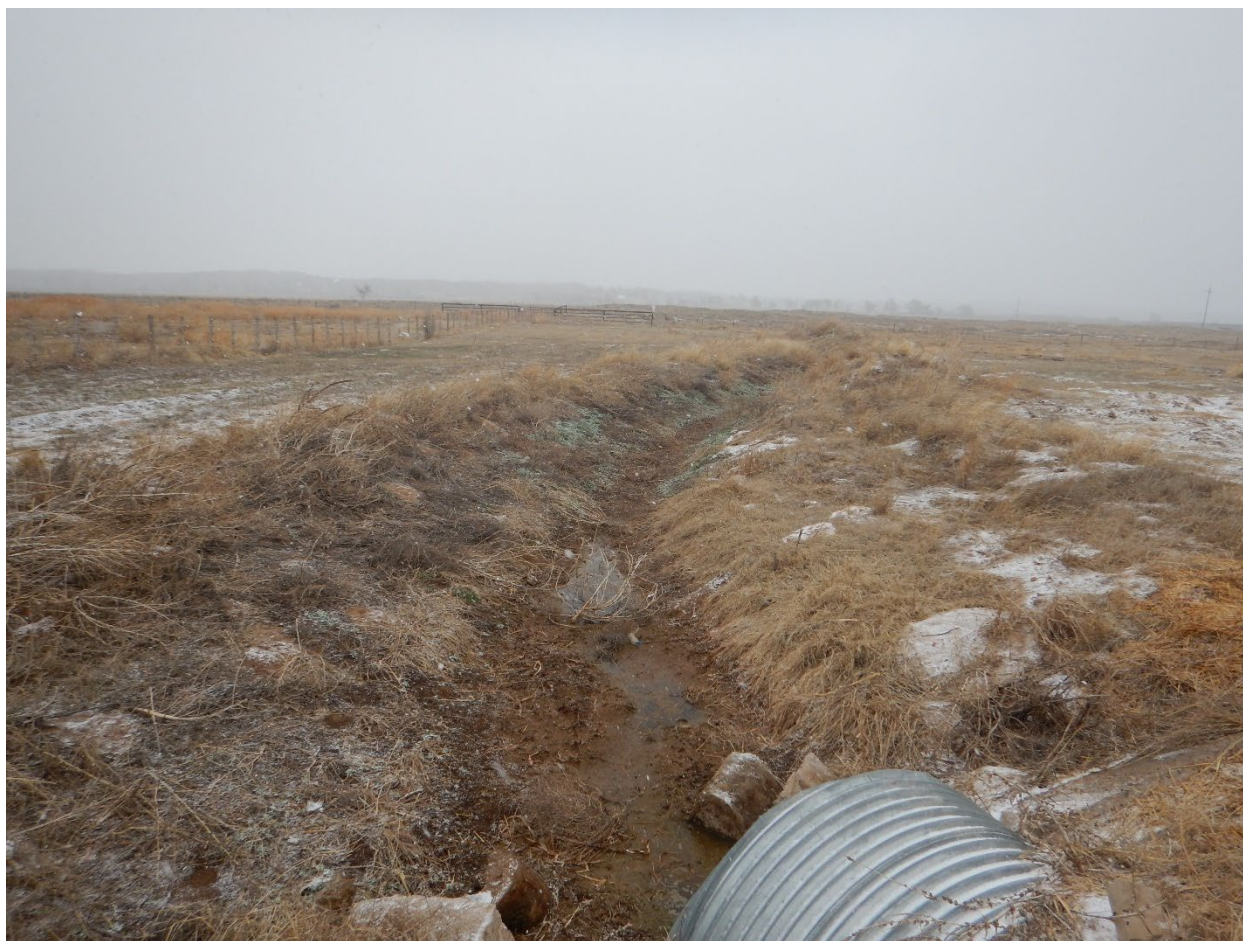
*Photo No. 12*

Description: View to the north. Other side of culvert from photo 11. Shows drainage channel that leads to the Beaver River in background.

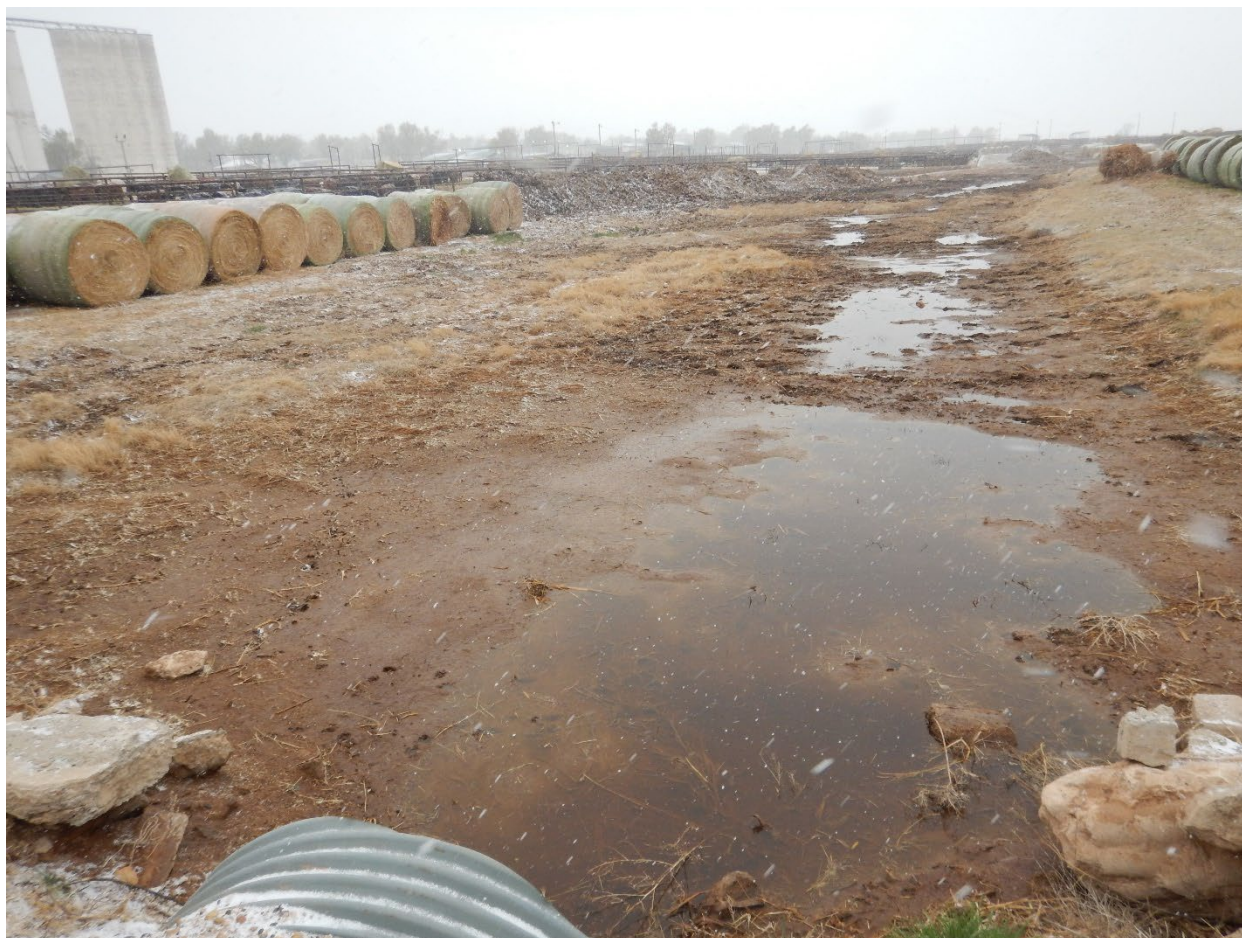
*Photo No. 13*

3) There is a culvert on the east end of the facility that collects runoff from the pens, manure stockpiles, and hay bales with a drainage channel to the Beaver River. (Agriculture Pollutant Discharge Elimination System General Permit for Discharges from Concentrated Animal Feeding Operations in Oklahoma Part II.A.1: There shall be no discharge of manure, litter, or process wastewater pollutants into waters of the United States from the production area..." )

Description: View to the west. Culvert on east end of the facility. Collects runoff from manure storage, hay bales, and pens to the west.

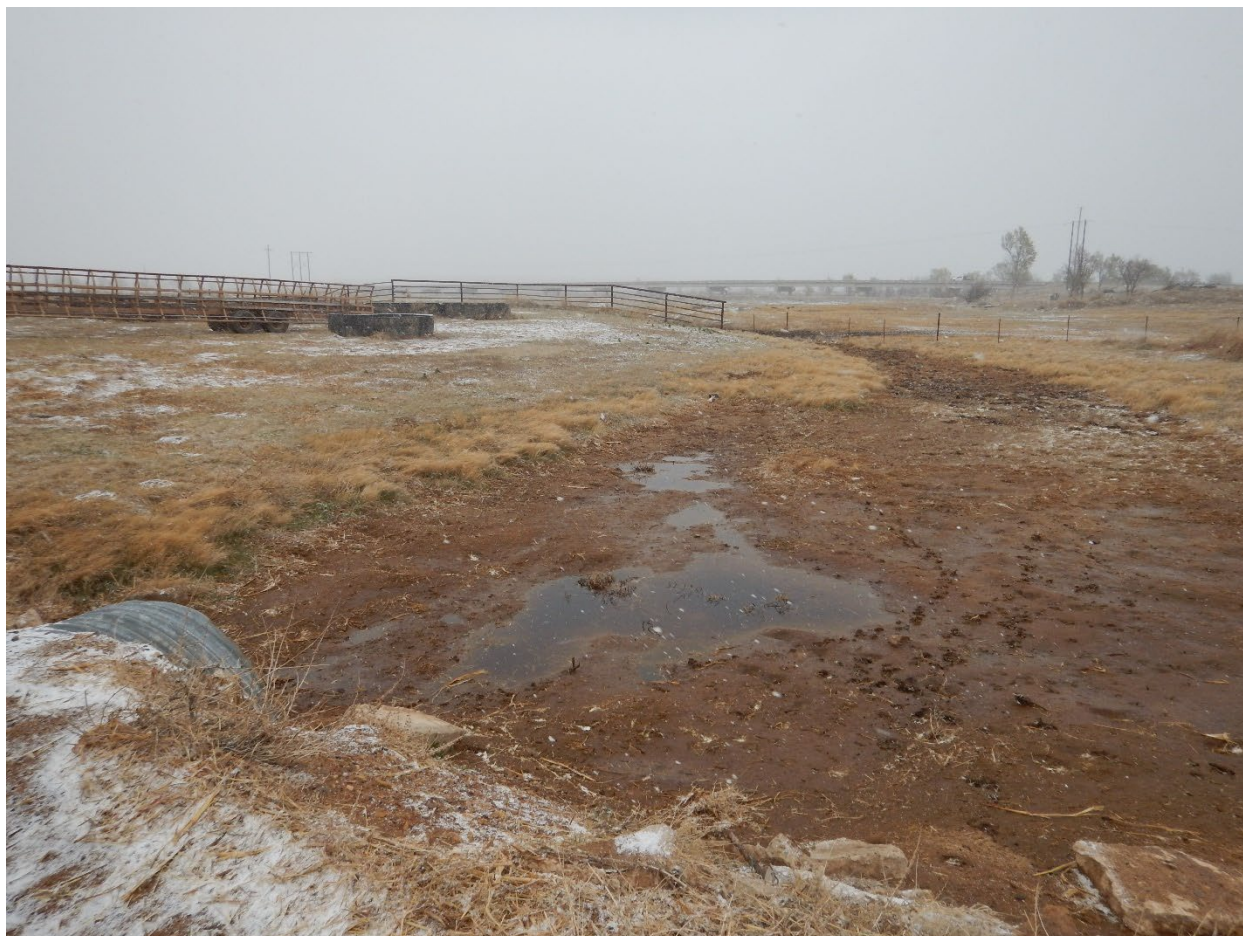
*Photo No. 14*

Description: View to the east. Other side of culvert from photo 13. Drainage channel leads to the Beaver River in the background.

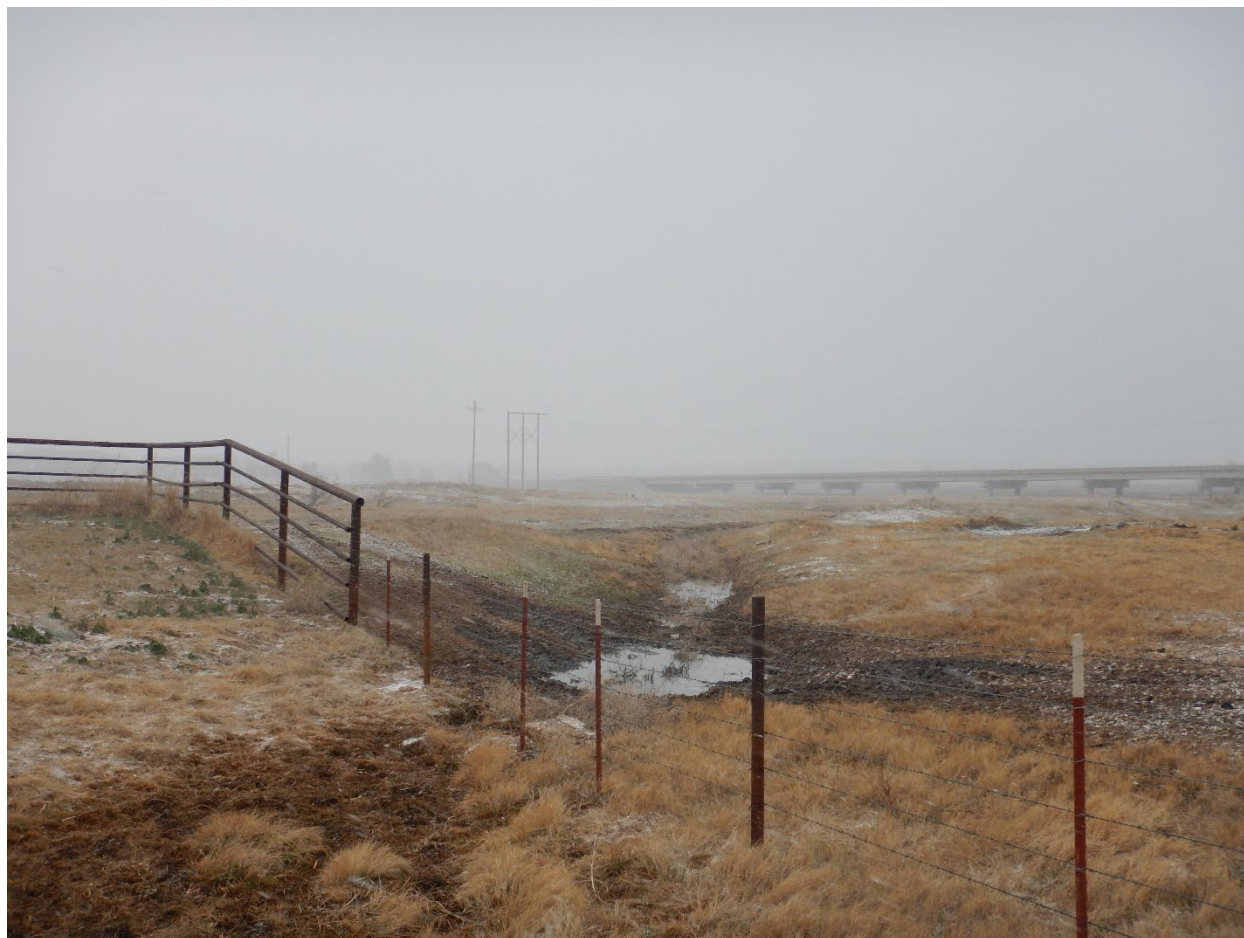
*Photo No. 15*

Description: View to the northeast. Continuation of the drainage channel from photo 14.
