## NPDES Inspection Report – Wastewater Treatment Facility

| National Database Information | |
|---|---|
| <b>Inspection Date:</b> June 29, 2021 | <b>Inspection Type:</b> CEI – Wastewater Treatment Facility, Minor |

| Facility Location Information | |
|---|---|
| <b>Site/Facility Name &amp; Location:</b><br>Fort Washakie Hotsprings Lagoon<br>N S12 T01S R02W<br>Fort Washakie, Wyoming 82514<br>43.007849° N, -108.824748° W | <b>Email Report to:</b><br>Erin Martin, Utility Director<br>Shoshone Utility Organization<br>emartin@easternshoshone.org |

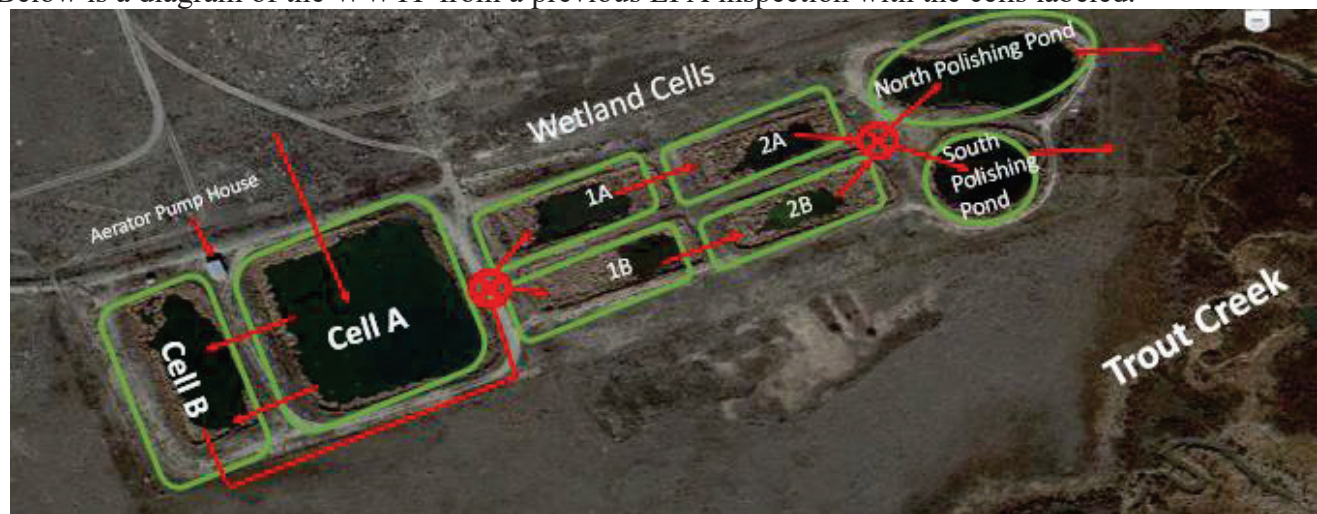
Below is a diagram of the WWTF from a previous EPA inspection with the cells labeled.
