**Region 6 - Enforcement & Compliance Assurance Division**  
**INSPECTION REPORT**

| Inspection Date(s): | August 22, 2023 | |
| Company Name: | Centurion Container, LLC. | |
| Facility Name: | <b>Houston Facility</b> | |

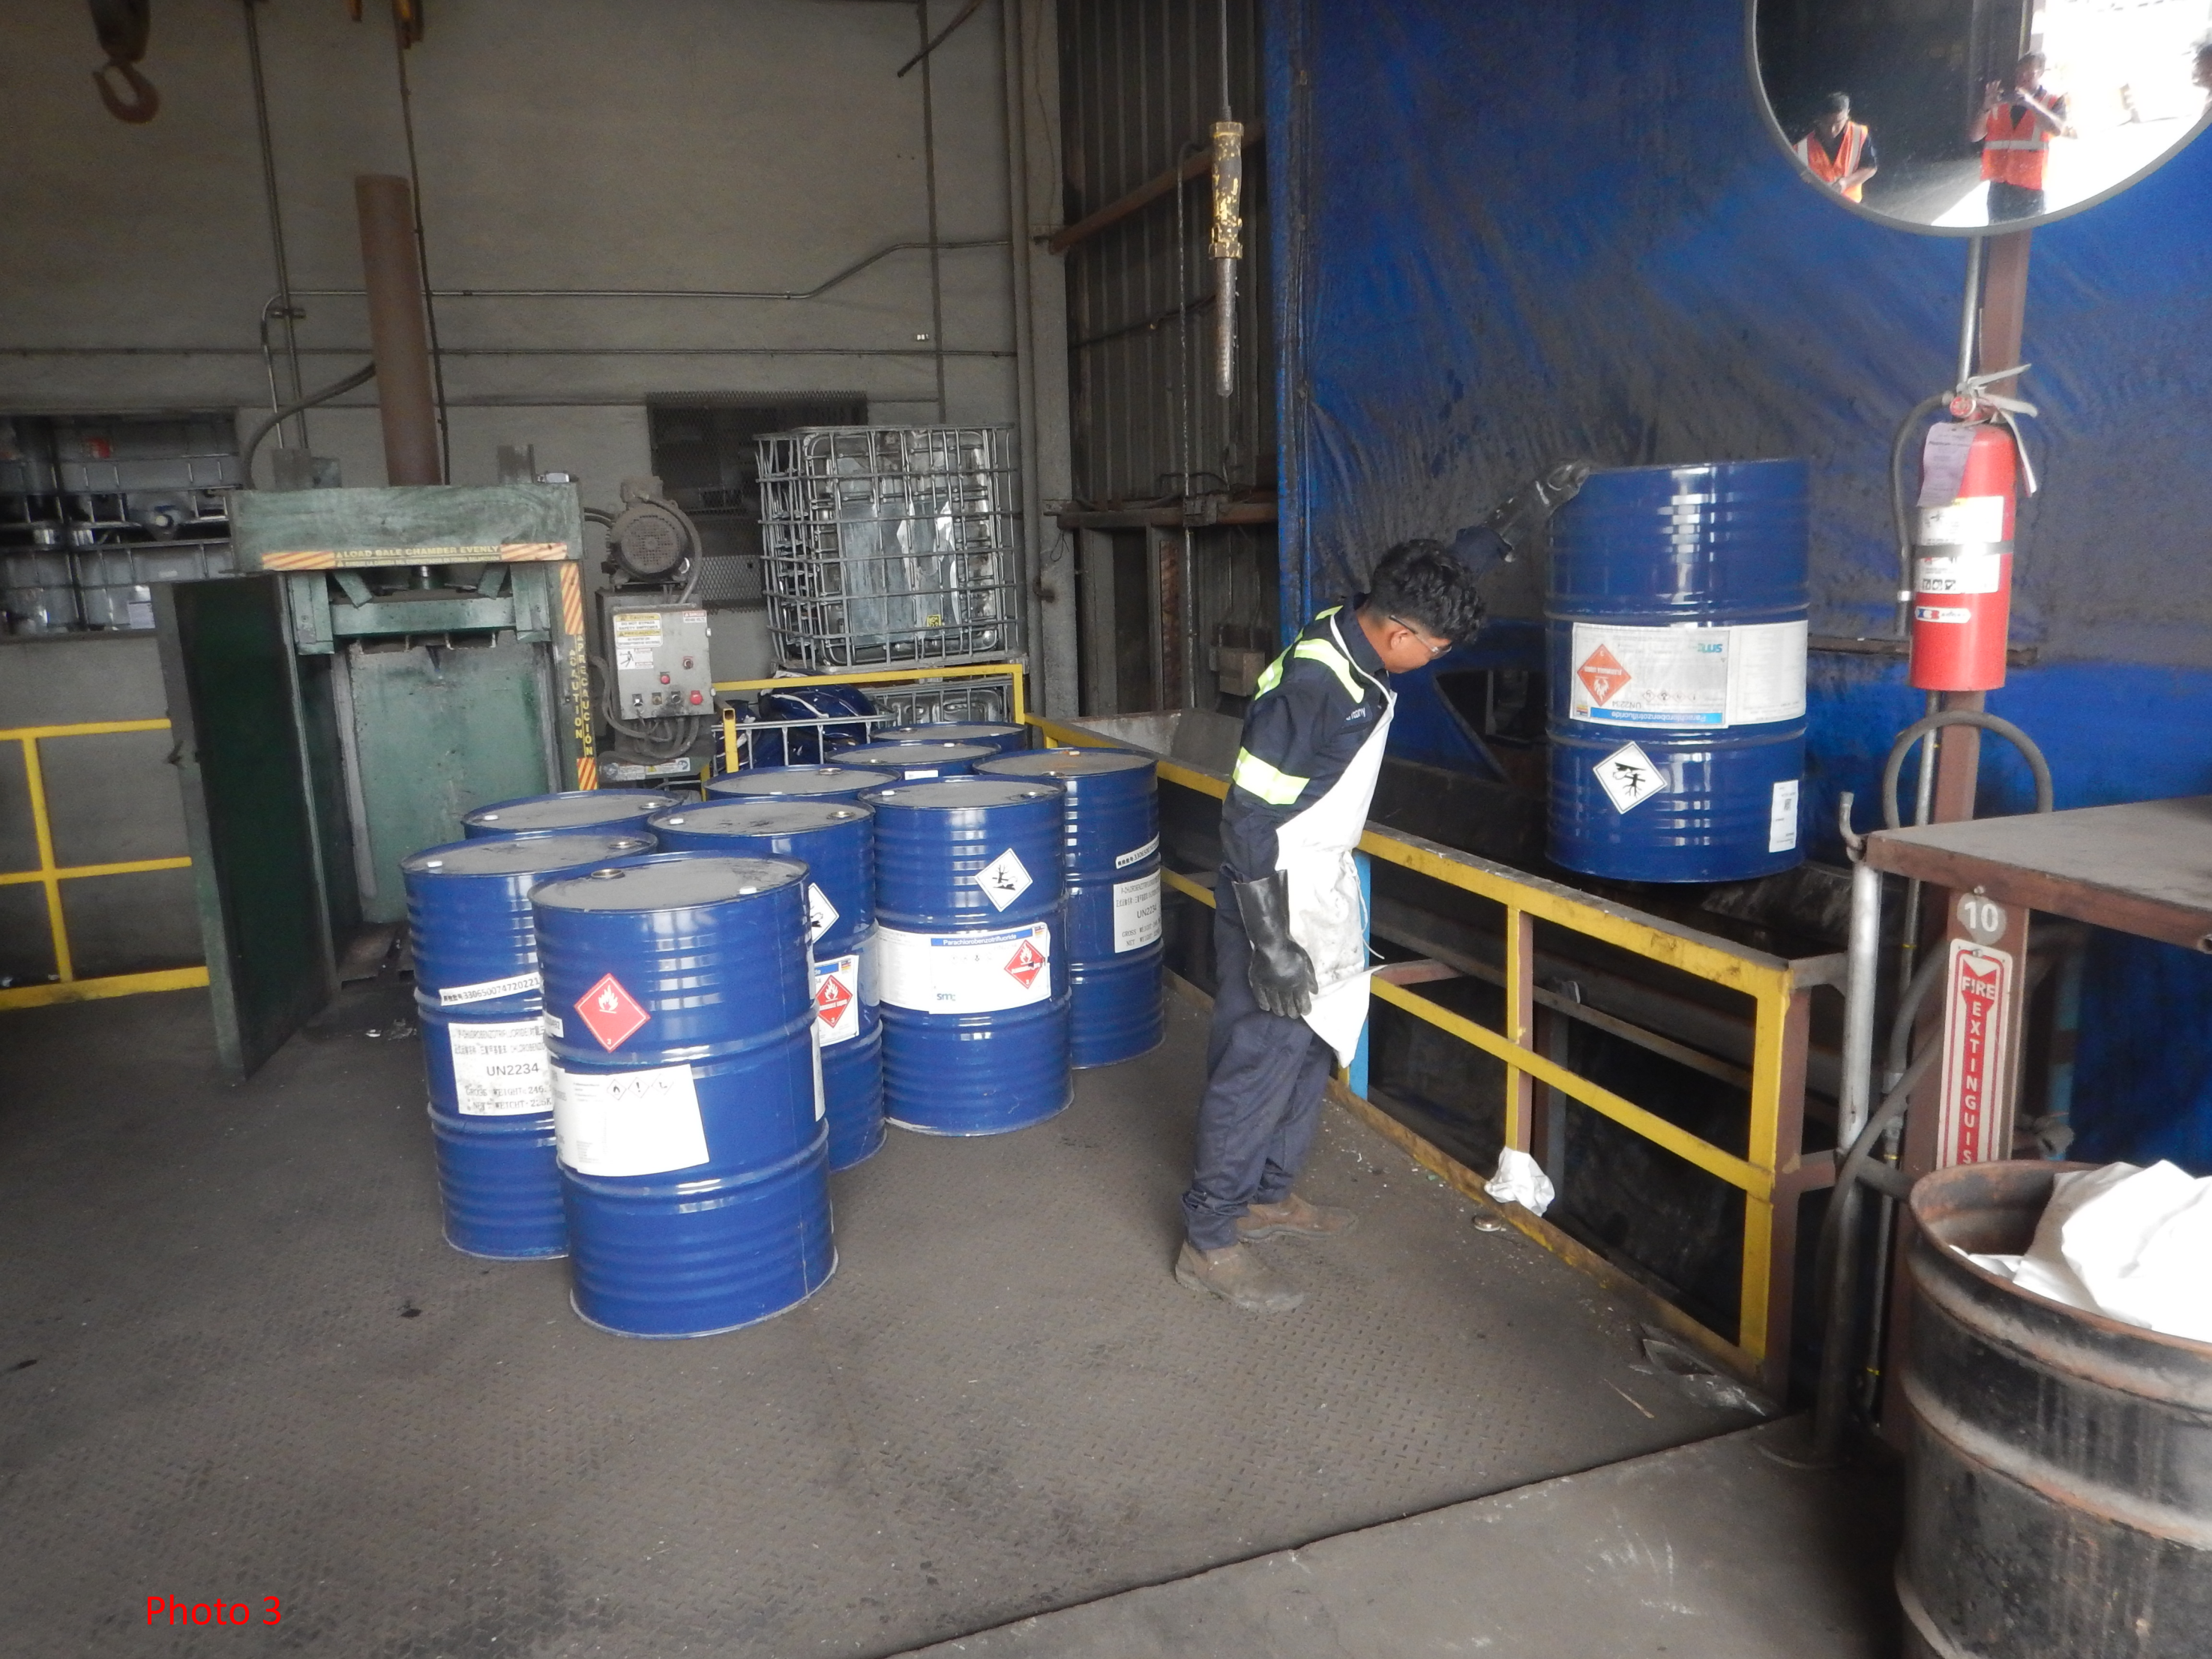
Photo 3

| Photo Number | File Name | | Date | Time | Photographer | Description |
|---|---|---|---|---|---|---|
| 3 | DSCN1129 | .JPG | 22-Aug-23 | 1036 | John Penland | Drum emptying in the container receiving area. Flammable liquid drums being emptied. |

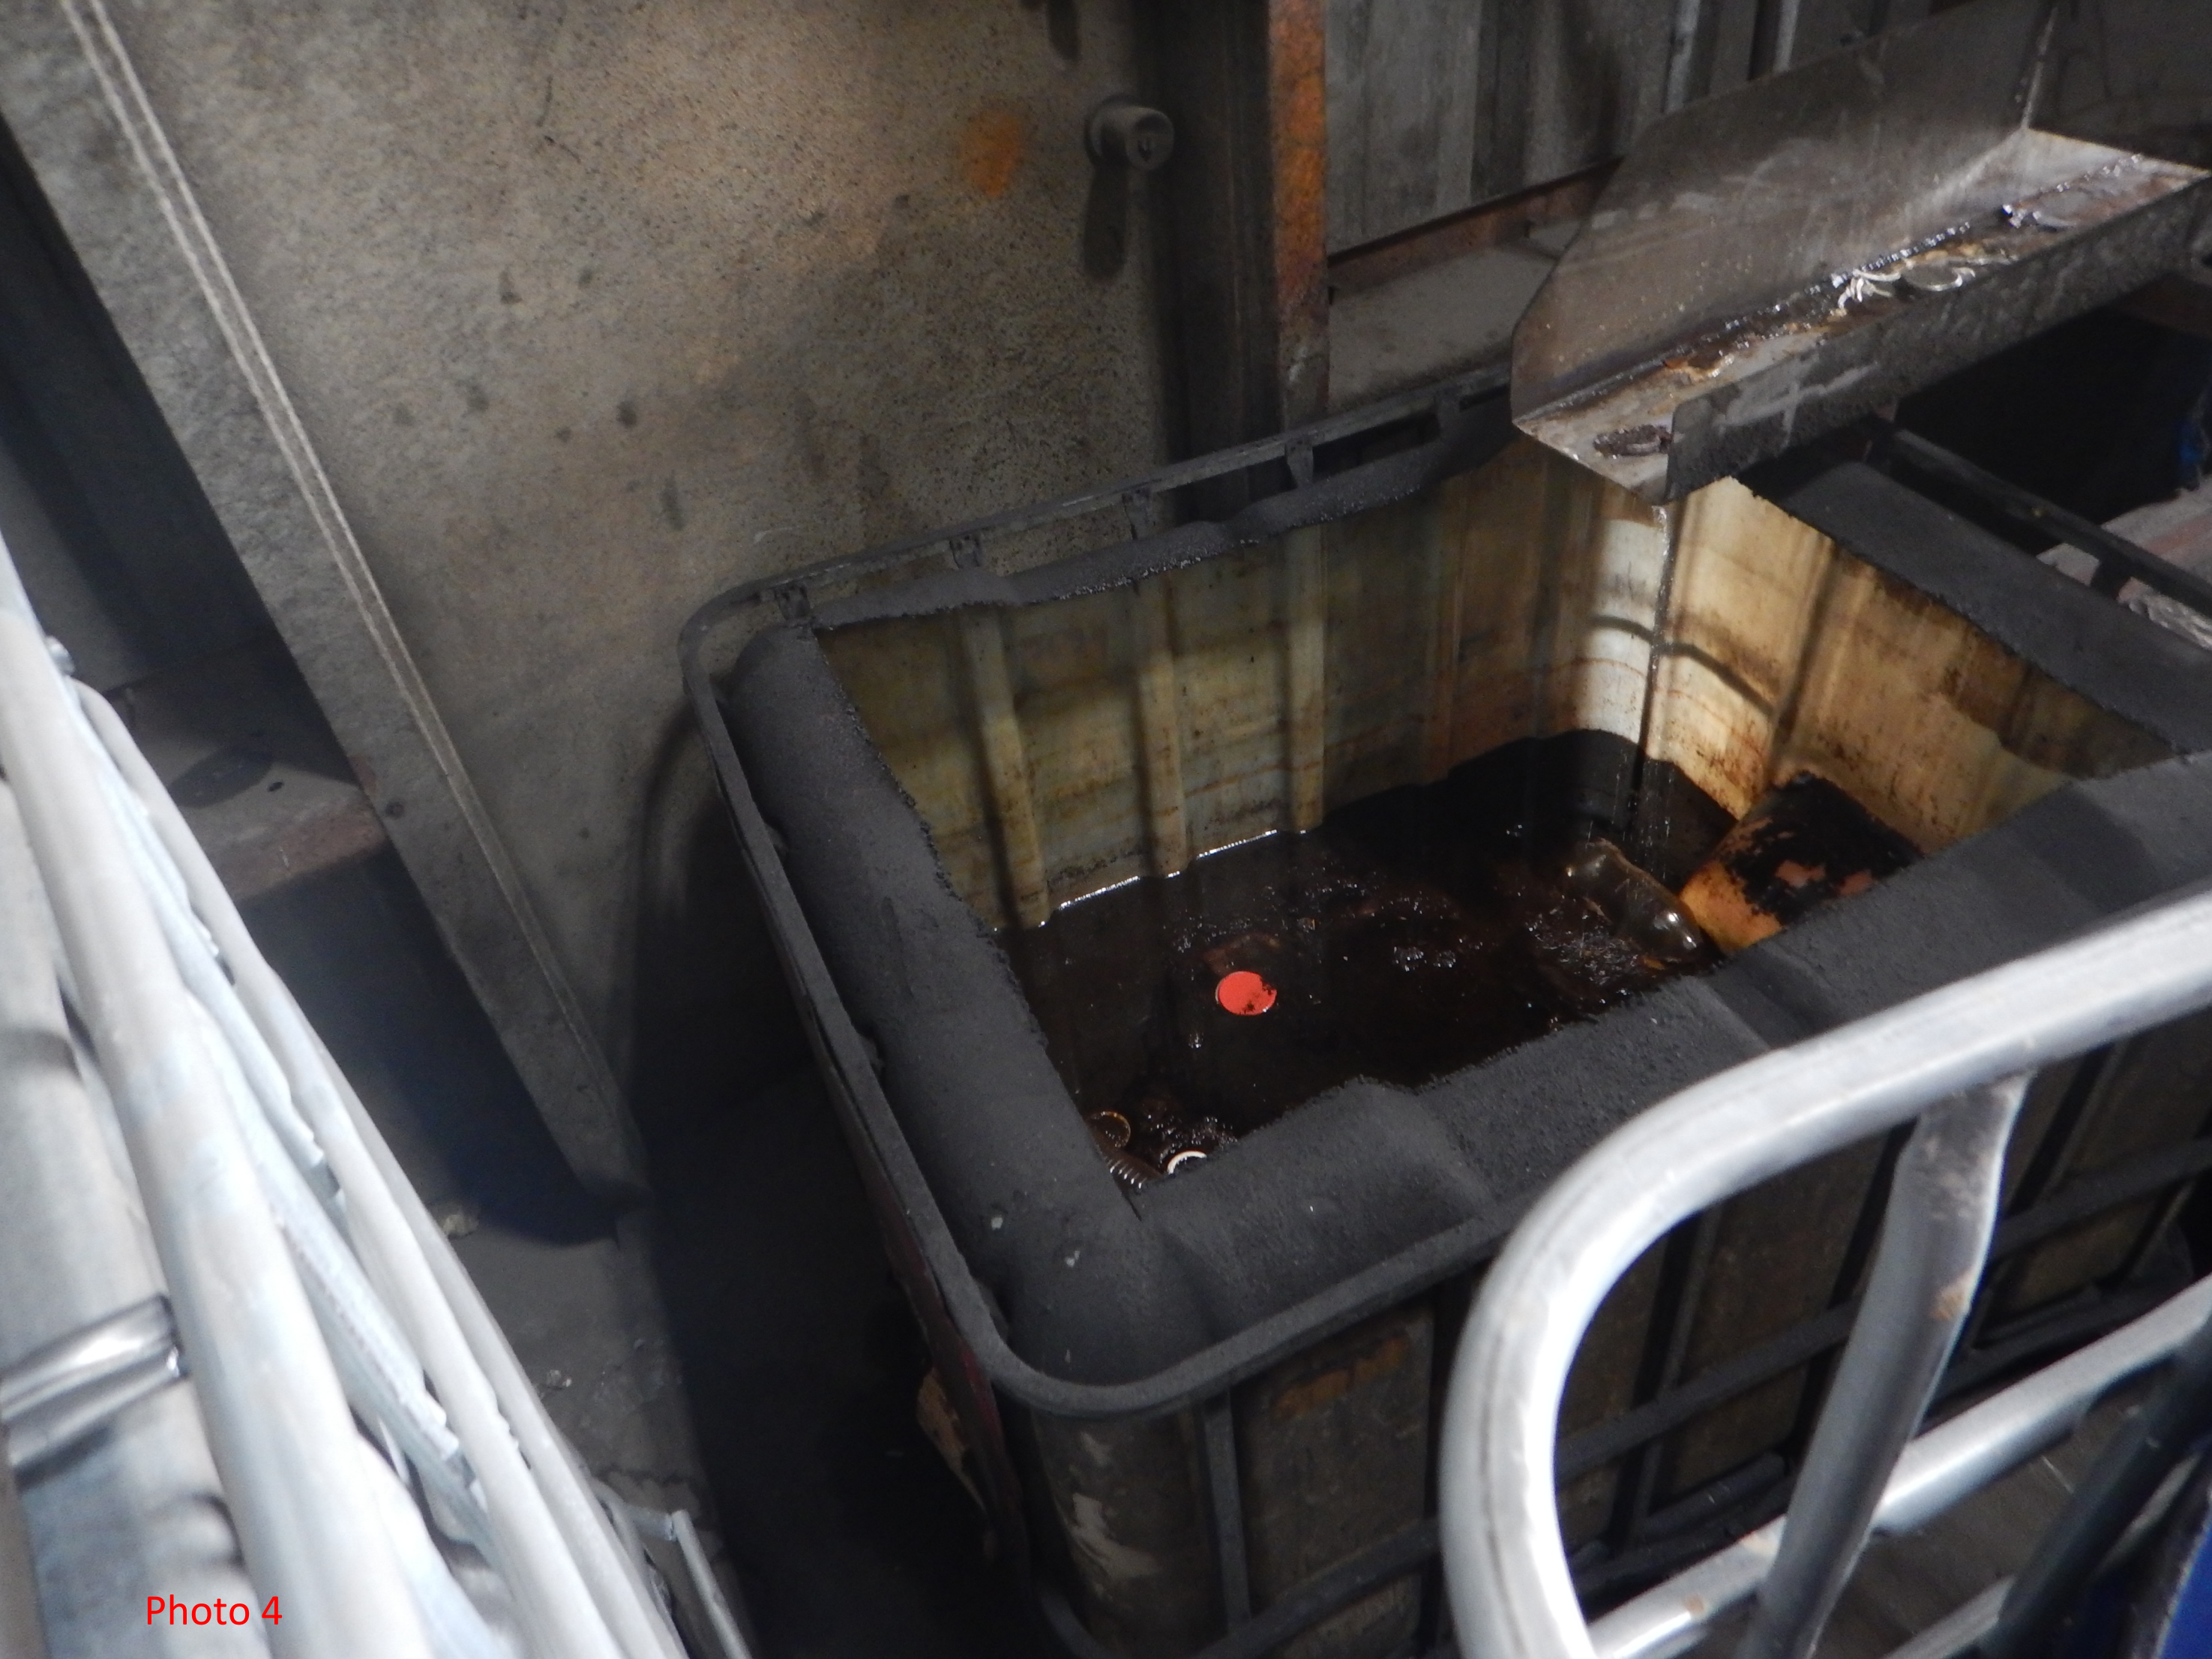
Photo 4

residues at the drum emptying trough was an open topped container and incapable of being closed. See Photos 1,2, and 4.

The container management standards require small and large quantity generators to mark containers used for the accumulation of hazardous waste with: the words “Hazardous Waste” and an indication of the hazards associated with the waste. During this inspection, we found that the hazardous waste container accumulating flammable residues at the drum emptying trough was not marked as a hazardous waste accumulation container. See Photo 4.

| Photo Number | File Name | | Date | Time | Photographer | Description |
|---|---|---|---|---|---|---|
| 4 | DSCN1130 | .JPG | 22-Aug-23 | 1037 | John Penland | Open-topped unlabeled container used for accumulation of waste residues from drum emptying in the container receiving area. |

- During our inspection we observed that the hazardous waste container accumulating flammable residues at the drum emptying trough was an open topped container and incapable of being closed.

- 40 CFR 262.15 (a)(5) – Failure to mark a hazardous waste accumulation container
    - During our inspection we observed that the hazardous waste container accumulating flammable residues at the drum emptying trough was not marked as a hazardous waste accumulation container.

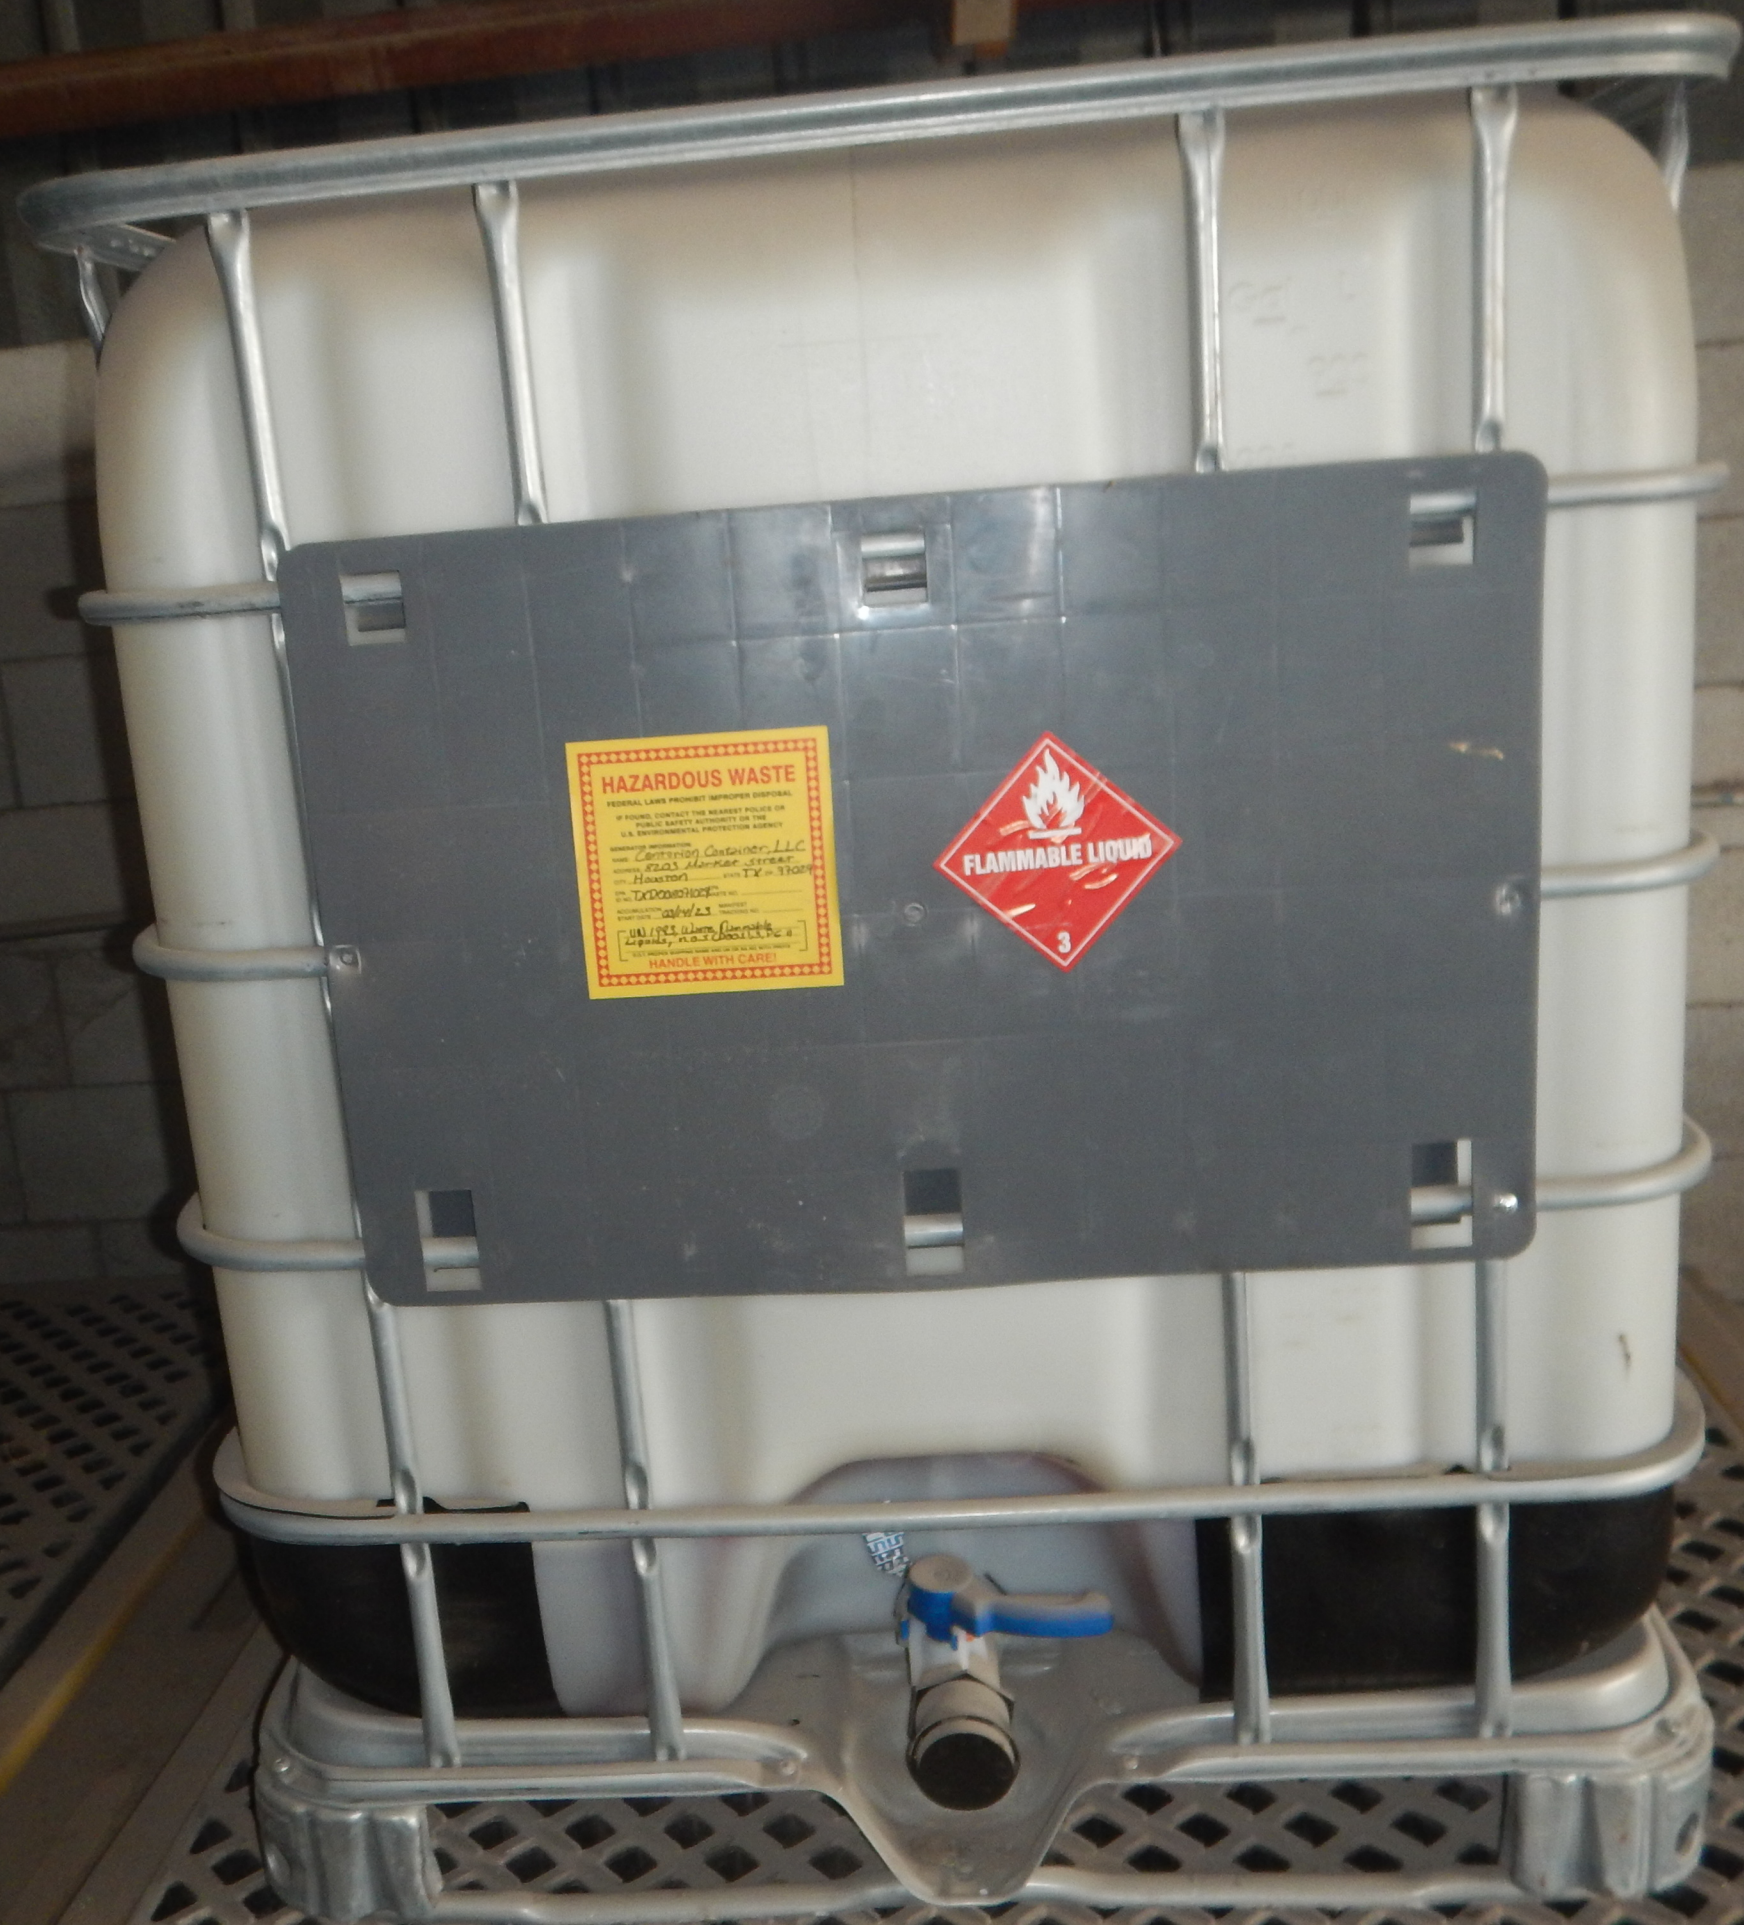
Photo 5

| Photo Number | File Name | | Date | Time | Photographer | Description |
|---|---|---|---|---|---|---|
| 5 | DSCN1131 | .JPG | 22-Aug-23 | 1040 | John Penland | Hazardous waste accumulation container (275-gallon IBC) located in the waste storage area. Used for the consolidation of flammable liquid waste from the container |

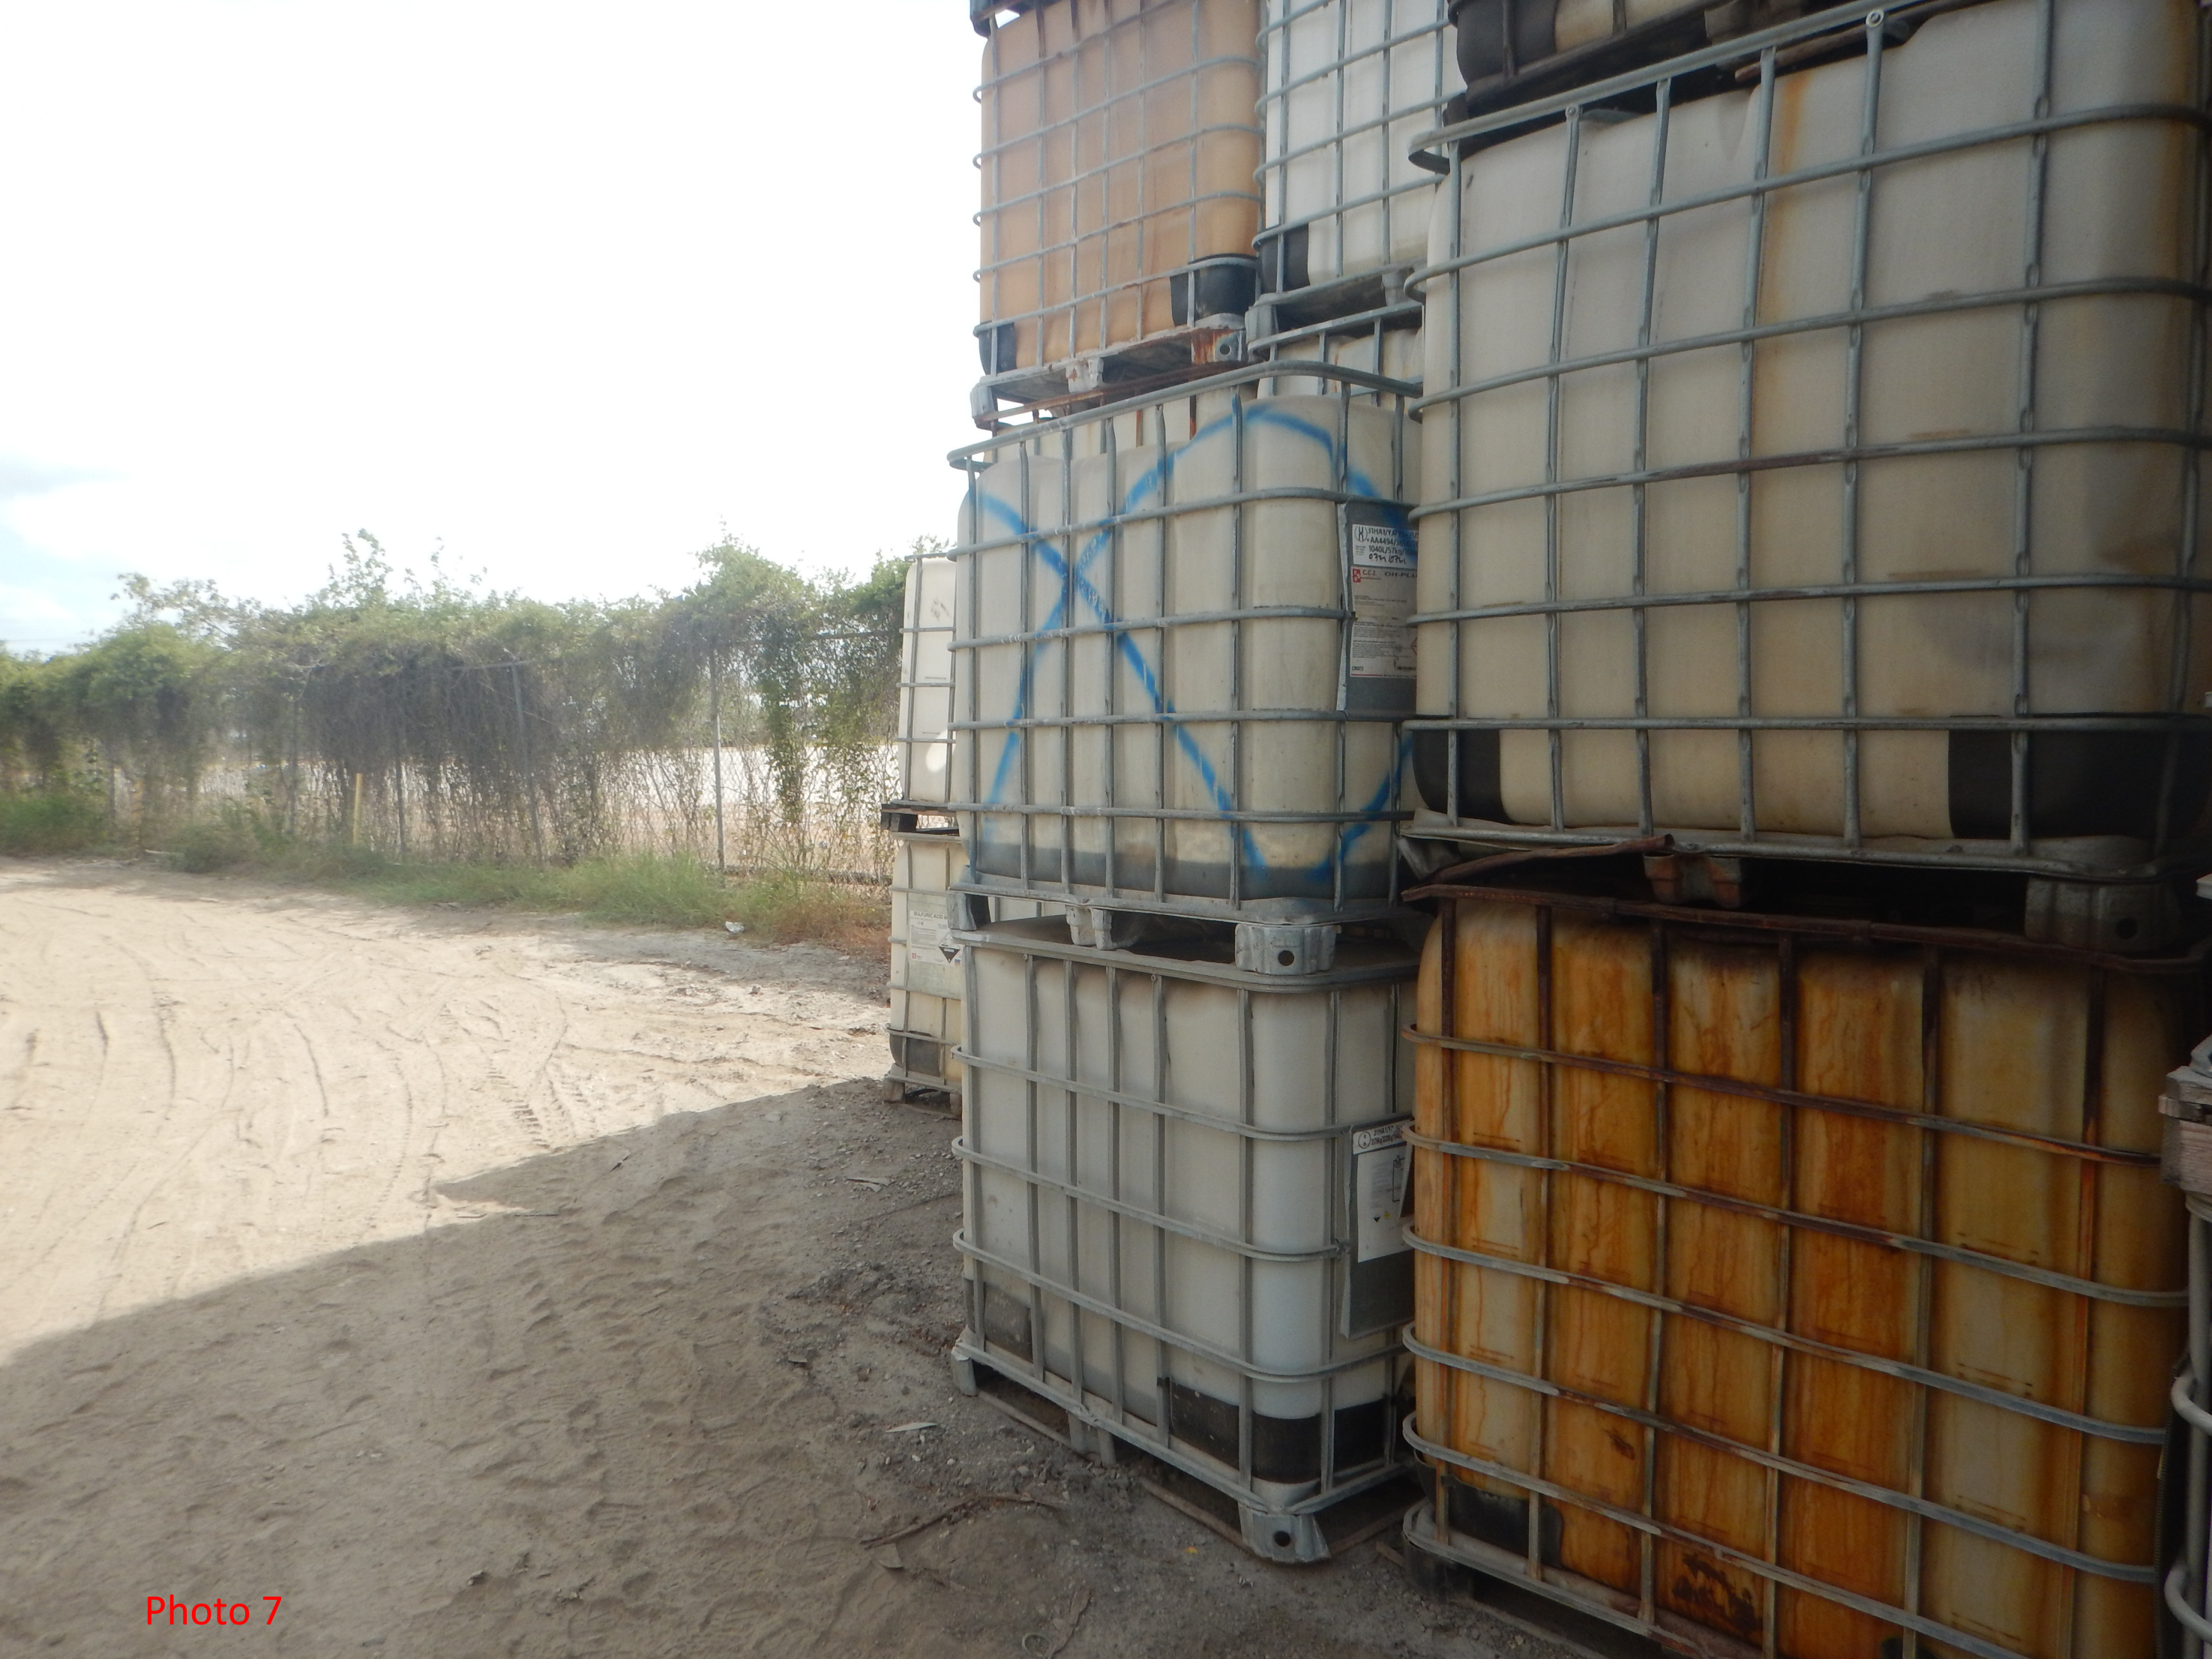
Photo 7

| Photo Number | File Name | | Date | Time | Photographer | Description |
|---|---|---|---|---|---|---|
| 7 | DSCN1133 | .JPG | 22-Aug-23 | 1046 | John Penland | Front left of photo: 2 rejected IBC totes stored in the exterior storage area. |

- Outdoor IBC storage area
  - Empty IBC totes are stored in this area east of the main building.
  - 2 rejected containers with excess heel were found during our inspection of this area. Both were received in October of 2022. (October 14 and 26). These containers were moved to the quarantine area upon discovery.

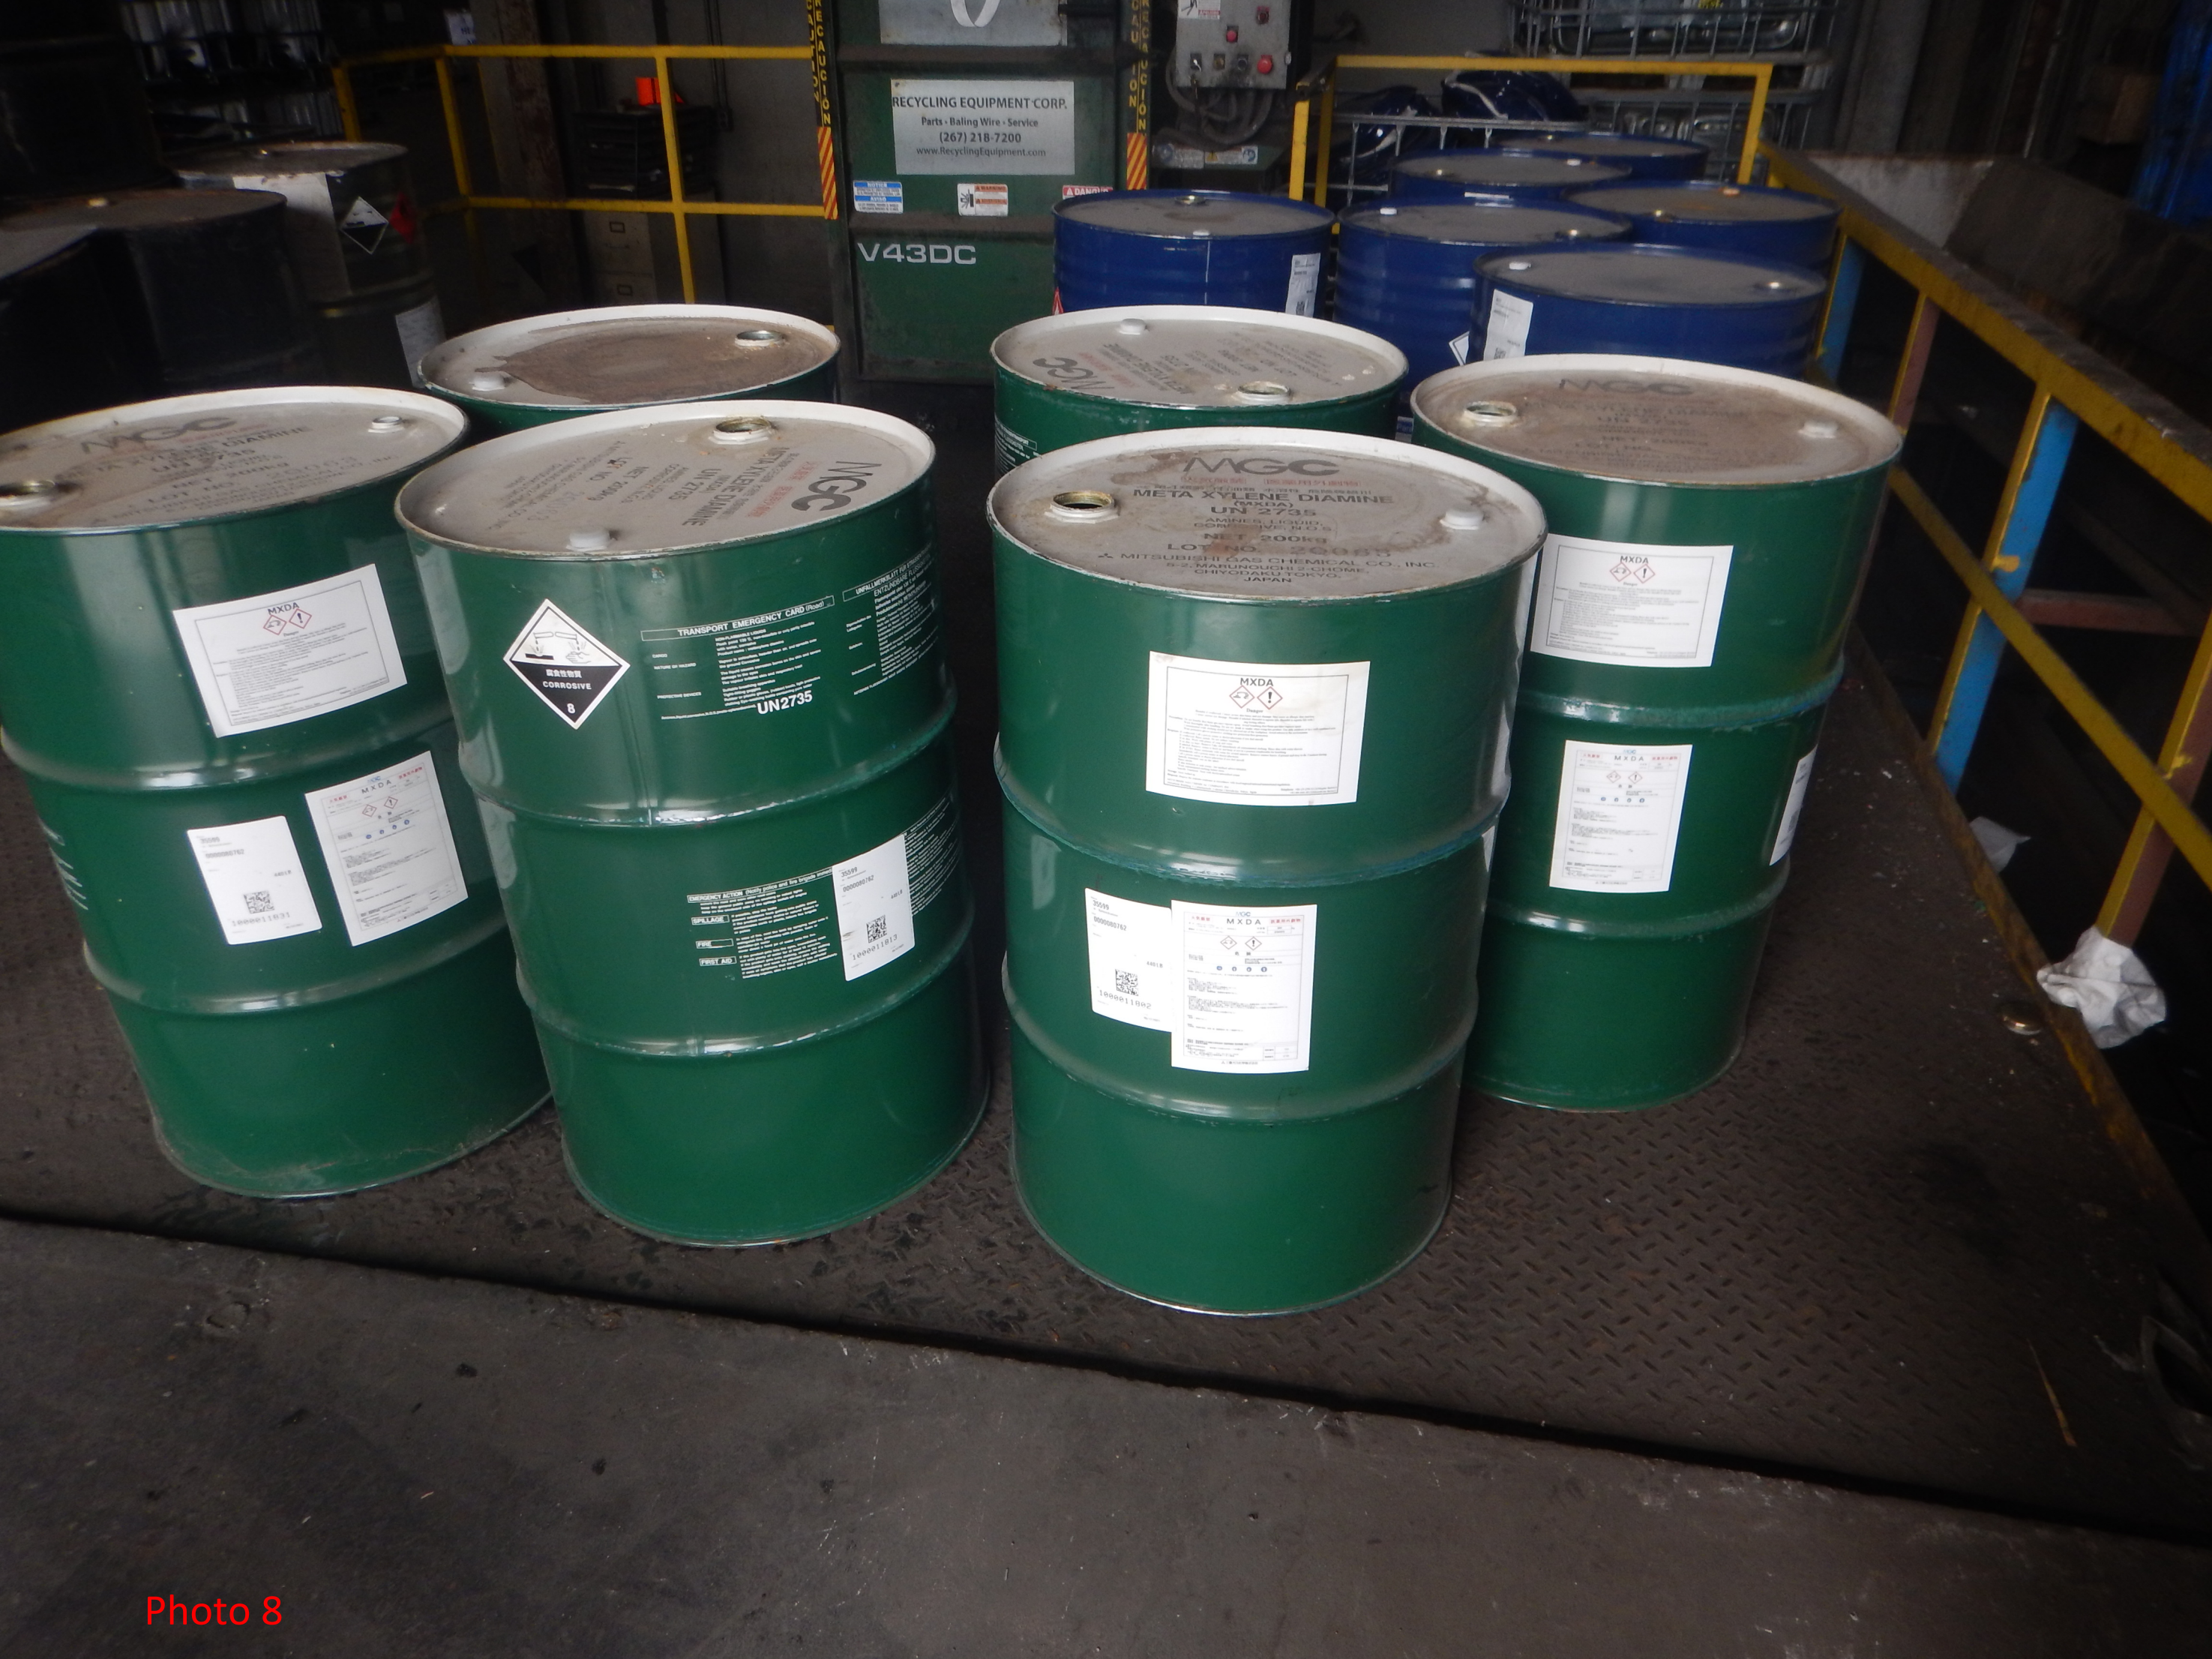
Photo 8

| Photo Number | File Name | | Date | Time | Photographer | Description |
|---|---|---|---|---|---|---|
| 8 | DSCN1134 | .JPG | 22-Aug-23 | 1052 | John Penland | Containers of staged for emptying on the containr receiving area. |
