**Well Inspection**  
**Osage DNR / Environmental Protection Agency**  
**1201 Elm Street, Suite 500**  
**Dallas, Texas 75270**

| <b>Operator Info</b> | Contango Resources, LLC<br>1717 South Boulder, Suite 900<br>Tulsa, OK 74119<br>Phone: 918-392-3396 | <b>Inventory ID</b> | OS2859000 | | |
| | | <b>Well ID</b> | 11W15 | | |
| <b>Inspection Reason</b> | MIT | <b>Responsible Company at Time of Inspection</b> | Contango Resources, LLC | | |

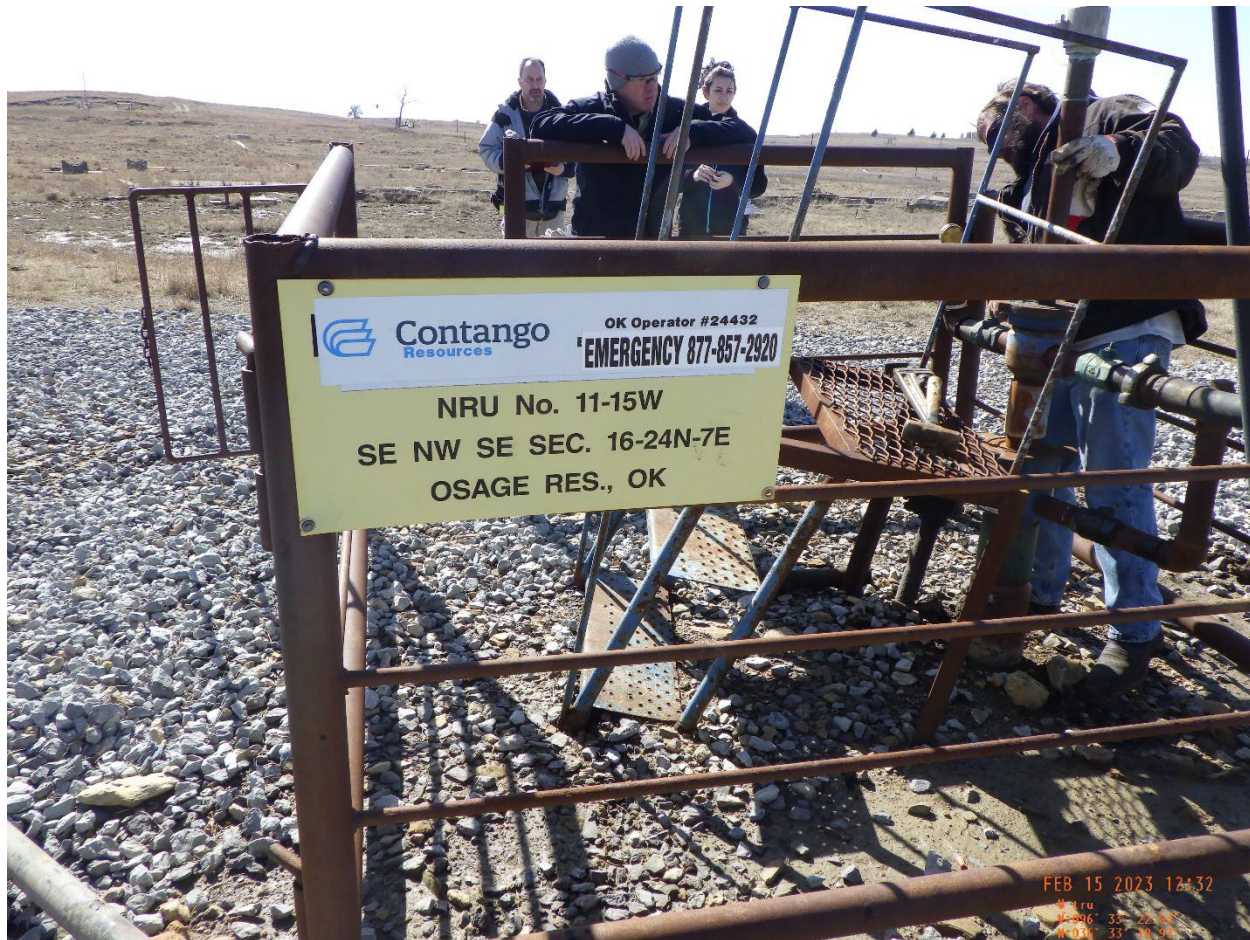
Photo No. 1

**Description:** This was well OS2859000 at the time of the inspection.
