**COMPLIANCE EVALUATION INSPECTION REPORT  
U.S. ENVIRONMENTAL PROTECTION AGENCY, REGION 5**

**Purpose:** NPDES Compliance Evaluation Inspection

Rantoul Foods, LLC  
205 East Turner Street  
Rantoul Illinois, 61866

**Date of Inspection:** July 3, 2023

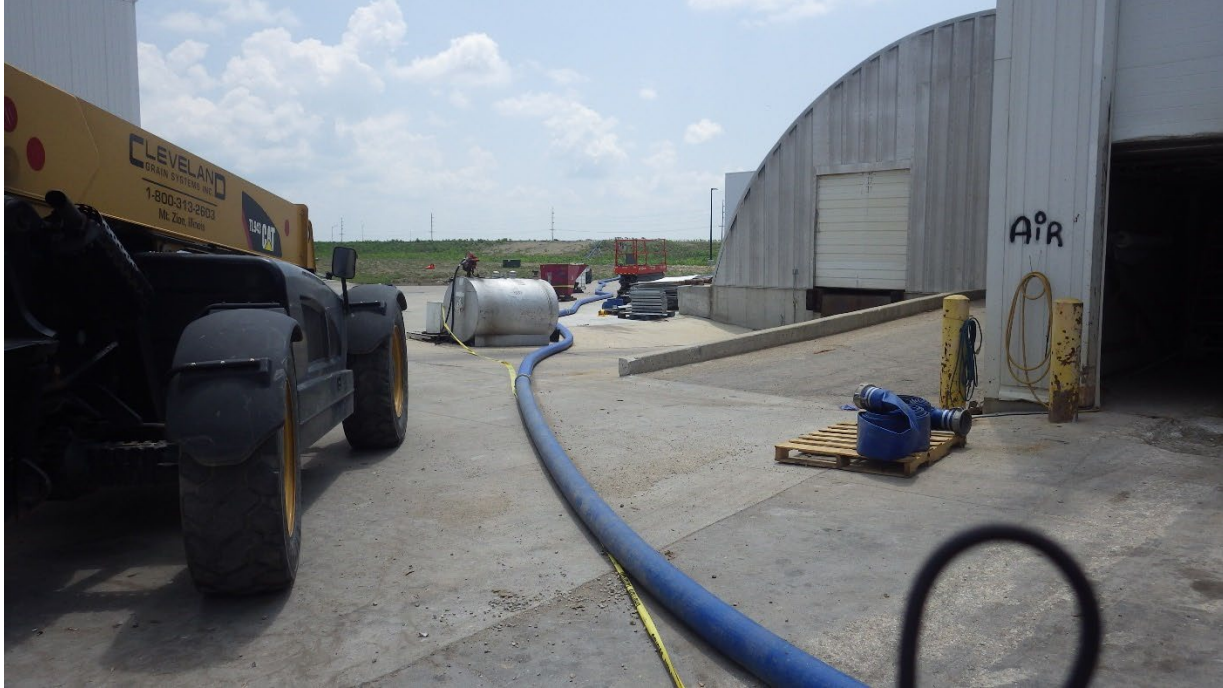
### 1. RIMG001

Description: Storage sheds next to the wastewater pretreatment facility. The blue hose used to transfer untreated process wastewater from Pit 1 to the lagoon. Inspectors noted the left loading dock is sloped with a stormwater inlet on the bottom (visible in Photo 13).

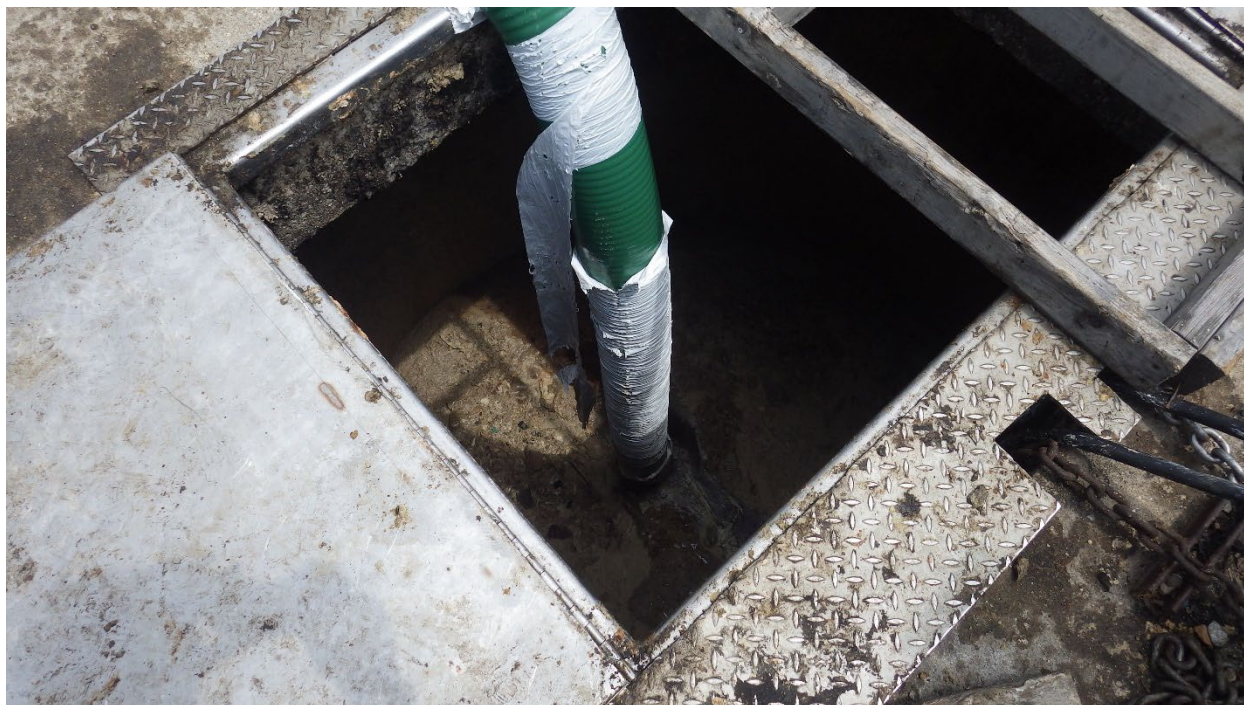
2. RIMG002

I observed a hose in pit 1 (Photo 2) connected to a pump (Photo 3) which would transfer untreated wastewater to the uncovered lagoon (Photo 30-31). Mr. Ernst confirmed that all wastewater was sent to the uncovered lagoon for holding and the existing wastewater pretreatment units were not operational although blowers were used to keep the bugs alive in the Biotank. Inspectors confirmed that a pump was in Pit 1 and transferring wastewater to the

Description: Pit 1 location with a hose and pump bypassing the existing pretreatment system and transferring process wastewater to the uncovered lagoon. This hose is connected to the pump in Photo 3 which pumps through the blue hose shown in Photos 1, 13, and 30-32.

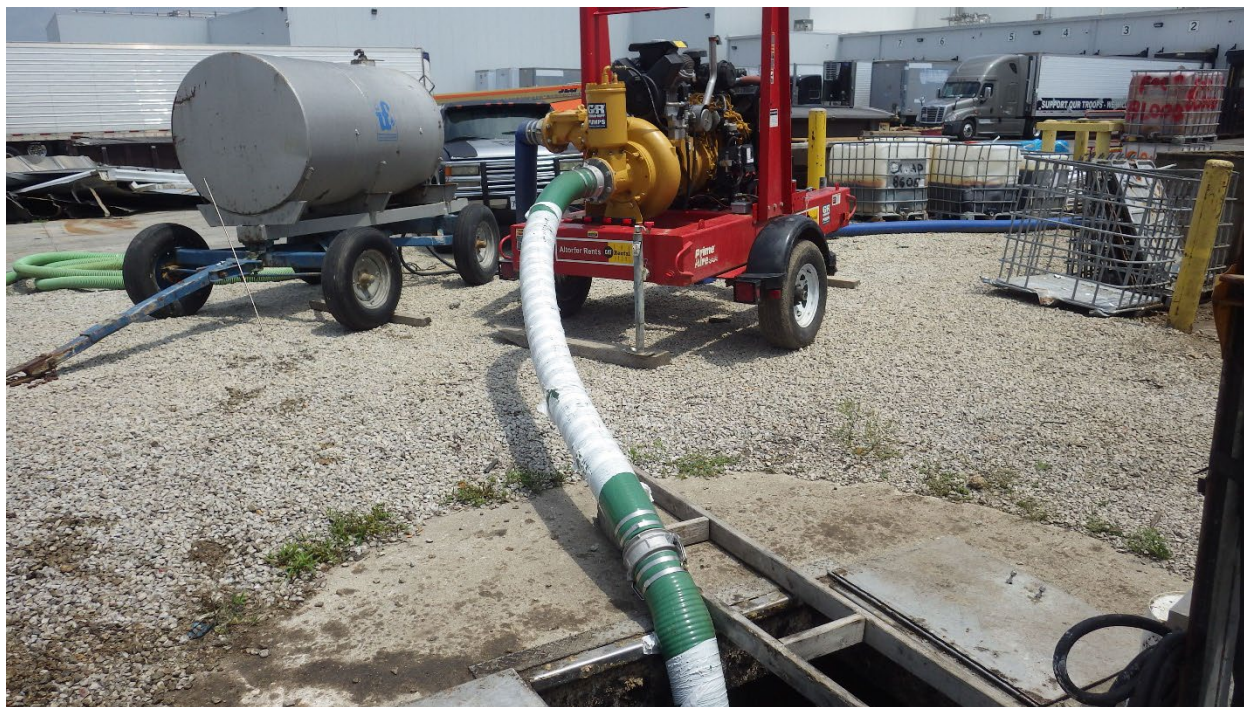
3. RIMG003

Description: A temporary pump is attached to a hose that is located in Pit 1 (Photo 2). The blue hose is attached to the back of this pump. In the center right are totes of blood used for growing bugs, according to Mr. Ernst.

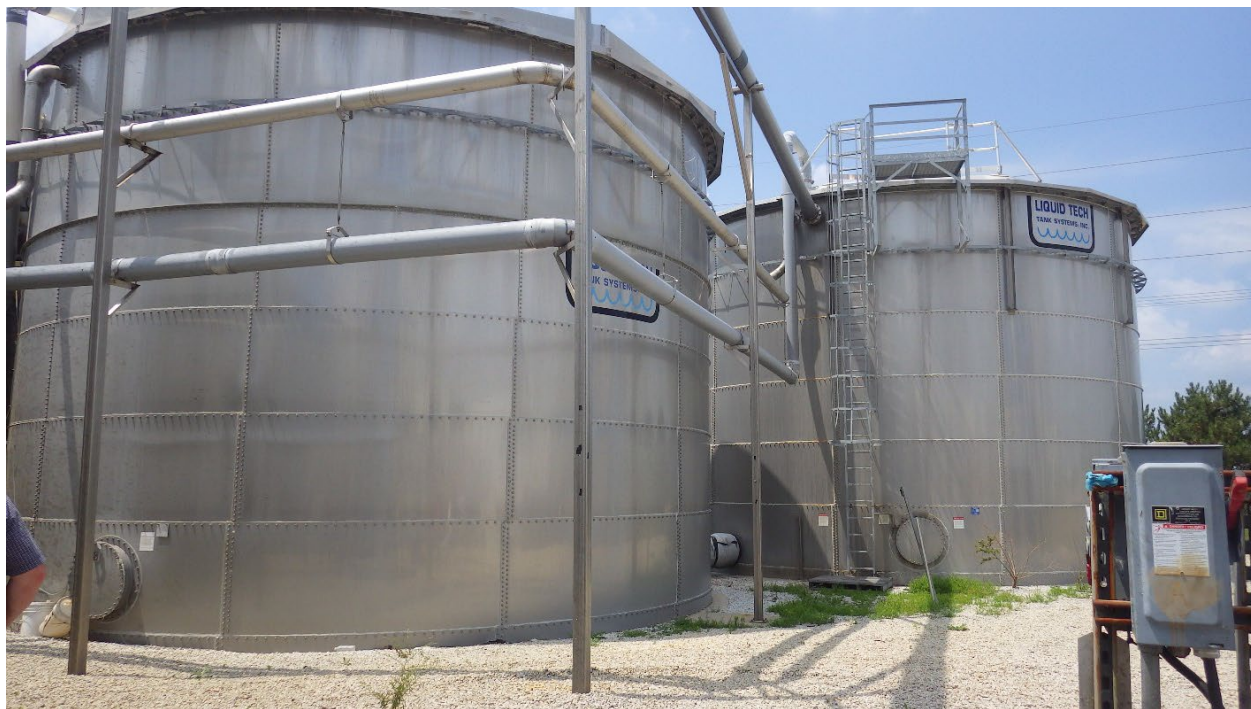
#### 4. RIMG004

Description: Two above ground equalization tanks. Each tank holds 150,000 gallons. At the time of the inspection, Mr. Ernst stated that these tanks were full but not in use, and all process wastewater was bypassing the pretreatment system to be stored in the uncovered lagoon.

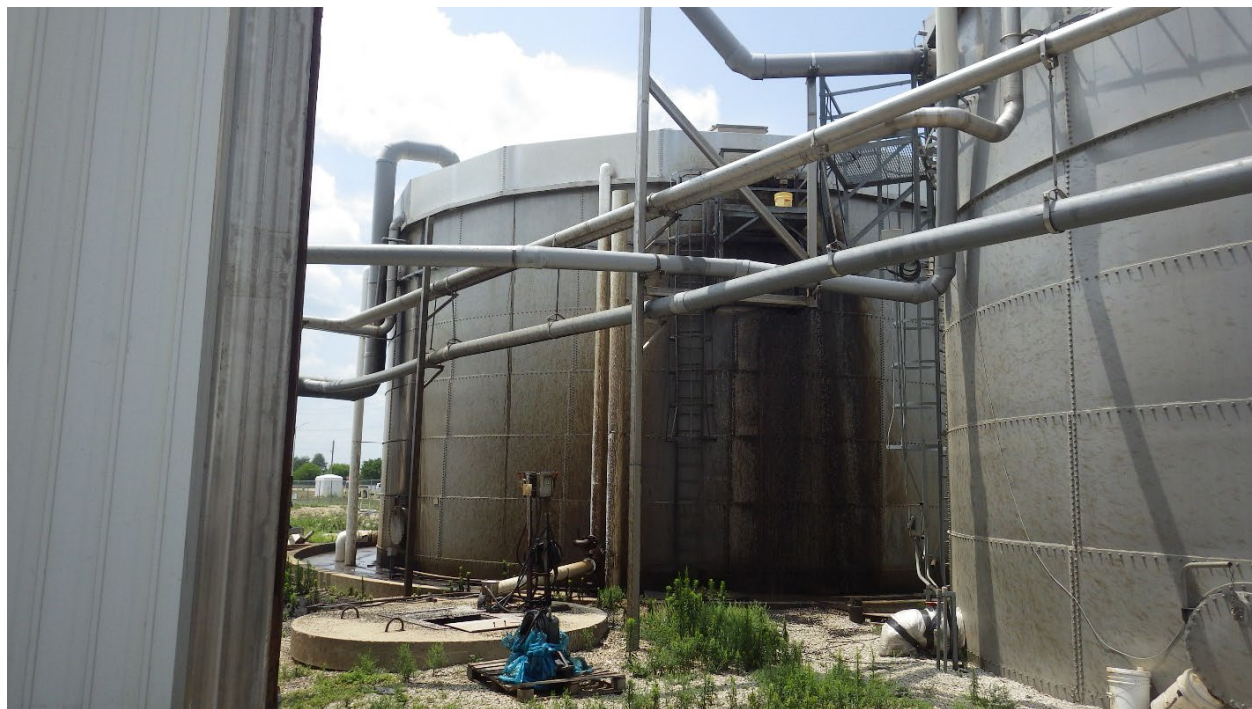
5. RIMG005

Description: Photo shows the east of one equalization tank (same one from Photo 4) on the far right and "Biotank" or aerated activated sludge tank (center). The opening to Pit 2 is on the ground in front of the Biotank. Note the cement barrier surrounding Biotank contained liquid at the time of the inspection and dried sludge, which appears as black grains, on the top of Pit 2.

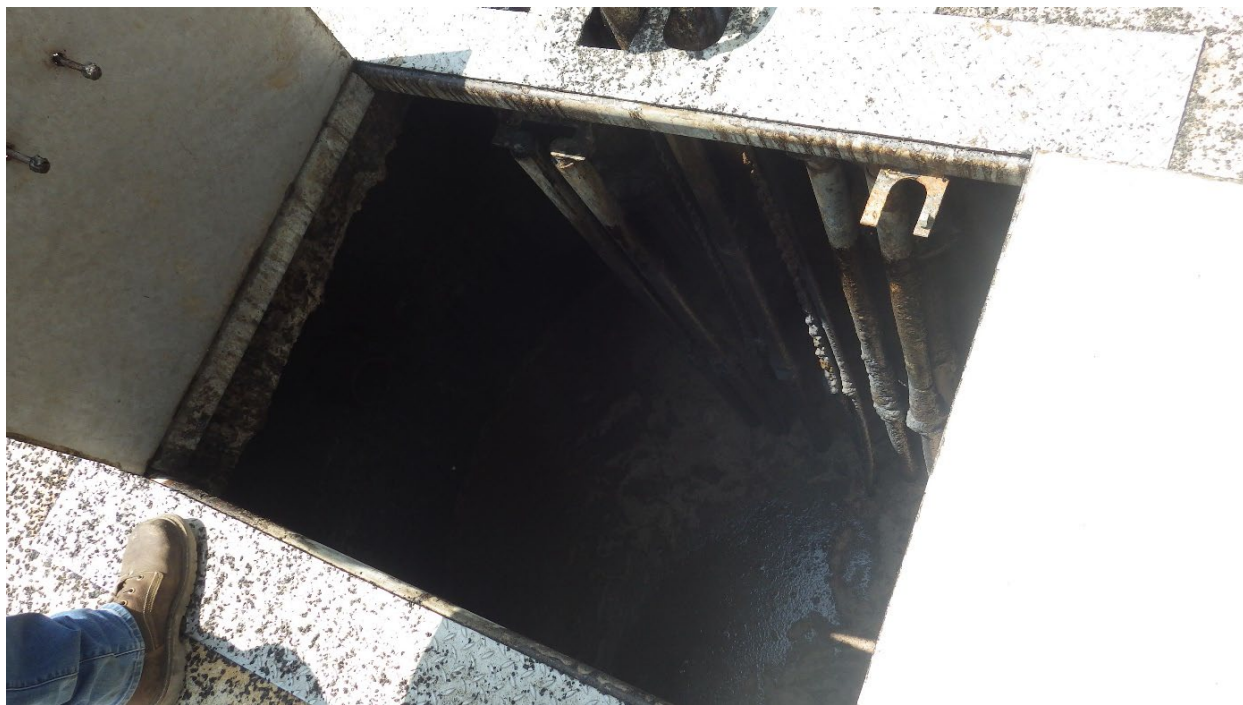
6. RIMG006

Description: View into Pit 2. Although the pretreatment facility was not expected to be operating at the time of inspection, inspectors noted some flow into Pit 2. Note dried sludge on the surface of Pit 2.

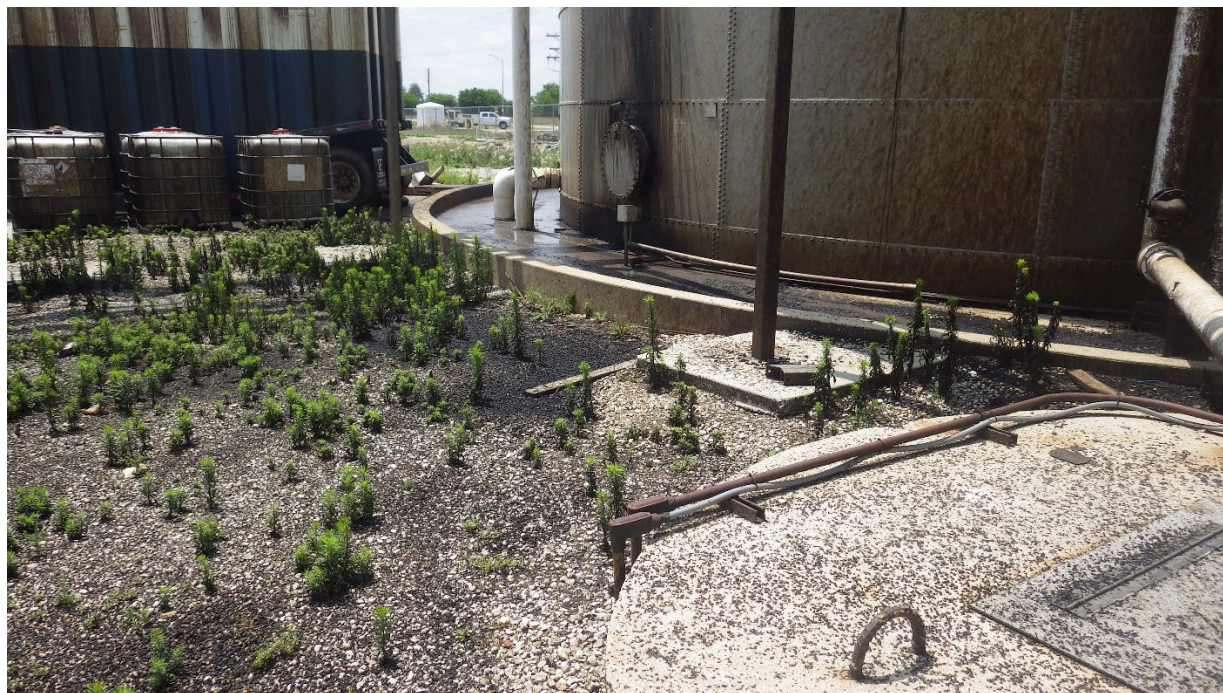
7. RIMG007

Description: Opening into Pit 2 on the right. Biotank in center and blood storage on top left. South stormwater pond in rear (not visible behind the blue and white truck). Note dried sludge on the ground which appears as black grains. Note liquid in the cement barrier surrounding the Biotank.

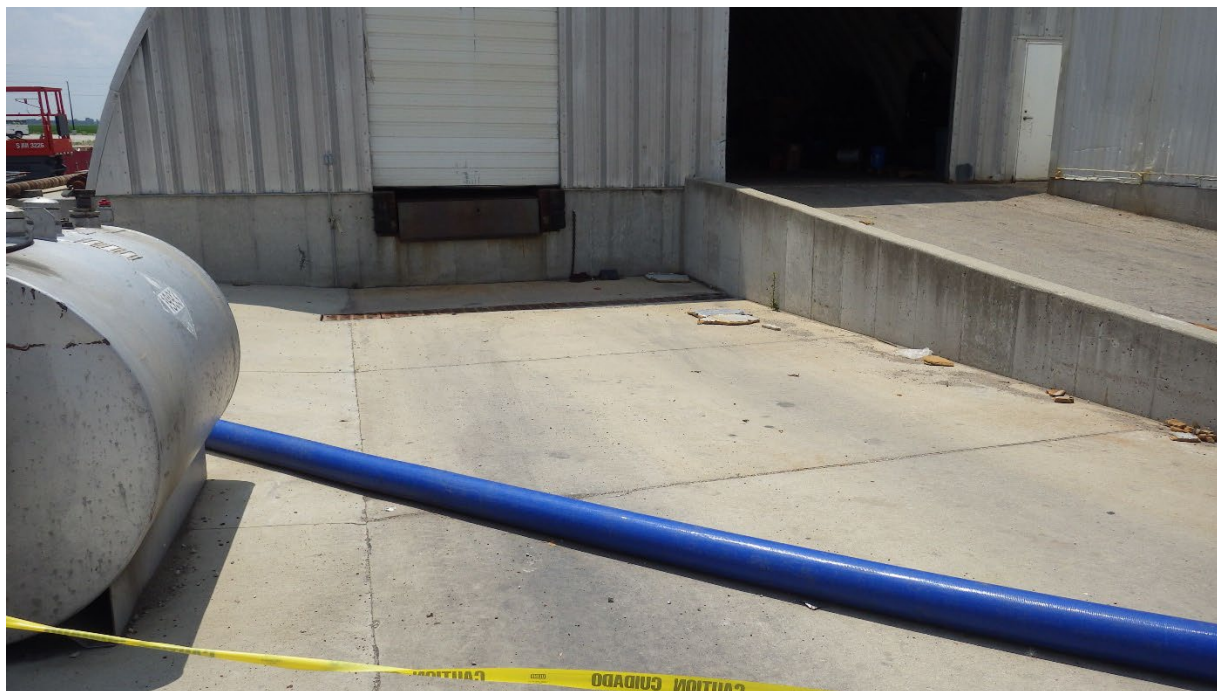
13. RIMG0013

Description: Quonset hut used for storage located next to the wastewater pretreatment facility (same in Photo 1). The blue hose used to transfer untreated process wastewater from Pit 1 to the lagoon is nearby. Inspectors noted the left loading dock is sloped with a stormwater inlet on the bottom.

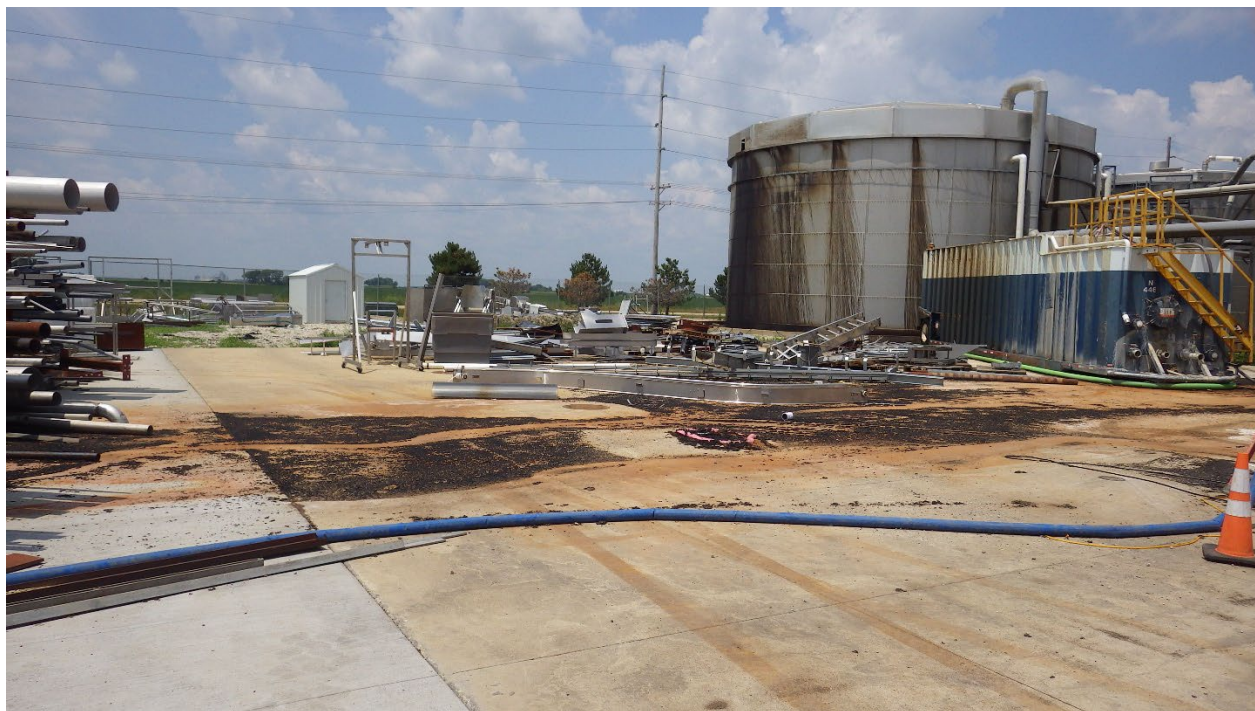
14. RIMG0014

5. Dried sludge from process wastewater was observed on the ground near the pretreatment facility and south stormwater pond. The secondary containment surrounding the Biotank had not been pumped down or cleaned out. Trash and process wastes such as blood spills

Description: View of the south of the Biotank. Note black grains on surface of cement that is dried sludge. South stormwater pond is just out of view on the left.

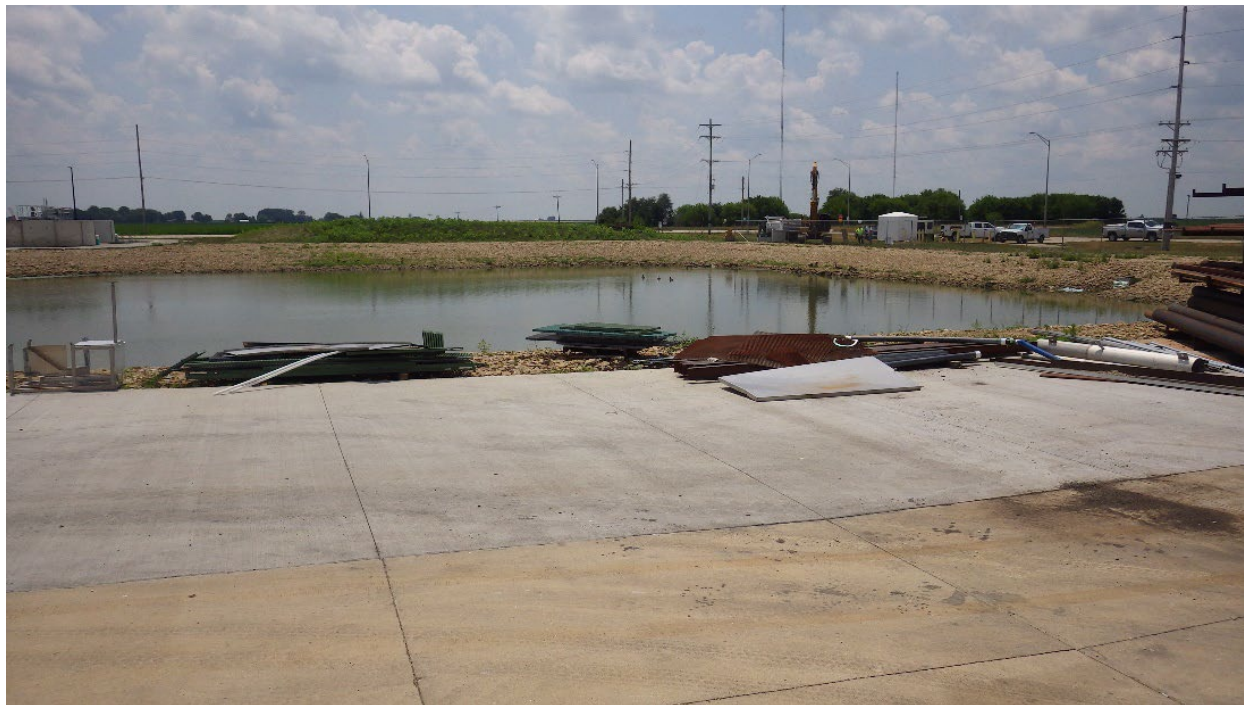
16. RIMG0016

Description: South stormwater pond, looking south. Note black dried sludge on concrete near the stormwater pond.

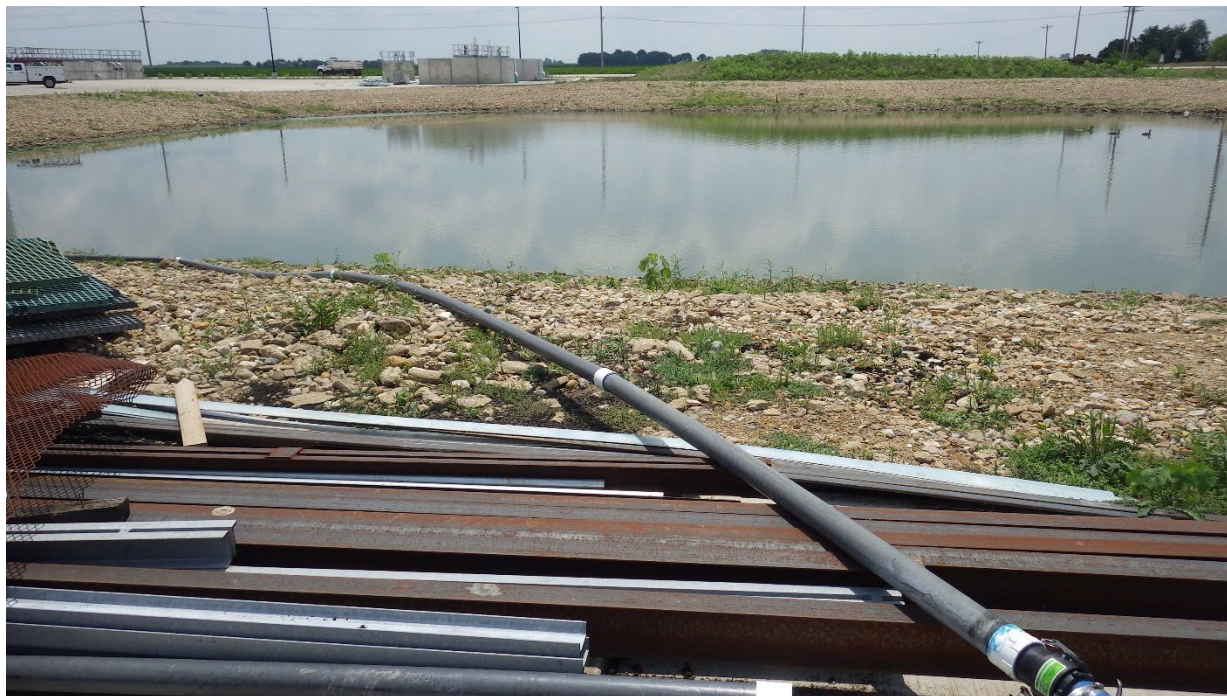
17. RIMG0017

Description: South stormwater pond, looking southeast. Note black dried sludge on the riprap near the stormwater pond. A hose with process wastewater from Pit 1 to the lagoon is located in the center leading towards the left of the photo.

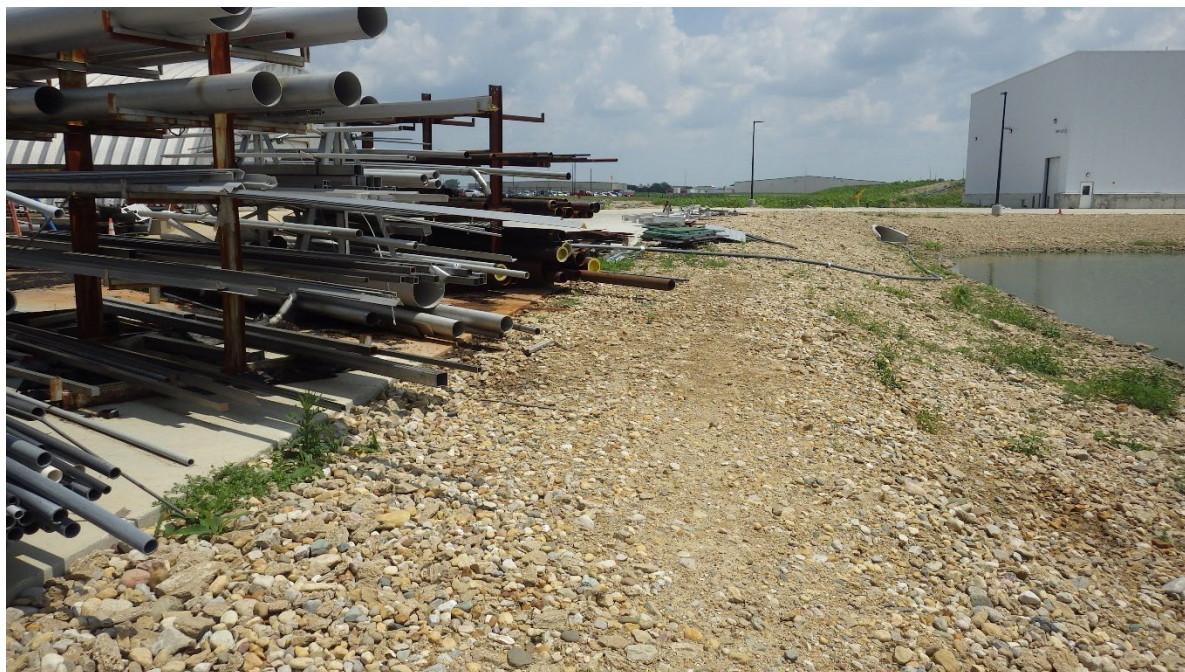
18. RIMG0018

At the south stormwater pond, I noted that the black dried sludge extended to the riprap but was not present on the area that sloped downwards toward the south pond (Photo 18). Mr. Ernst stated that all the rocks along the south stormwater pond were new and had been purchased in the last two years. I noted that the pond appeared low and was a few inches below the outfall

Description: South stormwater pond, looking east. Note black dried sludge on the riprap just beyond the concrete, but not on the riprap as it sloped towards the pond. A hose with process wastewater from Pit 1 to the lagoon is located in the center of the photo.

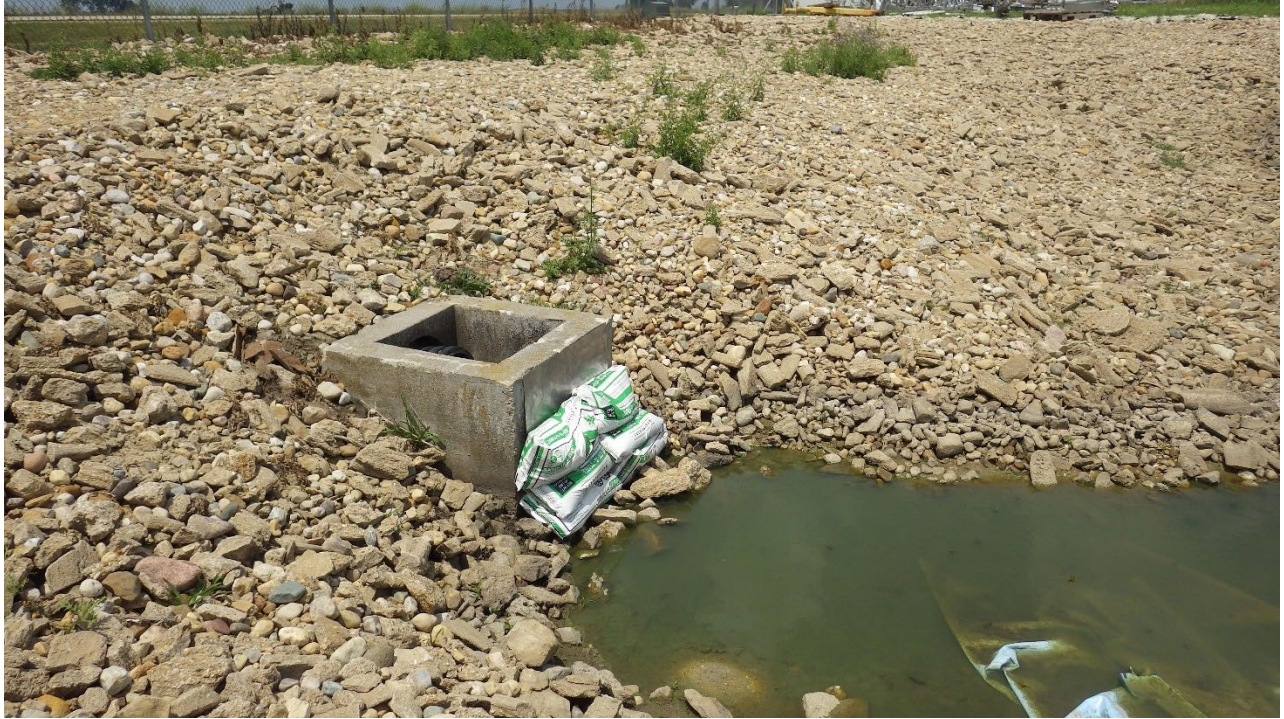
19. RIMG0019

pipe that leads off property into the Village storm sewer system. I noted a metal plate, held up by sandbags, was physically blocking the pond water from entering the outfall (Photos 19-20). The quarterly stormwater inspection report from 6/22/23 indicated that the ponds were 1-2 feet lower than normal and no rainfall occurred during the second quarter of 2023.

Description: Outfall at south stormwater pond that would discharge pond water to the village of Rantoul storm sewer system. Sandbags and metal plate were blocking the pond water from entering the outfall pipe. At the time of the inspection the pond water was below the outfall pipe. Note plastic trash present in pond.

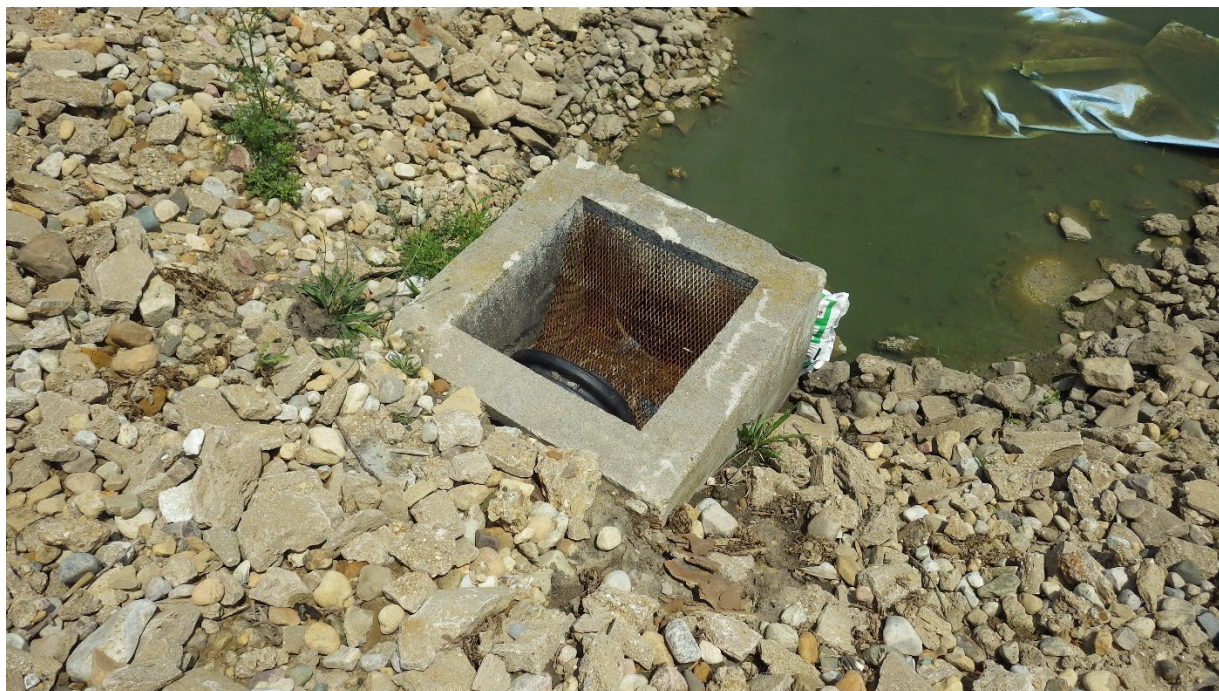
20. RIMG0020

Description: Top view of outfall pipe at south stormwater pond that would discharge pond water to the village of Rantoul storm sewer system. Same as Photo 19. Sandbags and metal plate were blocking the pond water from entering the outfall pipe. At the time of the inspection the pond water was below the outfall pipe. Note plastic trash present in pond.

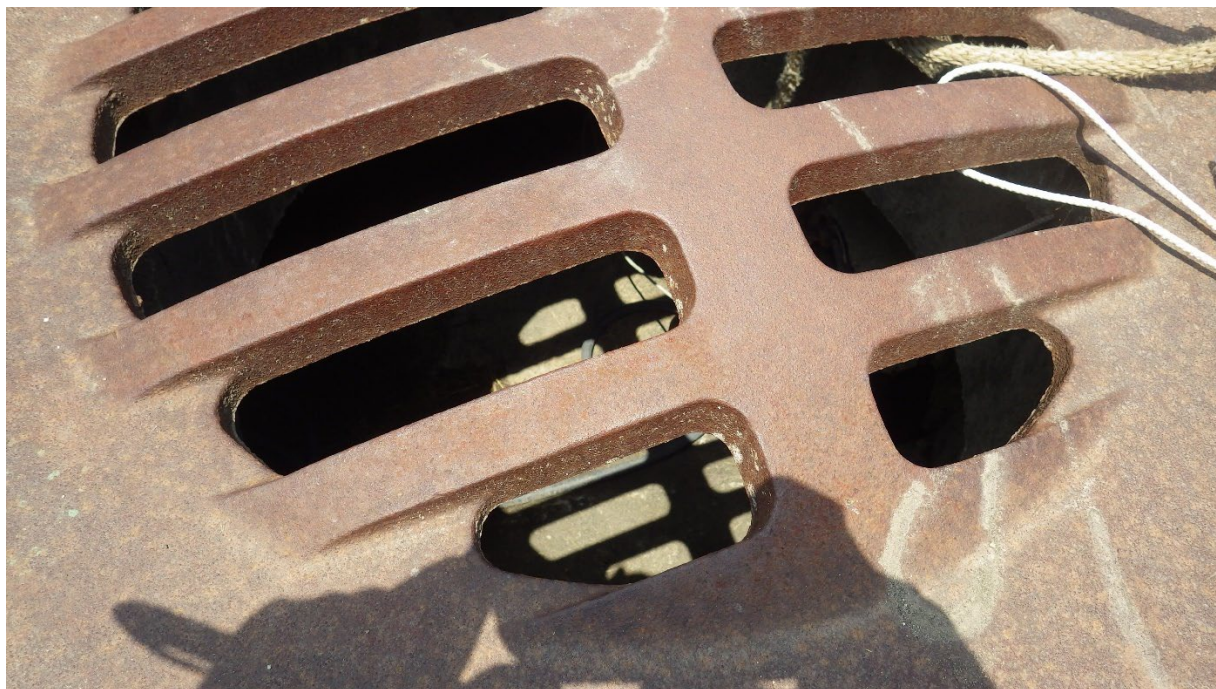
21. RIMG0021

Description: Village of Rantoul storm sewer inlet manhole that is closest to the Rantoul Foods south stormwater pond and on the east side of Route 1300. Two ropes are present at the top of the inlet. According to Mr. Ernst each rope is attached to an inflatable pig that prevents discharge of stormwater from entering the Village of Rantoul stormsewer system by plugging the underground pipe.

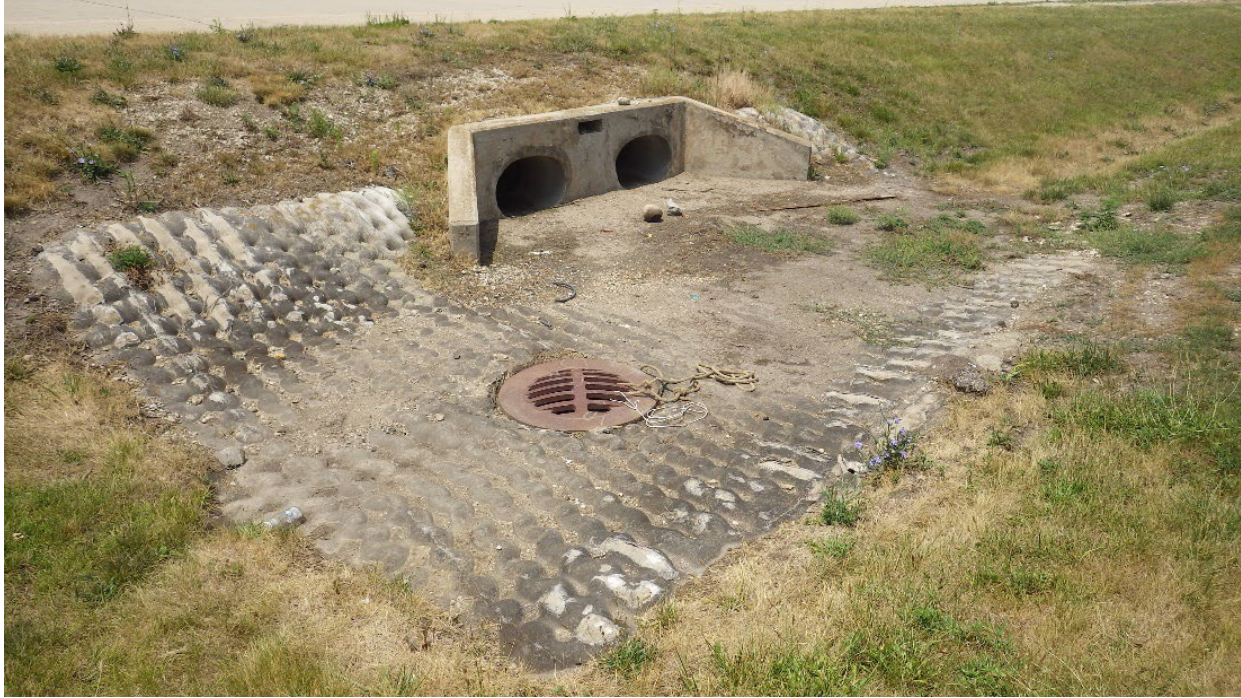
22. RIMG0022

Description: Village of Rantoul storm sewer inlet manhole from Photo 21 that is closest to the Rantoul Foods south stormwater pond and on the east side of Route 1300. The road is at the top of the photo. Two aboveground pipes connect the stormsystem to the west side of Route 1300. Note the two ropes present at the top of the inlet.

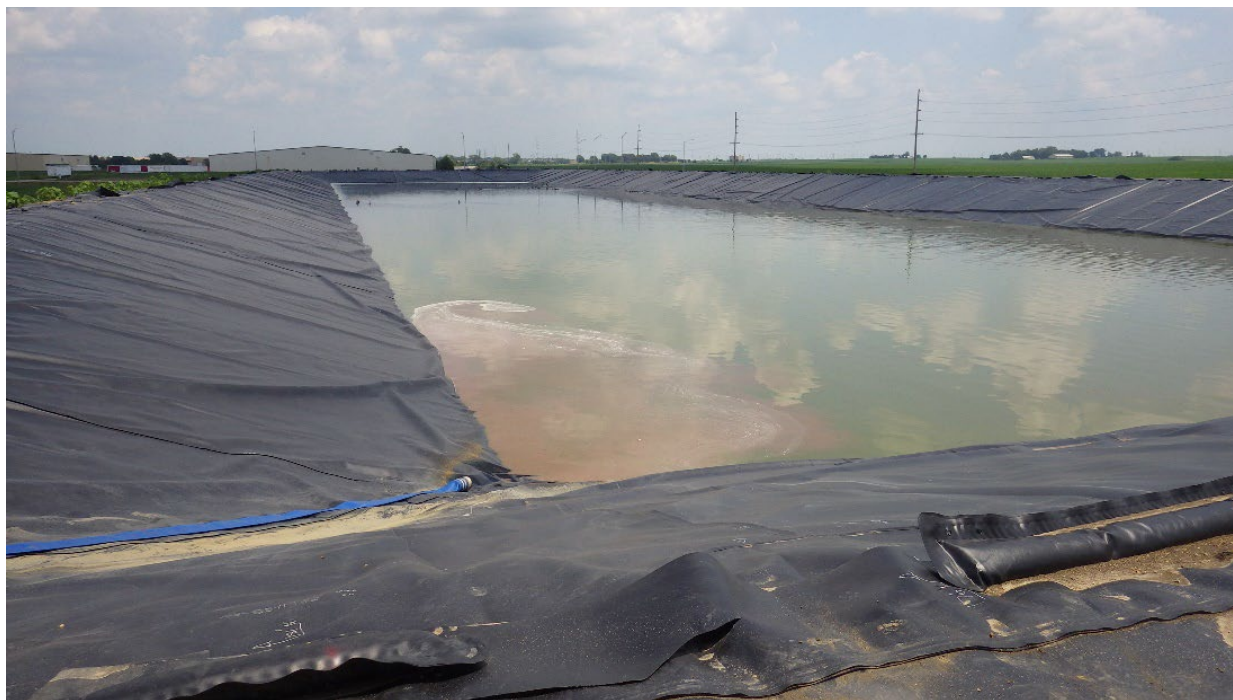
30. RIMG0030

Description: Blue hose that is pumping wastewater from Pit 1 into the lagoon. The lagoon is designed as an anaerobic lagoon however the cover has not yet been installed.

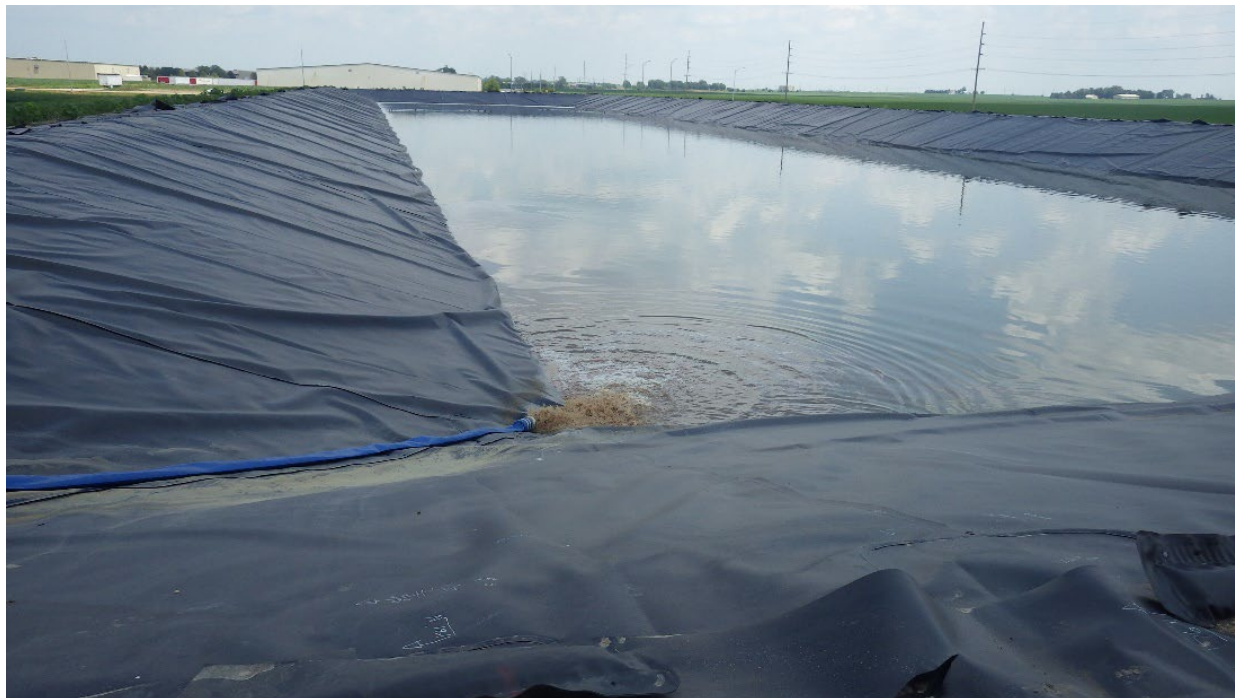
31. RIMG0031

Description: Same as photo 30. Wastewater was pumped into the lagoon during the time of the inspection.

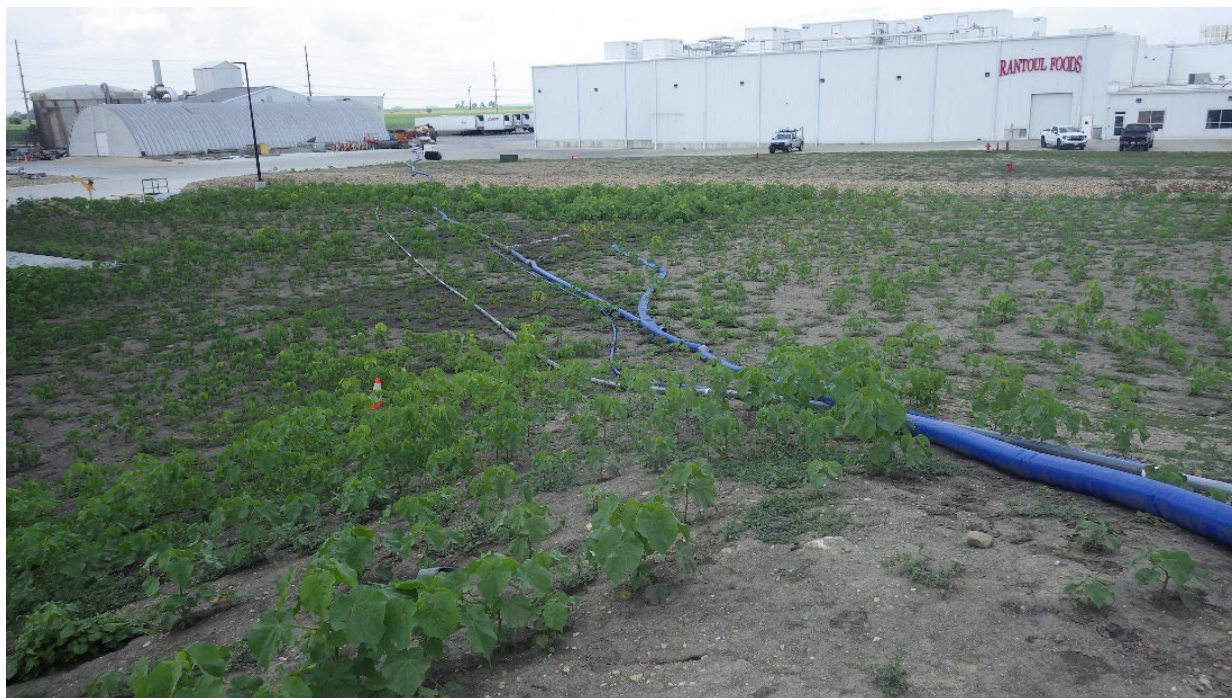
32. RIMG0032

Description: Photo taken from the top of the lagoon, showing the blue hose running back to the wastewater pretreatment system on the top left. Note the vegetation on the lagoon was not sufficient enough to close out the NPDES construction permit and Mr. Ernst stated that he was planning on reseeding the area.

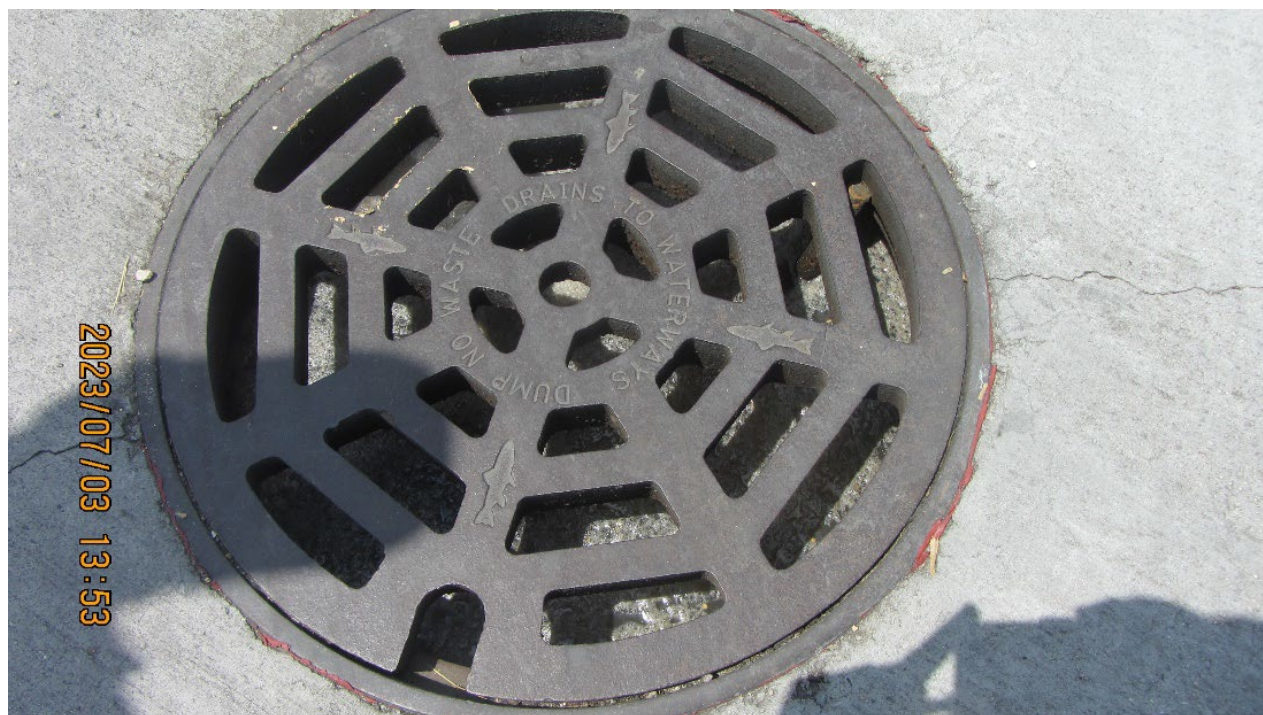
37. IMG\_0748

We then walked around the processing facility along the east then north towards the north stormwater pond. I noted that the stormwater inlet nearest the live animal unloading docks (Photo 36) appeared to be blocked and had foam and debris sitting on stagnant water (Photo 37). A stormwater drainage ditch ran along the north of the processing facility. EPA noted some trash and dried vegetative debris in the ditch area (Photos 38-40).

Description: Clogged sewer inlet nearest the live animal unloading area in Photo 36. The stormwater drain is connected to the north stormwater pond.

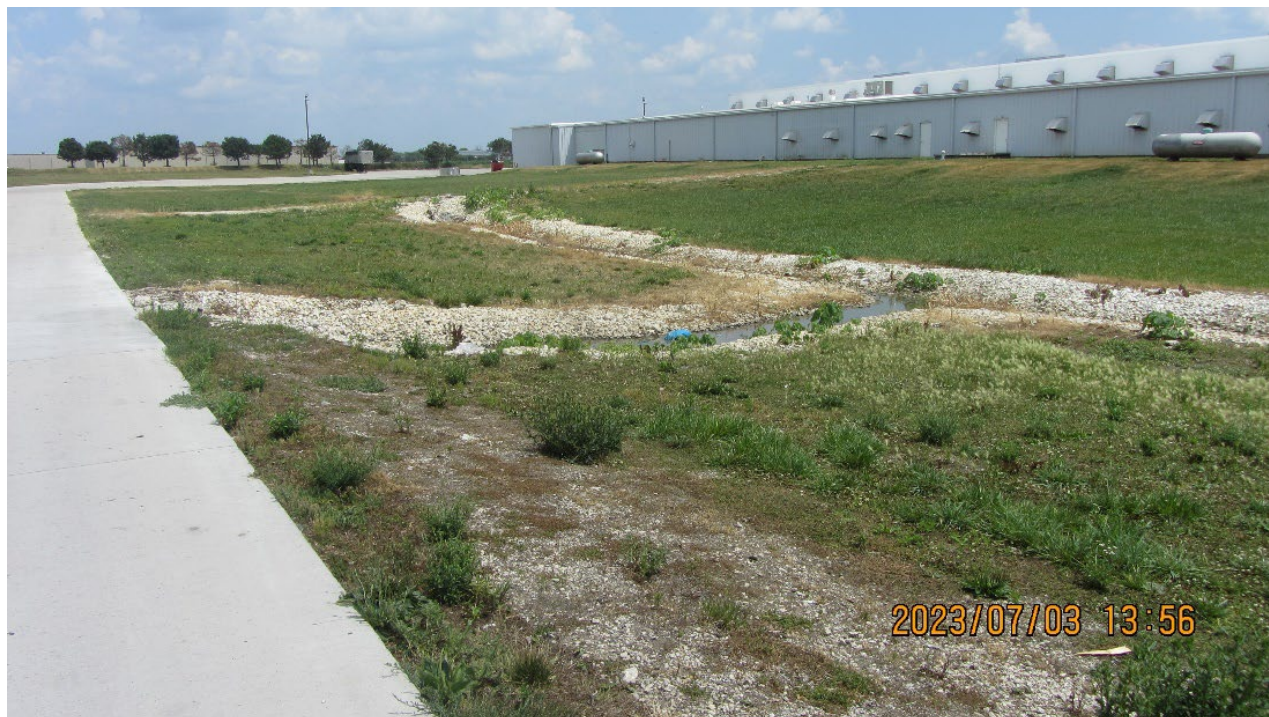
38. IMG\_0749

Description: Open stormwater channel on the north of the processing building upstream of the north stormwater pond. Stormwater was present in the channel at the time of the inspection. Note blue trash in center channel.

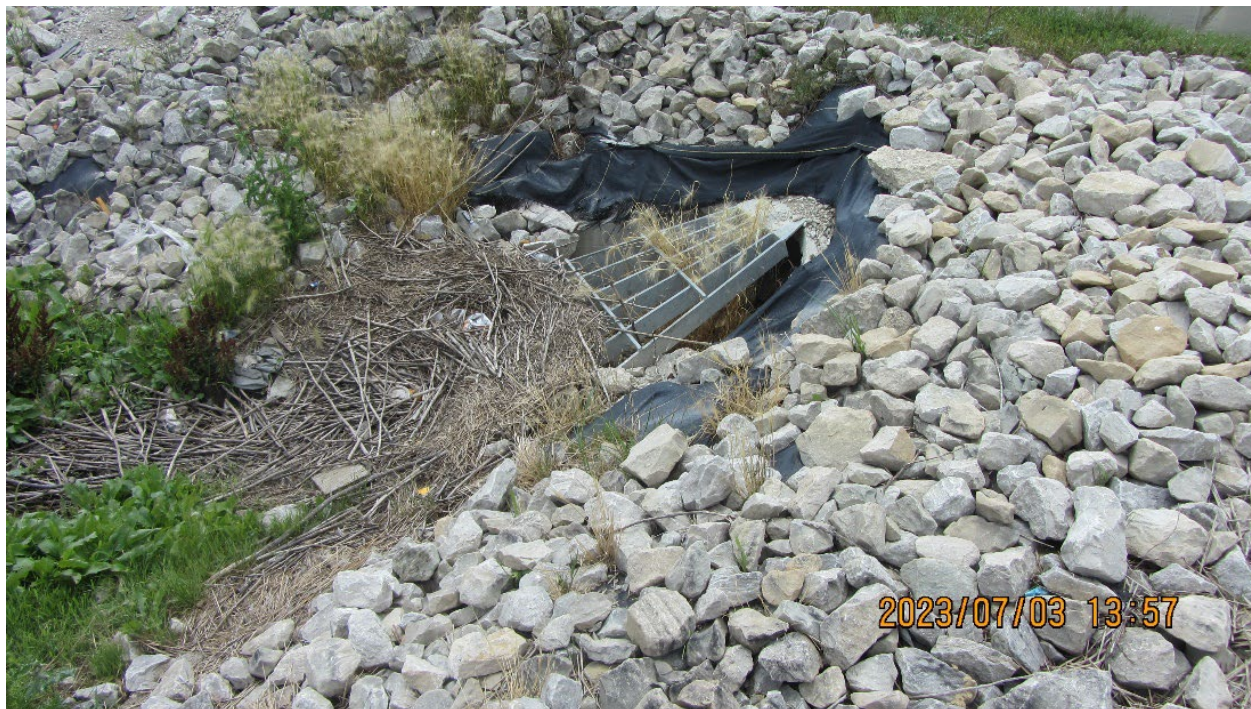
39. IMG\_0750

Description: Inlet in open stormwater channel seen in Photo 38. A silt fence or other type protective wrap is under the riprap. Note dried vegetation on the inlet grate.

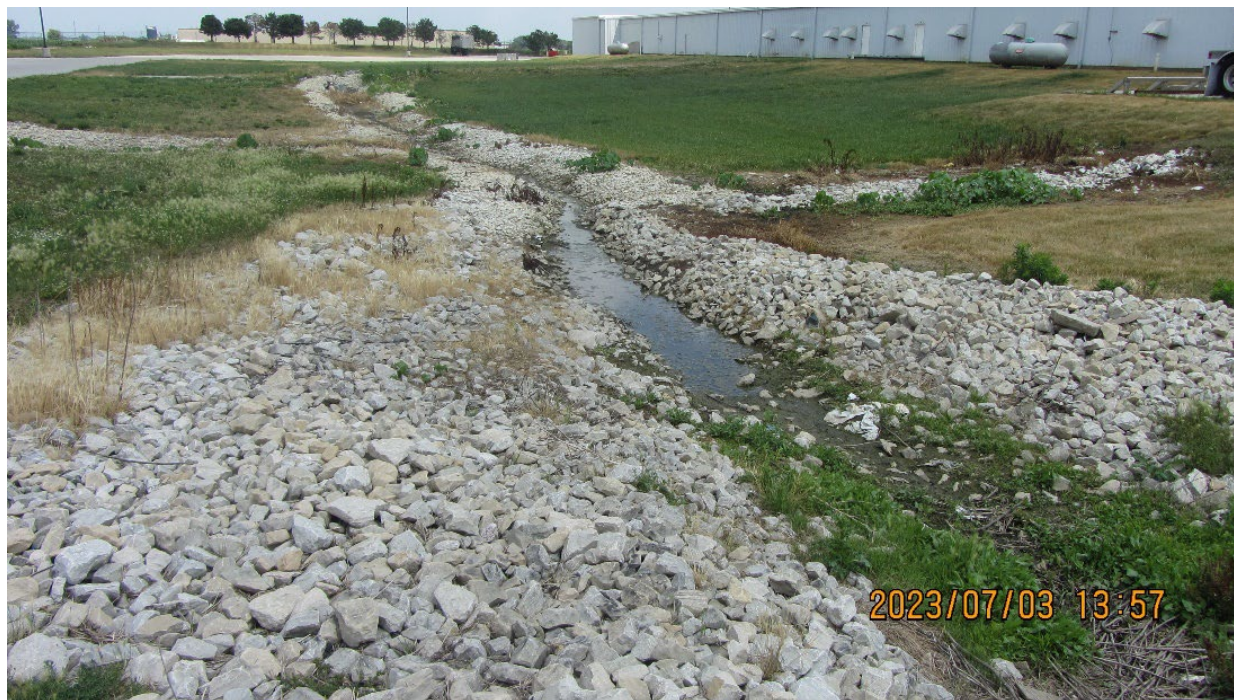
40. IMG\_0751

Description: Open channel upstream of the inlet from Photo 39. Inspectors noted some floatables near the middle of the channel.
