**COMPLIANCE EVALUATION INSPECTION REPORT  
U.S. ENVIRONMENTAL PROTECTION AGENCY, REGION 5**

**Purpose:** NPDES Compliance Evaluation Inspection

Rantoul Foods, LLC  
205 East Turner Street  
Rantoul Illinois, 61866

**Date of Inspection:** July 3, 2023

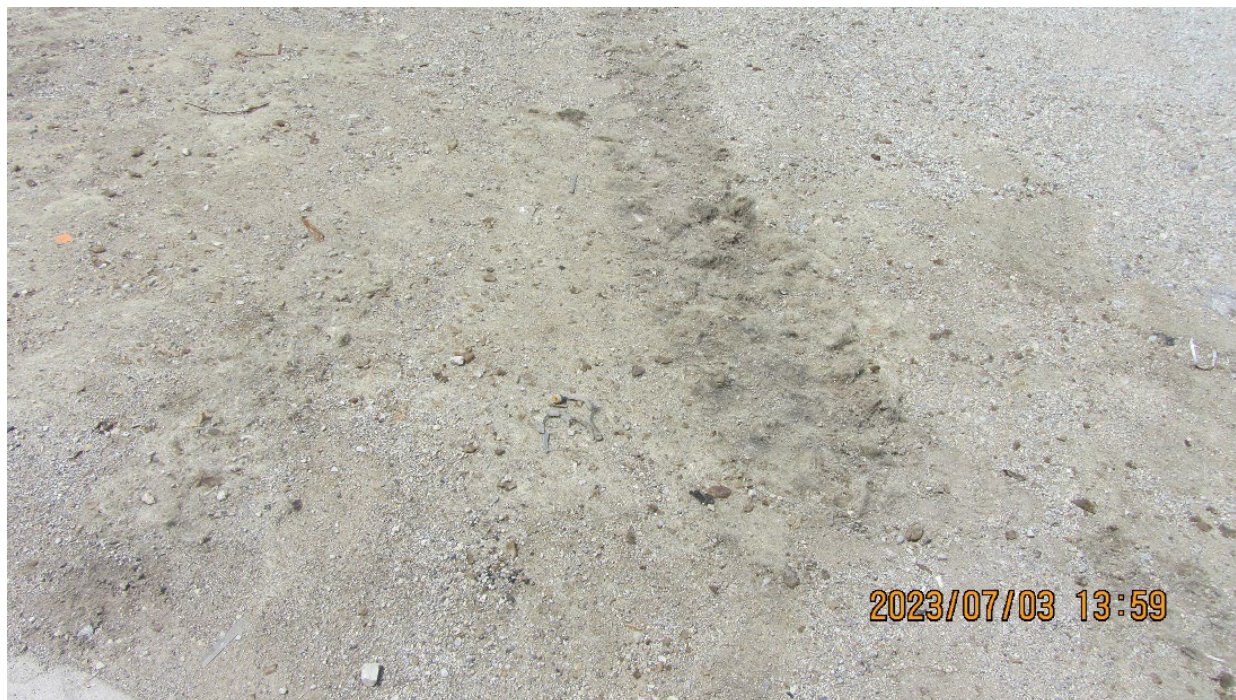
42. IMG\_0753

I noted that the hair and blood storage area on the north side of the processing facility appeared different than it was during the previous 2020 EPA Inspection (Photo 41). The loading area is paved and the storm drain is separated by a small berm at the edge of the pavement (Photo 43). Mr. Ernst stated that hair is mainly discarded through a hydrolysis process, which occurs indoors. On occasion hog hair could be removed from the facility via truck and the stormwater drain at this location is blocked to prevent any process wastewater, which would drip off the truck, from entering the stormwater system. I noted mats of hog hair on the ground outside of the paved area and some trash and hog hair at the blocked stormwater drain (Photos 42, 44).

Description: Inspectors noted dried mats of hog hair on gravel near the concrete hair loading area.

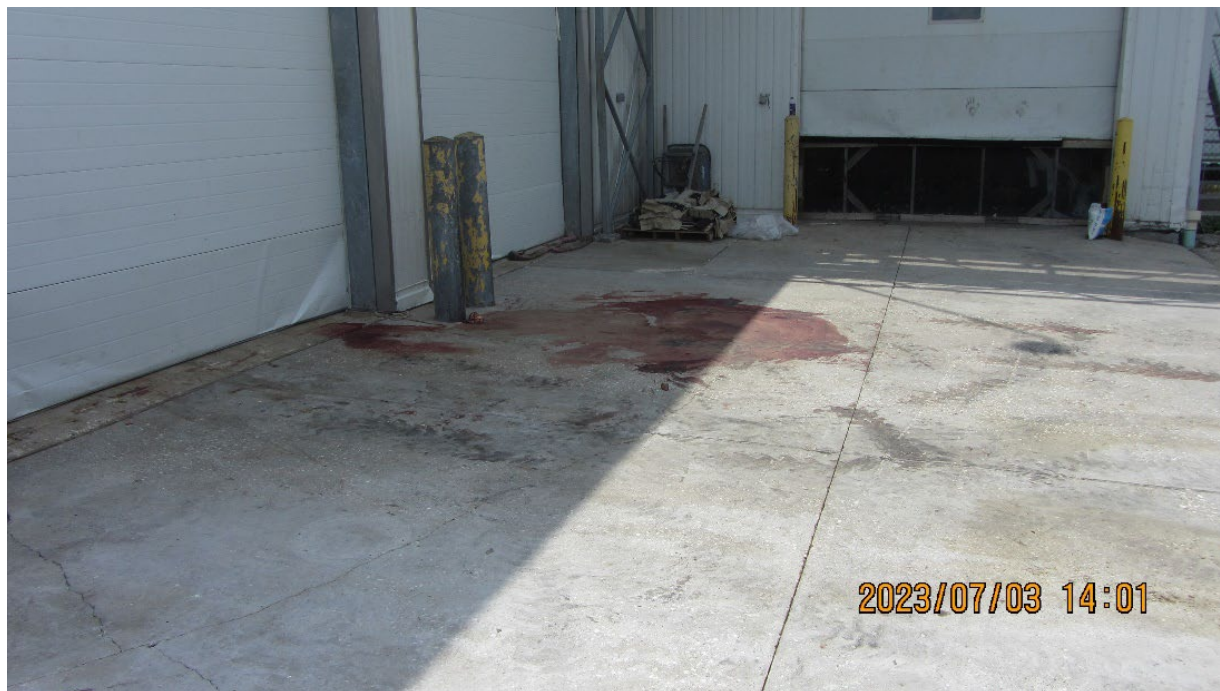
45. IMG\_0756

I noted a dried blood spill outside on a loading area near the hair and blood storage area (Photo 45). Mr. Ernst stated that is probably a downer that slipped off the skid steer on the way to the rendering area. Generally, inedibles are piped to rendering; however, an animal that arrives dead or is condemned will be transferred whole to rendering by skidsteer and on the way it can slip off onto the pavement. Mr. Ernst stated that the blood stains are cleaned up at the end of the processing shift. When I requested whether spill kits were accessible, Mr. Ernst stated that nine spill response kits have been strategically placed around the facility in areas most likely to need them.

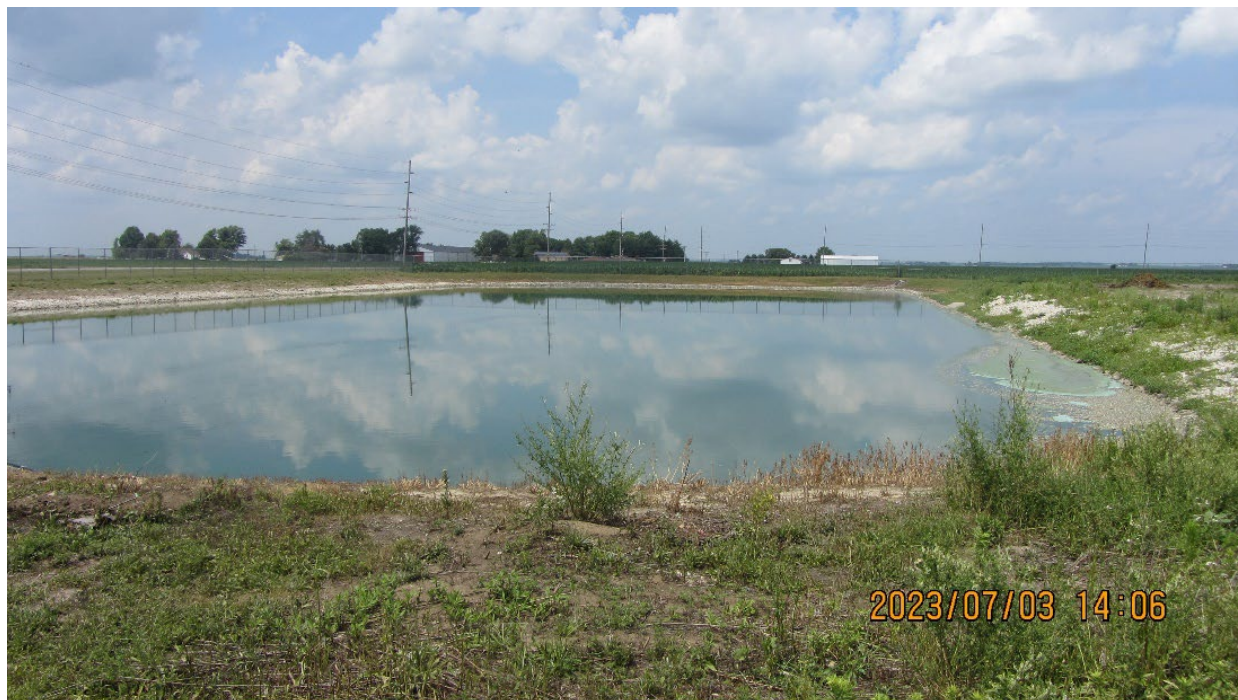
46. IMG\_0757

At the north pond, I noted that the water had an odor and had a turbid blue color (Photos 46-51). There was a floating mass of vegetation on the southeast corner of the pond and small dead fish floated on the surface. Mr. Ernst stated that the pond had an algae problem since springtime of this year, and he had blocked off the outfall with a metal plate and sandbags so the pond could not discharge (Photos 47 - 48). The quarterly inspection reports from first quarter visual

Description: North stormwater pond. Inspectors noted the pond water had an odor and appeared unnaturally turbid blue, as if blue-green algae was present.

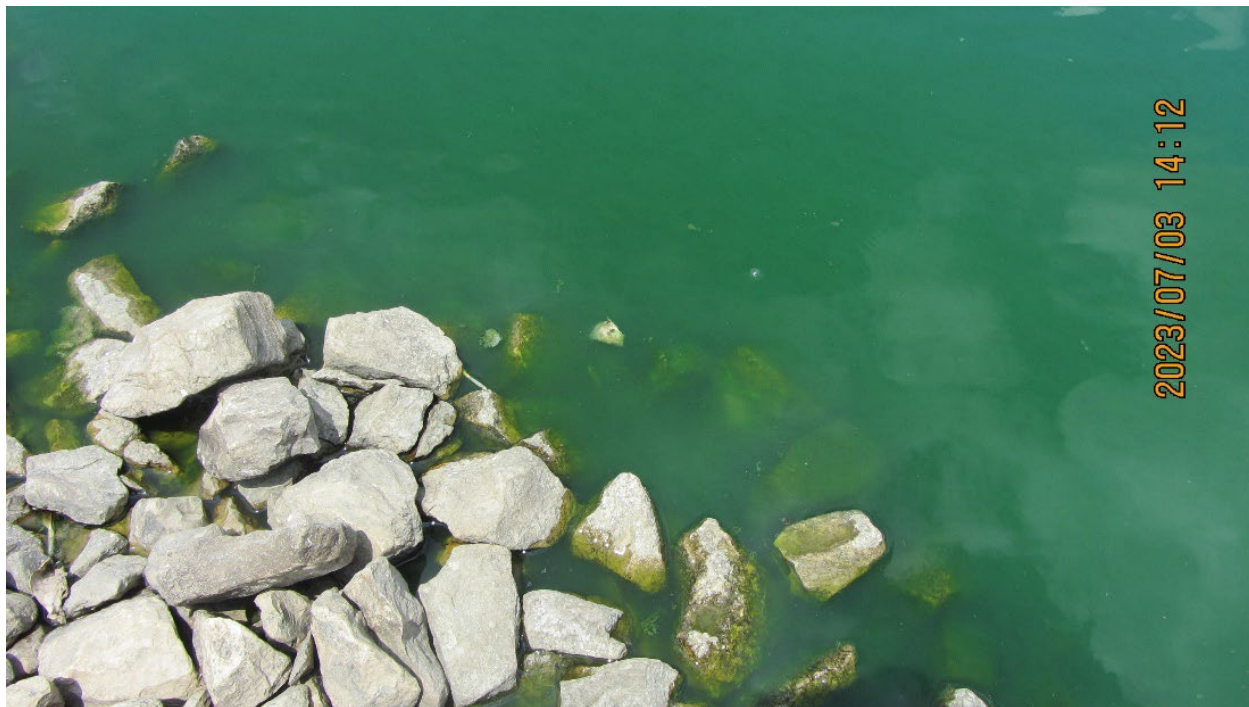
49. IMG\_0760

Description: Dead fish in north stormwater pond. Inspectors noted the pond water had an odor and appeared unnaturally turbid blue, as if blue-green algae was present.

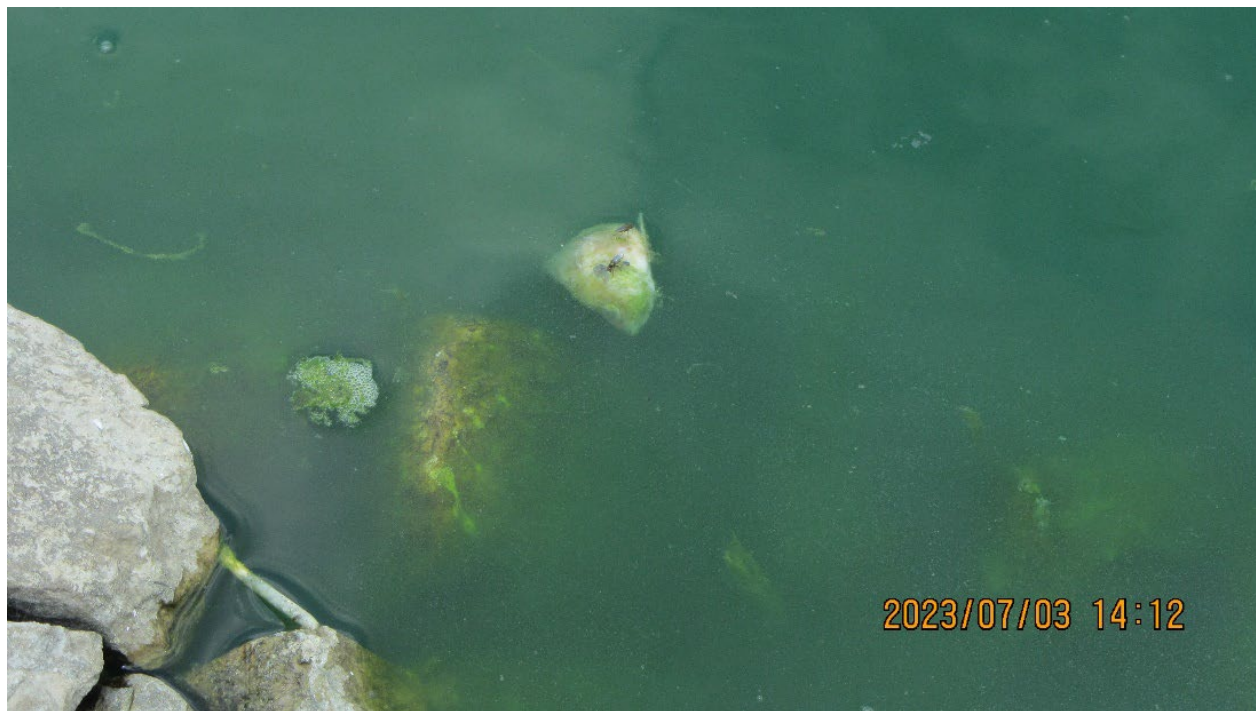
50. IMG\_0761

Description: Zoomed in photo of dead fish from Photo 49. View downward into the edge of the north stormwater pond. Rip rap from the edge of the pond is visible. Floating dead fish are visible. Inspectors noted the pond water had an odor and appeared unnaturally turbid blue, as if blue-green algae was present.

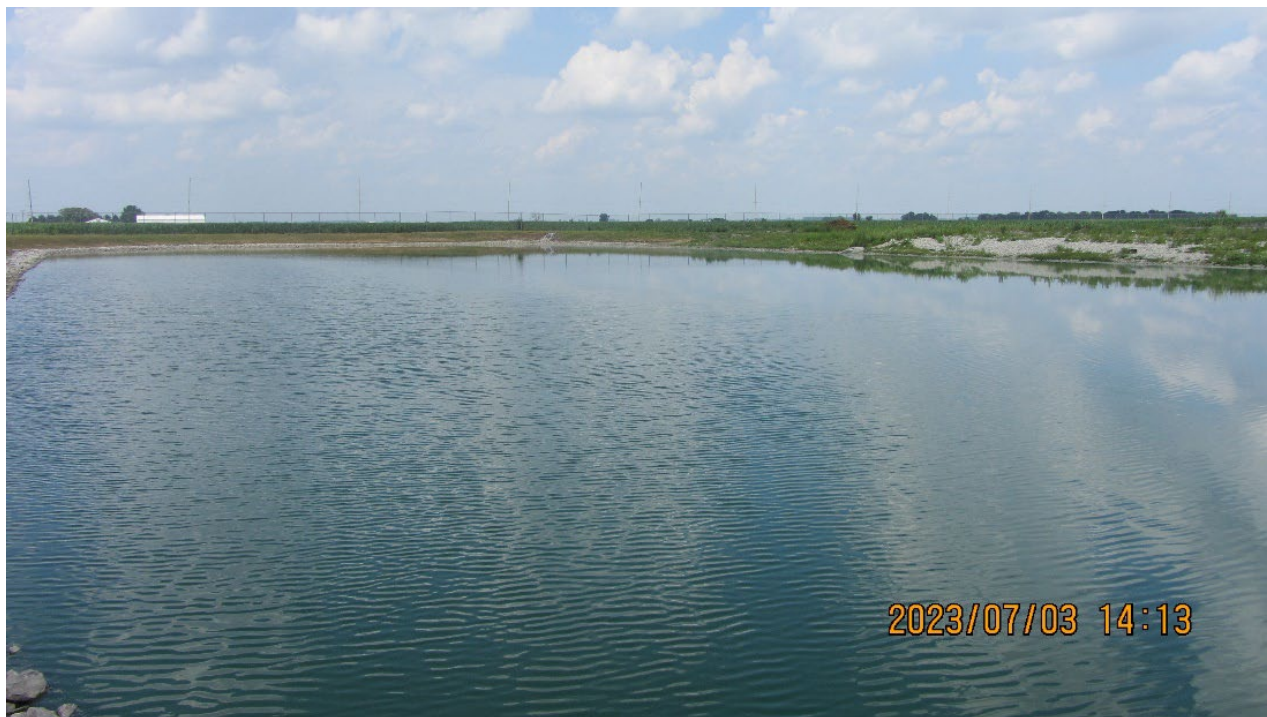
51. IMG\_0762

Description: North storm water pond with dugout material from old “boneyard” location. Inspectors noted the pond water had an odor and appeared unnaturally turbid blue, as if blue-green algae was present.

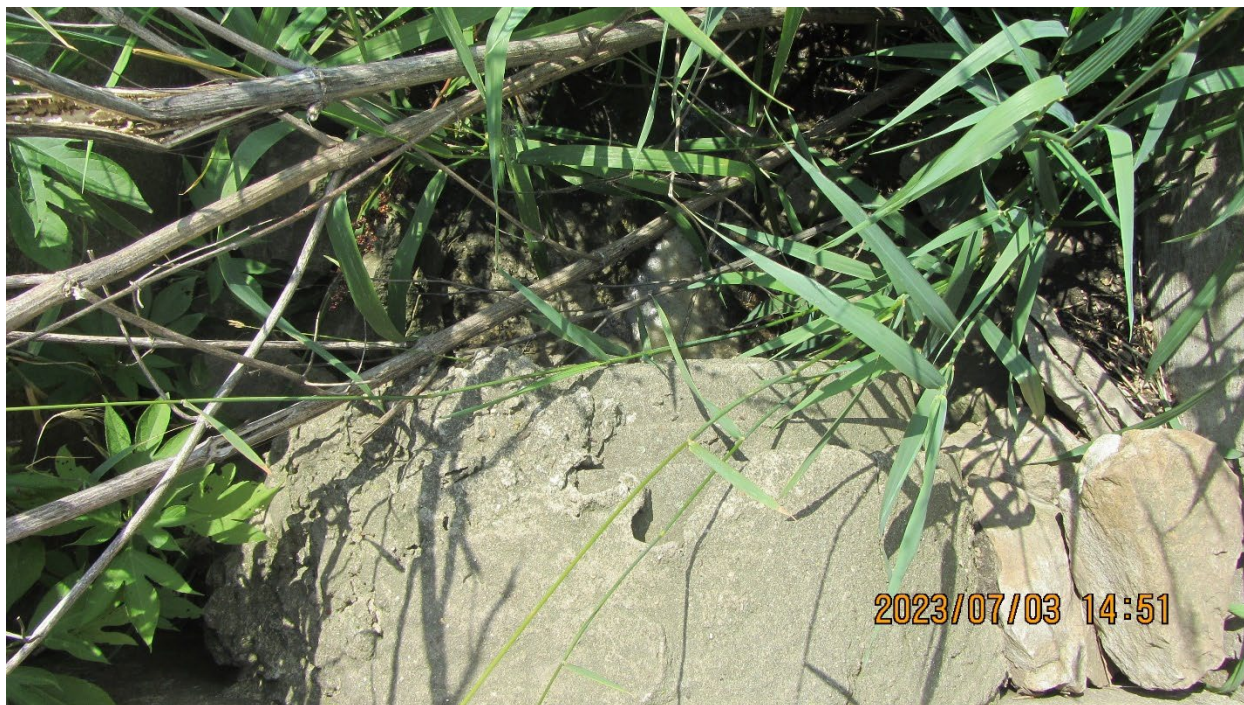
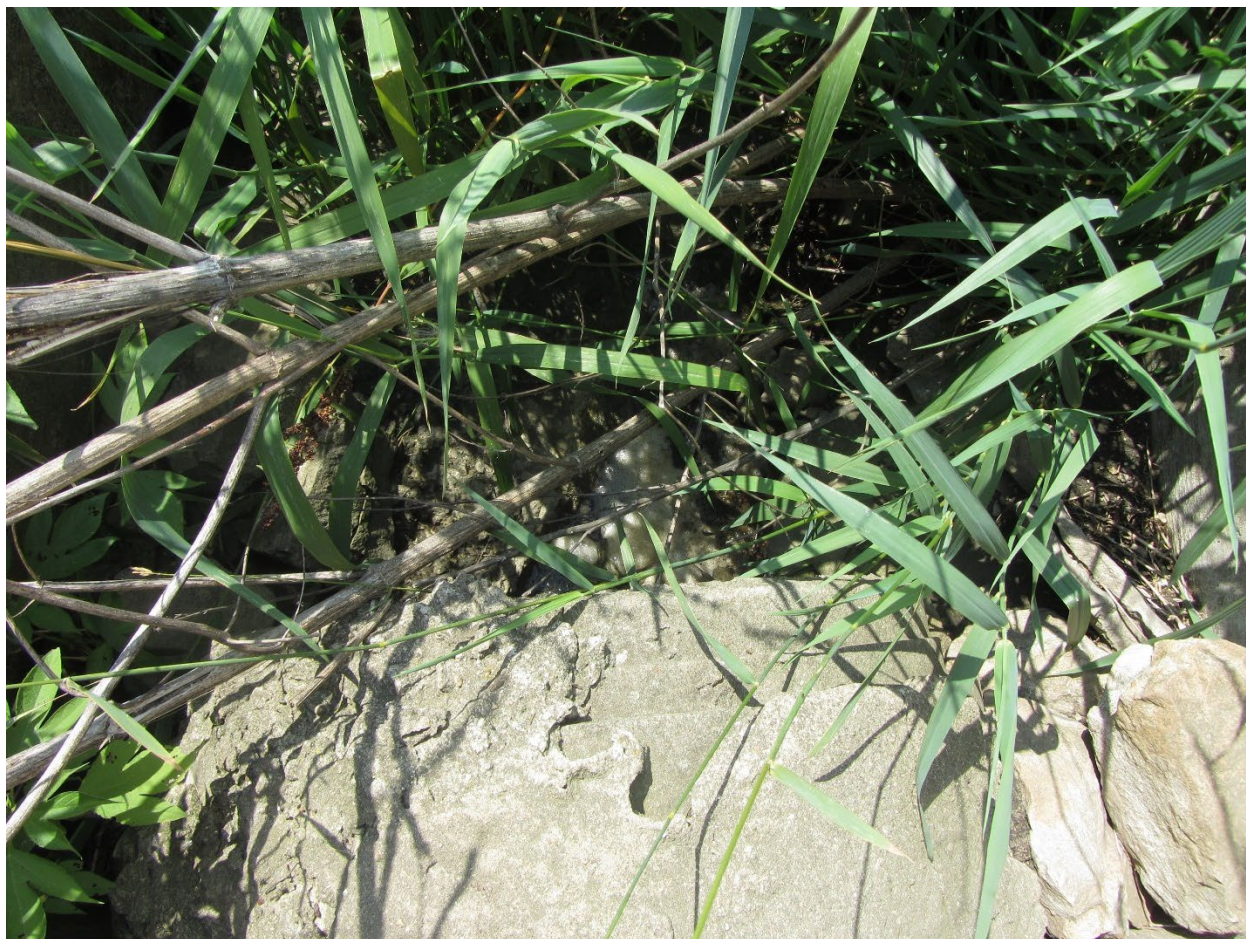
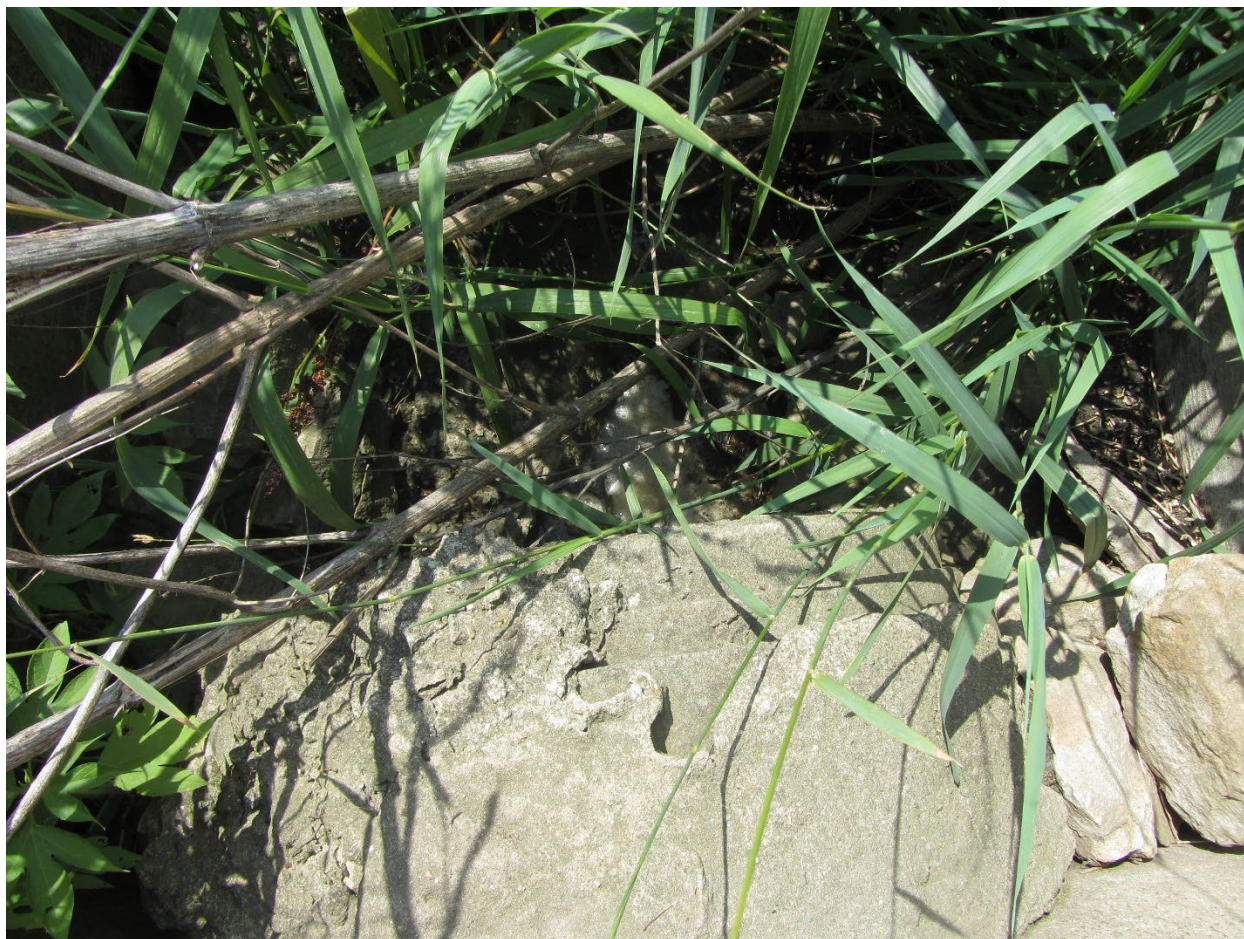
Description: Same as Photo 59 - 60. Storm sewer outfall discharging into Big Ditch. This is the storm sewer outfall that Rantoul Foods stormwater ponds discharge into. US EPA Inspectors noted a discharge at the time of the inspection.

Description: Same as Photos 58 and 60. Stormsewer outfall discharging into Big Ditch. This is the stormsewer outfall that Rantoul Foods stormwater ponds discharge into. US EPA Inspectors noted a discharge at the time of the inspection.

Description: Same as Photo 58-59. Stormsewer outfall discharging into Big Ditch. This is the stormsewer outfall that Rantoul Foods stormwater ponds discharge into. US EPA Inspectors noted a discharge at the time of the inspection.

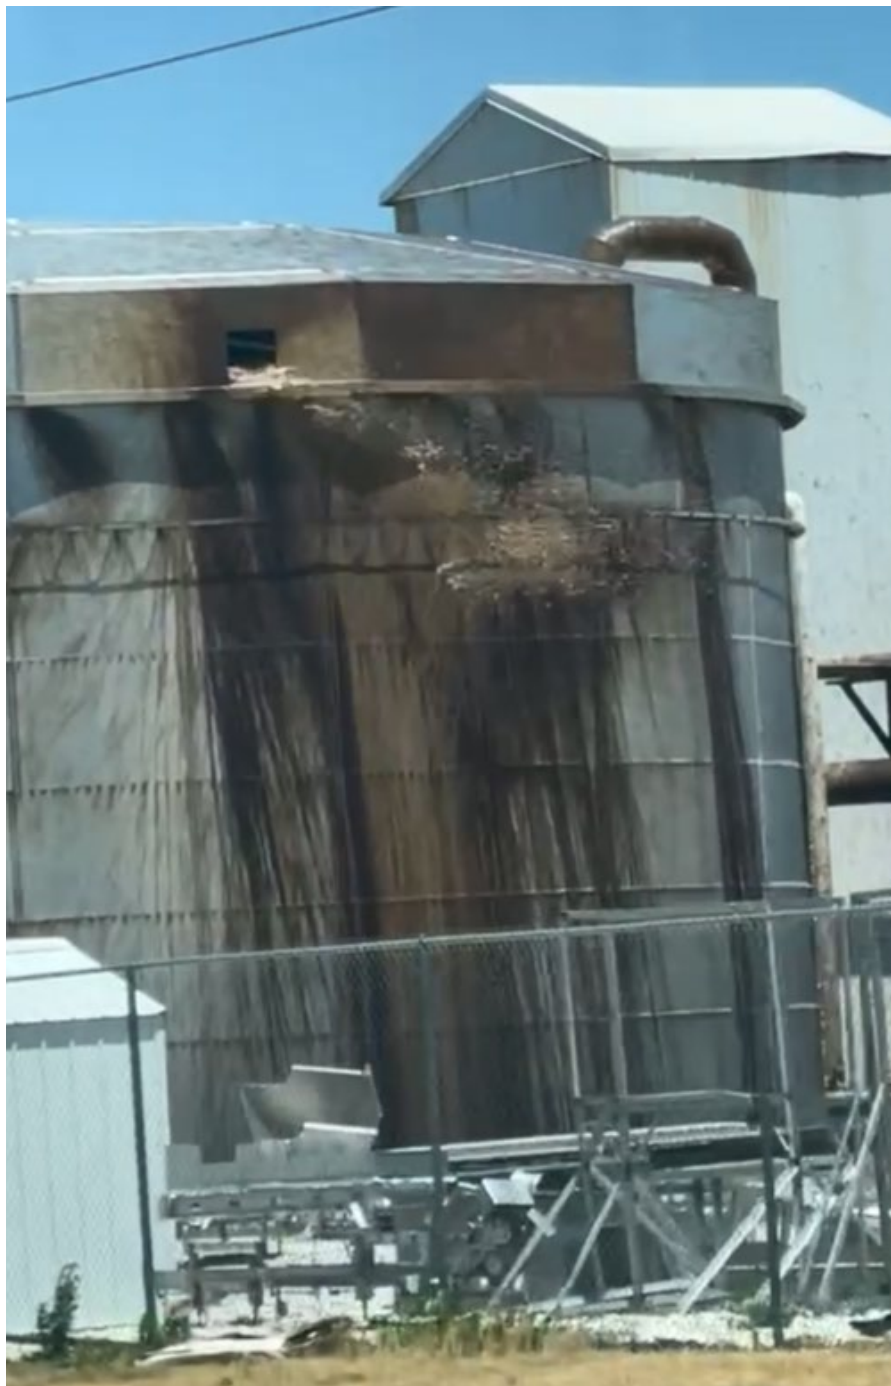
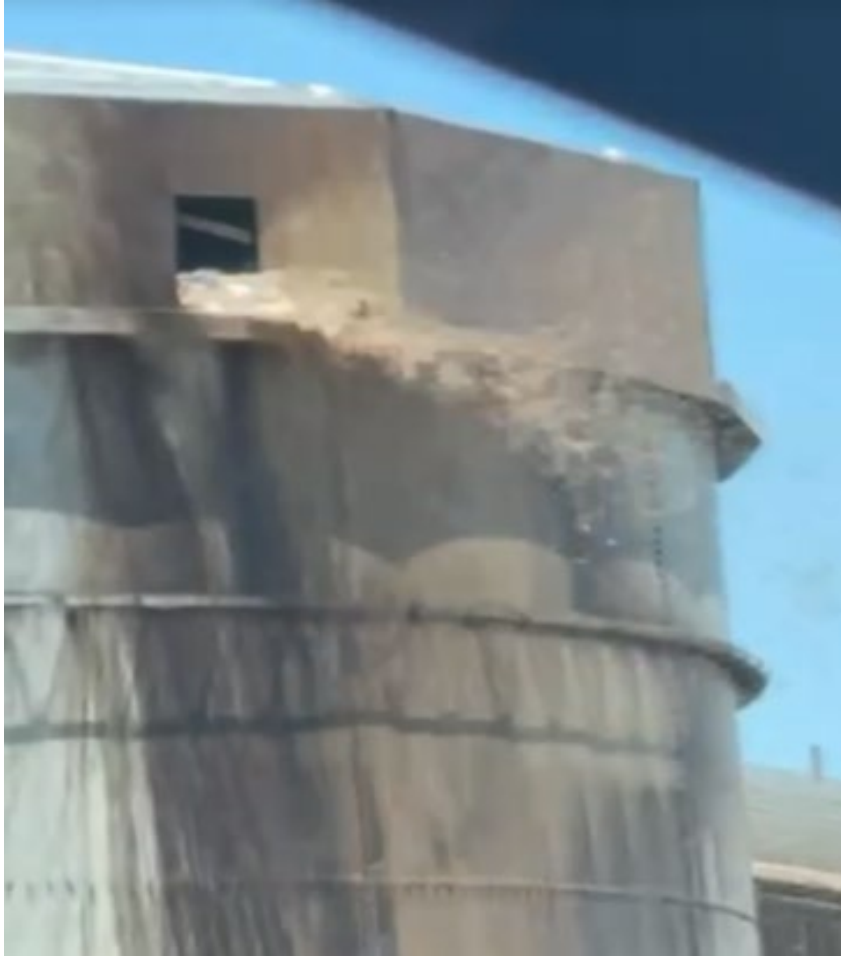
**Appendix E – Stills from video submitted to Illinois Environmental Protection Agency of untreated process wastewater blowing out of Rantoul Food’s Biotank on Sunday June 25, 2023.**

On Monday June 26, 2023, IEPA received an anonymous complaint with a video of liquid blowing out of Rantoul Food's wastewater tanks on the previous day (Appendix E). On June 29, 2023, Rantoul Foods filed a hazardous material report with the Illinois Environmental Protection Agency (Appendix C) concerning process wastewater entering its stormwater pond.

3. Process wastewater blew out of the Biotank on Sunday June 25, 2023 and onto the ground creating a spill of untreated wastewater which then had to be cleaned up. Permit ILR00 Attachment H.5 under proper operation and maintenance states: The permittee shall at all times properly operate and maintain all facilities and systems of treatment and control which are installed or used by the permittee to achieve compliance with condition of this permit.
