**UNITED STATES ENVIRONMENTAL PROTECTION AGENCY**  
**Enforcement and Compliance Assurance Division**  
**Water Compliance Branch**

**Clean Water Act (CWA) Inspection Report**

| <b>Permittee Name:</b> Culpeper of Belchertown, LLC | <b>NPDES/ICIS No.:</b> MAR053808 | |
| <b>Facility Inspected:</b> Culpeper of Belchertown, LLC<br>201 Springfield Road, Belchertown MA 01007 | <b>Lat, Long:</b> 42.260739°, -72.402248°<br><b>NAICS / SIC Code:</b> 2491 – Wood Preserving | |

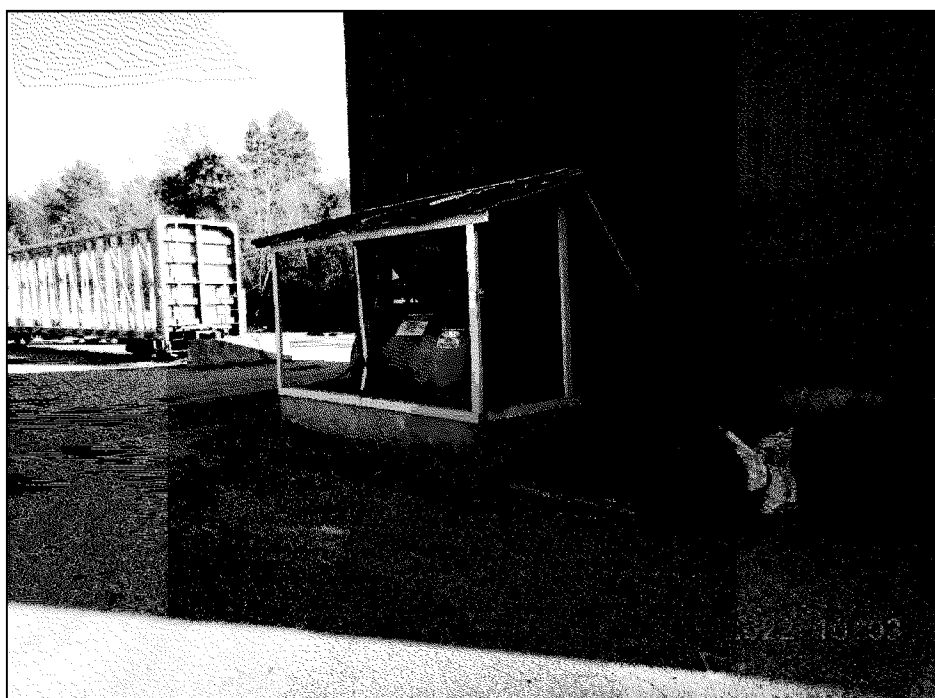
**Photograph 8.** View, facing northeast, of a 250-gallon diesel aboveground storage tank against the west wall of the garage in the southeast corner of the Facility. The tank is under a roof and within secondary containment.

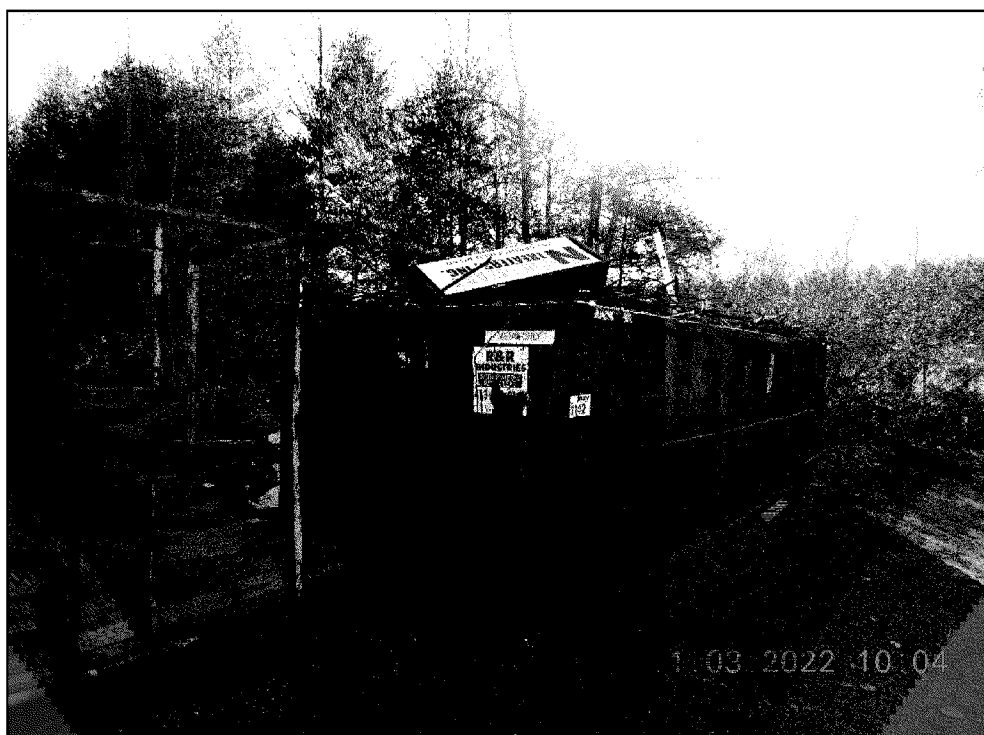
**Photograph 10.** View, facing south, of an uncovered dumpster used for plastic waste.

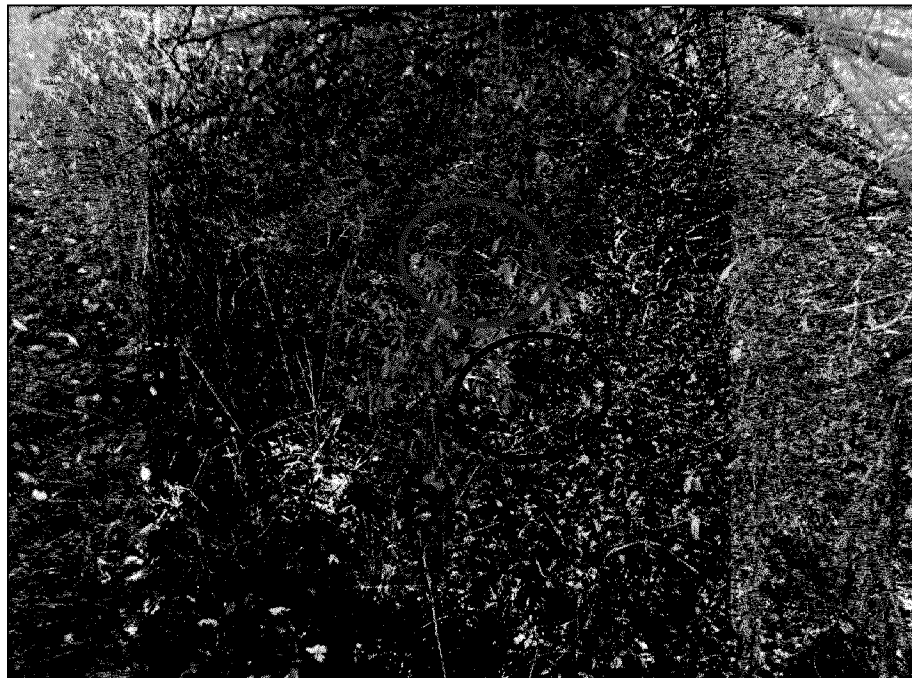
The Facility representatives stated the Facility has two stormwater outfalls (Outfalls 001 and 002), three stormwater detention basins, and three catch basins. Outfall 001 is located on the south perimeter of the Facility (refer to Appendix A, Photographs 11). The Facility representatives stated they had not observed discharge from the outfall, but that the site drainage was potentially designed for the outfall to receive piped flow from a ditch along the south perimeter and piped stormwater flow from the garage rooftop. The EPA Inspector did not observe discharge from the outfall during the inspection.

**Photograph 11.** View, facing southeast, of Outfall 001 (circled red). Two plastic pipes are connected to the ditch (circled blue). The Facility representatives stated the pipes could be connected to the garage's roof. The Facility representative stated the outfall also may be connected to the ditch along the south perimeter.

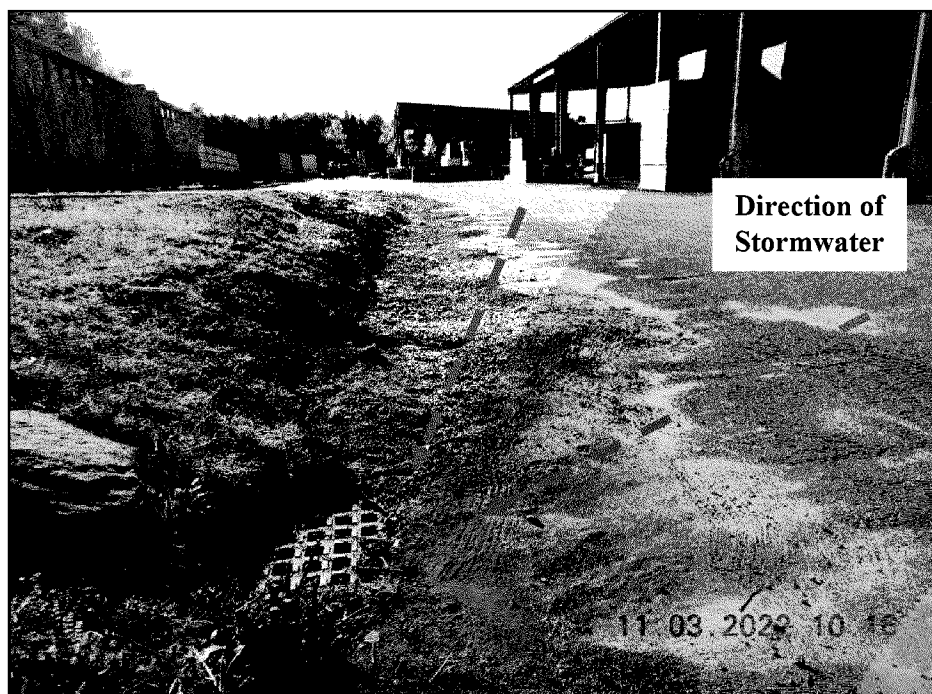
- The size of the Facility in acres
- The locations of all stormwater monitoring points at the Facility
- The mid-east catch basin that had the potential to discharge to Outfall 002 (refer to Appendix A, Photographs 16 and 17)

**Photograph 16.** View, facing south, of a catch basin in the mid-east area of the Facility. Stormwater in the south area of the Facility flows to this catch basin. The catch basin connects to catch basins in the mid-area of the Facility.

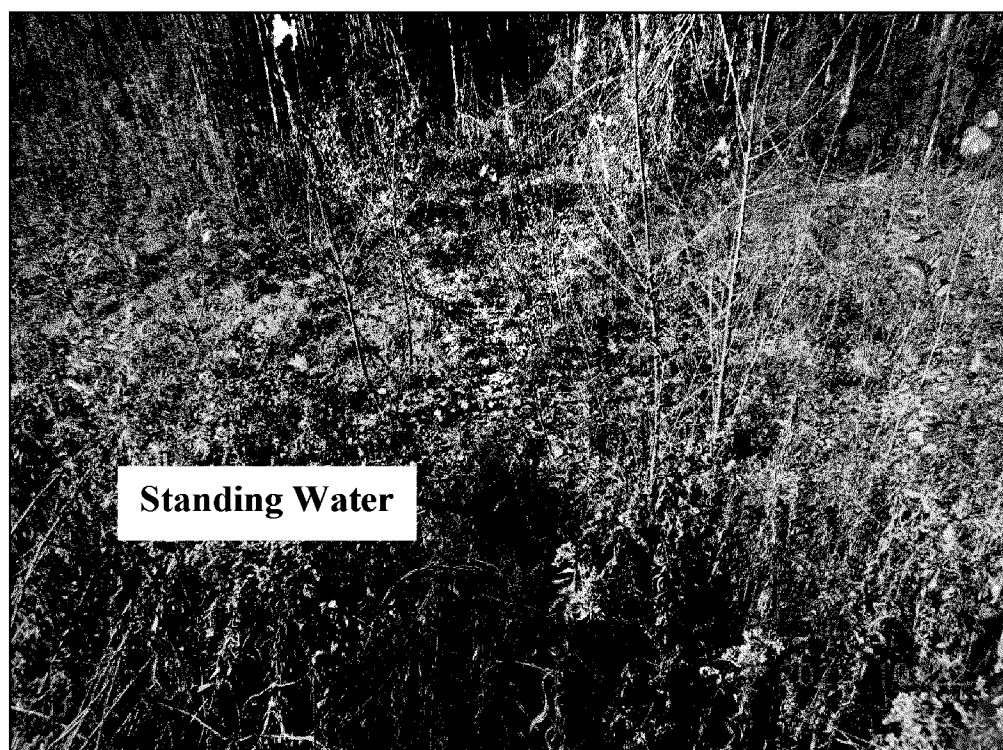
- The northwest and southwest detention basins were overgrown with vegetation and required maintenance. Due to the vegetative growth, the EPA Inspector was unable to observe the inlets where flow from the mid-north catch basins discharge into the basin (refer to Appendix A, Photograph 22 through 27).

**Photograph 22.** View of the northwest detention basin. The EPA Inspection Team observed standing water in the basin at the time of the inspection.

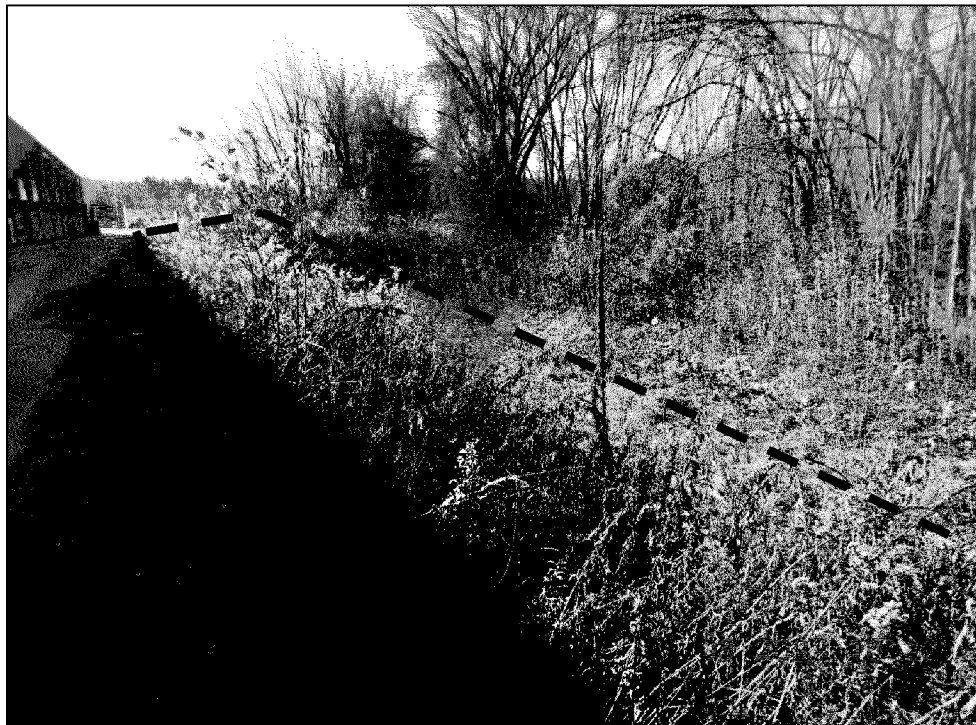
**Photograph 23.** View, facing southwest, of the northwest detention basin (red).

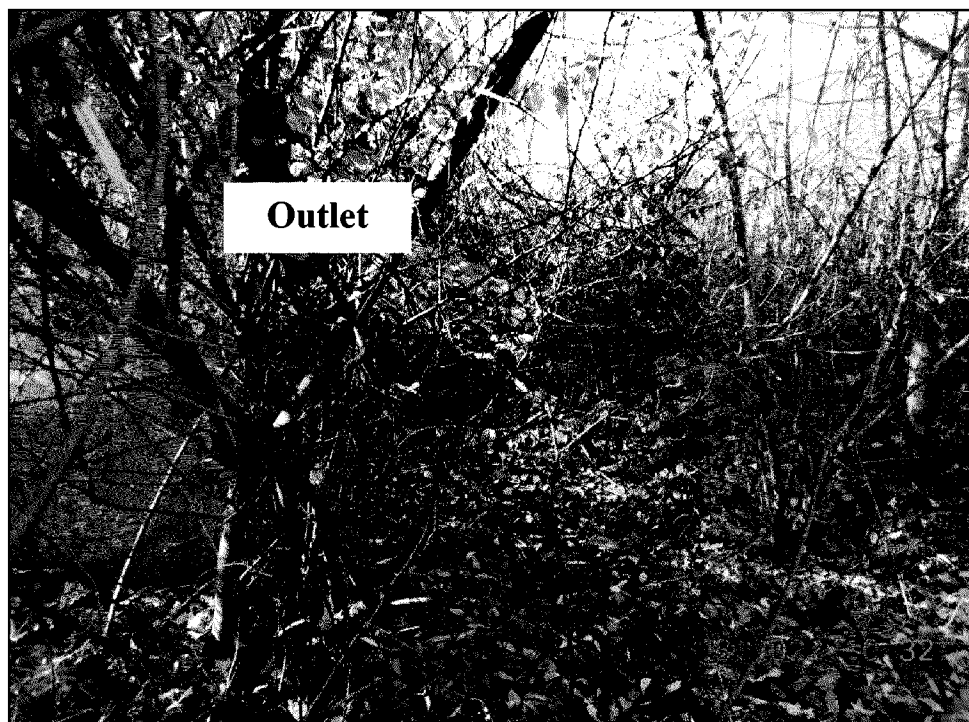
**Photograph 24.** View, facing south, of the northwest detention basin's outlet. Stormwater flows from the northwest detention basin outlet to the southwest detention basin.

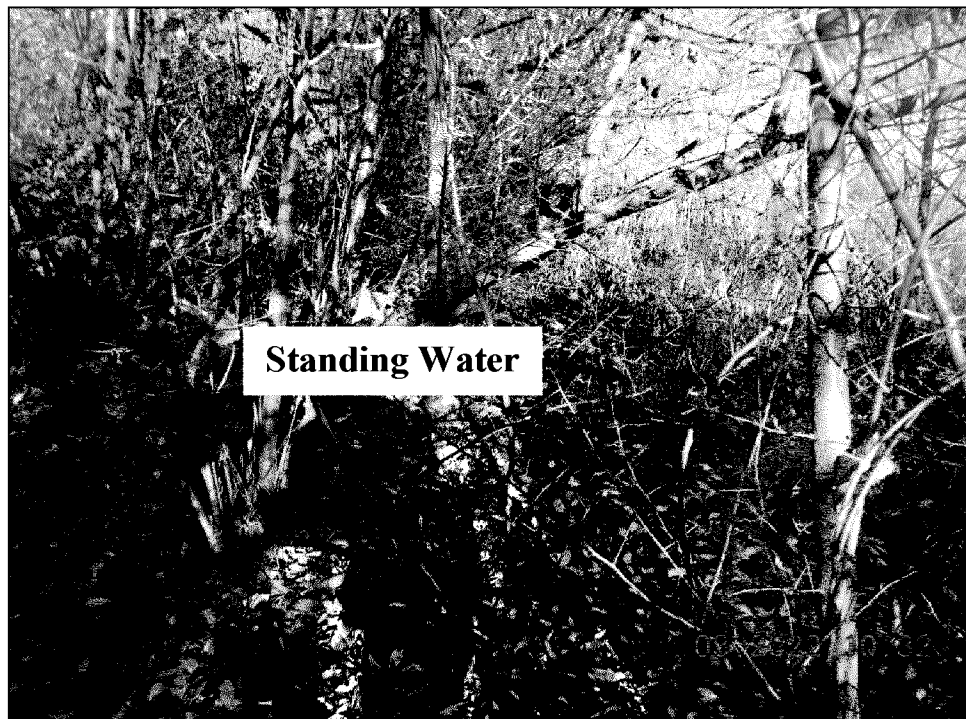
**Photograph 25.** View, facing north, above the northwest detention basin's outlet shown in Photograph 22. The EPA Inspector observed standing water in the detention basin.

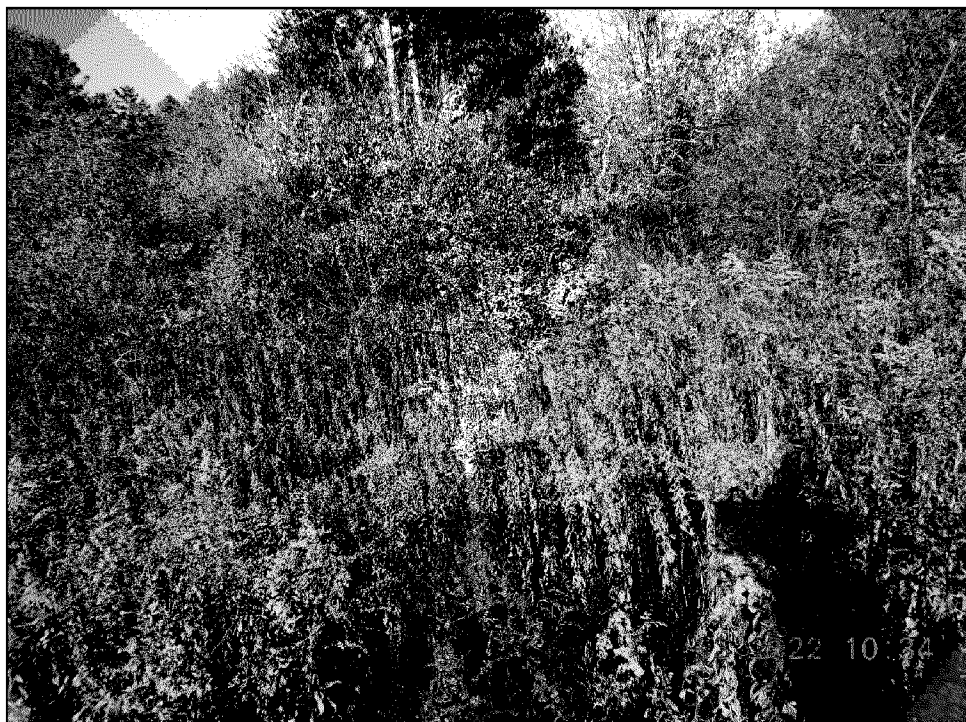
**Photograph 26.** View, facing west, of the southwest detention basin.

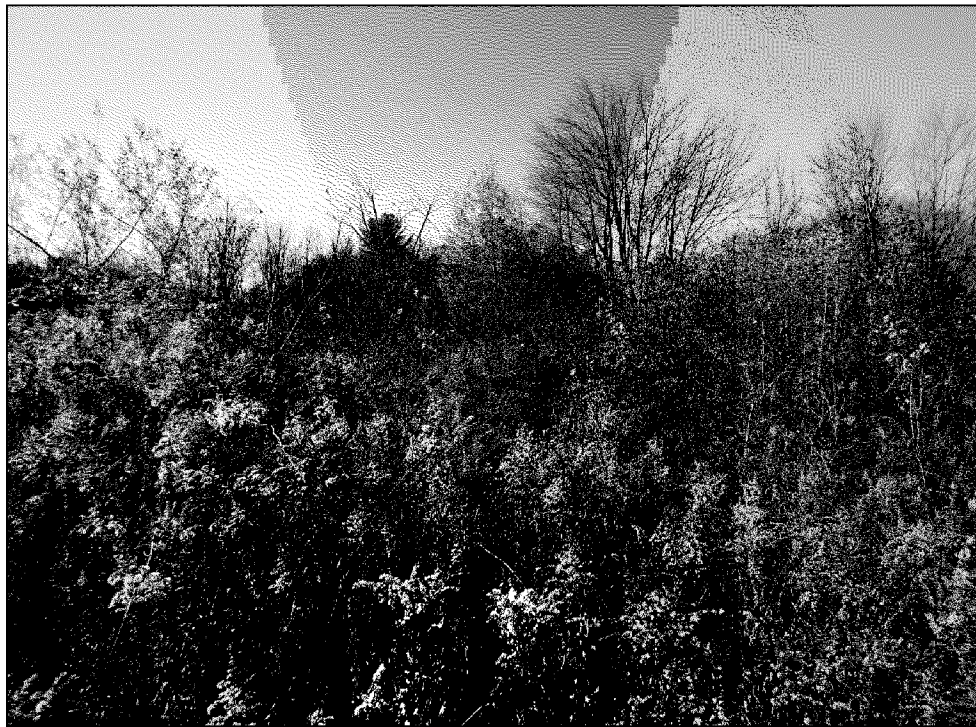
**Photograph 27.** View, facing southwest, of the southwest detention basin.

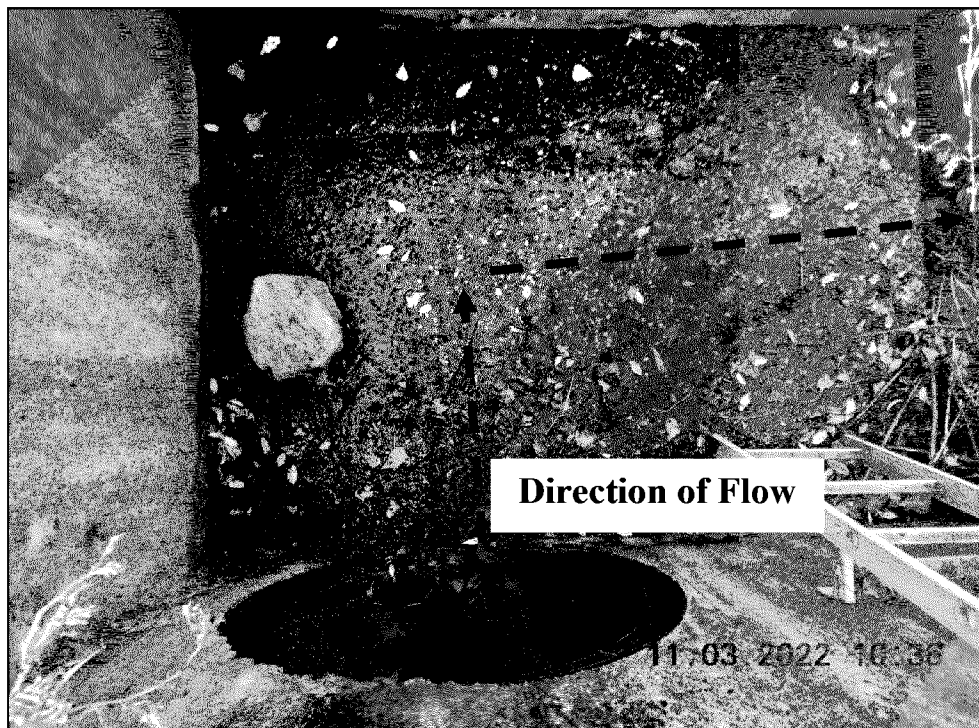
**Photograph 28.** View of Outfall 002. The pavement below the outfall was damp during the inspection. The EPA Inspection Team did not observe evidence of pollution during the inspection.

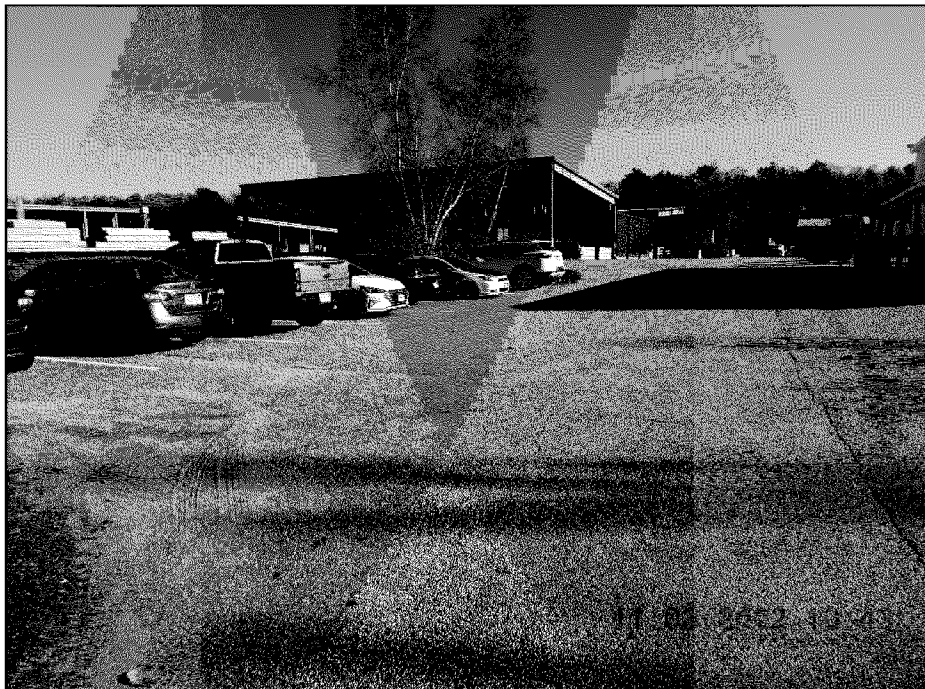
Facility representatives stated that stormwater has the potential to discharge from the southwest corner of the Facility to Jabish Brook at the entrance at the southwest corner of the Facility. Facility representatives reported seeing stormwater pool at this location (refer to Appendix A, Photographs 33 and 34).

**Photograph 33.** View, facing east, of the driveway at the southwest corner of the Facility. Stormwater from the parking lot appeared to drain to the southwest corner shown in Photograph 34.

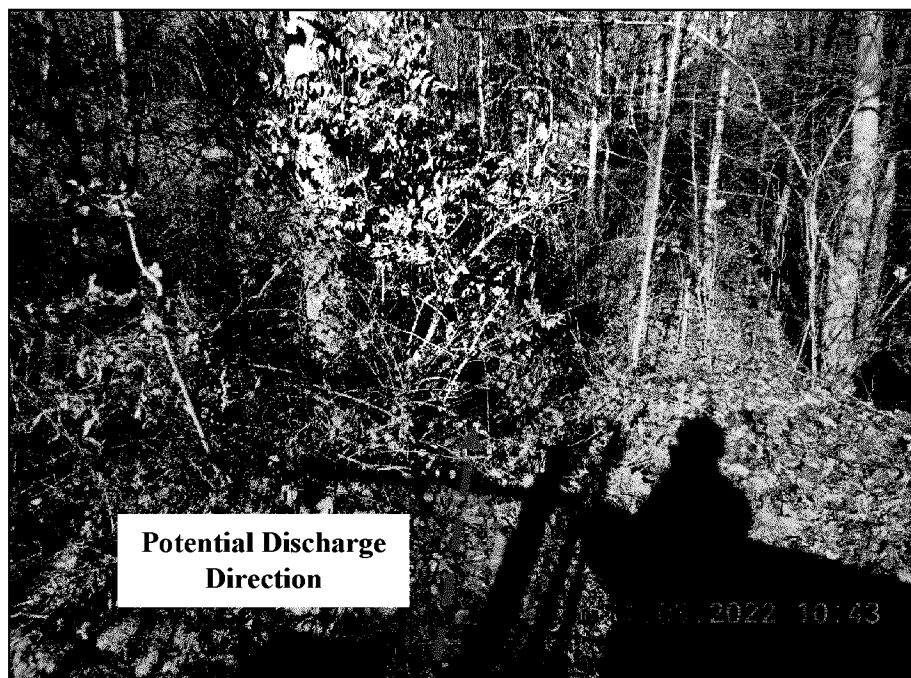
- The Facility representatives stated that a potential outfall exists at the southwest corner of the Facility at the site entrance because they had observed stormwater pooled at that location (refer to Appendix A, Photograph 34). The Facility representative stated they have never observed discharge at this location, but it is not regularly monitored. This location was not depicted as an outfall on the Site Drainage Plan or in the NOI.

**Photograph 34.** View, facing north, of a potential discharge location at the southwest corner of the Facility. The Facility representative stated that stormwater at this location pools.

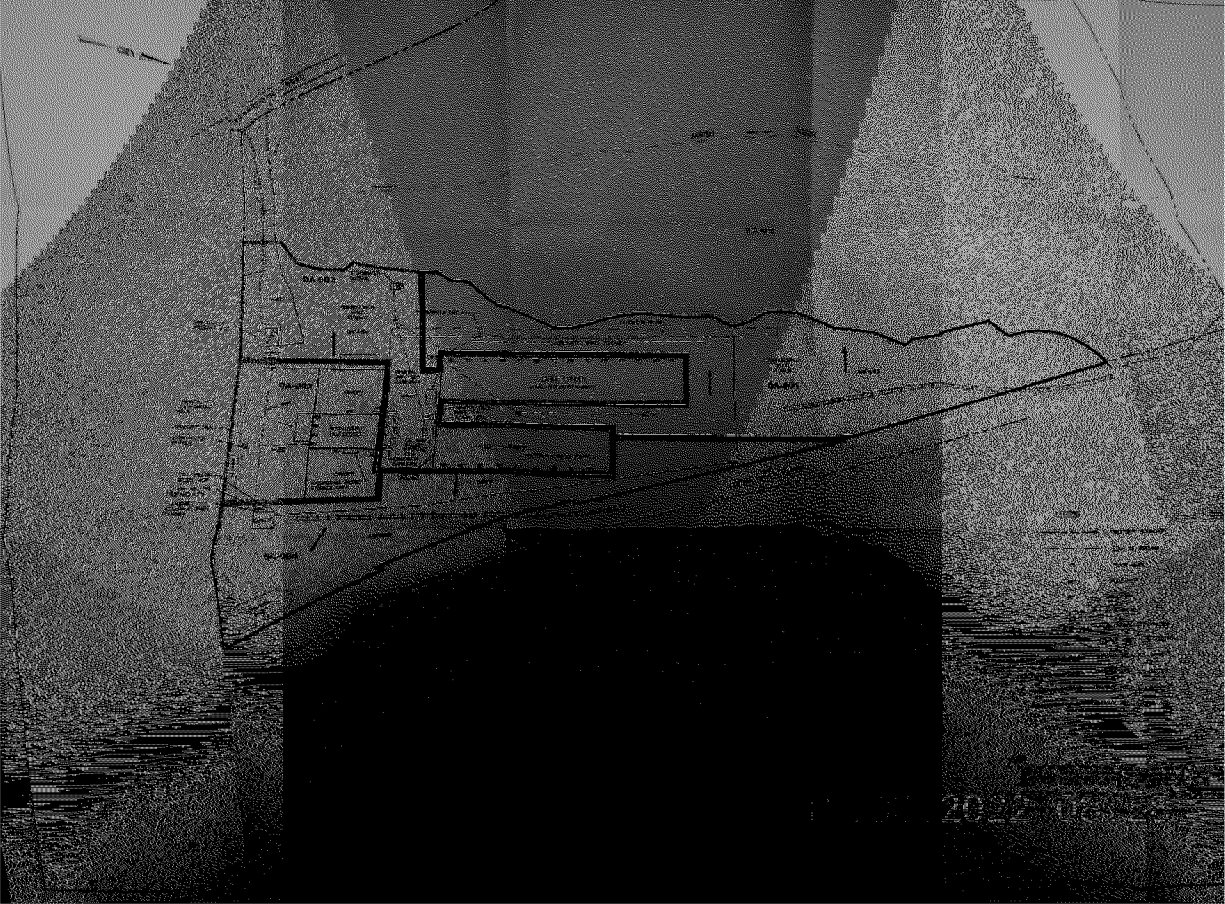
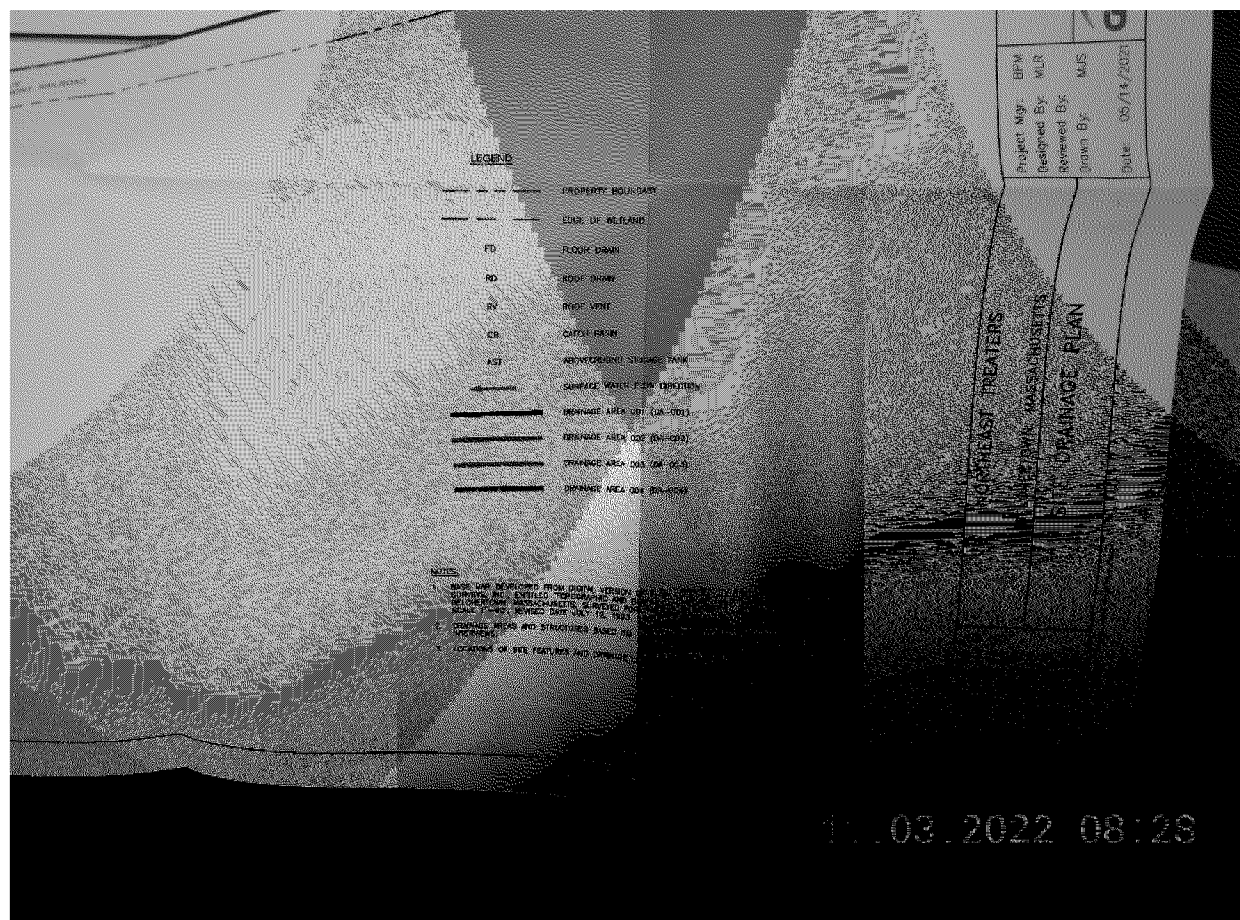
## **Site Map**

The EPA Inspector observed the Site Drainage Plan provided during the inspection was missing the following (refer to Appendix B, Exhibit 3):

The Site Drainage Plan depicted a stormwater outfall (Outfall 001) at the mid-west perimeter that the Facility representatives stated does not experience discharge and is not monitored (refer to Appendix A, Photograph 11). The Site Drainage Plan also did not depict the northwest and southwest detention basins as two separate basins but as one continuous basin.
