STUDY & REPORT  
ON  
**TETE BAYOU WWTP  
EQUALIZATION BASIN  
LEVEE FAILURES**

Prepared For  
**The City of New Iberia  
&  
Iberia Parish Sewerage District No. 1**

December, 2017

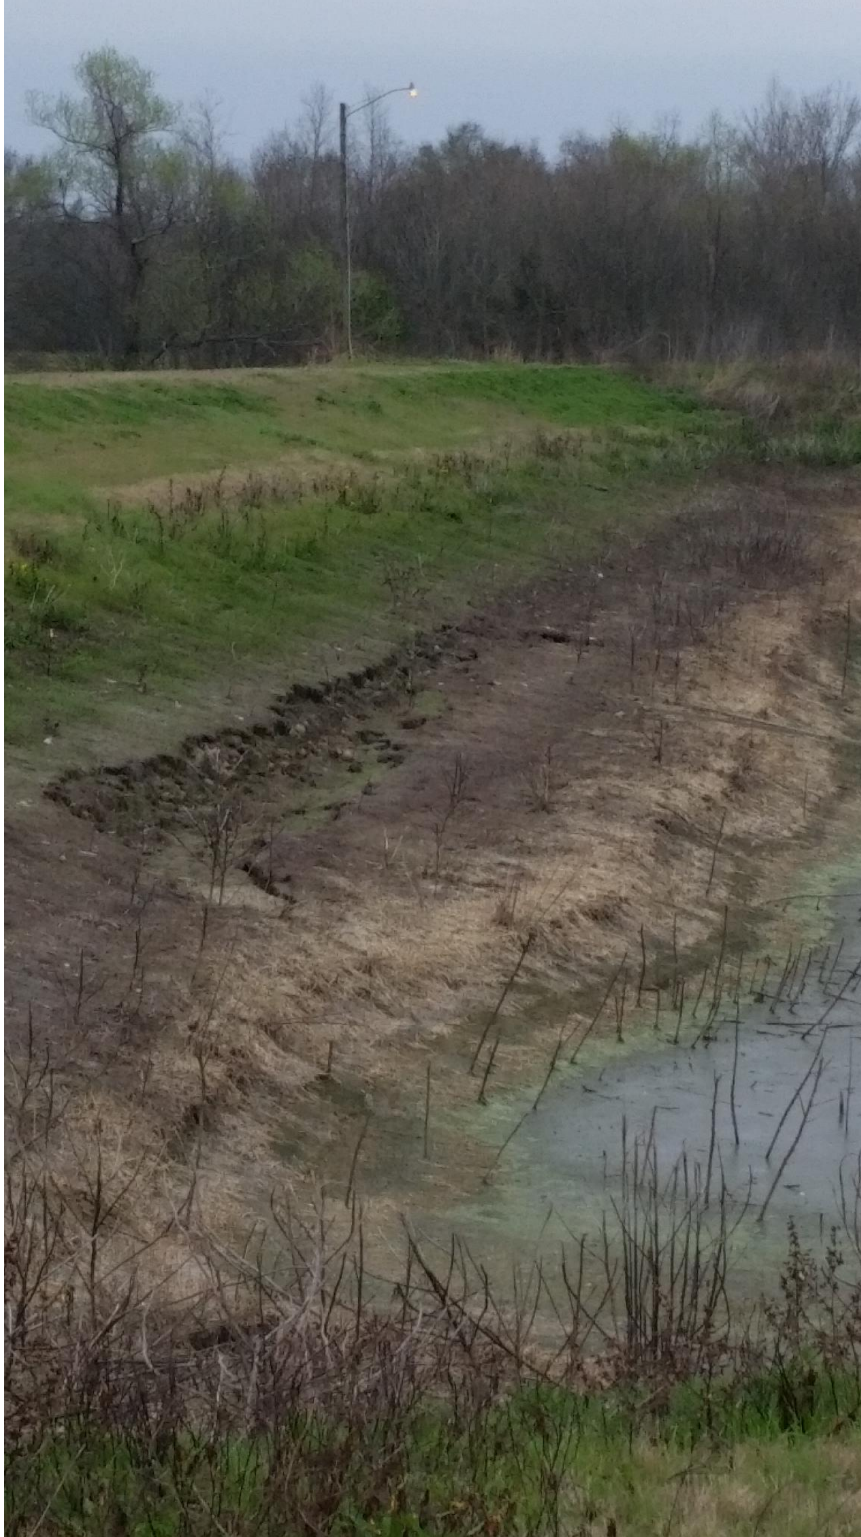
**PHOTOGRAPH 1 – Slope Failure South Levee Looking West**

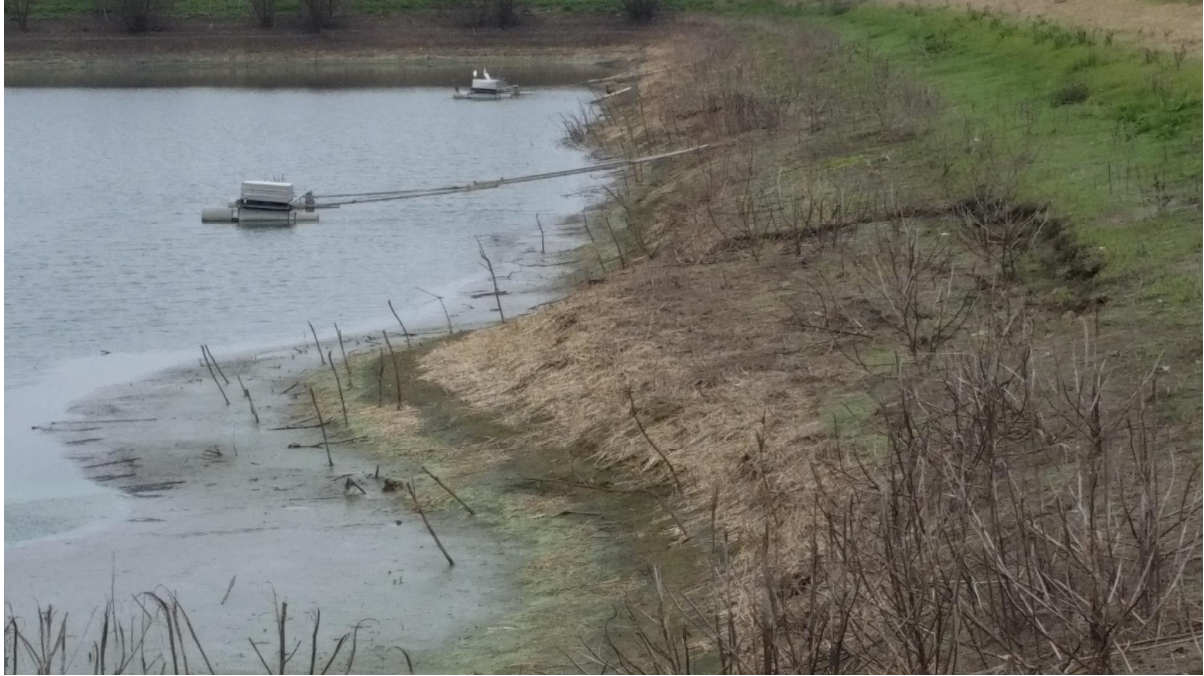
**PHOTOGRAPH 2** – Slope Failure South Levee Looking East

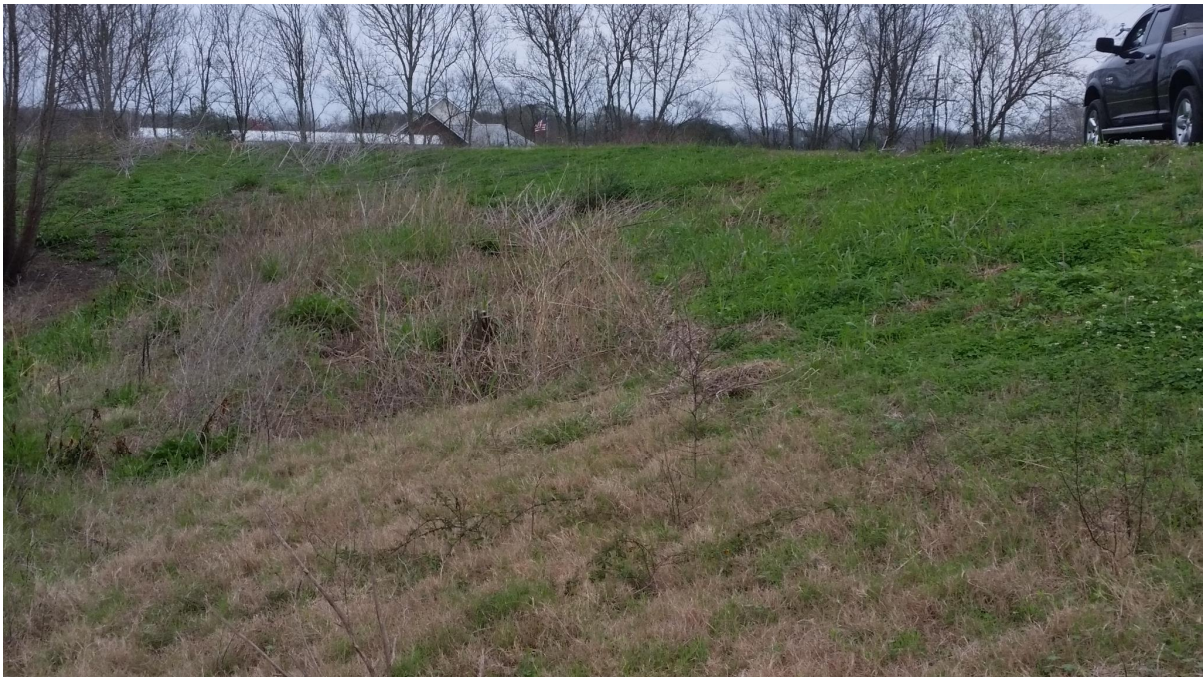
**PHOTOGRAPH 3** – Slope Failure East Levee Looking North

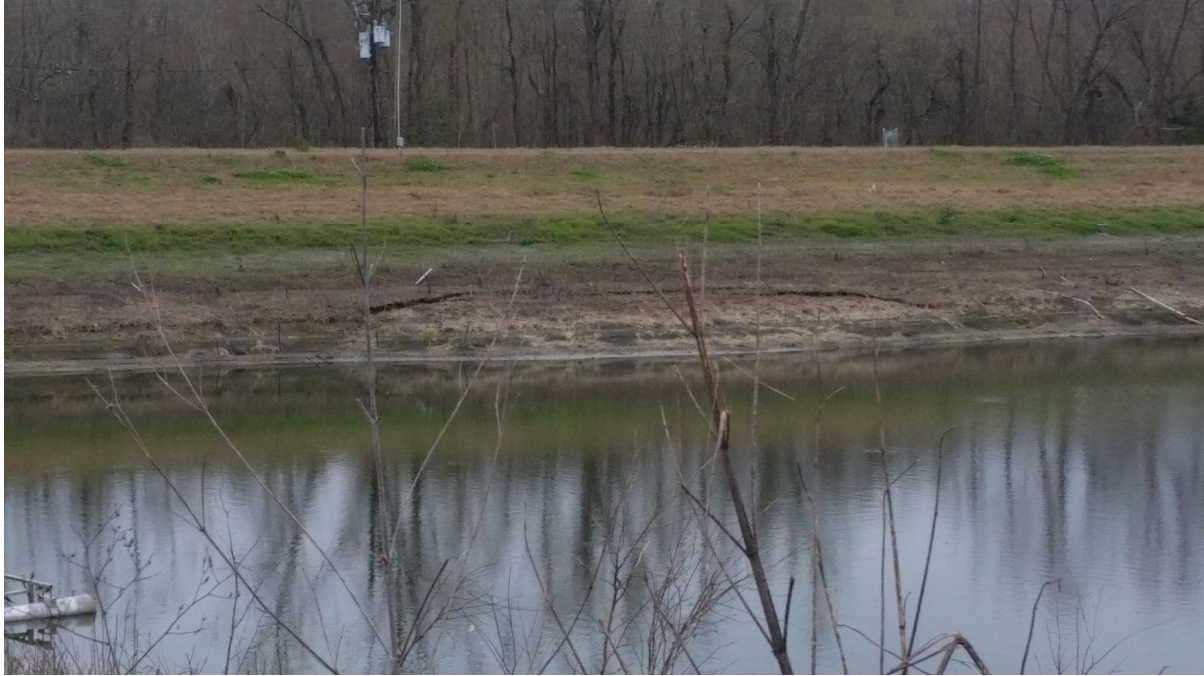
**PHOTOGRAPH 4** – Slope Failure East Levee Looking East

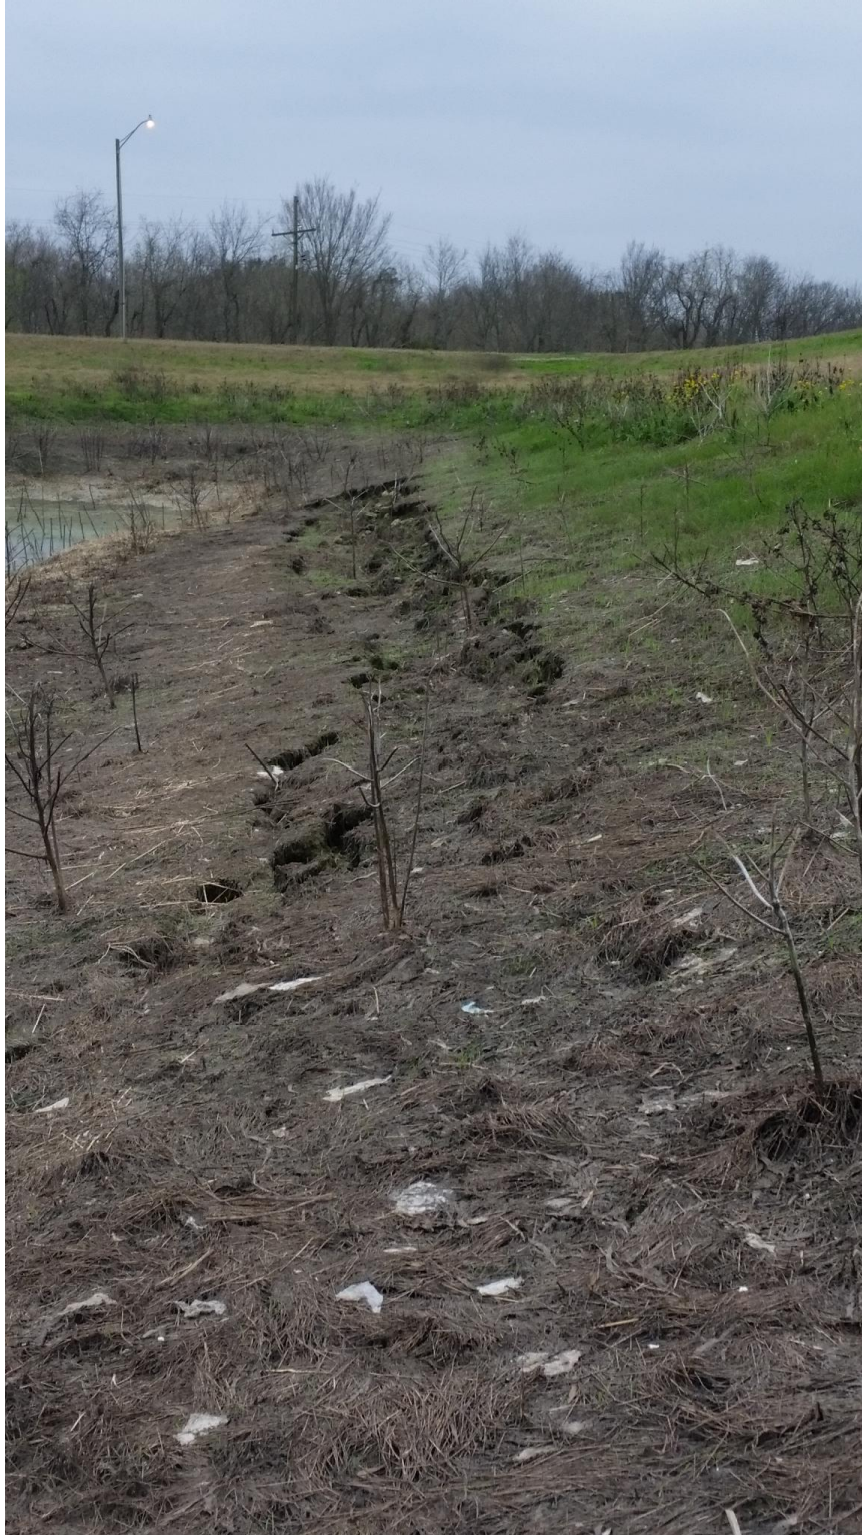
**PHOTOGRAPH 5** – Slope Failure South Levee Looking East
