**Inspection Report**  
**Mechanical Integrity Test**  
**Osage DNR / Environmental Protection Agency**  
**1201 Elm Street, Suite 500**  
**Dallas TX 75270**

| <b>Operator Info</b><br>Contango Resources, LLC<br>1717 South Boulder, Suite 900<br>Tulsa, OK 74119<br>Phone: 918-392-3396 | | <b>Inventory ID</b> OS3031000<br><b>API Well No</b><br><b>Lease Name</b> NEIMAN<br><b>Well ID</b> 7<br><b>Location</b> SE 15 26N 06E | | | |
| <b>Type of MIT</b> Ada Pressure Test | | <b>Test Reason</b> Routine | | | |

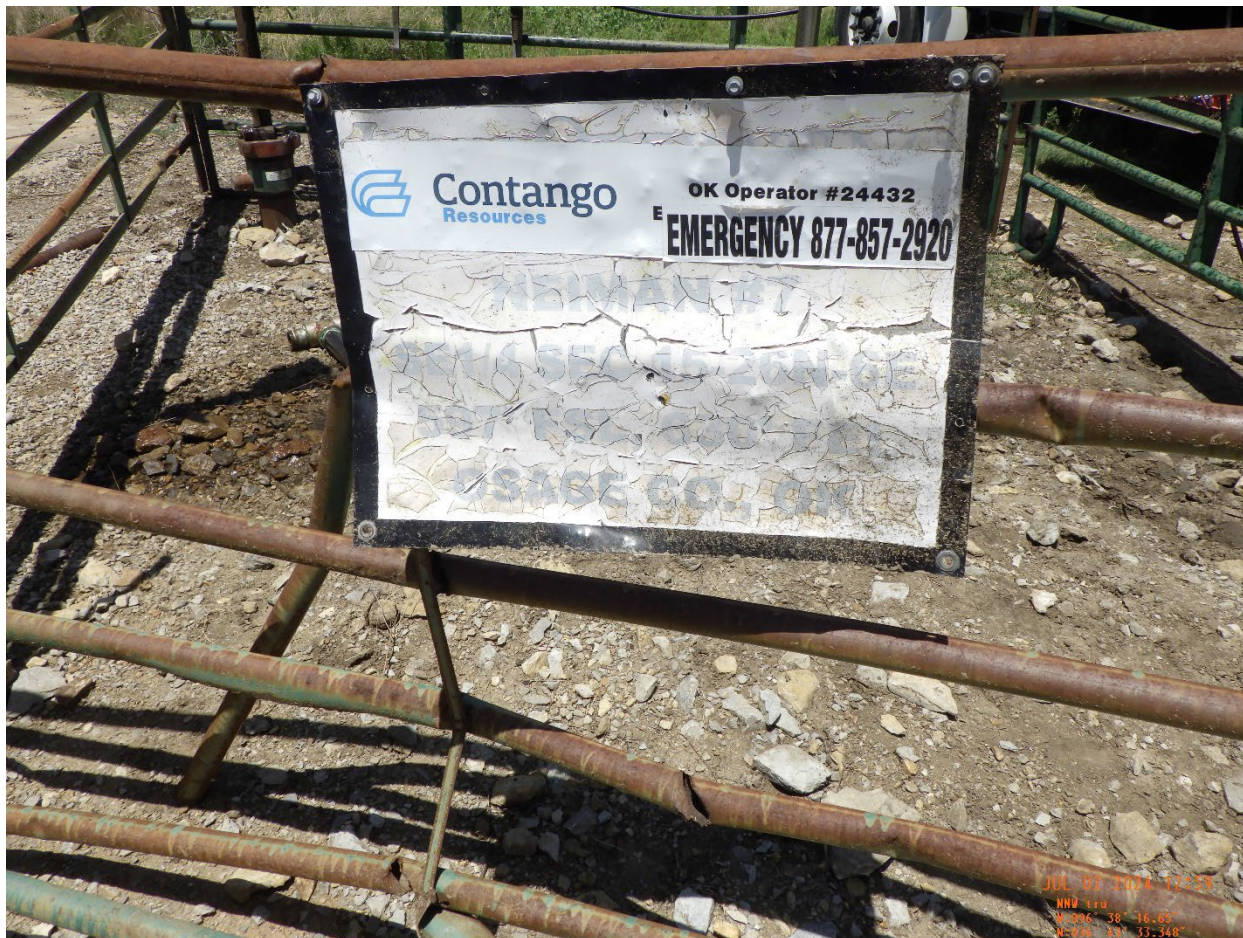
Photo No. 1

Description: This was the well sign for OS3031000.

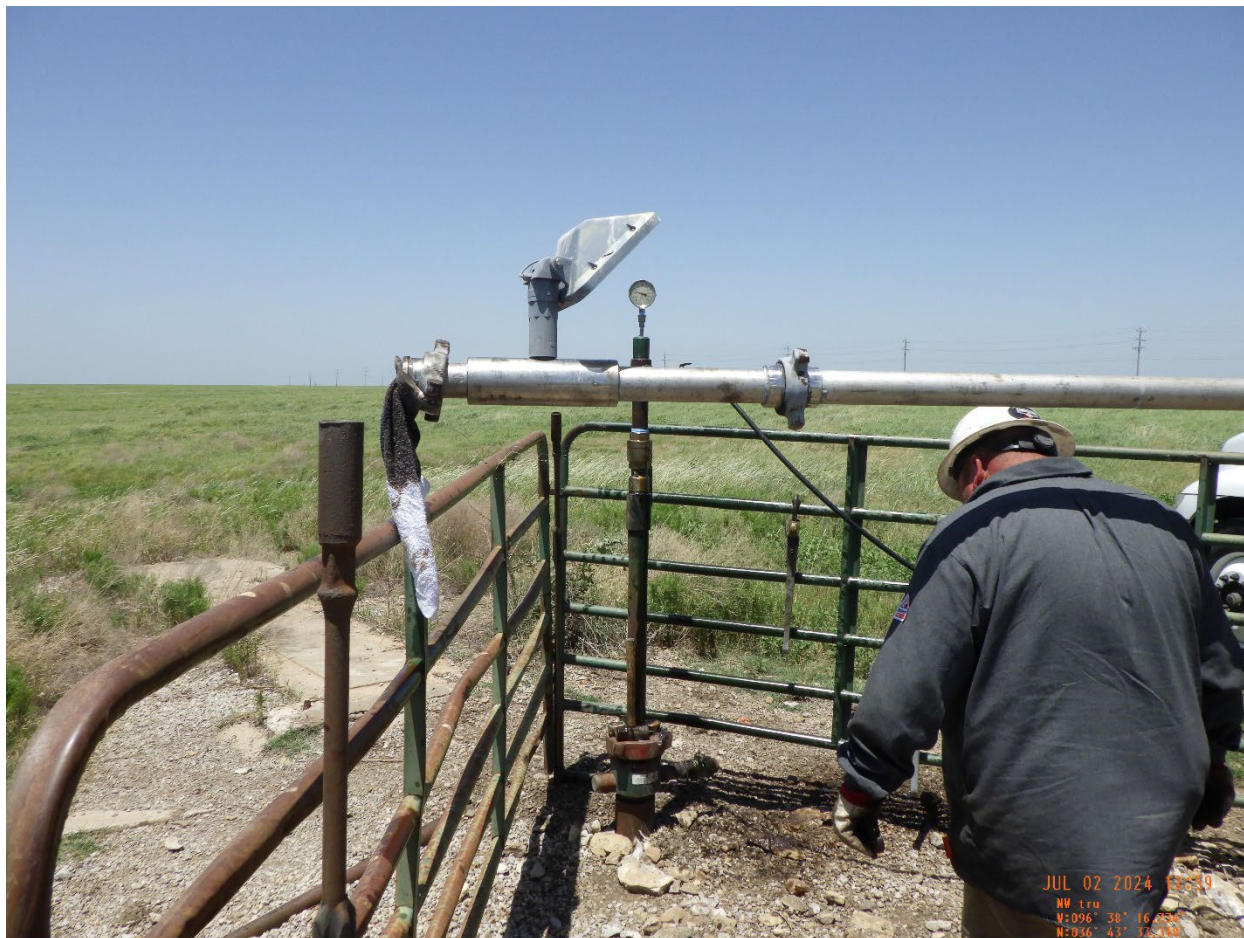
Photo No. 2

| <b>Inspection Comments</b> | | Well OS3031000 was observed with 480psig on the tubing prior to beginning the MIT. Twelve (12) full nitrogen cylinders were injected into the well and the pressure remained at 480psig. The calculated required test pressure was 974psig. The well failed to reach the required test pressure. | | | |

**Description:** This was well OS3031000 at the time of the mechanical integrity test.
