INVESTIGATION INTO AN UNCONTROLLED  
REACTION IN A DPP STORAGE TANK

Author: J.W. Potter

Date: November 20, 1964

SUMMARY

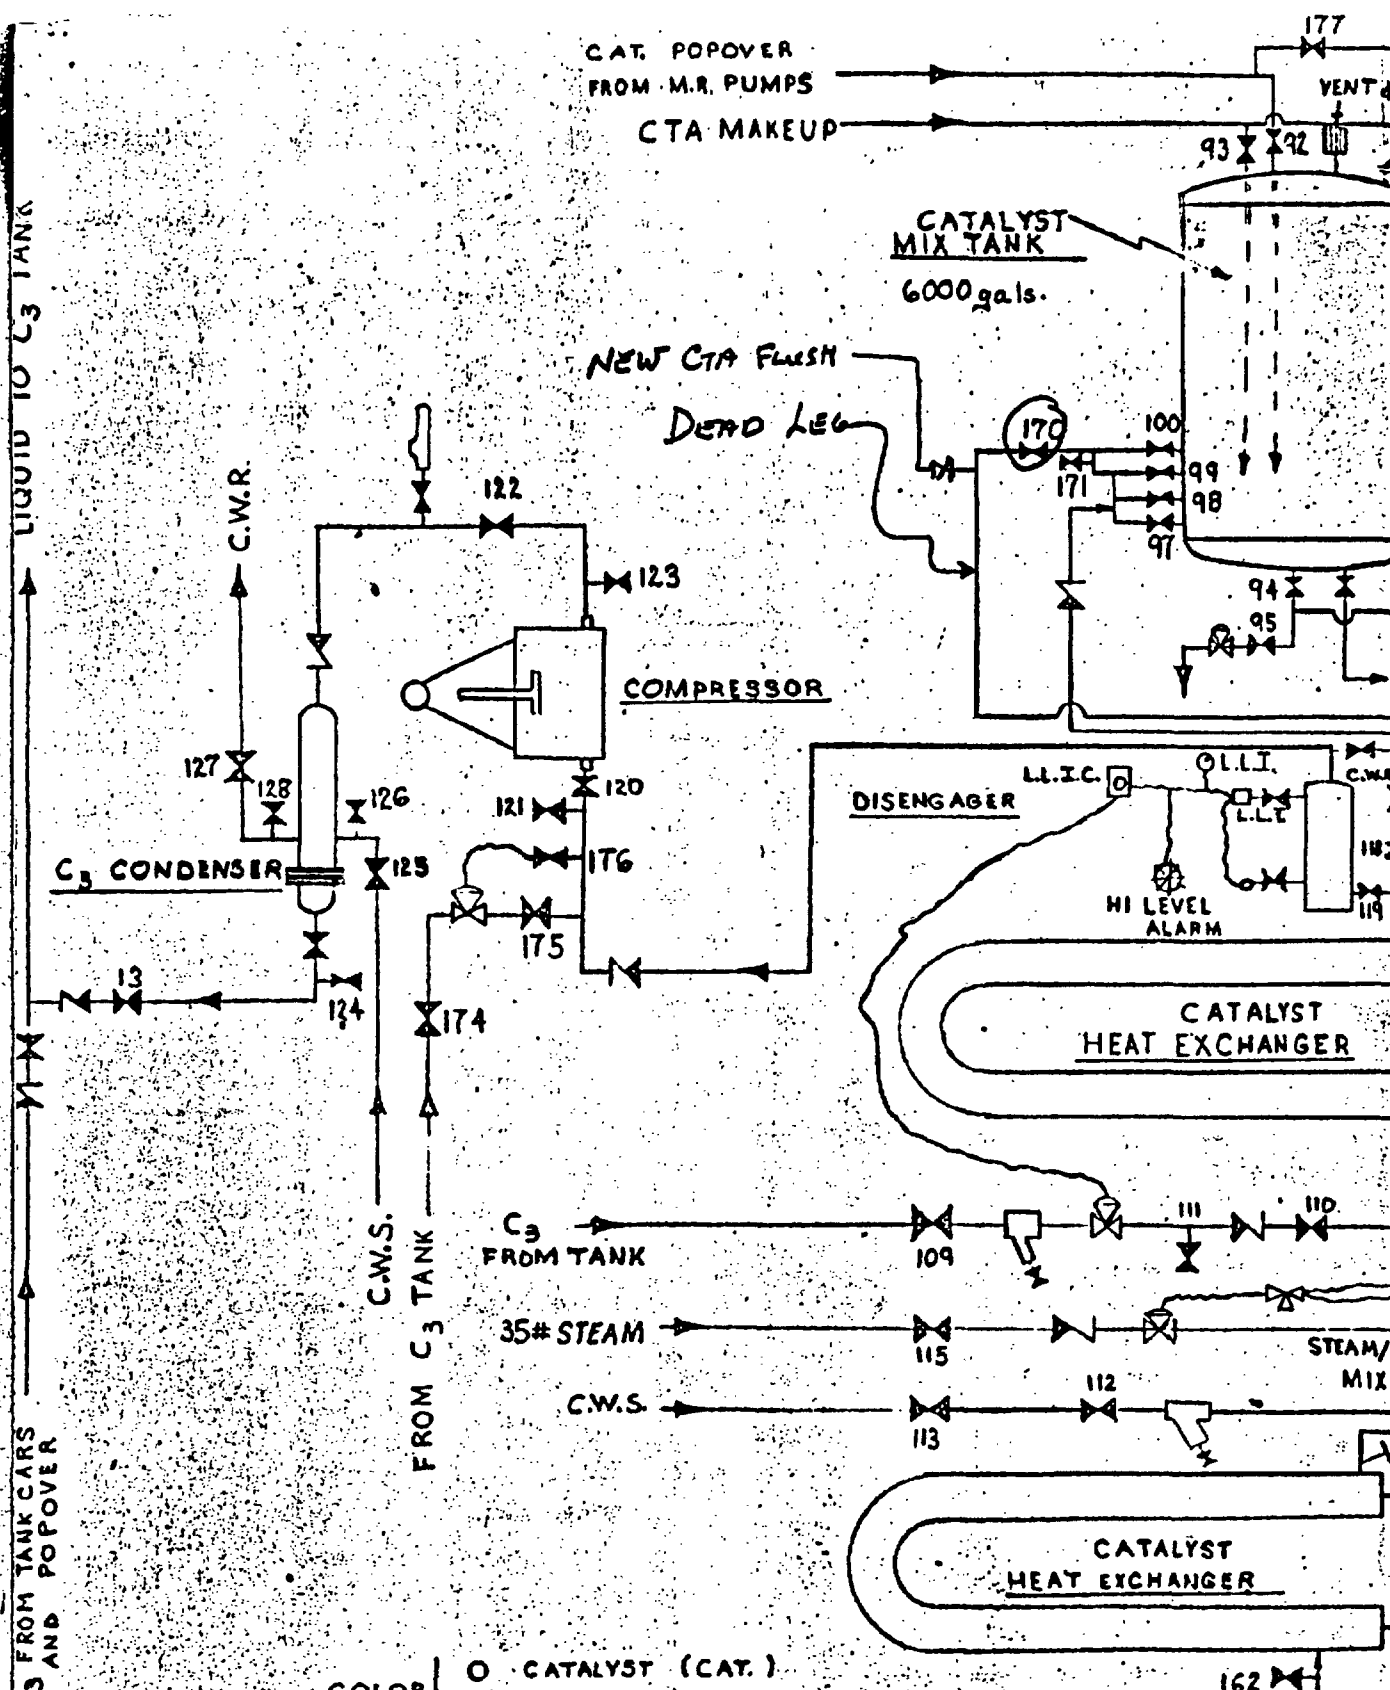
On August 30, 1964, an uncontrolled reaction occurred in a DPP concentrates storage tank which contained 20 wt. percent DPP in a nonane type solvent. The attached schematic drawing, MFD-C-1575-A, shows the system layout. The sequence of events leading up to the incident are as follows:
