**CWA COMPLIANCE EVALUATION INSPECTION REPORT  
U.S. ENVIRONMENTAL PROTECTION AGENCY, REGION 5**

**Purpose:** Compliance Evaluation Inspection

**Facility:** Benton Dairy, LLC  
8444 South 900 West  
Ambia, Indiana 47917-003

**Date of Inspection:** April 28 and 29, 2021

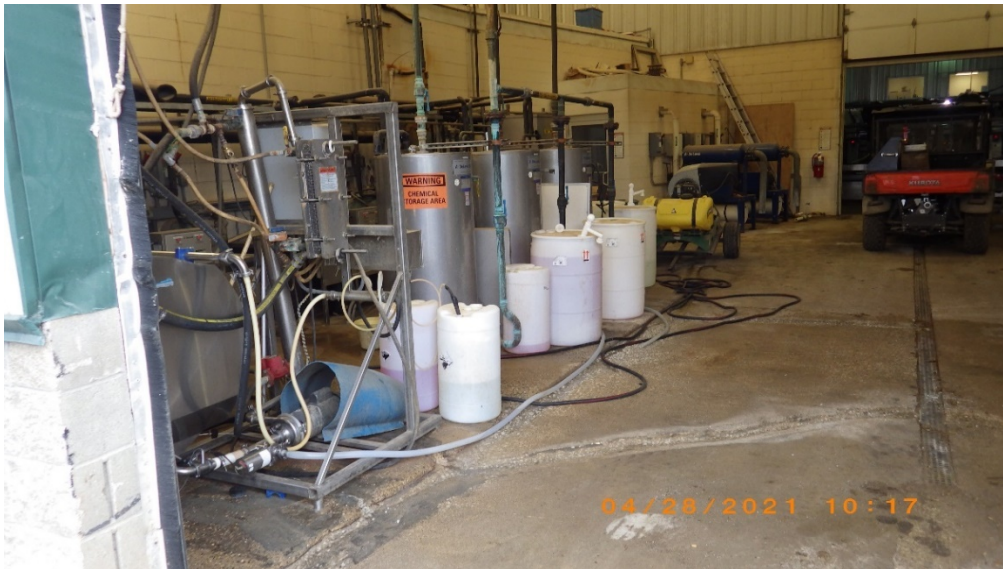
Photo Number: RIMG0067

We continued to the north side of the Milking Parlor where we observed the Chemical Storage Area. The Chemical Storage Area held teat dip, formaldehyde, and other chemicals. EPA observed drains in the Chemical Storage Area, which Mr. Benton explained would drain into the Sand Separation Lane (Photos RIMG0067 and RIMG0070) if there was a leak or spill from the chemicals. We continued to walk between Barn 2 and Barn 3 to the Recirculation Pit. The Milking Parlor has a drain that collects manure and process wastewater. The drain flows by gravity into the Recirculation Pit (Photo RIMG0071).

Description: The Chemical Storage Area has drains that convey flow to the Recirculation Pit between Barns 2 and 3.

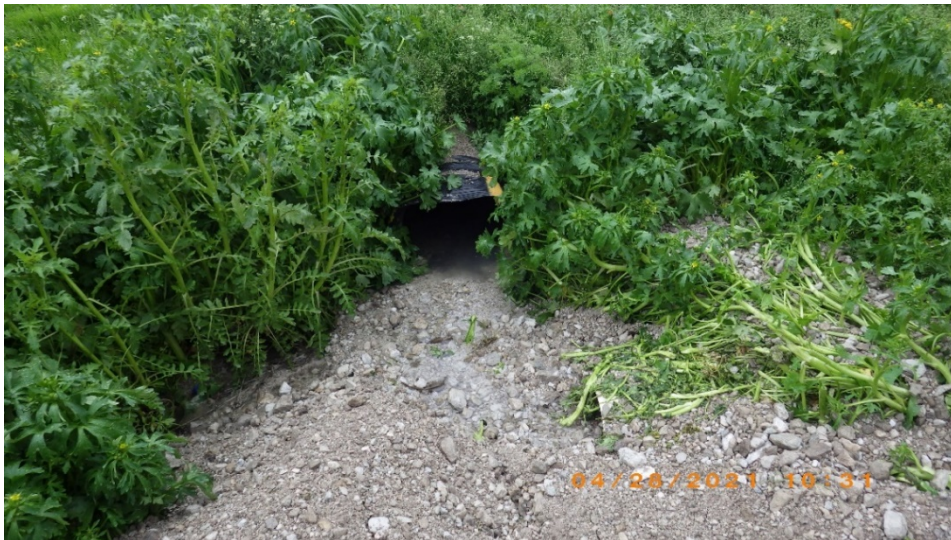
Photo Number: RIMG0074

Description: Drainage tile inlet between Barn 2 and Barn 3.

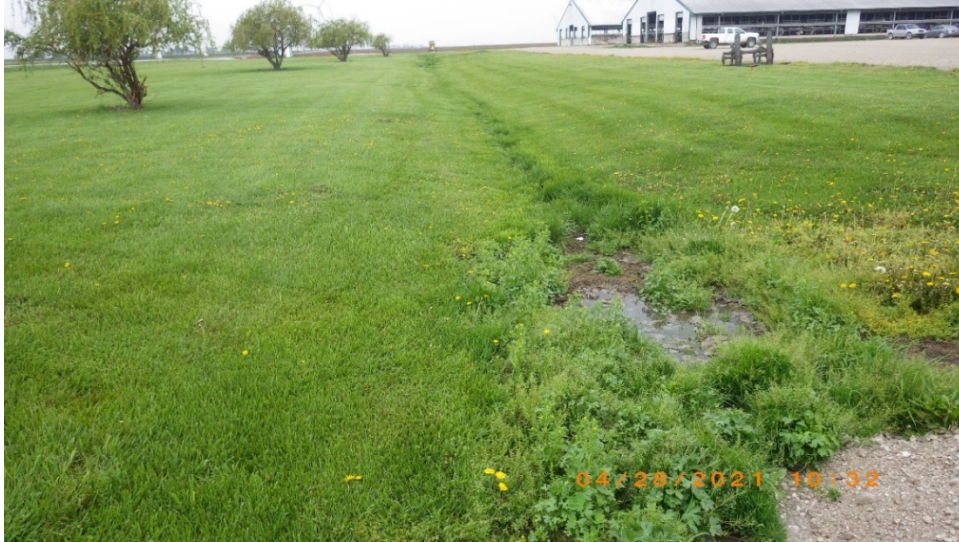
Photo Number: RIMG0075

Description: The drainage tile inlets collect the water between the barns and convey flow under the East Access Road into the East Drainage Channel identified above. The water within this East Drainage Channel will flow to the Stormwater Pond.

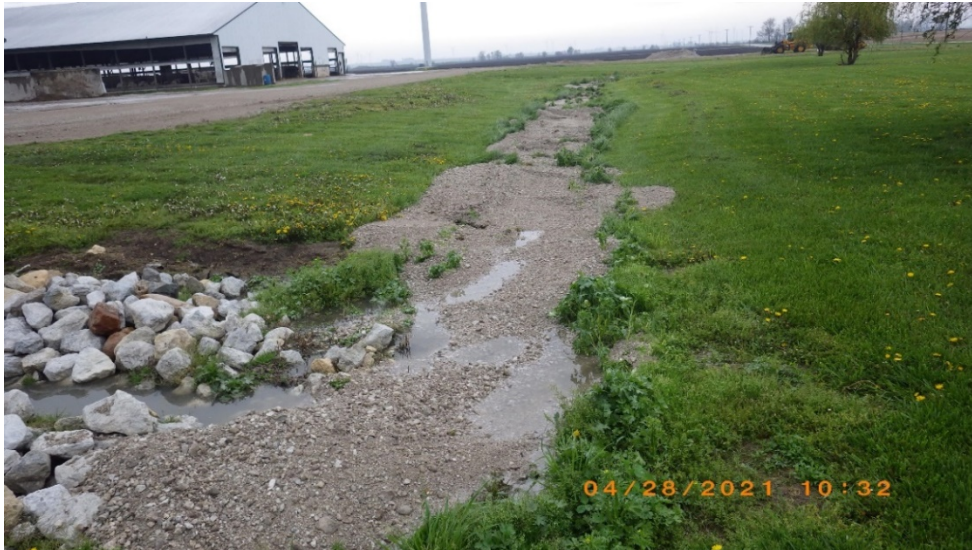
Photo Number: RIMG0077

Description: The drainage tile outlets into the East Drainage Channel.

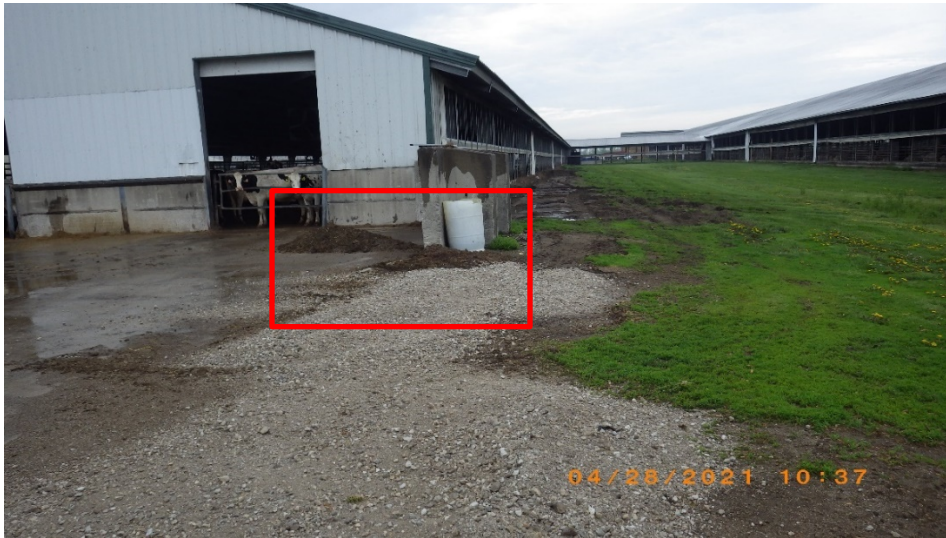
Photo Number: RIMG0078

Description: Used bedding that came out of Barn 2.

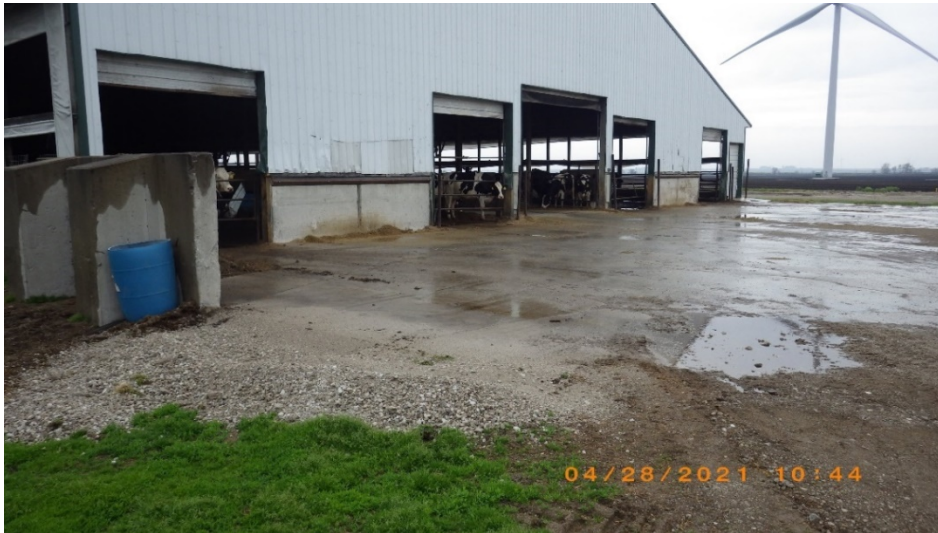
Photo Number: RIMG0082

Description: Used bedding pushed out of Barn 1 on the east side of Barn 1.

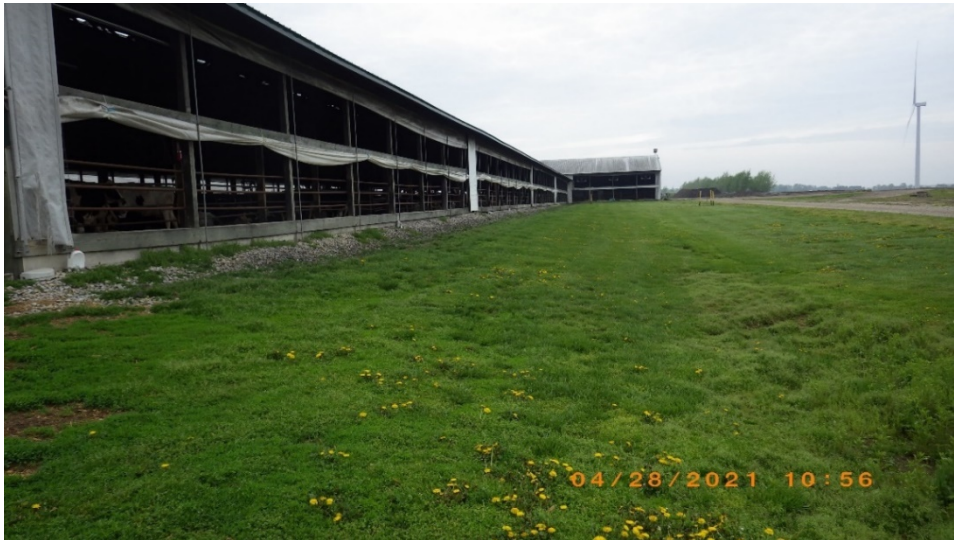
Photo Number: RIMG0084

Description: On the north side of Barn 1. The East Drainage Channel conveys flow to the north side of Barn 1, which eventually ends up in the Stormwater Pond.

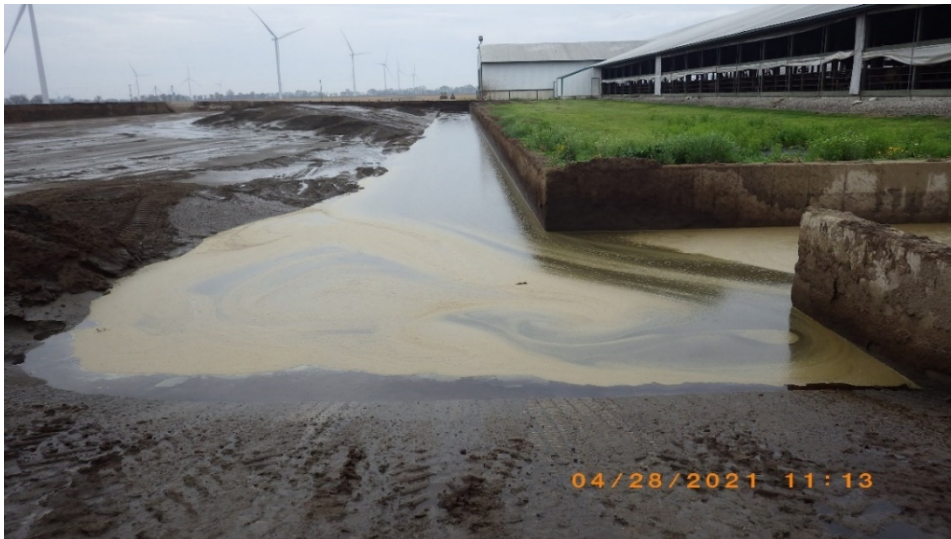
EPA continued walking west on the north side of the facility and observed solids pushed over the concrete wall of the Solid and Sand Stacking Pad. Mr. Boerman explained that any stormwater that comes into contact with the solids been pushed over the wall would flow to the Stormwater Pond (Photo RIMG0091). We walked on the Solid and Sand Stacking Pad to observe how the process wastewater is pumped into the 1<sup>st</sup> Stage Lagoon (Photos RIMG0095 and RIMG0096).

Photo Number: RIMG0095  
Description: Sand Separation Lane which is pumped into the 1<sup>st</sup> Stage Lagoon.  
Location: In the Solid and Sand Stacking Pad area west of the Sand Separation Lane.  
40.487351, -87.495501  
Facing: East.  
Date/Time: 4/28/2021/ 11:11 a.m.

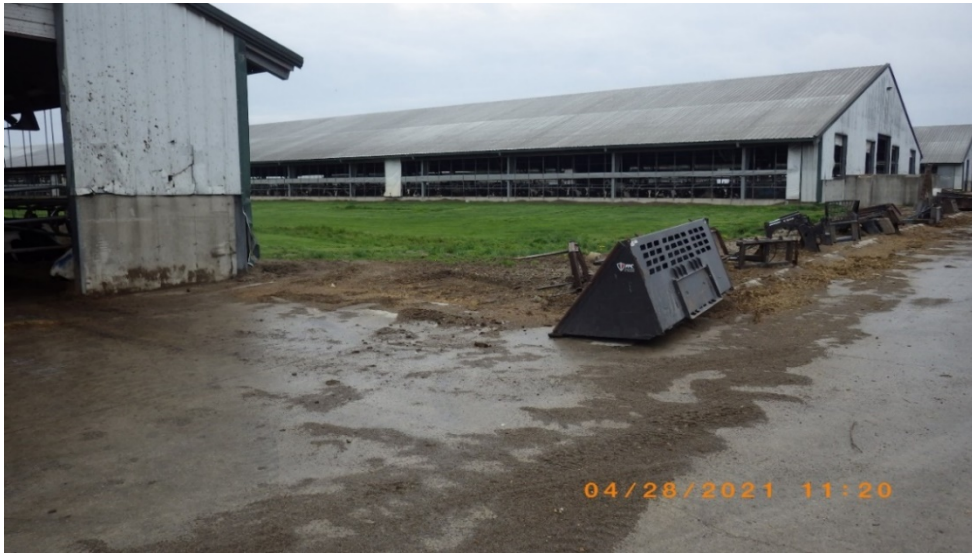
Photo Number: RIMG0102

Description: Used bedding and feed on the West Access Road between Barn 1 and Barn 2.

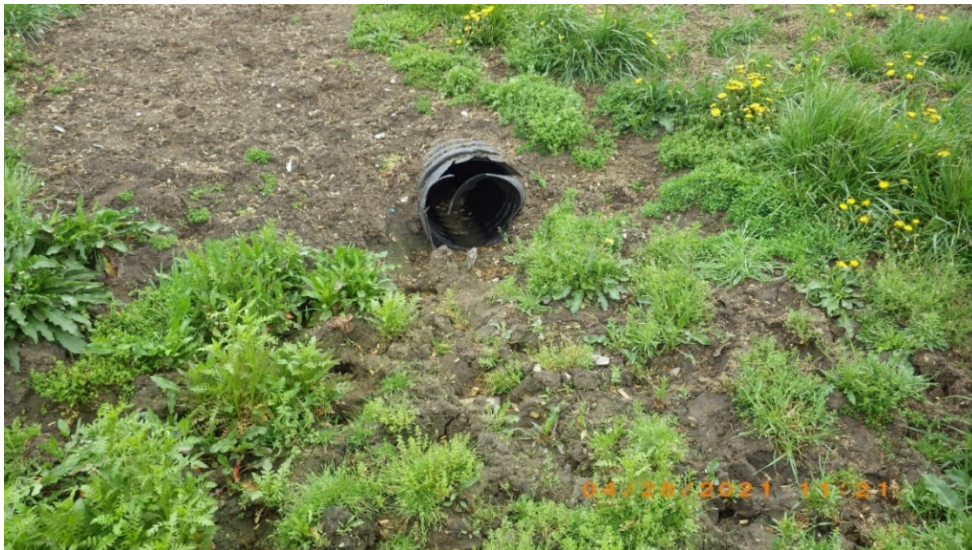
Photo Number: RIMG0103

Description: The drainage tile inlet between Barn 2 and Barn 3 on the west side of the Barns. The drain tile conveys flow between the barns to the Stormwater Pond.

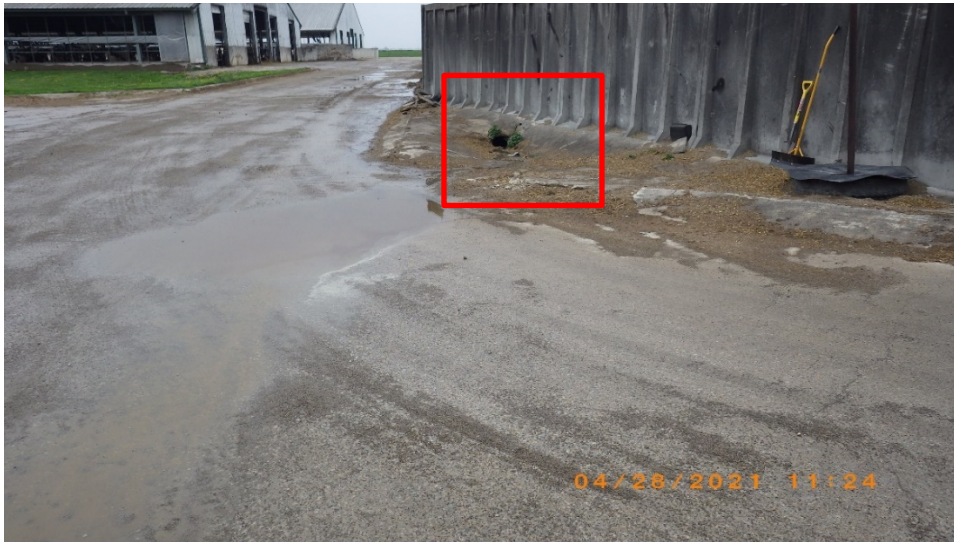
Photo Number: RIMG0106

Description: Stormwater mixed with used bedding and manure from Barns 1, 2, and 3 and feed on the West Access Road sloped to the southeast to drain into the tile inlet identified in the red outlined box.

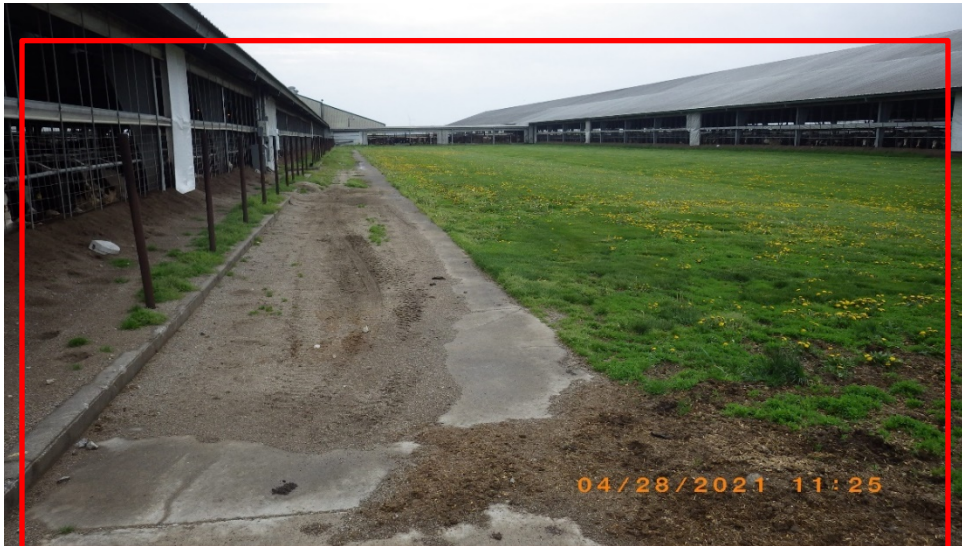
Photo Number: RIMG0108

Description: Looking between Barn 2 and Barn 3. Used bedding pushed out of the south side of Barn 3 shown in the red outlined box in the photo above.

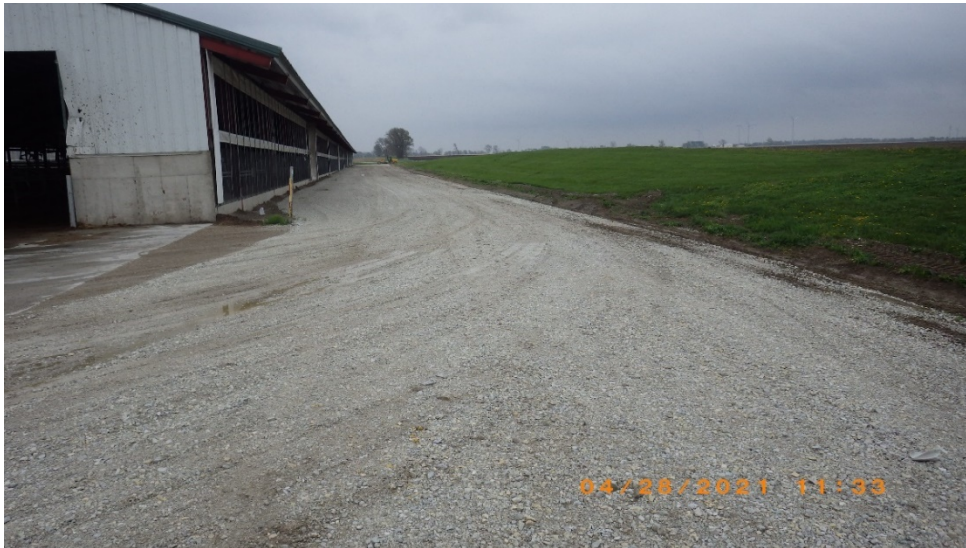
Photo Number: RIMG0116

We continued to the west side of the barns on the West Access Road (Attachment B). EPA observed the Hay Storage Barn on the west side of the facility and observed used bedding, feed, and manure on the West Access Road tracked out of Barn 1.(Photos RIMG0098 and RIMG0099). Mr. Boerman stated that any stormwater that comes into contact with solids tracked out of Barns 1, 2, or 3 flows either into the tile inlets between these barns or surface flows east along the West Access Road to the Solid and Sand Stacking Pad. Mr. Boerman stated that when stormwater comes into contact with solids on the West Access Road west of the Barn 4 and Barn 5, it surface flows to the South Drainage Ditch (Attachment B) and into the Stormwater Pond (Photos RIMG0115, RIMG0116, and RIMG0117).

Description: On the South Access Road on the south side of Barn 5.

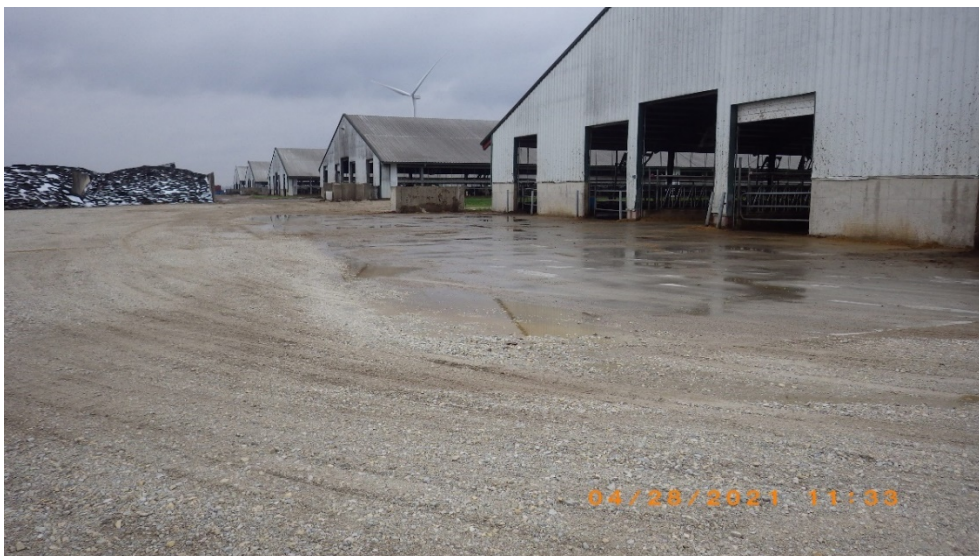
Photo Number: RIMG0117

Description: Observing the direction of flow on the west side of Barns 5 through 4, which is to the southwest.

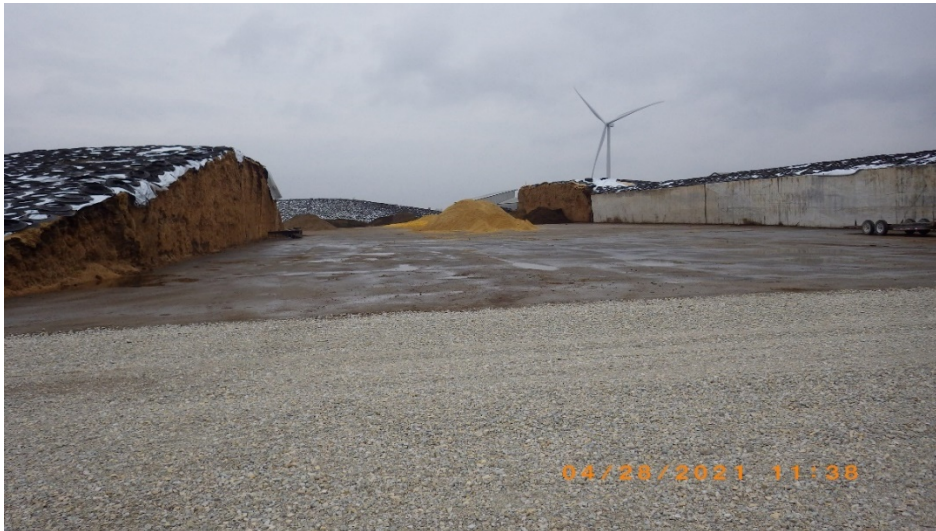
Photo Number: RIMG0120

Description: High grains stored in the concrete Feed storage Area that drain to the manholes that drain to the Silage Leachate Collection Pond.

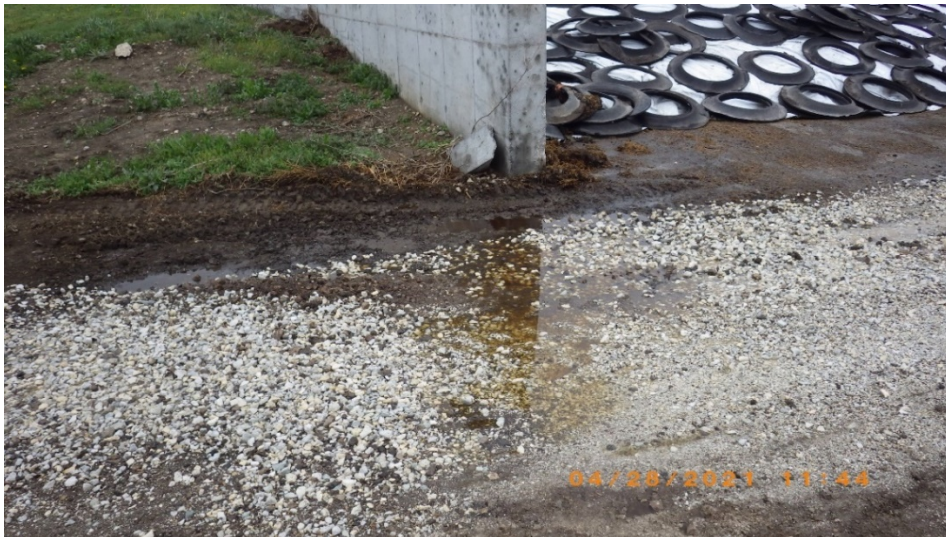
Photo Number: RIMG0123

We continued our walk-through to the south side of the Stormwater Pond and observed leachate from the silage stored in the silage bunkers. Any leachate, stormwater, and/or stormwater that comes into contact with the feed in the bunkers flows either into the South Drainage Ditch (Attachment B) or along the South Access Road (Attachment B) and into the Stormwater Pond (Photos RIMG0119 through RIMG0128).

Description: The process wastewater coming off of the silage stored in the Silage Bunkers flows to the west into the Stormwater Pond.

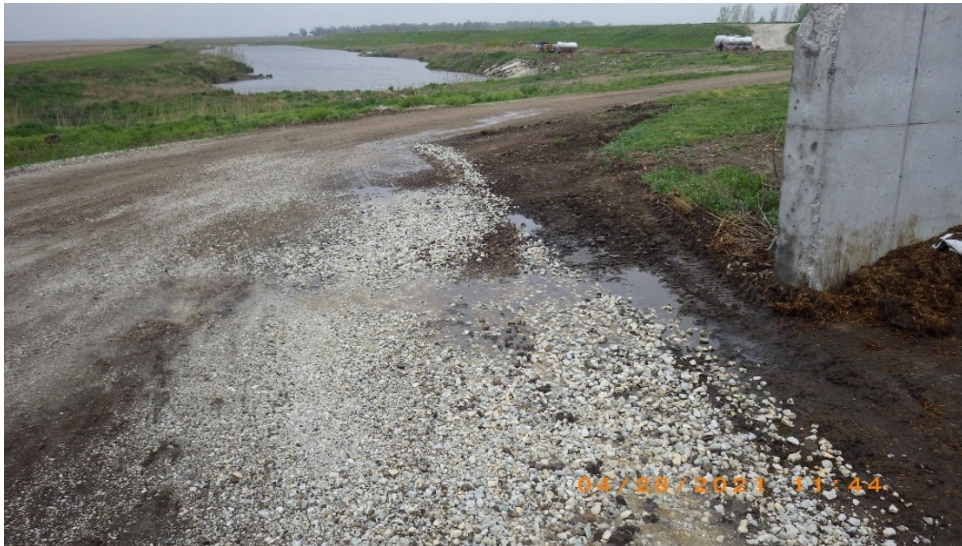
Photo Number: RIMG0124

Description: The process wastewater flowing to the south into the Stormwater Pond.

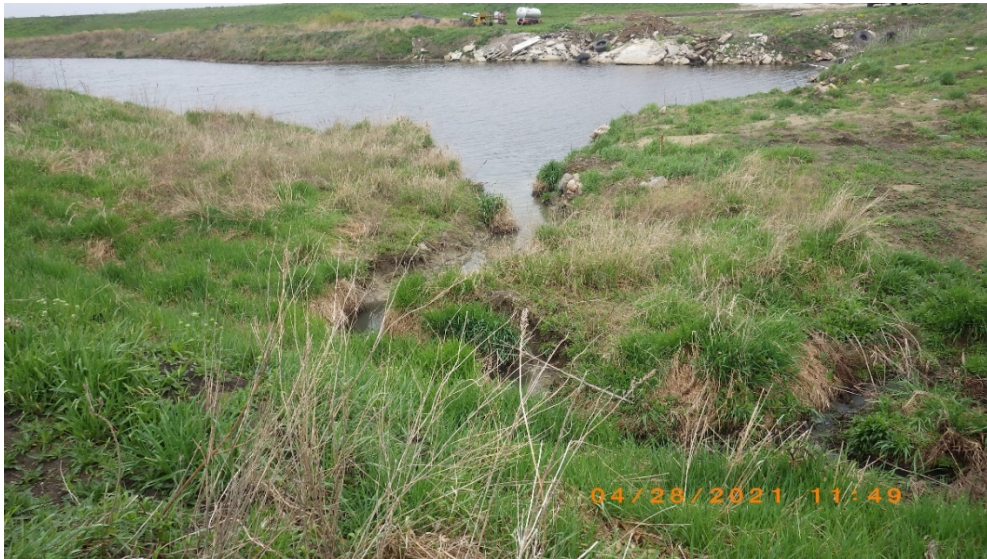
Photo Number: RIMG0128

Description: The eroded channel carries flow into the Stormwater Pond.

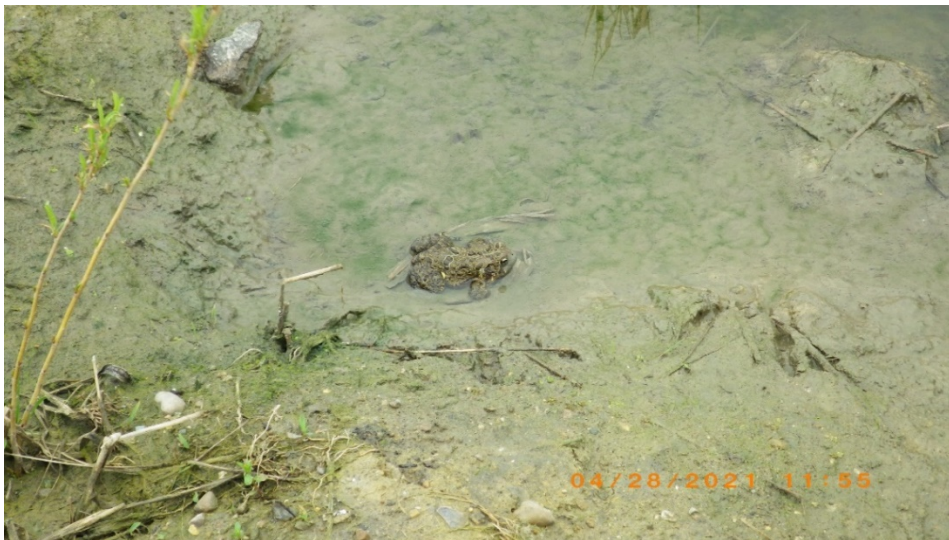
Photo Number: RIMG0129

As we were walking on the south side of the Stormwater Pond, we observed approximately one hundred frogs/toads within the Stormwater Pond (Photos RIMG0129 through RIMG0132). We continued to the southwest side of the Stormwater Pond where we observed the tile outlet into the Stormwater Pond. Mr. Boerman explained that the

Description: Observed hundreds of frogs in the Stormwater Pond.

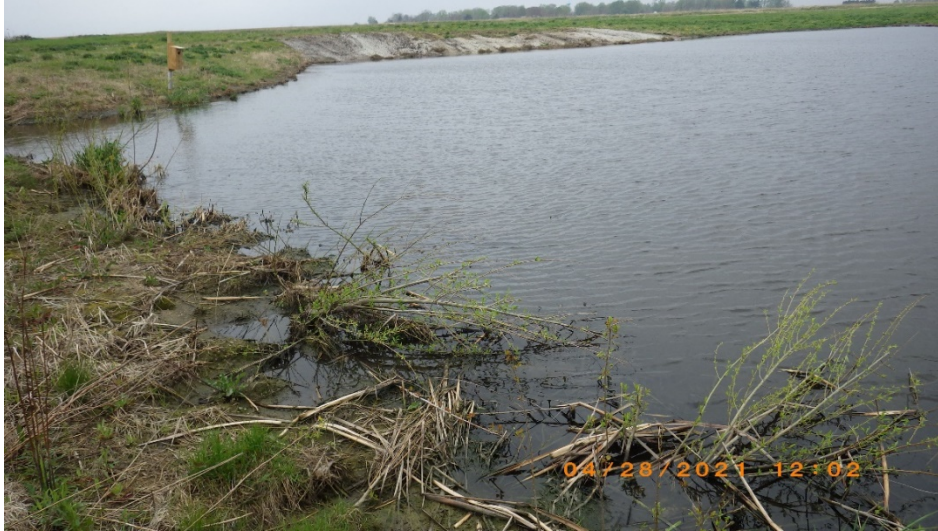
Photo Number: RIMG0130

Description: There were hundreds of frogs within the Stormwater Pond.

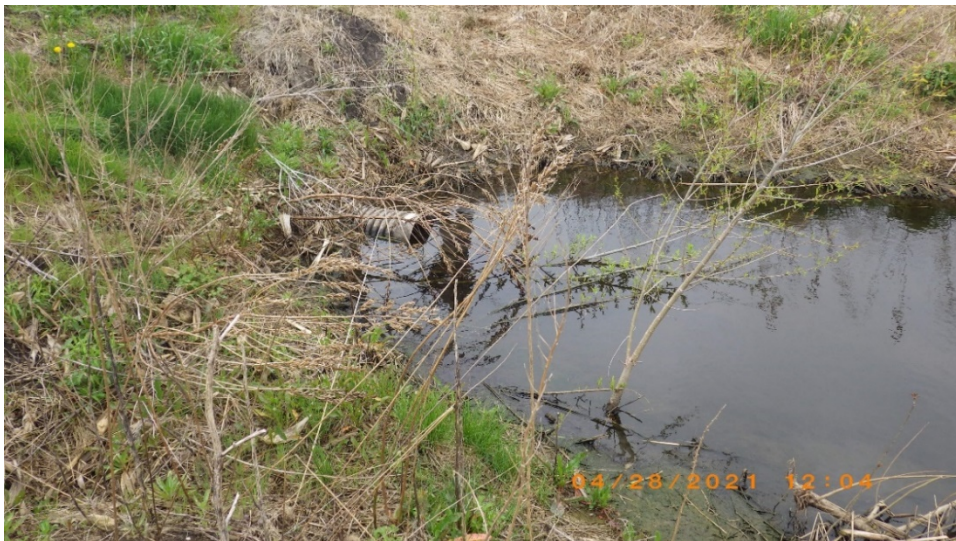
Photo Number: RIMG0133

agricultural field to the south was tiled to flow into Prudential Ditch (Photos RIMG0135 and RIMG0136), but this tile has been plugged and is now tiled to flow into the Stormwater Pond (Photo RIMG0133). We observed an access ramp into the Stormwater Pond, which Mr. Boerman explained farmers use to access the Stormwater Pond for irrigating their crops (Photo RIMG0134).

Description: Tile outlet from the agricultural field drains into the Stormwater Pond.

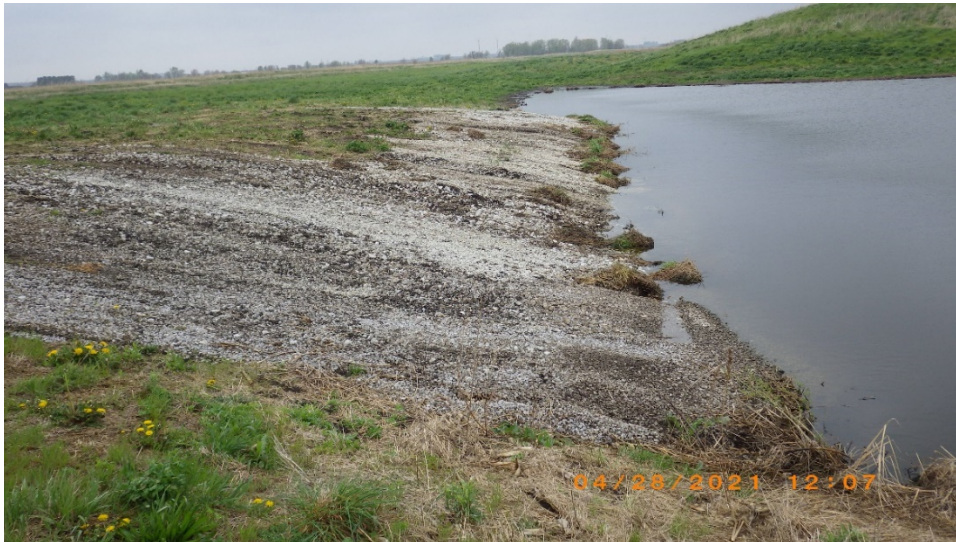
Photo Number: RIMG0134

Description: Access area to pump out the Stormwater Pond.

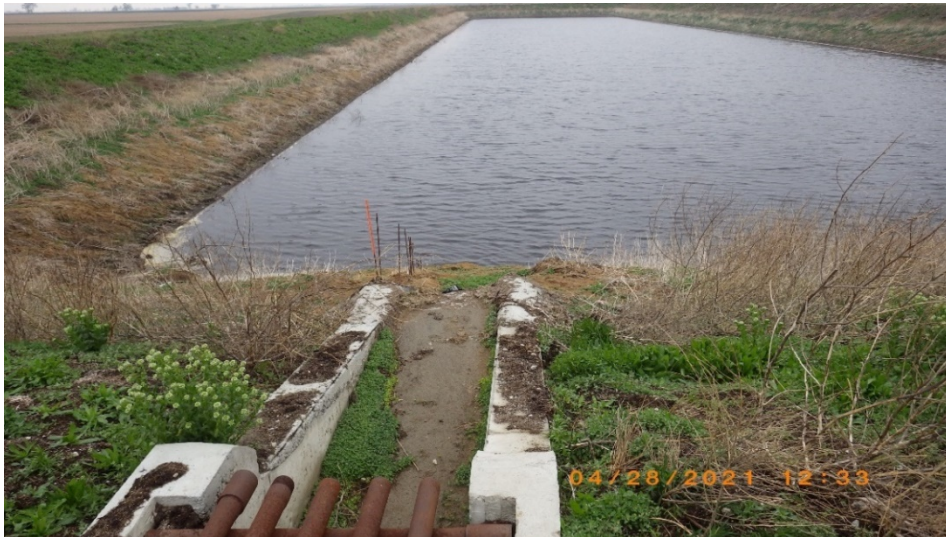
Photo Number: RIMG0143

We observed the concrete overflow between the 4<sup>th</sup> and 5<sup>th</sup> Stage Lagoon on the east side of the 5<sup>th</sup> Stage Lagoon (Photo RIMG0143). The concrete overflow works when the liquids reaches the height of the overflow, the liquids will gravity flow into the next stage lagoon, with less and less solids. We observed the depth marker within the 4<sup>th</sup> Stage Lagoon.

Description: The concrete overflow that conveys process wastewater from the 4<sup>th</sup> Stage Lagoon into the 5<sup>th</sup> Stage Lagoon.
