**Region 6 Compliance Assurance and Enforcement Division  
INSPECTION REPORT**

| Inspection Date(s): | 11/18/2015 – 11/19/2015 | | |
| Company Name: | Lutex Oil, Ltd | | |
| Facility Name: | Cora Malone A Lease | | |

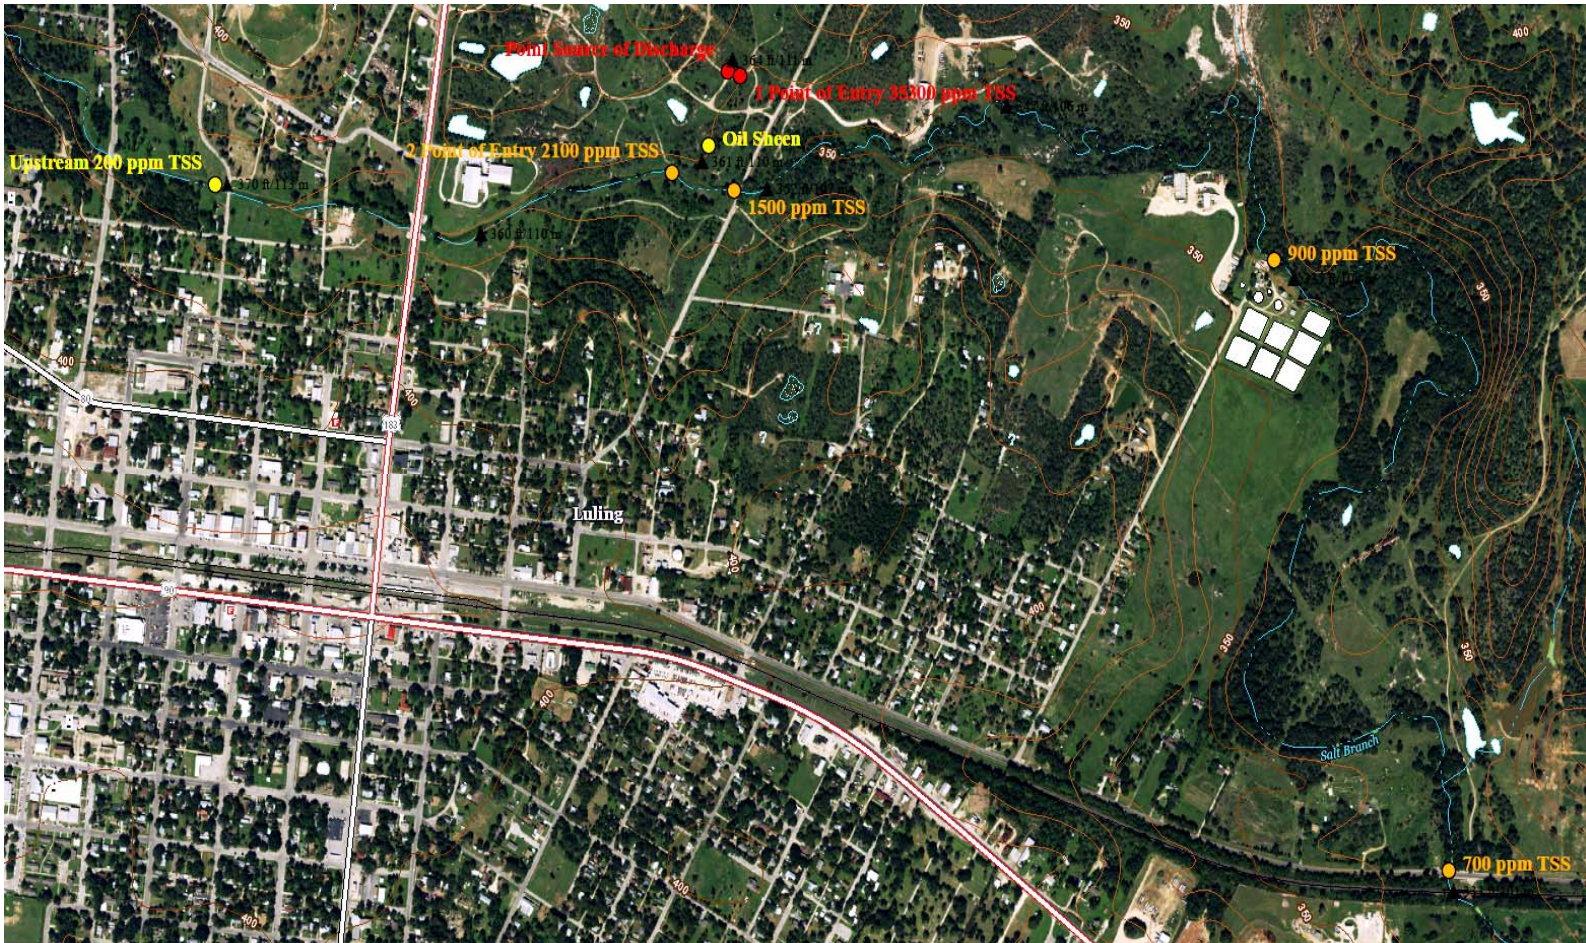
Photo No. 1

Description: This image shows a USGS Aerial Map of Lutex Oil, Ltd / Cora Malone A Lease. This is a layout of Lutex Oil Ltd. Red colored label indicates the location of tanks and point source of discharge 35,300 ppm Total Soluble Salts (TSS). The orange colored labels indicates TSS readings taken during the inspection (700 – 35,300 ppm TSS). Yellow colored label indicates background data and oil sheen. The black colored labels indicated the elevation at that position in feet.

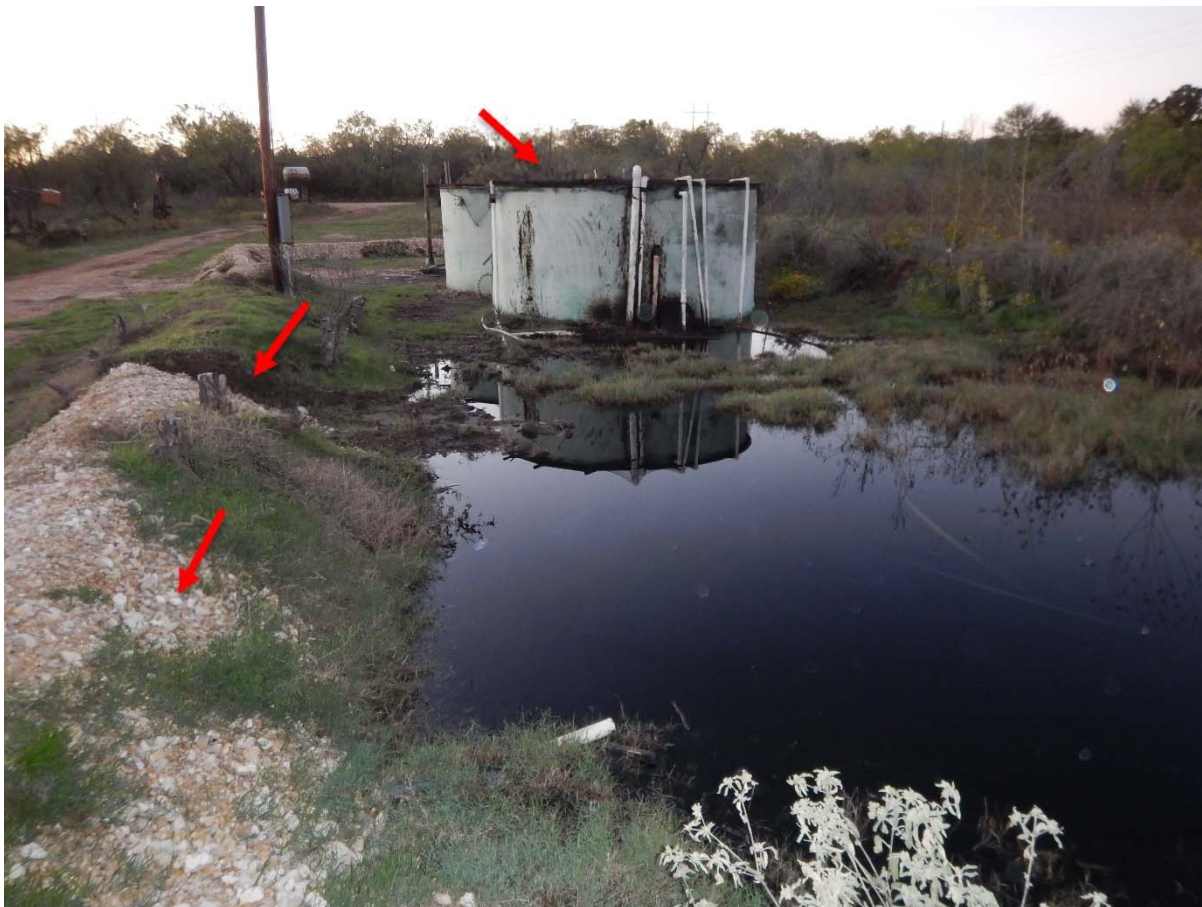
Photo No. 3

This image shows the facility with two operational tanks. The secondary containment walls are improperly constructed and inadequate for the size of the facility.

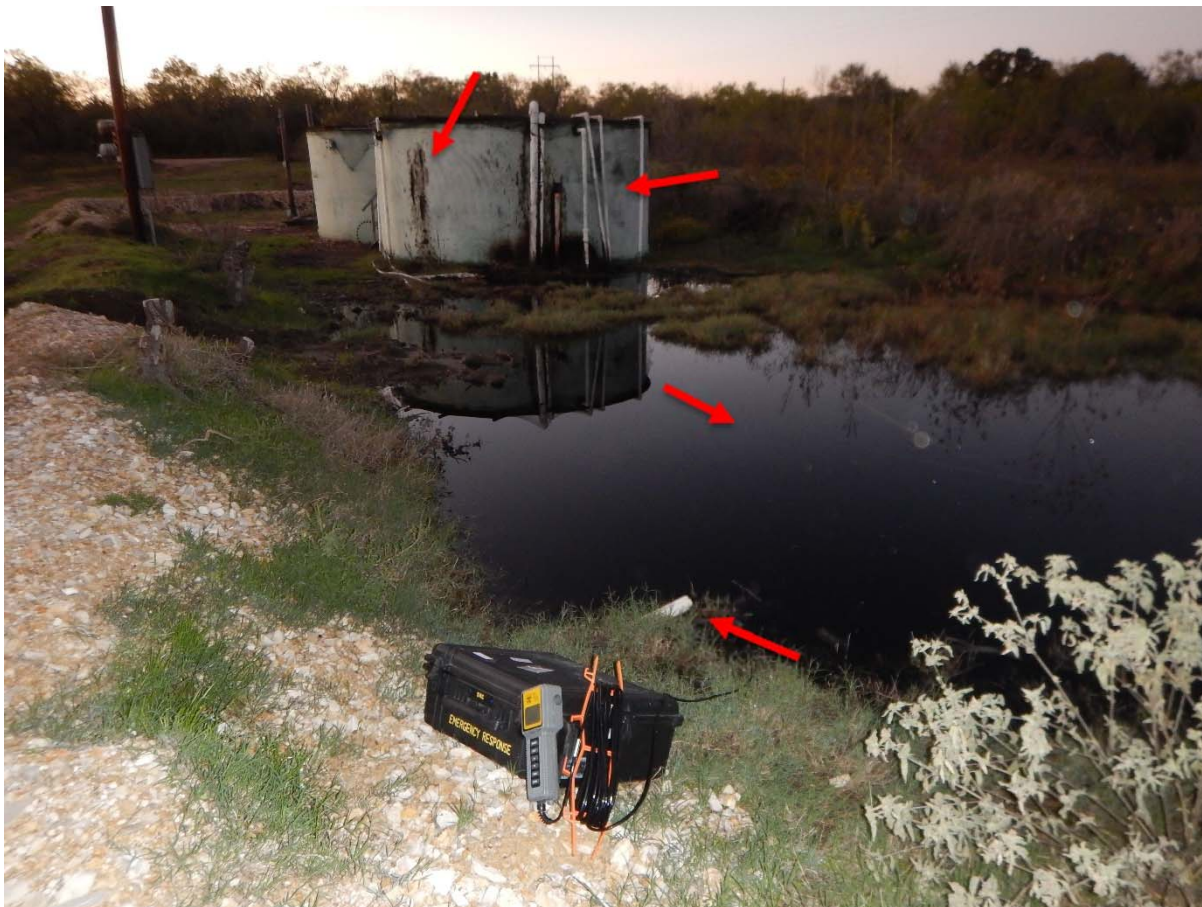
Photo No. 4

Description: This image shows two tanks associated with the facility, standing pond of fluids within the containment area, and visible oil on the sides of the tanks and the associated PVC flow lines at the tanks. There were also PVC flow lines coming out and connected to the tanks and a PVC pipe with unknown usage and destination.

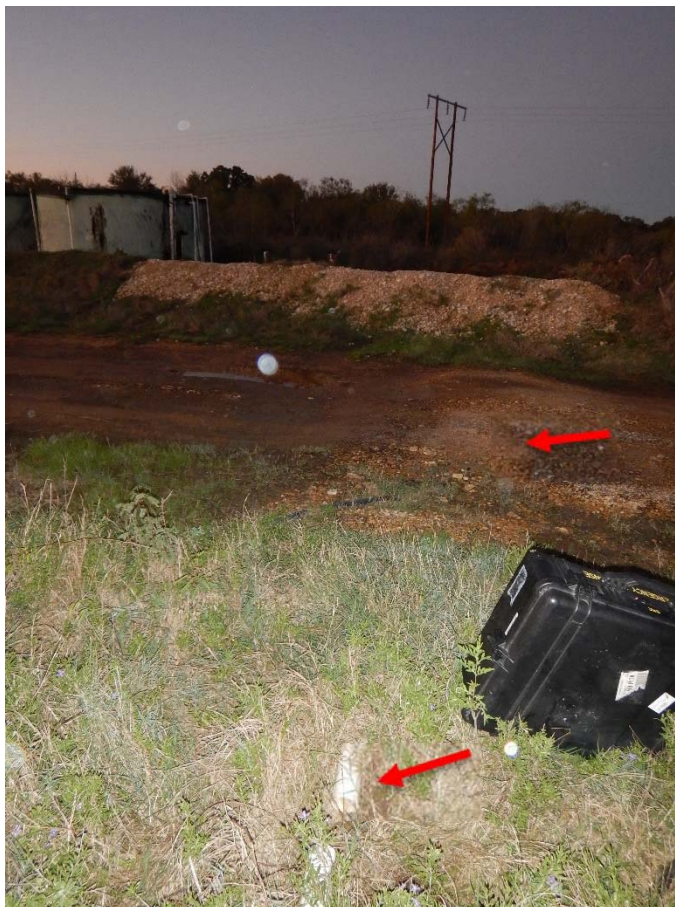
Photo No. 6

Description: This image shows a flow path of fluids away from the tank battery, and a PVC pipe.. At this tank battery, it was also observed an open ended PVC flow line going through the secondary containment wall towards the tributary of Salt Branch Creek. The PVC flow line is used as a drainage system for fluids within the containment area.

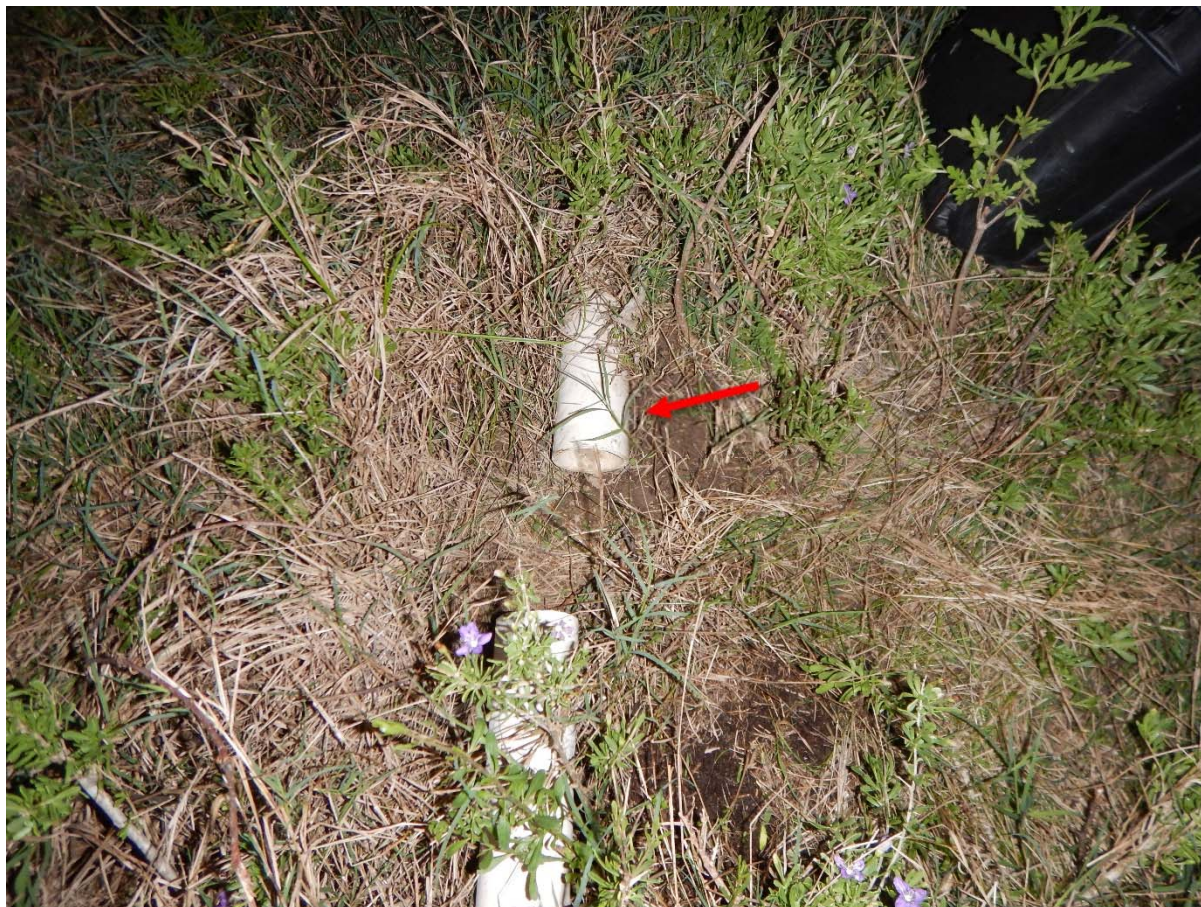
Photo No. 7

Description: This image shows an open ended PVC flow line going through the secondary containment wall towards the tributary of Salt Branch Creek. The PVC flow line is used as a drainage system for fluids within the containment area.

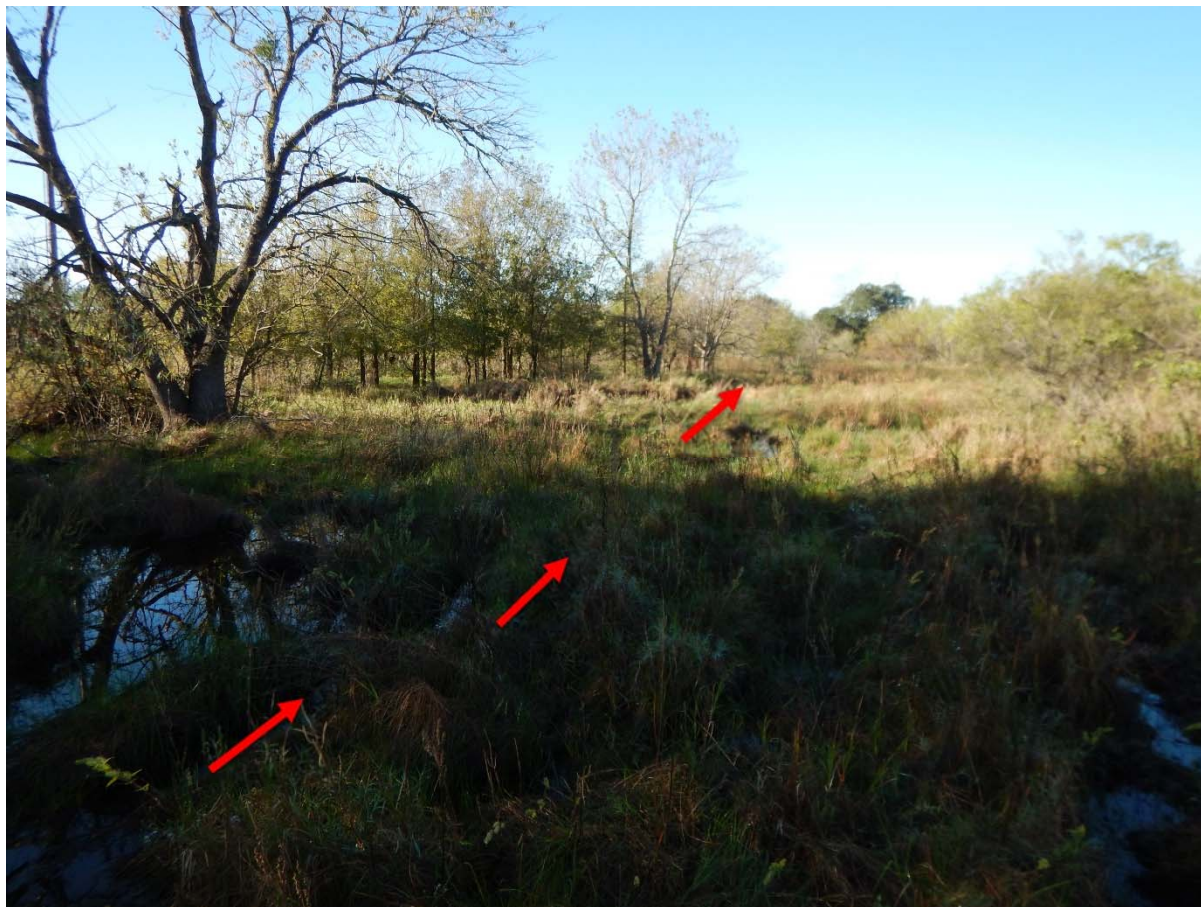
Photo No. 8

Description: This image shows a flow path of fluids away from the tank battery towards the tributary of Salt Branch Creek. Also we observe dead vegetation and oil sheens.

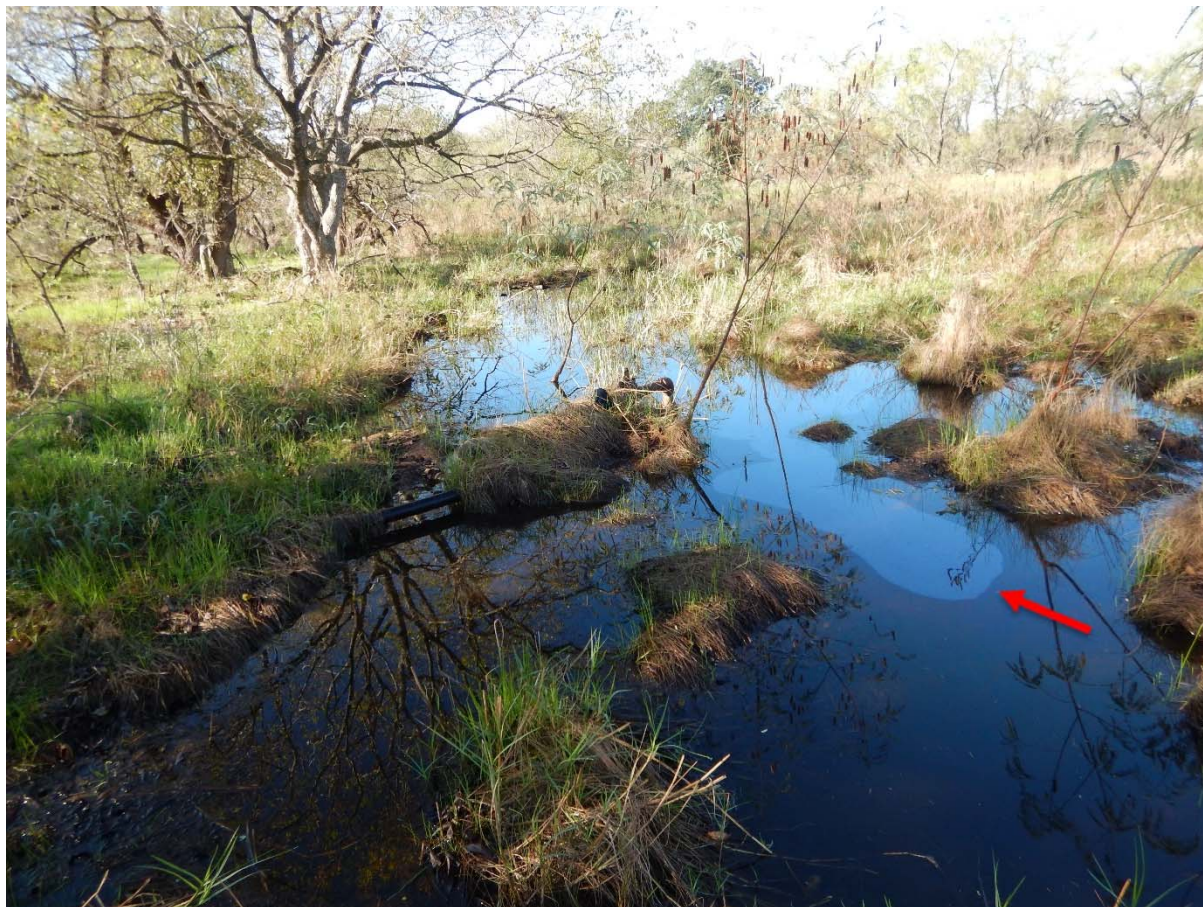
Photo No. 9

oil sheens at Latitude 29.688012 N and Longitude -97.640408 W. See Photo N°8 and photo N°9 in Appendix 1. A second TSS reading of 2,100 ppm, approximately 500 feet from the tanks, was obtained from Salt Branch Creek located at Latitude 29.687614 N and Longitude -97.641193 W. This is the second Point of Entry (POE) to Salt Branch Creek. At this point, the tributary shows a defined bed and bank and evidence of plants growing along the tributary, evidence of sediments, debris, and plants growing along the creek. Salt Branch Creek was approximately 4 feet deep and approximately 25 feet wide. See Photo N°10 and Photo N°11 in Appendix 1.

Description: This image shows a flow path of fluids, oil sheens, and dead vegetation.

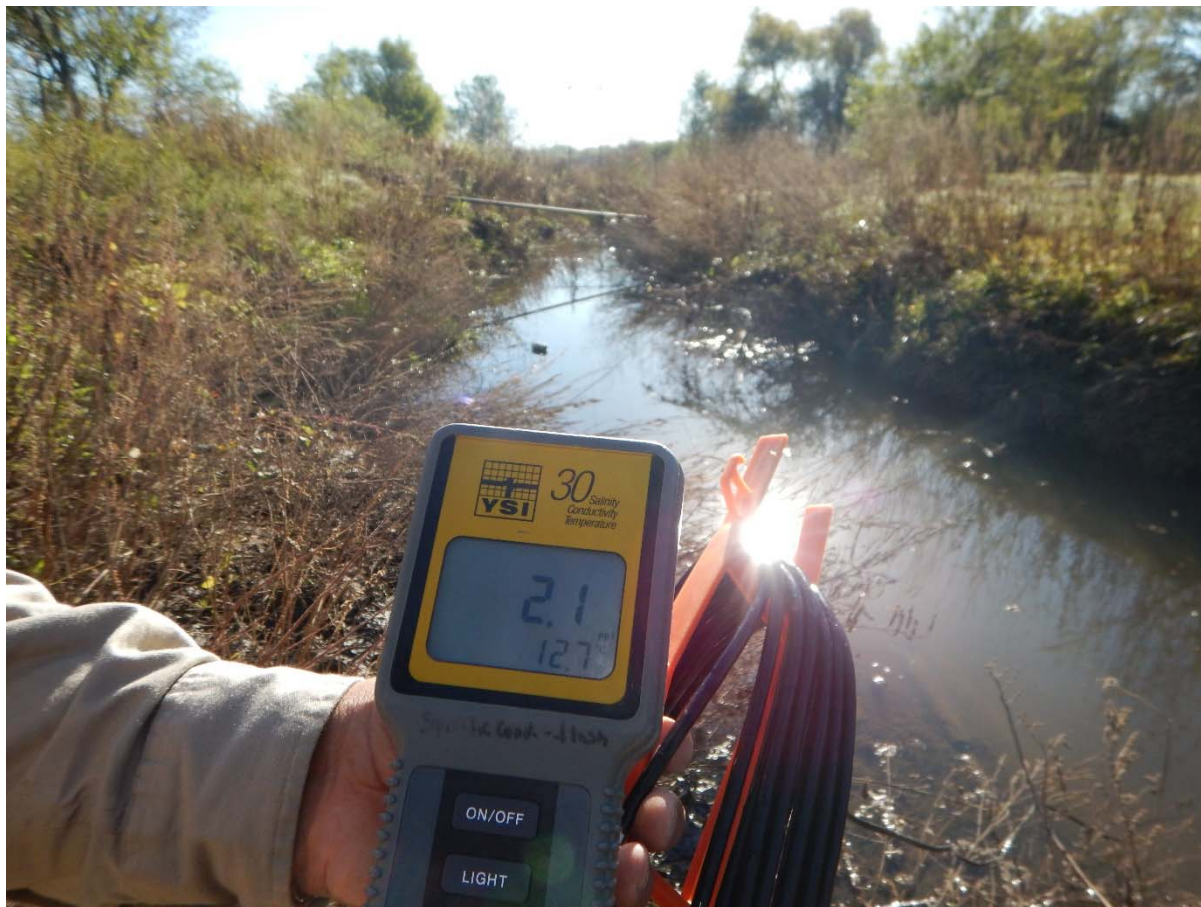
Photo No. 10

Description: This image shows a Total Soluble Salts (TSS) reading of 2,100 parts per million (ppm) at the second Point of Entry (POE) to Salt Branch Creek. This point is located approximately 500 feet southeast from the tanks.

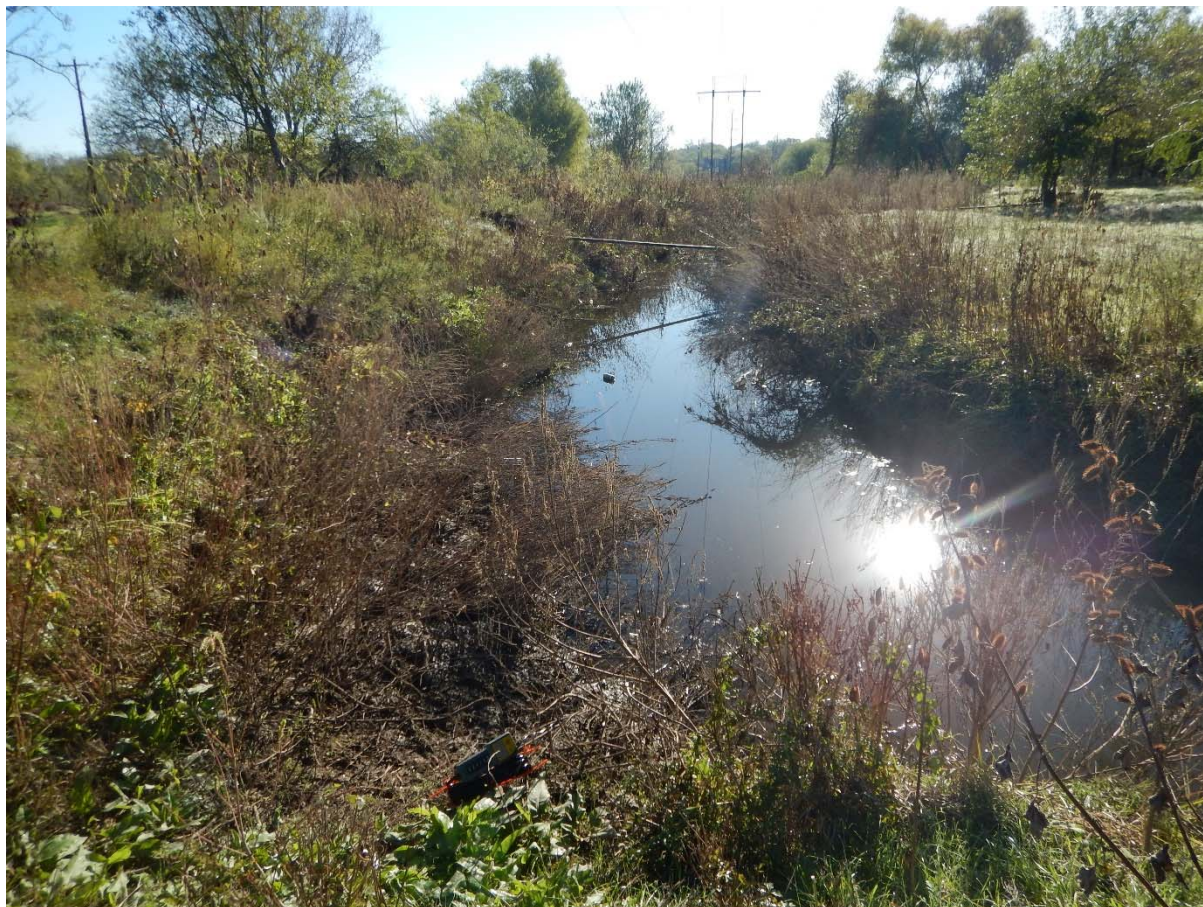
Photo No. 11

Description: This image shows Salt Branch Creek flowing at the time of the inspection. The creek shows a defined bed and bank, evidence of plants growing along the tributary, evidence of sediments, debris, and plants growing along the creek. The creek is approximately 25 feet wide by 4 feet deep.

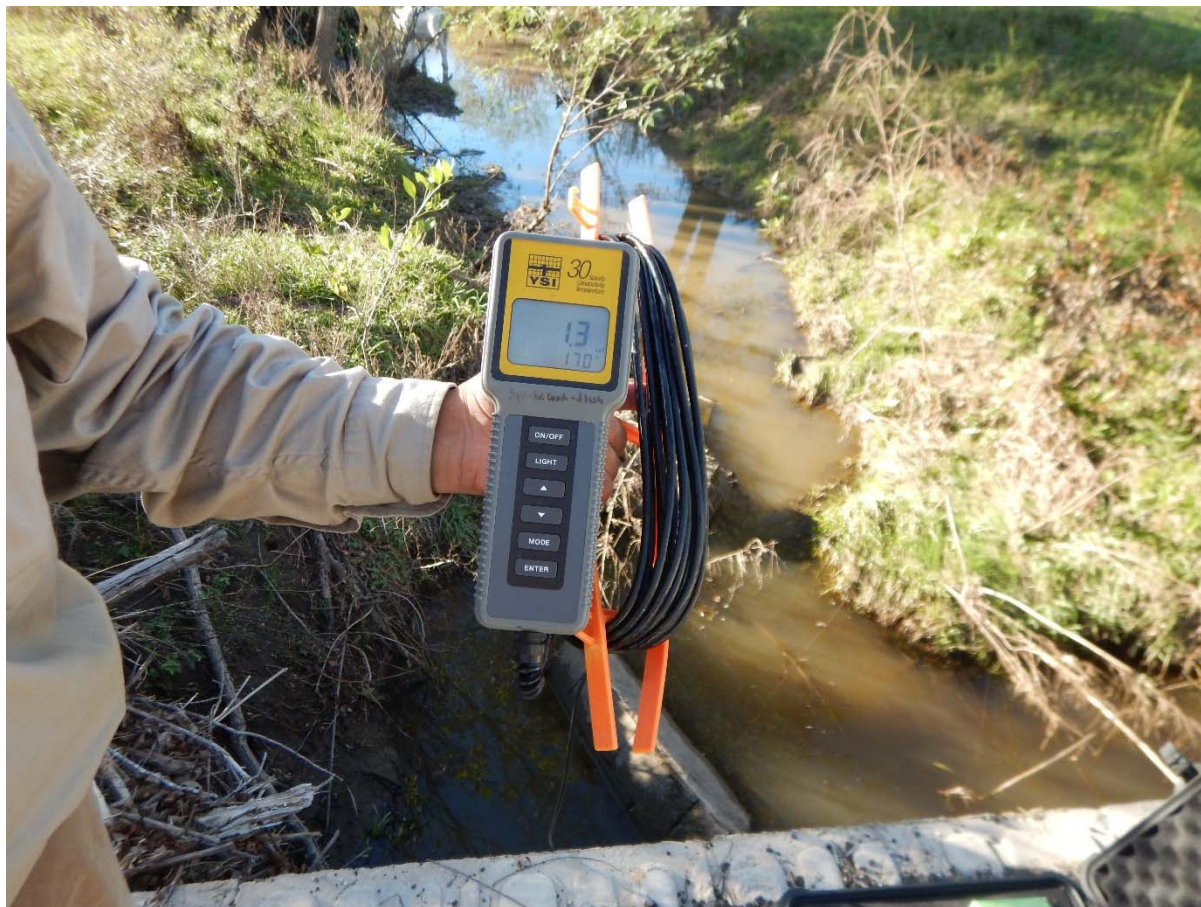
Photo No. 12

Description: This image shows a Total Soluble Salts (TSS) reading of 1,500 parts per million (ppm) downstream from the second POE of Salt Branch Creek. This point is located approximately 431 feet southeast from the second POE.

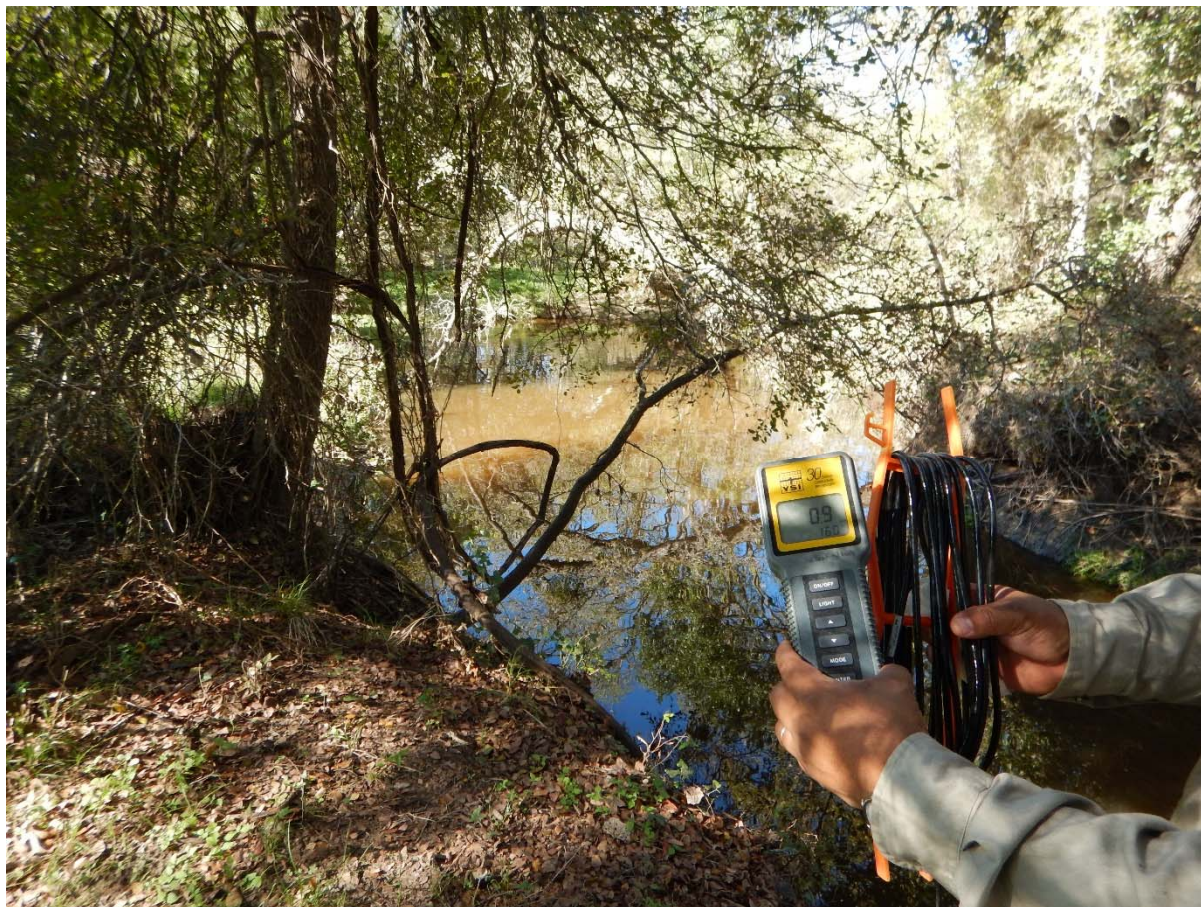
Photo No. 13

Description: This image shows a Total Soluble Salts (TSS) reading of 900 parts per million (ppm) downstream from the second POE of Salt Branch Creek. This point is located approximately 1.126 Miles southeast from the second POE.

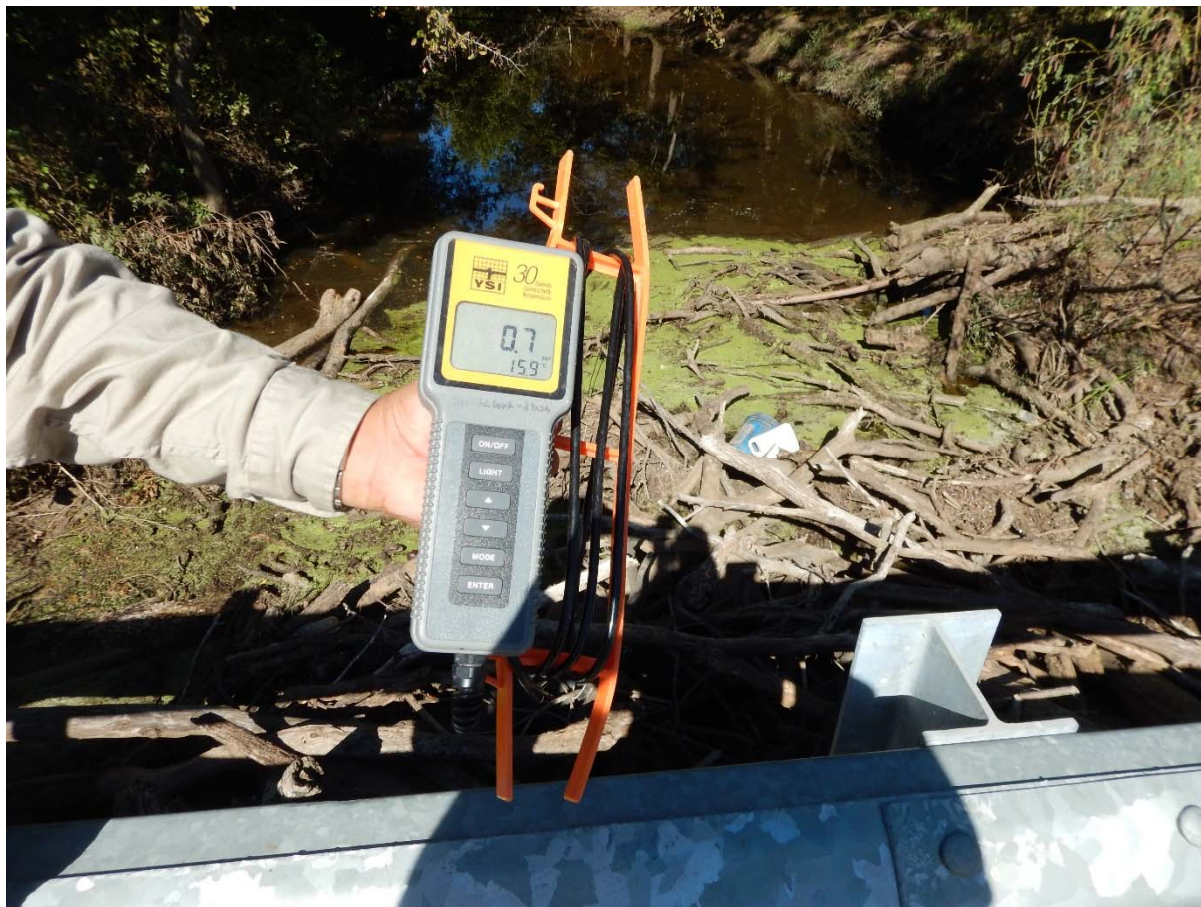
Photo No. 14

We followed the flow path southeast from the tank battery location approximately 2.45 Miles, to Salt Branch Creek, which is a tributary to Plum Creek, and performed different measurements to determine TSS concentrations. The tank battery is at approximately 361 feet elevation. We obtained a second POE TSS reading of 2,100 ppm at Latitude 29.687614 N and Longitude -97.641193 W. The second POE, where fluids reached Salt Branch Creek, was located at 500 feet from tanks and 352 feet elevation. At this location, Salt Branch Creek was approximately 4 feet deep and approximately 25 feet wide. See Photo N°10 in Appendix 1. We obtained at approximately 431 feet distance downstream from the second POE another TSS reading of 1,500 ppm at Latitude 29.687275 N and -97.639888 W at approximately 350 feet elevation. See Photo N°12 in Appendix 1. At approximately 1.126 miles distance downstream from the second POE, we obtained a third TSS reading of 900 ppm at Latitude 29.686192 N and -97.628506 W at approximately 335 feet elevation. See Photo N°13 in Appendix 1. Approximately 2.45 miles distance downstream from the second POE, we obtained a fourth TSS reading of 700 ppm at Latitude 29.676527 N and -97.624766 W at approximately 333 feet elevation. See Photo N°14 in Appendix 1. At this location Salt Branch Creek, which is a tributary of Plum Creek, was approximately 3 feet deep and approximately 55 feet wide. See Photo N° 14 in Appendix 1.

Description: This image shows a Total Soluble Salts (TSS) reading of 700 parts per million (ppm) downstream from the second POE to the tributary of Salt Branch Creek. This point is located approximately 2.45 Miles southeast from the second POE.

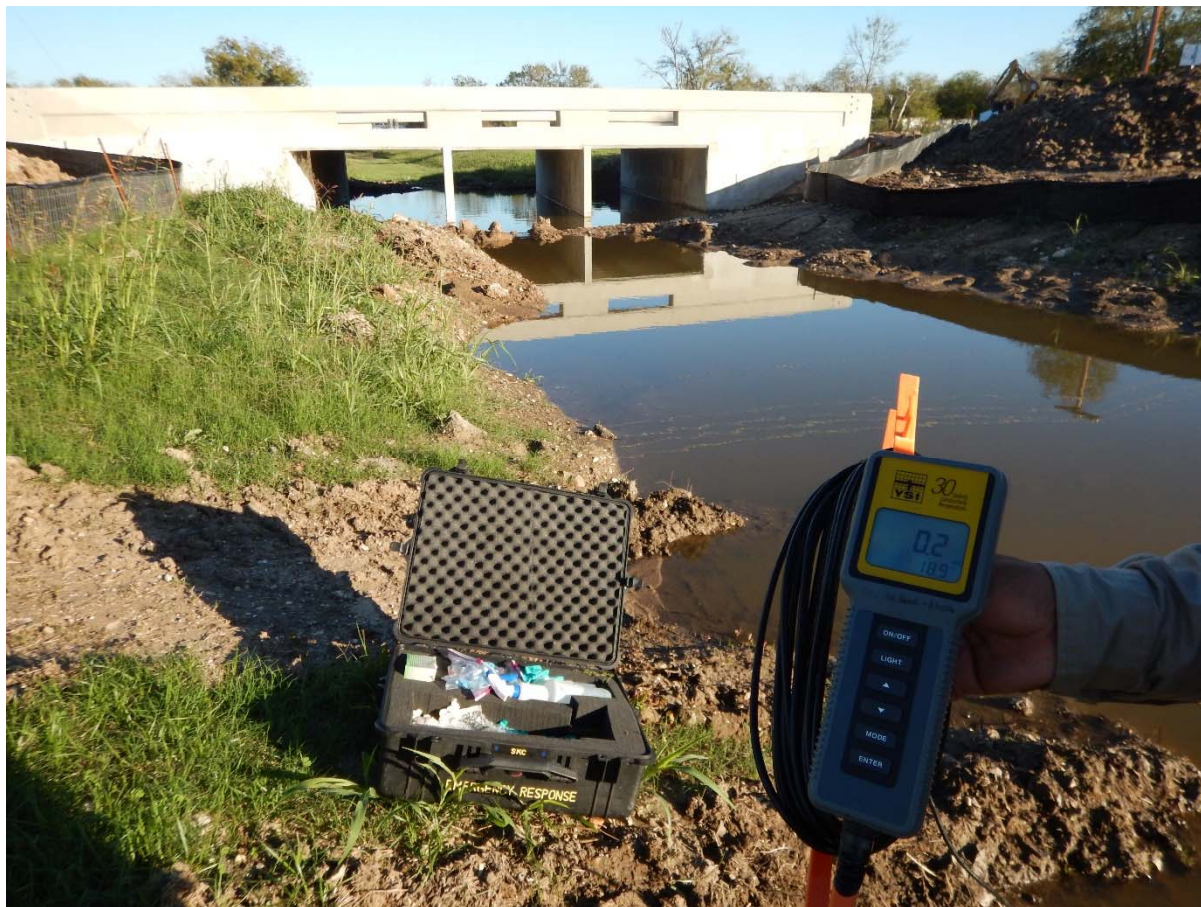
Photo No. 15

We measured the TSS to determine water quality data, such as water quality in the area. Therefore at approximately 0.728 miles upstream from the second POE, we measured the TSS and obtained a reading of 200 ppm at Latitude 29.687389 N and Longitude -97.650809 W. See Photo N°15 in Appendix 1.

Description: This image shows a Total Soluble Salts (TSS) reading of 700 parts per million (ppm) downstream from the second POE to the tributary of Salt Branch Creek. This point is located approximately 2.45 Miles southeast from the second POE.
