## Region 6 Compliance Assurance and Enforcement Division

### INSPECTION REPORT

| Company Name: | <b>Perdure Petroleum, LLC</b> | | |
| Facility Name: | <b>NBU 51</b> | | |

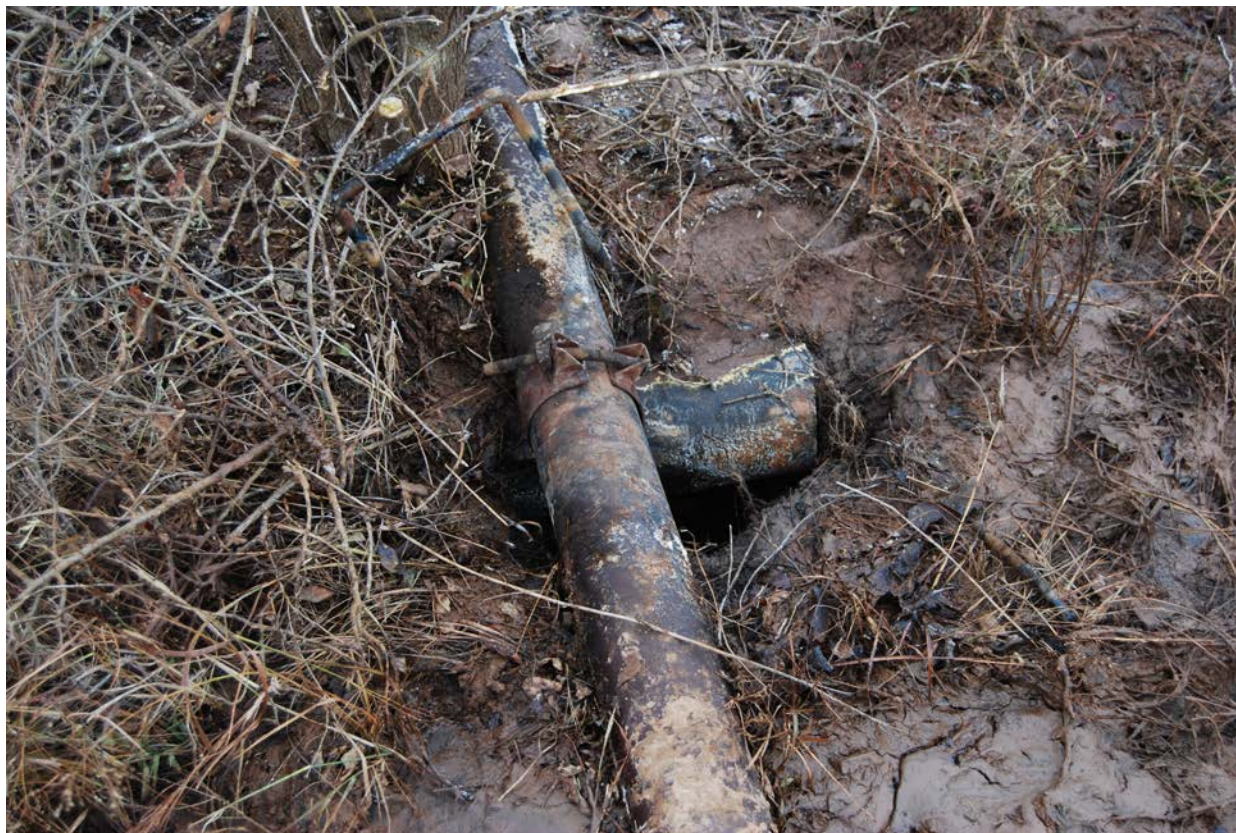
Photo No. 1

The origination point of discharge is a 5-inch steel injection well supply line that ruptured at a weak and corroded section in the line. The supply line carries brine to several wells in the area. I requested that Perdure Petroleum, LLC representatives provide pressure information and the number of injection wells that are serviced by the line, but that information has not been provided yet. The impacted tributary flows to Hay Creek, which flows south to Salt Creek, which enters the Arkansas River south of the area. The discharge was located north of the Webb City area and west of Shidler, Oklahoma.

Description: The discharge of produced water, or brine, originated from this 5-inch injection line associated with the Perdure Petroleum, LLC (North Burbank Unit 51) facility.

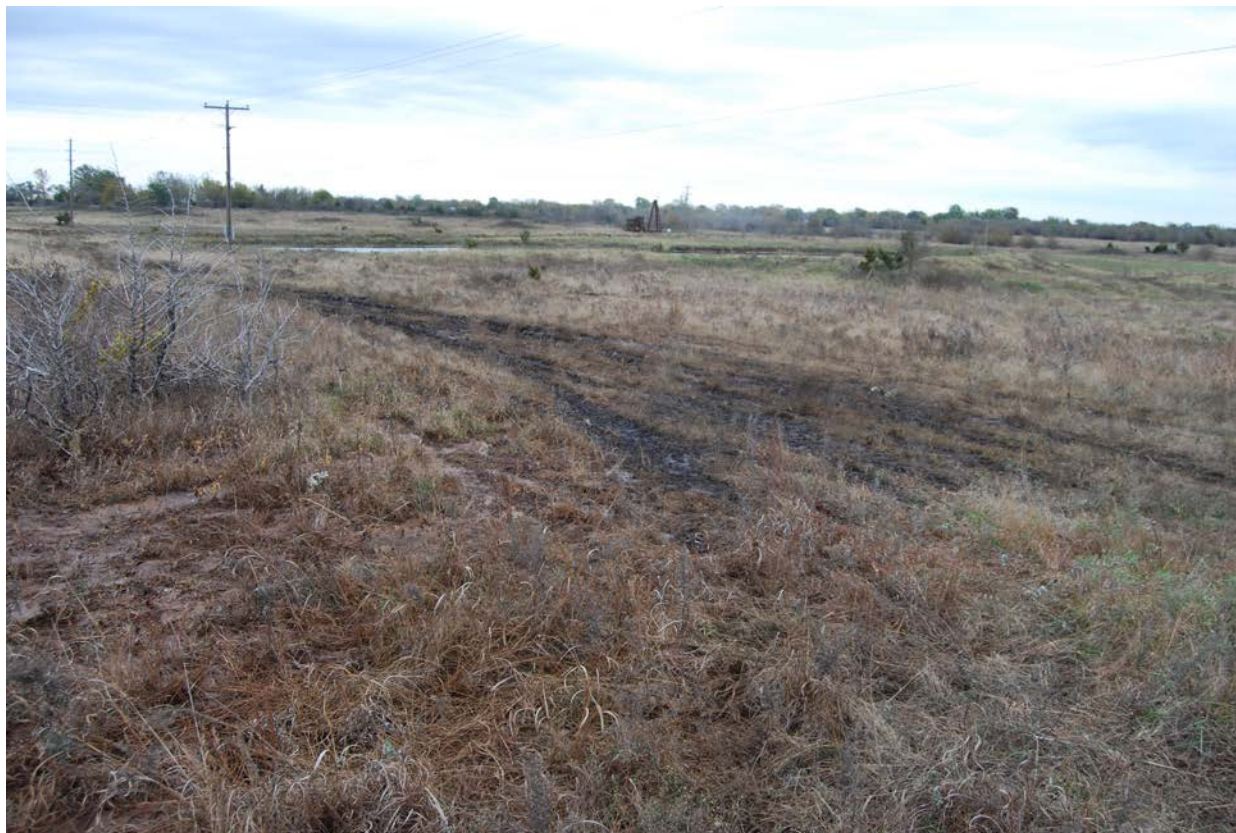
Photo No. 2

Description: The flow path from the leaking pipe toward the creek is shown here. The flow of brine did not enter the pond shown in this image.

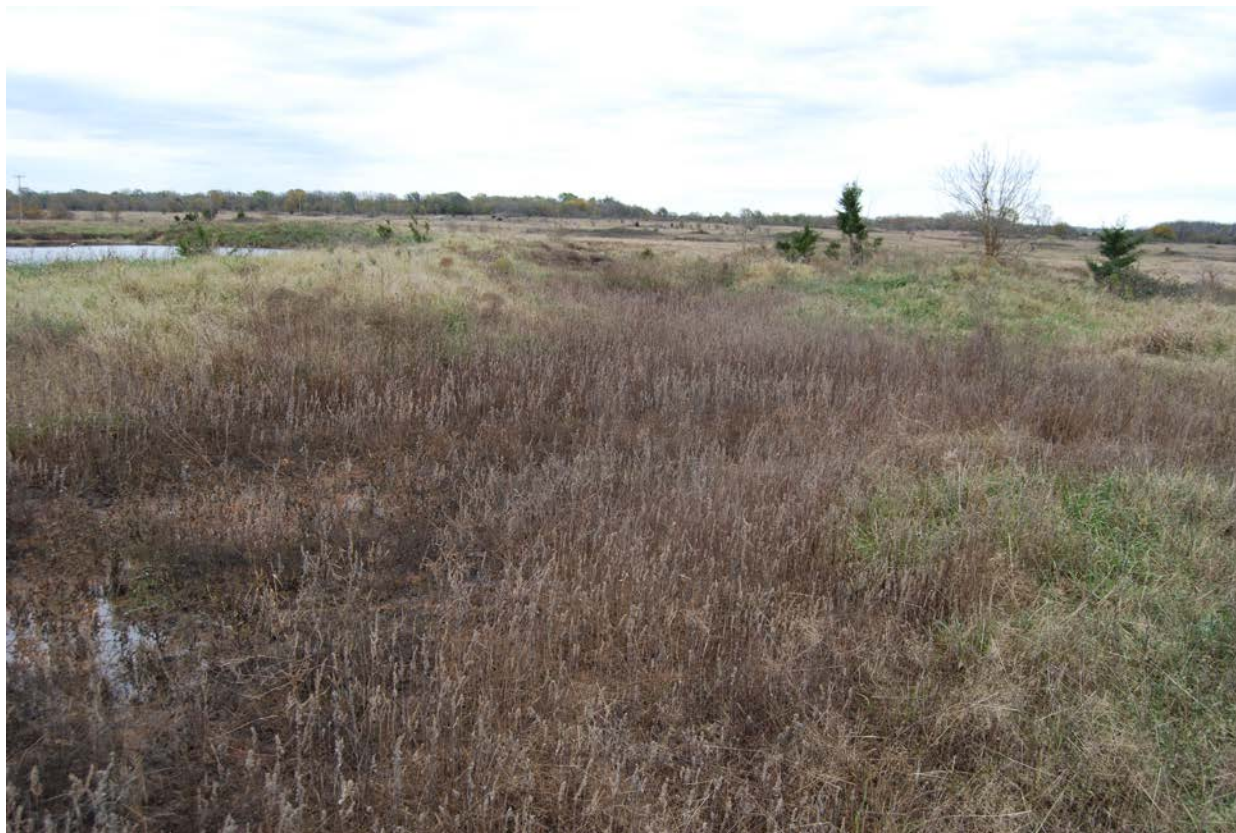
Photo No. 3

Description: The discharge of brine traveled east along the pond dam toward the tributary of Hay Creek.

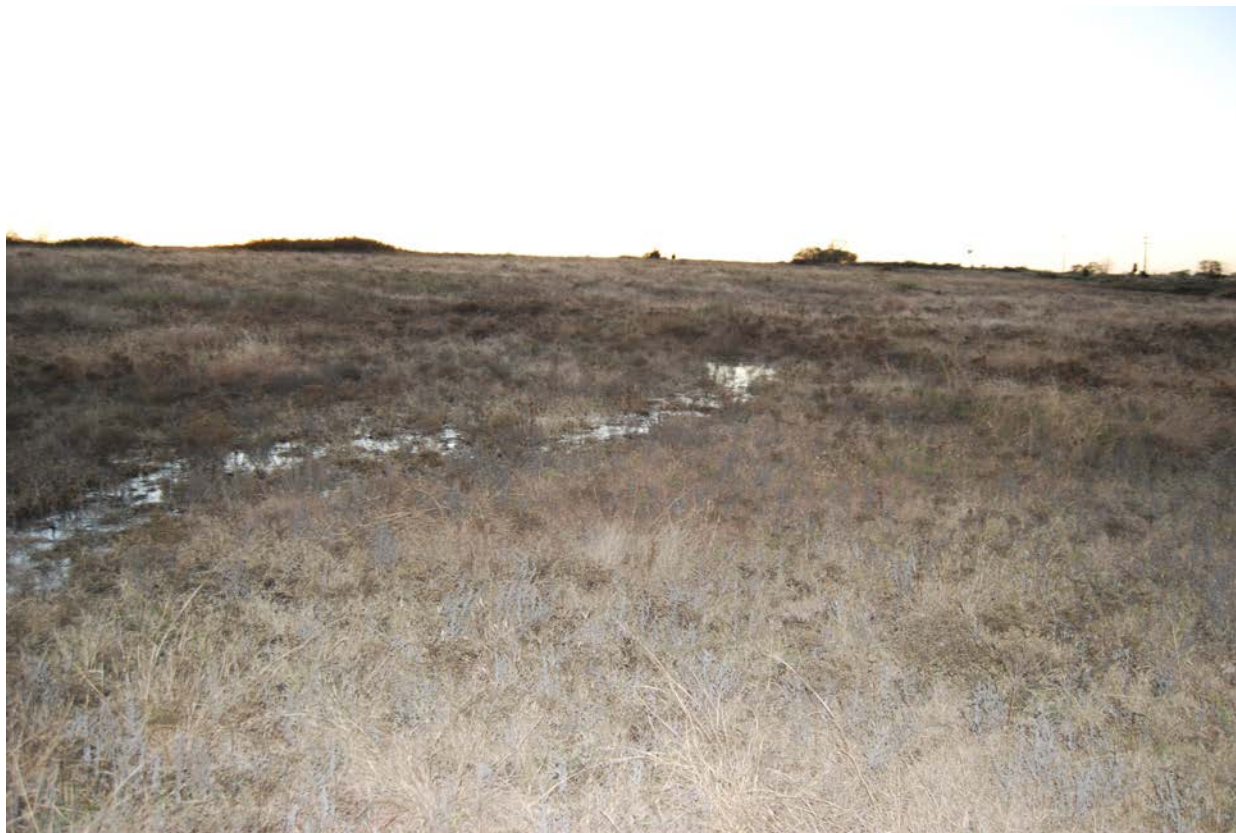
Photo No. 4

Description: The brine that was discharged, shown here, was entering the tributary of Hay Creek from the west.

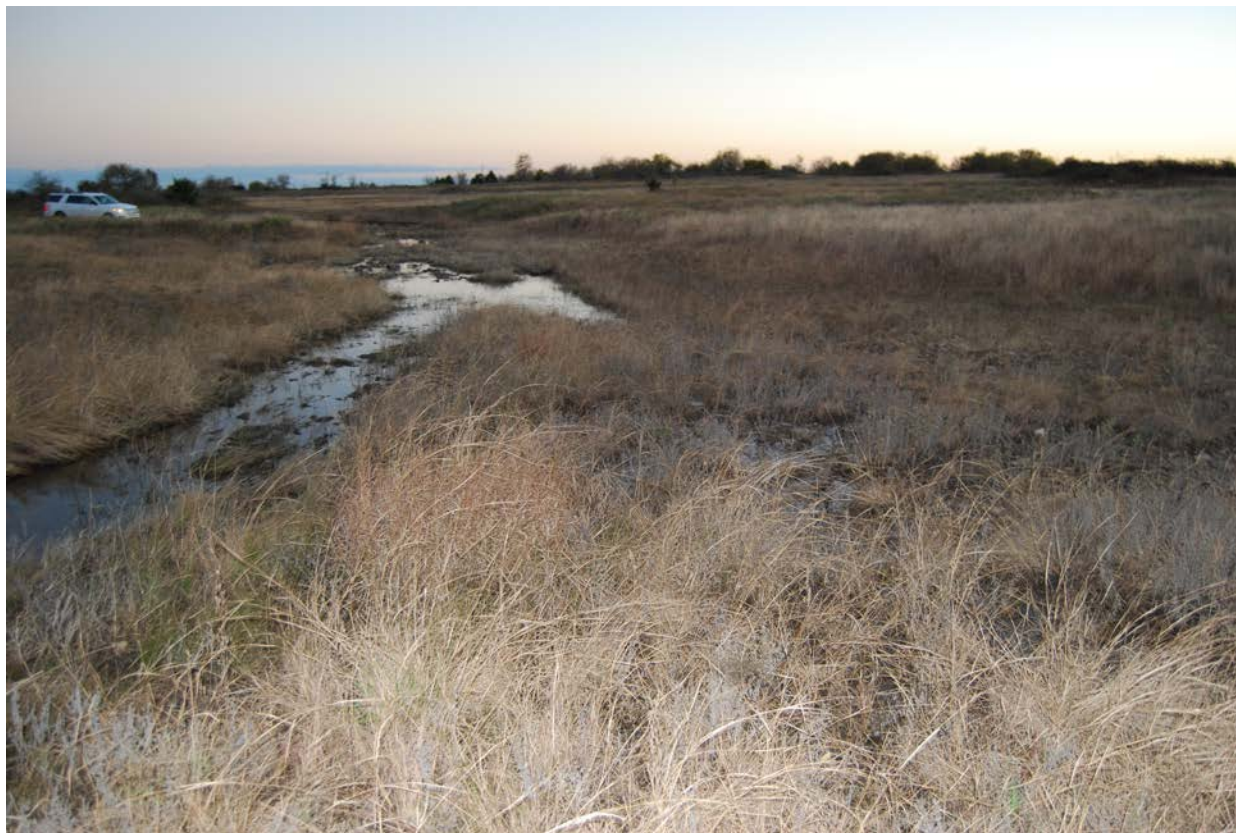
Photo No. 5

Description: The discharge enters the tributary of Hay Creek here from the hill to the west (or to the right in this photo).

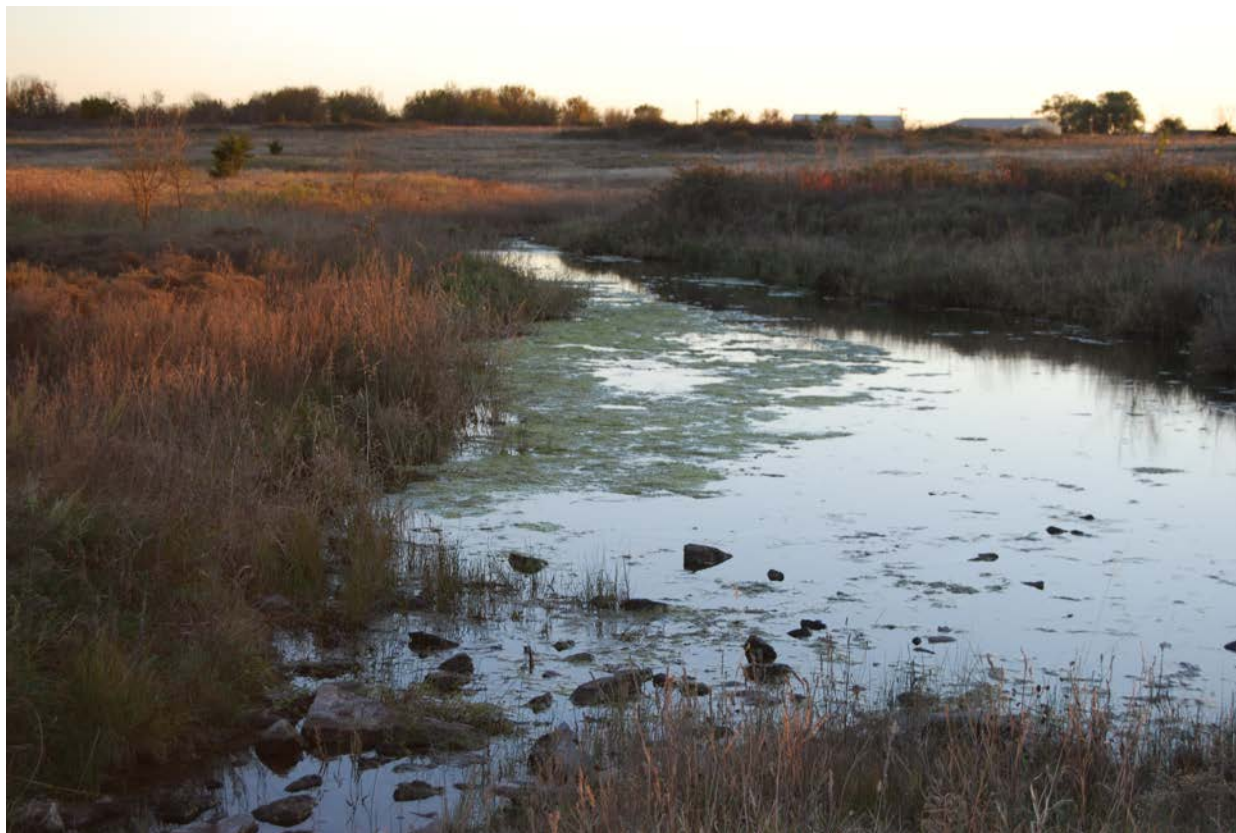
Photo No. 6

Description: The tributary of Hay Creek upstream is shown here. I observed green live algae in this location.

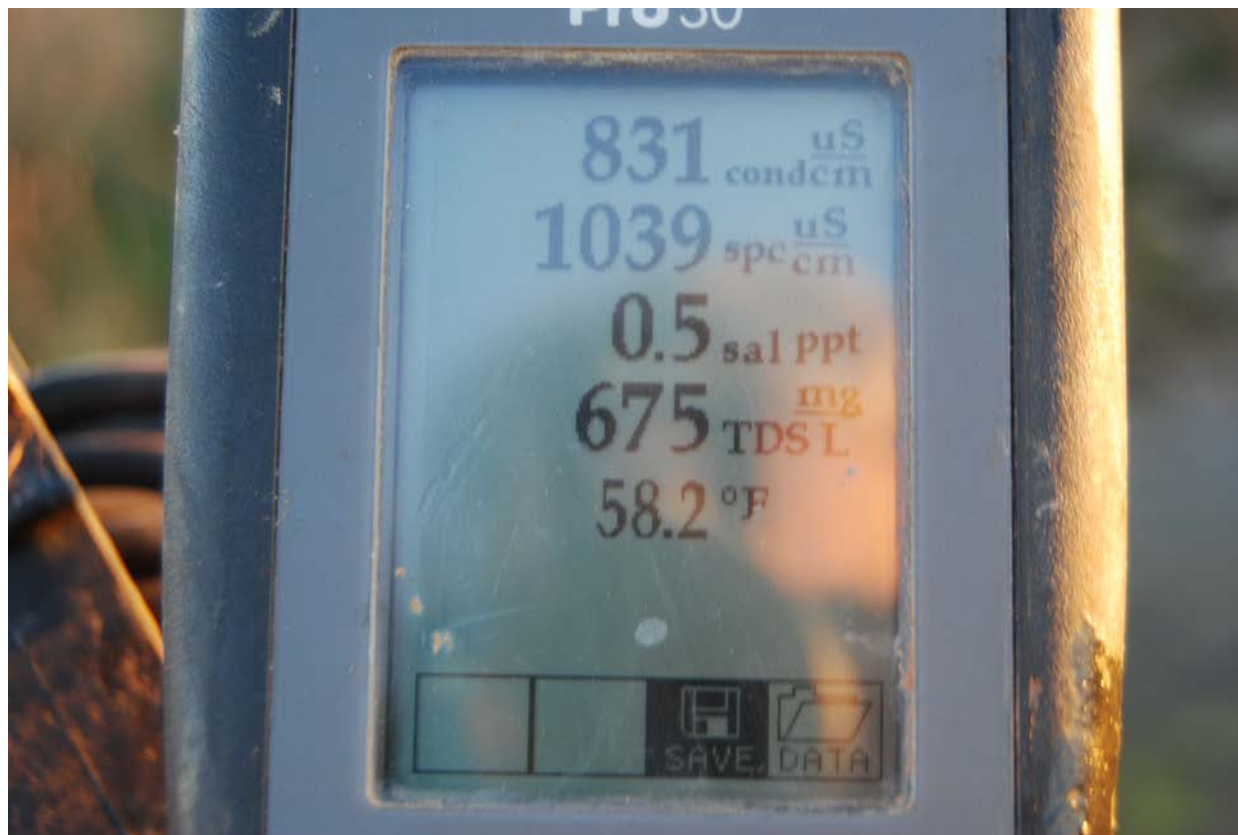
Photo No. 7

Description: A Total Dissolved Solids (TDS) reading was taken with a calibrated YSI Pro 30 Conductivity Meter of the unaffected tributary of Hay Creek upstream of the discharge point of entry into the tributary was 675 mg/L.

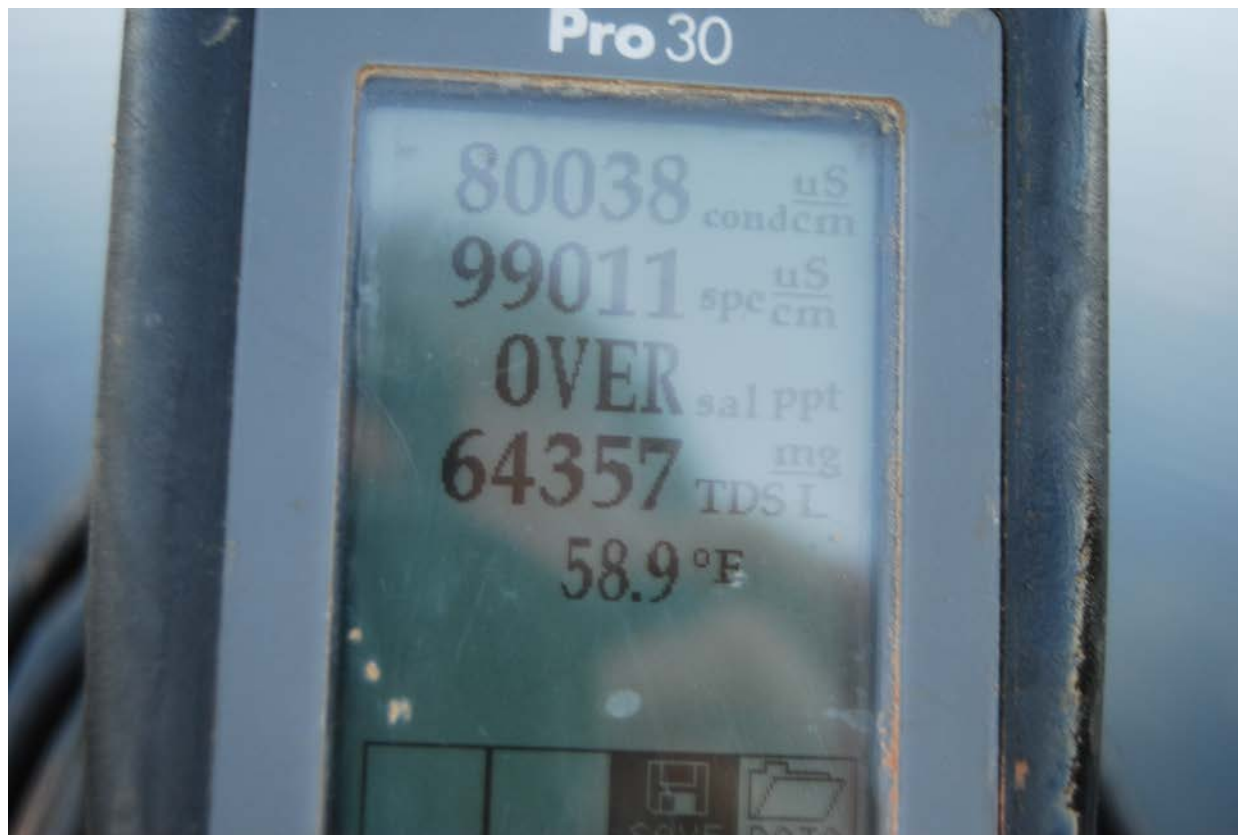
Photo No. 8

Description: TDS at the point of entry of the discharge to the tributary of Hay Creek is 64,357 mg/L.

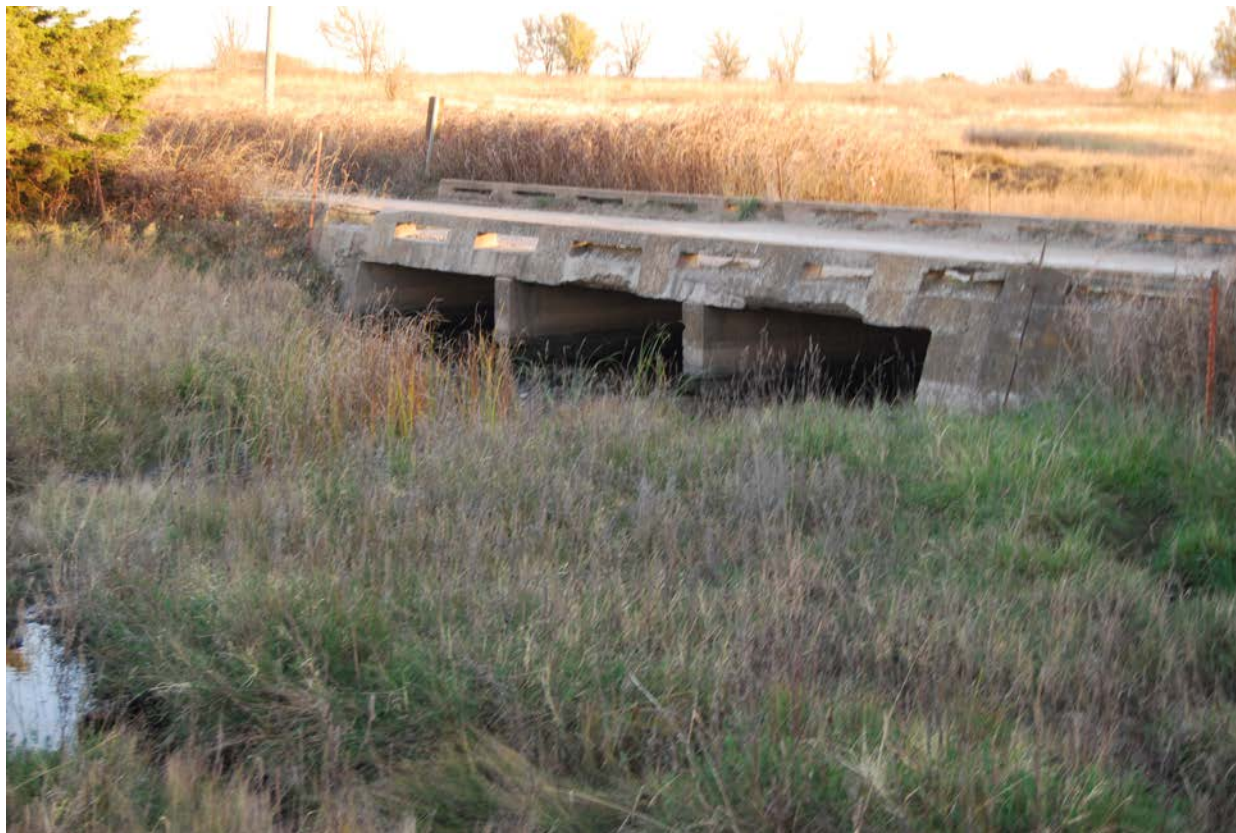
Photo No. 9

Description: The discharge flowed south under this county road (CR) bridge within the tributary of Hay Creek towards Hay Creek.

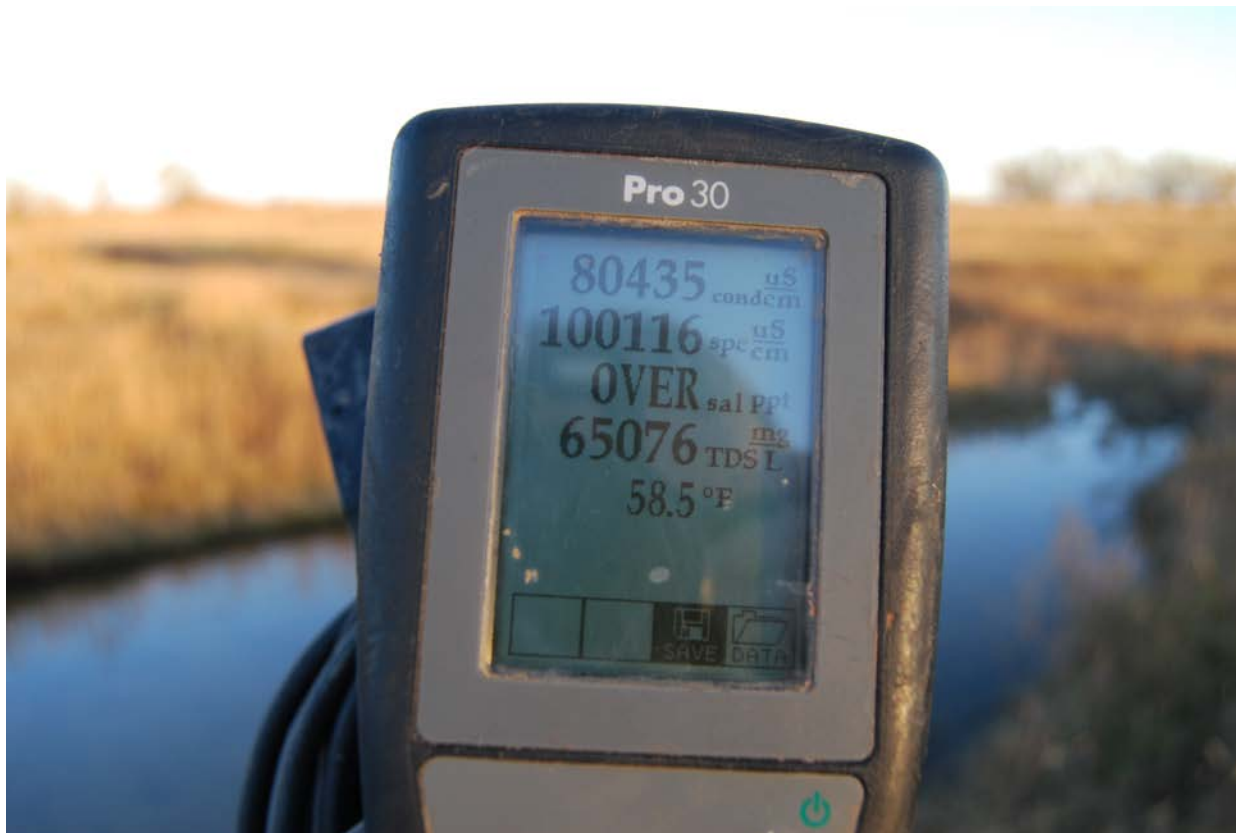
Photo No. 10

Description: TDS of the tributary at the CR bridge was 65,076 mg/L.

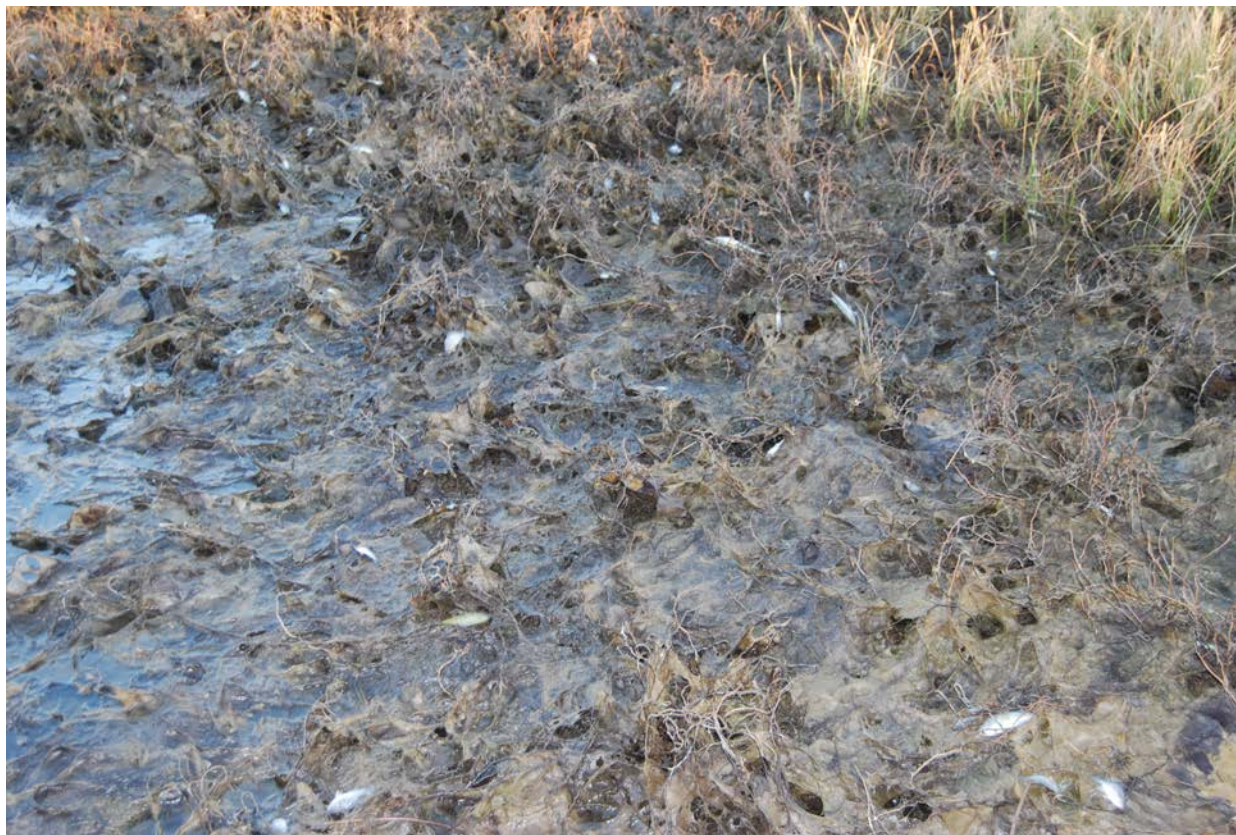
Photo No. 11

Description: Dead fish were observed in the tributary near the CR bridge.

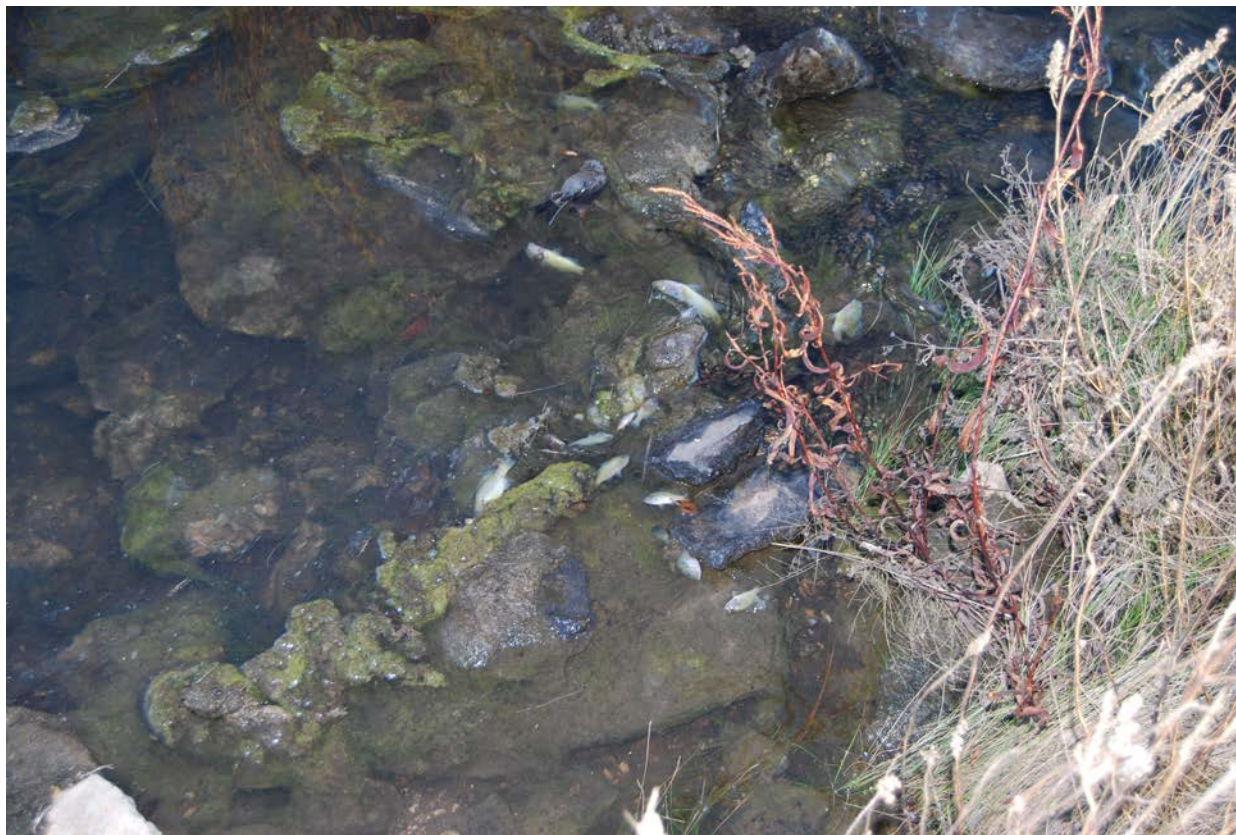
Photo No. 12

Description: There were hundreds of dead fish observed near the CR bridge crossing.

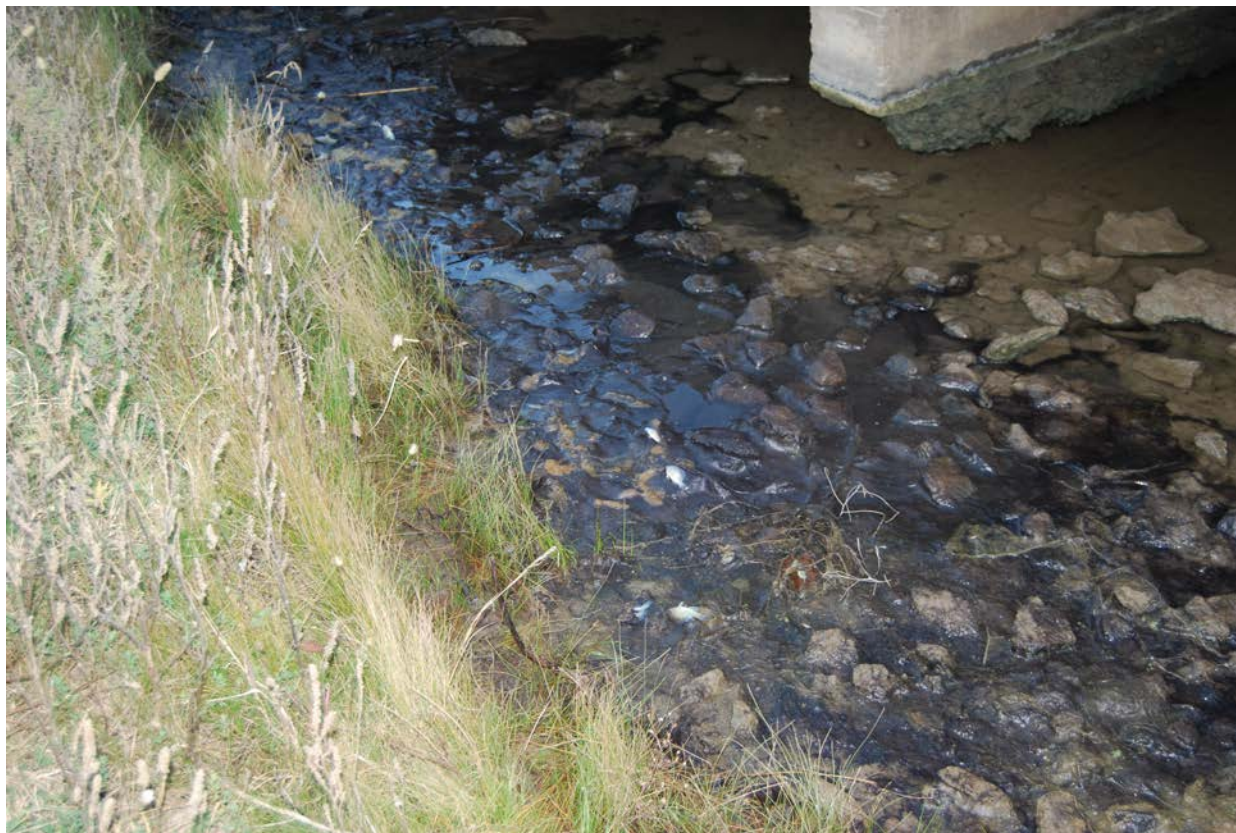
Photo No. 13

Description: I continued to observe dead fish in the tributary, including several large catfish seen partially eaten by animals.

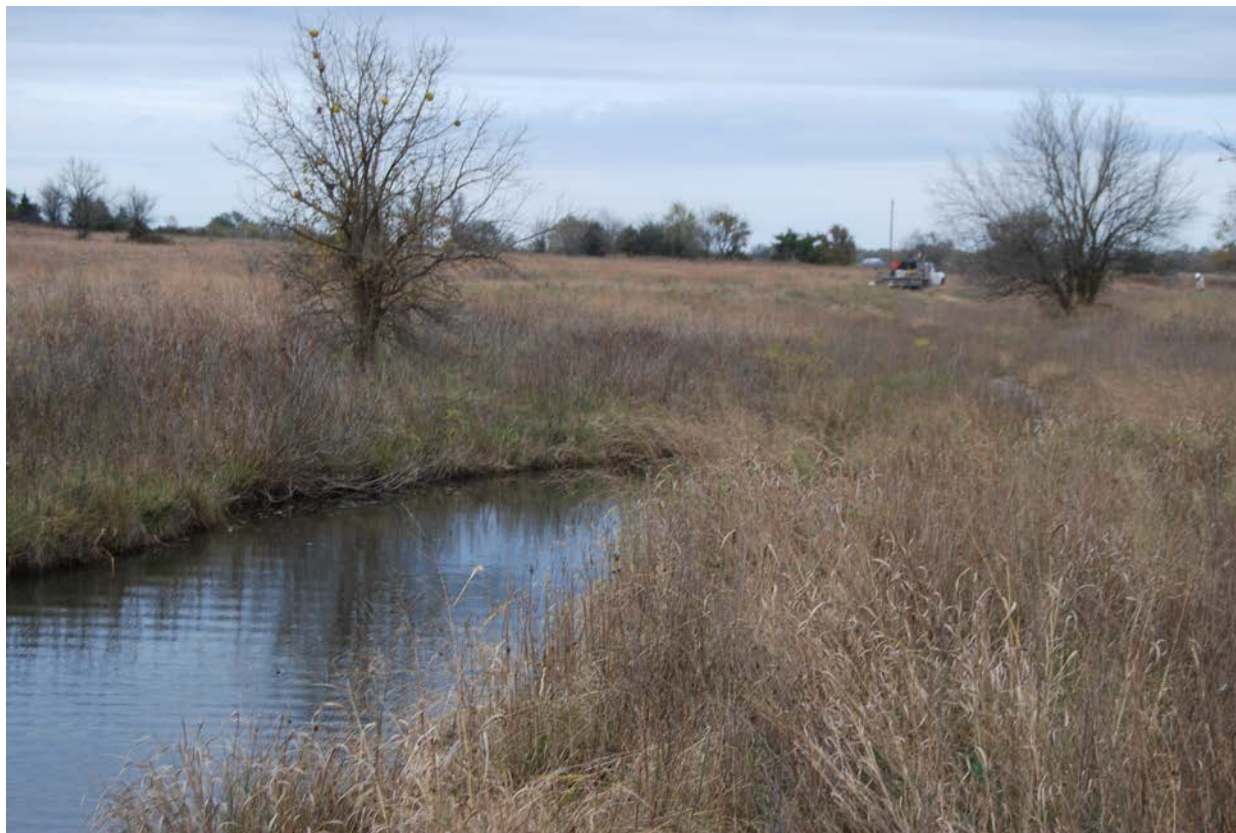
Photo No. 14

Description: This is the tributary of Hay Creek south of the CR bridge crossing. The tributary was deeper in this location and had defined bank.

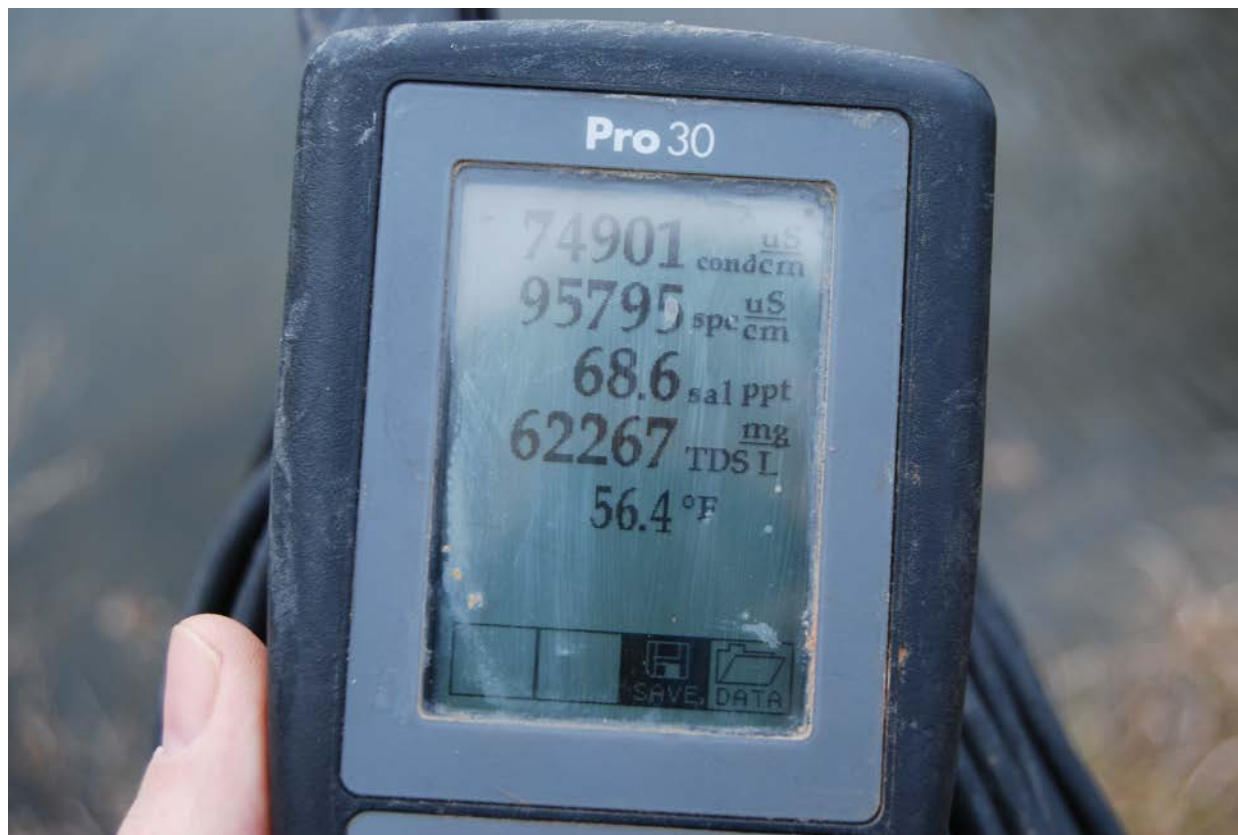
Photo No. 15

Description: The TDS in the tributary of Hay Creek at the point shown in Photo 14 was 62,267 mg/L.

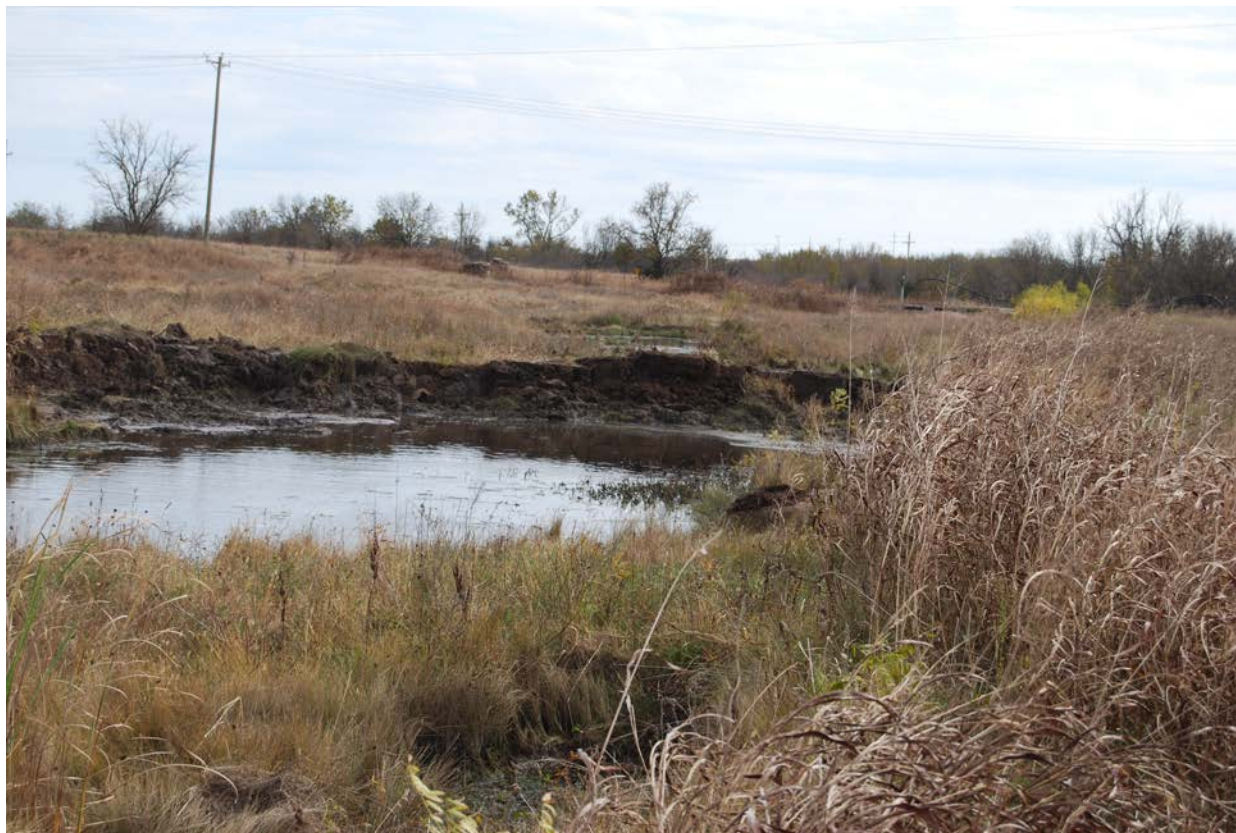
Photo No. 16

constructed on the creek is shown (Photo 16). The TDS at the dam location was 30,213 mg/L (Photo 17). Additionally, more dead fish were observed at this location (Photos 18, 19, and 20). A large pump was located here to keep the contaminants in the tributary from flowing south. However, some of the brine had already flowed south of this location before the dam was built. The last dam constructed on the tributary south of the site shown in Photo 16 is shown in Photo 21. The TDS at this last dam was measured at 2,175 mg/L. In total, I observed over 500 dead fish, including minnows, sun fish, some catfish, and bass downstream from the point of entry of brine into the tributary of Hay Creek during the two days of this inspection. Flow continued around this dam south toward Hay Creek, which flows to Salt Creek.

Description: This is the tributary of Hay Creek farther south. There were five dams built like this one to prevent the brine from flowing further downstream.

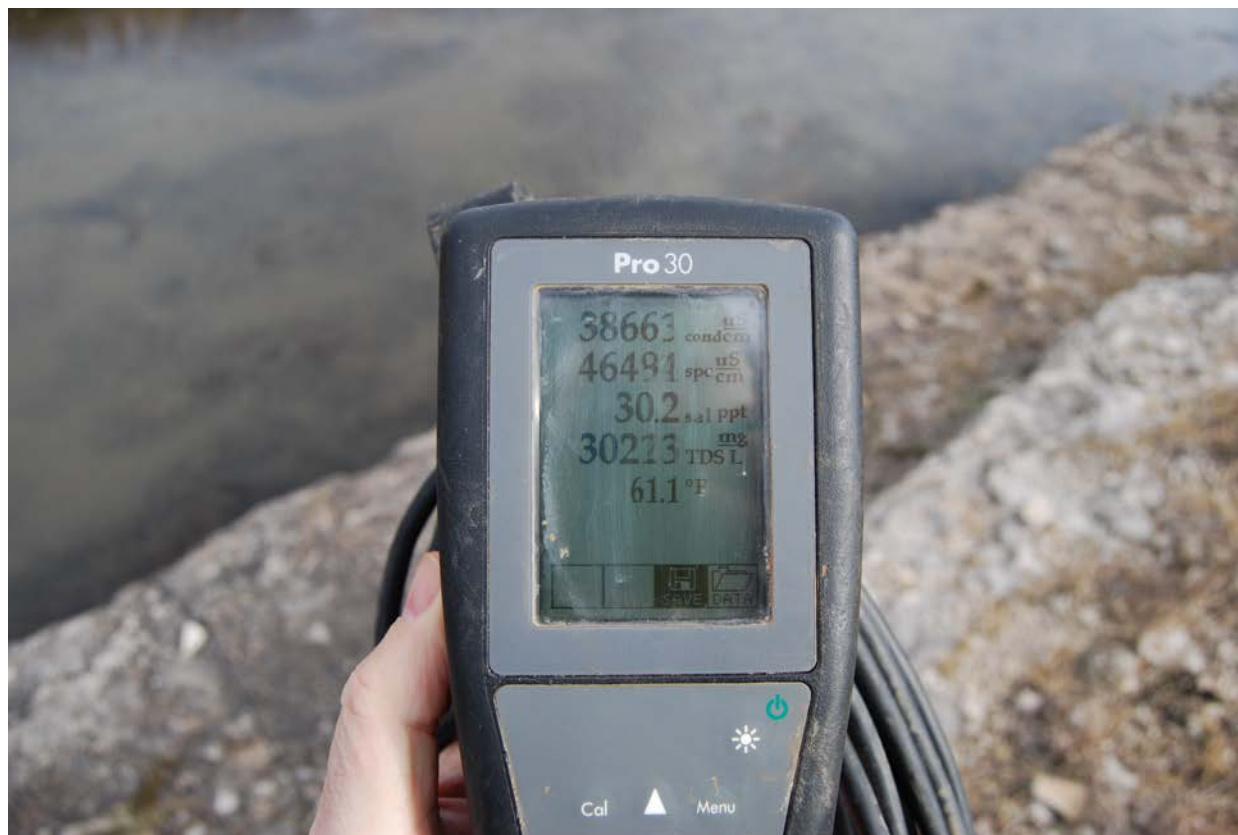
Photo No. 17

Description: TDS in the tributary shown in Photo 16 was 30,213 mg/L.

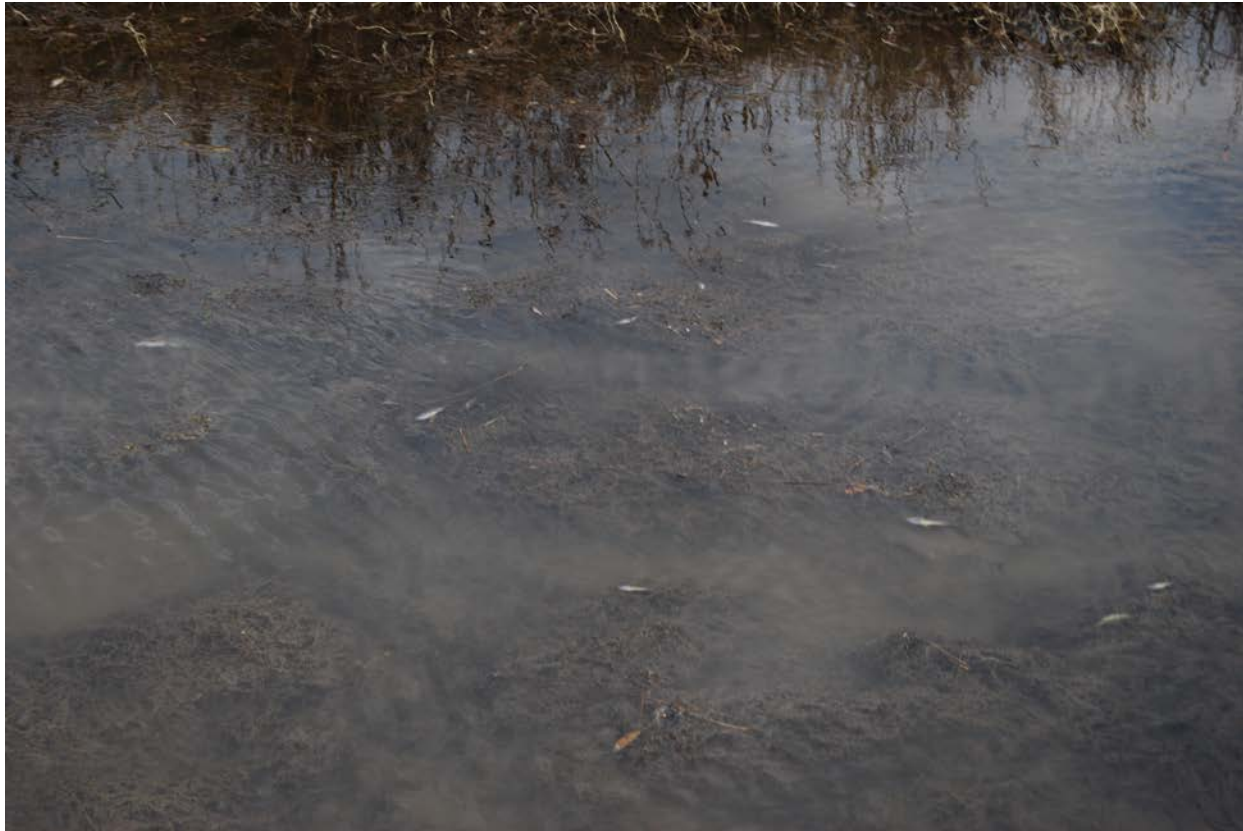
Photo No. 18

Description: Pools in the tributary had more dead fish observed near the dam shown in Photo 16.

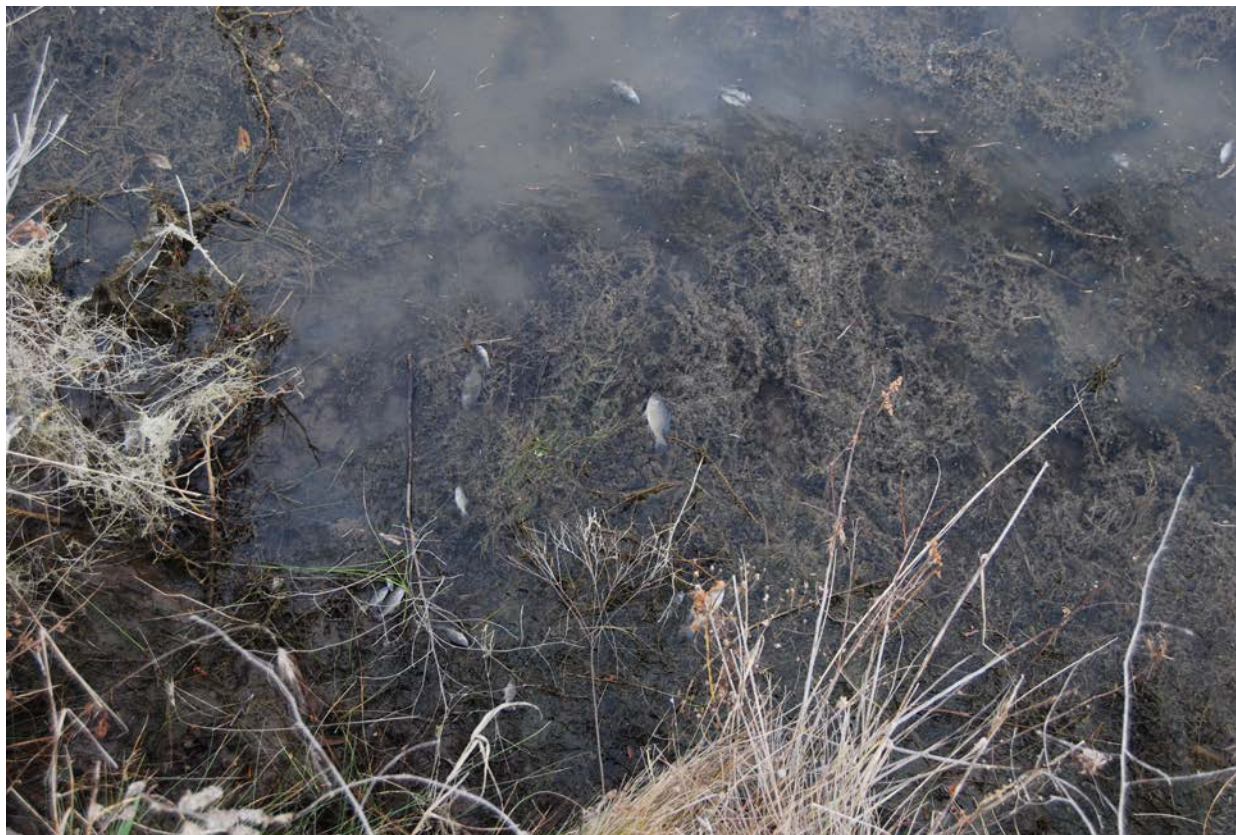
Photo No. 19

Description: There were more dead fish observed in the tributary.

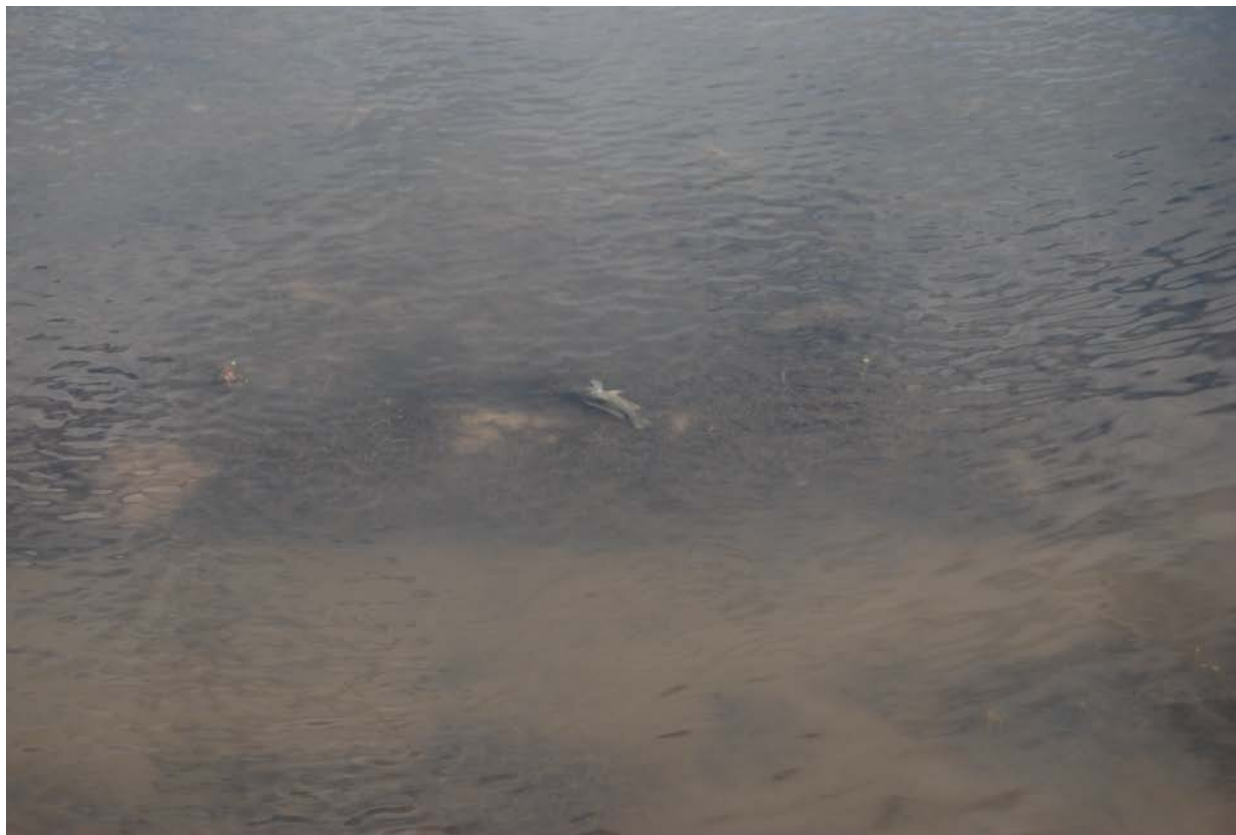
Photo No. 20

Description: A larger dead fish in the tributary was shown, in the same location as Photo 16.

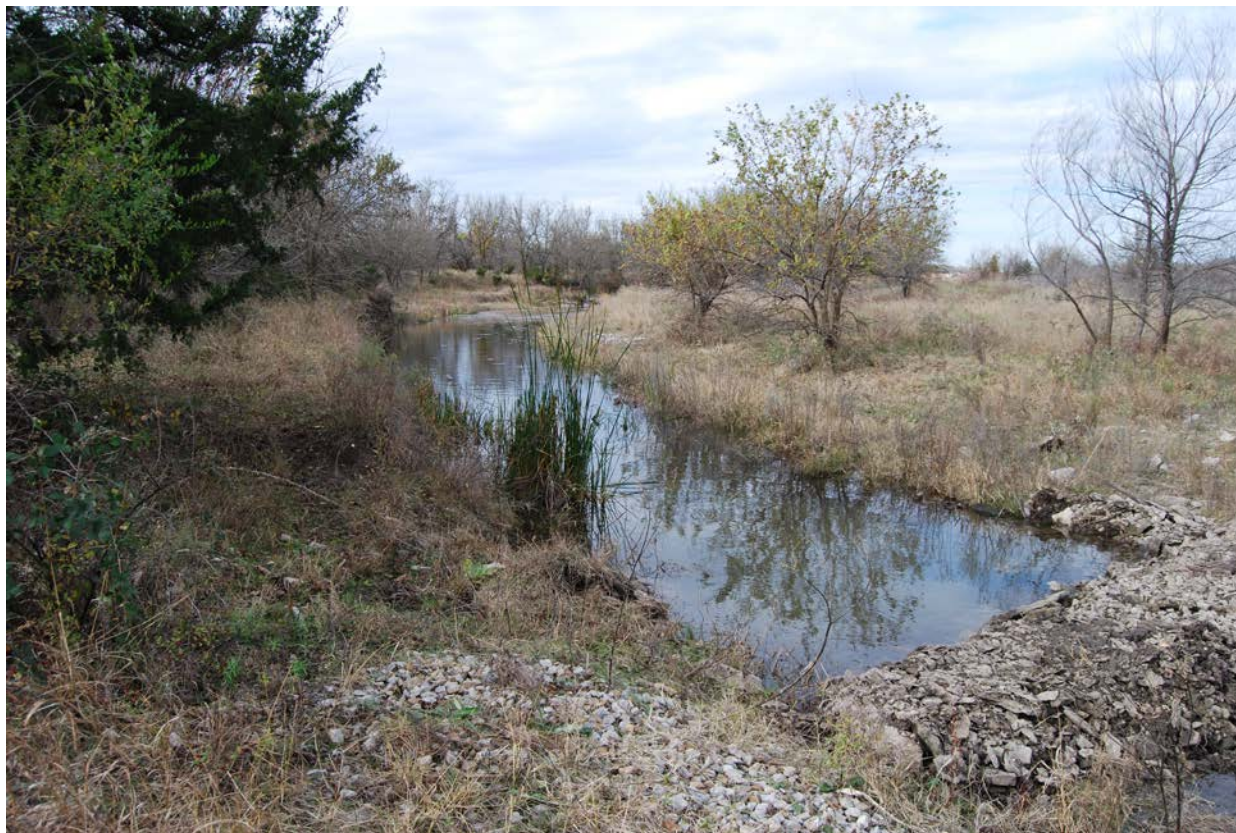
Photo No. 21

Description: The last dam in the tributary was constructed here.
