## Region 6 Compliance Assurance and Enforcement Division

### INSPECTION REPORT

| Company Name: | <b>Perdure Petroleum, LLC</b> | | |
| Facility Name: | <b>NBU 51</b> | | |

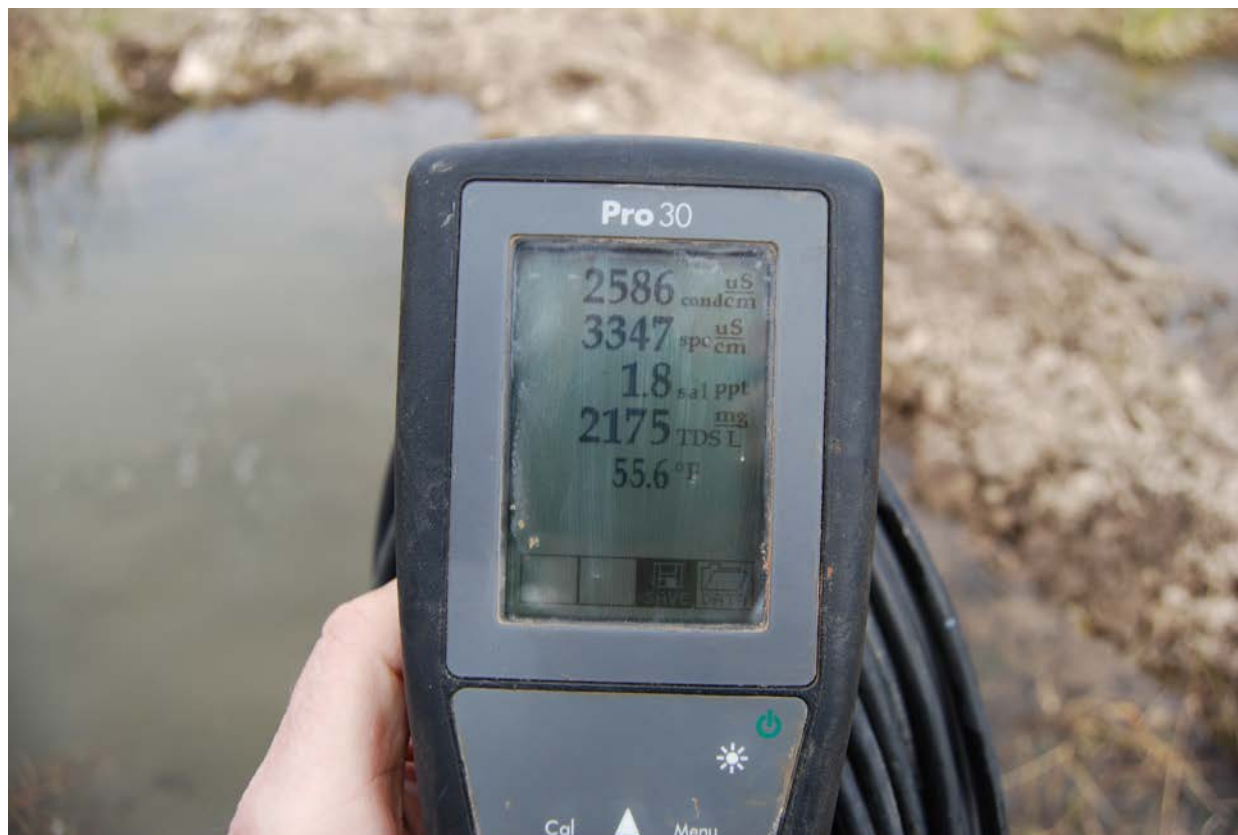
Photo No. 22

Description: TDS flowing around the dam was 2,175 mg/L. There are no other dams south of this site. The creek was being pumped out north of this point.
