REPORT OF COMPLIANCE EVALUATION INSPECTION  
(INDUSTRIAL STORMWATER)

**Alter Trading Corporation**  
**dba Alter Metal Recycling- Cedar Rapids**  
6305 11<sup>th</sup> Street  
Cedar Rapids, Iowa 5404  
Authorization Number: **IA-1986-1849**

BY  
U.S. ENVIRONMENTAL PROTECTION AGENCY  
REGION 7  
ENFORCEMENT AND COMPLIANCE ASSURANCE DIVISION (ECAD)  
WATER BRANCH/DRINKING WATER & INSPECTIONS SECTION (WB/DWIS)

ON  
**February 6 and 7, 2024**

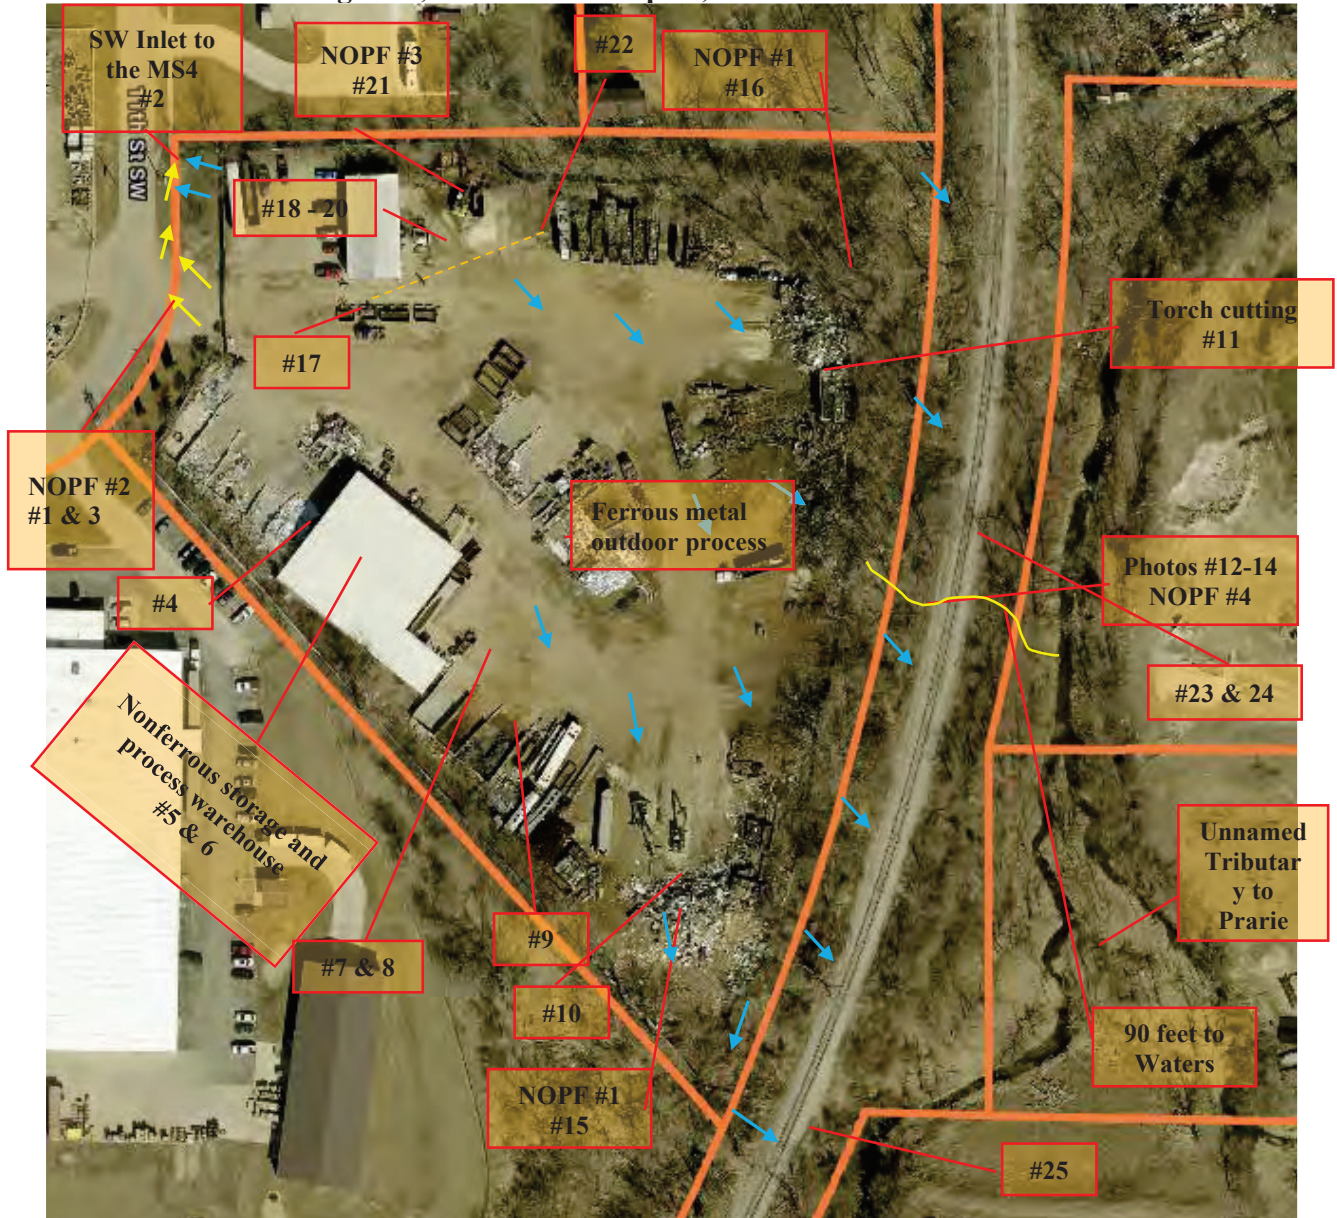
**Figure 1, AMR Cedar Rapids, Iowa Surface Runoff**

Based on the site's local topography, surface runoff would flow off site from the southeast corner and east off the site. There are two drainage areas as indicated in Figure 1:

*Drainage Area 1:* Stormwater runoff from outdoor ferrous process and storage area would flow east from beneath the fence (photos 12-14) onto a steep slope into the the CR & IC Railway tracks ditch (photos 23 and 24). Surface runoff would also flow toward the southeast corner of the site (photo 10) into the Cedar Rapids & Iowa City Railway tracks ditch as well (photo 25). Water in the railway ditch will eventually travel west via a storm pipe beneath the tracks approximately 90 feet and make its way into the unnamed tributary to Prairie Creek. The tributary would flow north approximately one mile into Prairie Creek. Prairie Creek flows north approximately 3 miles into Cedar River.

*Drainage Area 2: Stormwater runoff from the area just west of the site entrance (paved driveway) flows northwest onto 11<sup>th</sup> Street and enters the stormwater inlet (photo 2) which is part of the Cedar Rapids MS4.*

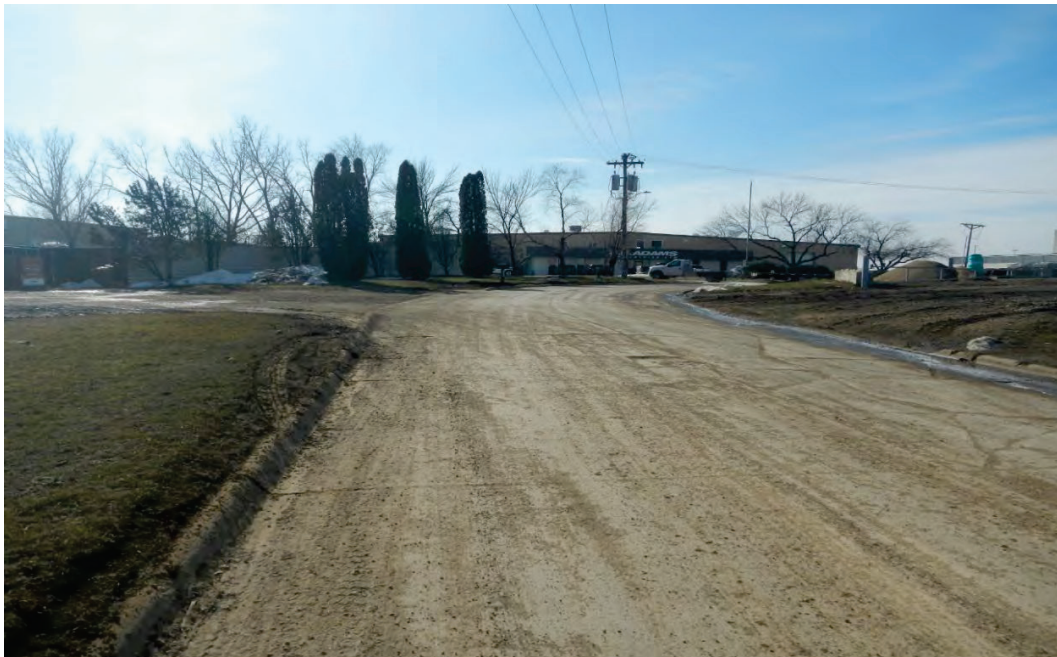
6. Upon our arrival at the facility, Connor Finn and I noticed a significant amount of sediment deposits on 11<sup>th</sup> Street SW. Evidence of trackout leads to AMR main entrance. Evidence also indicated that deposited sediment is caused by vehicular activities existing at the site. We discussed our observation with Mike Loeffelholz. Mike Loeffelholz recognized the issue. Mike Loeffelholz added that they sweep the road every other day or as needed. Based on the

**Photo 3, Sediment deposits at 11<sup>th</sup> Street SW caused by vehicular activity.**

7. trackout evidence (photos 1 and 3), and sediment entering the Cedar Rapids MS4 (photo 2), I issued Notice of Preliminary Findings number 2 (NOPF#2).

10. Upon our return to that facility on February 7, 2024, for the formal exit meeting, we noticed that Mike Loeffelholz was using the sweeper and swept the road.
11. On site structural control is the concrete-block walls that separate stored material. Nonstructural control is implementing the SWPPP such as conducting inspections and employee training.
12. On February 7, 2024, at 9:07AM I received an email from Loeffelholz just before our exit meeting, that included photos of corrective actions taken in response to our observations (Attachment 10).

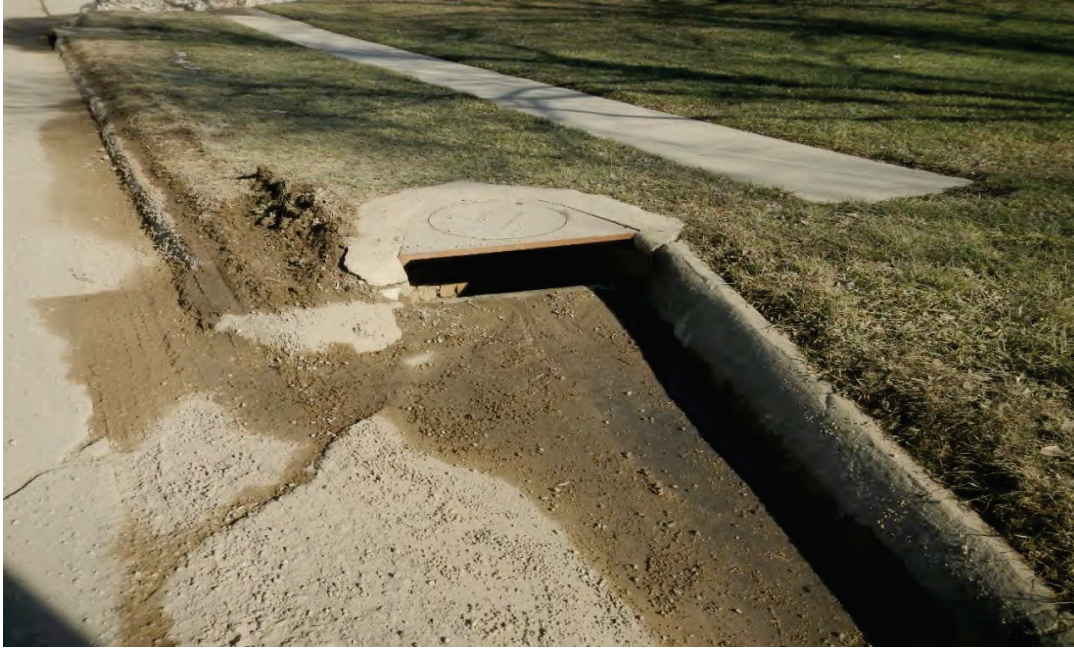
**Photo 2, Sediment entering street stormwater inlet which is part of the MS4.**

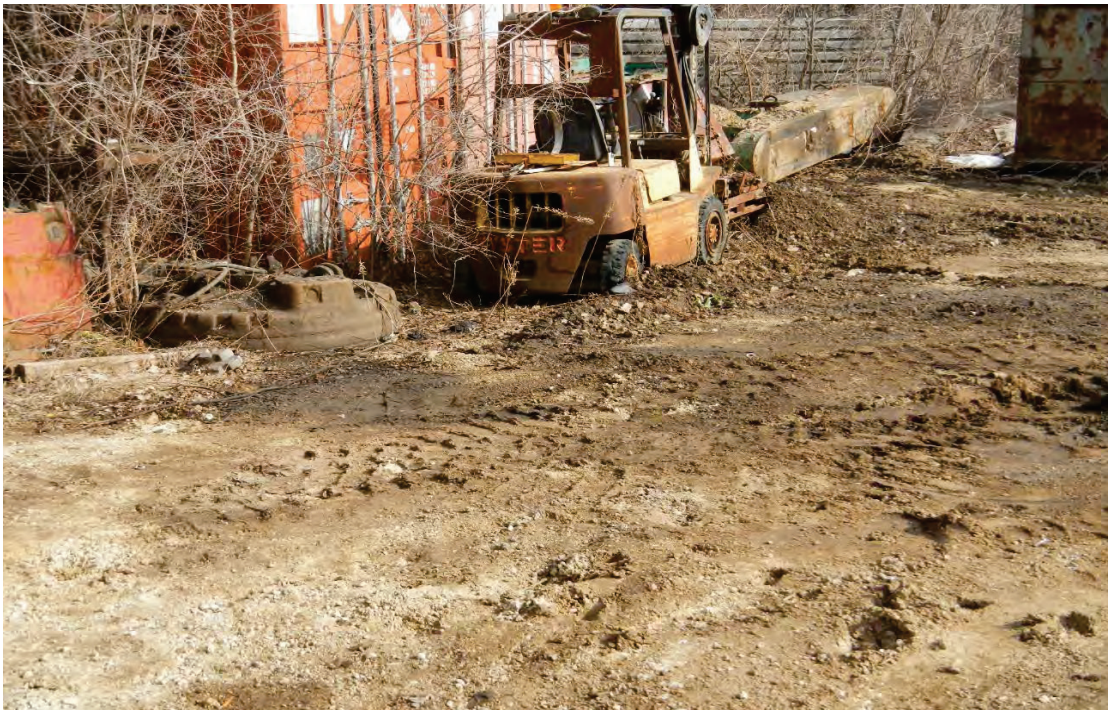
8. We issued NOPF #3 for the evidence of significant ground discoloration which appeared to be caused by leaky equipment stored at the west entrance of the maintenance shop (photo 21).

**Photo 21, Evidence of significant ground discoloration.**

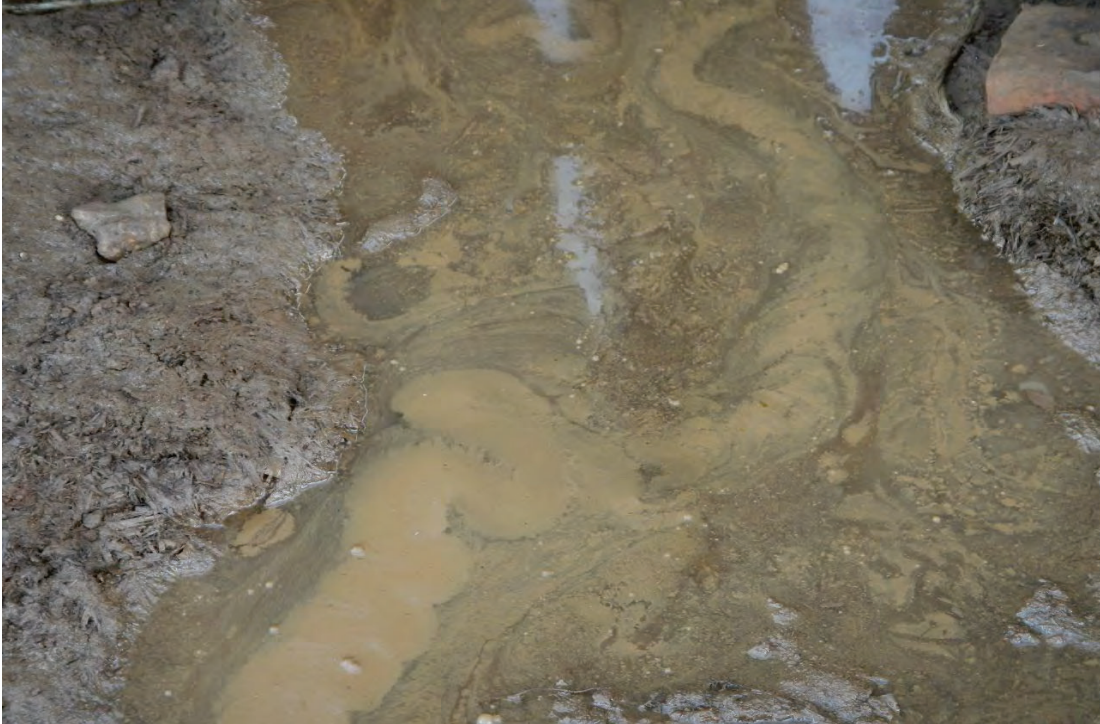
9. We issued NOPF #4 for the polluted surface runoff that was leaving the site from beneath the east fence line onto the steep slope and into the railway ditch. The water had a significant oil sheen caused by stormwater contact with stored piles of ferrous scrap metal stored at the edge of the fence (photos 12, 13, and 14). We also observed that the scrap metal had significant oil residue on it. Photo 13 below demonstrates the amount of sheen in the runoff. As mentioned above, runoff would flow east into the rail ditch then continue west through storm drainage pipe that runs beneath the rail and makes its way to the unnamed tributary to Prairie Creek.

**Photo 13, Significant sheen in the stormwater runoff leaving the site.**
