## EXPLOSION IN VCM PLANT IN 1988

Norsk Hydro's VCM plant is located at Rafnes, some 120 km south west of Oslo.

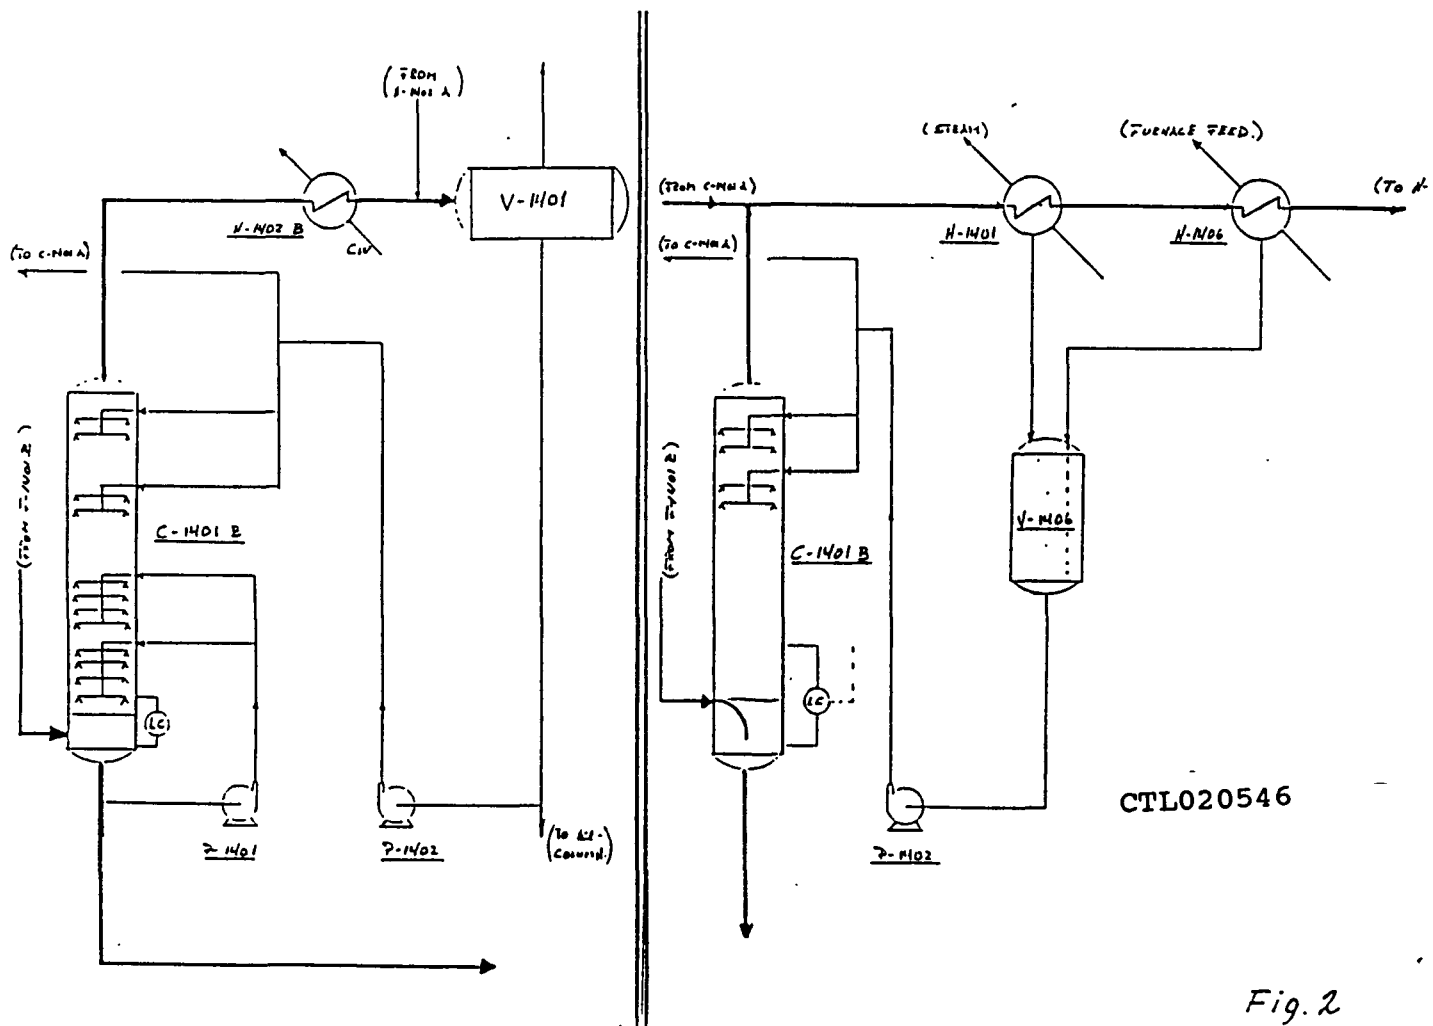
Fig. 2

Two important modifications in the cracking quench system are shown in figure 2. Originally the quench tower had a bottom circulation system. EDC/VCM/HCl at a ratio of about 87/9/4 and a temperature around 175 °C was circulated by a pump. The liquid contained some coke and there were constant troubles with the pump's mechanical seal. We also had indications of stress corrosion cracking in pipes and valves. In 1981 we therefor replaced this system with a submerged inlet into the quench tower.

The second important modification was carried out in 1984. To conserve energy, a steam boiler and a feed preheater were installed in the quench overhead.

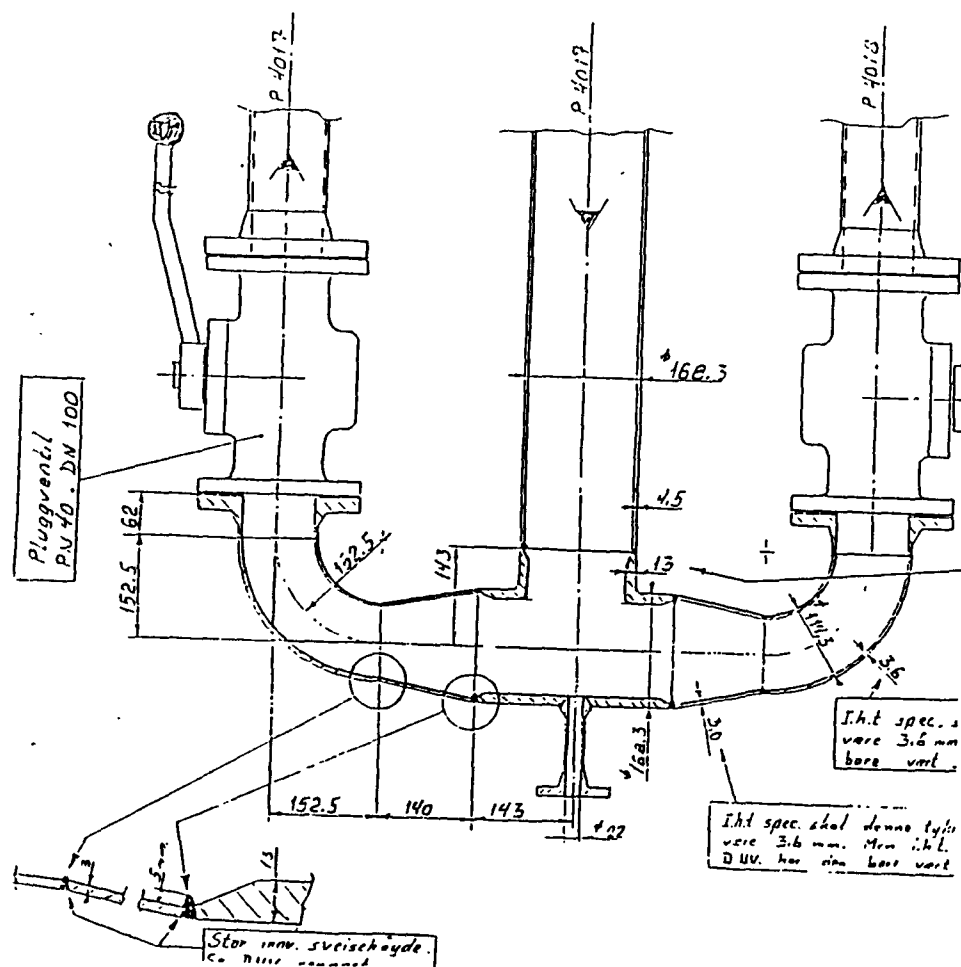
Fig 3.

A detailed drawing of the pipe fitting where the rupture occurred is shown in figure 3. The design of this fitting was unfavourable in several respects:

- The liquid flow was turned 180 degrees.
- The T-piece had a much greater wall thickness than the rest of the construction.
- Some internal welding seams had a protrusion of about 5 mm.
- There are indications that the bend that ruptured, initially had a wall thickness of only 3 mm instead of 3,6 mm.

The most likely causes for the thickness reduction in the bend that ruptured, are erosion and corrosion. These two factors will be discussed in more detail.

According to what is said in the preceding section, erosion must have been the main cause for the rupture of the bend. Erosion severeness will be dominated by the following three conditions: Fluid velocity, coke particles and geometry of the actual fitting.

The flow characteristics of the return bend was investigated using a fluid dynamics program (FLUENT). The investigation showed that high local velocities occurred, especially in the inner curve of the bend. This is just where the rupture took place.

- Bigger pipe diameter
- Pipes with greater wall thickness
- Zig-zag baffles in the top of the quench tower to hold back coke particles and liquid droplets.
- Redesign of return bend
- Thickness measurement program to include also bends.
