Region 10 Enforcement and Compliance Assurance Division

INSPECTION REPORT

| <b>Regulatory Program:</b> | CWA NPDES/Industrial Stormwater | |
| <b>Facility Name:</b> | Notus, Boise River Rd. Facility | |

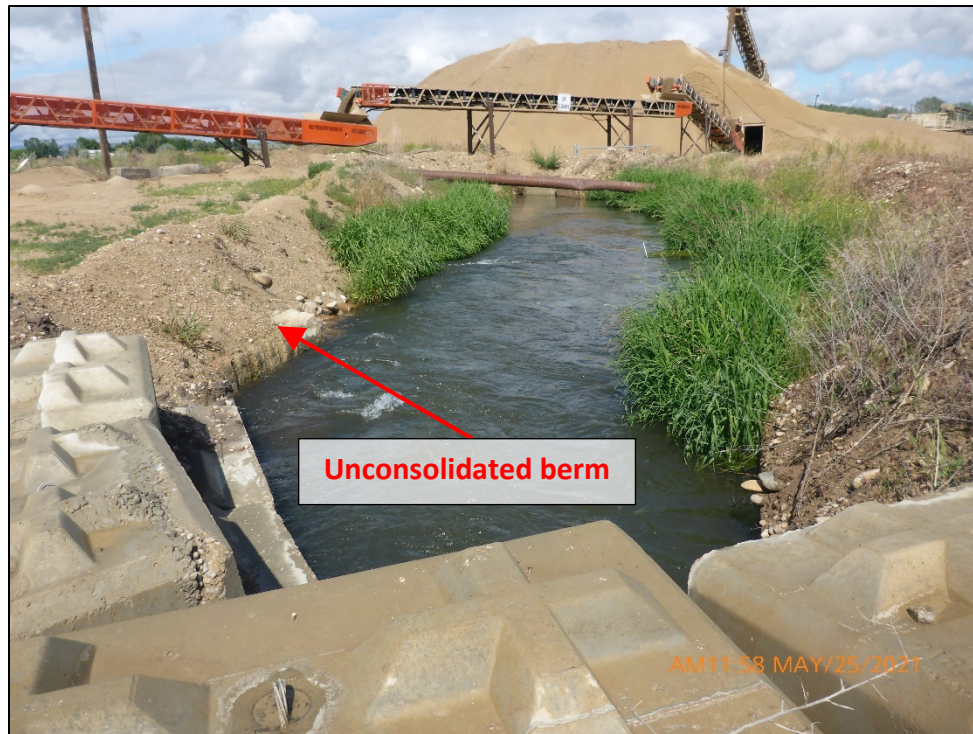
**Photograph 11.** View, facing west (downstream), of the tributary of the Center Point Canal that flows from east to west through the Facility. The Facility does not have outfalls that discharge into this waterbody. Note the unconsolidated soil berm adjacent to the canal.

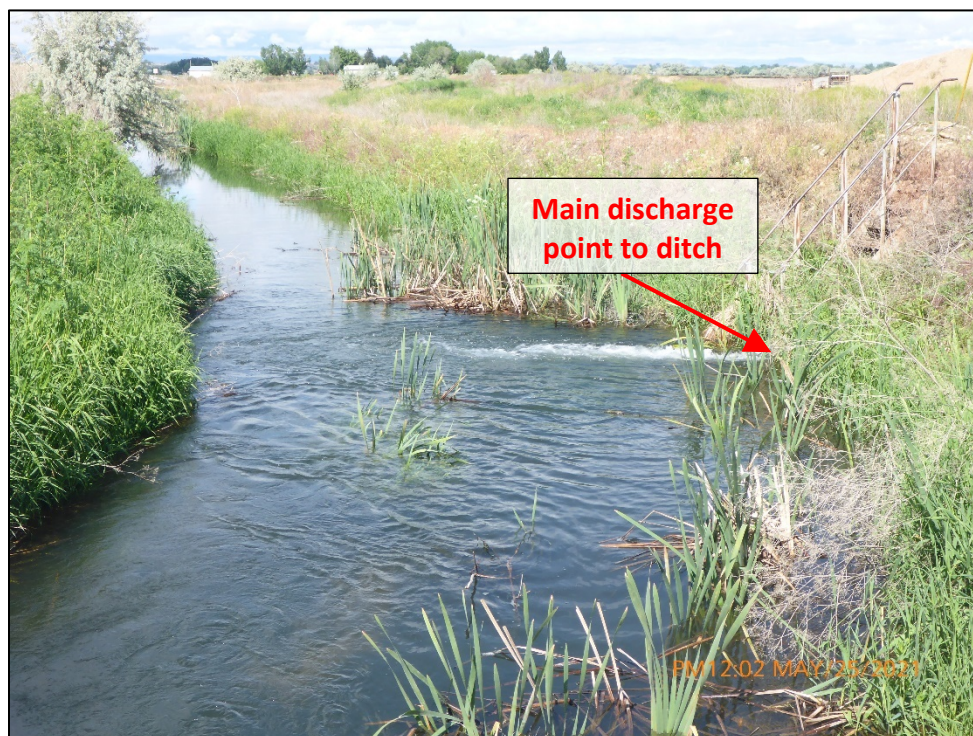
The SWPPP site map did not identify all stormwater discharge and monitoring points at the Facility. The Inspection Team noted that the SWPPP site map identifies two discharge points: 'Outfall 001' where the unnamed ditch leaves the property and 'Discharge 2' (refer to Exhibit 3). These points were indicated by an arrow pointing near where the two pipes from the groundwater retention basin discharge into the unnamed irrigation ditch, which was observed during the Facility walk-through. While it was unclear which discharge point was indicated by 'Discharge 2', the Inspection Team noted that at least one of the two discharge points was not identified on the site map. The site map also does not indicate whether Outfall 001 or Discharge 2 is a stormwater monitoring point. As stated above, the Permittee conducts sampling at the downstream discharge pipe (main discharge point) into the unnamed ditch (refer to Photographs 12 and 13).

**Photograph 12.** View, facing west, of the Facility's main discharge point from the Ground Water Sediment Pond into the unnamed irrigation ditch. The stairs provide access for NPDES compliance sampling.

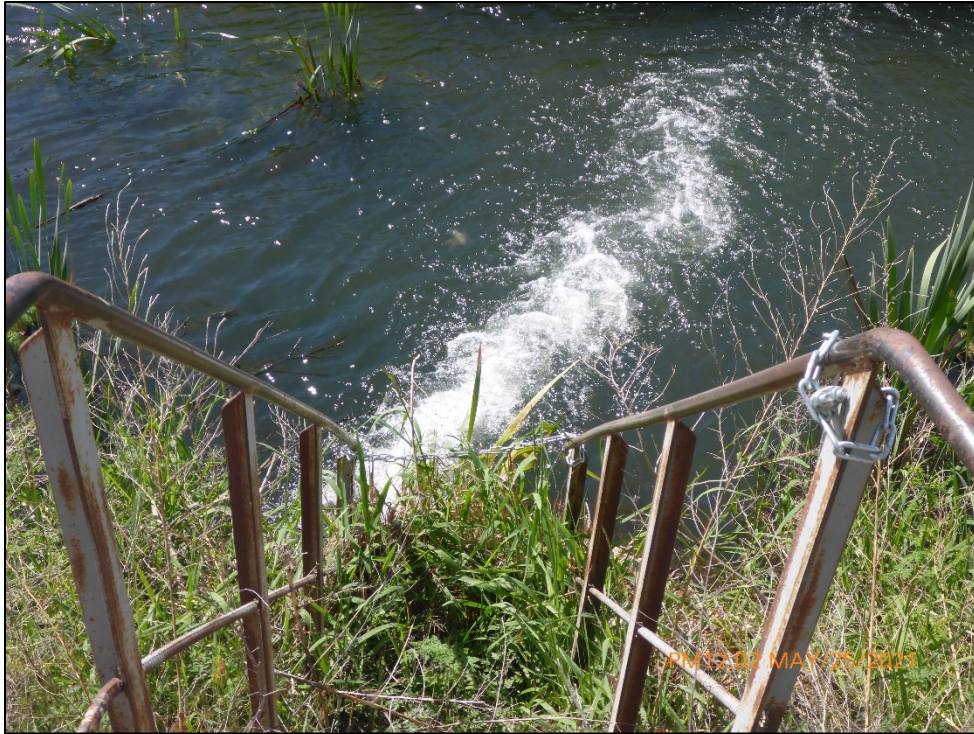
**Photograph 13.** Additional view of the Facility's main discharge point from the Ground Water Sediment Pond into the unnamed irrigation ditch. The stairs provide access for NPDES compliance sampling.

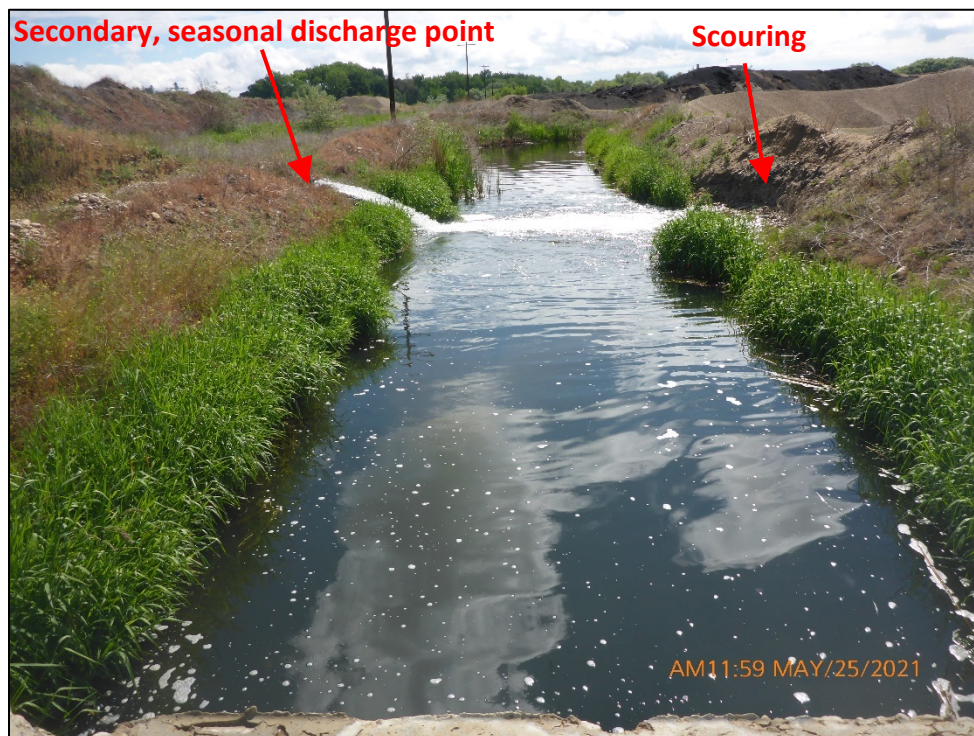
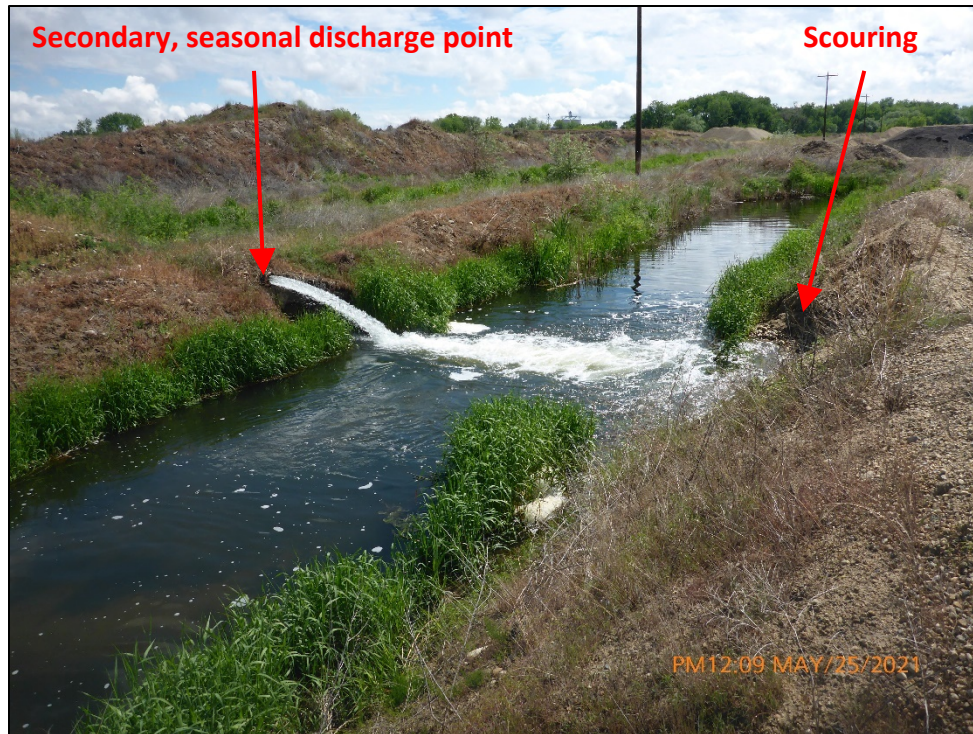
The Inspection Team observed scouring on the embankment of the unnamed irrigation ditch adjacent to the secondary, seasonal discharge pipe from the groundwater retention basin (refer to Photographs 14 and 15). It appeared that the velocity of discharge from the discharge pipe was causing the scouring in the embankment.

- Area of Concern 1 – The Inspection Team observed that the discharge velocity from the upstream, seasonal discharge pipe from the groundwater retention basin to the unnamed ditch was causing scouring on the embankment of ditch.

**Photograph 14.** View, facing east, of the Facility's secondary, seasonal discharge point from the Ground Water Sediment Pond into the unnamed irrigation ditch. Note the scouring on the embankment of the ditch adjacent to the discharge pipe.

**Photograph 15.** Additional view, facing northeast, of the Facility's secondary, seasonal discharge point shown in Photograph 14. Note the scouring on the embankment of the ditch adjacent to the discharge pipe.

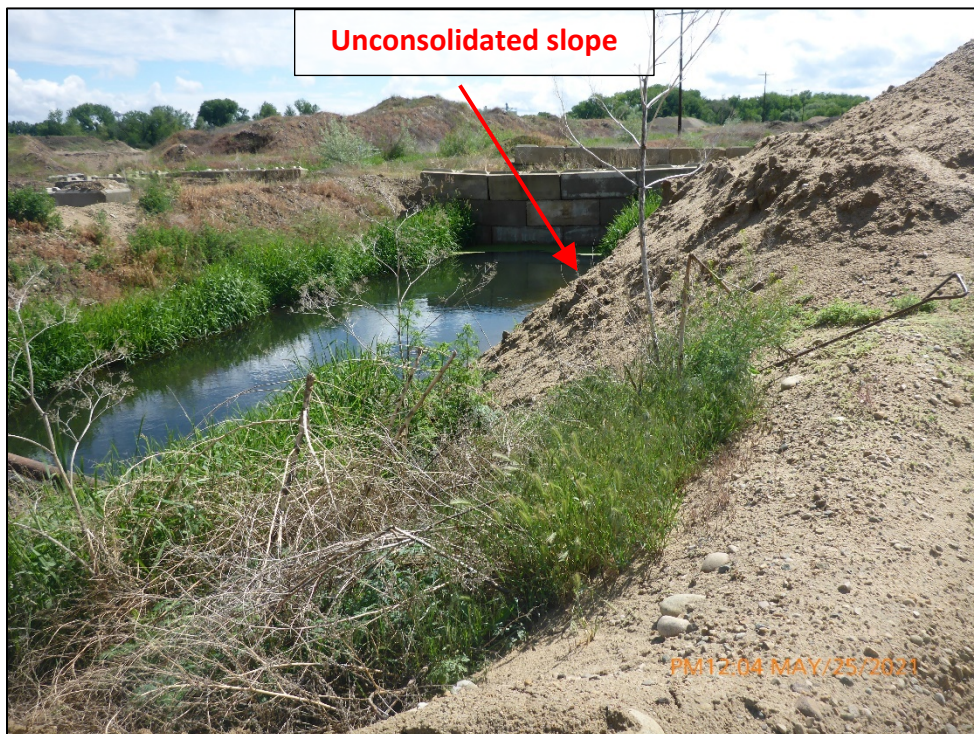
The Inspection Team observed large, unconsolidated and unstabilized slopes and berms of sand and soil immediately adjacent to the tributary of the Upper Center Pointe Canal that runs from east to west through the Facility. One slope of sand had eroded into the ditch (refer to Photographs 11, 22, 23, and 24). Section 3.1.1, Minimize Exposure, of the SWPPP states, "Overburden generated during the initial phases of mining will be used to construct topsoil berms along the perimeters of immediately adjacent properties, canals and irrigation ditches." Additionally, BMP #1 of Section 3.1.1 of the SWPPP states, "If berms are created in fine grained soil (topsoil) they should be re-vegetated to stabilize the berm from eroding."

- Area of Concern 2 – The Inspection Team observed large, unconsolidated and unstabilized slopes of sand and soil immediately adjacent to the unnamed irrigation ditch that receives discharges from the groundwater retention basin.

**Photograph 22.** View of unconsolidated and unstabilized sand and soil slopes immediately adjacent to the tributary of Center Point Canal.

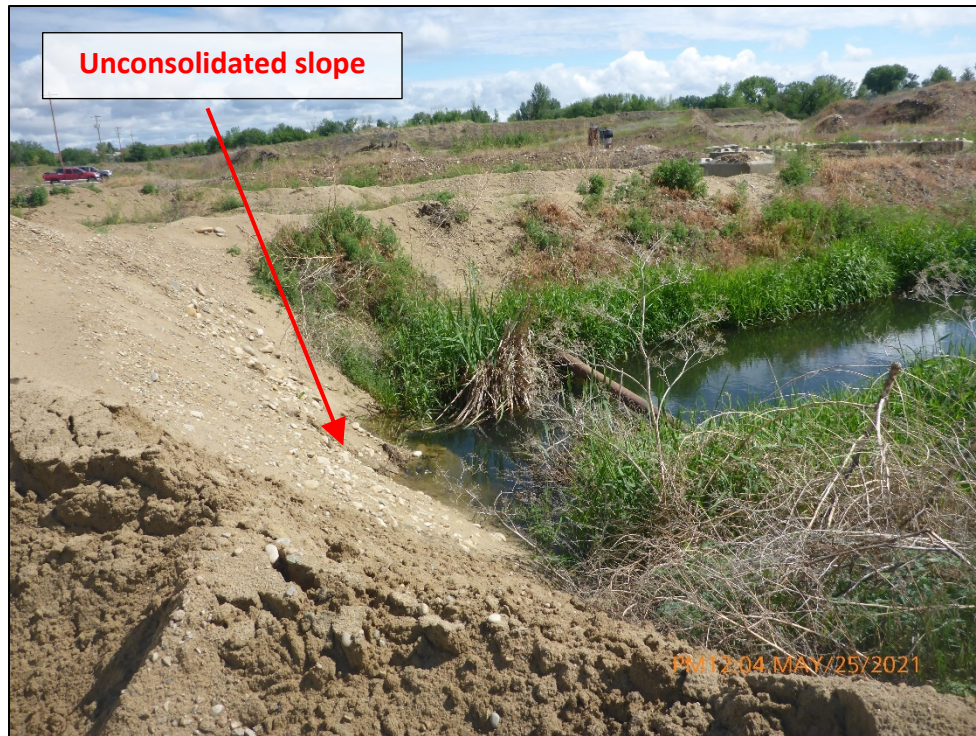
**Photograph 23.** View of an unconsolidated and unstabilized sand and soil slopes immediately adjacent to the tributary of Center Point Canal.

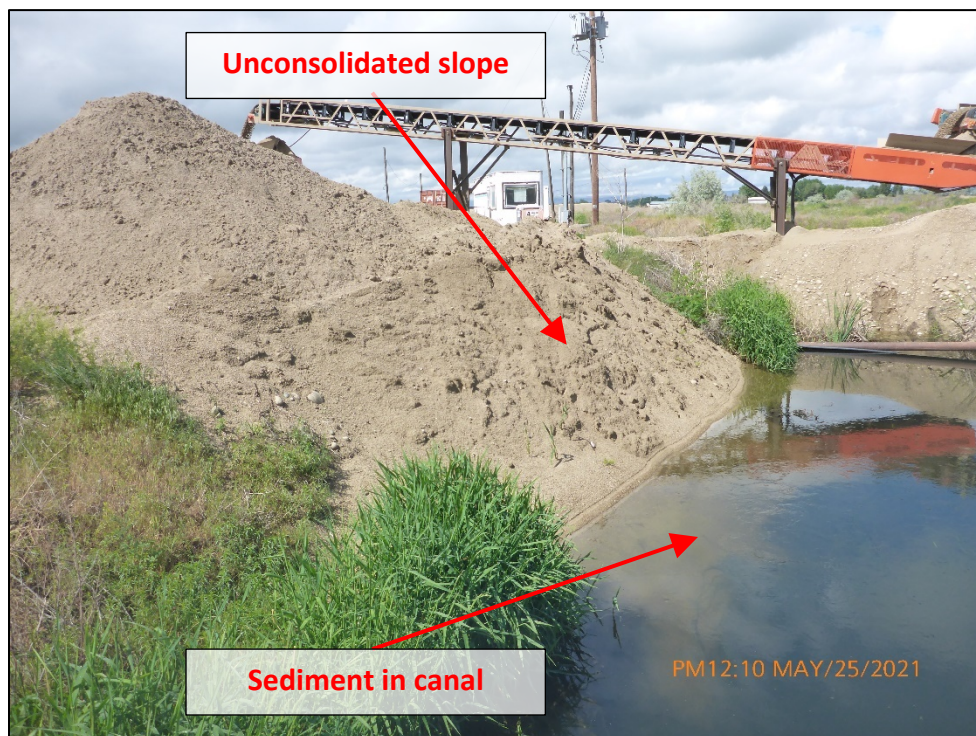
**Photograph 24.** View of an unconsolidated and unstabilized sand and soil slopes immediately adjacent to the tributary of Center Point Canal. Note that the sand slope had eroded into the canal.

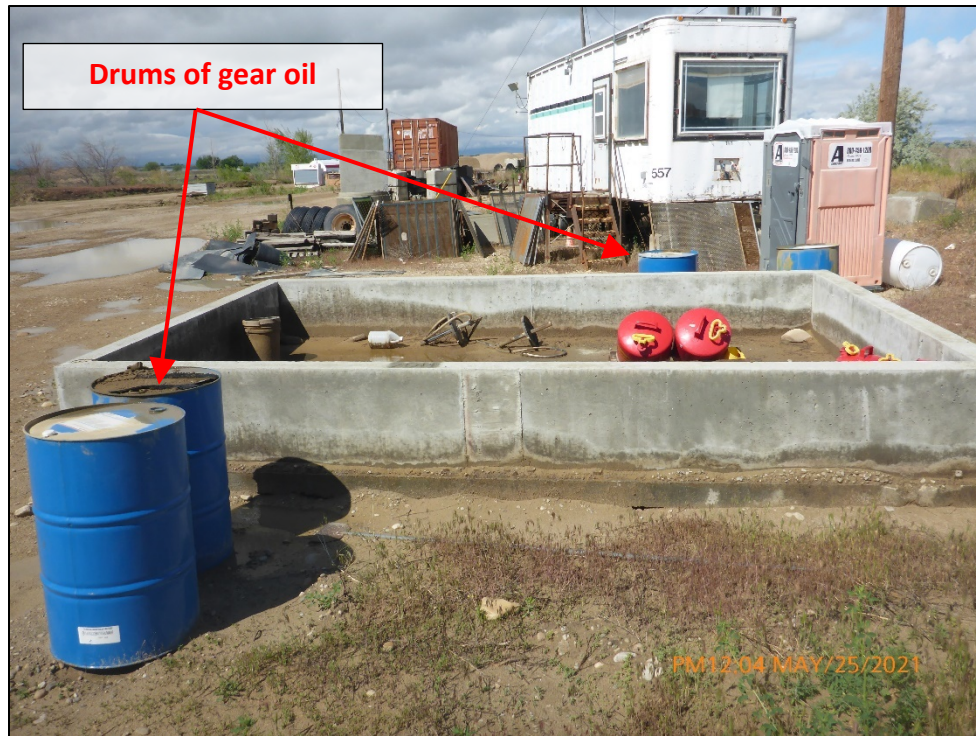
The Inspection Team observed four 55-gallon drums of gear oil stored outside of the designated petroleum product storage area, with secondary containment, near the aggregate wash plant (refer to Photograph 25). Two of the drums contained product and two were empty. Section 2.2, Spills and Leaks, of the SWPPP states, "Fueling Island: Bulk fuel tanks will be inside secondary containment and fueling area will be graded to contain stormwater on site." It should be noted that stormwater runoff from this area appeared to flow into the aggregate wash water settling ponds and may remain onsite.

- Area of Concern 3 – The Inspection Team observed four 55-gallon drums of gear oil (two with product, two empty) stored outside of the designated petroleum product secondary containment storage area near the aggregate wash plant.

**Photograph 25.** View of the secondary containment structure for petroleum product storage near the aggregate wash plant. Four drums of gear oil, two empty drums and two containing product, were stored outside of the containment structure.

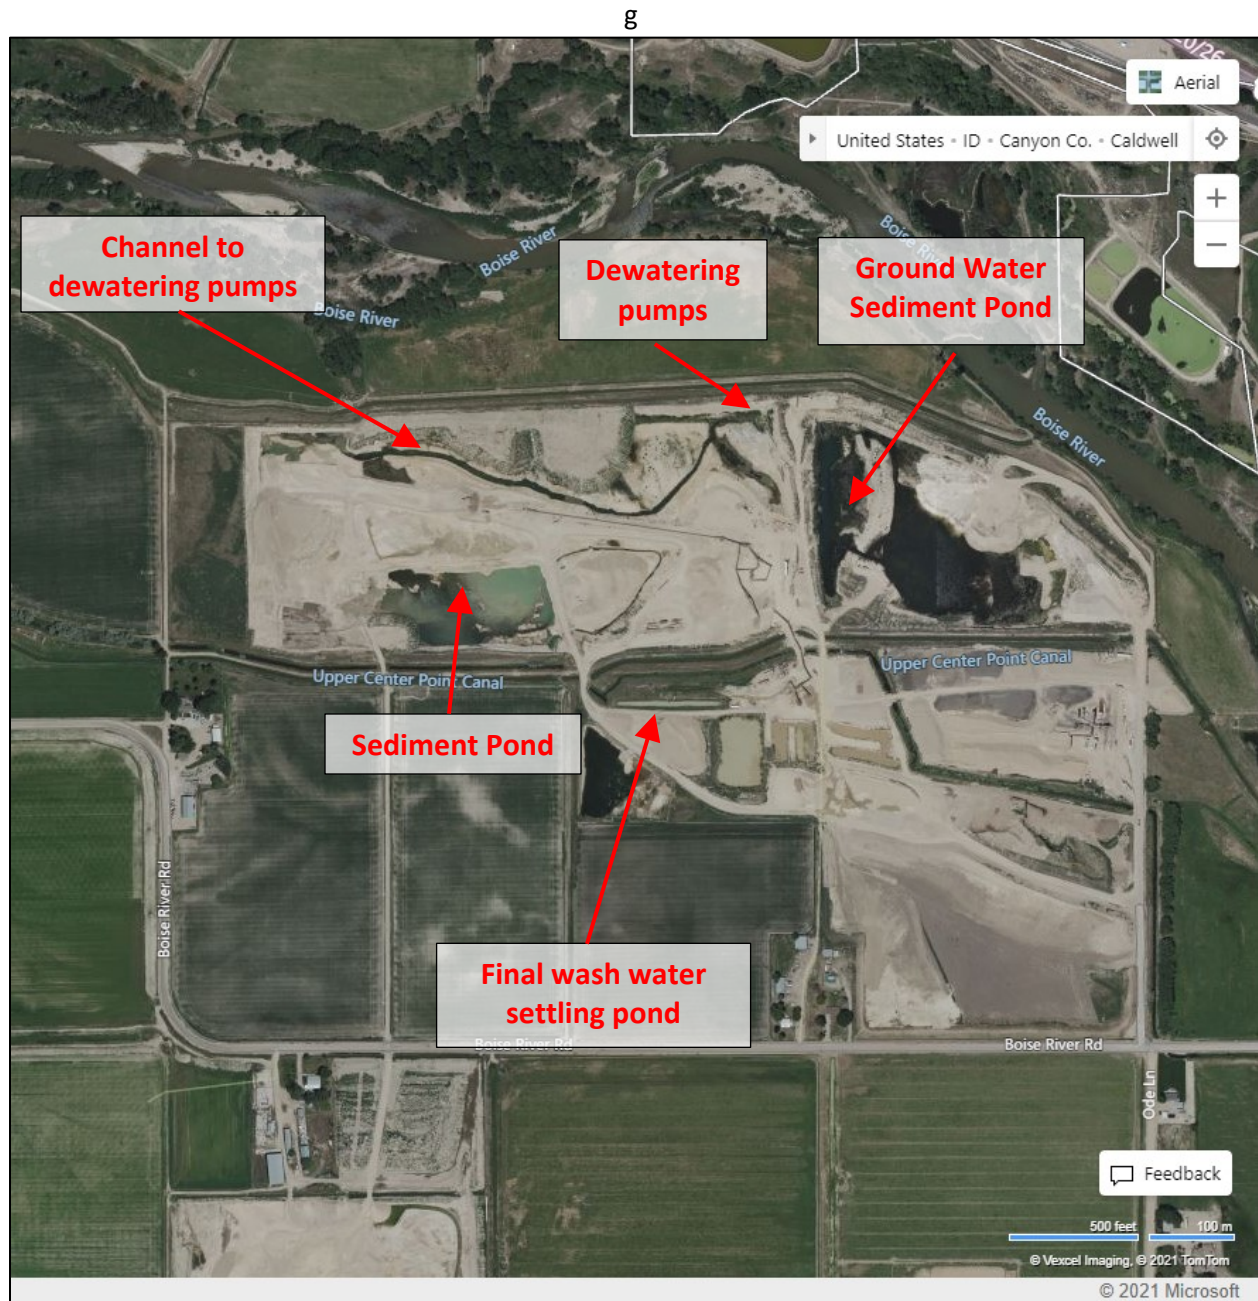
The SWPPP site map did not clearly identify groundwater conveyances in the pit area. Since the SWPPP was developed, the pit has expanded within its limits of disturbance (refer to Exhibit 2). As such, flow paths and conveyance locations had changed slightly. Of note, the conveyance of groundwater from the groundwater low point identified by Mr. Kalmbach (referred to as Sediment Pond on SWPPP Site Map), through a pipe, and into the channel that flows to the northeastern dewatering pumps shown in Photograph 6 is not clearly identified (refer to Exhibit 3). The SWPPP Site Map also does not identify any structural controls (berm) used by the Facility to segregate stormwater and groundwater.

**Exhibit 2.** Bing Map of the Facility (imagery undated). This aerial imagery shows the expansion of the mining pit, the Sediment Pond, as well as the groundwater conveyance channel that leads to the dewatering pumps which pump to the Ground Water Sediment Pond.

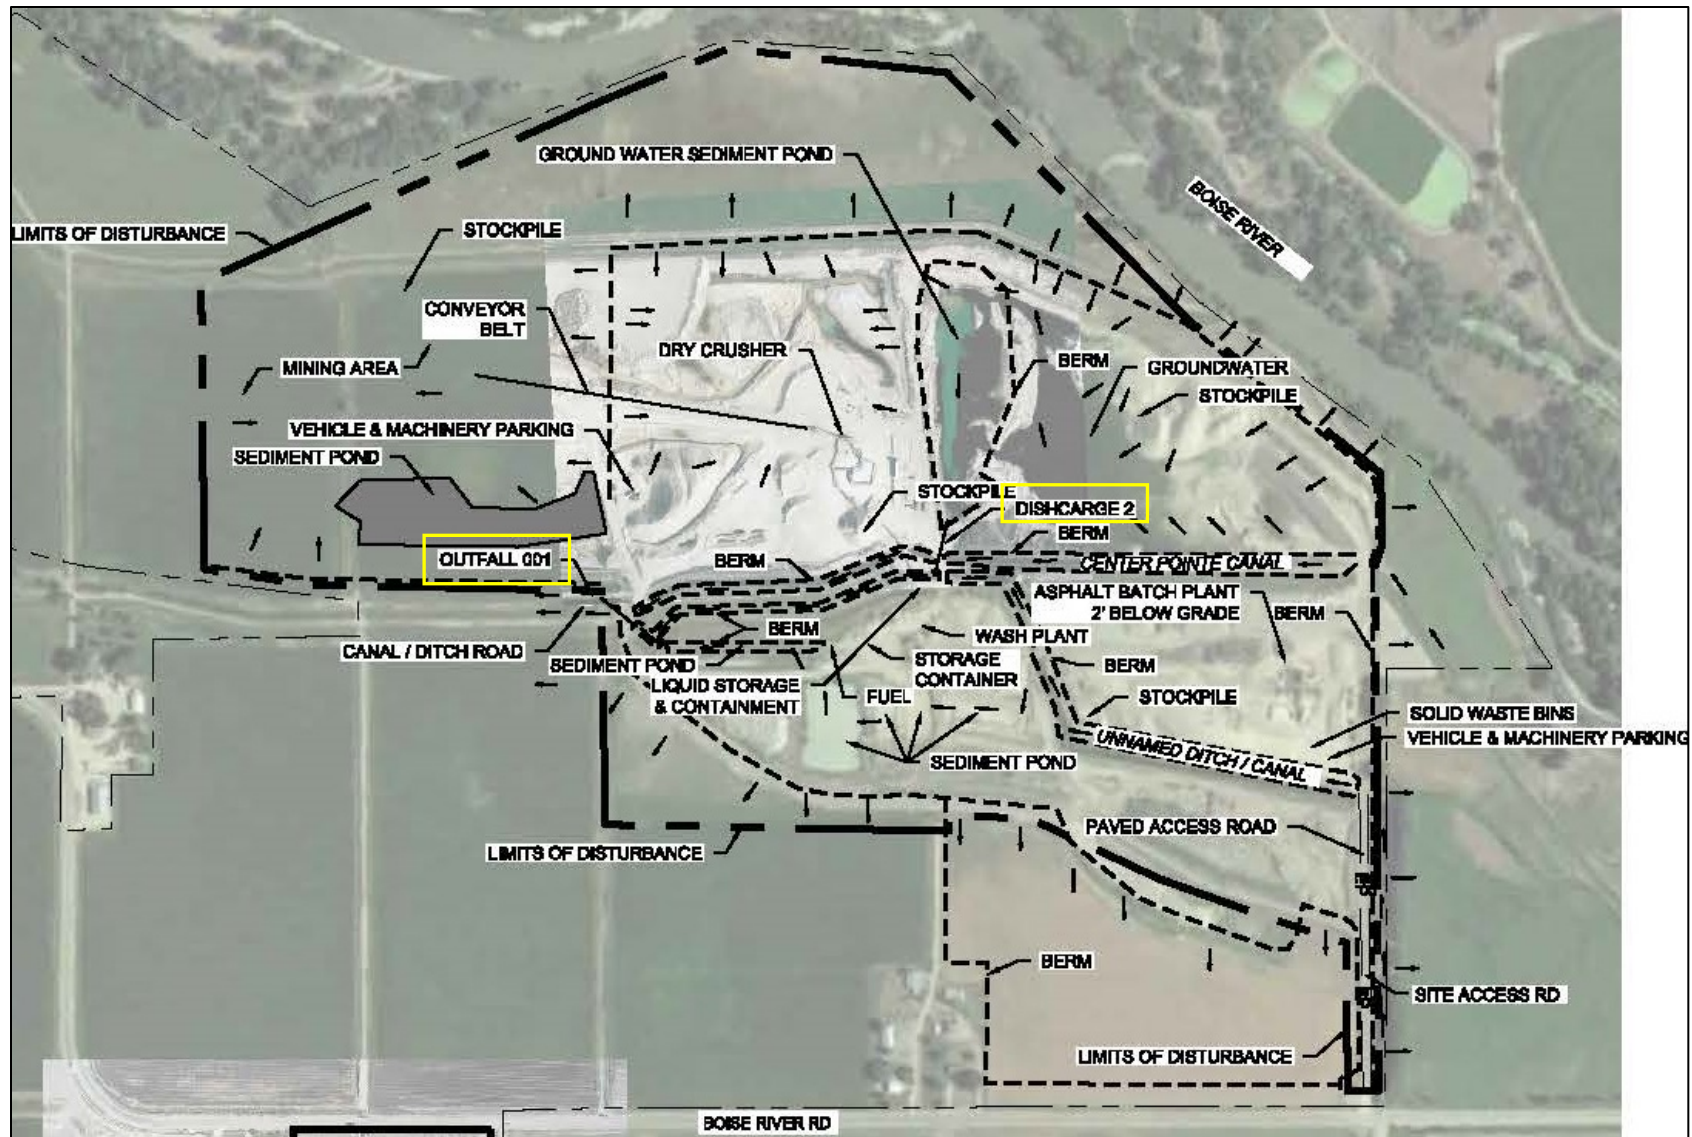
The Inspection Team noted that the Facility's NOI and SWPPP identify one outfall: Outfall 001, located at 43.7206, -116.8166. These coordinates align with Outfall 001 noted on the SWPPP site map and appear to be the point where the unnamed irrigation ditch leaves the Facility property to the west. During the inspection, we reviewed a quarterly routine inspection report from May 15, 2020 that denotes a second discharge point 200 yards upstream of "discharge #1" (refer to Exhibit 4). The report identifies a corrective action to add this discharge point to the SWPPP. It remained unclear if this was the second, seasonal discharge pipe from the retention basin to the unnamed irrigation ditch, identified by Mr. Kalmbach during the inspection, and whether this was "Discharge 2" on the SWPPP site map (refer to Photographs 14 and 15, and Exhibit 3). The Permittee should ensure that the NOI and SWPPP identify all stormwater discharge points from the Facility to a receiving water, including any determination of substantially identical outfalls.

**Exhibit 3. Close-up:** SWPPP Site Map (denoted by red box on previous page). Yellow boxes highlight the two discharge points identified on the site map: "Outfall 001" and "Discharge 2".
