**Inspection Report Addendum for Well: MT20000-01067**  
**Inspection Date: 10/24/2023**

| <b>U.S. Environmental Protection Agency</b><br><b>Region 8</b> | | <b>UIC PHOTOGRAPHIC LOG</b> | |
| <b>Facility Location:</b><br>MT20000-01067 (66-W1), Glacier County, UT | | <b>Photographer:</b><br>Gary Wang | <b>Camera:</b><br>Ricoh WG-5 |

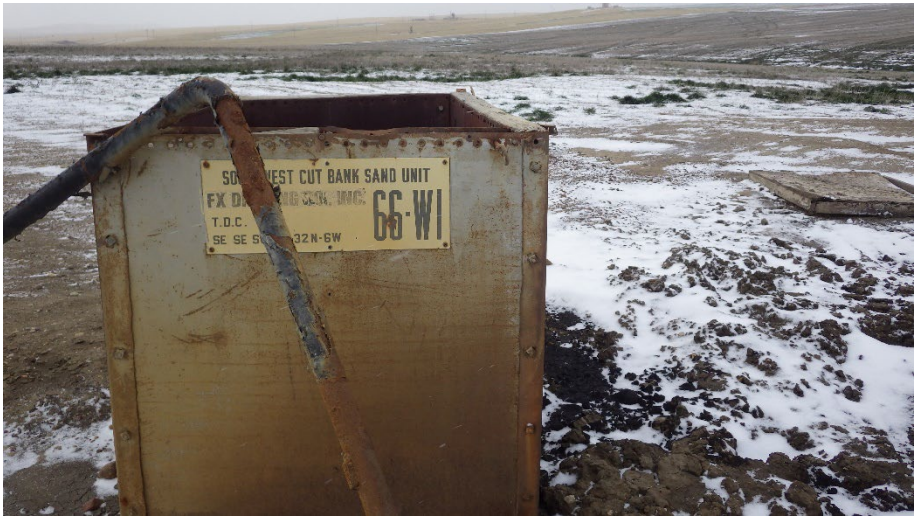
| <b>Photo No.</b><br>1 of 6 | <b>Time:</b><br>3:55 pm | | |

| <b>Photo Description:</b><br>Well sign by wellhead. | | | |

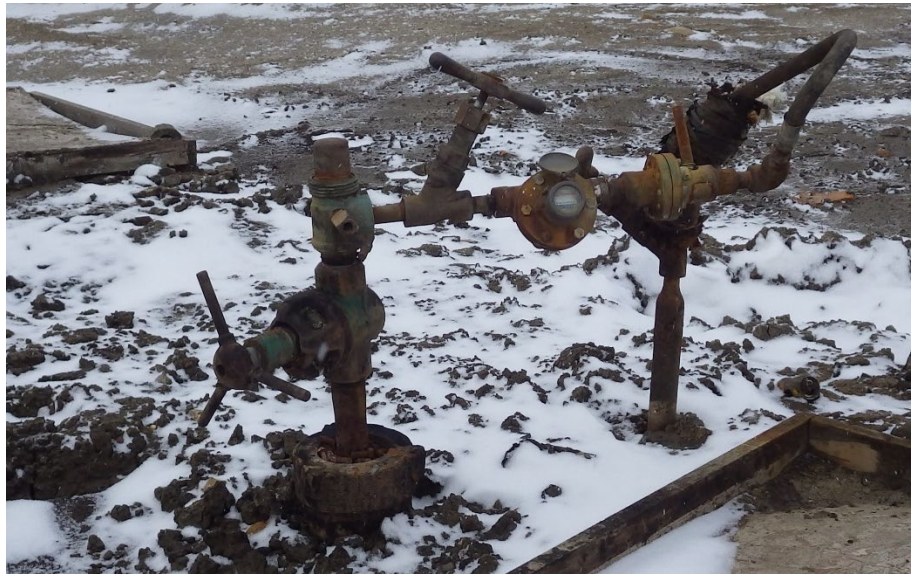
| <b>Photo No.</b><br>2 of 6 | <b>Time:</b><br>3:55 pm | | |

| <b>Photo Description:</b><br>Wellhead. Operator noted well is an active injector. Wellhead was observed to be connected to pipe flowline. | | | |

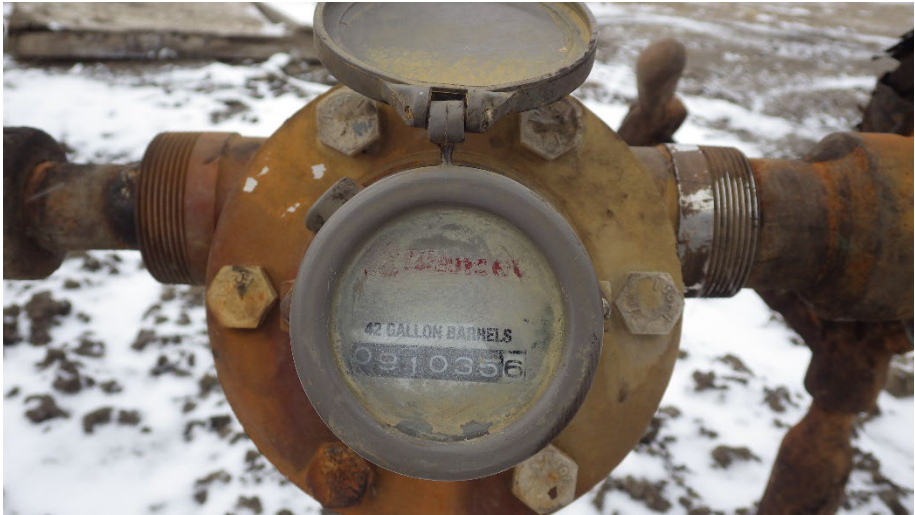
| <b>Photo No.</b><br>3 of 6 | <b>Time:</b><br>3:55 pm | | |

| <b>Photo Description:</b><br>Volume meter on wellhead read 91035.6 bbl. | | | |

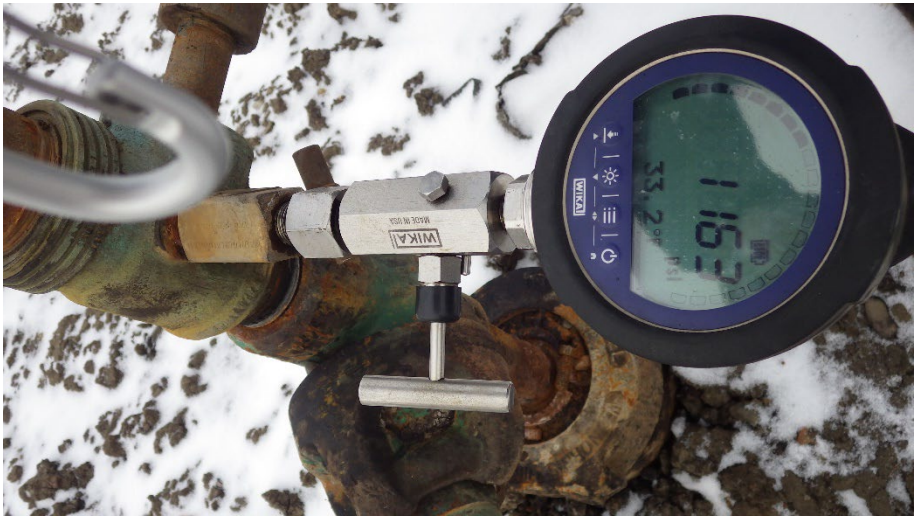
| <b>Photo No.</b><br>4 of 6 | <b>Time:</b><br>3:56 pm | | |

| <b>Photo Description:</b><br>EPA's digital pressure gauge on tubing read 1163 psi on a 3000-psi range gauge.<br>MAIP for well is at 2829 psi. | | | |

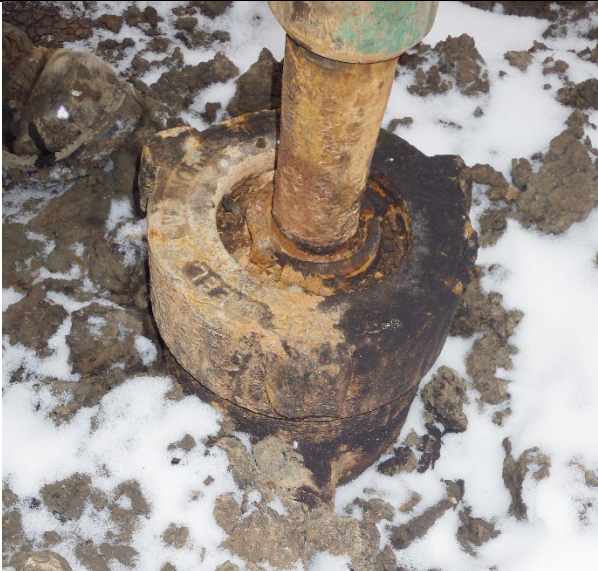
| <b>Photo Description:</b><br><p>Tubing-casing annulus is maintained continuously open to atmospheric pressure.</p> <p>Open hole for tubing-casing annulus was initially observed to be partially buried during the inspection.</p> | | | |
