CAA Inspection Report

Inspection Date: 4/12/2024
Facility Name: Oil Energy Systems Inc.
Facility Address: PR-2, Km. 62.5 Arecibo, Puerto Rico 00688
ICIS-Air ID #: PR0000007201300111
EPA Lead Inspector: Alex Rivera, Enforcement Officer, rivera.alex@epa.gov, 787-977-5845
EPA Asst. Inspector: Gloria Diaz-Galarza, Enforcement Officer, diaz-galarza.gloria@epa.gov, 787-977-5882
Facility Contact(s): Barbara Ramos Sanfiorenzo, Process Coordinator, bramos@oespr.net
Jorge A. González, President, gonzalezja@oespr.net
Daniel Martínez, Plant Supervisor

Appendix A: Digital Image Log for Oil Energy Systems Inc., Arecibo, PR

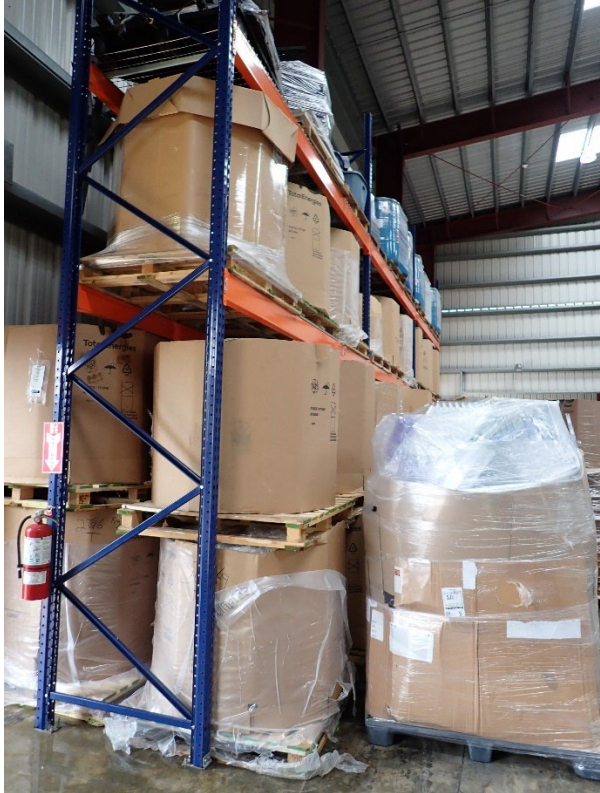
Image Number	File Name	Description	Date Taken	Time taken
1	P4120033.JPG

1. The Facility is storing plastic material within the Pyrolysis Unit building. Several large cardboard boxes were observed shelved in pallets racks. Some of the cardboard boxes were full of shredded plastic material. See images P4120033-P4120036 and P4120038 in Appendix A for more details.

<p>Partial view of shredded plastic material storage area within the Pyrolysis Unit building.</p>	4/12/2024	11:11 am

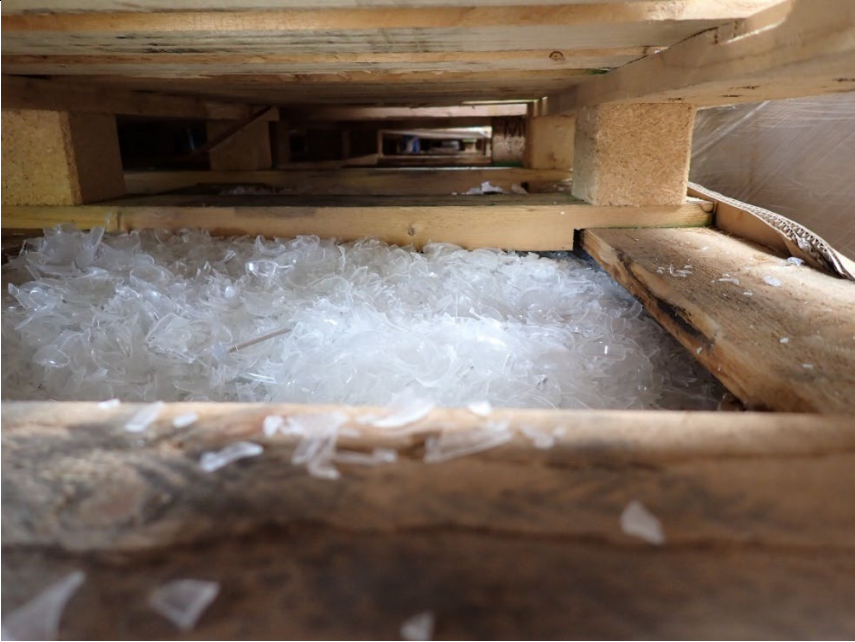
2	P4120034.JPG

4/12/2024	11:12 am
		<p>Partial view of shredded plastic material stored at the Pyrolysis Unit building.</p>		
3	P4120035.JPG

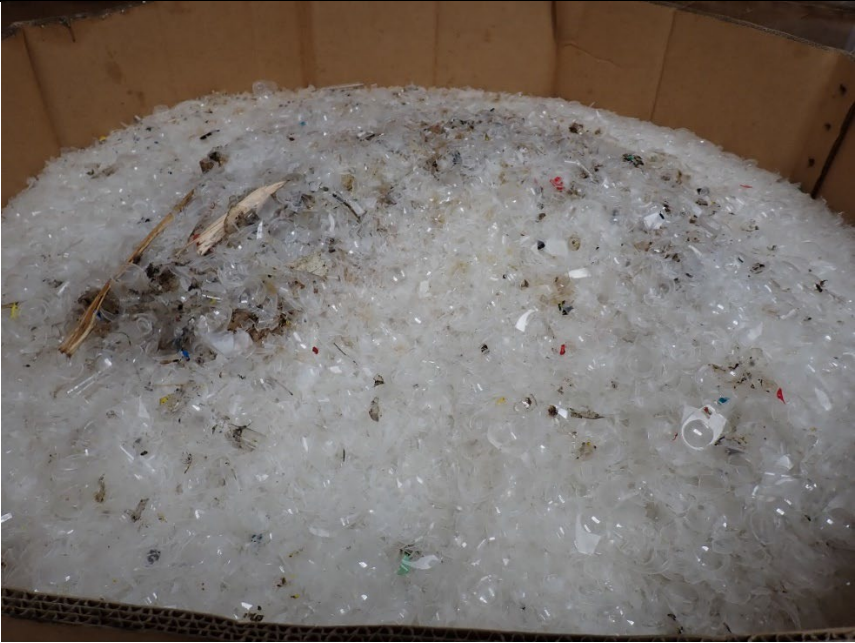
4/12/2024	11:12 am
		<p>Partial view of shredded plastic material stored at the Pyrolysis Unit building.</p>

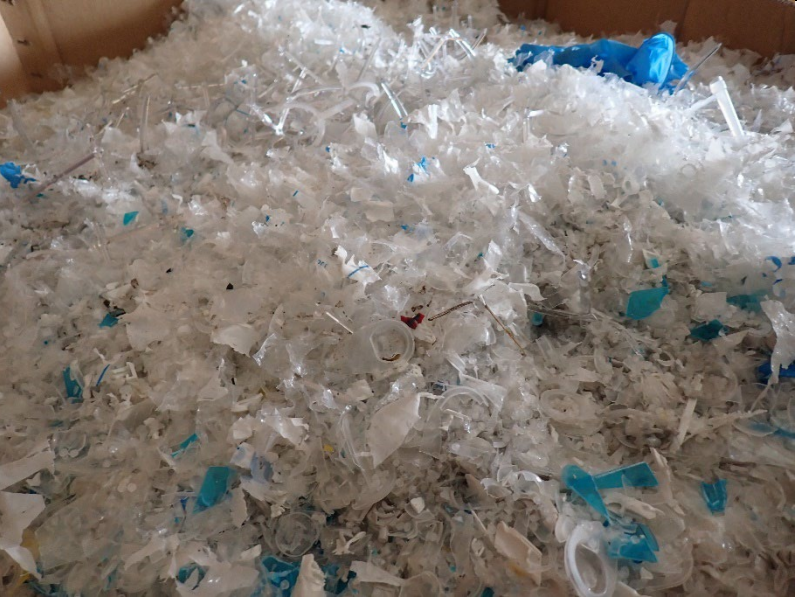
6	P4120038.JPG

Shredded plastic material stored at the Pyrolysis Unit building.

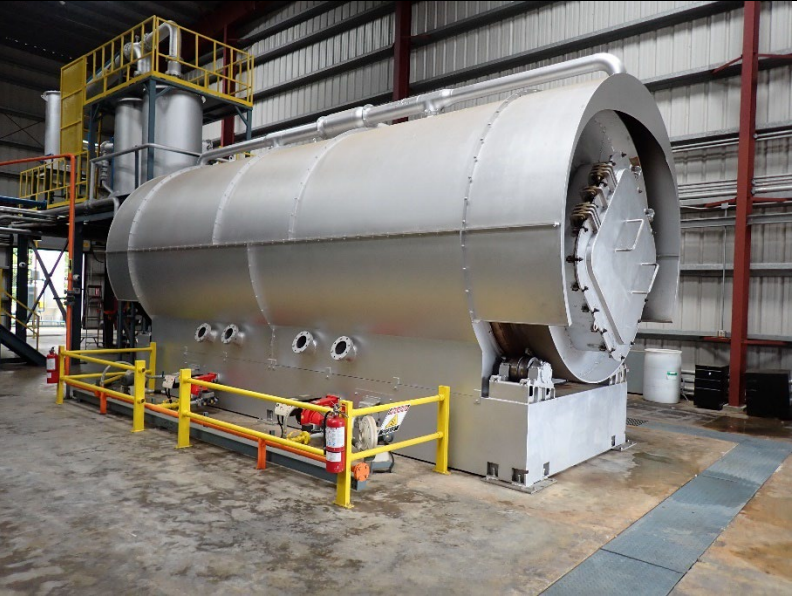
7. The Facility has one (1) pyrolysis rotary kiln reactor. See images P4120039, P4120040, and P4120059 in Appendix A for more details. The reactor has a burner box on which propane and excess syngas are used as fuel. Eng. Ramos explained that the combustion gases that are generated as part of the burner box and the enclosure of the rotary kiln are collected and conveyed through a wet scrubber. Eng. Ramos further explained that the syngas is generated as a result of the the pyrolysis process within the reactor and that prior to be used as supplemental gas in the rotary kiln burner box it is treated using a series of catalysts, heat exchangers and scrubbers. Eng. Ramos also mentioned that the excess syngas that it is not used as supplemental gas, is conveyed, and treated through a thermal oxidizer. See image P4120041 in Appendix A for more details about the syngas scrubbers.

View of the Pyrolysis Unit reactor facing northwest.

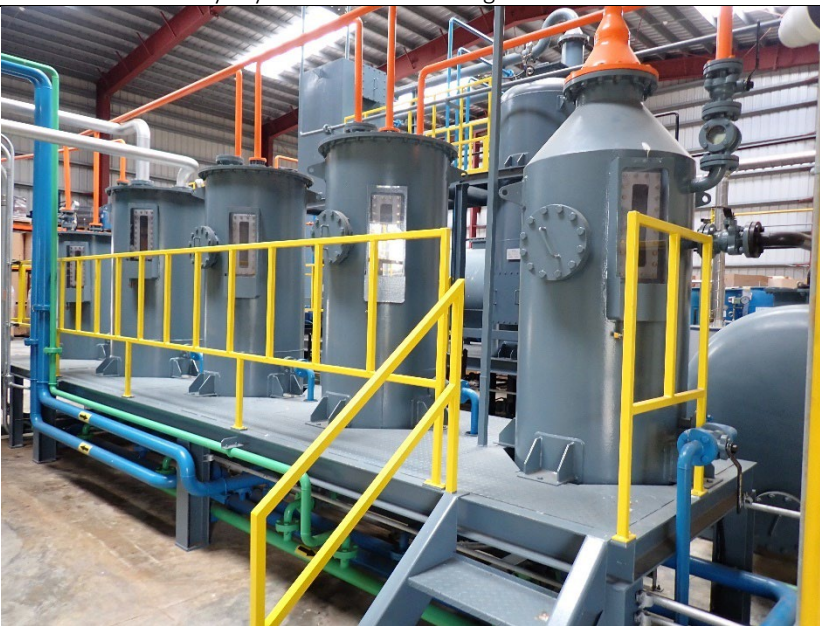
<p data-bbox="573 1333 1388 1360">View of the Pyrolysis Unit syn-gas scrubbers facing southeast.</p>	4/12/2024	11:28 am

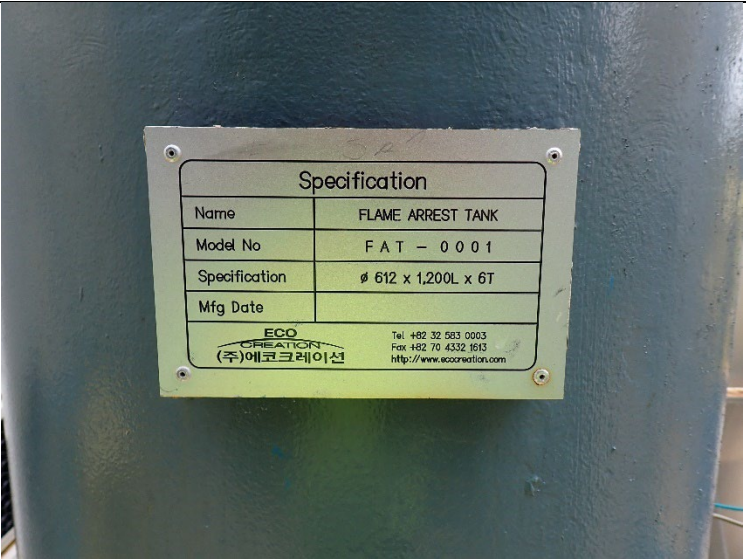
16	P4120048.JPG

9. The inspectors were led outdoors where the Facility thermal oxidizer and wet scrubber are located. See images P4120042-P4120049 in Appendix A for more details. The inspectors informed Mr. Martínez and Eng. Ramos that both units are starting to show corrosion issues and that the wet scrubber is identified as a dust collector in the process layout that was included in the Facility air emission source construction permit application.

<p>View (facing west) of the thermal oxidizer flame arrestor specification plate.</p>	4/12/2024	11:33 am
17	P4120049.JPG

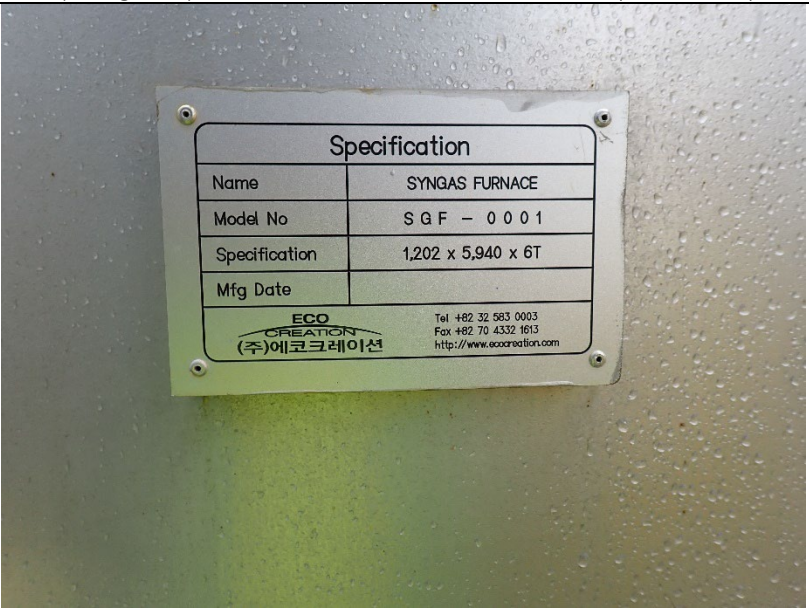
<p>View (facing west) of the thermal oxidizer specification plate.</p>	4/12/2024	11:35 am

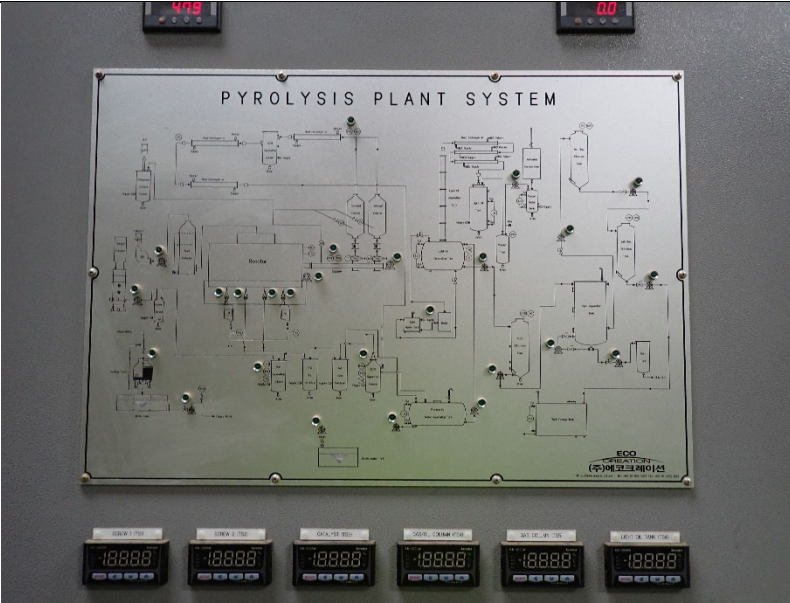
View of the Pyrolysis Unit process diagram.

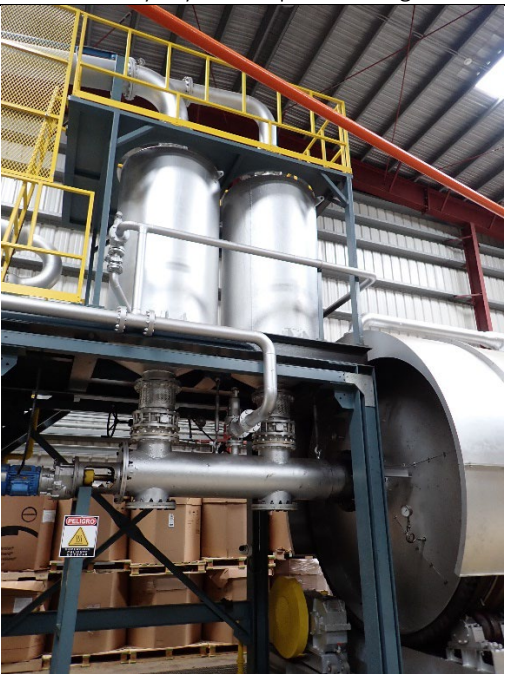
View (facing north) of the Pyrolysis Unit two (2) catalyst columns.

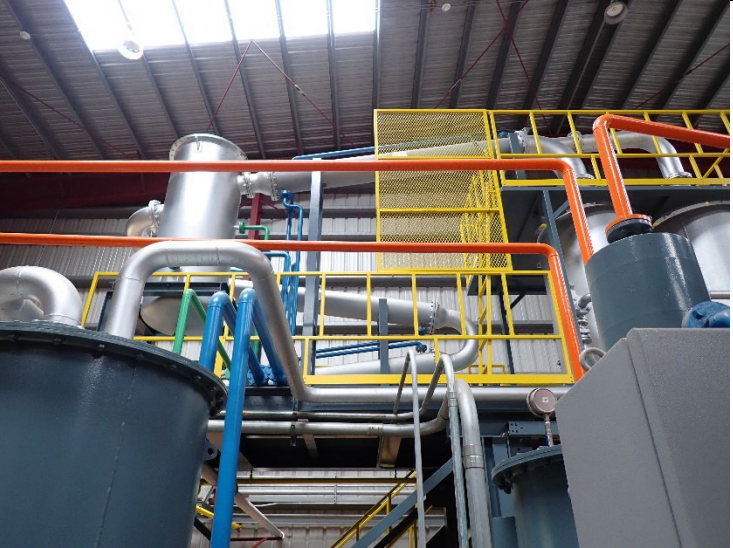
22	P4120054.JPG

<p data-bbox="575 618 1514 678">Partial view (facing north) of the Pyrolysis Unit heat exchanger located after the catalyst columns.</p>	4/12/2024	12:00 pm
23	P4120055.JPG

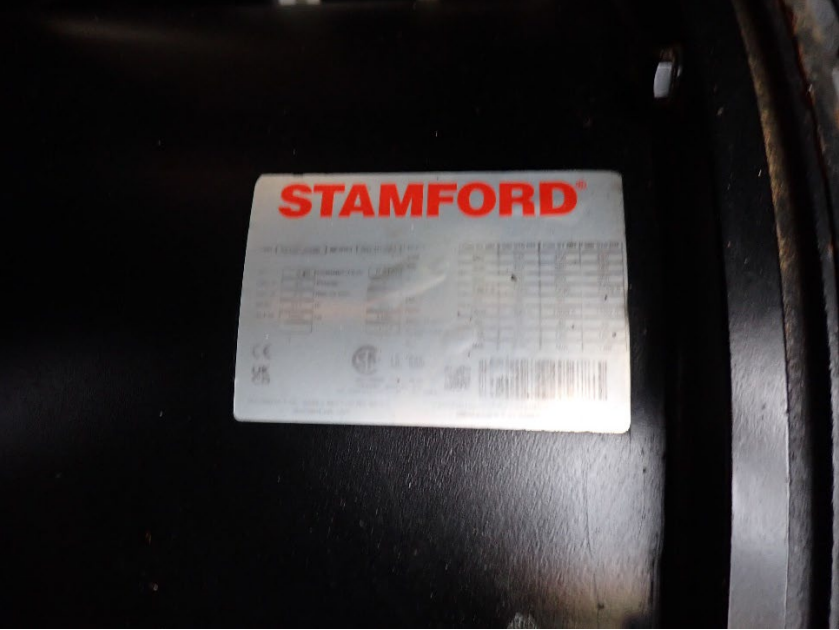
<p data-bbox="575 1312 1514 1341">View of the emergency generator specification plate.</p>	4/12/2024	12:11 pm
