**CWA COMPLIANCE EVALUATION INSPECTION REPORT  
U.S. ENVIRONMENTAL PROTECTION AGENCY, REGION 5**

**Facility:** TLB Wood Products, LLC  
N5624 County Road C  
Seymour, Wisconsin 54311

**Date of Inspection:** April 29, 2025

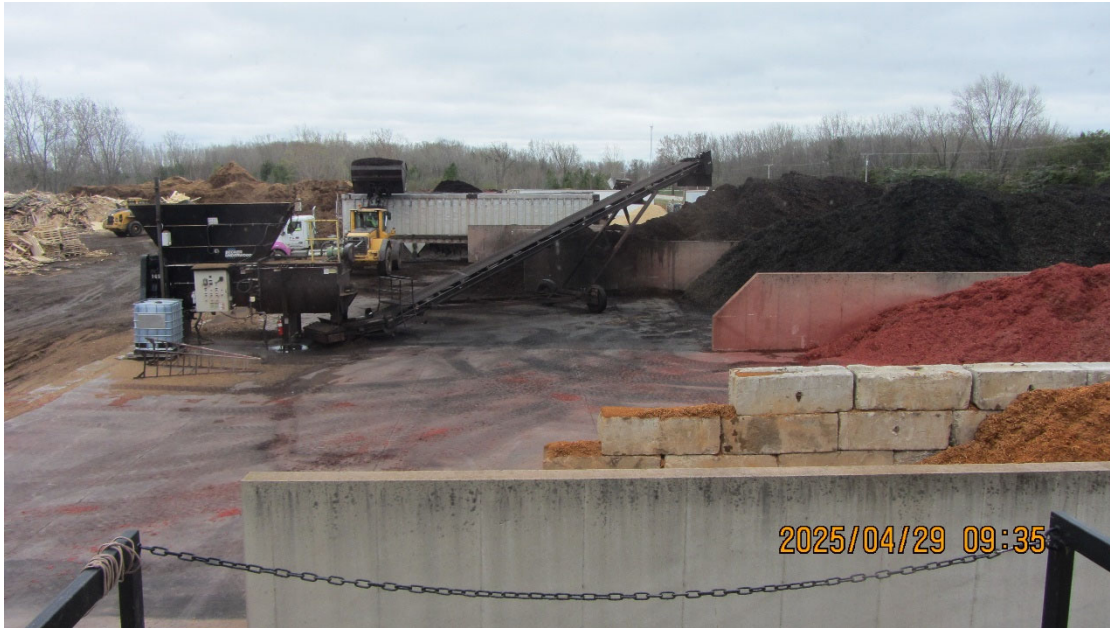
1: IMG\_1173

Next, EPA and Mr. Olson walked to the south in the center of the facility to the colorizer mulch unit (Photograph 1, 14, and 15 in Attachment A). At the colorizer mulch unit, EPA observed a tote of dye that was next to the colorizer mulch unit with uncolored mulch being loaded into the unit by a front loader. Mr. Olson explained that the pumped discharge from the colorizer mulch unit is located underneath the center of the unit and will only discharge when stormwater flows into the drain. At the time of the inspection, the facility was dyeing mulch brown. This dyed mulch would be then stored into one of three bins located west of the colorizer mulch unit, based on the color of the mulch.

Description: Colorizer and Finished Mulch Piles

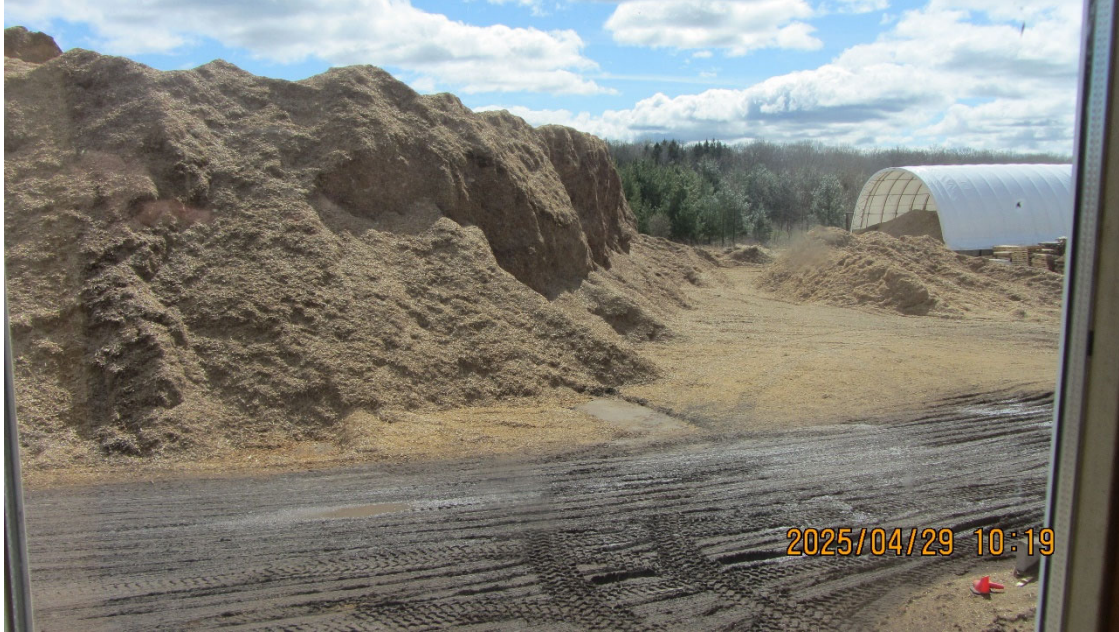
2: IMG\_1174

EPA and Mr. Olson then continued walking to the south on the east facility property boundary. Near the area on the site map where Discharge Point F was identified, EPA and Mr. Olson stopped to observe this area (Photograph 13 in Attachment A). A large storage pile of natural grinded mulch was stored in this area (the pile on the left in Photograph 2 in Attachment A).

Description: Natural/Virgin Wood Pile

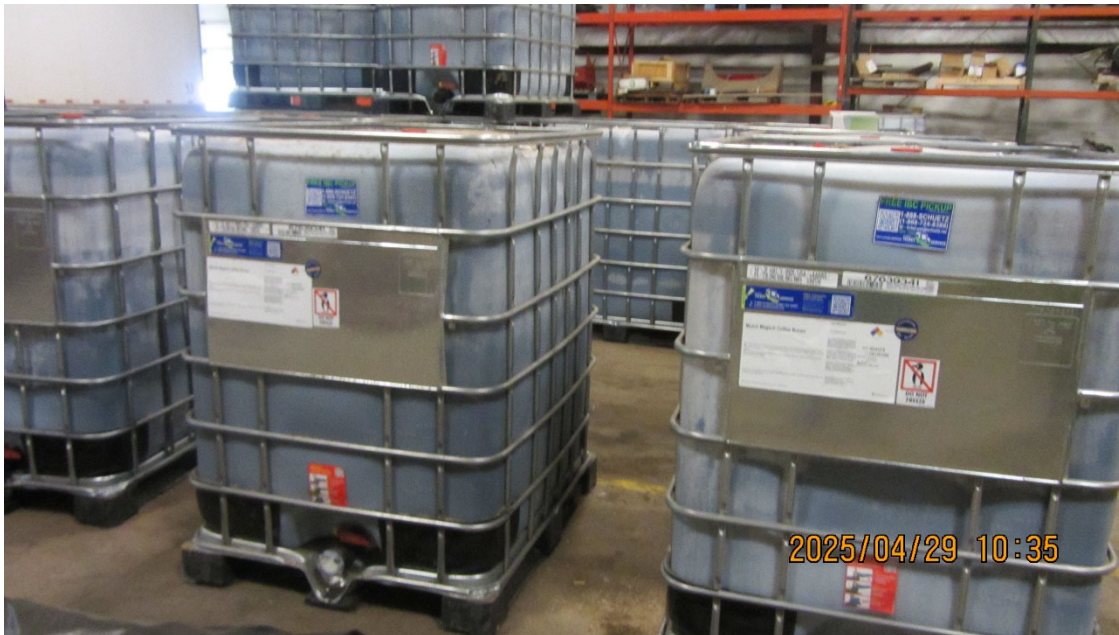
3: IMG\_1175

Description: Wood Colorizer Dye Tote Storage

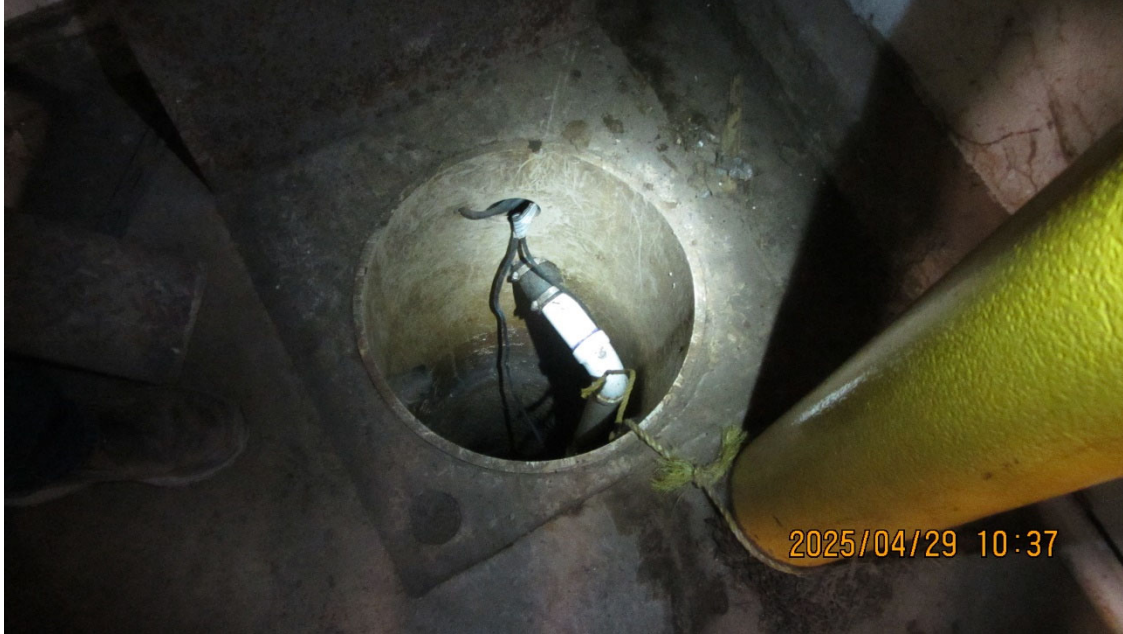
4: IMG\_1176

Description: Dock Stormwater Sump Pump

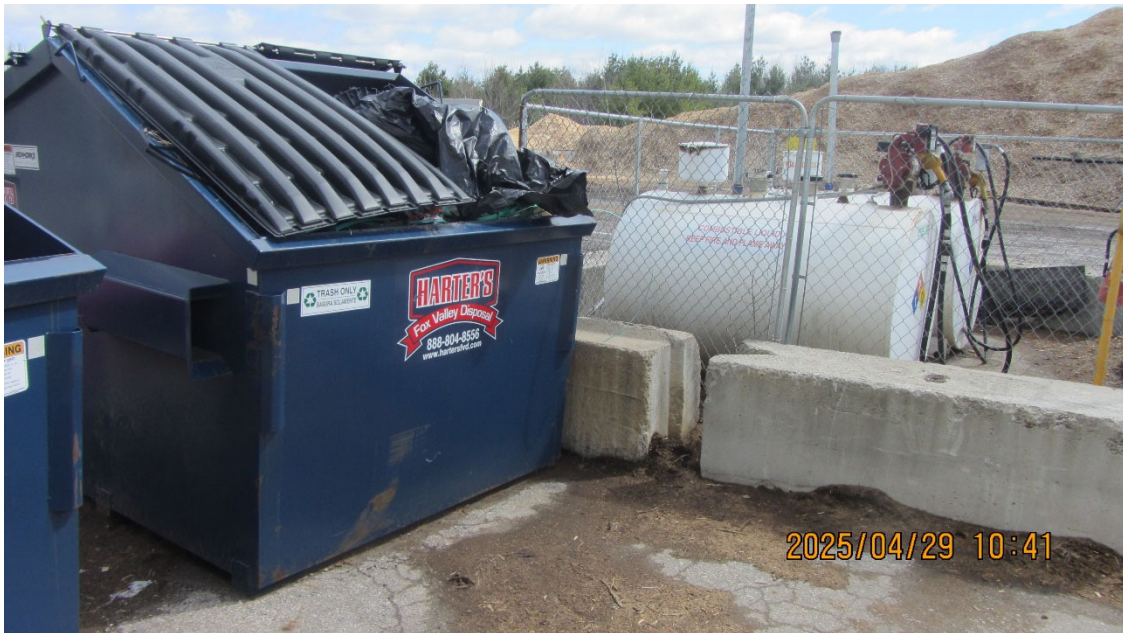
5: IMG\_1177

EPA and Mr. Olson then walked outside to observe the loading dock (Photograph 7 in Attachment A). EPA observed the drain that is near the building in the loading dock that is connected to the dock stormwater pump. Next, EPA walked past the fuel tank locations and onsite dumpsters (Photograph 5 and 6 in Attachment A). Note the lid for both dumpsters were open at the time of the inspection.

4. Housekeeping/Dumpster Issues: During the inspection, EPA observed that onsite dumpster lids near the loading dock were left open (see Photograph 5 and 6 in

Description: Garbage Dumpster and Diesel Tanks

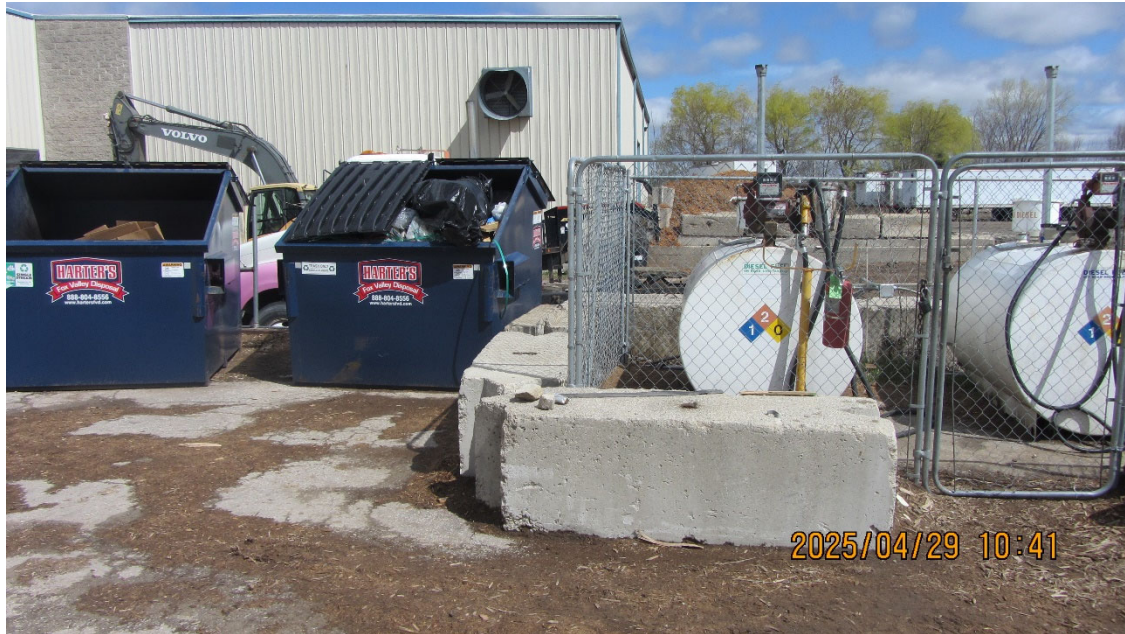
6: IMG\_1078

Description: Garbage Dumpster and Diesel Tanks (2)

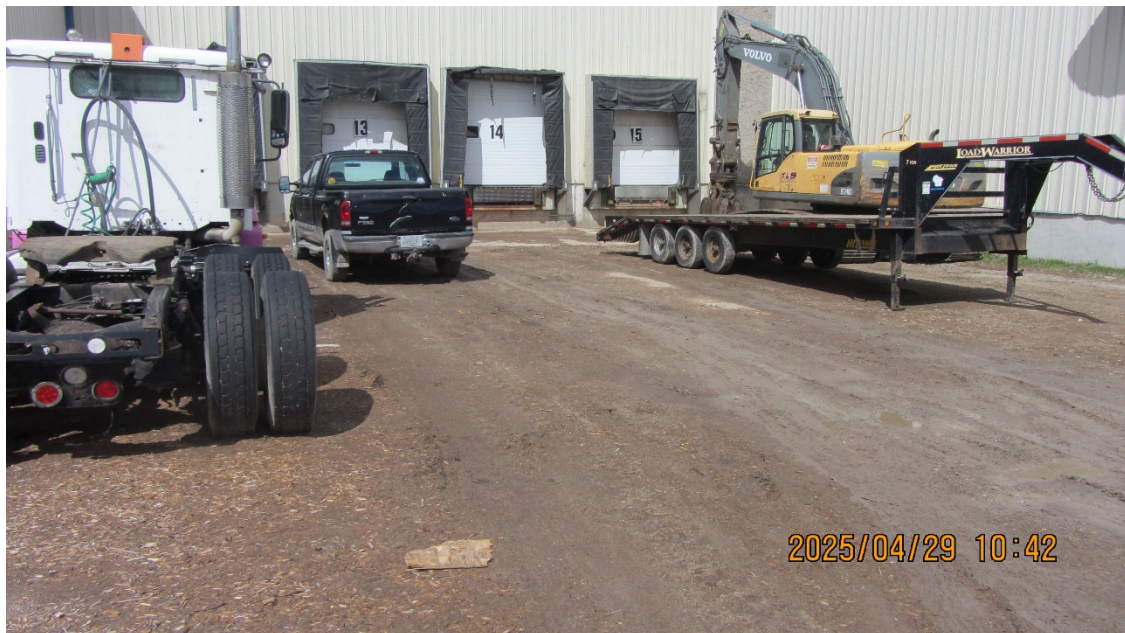
7: IMG\_1079

Description: Loading Dock

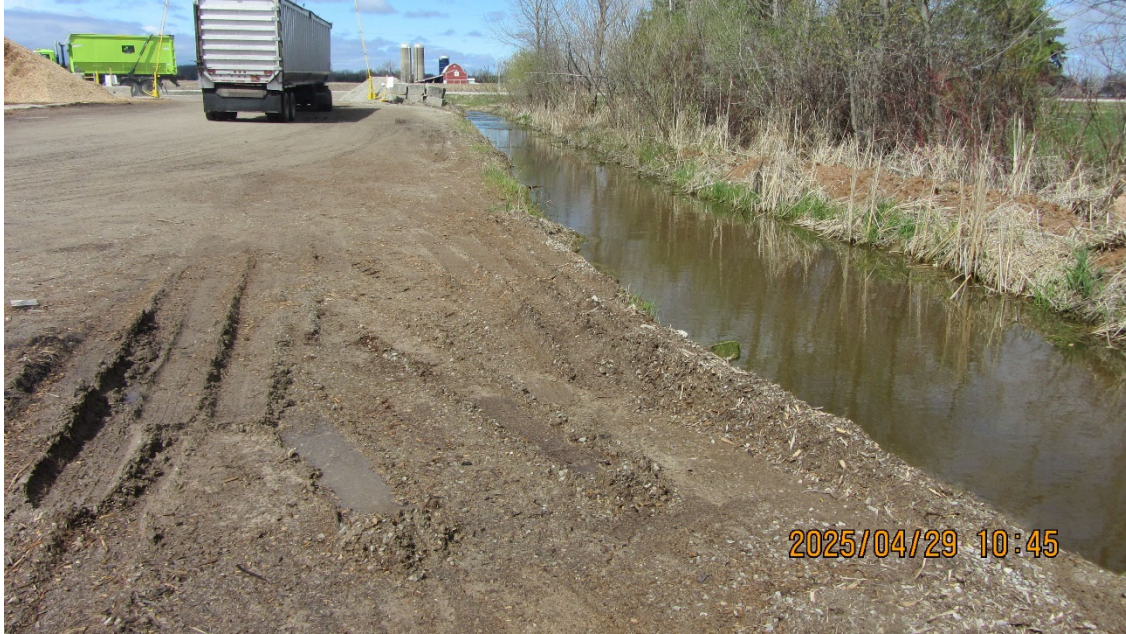
8: IMG\_1180

Next, EPA and Mr. Olson walked to the northeast to the facility's low elevation at the northeast corner of the site. When arriving at the northeast corner of the facility, EPA observed the north perimeter stormwater ditch (Photograph 8, 9, and 10 in Attachment A). At this location, EPA did not observe any stormwater erosion or any other evidence that would identify a point stormwater discharge to the north perimeter stormwater ditch. Photograph 9 in Attachment A shows a hydraulic connection from the north property. Mr. Olson indicated to EPA that during heavy precipitation, stormwater runoff from the north property will flow onto the facility and then into the north perimeter stormwater ditch. EPA and Mr. Olson then walked to a trailer

Description: North Perimeter Stormwater Ditch

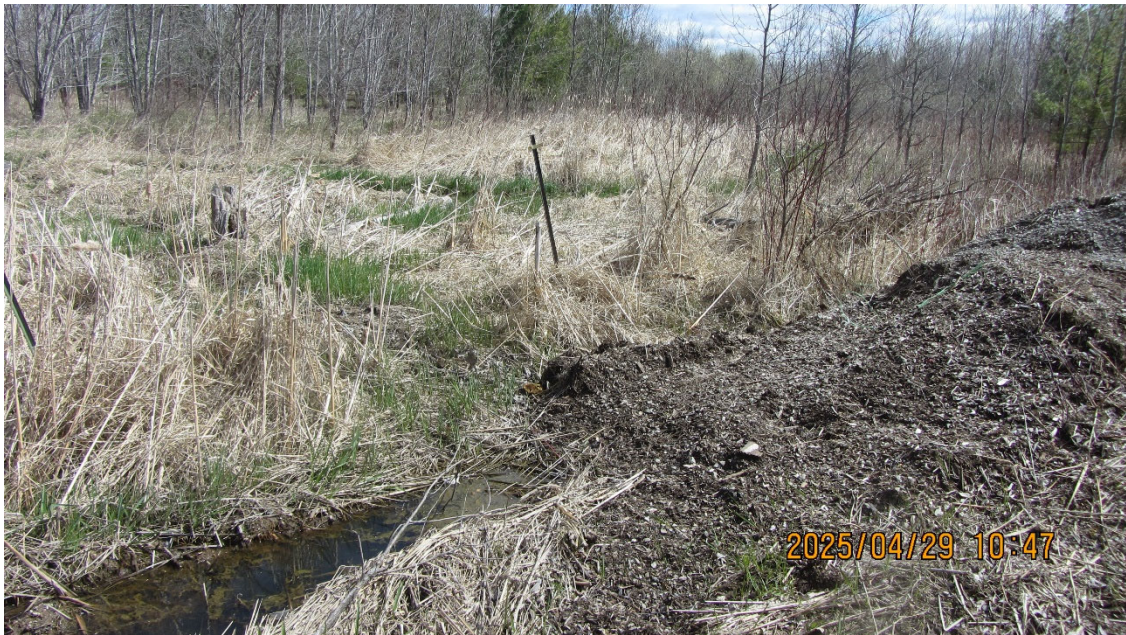
9: IMG\_1181

Description: Northeast Corner of the Facility's Site and the Start of the North Perimeter Stormwater Ditch

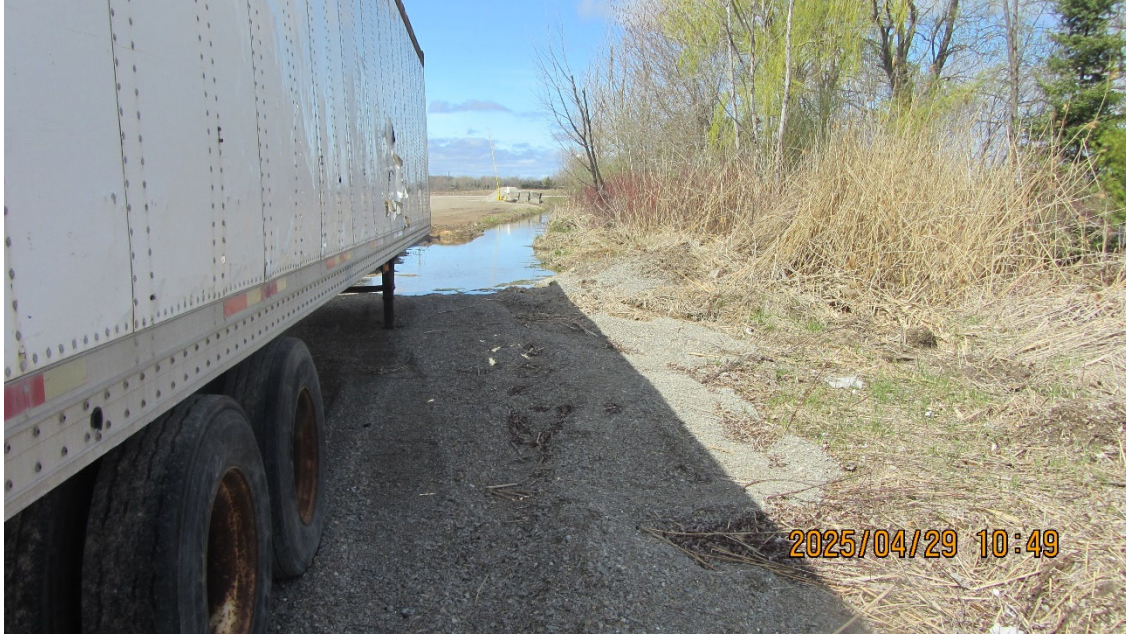
10: IMG\_1182

10. Offsite Stormwater from North Property: During the inspection, EPA observed the potential for stormwater flow from the north adjacent property to flow onto the facility's site/north perimeter stormwater ditch. If stormwater from the property to the north does flow onto the facility's site and there are significant quantities of pollutants in the stormwater run-on, the facility needs to include the location of this flow in the SWPPP site map, pursuant to Part 6.2.2.3.m(x) of the Stormwater Permit.

Description: Facility's Northern Property Line and the Start of the North Perimeter Stormwater Ditch

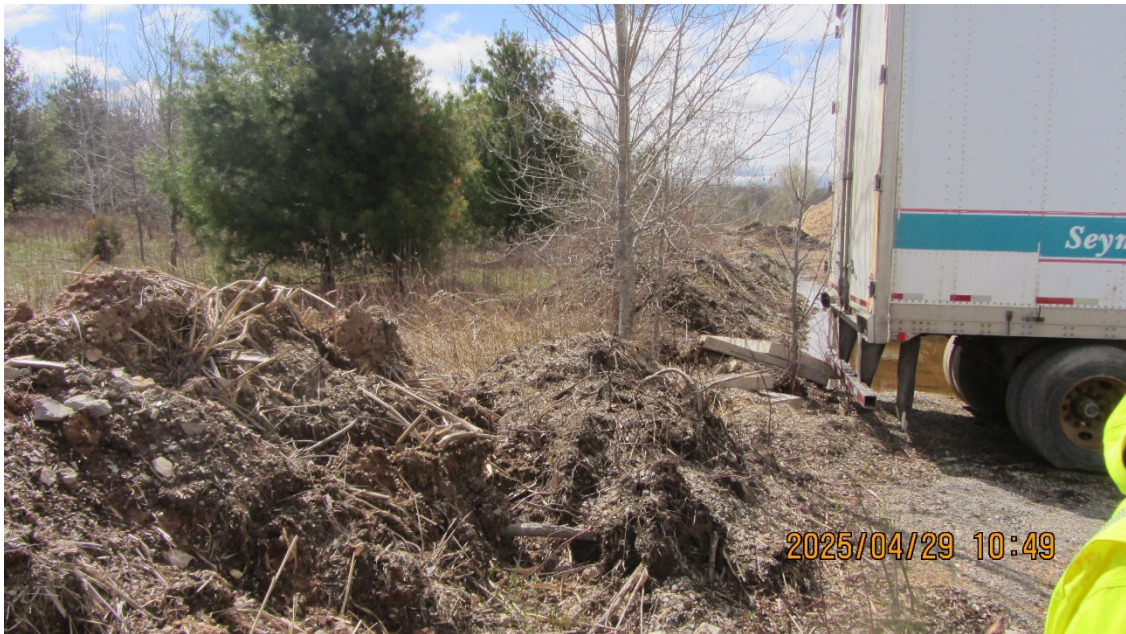
11: IMG\_1183

storage area in the northeast corner of the site. Mr. Olson indicated to EPA that in the Fall of 2024, the facility began burying cement blocks in this area to allow the trailers being stored here not to be stuck in the mud during wet periods. EPA and Mr. Olson then viewed and discussed the property north of the facility (Photographs 11 and 12 in Attachment A).

Description: Facility's Eastern Property Line

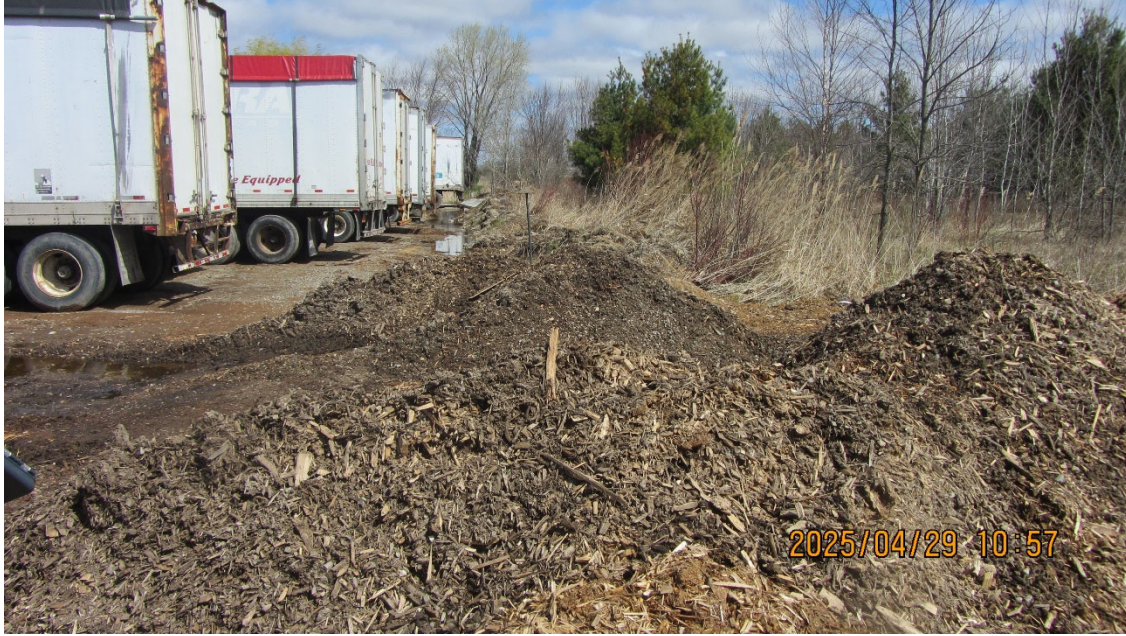
12: IMG\_1184

Description: Looking Towards the Facility's Northeast Corner

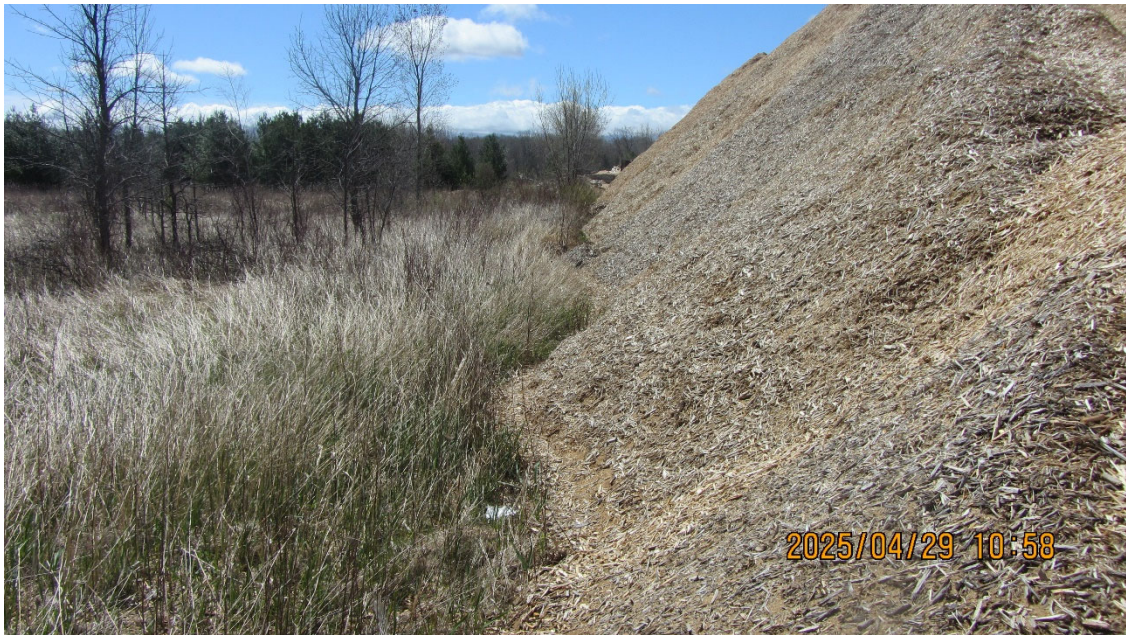
13: IMG\_1185

Description: Facility's Eastern Property Line; near Stormwater Discharge Point F

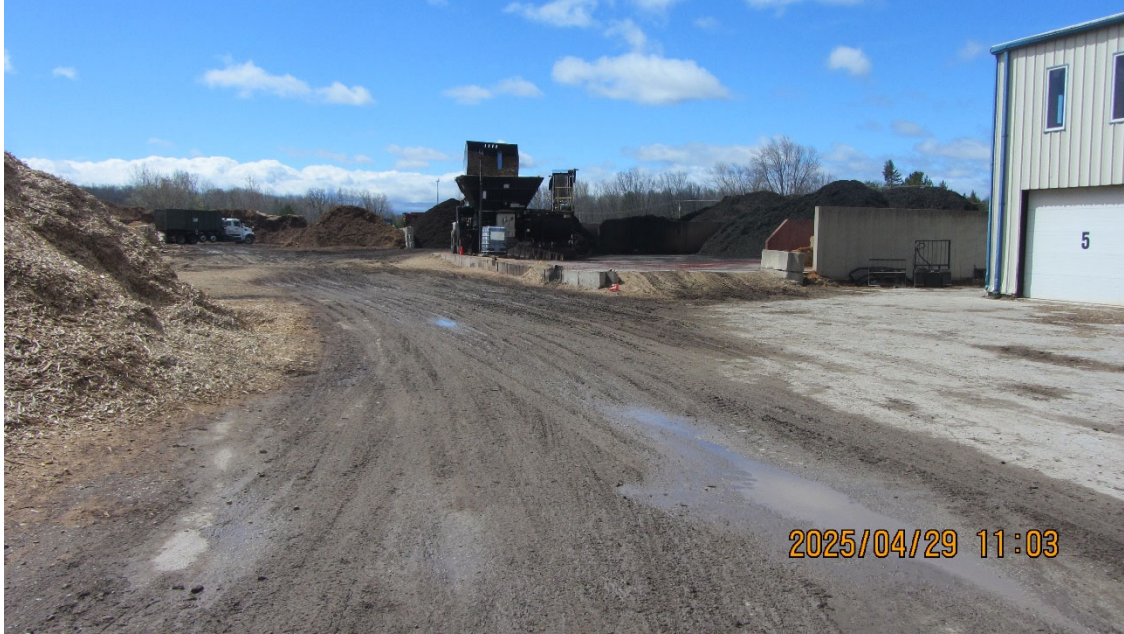
14: IMG\_1186

Description: Colorizer Unit

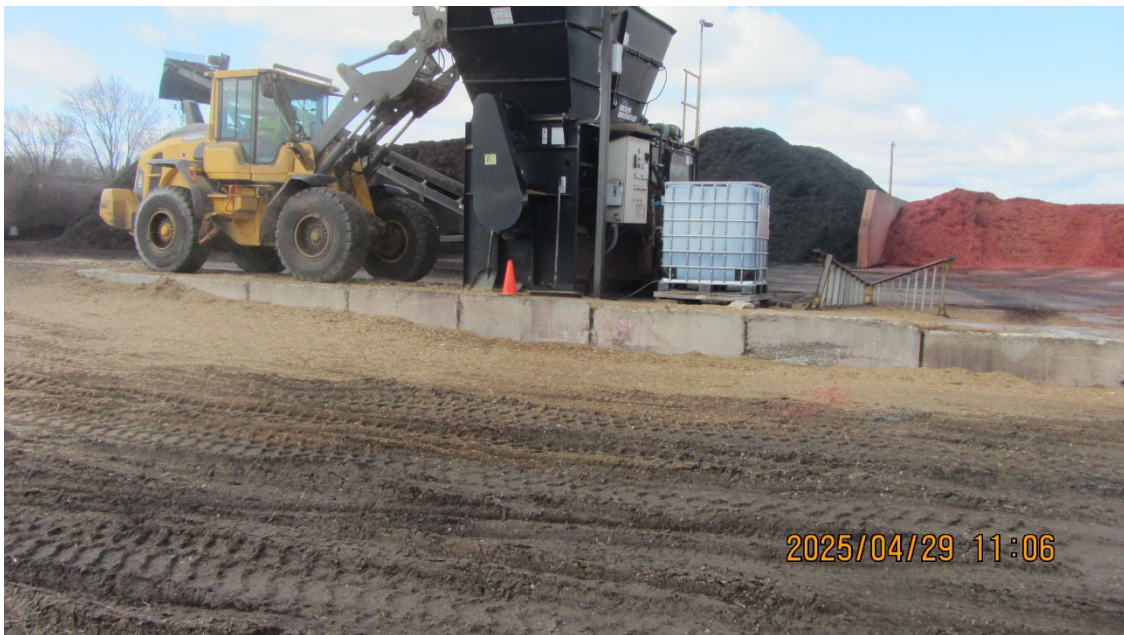
15: IMG\_1187

Description: Colorizer Being Loaded with Mulch

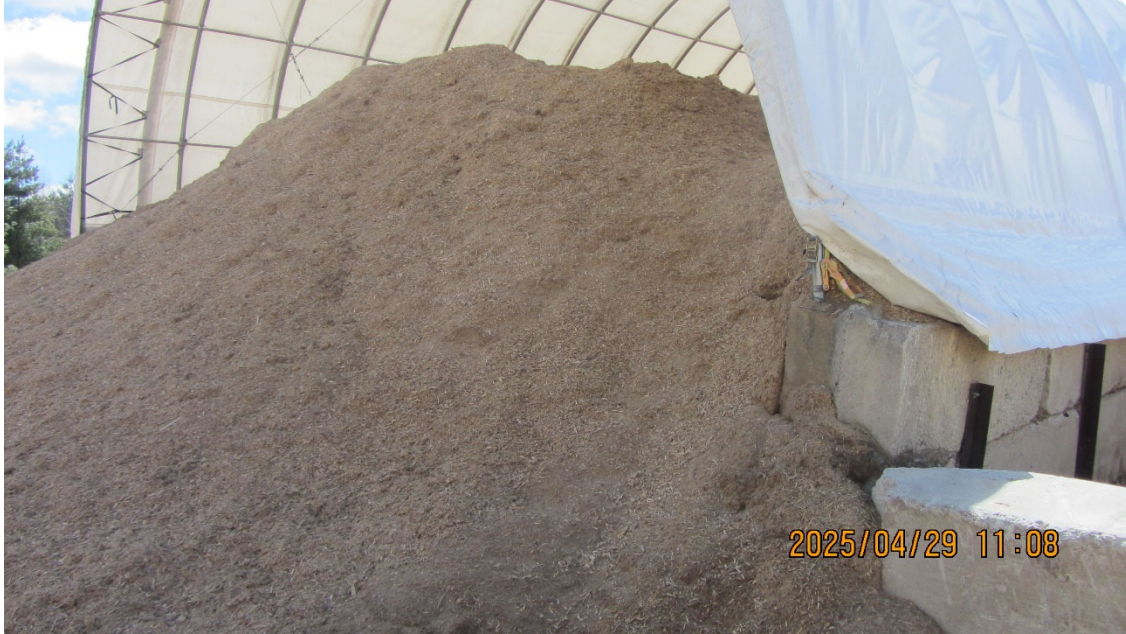
16: IMG\_1188

Description: Covered Animal Bedding Produced

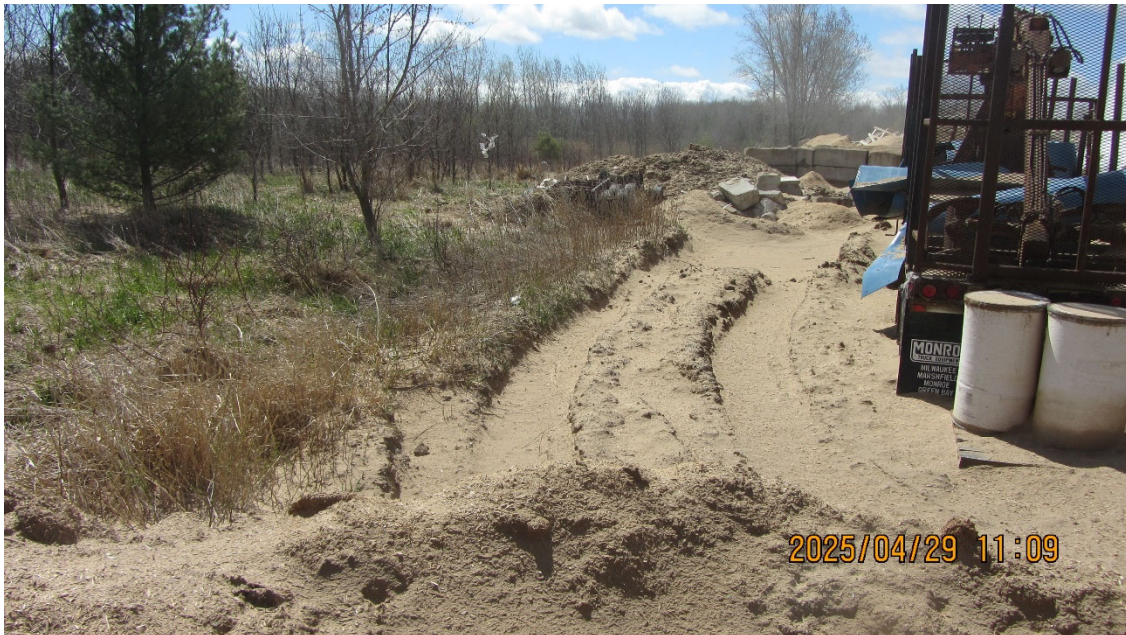
17: IMG\_1189

Description: Eastern Property Boundary; Further South Near Bedding Storage

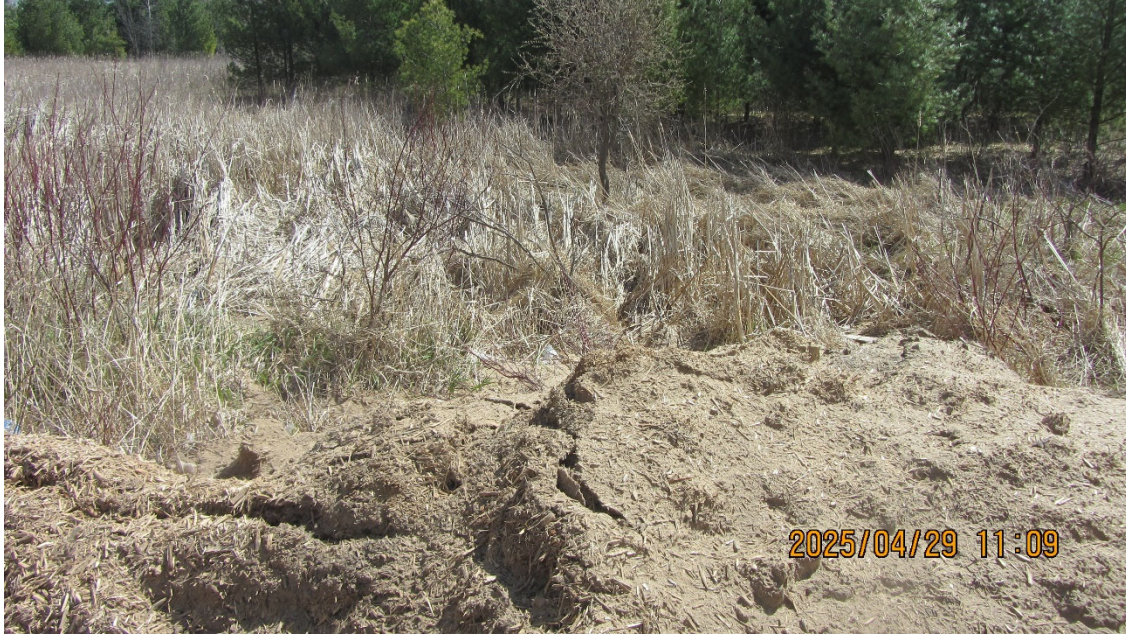
18: IMG\_1190

Description: East Boundary of Facility; near Bedding Coverage Storage Area/Stormwater Discharge Point E

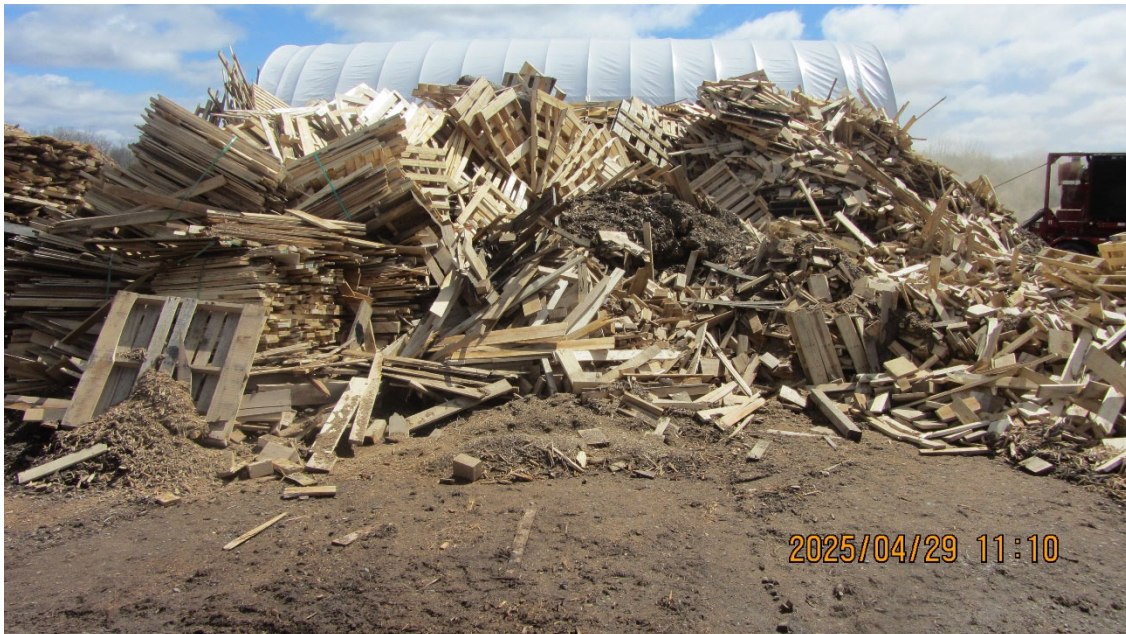
19: IMG\_1191

EPA and Mr. Olson then turned around and walked to the southwest. During this walk, EPA walked past a #2 waste wood storage pile that contained mostly pallets that was used for some products (Photograph 19 in Attachment A). Then EPA and Mr. Olson reached the bark storage pile on the south side of the facility (Photograph 20 in Attachment A). EPA observed the south boundary of the facility (Photograph 24 in Attachment A) and did not observe any stormwater erosion or any other evidence that would identify a stormwater discharge from the facility offsite to the south.

Description: #2 Waste Wood Storage Pile

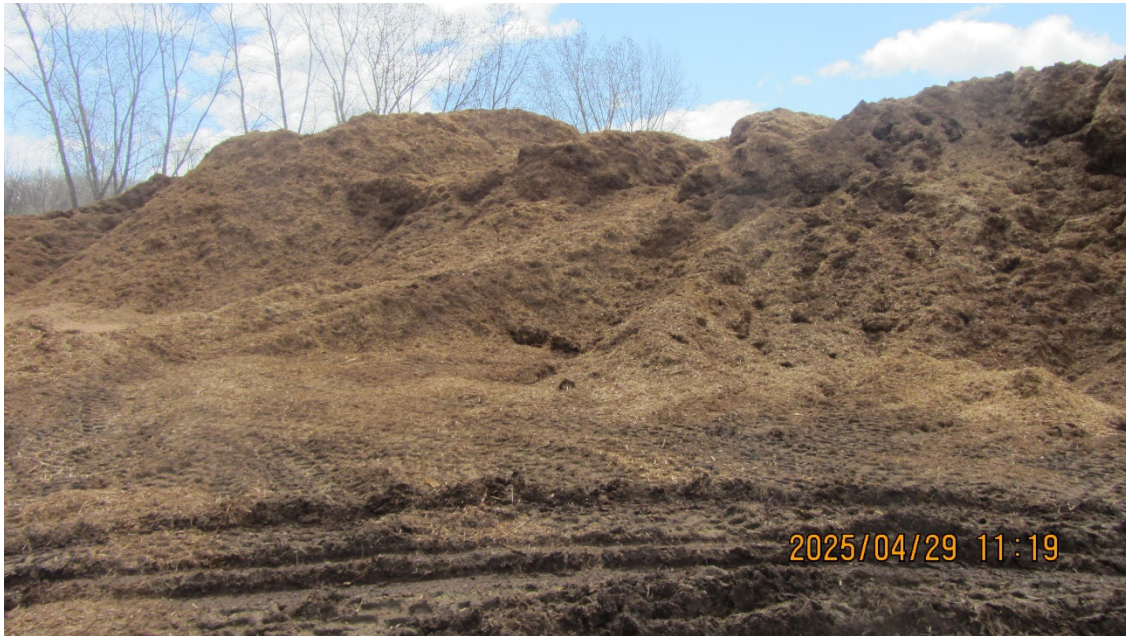
20: IMG\_1192

Description: Bark Storage Pile

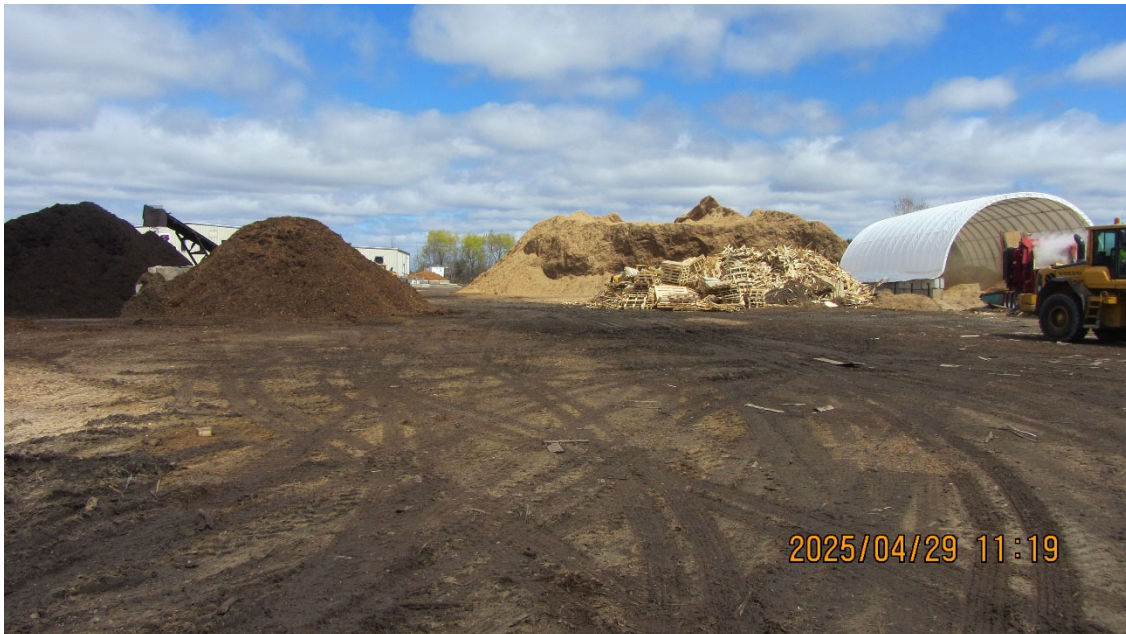
21: IMG\_1193

Description: TLB Wood Product Site; From South Boundary

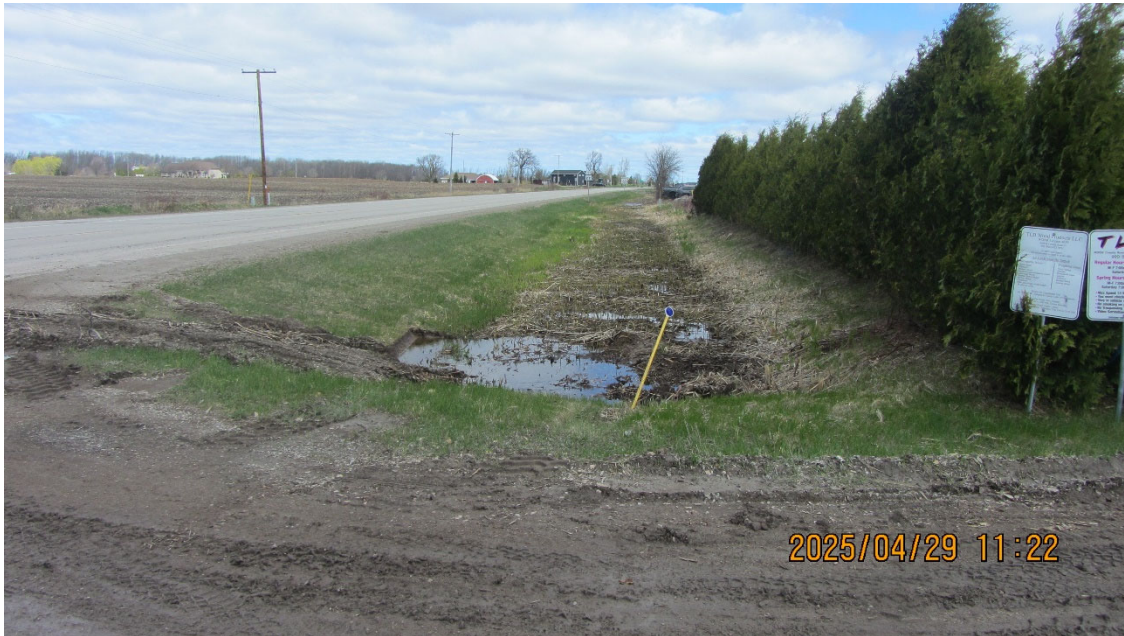
22: IMG\_1194

Next, EPA and Mr. Olson walked to the west to view the County C roadside ditch. Photographs 22 and 23 in Attachment A show the County C roadside ditch upstream and downstream from

Description: Roadside Ditch; at Facility's South Entrance

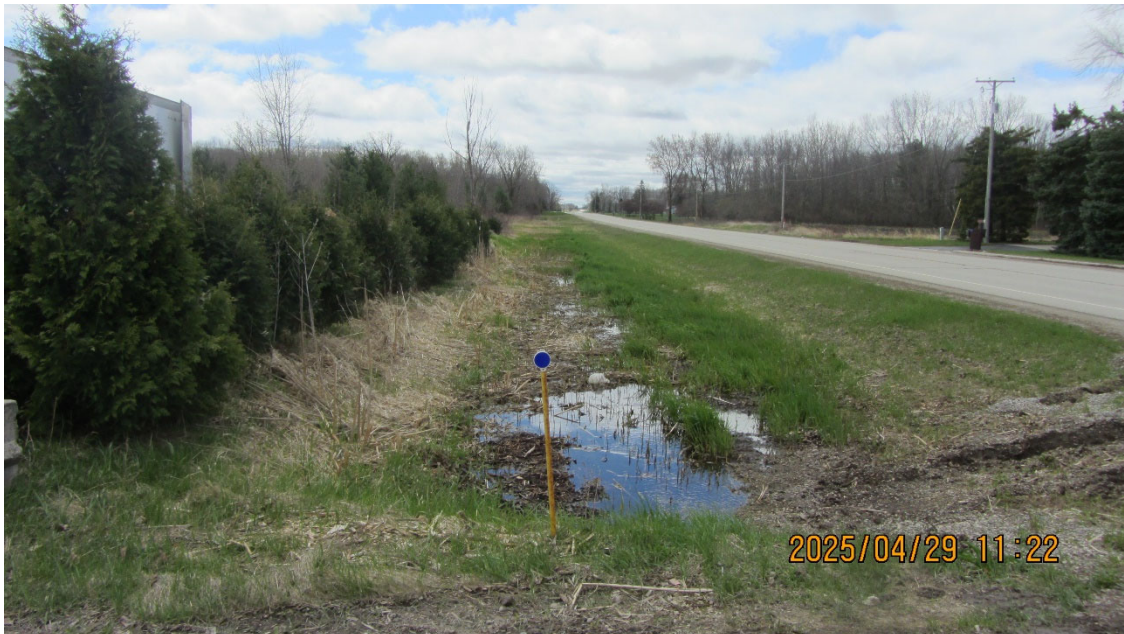
23: IMG\_1195

Description: Roadside Ditch; at Facility's South Entrance

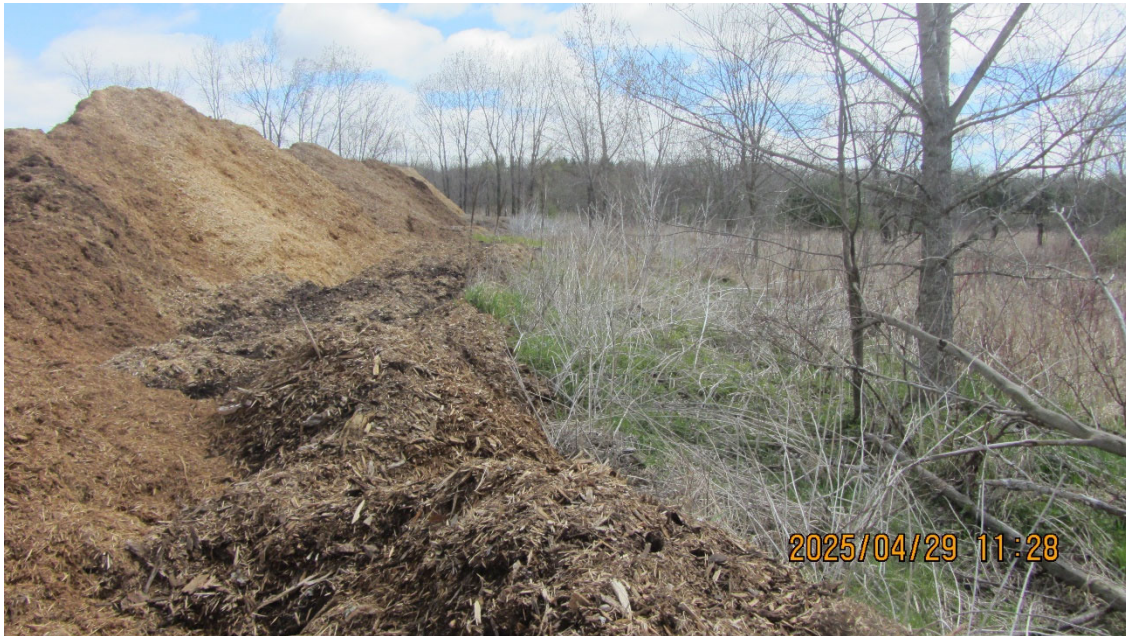
24: IMG\_1196

Description: South Boundary of the Facility

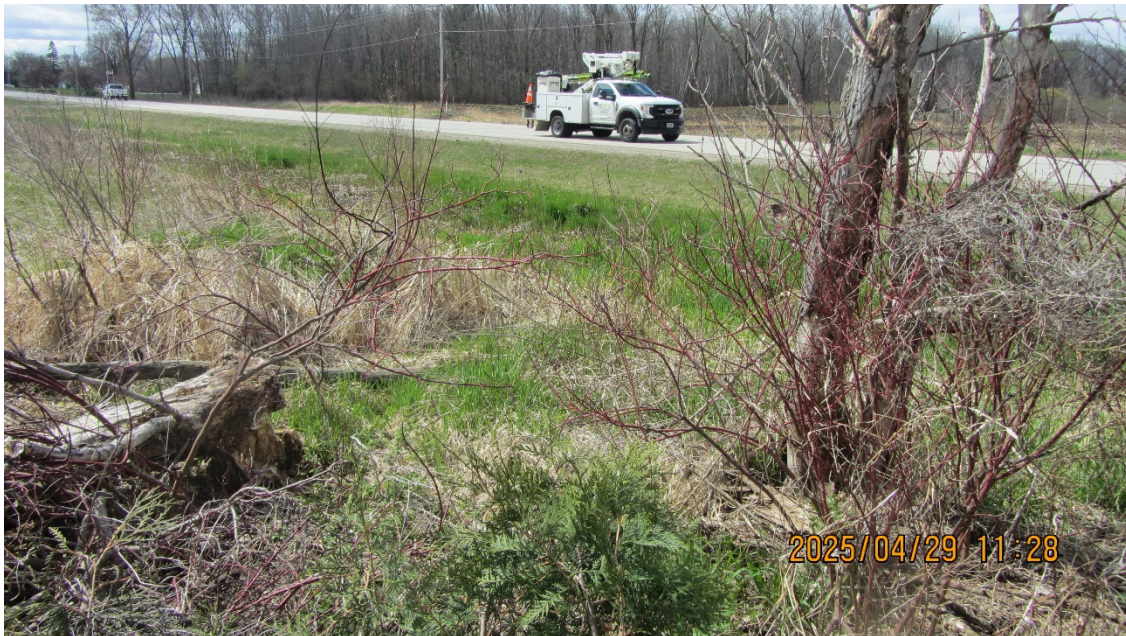
25: IMG\_1197

Description: Roadside Ditch; South Property Line

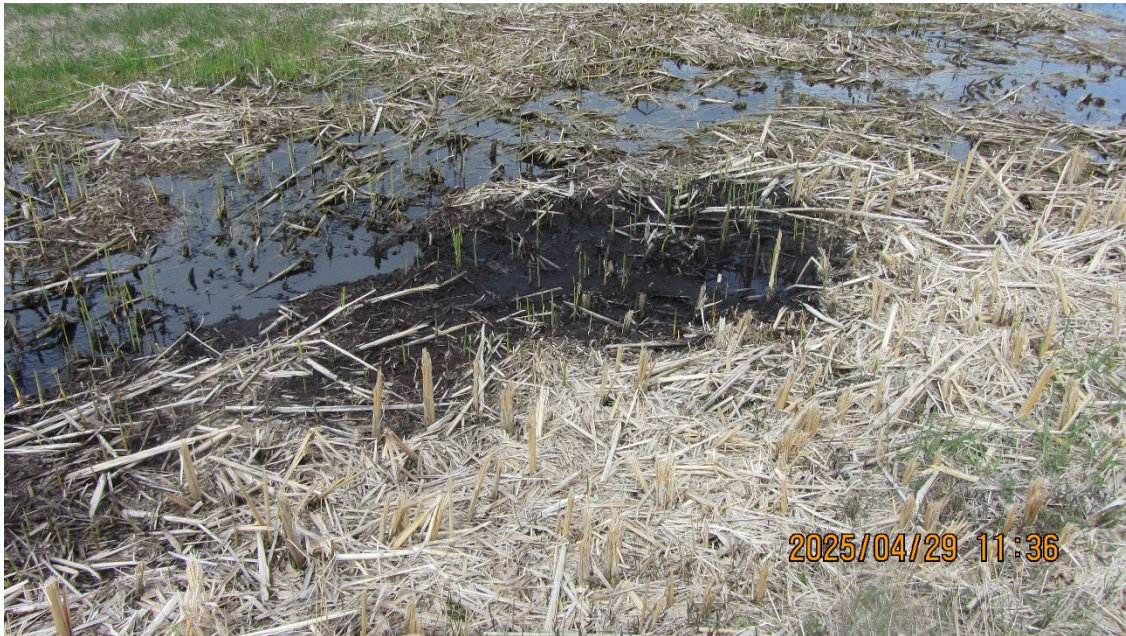
26: IMG\_1198

Approximately 250 feet north of the south entrance to the facility, EPA inspectors observed the colorizer unit discharge location on the east side of the roadside ditch. During the inspection, a discharge did not occur from the colorizer unit when EPA was observing this location. At the discharge location, it appears that the vegetation around the discharge pipe was stained a dark brown color (Photographs 26, 27, and 28 in Attachment A).

6. Discolored Area Near Colorized Mulch Unit Pump Discharge: During the inspection, EPA observed the location where the colorized mulch unit pump discharged to the County C roadside ditch. The area around the location appeared to be stained a dark brown (Photograph 26 in Attachment A). EPA is concerned that the discharge from the colorized mulch unit could signify that stormwater pollution from this discharge point may be affecting the County C roadside ditch, due to the presence of color. Note that Part 3.2.2.5 of the Stormwater Permit would require corrective action procedures, pursuant to Part 5.1.1 of the Stormwater Permit, if a visual assessment of the stormwater pollution in the discharge, such as color.

Description: Colorizer Unit Discharge

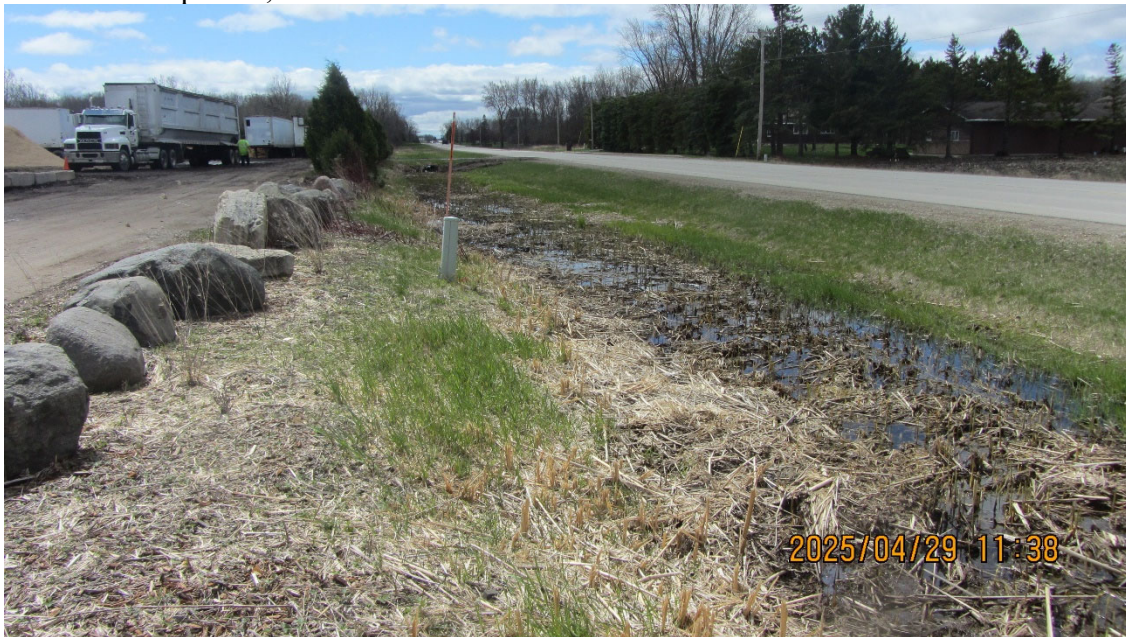
27: IMG\_1199

Description: Roadside Ditch; South of Colorizer Unit Discharge

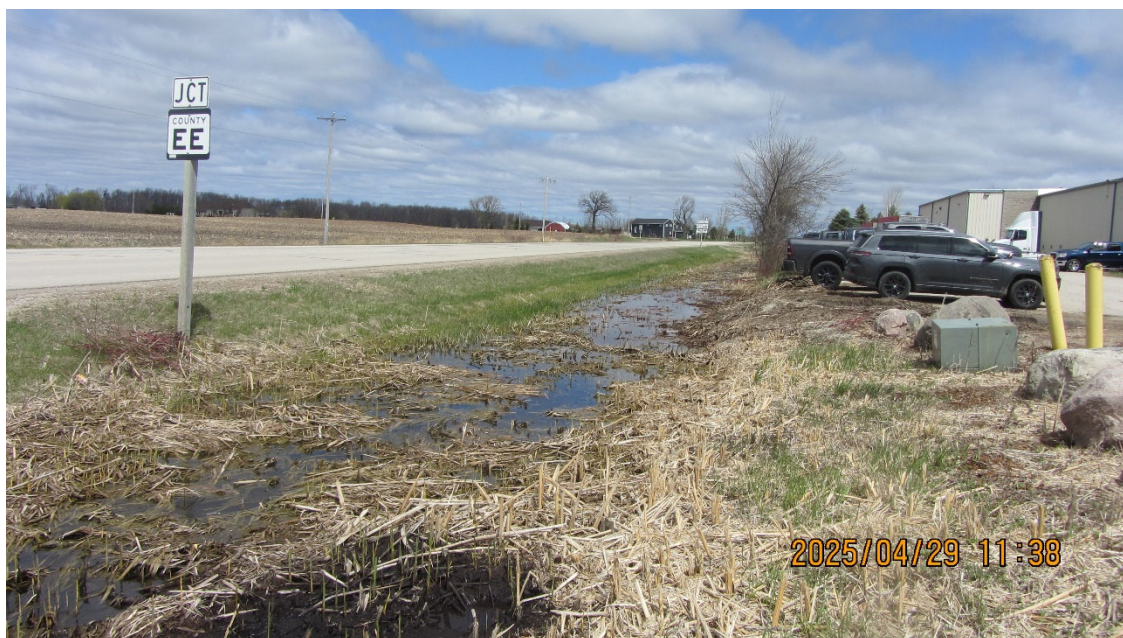
28: IMG\_1200

Description: Roadside Ditch; North of Colorizer Unit Discharge

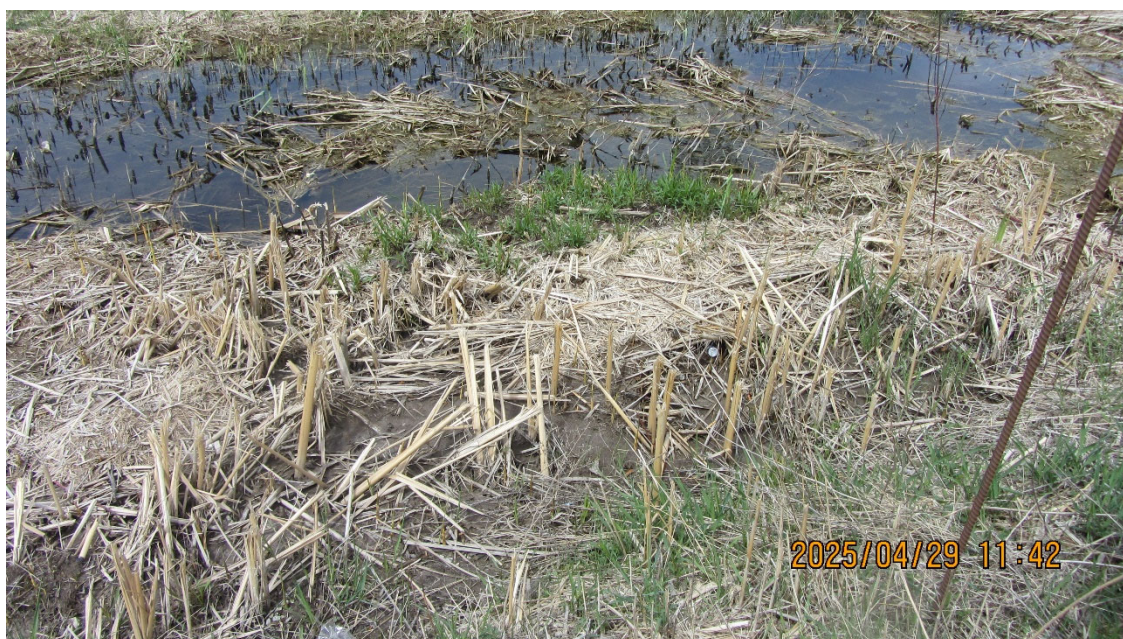
29: IMG\_1201

About 225 feet north from the colorizer unit discharge, EPA observed the discharge location from the loading dock stormwater pump on the east side of the County C roadside ditch. During the inspection, a discharge did not occur from the loading dock stormwater pump when EPA was at this location. EPA was unable to see the exact discharge location, given that the discharge pipe was covered by vegetation and submerged.

Description: Dock Pump Discharge Location to Roadside Ditch
