**CWA COMPLIANCE EVALUATION INSPECTION REPORT  
U.S. ENVIRONMENTAL PROTECTION AGENCY, REGION 5**

**Facility:** TLB Wood Products, LLC  
N5624 County Road C  
Seymour, Wisconsin 54311

**Date of Inspection:** April 29, 2025

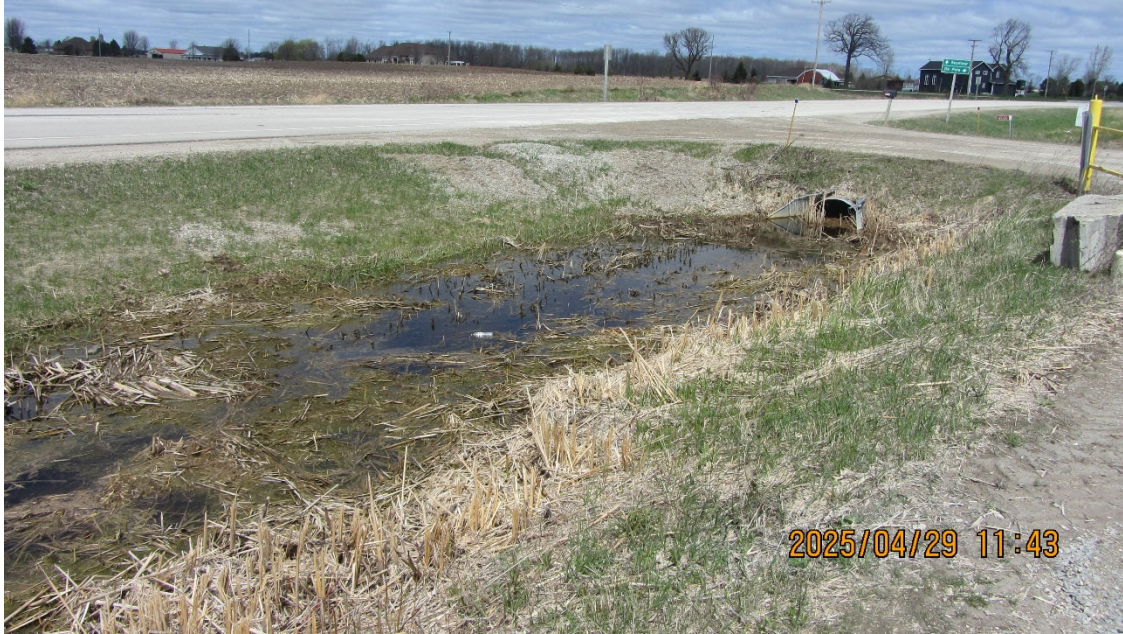
30: IMG\_1202

Description: Roadside Ditch; North Entrance/Culvert

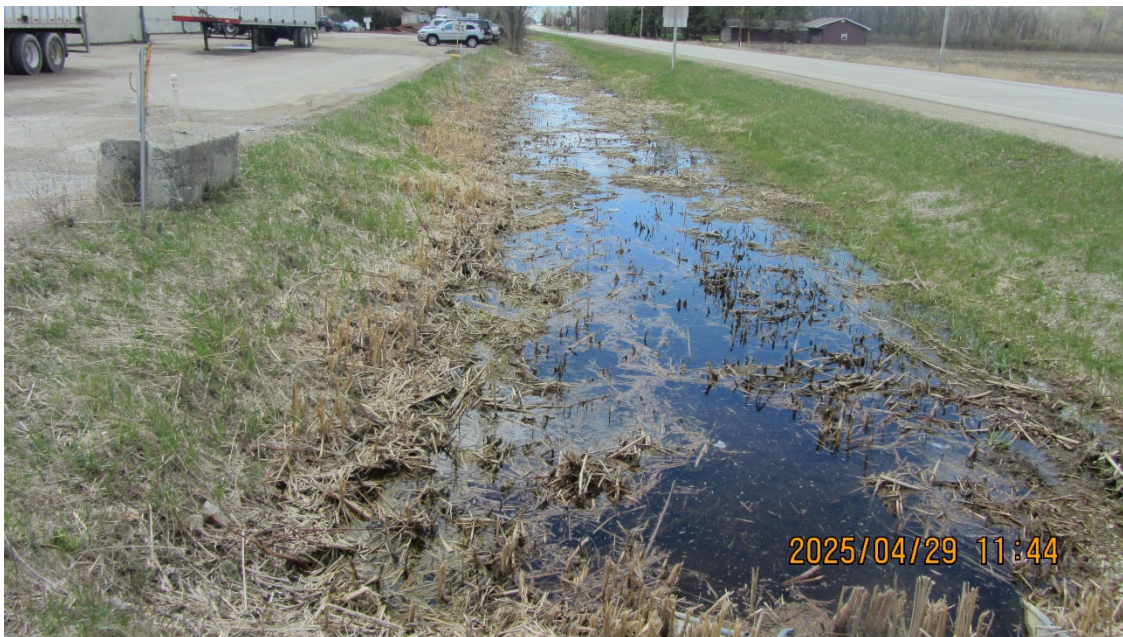
31: IMG\_1203

EPA and Mr. Olson then continued to walk north along the roadside ditch to the facility's north entrance. EPA then observed the County C roadside ditch at the north entrance, both upstream and downstream of the entrance (Photographs 31 and 32 of Attachment A). EPA and Mr. Olson walked east along the north property perimeter stormwater ditch approximately to the point where EPA and the facility's started the perimeter walkthrough. EPA and Mr. Olson then walked back to the office to the south. Along the way while walking through the shop indoors, EPA observed the storage location of used chemicals in the shop (Photograph 34 in Attachment A).

Description: Roadside Ditch; South of North Entrance

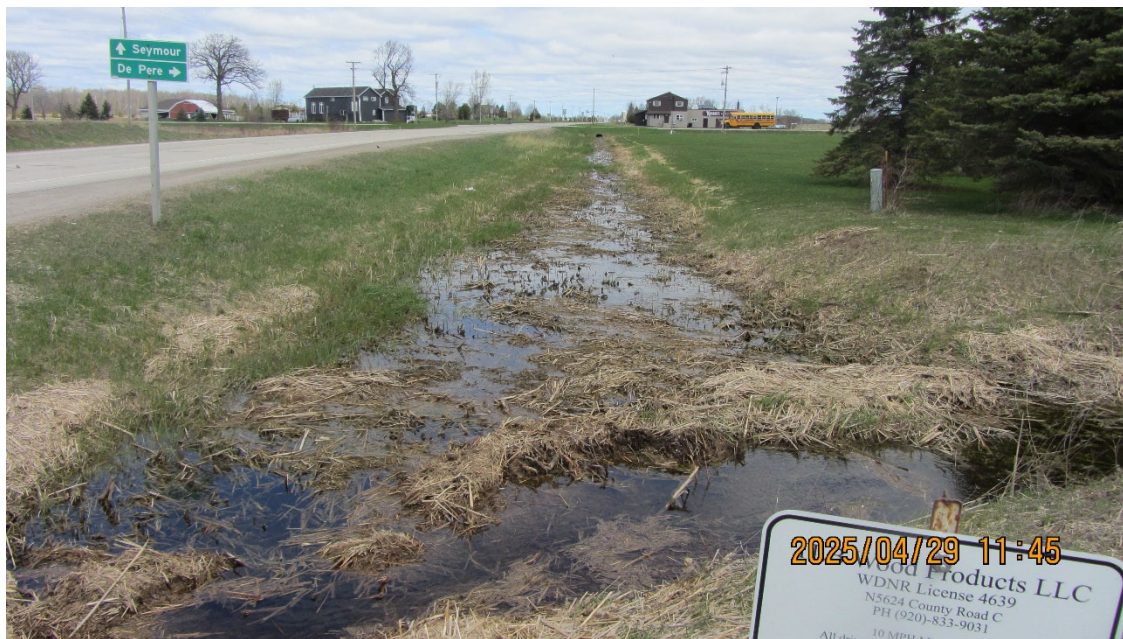
32: IMG\_1204

Description: Roadside Ditch; North of North Entrance (Upstream of Facility)

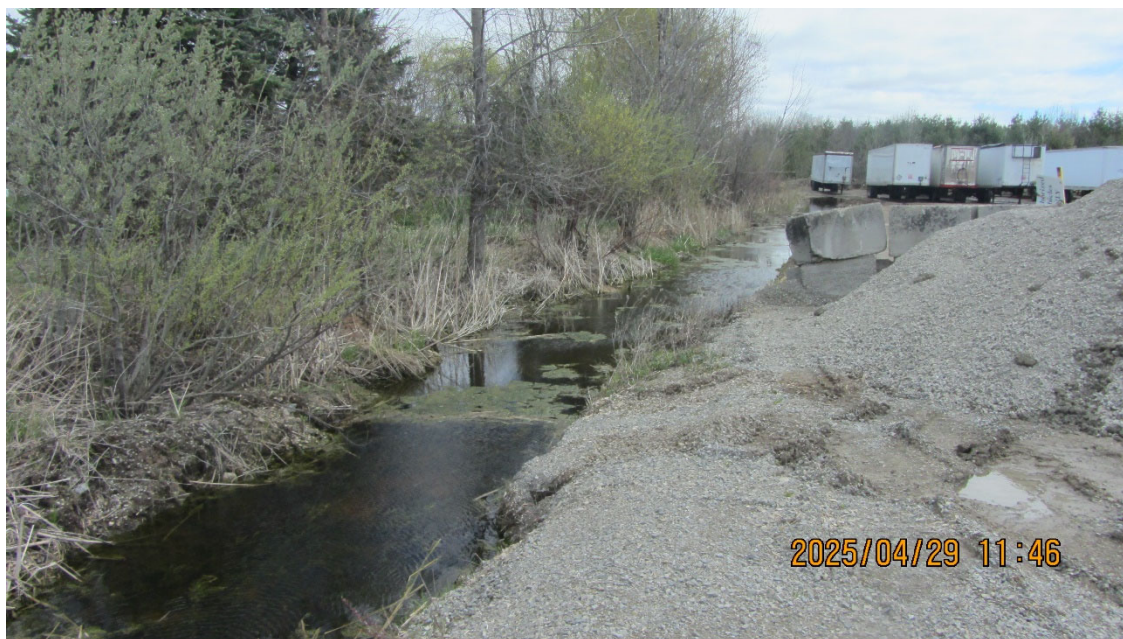
33: IMG\_1205

Description: North Property Perimeter Ditch

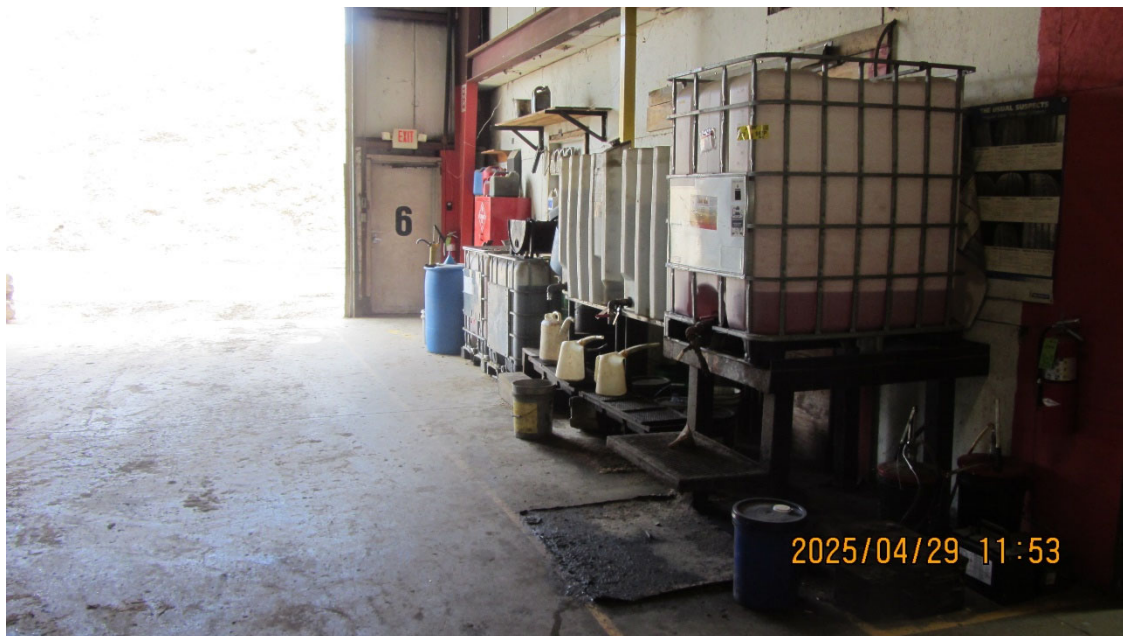
34: IMG\_1206

Description: Storage Location of Chemicals in Shop
