## **RCRA Inspection Report**

Techtrix, Inc.  
525 Plainview Street  
Gadsden, Alabama 35901-2027  
Etowah County  
EPA ID No.: ALD982167678  
NAICS: 332813 Electroplating, plating, polishing, anodizing, and coloring

July 27, 2022, 12:15 p.m. – 5:00 p.m. C.D.T. and July 28, 2022, 7:30 a.m. – 4:30 p.m. C.D.T

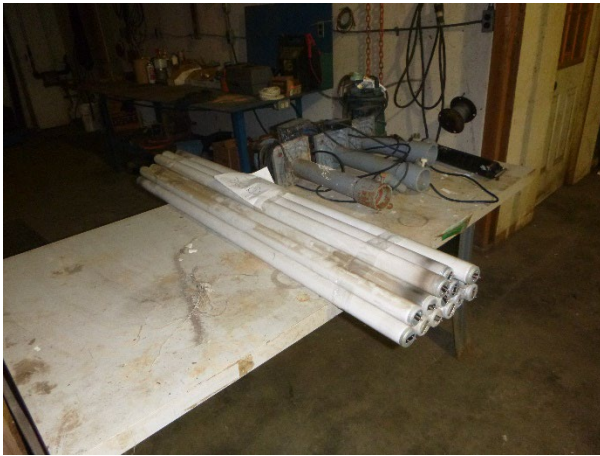
Techtrix was storing fourteen universal waste lamps on a table in the Maintenance Storage Area. These lamps were labeled, “Blown Bulbs – Discard” (Photos 1-2); these lamps were not labeled with either with the words universal waste or with the date of accumulation. These lamps were not secured in a closed container (Photo 1), that would prevent the release of any component of the universal waste.

Photo 1: Universal Waste lamps.

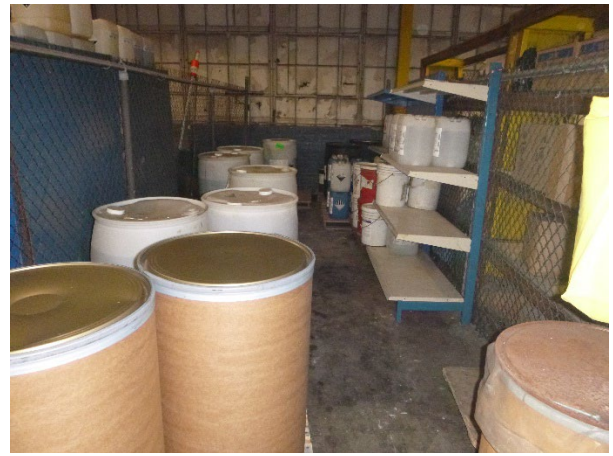
Techtrix was storing usable chemicals in multiple adjacent areas separated by chain-link fences. The supplies were separated into alkaline cleaners, brighteners and additives, and acids (Photos 3-7). The Chemical Storage Area contains supply chemicals in containers in good condition that were labeled as to their contents. The Former Expired Chemical Storage Area held expired chemicals, chemicals in containers in poor condition, and open containers during the March 2021 inspection. This area has been remediated such that all chemicals in this area are in containers in good condition that are labeled and are purported to be usable (Photos 8-11).

Photo 4: Chemical Storage.

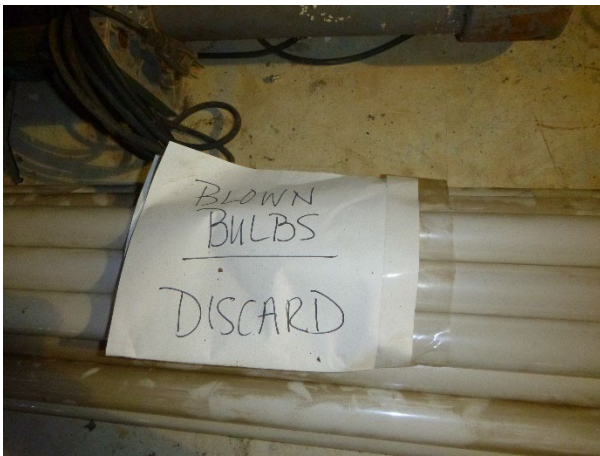
Photo 2: Universal Waste lamps.

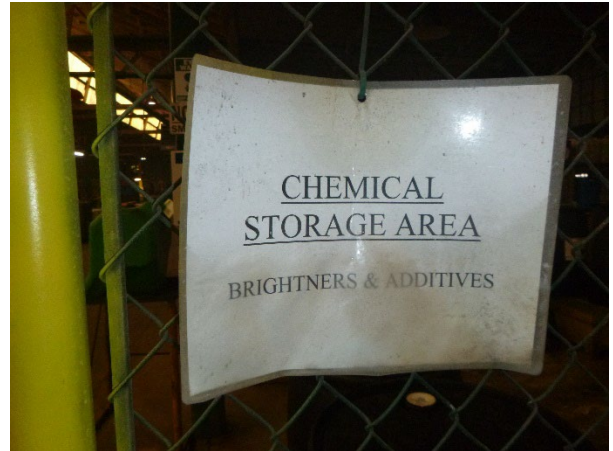
Photo 5: Chemical Storage.

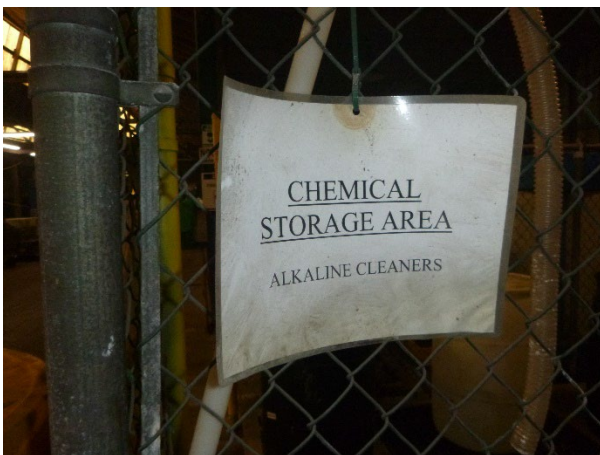
Photo 3: Chemical Storage.

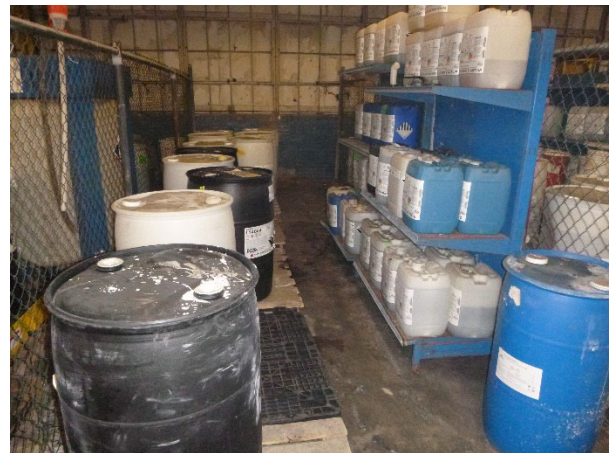
Photo 6: Chemical Storage.

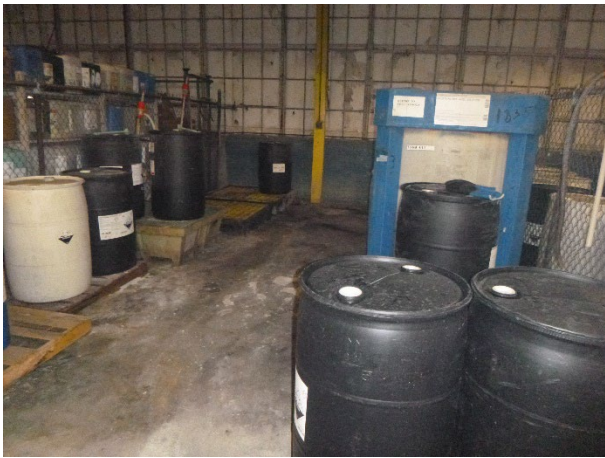
Photo 7: Chemical Storage.

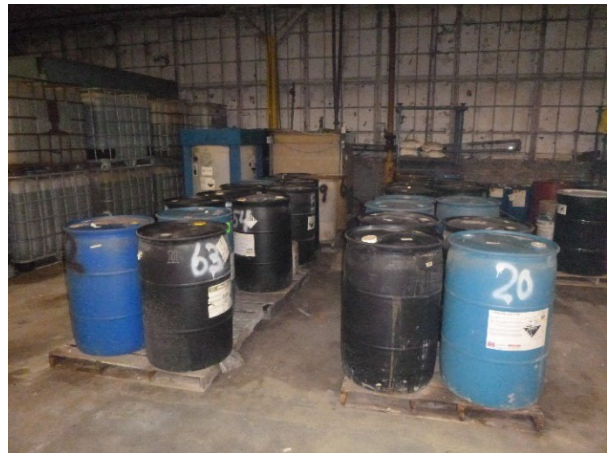
Photo 10: Chemical Storage.

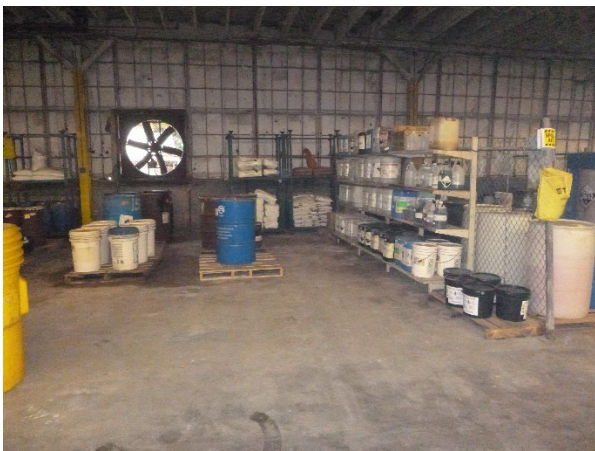
Photo 8: Chemical Storage.

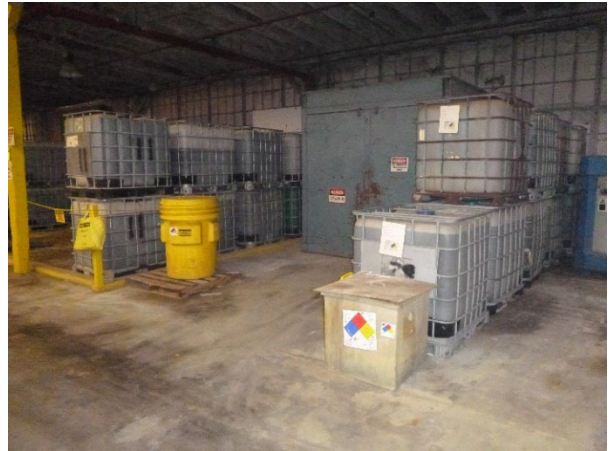
Adjacent to the Former Expired Chemical Storage Area, Techtrix was storing products to be used in the plating process in totes (Photo 11). There was one blue former chicken incubator with two doors used to store cyanide products. This Cyanide Storage Area has been remediated to remove compromised containers and clean up spilled material (Photos 11-12).

Photo 11: Chemical Storage.

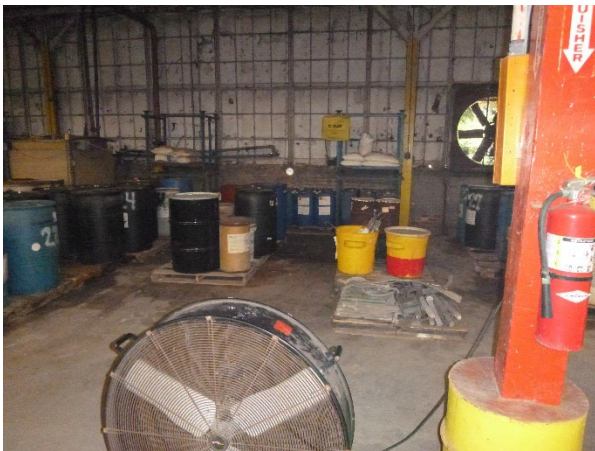
Photo 9: Chemical Storage.

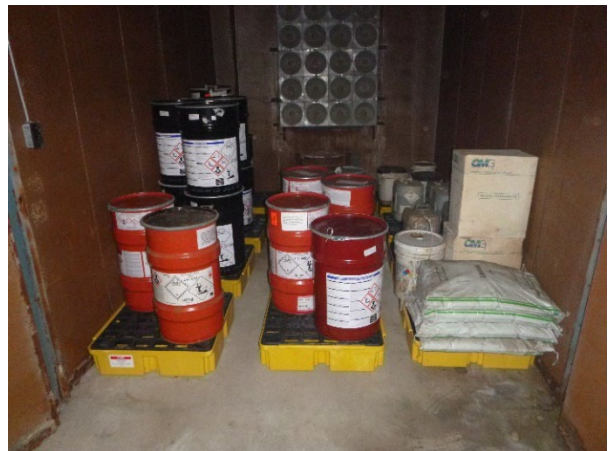
Photo 12: Cyanide Storage Area

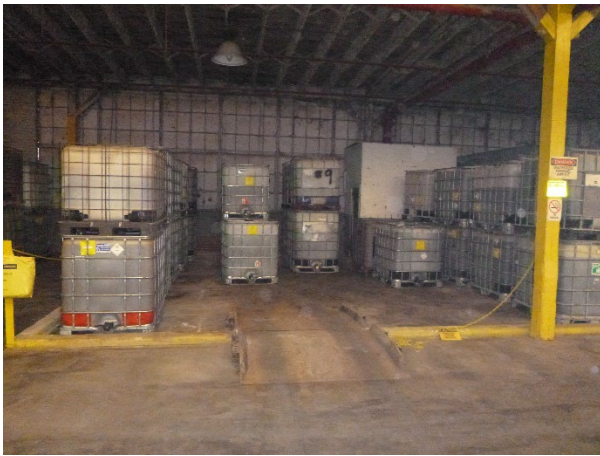
The inspection team noted that Techtrix was storing hazardous waste containers in CAA 1 that in some cases had labels that were failing to adhere to the containers, not turned toward the aisle for inspection, and/or were not labeled with an accumulation start date (Photo 13). Facility personnel stated that the labels falling off was a due to the variable humidity in the storage areas. The secondary containment in this area appeared to be worn and did not appear to be impervious.

Photo 13: CAA 1.

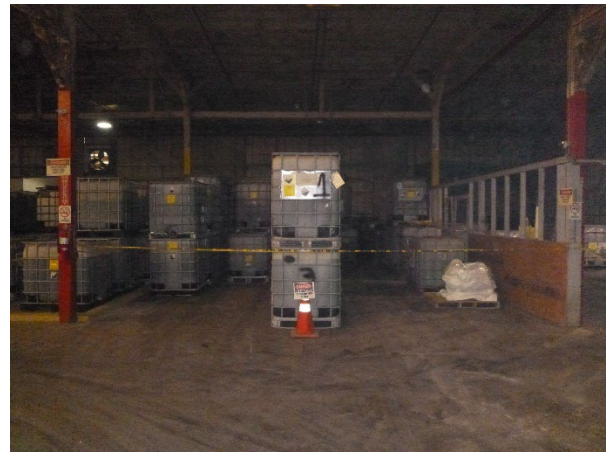
The inspection team noted in the Former Non-hazardous Waste CAA some containers were open, not labeled with hazardous waste labels, were not labeled with accumulation start dates,

and/or in some cases had labels that were failing to adhere to the containers. The secondary containment in this area was not coated with an impervious coating (Photos 16, 18-20).

Photo 16: Former Non-Hazardous Waste CAA.

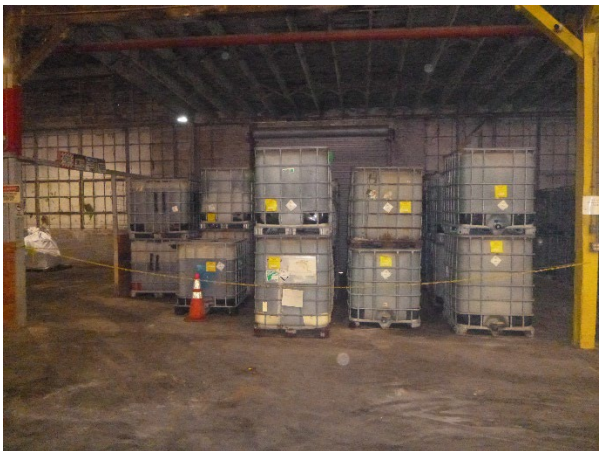
The inspection team noted that containers at the Bay Door CAA were stored with insufficient aisle space and not turned toward the aisle for inspection (Photo 14). There was no impervious coating on the secondary containment in this area. Some of the labels did not include an accumulation start date.

Photo 14: Bay Door CAA.

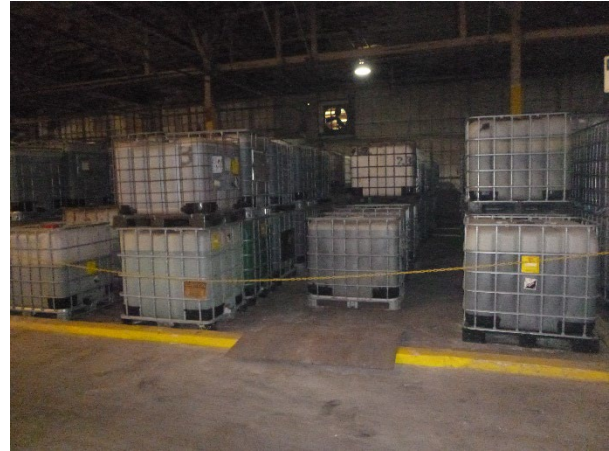
- Labels were failing to adhere to some of the containers;
- Labels not turned toward the aisle for inspection; and
- Secondary containment coating has been in disrepair since the March 2021 CEI (Photo 17).

Photo 17: CAA 2.

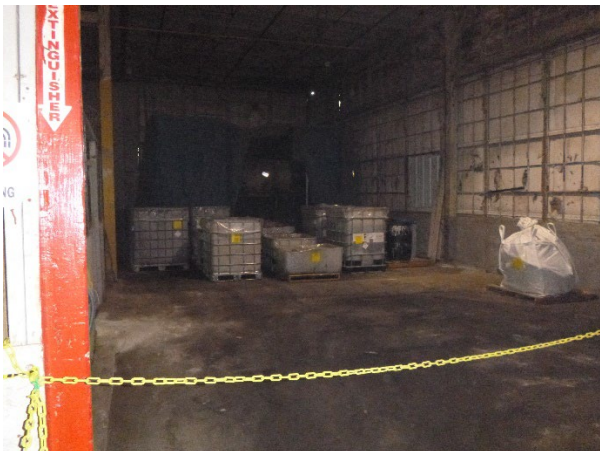
The inspection team noted that containers in the Solids Hazardous Waste CAA did not have sufficient aisle space and in some cases had labels that were failing to adhere to the containers. (Photo 15).

Photo 15: Solid Hazardous Waste CAA.

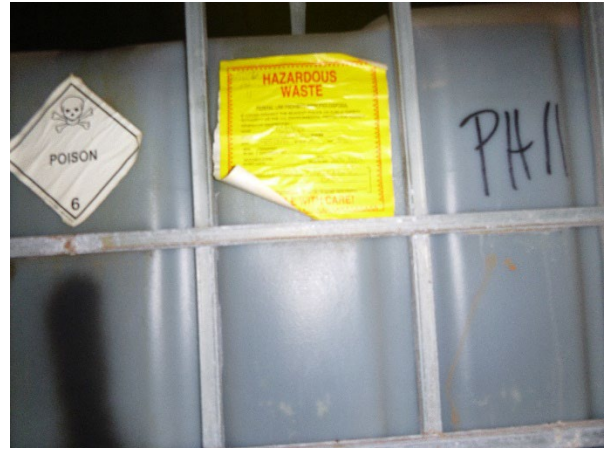
Photo 18: Former Non-Hazardous Waste CAA container without accumulation start date.

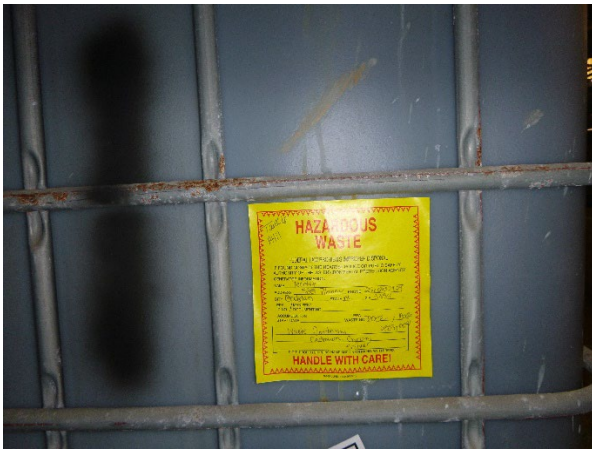
Photo 19: Former Non-Hazardous Waste CAA container without accumulation start date.

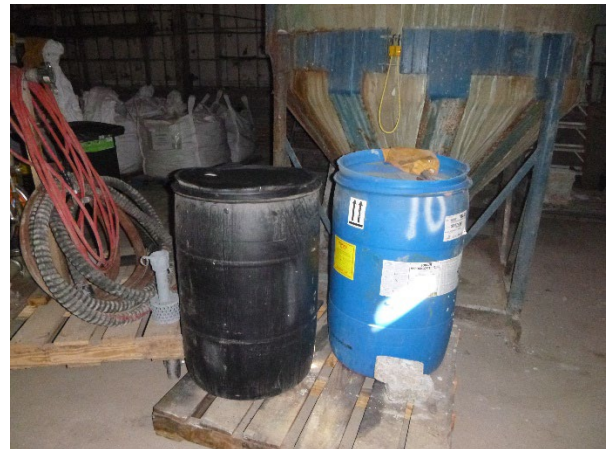
Tanks 1 and 2 were located side by side along the back wall of the facility. Both tanks were labeled as hazardous waste, with an indication of the hazard, and with accumulation start dates of March 30, 2020 (>90 days). The liquids removed from these tanks had been stored in totes in one of the CAAs. There were two plastic 55-gallon containers in this area being used to accumulate solids from tank cleanout activities (Photo 21-22). Techtrix personnel stated that Tank 2, once cleaned out would be cut up and disposed of as hazardous waste. These accumulation containers were labeled and in good condition. Techtrix has cut the lids off two poly containers for ease of placing the solids in the container. The tops were lying on top of the containers and making contact all the way around.

Photo 22: Tank cleanout solids collection containers near Tank 2.

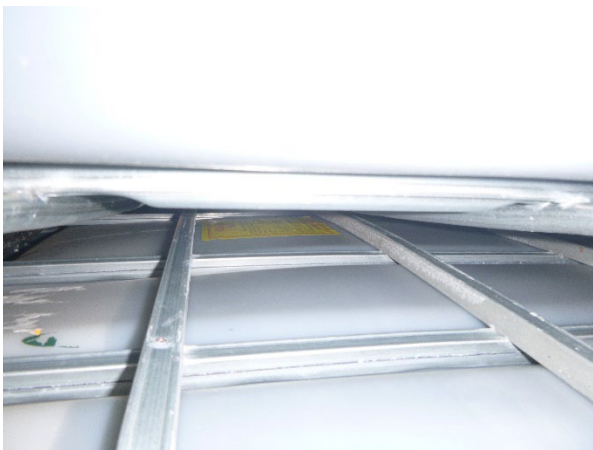
Photo 20: Former Non-Hazardous Waste CAA container with label not turned toward aisle.

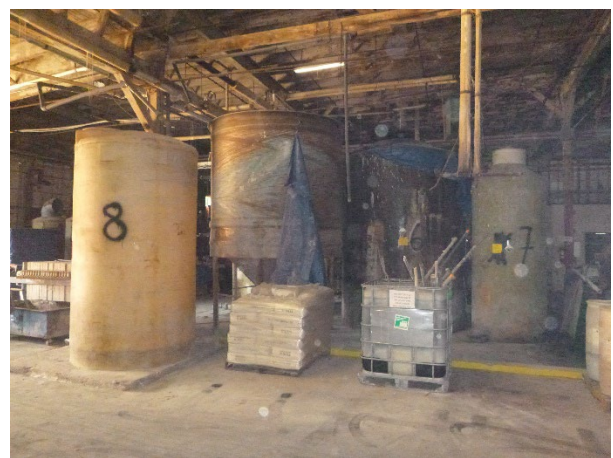
Techtrix selected Tank 3 located between Tanks 4 and 5 to be the initial treatment tank for their wastes. Techtrix had removed the liquids and solids from this tank and placed the waste in containers. Techtrix had cut holes in the tank to remove the solids (Photo 25). The tank was refurbished and readied to serve as a treatment tank for liquids. Techtrix renamed Tank 3 to WWT #1. Techtrix began treating hazardous waste liquids in WWT #1 by adjusting pH and converting Chrome 6 to Chrome 3 in June 2022. Techtrix was dual treating in WWT #1 and in the laboratory. Their efforts were to refine the process to remove metals from the liquid wastes.

Tectrix containerized all liquid waste from Tanks 4, 6, 7, and 11 and placed the containers in one of the CAAs. Each tank is scheduled to have the solids removed in due course. Each tank was labeled as hazardous waste, with an indication of the hazard, and marked with an accumulation start date of March 20, 2020 (>90 days).

Photo 23: Tanks 3, 6, 7, and 8.

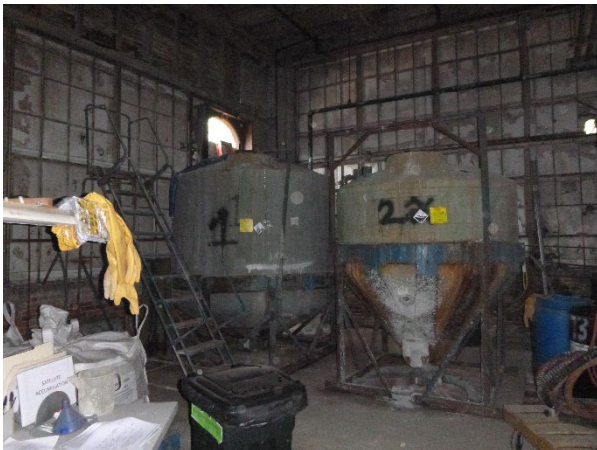
Photo 21: Tanks 1 and 2.

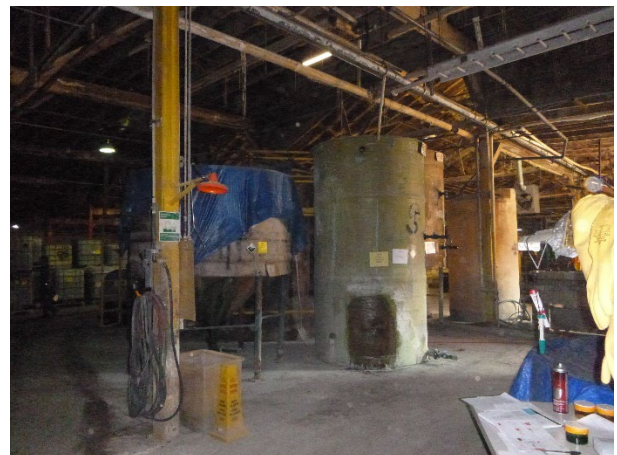
Photo 24: Tanks 3, 4, 5, and 8.

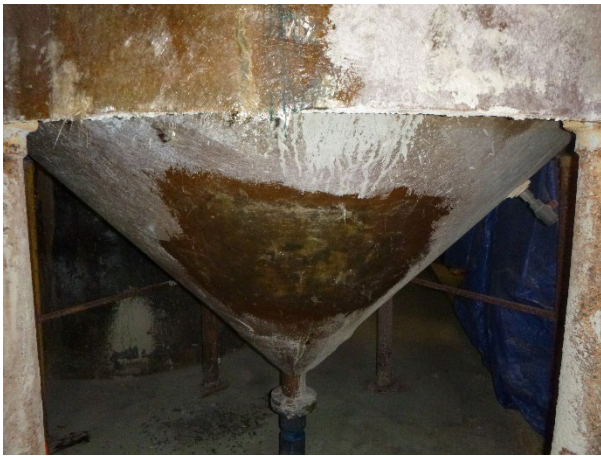
Photo 25: Tank WWT #1 (Tank 3).

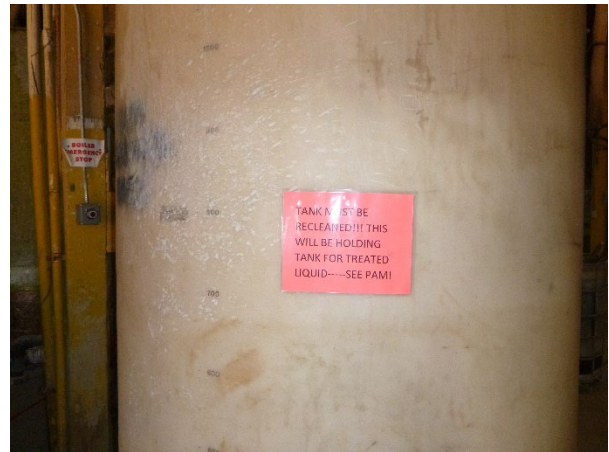
Techtrix selected Tank 8 to serve as the treated liquids holding tank. This tank was cleaned out and evaluated. The evaluation determined that a more aggressive cleanout was necessary. This tank was labeled and in good condition. Techtrix renamed Tank 8 to WWT #3.

Photo 28: Tank WWT #3 (Tank 8).

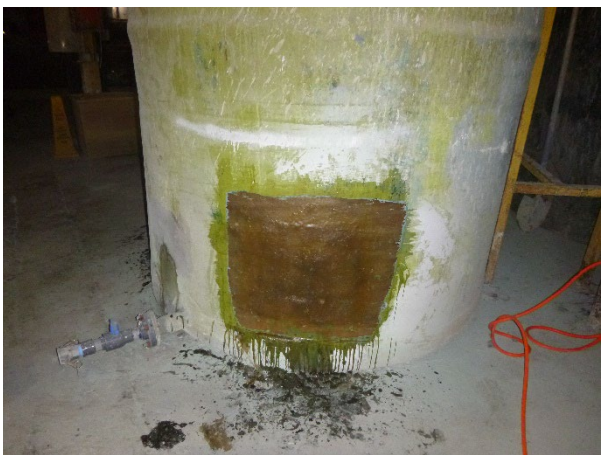
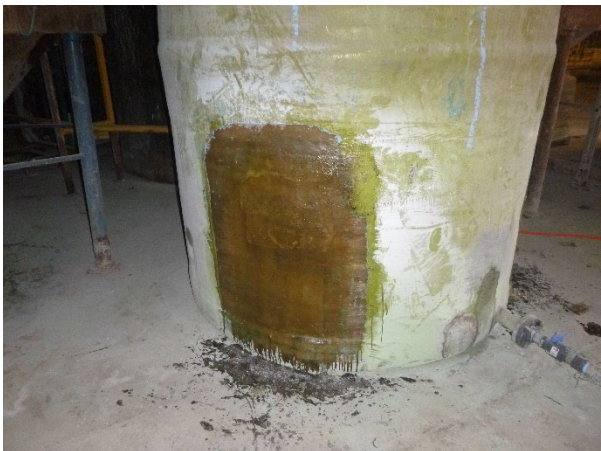
Techtrix selected Tank 5 to serve as the thickening tank for solids removed during the treatment process. Techtrix had removed the liquids and solids from this tank and placed the waste in containers. Techtrix had cut holes in the tank to remove the solids (Photos 26-27). Techtrix renamed Tank 5 to WWT #2.

Photo 26: Tank WWT #2 (Tank 5).

Photo 27: Tank WWT #2 (Tank 5).

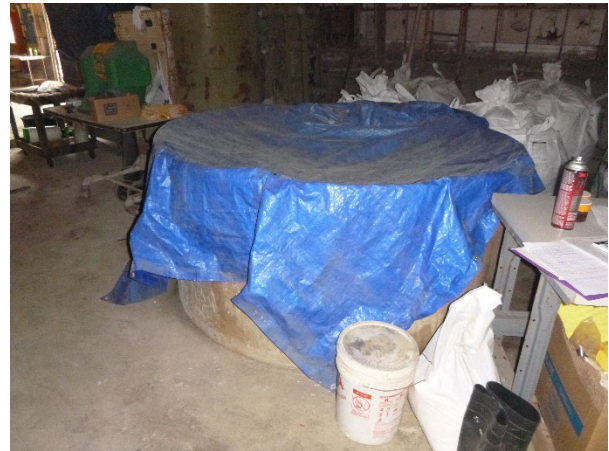
Techtrix excised horizontally the top of Tank 10 to accumulate solids from cleanouts of other tanks. This tank was covered with a blue tarp and was labeled as hazardous waste, with the indication of the hazard, and marked with an accumulation start date of March 20, 2020 (>90 days).

Photo 29: Tank 10

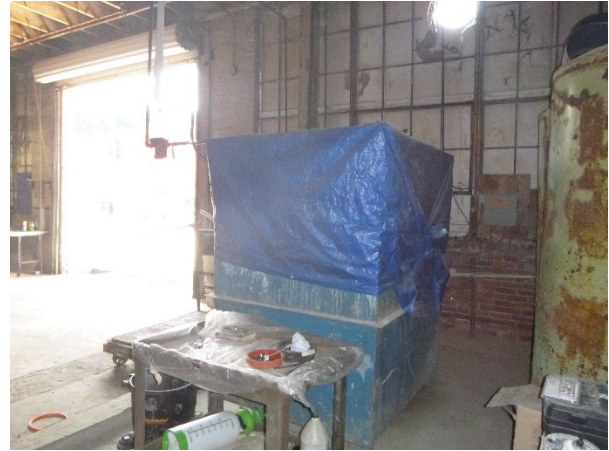
Photo 30: Tank 11.

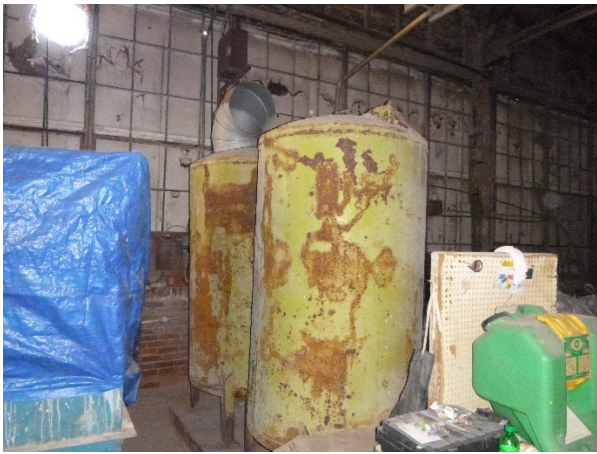
Facility personnel stated that the rusting green tank in Photo 31 was empty. The filter press appeared to be in good condition and was purported to be ready for service (Photo 32). Techtrix replaced the old leaking boiler with a new one (Photo 33).

Photo 31: Tank 11 and empty old equipment.

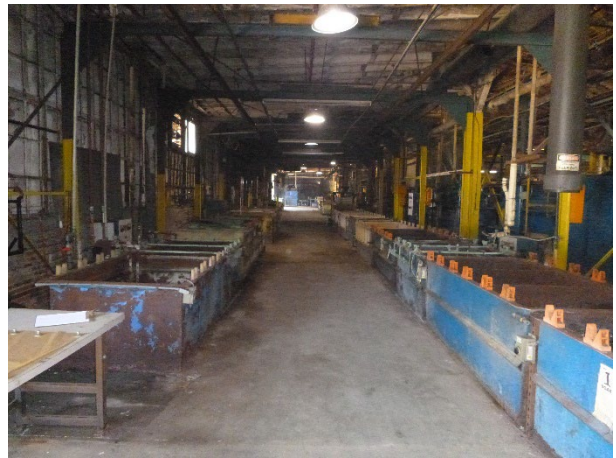
The inspection team toured the plating lines and noted much improved housekeeping (Photo 34). Techtrix was accumulating plating line debris in an SAA near one of the plating lines (Photo 35). This container was in good condition and labeled. The bung on this container was open. Containers of hazardous waste must be closed except when adding or removing waste. The cadmium plating line tanks which formerly held waste had been cleaned out (Photos 36-38). The inspection team noted a 5-gallon open plastic container holding plating line filters on one of the plating lines (Photo 39). Techtrix personnel stated that these filters were still usable.

Photo 34: Aisle way in plant.

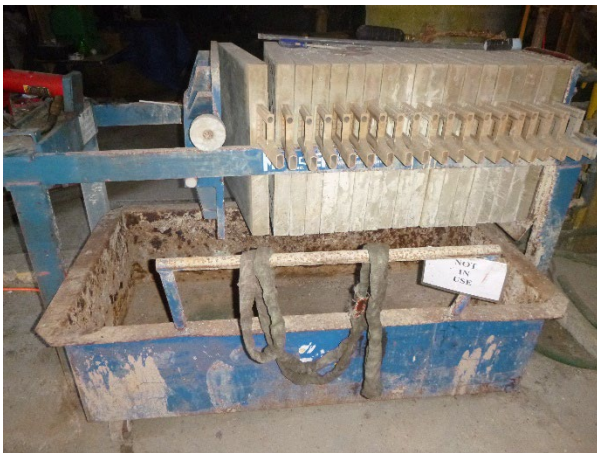
Photo 32: Filter Press.

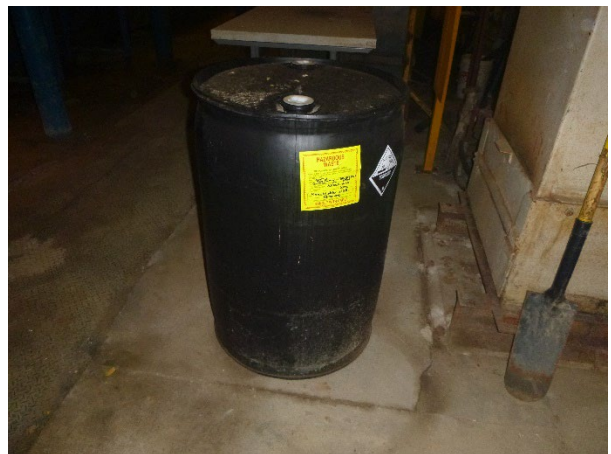
Photo 35: SAA for plating line debris.

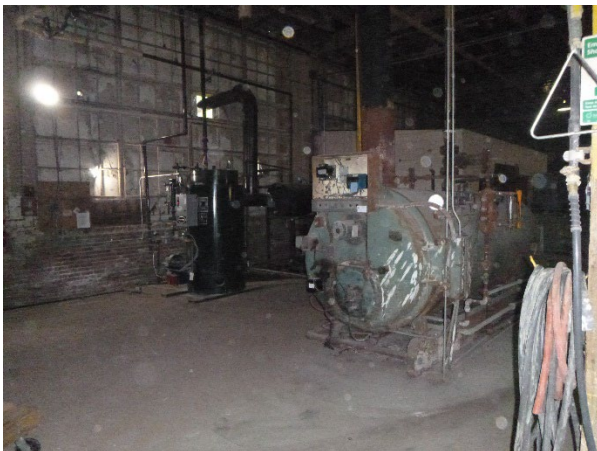
Photo 33: Old and New Boiler.

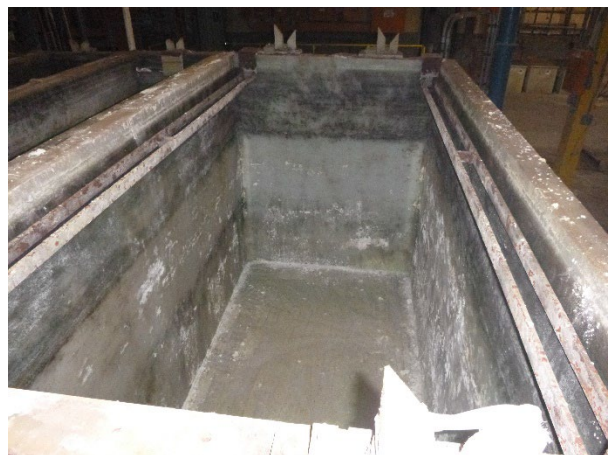
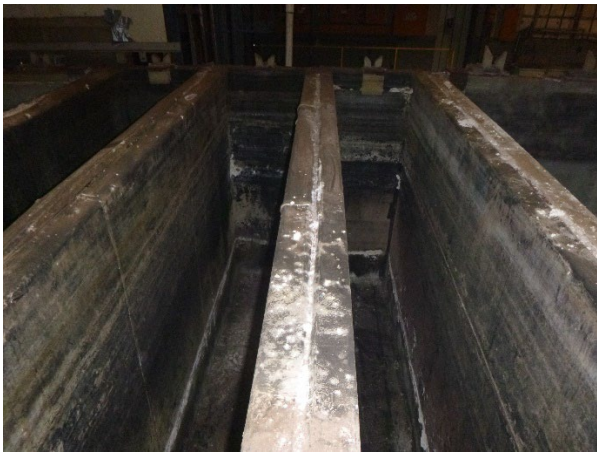
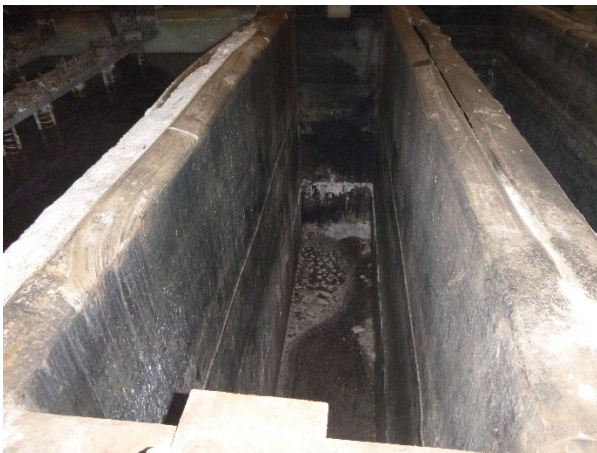
Photo 36: Cadmium Line.

Photo 37: Cadmium Line.

Photo 38: Cadmium Line.

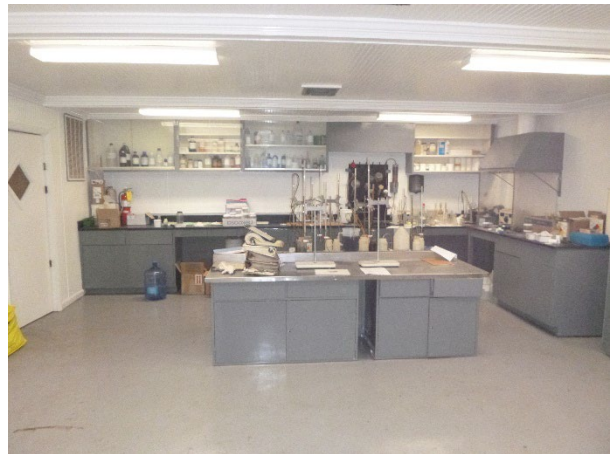
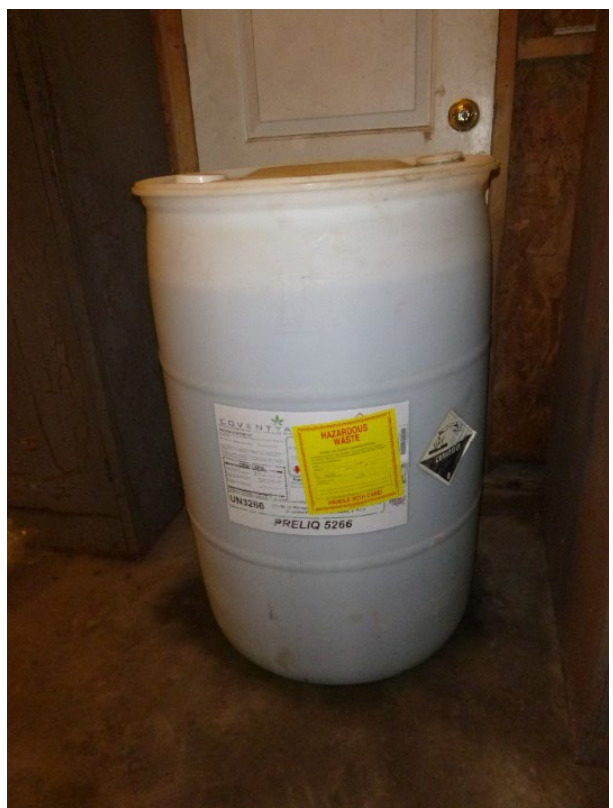
Techtrix operates a laboratory to determine the amount of chemicals to use to treat waste on site. The laboratory was in good order and neat. Techtrix was accumulating laboratory waste in one SAA that was labeled, in good condition and closed (Photos 40-41).

Photo 40: Laboratory.

Photo 41: Laboratory SAA.

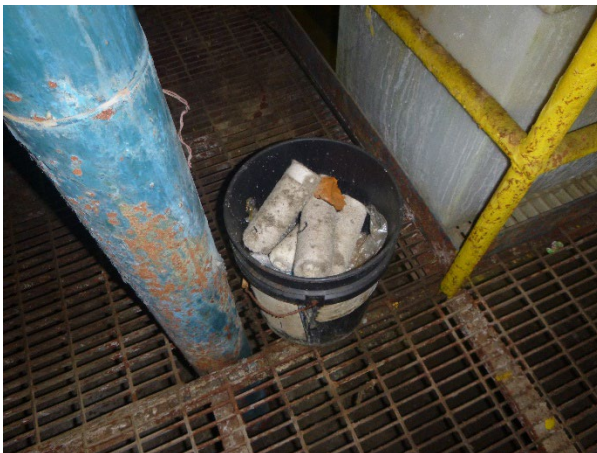
Photo 39: Reusable Filters for plating baths.

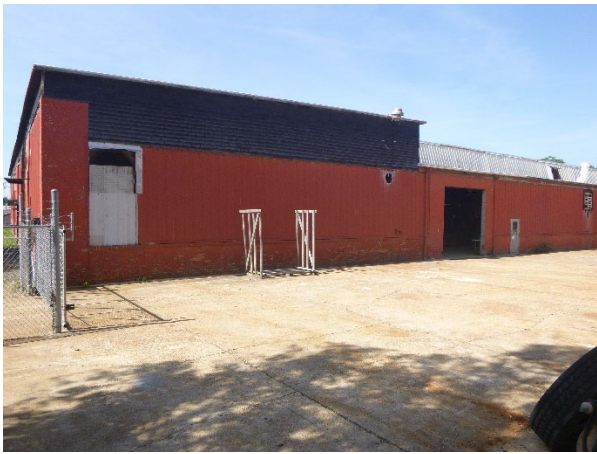
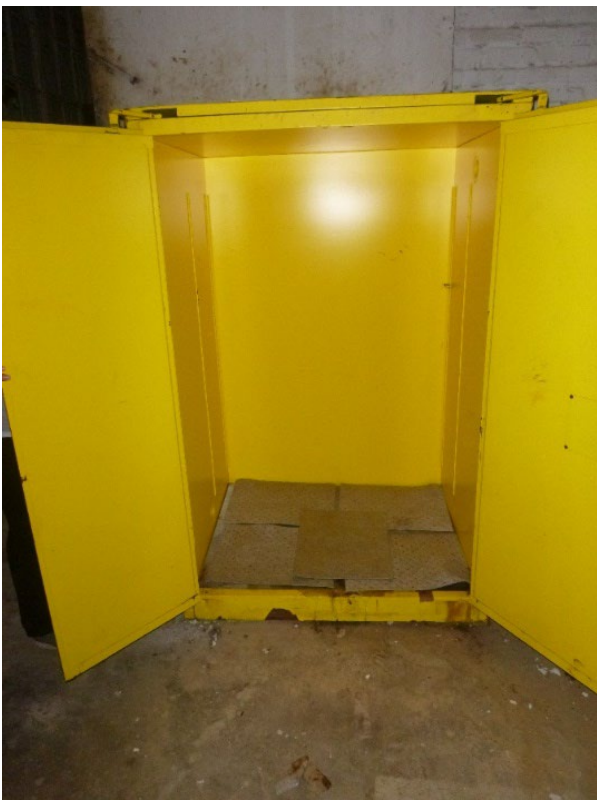
There was no waste in the red building on the day of the inspection (Photos 42-43).

Photo 42: Red Building.

Photo 43: Red Building.
