**UNITED STATES ENVIRONMENTAL PROTECTION AGENCY  
REGION 8  
RESOURCE CONSERVATION AND RECOVERY ACT**

**Facility Name:** Yellowtail Hydroelectric Power Plant and Maintenance Facility, U.S. Bureau of Reclamation

**Date of Inspection:** September 21, 2023  
**Arrival Time:** 10:05 a.m.  
**Departure Time:** 4:10 p.m.

**Type and Purpose of Inspection:** Compliance Evaluation Inspection  
Compliance with RCRA Subtitle C

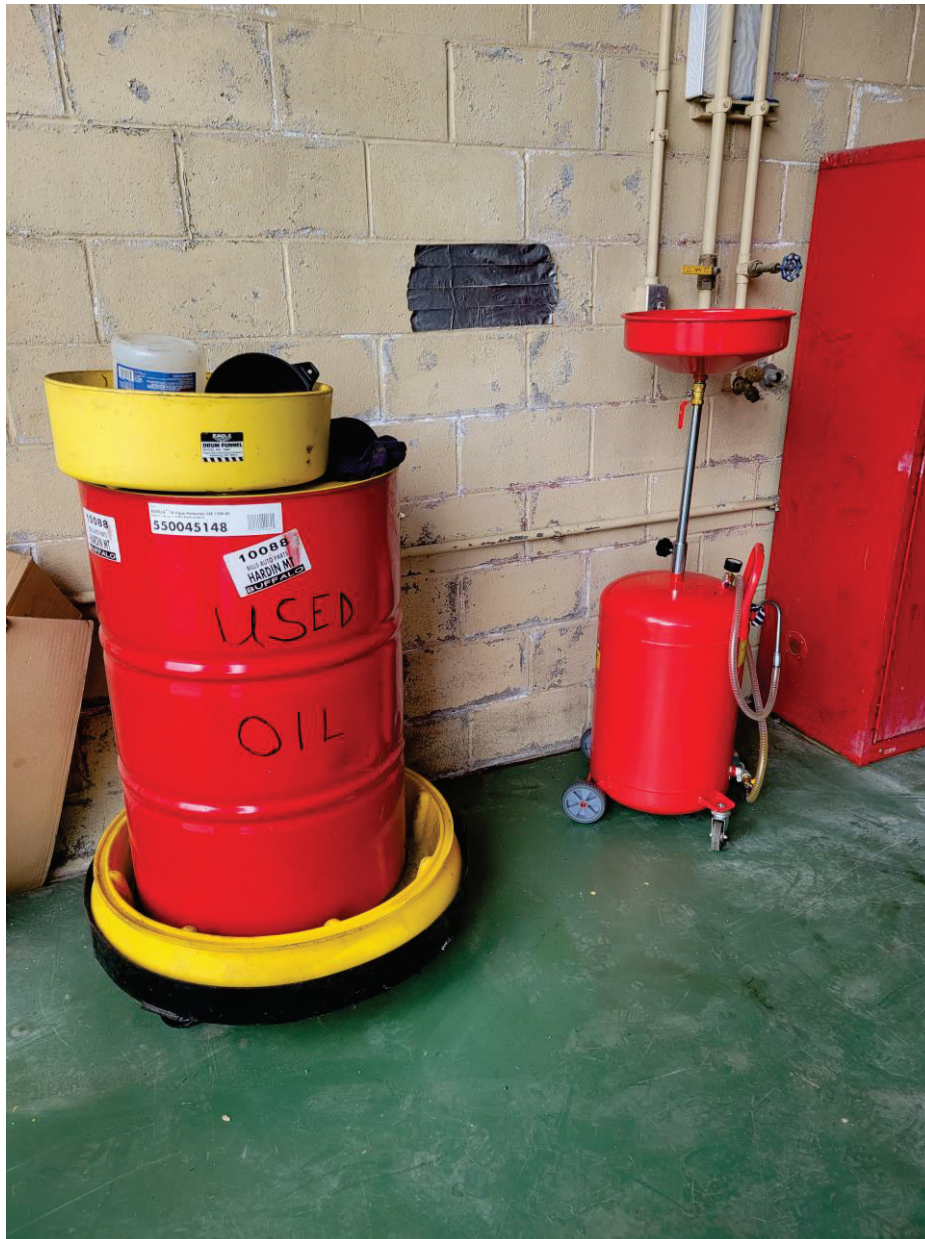
In a vehicle maintenance bay, used oil is accumulated in a 55-gallon drum following transfer from a collection caddy. See photo 1. I observed as the drum and caddy were marked with the words "Used Oil", though photo 1 was taken before the marking was added to the caddy.

Photo 1: 20230921\_114032.jpg, 11:40 a.m. – photo of a drum and caddy containing used oil located in the vehicle maintenance building.

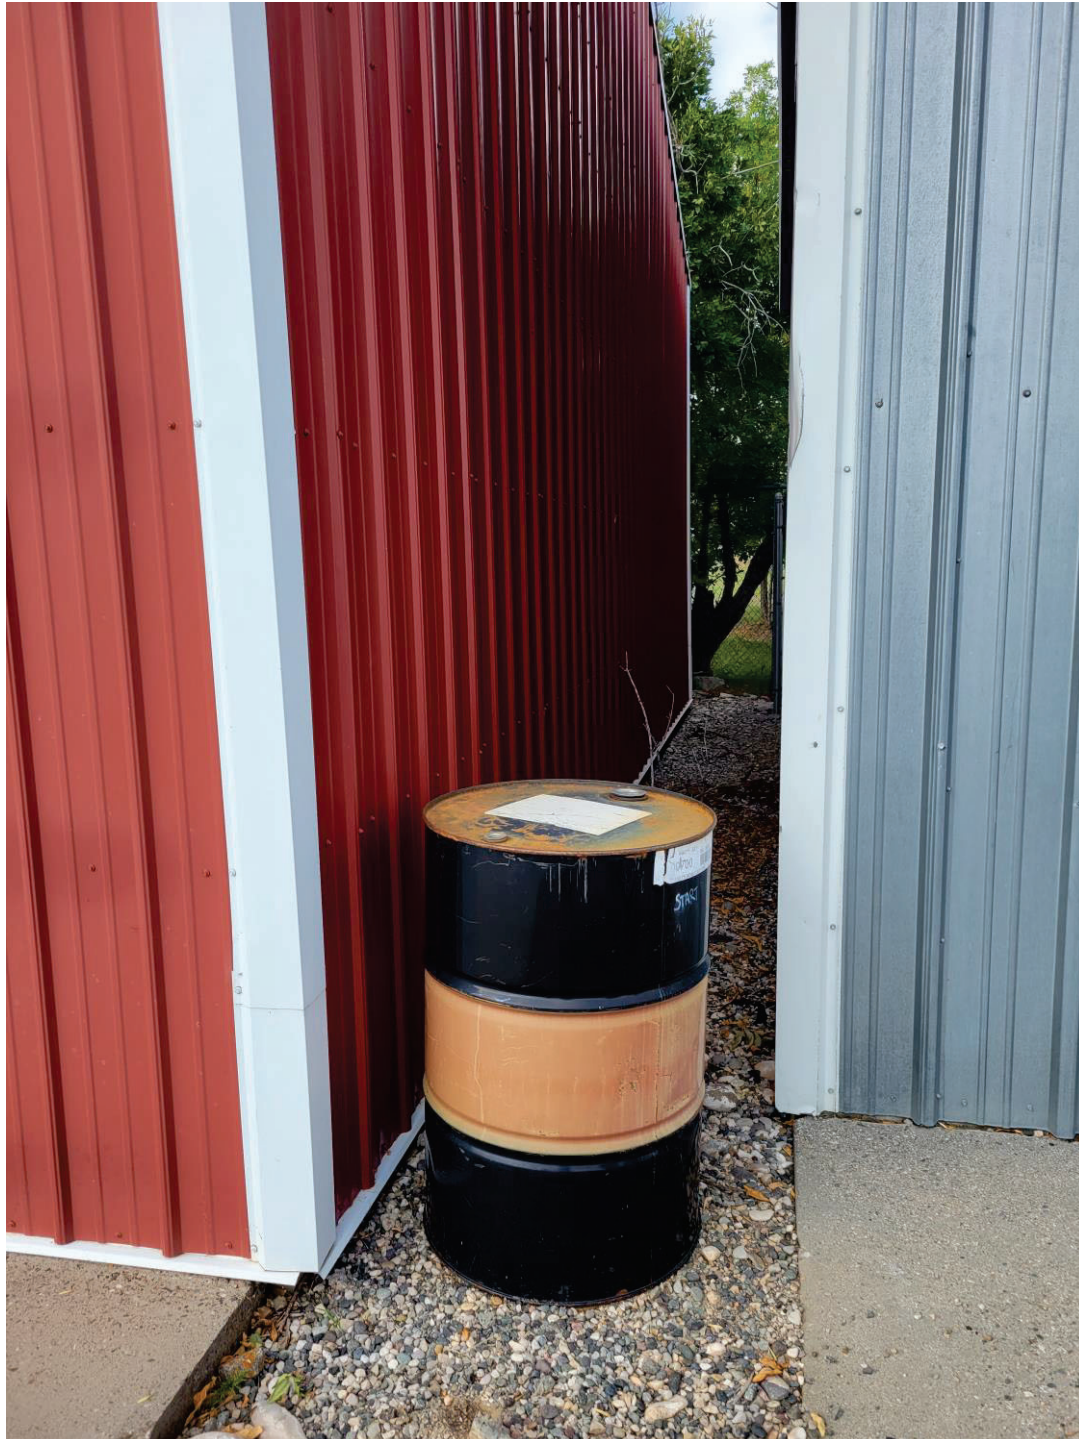
Between the hazardous waste and wire storage buildings, I observed a black and tan drum placed outside on the ground, the tan portion of which may have once been red but become faded due to weathering. The drum had some rusting on the top. The contents were not marked on the container, but it was marked "Start Date 7-31-17" indicating that waste had begun accumulating (accumulation start date) in the container in 2017. See photos 2 and 3.

Photo 2: 20230921\_115631.jpg, 11:56 a.m. – photo of a drum located near the wire storage building. The drum was marked “start date 7-31-17”.

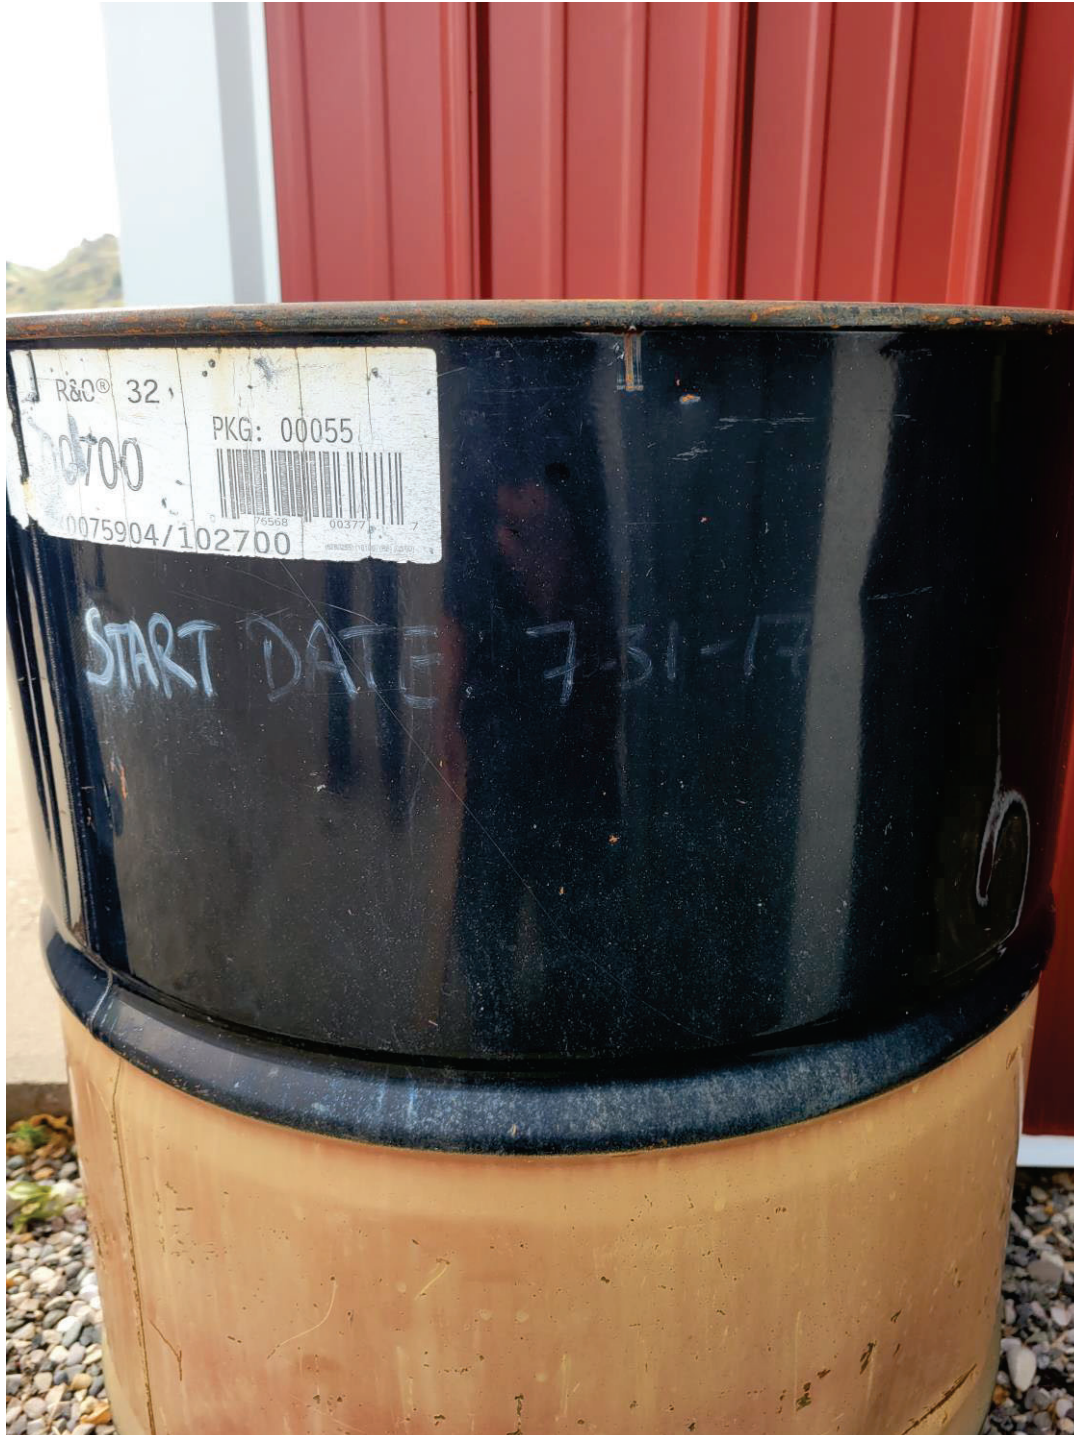
Photo 3: 20230921\_115638.jpg, 11:56 a.m. – close-up of the marking on the drum shown in photo 2.

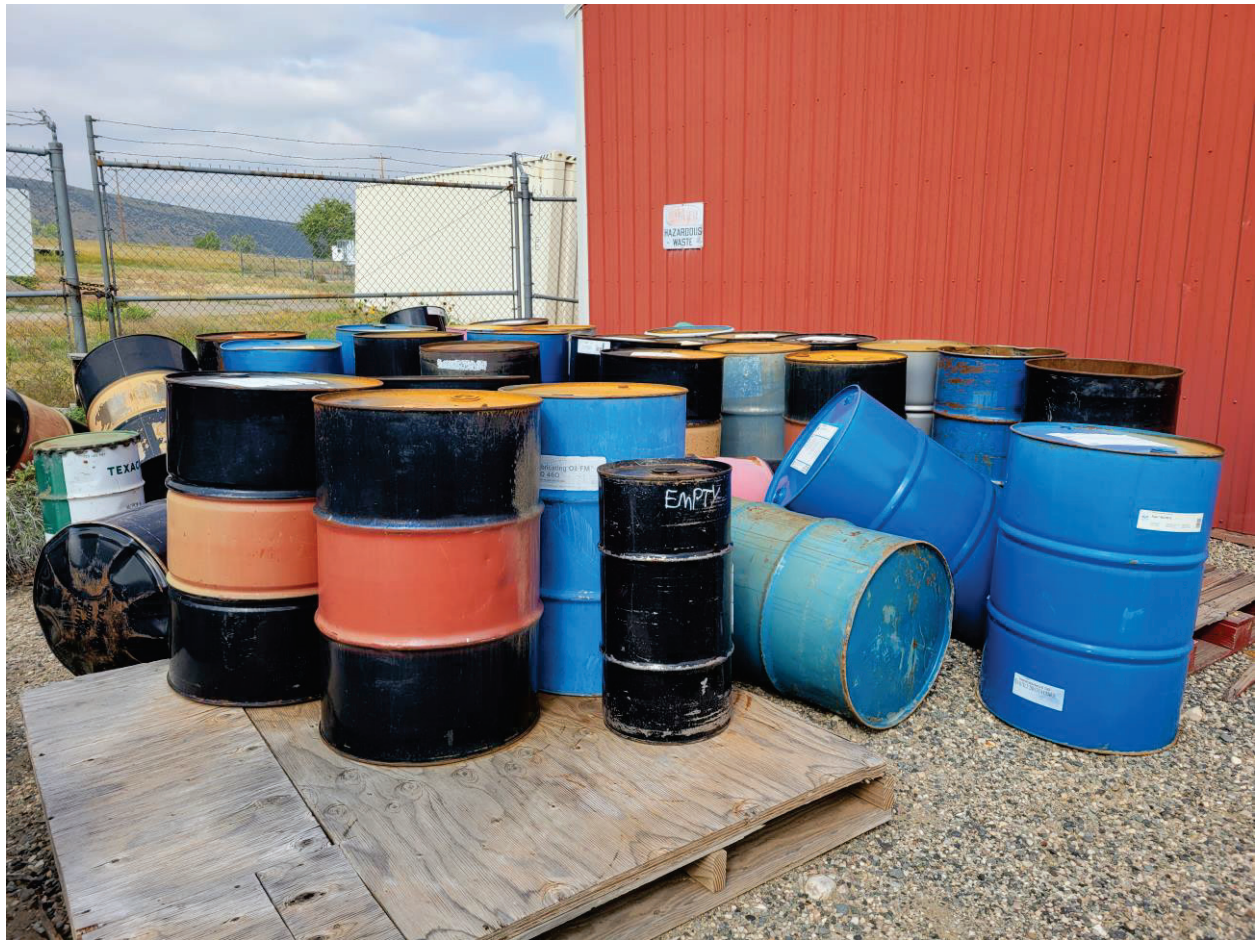
On the south side of the hazardous waste building, I observed approximately 30 55-gallon drums and a few smaller drums. See photo 4. A sign near the drums on the exterior of the hazardous waste building wall was marked "Hazardous Waste". I was not able to approach many of the drums because they were closely packed together, but I was able to determine that at least four of the drums were not empty. Mr. Curtis stated that he did not know the contents of the drums but did confirm that some of the drums were not empty. One drum was laid on its side and was bulging; I was not able to determine whether this container was empty.

Photo 4: 20230921\_120143.jpg, 12:01 p.m. – photo of outdoor drum storage located just south of the hazardous waste storage building. Some of the containers were empty, but at least four were not. Most of the drums were not reachable to try to determine whether they were empty. All but one of the containers appeared to be rusting. A hazardous waste sign is posted on the wall behind the drums. A drum on its side at the far left of the photo was bulging.

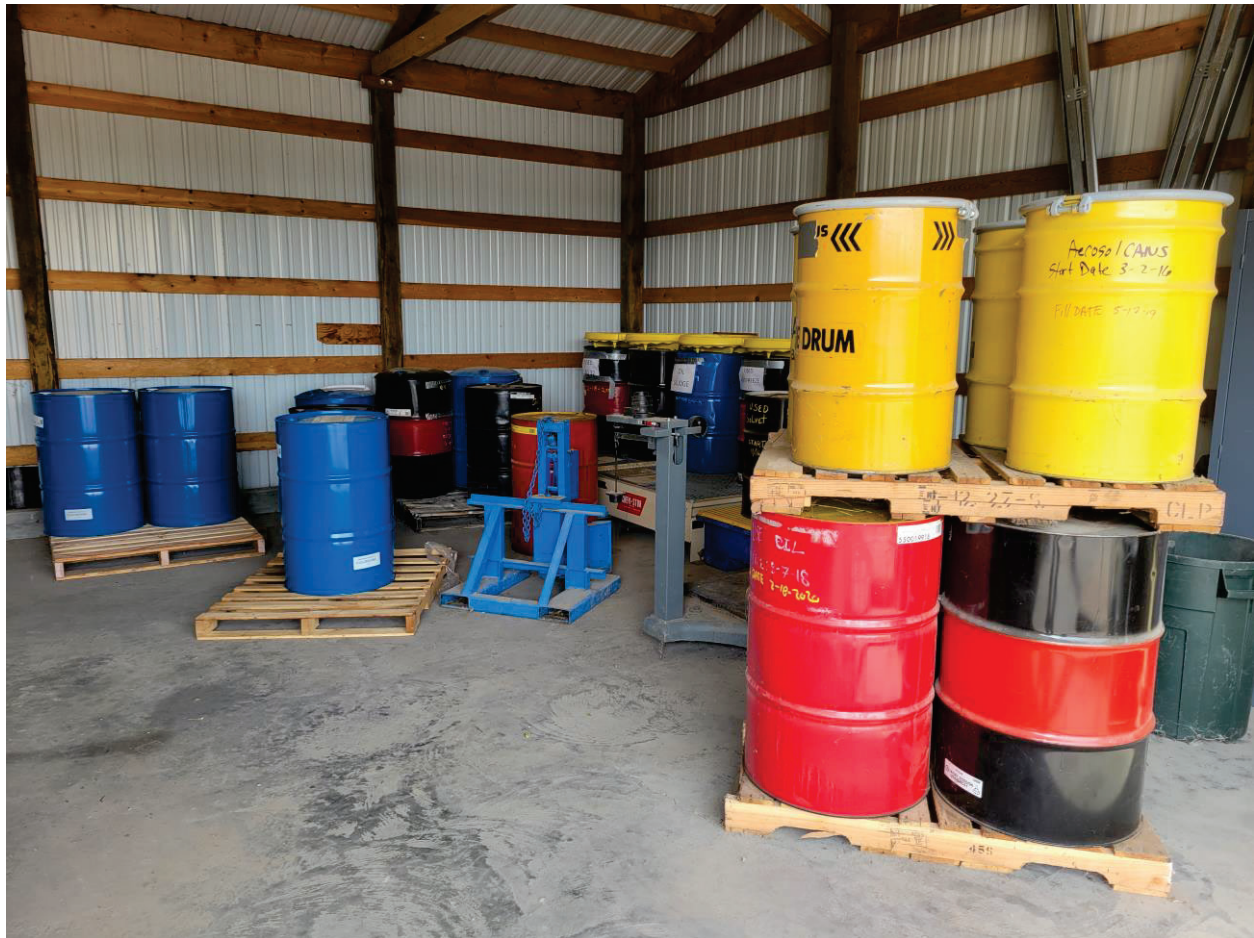
- Eight drums stacked and on pallets (photos 5 and 6)
  - Two yellow metal drums marked "Aerosol cans" and "Fill Date 5-17-19" indicating the waste may have been in storage for approximately four years since the date the container became full

Photo 5: 20230921\_121358.jpg, 12:13 p.m. – photo of the northern portion of the interior of the hazardous waste storage building. Three bulging drums are visible in the photograph: along the far wall to center-left, one blue metal drum and one black and red metal drum, both on the same pallet, and a blue metal drum located immediately to the left of the black and red drum off of the pallet.

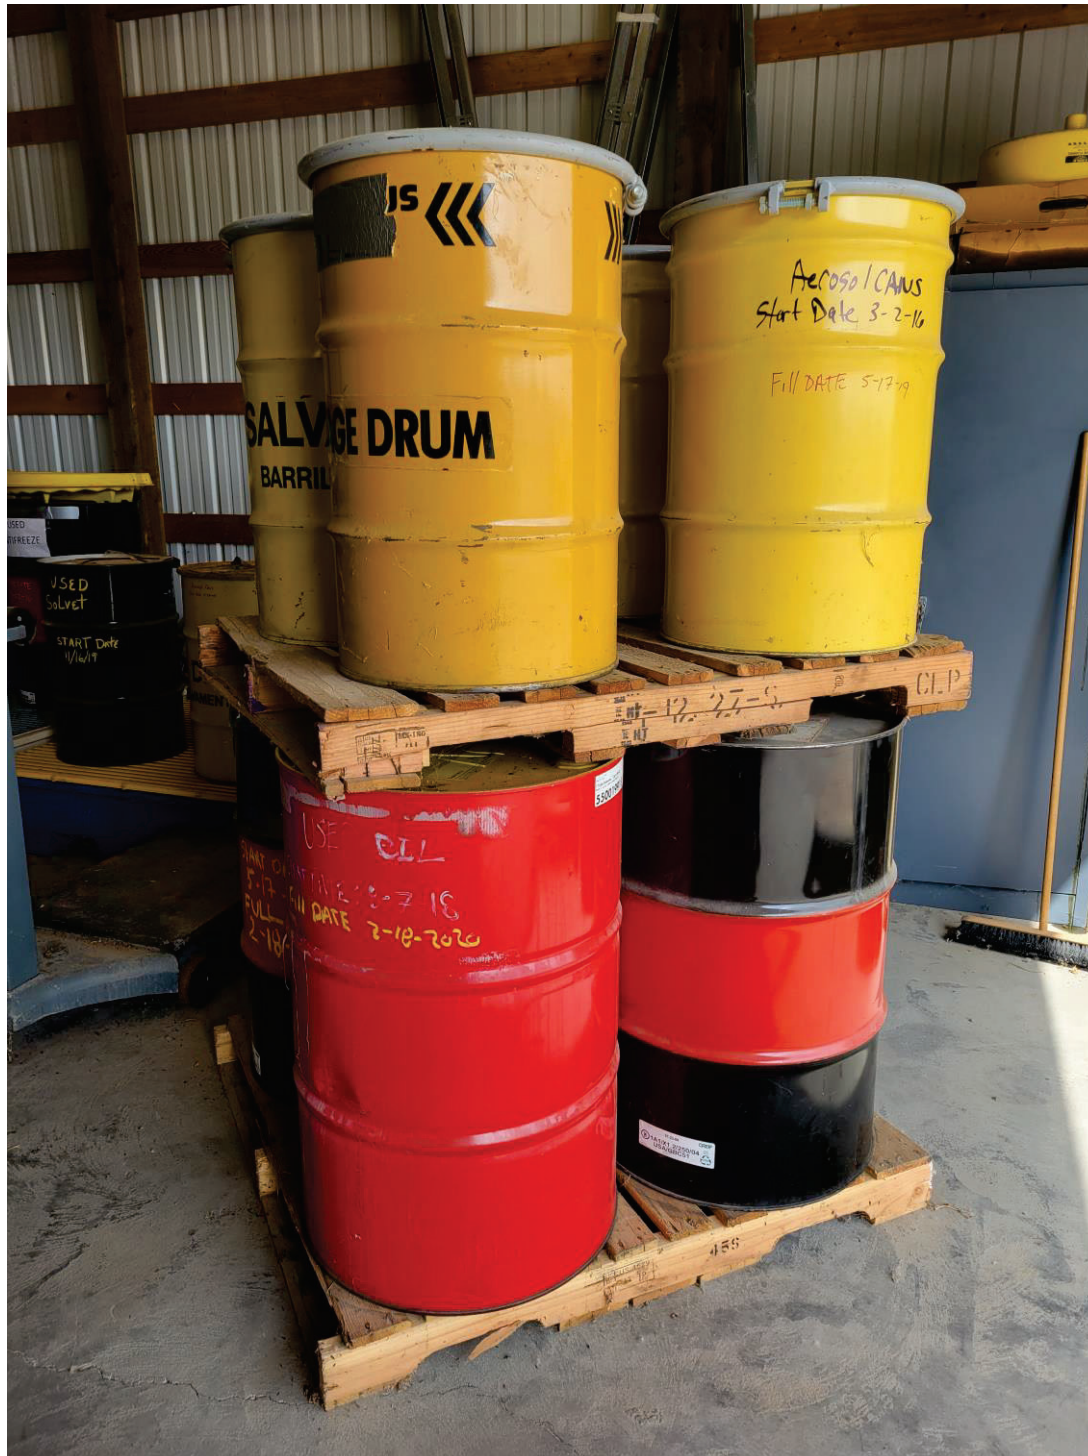
Photo 6: 20230921\_121422.jpg, 12:14 p.m. – photo of drums located in the hazardous waste storage building, also shown in photo 5.

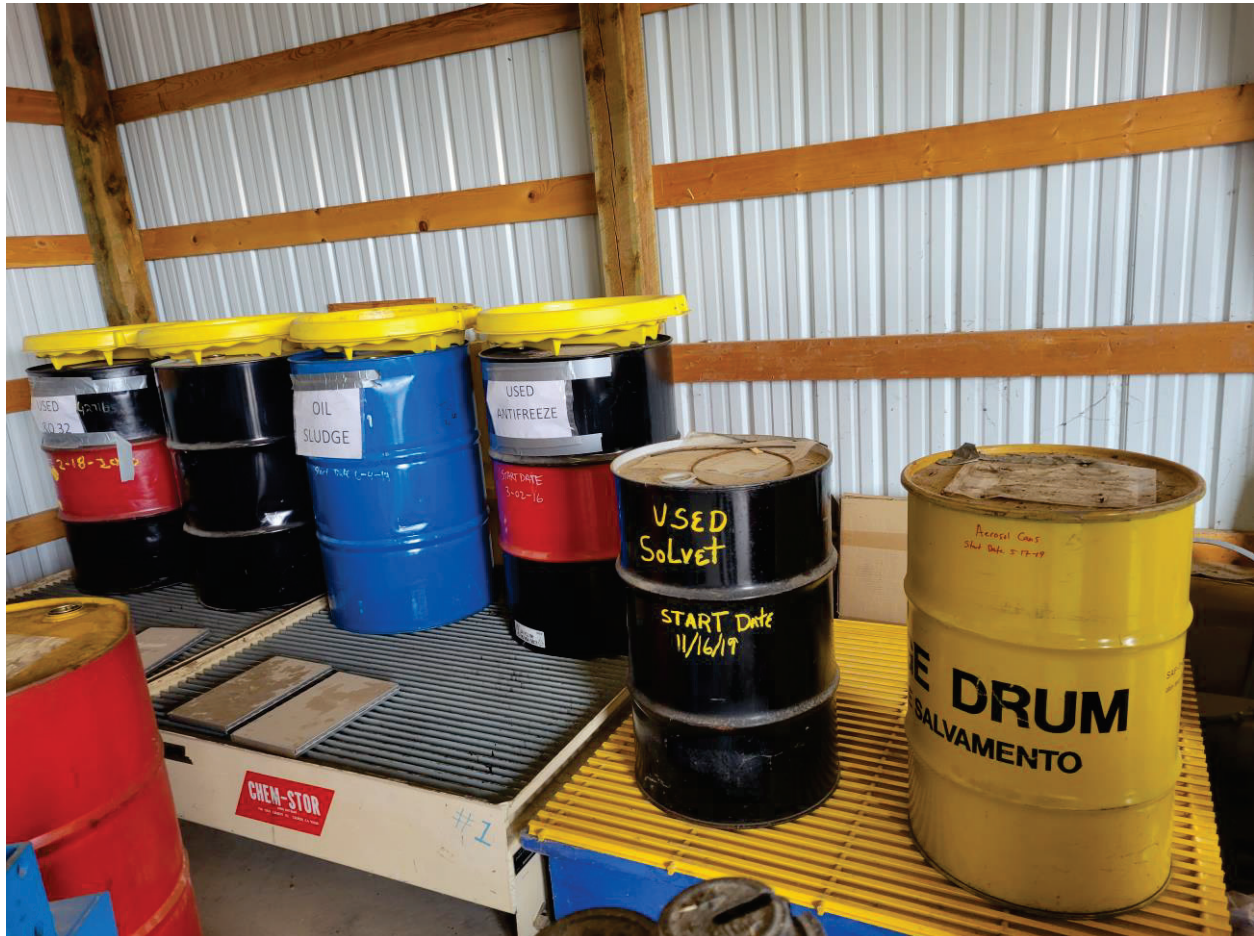
- Six drums placed on secondary containment along the north wall near the western portion of the hazardous waste building (photo 7):
  - Yellow salvage drum marked "Aerosol cans" and "start date 5-17-19"

- Black metal drum marked "Used Solvet" and "Start Date 11/16/19"
  - Black and red metal drum marked "Used Antifreeze" and "Start Date 3-02-16" - the bung on this drum was open until Mr. Curtis closed it

- Blue metal drum marked "Oil sludge" and "Start Date 6-4-19" - the bung on this drum was open until Mr. Curtis closed it
  - Black metal drum, unmarked - the bung on this drum was open until Mr. Curtis closed it

- Black and red metal drum marked "Used R&O 32" and "Start Date 2-18-2020" - the bung on this drum was open until Mr. Curtis closed it
- 10 drums near the west side of the building (photo 8):

Photo 7: 20230921\_122027.jpg, 12:20 p.m. – photo of drums stored on secondary containment along the northern wall inside the hazardous waste storage building, to the left of the drums shown in photo 6.

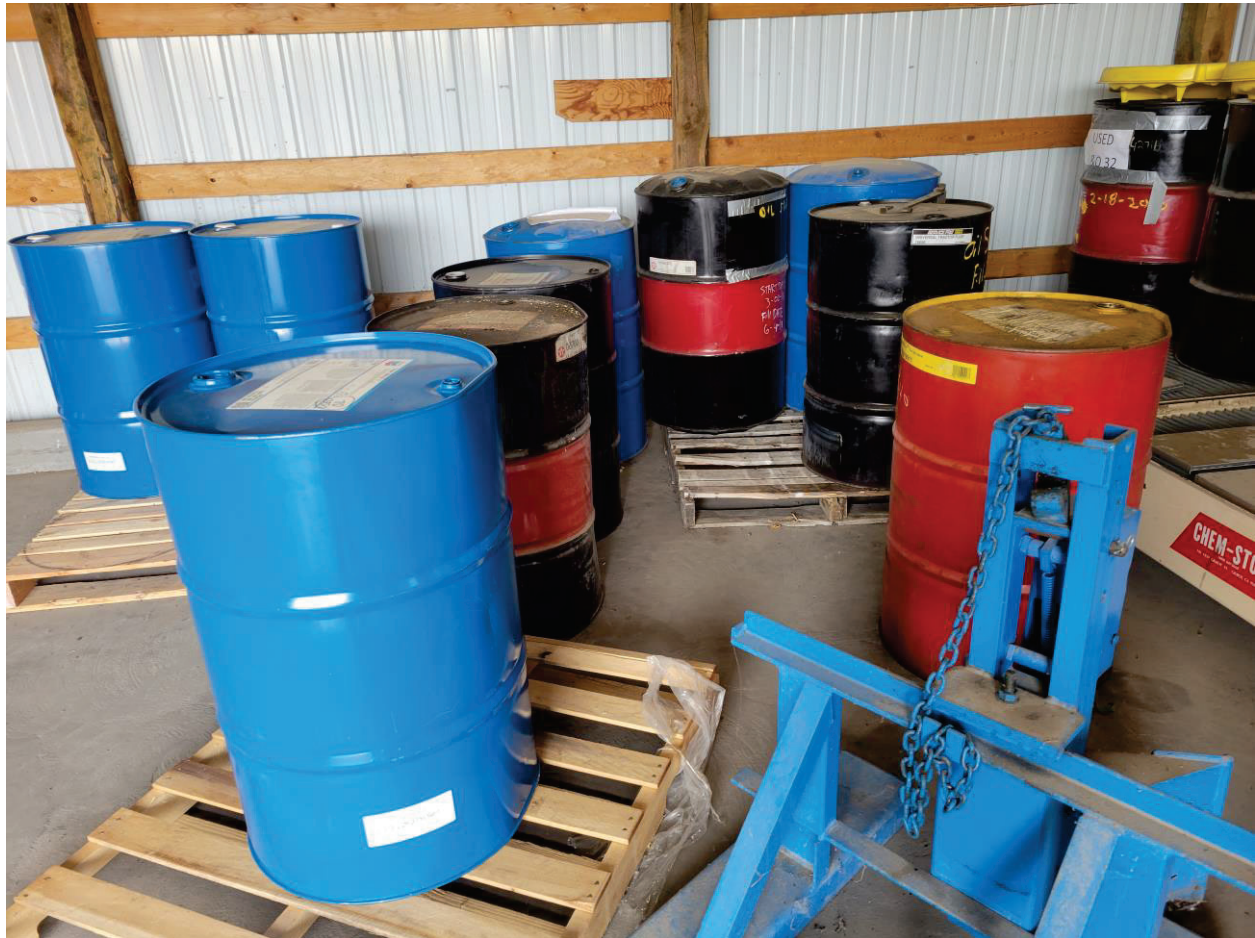
- One red metal drum on the floor, marked “used engine oil”
- One black metal drum on a pallet, marked “oil sludge” and “fill date 8-6-19 #1”
- One blue metal drum on a pallet, bulging, marked “sludge” and “start date 6-3-19” and “fill date 6-4-19”

- One black and red metal drum on a pallet, bulging, marked “oil sludge” and “start date 3-2-16” and “fill date 6-4-19”
- One blue metal drum on the floor, bulging, marked “sludge” and “fill date 11-30-20” and “Barrel #2”

- One black metal drum on the floor, no written marking; label states “Universal Tractor Fluid” but may not represent the contents of the drum
- One black and red metal drum on the floor, marked with “start date 7-11-16” and “old/dirty fuel”

- One blue metal drum on a pallet, marked “used oil”
- Two blue metal drums on one pallet, no handwritten markings, appear new/potentially unused raw material (not waste), labeled “Regal R&O32”

Photo 8: 20230921\_122147.jpg, 12:21 p.m. – photo of drums located near the western wall inside the hazardous waste storage building, to the left of the drums shown in photo 7. The drums in this photo are also shown in photo 5.

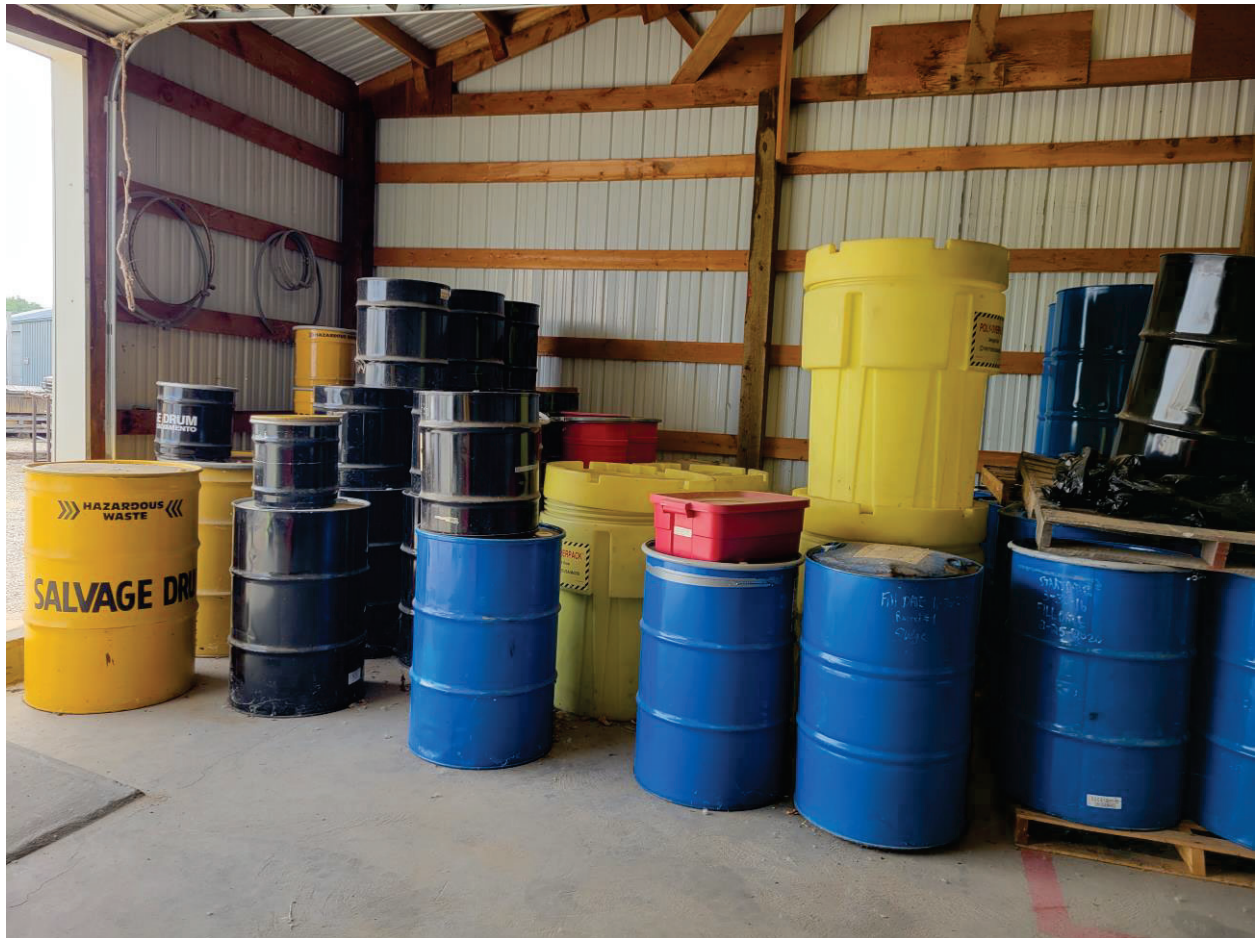
- Drums, overpacks and small containers along the south wall (photos 9-10 and 13-18): some of these containers were not accessible for closer inspection due to no aisle space:

- 9 silver drums and 9 blue drums on pallets, stacked 3-high, appeared to be unused turbine oil awaiting use (not waste)
  - 10 blue metal drums and one black metal drum on pallets, stacked two-high; one blue metal drum located under the black drum was bulging to the extent that the pallet holding the black drum was uplifted at that corner; markings on most of these 11 drums were not readable due to no aisle space affording physical access, except:

Inside the power plant building, I observed a sand blast cabinet. After the inspection on 10/5/2023, Mr. Curtis provided additional information regarding sand blast waste, see Attachment 3 - Facility Correspondence. This correspondence appears to identify sand blast waste as being the material stored in the smaller yellow metal drums shown in the background of photos 9 and 16.

Photo 9: 20230921\_123614.jpg, 12:36 p.m. – photo of drums and other containers stored along the southern wall of the hazardous waste building. Photo taken facing south. One blue metal drum shown at center-right to the left of the red floor markings is bulging. At right in the photo another bulging blue metal drum stacked beneath a pallet with a black metal drum on; this bulging is pushing the pallet up.

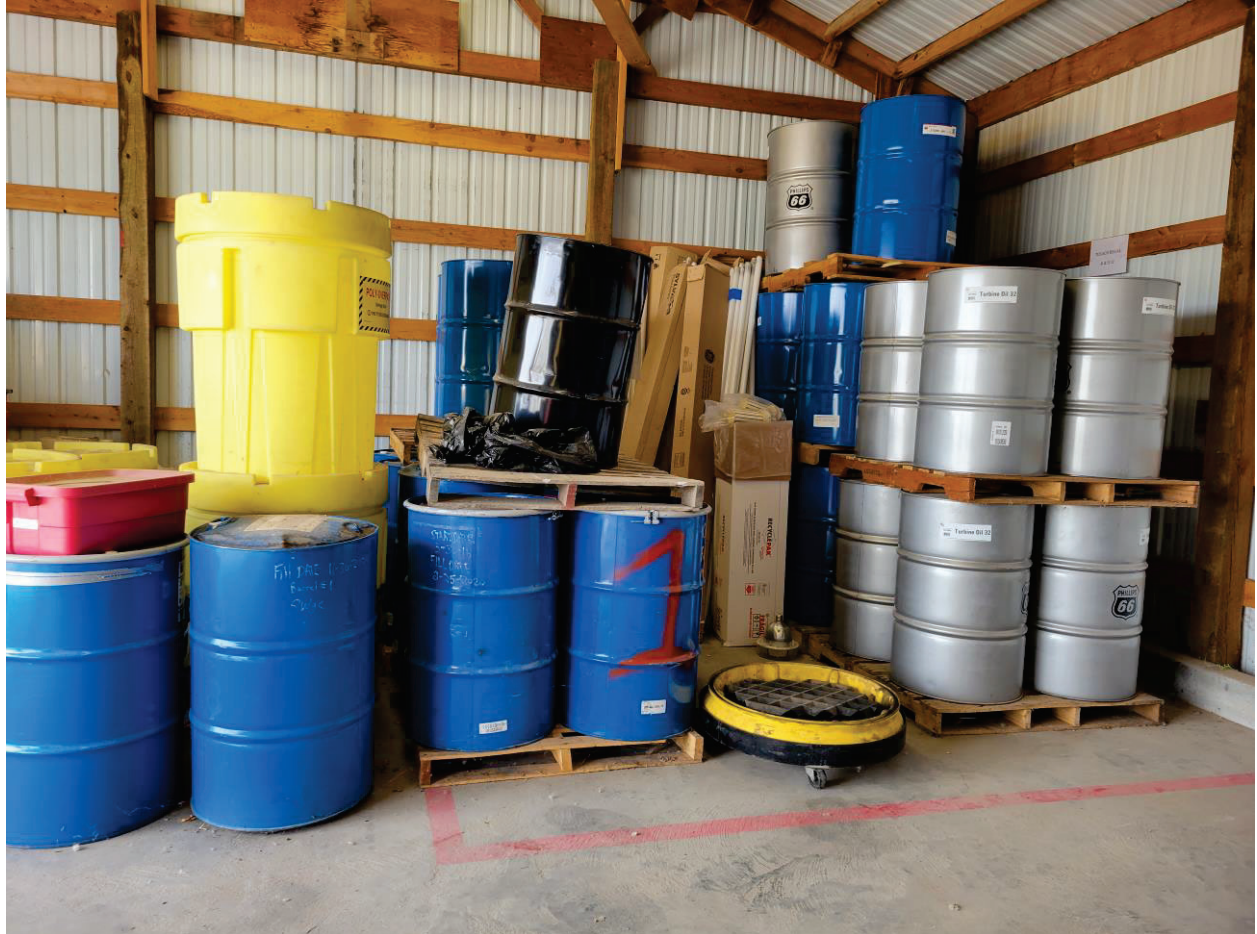
In addition, spent mercury-containing light bulbs were stored in the hazardous waste storage building, see photos 10-12. Ballasts were stored in boxes on a pallet shown in photo 13.

Photo 10: 20230921\_123619.jpg, 12:36 p.m. – photo panned right from photo 9. The two bulging blue metal drums shown in photo 9 are also visible in this photo.

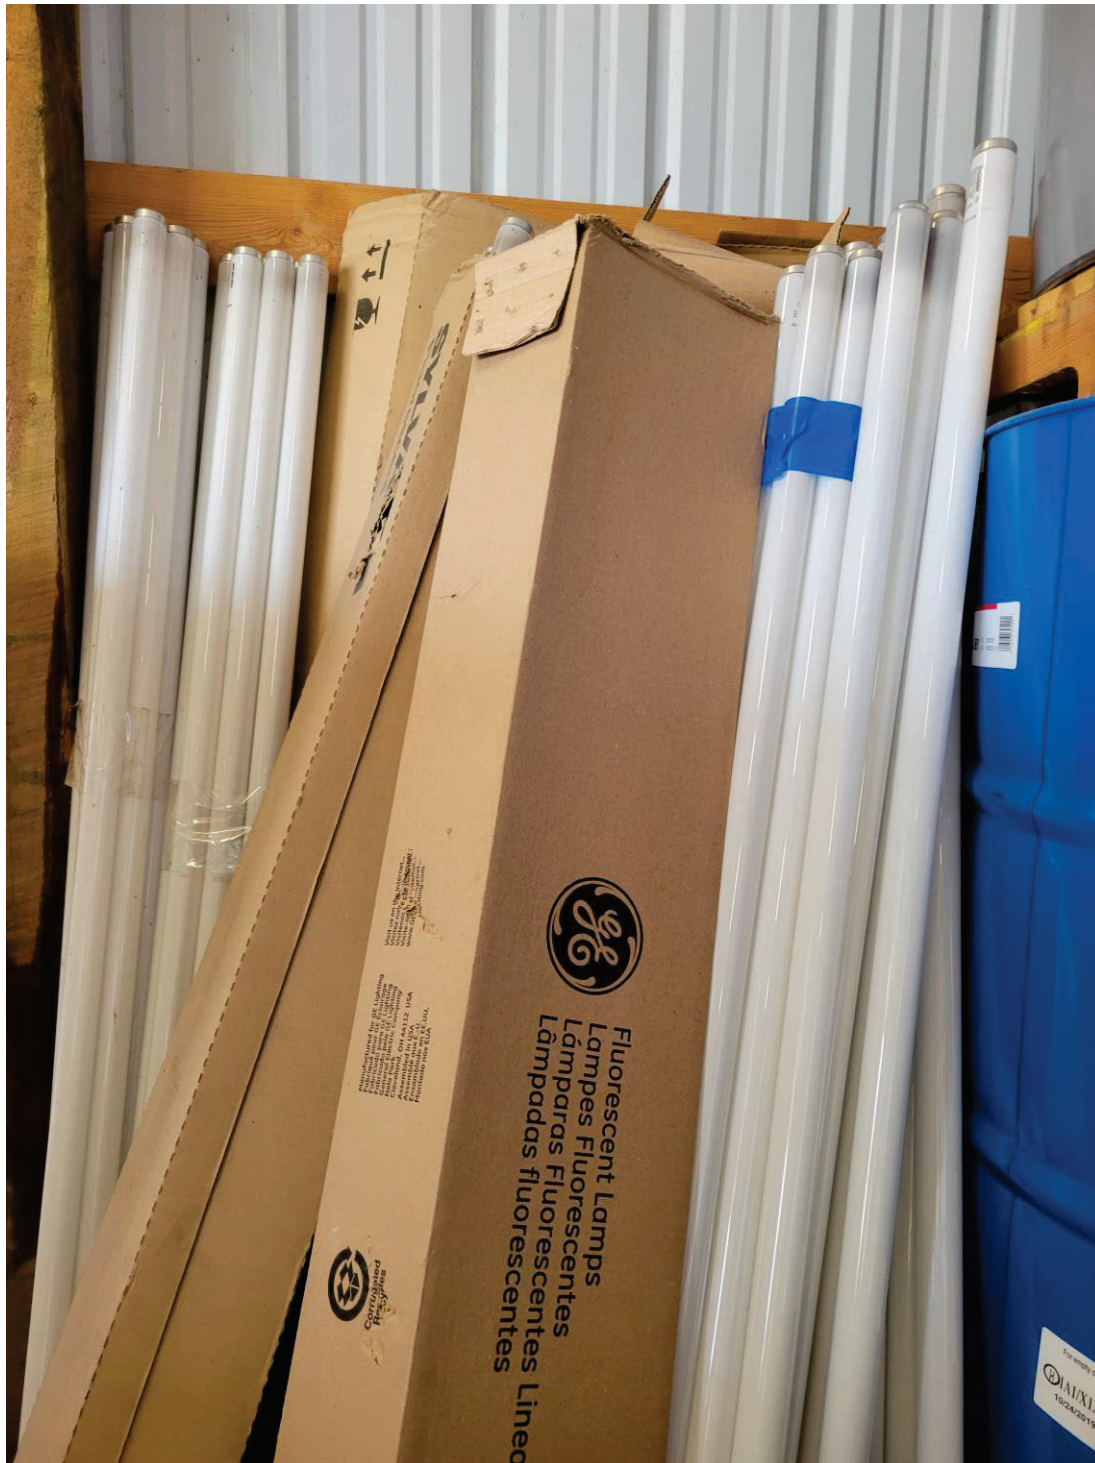
Photo 11: 20230921\_124023.jpg, 12:40 p.m. – close-up of light bulbs visible in photo 10.

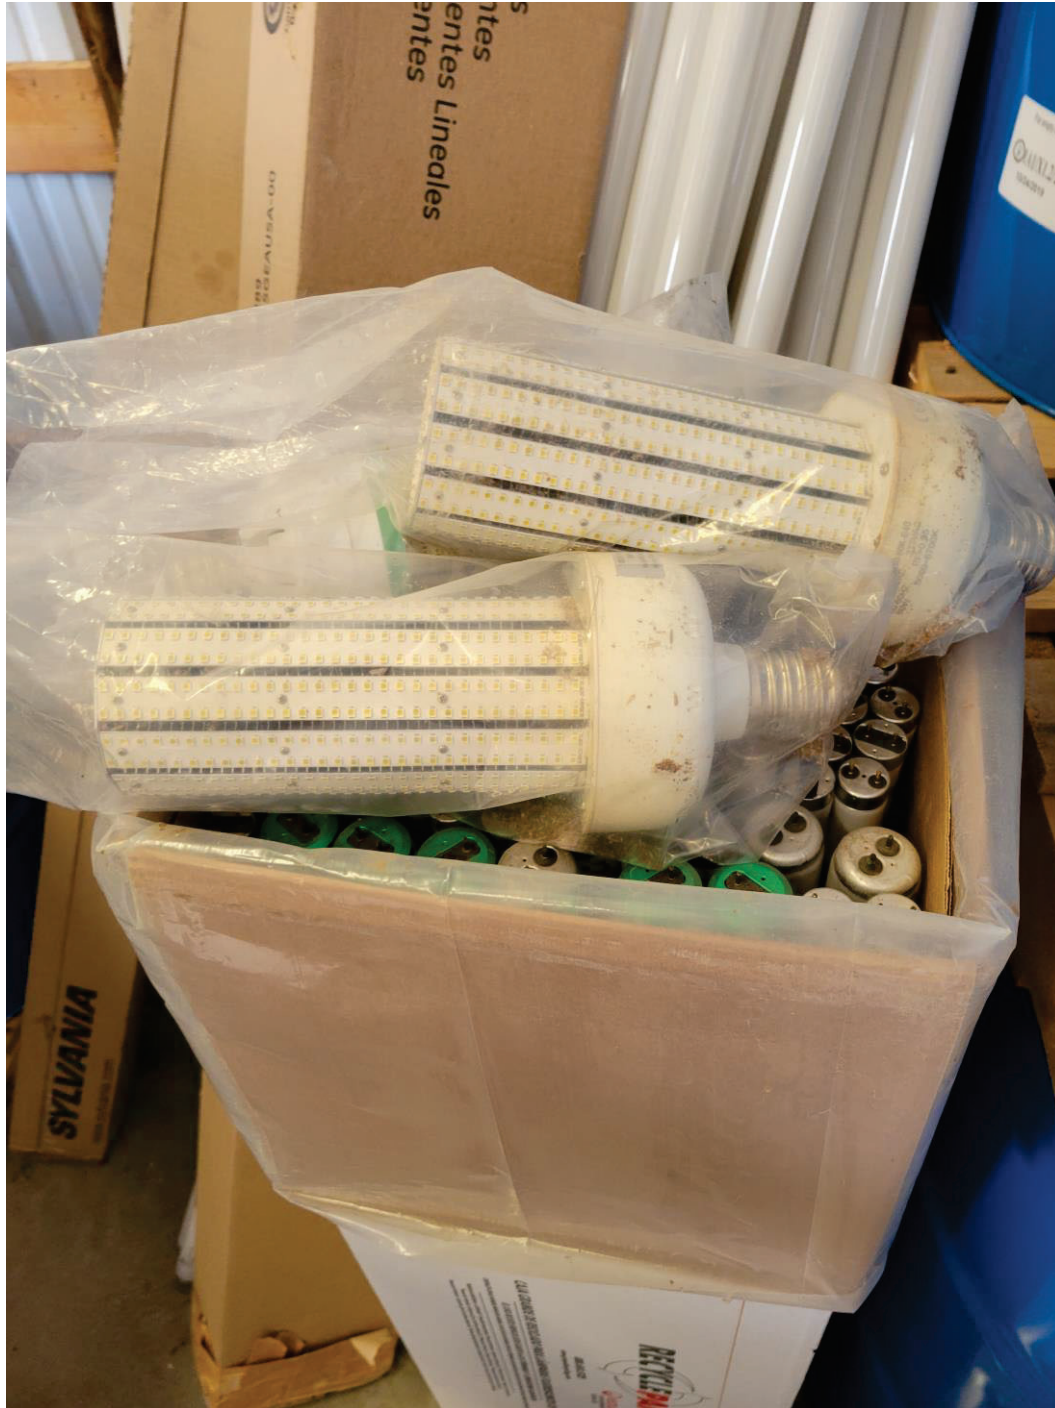
Photo 12: 20230921\_124219.jpg, 12:42 p.m. – photo of additional light bulbs, with the bulbs shown in photo 11 visible in the background.

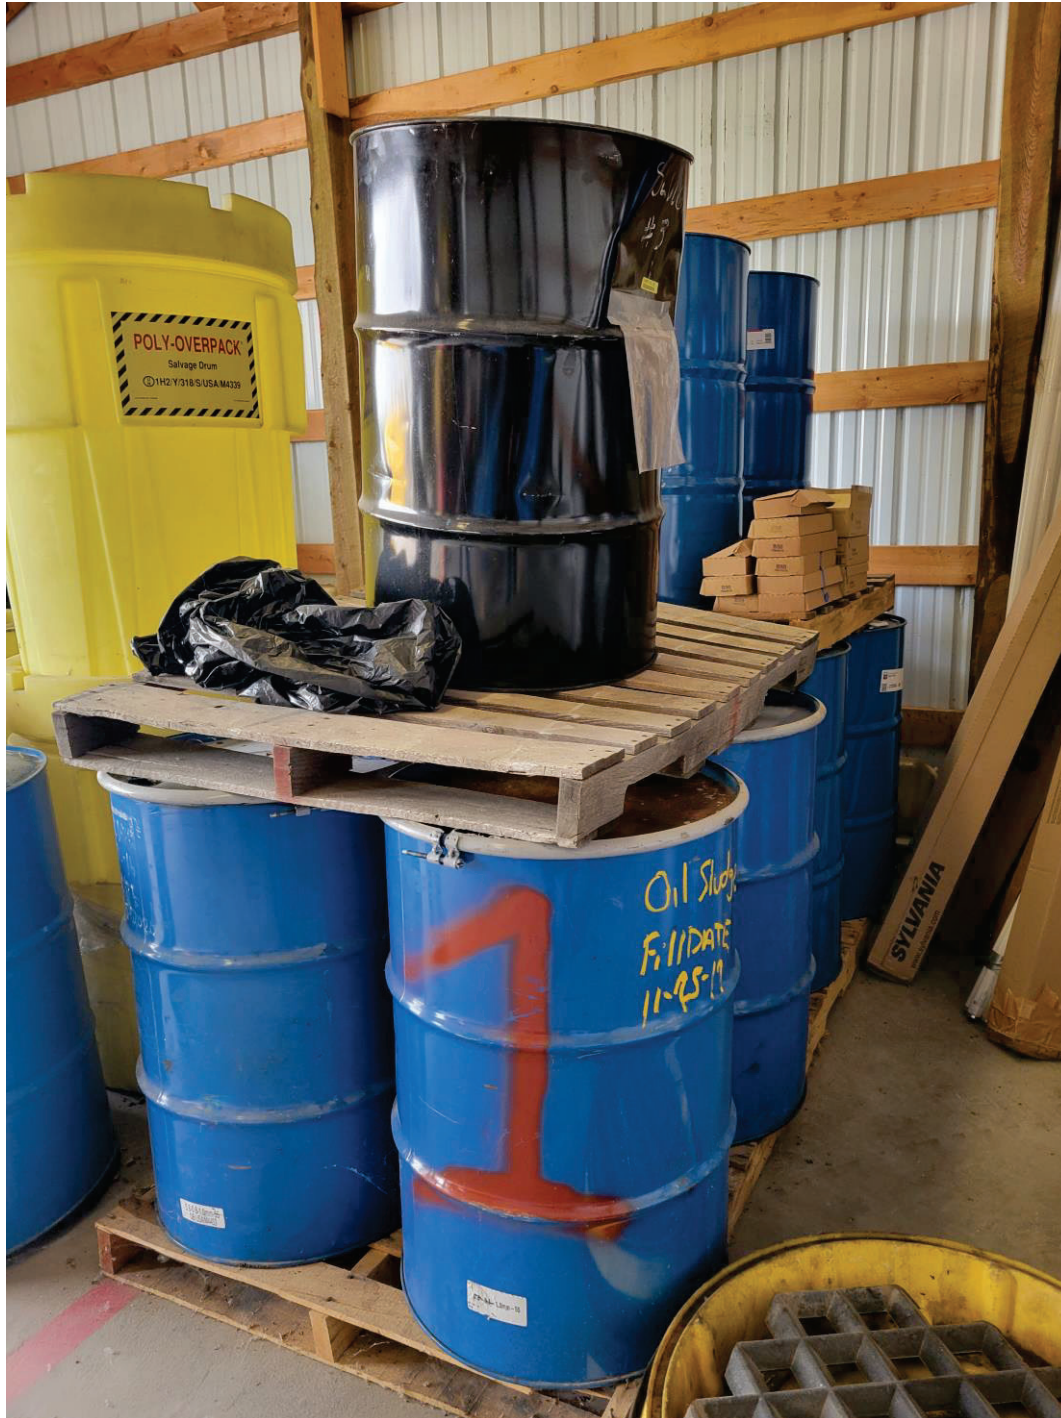
Photo 13: 20230921\_124240.jpg, 12:42 p.m. – photo of drums also shown in photo 10, located to the left of the light bulbs.

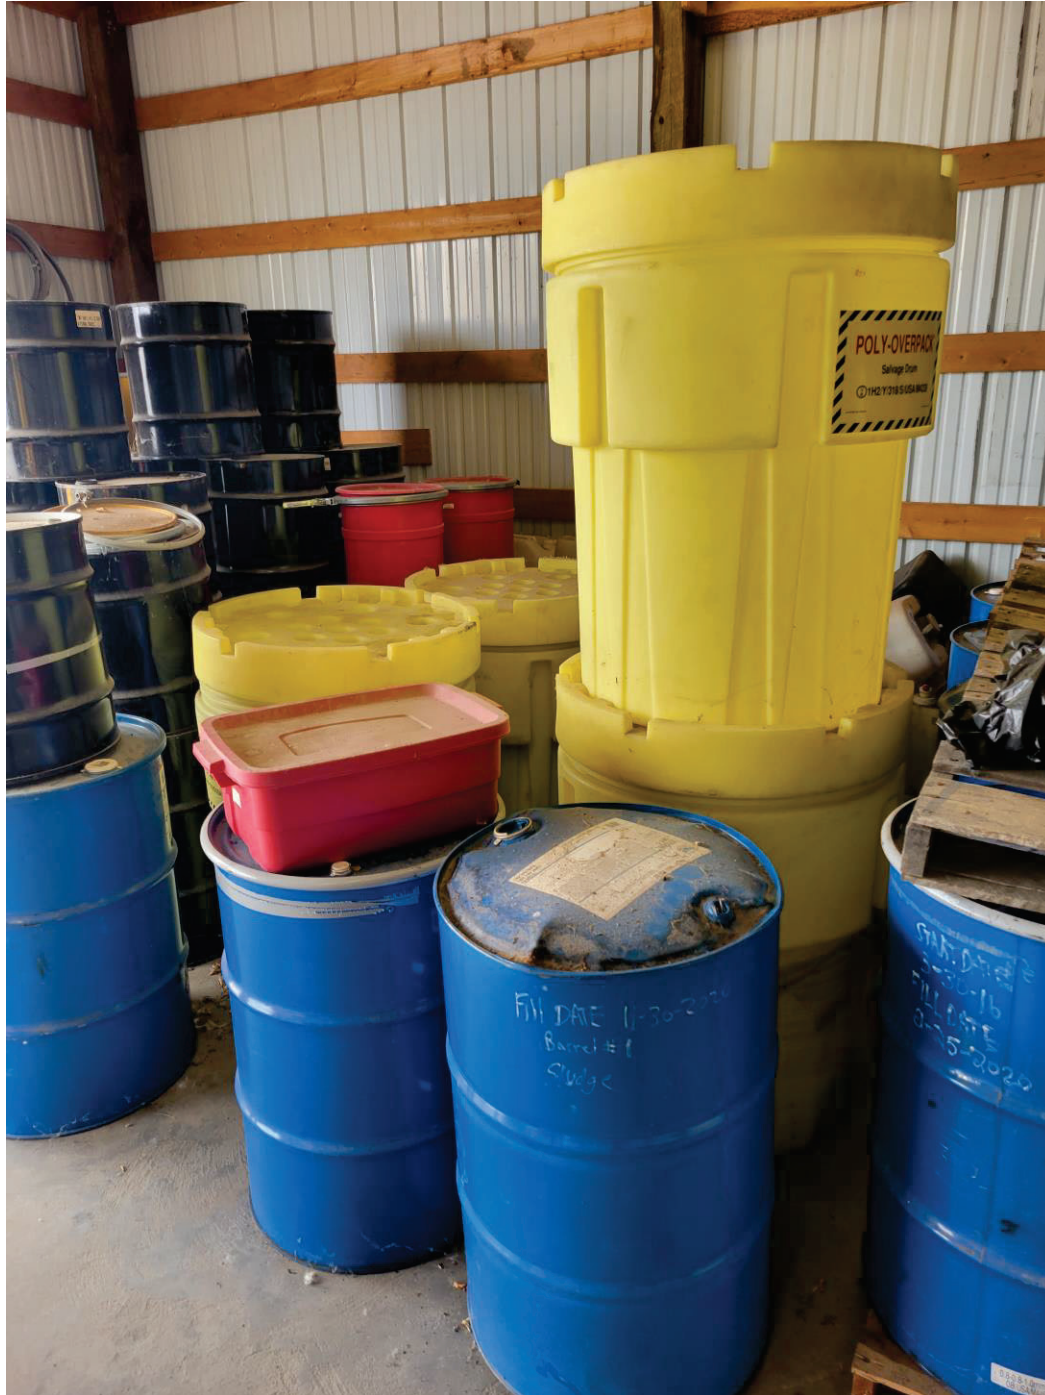
Photo 14: 20230921\_124850.jpg, 12:48 p.m. – additional photo of the containers on the south side of the hazardous waste building. The bulging blue metal drum is also shown in photos 9 and 10.

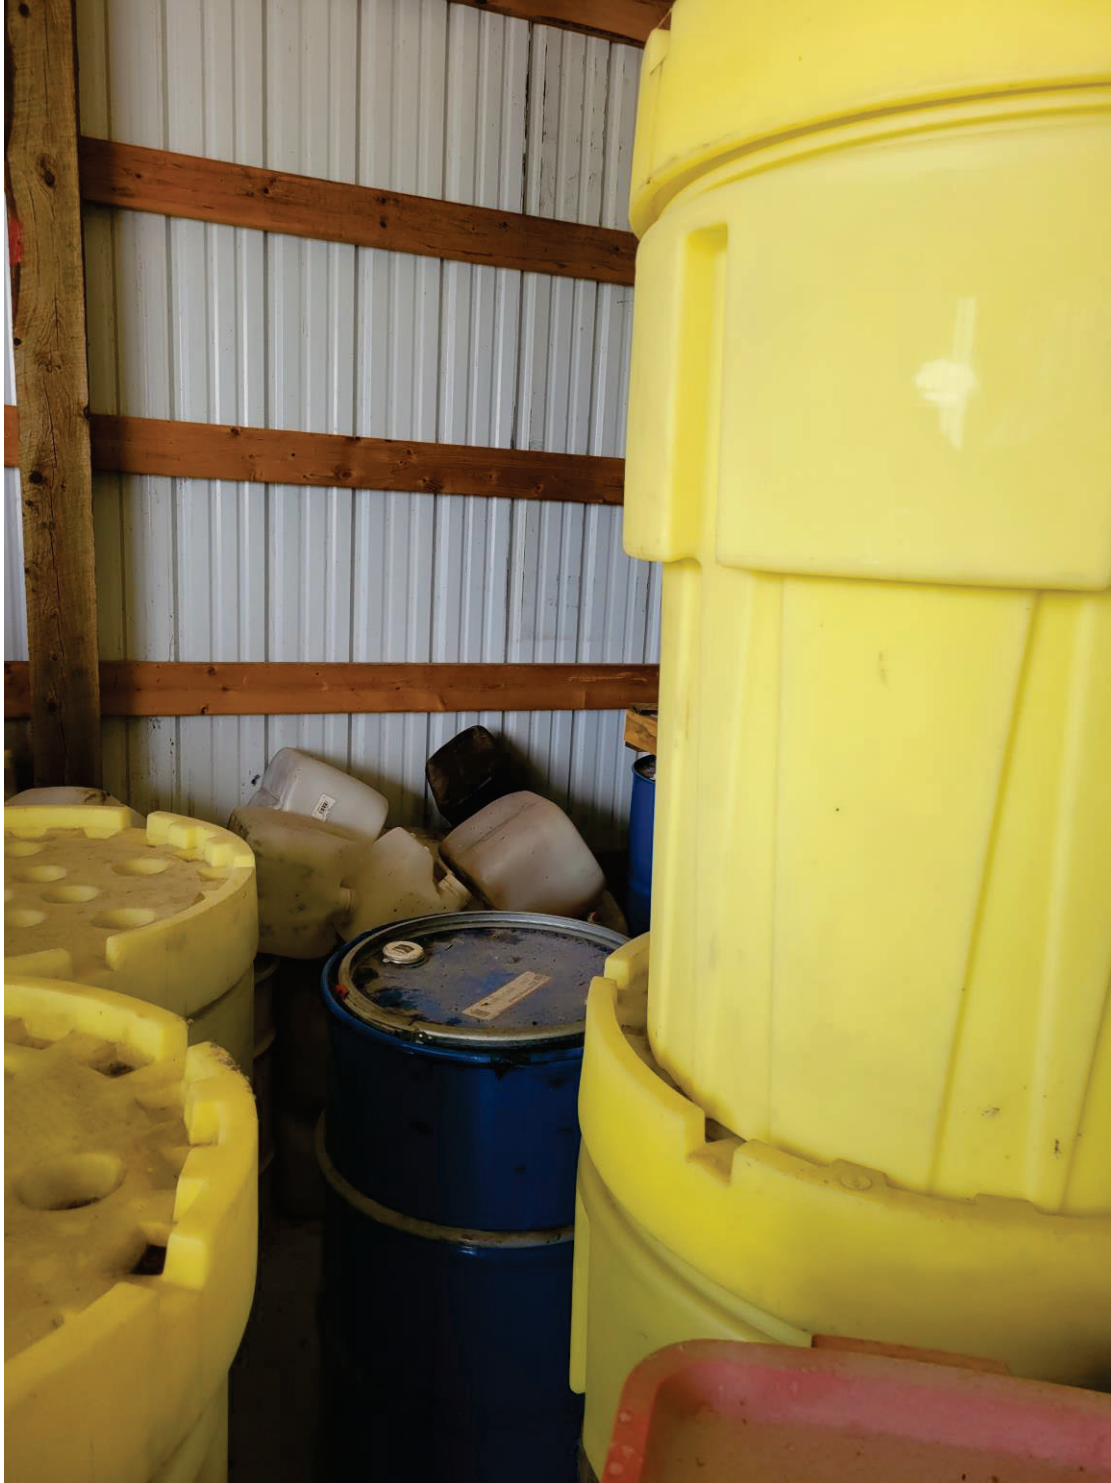
- Small containers piled against the south wall, photo 15
    - Four yellow poly overpack drums, no visible markings of the contents, at least one was empty, and at least one contained asbestos fibers in a bag

Photo 15: 20230921\_125037.jpg, 12:50 p.m. – photo of smaller containers located against the back wall. These containers were not accessible for closer inspection due to no aisle space.
