**UNITED STATES ENVIRONMENTAL PROTECTION AGENCY  
REGION 8  
RESOURCE CONSERVATION AND RECOVERY ACT**

**Facility Name:** Yellowtail Hydroelectric Power Plant and Maintenance Facility, U.S. Bureau of Reclamation

**Date of Inspection:** September 21, 2023  
**Arrival Time:** 10:05 a.m.  
**Departure Time:** 4:10 p.m.

**Type and Purpose of Inspection:** Compliance Evaluation Inspection  
Compliance with RCRA Subtitle C

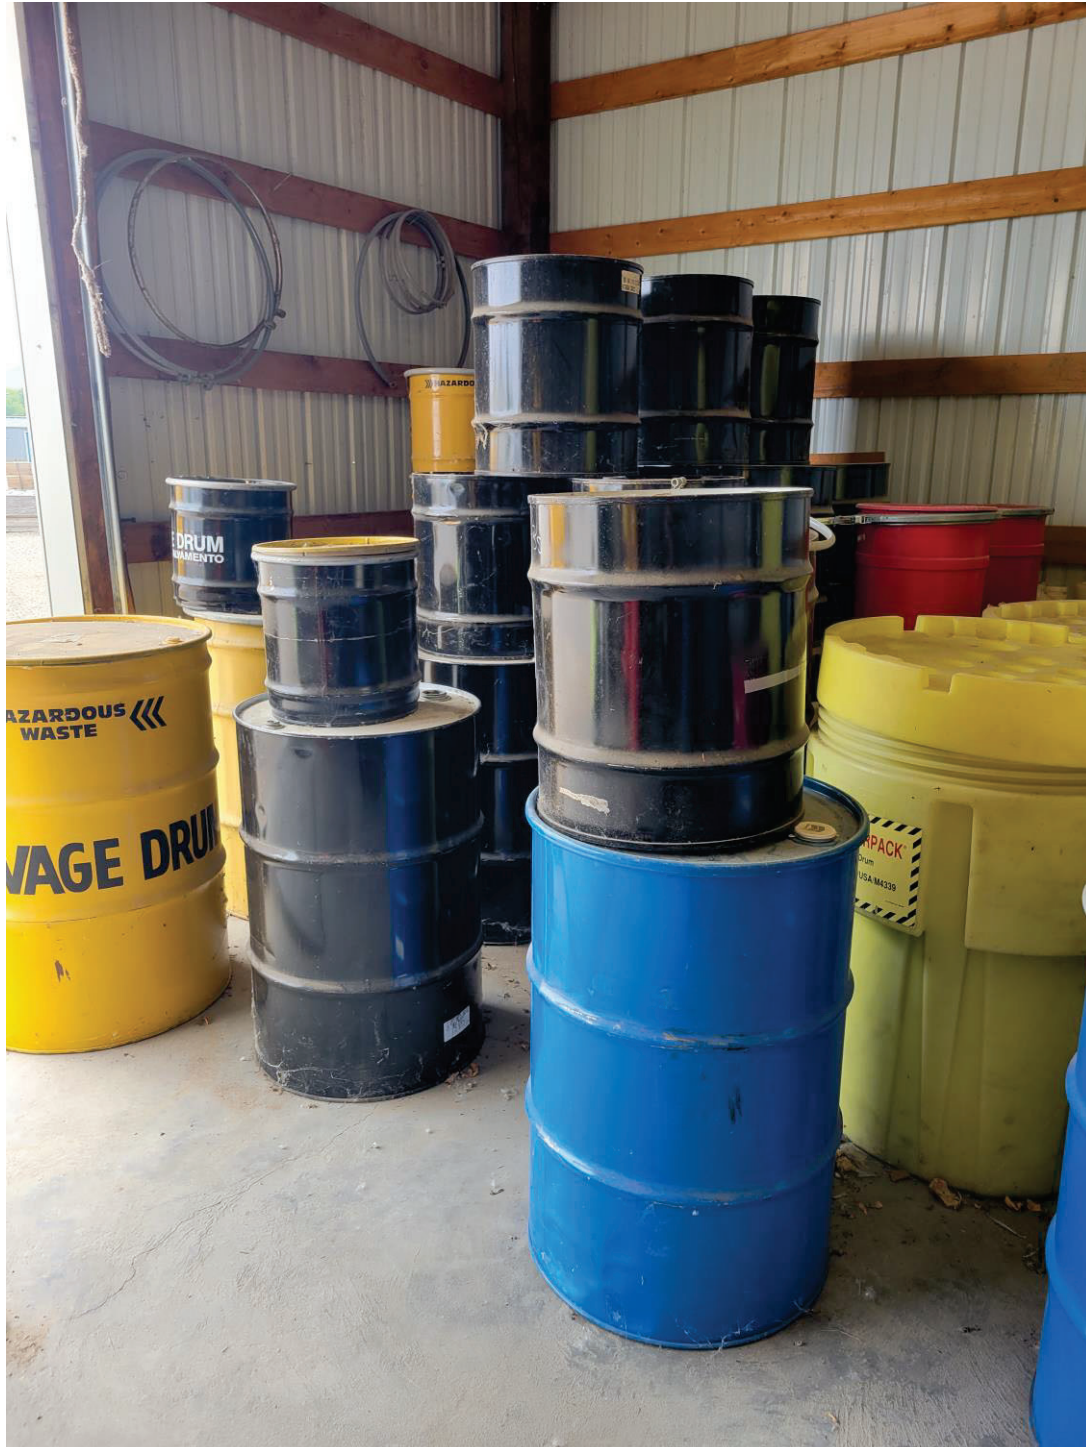
Inside the power plant building, I observed a sand blast cabinet. After the inspection on 10/5/2023, Mr. Curtis provided additional information regarding sand blast waste, see Attachment 3 - Facility Correspondence. This correspondence appears to identify sand blast waste as being the material stored in the smaller yellow metal drums shown in the background of photos 9 and 16.

Photo 16: 20230921\_125427.jpg, 12:54 p.m. – photo of the same area as that shown in photo 9, taken facing southeast.

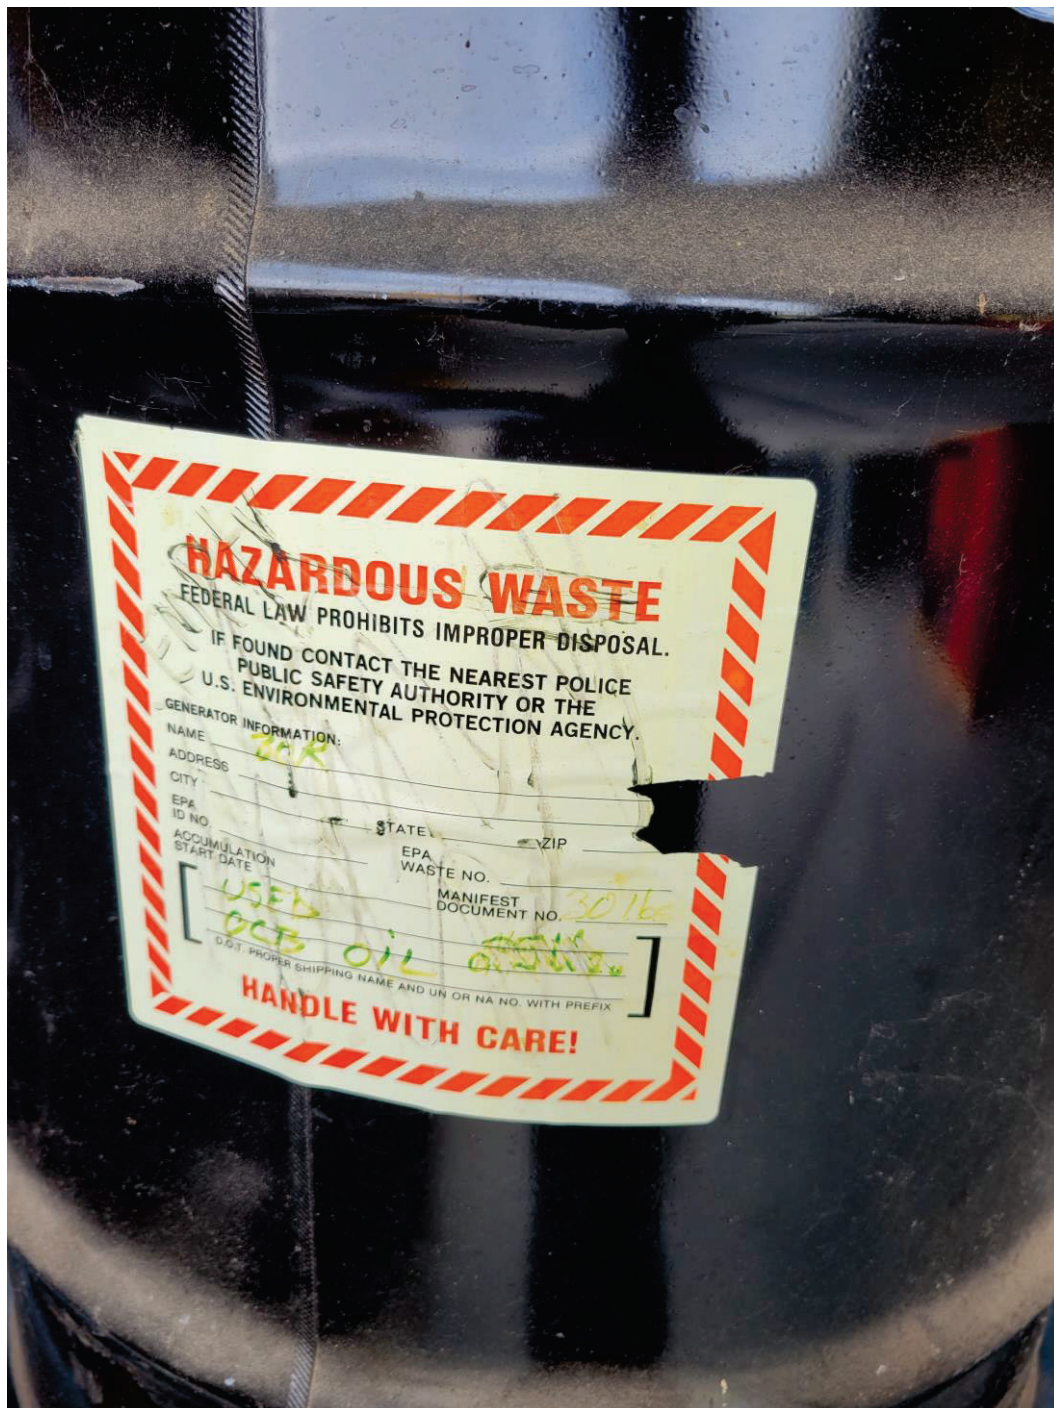
Photo 17: 20230921\_125504.jpg, 12:55 p.m. – photo of a hazardous waste label on a small black metal drum, visible in photo 16 atop a 55-gallon blue metal drum. The label indicates the container once held or was intended to hold hazardous waste, but the container was determined to be empty at the time of the inspection.

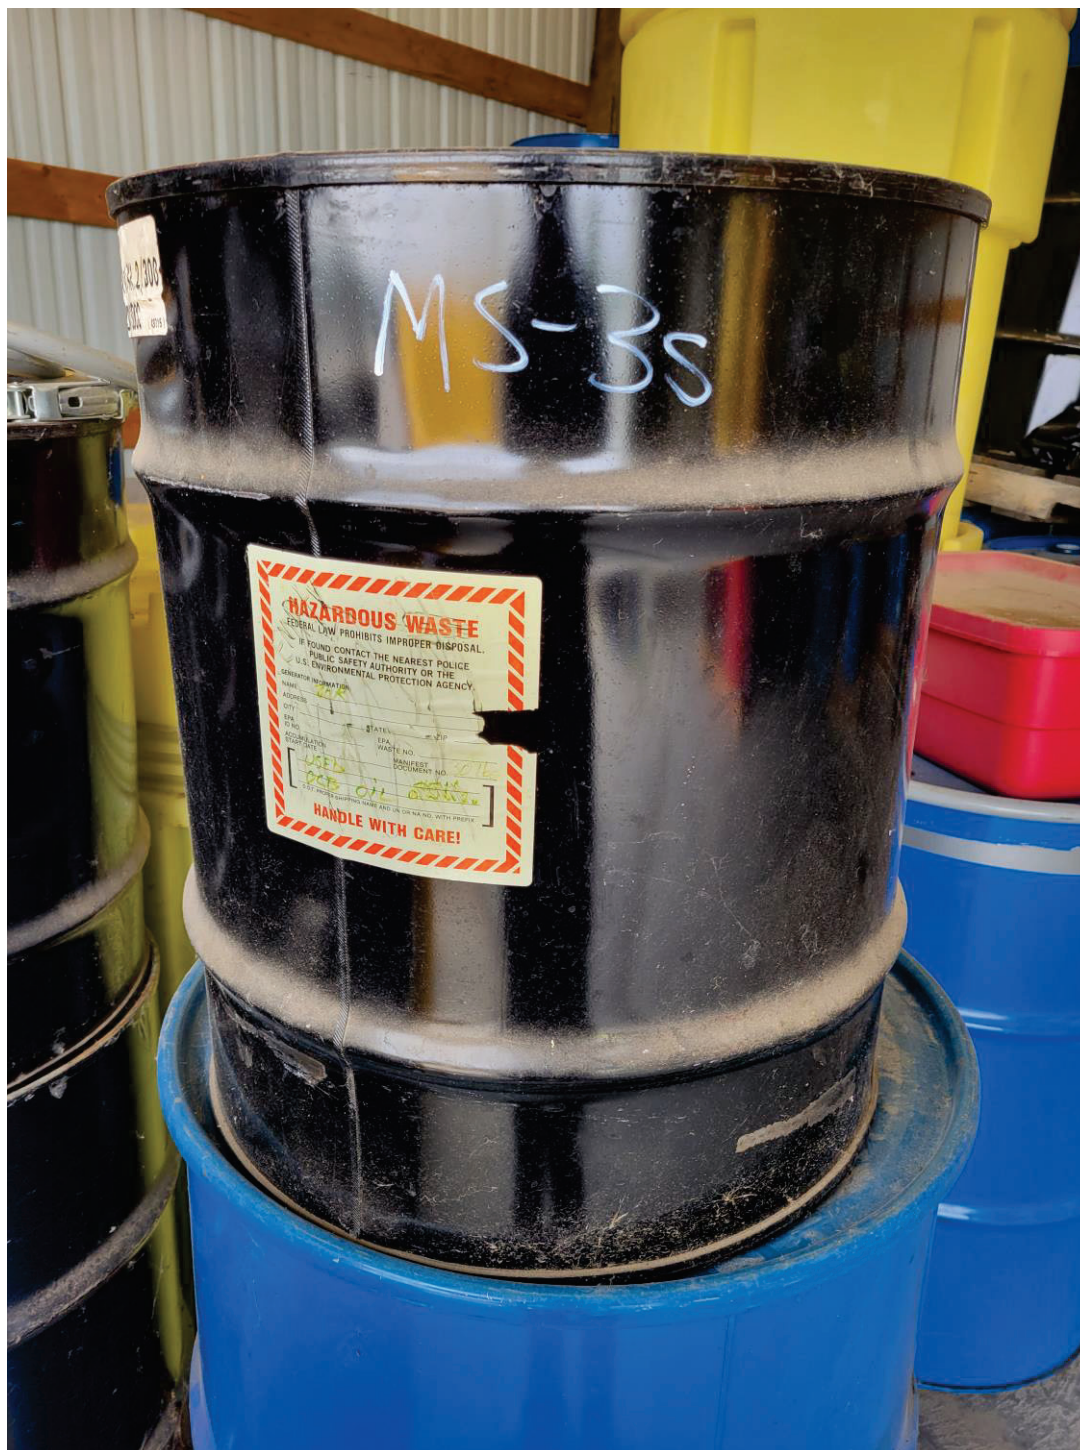
Photo 18: 20230921\_125508.jpg, 12:55 p.m. – photo of the same drum shown in photo 17.

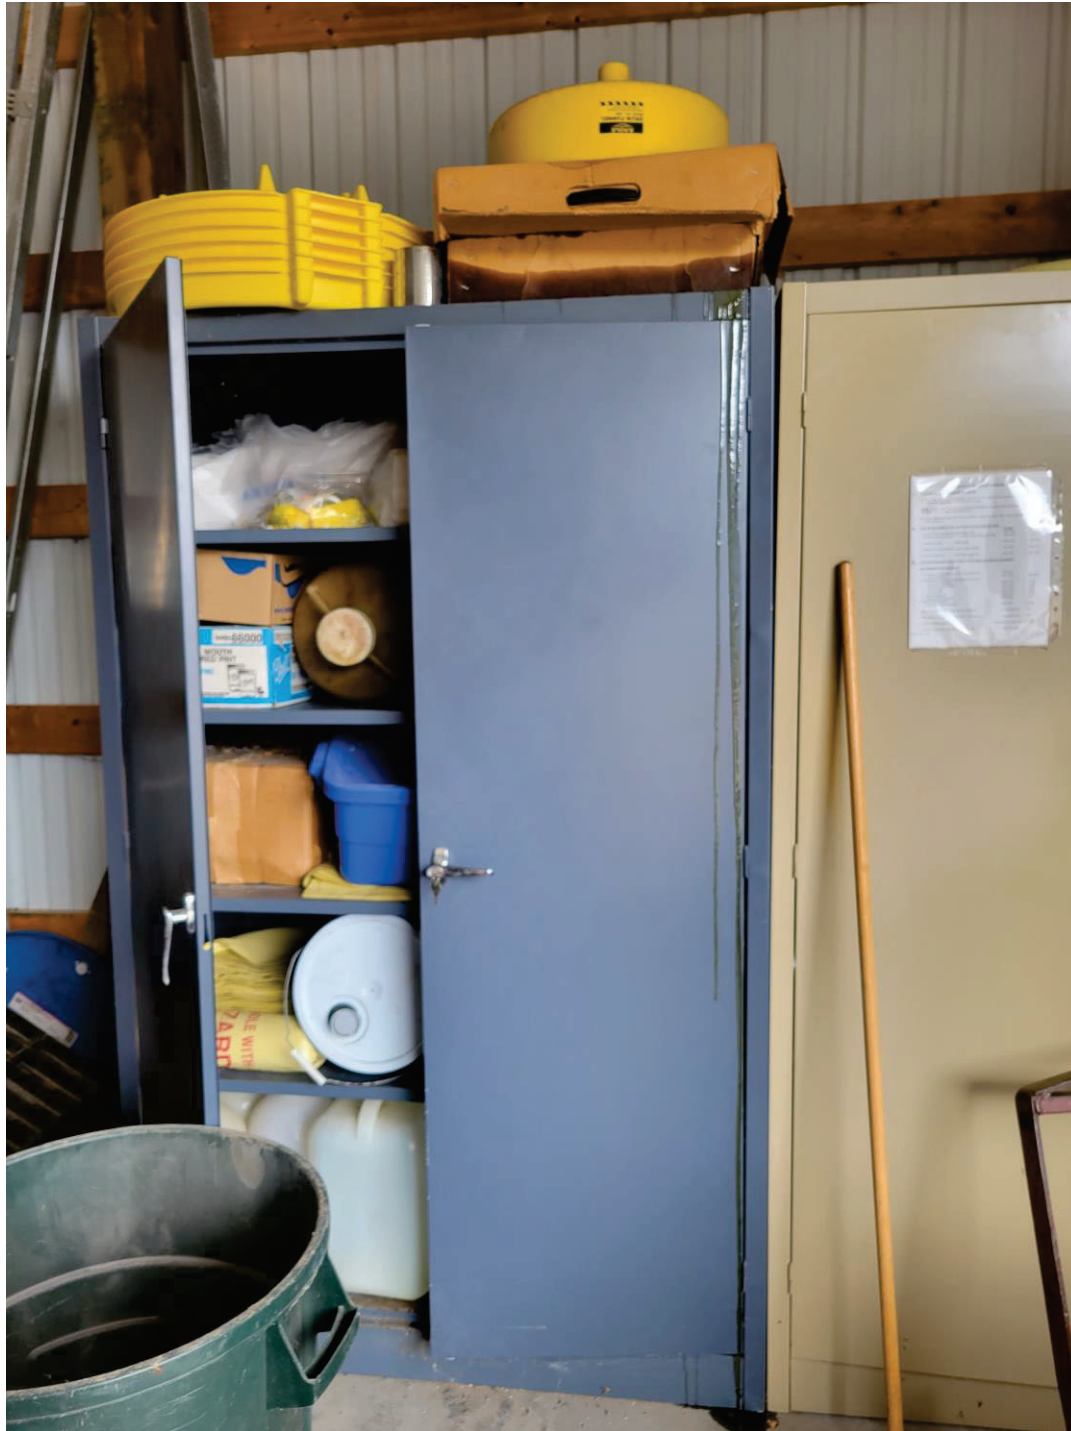
In the northeast corner of the building, one of two metal cabinets held supplies and containers. A box sitting on top of the cabinet appeared to be saturated with oil, which had leaked down the front exterior of the cabinet on the right door. See photos 19 and 20.

Photo 19: 20230921\_130435.jpg, 1:04 p.m. – photo of a storage cabinet located along the north wall of the hazardous waste building near the eastern side.

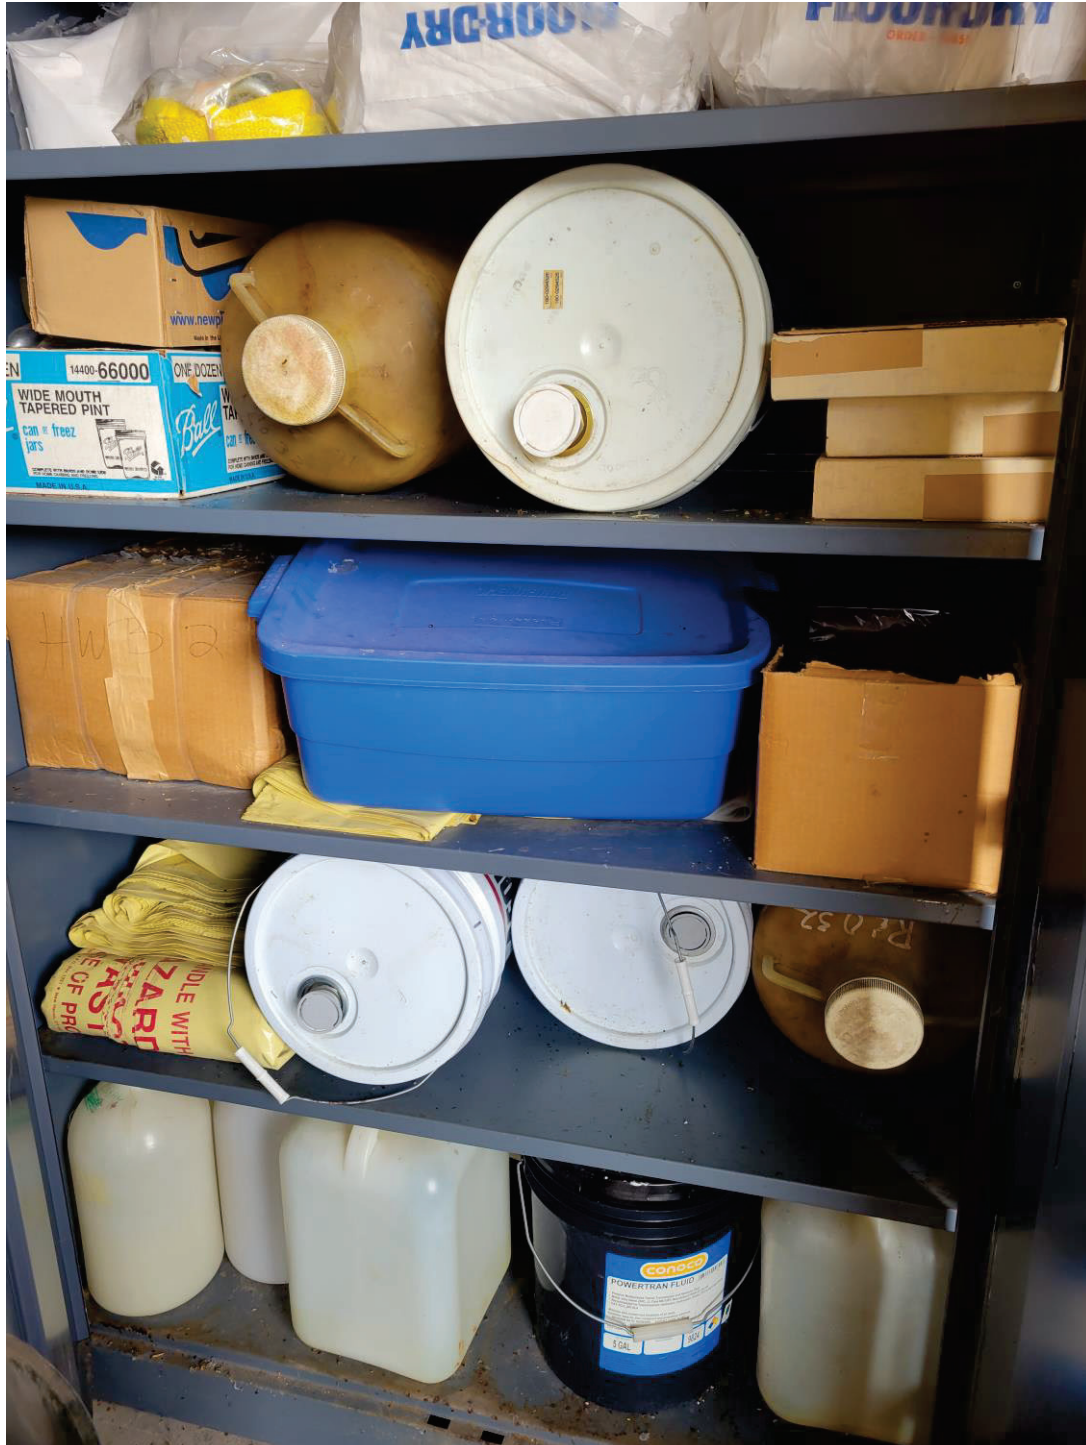
Photo 20: 20230921\_130501.jpg, 1:05 p.m. – photo of the contents of the same cabinet shown in photo 19.

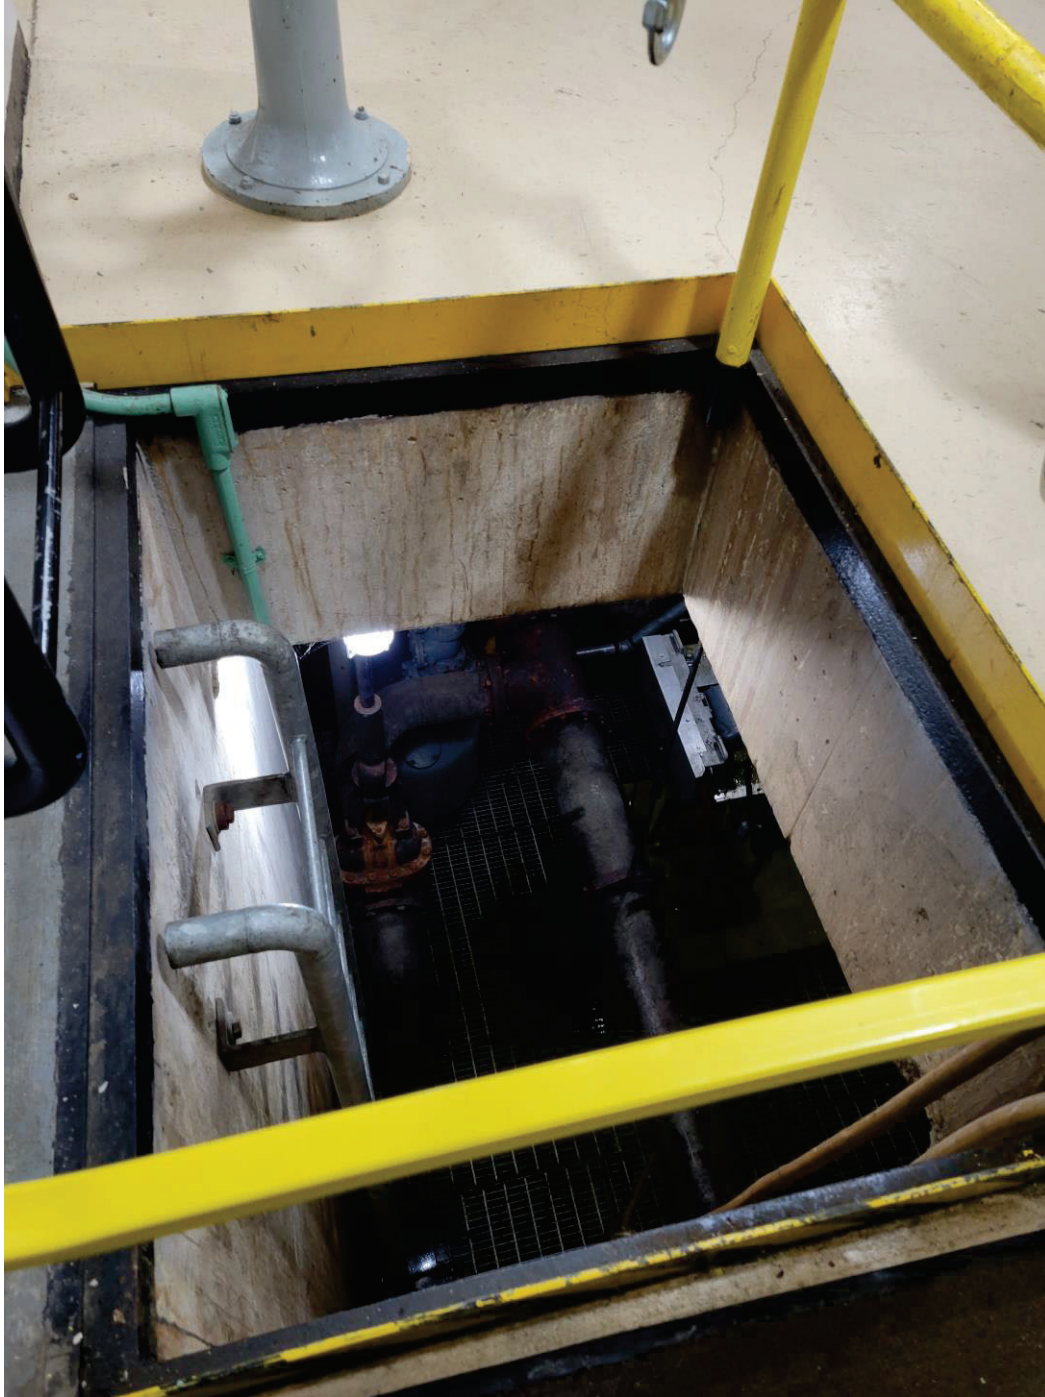
I also observed that sump room 101 was on a lower level and was marked as a confined space, which we did not enter. I was able to look through a passageway leading to the room, see photo 21. Below the floor grate I could see the movement of water, and Mr. Curtis explained that oil on the surface of the water is generated by leaks from various processes and is removed by skimming prior to discharge of the water to the river.

Photo 21: 20230921\_142253.jpg, 2:22 p.m. – photo of sump room 1, taken from the floor above because the area is a confined space.

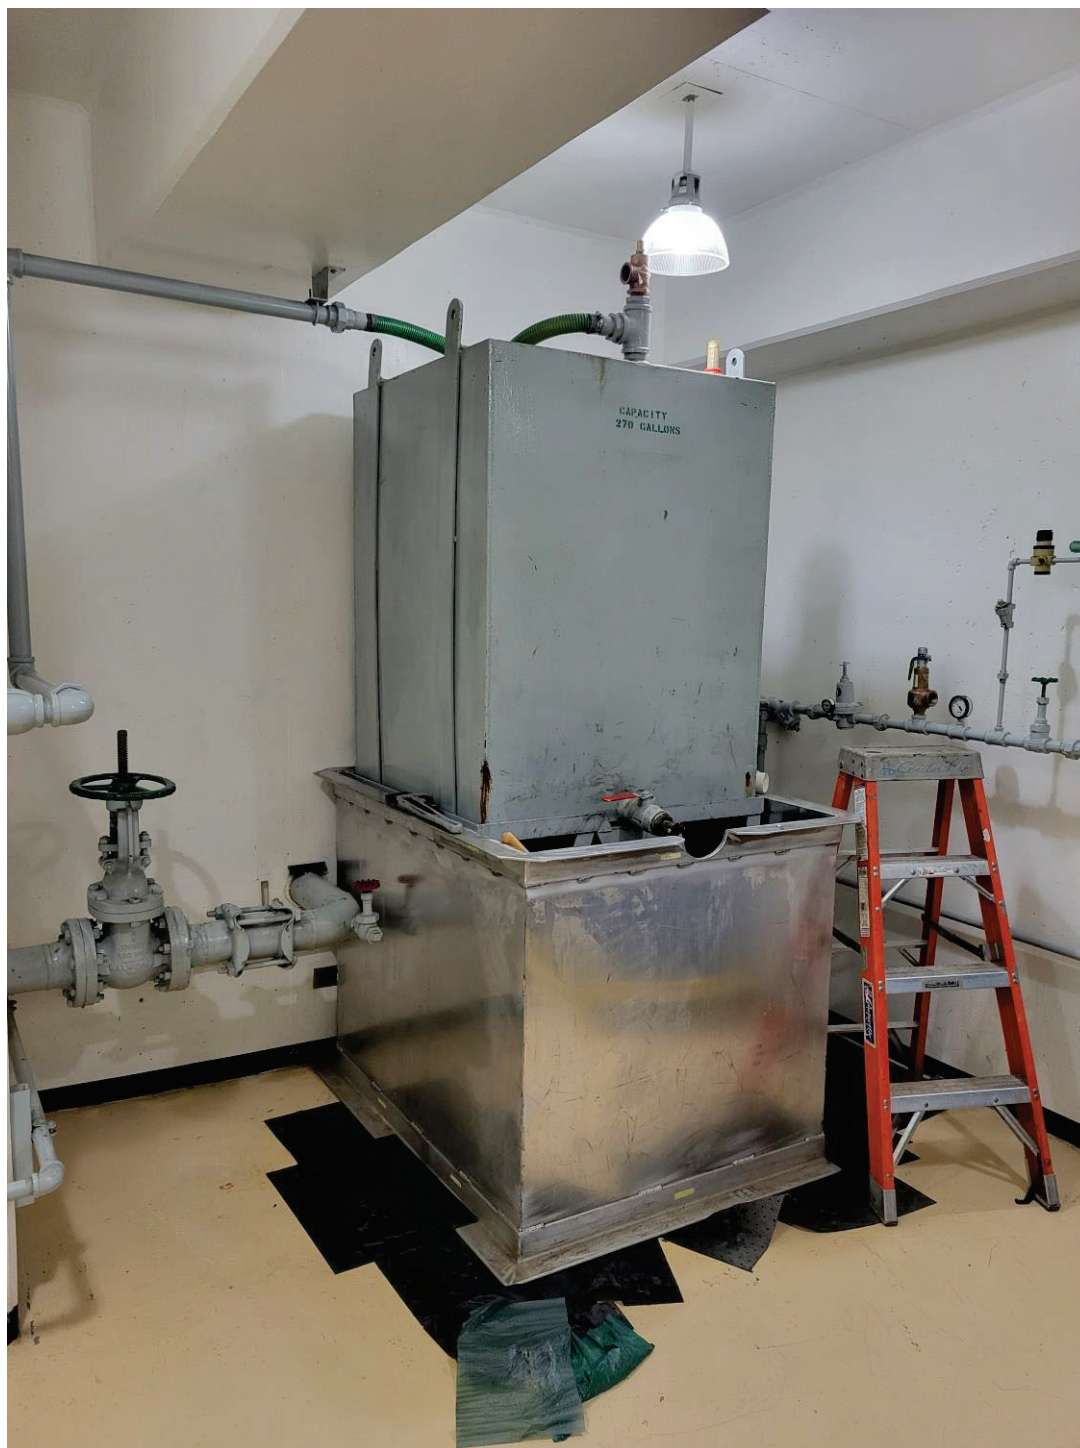
A tank located on a floor above the sump room was marked "Capacity 275 Gallons" and was described by Mr. Curtis as being used for collection of oil sludge and skimmed oil. See photo 22. The spent oil is transferred to the tank via piping from the sump after collection by the skimmer. It is later removed by connecting a flexible hose and pumping into 55-gallon drums, which are then transported to the hazardous waste storage building. Mr. Curtis stated that a second identical tank is located in sump room 101.

Photo 22: 20230921\_142610.jpg, 2:26 p.m. – photo of an oily sludge/skimings tank.

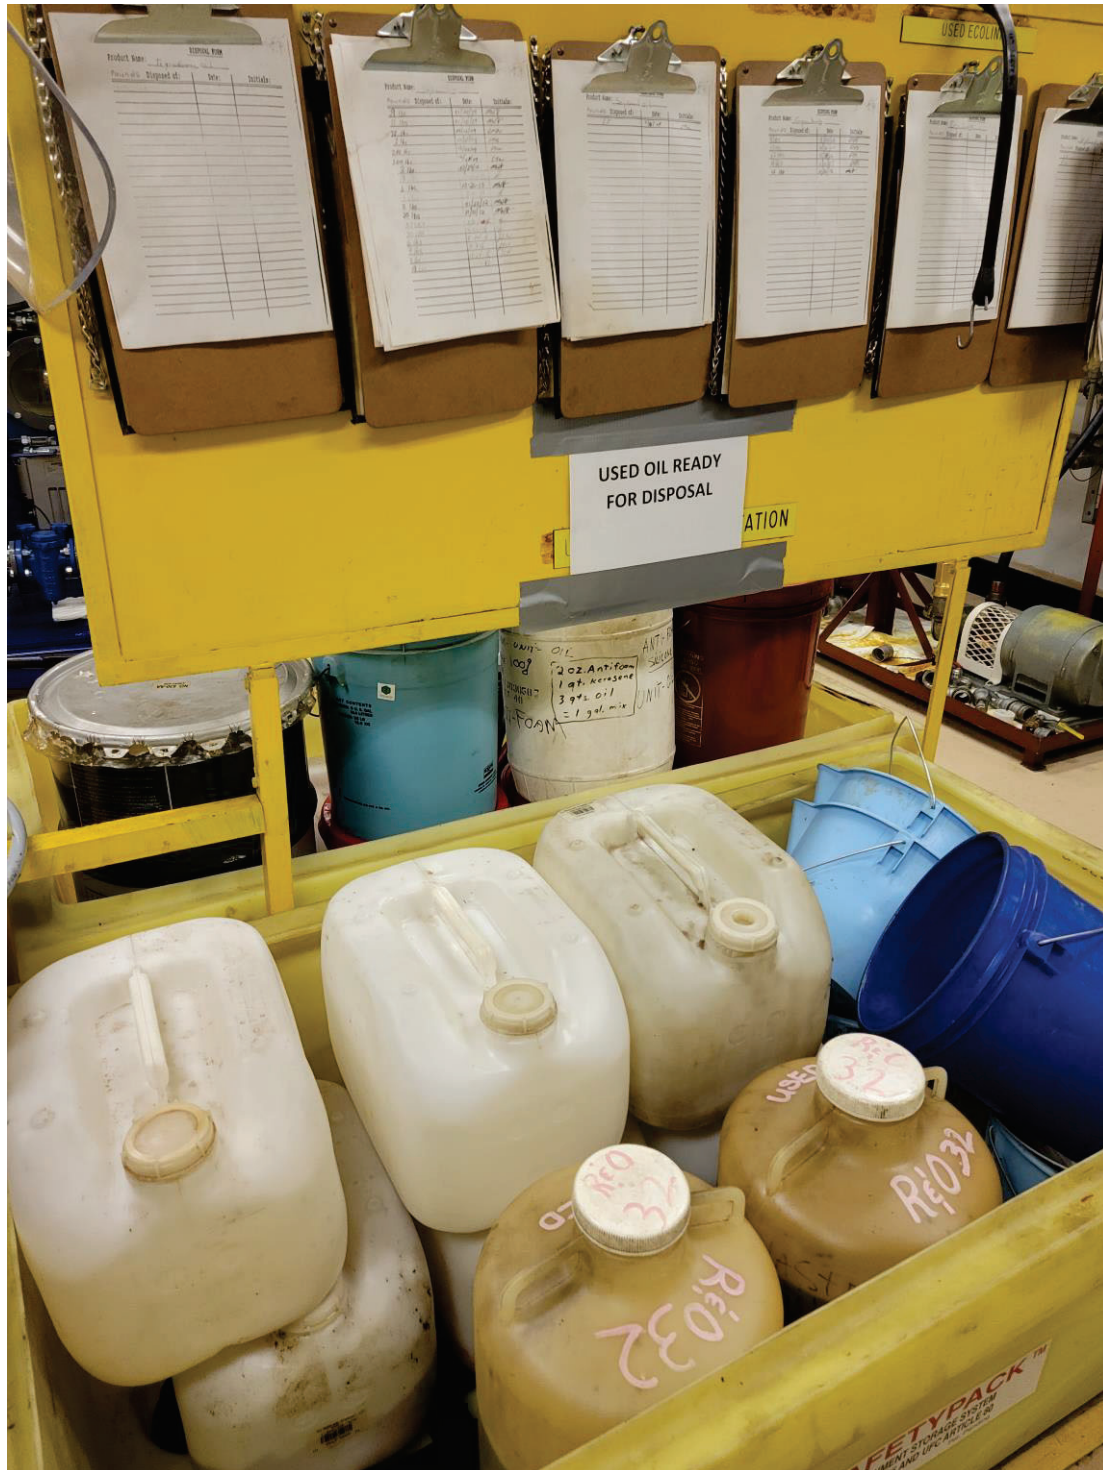
In the Oil Purifier Room, Mr. Curtis stated that turbine oil is filtered for reuse. Oil that meets quality specifications is reused, and that which cannot be reused is sent for disposal. I observed a storage bin marked "Used Oil Ready for Disposal" that held multiple small, approximately 5-gallon containers, some of which were marked with the words "Used Oil" and other markings. See photo 23.

Photo 23: 20230921\_143601.jpg, 2:36 p.m. – photo of a used oil storage bin inside the plant building
