**Report Title:** Clean Water Act, Section 404 Inspection Report for Susquehanna Union Green

**Inspection Date(s):** 05/23/2024

**Site Name:** Susquehanna Union Green

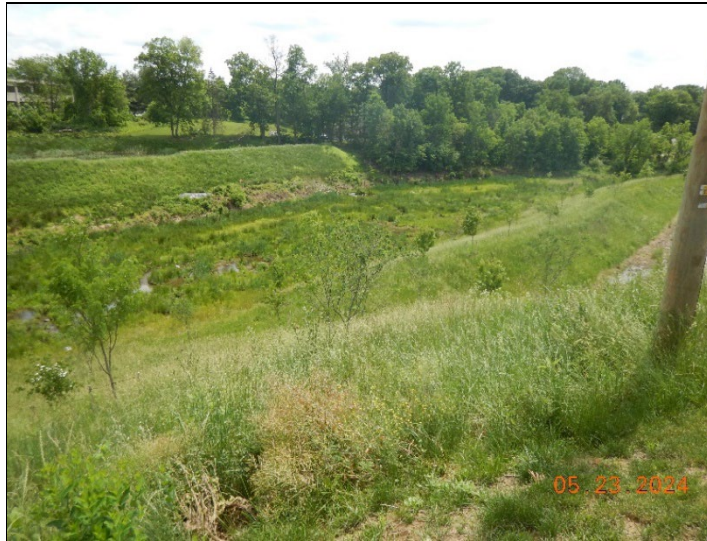
Susquehanna Union Green  
Date: 23 May 2024  
Photo ID: DSCN5396.JPG  
Photo taken by: Katelyn Almeter

Notes: Downstream view of Black Run Creek and surrounding areas.

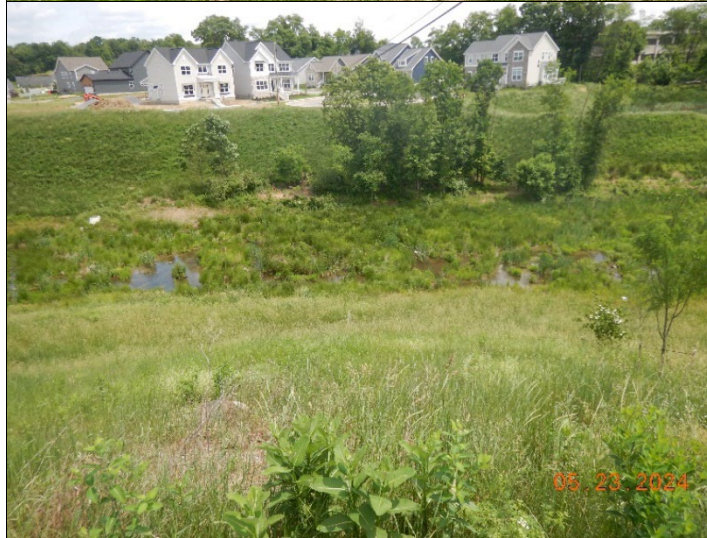
Susquehanna Union Green  
Date: 23 May 2024  
Photo ID: DSCN5397.JPG  
Photo taken by: Katelyn Almeter

Notes: South facing view of a cross section of Black Run Creek with residential development in the background.

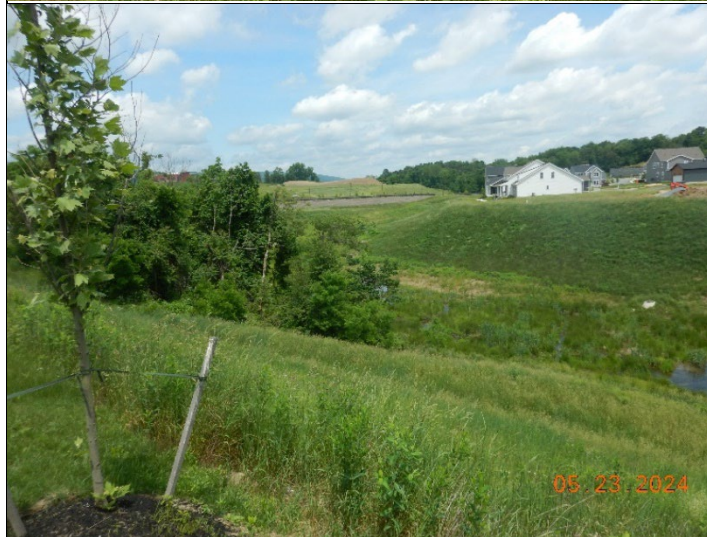
Susquehanna Union Green  
Date: 23 May 2024  
Photo ID: DSCN5398.JPG  
Photo taken by: Katelyn Almeter

Notes: Looking upstream of Black Run Creek with graded slopes with vegetation.

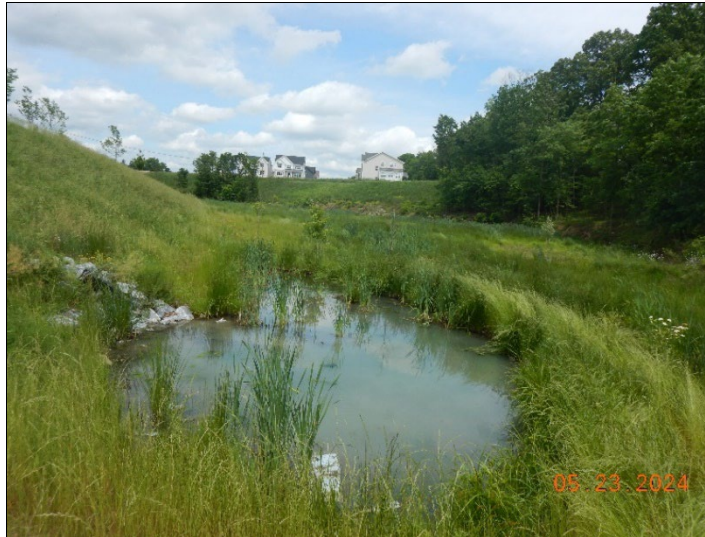
Susquehanna Union Green  
Date: 23 May 2024  
Photo ID: DSCN5399.JPG  
Photo taken by: Katelyn Almeter

Following opening conference, the inspection walkthrough began at the downstream end of Black Run near where the creek flows under Progress Road (DSCN5401). A stormwater retention pond was observed near the toe of the slope on the right side of the creek (DSCN5399) that appears to be capturing stormwater runoff from the top of the slope, and a tributary was observed flowing into Black Run on the left side of the creek near the culvert. Generally, the floodplain was densely vegetated with herbaceous vegetation including multiple species of sedges (*Carex sp.*), arrowhead (*Sagittaria latifolia*), soft rush (*Juncus effusus*), and sensitive fern (*Onoclea sensibilis*) (DSCN5403 and DSCN5404). The vegetation was observed to be sparse in some locations where vegetative coverage was less than 70% (DSCN5406, DSCN5413, DSCN5415, and DSCN5416). Planted woody vegetation was also noted along the banks of the stream. The planted woody stems were observed to have a high rate of survivability.

Notes: A stormwater retention pond located at the toe of the slope that leads to Black Run Creek.

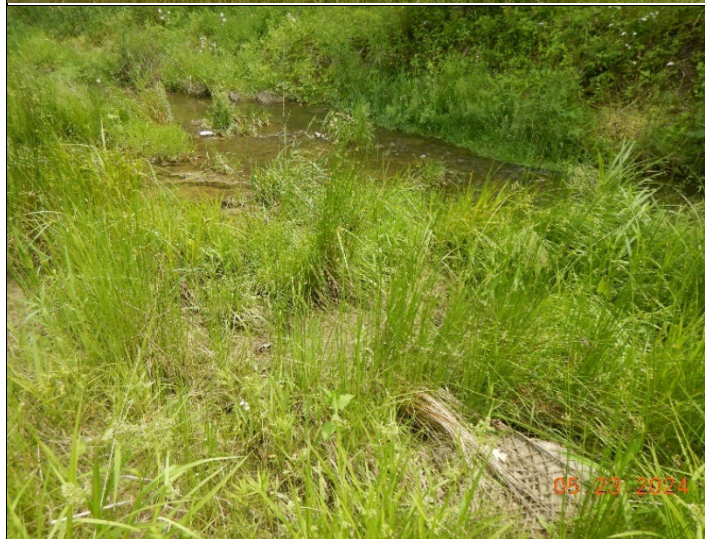
Susquehanna Union Green  
Date: 23 May 2024  
Photo ID: DSCN5400.JPG  
Photo taken by: Katelyn Almeter

Notes: View facing upstream of Black Run Creek. Note the exposed matting in the foreground.

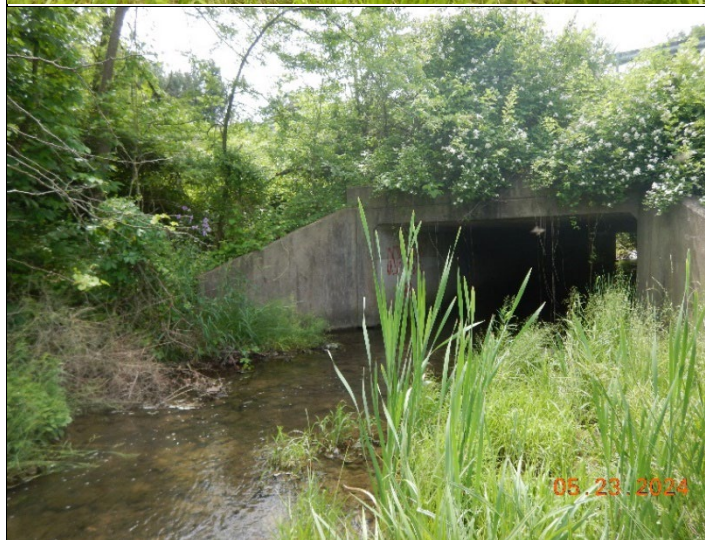
Susquehanna Union Green  
Date: 23 May 2024  
Photo ID: DSCN5401.JPG  
Photo taken by: Katelyn Almeter

Notes: Downstream view of Black Run Creek flowing into the culvert at the boundary of the site.

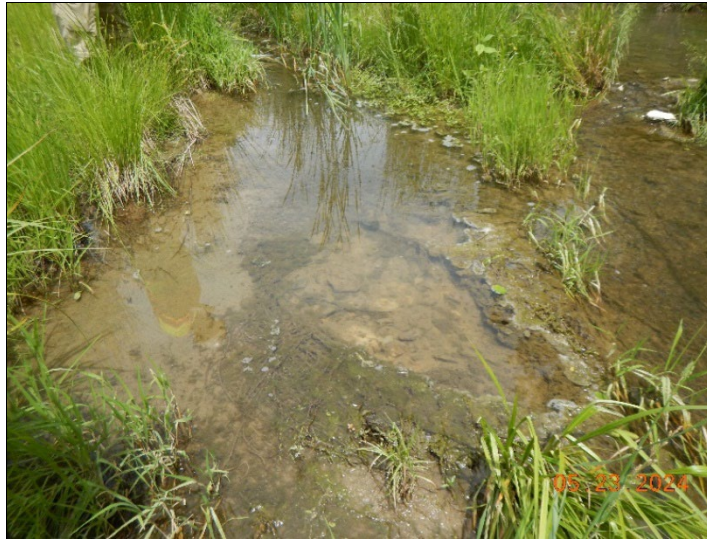
Susquehanna Union Green  
Date: 23 May 2024  
Photo ID: DSCN5402.JPG  
Photo taken by: Katelyn Almeter

The inspection moved upstream where tadpoles were observed, and exposed matting with filamentous algae attached was observed in stream bed (DSCN5402). Farther upstream, the inspection team noted several wetland areas throughout the floodplain, including areas of ponded surface water that were connected to Black Run via surface water flow pathways (DSCN5416). The inspectors conducted a soil boring at 40.3241667, -76.8569444 and observed the soil profile as 0 to 6 inches (DSCN5405) with a matrix that was characterized as 5Y 5/1 with 20% 5YR 5/8 redoximorphic features. The soils met the hydric soil indicator of **F3: depleted matrix**. Soils were saturated with a high water table present. Manganese deposits were also observed in the soil profile. Herbaceous vegetation observed in this area included rice cutgrass (*Leersia oryzoides*), spike rush (*Eleocharis palustris*), broadleaf cattail (*Typha latifolia*), and iris (*Iris versicolor*).

Notes: Exposed matting with filamentous algae in the stream bed.

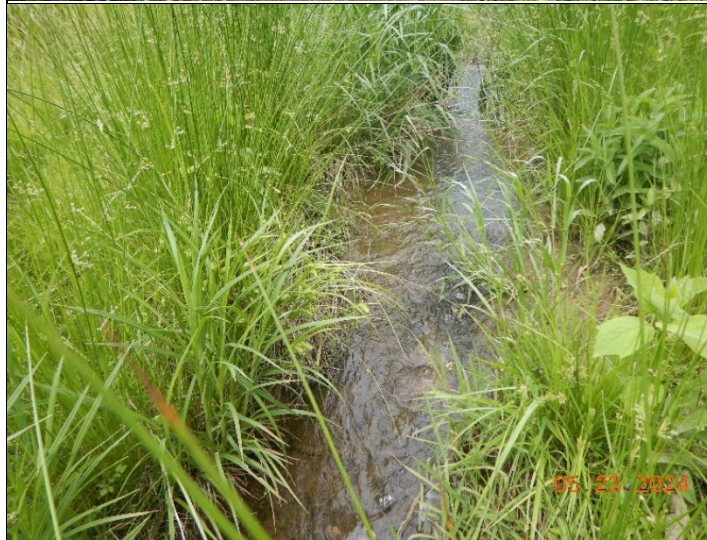
Susquehanna Union Green  
Date: 23 May 2024  
Photo ID: DSCN5403.JPG  
Photo taken by: Katelyn Almeter

Notes: Black Run Creek with herbaceous vegetation along the stream banks.

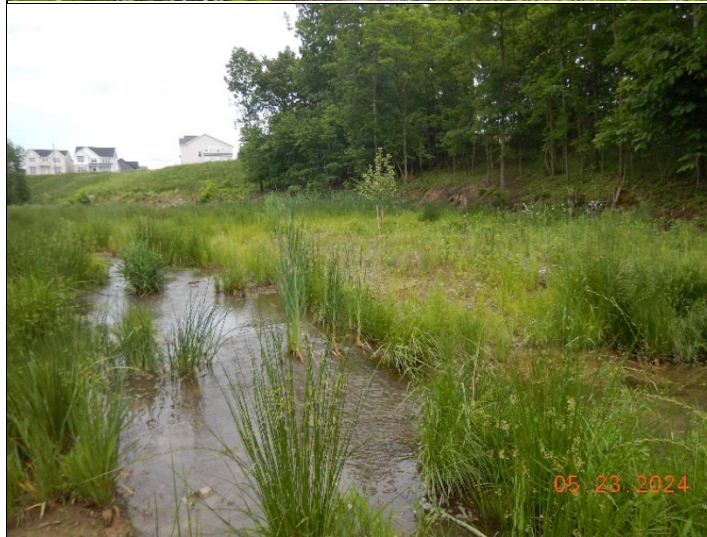
Susquehanna Union Green  
Date: 23 May 2024  
Photo ID: DSCN5404.JPG  
Photo taken by: Katelyn Almeter

Notes: View facing upstream of Black Run Creek with vegetated floodplains. Note the presence of planted woody vegetation.

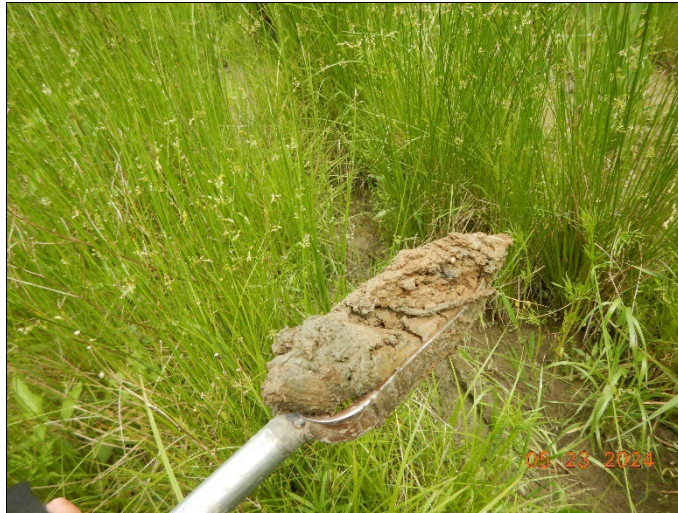
Susquehanna Union Green  
Date: 23 May 2024  
Photo ID: DSCN5405.JPG  
Photo taken by: Katelyn Almeter

Notes: Soil boring with a depleted matrix.

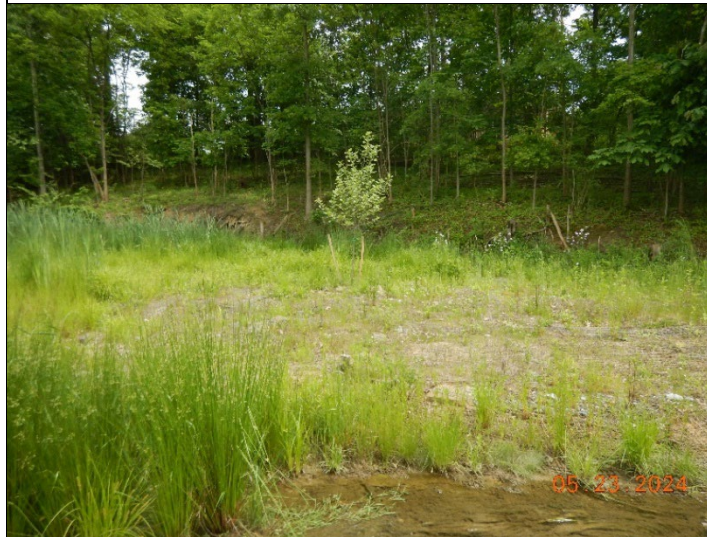
Susquehanna Union Green  
Date: 23 May 2024  
Photo ID: DSCN5406.JPG  
Photo taken by: Katelyn Almeter

The inspection continued upstream, most of the restored area was densely vegetated with herbaceous vegetation (DSCN5408, DSCN5411, DSCN5412, DSCN5414, DSCN5421, and DSCN5422), with some sparsely vegetated areas observed along the stream banks with exposed matting

Notes: An area of the floodplain lacking vegetation.

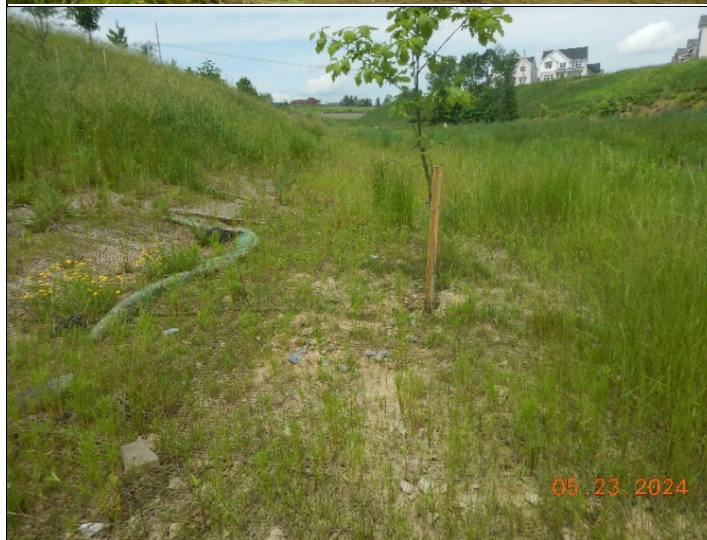
Susquehanna Union Green  
Date: 23 May 2024  
Photo ID: DSCN5407.JPG  
Photo taken by: Katelyn Almeter

(DSCN5406, DSCN5409). Silt socks were also observed along the slopes on either side of Black Run (DSCN5407 and DSCN5420). The inspection team noted that the streambed appeared to be primarily composed of fine-grained silts and sands (DSCN5418). Moving upstream, the inspectors observed constructed in-stream features, including constructed log vanes and pool features (DSCN5419). These constructed in-stream features appeared to be function as designed.

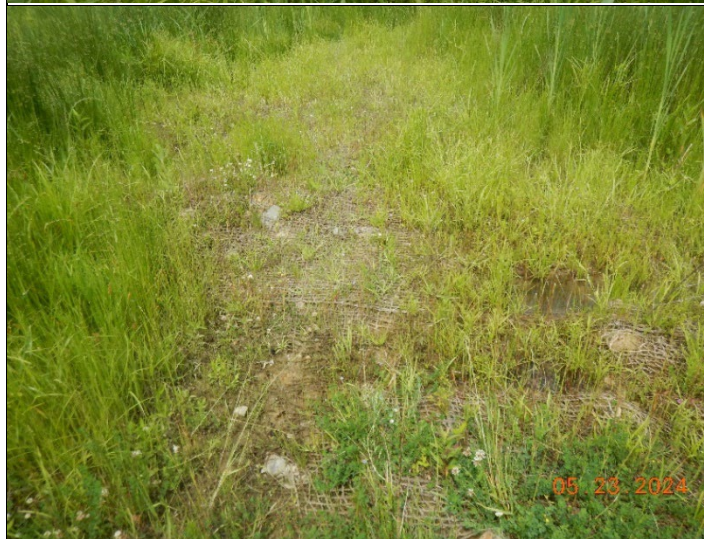
Susquehanna Union Green  
Date: 23 May 2024  
Photo ID: DSCN5409.JPG  
Photo taken by: Katelyn Almeter

Notes: Another area of the floodplain with exposed matting and little vegetation.

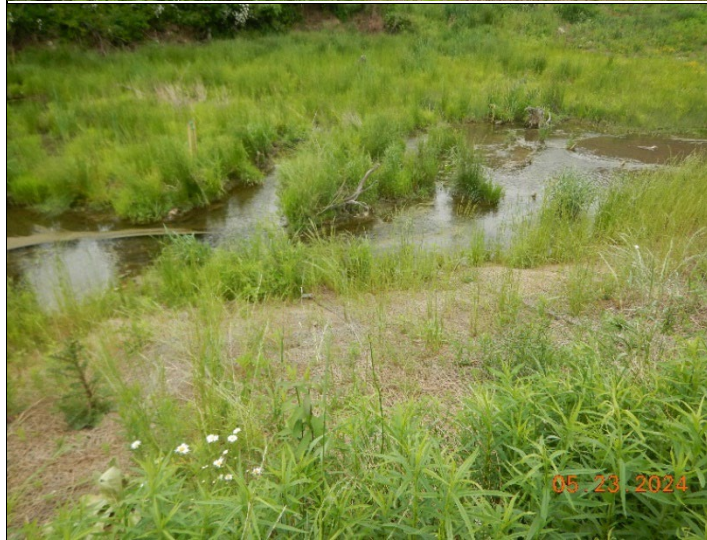
Susquehanna Union Green  
Date: 23 May 2024  
Photo ID: DSCN5415.JPG  
Photo taken by: Katelyn Almeter

Notes: Black Run Creek with densely vegetated area in the background and sparsely vegetated area in the foreground.

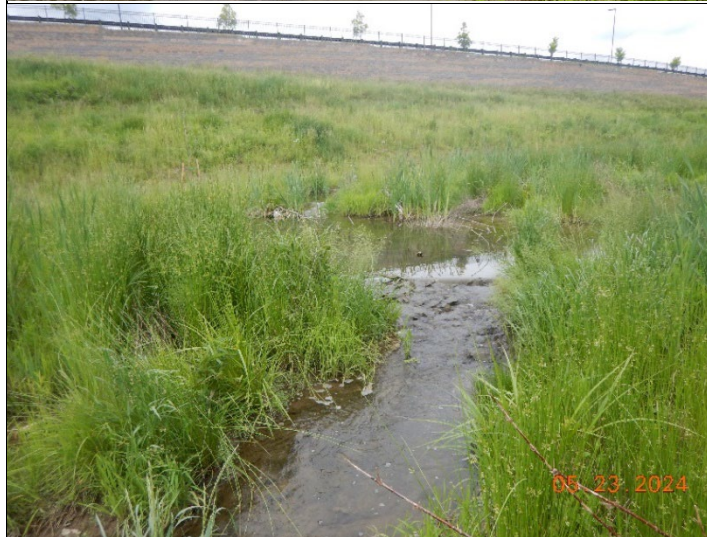
Susquehanna Union Green  
Date: 23 May 2024  
Photo ID: DSCN5419.JPG  
Photo taken by: Katelyn Almeter

Notes: Pool and glide stream features observed in Black Run Creek.

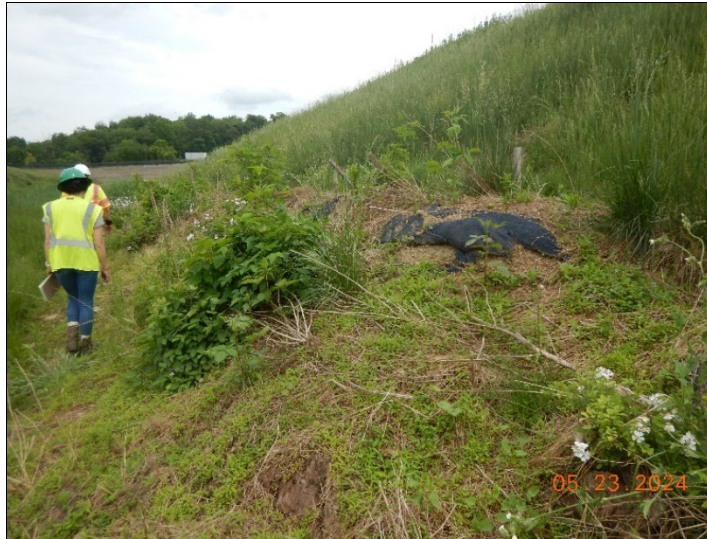
Susquehanna Union Green  
Date: 23 May 2024  
Photo ID: DSCN5420.JPG  
Photo taken by: Katelyn Almeter

Notes: Silt sock observed part way up the slope.

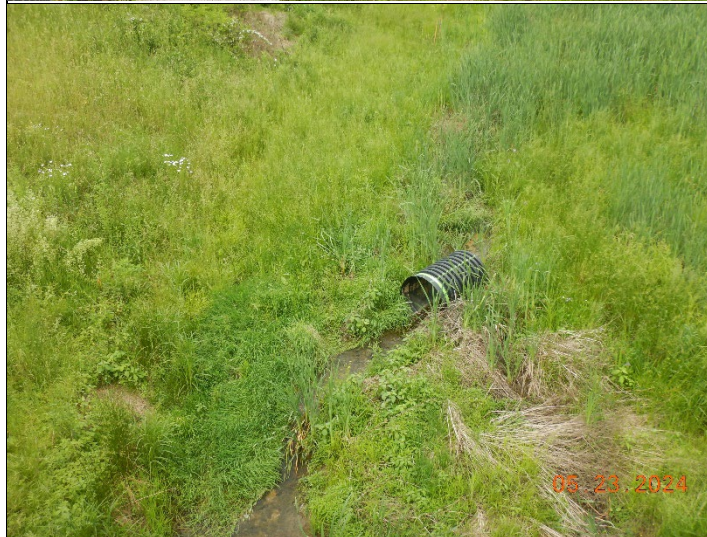
Susquehanna Union Green  
Date: 23 May 2024  
Photo ID: DSCN5428.JPG  
Photo taken by: Katelyn Almeter

The inspection moved upstream where Black Run flows through a culvert under Hawthorne Drive (DSCN5423). Two overflow pipes were observed on either side of the culvert (DSCN5424), and the area was densely vegetated with broadleaf cattails (*Typha latifolia*), rice cutgrass (*Leersia oryzoides*), soft rush (*Juncus effusus*), soft-stem bulrush (*Scirpus validus*), and foxtail (*Alopecurus aequalis*). The inspectors moved up the slope on the left side of Black Run towards Hawthorne Dr and noted a retention basin near the toe of the slope (DSCN5424). The inspectors then noted that the Black Run floodplain upstream of the culvert was densely vegetated (DSCN5429) prior to flowing through the culvert under the road (DSCN5427 and DSCN5430). A portion of a black drainpipe was noted in the hillslope along the stream. It appeared that a portion of streamflow was being captured and transported through the pipe (DSCN5428).

Notes: A drainpipe observed within Black Run Creek. The stream was flowing through the drain.

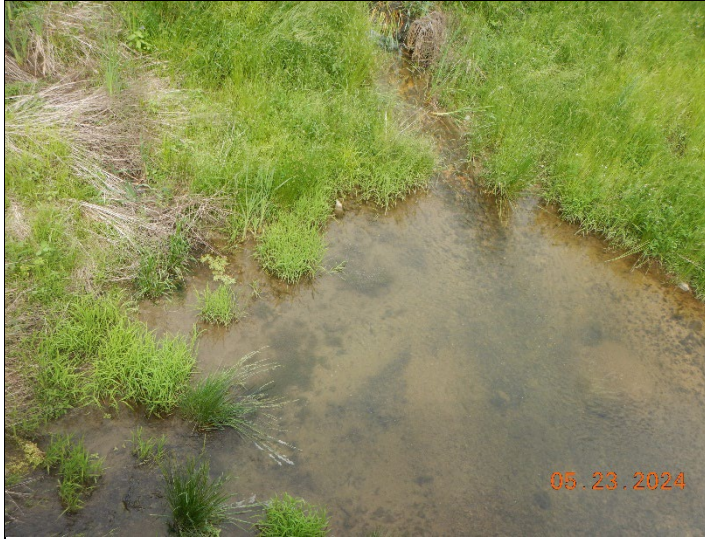
Photo ID: DSCN5430.JPG

Notes: View of the sediment stream bed  
as Black Run Creek enters the culvert.
