**Report Title:** Clean Air Act Inspection of Roger Auto Collision  
**Inspection Date(s):** December 6, 2023  
**Regulatory Program(s):** NESHAP, SIP

**Company Name:** Same as below  
**Facility Name:** Roger Auto Collision  
**Facility Location:** 1810 Edwin St. NE,  
Washington, DC 20018

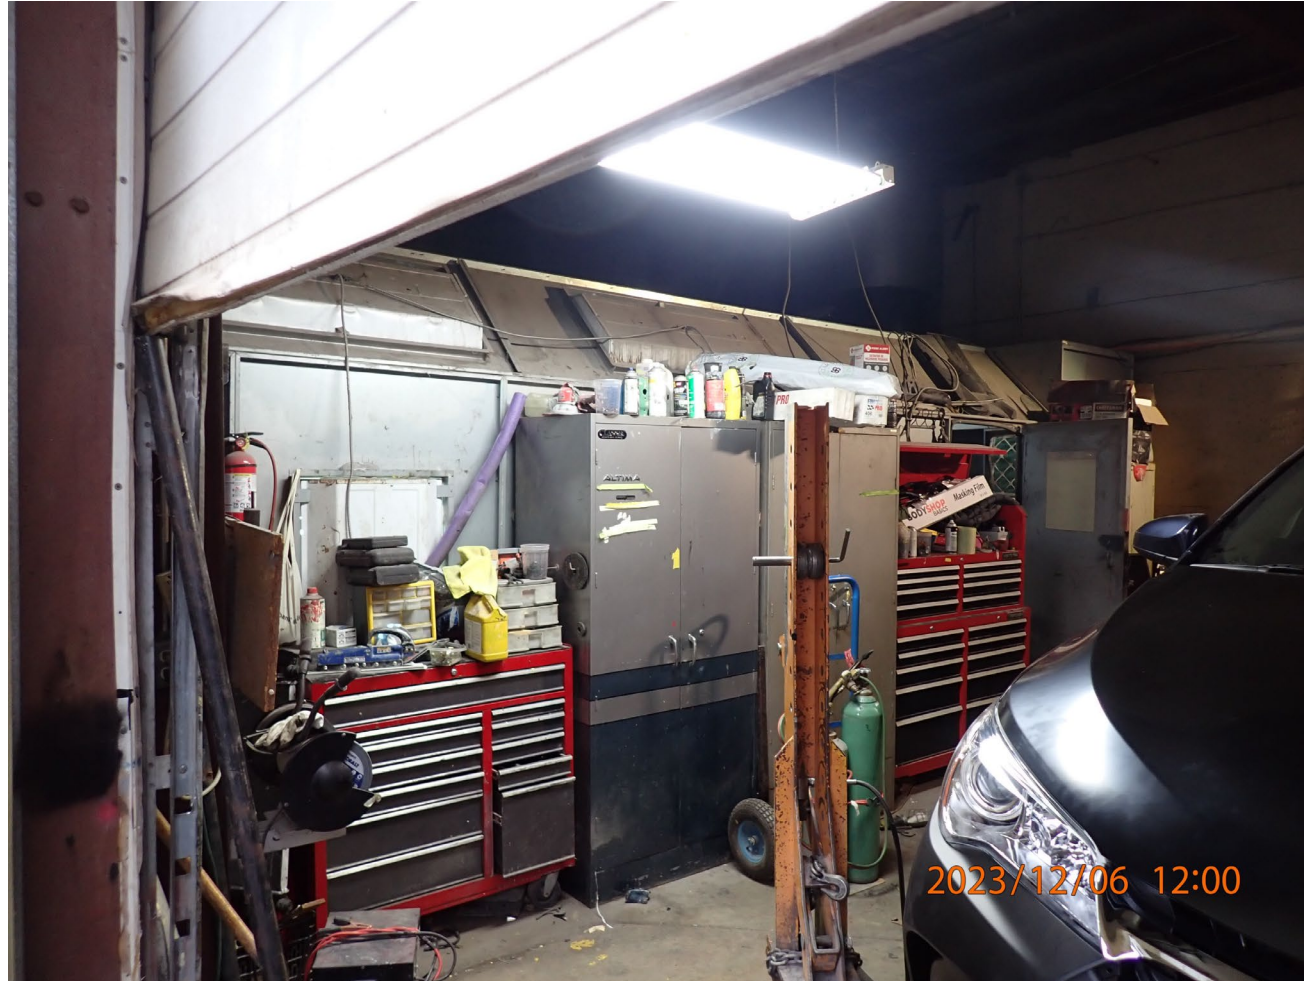
Photo Number: 73

Photo Description: Spray booth from right bay (bay #6)

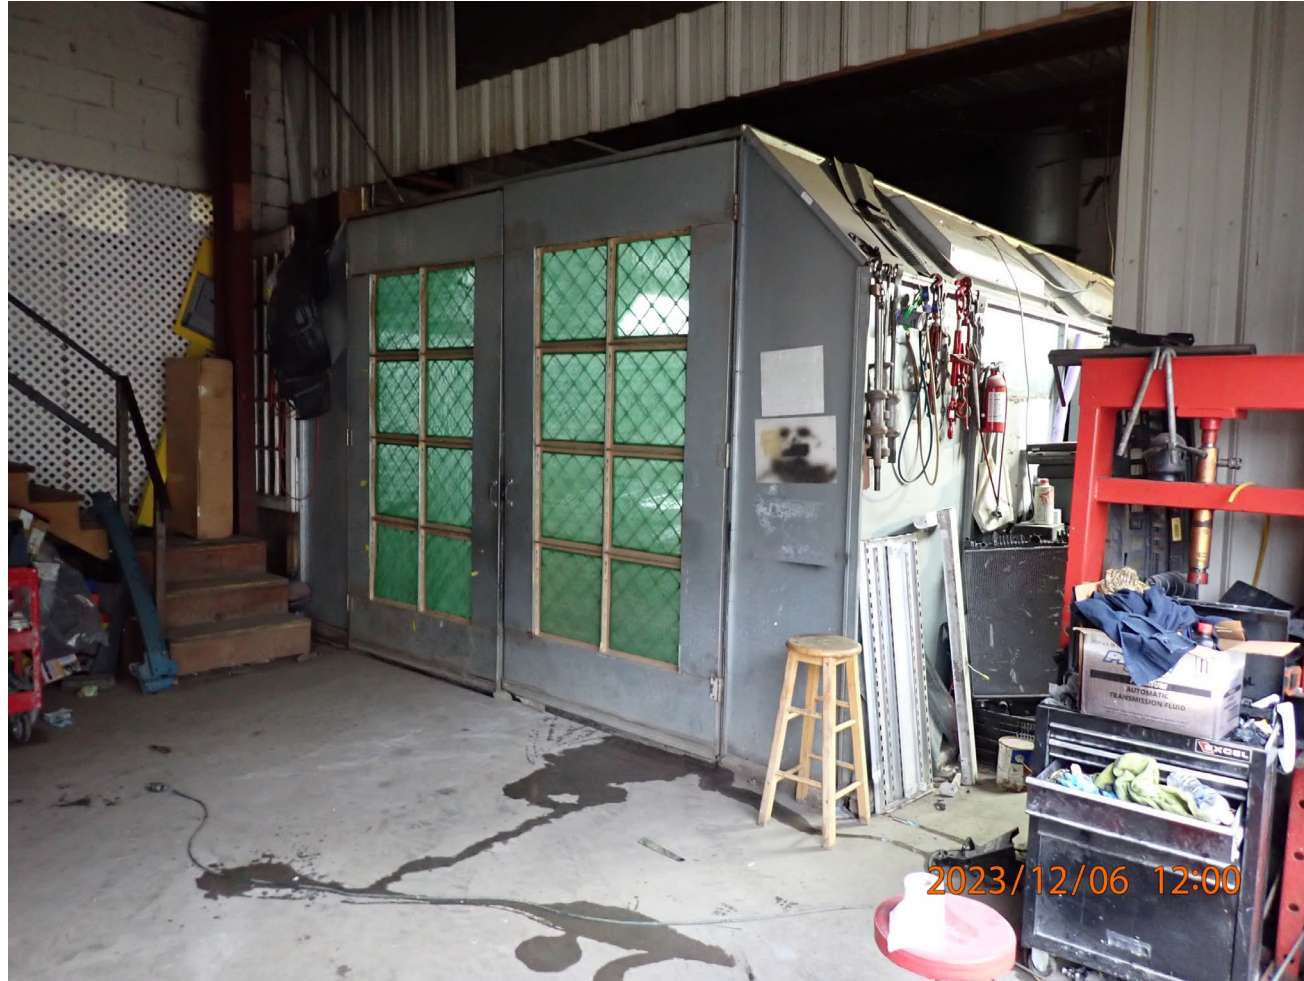
Photo Number: 74

Photo Description: Spray booth from left bay (bay #5)

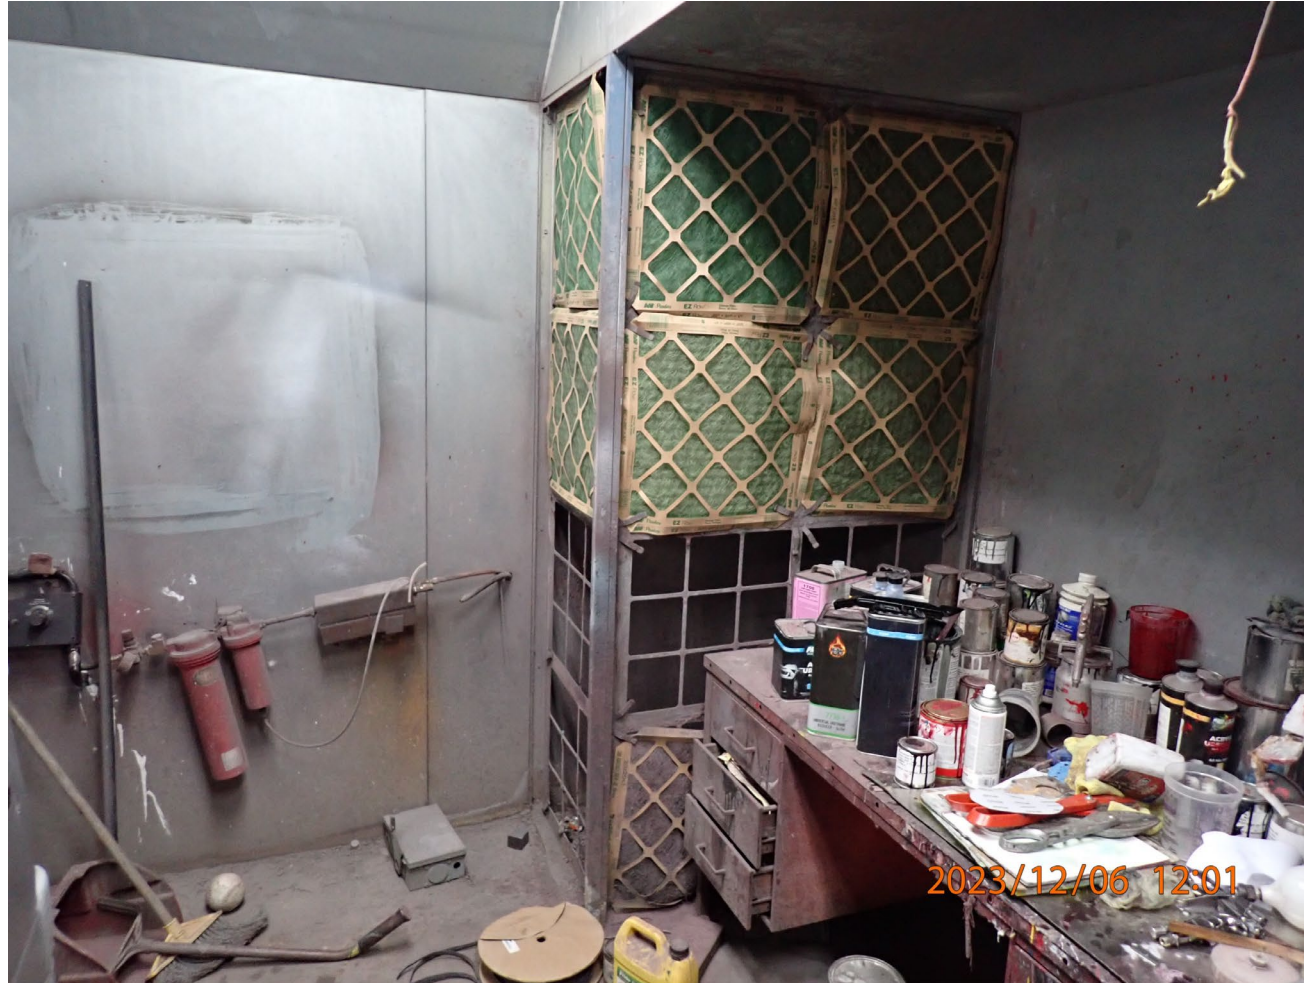
Photo Number: 75

Also located near the exhaust and opposite the paint booth vehicle doors was the paint storage area and an Anest Iwata WS400 Evo spray gun. There was a multitude of different paints and liquids located in this area of the spray booth. Roger stated these are nearly all leftover from the prior business owner. He stated the materials were left because the prior owner was evicted, which is how Roger was able to start his business at the location. Roger explained how other painters don't like the water-based paints, but he prefers to use them. Roger stated his business purchases the water-based paint line from Wandabase and showed the inspection team one of these cans. There were also Limco and R & M paint cans observed in this area.

Photo Description: Front left of spray booth with paint storage

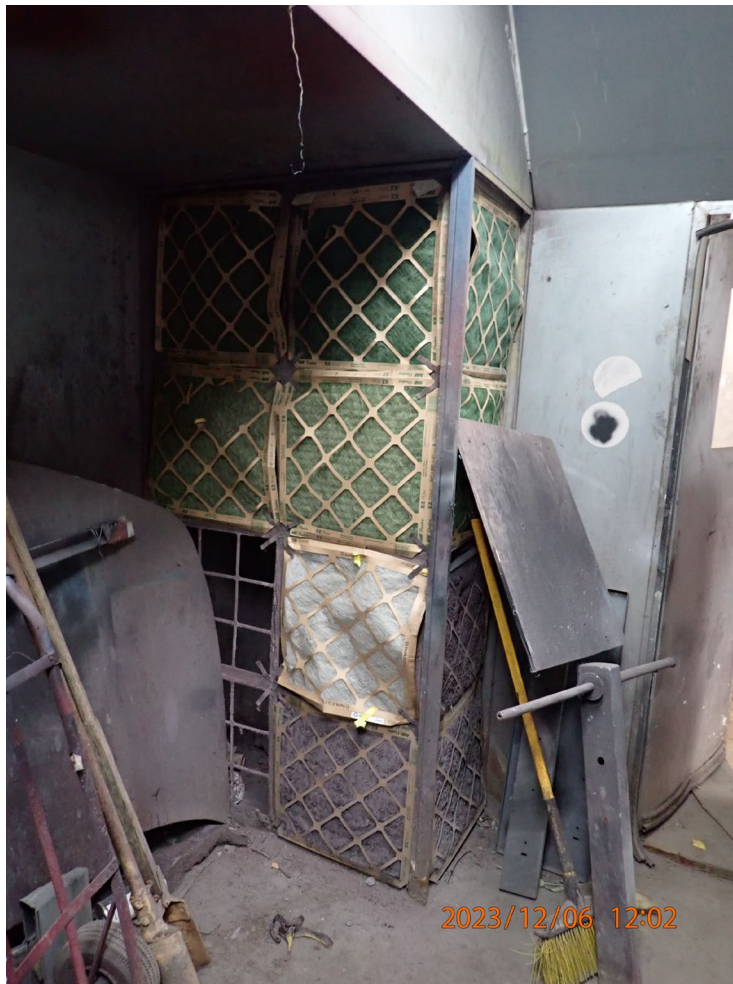
Photo Number: 76

Photo Description: Front right of spray booth

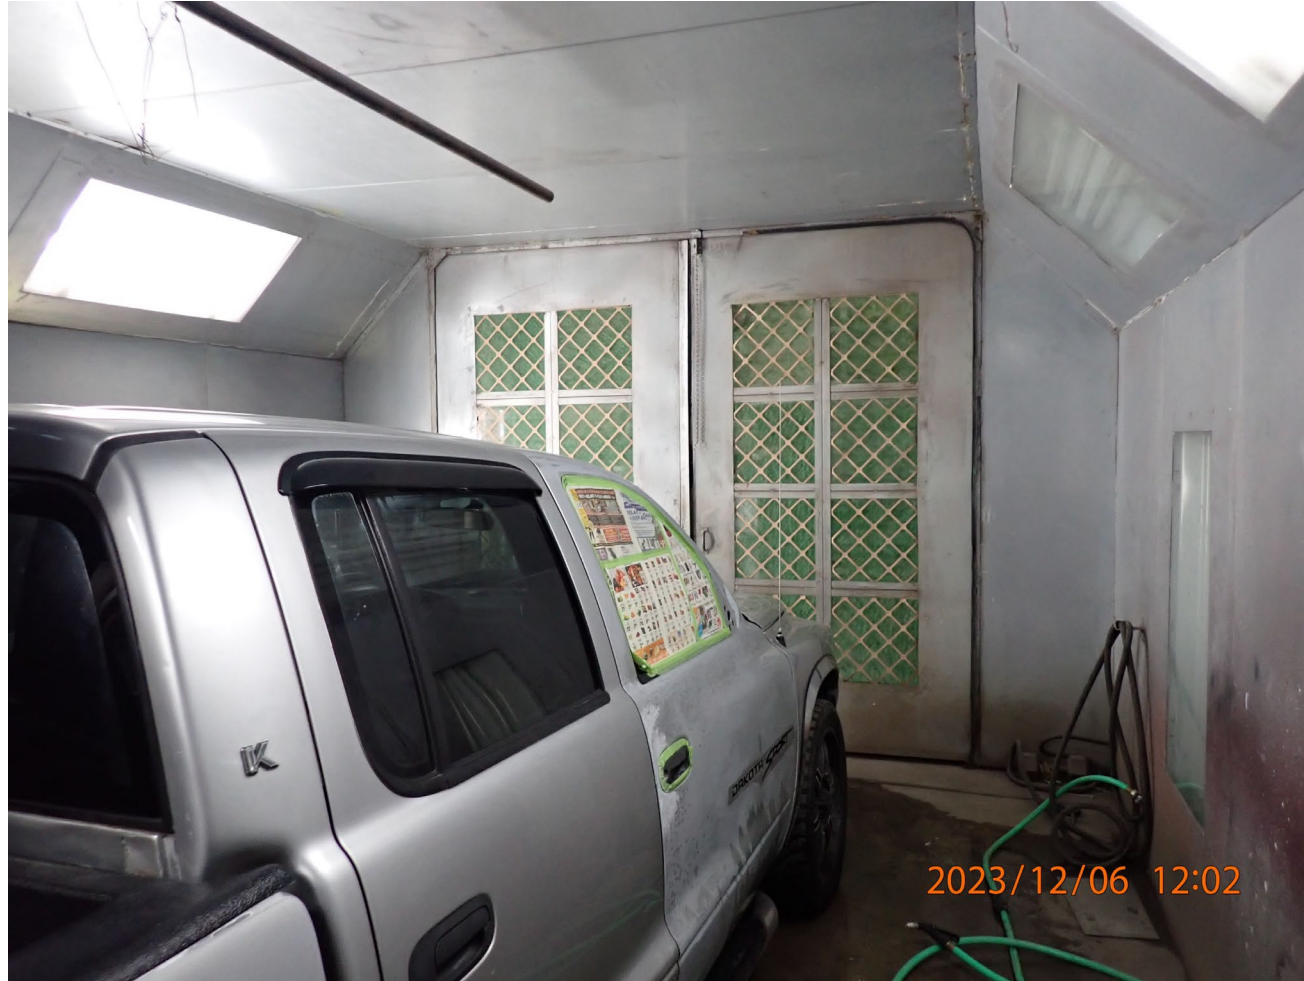
Photo Number: 77

Photo Description: Spray booth entry

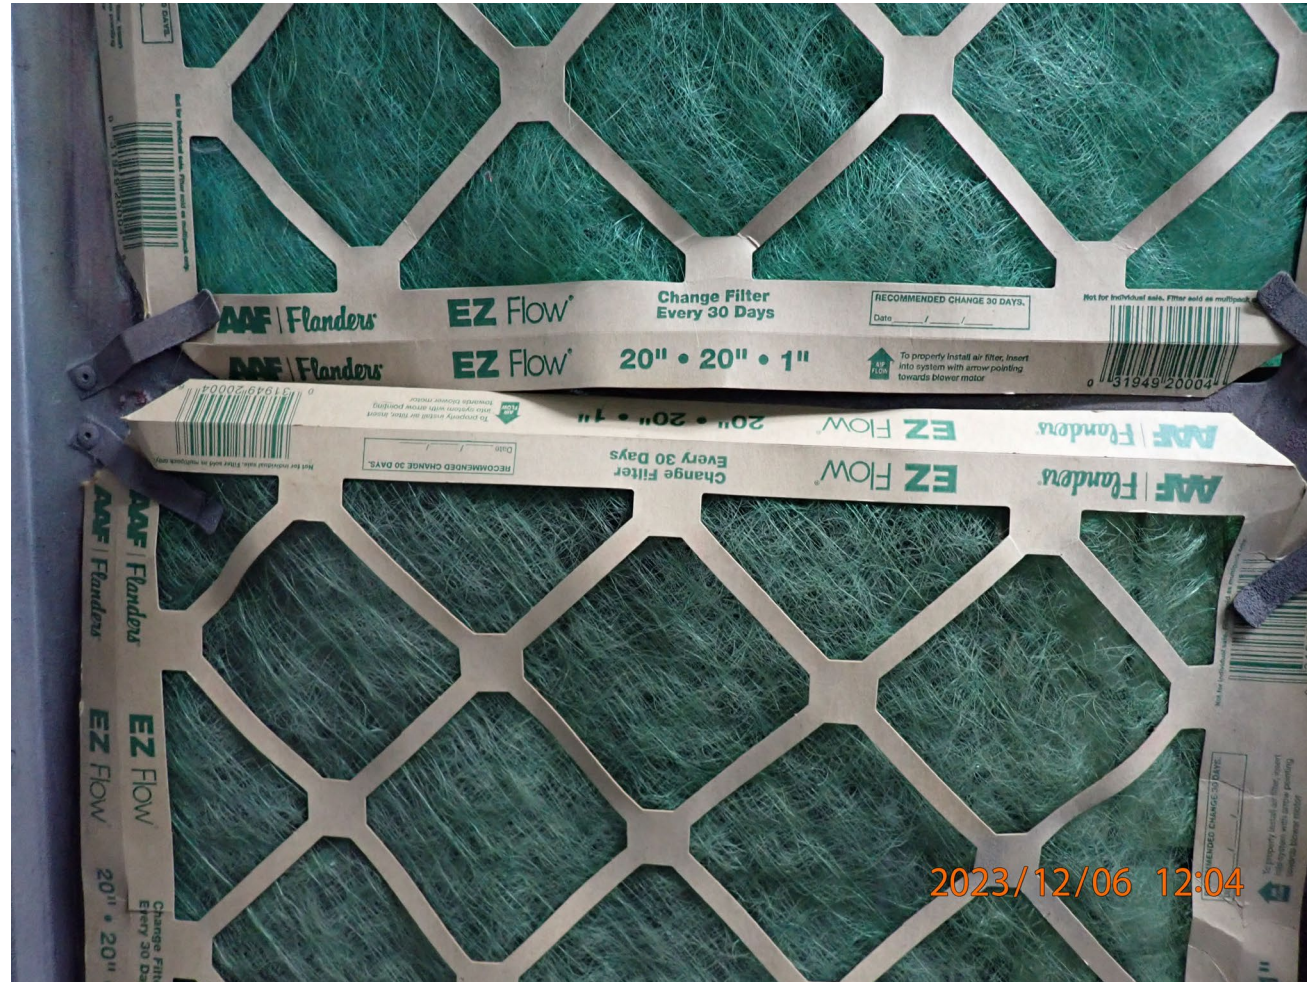
Photo Number: 78

The Facility consists of the two bays which includes a single spray booth. The main doors to the spray booth are in bay #5 but there is a pedestrian door from bay #6. The inspection team entered the spray booth and observed a truck inside the booth. The exhaust filters were located opposite the vehicle entry indicating a crossdraft spray booth. There were multiple exhaust locations which were missing exhaust filters. Some of the filters were heavily laden with dirt and dust which could potentially decrease airflow. The filters present in the booth during the inspection were AAF Flanders EZ Flow 20"x20"x1" filters with markings saying they should be changed every 30 days.

Photo Description: Spray booth filters

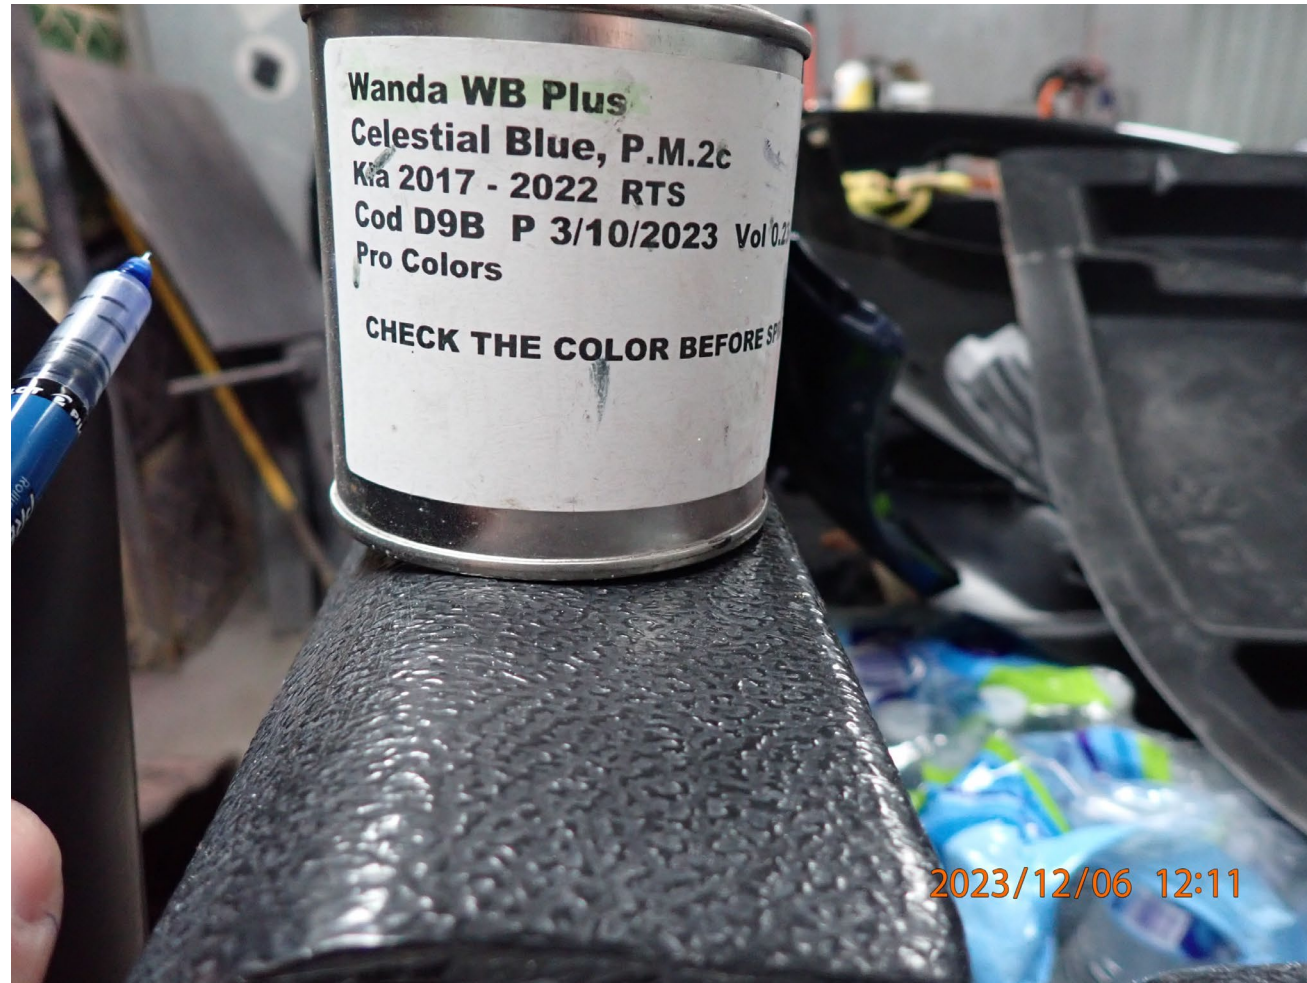
Photo Number: 79

Photo Description: Water-based paint can
