**Report Title:** Clean Air Act Inspection of Big Jones Auto Repairs  
**Inspection Date(s):** December 5, 2023  
**Regulatory Program(s):** NESHAP, SIP

**Company Name:** Same as below  
**Facility Name:** Big Jones Auto Repairs  
**Facility Location:** 1851 Adams St. NE,  
Washington, DC 20018

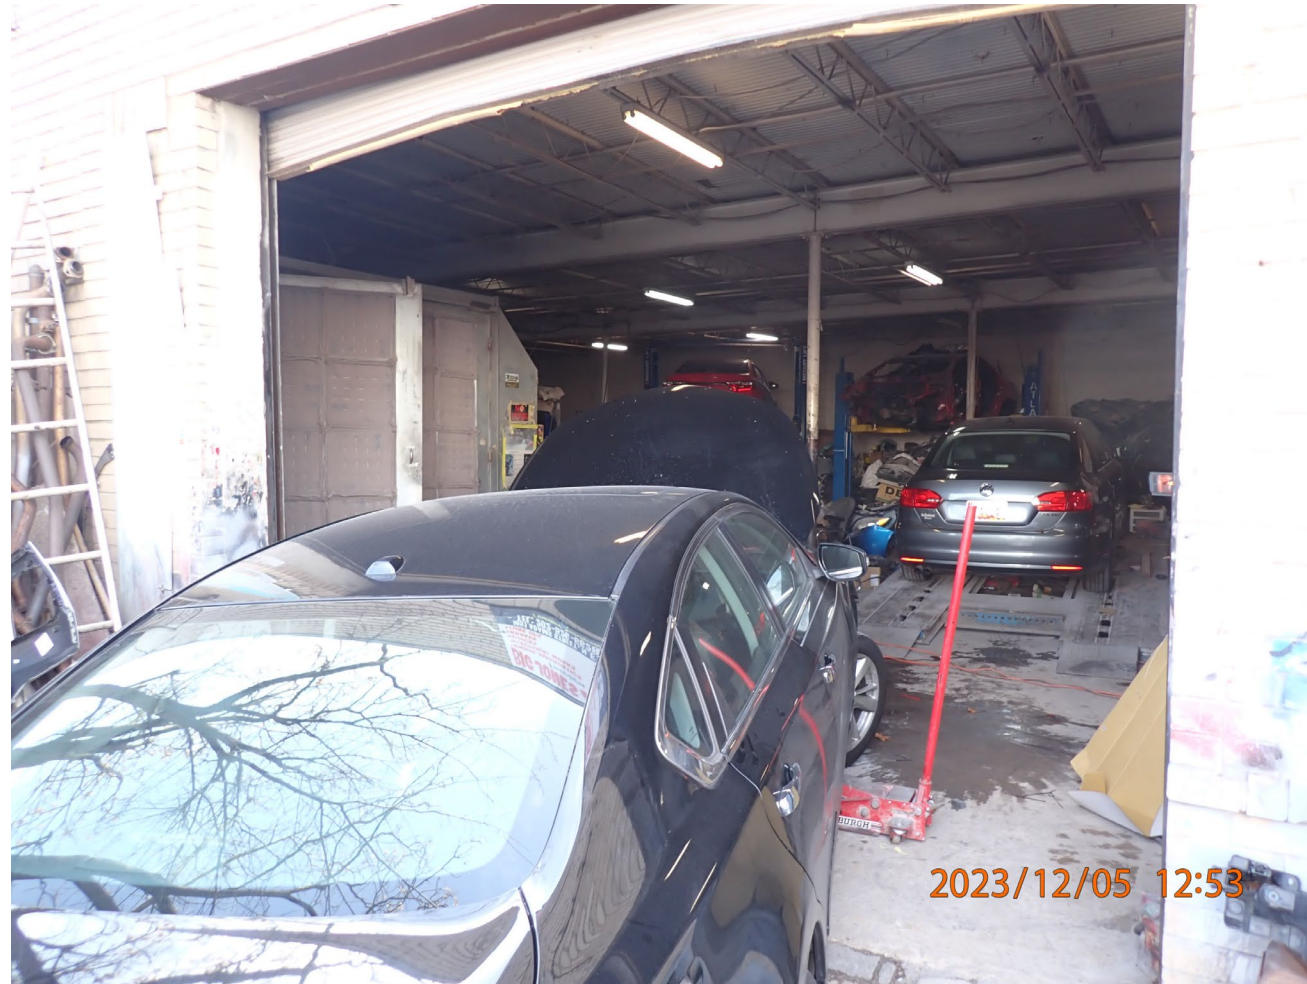
Photo Number: 34

Photo Description: Exterior of Big Jones Auto Repairs

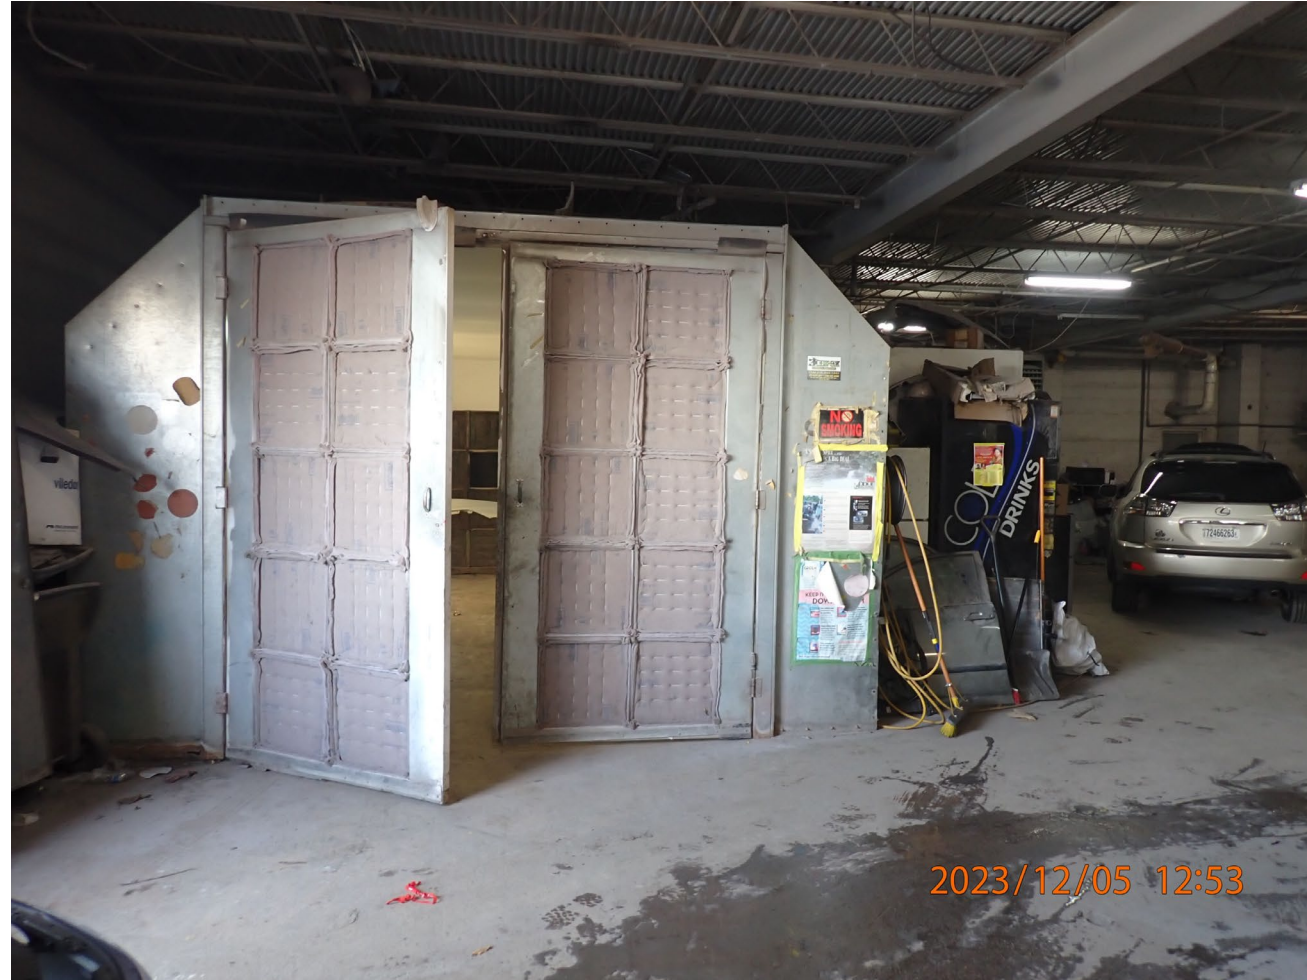
Photo Number: 35

Photo Description: Exterior of paint booth

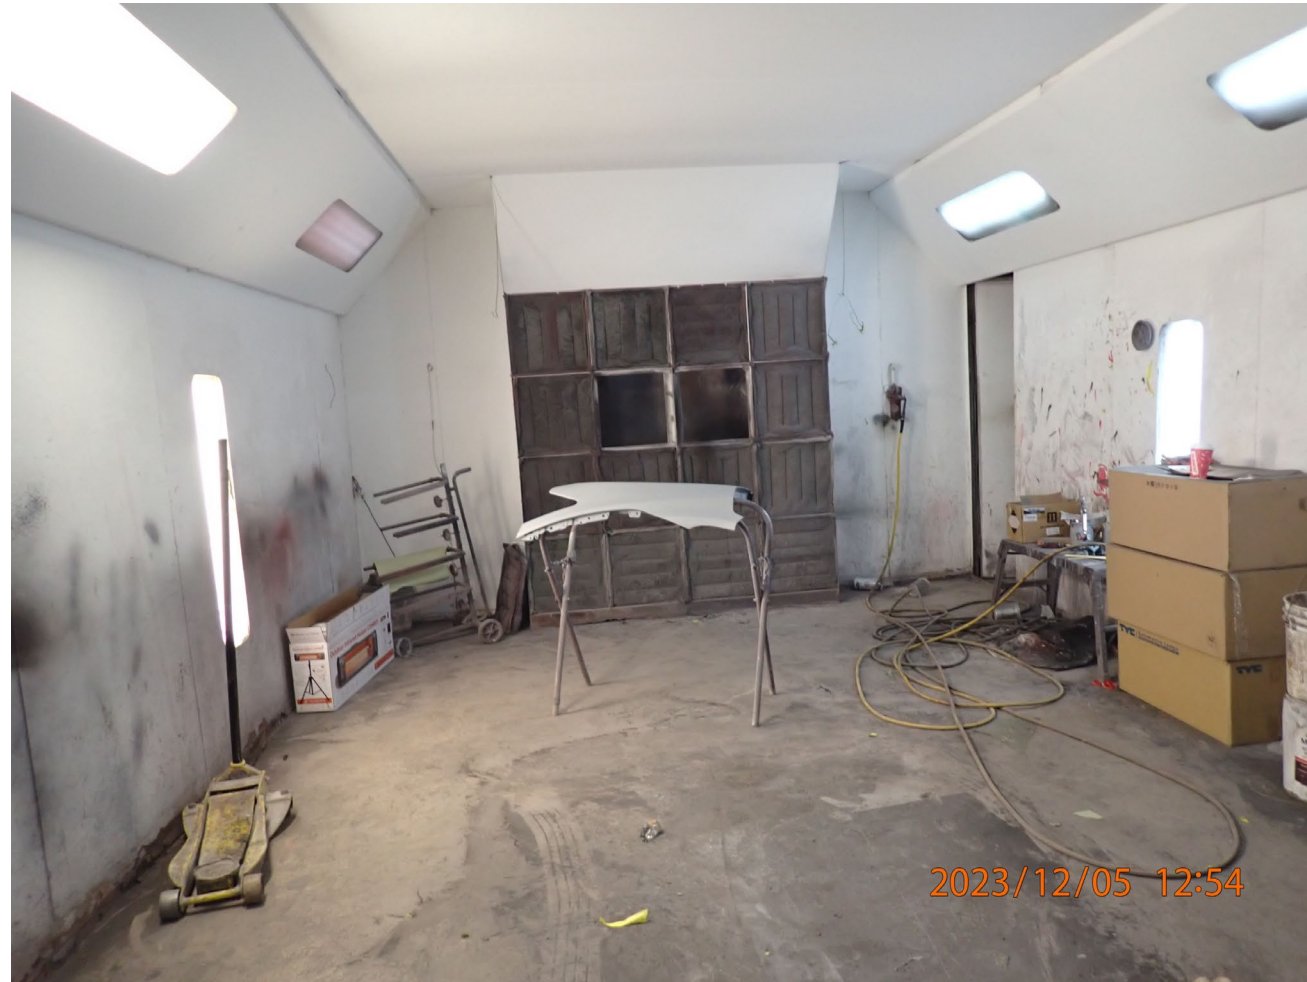
Photo Number: 36

During the inspection, there was a vehicle part located on a stand in the crossdraft paint booth. The team observed a stack inside the enclosed paint booth that vents to the atmosphere. Viledon Freudenberg air filters were located on the vehicle door to the paint booth. There was a small amount of odor observed in the paint booth indicating painting had recently occurred. There were two filter panels missing on the exhaust side of the paint booth and all exhaust filters looked to be heavily covered in dirt, dust, or paint overspray which could hinder airflow. Jones stated the filters are changed every couple of months.

The inspection team then asked the Facility to turn on the spray booth to see how the air flows through the booth. Air was being drawn into the spray booth at the vehicle doors, but there was minimal power drawing air out through the exhaust.

- During the inspection, the spray booth demonstrated that it was ventilated at a negative pressure by drawing air into the spray booth but did not demonstrate that all air was exhausting the booth through the filters.

Photo Description: Interior of paint booth

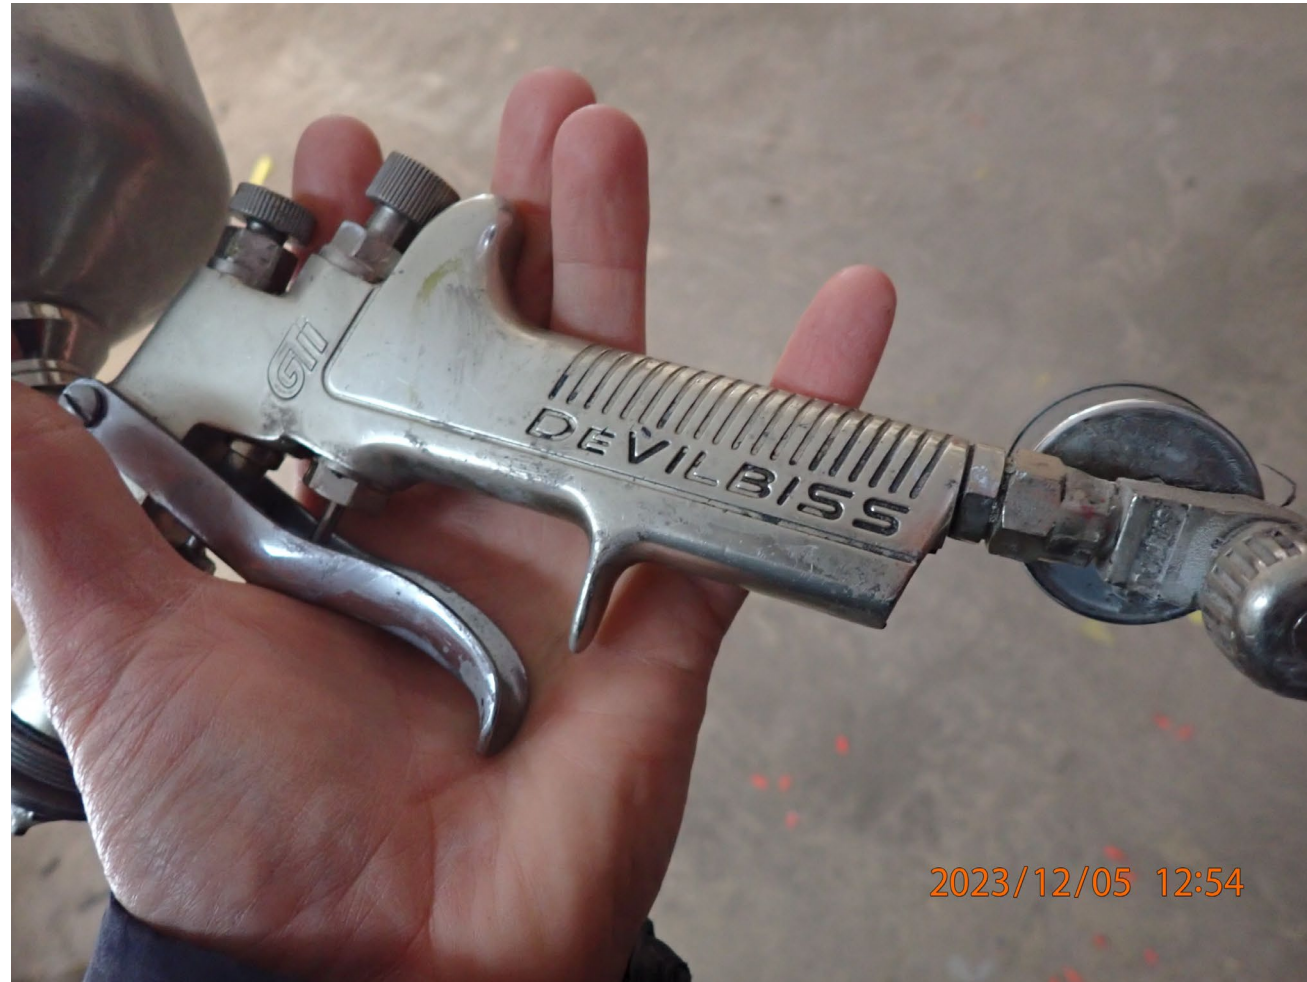
Photo Number: 37

There were three spray paint guns were observed at the Facility: Devilbiss GTi; Binks 2001; and Devilbiss DV1. The Facility said they used to use HVLP spray guns but didn't like them.

- EPA will review the paint spray guns observed at the Facility to determine if all spray guns are high volume low pressure (HVLP), electrostatic application, airless, air-assisted airless, or an equivalent technology.

Photo Description: Devilbiss spray gun

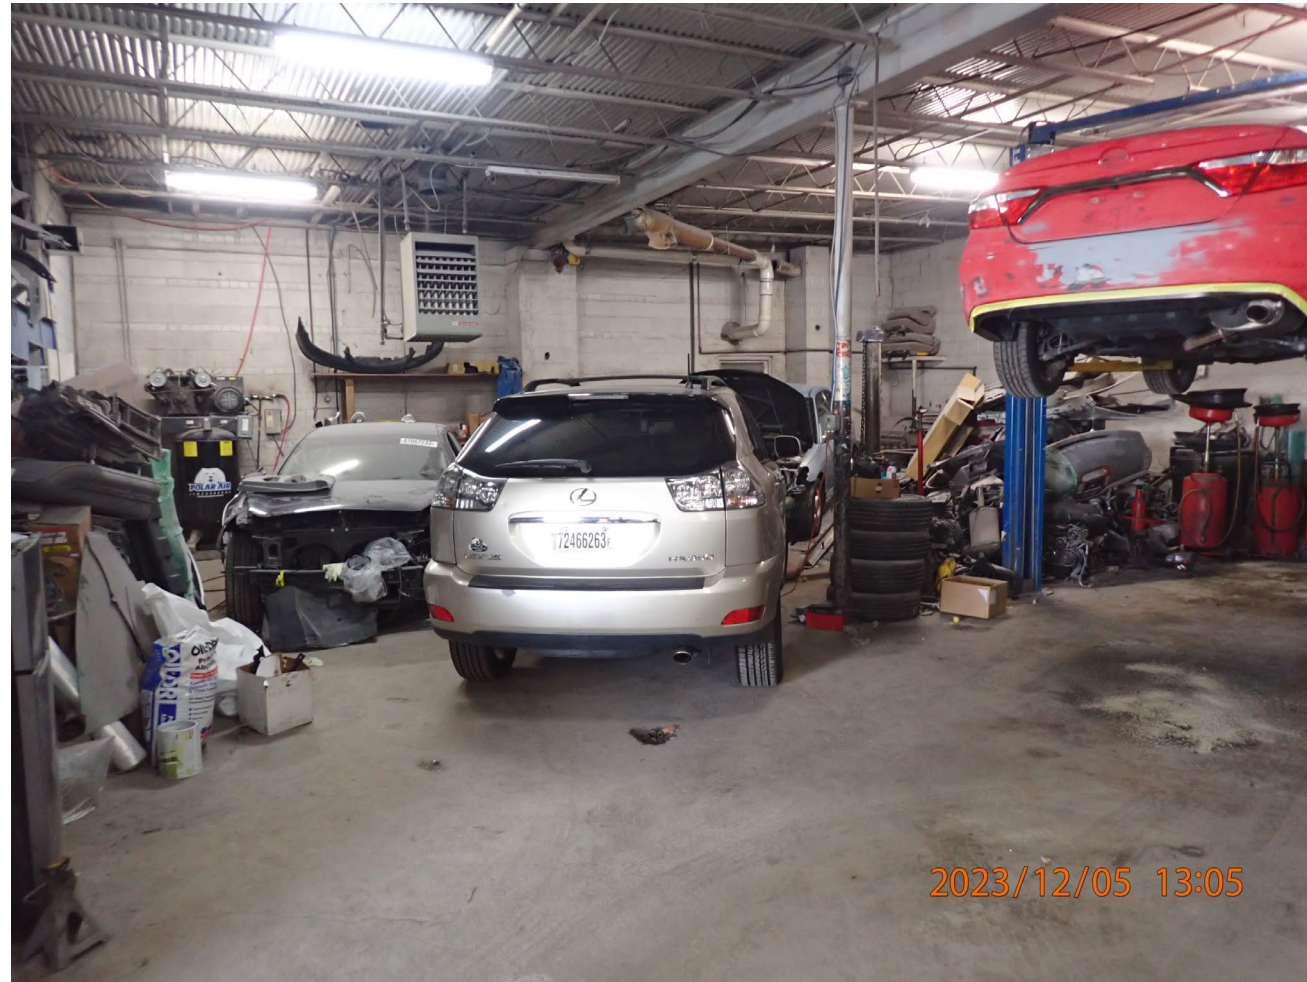
Photo Number: 38

Photo Description: Interior of Big Jones Auto Repairs
