**SUBJECT:** CLEAN AIR ACT INSPECTION REPORT  
Tower Landfill, Commerce City, CO

**Facility Name:** Tower Landfill

**Date of Inspection:** October 17, 2023

**Purpose of Inspection:** To determine Clean Air Act (CAA) compliance, including comparative Method 21 surface emission monitoring (SEM).

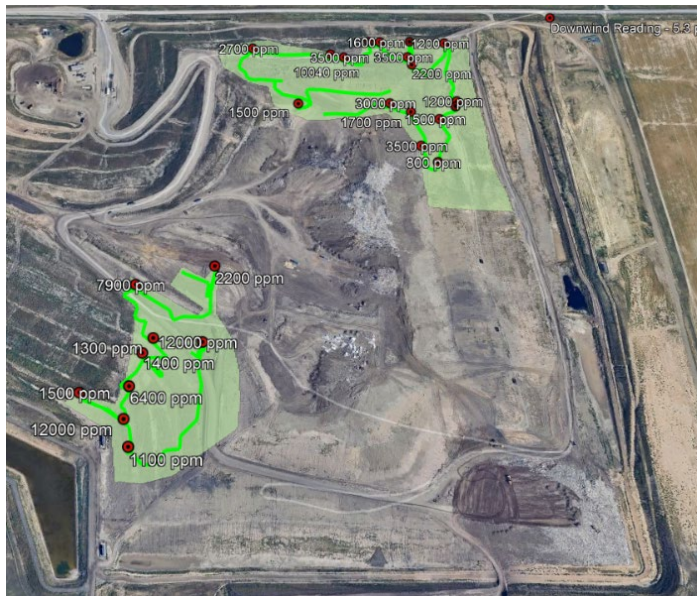
The EPA SEM survey covered portions of the north-east and south-central slopes of the landfill, estimated to constitute roughly 10% of the area routinely monitored during quarterly SEM events. EPA did not monitor any portions of the western half of the landfill, which has been under final cover for several years. Additionally, EPA inspectors were limited to SEM monitoring only along the slopes of the eastern half of the landfill in order to avoid the working face, which extended throughout the top-central portions of the eastern cell and was designated as unsafe to monitor by TLF staff. Areas monitored during the EPA SEM survey were selected in accordance with regulatory requirements, focusing on locations with visual indicators of elevated landfill gas (e.g., distressed vegetation, cracks, seeps, cover penetrations) and areas with sparse vegetation, which are also prone to elevated emissions. EPA inspectors recorded 26 points on the landfill surface where methane concentrations equaled or exceeded 500 ppm, including 11 exceedances recorded at penetrations and 15 exceedances recorded on the landfill surface. Note that exceedance #26 of Appendix B is labeled as a penetration exceedance, although it does not meet TLF’s definition of a penetration. See Appendix B for more details.

1. SEM hit locations plotted over satellite imagery from September 4, 2023, as depicted on Google Earth. Approximate monitoring path and monitored areas included (green line and green highlight), derived from GPS data.

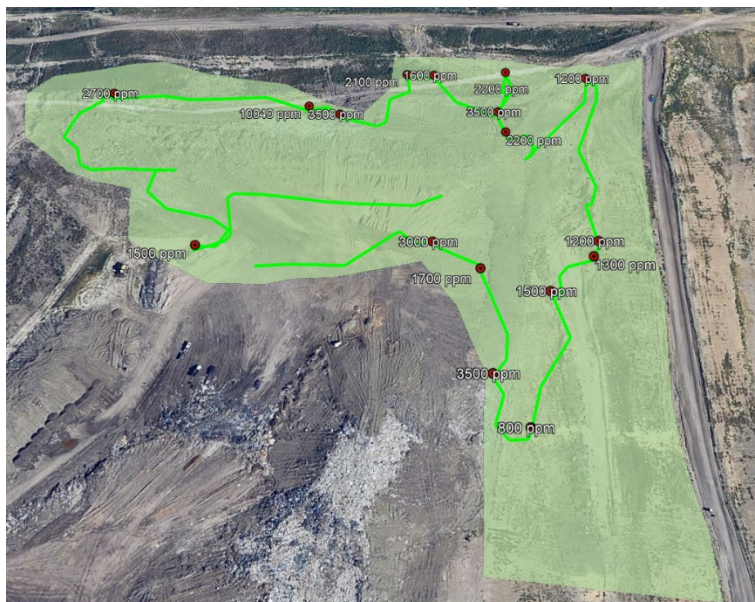
2. Detailed view of exceedances on the Northeast portion of landfill

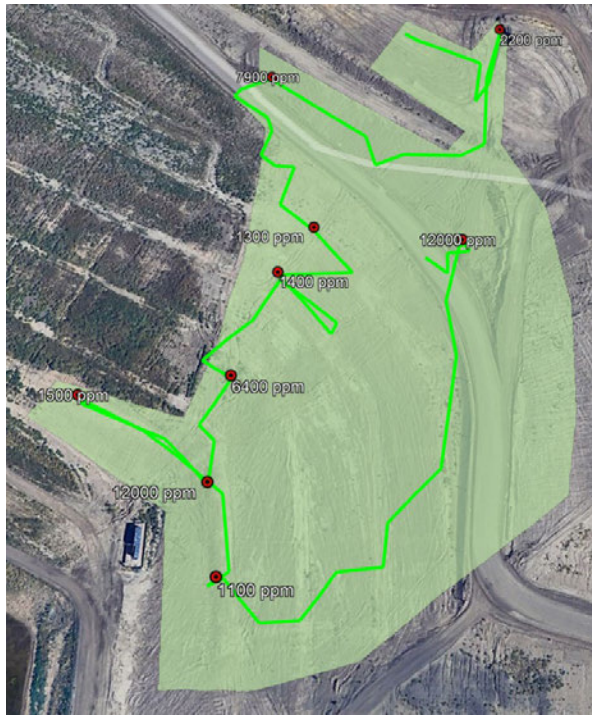
3. Detailed view of exceedances on the South-Central portion of landfill

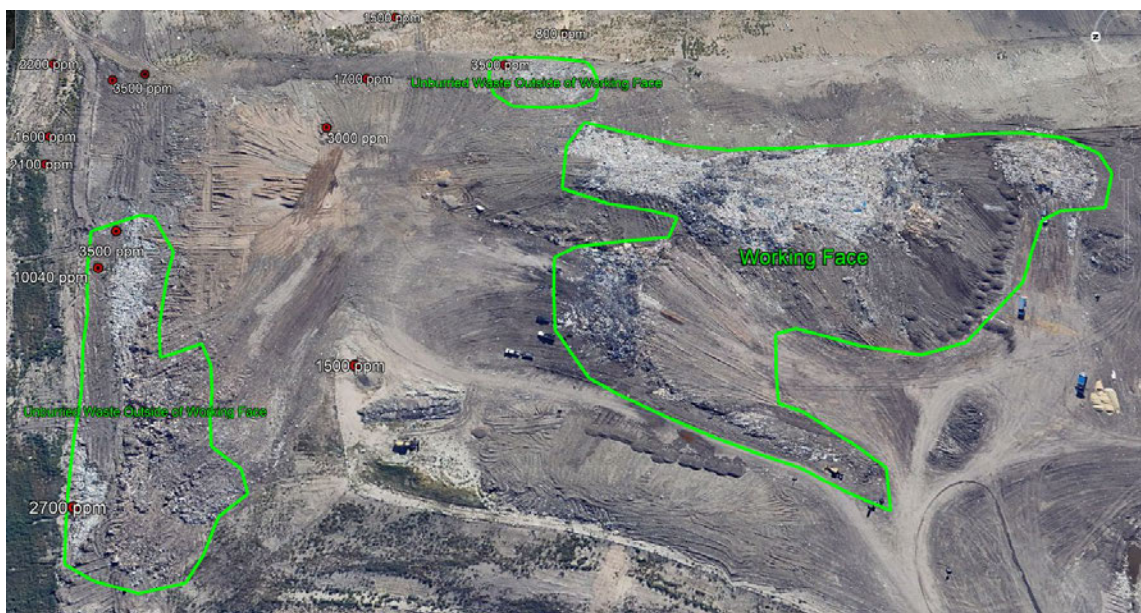
1. On the northern slope, EPA inspectors observed large swaths of unburied waste and loose dirt. The area was part of the working face several months prior, although the working face had shifted south, and large amounts of waste remained exposed at the time of the inspection. This area is associated with exceedances #4 - #6 and is captured in images IMG\_0001.JPG – IMG\_0005.JPG of Appendix A and satellite images 4, 5, and 6 of Appendix D.

4. Satellite imagery demonstrating exposed waste, separate from the active working face of the landfill, as seen on Google Earth satellite imagery from September 4, 2023. The two smaller green circled areas indicate swaths of unburied waste, as observed by inspectors during the EPA inspection.

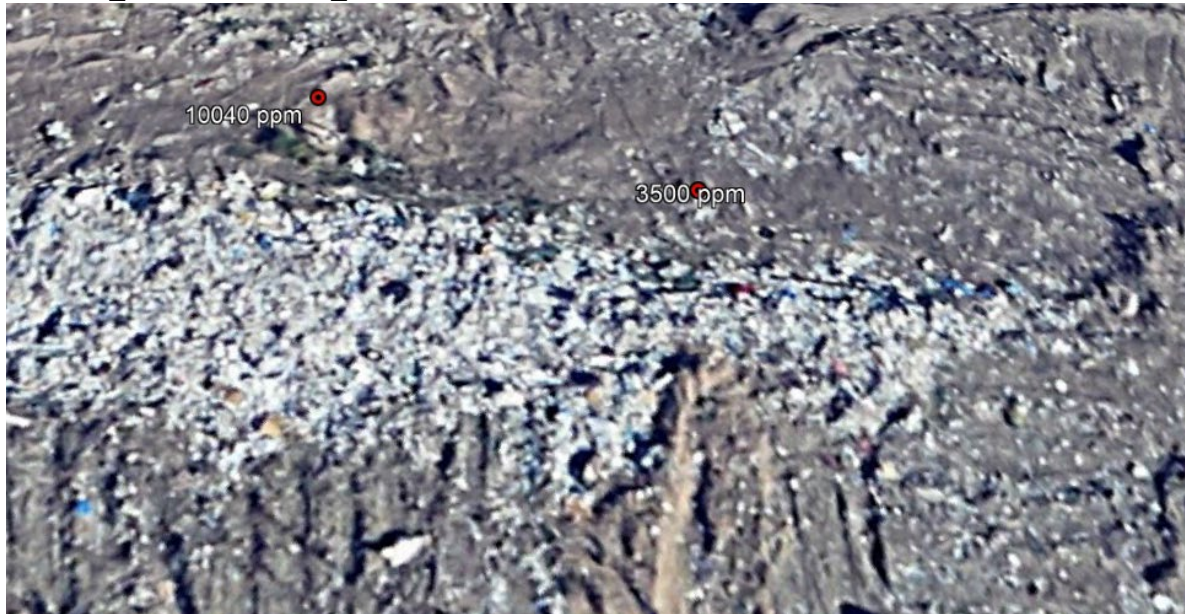
| # | Reading Time | Well / Location / Description/ Observations | Reading (ppm) | Conf. Reading (ppm) | Latitude | Longitude | Media Records |
|---|---|---|---|---|---|---|---|
| 5 | 10:58 AM | EW-40 penetration exceedance. No vegetation noted; some exposed trash visible. | 10040 | 10020 | N<br>39.85546 | W -<br>104.75826 | IMG_0002.JPG<br>IMG_0003.JPG |
| 6 | 11:02 AM | Surface exceedance. The absence of vegetation, an exposed mattress, and fresh unpacked dirt was noted. This was noted as a wide area of exceedances rather than a single point source. | 3500 | 1600 | N<br>39.8554 | W -<br>104.75802 | IMG_0004.JPG<br>IMG_0005.JPG |

5. Satellite imagery demonstrating exposed waste near exceedances #5 and #6, as seen on Google Earth satellite imagery from September 4, 2023. This area is also captured in IMG\_0002.JPG – IMG\_0005.JPG.

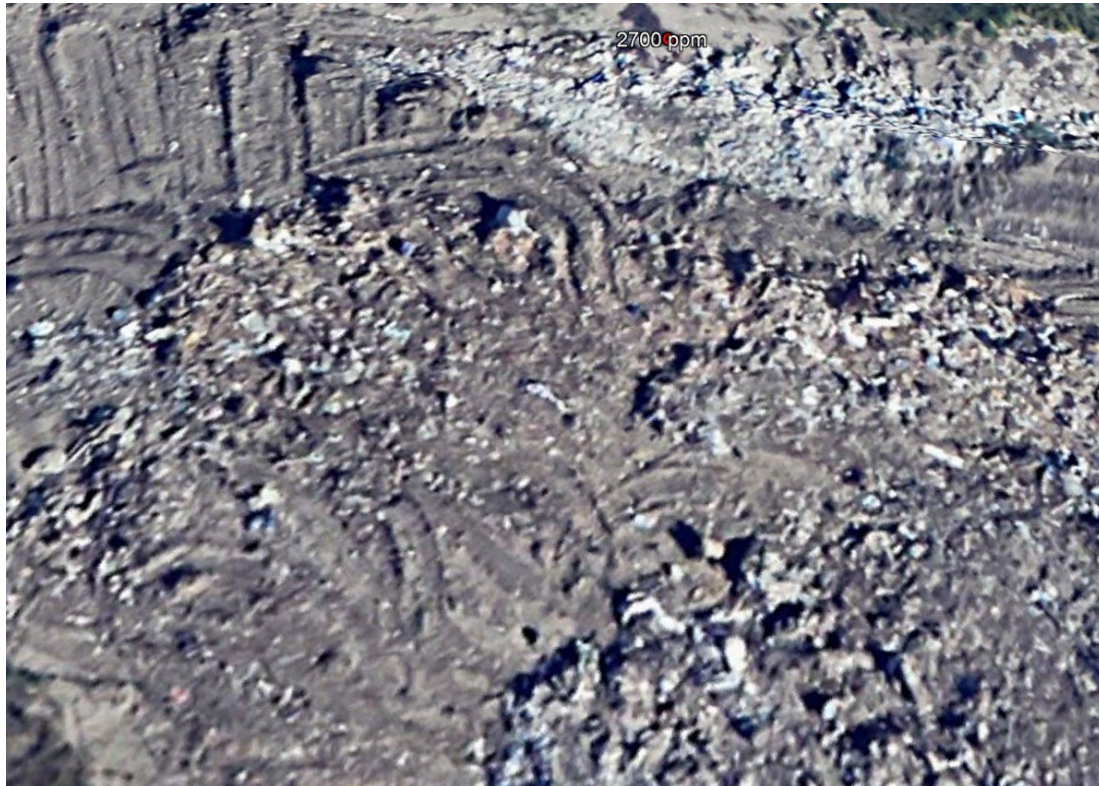
| # | Reading Time | Well / Location / Description/ Observations | Reading (ppm) | Conf. Reading (ppm) | Latitude | Longitude | Media Records |
|---|---|---|---|---|---|---|---|
| 4 | 10:49 AM | Well EW-39A, exceedances noted at both penetrations. Lack of vegetation, exposed waste, and discolored standing water also noted. | 2700 | 2500 | N<br>39.85544 | W -<br>104.75972 | IMG_0001.JPG |

6. Satellite imagery demonstrating exposed waste near exceedance #4, as seen on Google Earth satellite imagery from September 4, 2023. This area is also captured in IMG\_0001.JPG.

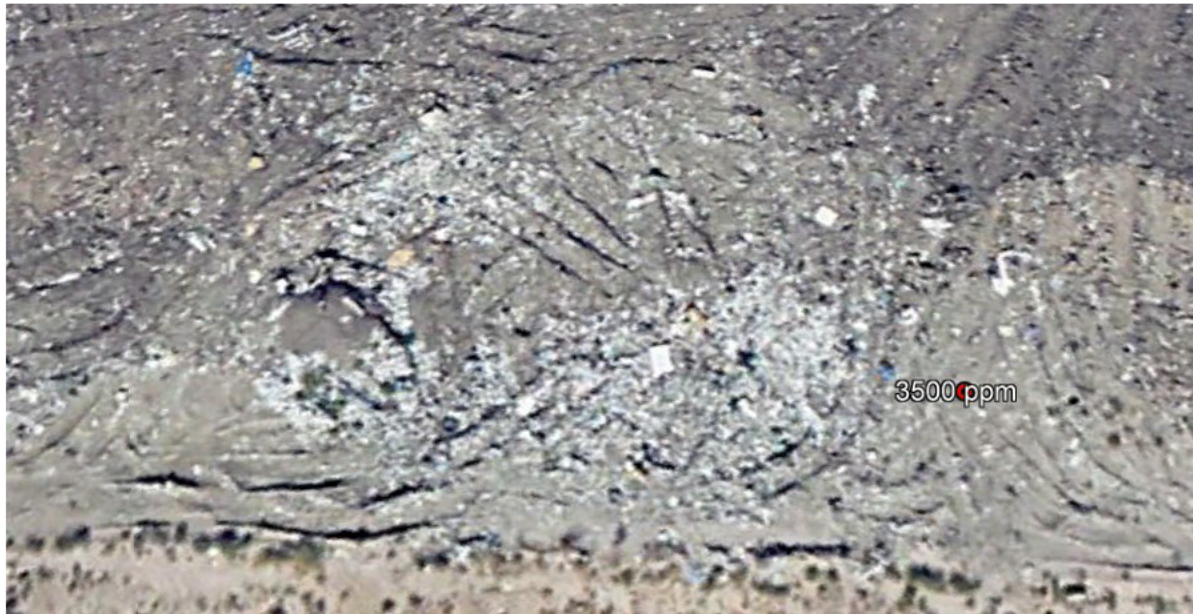
2. On the central portion of the eastern slope, EPA inspectors discovered a large, continuous swath of unburied waste with vegetation, including an unknown variety of fruiting melon, growing through the waste. Some of the melons were fully developed (IMG\_0018 and IMG\_0019), indicating that this patch of waste had been left unburied for at least 80-100 days (average period for melons to mature from seed), which corresponds to at least 3 monthly cover integrity monitoring events. TLF representatives initially guessed the unburied waste had only been left unburied for a week. However, upon sighting the melons in the waste, they concurred with EPA that the waste had been left unburied for at least several months. This area is associated with exceedance #17 and is captured in images IMG\_0016.JPG – IMG\_0021.JPG and satellite images 4 and 7 of Appendix D.

7. Satellite imagery demonstrating exposed waste near exceedance #17, as seen on Google Earth satellite imagery from September 4, 2023. This area is also captured in IMG\_0016.JPG – IMG\_0021.JPG.

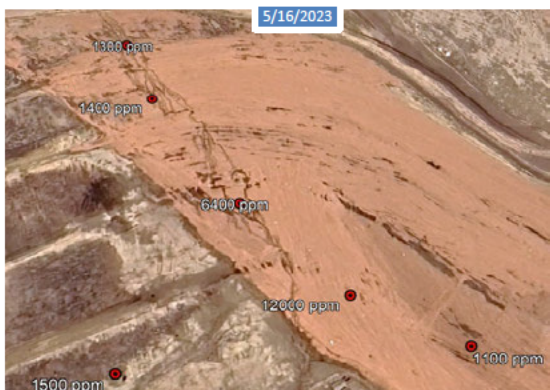
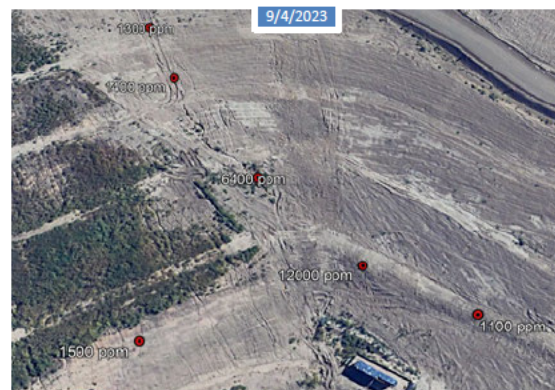
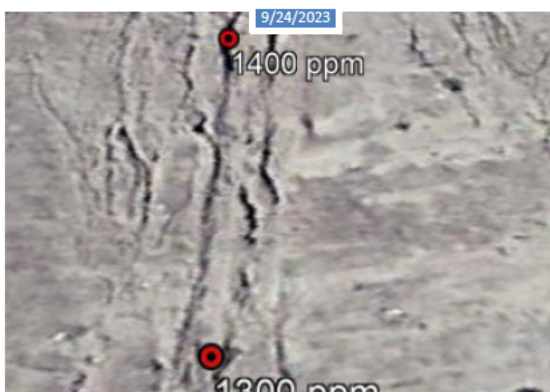
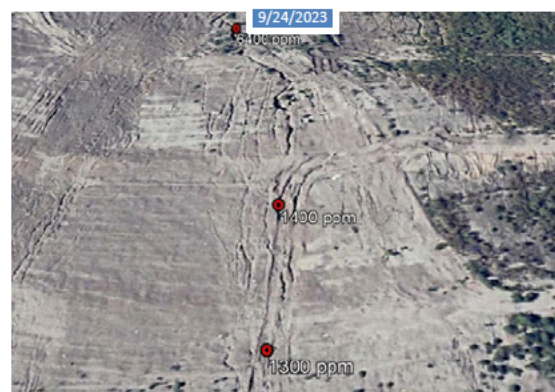
4. On the south-eastern slope, EPA inspectors noted large erosion rills running the extent of the slope from top to bottom with very little vegetation established on the slope. This area is associated with exceedances #22 – #24 and is captured in images IMG\_0026.JPG – IMG\_0033.JPG of Appendix A and satellite images 1, 3, and 8 of Appendix D.

| 22 | 2:50 PM | Surface exceedance recorded in an erosion rill with exposed waste visible. Fleeting exceedances were observed throughout the large area in and surrounding the rill. | 1300 | 900 | N<br>39.8503 | W -<br>104.76164 | IMG_0026.JPG |
| 23 | 2:52 PM | Surface exceedance recorded in an erosion rill with exposed waste visible. Fleeting exceedances were observed throughout the large area in and surrounding the rill. | 1200 | 1400 | N<br>39.85009 | W -<br>104.76181 | IMG_0027.JPG<br>IMG_0028.JPG |
| 24 | 3:01 PM | Surface exceedance recorded in a 3'X3' erosion rill. Exceedances greater than 1000 ppm were recorded throughout the rill. Dead vegetation was noted nearby, and a methane concentration of >500 ppm was recorded at the dead vegetation. A strong pervasive landfill gas odor was also noted. | 6400 | 900 | N<br>39.84966 | W -<br>104.76201 | IMG_0029.JPG --<br>IMG_0033.JPG |

8. Satellite imagery demonstrating a large erosion rill near exceedances #22 - #24, as seen on Google Earth satellite imagery from both May 16 and September 4, 2023.

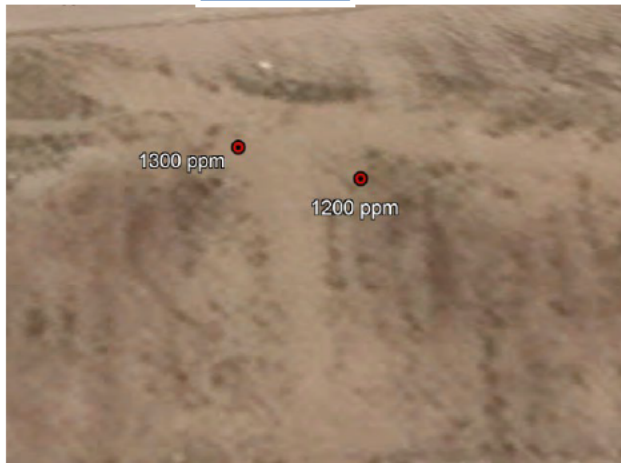
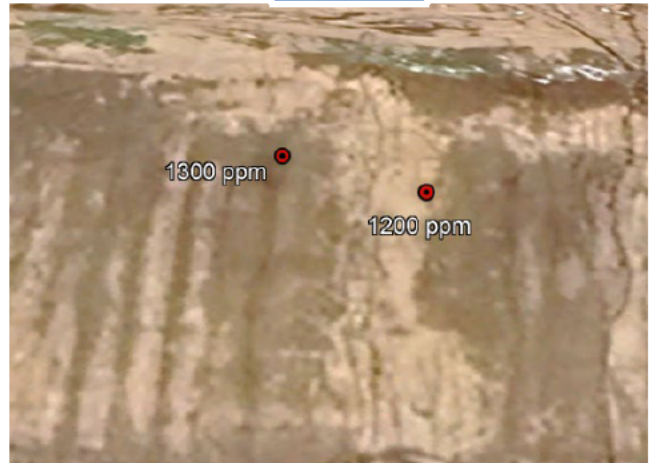
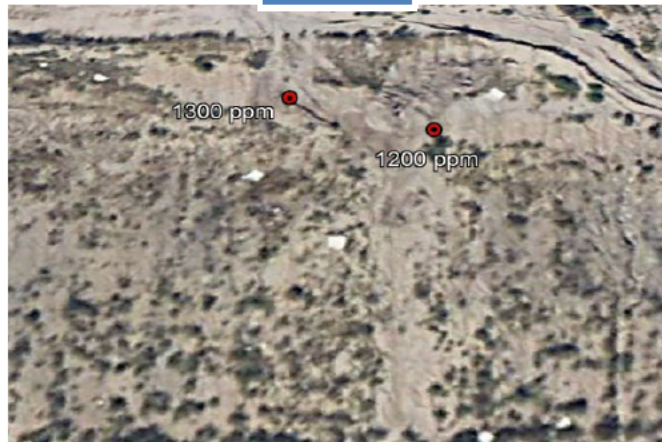
3. On the northern portion of the eastern slope, EPA inspectors noted sparse vegetation, exposed waste, loosely packed dirt, and extensive erosion. Although the satellite image resolution is poor, satellite image 9 of Appendix D demonstrates that there has been a “T”-shaped area with sparse vegetation and erosion since at least July 14, 2022. It is widely recognized that establishing landfill surface vegetation helps mitigate erosion, minimizing potential pathways for landfill gas to escape. Consistent with areas with persistent lack of vegetation, the “T”-shaped subject area displayed signs of erosion observed by EPA inspectors. Given the observed erosion and lack of vegetation, SEM was appropriately conducted in the area, revealing methane exceedances (#13-15). Furthermore, SEM exceedances were detected in the same area during TLF SEM events during the first and third quarters of 2023. This data, along with EPA inspector observations, support this area as a persistent source of surface emissions requiring attention. This area is associated with exceedances #13 - #15 and is captured in images IMG\_0013.JPG – IMG\_0014.JPG and DSCN0002.JPG of Appendix A and satellite images 4 and 9 of Appendix D.

9. Satellite imagery demonstrating persistent sparse vegetation and erosion near exceedances #13 and #14, as seen on Google Earth satellite imagery between July 14, 2022, and September 4, 2023.
