**Region 6 - Enforcement & Compliance Assurance Division**  
**INSPECTION REPORT**

| Inspection Date(s): | 12/12/2023 | |
| Company Name: | <b>Jamie Oil, Inc.</b> | |
| Facility Name: | <b>Frost F#3, F#4, and F#5 Tank Battery</b> | |

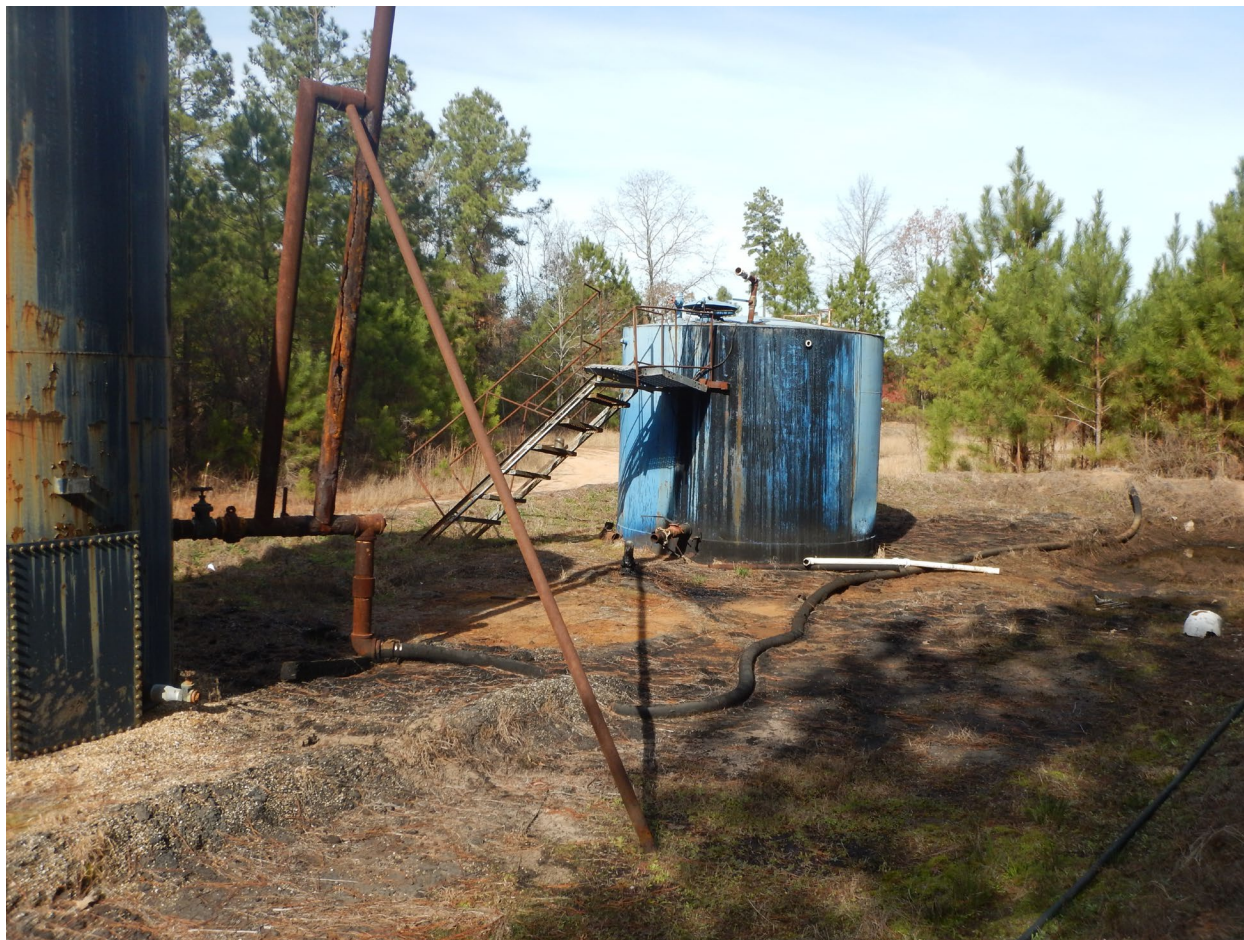
Photo No. 2

I observed **leaking around separator and loose oil within secondary containment, see photo number 2.**

No closing conference was held due to no Jamie Oil, Inc. staff being present during the inspection. Areas of concern at the time of the inspection include: 1) storage tank open and not cleaned out and should be if out of service; 2) oil tank and separator leaking; 3) loose oil within secondary containment; and 4) no caps on pipes from oil tanks.

**Description:** This photo was taken looking N at the facility showing leaking from separator and loose oil in secondary containment.

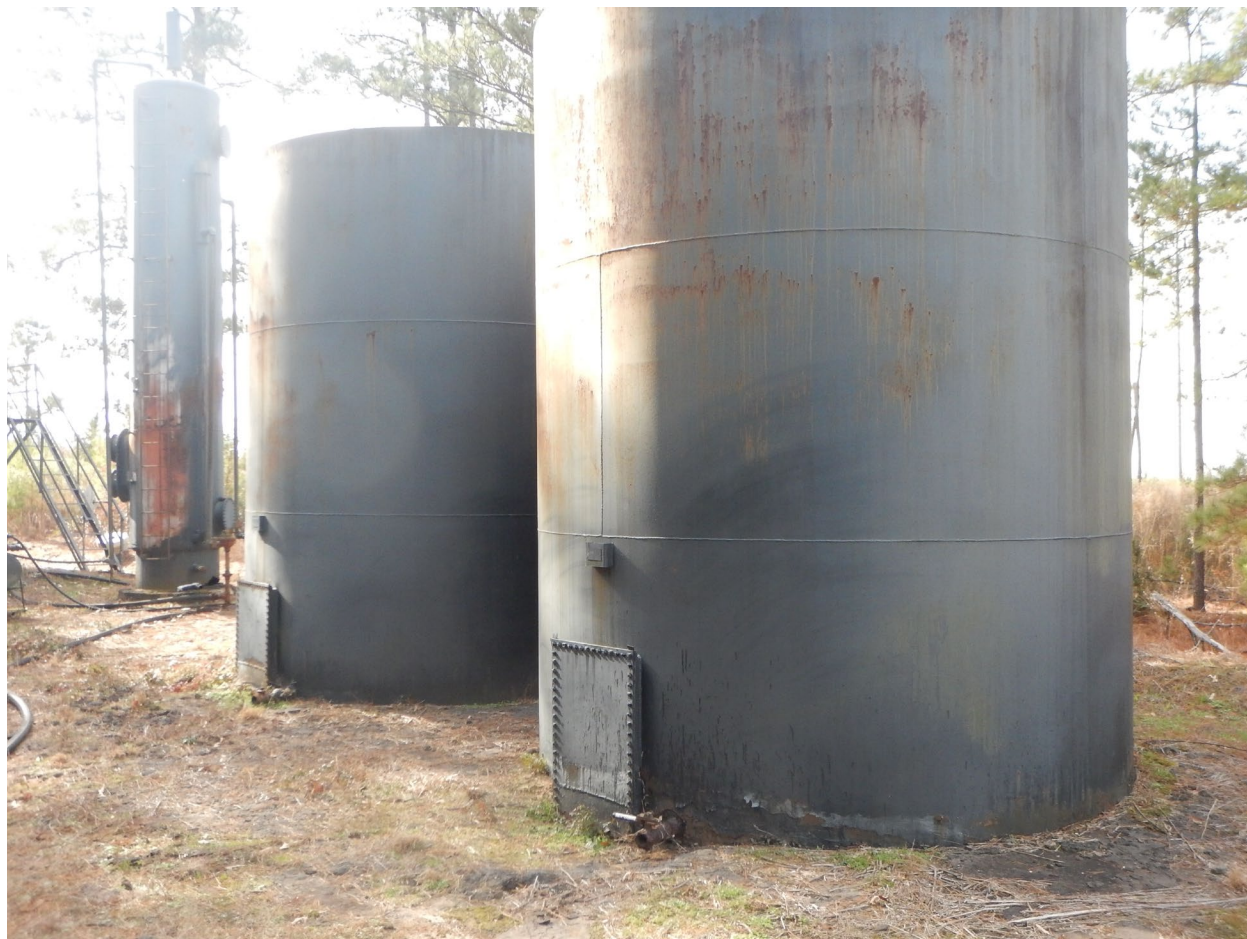
Photo No. 3

I observed **no caps on pipes from oil tanks, see photo number 3.**

**Description:** This photo was taken looking W at the facility showing an overview of the facility. Note no caps on pipes.
