INSPECTION REPORT

| Type of Inspection | Industrial Stormwater Inspection (ISI) | |
| Permittee Name | Schmitz Ready Mix | |
| Facility/Site Physical Address | 5400 N 124Th Street | |

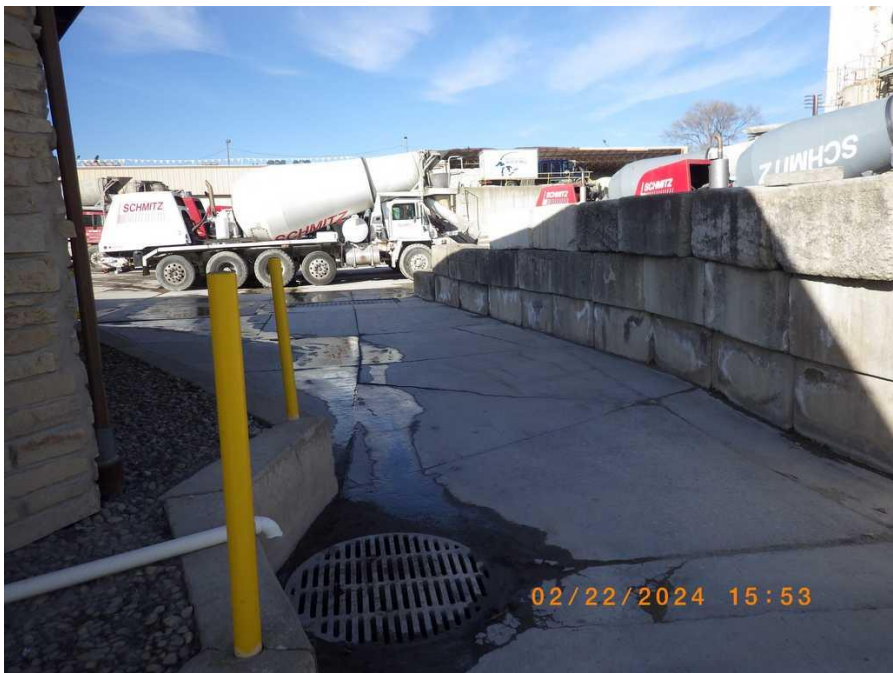
| Stormwater Catch Basin | | | RIMG3266.JPG |

| Stormwater Catch Basin east of the office building that drains the north part of the property and flows into Menomonee River via outfall 001. | | | |

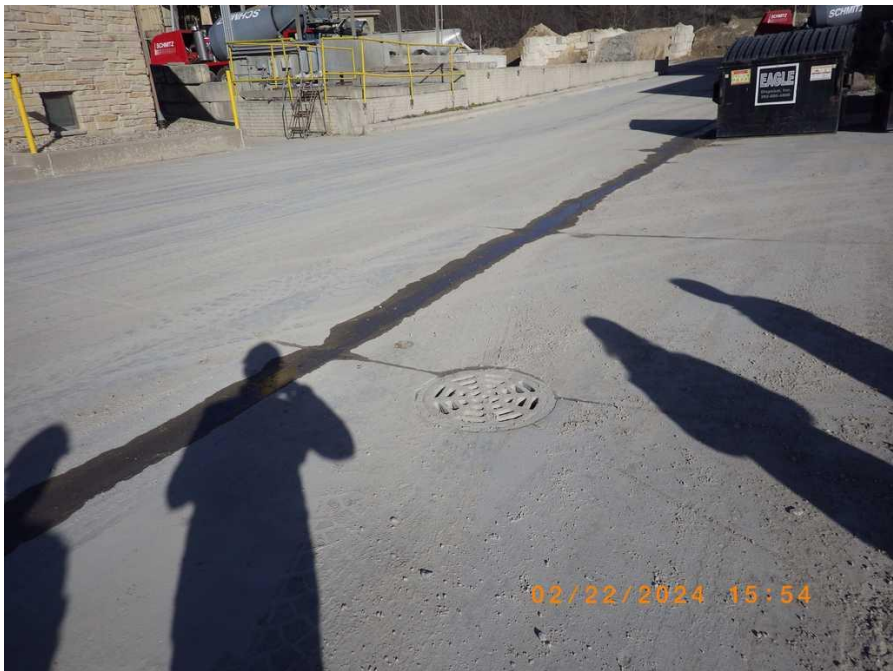
| Stormwater Catch Basin | | | RIMG3267.JPG |

| Stormwater Catch Basin south of the showroom building that drains into Menomonee River via outfall 001. This catch basin did not have a sediment filter in it. | | | |

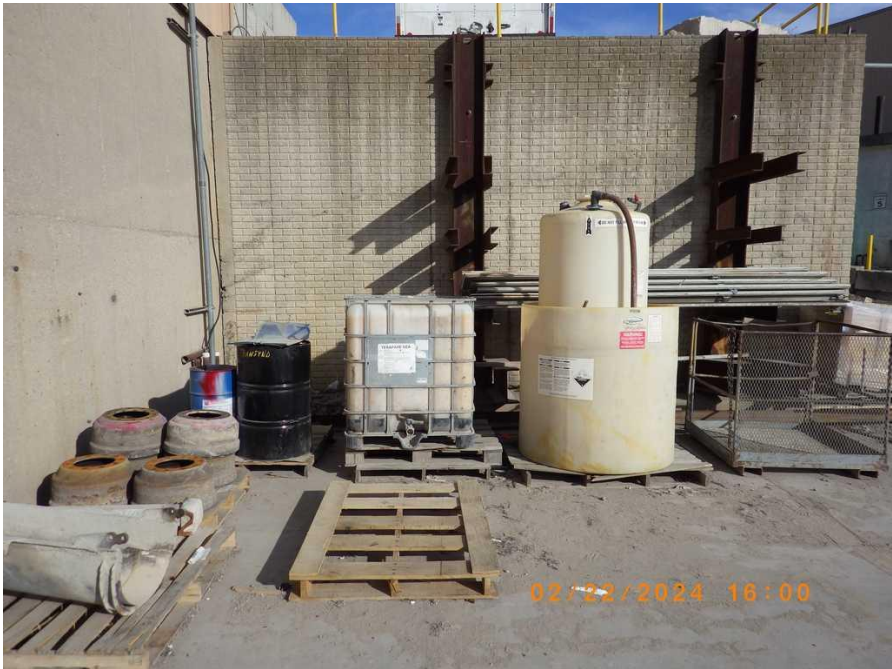
| Used oil tanks | | | RIMG3268.JPG |

| AOC:<br><br>Outside and at the southeast corner of the machine shop, EPA observed a couple of drums containing used oil and an IBC tote that did not have secondary containment. This area sloped towards one of the stormwater catch basins on site. | |

| Used oil tanks and IBC tote with no secondary containment next to the machine shop. | | | |

On February 26, 2024, Schmitz Ready Mix sent EPA two photos that show the used oil containers were removed from outside the machine shop and a concrete block placed on in front of the gap in the concrete wall along the Menomonee River, right above outfall 002.

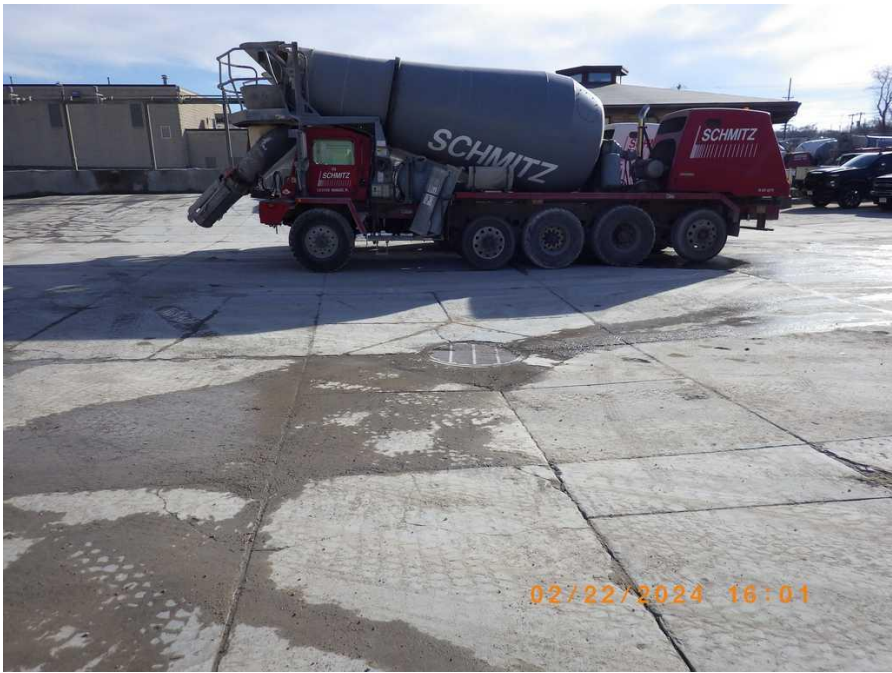
| Stormwater Catch Basin | | | RIMG3269.JPG |

Most of the runoff from the area outside the machine shop, the shed area and the east side of the Facility where the concrete mixing happens would drain into the first catch basin. The first catch basin then connects underground to the second one. EPA observed runoff going into the second catch basin at the time of the inspection. Both catch basins had sediment filters in them. EPA noted that there was a significant buildup of sediments in both filters.

| Stormwater Catch Basin south of the machine shop that drains the north part of the property. This catch basin had a sediment filter in it that seemed packed with sediments. | | | |

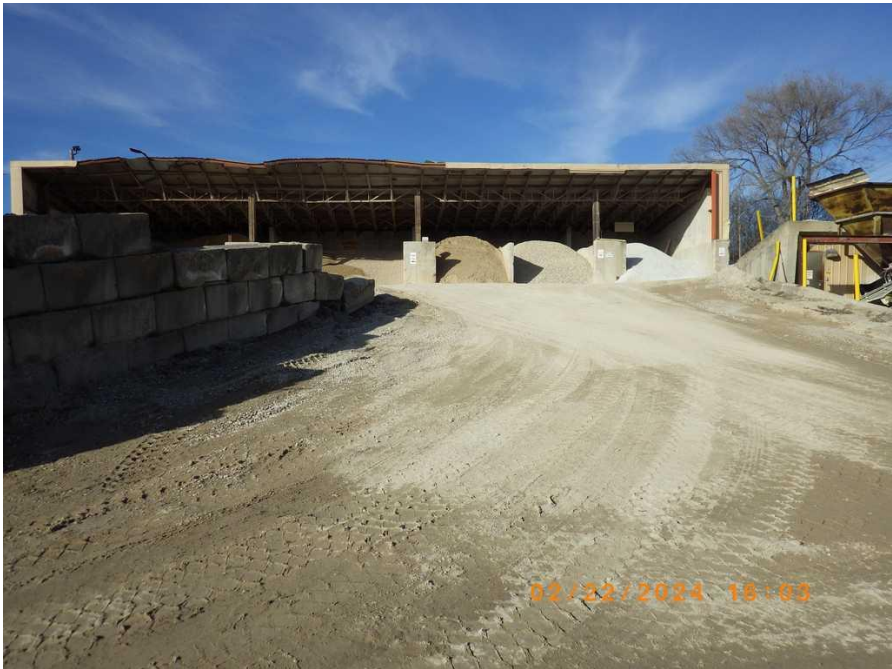
| Open front storage shed | | | RIMG3270.JPG |

| Open front storage shed where piles of aggregates were stored under roof at the north end of the property. | | | |

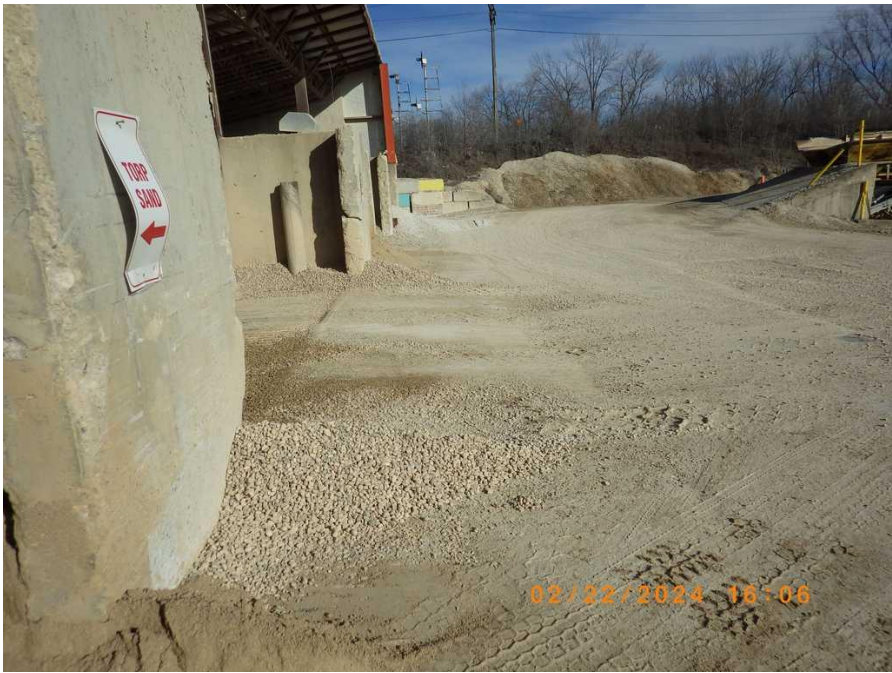
| Open front shed | | | RIMG3271.JPG |

| Open front shed where piles of aggregates were stored under roof at the north end of the property. The photos shows aggregates outside the shed. | | | |

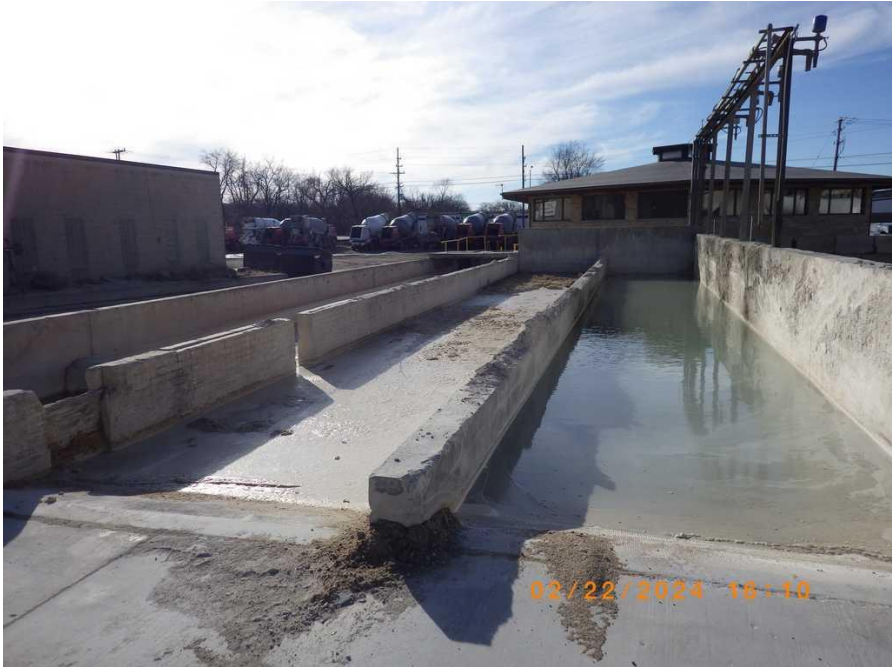
| Settling Pit | | | RIMG3272.JPG |

| 3-tiered settling pit where washwater from the trucks is routed and reused. | | | |

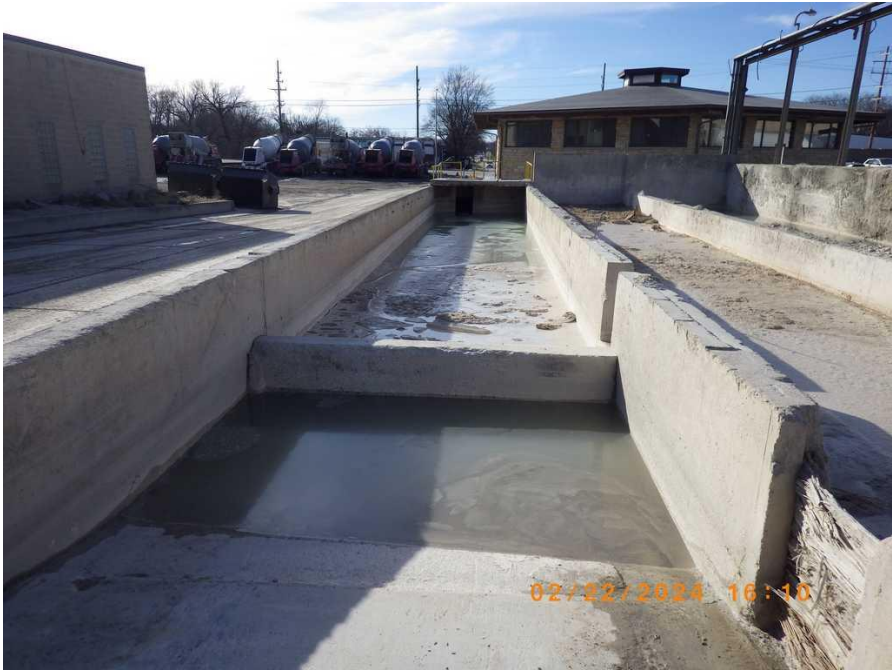
| Settling Pit | | | RIMG3273.JPG |

| 3-tiered settling pit where wash water from the trucks is routed and reused. | | | |

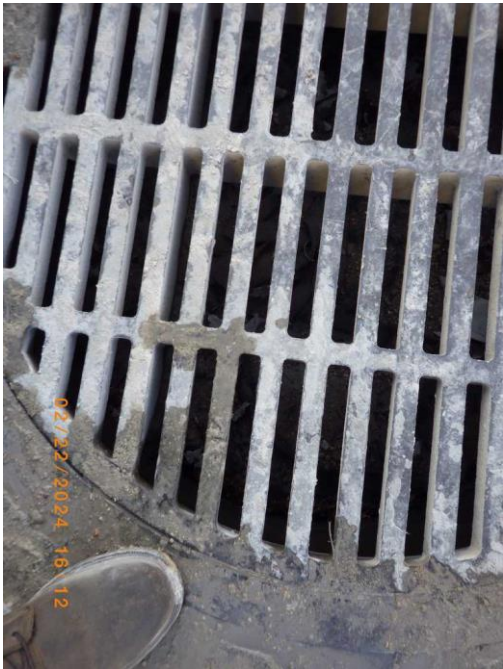
| Stormwater Catch Basin | | | RIMG3274.JPG |

| Stormwater catch basin located south of the office building. | | | |

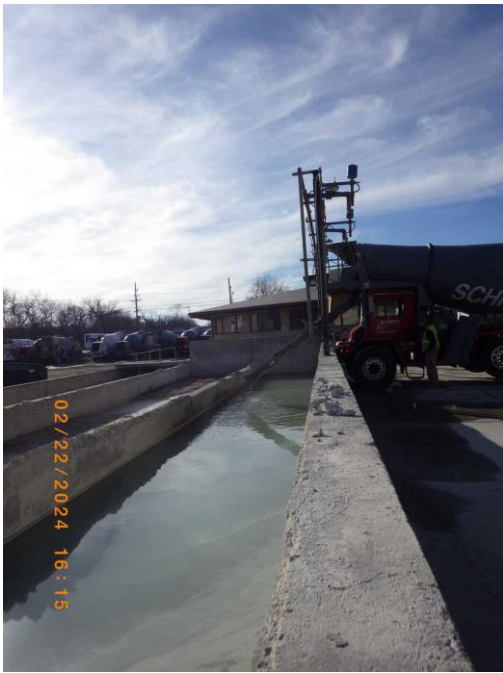
| Truck washing | | | RIMG3275.JPG |

| 3-tiered settling pit where wash water from the trucks is routed and reused after settling. | | | |

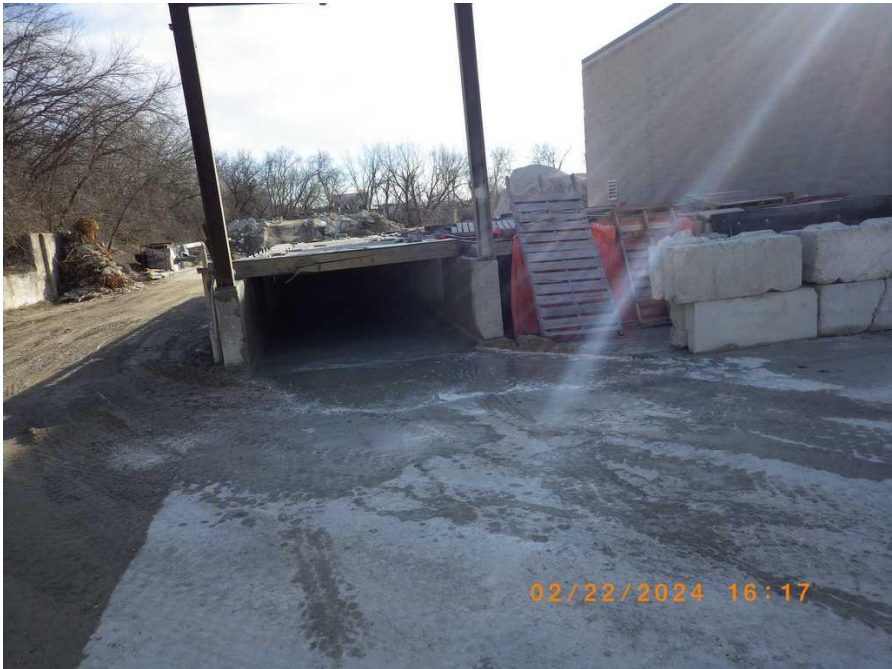
| Settling Pit | | | RIMG3276.JPG |

| Covered, 3-tiered settling pit where wash water from the trucks is routed and reused during the winter months. | | | |

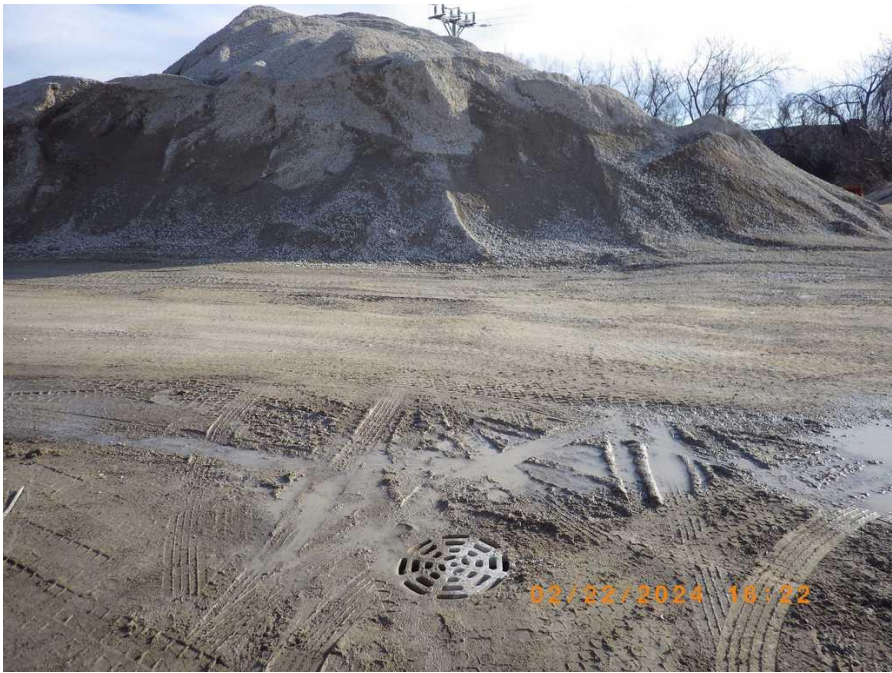
| Stormwater Catch Basin | | | RIMG3277.JPG |

Just south of the Showroom building, EPA observed another stormwater catch basin that had a filter in it with plenty of sediments buildup in and around it and next to a big aggregate pile.

| Stormwater Catch Basin south of the showroom building and next to a big pile of aggregates. No sediment filter was visible in this catch basin. | | | |

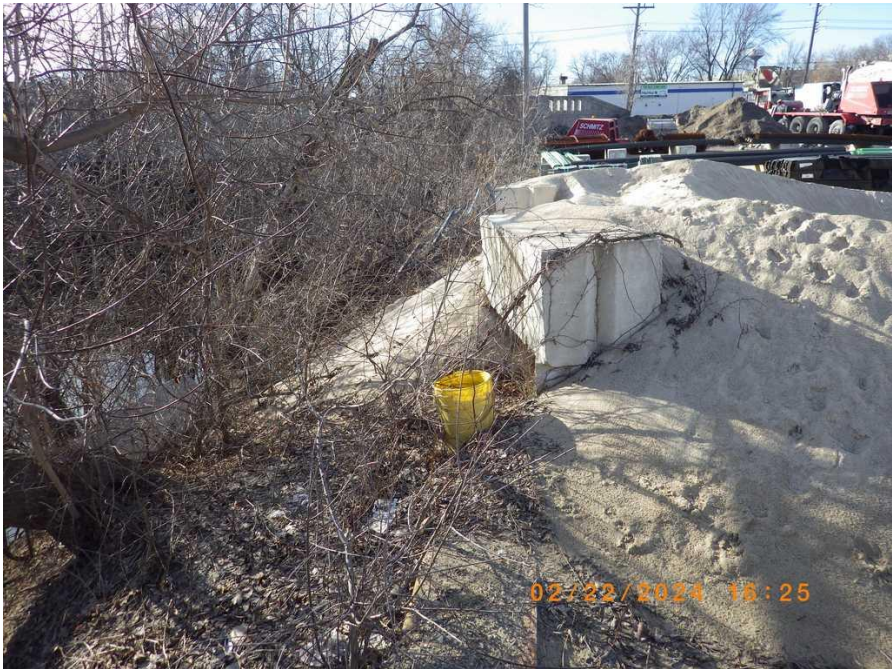
| Overflowing pile | | | RIMG3278.JPG |

| Overflowing pile of sand on the north bank of the Menomonee River. | | | |

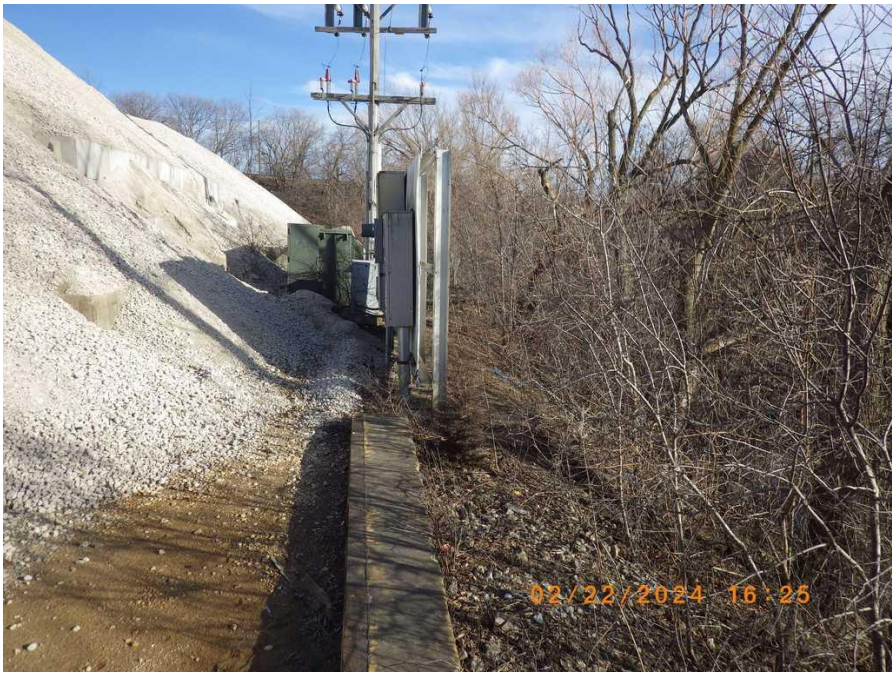
| Overflowing pile | | | RIMG3279.JPG |

EPA observed big piles of aggregates and recycled material from the settling basins next to the Menomonee River. There is a concrete wall south of the piles, about 1 foot high, to contain the material from falling on the banks of the Menomonee River. However, EPA observed material falling above the wall and into the banks of the river.

| Overflowing pile of aggregates on the north bank of the Menomonee River at the south end of the property. | | | |

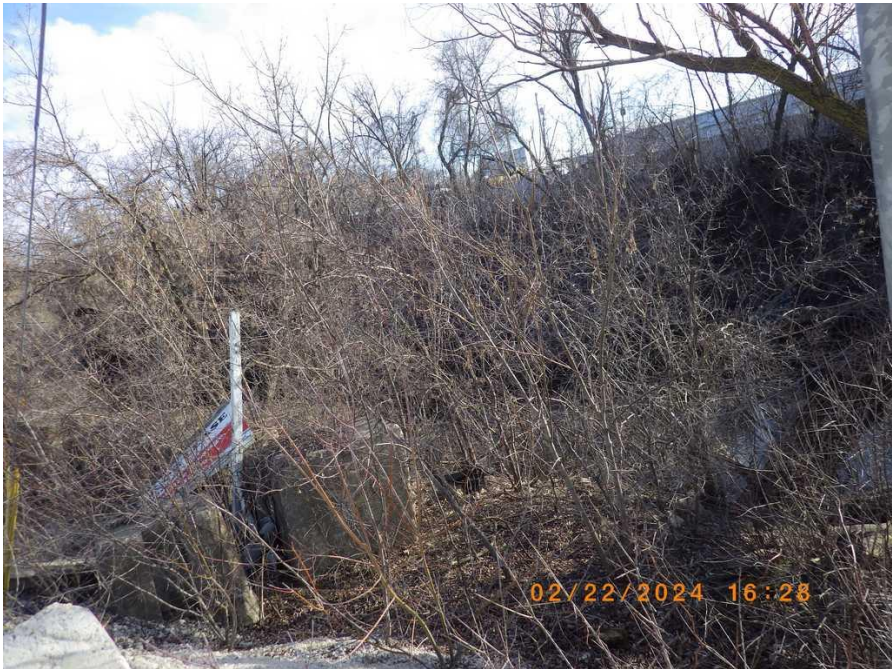
| Aggregates on the bank of Menomonee River | | | RIMG3280.JPG |

| Aggregates on the north bank of the Menomonee River at the south end of the property. | | | |

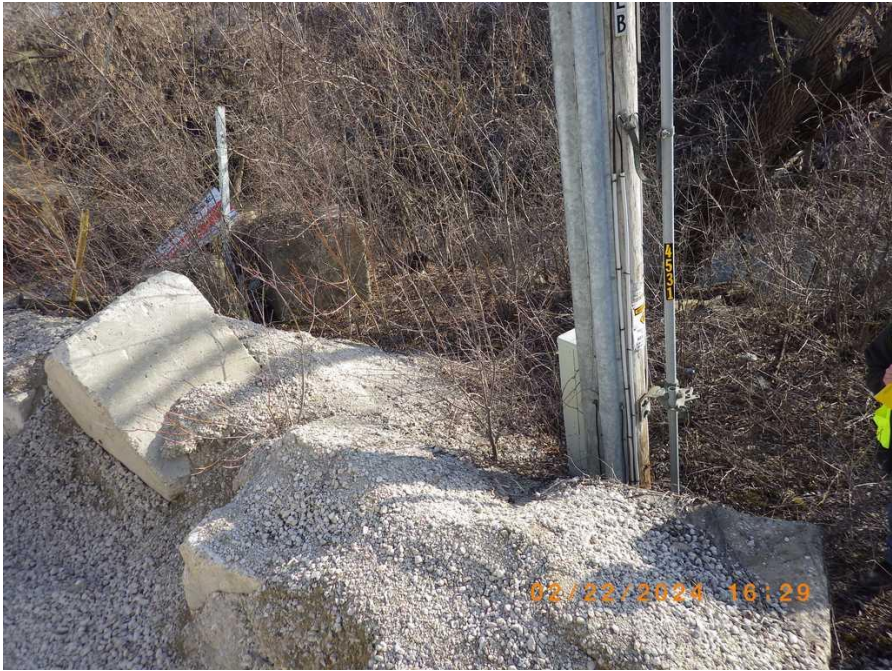
| Aggregates on the bank of Menomonee River | | | RIMG3281.JPG |

| Aggregates on the north bank of the Menomonee River at the south end of the property. | | | |

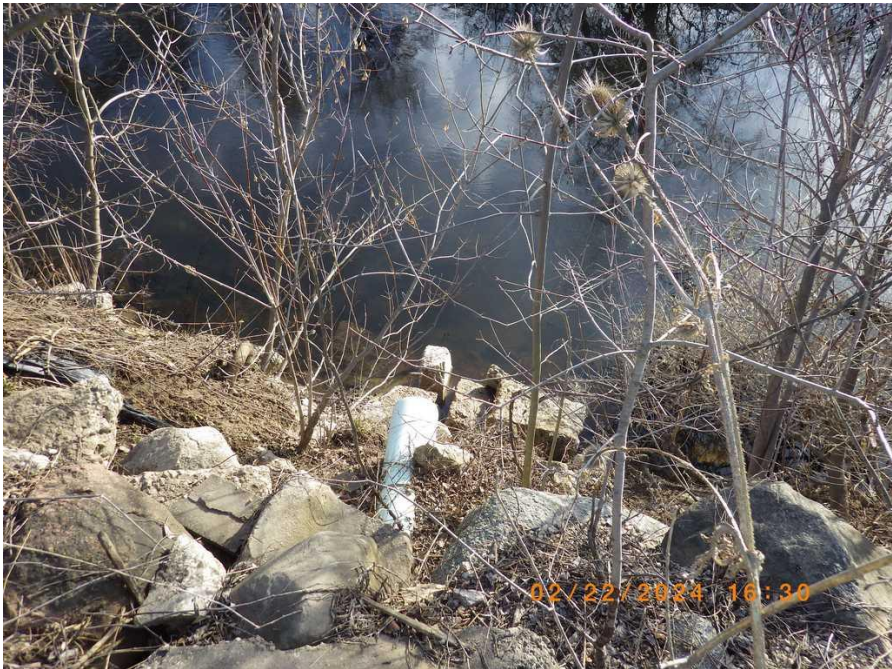
| Outfall 002 | | | RIMG3282.JPG |

| Outfall 002 was discharging at the time of the inspection. | | | |

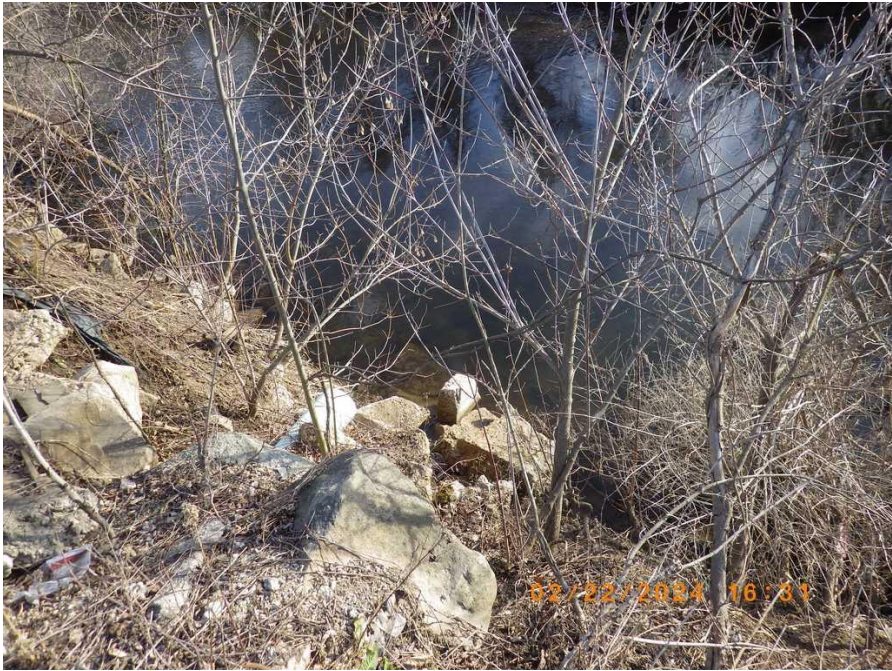
| Outfall 002 | | | RIMG3283.JPG |

| Outfall 002 was discharging at the time of the inspection. | | | |

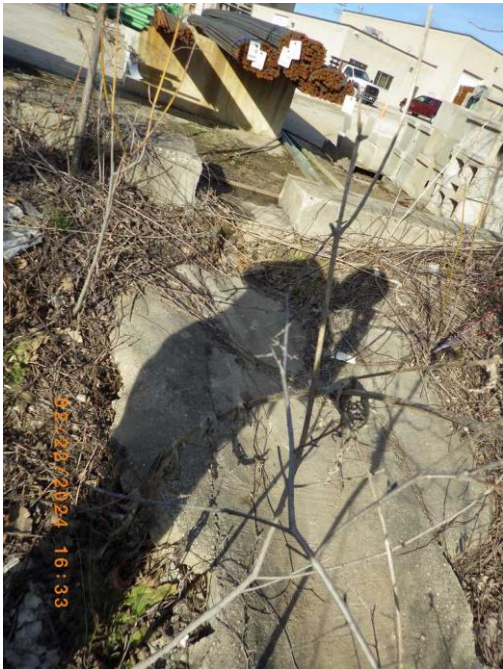
| Concrete conveyance | | | RIMG3284.JPG |

| Concrete conveyance draining the southwest part of the property into the Menomonee River. | | | |

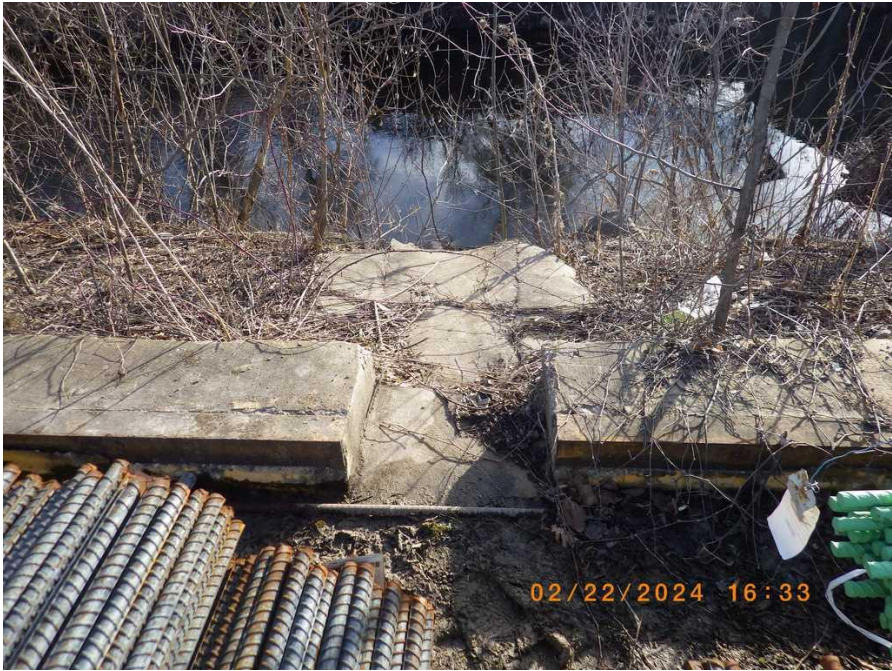
| Concrete conveyance | | | RIMG3285.JPG |

| Concrete conveyance draining the southwest part of the property into the Menomonee River. | | | |

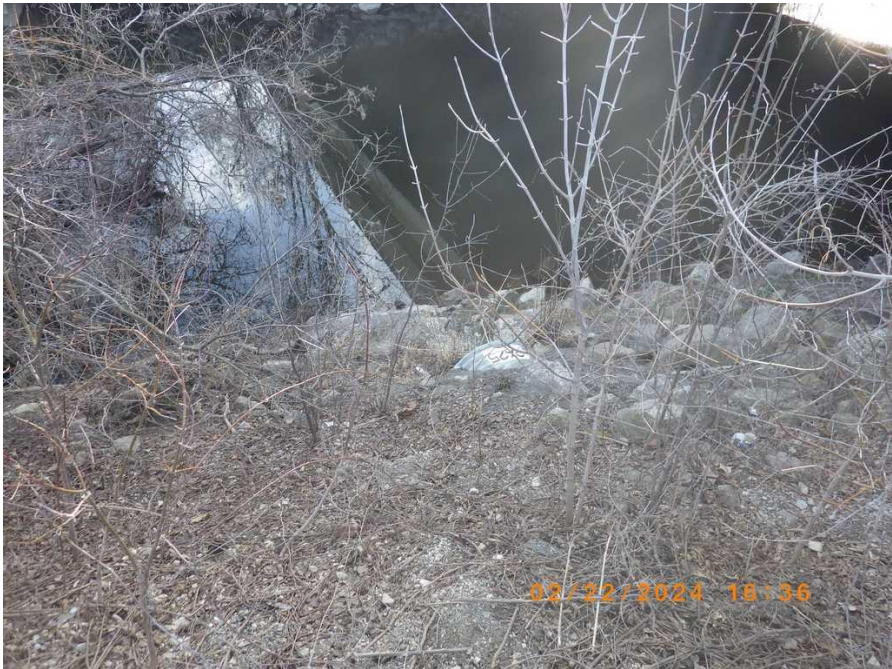
| Corrugated pipe into Menomonee River | | | RIMG3286.JPG |

| Corrugated pipe into Menomonee River at the southwest corner of the property that according to Mr. Schulz is not connected to the property. | | | |

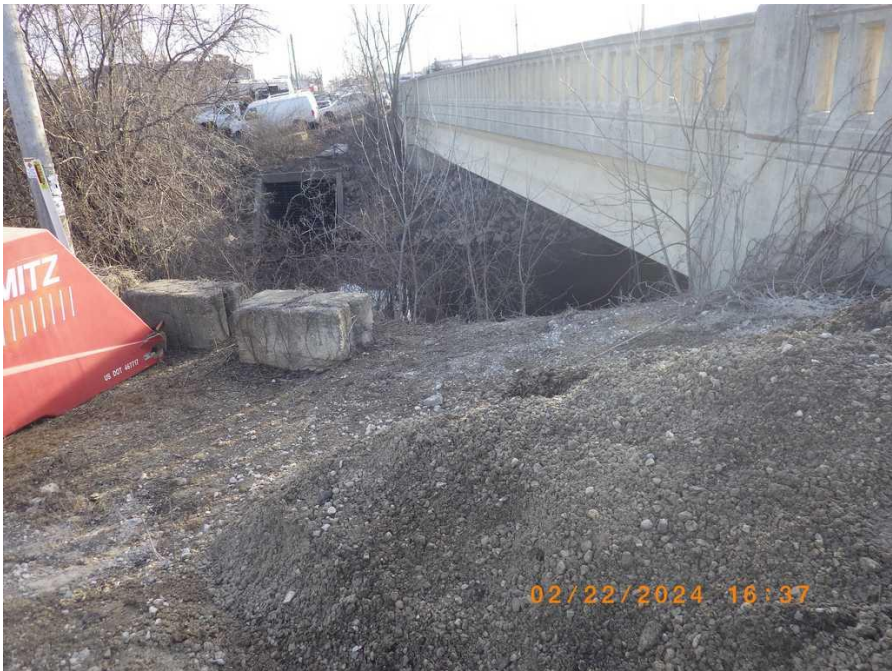
| Aggregate pile | | | RIMG3287.JPG |

| Aggregate pile at the southwest corner of the property and next to the Menomonee River. | | | |

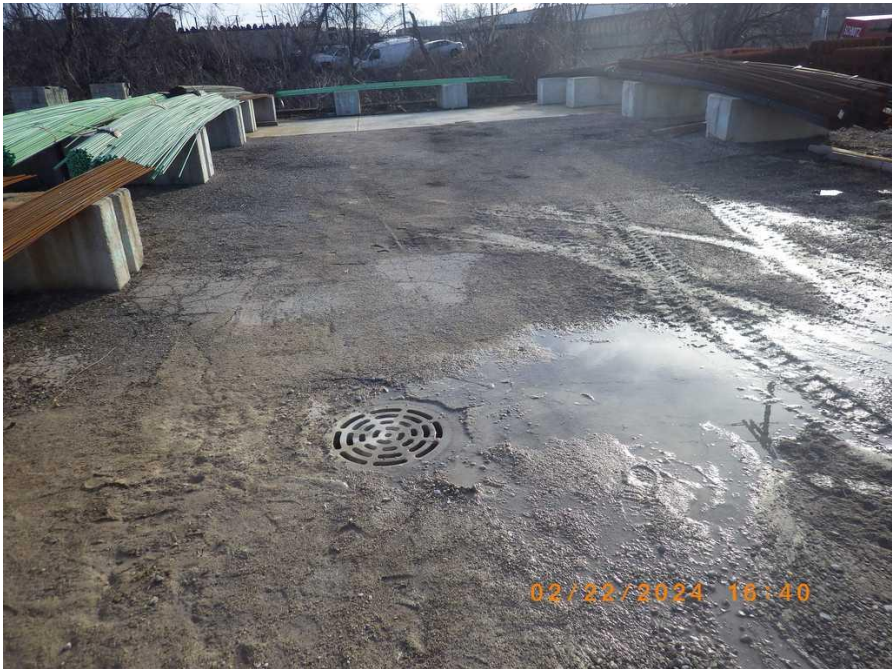
| Stormwater Catch Basin | | | RIMG3288.JPG |

At the southwest part of the Facility, EPA observed more aggregate piles, a sand pile, a rebar pile and a stormwater catch basin that did not have a sediment filter in it. The area had an opening in the concrete wall by the river and a constructed channel/pathway on the north bank of the Menomonee River.

| Stormwater Catch Basin at the southwest end of the property that drains into the Menomonee River via outfall 002. | | | |
