**Report Title:** Clean Air Act Inspection of Advance Auto Service  
**Inspection Date(s):** December 5, 2023  
**Regulatory Program(s):** NESHAP, SIP

**Company Name:** Advance Auto Service  
**Facility Name:** Same as above  
**Facility Location:** 1850 Adams Street NE,  
Washington, DC 20018  
**Latitude:** 36.01601848 **Longitude:** -76.97835  
**County/Parish:** District of Columbia

# PHOTO LOG

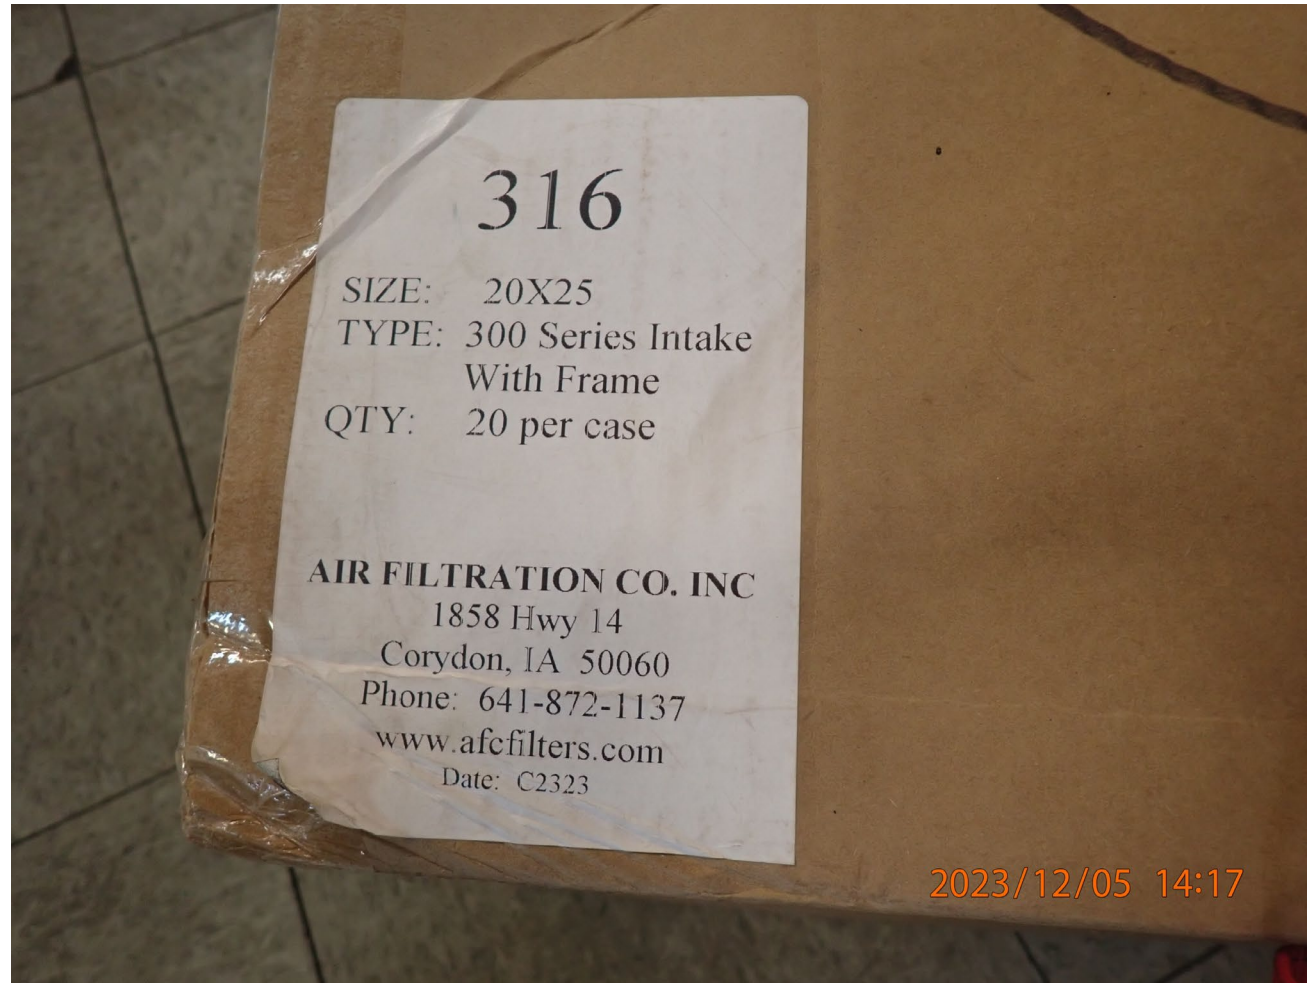
Photo Number: 39

Photo Description: Air Filters Box Label for Paint Booth

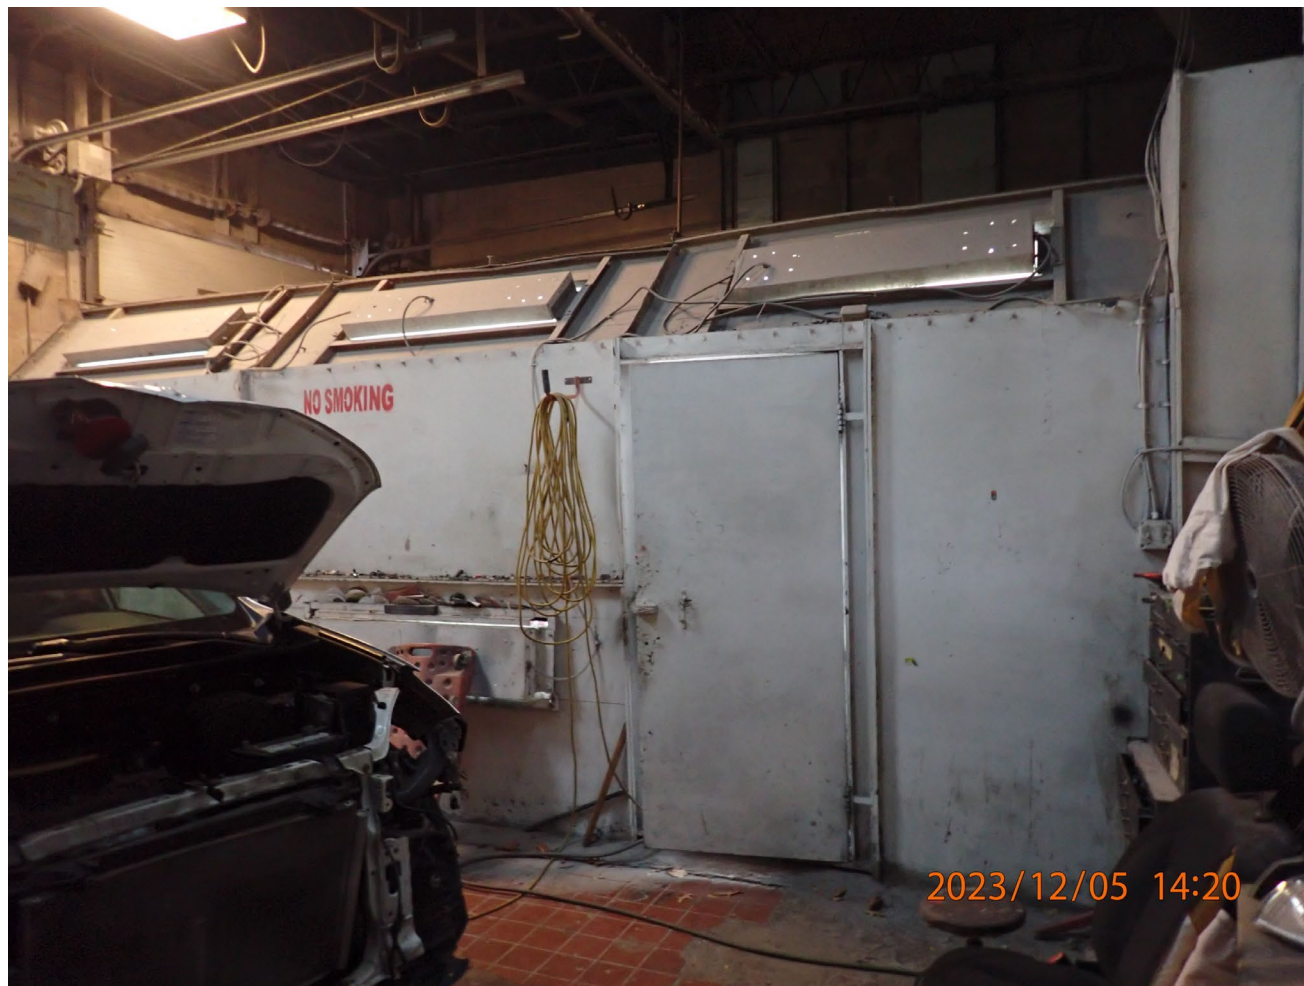
Photo Number: 40

Photo Description: Exterior of Paint Booth

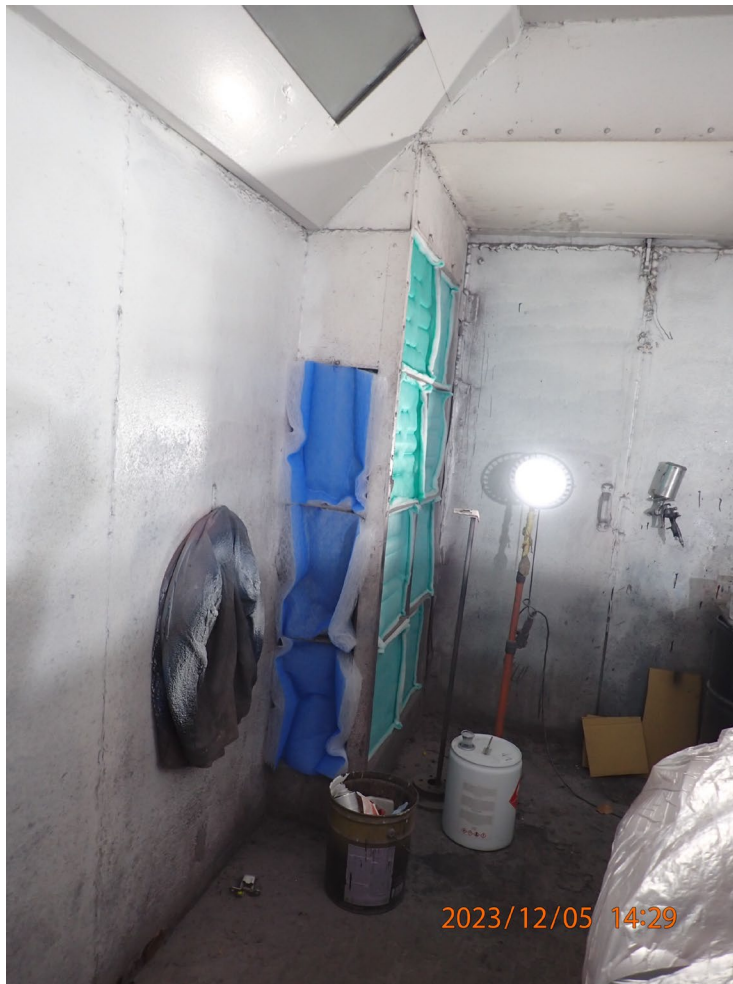
Photo Number: 41

Mr. Woldegebriel led the inspection team to observe the Facility's enclosed paint booth. Light bulbs were missing from the light fixtures, some of the paint booth filters were heavily laden with dirt, dust, or paint overspray, and there was a gap in the filters observed where the exhaust exits the paint booth. Mr. Deluca asked Mr. Woldegebriel to turn on the paint booth so that the inspection team could observe the paint booth during operation. The air was observed coming in through the front of the booth but did not appear to exit through the filters when exiting the exhaust stack. Advance Auto uses 20" x 25" 300 series filters made by Air Filtration Co. Inc. Mr. Woldegebriel, stated the Facility changes it's filters every two months and does not perform a lot of paint jobs. The Facility mostly does auto repair work. Advance Auto employs one painter, Castolo Perez. Mr. Woldegebriel stated the painter does not have a paint certificate. Castolo Perez, explained that he cleans the spray guns over a hazardous waste drum by pouring economy thinner through the spray gun. Crystal Clean is an environmental service that the Facility uses to discard of its hazardous waste offsite from the parts degreaser, waste oil, anti-freeze, and paint waste.

Photo Description: Interior of Paint Booth

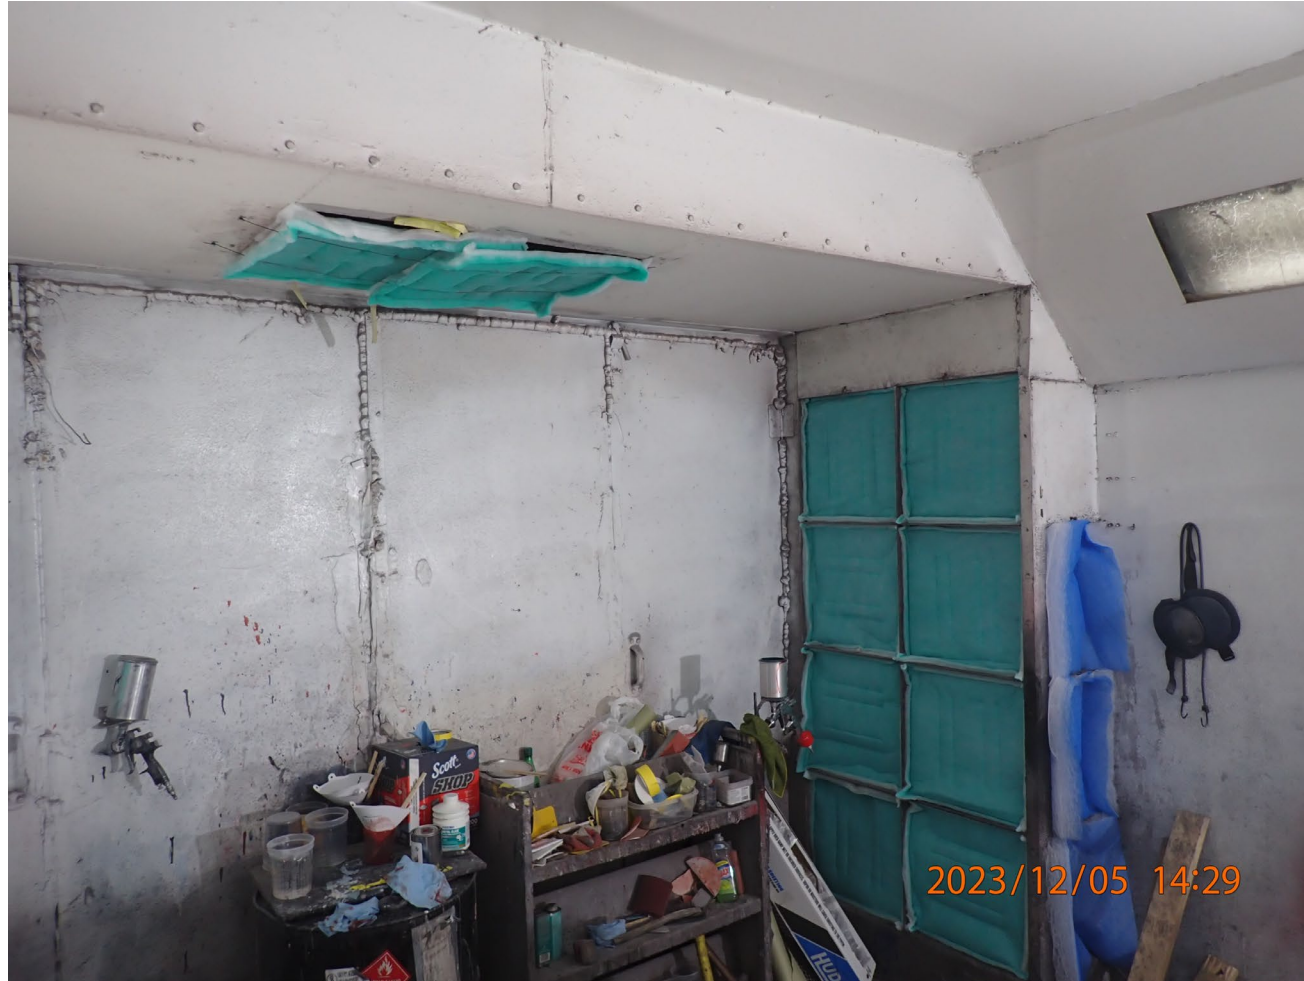
Photo Number: 42

Photo Description: Interior of Paint Booth

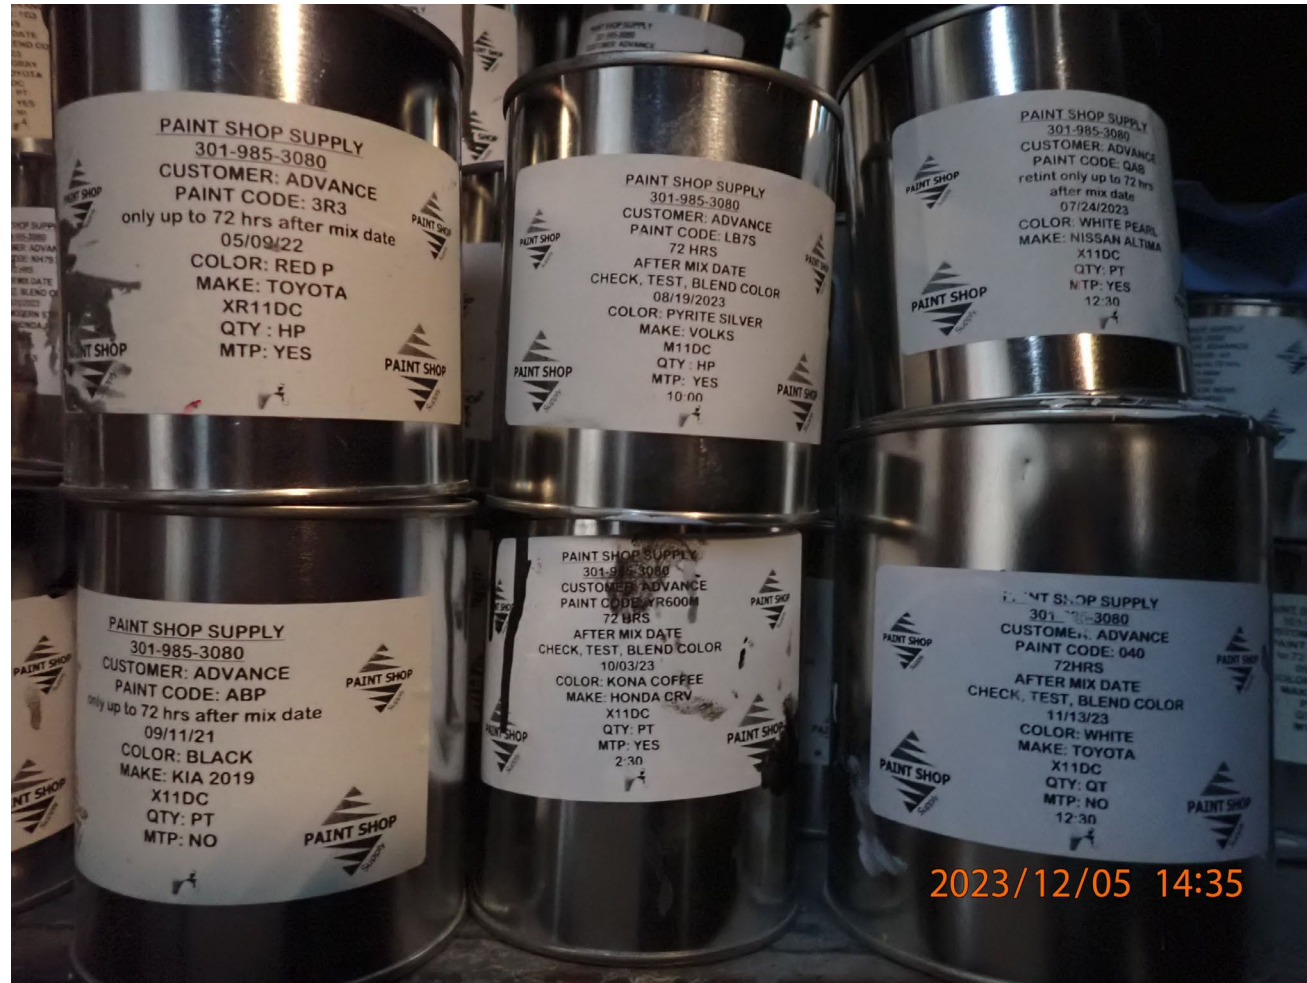
Photo Number: 43

Photo Description: Paint Shop Supply Paint Label's

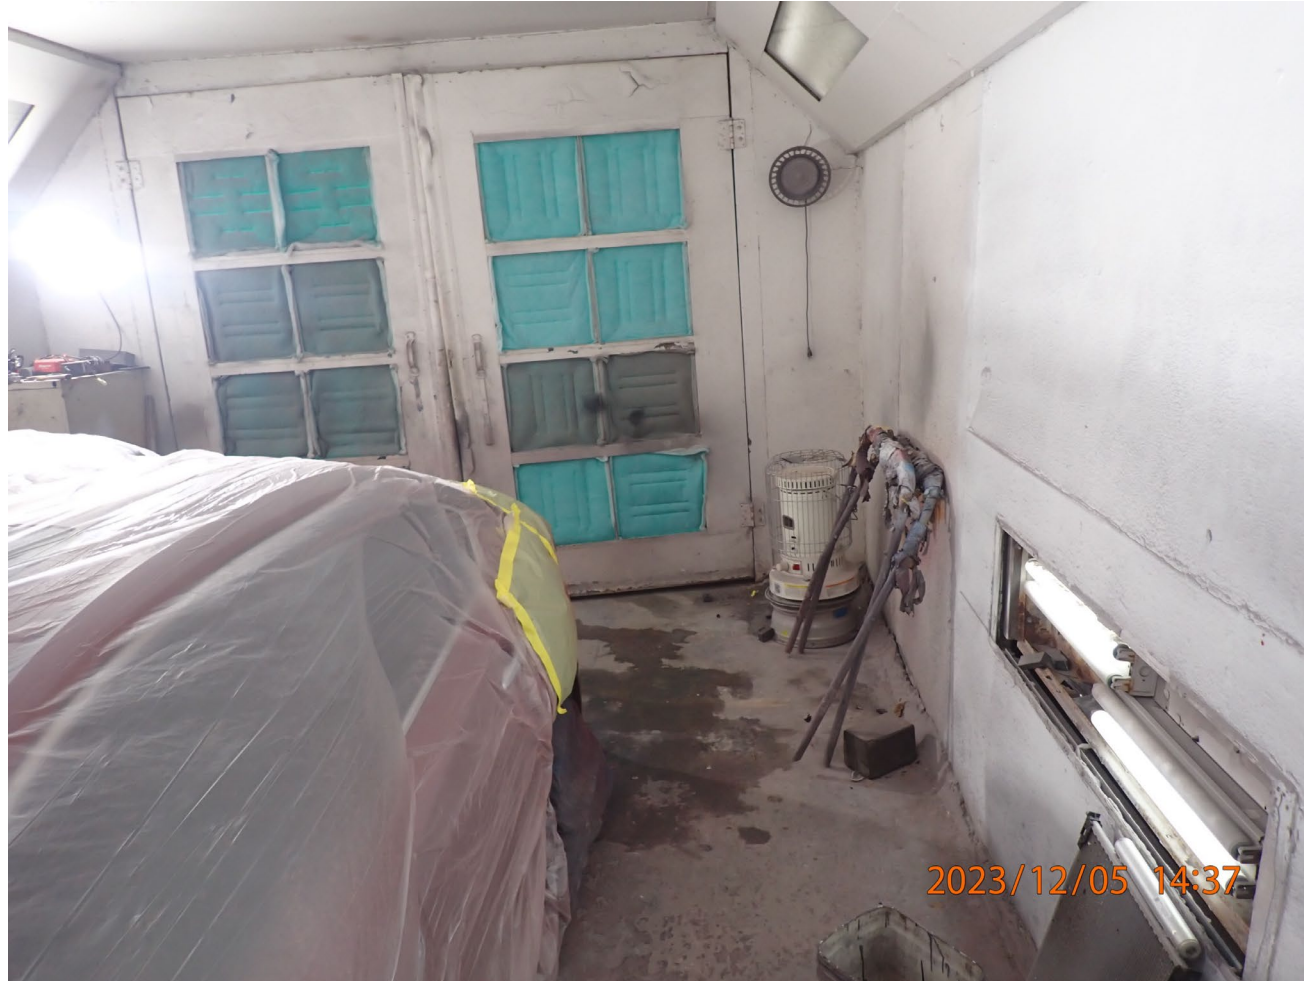
Photo Number: 45

Photo Description: Interior of Paint Booth

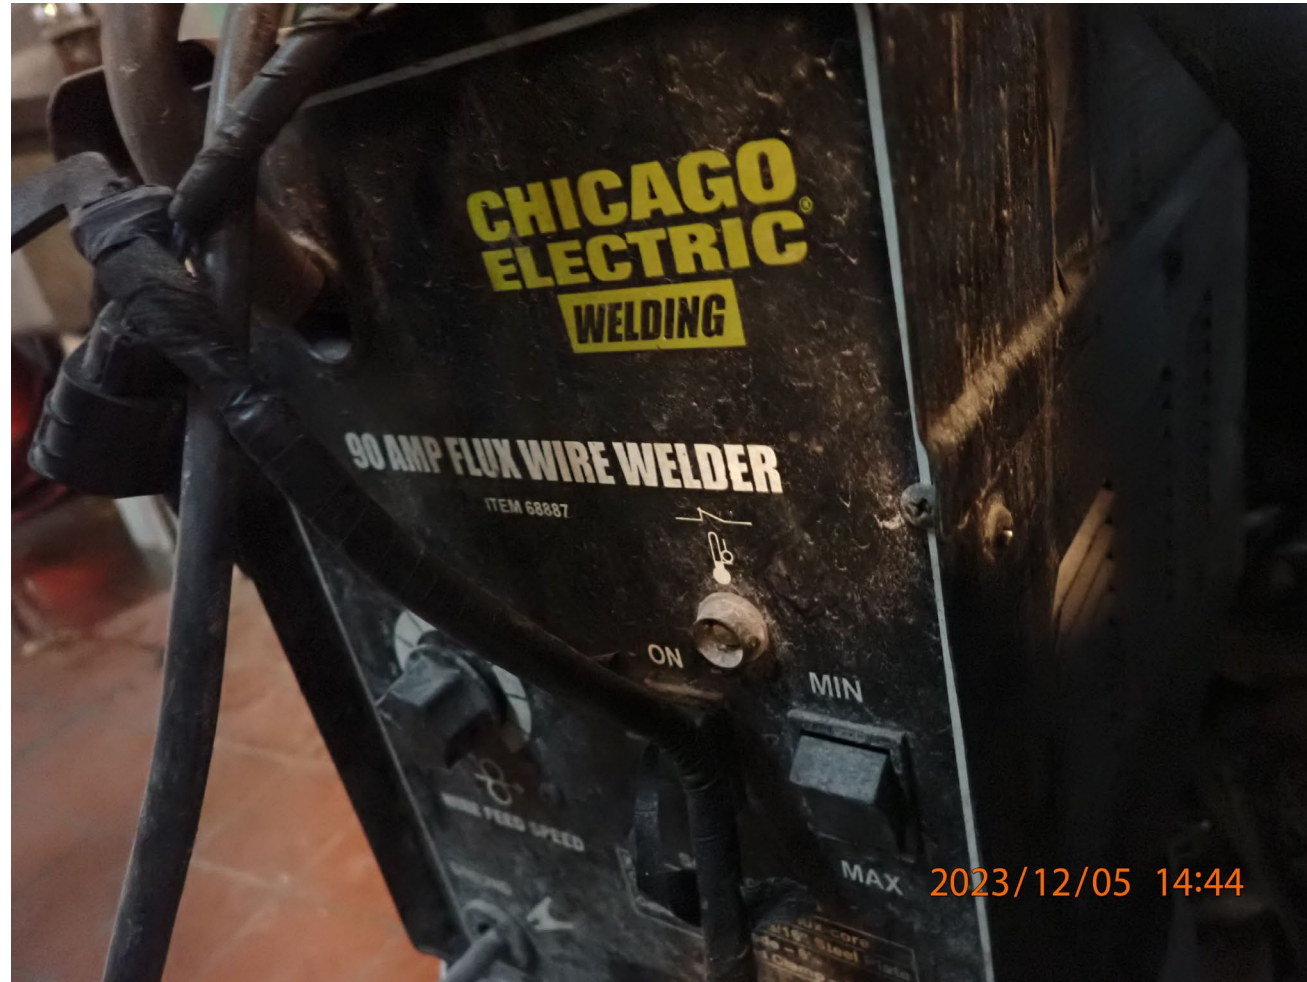
Photo Number: 46

Photo Description: Chicago Electric Welder

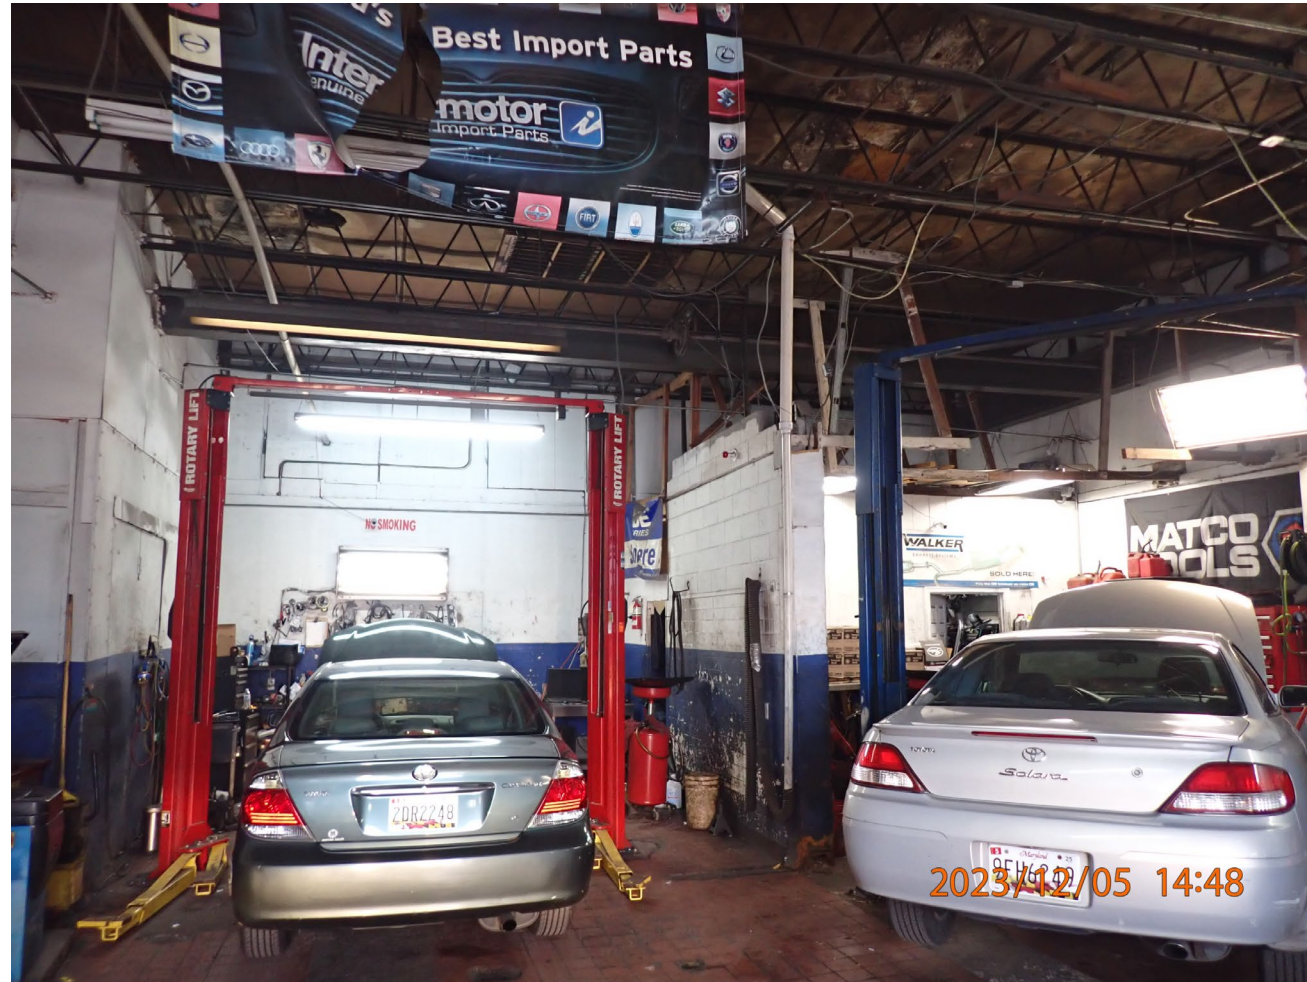
Photo Number: 47

Photo Description: Interior of Garage

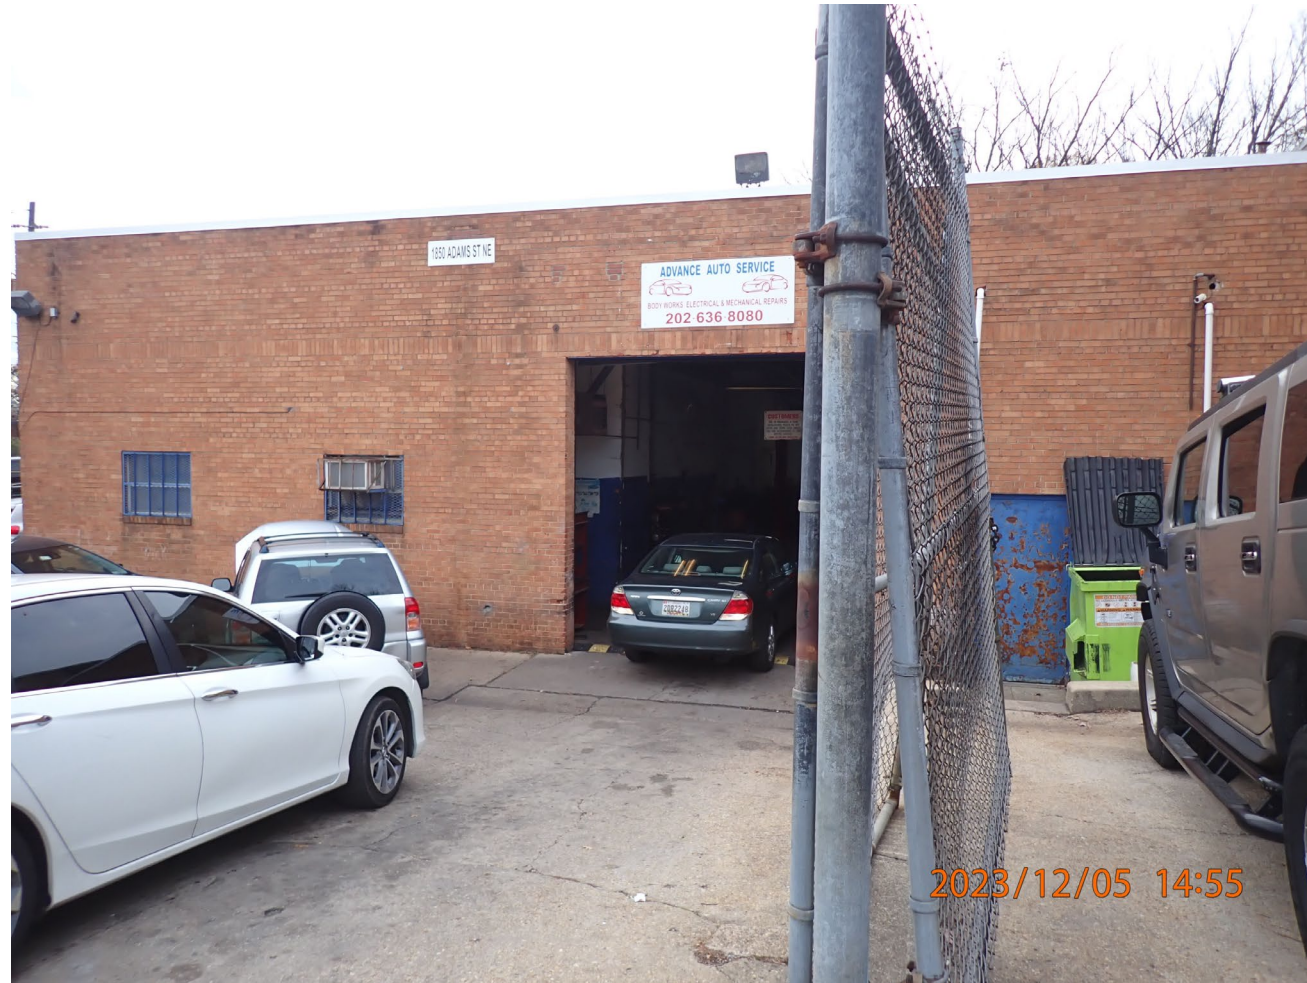
Photo Number: 48

Photo Description: Exterior of Advance Auto Service Garage
