## Region 6 - Enforcement & Compliance Assurance Division

### INSPECTION REPORT

| Company Name: | <b>Contango Resources, LLC</b> | |
| Facility Name: | <b>Fanny Lease</b> | |

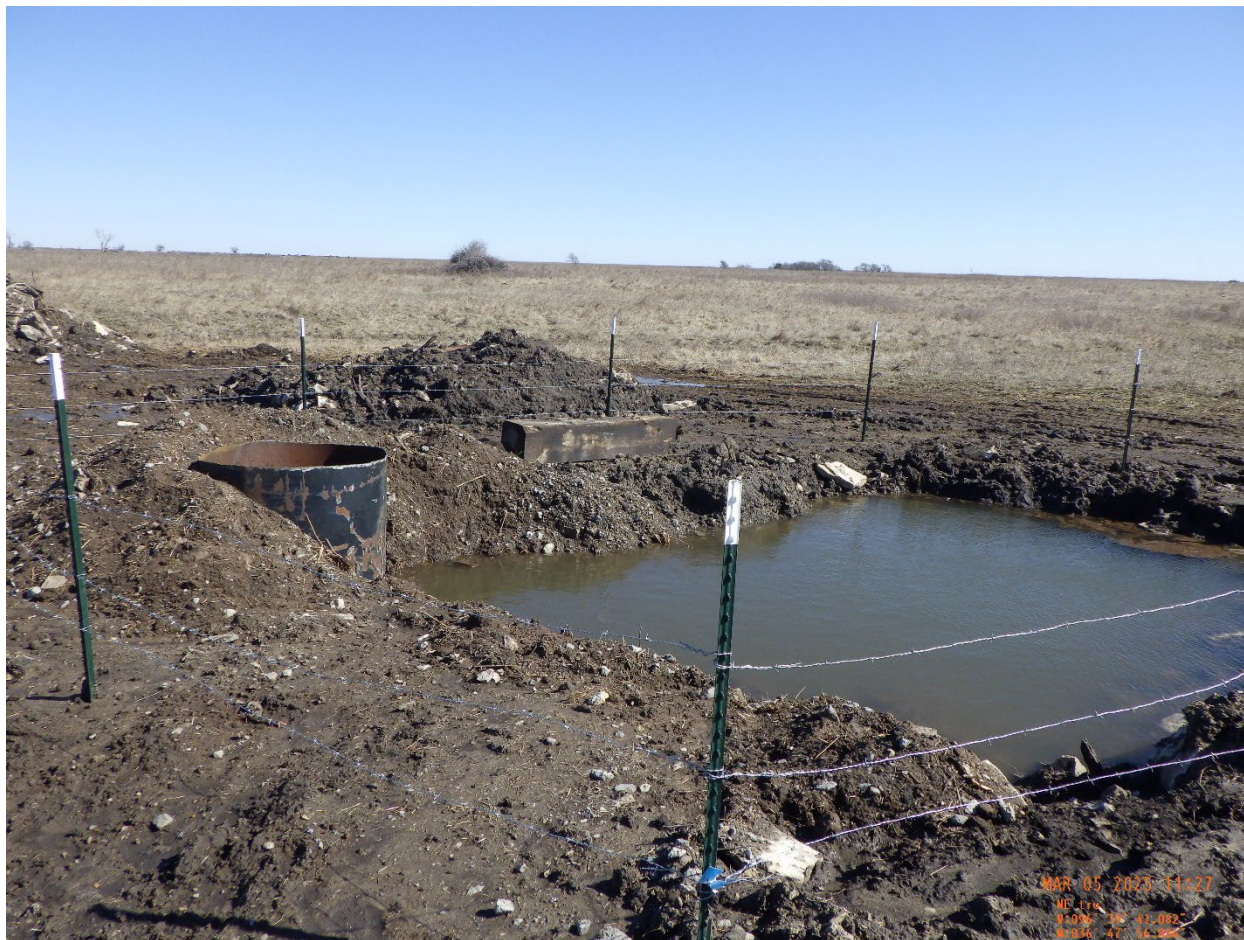
Photo No. 1

I observed the release point of the spill, which was the previously plugged and abandoned Fanny #3 well. There was a fenced containment pit and well cellar at the location. See photo No. 1, Appendix 1 (photo log). For additional GPS location information and photo metadata, see the attached photo log.

**Description:** This was the pit, fence, well basement and release point for the spill which originated from the Fanny #3 well.

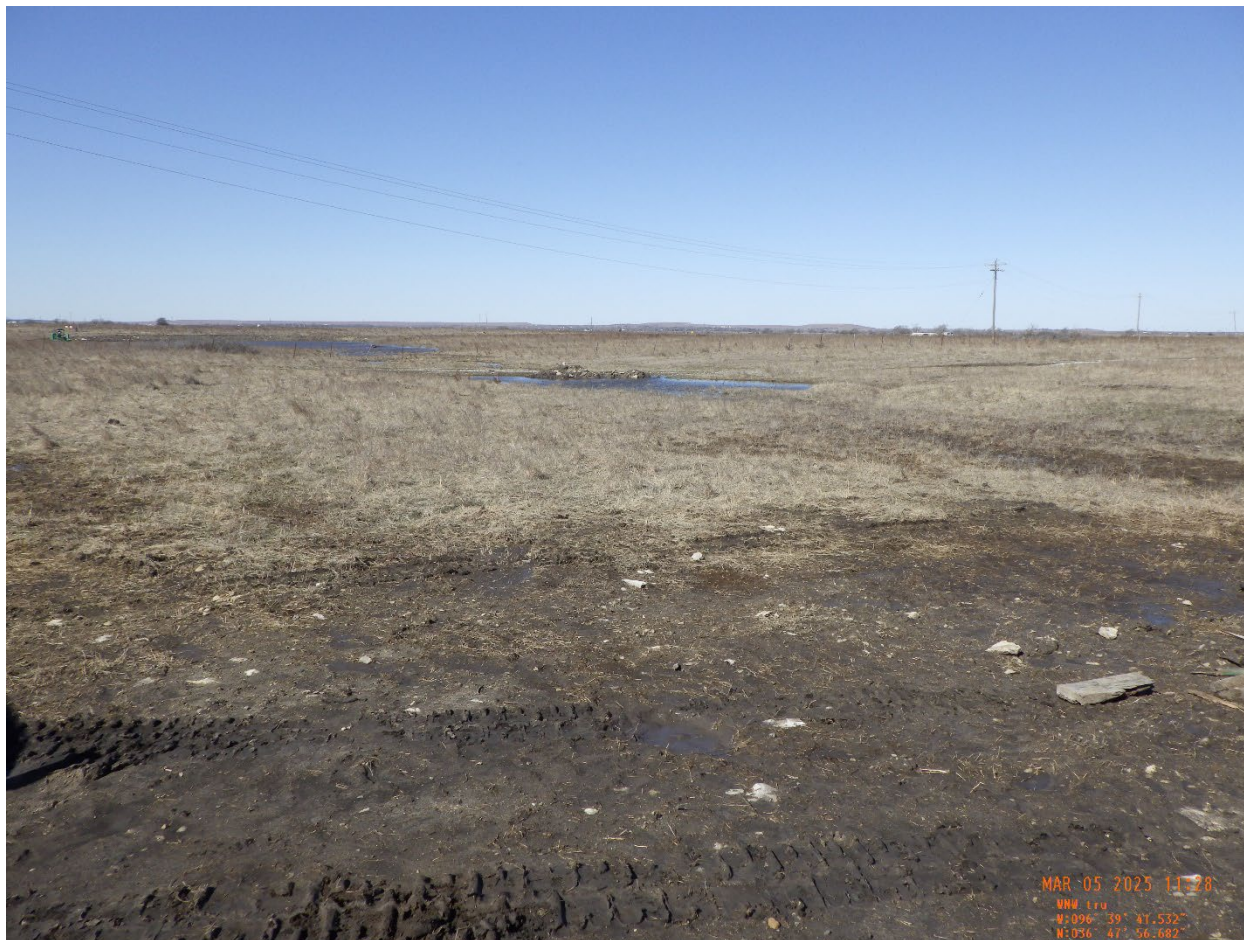
Photo No. 2

Standing at the release point, I observed the flowpath of the spill which continued approximately 500 feet toward the west, terminating in a stock pond. See photo No. 2.

**Description:** This was a photo from the Fanny #3 (release point) with a view to the WNW showing the flowpath of the spill, which ended at the pond and green pump in the top left of the photo.

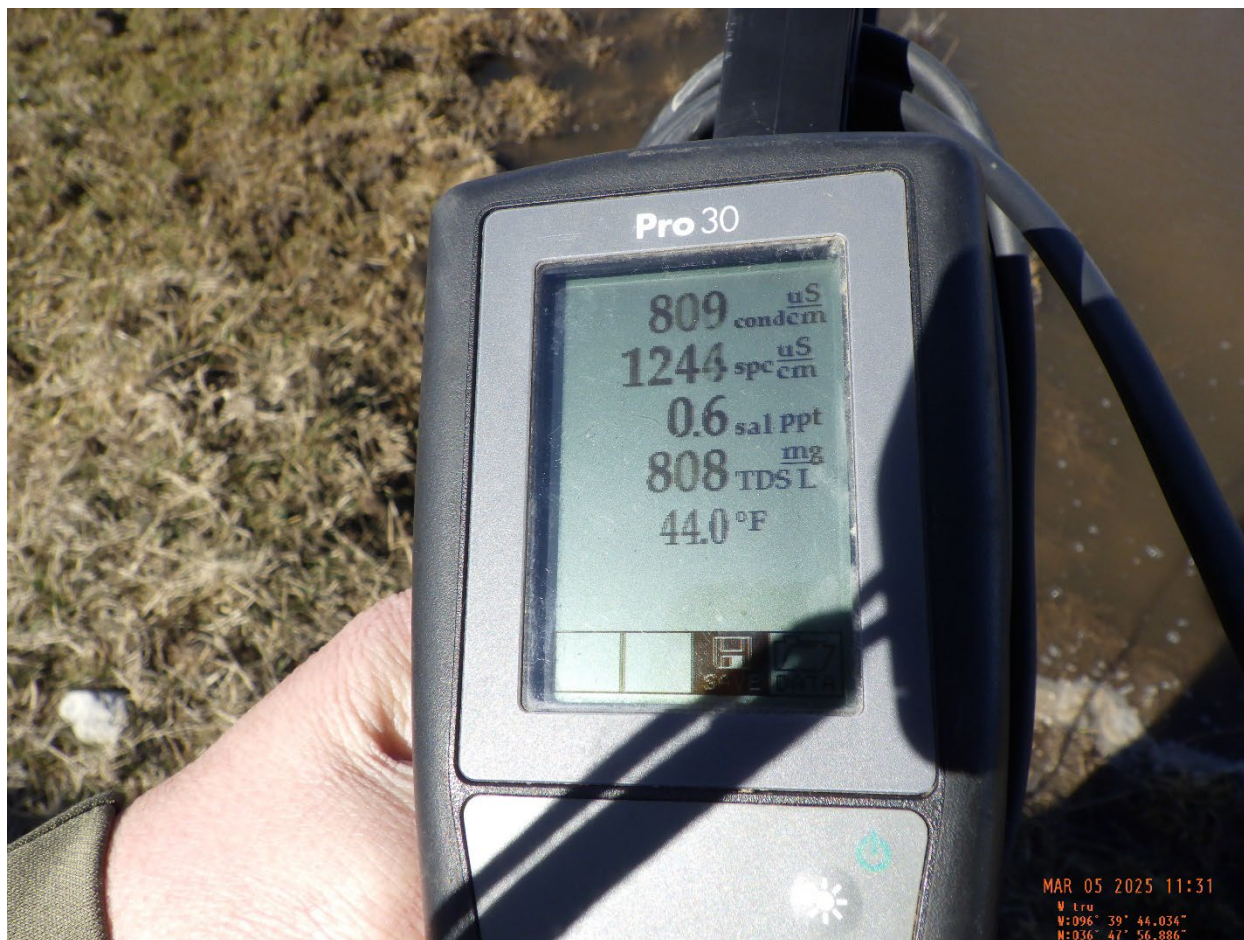
Photo No. 3

Approximately 125 feet west of the release point/Fanny #3, I observed a TDS field reading of 808 mg/L where the flowpath crossed the nearby lease road. See photo No. 3.

**Description:** This was a TDS field reading of 808 mg/L taken approximately 100 feet west of the release point where the spill crossed the lease road.

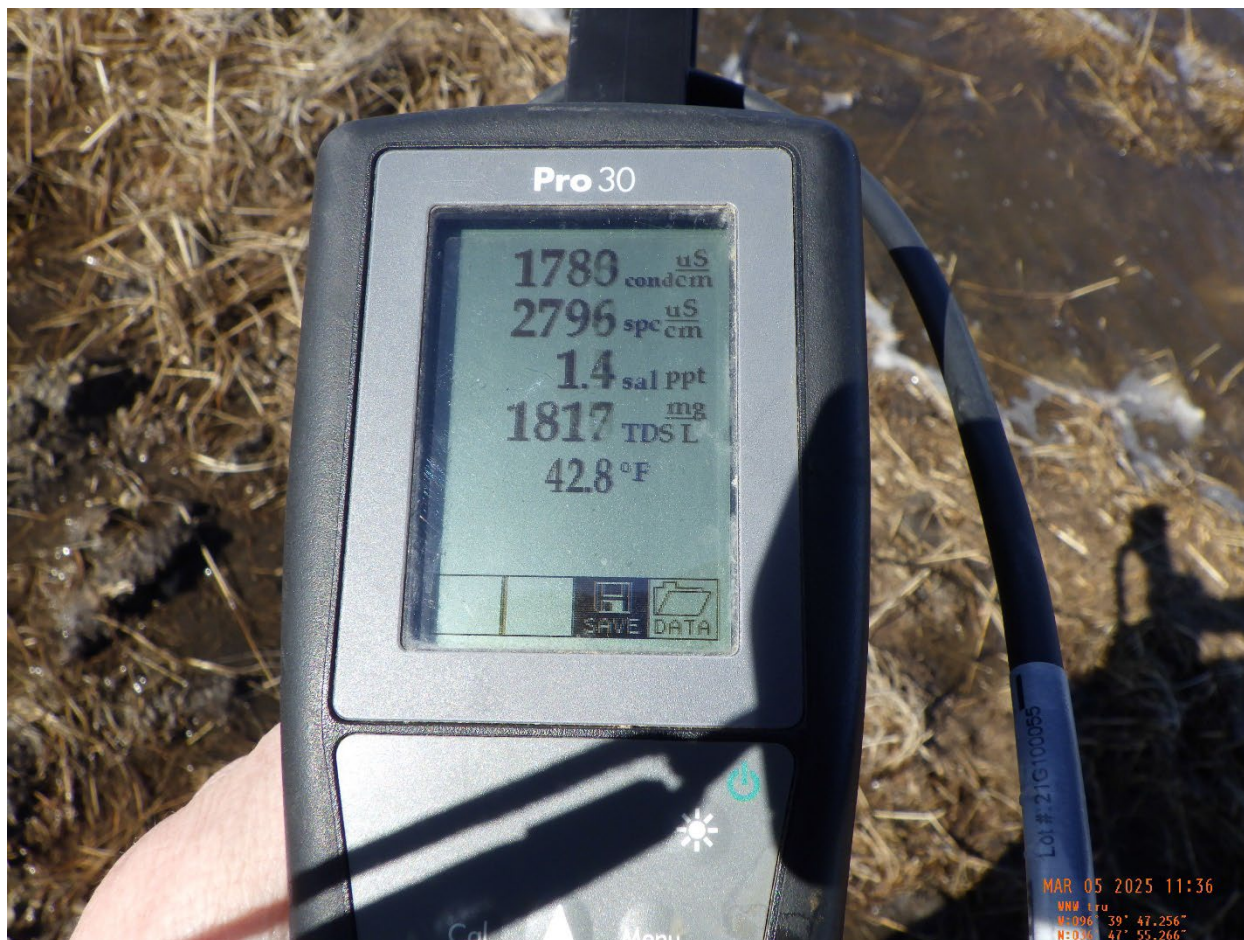
Photo No. 4

Approximately 500 feet west of the release point, at the end of the spill impacts, I observed a TDS field reading of 1817 mg/L. This was the highest TDS reading observed during the inspection. See photo No. 4. At the same location, I observed a trailer mounted water pump and two (2) frac tanks which were being used to remove the impacted water from the stock pond, see photo No. 5.

**Description:** This was a TDS field reading of 1,817 mg/L taken in the pond/end of spill impacts, approximately 500 feet west of the release point.

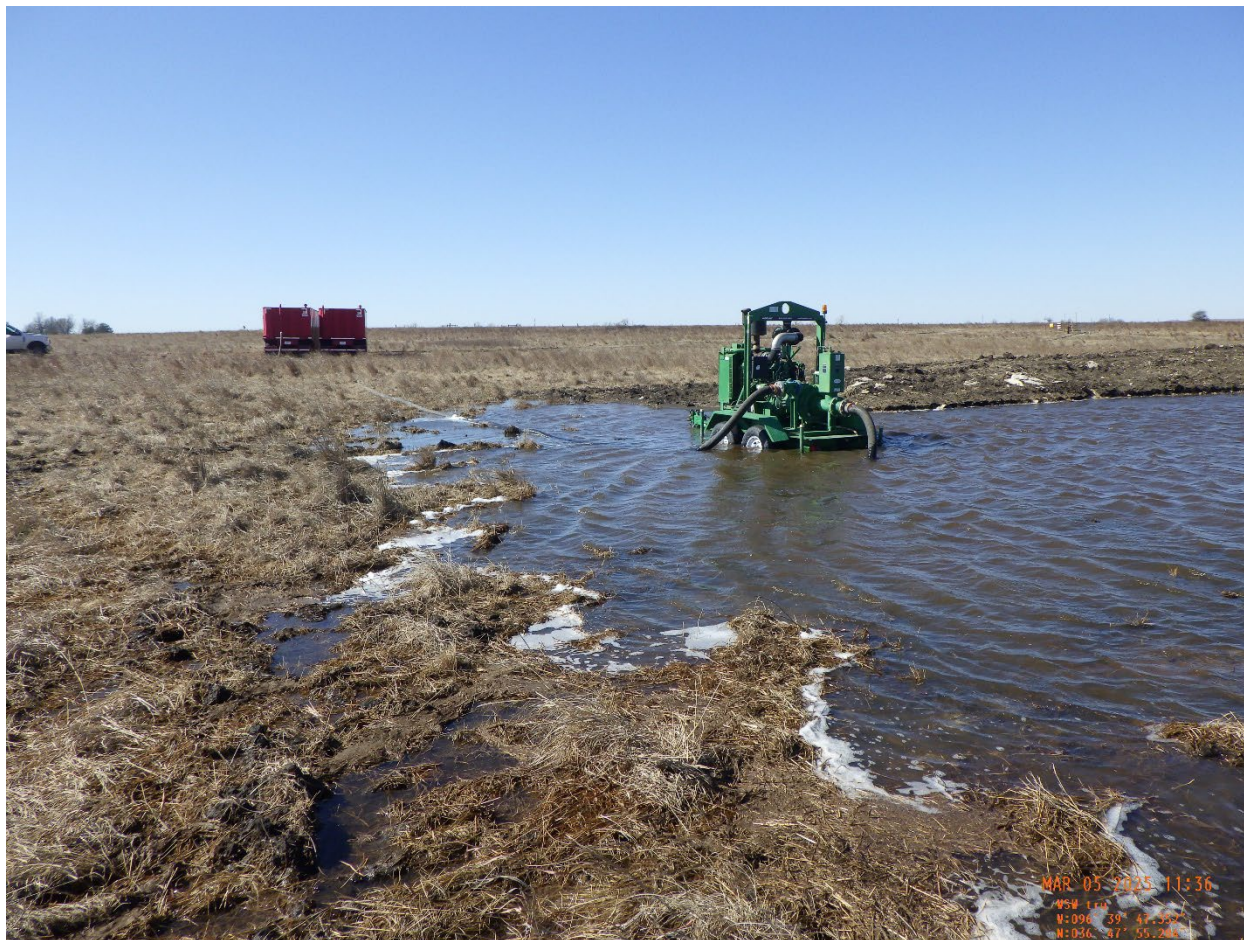
Photo No. 5

**Description:** This was the pump and frac tanks being used to remove the impacted water from the stock pond.
