**Region 6 - Enforcement & Compliance Assurance Division**  
**INSPECTION REPORT**

| Inspection Date(s): | 03/15/2024 | |
| Company Name: | <b>ArklaTx Operating Company, Inc.</b> | |
| Facility Name: | <b>SWWS #3 – Flenniken A-12 SWD</b> | |

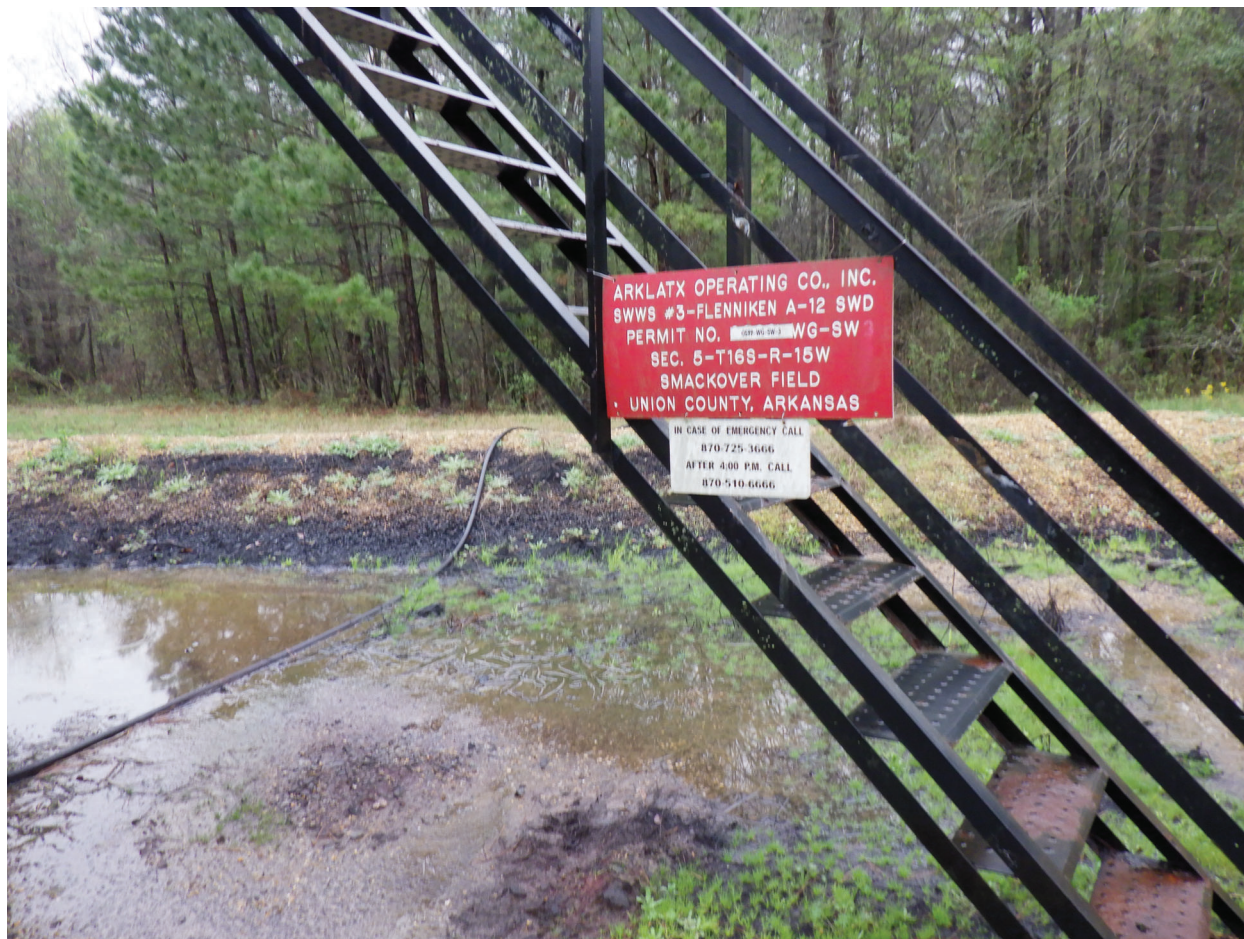
Photo No. 1

I observed the facility sign, secondary containment, pipes, valves, and storage tank located at the facility; see Appendix 1 (photo log), photo No. 1 and No. 2. For additional GPS location and photo metadata, see Appendix 1.

**Photo File Name:** R0010438**Orientation:** SE**Date of Photo:** 03/15/2024**Time of Photo:** 11:17 AM**Latitude:** 33.3557**Longitude:** -92.6773**Photographer:** Uma Lad**Description:** This photo was taken looking southeast and shows the facility sign.

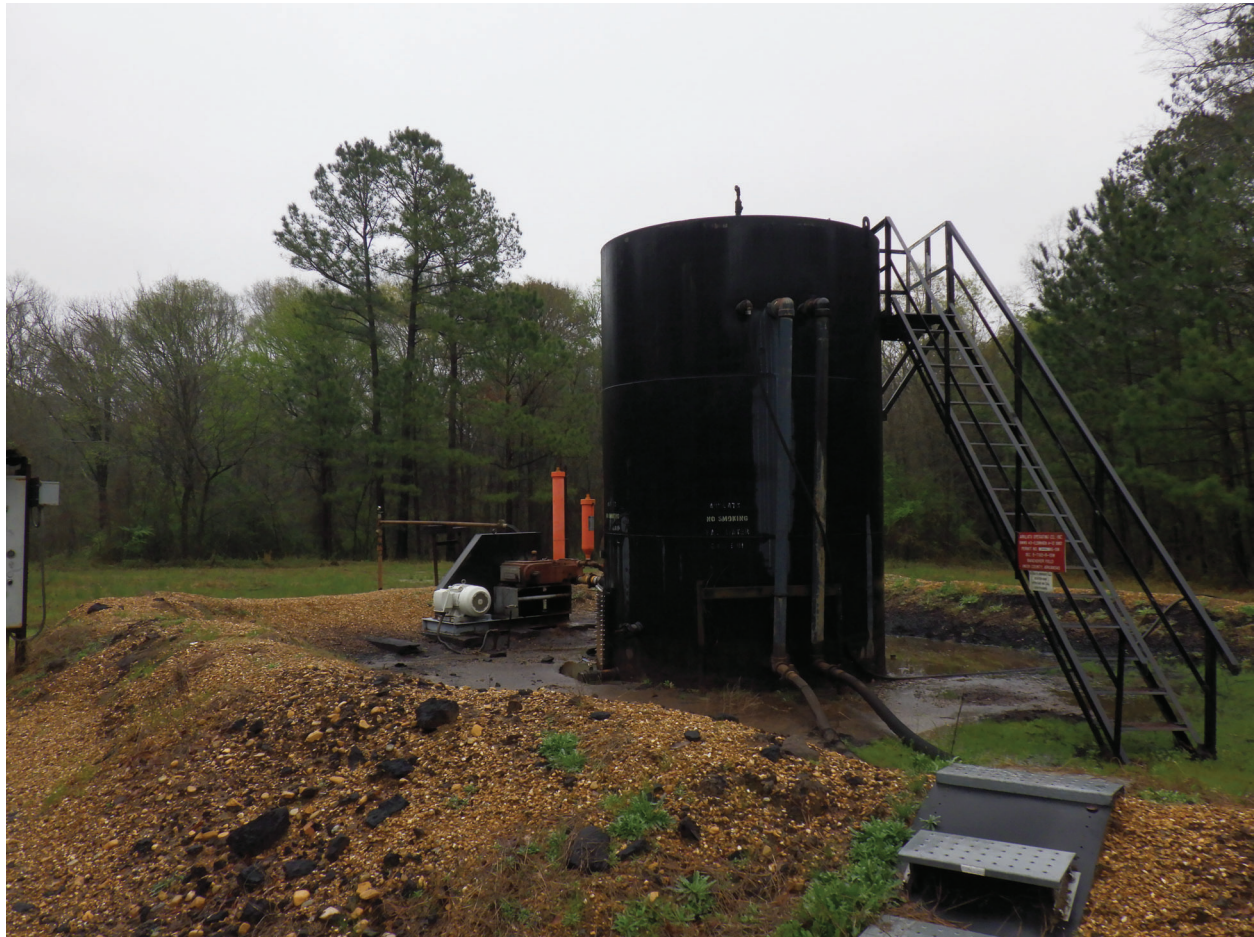
Photo No. 2

I observed oil staining inside secondary containment, see photo No. 2. I also observed fluid leaking from the motor that is connected to the injection well, see photo No. 3.

No closing conference was held due to no ArklaTx Operating Company, Inc. staff being present during the inspection. Areas of concern at the time of the inspection include the oil staining within secondary containment and the leaking motor.

**Photo File Name:** R0010439**Orientation:** E**Date of Photo:** 03/15/2024**Time of Photo:** 11:18 AM**Latitude:** 33.3557**Longitude:** -92.6774**Photographer:** Uma Lad**Description:** This photo was taken looking east and shows an overview of the facility and oil staining inside secondary containment.

Inspector will conduct follow-up phone calls with the company representatives over the coming weeks and months to ensure areas of concern are properly addressed.

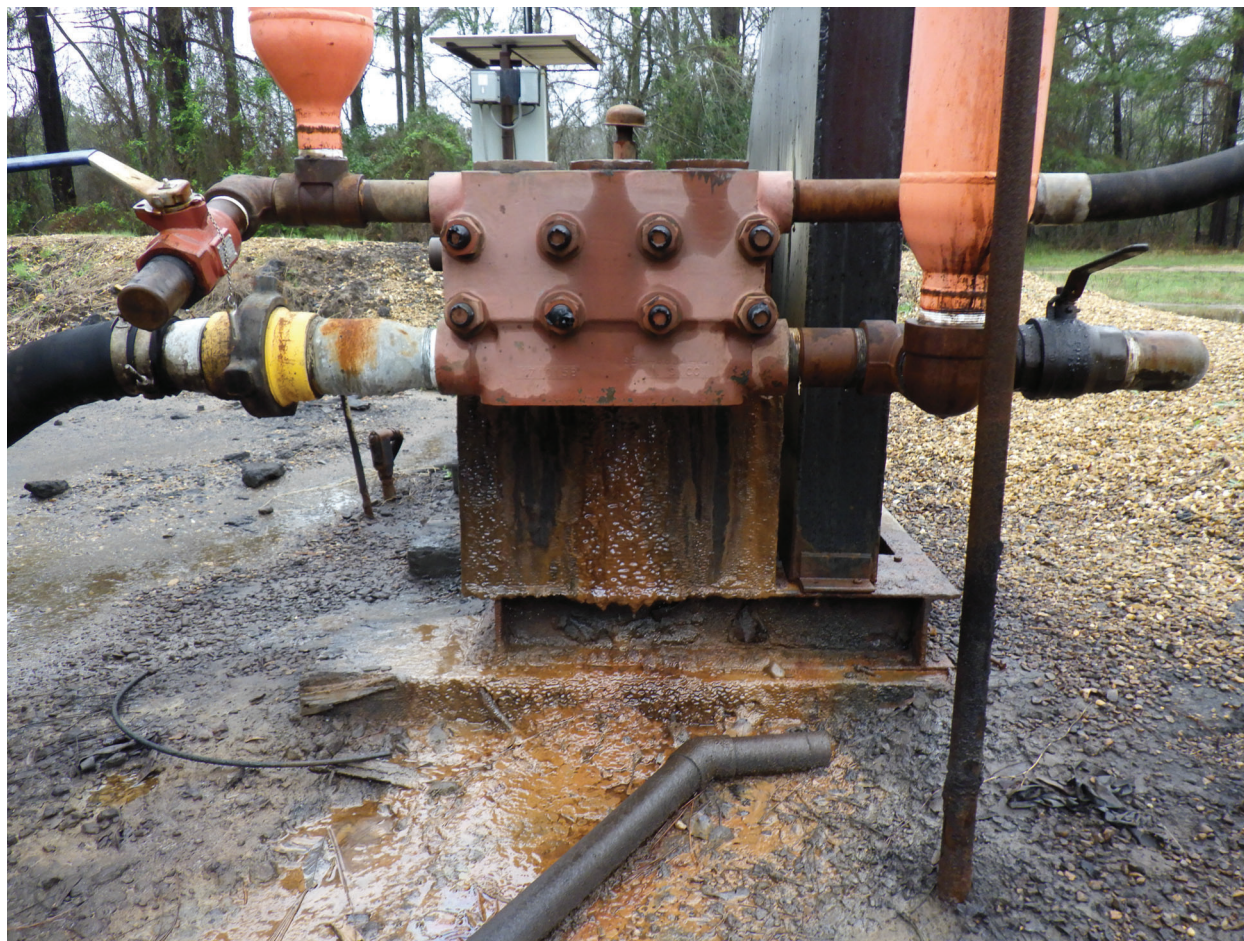
Photo No. 3

**Photo File Name:** R0010440**Orientation:** WSW**Date of Photo:** 03/15/2024**Time of Photo:** 11:19 AM**Latitude:** 33.3558**Longitude:** -92.6772**Photographer:** Uma Lad**Description:** This photo was taken looking west-southwest and shows a leak from the motor connected to the injection well.
