Region 2 Enforcement & Compliance Assurance Division  
Air Compliance Branch  
CAA Inspection Report

Inspection Date: 10/16/2024  
Facility Name: 49 Gingerbread Castle Rd  
Facility Address: 49 Gingerbread Castle Rd, Hamburg NJ  
ICIS-Air ID #: 3601694258  
EPA Lead Inspector: Christopher Collins, EPA Inspector, Collins.Christopher.W@epa.gov  
EPA Asst. Inspector: Victor Tu, EPA Inspector, tu.victor@epa.gov  
Facility Contact: Joseph Park, Owner, [joseph@selininy.com](mailto:joseph@selininy.com)  
State Inspector(s): James Harris, NJDOL, james.harris@dol.nj.gov  
State Inspector(s): Ray Djurin, NJDOL, radovan.djurin@dol.nj.gov

40 CFR Part 61 Subpart M – Asbestos NESHAPs

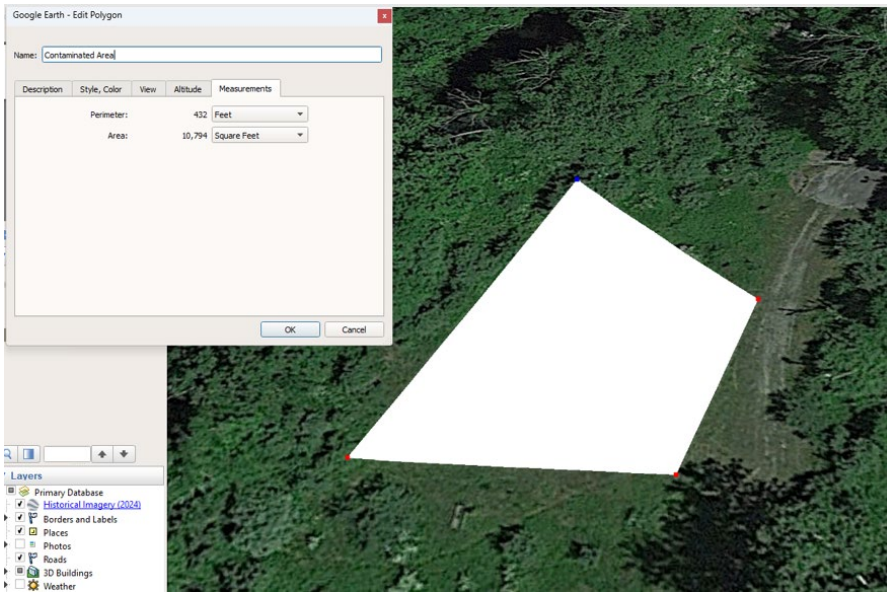
EPA inspectors requested Mr. Sarkisen walk around the perimeter of the site where debris was initial placed for processing and the location that it is currently at. Based the points that Mr. Sarkisen provided, EPA inspector estimated the perimeter and surface area of the potentially contaminated area using Google Earth. The result is provided in figure 2 and 3.

Fig 2, Perimeter and surface area of debris processing area

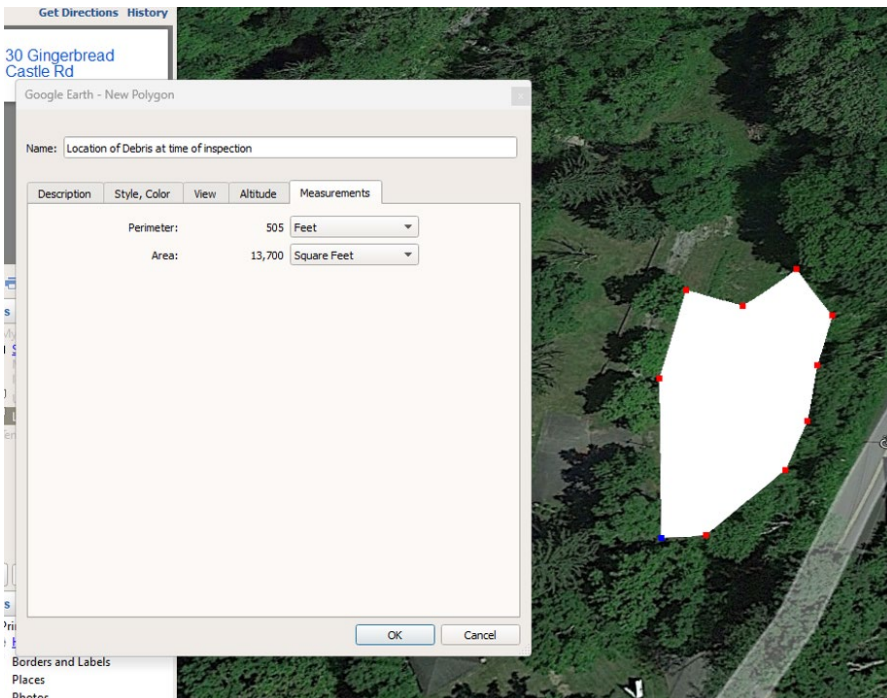
Fig 3, Perimeter and surface area of debris storage area

According to Mr. Sarkisen the debris depth is approximately 7 feet. Bella explained that when the material was moved from the original site, it was scraped from ground level and put into containers in order to transfer it to the current location. No excess soil under the debris was intentionally removed when they were moving the debris from the debris processing area to the storage area.

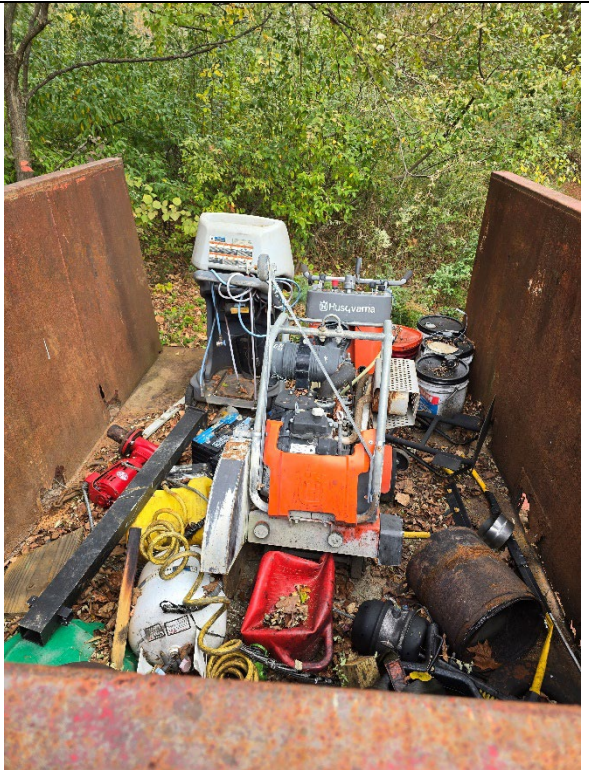
20241016\_105211.jpg

Container with material and equipment from Bella in the debris storage area at the entrance of 30 Gingerbread castle road

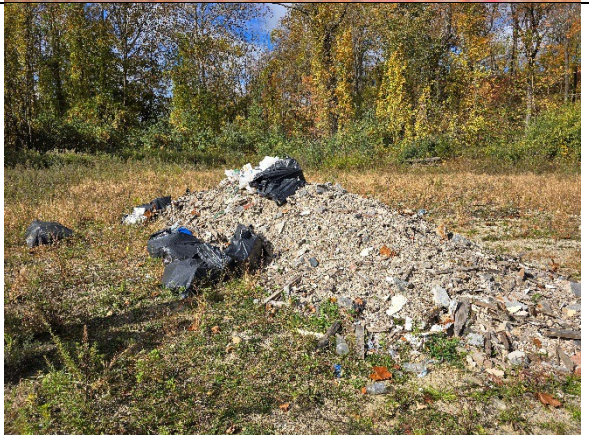
20241016\_110903.jpg

Debris said to be dumped by unknown parties in the debris processing area.

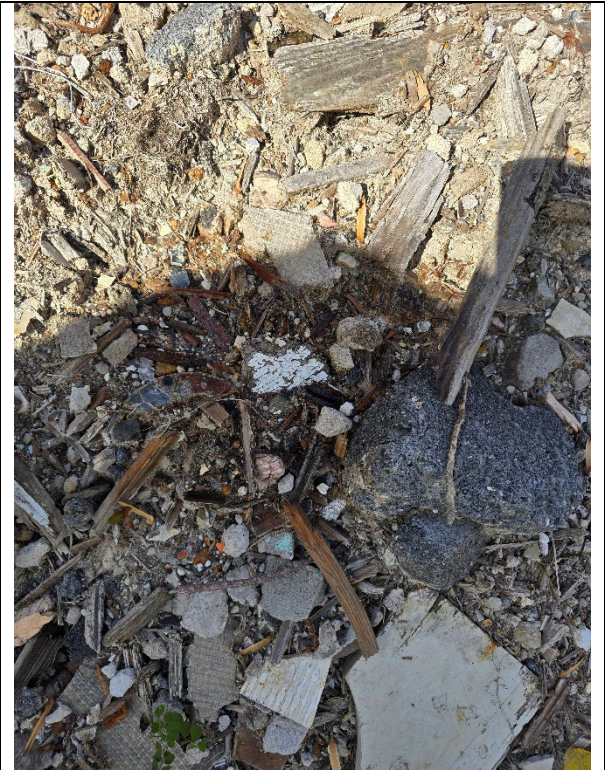
20241016\_113536.jpg

Sample GBC001: White Material

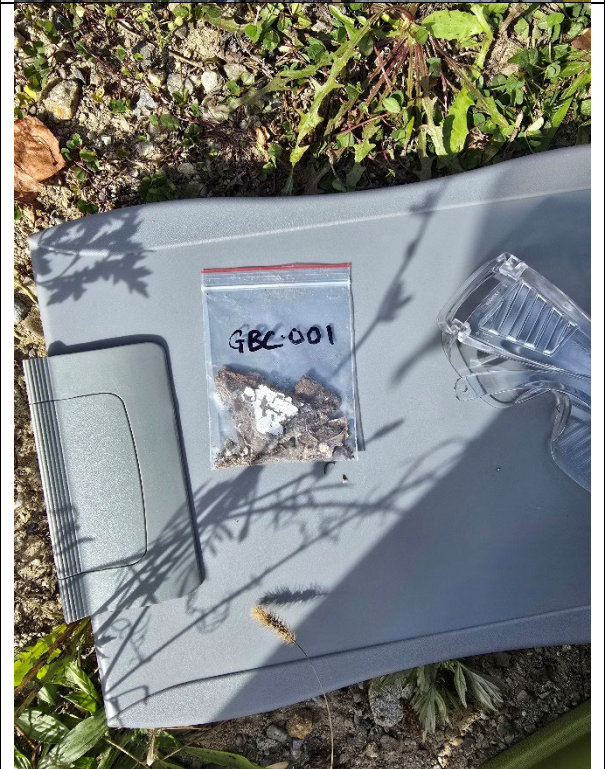
20241016\_113753.jpg

Sample GBC001 (in bag)

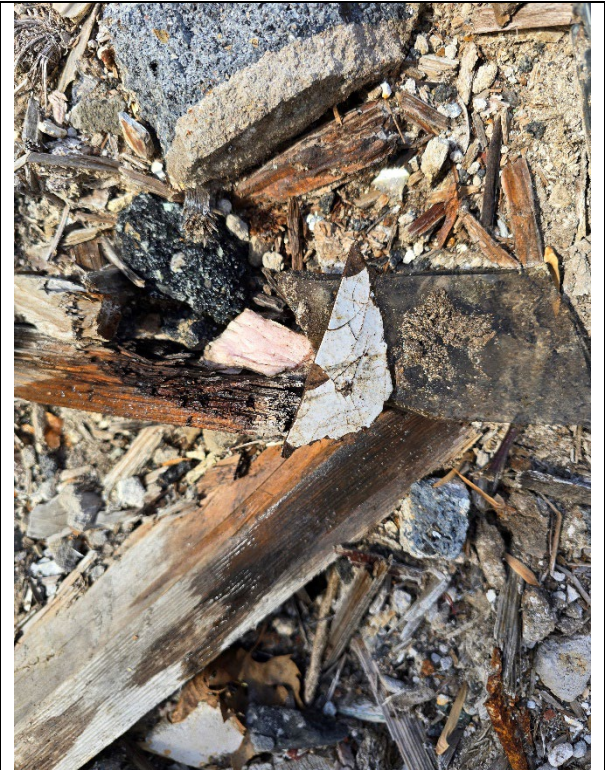
20241016\_113912.jpg

Sample GBC002: White  
Decorative Panel

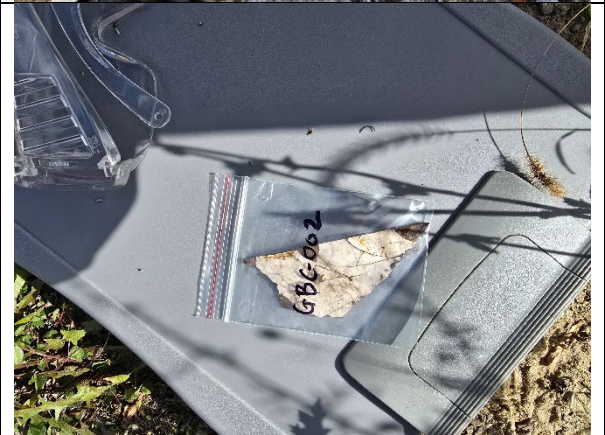
20241016\_114004.jpg

Sample GBC002 (in bag)

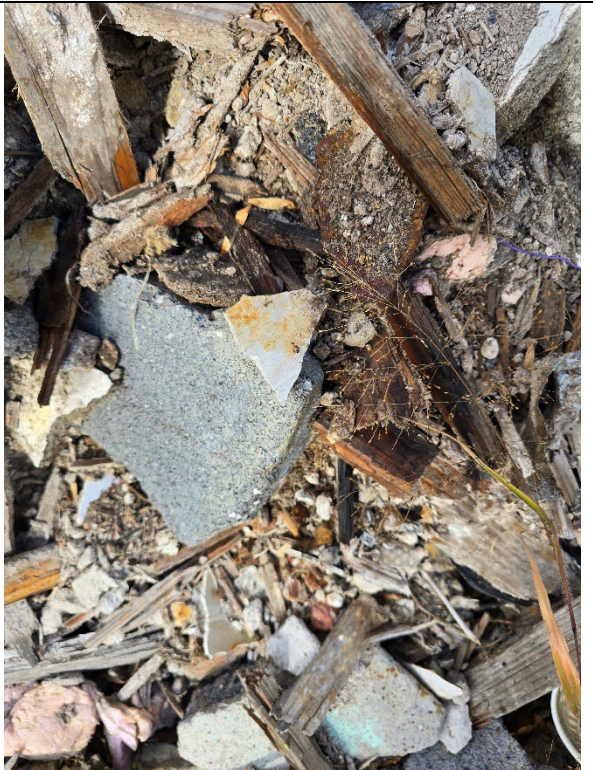
20241016\_114120.jpg

Sample GBC003: Floor Tile

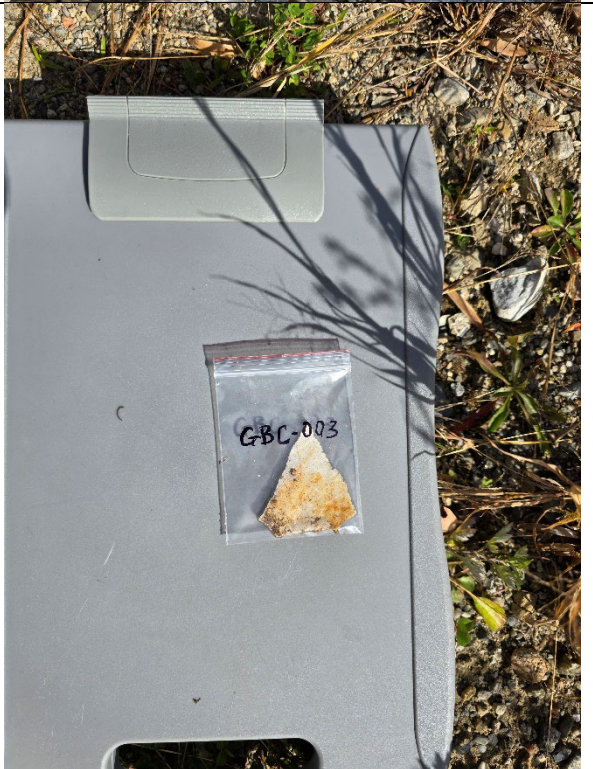
20241016\_114244.jpg

Sample GBC003 (in bag)

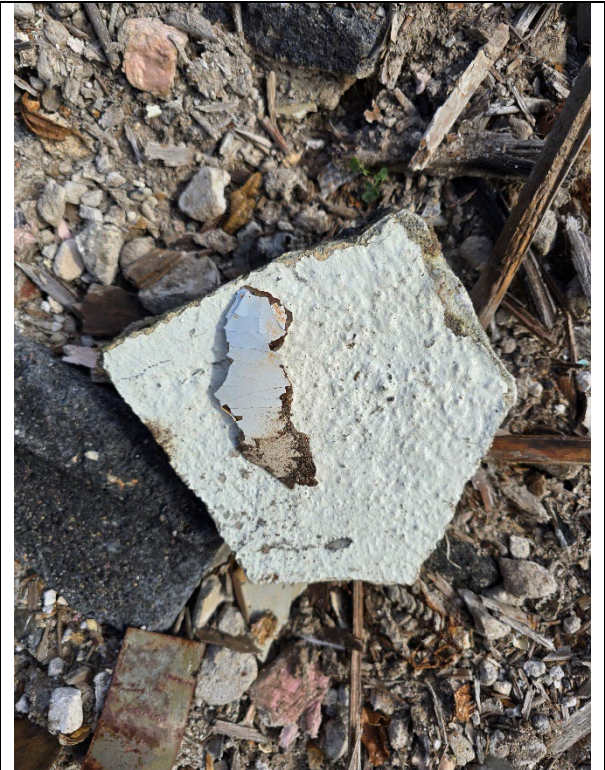
20241016\_114632.jpg

Sample GBC004: White Material

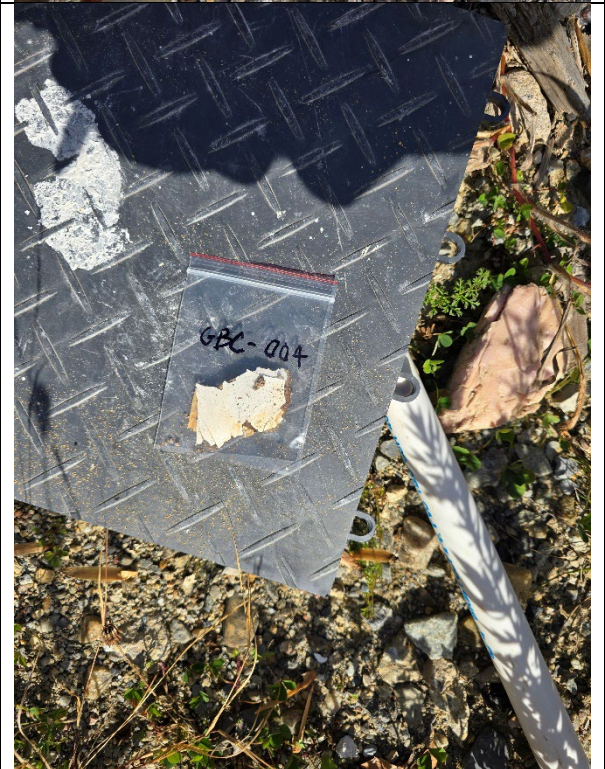
20241016\_114905.jpg

Sample GBC004 (in bag)

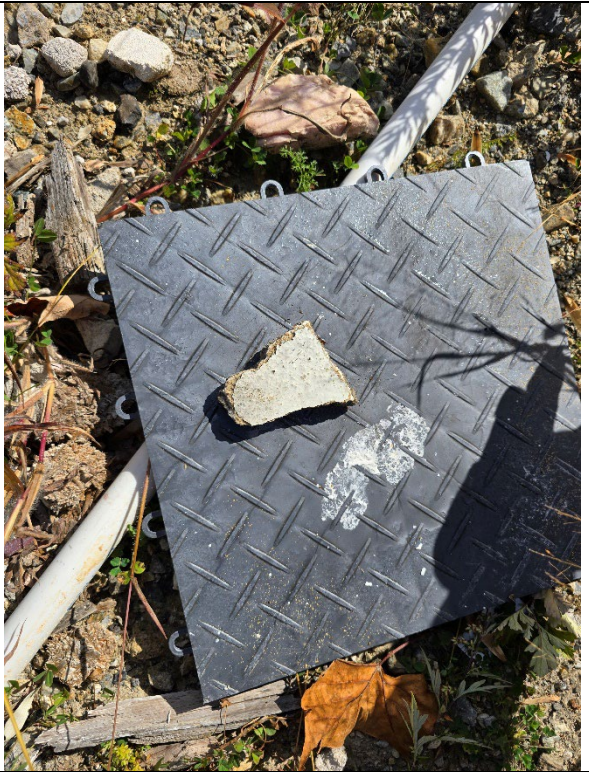
20241016\_115127.jpg

Sample GBC005: Multiple Layered Troweled-On Material

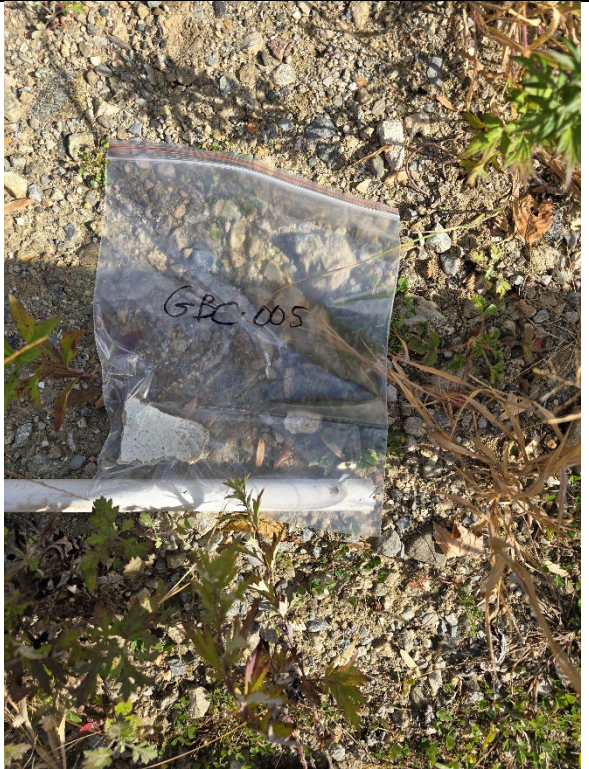
20241016\_115339.jpg

Sample GBC005 (in bag)

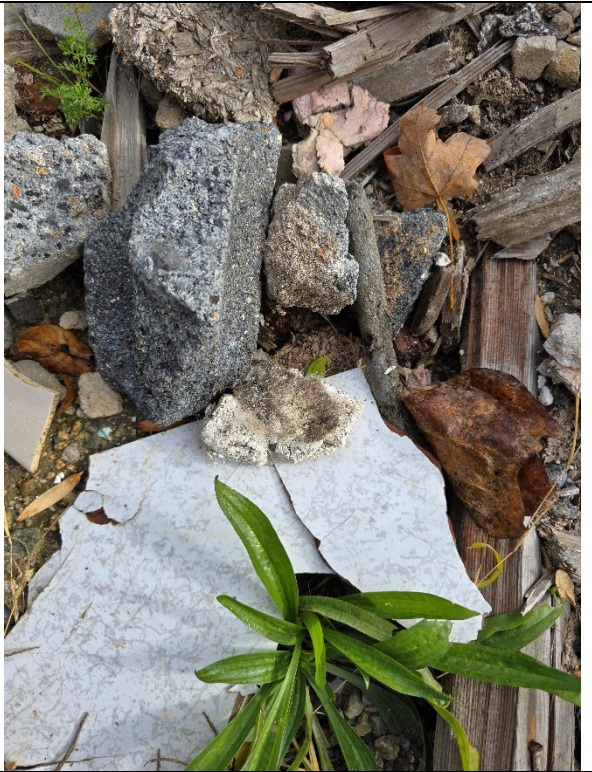
20241016\_115601.jpg

Sample GBC006: Wall Board / Gypsum

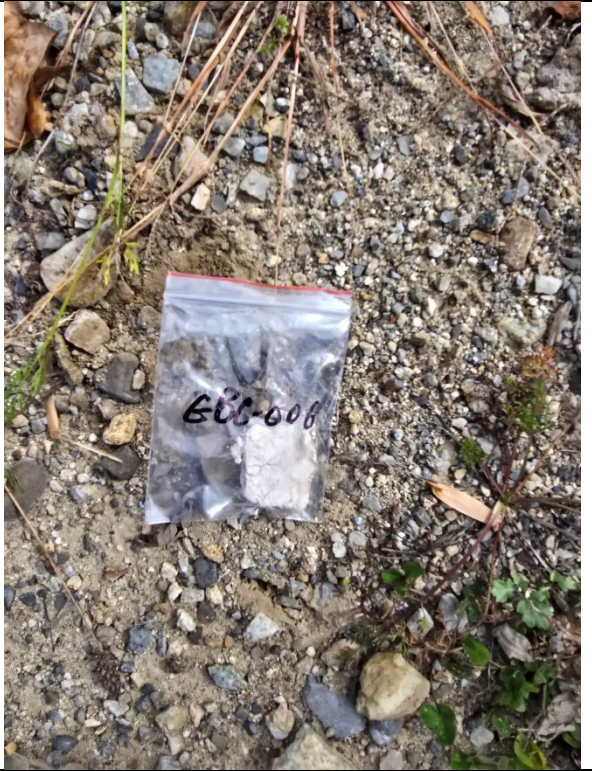
20241016\_115632.jpg

Sample GBC006 (in bag)

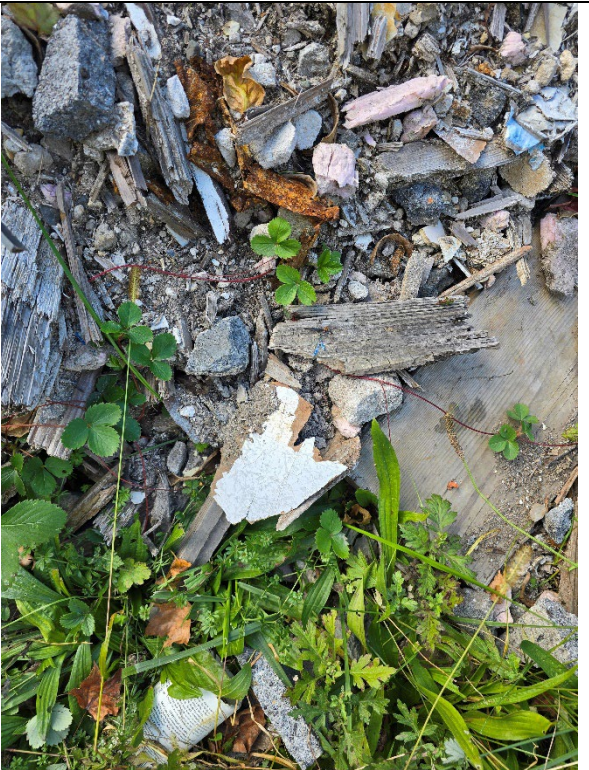
20241016\_123649.jpg

At approximately 12:30 PM, EPA inspectors start looking at the debris said to be dumped by unknown parties in the debris storage area at the entrance of 30 Gingerbread castle road. The material appears to have same consistency as material found in pile in the processing area.

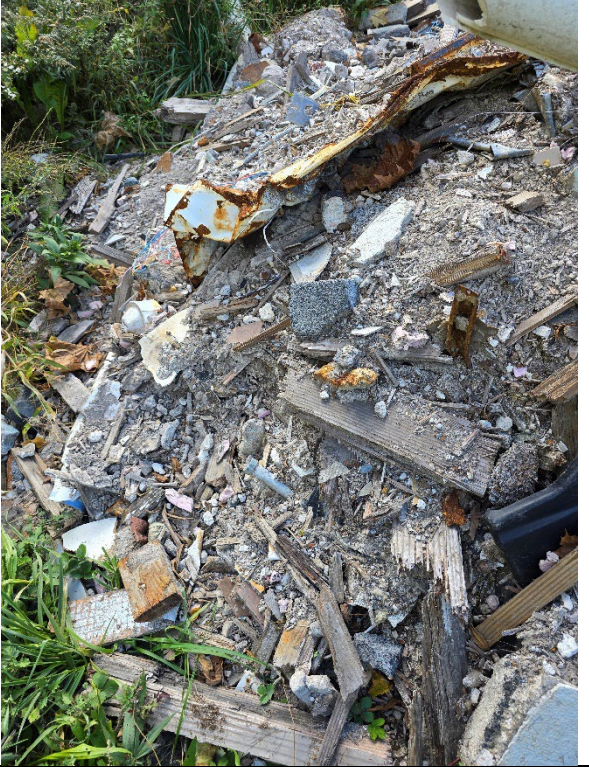
20241016\_123655.jpg

At approximately 12:30 PM, EPA inspectors start looking at the debris said to be dumped by unknown parties in the debris storage area at the entrance of 30 Gingerbread castle road. The material appears to have same consistency as material found in pile in the processing area, thus EPA inspectors decide to take only two samples from this pile. Sample 007 and 008 was taken.

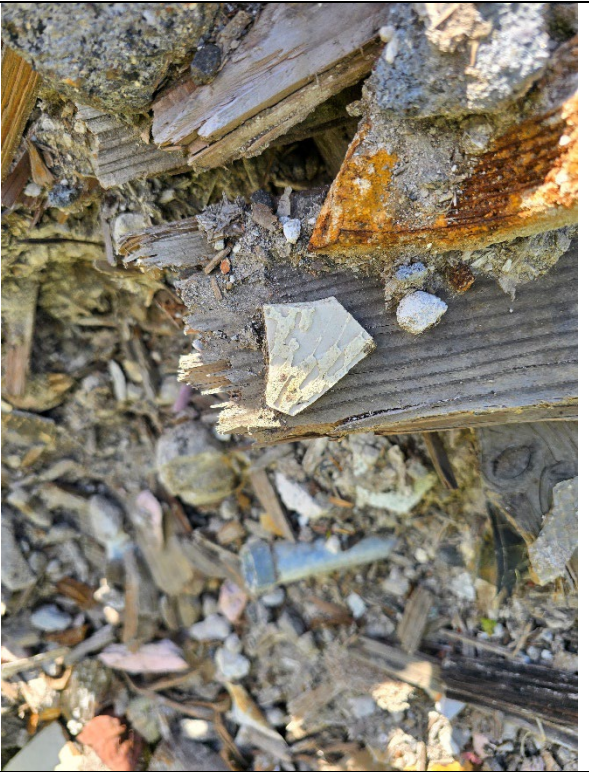
20241016\_123904.jpg

Sample GBC007: Plaster from Tiles (ceramic) Mastic

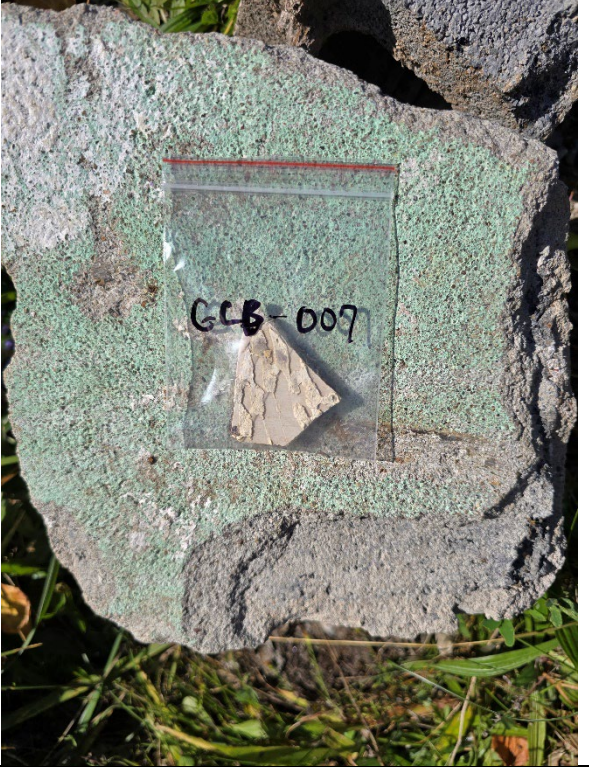
20241016\_123955.jpg

Sample GBC007 (in bag)

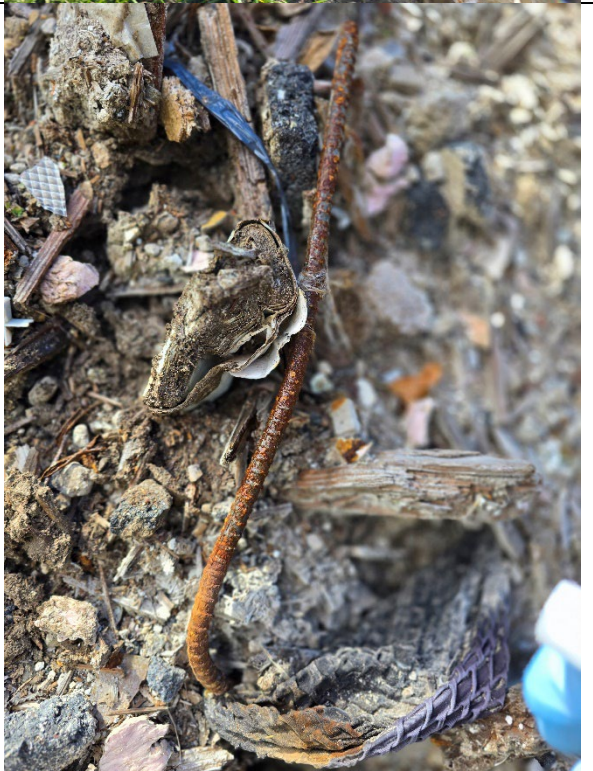
20241016\_124117.jpg

Sample GBC008: Pipe  
Insulation

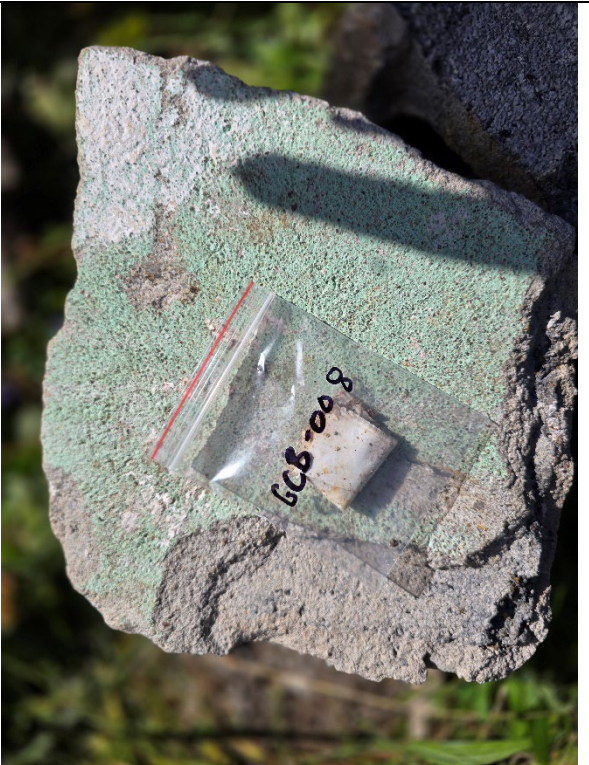
20241016\_124242.jpg

Sample GBC008 (in bag)

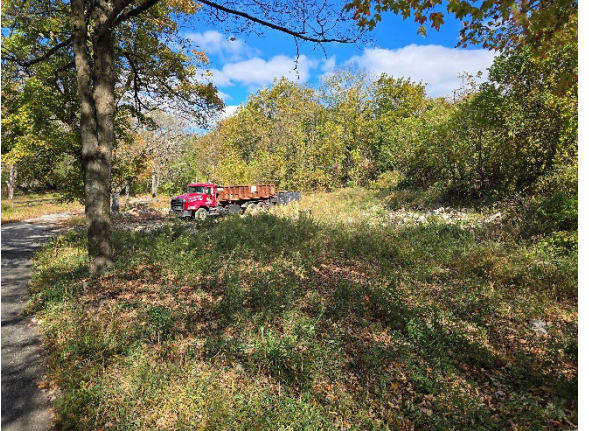
20241016\_131416.jpg

Site where construction debris currently resides.
