**Region 6 - Enforcement & Compliance Assurance Division**  
**INSPECTION REPORT**

| Media Program: | RCRA Compliance Evaluation Inspection | |
| Company Name: | <b>Berridge Manufacturing Company</b> | |
| Facility Physical Location: | 6515 Fratt Road | |

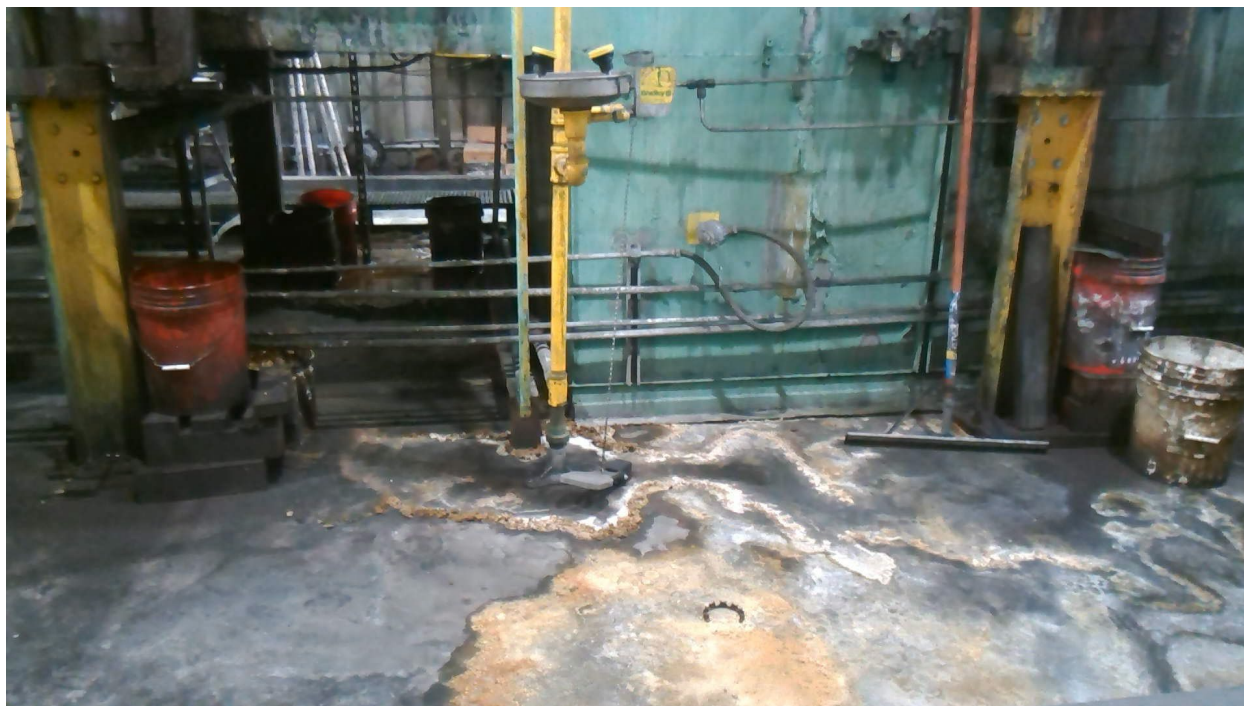
| Photo #: | WIN_20220712_11_20_05_Pro |

| Description: Corrosion along front side at the beginning of the process production line | |

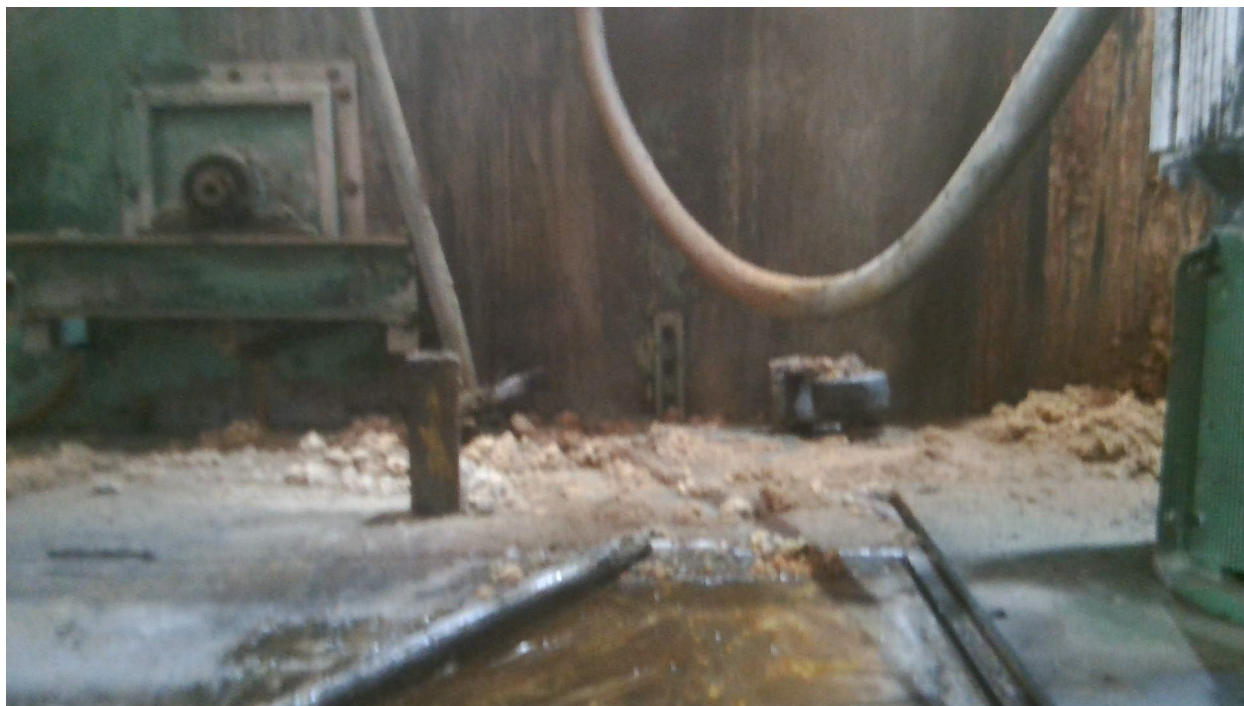
| Photo #: | WIN_20220713_10_11_17_Pro |

During our walkthrough we observed a collection of 5-gallon buckets of a material that was possibly being generated from leaks and splashes of the wash water on the wash unit. This material was a solid with a greyish white appearance. According to the operator, this material was being disposed of by mixing it into the wastewater tanks. According to Tom and Peter Kane, no waste determination had been made on this material.

| Description: | Close up of waste accumulation observed along production line |
