DOCUMENT DESCRIPTION: Draft of Investigation Report - U.S. Chemical Safety and Hazard Investigation Board RE E.I. DuPont de Nemours & Co., Inc.

# **INVESTIGATION REPORT**

## **E.I. DUPONT DE NEMOURS & CO., INC.**

**BELLE, WEST VIRGINIA**

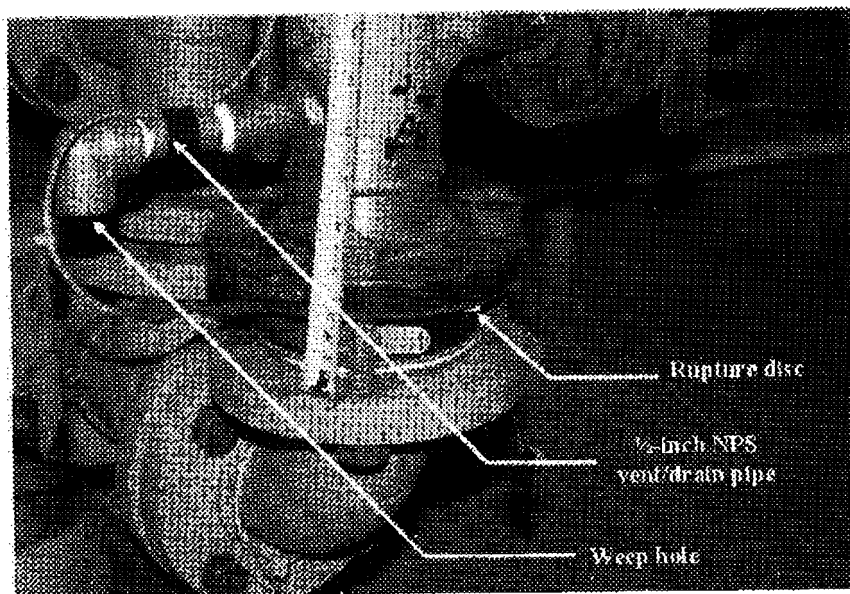
diffused fog and a liquid puddle near a 0.5-inch nominal pipe size (NPS) vent/drain pipe referred to as a weep hole (Figure 3). This connection was associated with a thermal oxidizer "vent stack," which, vents to the atmosphere on the roof of the building under normal operation. Operators notified the board operator at 5:19 a.m. when they found the source of the release.

Figure 3. 0.5-inch NPS vent/drain pipe and rupture disc

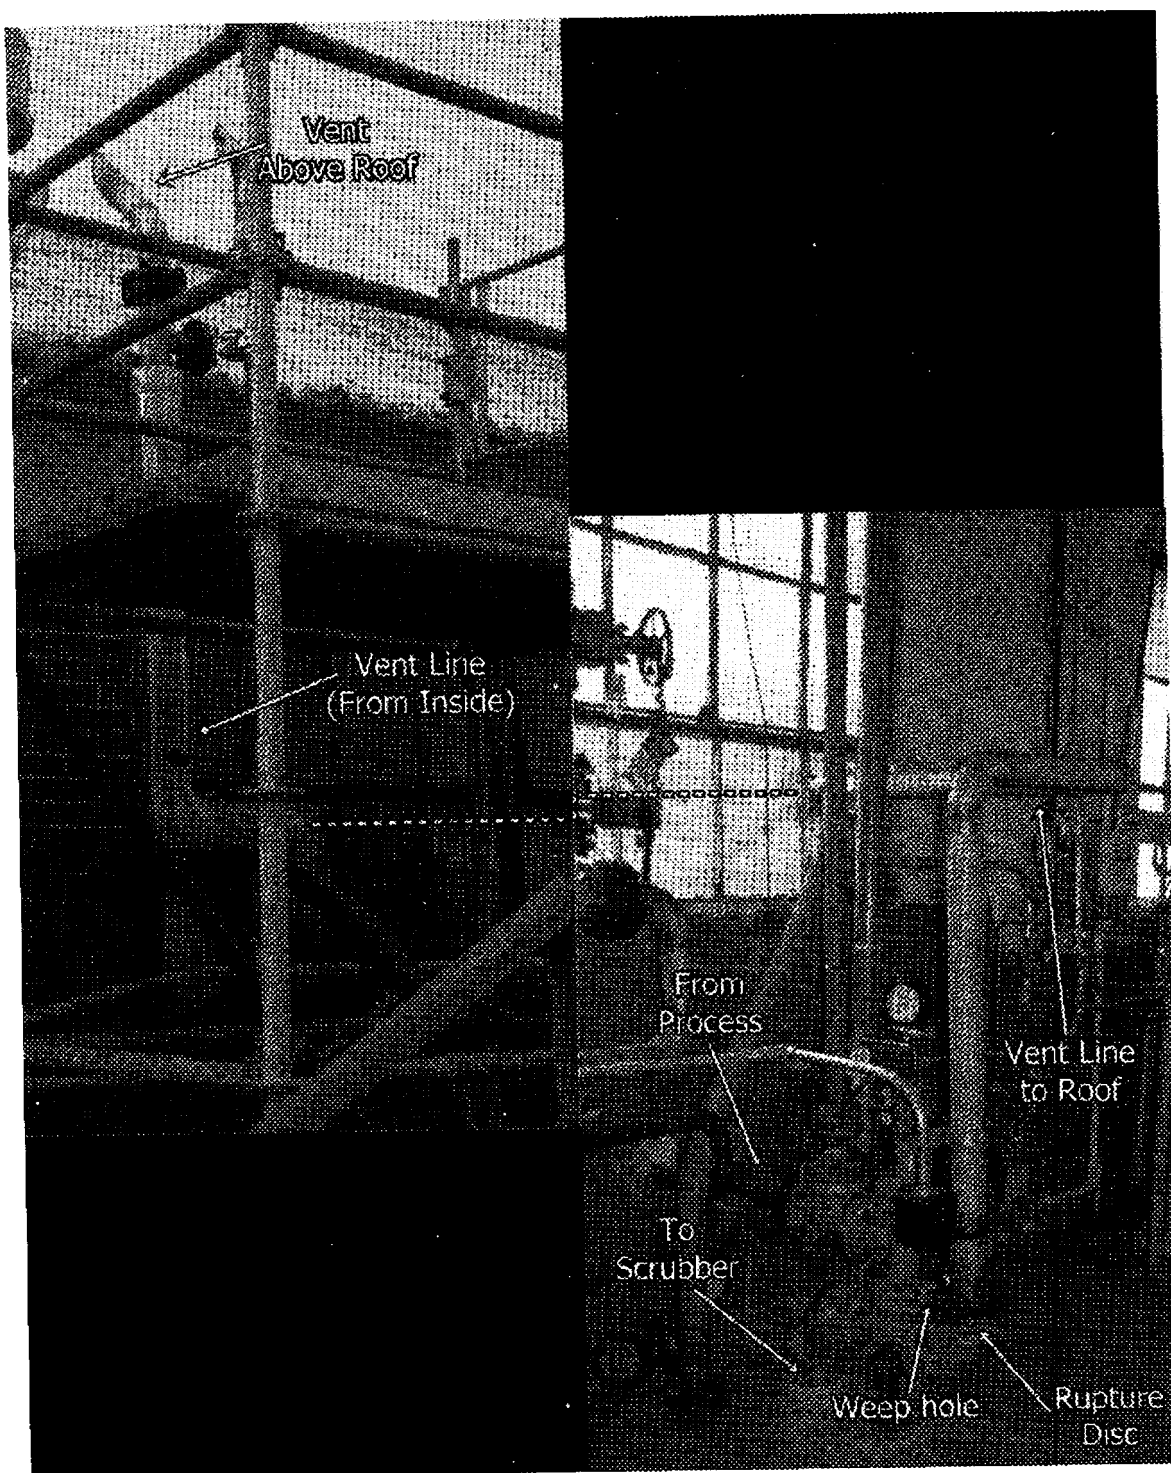
The rupture disc piping was routed to the atmosphere above the roof of the building, which would have provided an outlet path for the methyl chloride vapor where it would have dissipated and dispersed without notice.

Figure 4. Rupture disc piping and vent pipeline to atmosphere on roof

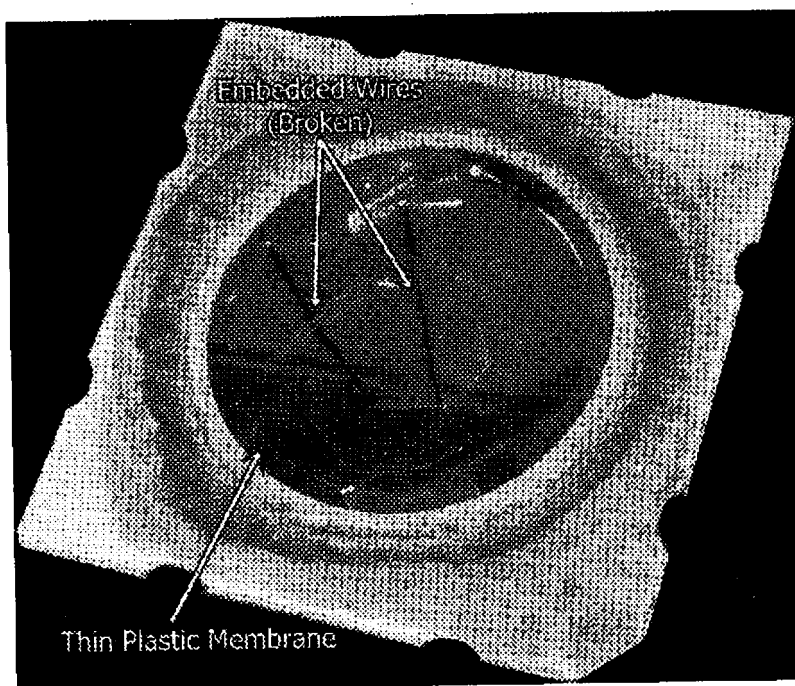
Figure 5. Rupture disc burst sensor post-incident

DuPont Belle used a “burst sensor” intended to notify the board operator that the rupture disk (Figure 5) activated. A burst sensor is a thin plastic membrane with embedded wires installed on top of the rupture disc. Small electrical current passes through the wires. If the rupture disc activates, it breaks the membrane and embedded wires and triggering the alarm.

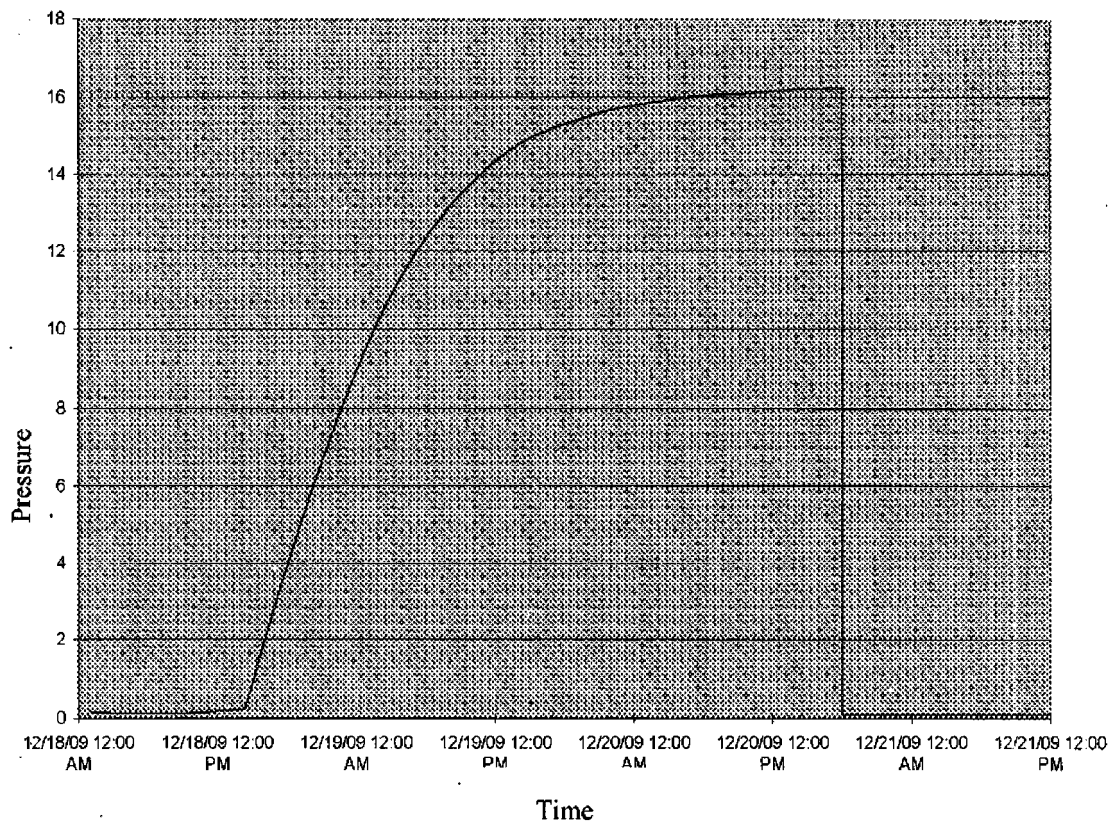
Figure 7. Process data showing sudden pressure decrease when rupture disc burst

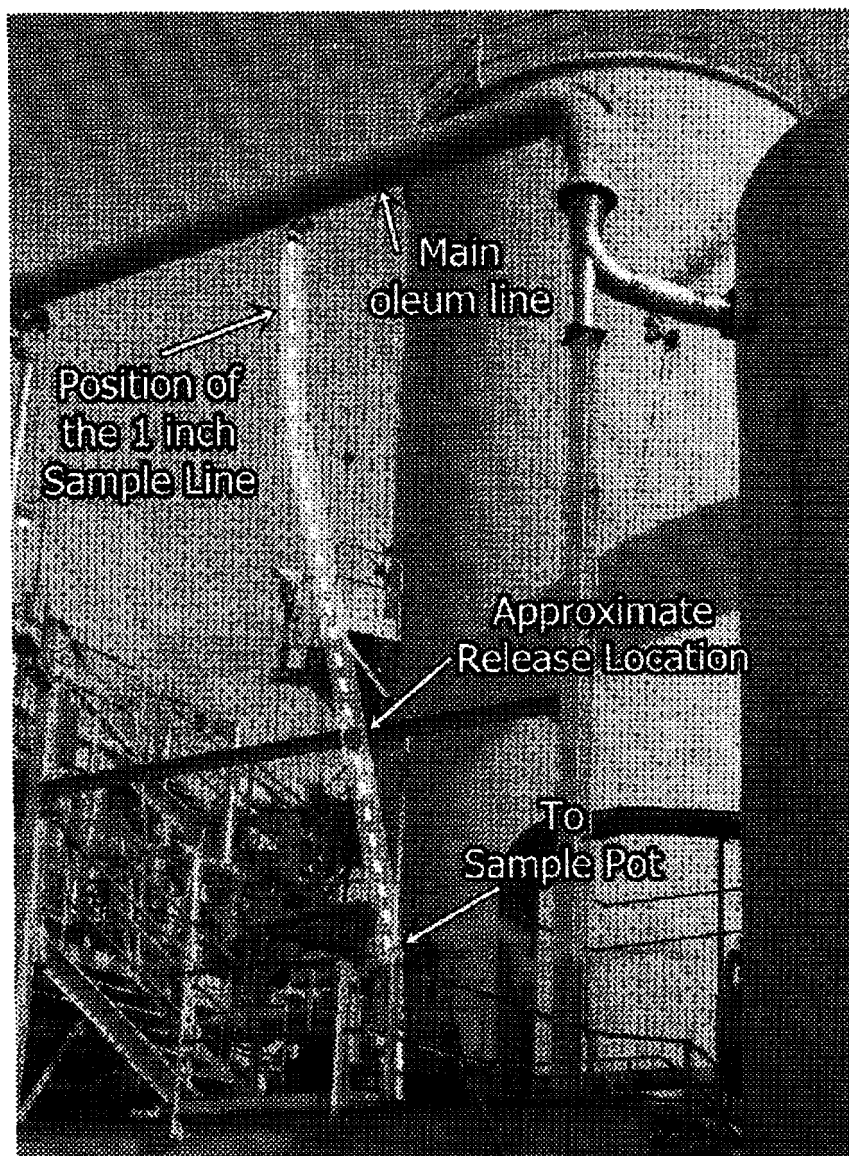
Figure 8. Photo of the position of the 1-inch sample line, which had not yet been replaced

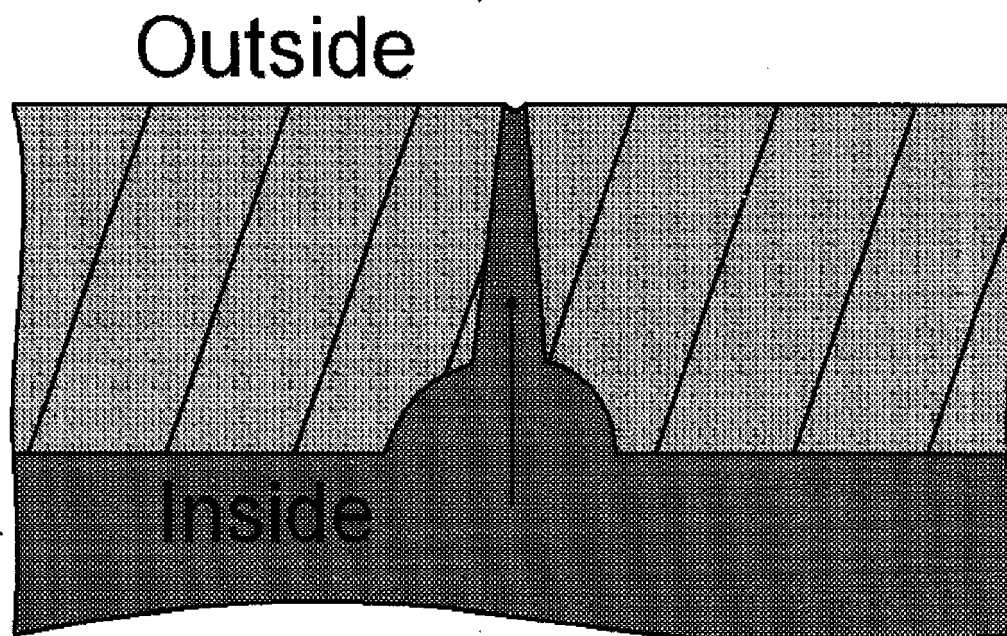
Caused by an unknown defect, oleum corroded through a small section of the pipe involved in the release on January 23, 2010. Starting as a pitting phenomena and finishing slightly larger than a pin hole, the corrosion penetrated the insulated stainless steel sample pipe (Figure 9).

Figure 9. The pitting phenomena observed in the small initial hole of the oleum sample line wall

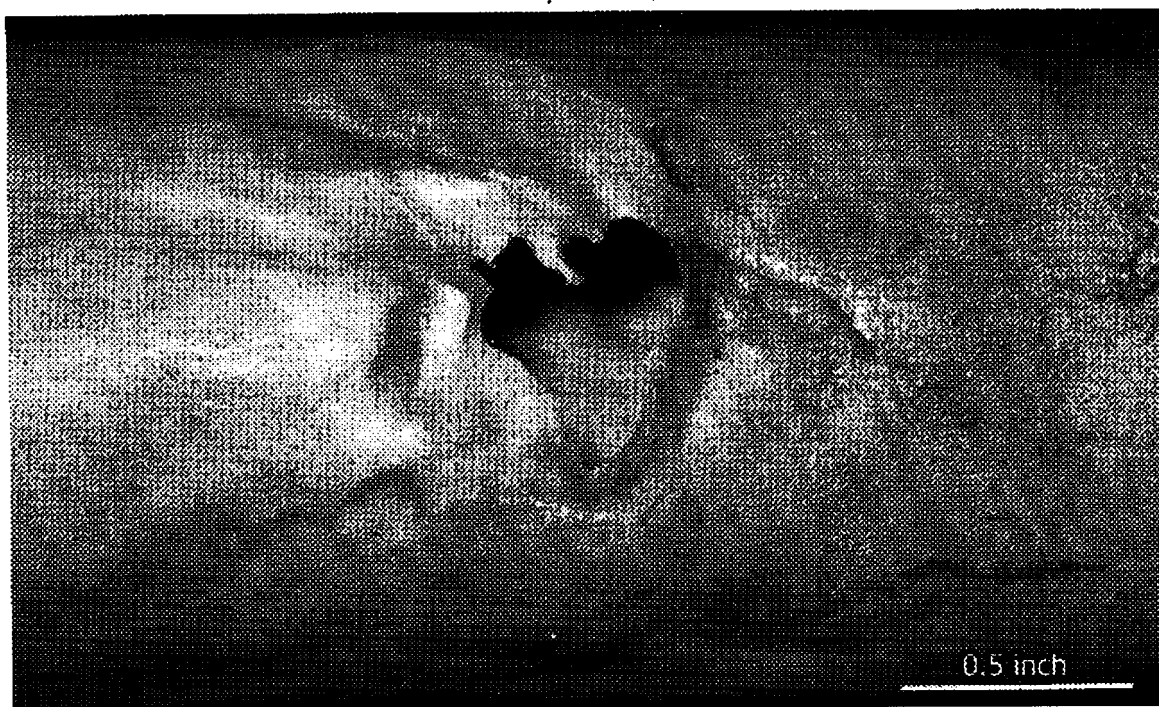
Once oleum was present on the exterior of the oleum pipe, it readily corroded the insulation and steam tracing line and then created a leak in the steam tracing, causing the steam and oleum to mix. This reaction created a strong solution of sulfuric acid that rapidly and effectively corroded the stainless steel sample line exterior, until a second larger hole developed at a location near the original small leak. The second hole clearly shows corrosion occurring from the outside-in (Figure 10).

Figure 10. The large hole eroded from the outside-in on the oleum sample line<sup>26</sup>

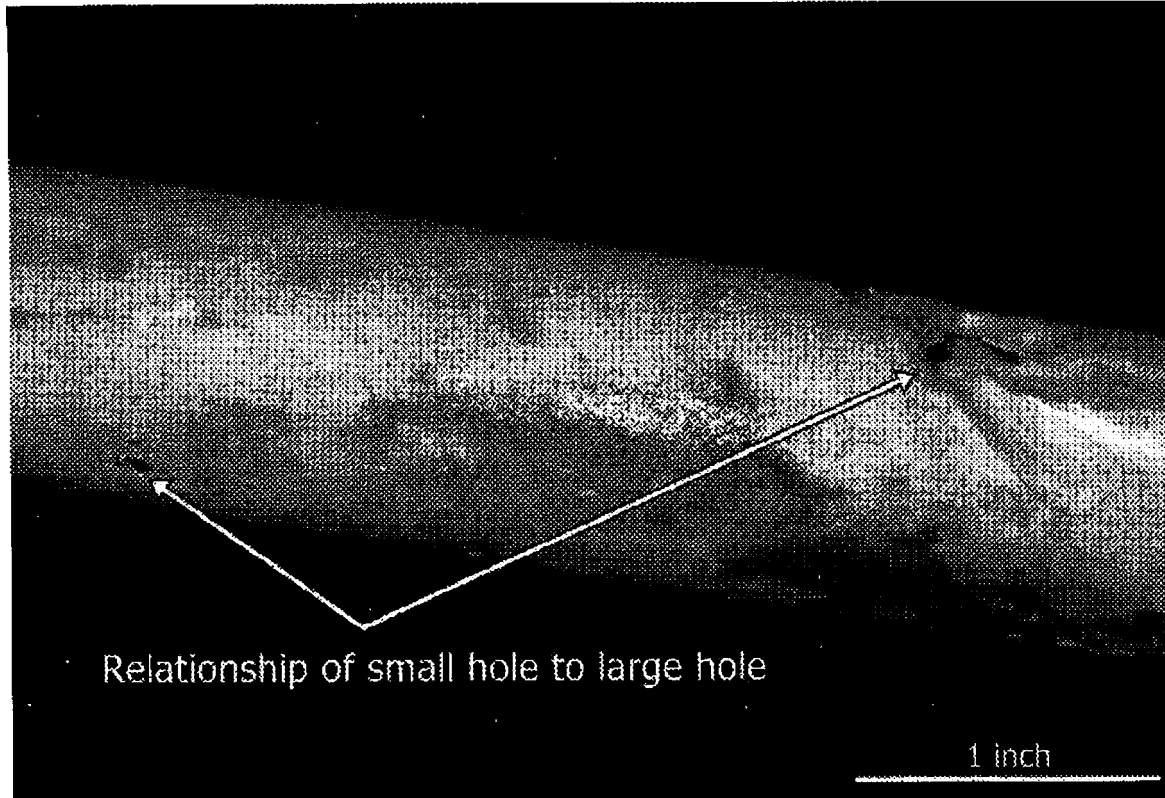
When DuPont removed the oleum-soaked insulation and cover, a large hole was visible; the acid had also corroded a large amount of the steam tracing. When the sample line was properly cleaned, inspection revealed that the smaller hole was only a few inches away from the larger hole, and after thorough examination, metallurgists concluded that the small hole in the sample line initiated the oleum release (Figure 11).

Figure 11. Photo showing the orientation of the small hole to the main hole

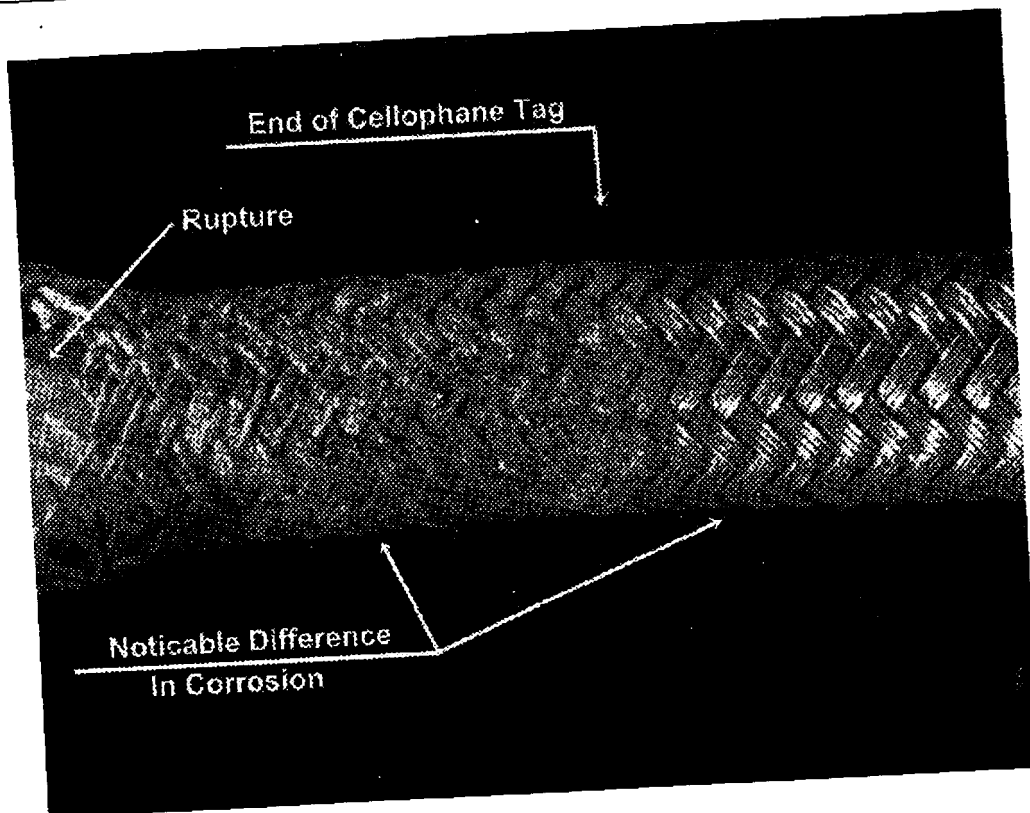
The PTFE, 304 stainless steel, and the clear plastic adhesive tape contributed to the incident. The PTFE inner core was permeable and susceptible to phosgene vapor diffusing through the hose. The adhesive tape used to secure the tag contributed to the retention of phosgene gas on the exterior of the stainless steel overbraid. The phosgene gas converted to HCl, and 304 stainless steel overbraid is subject to corrosive attack by HCl. Since the clear plastic adhesive tag trapped the phosgene permeating through the PTFE inner core, the resulting concentration of HCl was much higher under the tag than elsewhere on the hose (Figure 14).

Figure 14. The distinct effect of the clear plastic adhesive tag on the corrosion of the stainless steel overbraid

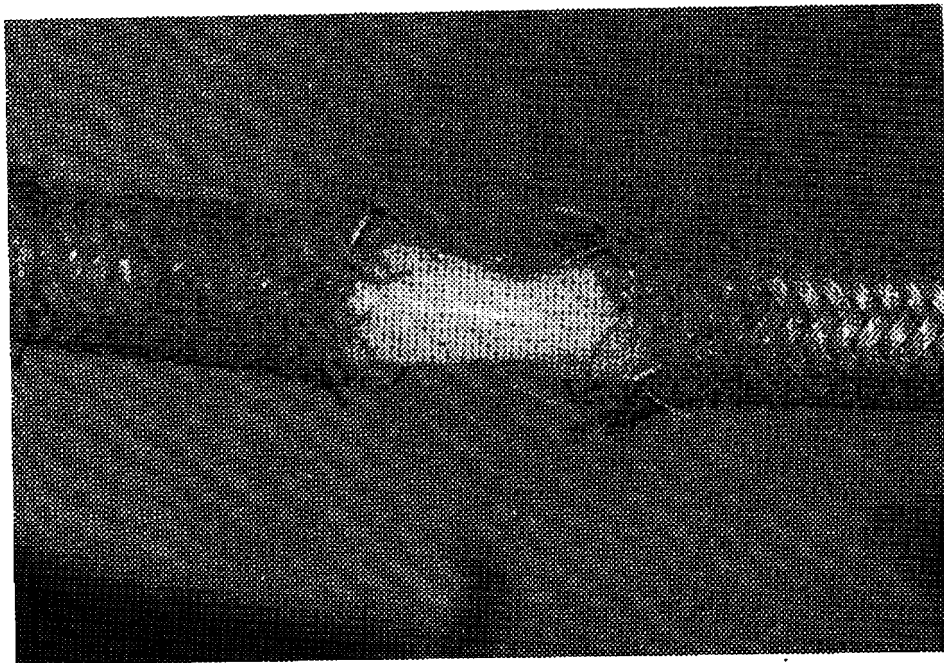
The hillside phosgene supply hose and valve assembly were removed and decontaminated in a water bath. When the hose was removed from the water, the clear adhesive ID tag had fallen off, revealing a broken stainless steel braid and collapsed PTFE liner, a possible cause of the flow restriction (Figure 15).

Figure 15. Damaged hillside phosgene hose removed from phosgene cylinder. The plastic adhesive tag that covered the damaged section fell off during the hose decontamination procedure.

An operator stated during an interview that when he saw the physically defective section of the frayed hose, he told his co-workers, stressing that the hose was close to rupturing and that they were lucky to have found it and changed out the hose in time. Unfortunately, this discovery was not captured as a near-miss, since supervisors were not made aware of the issue.

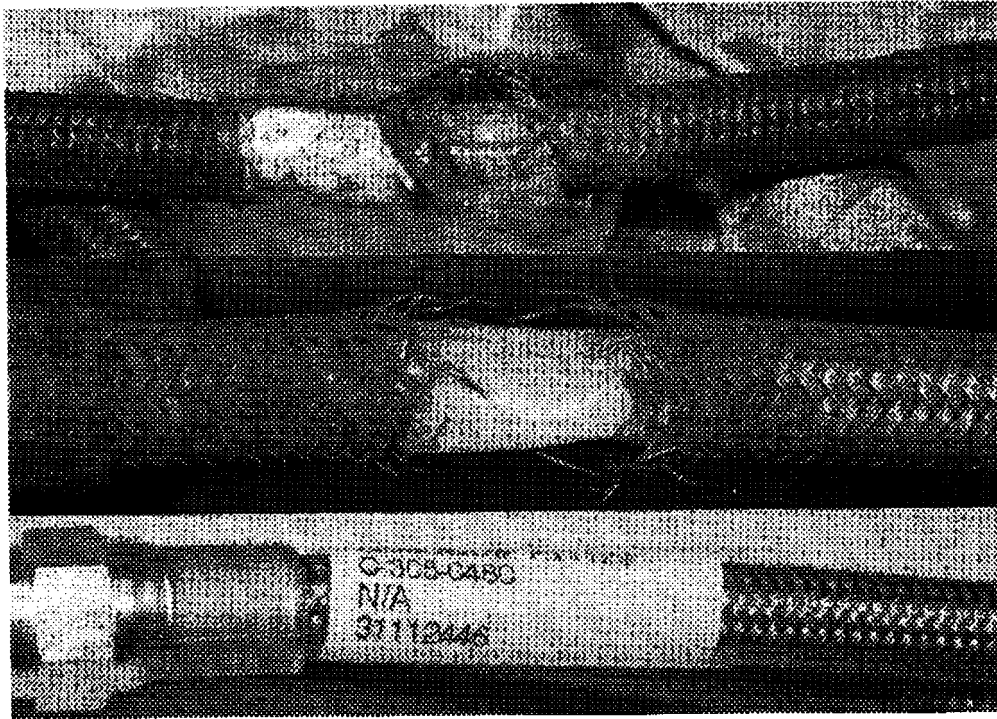
Figure 16. Flex hose comparison photographs: (top to bottom) ruptured riverside hose, flow restricted hillside hose, a new hose with attached ID tag

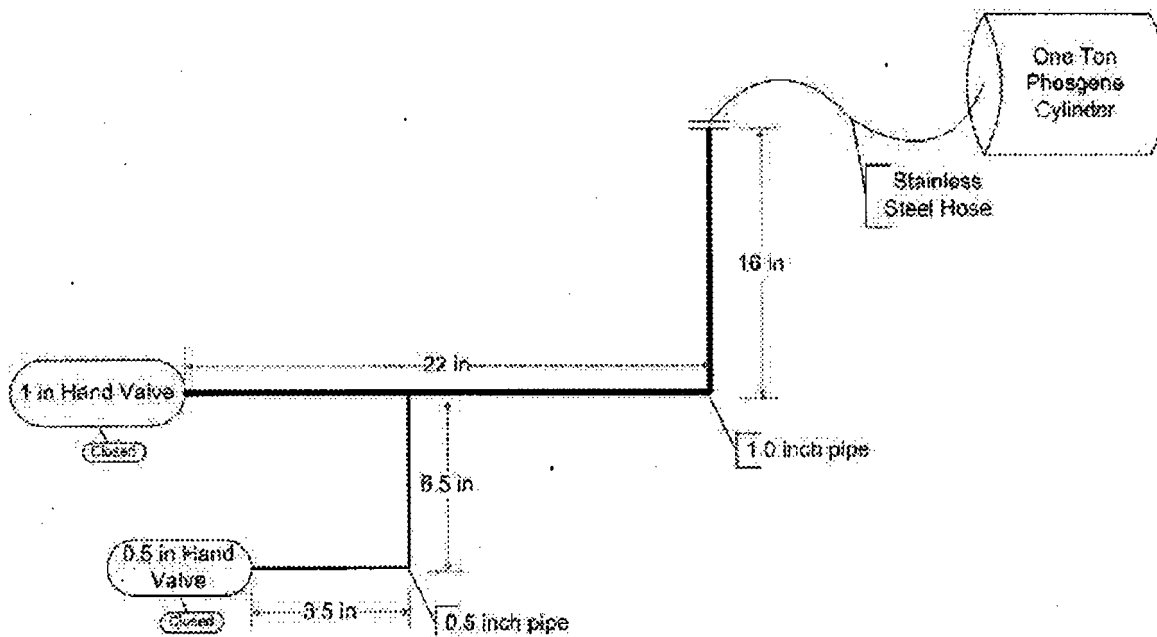
Figure 18 shows the hose and piping dimensions and the maximum amount of phosgene present in the piping system associated with the hose failure.

Figure 18. The hose and piping system that supplied phosgene for the release
