**Region 6 Compliance Assurance and Enforcement Division  
INSPECTION REPORT**

| Inspection Date(s): | 10/17/2017 | | |
| Regulatory Program(s) | NPDES | | |
| Facility Name: | [REDACTED] | | |

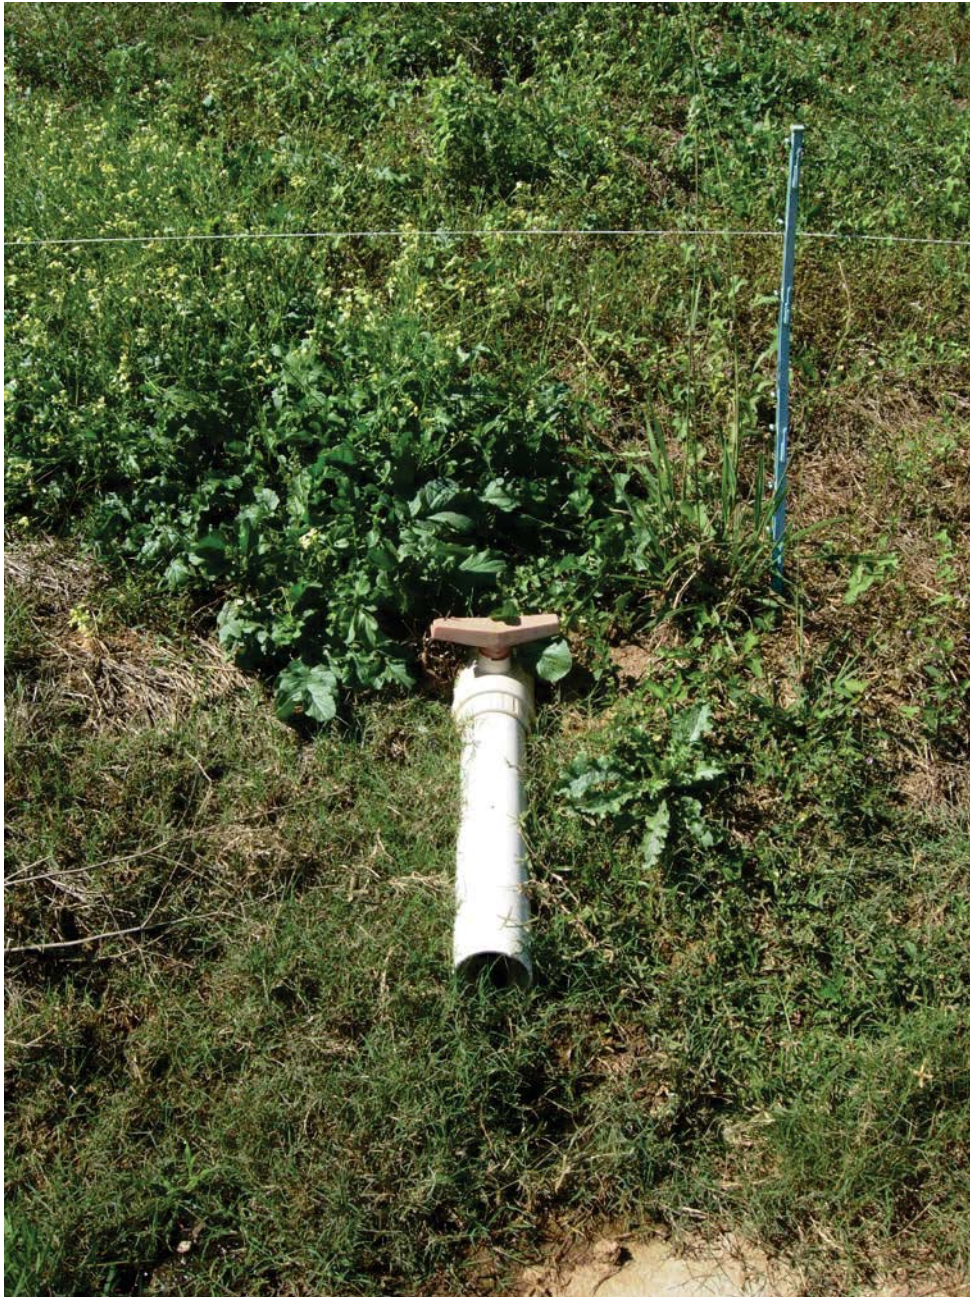
Photo No. 1

We observed a PVC pipe with a ball valve jutting out from the base of the west berm of the RCS. [REDACTED] explained that a fifty-yard length of perforated PVC can be connected to this effluent pipe to allow for the wastewater to be applied to the adjacent pasture. Additionally, [REDACTED] informed us that a new diesel pump would be included in the equipment scheduled to be provided by NRCS.

Description: Photo taken facing east toward PVC pipe which emanates from the base west berm of the RCS. Note the red valve which can be opened and closed to allow flow from the RCS to land application field.

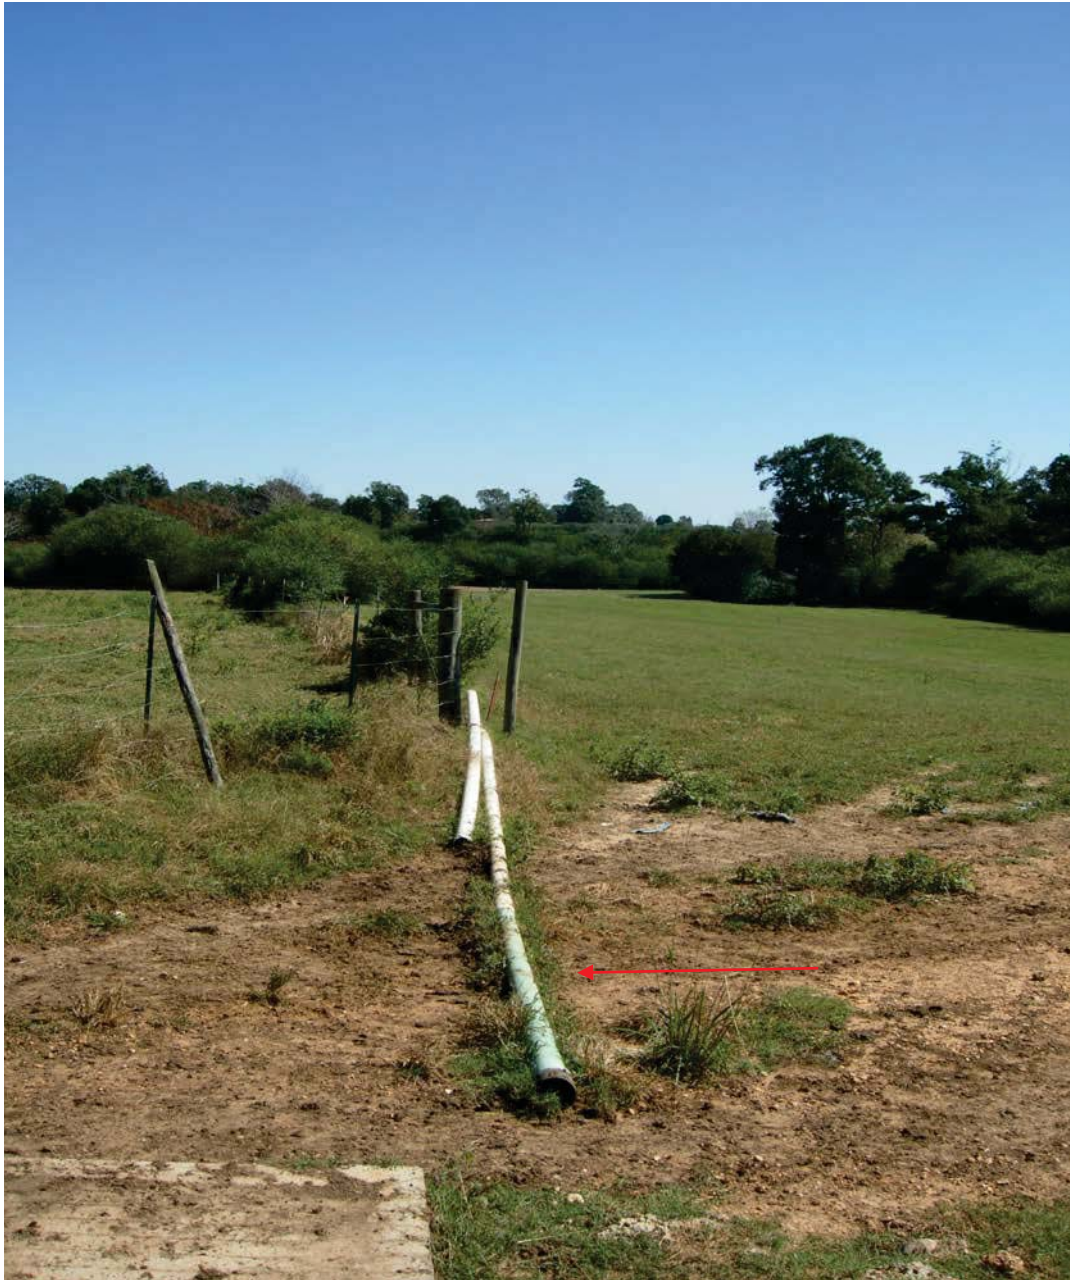
Photo No. 2

Description: Photo taken facing west toward pipe which carries wastewater to land application field.

The green pipe highlighted above is connected to RCS effluent pipe when land application of wastewater is necessary and disconnected when cattle pass through this area.

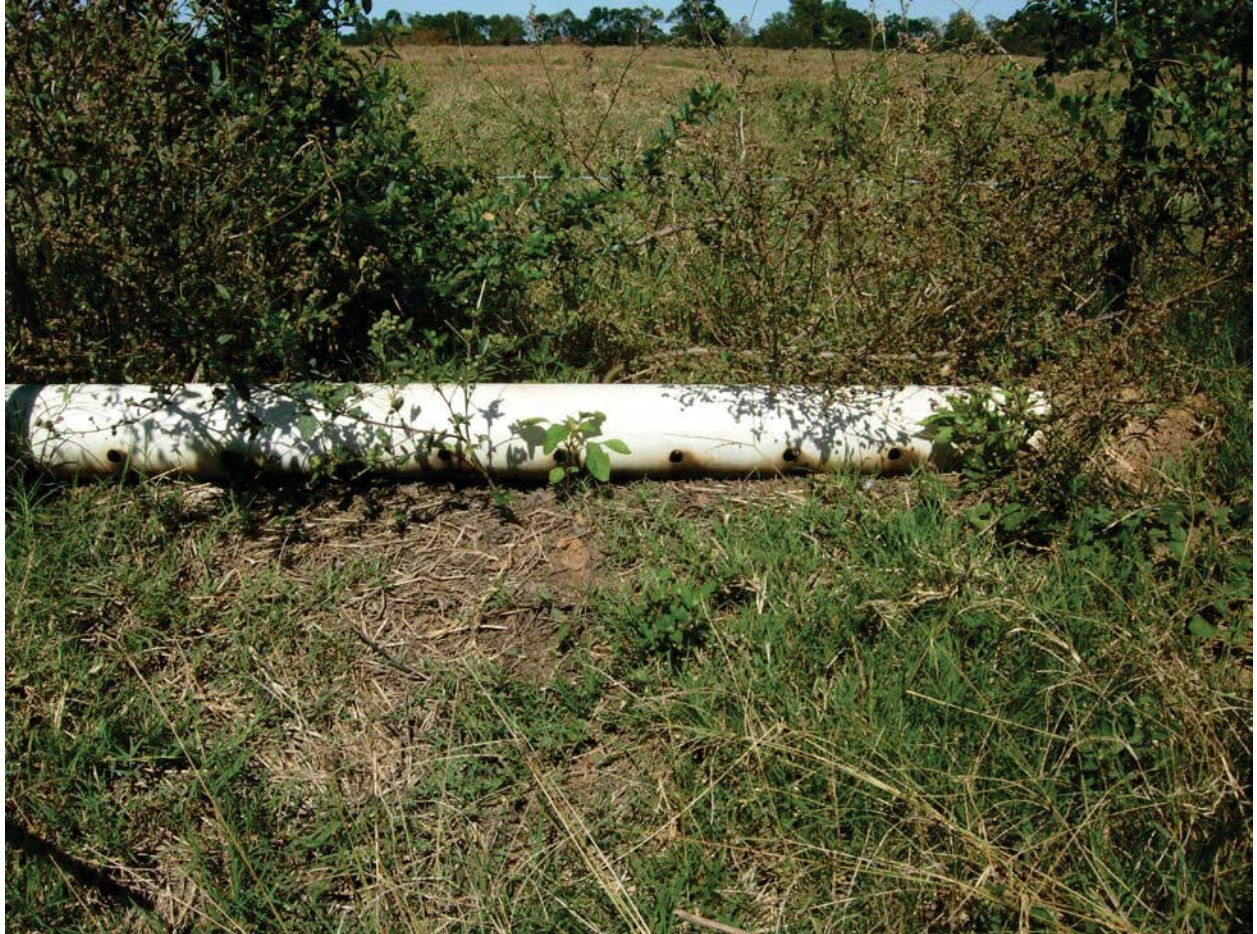
Photo No. 3

Description: Photo taken facing north towards perforated PVC pipe which spreads wastewater from RCS across land application area.
