**CWA COMPLIANCE EVALUATION INSPECTION REPORT
U.S. ENVIRONMENTAL PROTECTION AGENCY, REGION 5**

Purpose: Compliance Evaluation Inspection

Facility: Befesa Zinc US Inc.
2701 East 114th Street
Chicago, Illinois 60617
41.68482160845534, -87.54572106929497

Date of Site Inspection: 11/05/2024

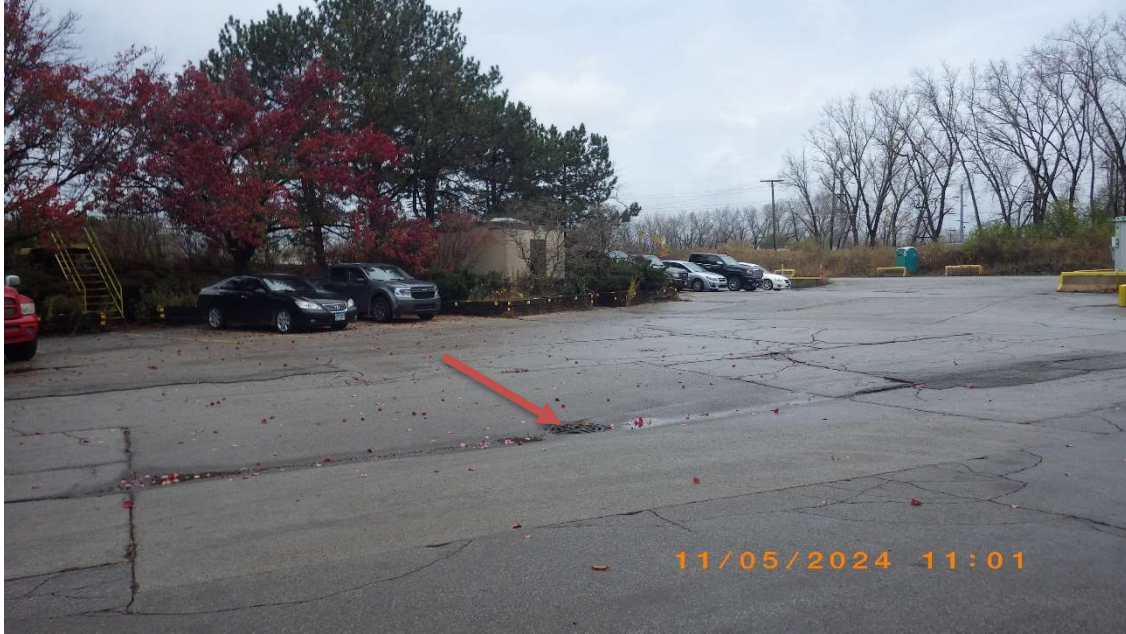
6: RIMG0006

Description: Stormwater collection grate (red arrow) in internal road southeast of office.

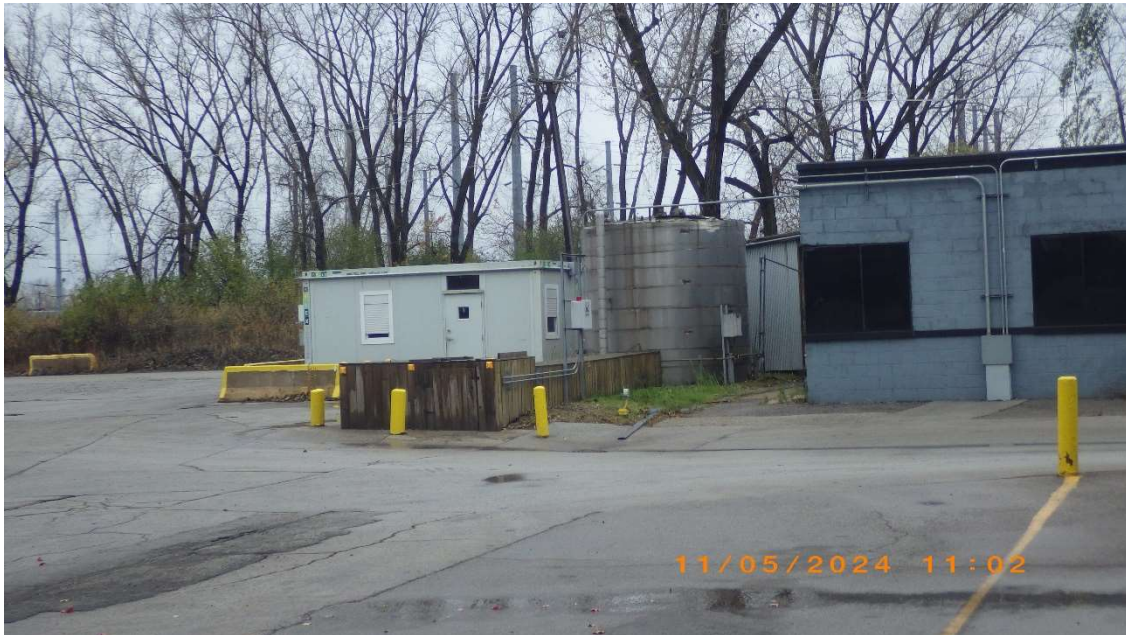
7: RIMG0007

Description: Stormwater collection pit #3.

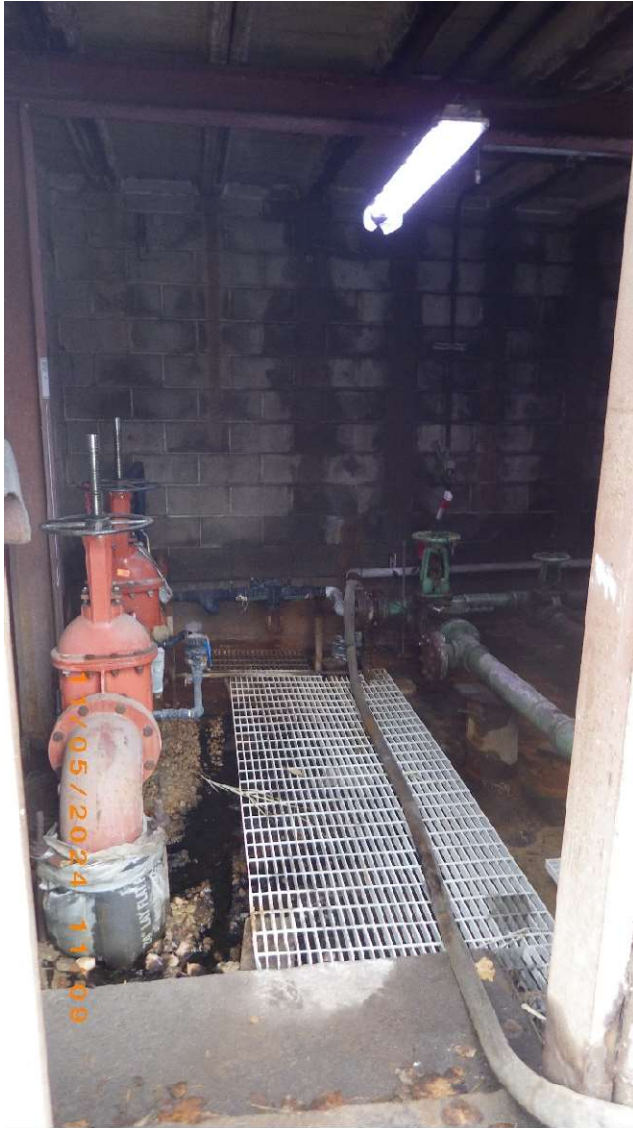
8: RIMG0008

Description: Interior of pump house on the north side of the Facility. Hose is attached to a sump pump. Facility personnel stated that ground water in the building requires water to be pumped out regularly.

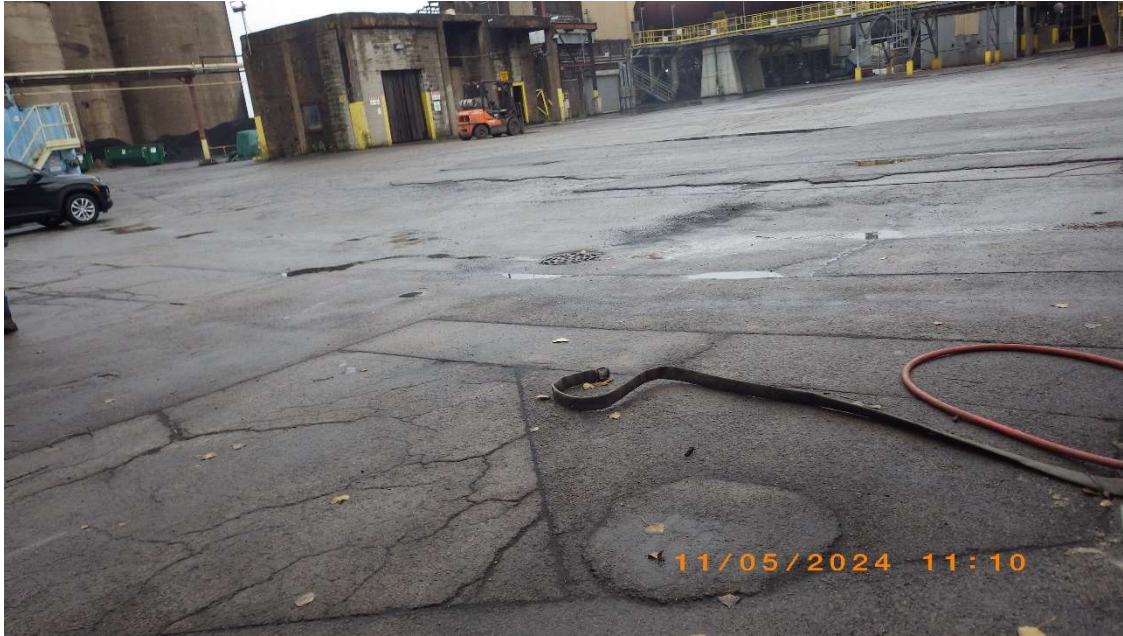
9: RIMG0009

Description: End of hose shown in photo 8. Facility personnel noted that water would go to the storm water collection system and be sent to the storm water pond.

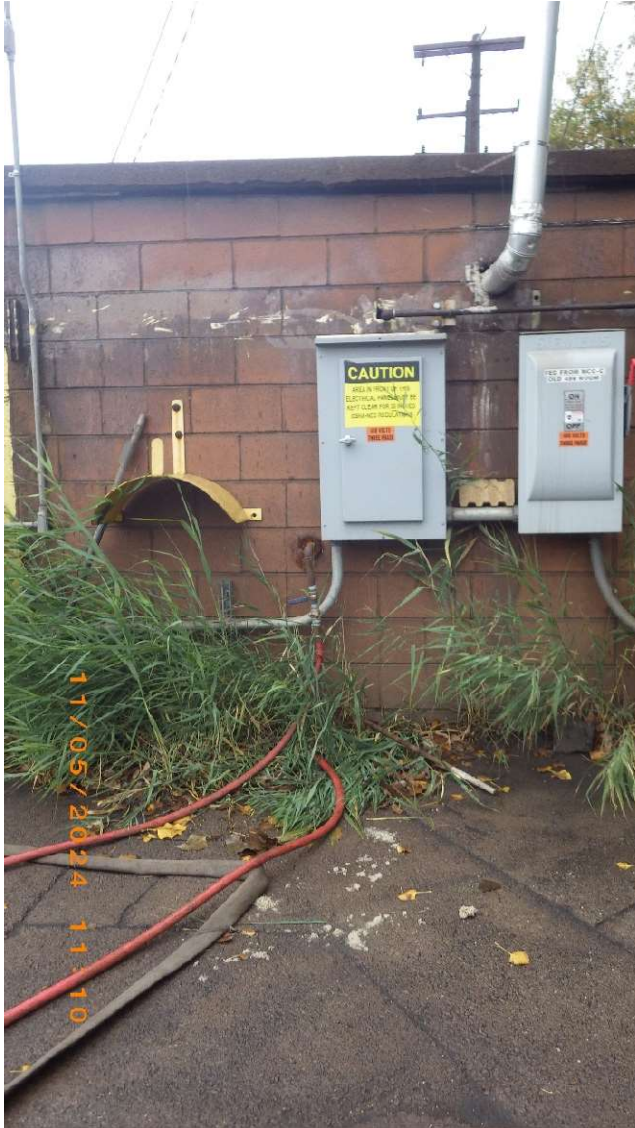
10: RIMG0010

Description: Red hose connected to faucet outside pump house. Facility personnel stated that the hose was used when filling dust control trucks with city water.

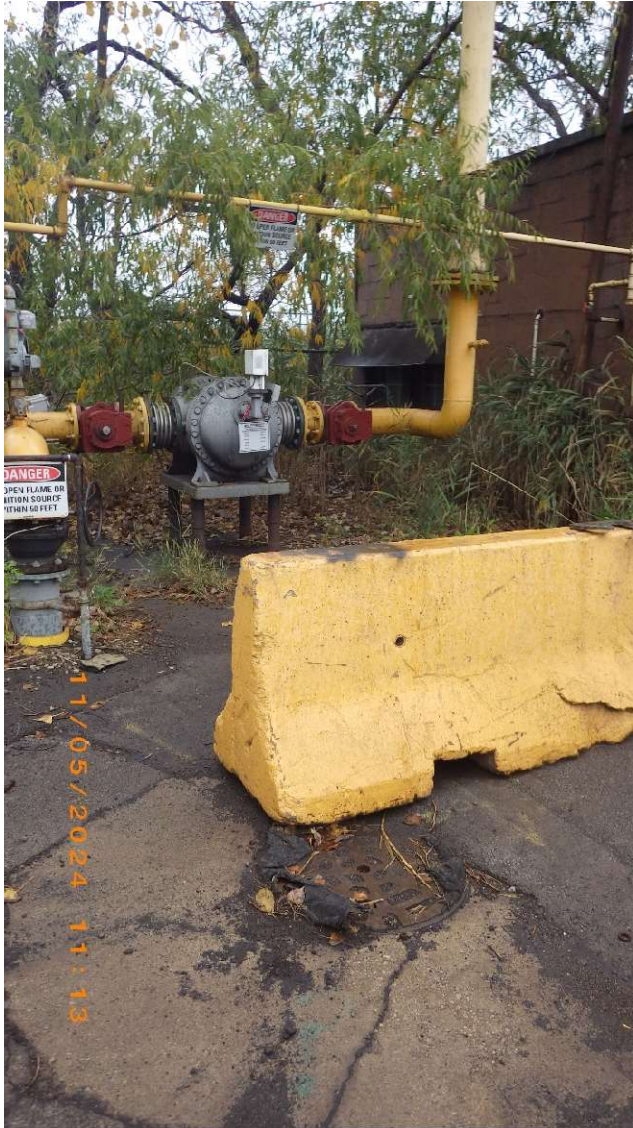
11: RIMG0011

Description: Storm drain located between pump house and foreman's office. Note that this drain has a filter fabric. When asked why this storm drain was different, facility personnel stated that they were unsure.

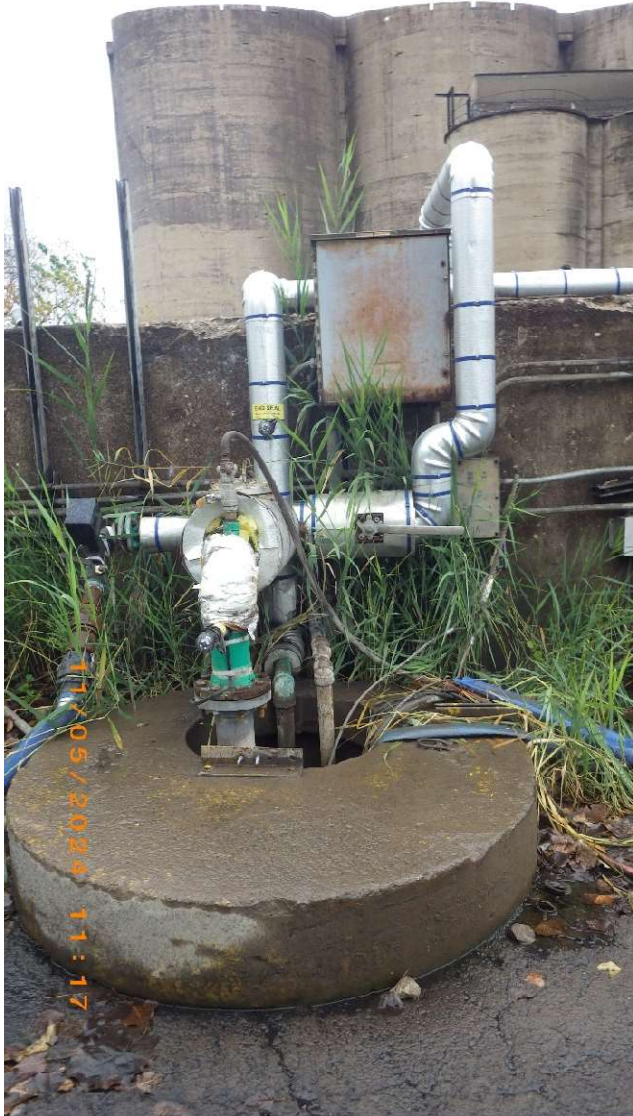
12: RIMG0012

Description: Reception and pump pit for stormwater located on the west side of the dike area. Note the blue hoses used to convey flow to the temporary frac tanks being utilized for storage while the dike area is being upgraded.

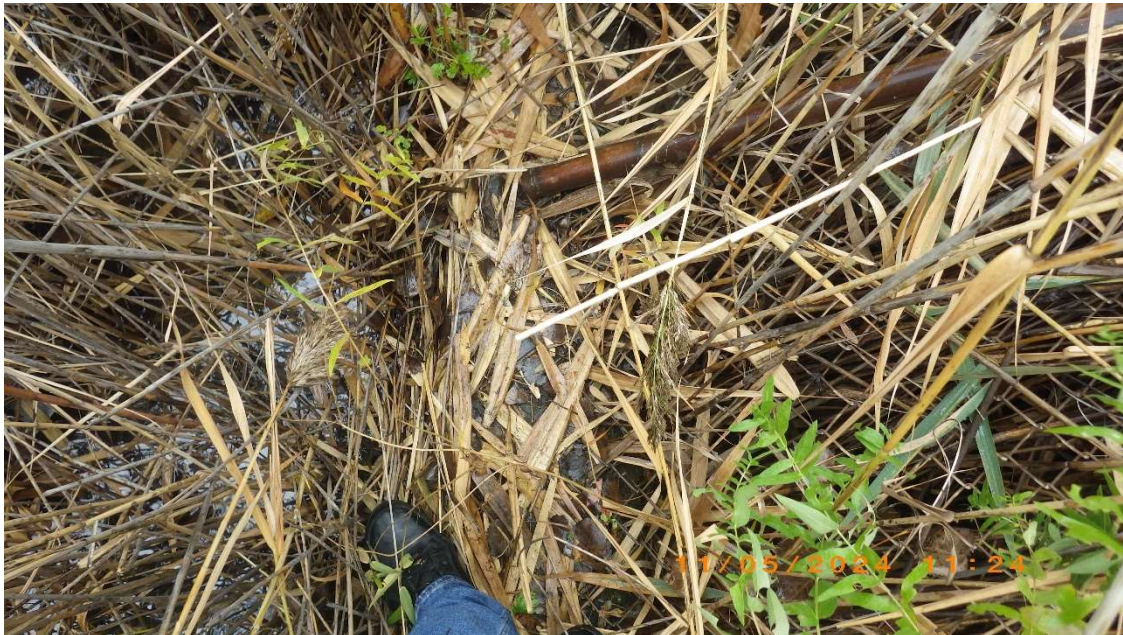
14: RIMG0014

The Inspectors continued east and observed the diked area including the reception/pump pit and temporary frac tanks (photos 12 and 13). The Inspectors walked around the north end of the diked area and observed the concrete berm along the north side of the Facility. The Inspectors observed that there was standing water on the south side of the berm but no observed water on the north side (photo 14).

Description: Looking down at concrete berm along the north side of the Facility. Note water on south side of the berm (left). No water was observed on the north side of the berm.

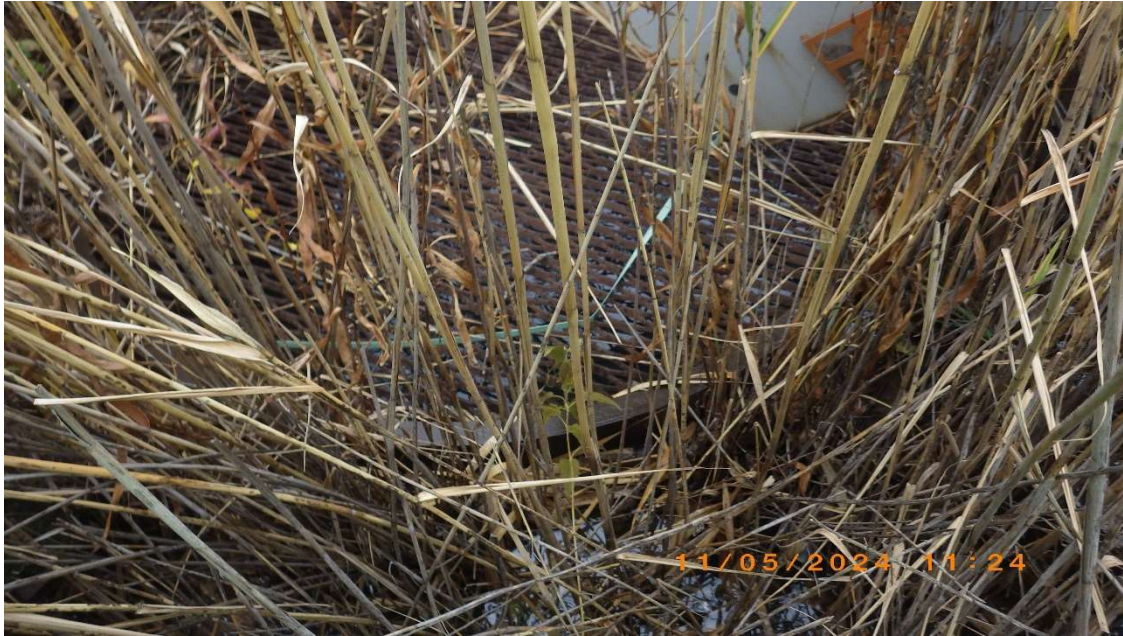
15: RIMG0015

Description: A cylindrical concrete structure covered by an expanded metal grate. Water was observed around and in the structure.

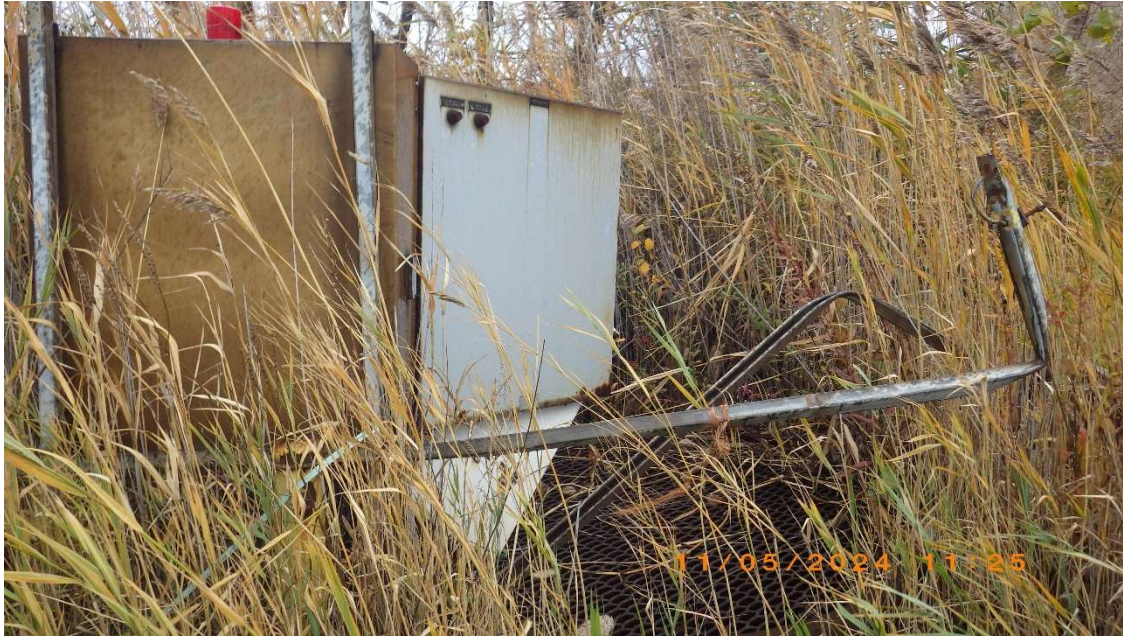
17: RIMG0017

Description: Electric control box located at cylindrical concrete structure.

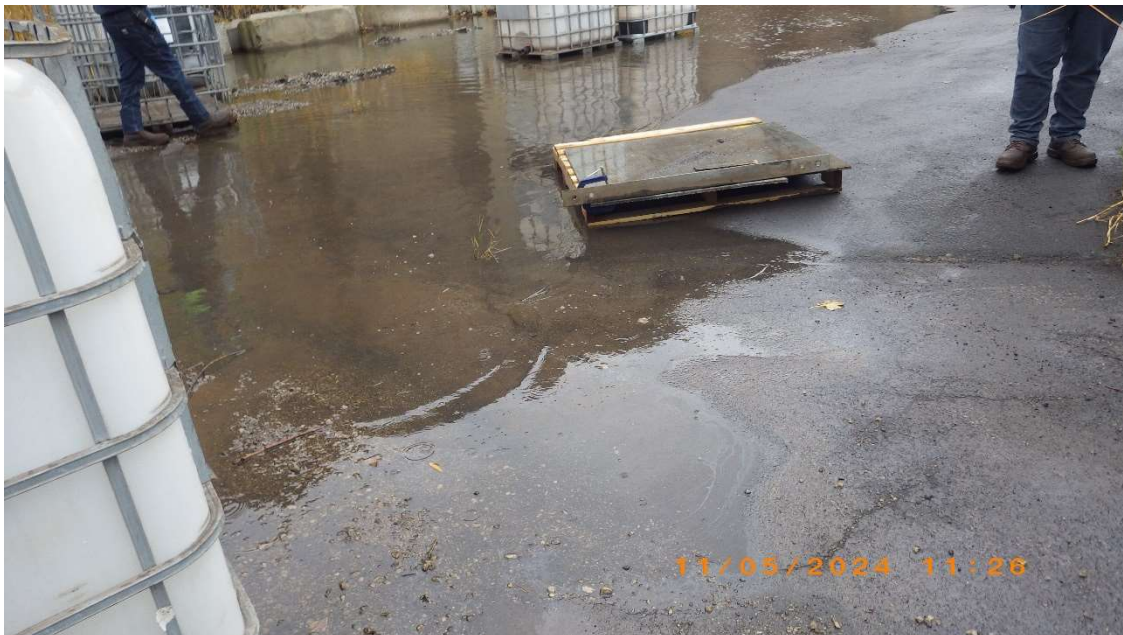
18: RIMG0018

Description: Stormwater standing in northeast part of the Facility around storage totes.

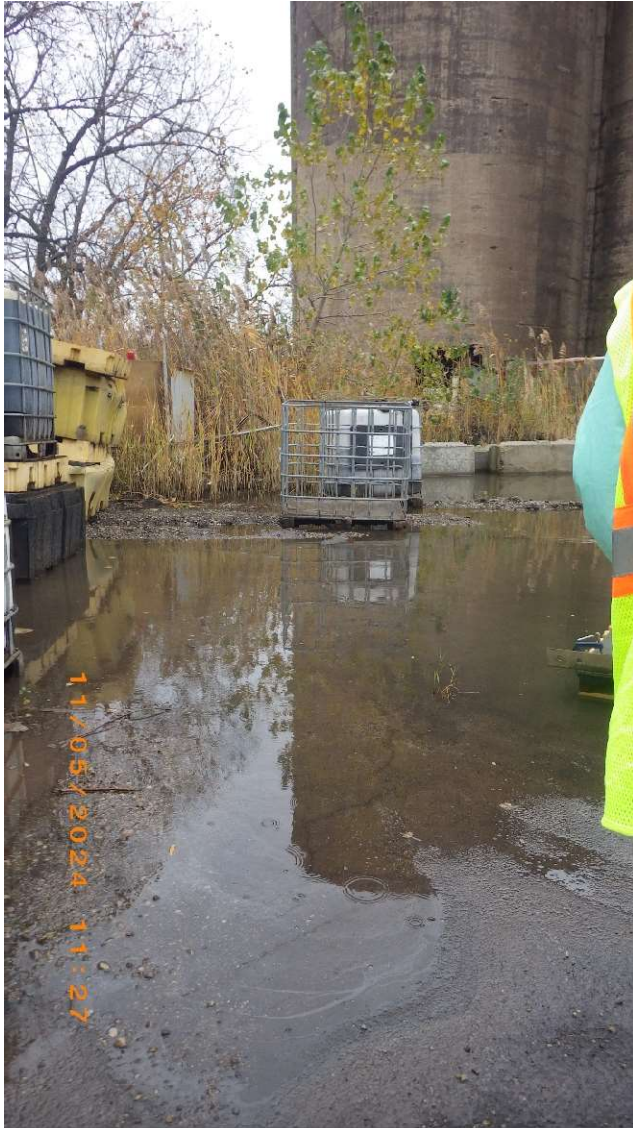
19: RIMG0019

Description: Stormwater standing in northeast part of the Facility around storage totes.

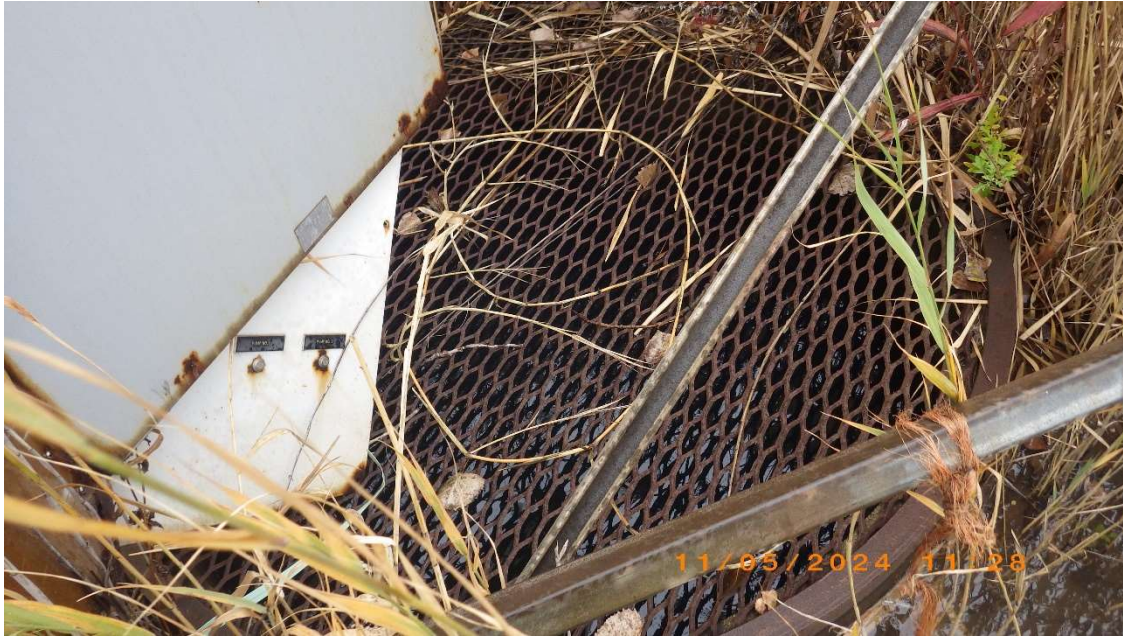
20: RIMG0020

Description: A cylindrical concrete structure covered by an expanded metal grate. Water was observed around and in the structure.

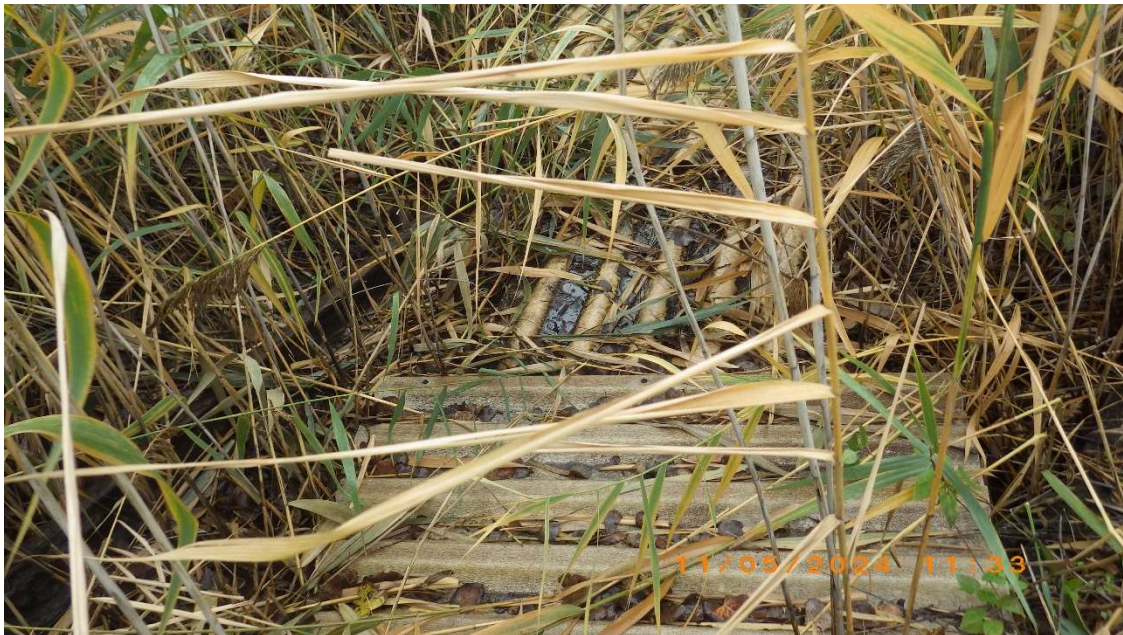
21: RIMG0021

Description: Corrugated roofing pieces blown into the area north of the Facility.

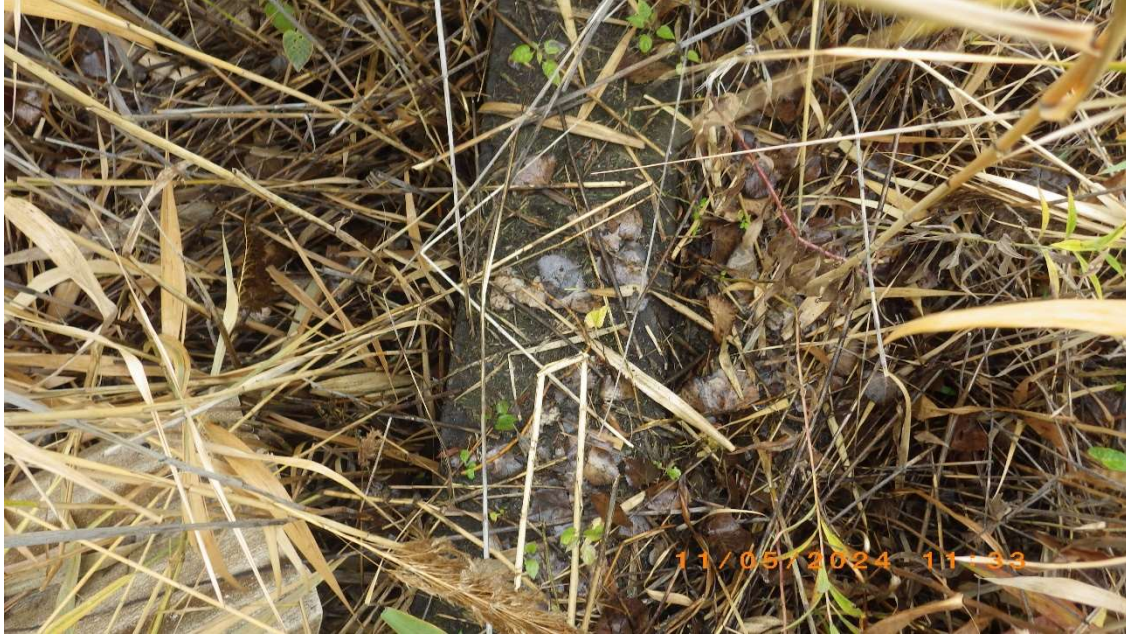
22: RIMG0022

Description: Looking down at concrete berm along the north side of the Facility. Note water on south side of the berm (left). No water was observed on the north side of the berm.

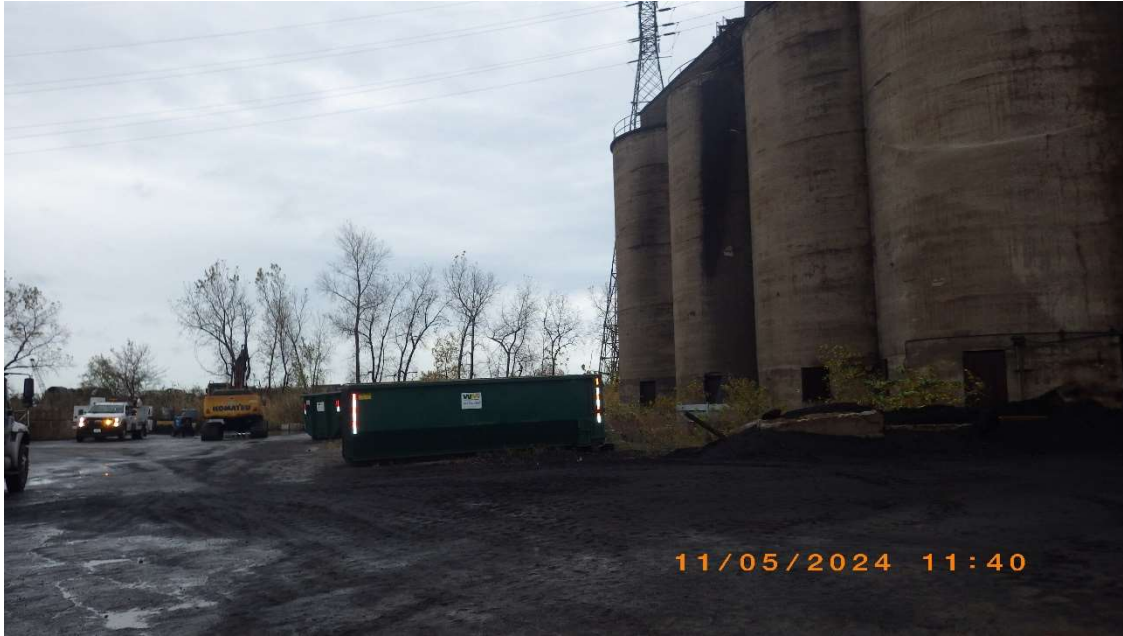
24: RIMG0024

Description: Looking north along the south side of the concrete silos located at the northeast corner of the Facility. Note the black Iron Rich Material being stored in this area.

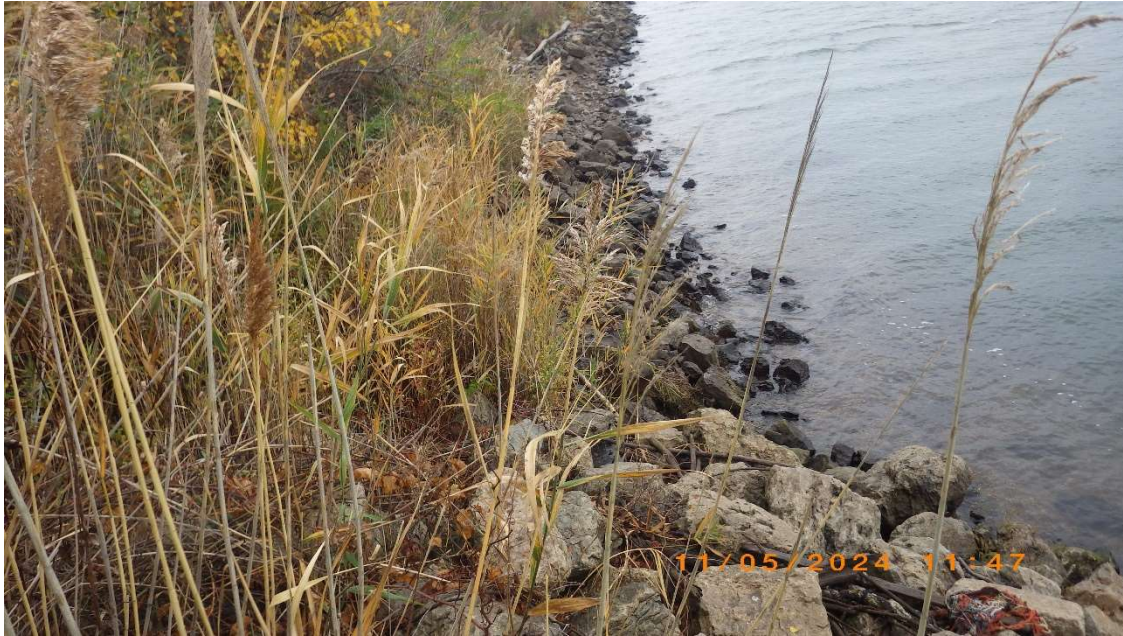
26: RIMG0026

Description: Looking north along the west bank of the Calumet River from the northeast corner of the Facility. This is the area that appeared to be where the stormwater swale north of the Facility would flow into the Calumet River. No flow observed at the time of the inspection.

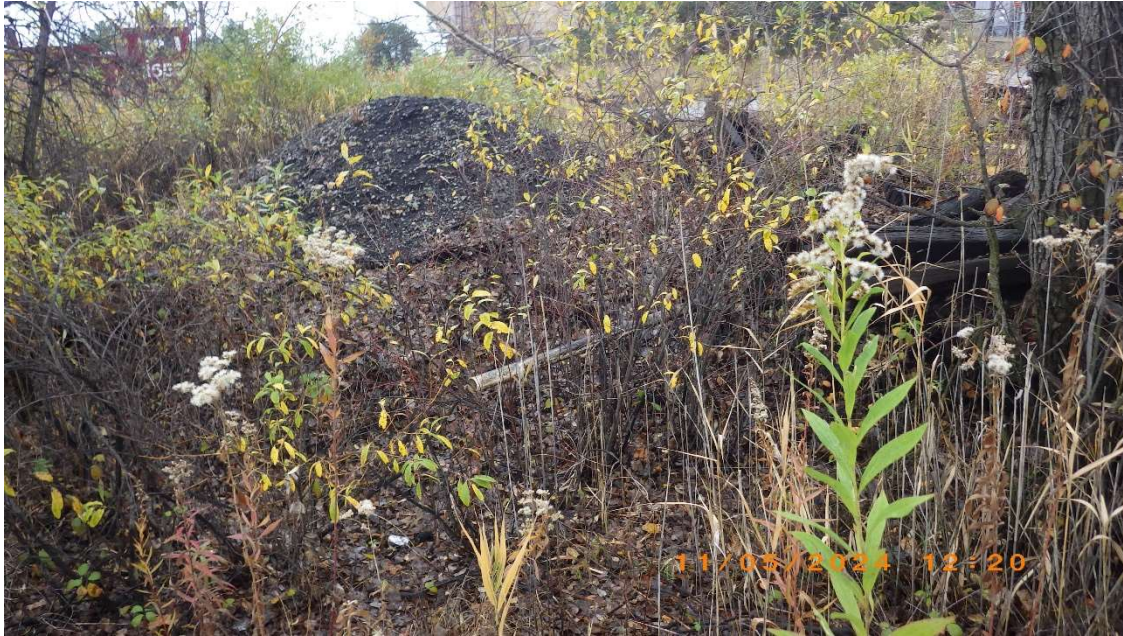
43: RIMG0043

The Inspectors then walked west along the berm on the south side of the Facility. The Inspectors observed a white PVC pipe protruding from a pile of debris near the southwest corner of the Facility (photo 43). Facility personnel stated they did not believe that the pipe was connected to anything. No flow was observed at the time of the Inspection.

Description: White PVC pipe protruding from a pile of debris near the southwest corner of the Facility. Facility personnel stated that they did not think the pipe was connected to anything.

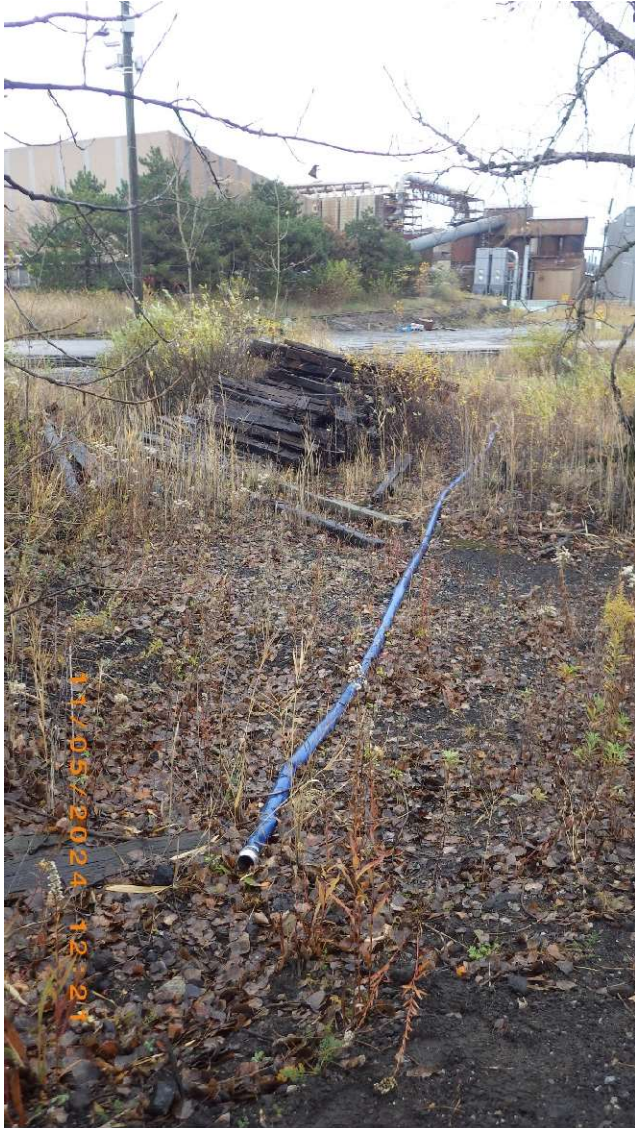
44: RIMG0044

The Inspectors also observed a blue hose extending from a low area with standing toward the southern edge of the Facility (photo 44). Facility personnel stated that the Facility utilized portable pumps to move stormwater from low lying areas to the stormwater storage system during heavy precipitation and the hose had been laid here to keep it out of the way of truck and rail traffic.

Description: Blue hose on ground at the southwest corner of the Facility. Facility personnel stated that they suspected that the hose had been placed there after stormwater dewatering had occurred to pump standing stormwater to stormwater collection.

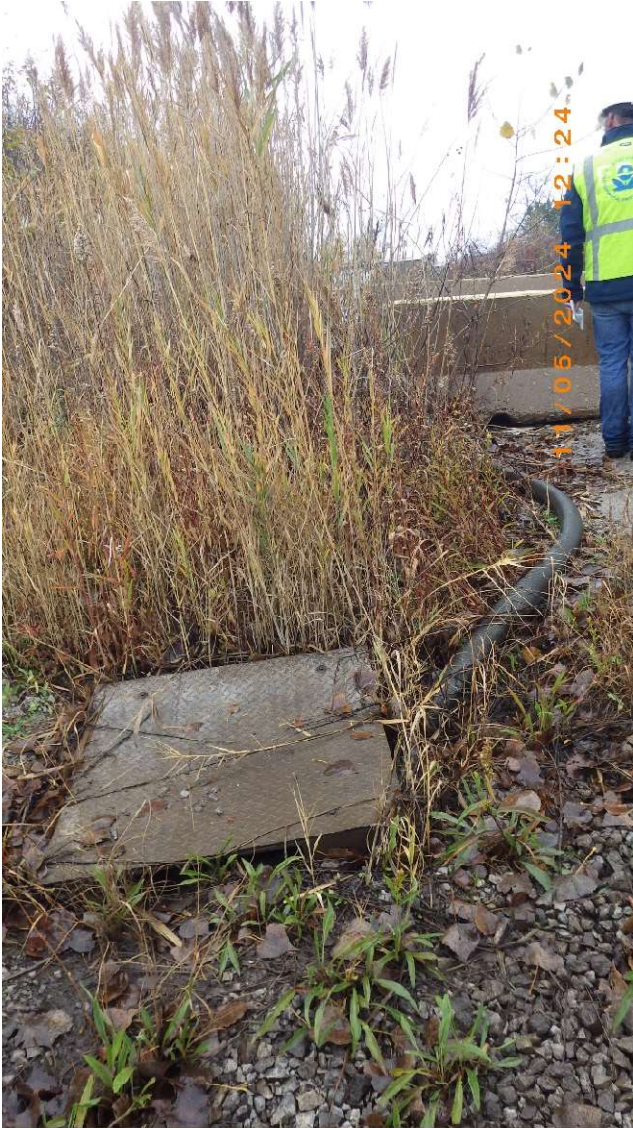
45: RIMG0045

Description: Stormwater collection location on the north side of the rail line entering the Facility. Facility personnel stated that this was a sump pit that could be used to pump stormwater from the area to stormwater collection, but that it was not regularly used. EPA noted that the hose coming out of the pit was cracked.

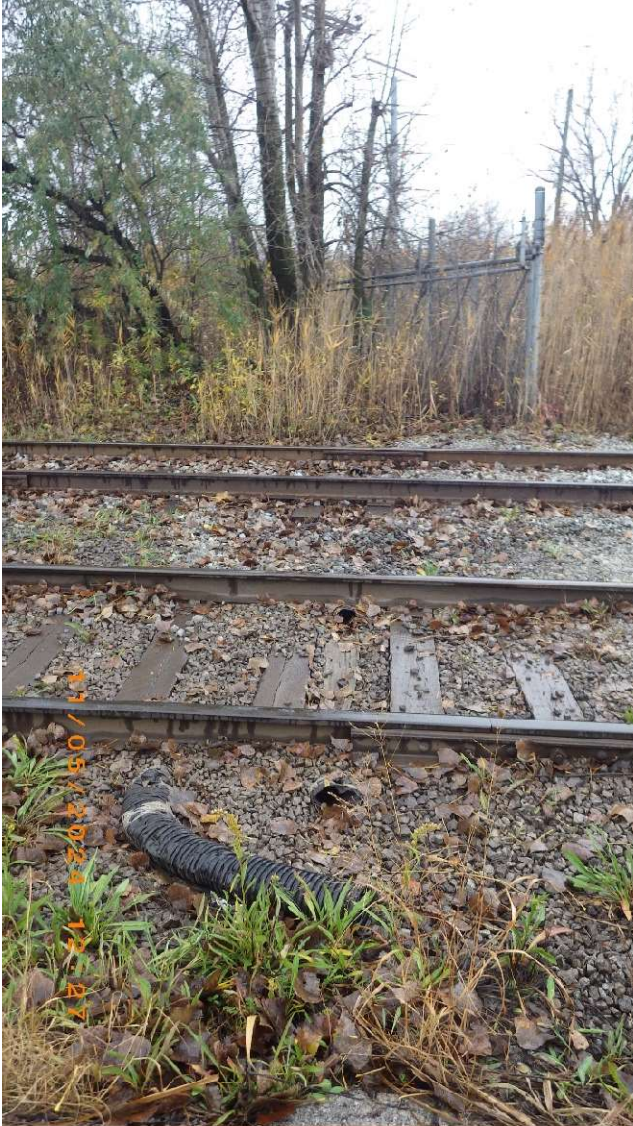
48: RIMG0048

Description: Looking south across the rail lines as they enter the Facility. Note the corrugated black pipe under the rail lines.

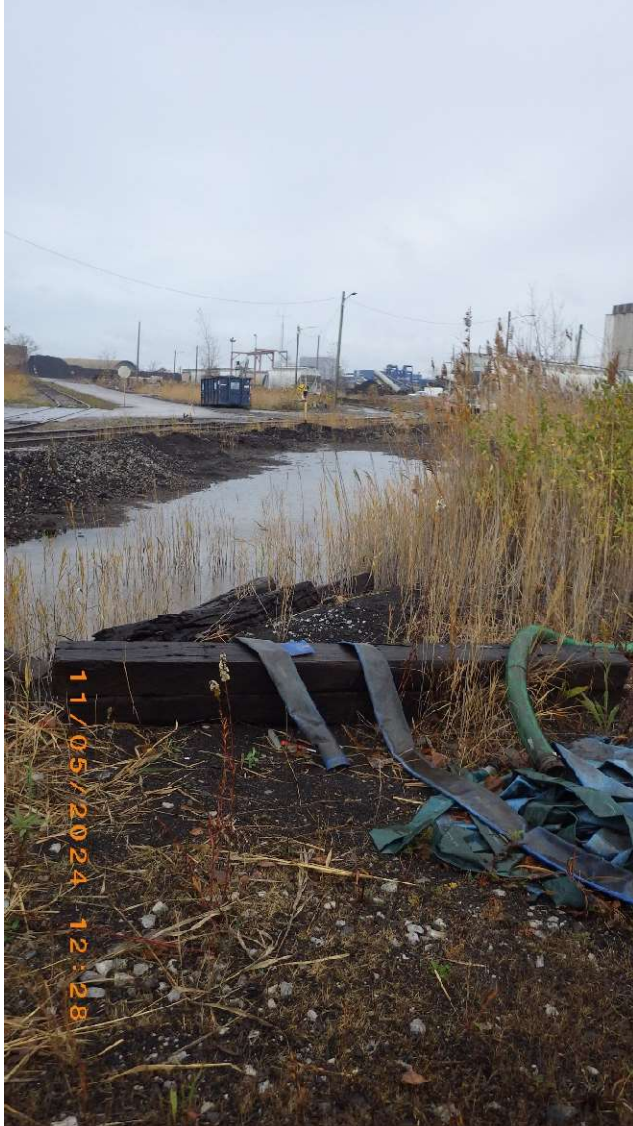
49: RIMG0049

Description: Looking southeast at stormwater collection point with hoses lying adjacent. Facility personnel stated that in periods of high precipitation, portable pumps would be used to pump this area to the stormwater collection system and that the hoses are used for that purpose.

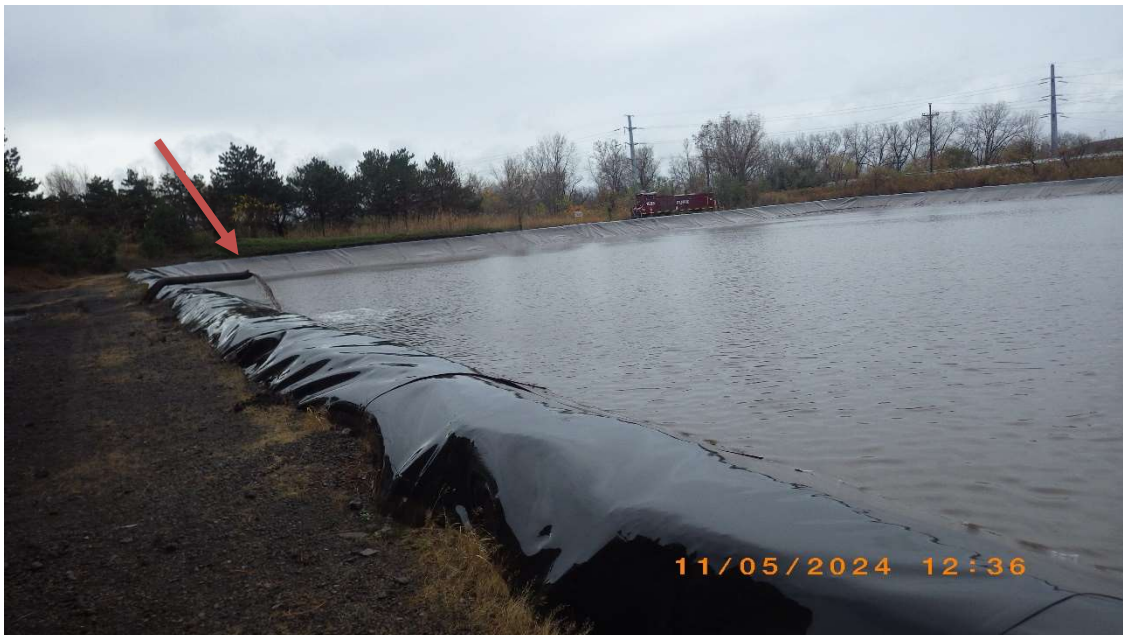
51: RIMG0051

Description: Looking southwest from the north end of the east side of the Pond. Note the pipe discharging to the Pond (red arrow).

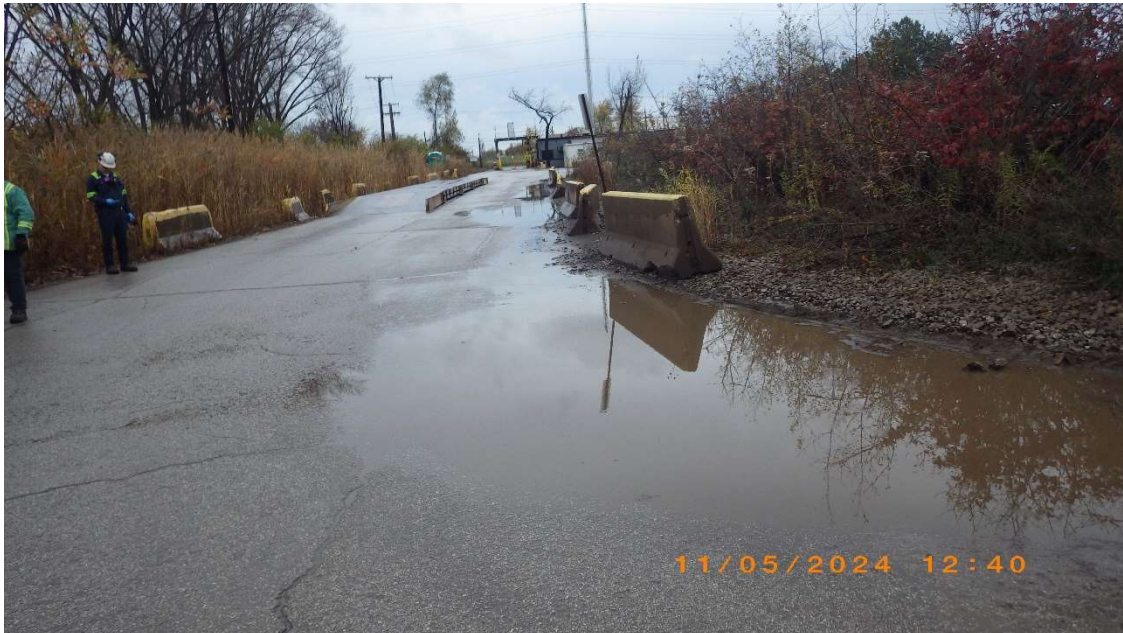
53: RIMG0053

Description: Looking north along the access road on the west side of the Pond. Stormwater in this area was observed to be flowing north to a stormwater drain.

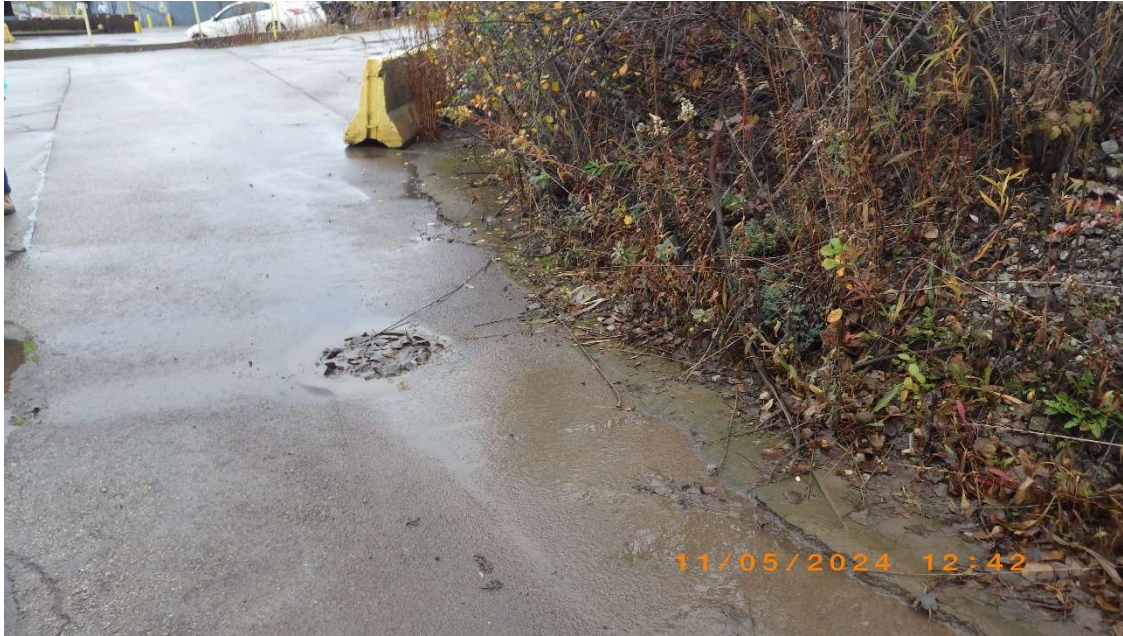
54: RIMG0054

Description: Stormwater drain located in the access road on the west side of the Pond.
