# Clean Water Act Section 404: Site Visit/Case Development

Site Name	SVG Holdings Property	Start Date	September 9, 2022
		End Date	September 9, 2022
Inspection Purpose	Initial site visit		
<b>Opening Conference</b>			
<input checked="" type="checkbox"/> Presentation of Inspector Credentials			
Name and Title (Use N/A if owner/operator not available to join the inspection)			
Credentials were presented to Mr. Seamus Glynn, owner of SVG Holdings			
<input checked="" type="checkbox"/> Opening Conference			
Name of person authorizing access if applicable			
I corresponded with Mr. Glynn via phone and e-mail to arrange the inspection.			
Notes from Opening Conference			
Mr. Glynn explained that the property was a working farm when he purchased it 5-6 years ago. While developing the farm, he worked under the advisement of the Ulster County SWCD.			
<input type="checkbox"/> Access Issues if Any			
Describe			
N/A			
<b>Inspection Observations and Sample Collection</b>

CWA 404 Inspection  
SVG Holdings Property  
260 Bruyn Turnpike  
Wallkill, Ulster County, NY

September 9, 2022

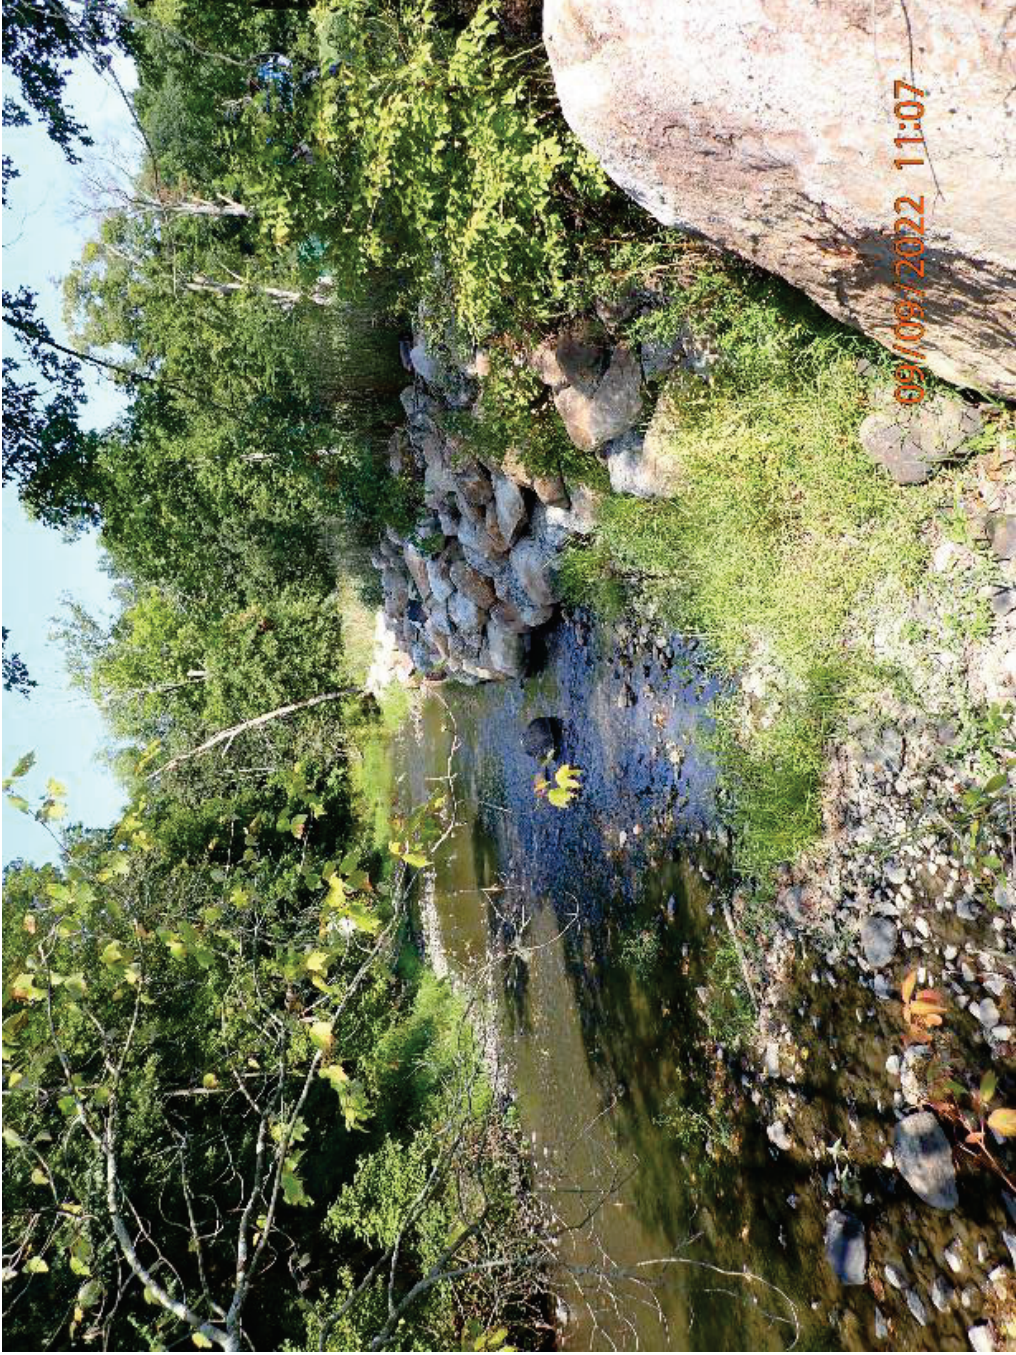
**Date:** 9/9/2022  
**Time:** 11:07 AM  
**Photographer:** SSA  
**Photo ID:** 9 – P9090472

EPA started the inspection at the parking area near the structure and then walked west to the section of the Dwaar Kill where the river bends to the north. EPA observed that boulders had been placed below the Ordinary High Water Mark (OHWM) on the eastern bank of the Dwaar Kill. The boulders appeared to be used to stabilize the river bank. Mr. Glynn stated that these boulders were sourced from the property.

Boulders placed on eastern bank of Dwaar Kill below the Ordinary High Water Mark

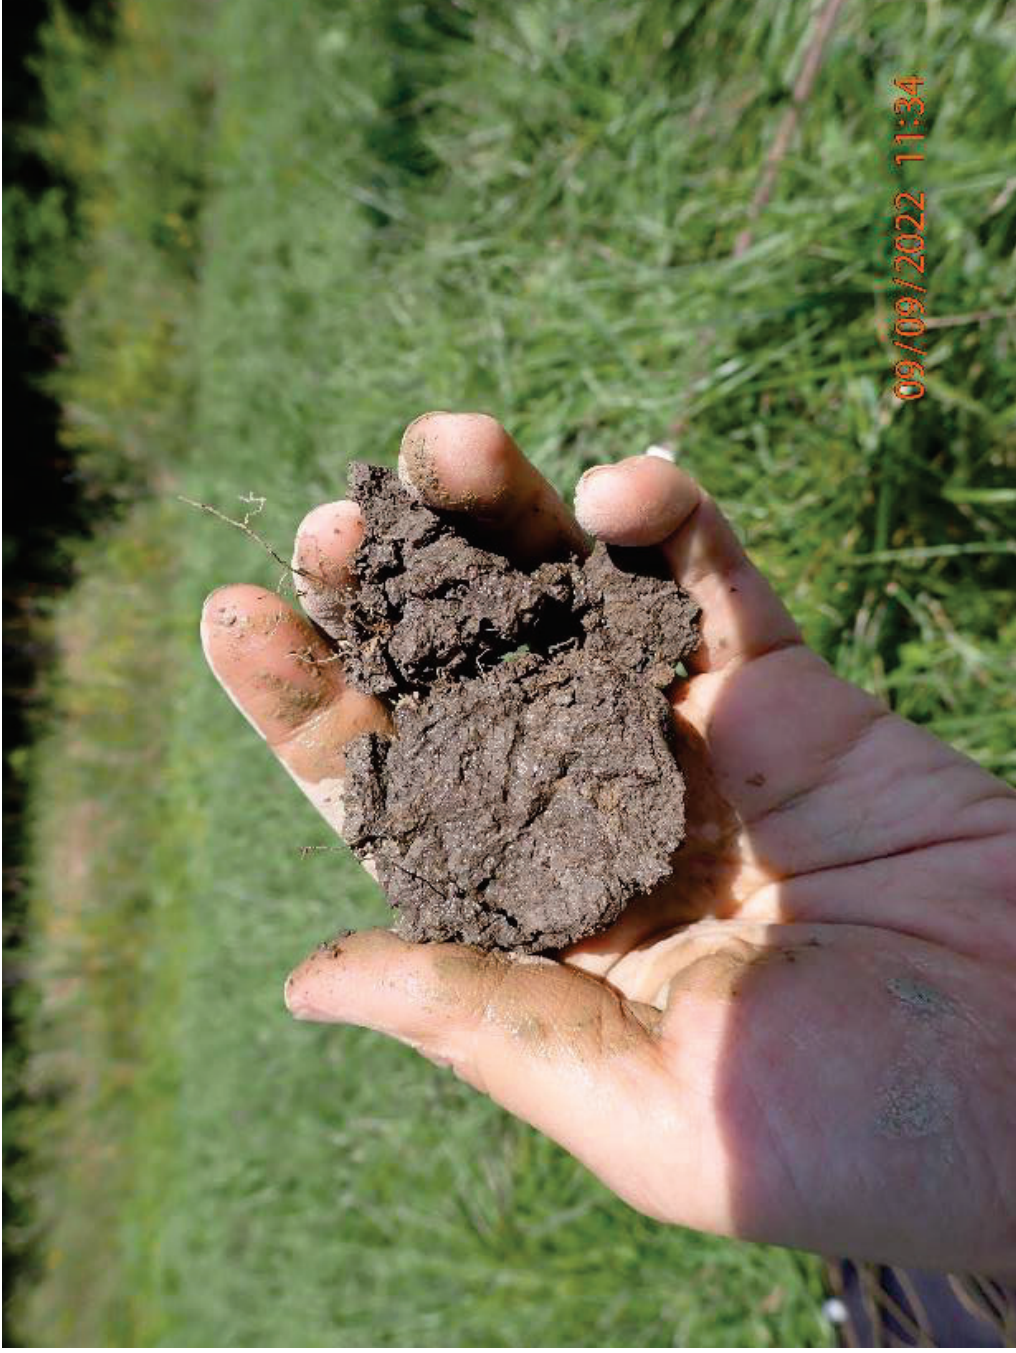
**Date:** 9/9/2022  
**Time:** 11:34 AM  
**Photographer:** SSA  
**Photo ID:** 10 – P9090473

Remarks:  
 Oxidized rhizospheres observed in layer below fill

8-12" layer of soil profile SS1  
showing oxidized rhizospheres

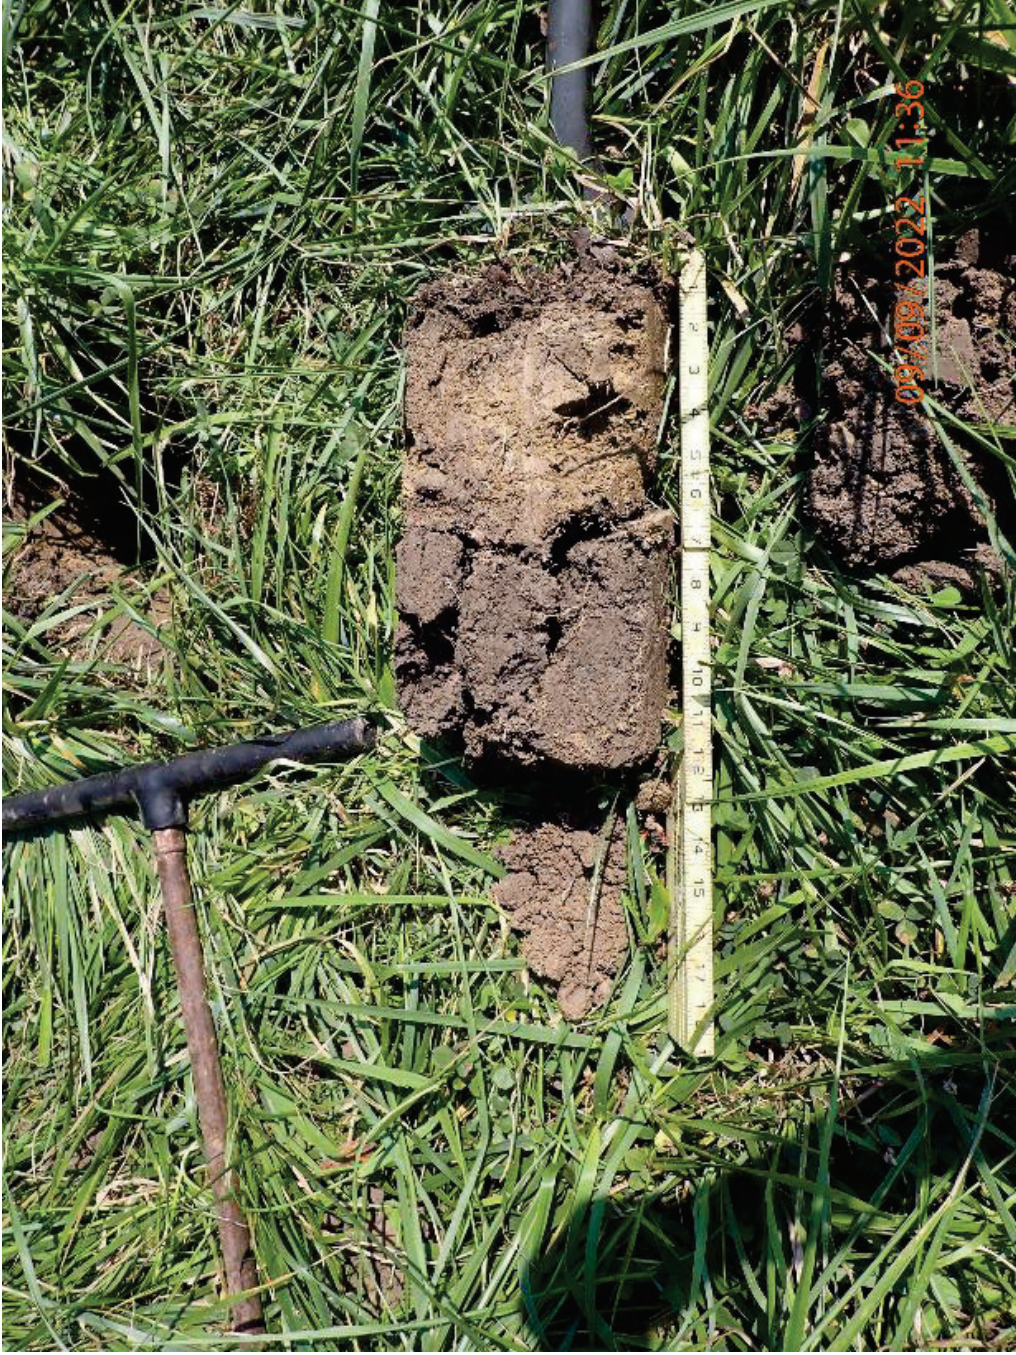
**Date:** 9/9/2022  
**Time:** 11:36 AM  
**Photographer:** SSA  
**Photo ID:** 11 – P9090474

EPA then walked along the river in the northwestern portion of the property. This area had been cleared and filled several years ago to create additional level land for hayfield. A soil profile from the area showed approximately 8 inches of fill material on top of a thin layer of twigs and bark. Hydric soil was observed below the fill layer (Photo P9090474).

SS1 soil profile showing 8 inches of fill material on top of hydric soil

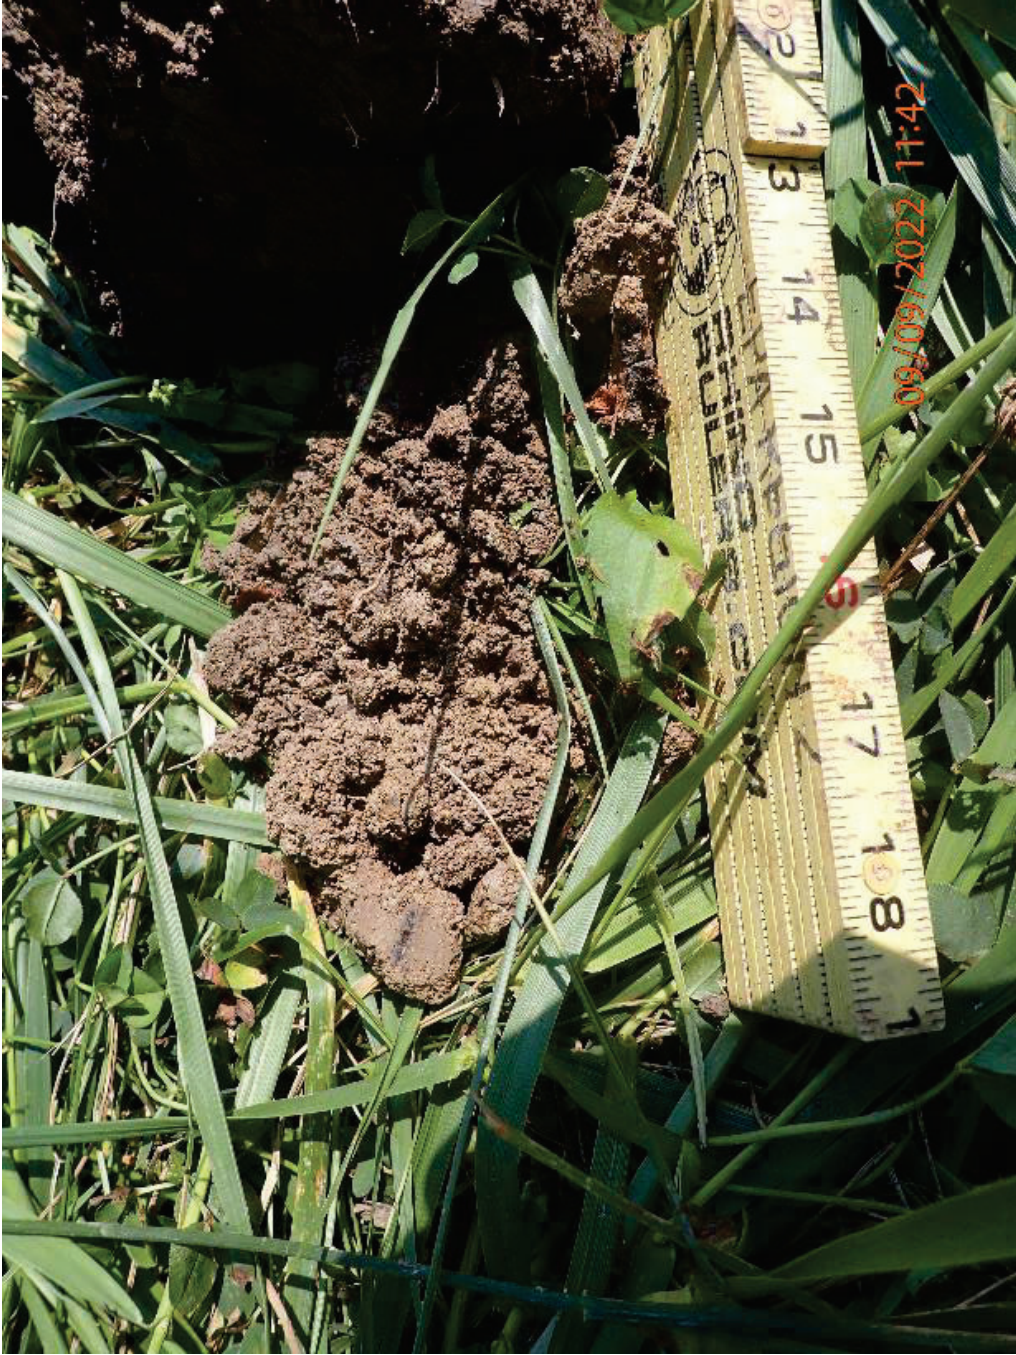
**Date:** 9/9/2022  
**Time:** 11:42 AM  
**Photographer:** SSA  
**Photo ID:** 12 – P9090475

12-18" layer of SS1 soil profile showing redoximorphic features

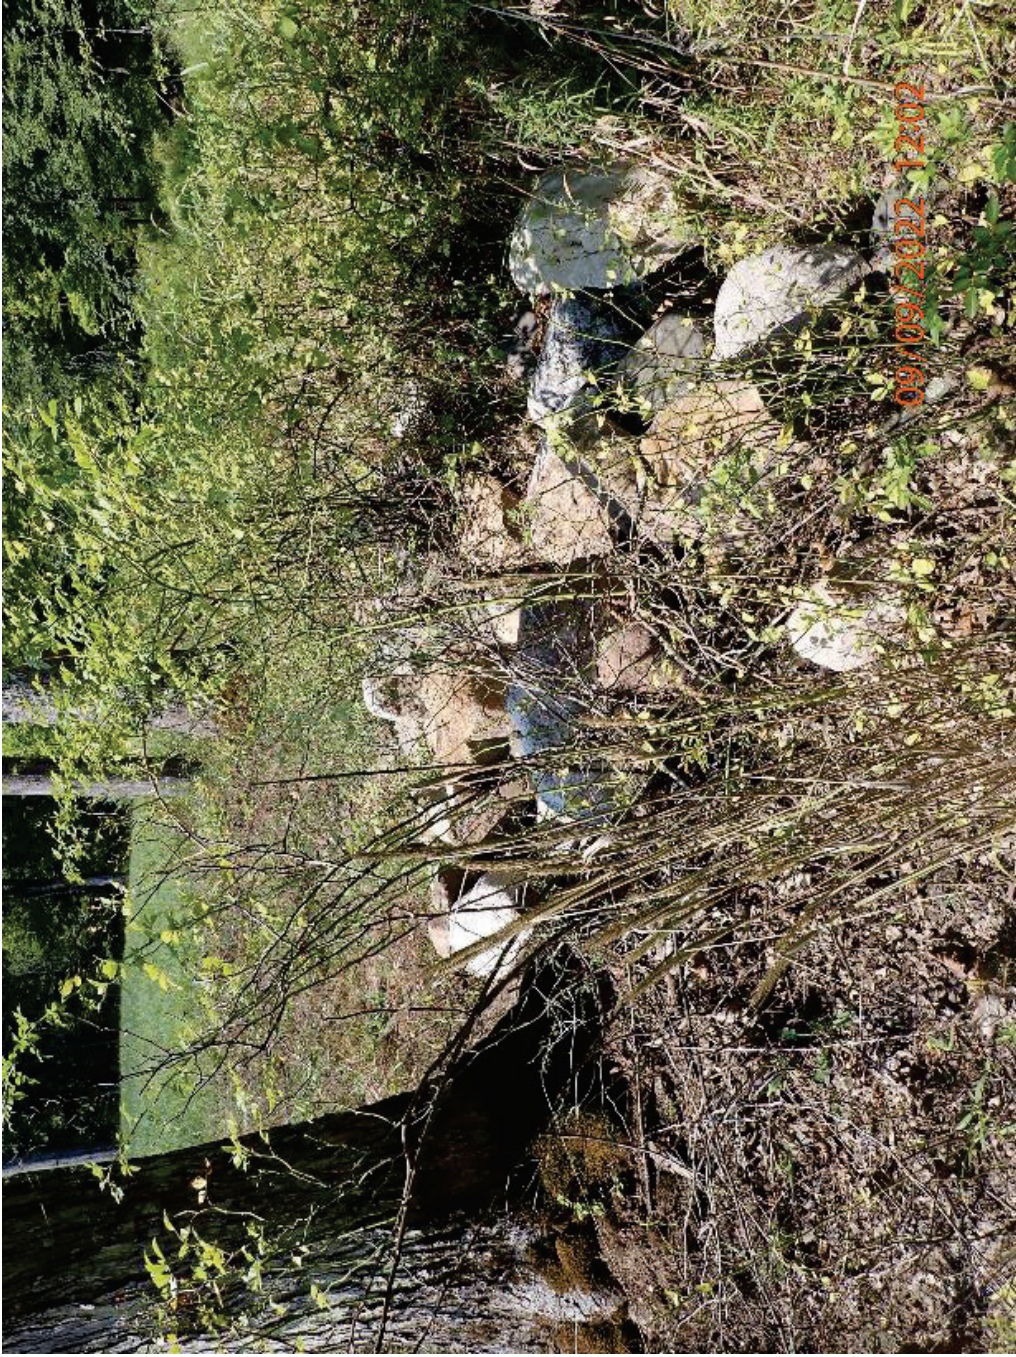
**Date:** 9/9/2022  
**Time:** 12:02 PM  
**Photographer:** SSA  
**Photo ID:** 14 – P9090477

From the first soil sample location, EPA walked east along the Dwaar Kill and took a GPS point at a low spot in the hayfield that had boulders in it. EPA then continued to walk east to an undisturbed forested/scrub shrub area to take a second soil sample. This soil sample was found to be in upland.

Low spot along Dwaar Kill filled with boulder.  
GPS point taken

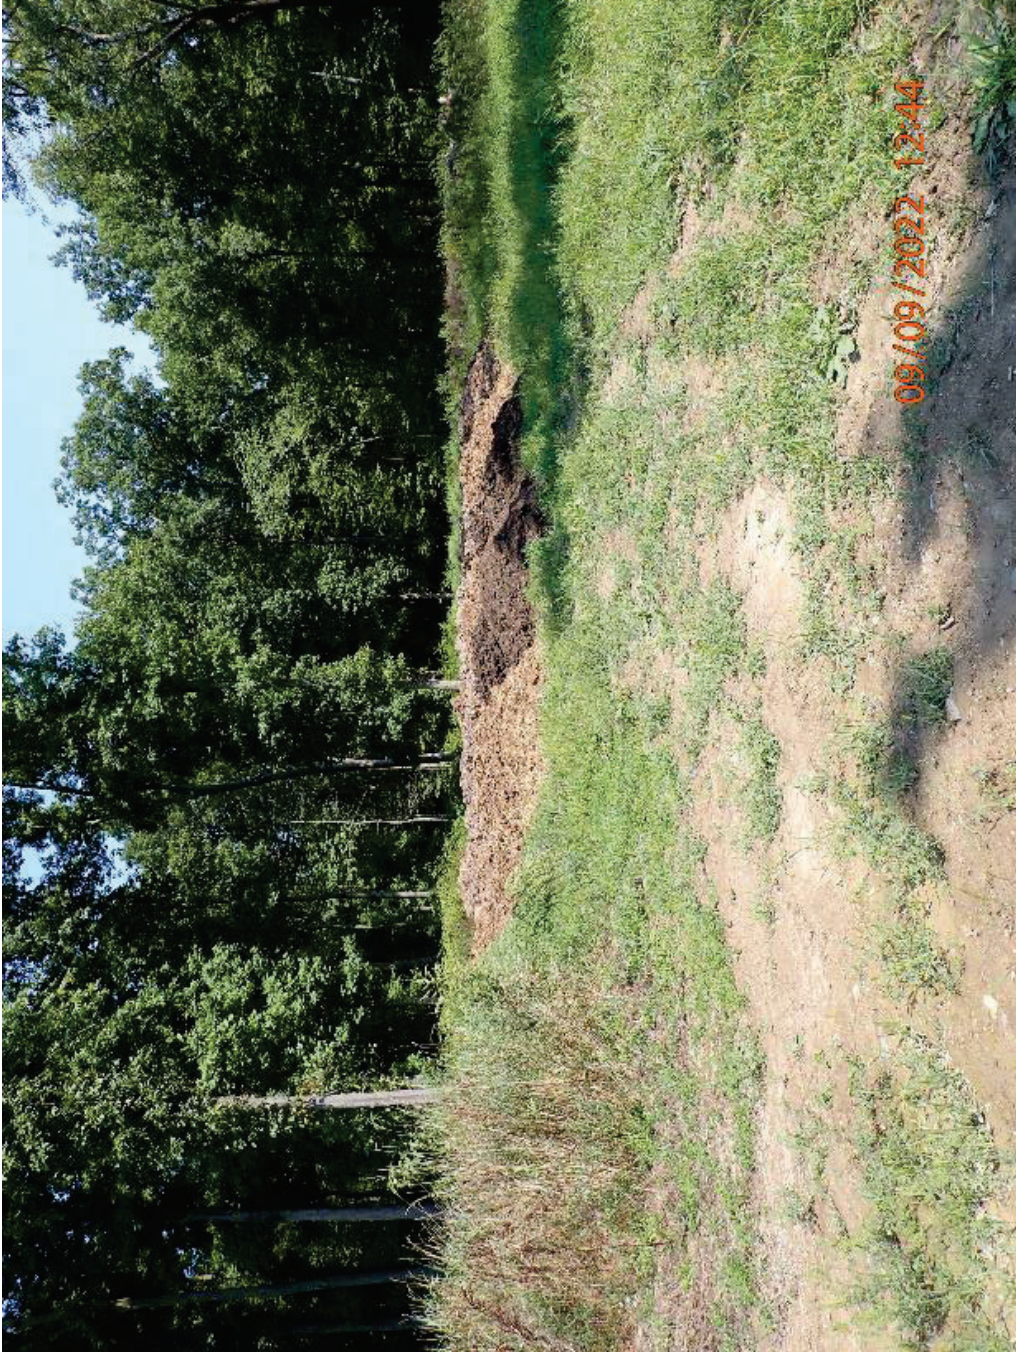
**Date:** 9/9/2022  
**Time:** 12:44 PM  
**Photographer:** SSA  
**Photo ID:** 17 – P9090480

EPA walked south and observed an area where manure piles were being stored (Photo P9090480). Continuing south, EPA observed a stockpile of logs (Photo P9090481).

Manure Piles south of SS2  
Eastern side of northwestern  
hayfield

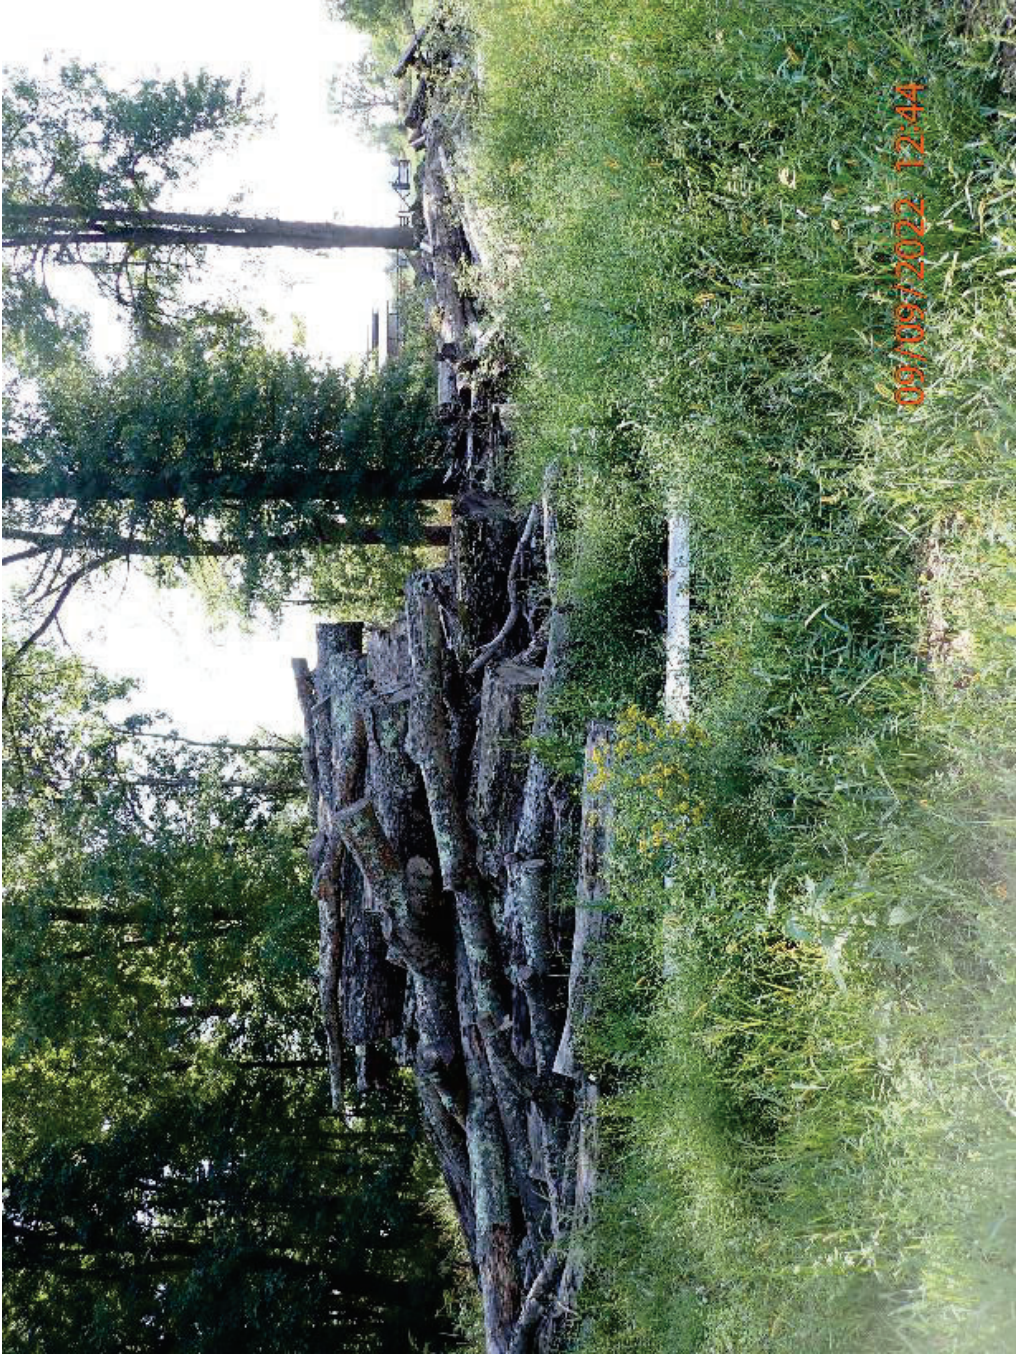
**Date:** 9/9/2022  
**Time:** 12:44 PM  
**Photographer:** SSA  
**Photo ID:** 18 – P9090481

**Description:**  
Log stockpile  
Eastern side of northwestern  
hayfield

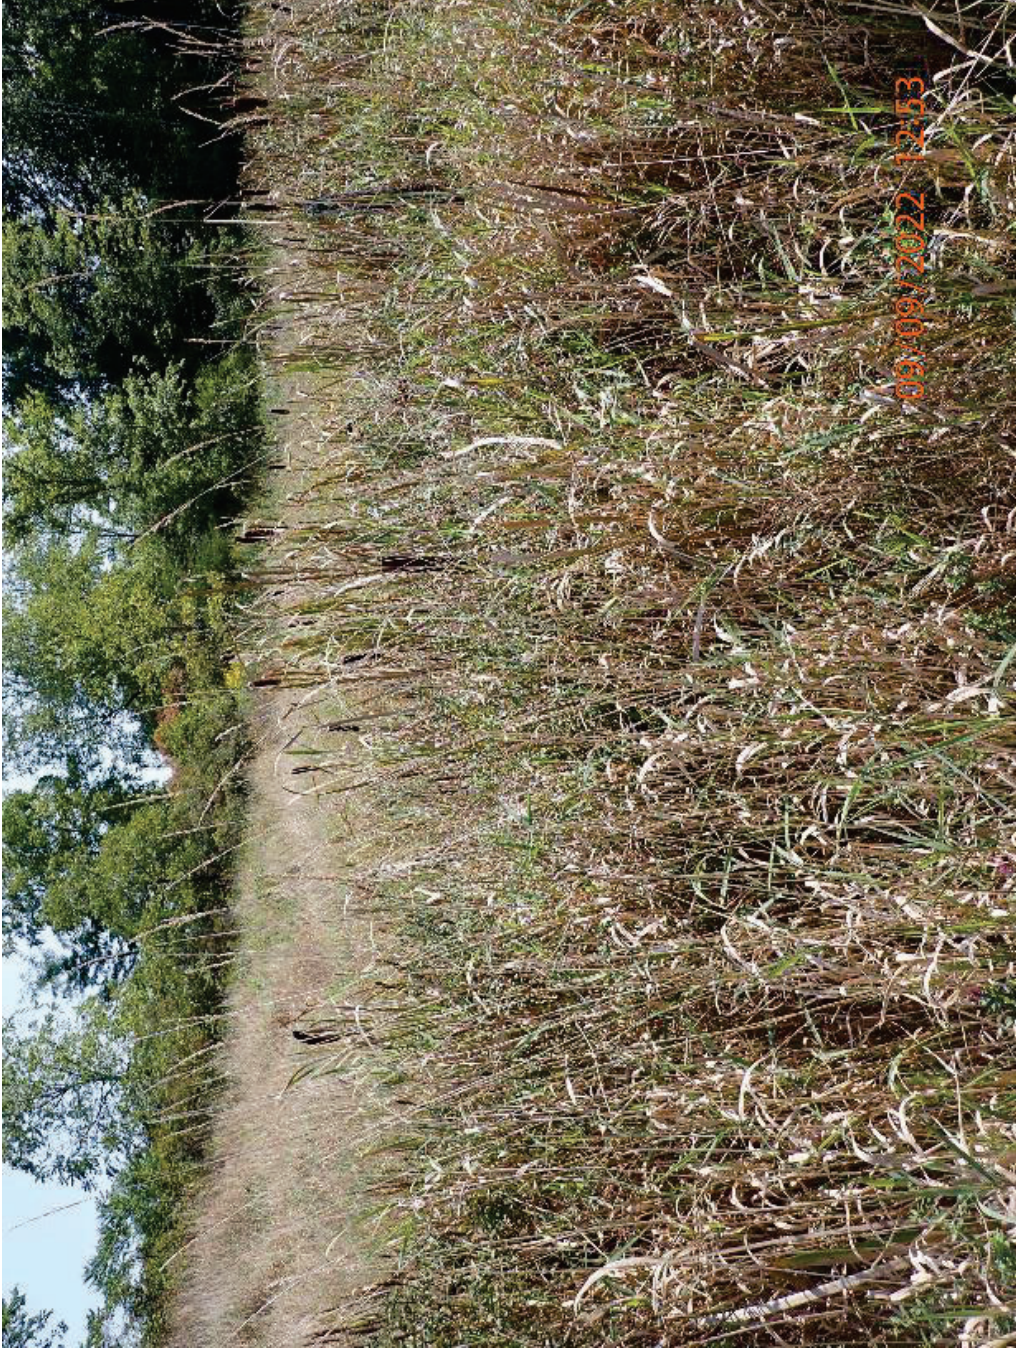
**Date:** 9/9/2022  
**Time:** 12:53 PM  
**Photographer:** SSA  
**Photo ID:** 22 – P9090485

Presumed wetland area on neighboring property  
Adjacent to southwestern hay field

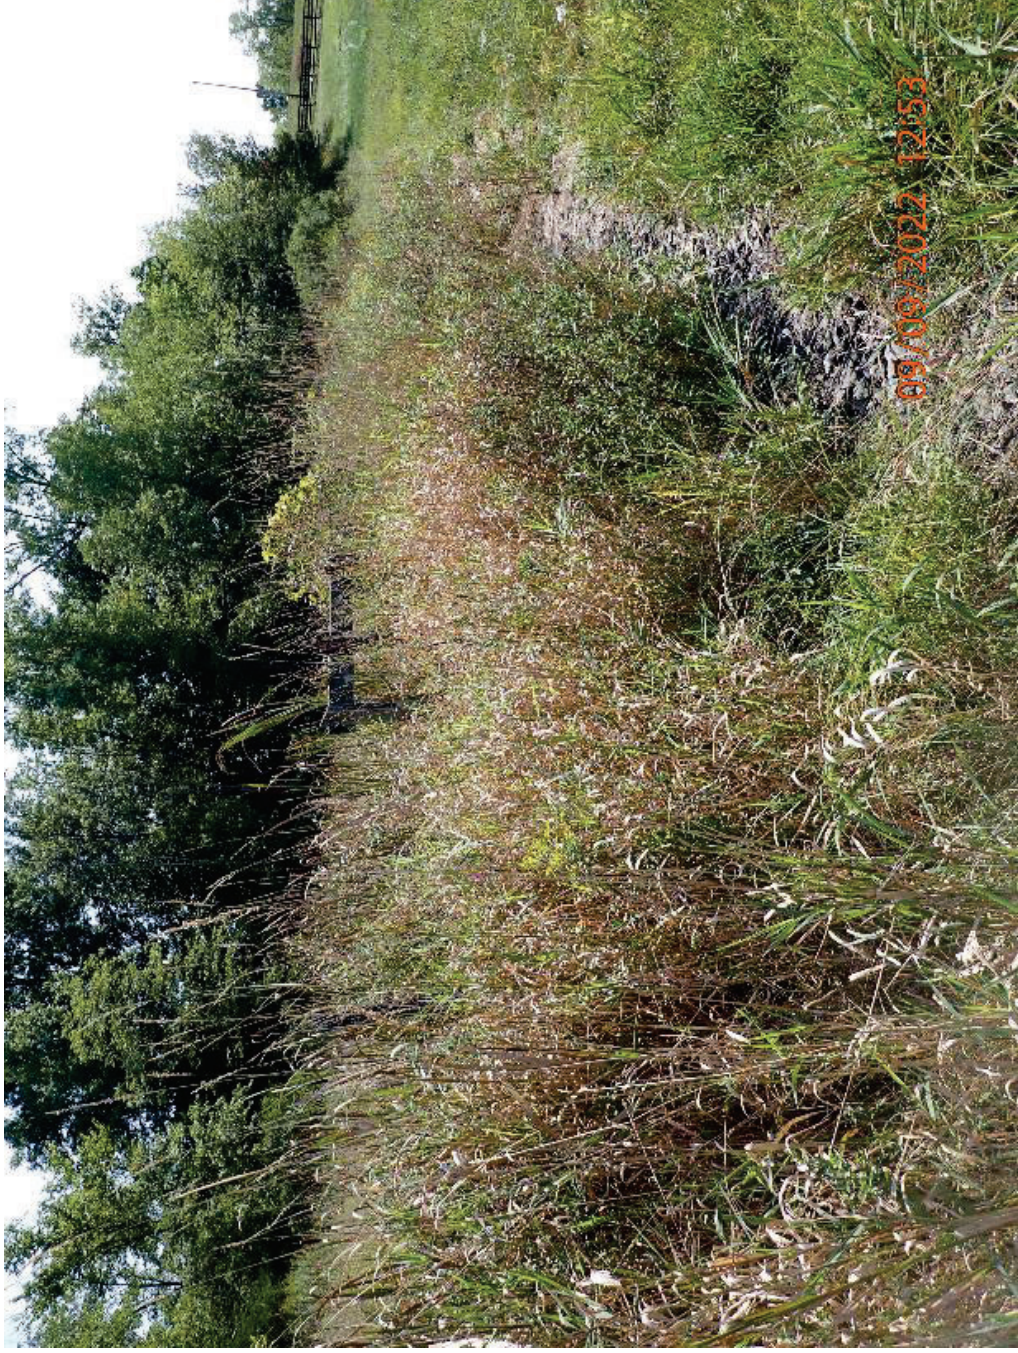
**Date:** 9/9/2022  
**Time:** 12:53 PM  
**Photographer:** SSA  
**Photo ID:** 23 – P9090486

EPA then walked to the southwestern hayfield. EPA observed that some sort of gravel trench or French drain had been installed between the eastern edge of the southwestern hayfield and the neighboring property (Photo P9090486) to presumably keep the hayfield dry. According to Mr. Glynn, there was a spring on or coming out of the hill on his neighbor's property. While most of the field had been planted with grasses for hay farming, EPA observed hydrophytic vegetation near the property boundary. A GPS point was taken in this vicinity.

Presumed wetland area on neighboring property; drain; hydrophytic vegetation  
Adjacent to southwestern hay field

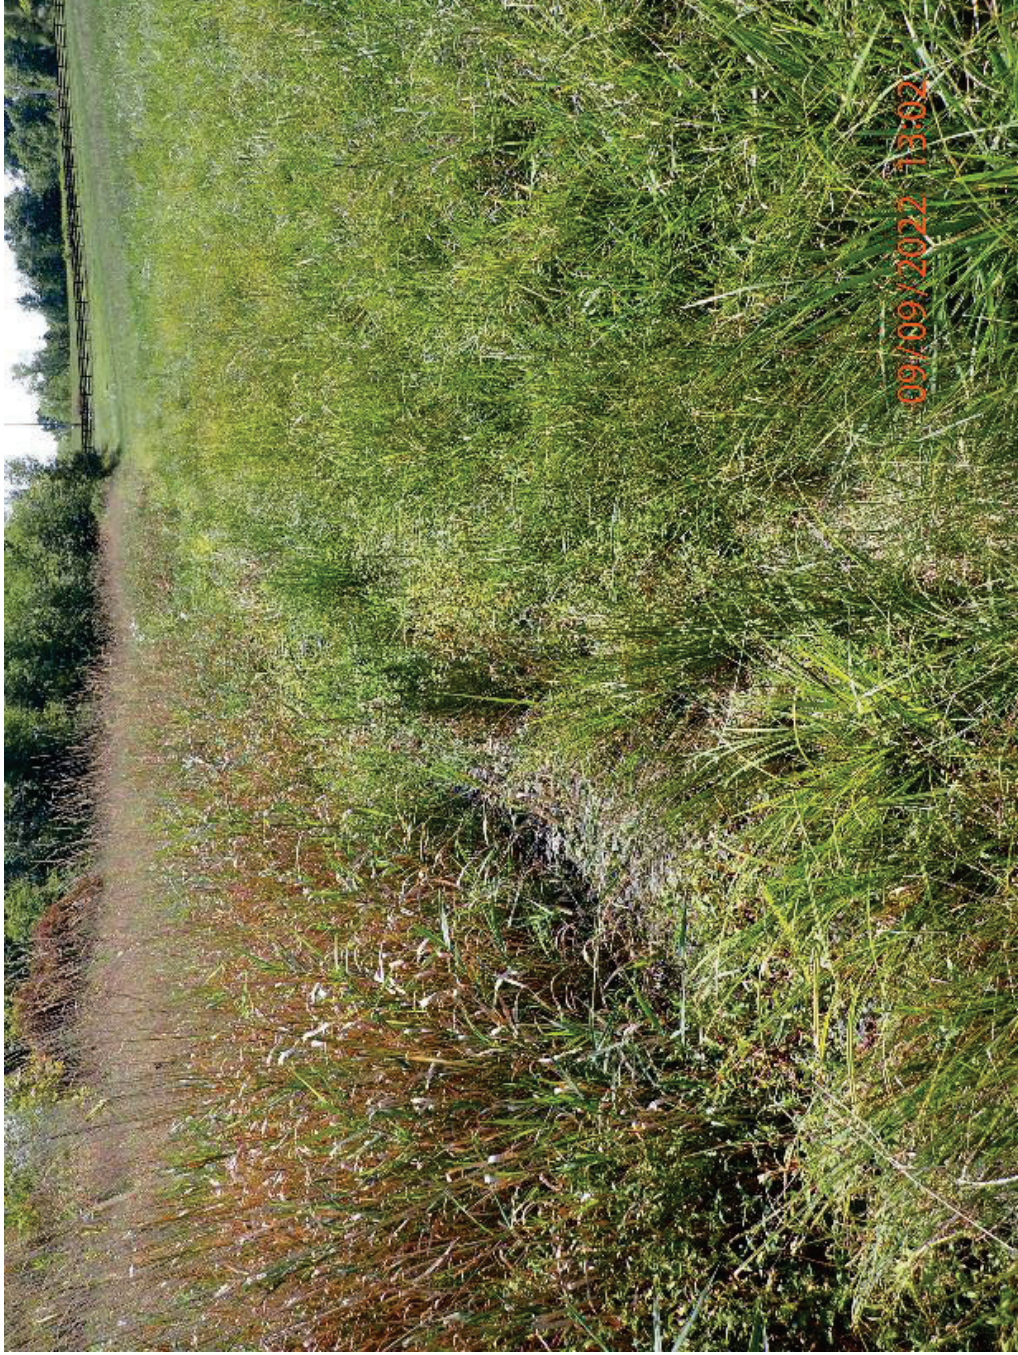
**Date:** 9/9/2022  
**Time:** 1:02 PM  
**Photographer:** SSA  
**Photo ID:** 24 – P9090487

Wetland vegetation growing in  
low spot in field  
GPS Point taken
