## Region 6 - Enforcement & Compliance Assurance Division

### INSPECTION REPORT

| Inspection Date(s): | 01/18/2022 | |
| Facility Name: | <b>Cimarron Wastewater Treatment Plant</b> | |

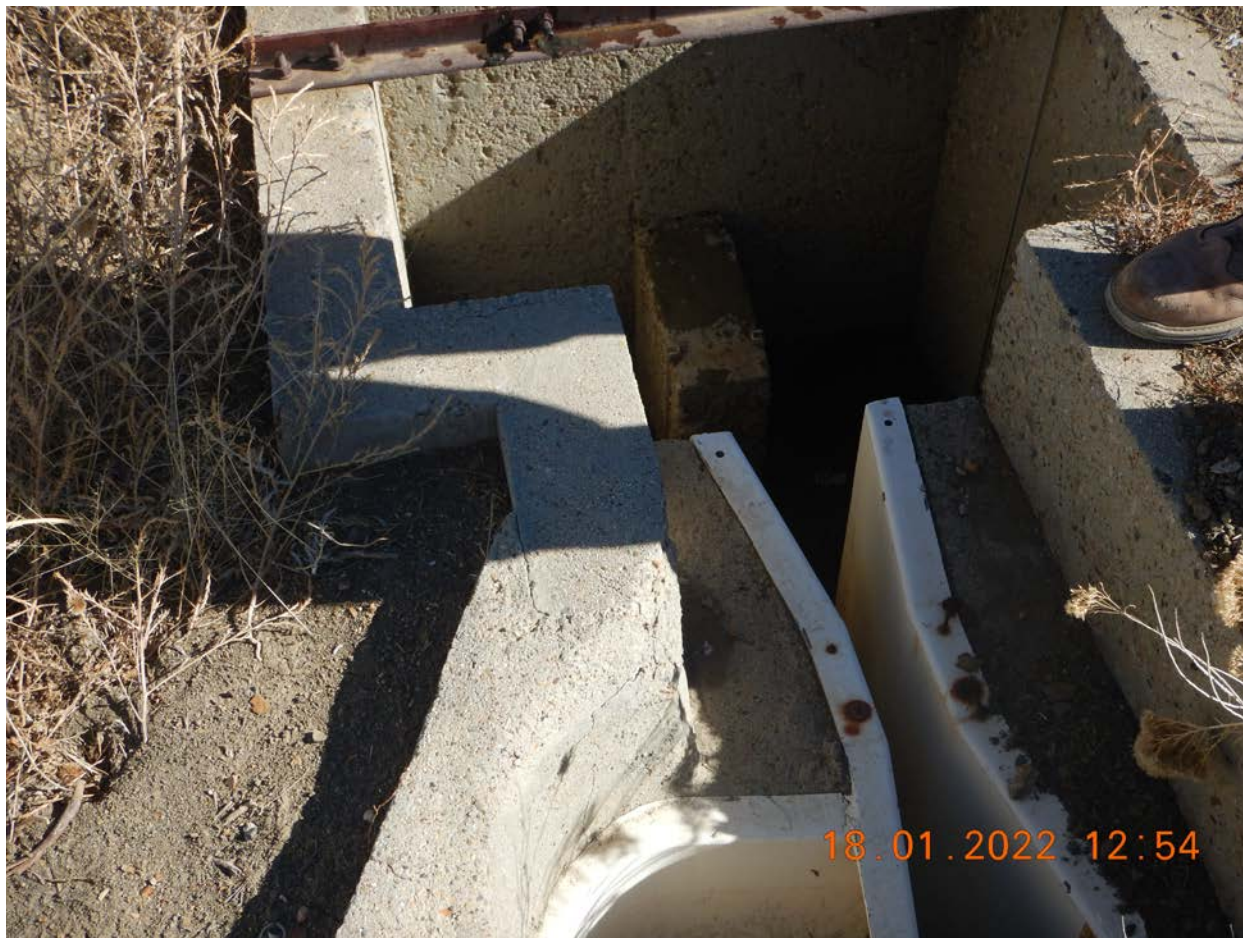
Photo No. 1

- The head works operate without any trash collecting bar screens therefore all inorganic material and coarse solids enter the lagoons, which in turn sometimes exit into French Lake, thence Ponil Creek, thence to the Cimarron River.

View of the influent headworks that consist of a Parshall flume without any screening of coarse solids, i.e., a bar screen system. (DSCN2085) Photographed by D. Esparza

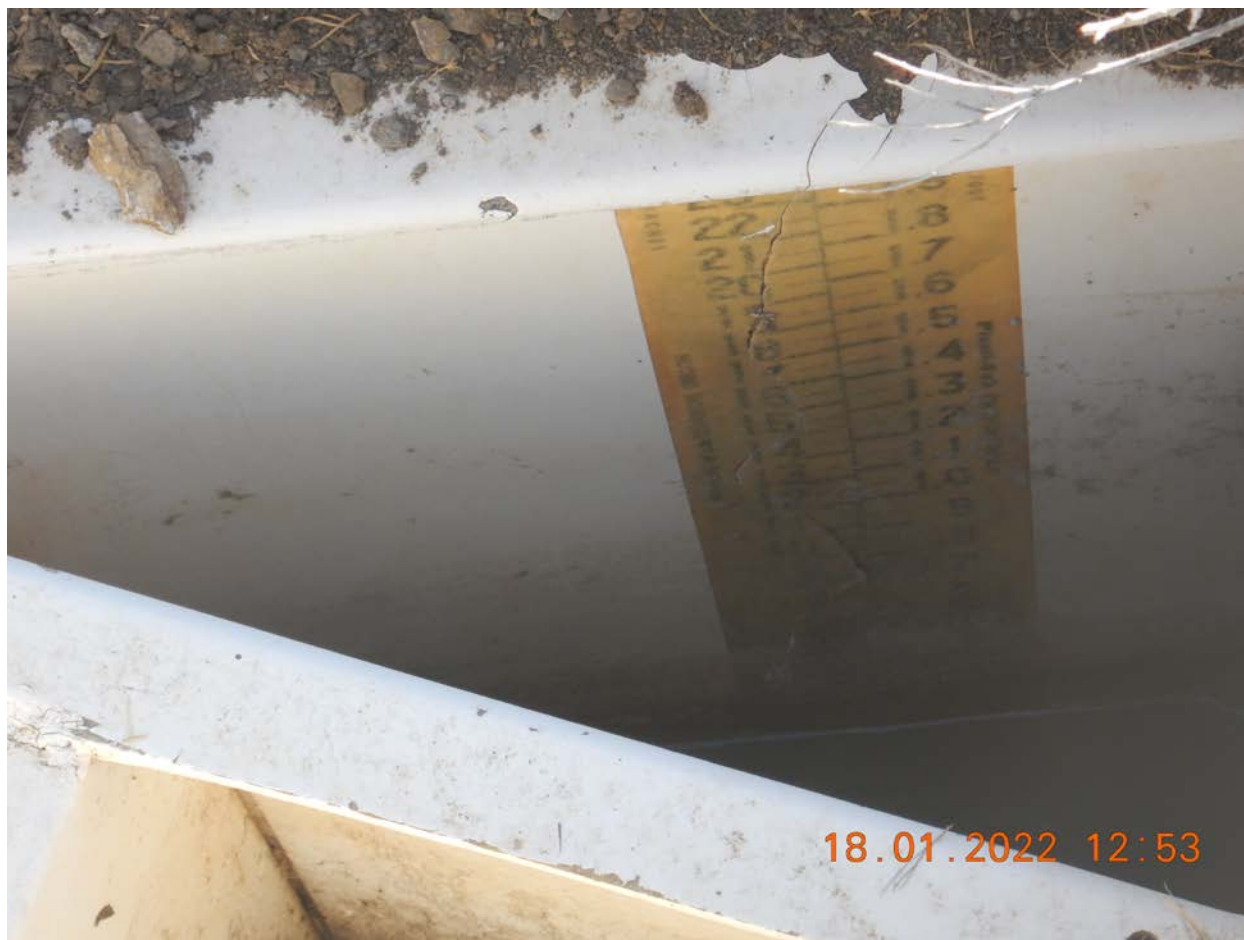
Photo No. 2

View of the flow staff at the entrance of the influent headworks-Parshall flume. (DSCN2086).  
Photographed by D. Esparza

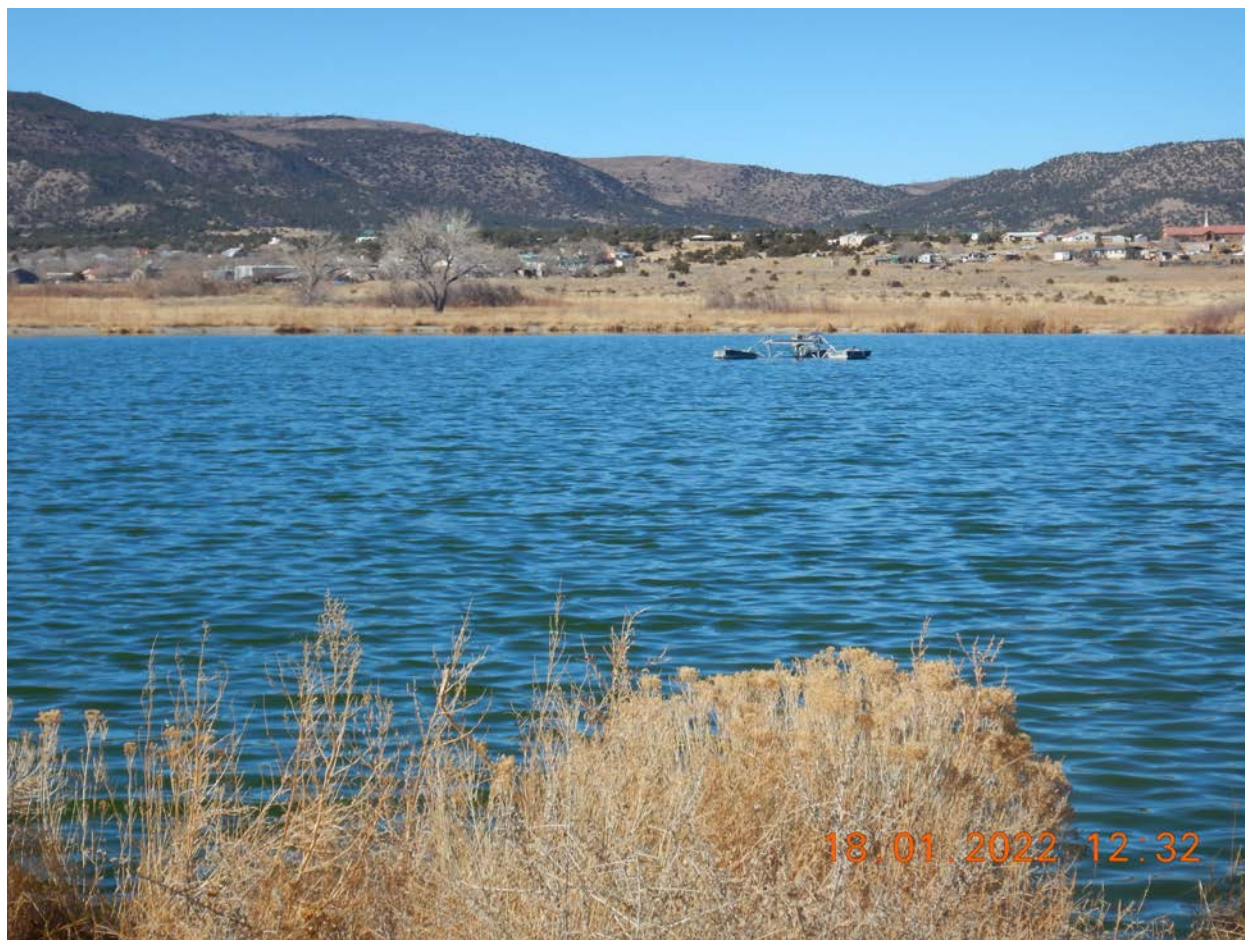
Photo No. 3

In May 2004, a SB40000R unit also known as (aka) "Solar Bee" was installed in the east lagoon with the objective to reduce the sludge depth, improve dissolved oxygen levels, reduce/eliminate odors, and improve the effluent water quality (Appendix 1 Photograph #3). These stationary mixing units do not provide any aeration; they simply mix a small section of the solids and water in the lagoons. Visual observation indicated both concrete-lined lagoons which equate to approximately 2-acres in surface area each, exhibit cracking, extensive vegetative overgrowth and slope in easterly direction as minimal free board remained along their perimeters (Appendix 1 Photograph #4 and Photograph #5). During the winter months the evaporation rate is low, and the lagoons tend to fill. In the spring high winds and warmer temperatures lower the pond levels. The head works operate without any trash collecting bar screens therefore all inorganic material and coarse solids enter the lagoons, which in turn sometimes exit into French Lake, thence Ponil Creek, thence to the Cimarron River.

- The existing SB40000R units also known as (aka) "Solar Bee" installed in the lagoons with the objective to reduce the sludge depth, improve dissolved oxygen levels, reduce/eliminate odors, and improve the effluent water quality, do not provide any aeration; they simply mix a small section of the solids and water in the lagoons.

- The existing SB40000R units also known as (aka) "Solar Bee" installed in the lagoons with the objective to reduce the sludge depth, improve dissolved oxygen levels, reduce/eliminate odors,

and improve the effluent water quality, do not provide any aeration; they simply mix a small section of the solids and water in the lagoons.

View of the SB40000R unit also known as (aka) "Solar Bee" installed in the east lagoon. (DSCN2084). Photographed by D. Esparza

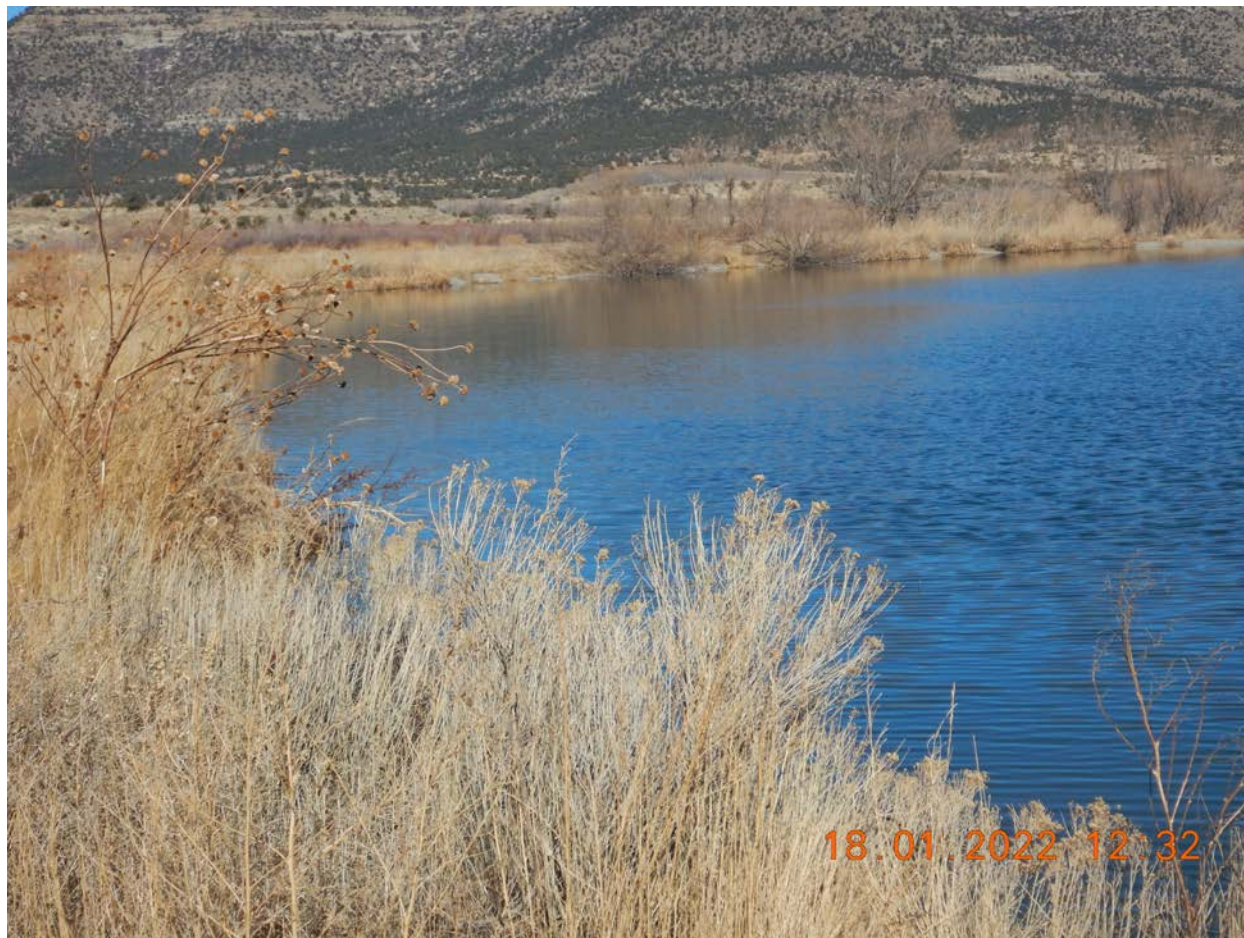
Photo No. 4

- Visual observation indicated both concrete-lined lagoons which equate to approximately 2-acres in surface area each, exhibit cracking, extensive vegetative overgrowth and slope in easterly direction as minimal free board remained along the perimeter of both (Appendix 1 Photograph #4 and Photograph #5). The extensive overgrowth could potentially attract rodents and/or vermin; thus, causing undermining of the weakened structures.

View of the perimeter of the West facultative lagoon. Note: the minimal free board and the extensive overgrowth of vegetation. (DSCN 2082). Photographed by D. Esparza

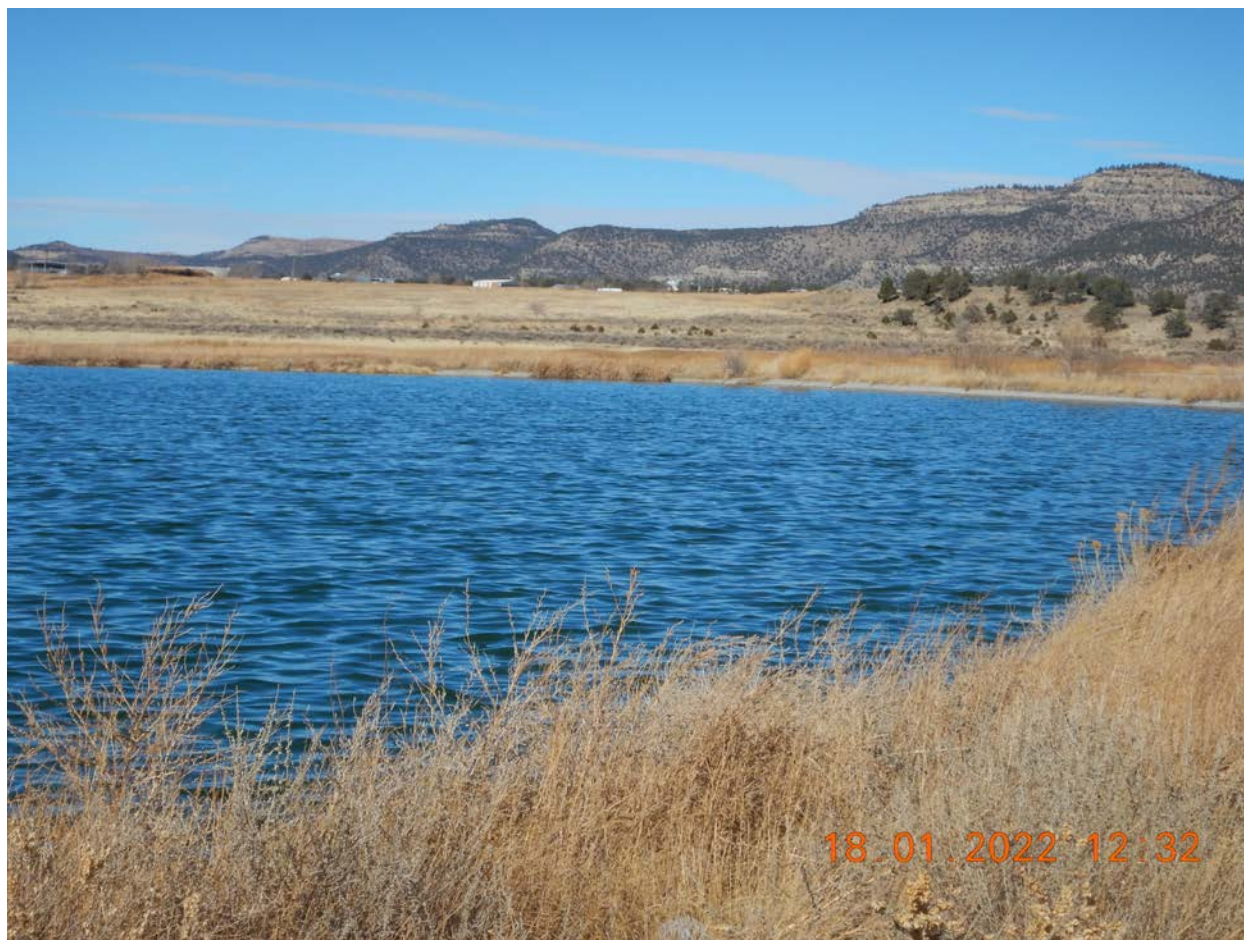
Photo No. 5

View of the perimeter of the East facultative lagoon. Note: the minimal free board and the extensive overgrowth of vegetation. (DSCN 2083). Photographed by D. Esparza
